VISUAL INSPECTION AND EVALUATION REPORT

Rockwall-Forney Dam
Dallas Water Utilities
Dallas/Kaufman Counties, Texas

Schnabel Reference #20C22001.00
July 30, 2021

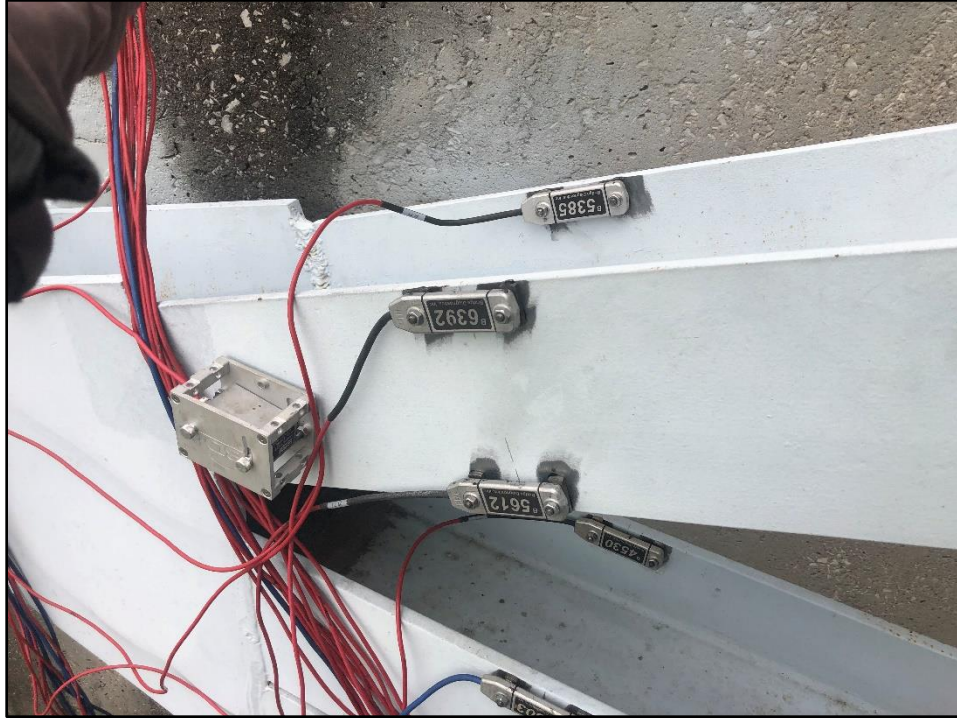
Figure 1 – BDI tiltmeter rotation sensor and reusable strain transducers installed near trunnion hub (Typical)

A typical installation has been shown in Figure 1 through Figure 4. Access to all the sensor locations was provided by BDI's own SPRAT certified rope access technicians and engineers as shown in Figure 5

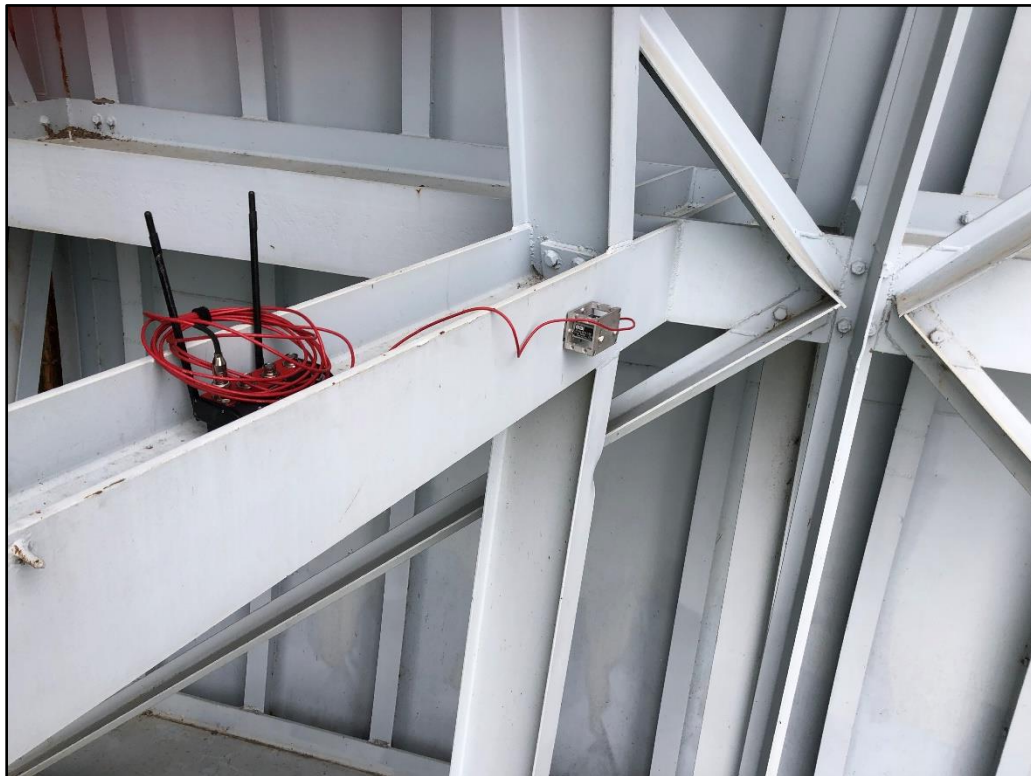
Figure 2 – BDI tiltmeter rotation sensor installed near skin plate (Typical)

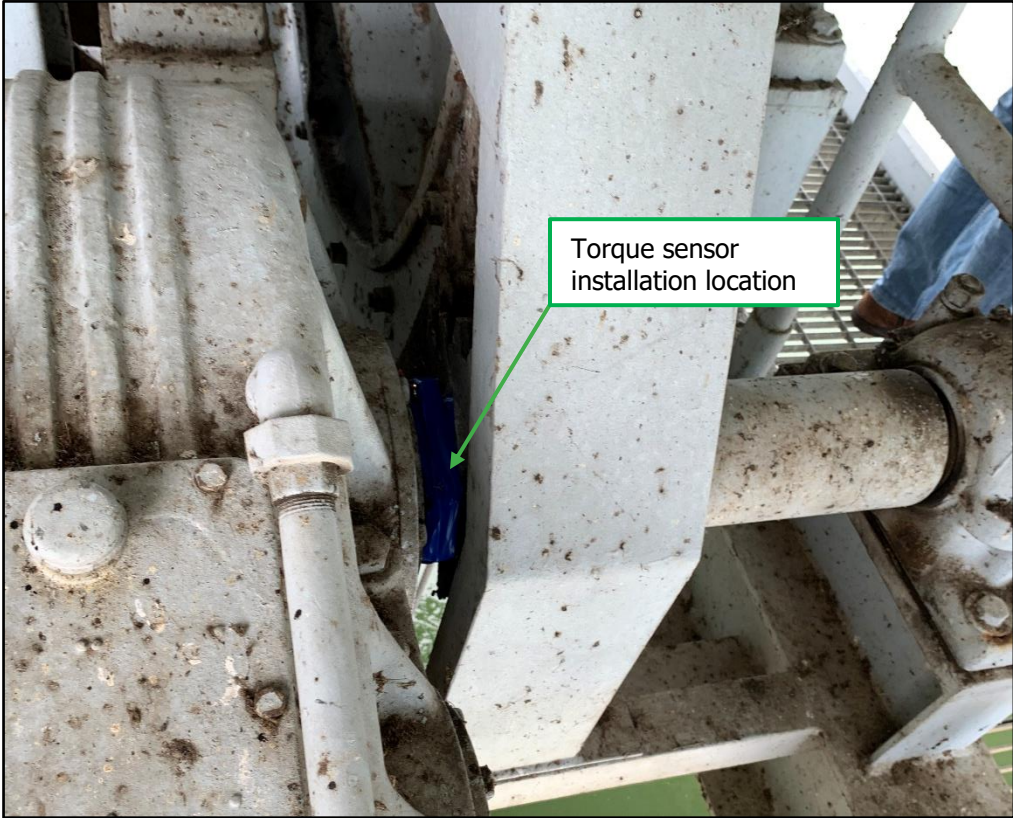
Figure 3 – Torque sensor installation on hoist pinion shaft (Typical)

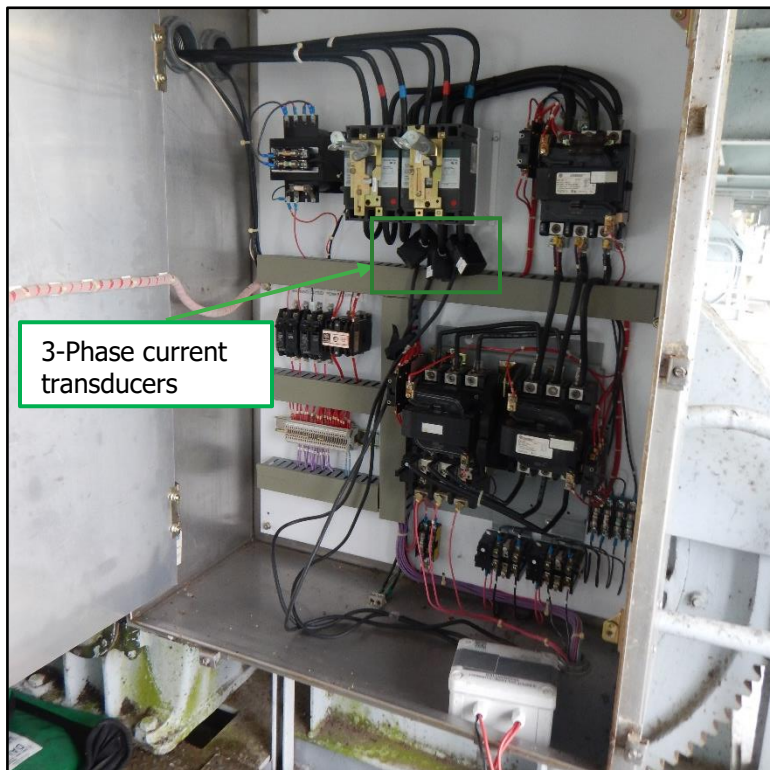
Figure 4 – Current transducers installed on hoist motor controls (Typical)

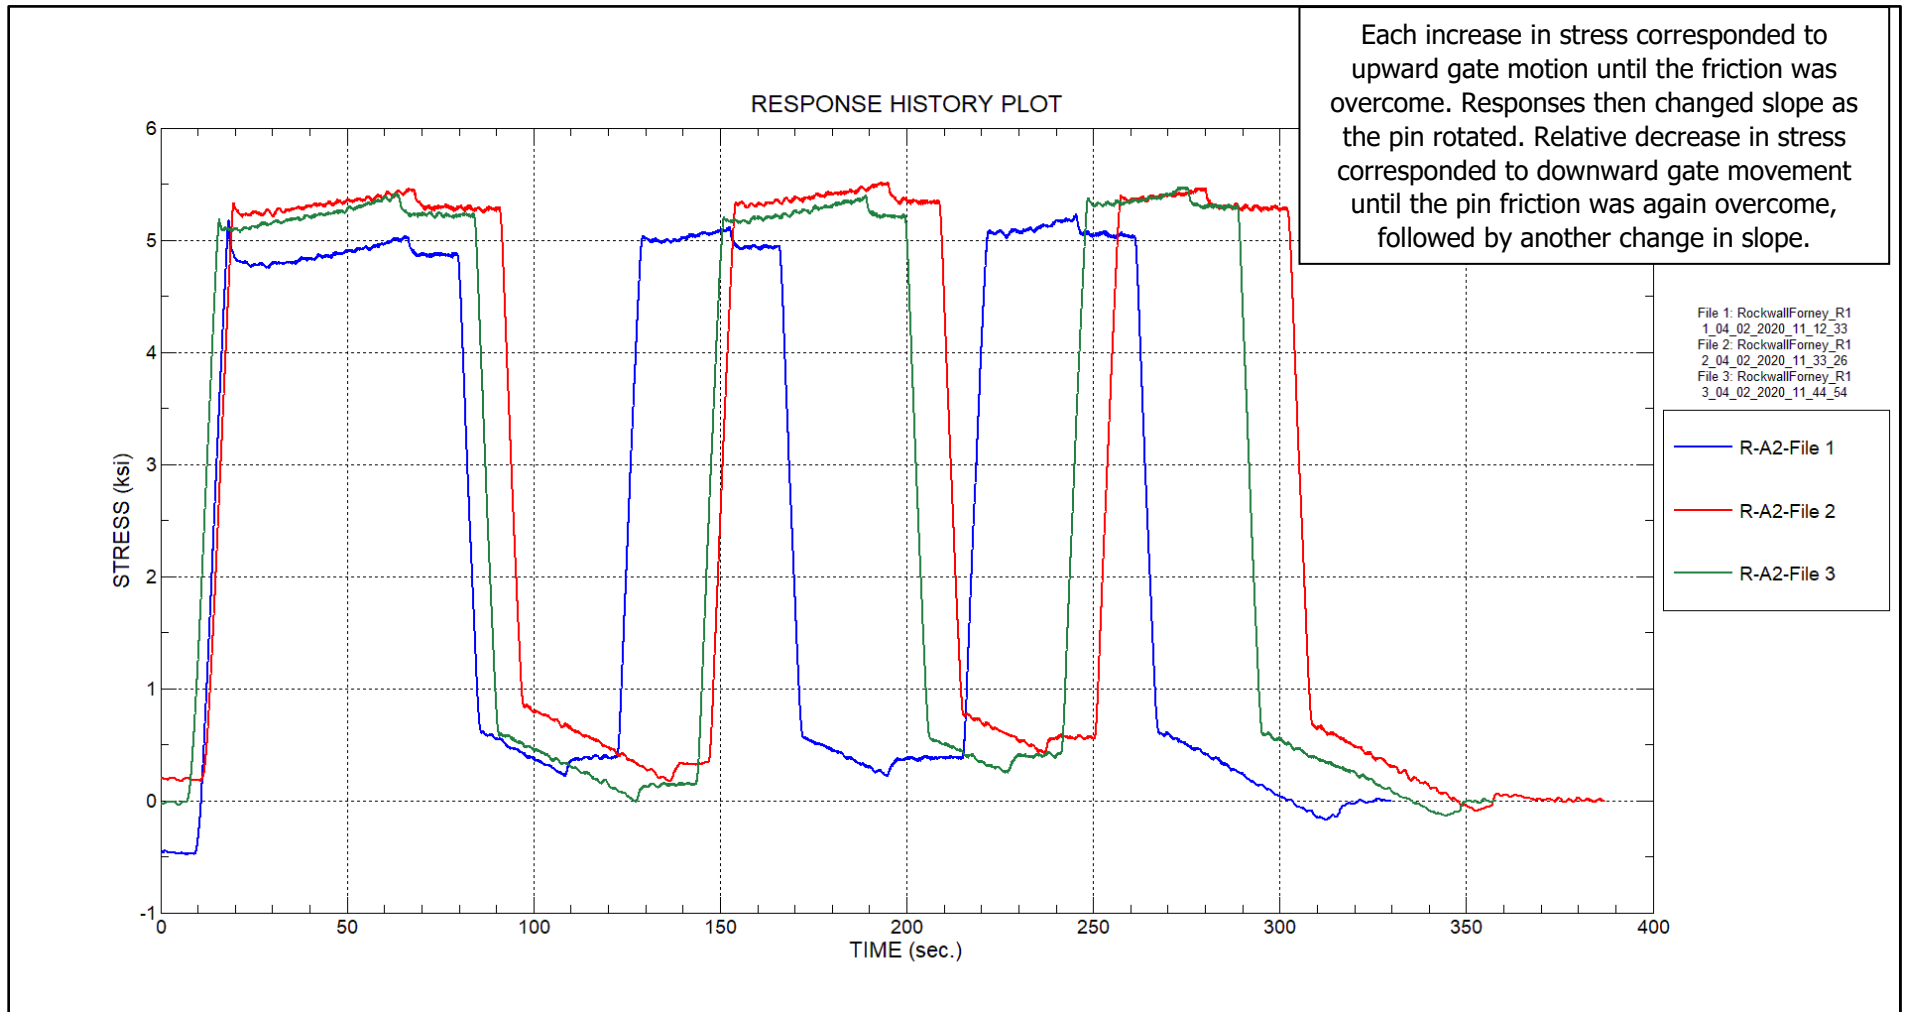
Figure 6 – Stress response history – Right arm – Gage A2 – Time based
File 1 = test run 1, File 2 = test run 2, File 3 = test run 3
(Section A along top strut near pin – Sensor location 2 along bottom of inner flange)

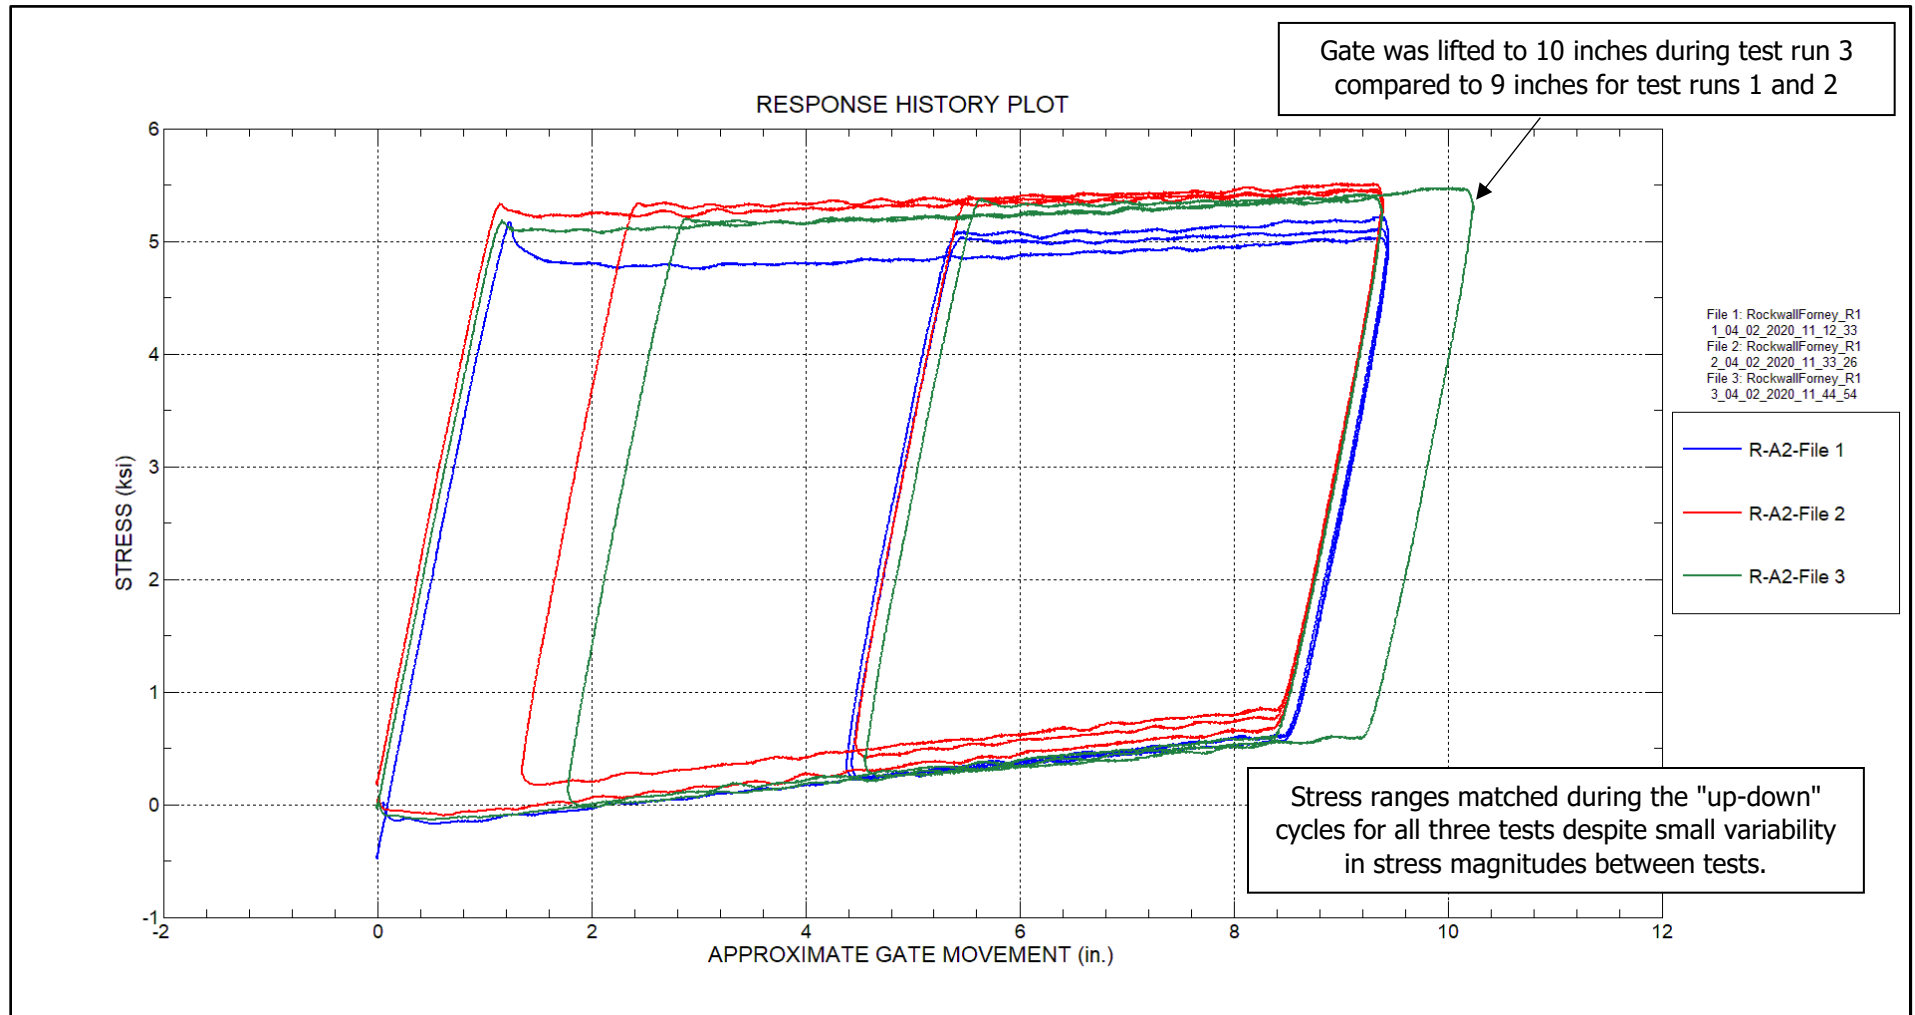
Figure 7 – Stress response history – Right arm – Gage A2 – Function of gate movement
File 1 = test run 1, File 2 = test run 2, File 3 = test run 3
(Section A along top strut near pin – Sensor location 2 along bottom of inner flange)

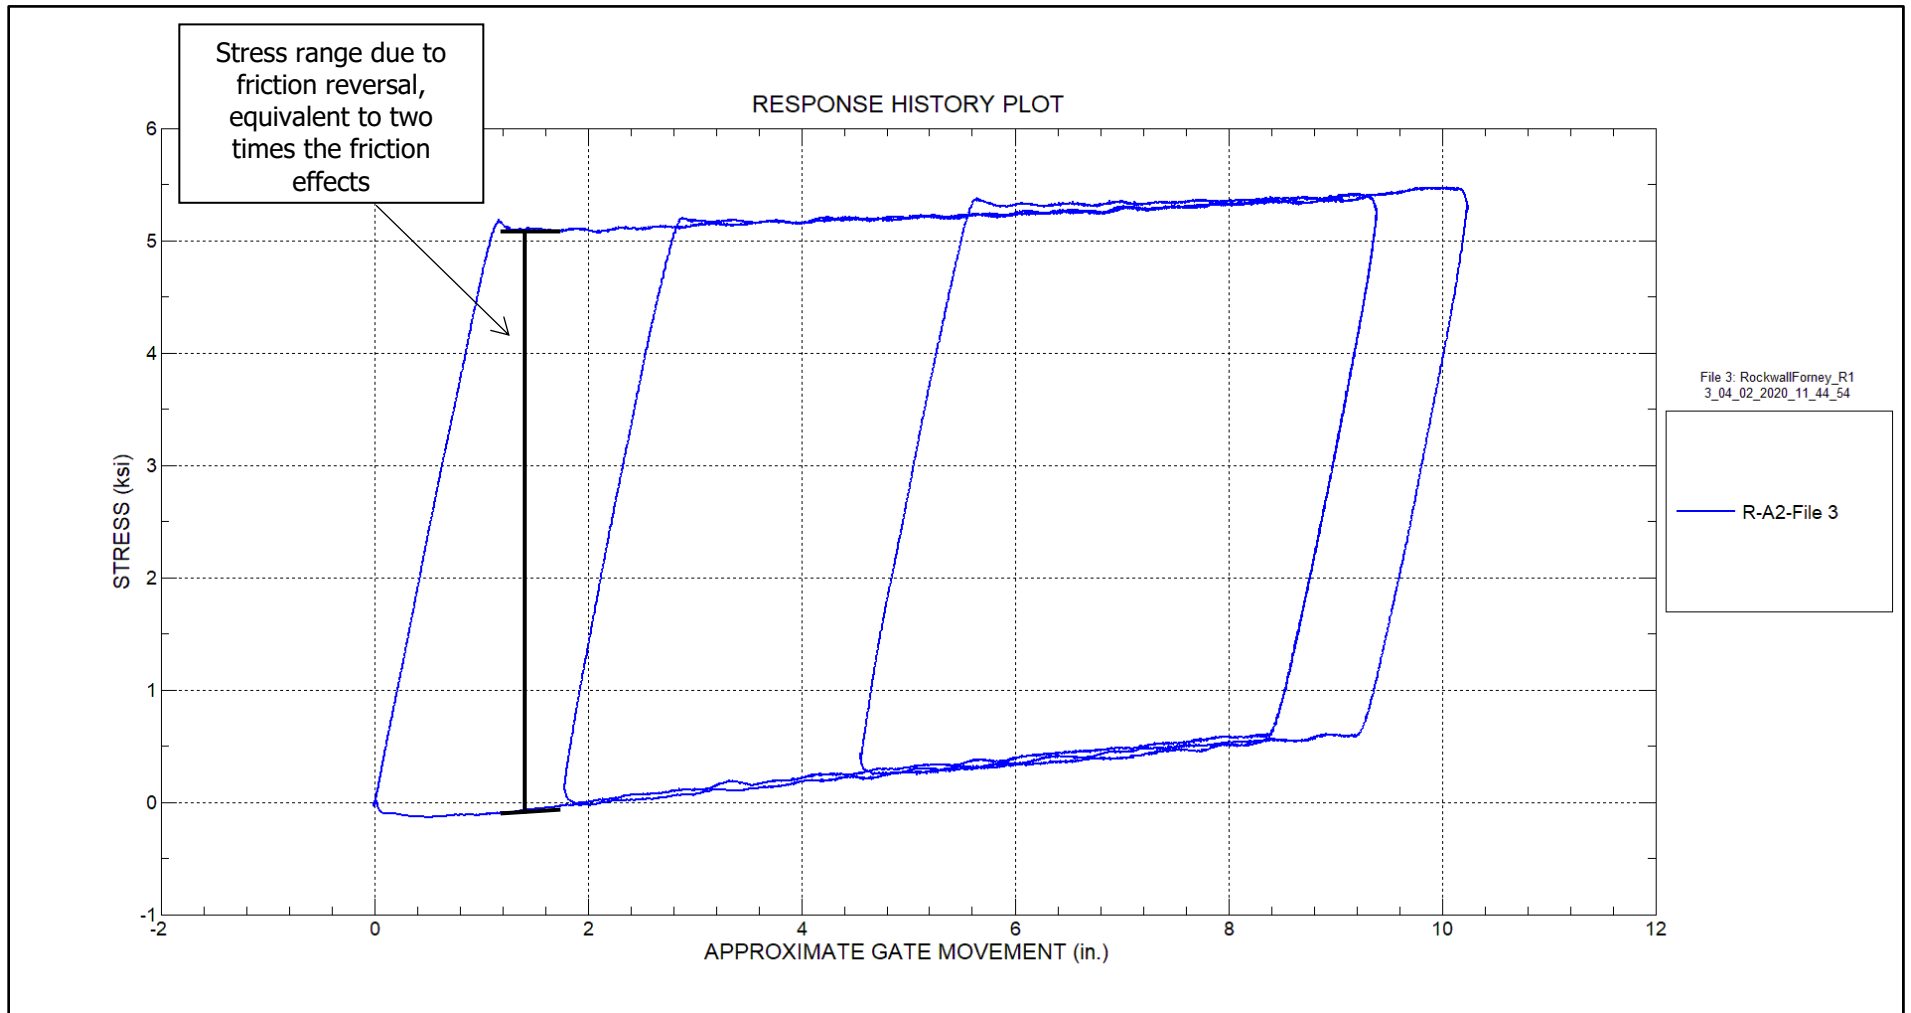
Figure 8 – Stress response history – Right arm – Gage A2 – Friction effect in stress responses
(Section A along top strut near pin – Sensor location 2 along bottom of inner flange)

- + **DIRECTION/FRICTION REVERSAL IN RESPONSES:** The difference in stress during gate opening and closing for a given position is shown in Figure 8. The stress variation at any given gate position was a result of direction reversal and in turn due to trunnion friction reversal. This statement is true since all other loads such as dead-load and hydrostatic pressure were essentially constant barring small changes in hydrostatic pressure due to slight changes in head. This direction/friction reversal is depicted in Figure 9, with deflected shape renderings from a gate arm finite element model under lifting and lowering loads. Note that this figure shows an arm configuration that does not match this gate, but the concept of the direction/friction reversal still applies.

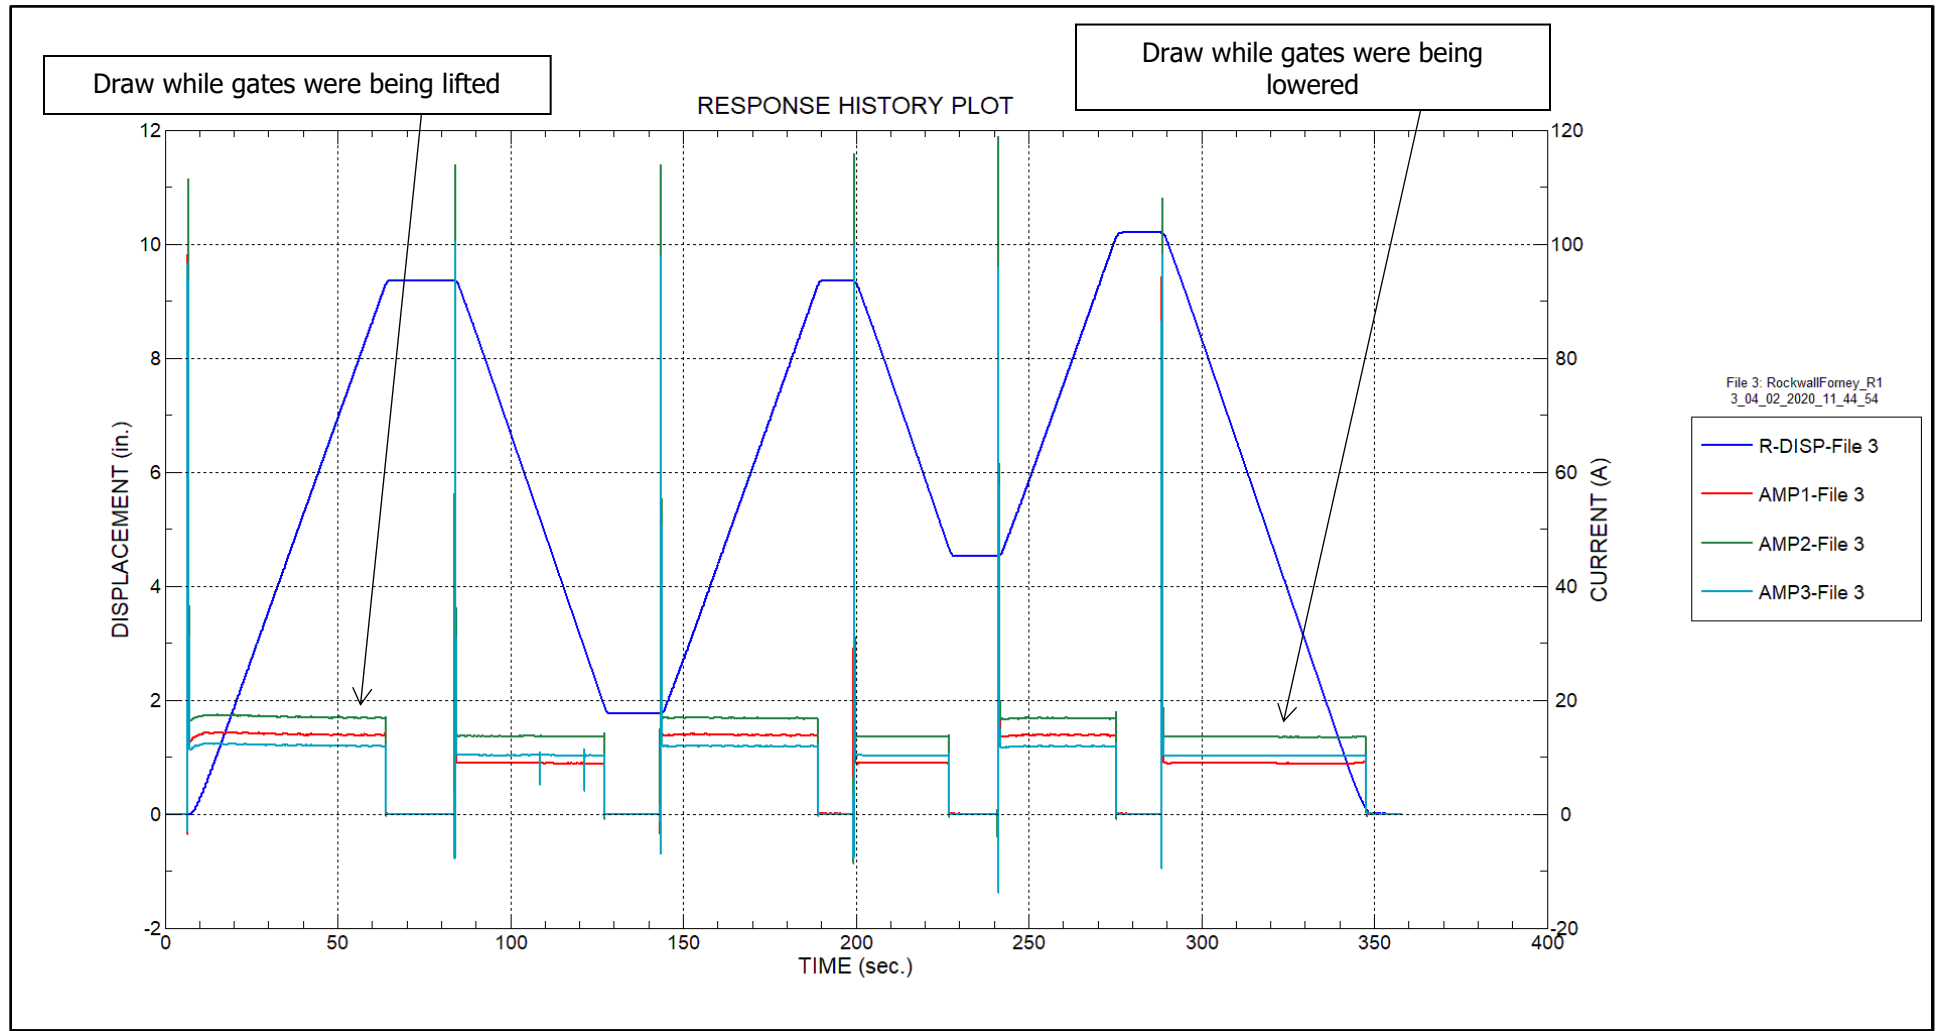
Figure 10 – Motor current & gate movement response history – Lift motor – Highlighting motor draw during lift and lower cycles

- + **MOTOR PERFORMANCE:** Current measurements taken at the hoist motor indicated steady and stable current draws during the lifting and lowering portions. An example plot of current draw and gate position is provided in Figure 10. Current draw ranges during lifting were higher than the ranges during lowering, which is common due to gravity/dead load. These results are summarized along with recorded peak in-rush current in Table 2. Note that the sample rates used during testing were set for collecting gate responses and may not have been appropriate to fully capture the in-rush current. The readings should be evaluated by a licensed electrician with knowledge of the operating parameters.

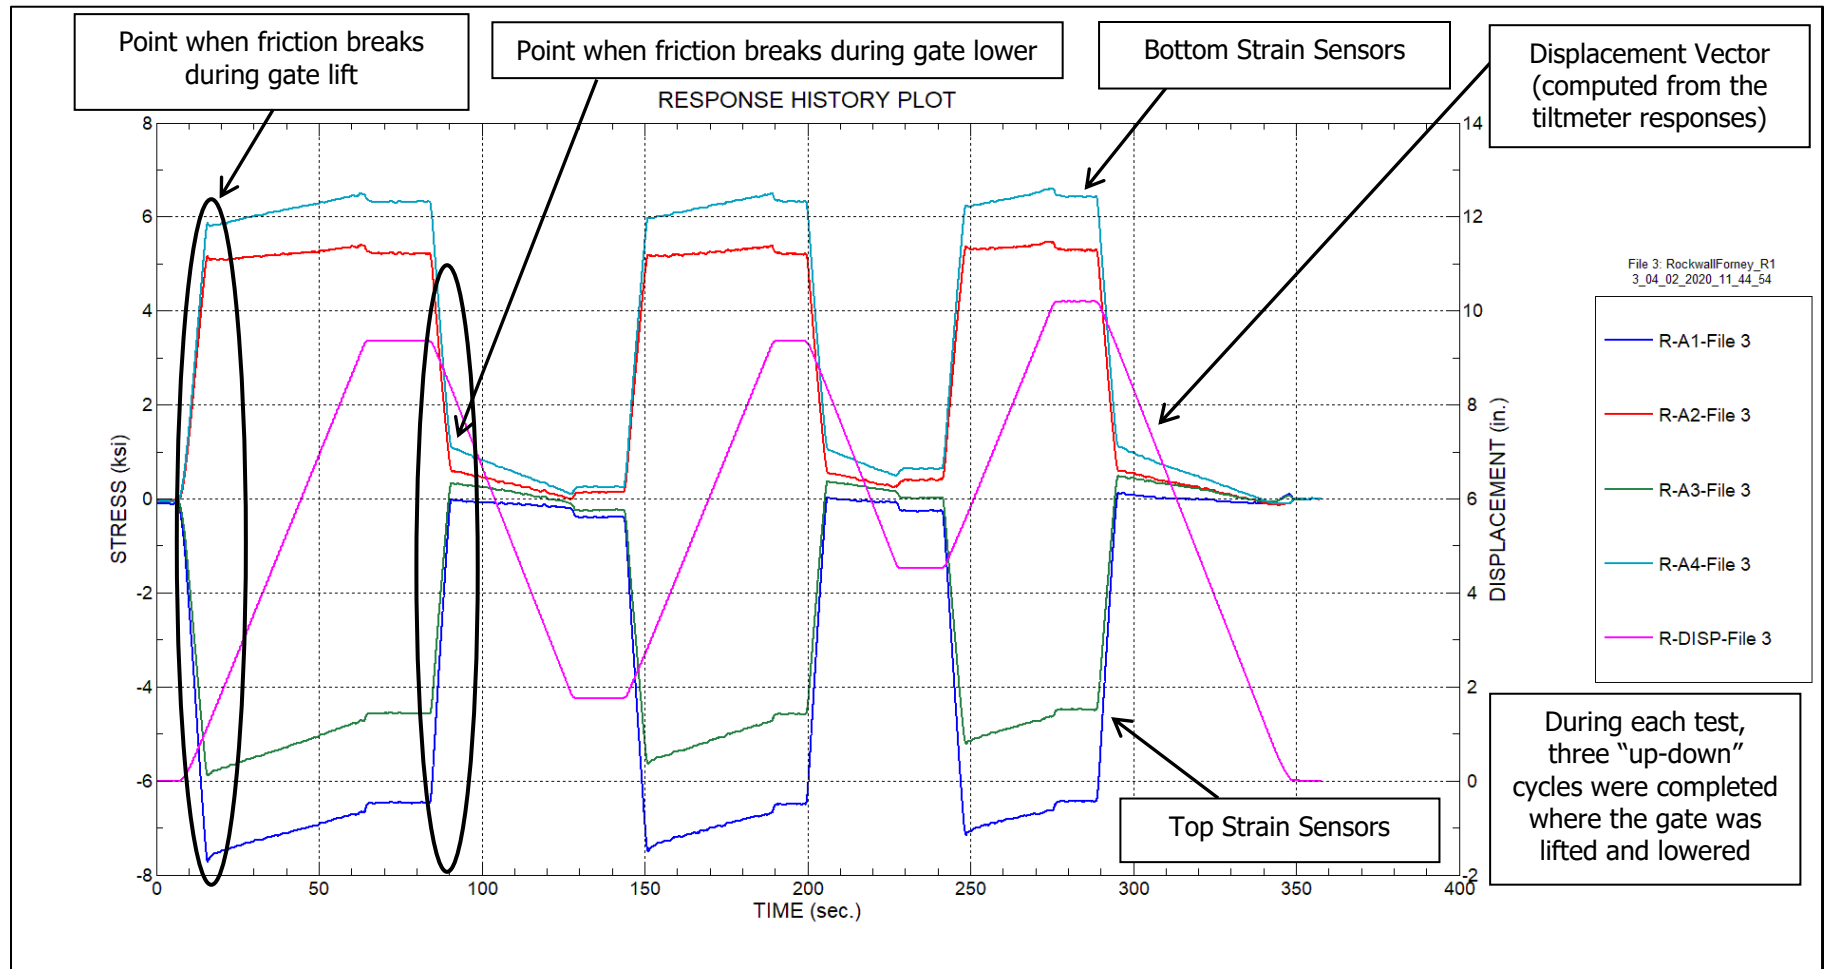
Figure 11 – Stress response & gate movement history – Right arm – Section A - Highlighting friction behavior

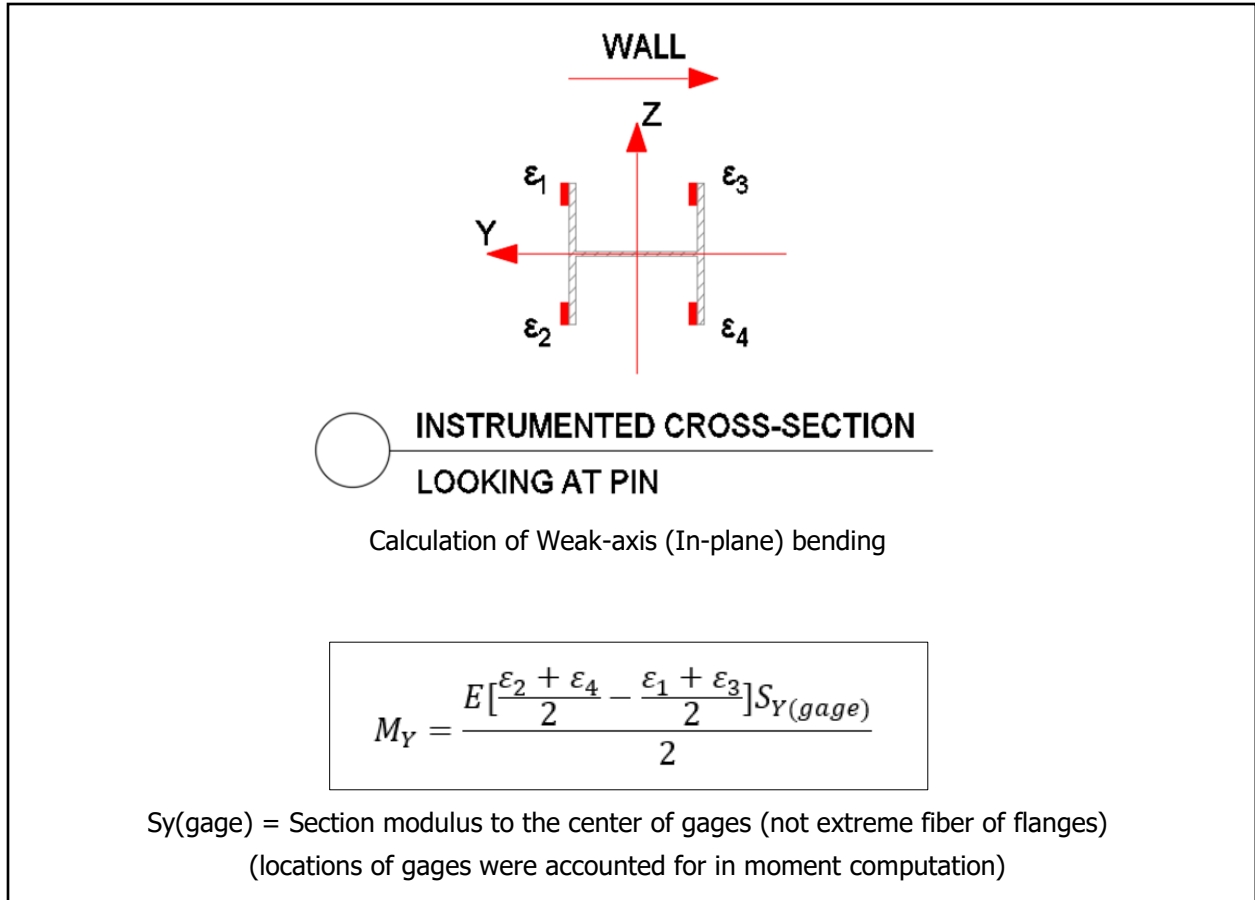
Figure 12 – Basic mechanic equation used to calculate moment

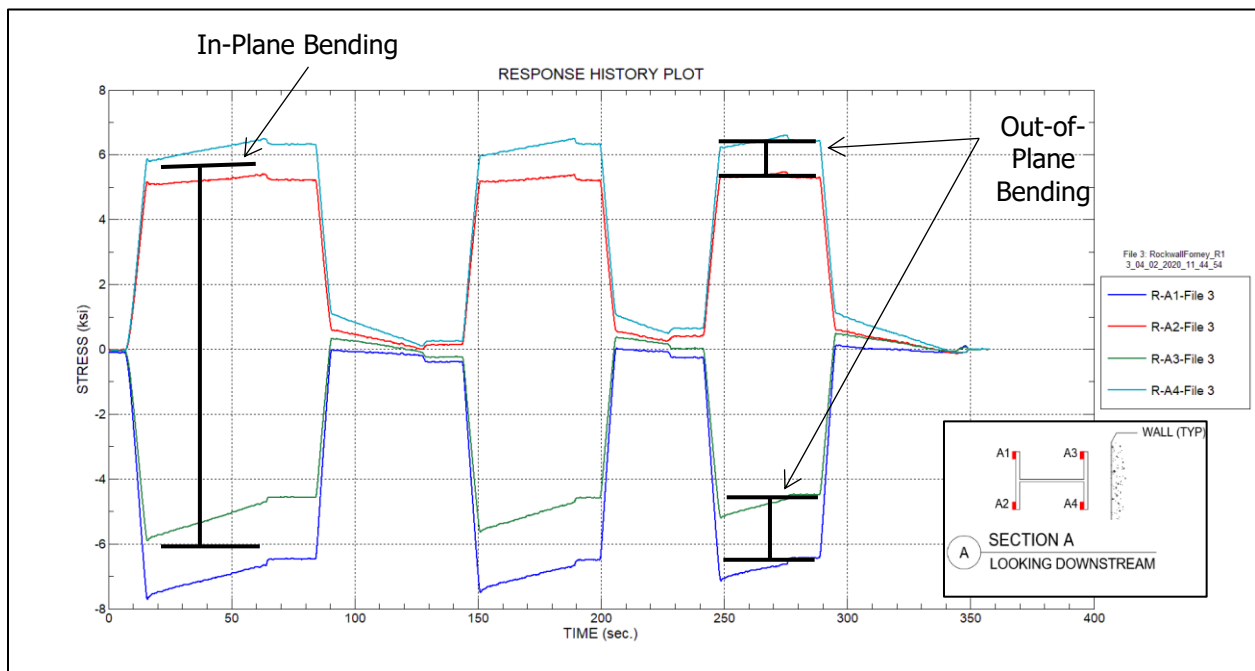
Figure 13 – Stress response history – Right arm – Section A – Bending components
(Section A along top strut near pin)

In-plane or weak-axis flexure refers to bending about a given strut's web. This designation is consistent with typical nomenclature. In-plane bending can be observed visually from the strain response histories as a difference between the top and bottom stresses, whereas out-of-plane or strong-axis bending is visualized as the difference in stress from side to side. Figure 13 provides a visual reference for both types of strut flexure.

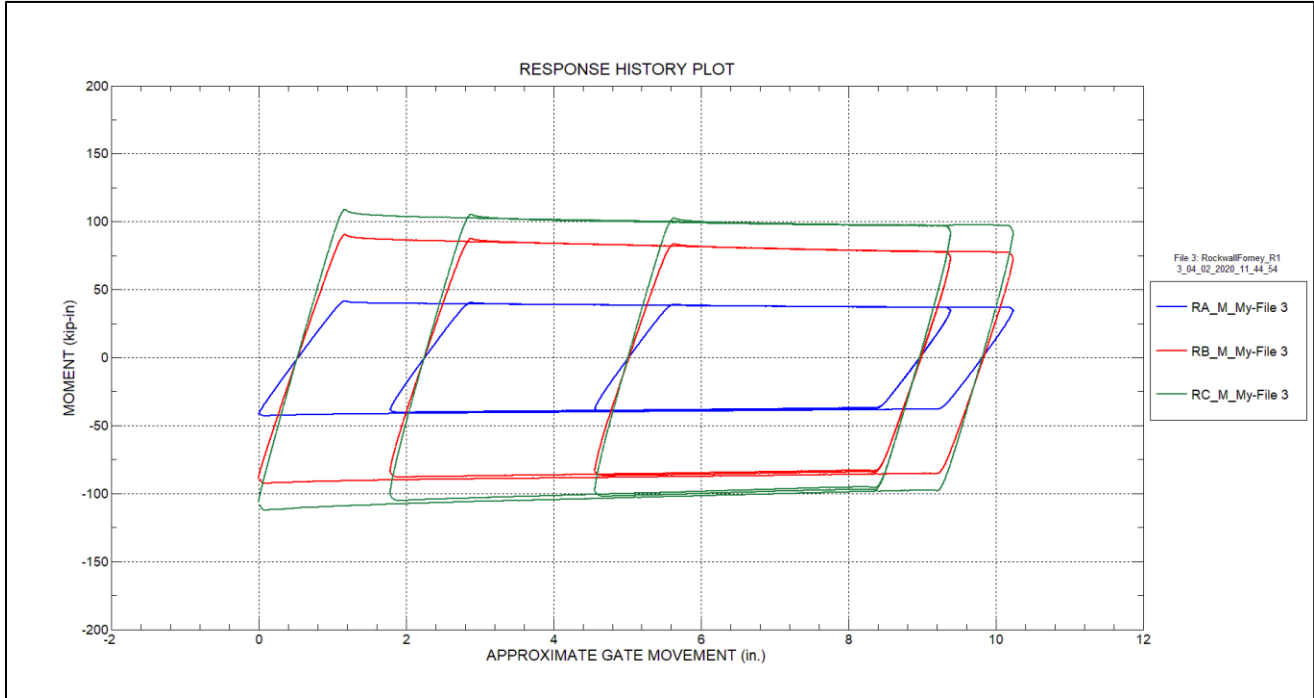
Figure 14 – In-plane moment response history – Right arm – Sections near pin
(RA = Right Arm Top Strut, RB = Right Arm Middle Strut, RC = Right Arm Bottom Strut)

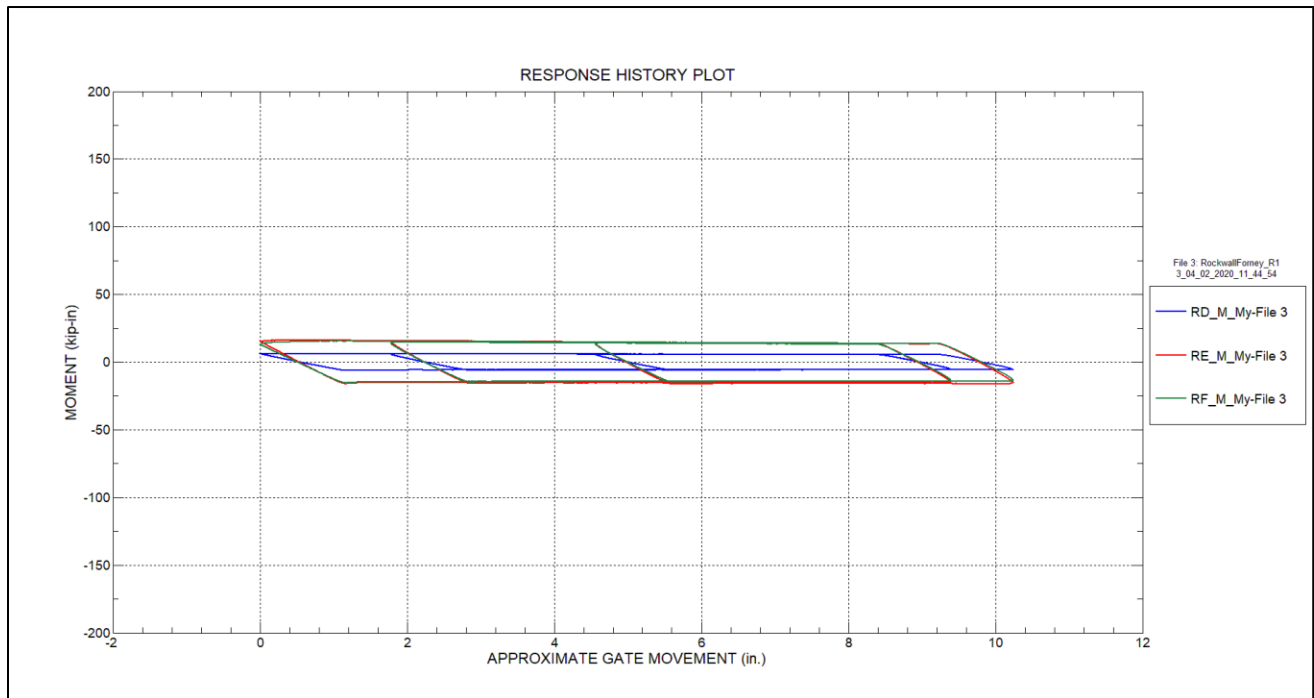
Figure 15 – In-plane moment response history – Right arm – Sections away from pin
(RD = Right Arm Top Strut, RE = Right Arm Middle Strut, RF = Right Arm Bottom Strut)

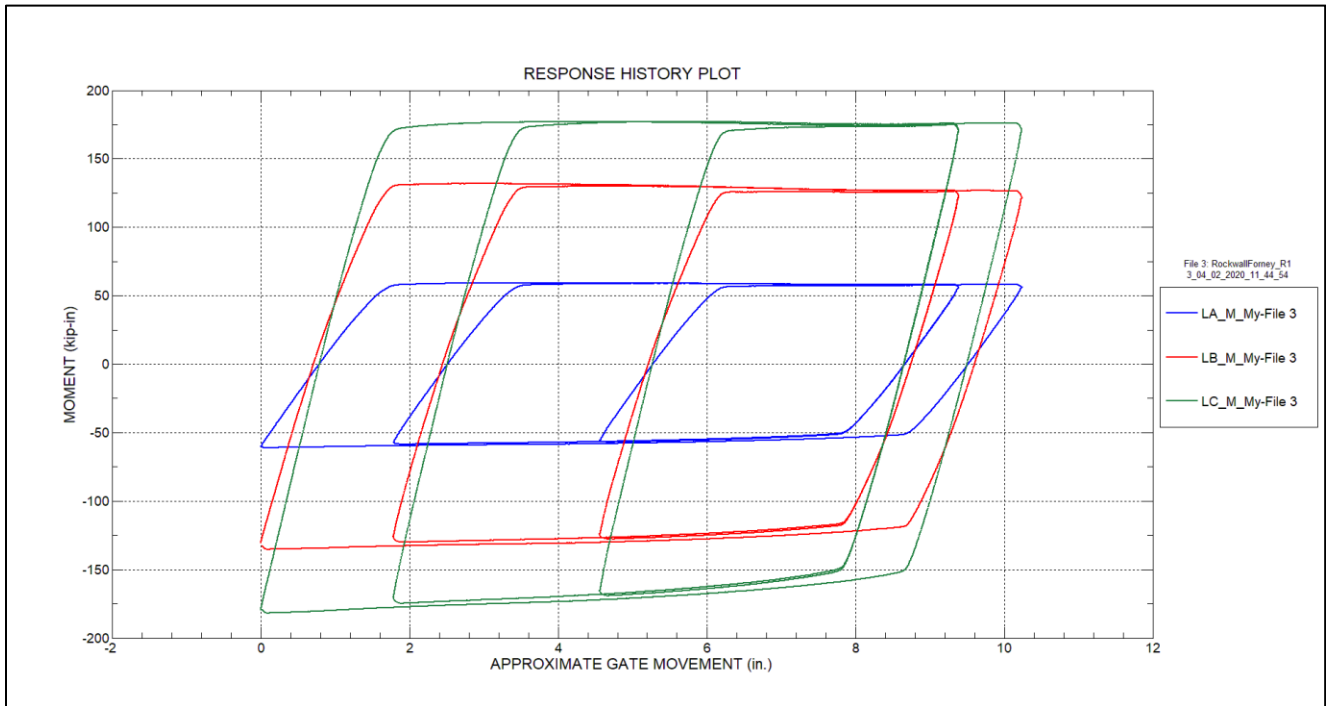
Figure 16 – In-plane moment response history – Left arm – Sections near pin
(LA = Left Arm Top Strut, LB = Left Arm Middle Strut, LC = Left Arm Bottom Strut)

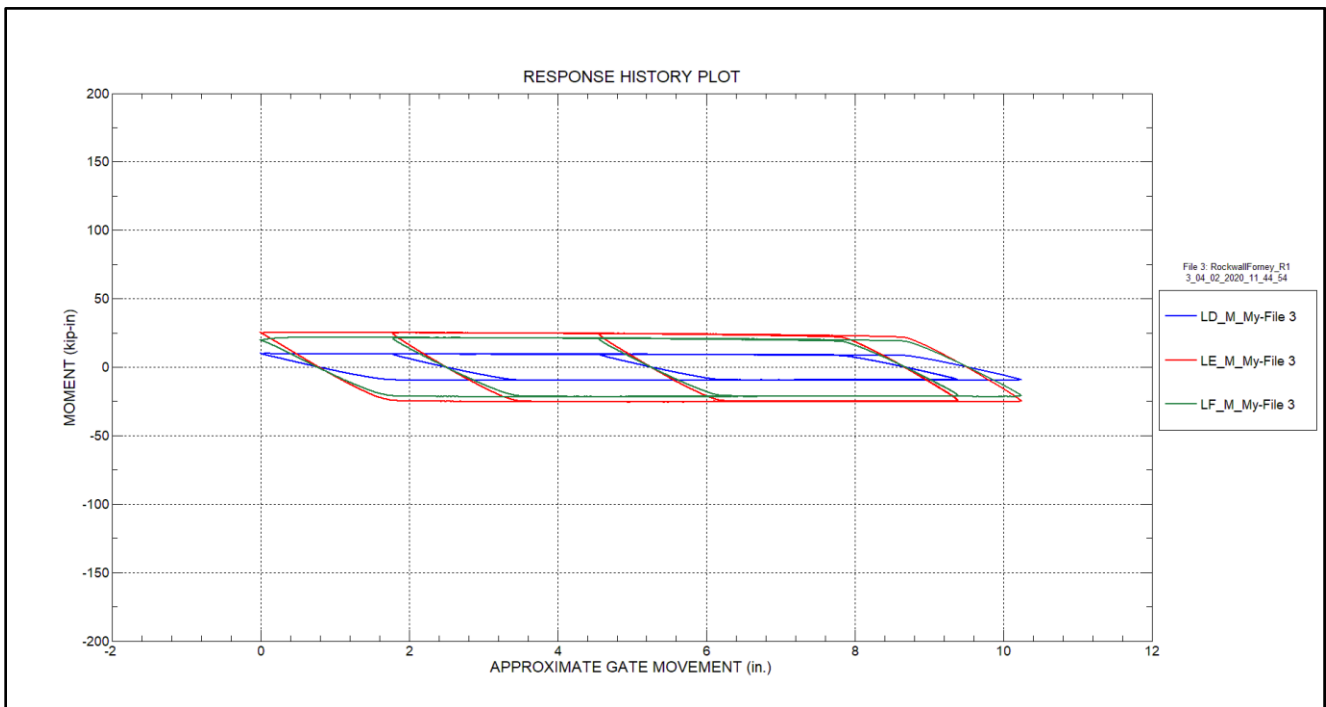
Figure 17 - In-plane moment response history – Left arm – Sections away from pin
(LD = Left Arm Top Strut, LE = Left Arm Middle Strut, LF = Left Arm Bottom Strut)

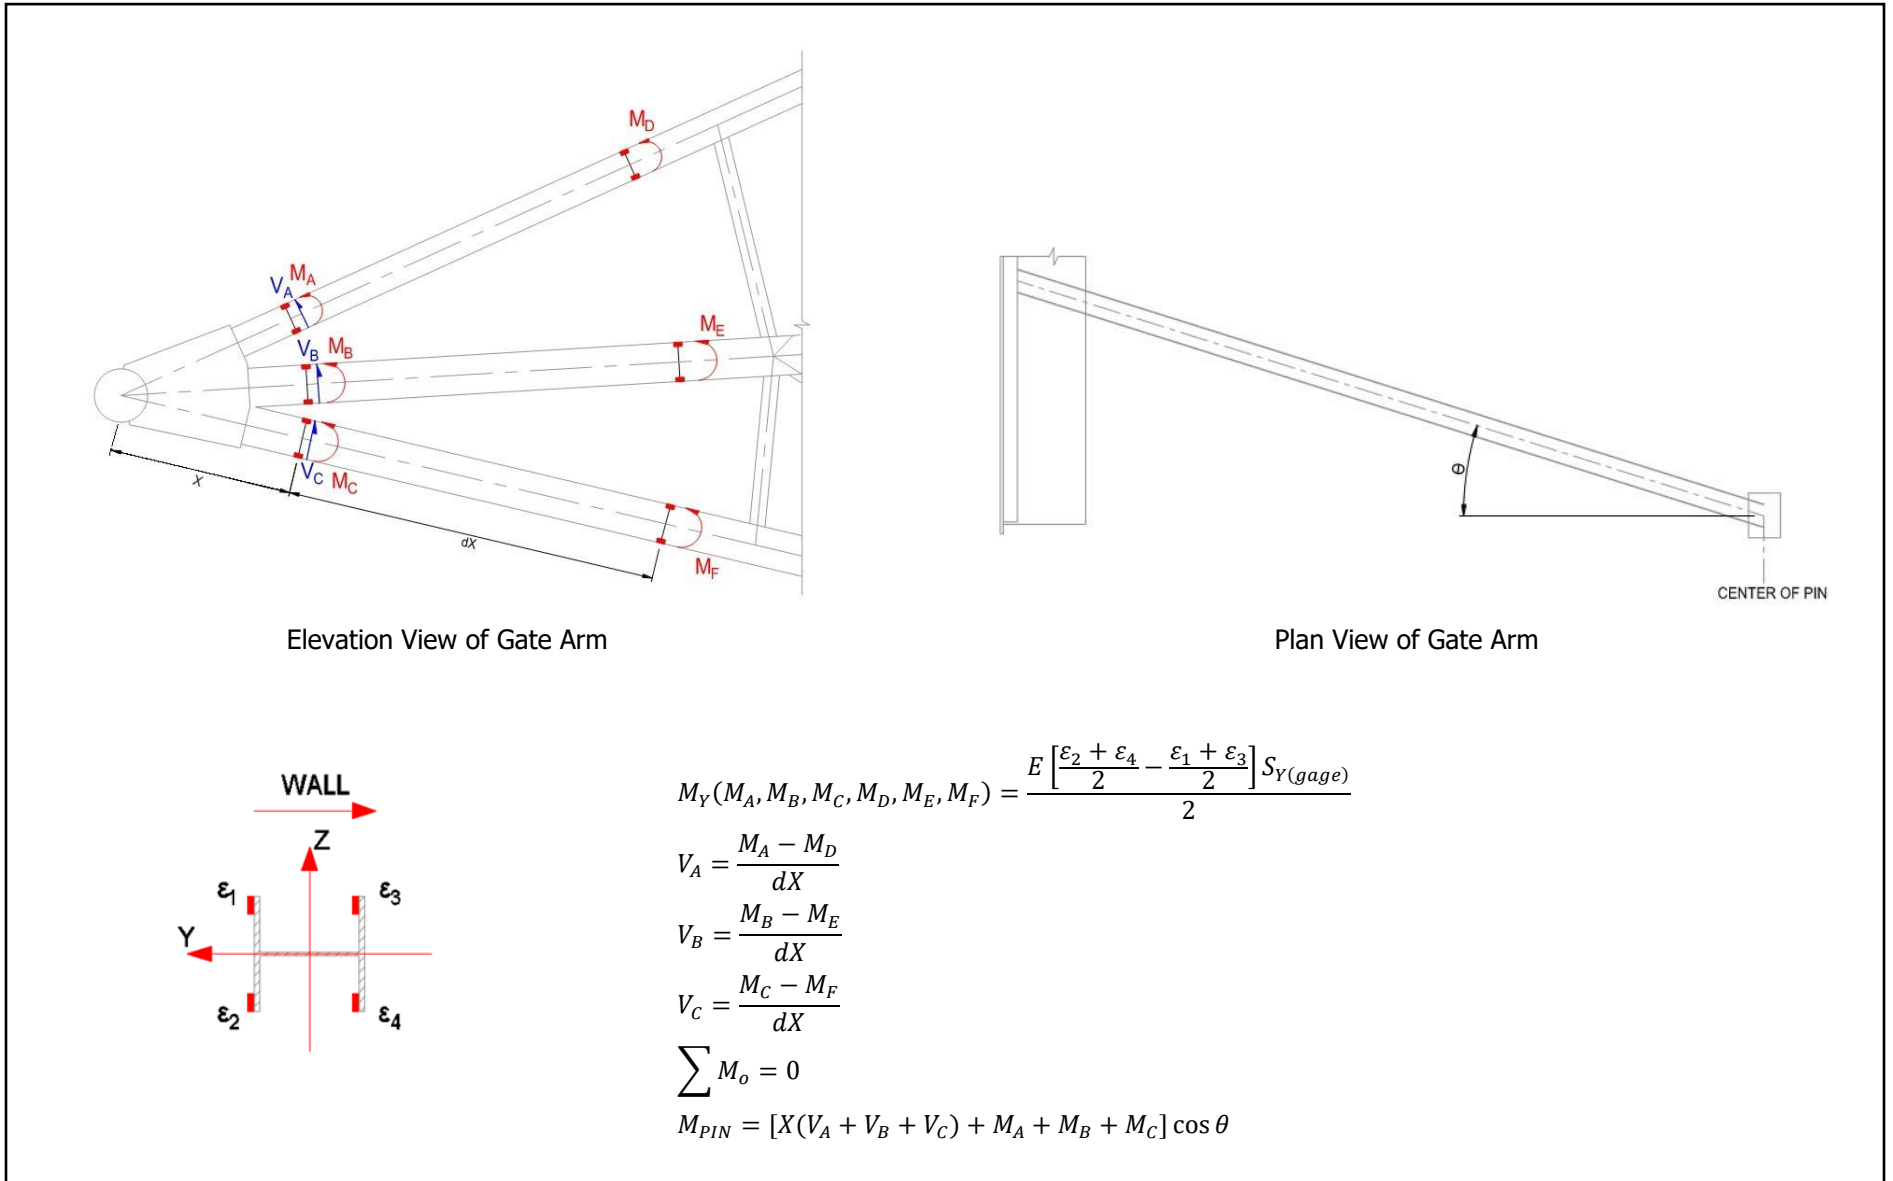
Figure 18 – Direct calculation of pin moment from strain measurements

- + **TRUNNION FREE-BODY-DIAGRAM & PIN MOMENT CALCULATION:** Figure 18 shows the instrumented member cross-sections and shows how the measured cross-sectional flexural responses were used to compute pin moment. The in-plane moment values used in these calculations were determined directly from the strain measurements at each cross-section using the provided mechanics equations. It should be noted that the out-of-plane moments were not considered in the calculation of pin moment since they were orthogonal to the axis of the pin rotation. Total pin moment was then determined by summing all the moment components about the pin, which included the in-plane moment and the shear components at the strut cross-sections nearest the pin.

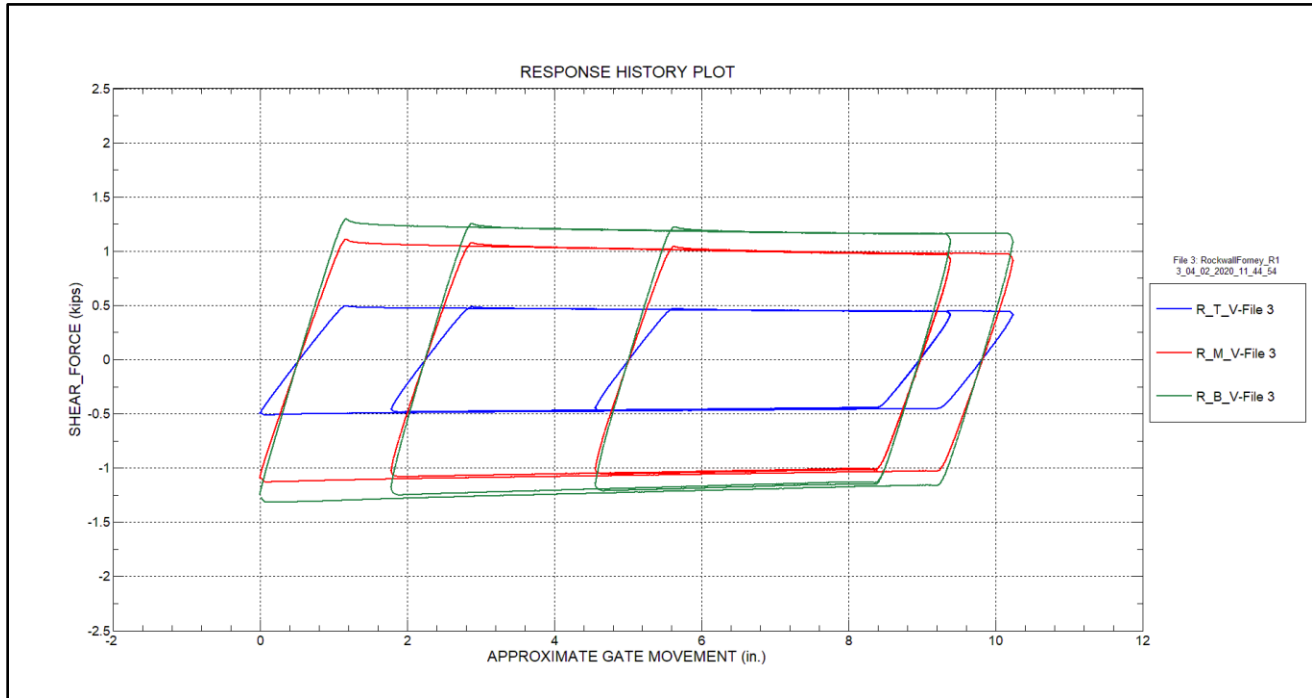
Figure 19 – Strut shear response history – Right arm

(R_T = Right Arm Top Strut, R_M = Right Arm Middle Strut, R_B = Right Arm Bottom Strut)
