VISUAL INSPECTION AND EVALUATION REPORT

Rockwall-Forney Dam
Dallas Water Utilities
Dallas/Kaufman Counties, Texas

Schnabel Reference #20C22001.00
July 30, 2021

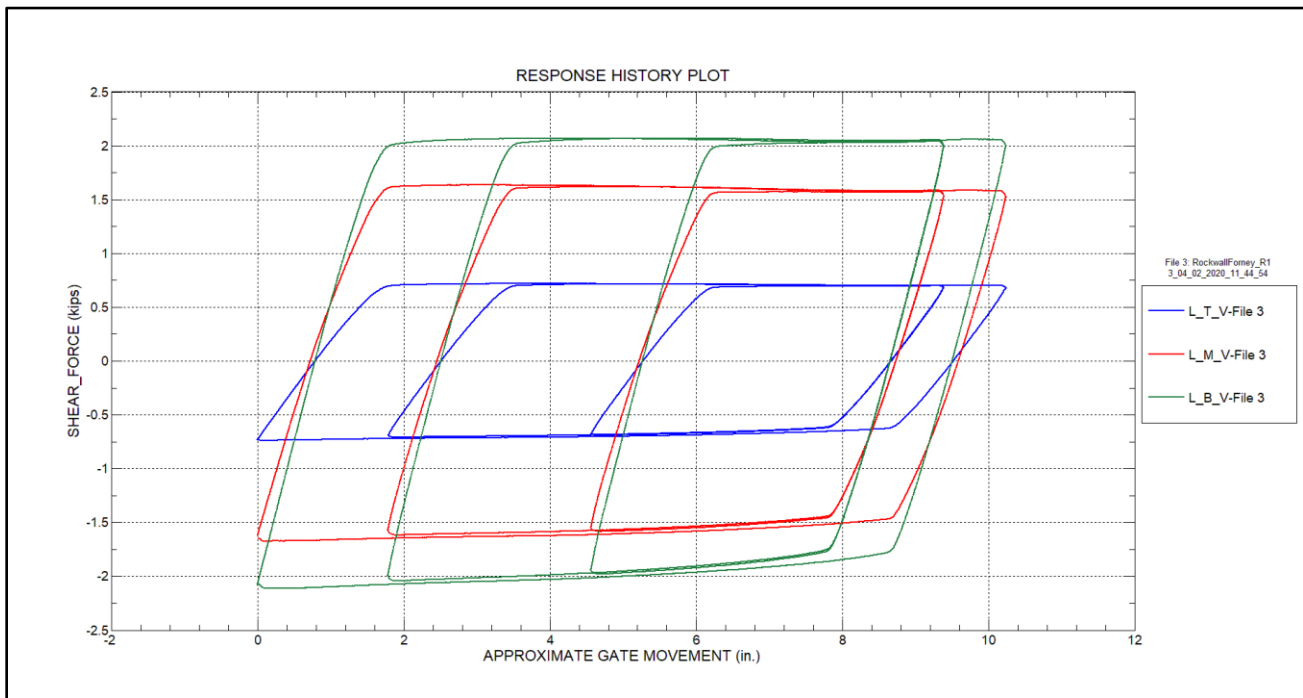
Figure 20 – Strut shear response history – Left arm

(L_T = Left Arm Top Strut, L_M = Left Arm Middle Strut, L_B = Left Arm Bottom Strut)

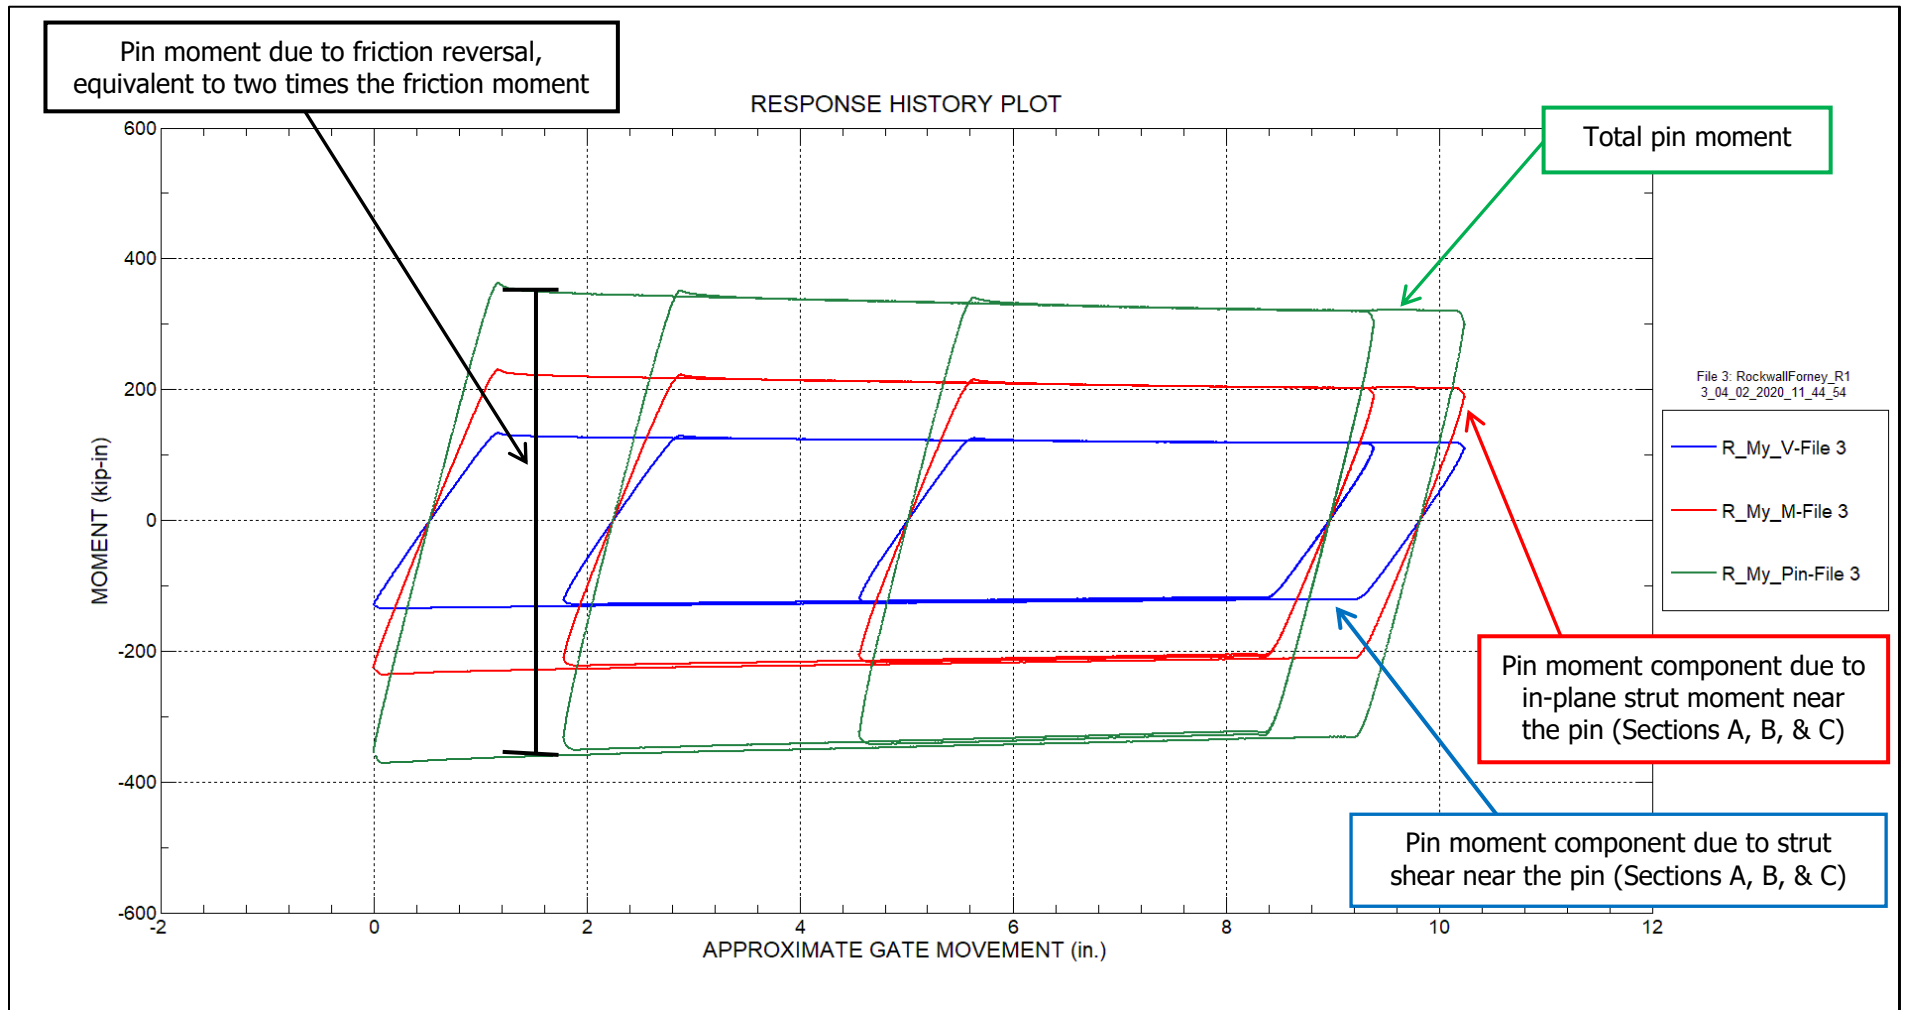
Figure 21 – Pin moment response history – Right arm

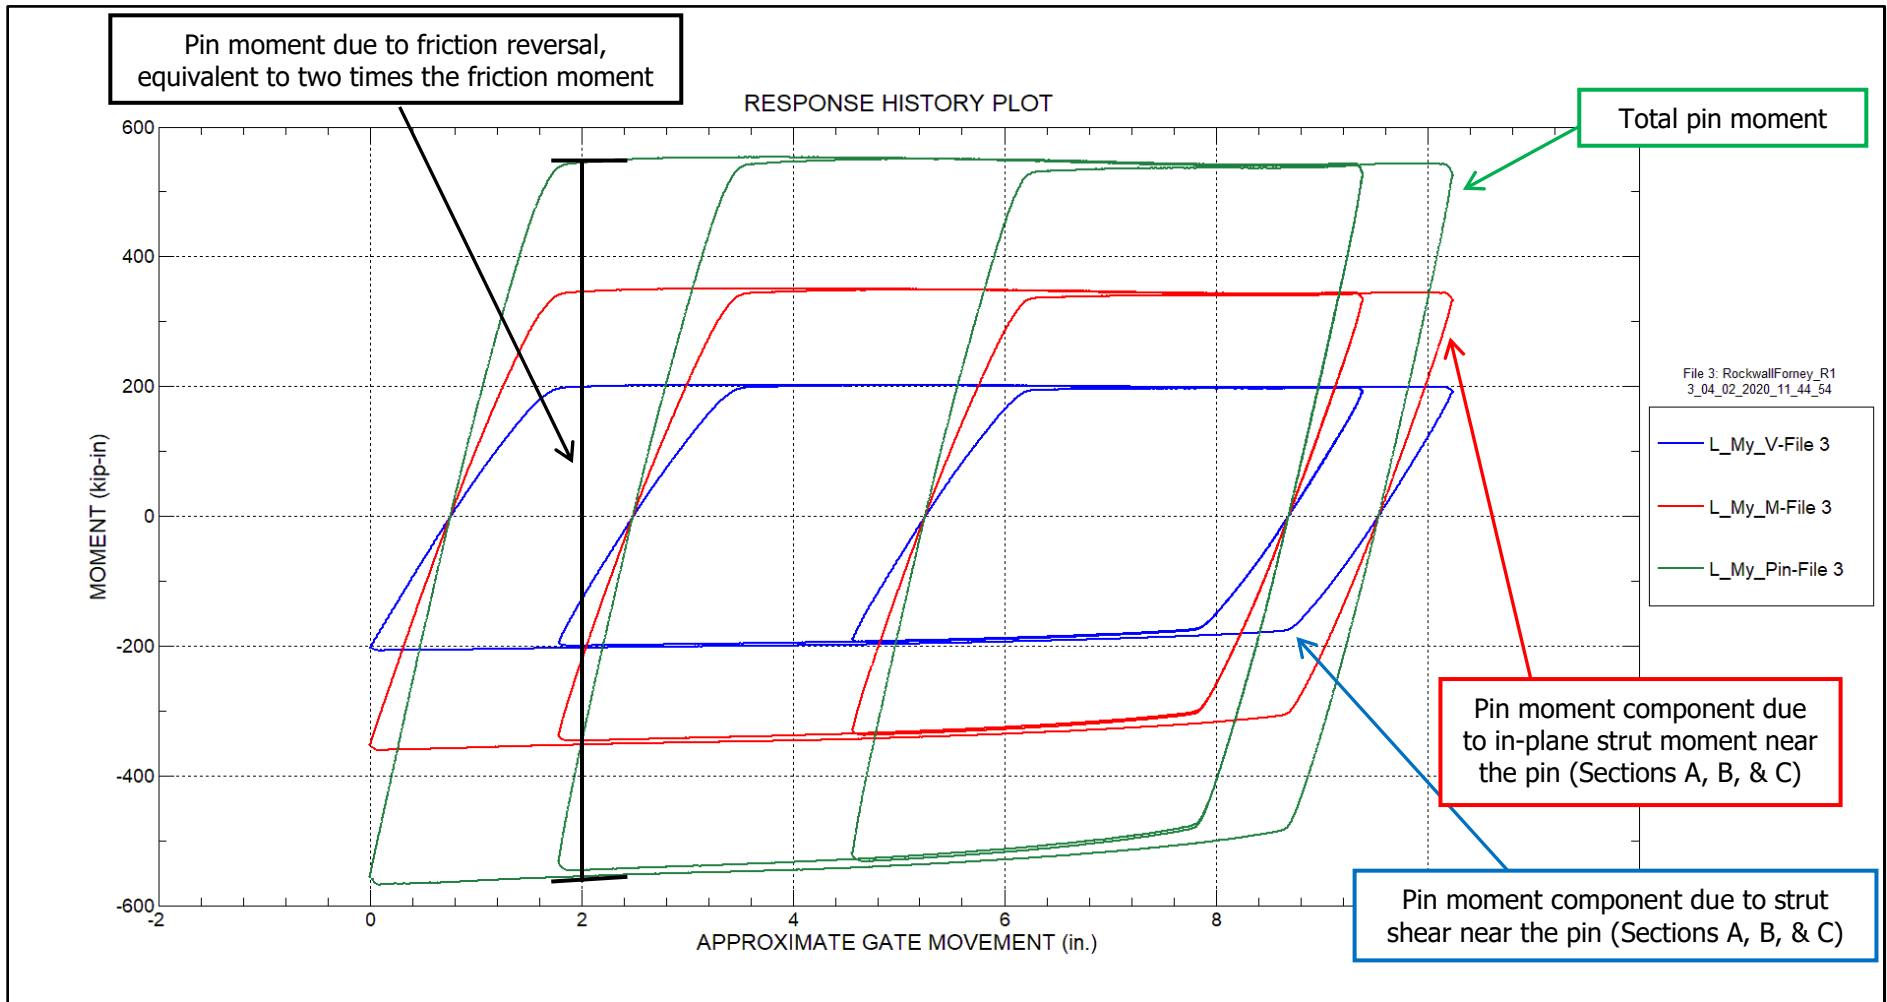
Figure 22 – Pin moment response history – Left arm

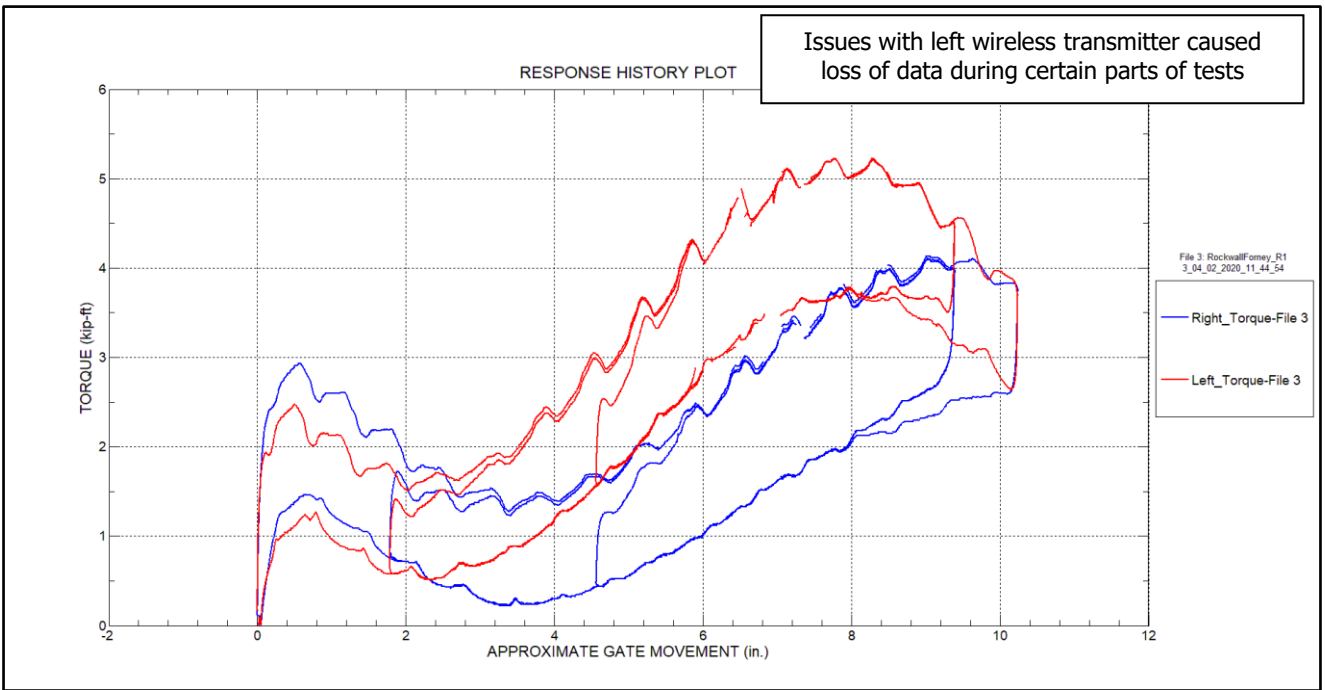
Figure 23 – Hoist torque response history – Gate 2 – Test 3

Note: missing data due to wireless connectivity issues as the sensor rotates with the pinion shaft

Figure 23 shows example torque measurements, recorded on the Gate 2 torque shafts. Best practices for torque measurements is to measure torque on opposite sides of the shaft so that any bending in the shaft can be removed by averaging the two responses. Due to access limitations, only one gage at each location could be installed. Therefore, any bending in the shaft may be reflected in the torque measurements and may be related to the peaks and valleys observed in the torque responses.

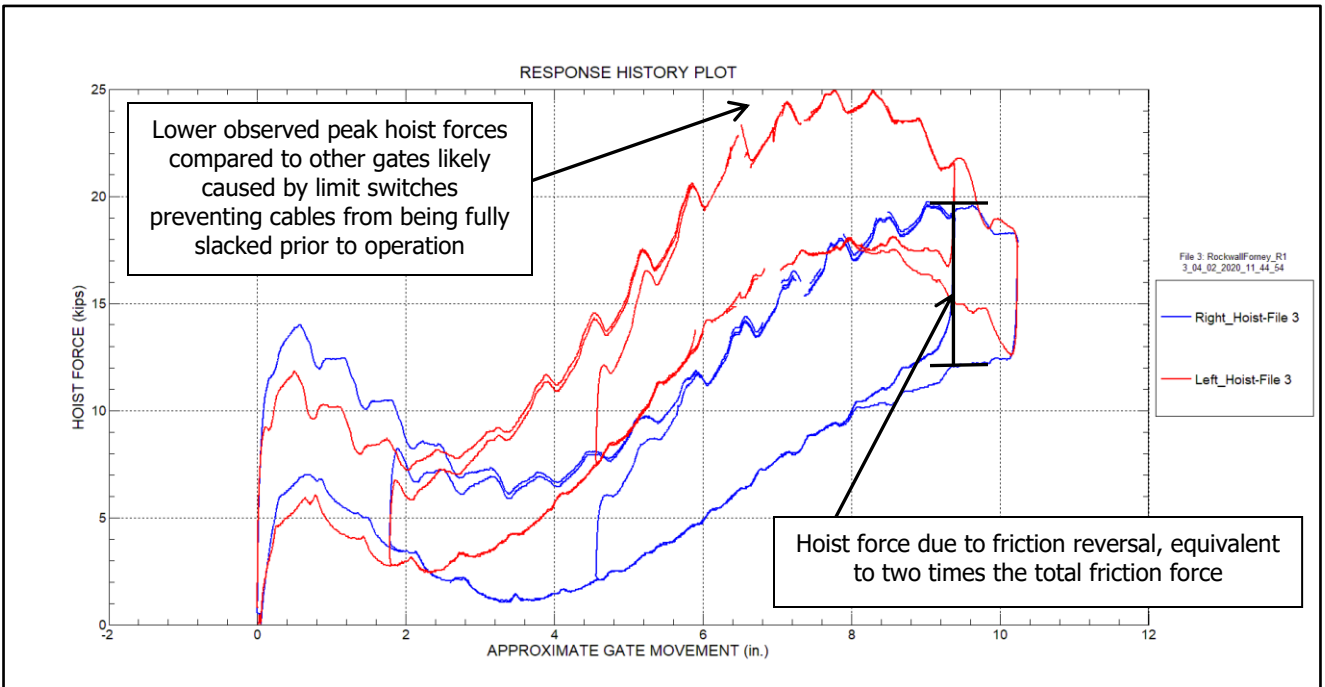
Figure 24 – Hoist force response history – Gate 2 – Test 3

Note: missing data due to wireless connectivity issues as the sensor rotated with the pinion shaft

Torque values were converted to force in the hoist cables per gate arm using the gear ratio and drum radius, as shown in Figure 24. The gear ratio and drum radius were 5.182 and 1.086 feet respectively, as defined in the provided as-built shop drawings. It should be noted that the hoist force calculated may be smaller than the actual hoist force applied. This difference is due to the limit switch engaging the brake before the hoist cable was fully slacked, resulting in an initial force in the cable. A hoist force due to total gate friction was then calculated. This friction hoist force was equal to half the differential in force measured during the lifting and lowering of the gate (similar to the pin friction calculations). As shown in Table 3, the change in cable force due to friction was generally consistent between tests. Note that the total hoist force was due to the total friction effects, including side seal, hoist bearings, trunnion friction effects, etc. It is difficult to determine the exact proportion and composition of the total friction sources. Additional torque and hoist force plots for all collected data files are provided in Appendix A – Gate 2 Torque and Hoist Force Plots.

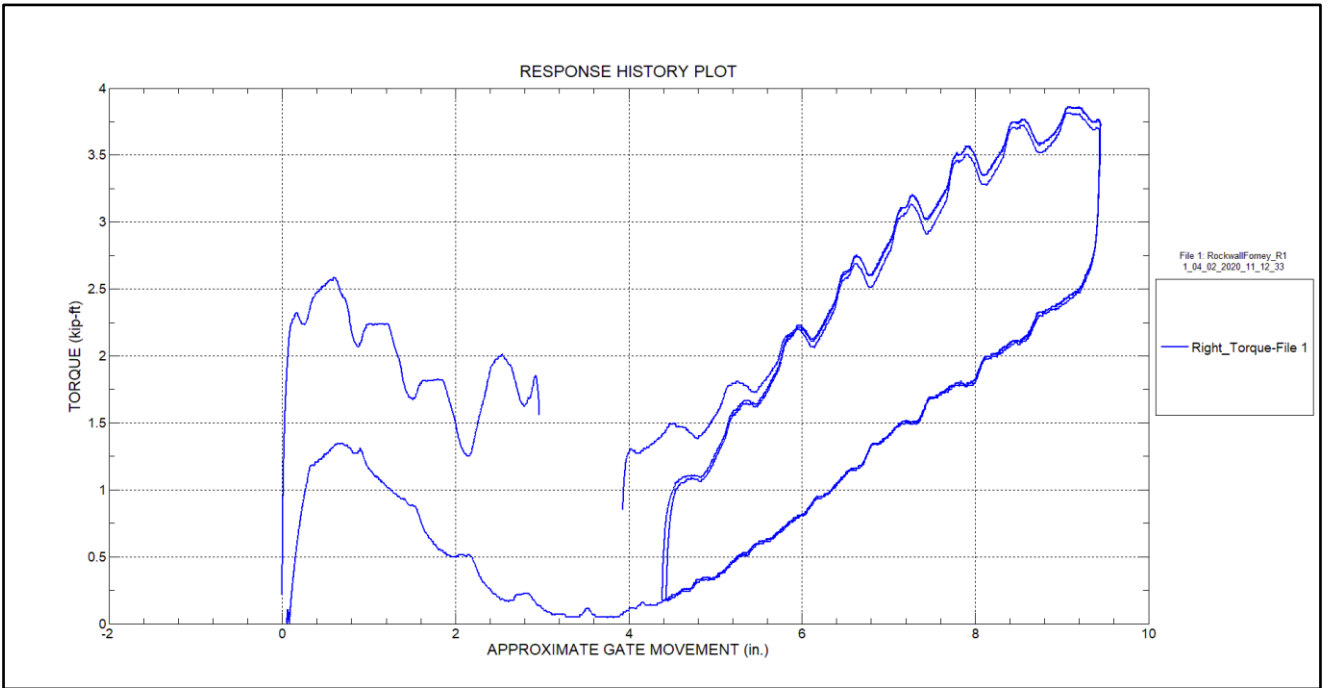
Figure 25 – Hoist torque response history – Gate 2 – Test 1

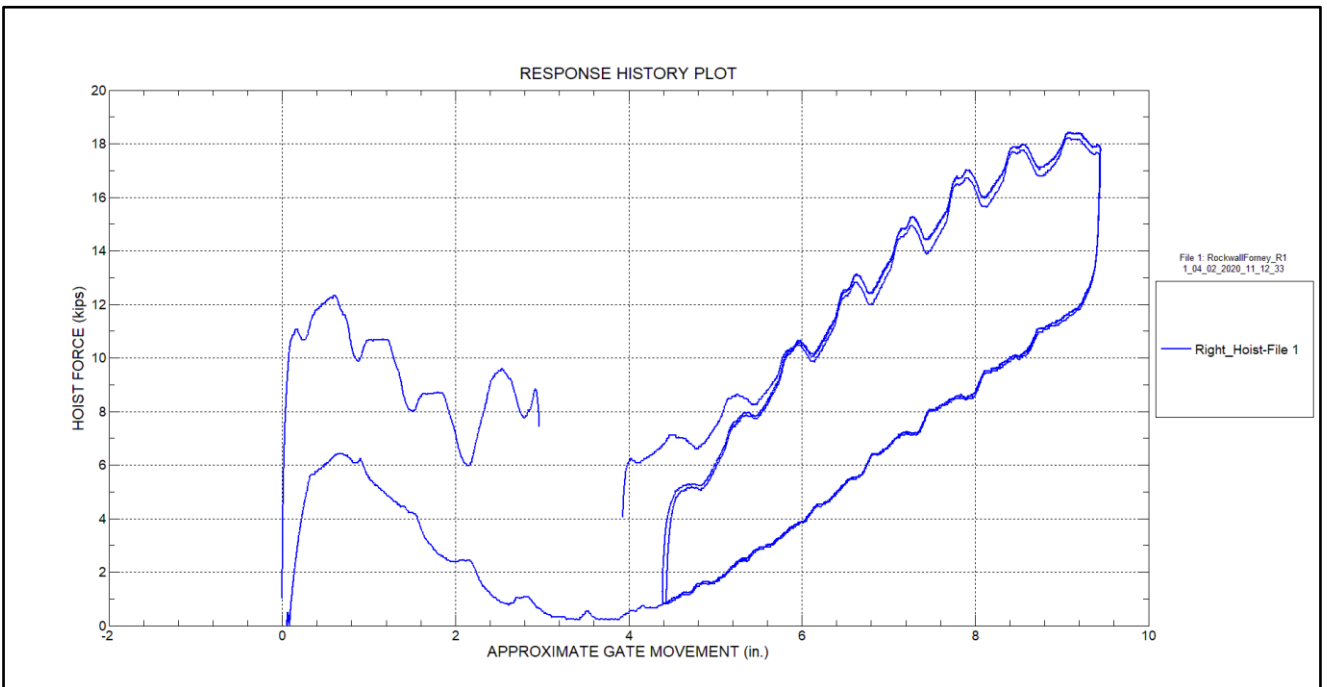
Figure 26 – Hoist force response history – Gate 2 – Test 1

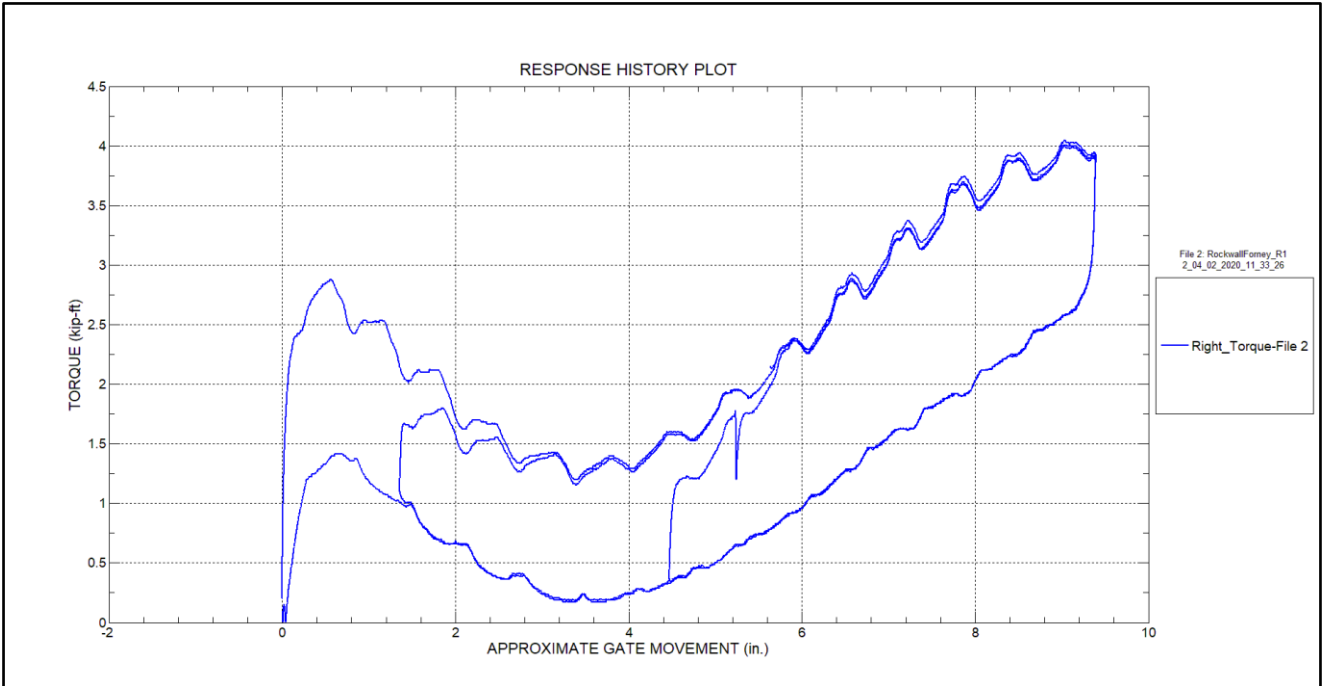
Figure 27 – Hoist torque response history – Gate 2 – Test 2

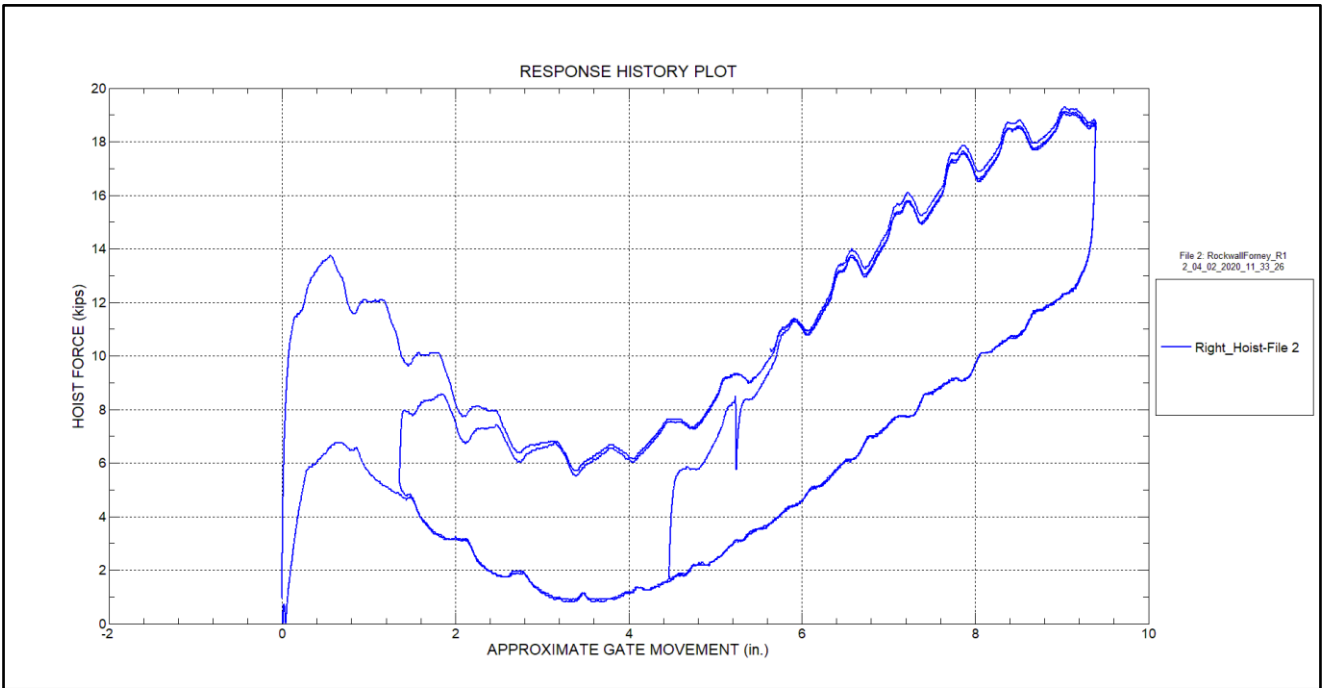
Figure 28 – Hoist force response history – Gate 2 – Test

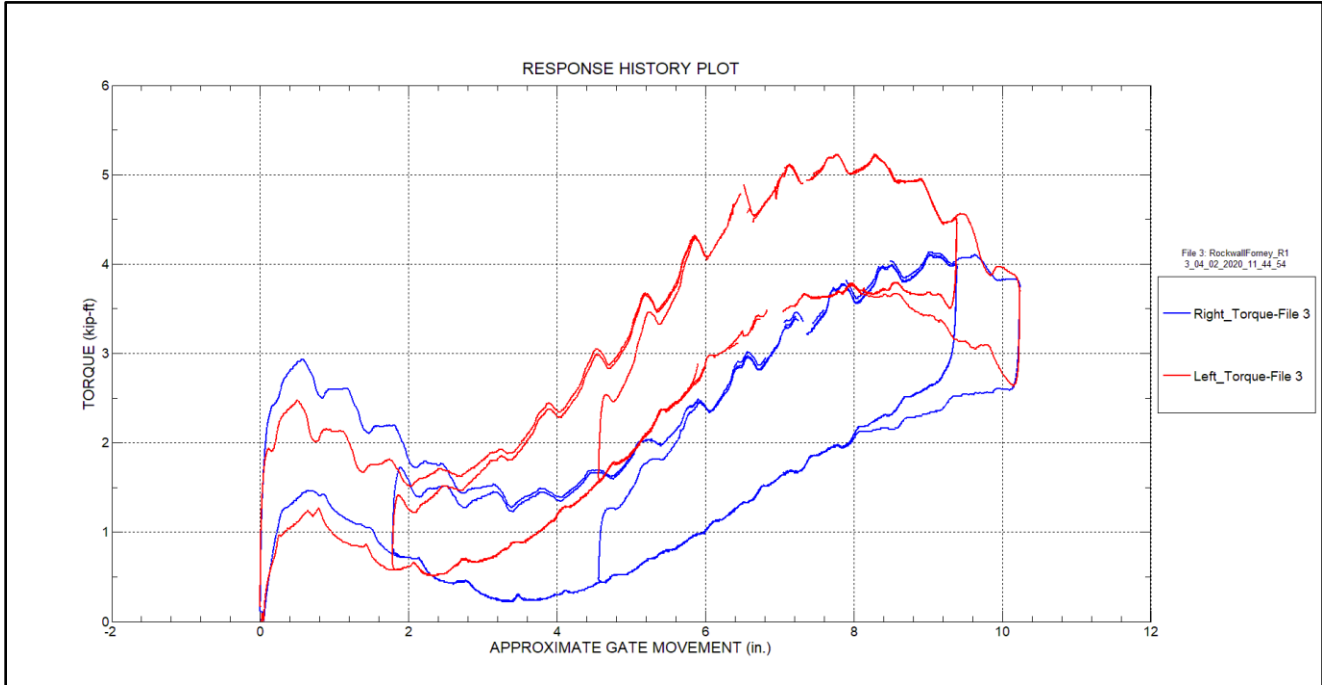
Figure 29 – Hoist torque response history – Gate 2 – Test 3

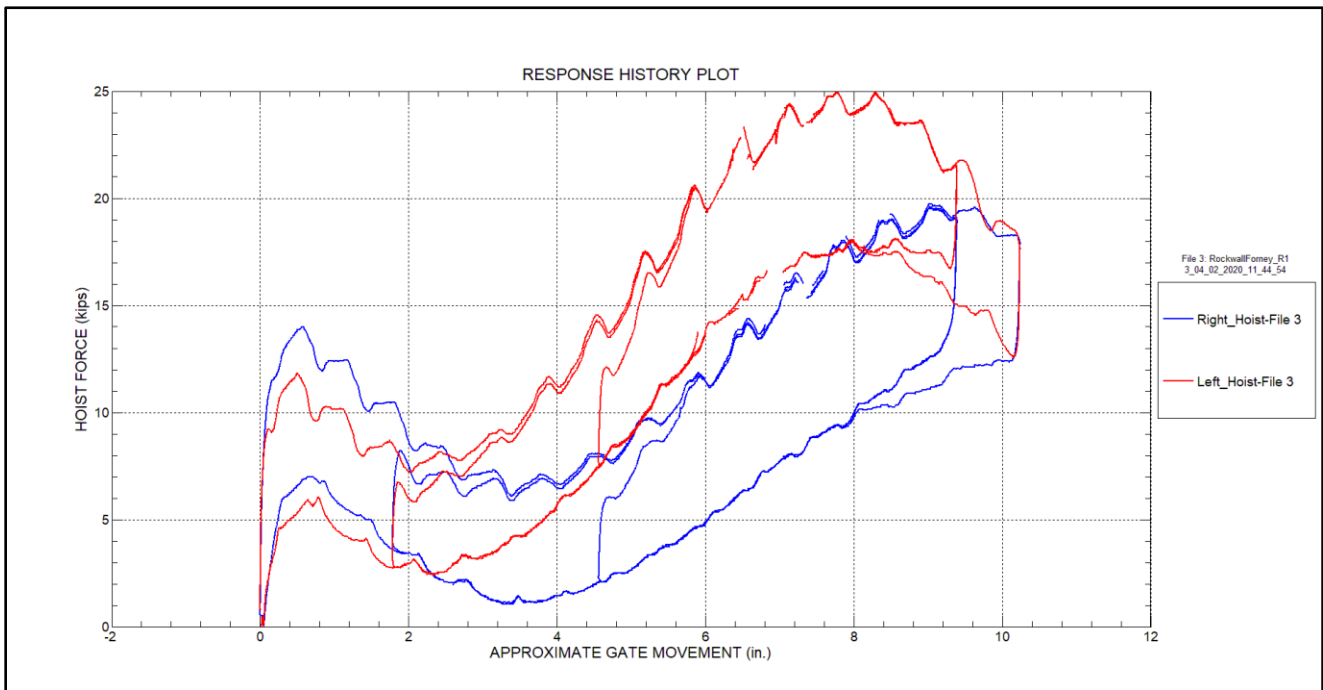
Figure 30 – Hoist force response history – Gate 2 – Test 3

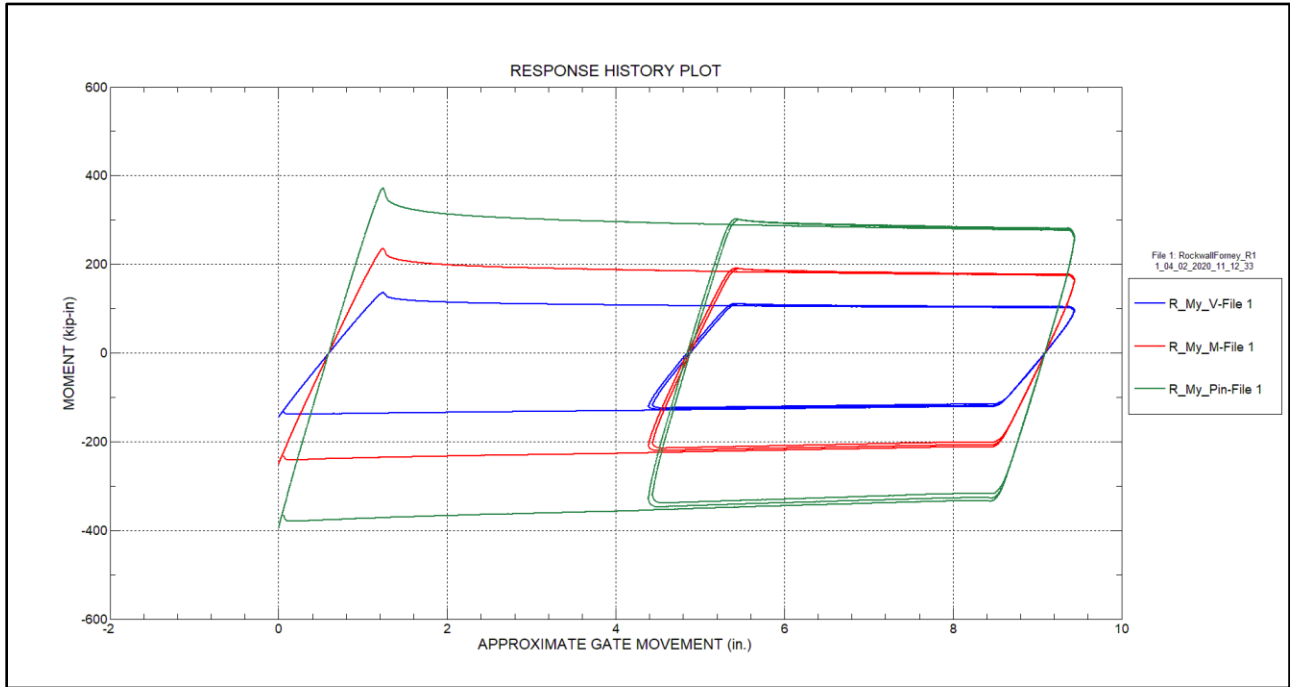
Figure 31 – Pin moment response history – Right arm – Test run 1

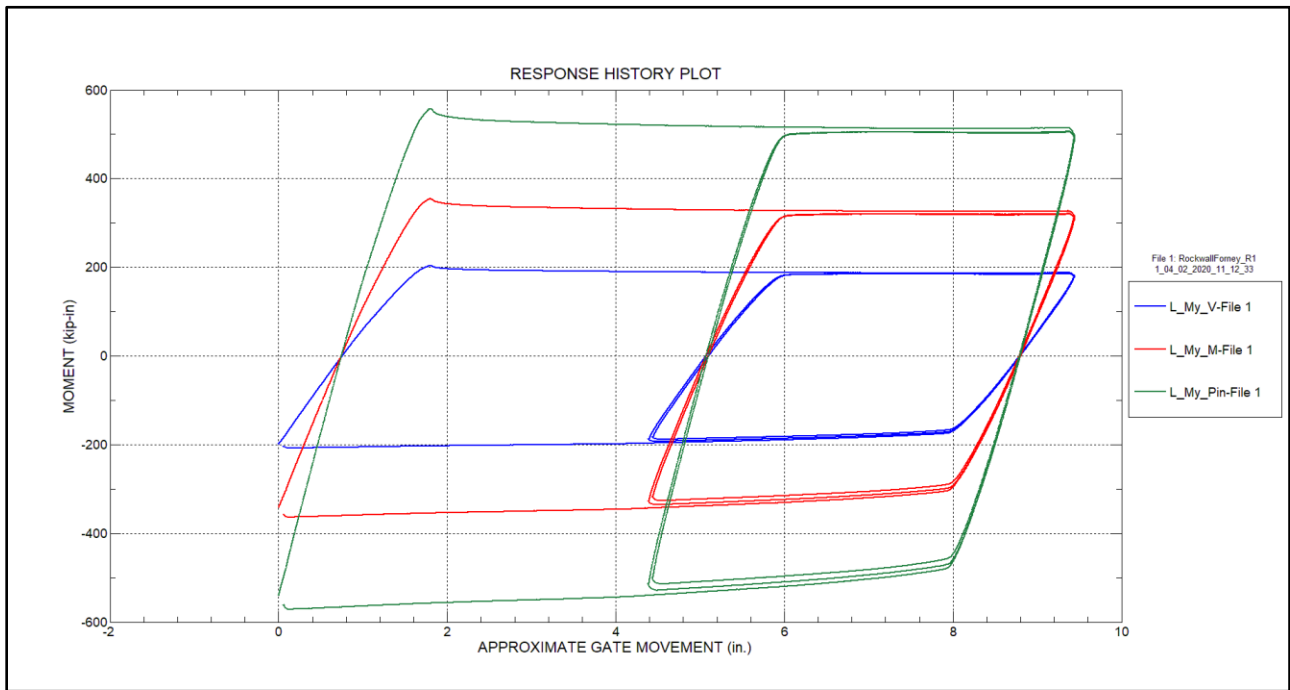
Figure 32 – Pin moment response history – Left arm – Test run 1

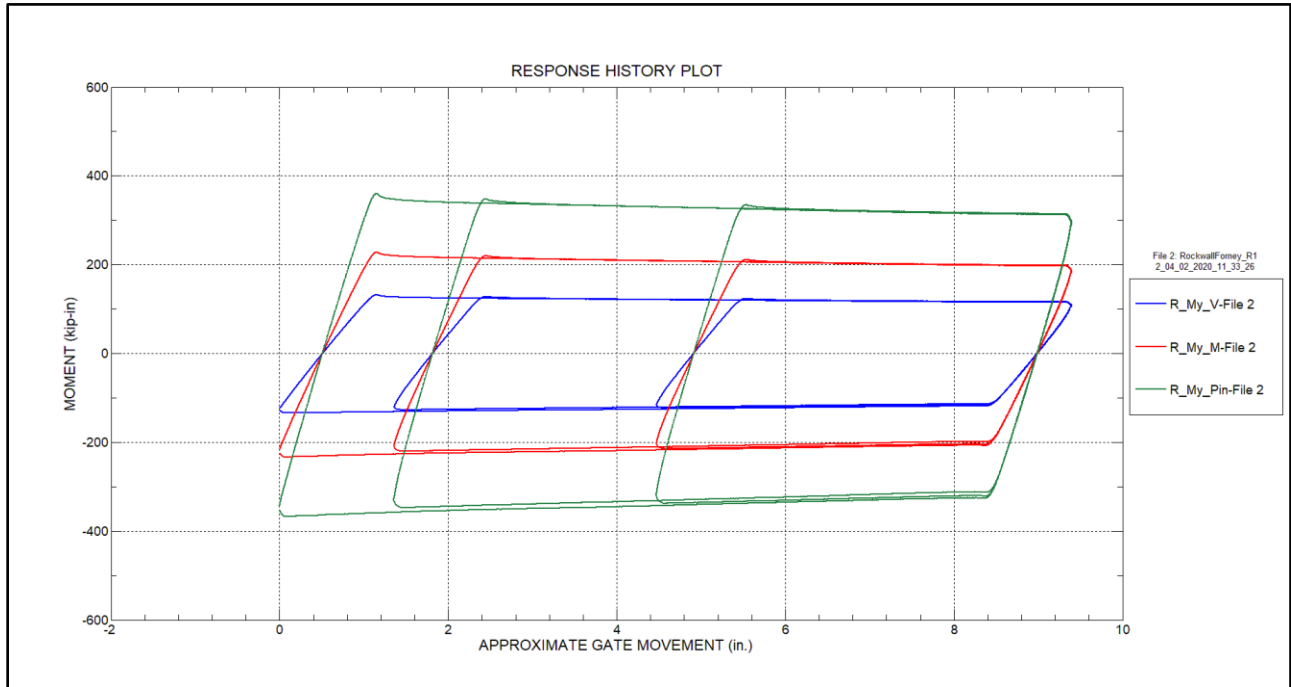
Figure 33 – Pin moment response history – Right arm – Test run 2

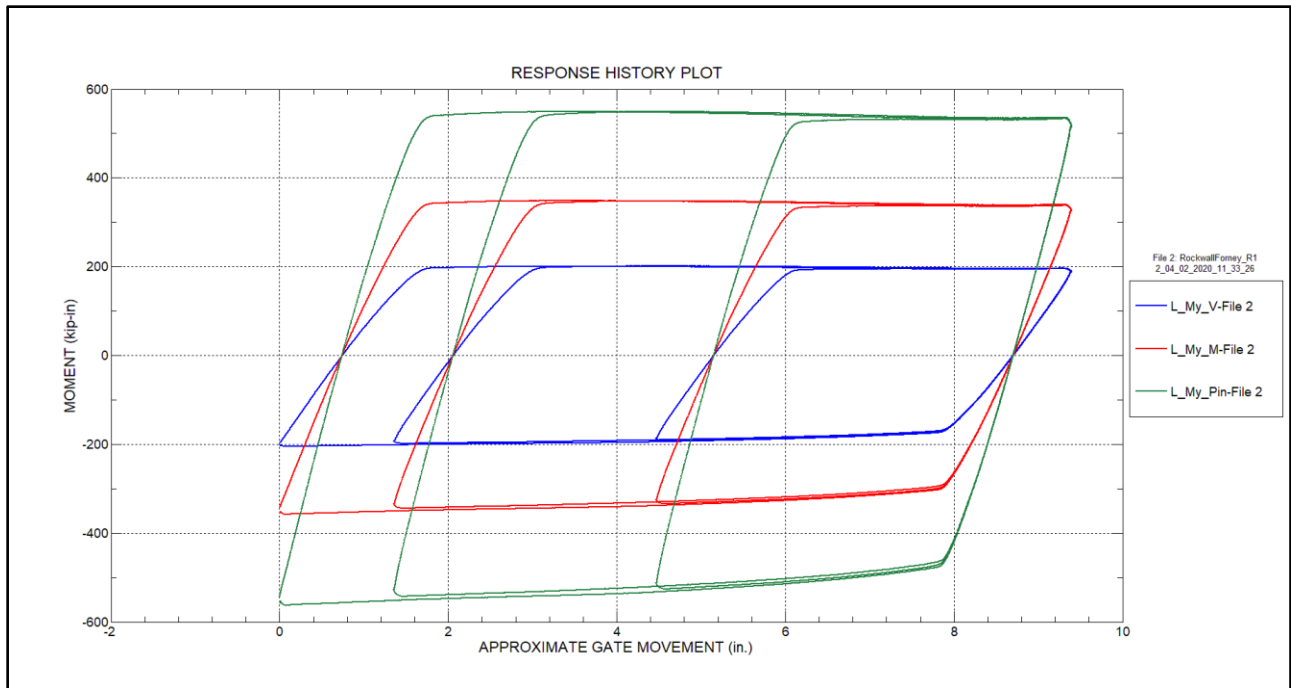
Figure 34 – Pin moment response history – Left arm – Test run 2

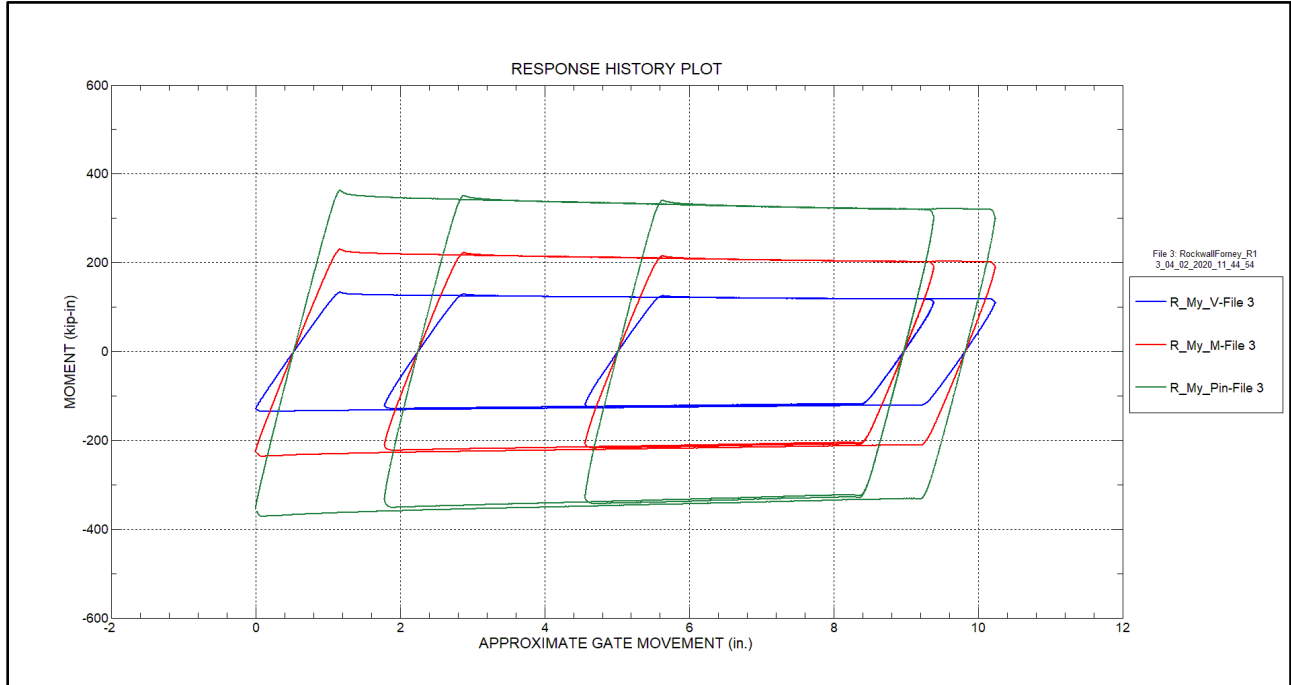
Figure 35 – Pin moment response history – Right arm – Test run 3

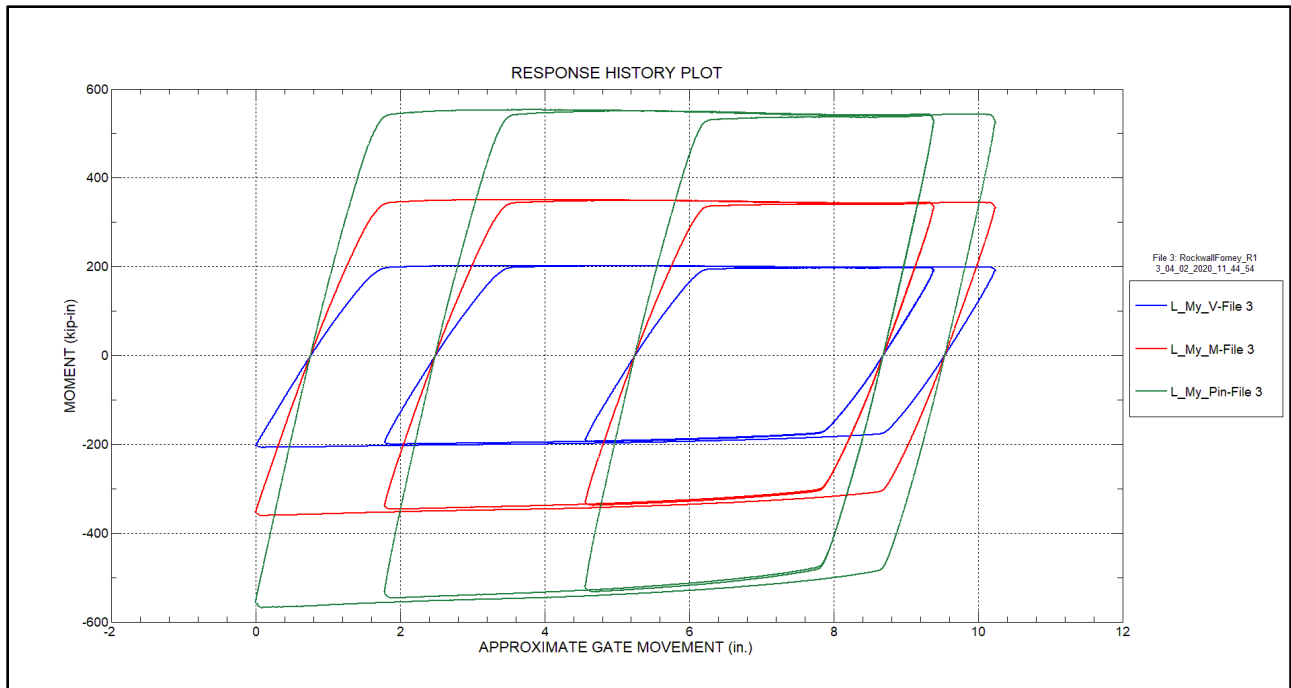
Figure 36 – Pin moment response history – Left arm – Test run 3

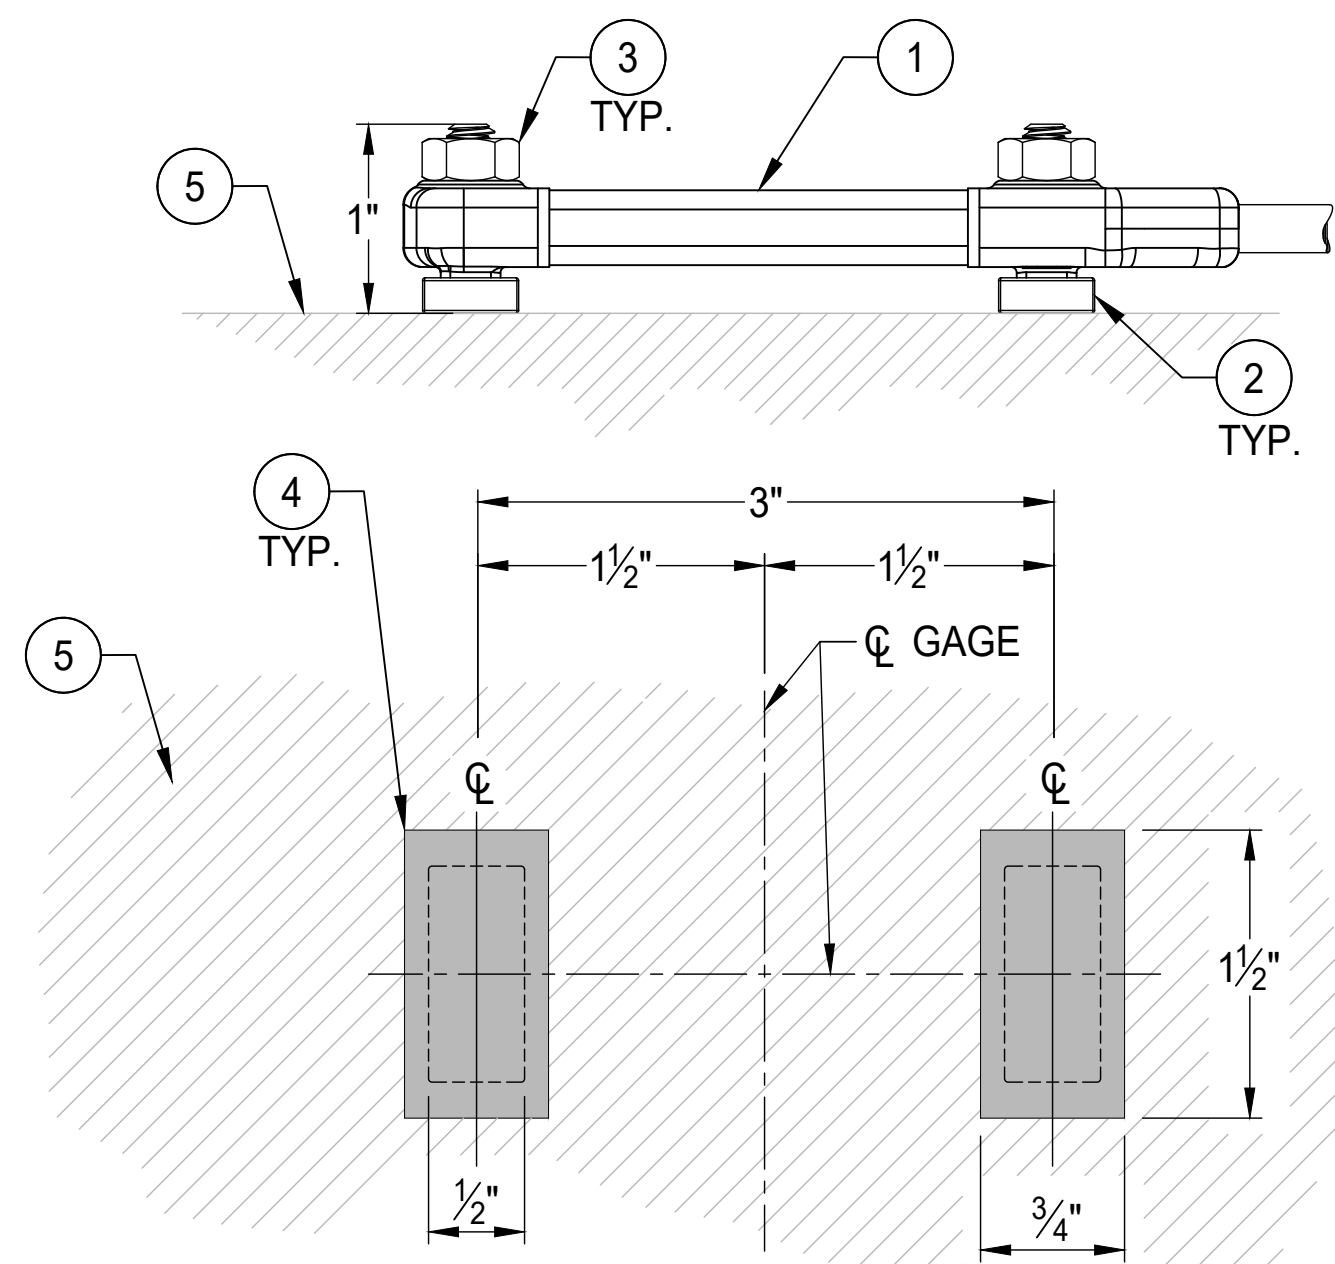
1 TYPICAL ST350 STRAIN GAGE INSTALLATION

1. ST350 STRAIN GAGE
2. 1/4"-20 THREADED MOUNTING TAB
3. 1/4"-20 STAINLESS STEEL NUT
4. TYPICAL SURFACE PREP REQUIRED TO MOUNT STRAIN GAGES
5. TYPICAL MOUNTING SURFACE

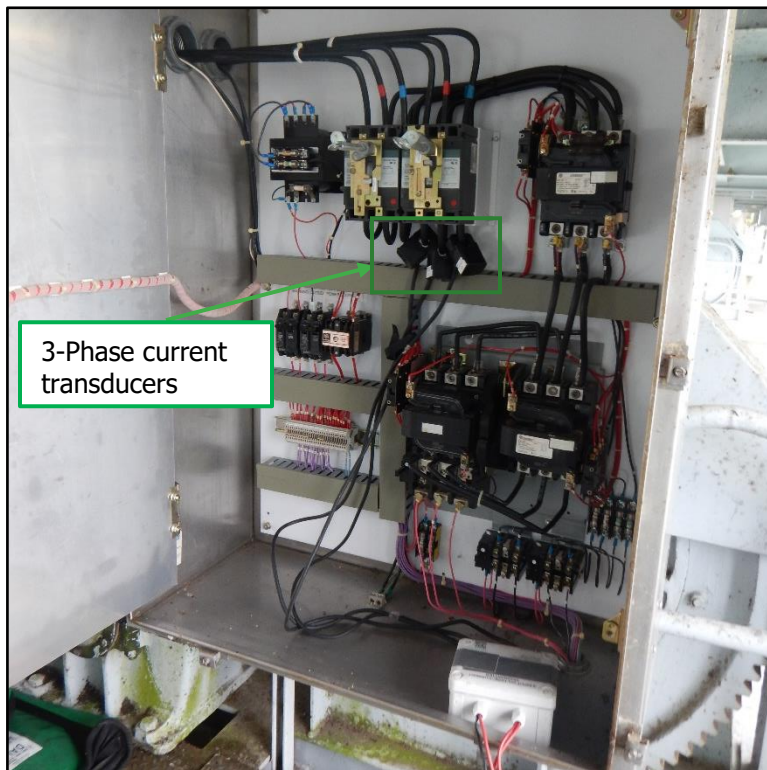
Figure 4 – Current transducers installed on hoist motor controls (Typical)

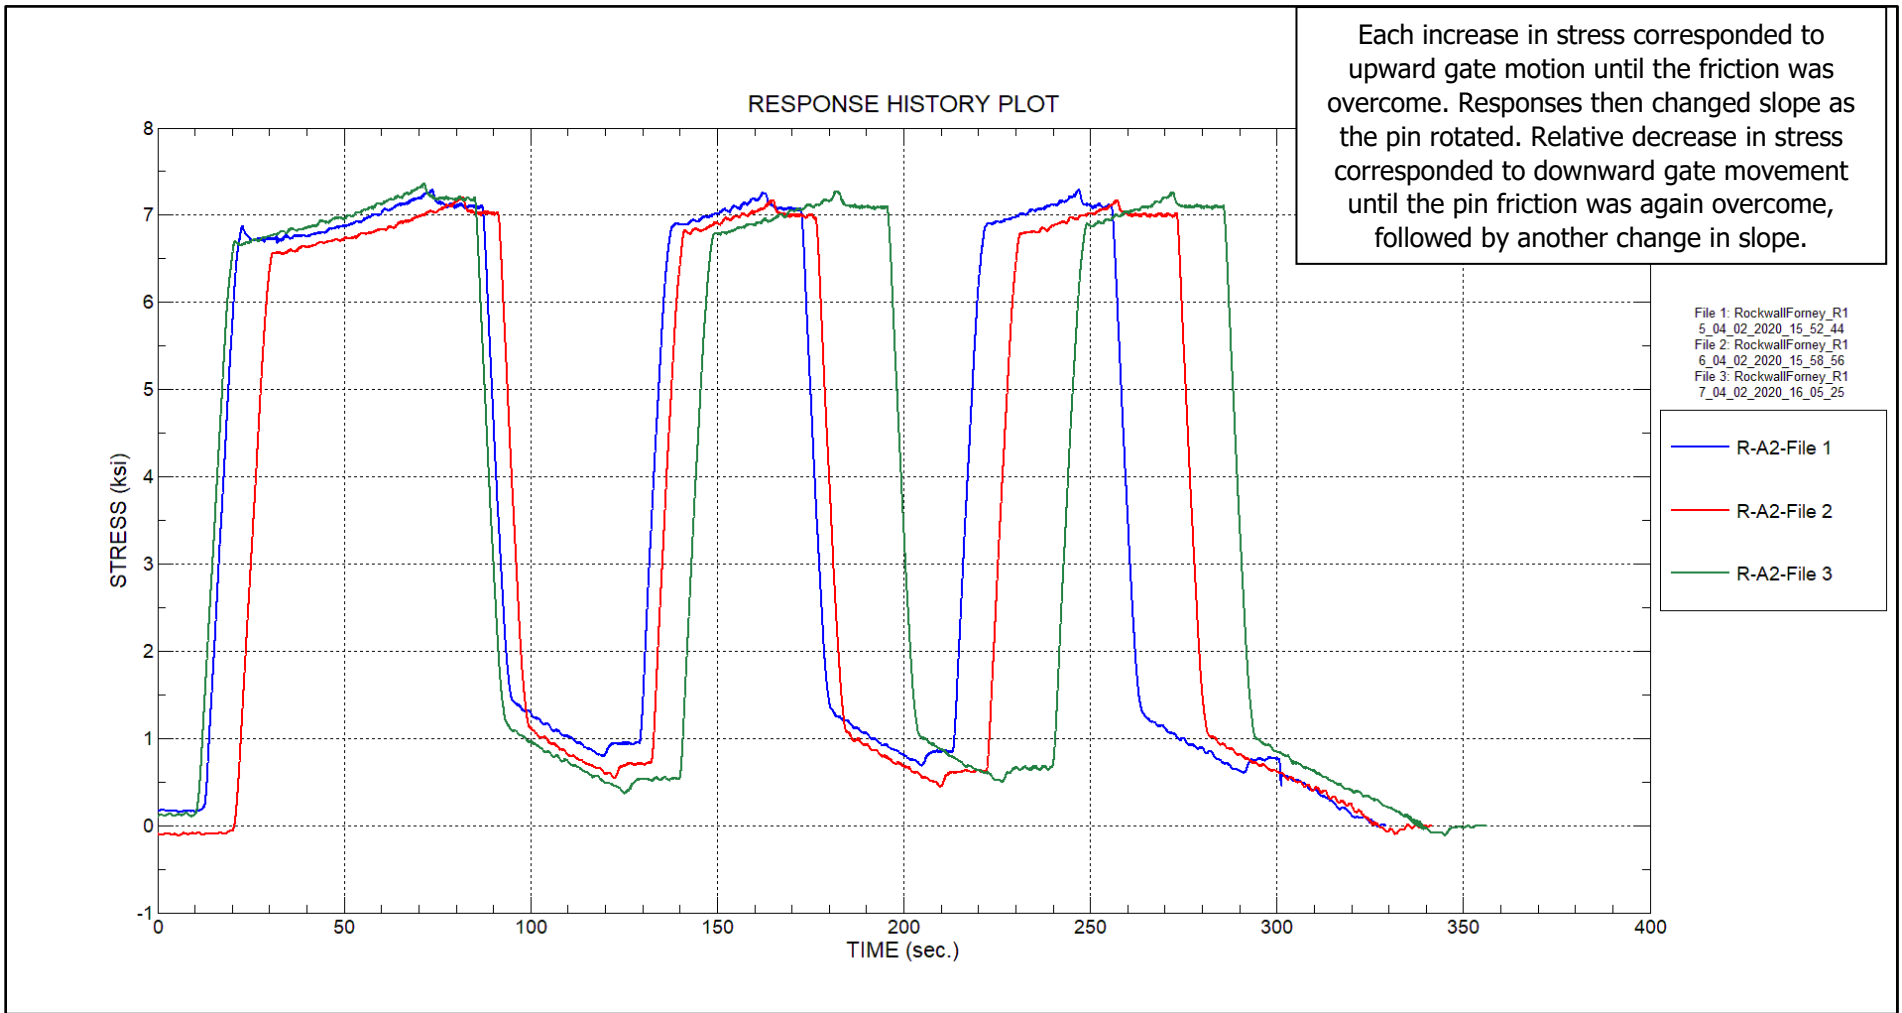
Figure 6 – Stress response history – Right arm – Gage A2 – Time based
File 1 = test run 1, File 2 = test run 2, File 3 = test run 3
(Section A along top strut near pin – Sensor location 2 along bottom of inner flange)
