VISUAL INSPECTION AND EVALUATION REPORT

Rockwall-Forney Dam
Dallas Water Utilities
Dallas/Kaufman Counties, Texas

Schnabel Reference #20C22001.00
July 30, 2021

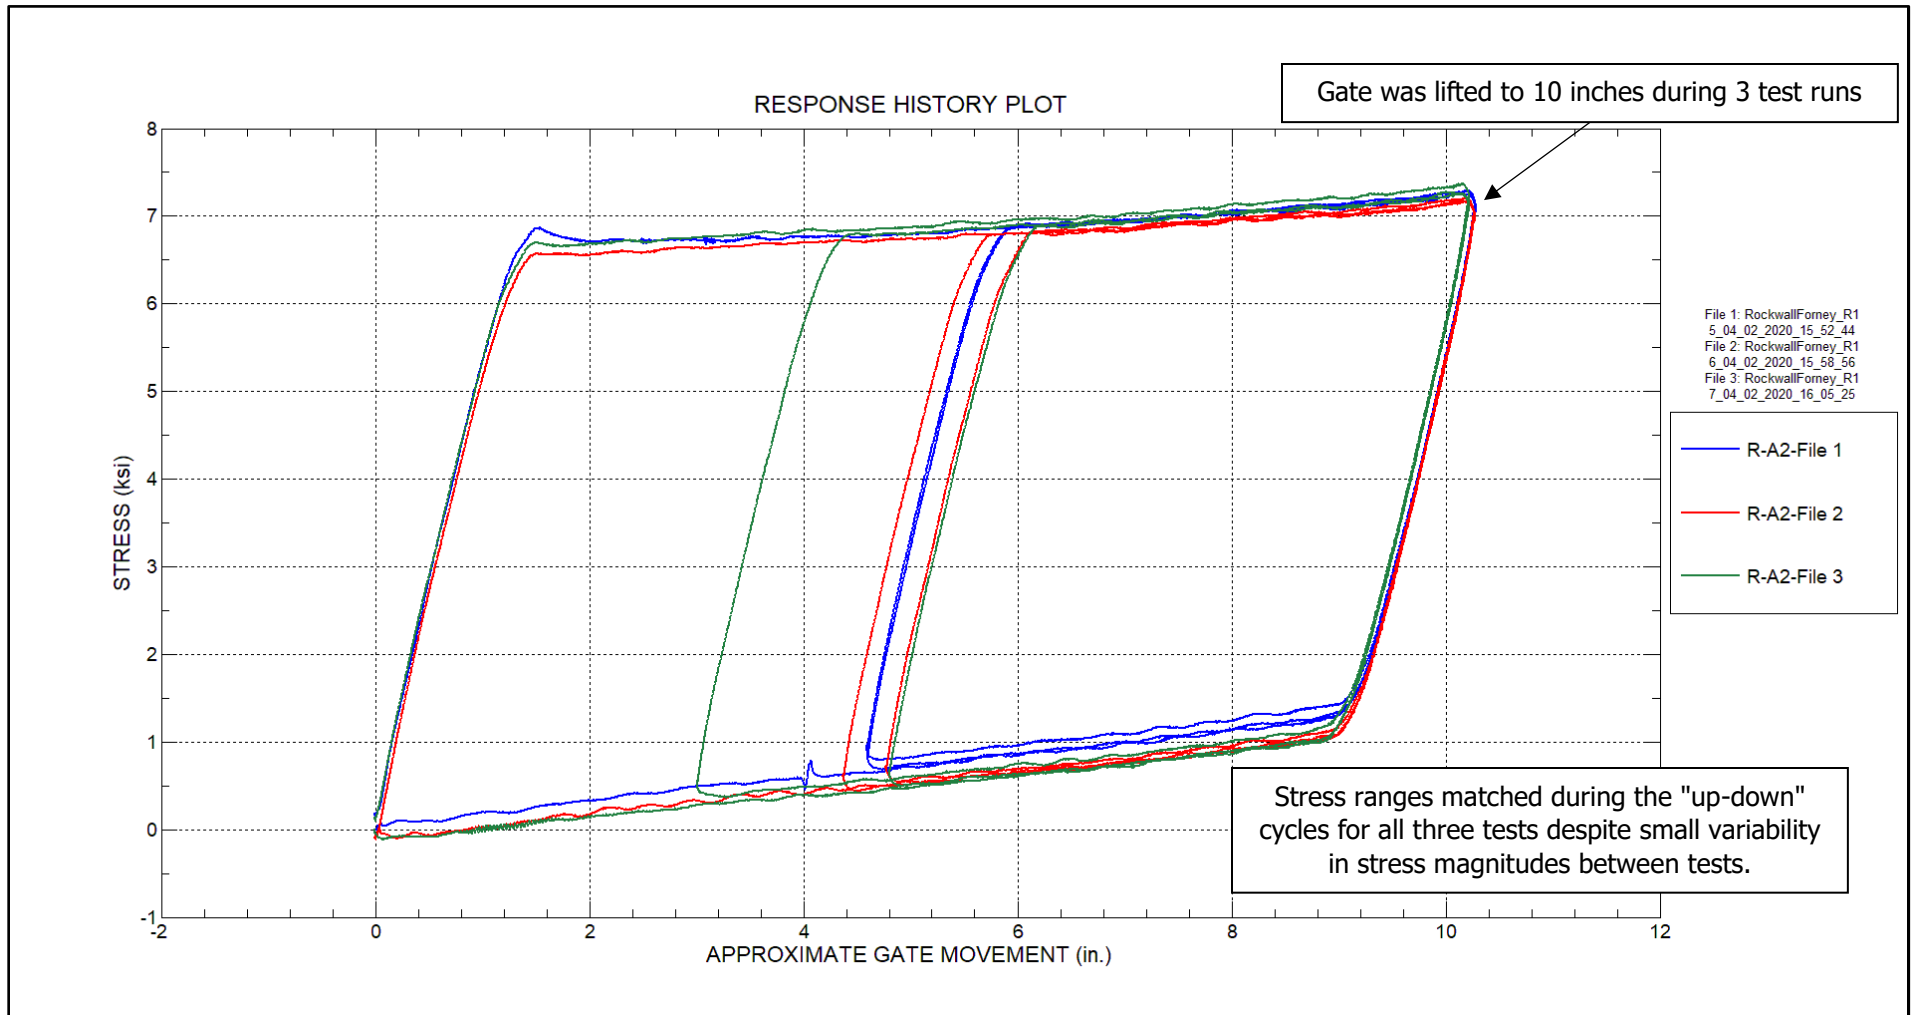
Figure 7 – Stress response history – Right arm – Gage A2 – Function of gate movement
 File 1 = test run 1, File 2 = test run 2, File 3 = test run 3
 (Section A along top strut near pin – Sensor location 2 along bottom of inner flange)

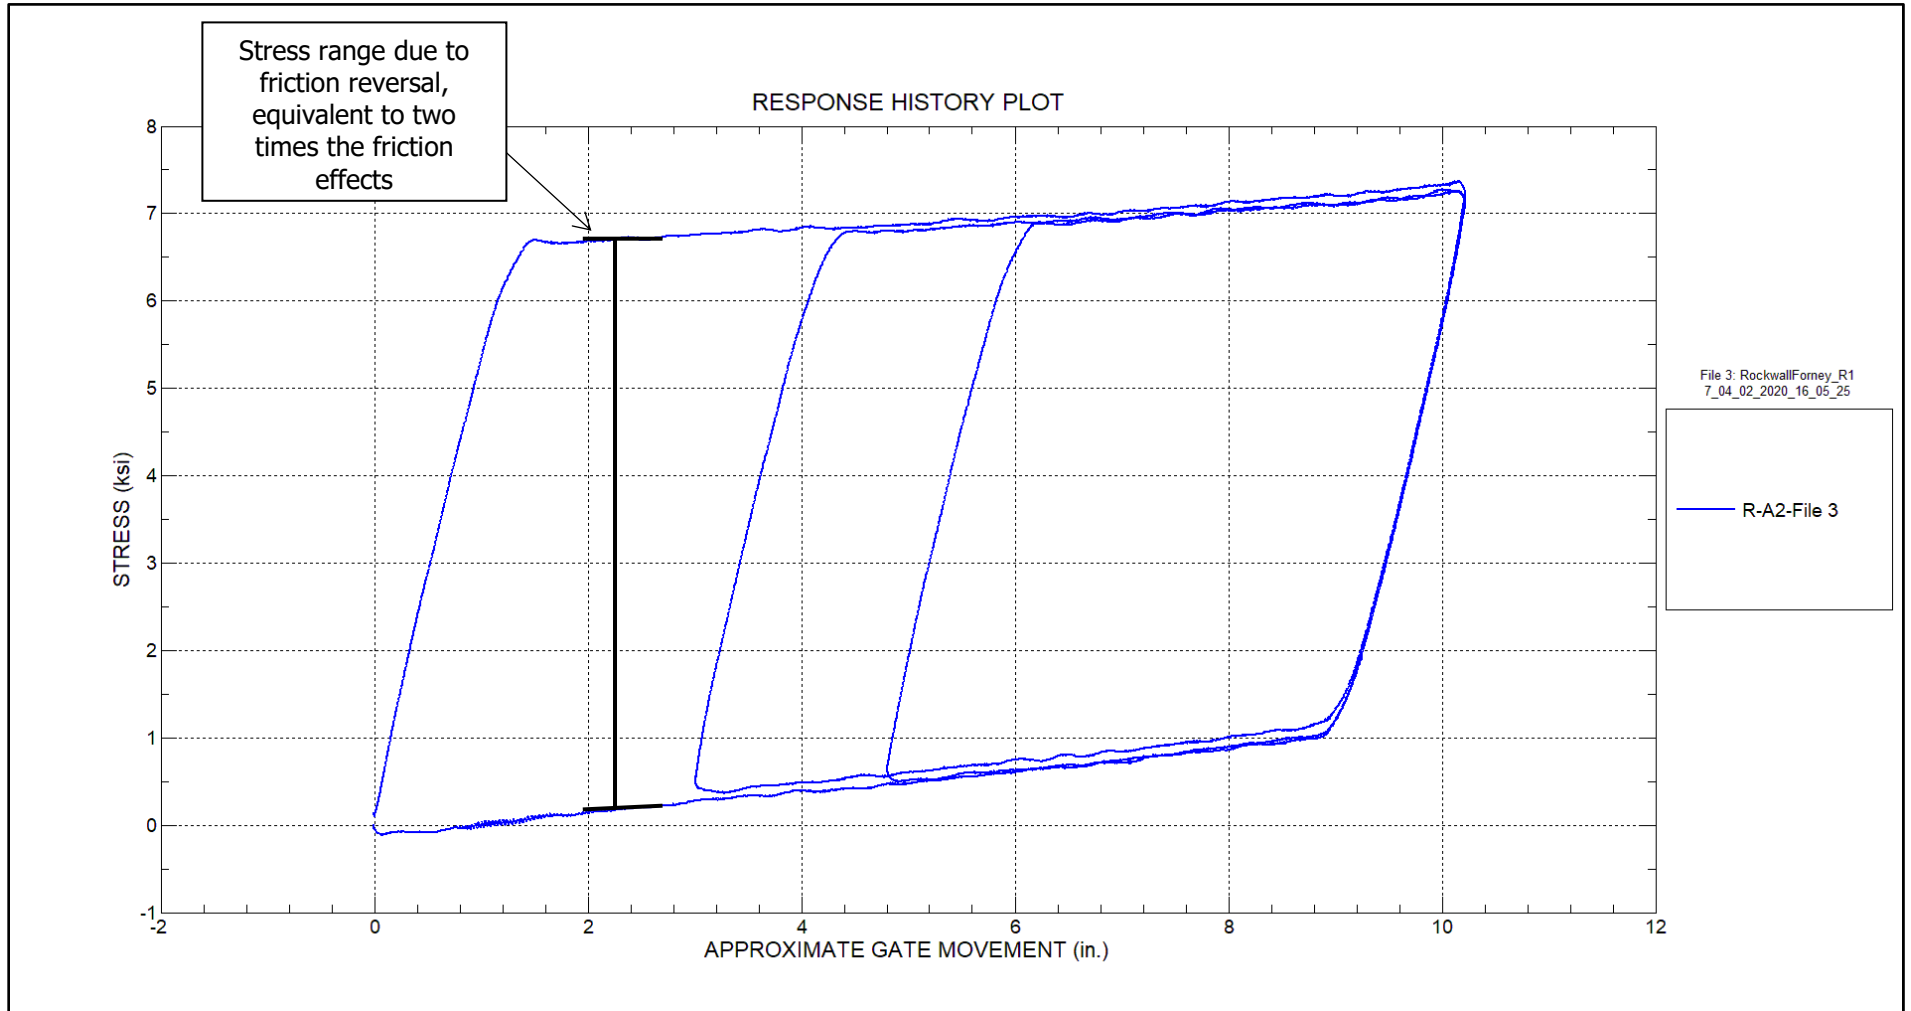
Figure 8 – Stress response history – Right arm – Gage A2 – Friction effect in stress responses
(Section A along top strut near pin – Sensor location 2 along bottom of inner flange)

- + **DIRECTION/FRICTION REVERSAL IN RESPONSES:** The difference in stress during gate opening and closing for a given position is shown in Figure 8. The stress variation at any given gate position was a result of direction reversal and in turn due to trunnion friction reversal. This statement is true since all other loads such as dead-load and hydrostatic pressure were essentially constant barring small changes in hydrostatic pressure due to slight changes in head. This direction/friction reversal is depicted in Figure 9, with deflected shape renderings from a gate arm finite element model under lifting and lowering loads. Note that this figure shows an arm configuration that does not match this gate, but the concept of the direction/friction reversal still applies.

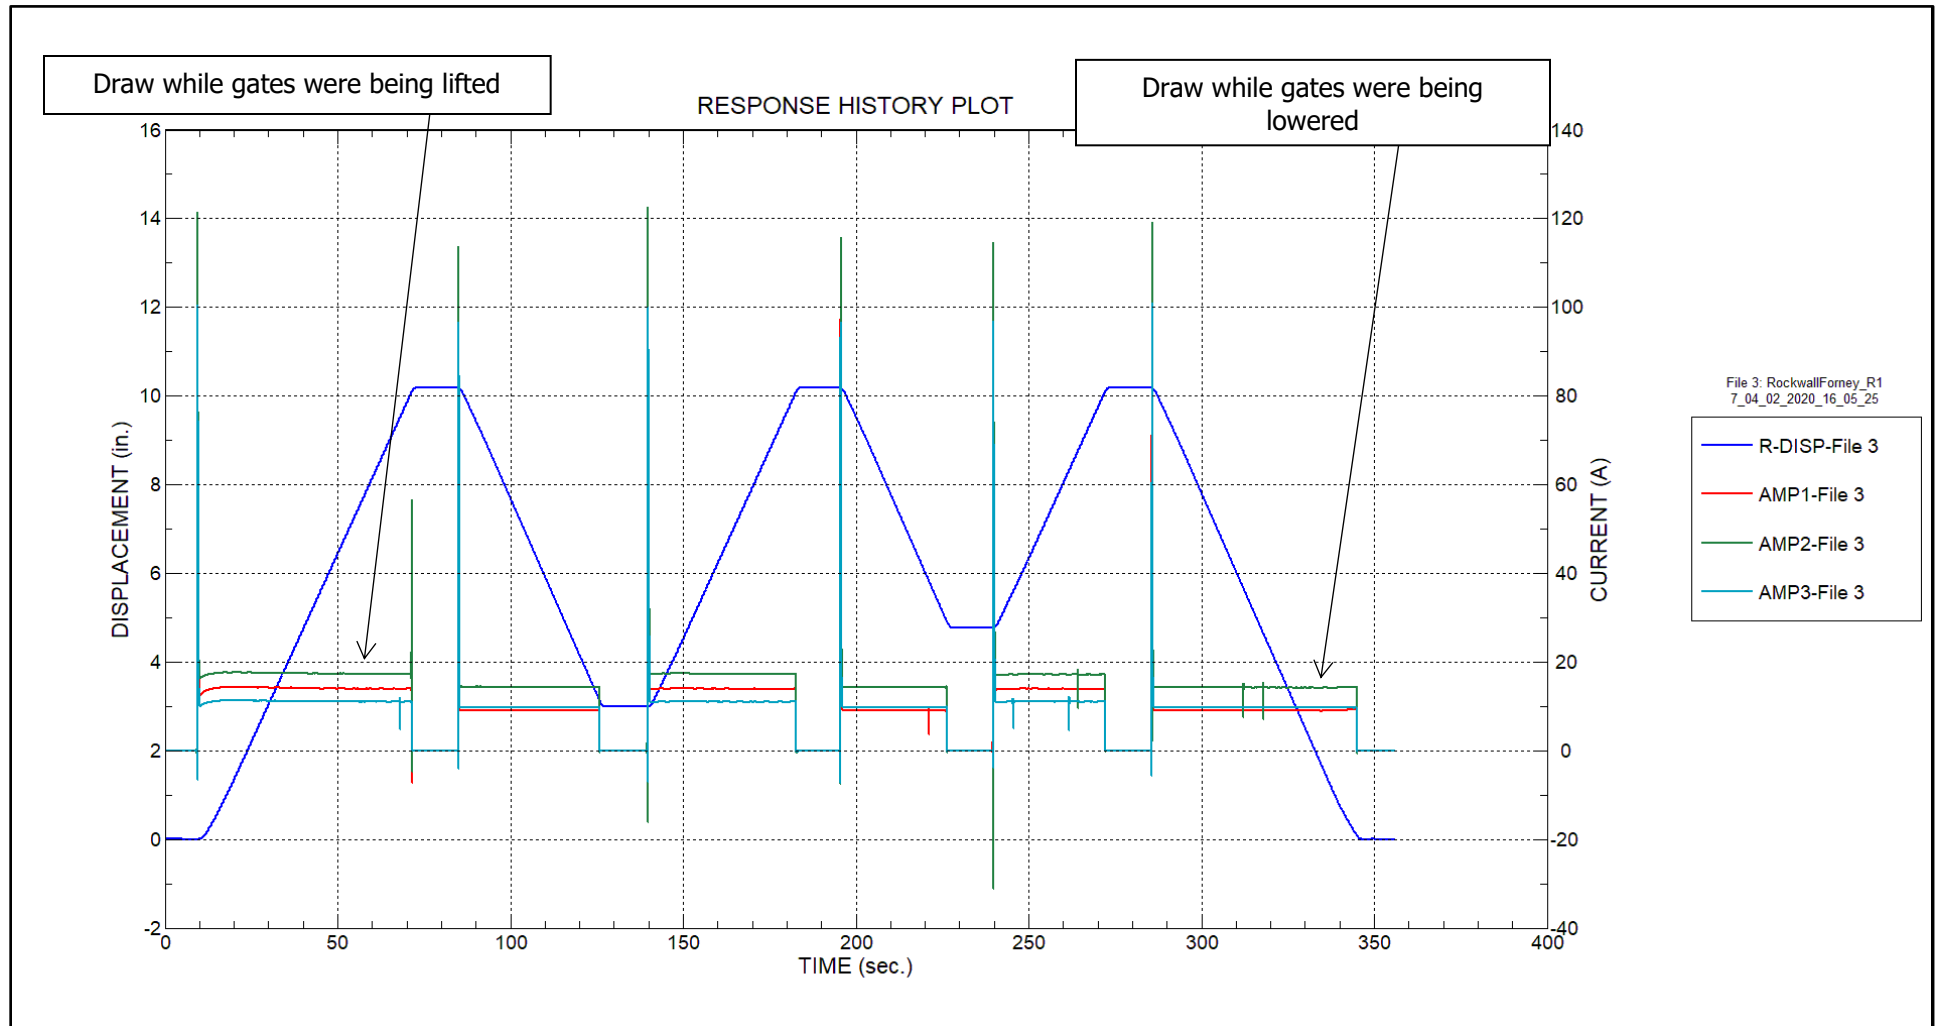
Figure 10 – Motor current & gate movement response history – Lift motor – Highlighting motor draw during lift and lower cycles

- + **MOTOR PERFORMANCE:** Current measurements taken at the hoist motor indicated steady and stable current draws during the lifting and lowering portions. An example plot of current draw and gate position is provided in Figure 10. Current draw ranges during lifting were higher than the ranges during lowering, which is common due to gravity/dead load. These results are summarized along with recorded peak in-rush current in Table 2. Note that the sample rates used during testing were set for collecting gate responses and may not have been appropriate to fully capture the in-rush current. The readings should be evaluated by a licensed electrician with knowledge of the operating parameters.

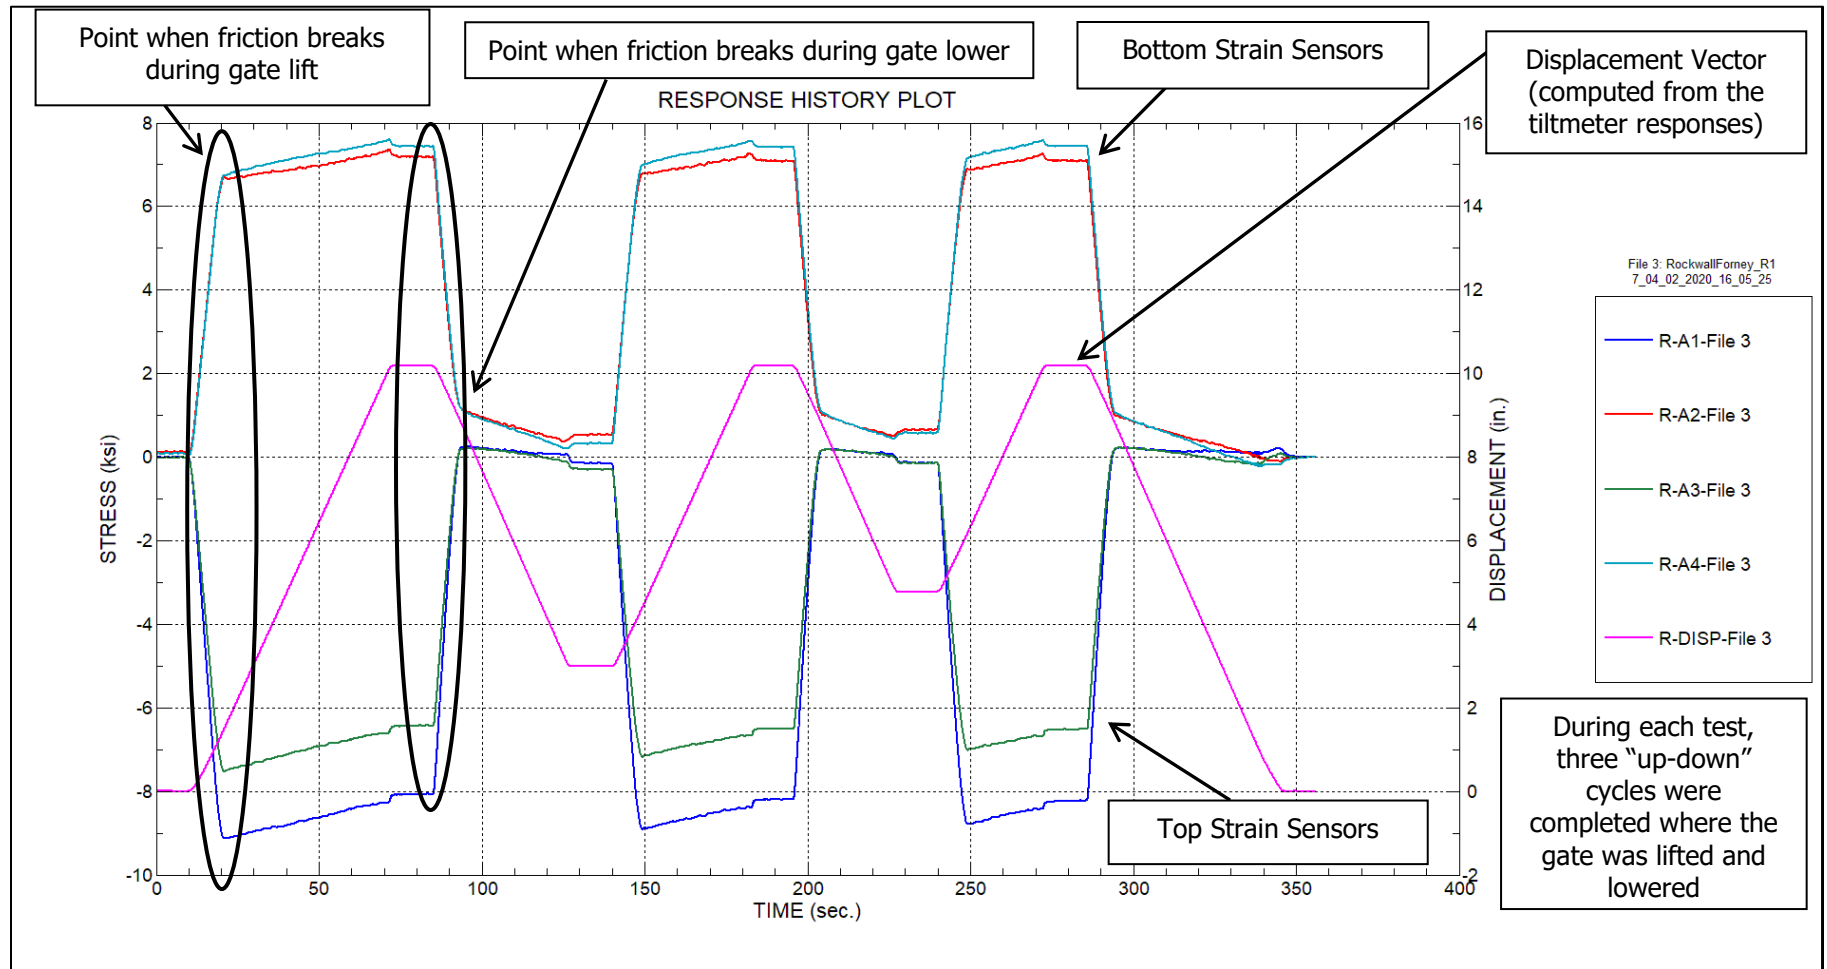
Figure 11 – Stress response & gate movement history – Right arm – Section A - Highlighting friction behavior (Section A along top strut near pin)

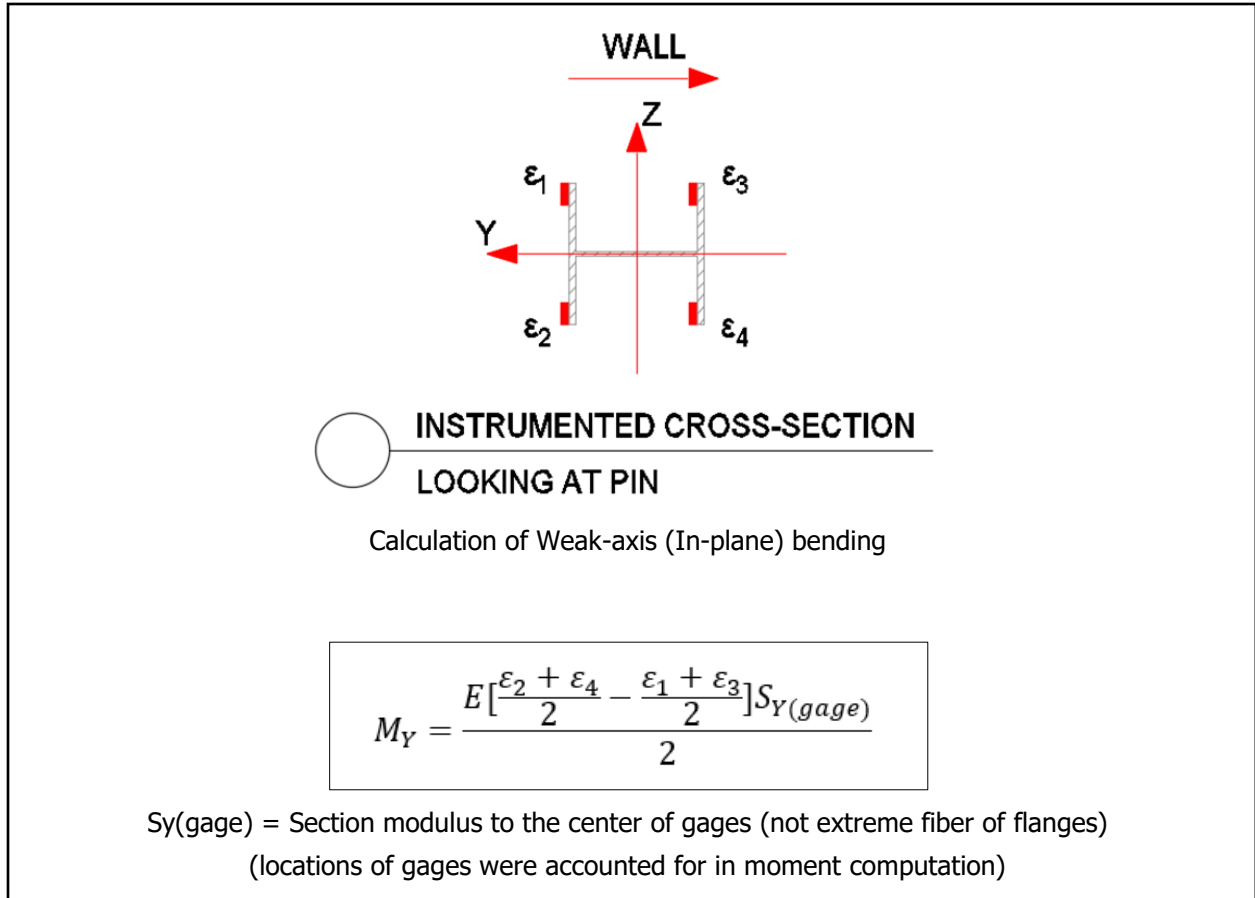
Figure 12 – Basic mechanic equation used to calculate moment

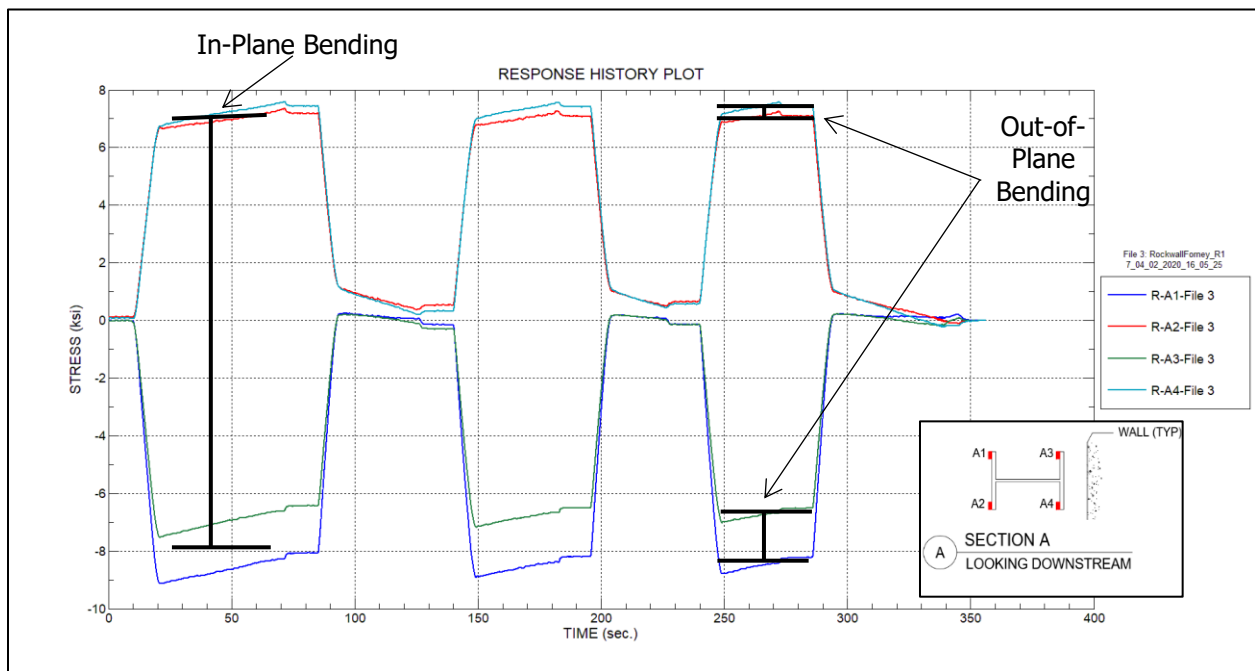
Figure 13 – Stress response history – Right arm – Section A – Bending components
(Section A along top strut near pin)

In-plane or weak-axis flexure refers to bending about a given strut's web. This designation is consistent with typical nomenclature. In-plane bending can be observed visually from the strain response histories as a difference between the top and bottom stresses, whereas out-of-plane or strong-axis bending is visualized as the difference in stress from side to side. Figure 13 provides a visual reference for both types of strut flexure.

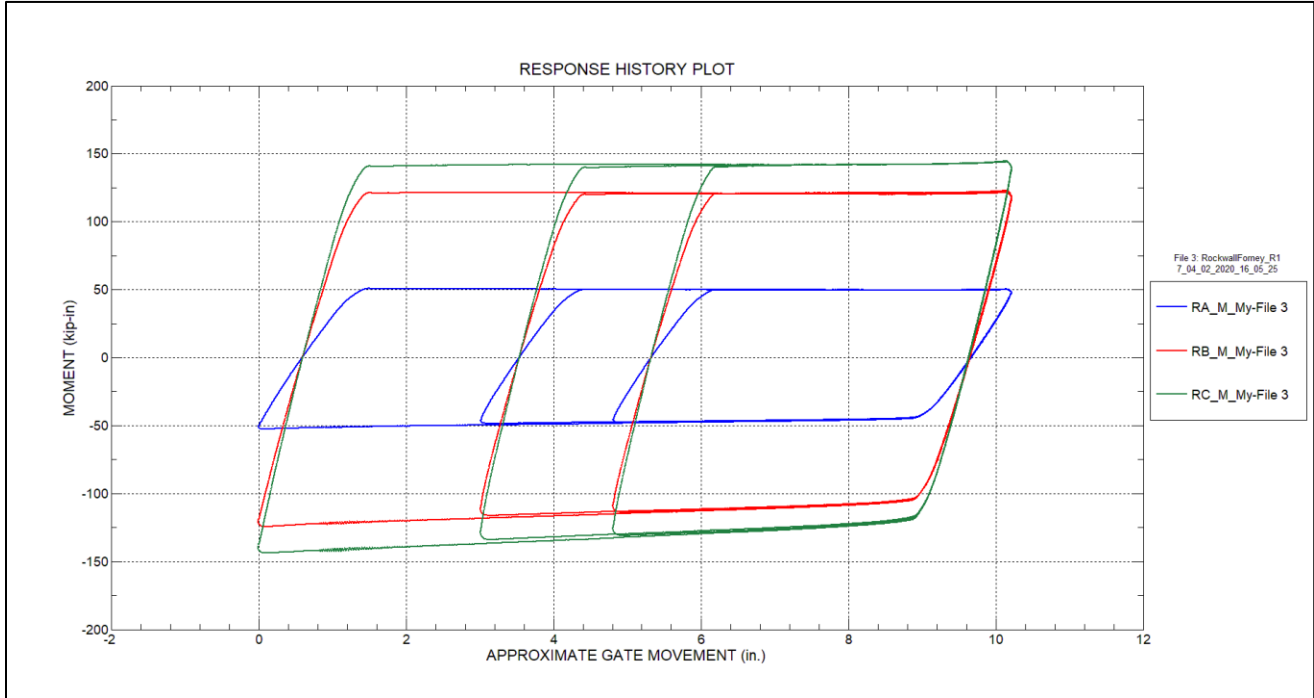
Figure 14 – In-plane moment response history – Right arm – Sections near pin
(RA = Right Arm Top Strut, RB = Right Arm Middle Strut, RC = Right Arm Bottom Strut)

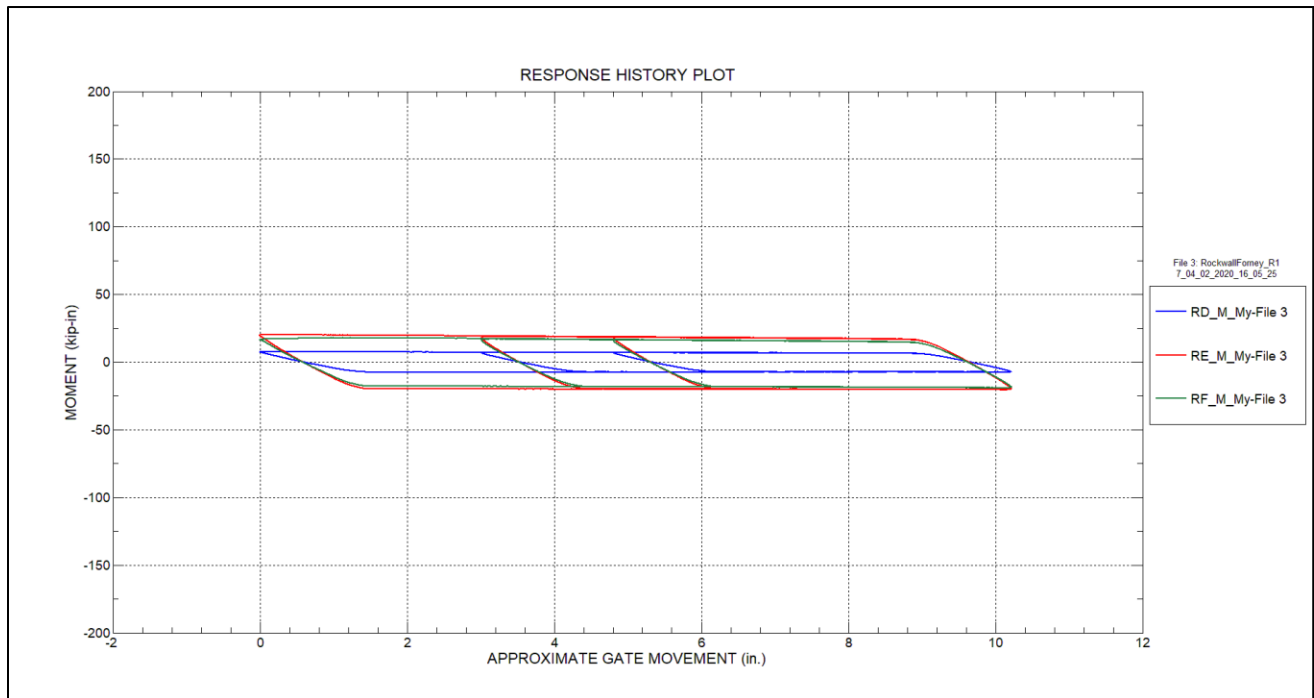
Figure 15 – In-plane moment response history – Right arm – Sections away from pin
(RD = Right Arm Top Strut, RE = Right Arm Middle Strut, RF = Right Arm Bottom Strut)

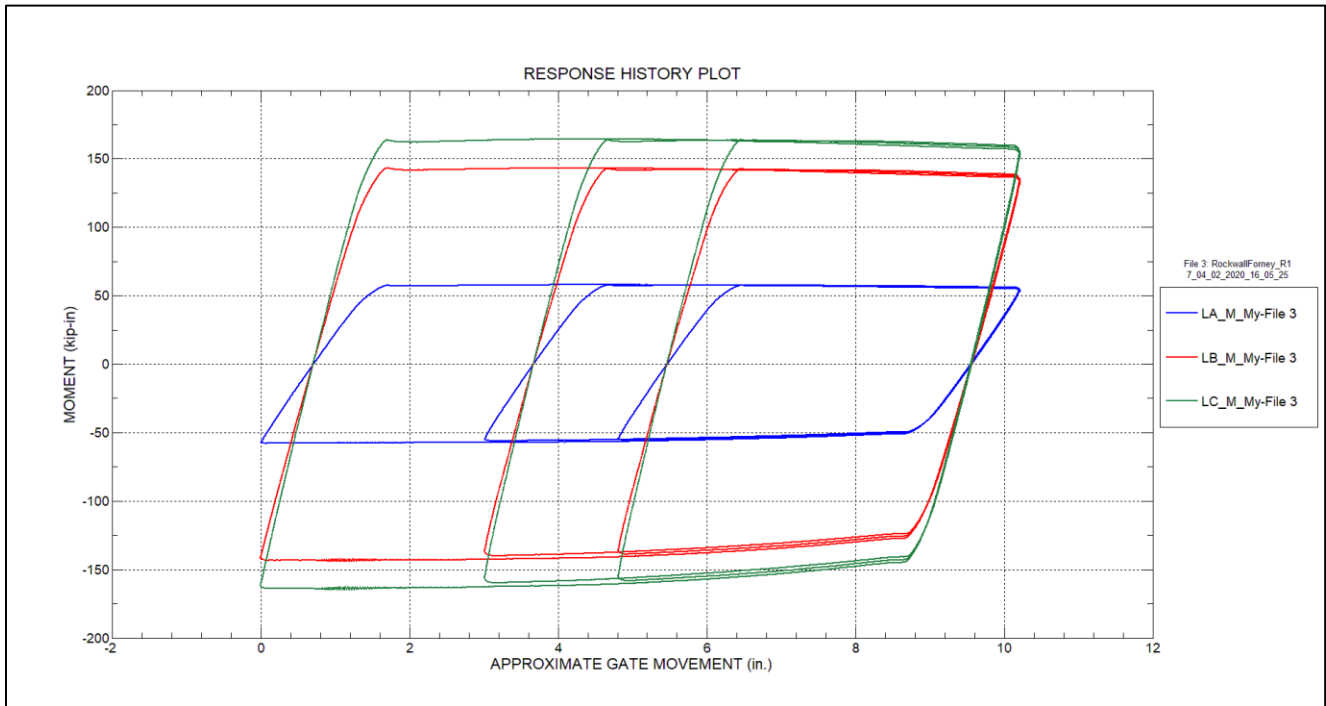
Figure 16 – In-plane moment response history – Left arm – Sections near pin
(LA = Left Arm Top Strut, LB = Left Arm Middle Strut, LC = Left Arm Bottom Strut)

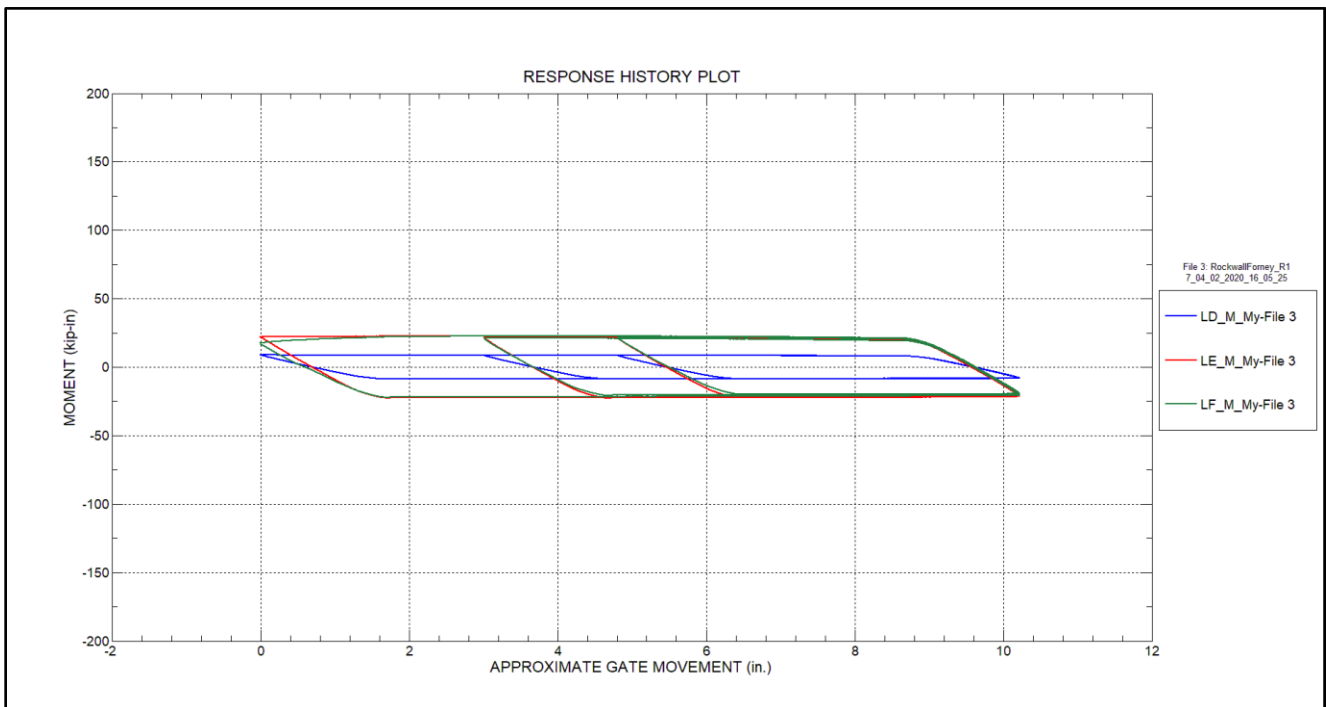
Figure 17 - In-plane moment response history – Left arm – Sections away from pin
(LD = Left Arm Top Strut, LE = Left Arm Middle Strut, LF = Left Arm Bottom Strut)

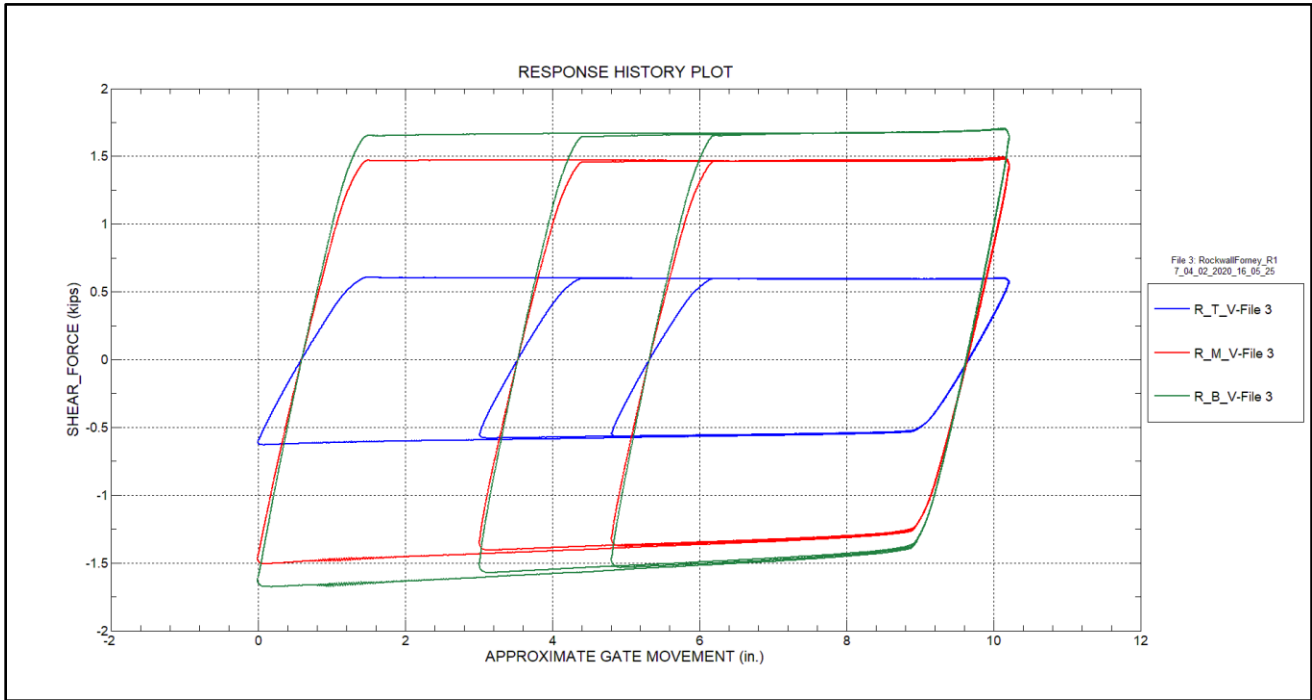
Figure 19 – Strut shear response history – Right arm

(R_T = Right Arm Top Strut, R_M = Right Arm Middle Strut, R_B = Right Arm Bottom Strut)

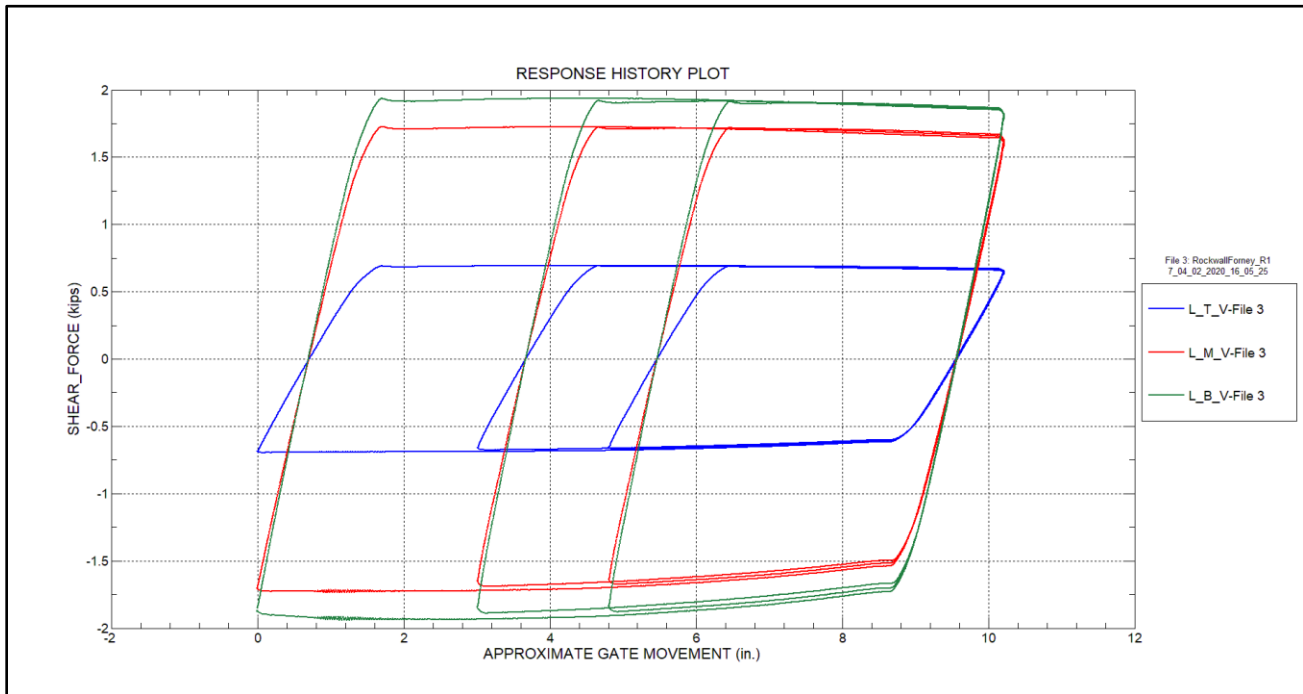
Figure 20 – Strut shear response history – Left arm

(L_T = Left Arm Top Strut, L_M = Left Arm Middle Strut, L_B = Left Arm Bottom Strut)

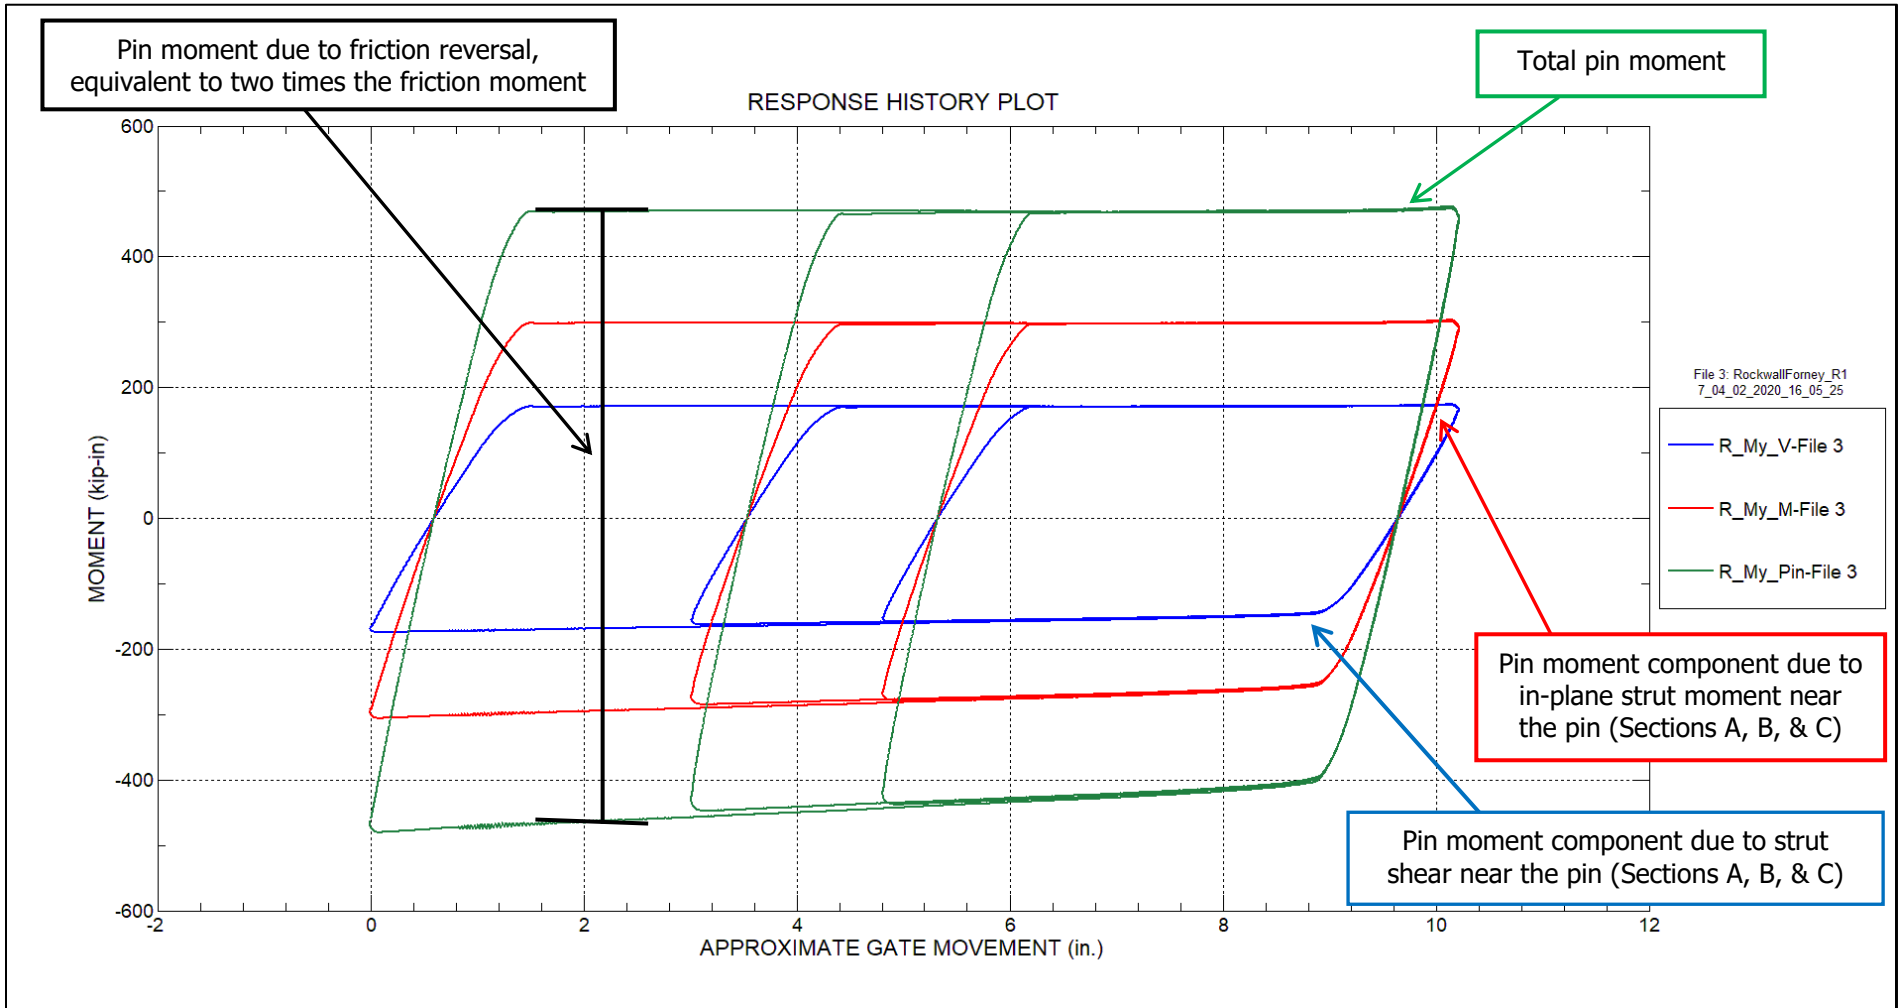
Figure 21 – Pin moment response history – Right arm

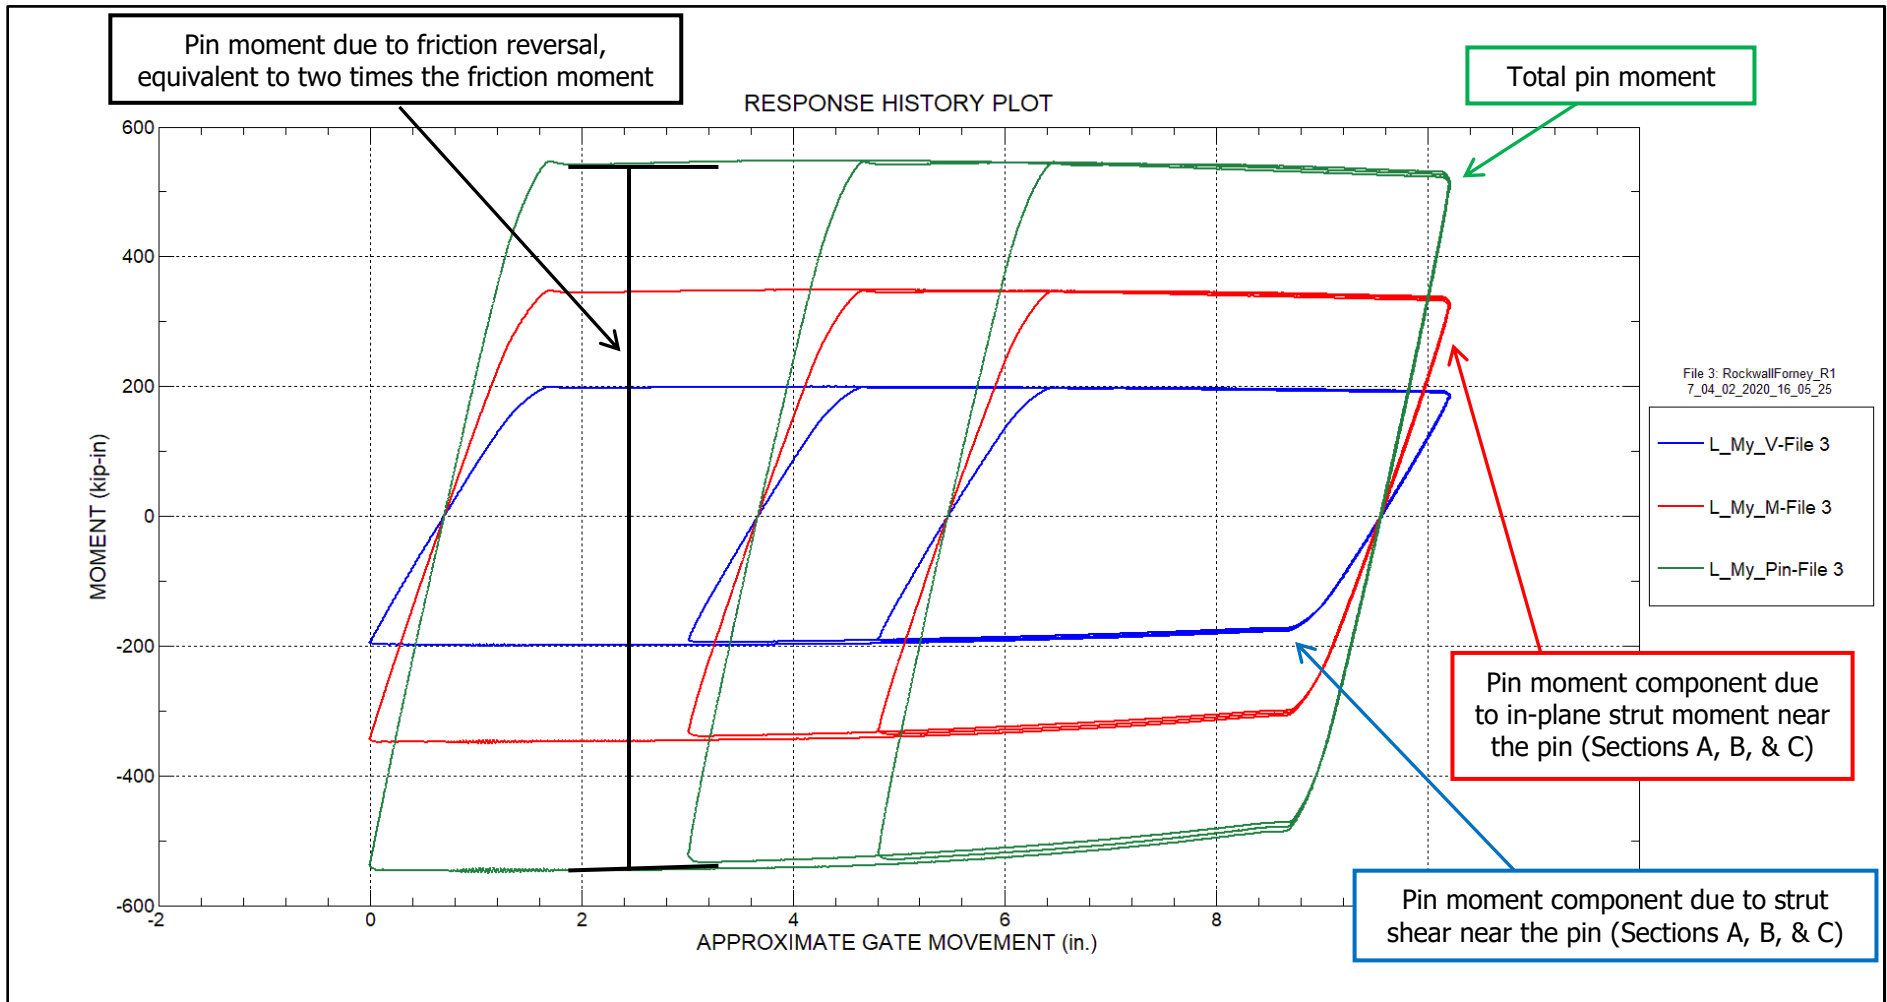
Figure 22 – Pin moment response history – Left arm

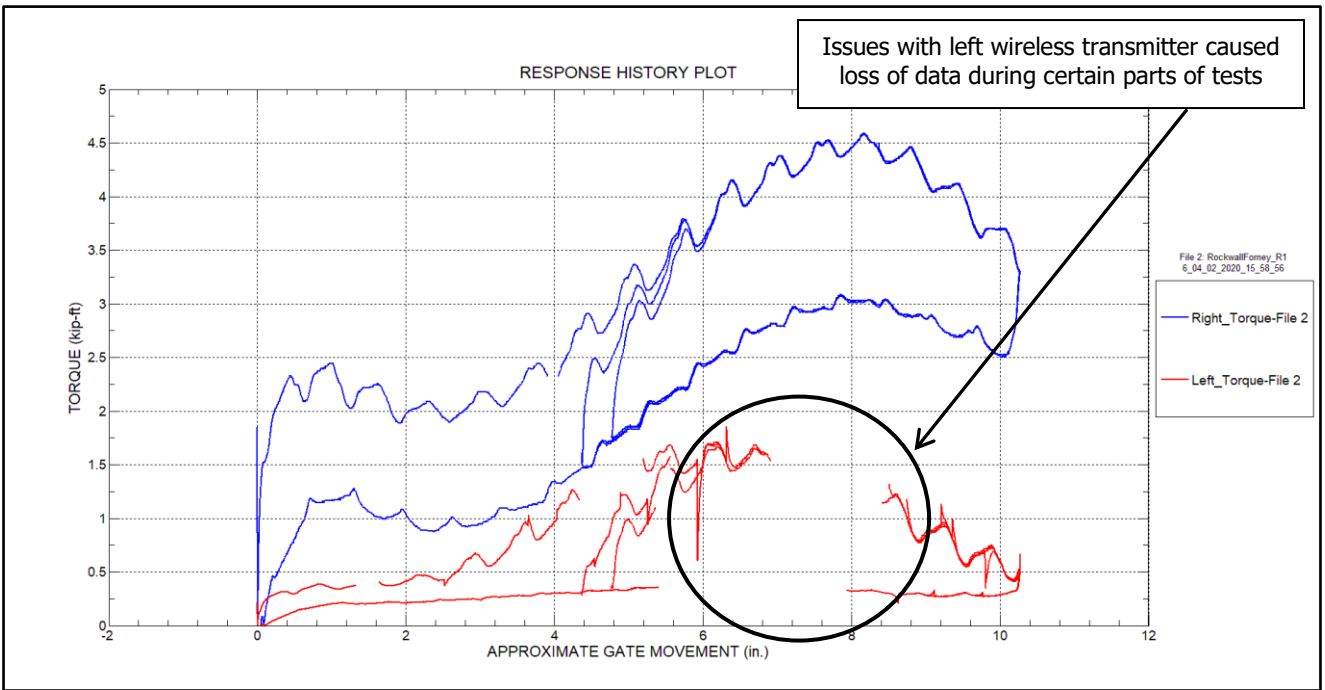
Figure 23 – Hoist torque response history – Gate 3 – Test 2

Note: missing data due to wireless connectivity issues as the sensor rotates with the pinion shaft

Figure 23 shows example torque measurements, recorded on the Gate 3 torque shafts. Best practices for torque measurements is to measure torque on opposite sides of the shaft so that any bending in the shaft can be removed by averaging the two responses. Due to access limitations, only one gage at each location could be installed. Therefore, any bending in the shaft may be reflected in the torque measurements and may be related to the peaks and valleys observed in the torque responses.

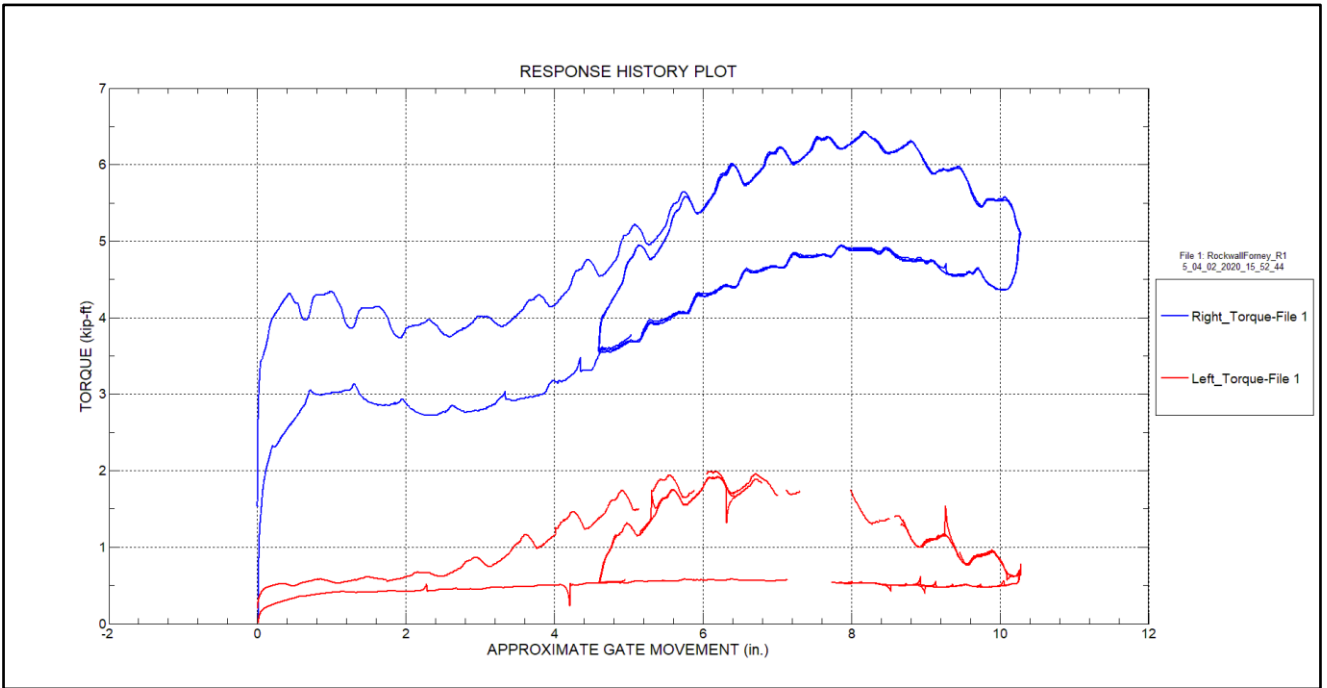
Figure 25 – Hoist torque response history – Gate 3 – Test 1

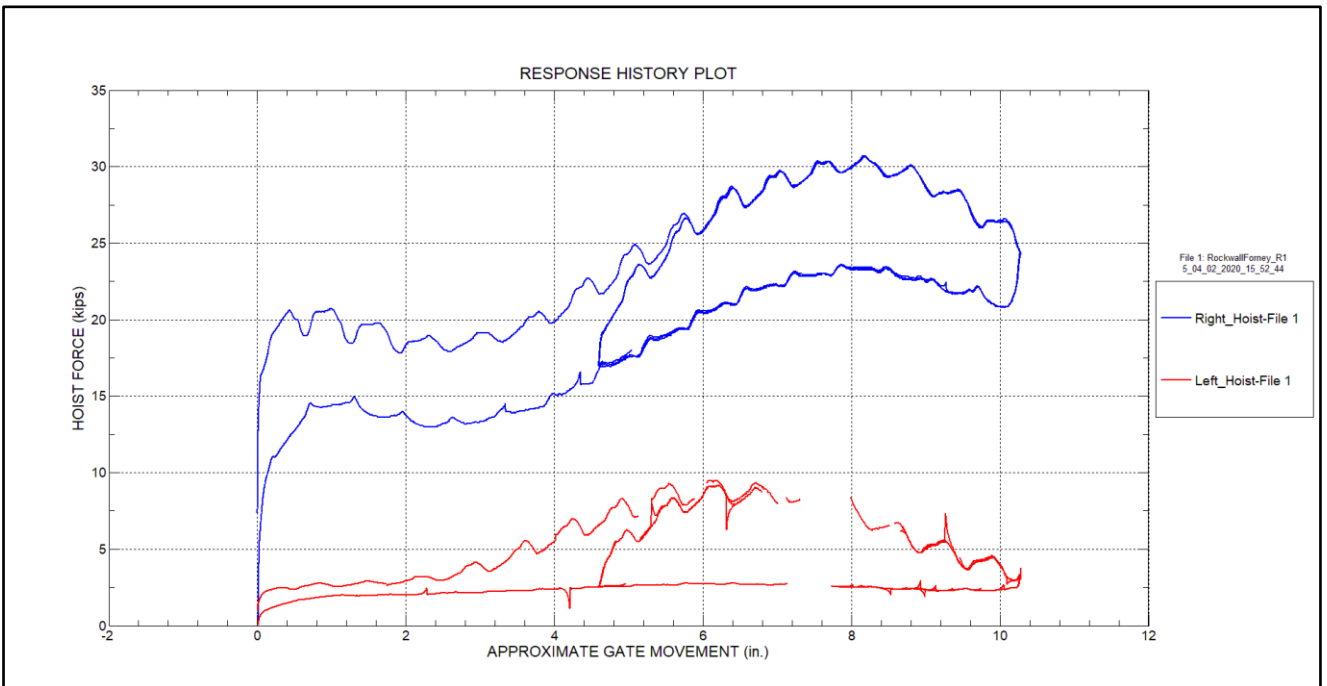
Figure 26 – Hoist force response history – Gate 3 – Test 1
