VISUAL INSPECTION AND EVALUATION REPORT

Rockwall-Forney Dam
Dallas Water Utilities
Dallas/Kaufman Counties, Texas

Schnabel Reference #20C22001.00
July 30, 2021

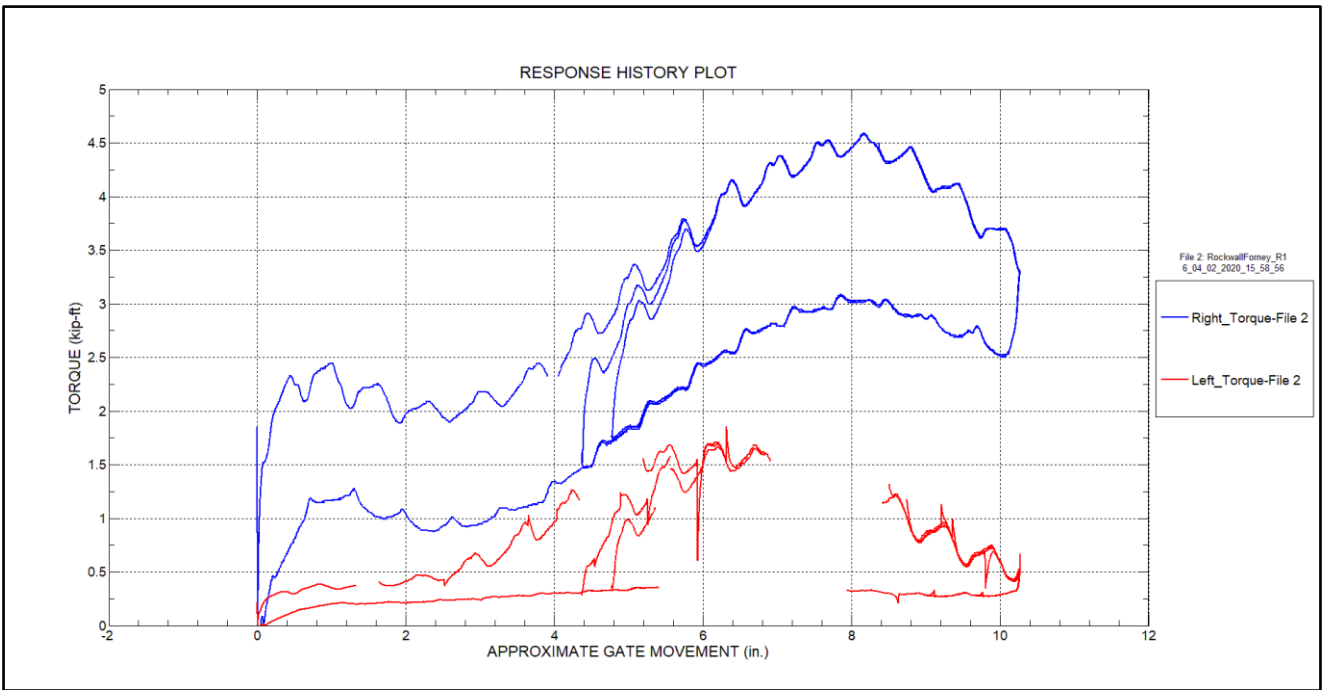
Figure 27 – Hoist torque response history – Gate 3 – Test 2

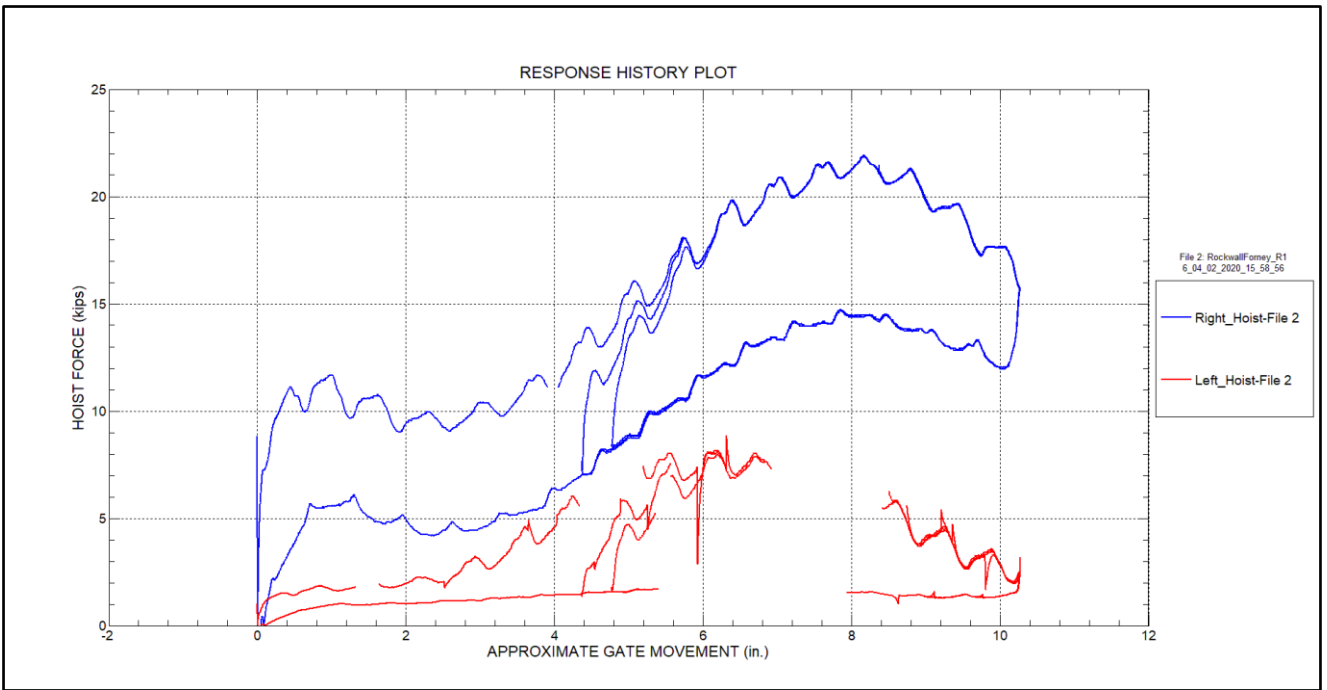
Figure 28 – Hoist force response history – Gate 3 – Test 2

Torque values were converted to force in the hoist cables per gate arm using the gear ratio and drum radius, as shown in Figure 24. The gear ratio and drum radius were 5.182 and 1.086 feet respectively, as defined in the provided as-built shop drawings. It should be noted that the hoist force calculated may be smaller than the actual hoist force applied. This difference is due to the limit switch engaging the brake before the hoist cable was fully slacked, resulting in an initial force in the cable. A hoist force due to total gate friction was then calculated. This friction hoist force was equal to half the differential in force measured during the lifting and lowering of the gate (similar to the pin friction calculations). As shown in Table 3, the change in cable force due to friction was generally consistent between tests. Note that the total hoist force was due to the total friction effects, including side seal, hoist bearings, trunnion friction effects, etc. It is difficult to determine the exact proportion and composition of the total friction sources. Additional torque and hoist force plots for all collected data files are provided in Appendix A – Gate 3 Torque and Hoist Force Plots.

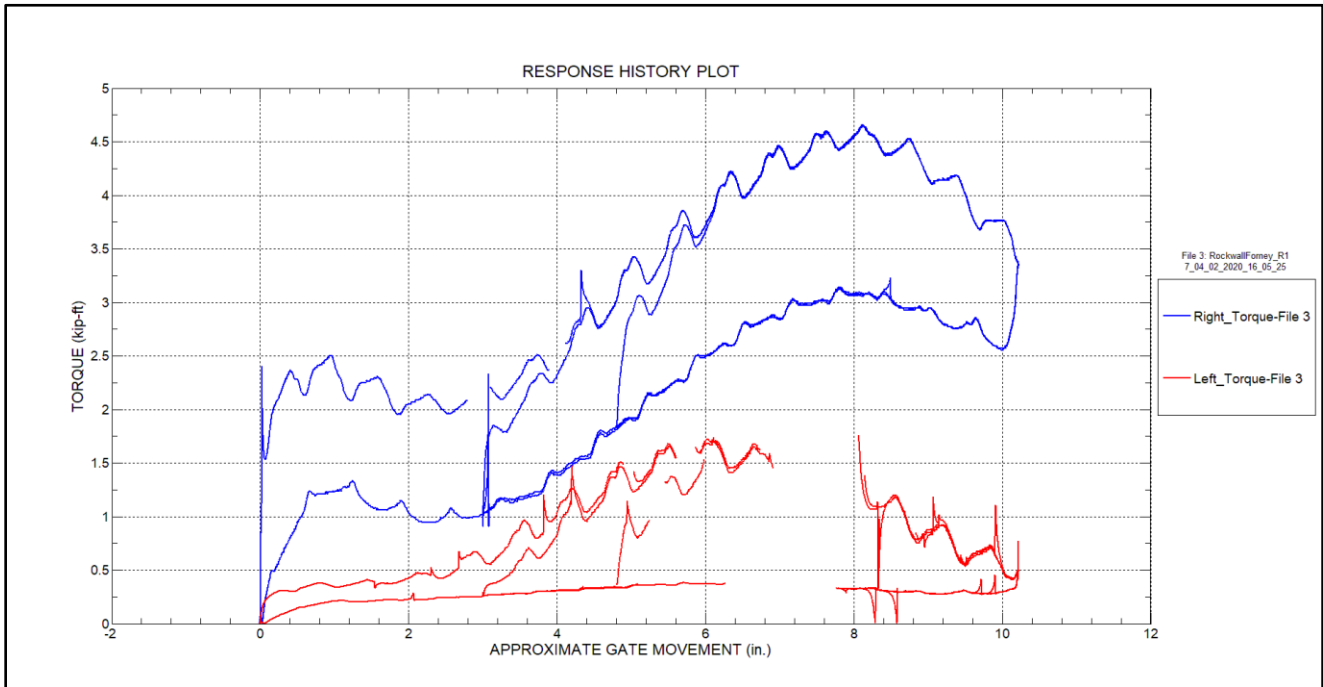
Figure 29 – Hoist torque response history – Gate 3 – Test 3

Figure 23 shows example torque measurements, recorded on the Gate 3 torque shafts. Best practices for torque measurements is to measure torque on opposite sides of the shaft so that any bending in the shaft can be removed by averaging the two responses. Due to access limitations, only one gage at each location could be installed. Therefore, any bending in the shaft may be reflected in the torque measurements and may be related to the peaks and valleys observed in the torque responses.

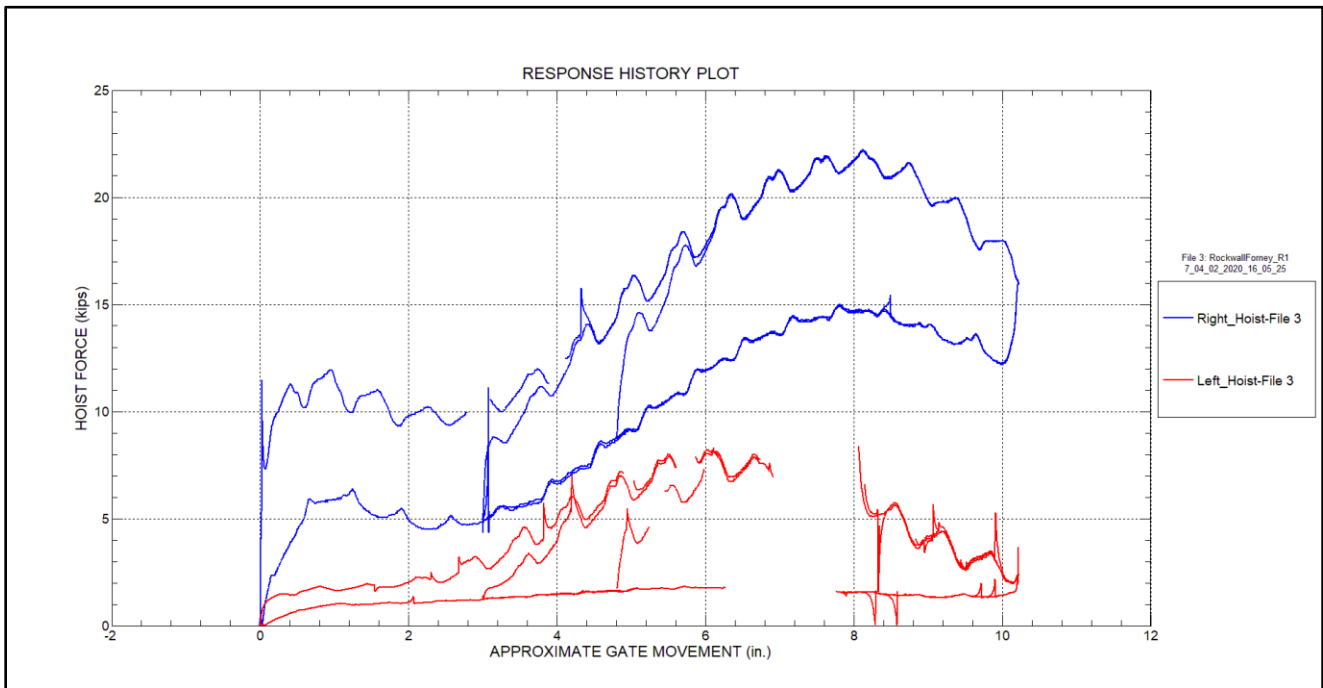
Figure 30 – Hoist force response history – Gate 3 – Test 3

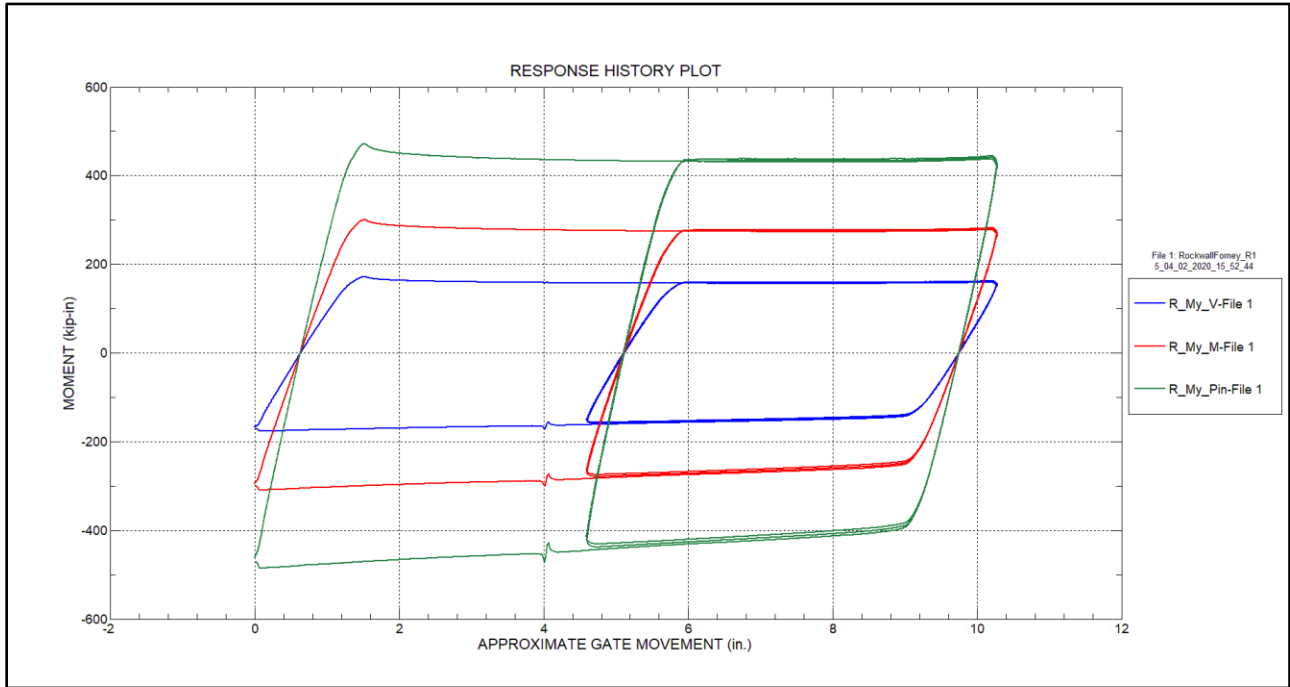
Figure 31 – Pin moment response history – Right arm – Test run 1

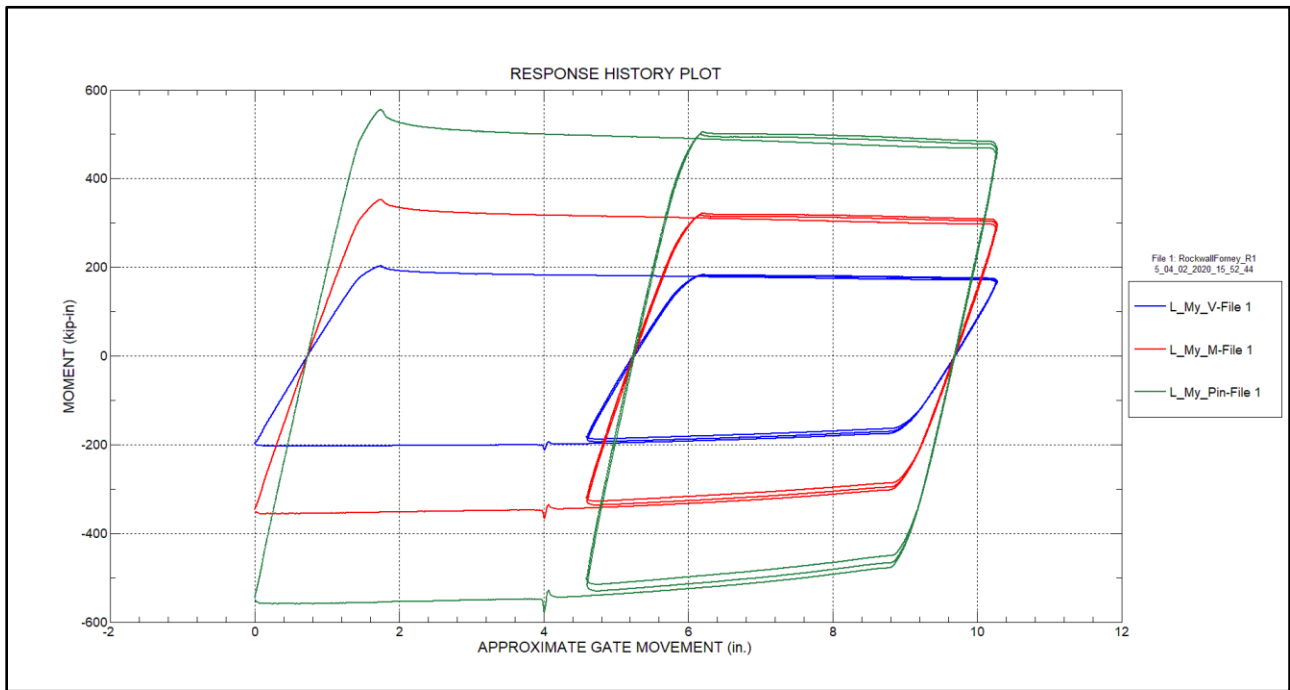
Figure 32 – Pin moment response history – Left arm – Test run 1

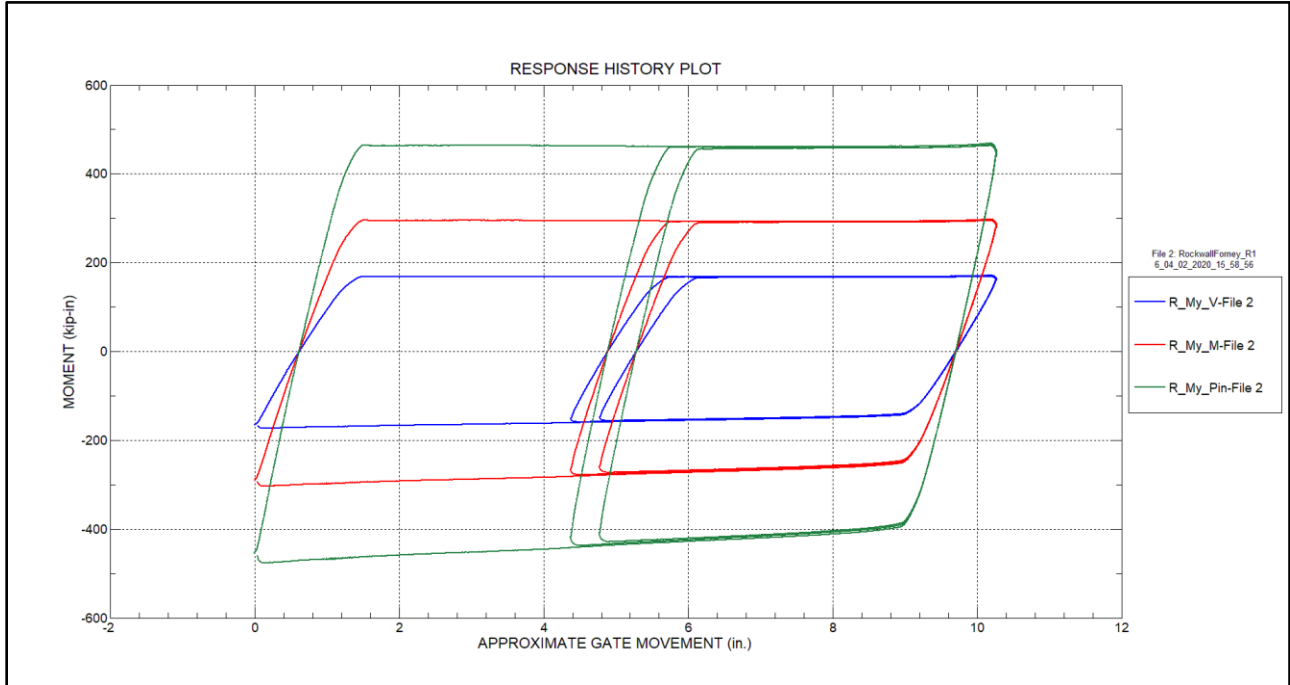
Figure 33 – Pin moment response history – Right arm – Test run 2

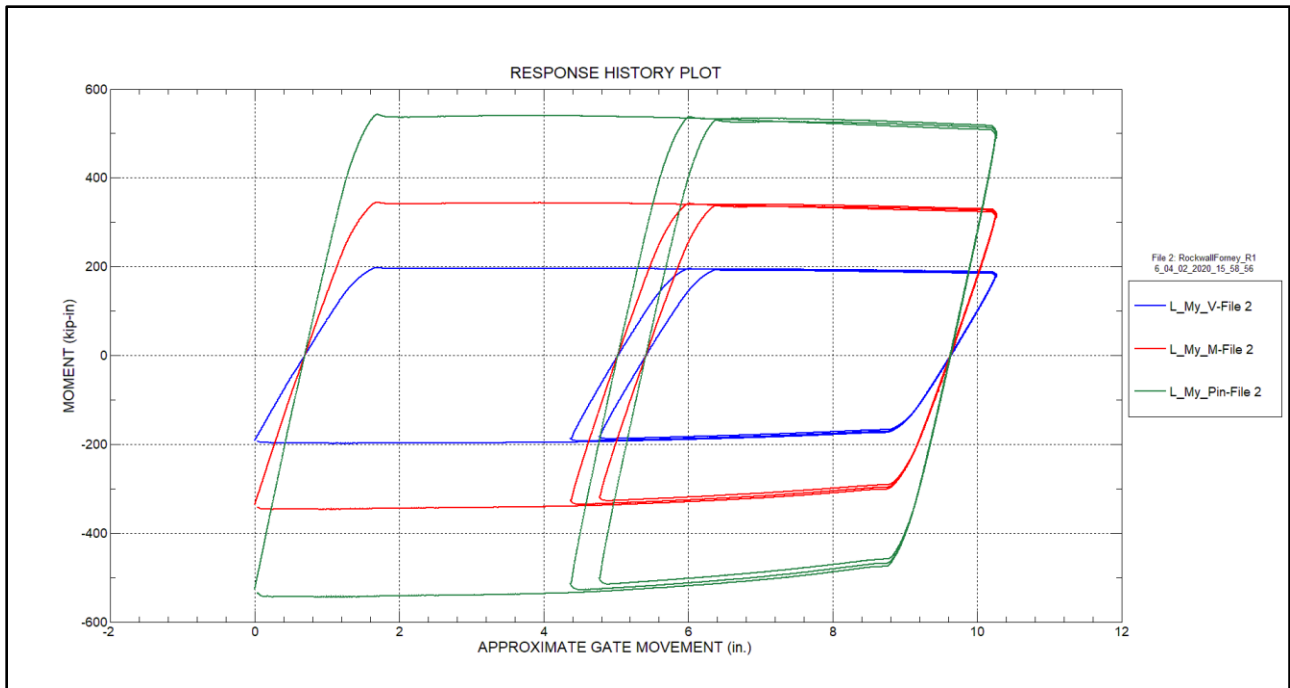
Figure 34 – Pin moment response history – Left arm – Test run 2

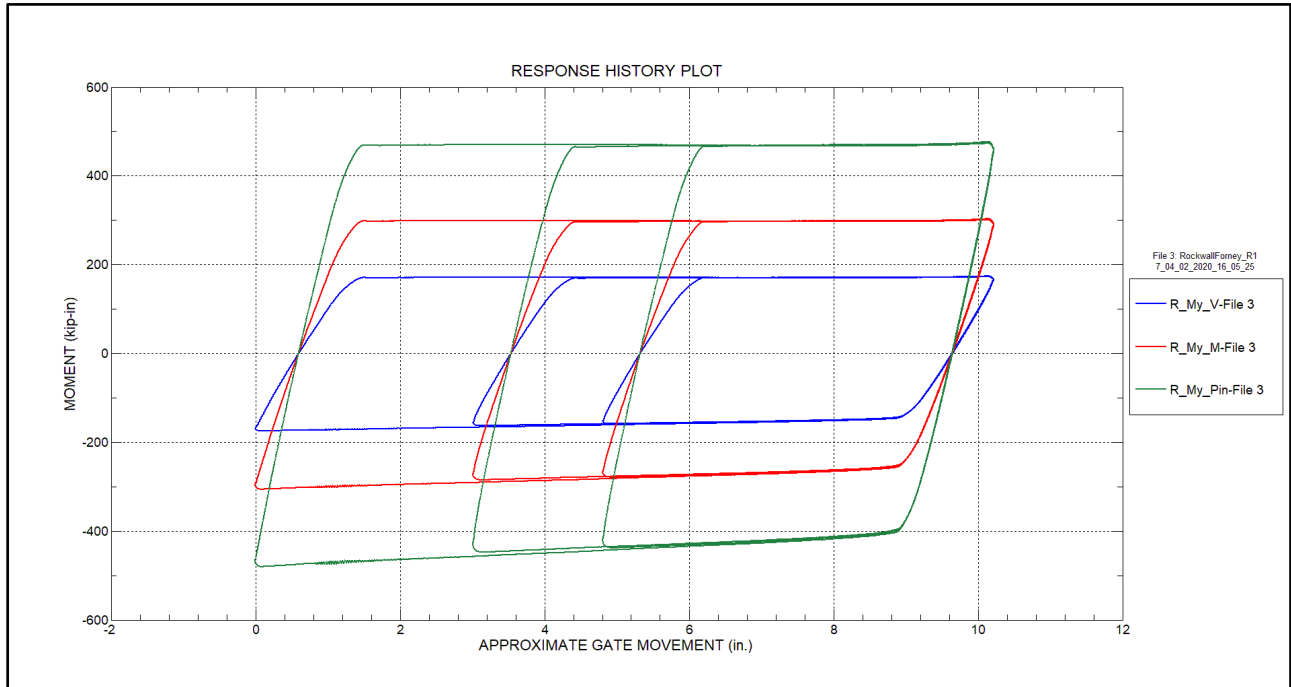
Figure 35 – Pin moment response history – Right arm – Test run 3

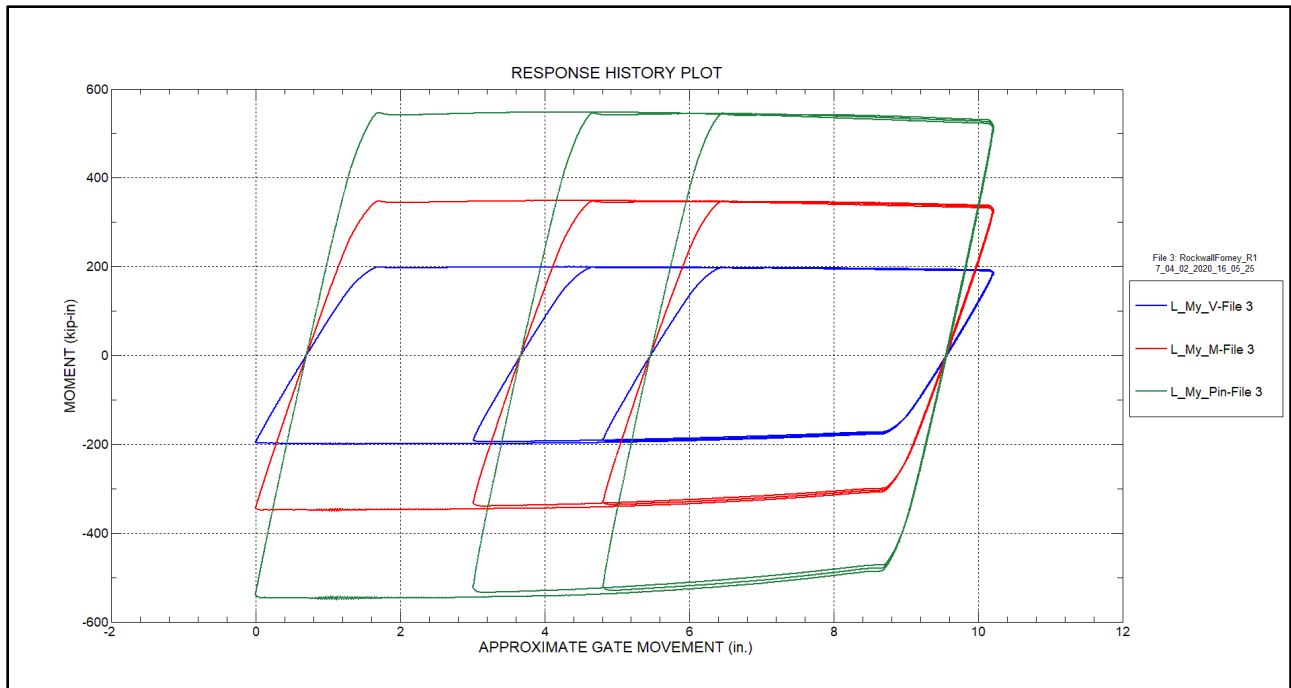
Figure 36 – Pin moment response history – Left arm – Test run 3

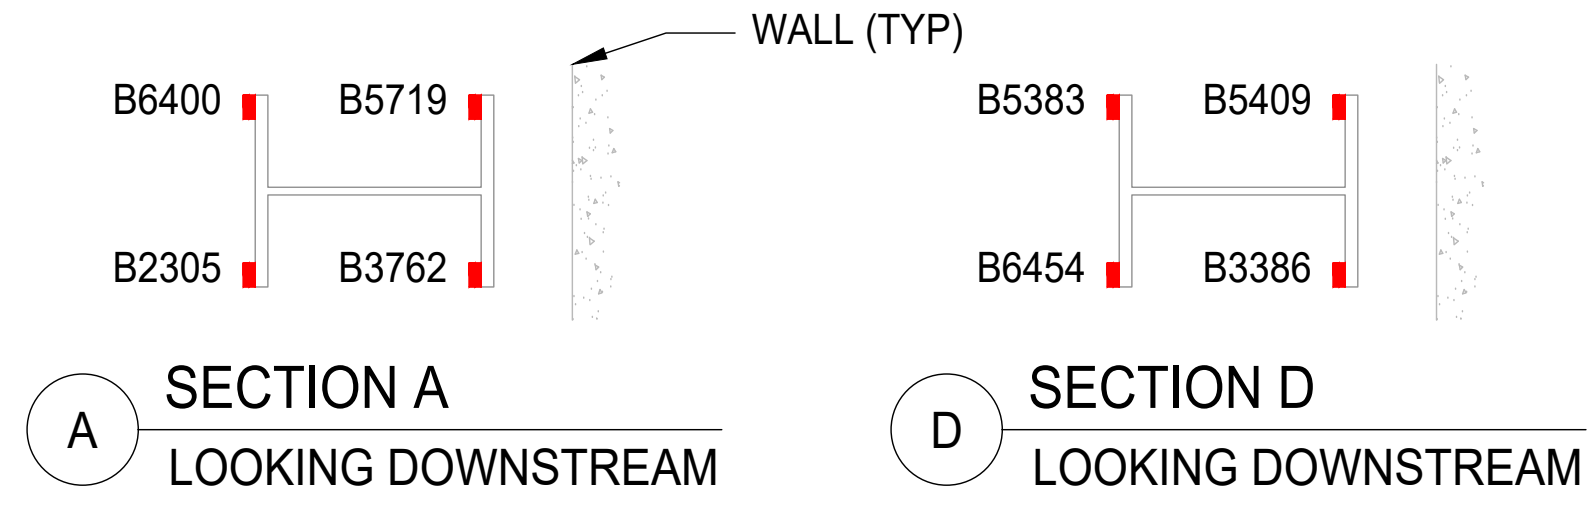
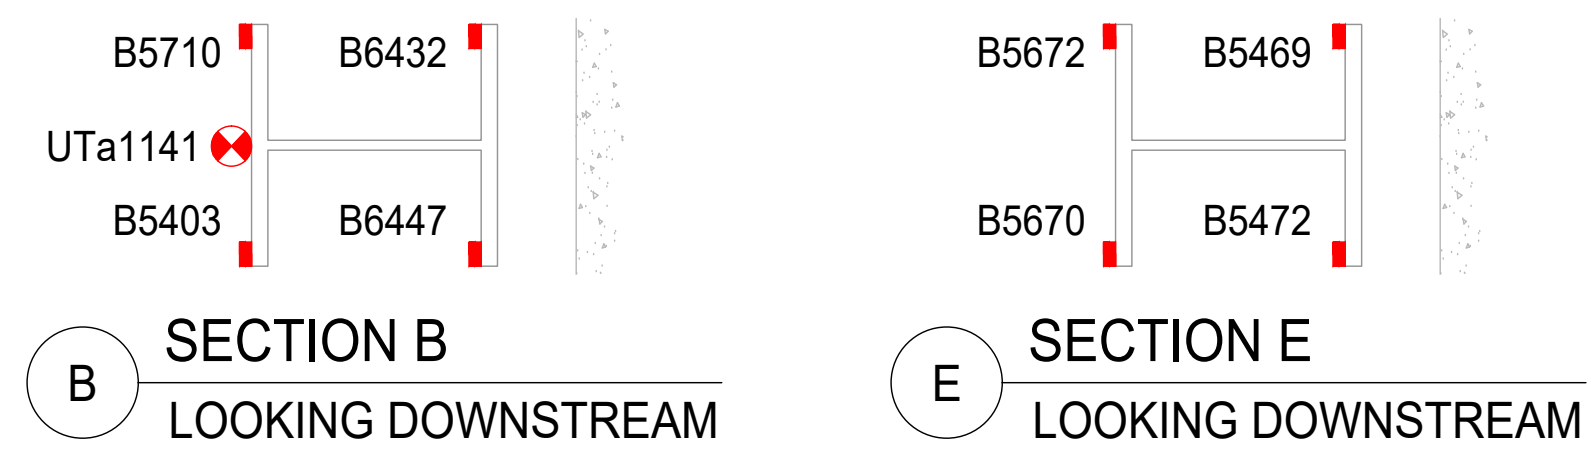
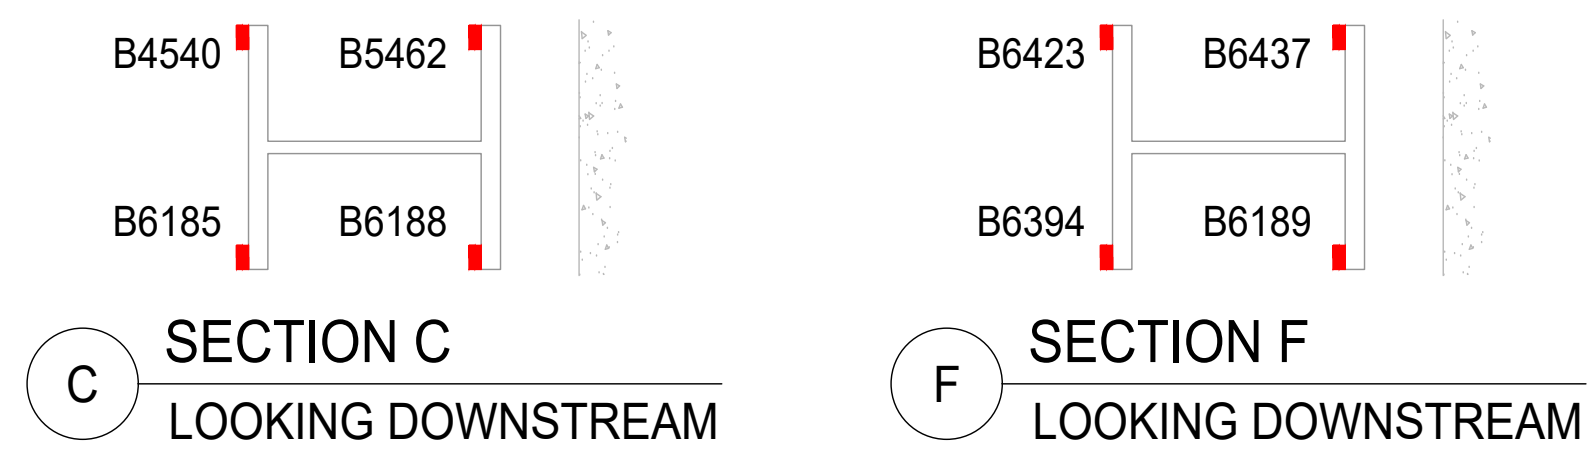
1 GATE 3
RIGHT ARM

- NOTES:
1. SECTIONS A, B, & C SHALL BE INSTALLED 15 INCHES AWAY FROM TRUNNION PLATE.
 2. TILTMETERS SHALL BE INSTALLED CENTERED ON THE MIDDLE STRUT FLANGE.
 3. SECTION G'S TILTMETER SHALL BE INSTALLED AS CLOSE TO THE SKINPLATE AS POSSIBLE.

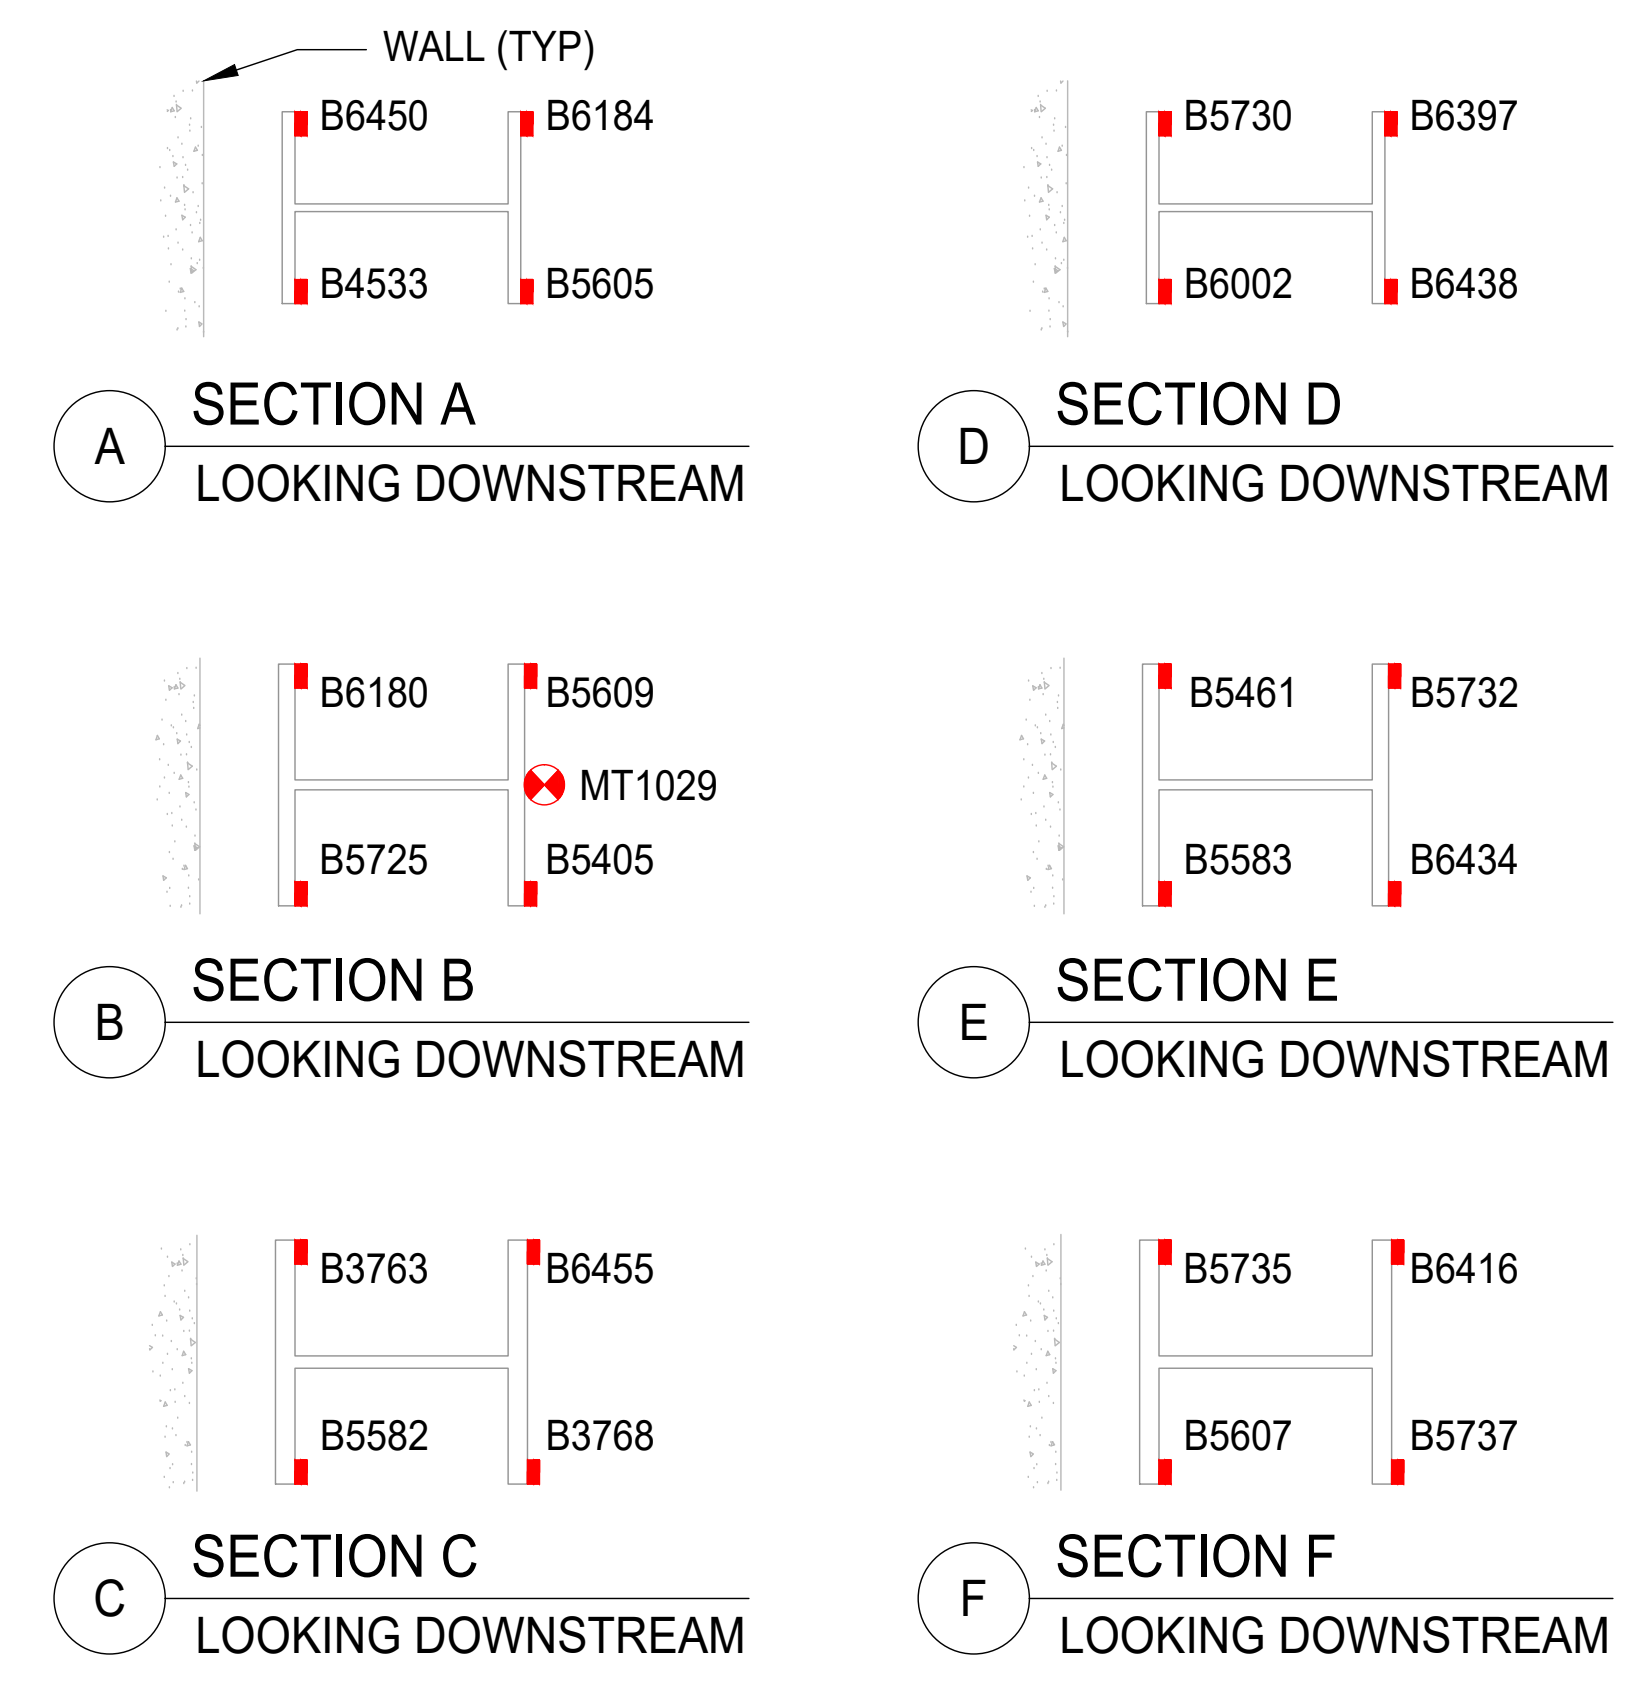
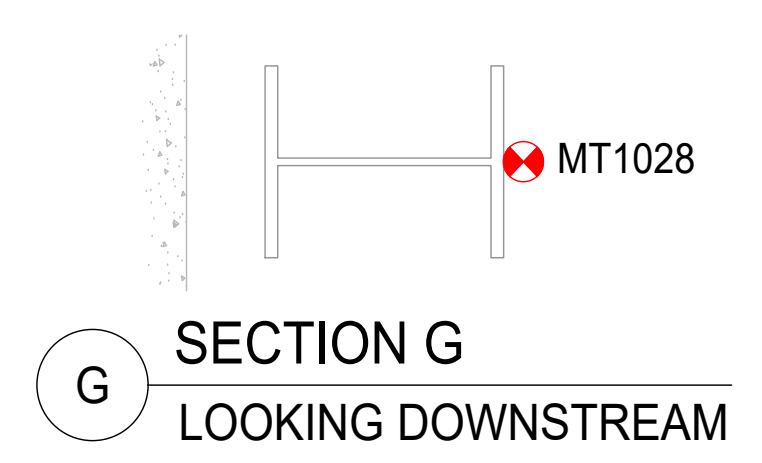
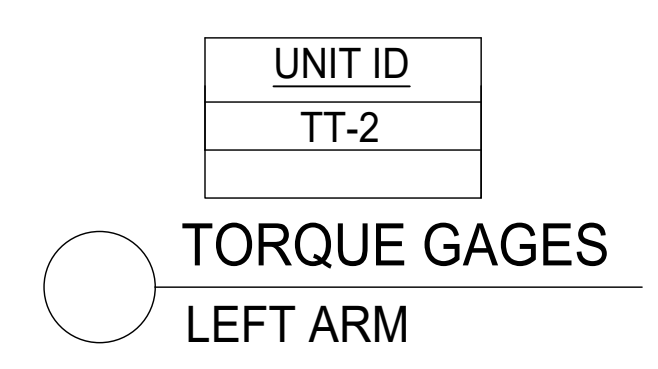
2 GATE 3
LEFT ARM

- NOTES:**
1. SECTIONS A, B, & C SHALL BE INSTALLED 15 INCHES AWAY FROM TRUNNION PLATE.
 2. TILTMETERS SHALL BE INSTALLED CENTERED ON THE MIDDLE STRUT FLANGE.
 3. SECTION G'S TILTMETER SHALL BE INSTALLED AS CLOSE TO THE SKINPLATE AS POSSIBLE.

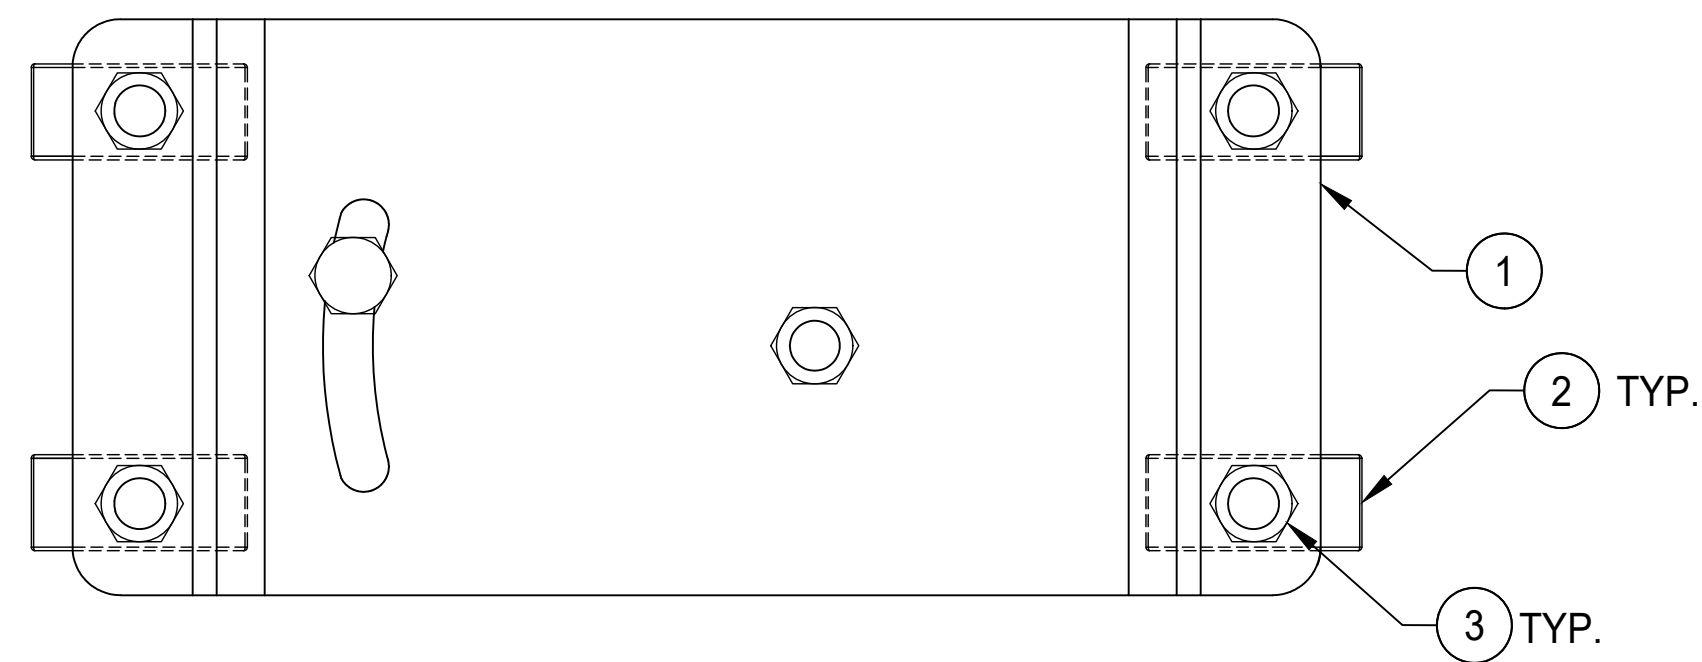
2 TYPICAL BDI TILTMETER INSTALLATION

1. BDI +/- 15 DEGREE TILTMETER WITH COVER AND ADJUSTMENT BOLTS
2. 1/4"-20 THREADED MOUNTING TAB
3. 1/4"-20 STAINLESS STEEL NUT
4. TYPICAL SURFACE PREP REQUIRED TO MOUNT TILTMETERS
5. TYPICAL MOUNTING SURFACE

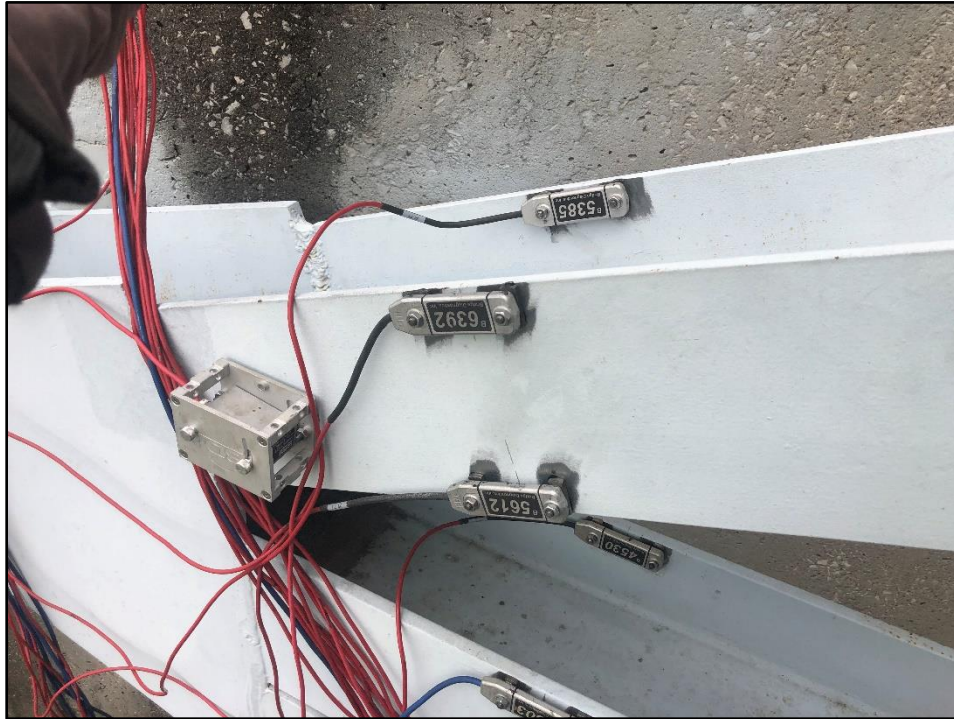
Figure 1 – BDI tiltmeter rotation sensor and reusable strain transducers installed near trunnion hub (Typical)

A typical installation has been shown in Figure 1 through Figure 4. Access to all the sensor locations was provided by BDI's own SPRAT certified rope access technicians and engineers as shown in Figure 5.

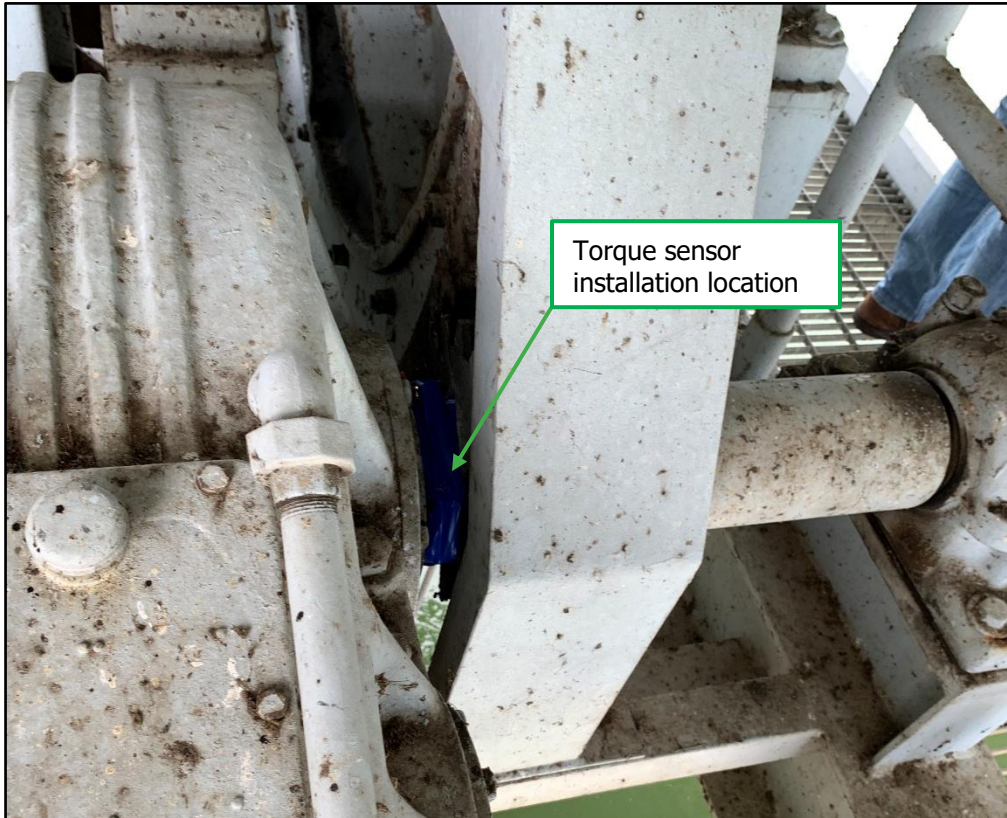
Figure 3 – Torque sensor installation on hoist pinion shaft (Typical)

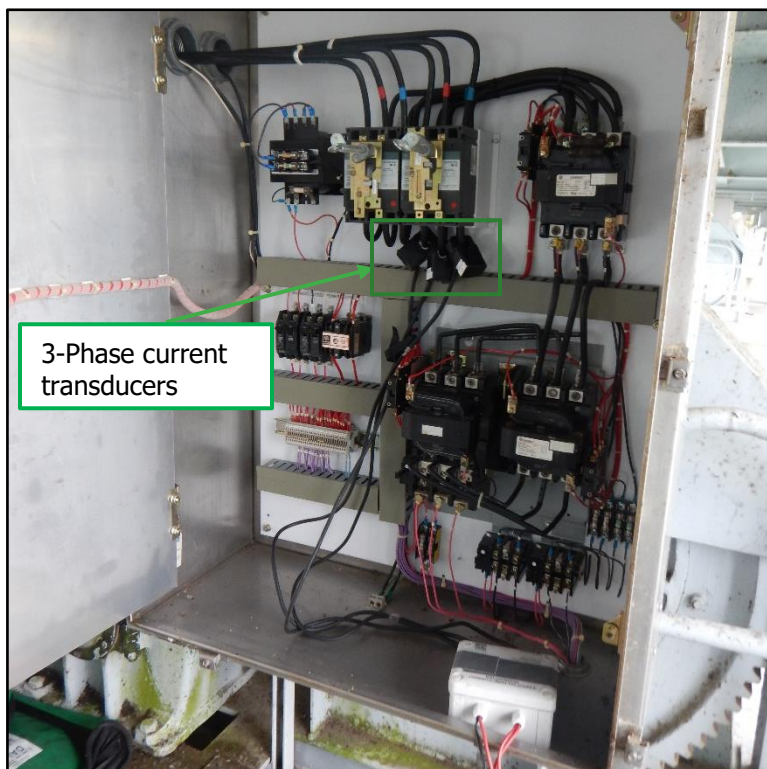
Figure 4 – Current transducers installed on hoist motor controls (Typical)

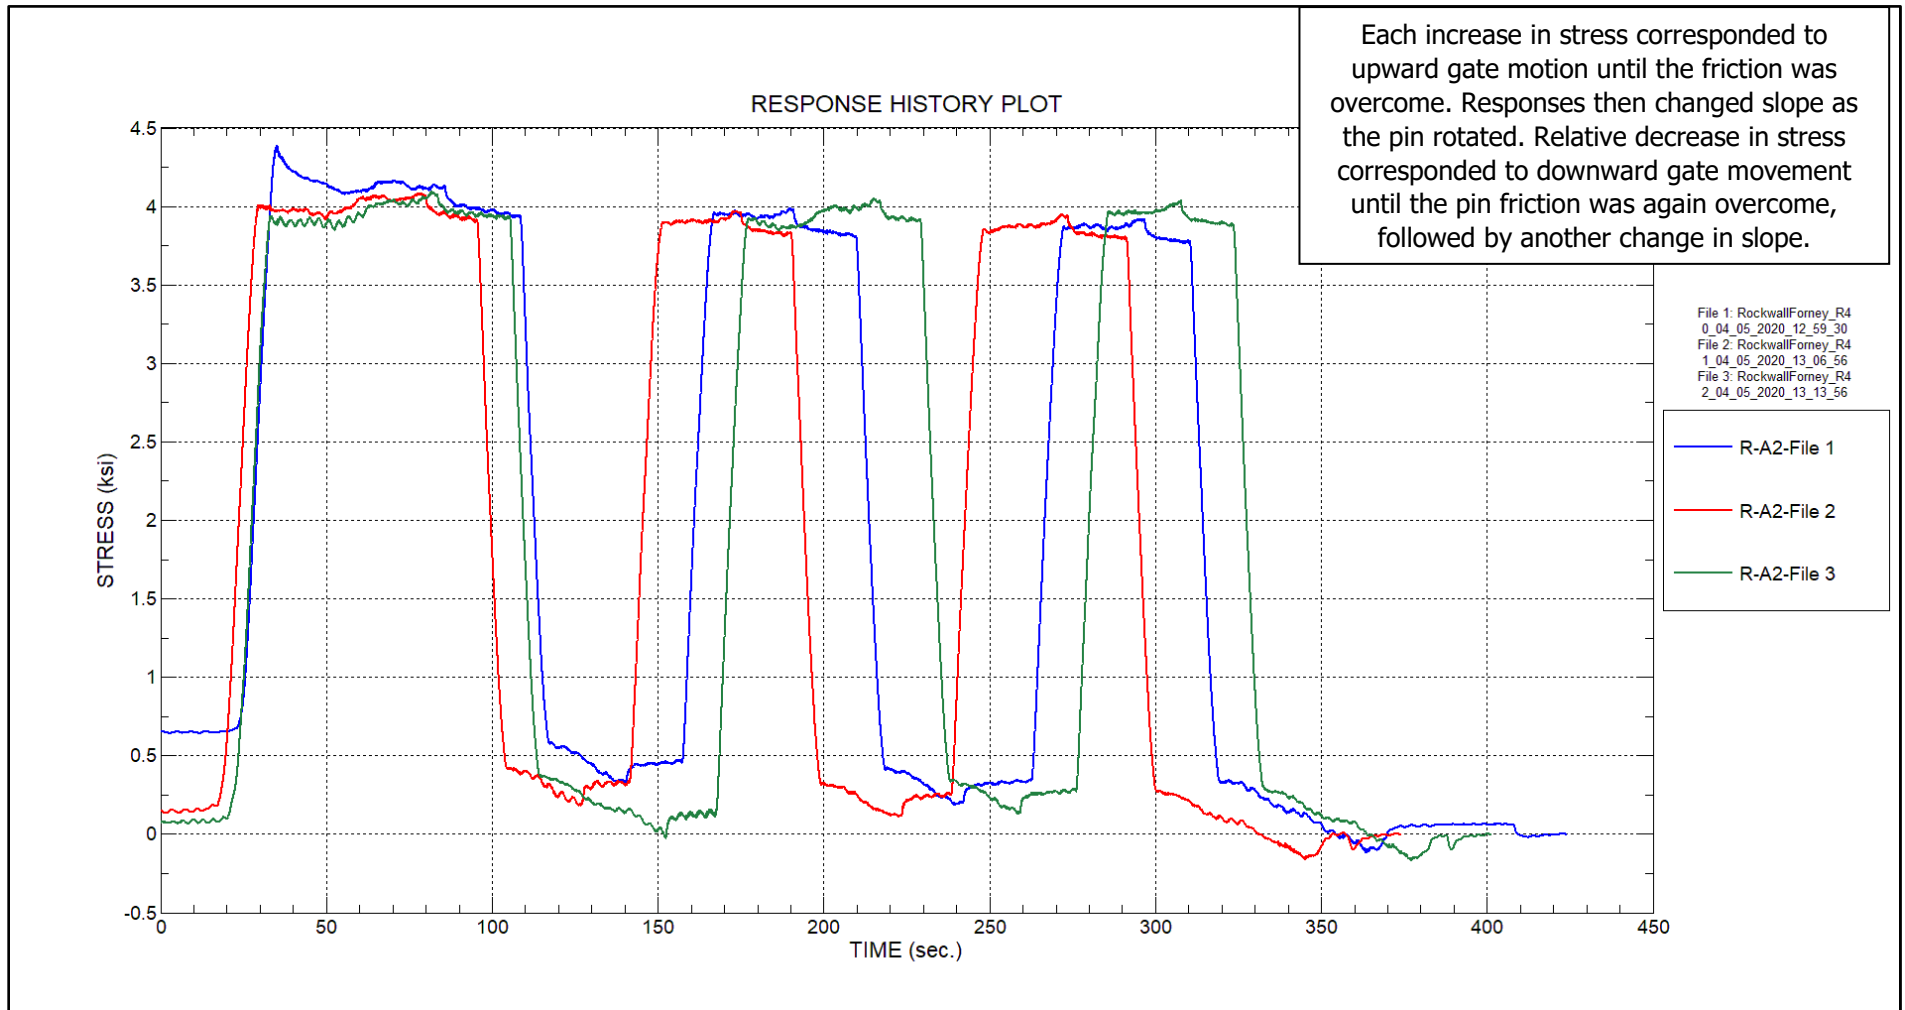
Figure 6 – Stress response history – Right arm – Gage A2 – Time based
 File 1 = test run 1, File 2 = test run 2, File 3 = test run 3
 (Section A along top strut near pin – Sensor location 2 along bottom of inner flange)

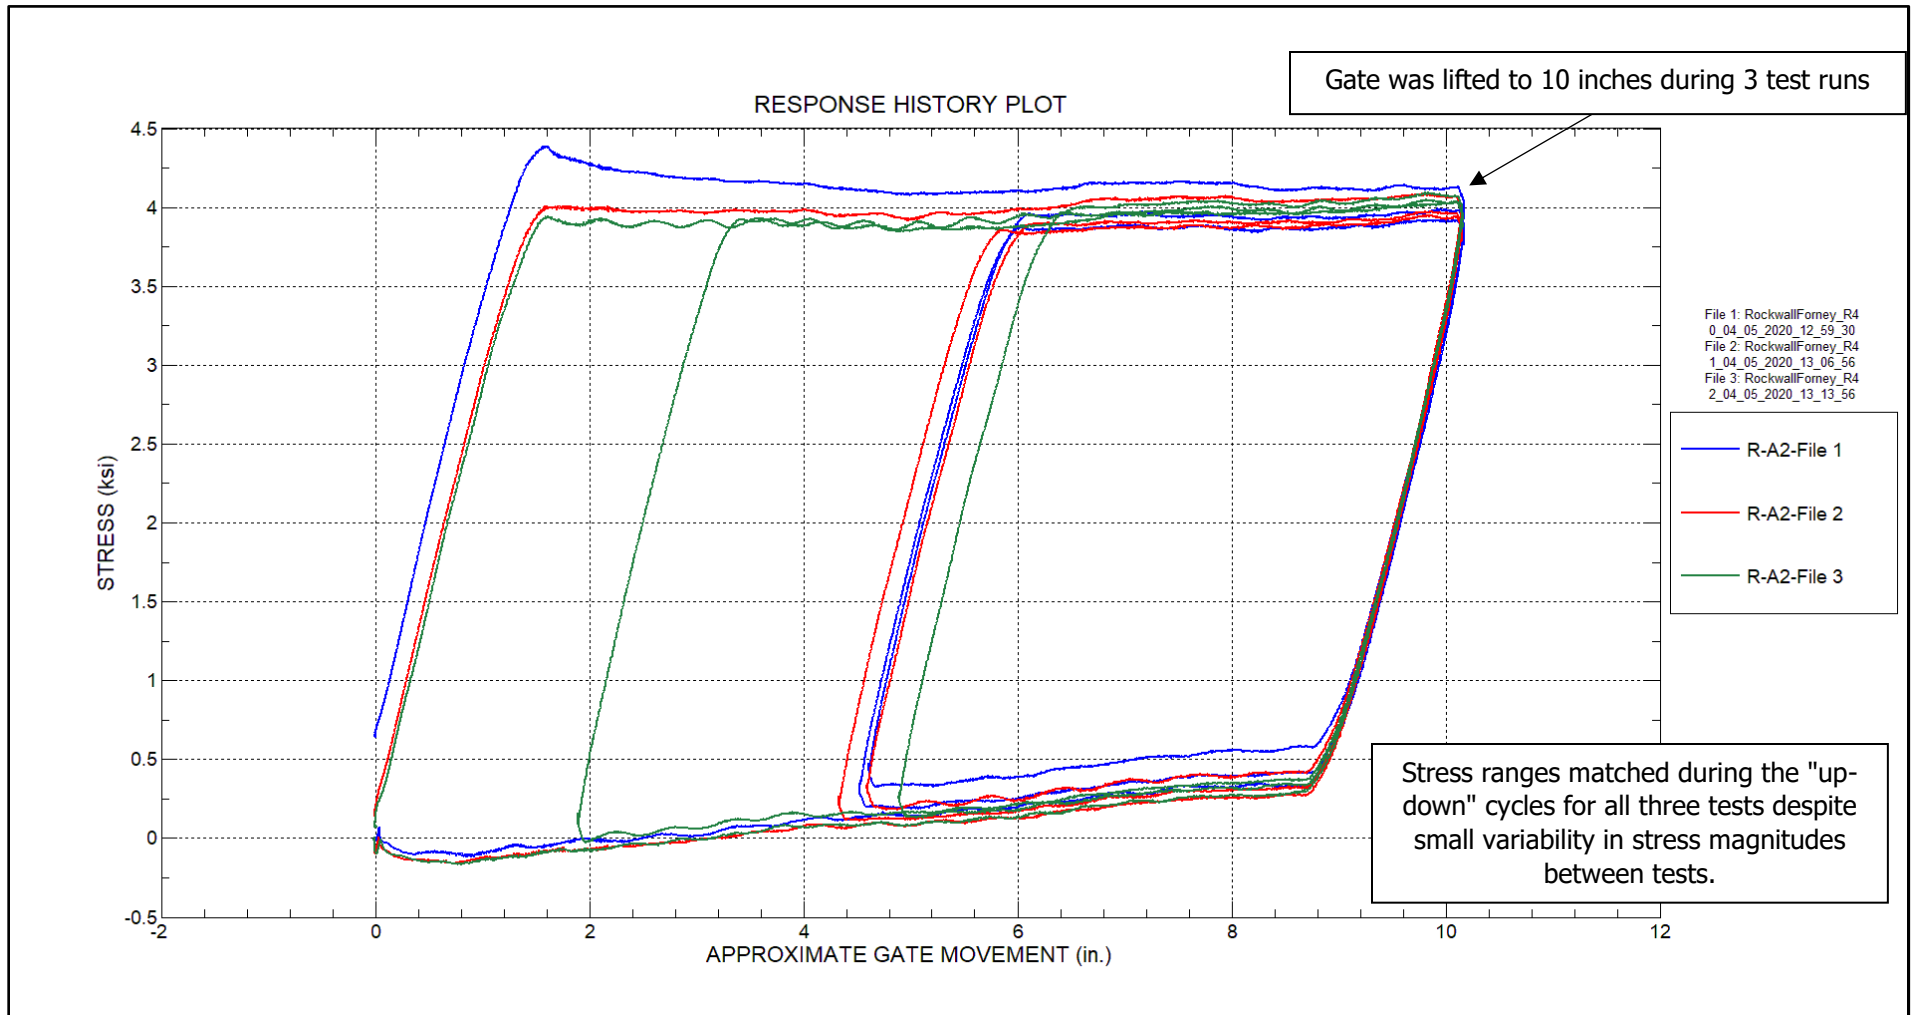
Figure 7 – Stress response history – Right arm – Gage A2 – Function of gate movement
File 1 = test run 1, File 2 = test run 2, File 3 = test run 3
