VISUAL INSPECTION AND EVALUATION REPORT

Rockwall-Forney Dam
Dallas Water Utilities
Dallas/Kaufman Counties, Texas

Schnabel Reference #20C22001.00
July 30, 2021

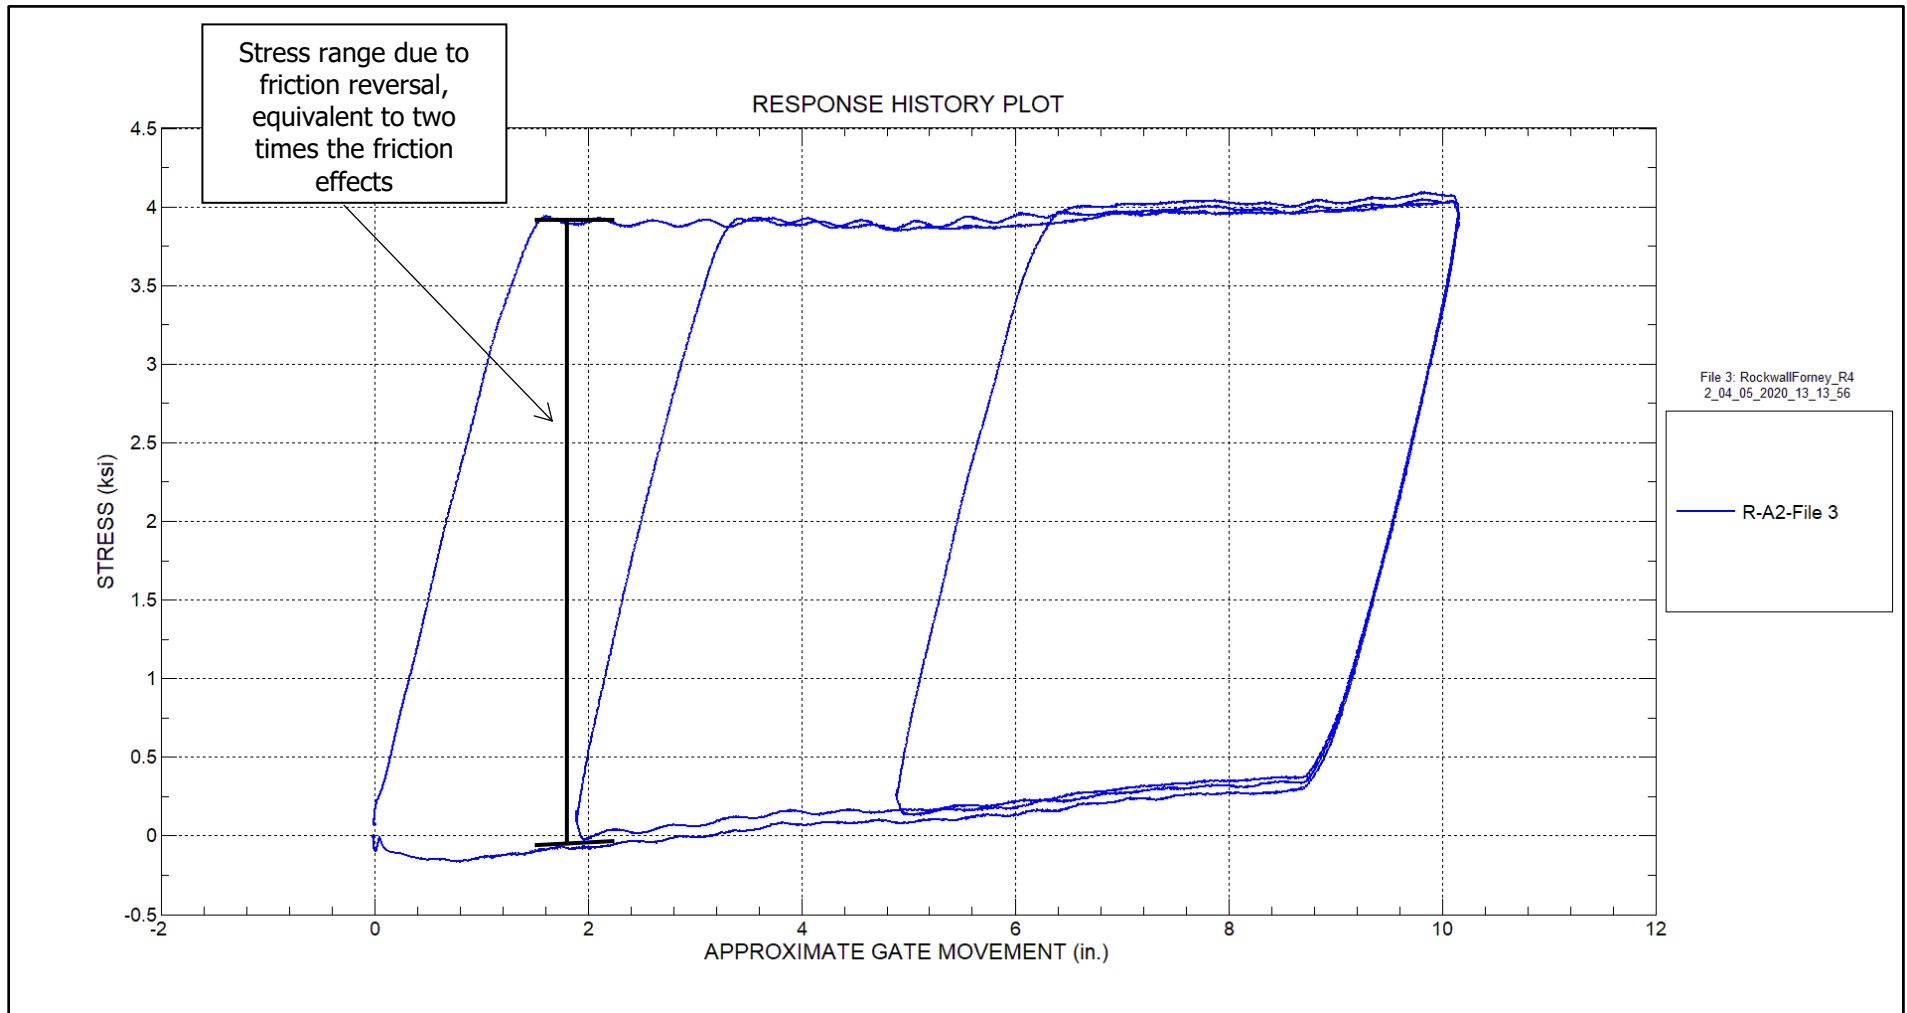
Figure 8 – Stress response history – Right arm – Gage A2 – Friction effect in stress responses
(Section A along top strut near pin – Sensor location 2 along bottom of inner flange)

- + **DIRECTION/FRICTION REVERSAL IN RESPONSES:** The difference in stress during gate opening and closing for a given position is shown in Figure 8. The stress variation at any given gate position was a result of direction reversal and in turn due to trunnion friction reversal. This statement is true since all other loads such as dead-load and hydrostatic pressure were essentially constant barring small changes in hydrostatic pressure due to slight changes in head. This direction/friction reversal is depicted in Figure 9, with deflected shape renderings from a gate arm finite element model under lifting and lowering loads. Note that this figure shows an arm configuration that does not match this gate, but the concept of the direction/friction reversal still applies.

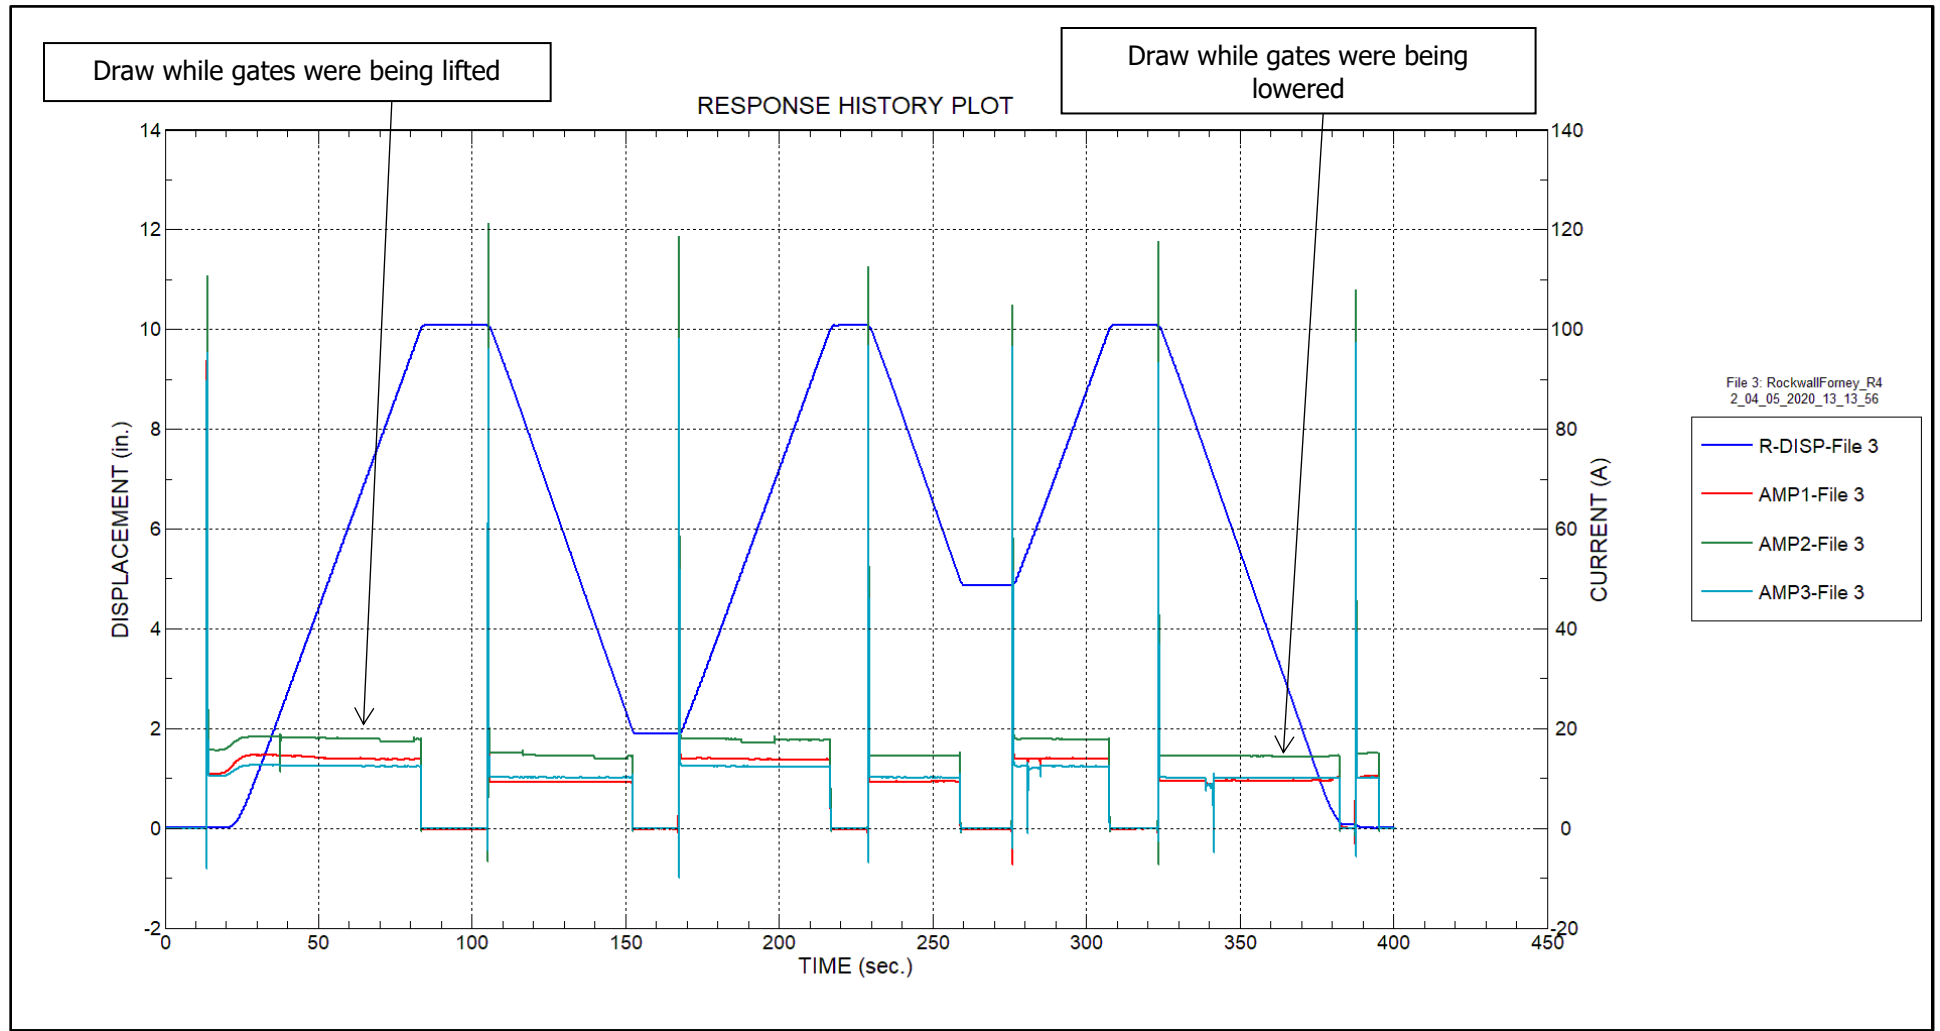
Figure 10 – Motor current & gate movement response history – Lift motor – Highlighting motor draw during lift and lower cycles

- + **MOTOR PERFORMANCE:** Current measurements taken at the hoist motor indicated steady and stable current draws during the lifting and lowering portions. An example plot of current draw and gate position is provided in Figure 10. Current draw ranges during lifting were higher than the ranges during lowering, which is common due to gravity/dead load. These results are summarized along with recorded peak in-rush current in Table 2. Note that the sample rates used during testing were set for collecting gate responses and may not have been appropriate to fully capture the in-rush current. The readings should be evaluated by a licensed electrician with knowledge of the operating parameters.

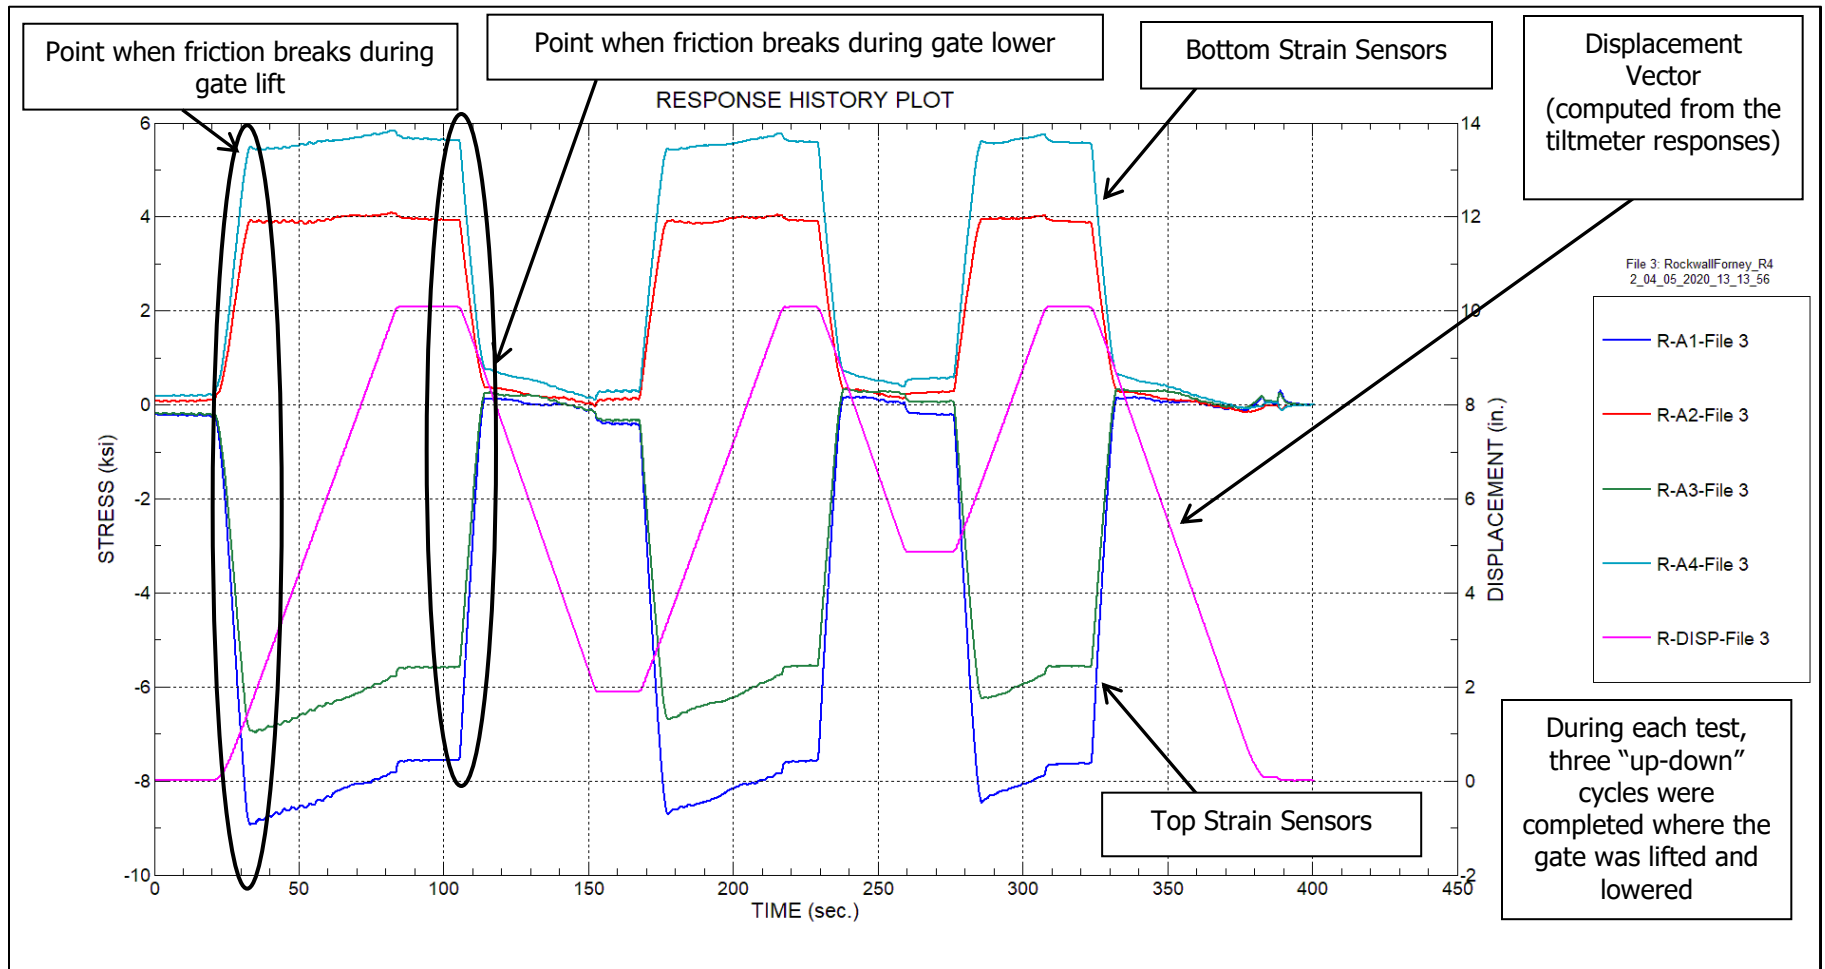
Figure 11 – Stress response & gate movement history – Right arm – Section A - Highlighting friction behavior (Section A along top strut near pin)

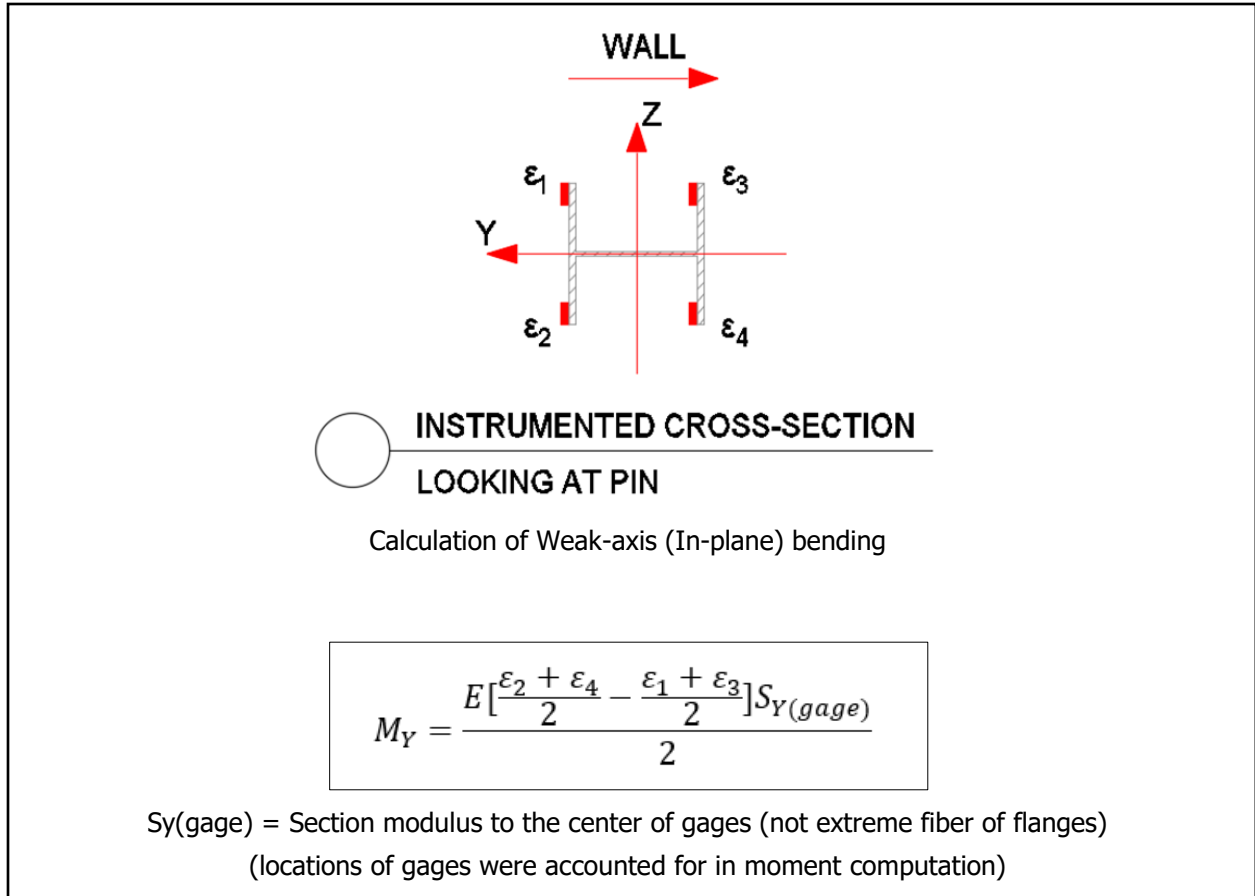
Figure 12 – Basic mechanic equation used to calculate moment

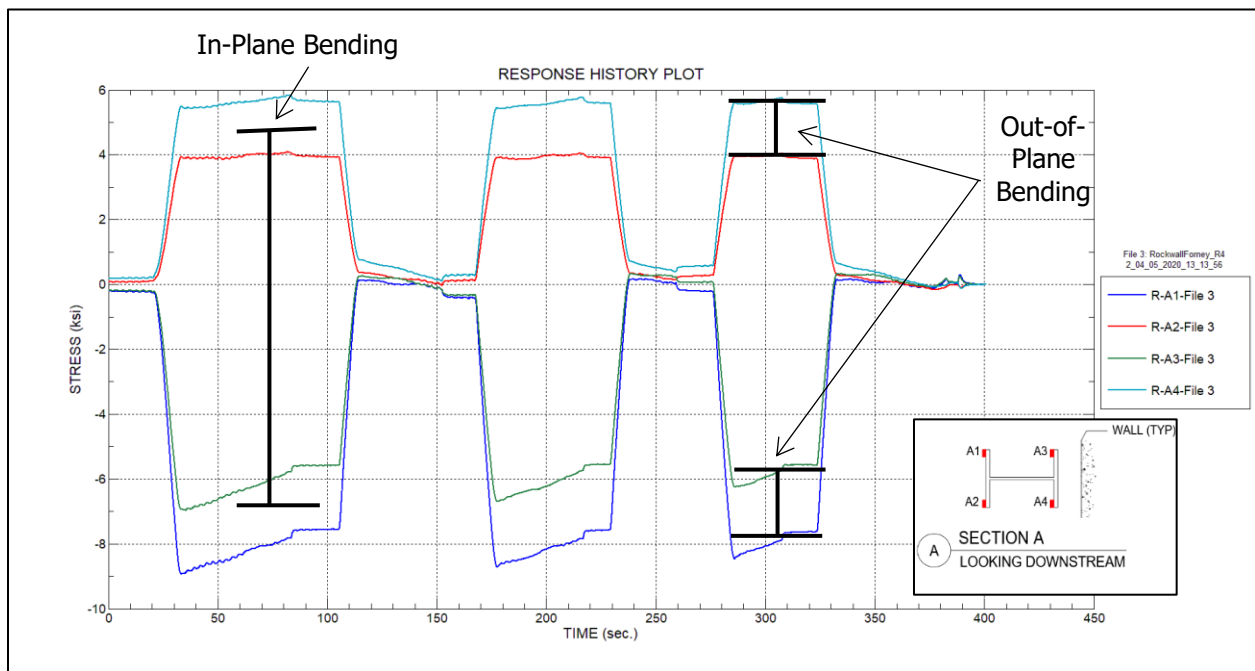
Figure 13 – Stress response history – Right arm – Section A – Bending components
(Section A along top strut near pin)

In-plane or weak-axis flexure refers to bending about a given strut's web. This designation is consistent with typical nomenclature. In-plane bending can be observed visually from the strain response histories as a difference between the top and bottom stresses, whereas out-of-plane or strong-axis bending is visualized as the difference in stress from side to side. Figure 13 provides a visual reference for both types of strut flexure.

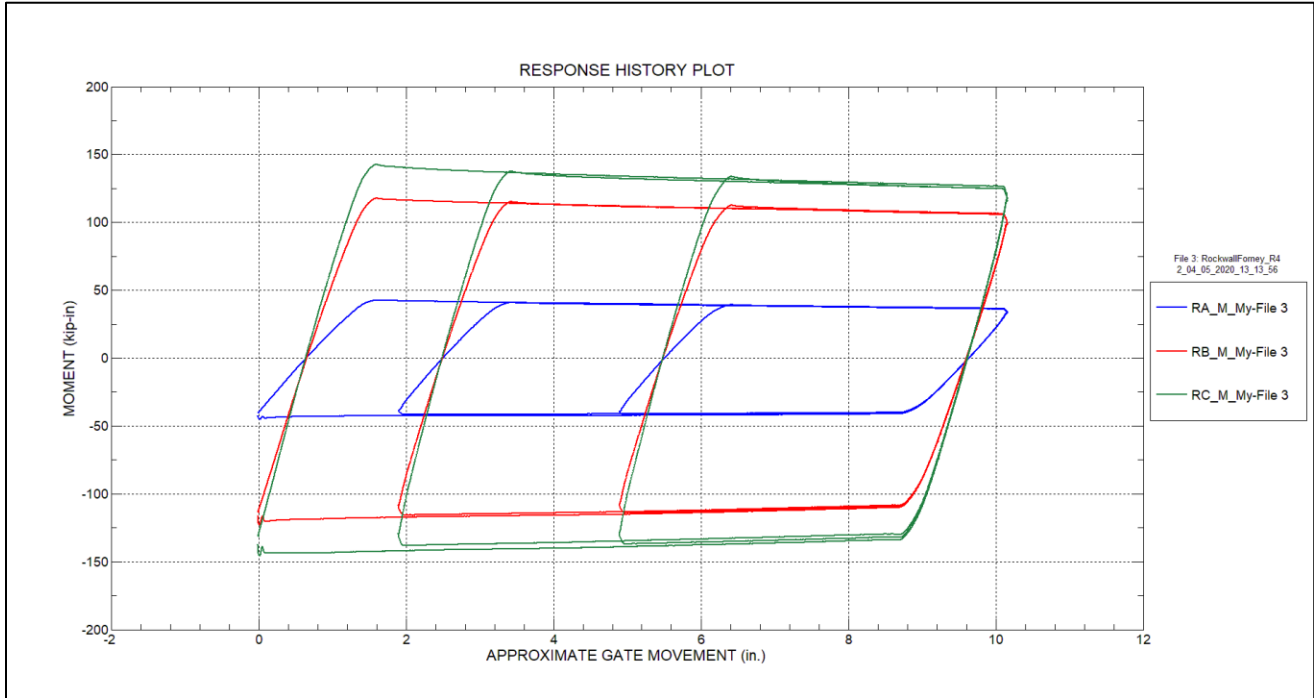
Figure 14 – In-plane moment response history – Right arm – Sections near pin
(RA = Right Arm Top Strut, RB = Right Arm Middle Strut, RC = Right Arm Bottom Strut)

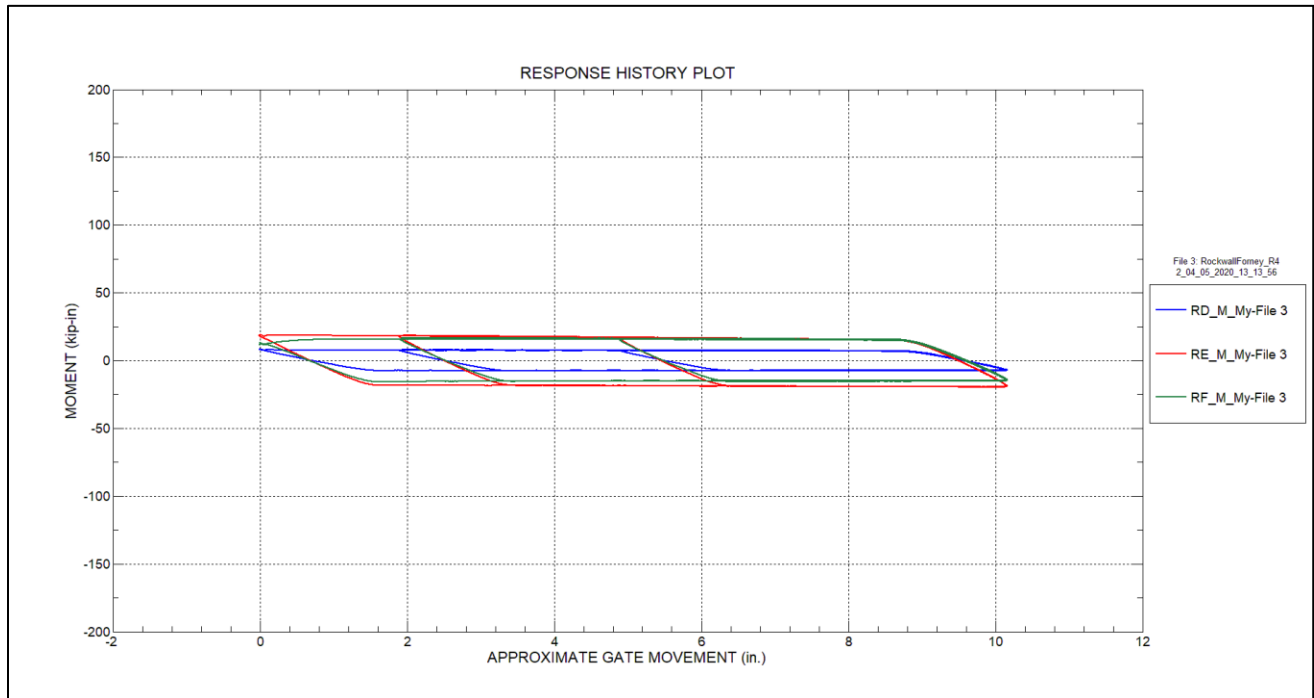
Figure 15 – In-plane moment response history – Right arm – Sections away from pin
(RD = Right Arm Top Strut, RE = Right Arm Middle Strut, RF = Right Arm Bottom Strut)

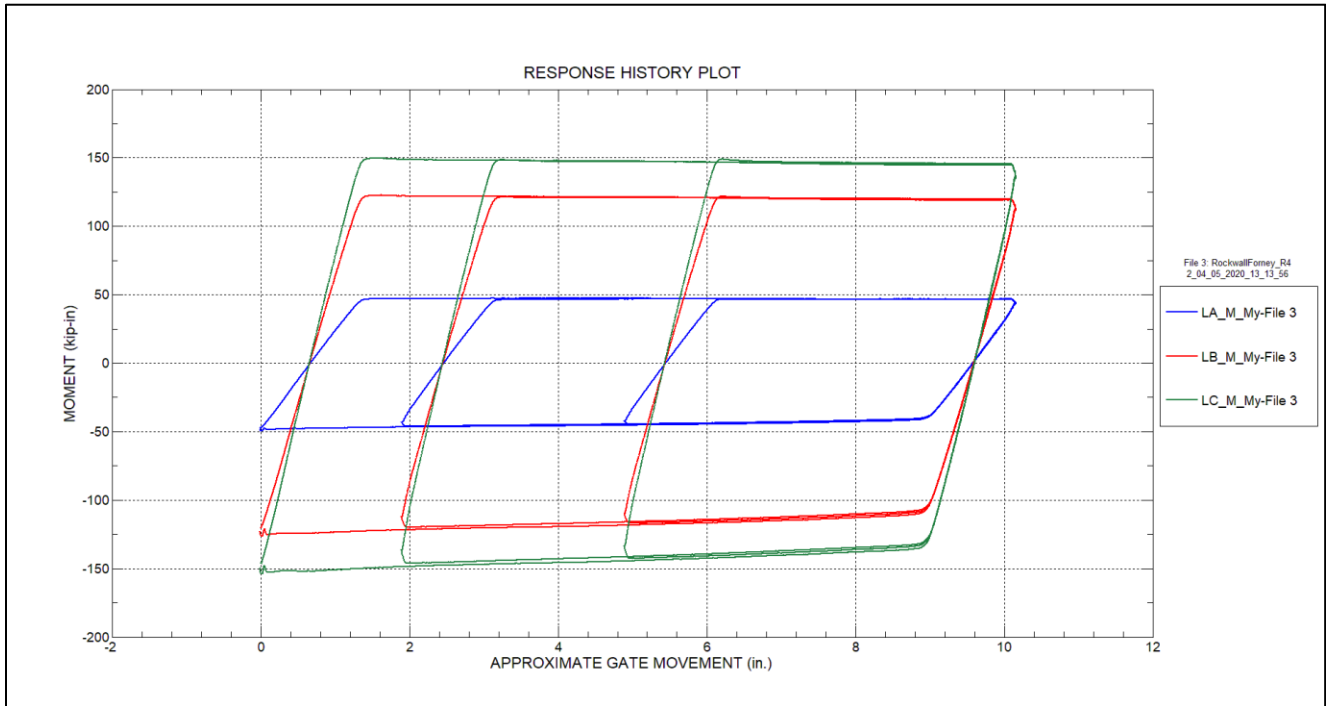
Figure 16 – In-plane moment response history – Left arm – Sections near pin
(LA = Left Arm Top Strut, LB = Left Arm Middle Strut, LC = Left Arm Bottom Strut)

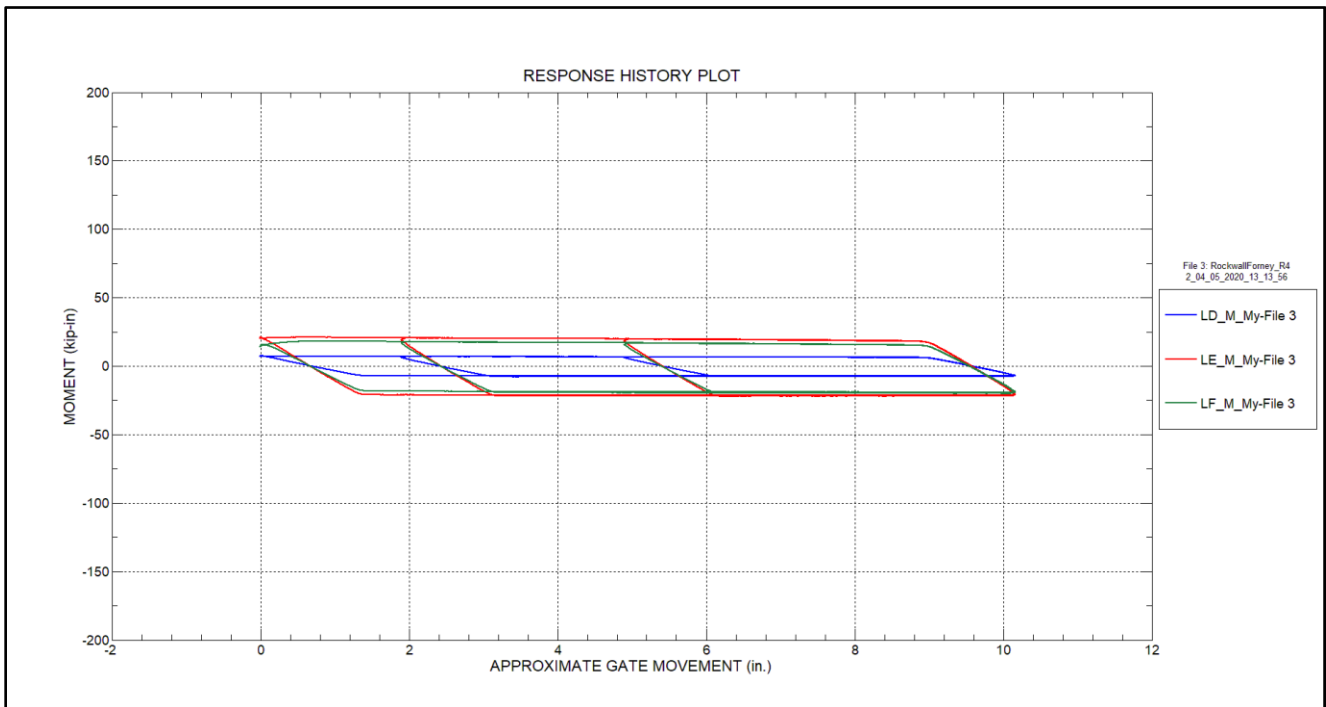
Figure 17 - In-plane moment response history – Left arm – Sections away from pin
(LD = Left Arm Top Strut, LE = Left Arm Middle Strut, LF = Left Arm Bottom Strut)

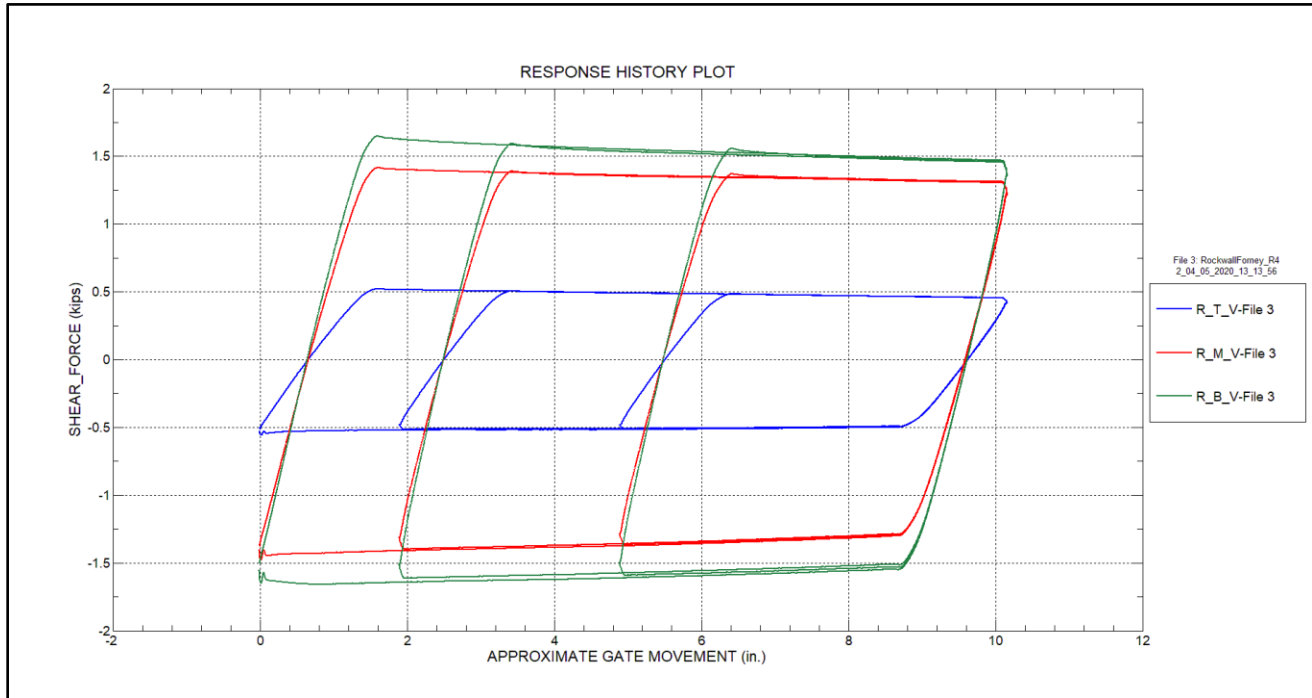
Figure 19 – Strut shear response history – Right arm

(R_T = Right Arm Top Strut, R_M = Right Arm Middle Strut, R_B = Right Arm Bottom Strut)

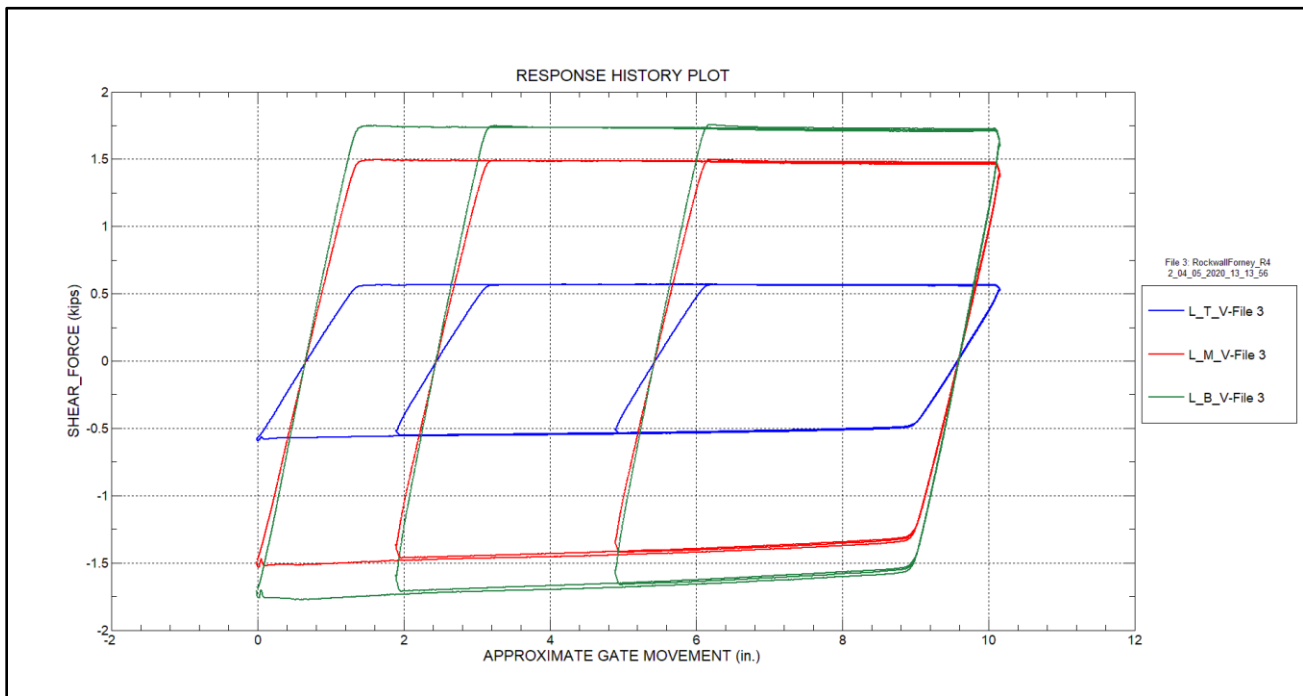
Figure 20 – Strut shear response history – Left arm

(L_T = Left Arm Top Strut, L_M = Left Arm Middle Strut, L_B = Left Arm Bottom Strut)

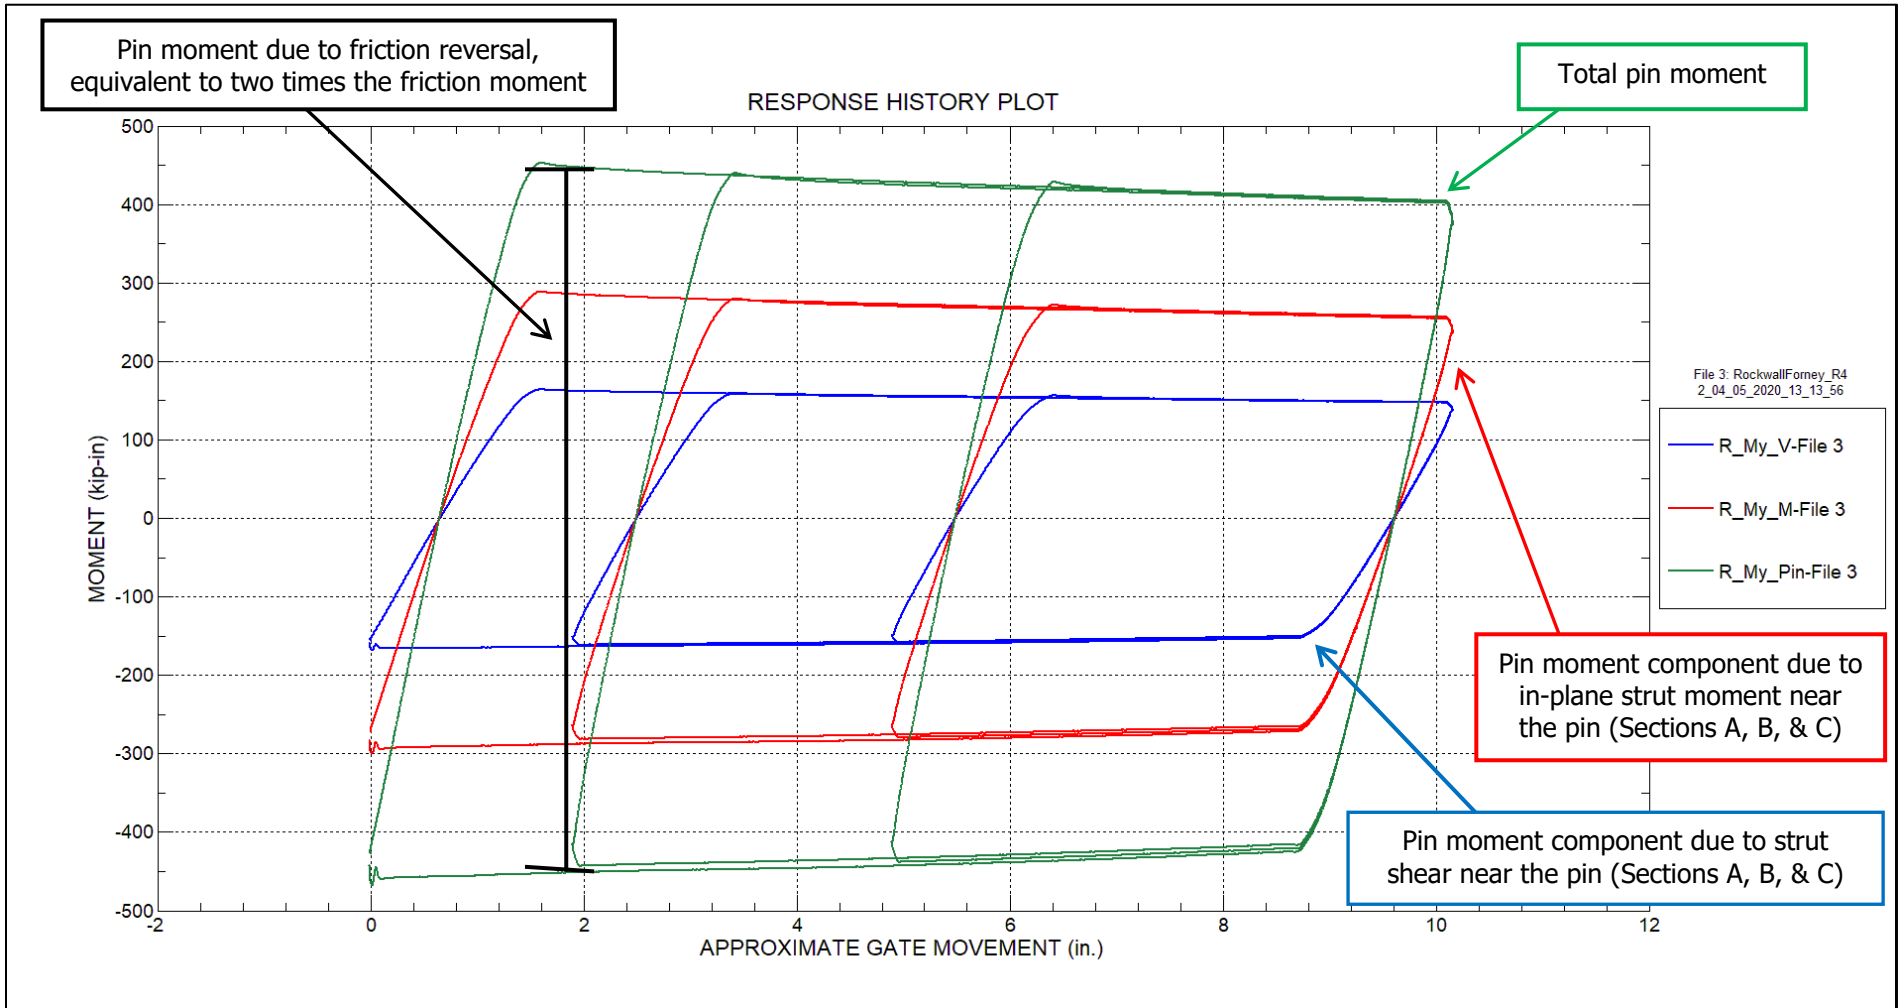
Figure 21 – Pin moment response history – Right arm

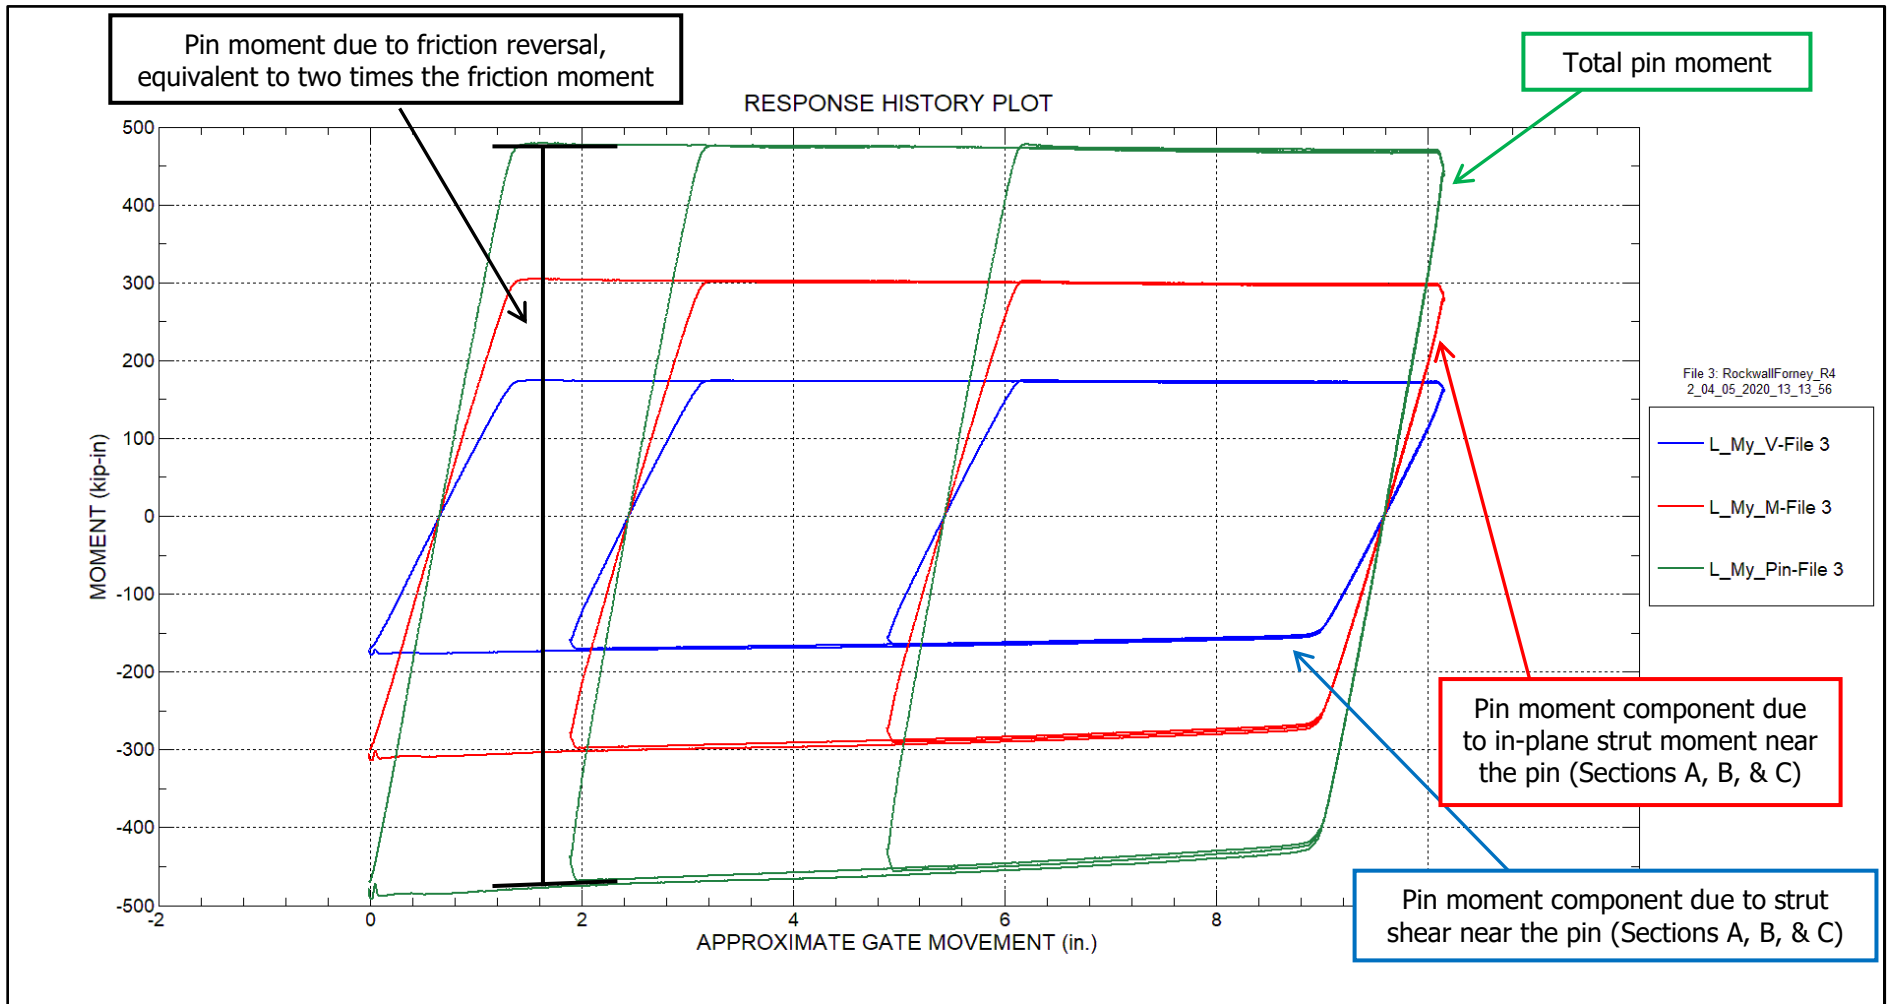
Figure 22 – Pin moment response history – Left arm

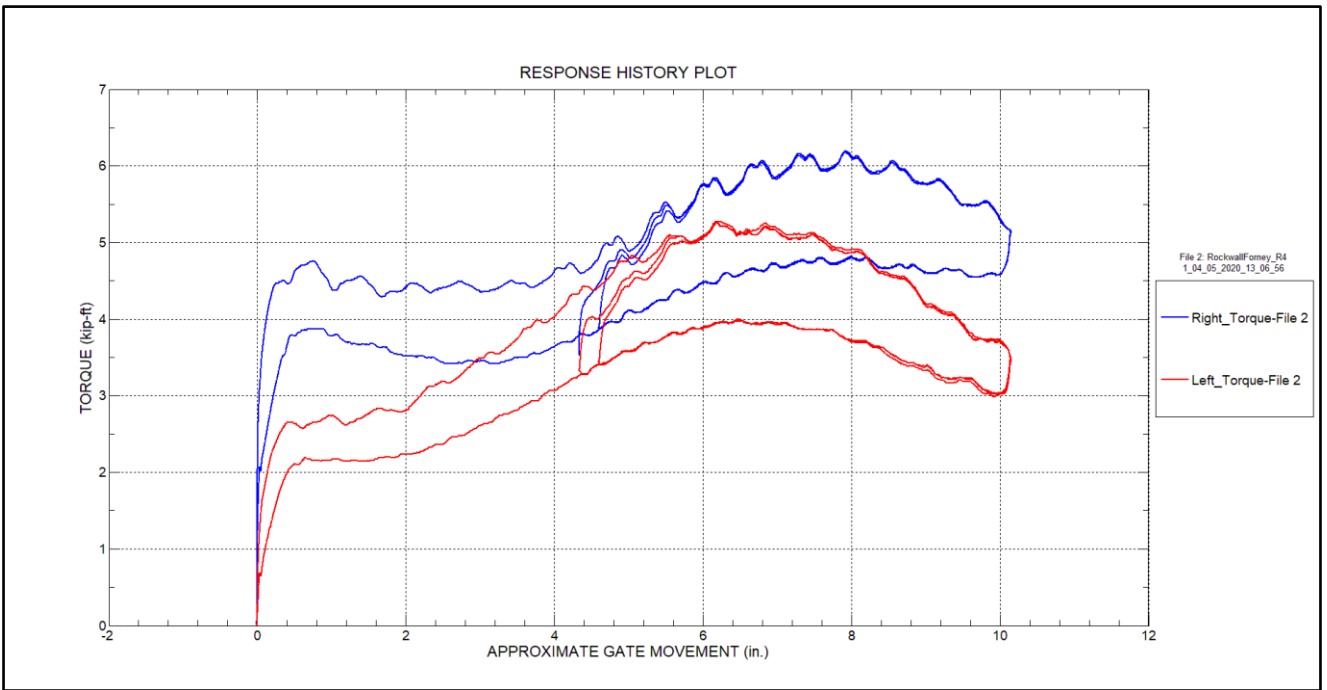
Figure 23 – Hoist torque response history – Gate 4 – Test 2

Figure 23 shows example torque measurements, recorded on the Gate 4 torque shafts. Best practices for torque measurements is to measure torque on opposite sides of the shaft so that any bending in the shaft can be removed by averaging the two responses. Due to access limitations, only one gage at each location could be installed. Therefore, any bending in the shaft may be reflected in the torque measurements and may be related to the peaks and valleys observed in the torque responses.

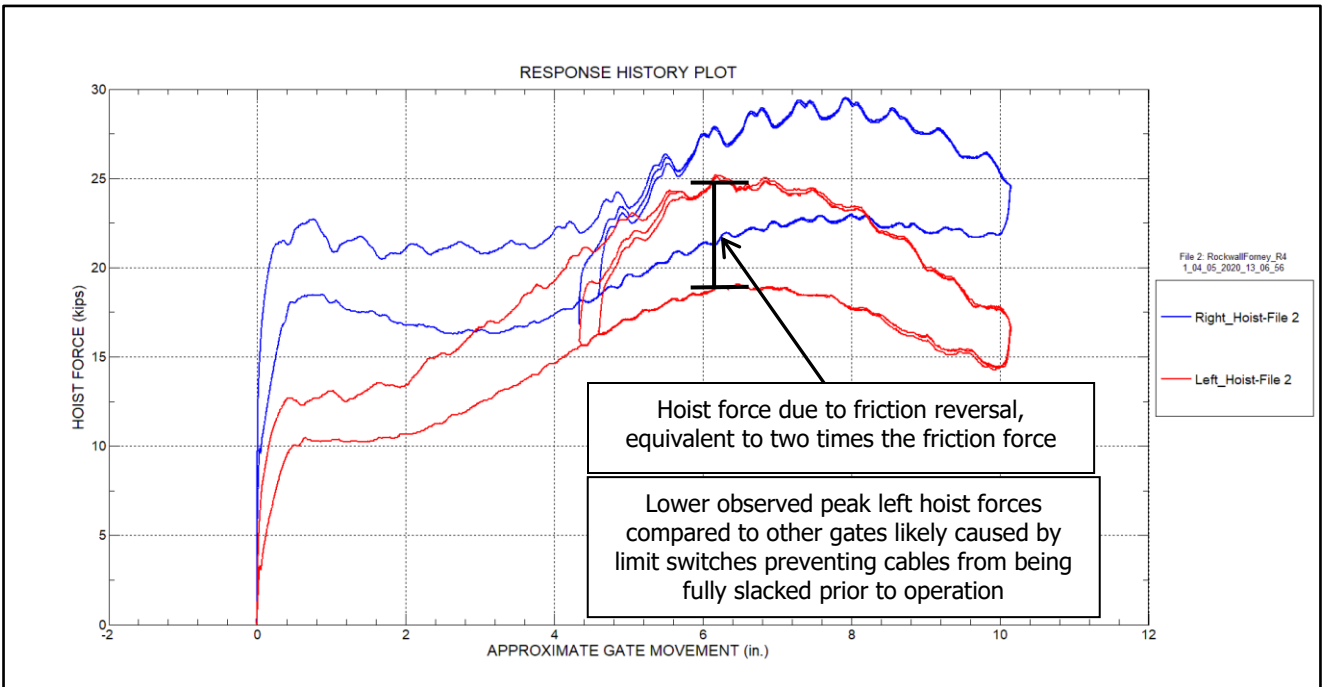
Figure 24 – Hoist force response history – Gate 4 – Test 2

Torque values were converted to force in the hoist cables per gate arm using the gear ratio and drum radius, as shown in Figure 24. The gear ratio and drum radius were 5.182 and 1.086 feet respectively, as defined in the provided as-built shop drawings. It should be noted that the hoist force calculated may be smaller than the actual hoist force applied. This difference is due to the limit switch engaging the brake before the hoist cable was fully slacked, resulting in an initial force in the cable. A hoist force due to total gate friction was then calculated. This friction hoist force was equal to half the differential in force measured during the lifting and lowering of the gate (similar to the pin friction calculations). As shown in Table 3, the change in cable force due to friction was generally consistent between tests. Note that the total hoist force was due to the total friction effects, including side seal, hoist bearings, trunnion friction effects, etc. It is difficult to determine the exact proportion and composition of the total friction sources. Additional torque and hoist force plots for all collected data files are provided in Appendix A – Gate 4 Torque and Hoist Force Plots.

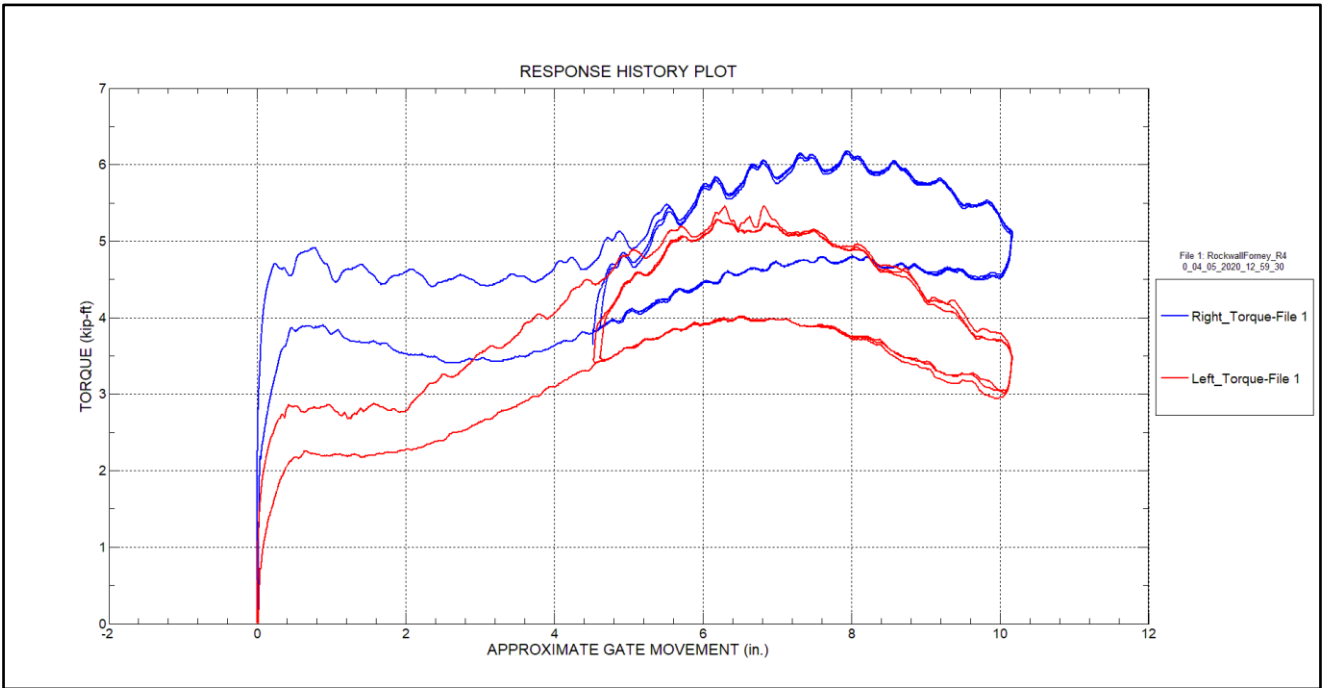
Figure 25 – Hoist torque response history – Gate 4 – Test 1

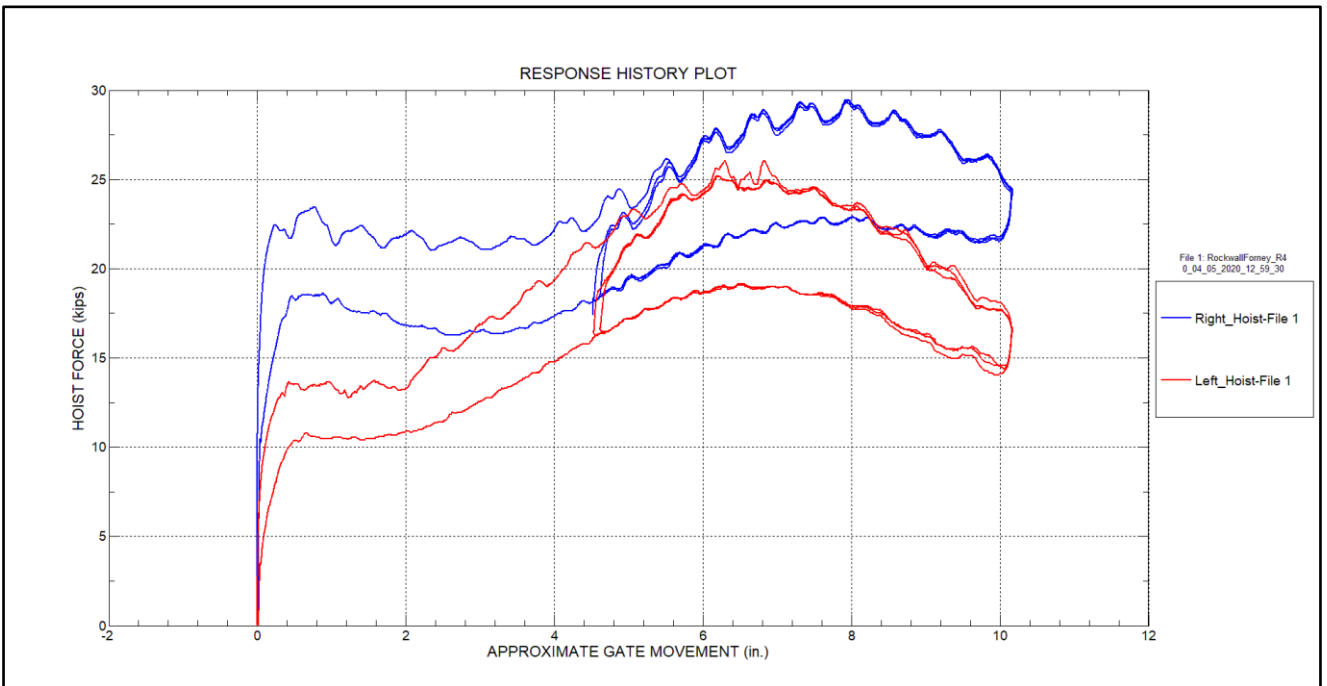
Figure 26 – Hoist force response history – Gate 4 – Test 1

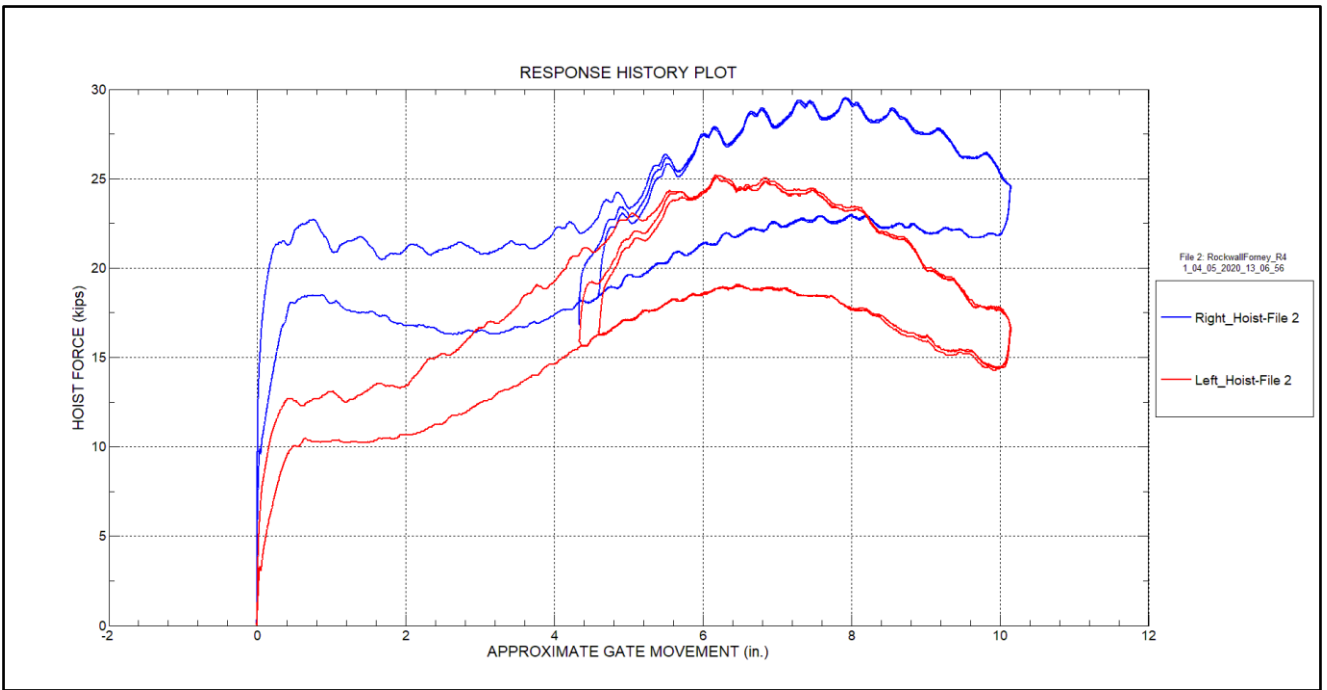
Figure 28 – Hoist force response history – Gate 4 – Test 2
