VISUAL INSPECTION AND EVALUATION REPORT

Rockwall-Forney Dam
Dallas Water Utilities
Dallas/Kaufman Counties, Texas

Schnabel Reference #20C22001.00
July 30, 2021

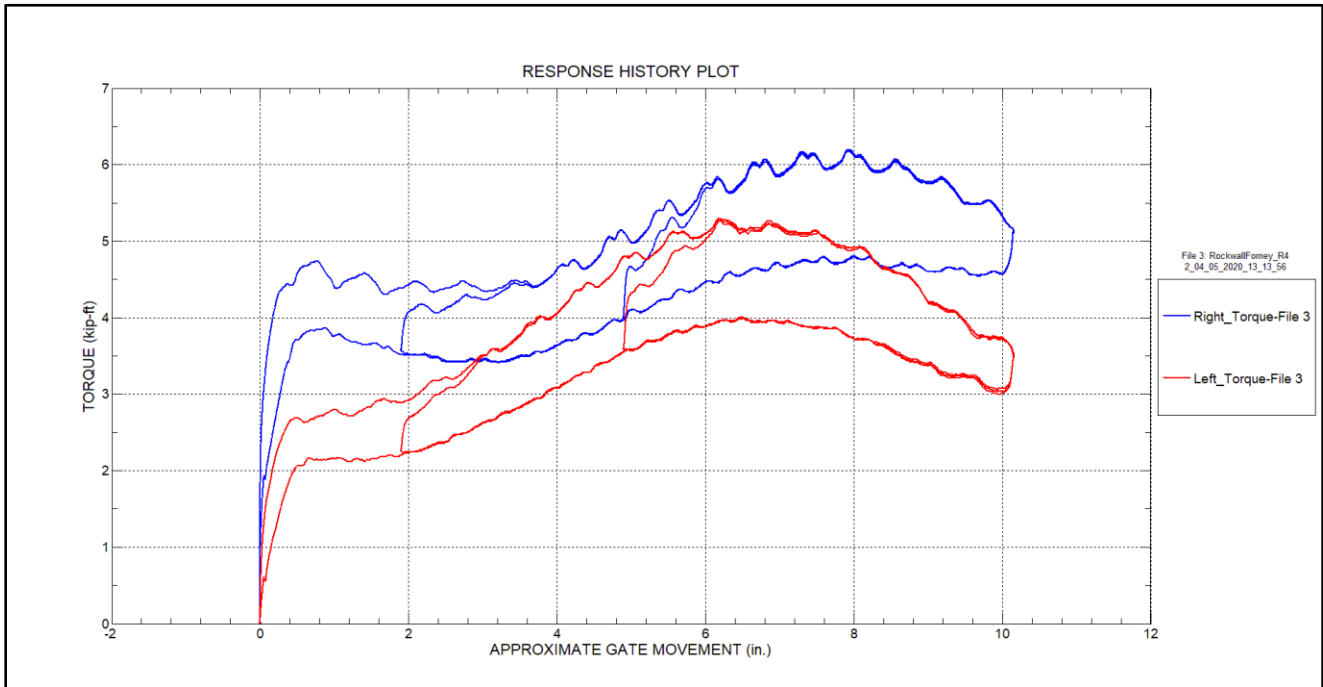
Figure 29 – Hoist torque response history – Gate 4 – Test 3

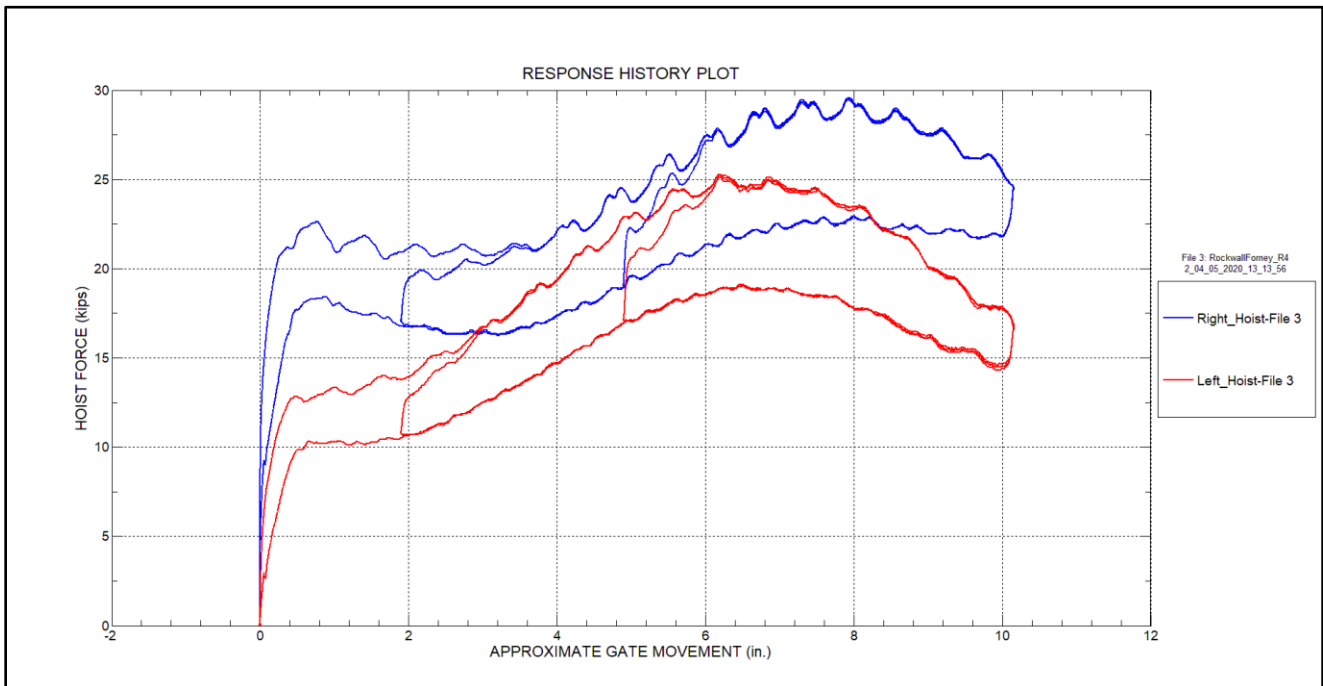
Figure 30 – Hoist force response history – Gate 4 – Test 3

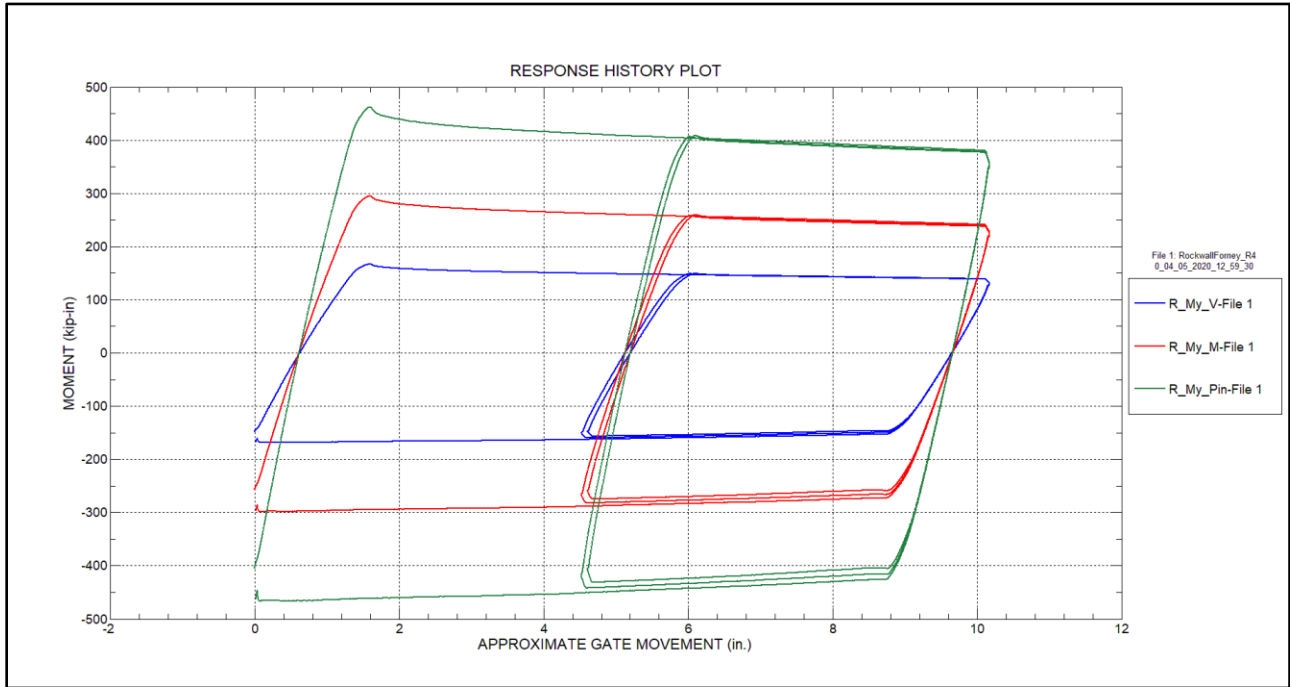
Figure 31 – Pin moment response history – Right arm – Test run 1

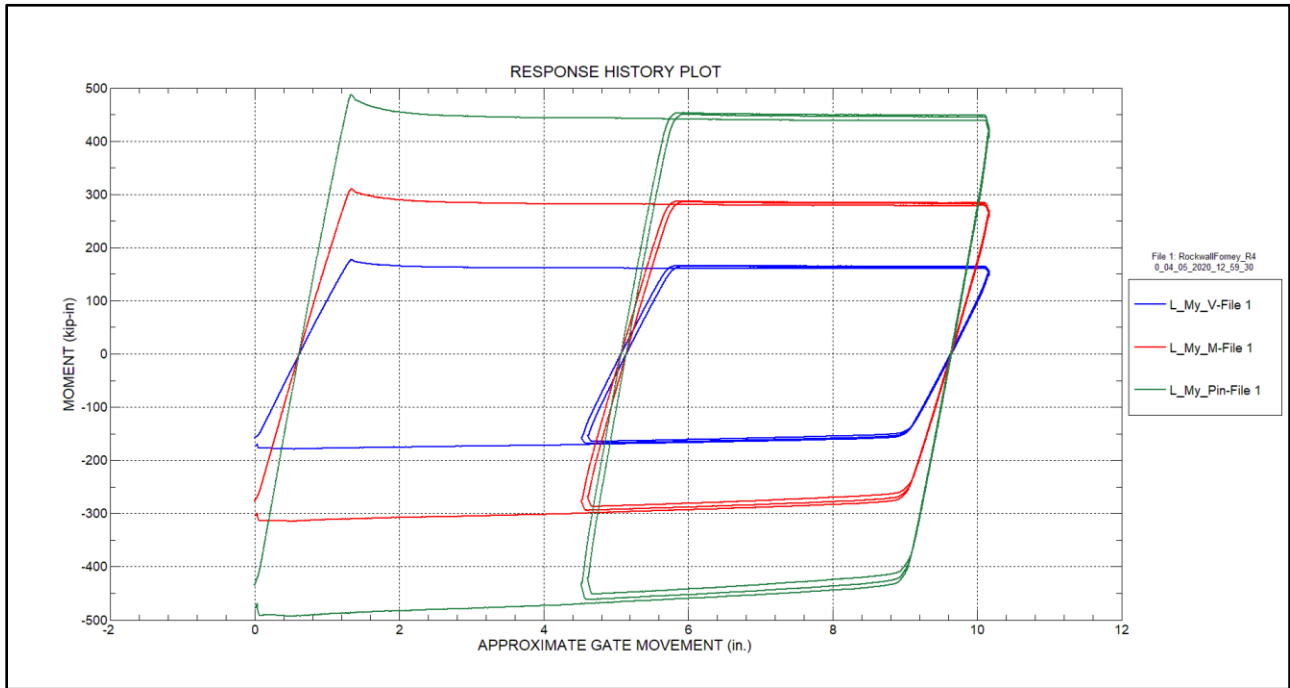
Figure 32 – Pin moment response history – Left arm – Test run 1

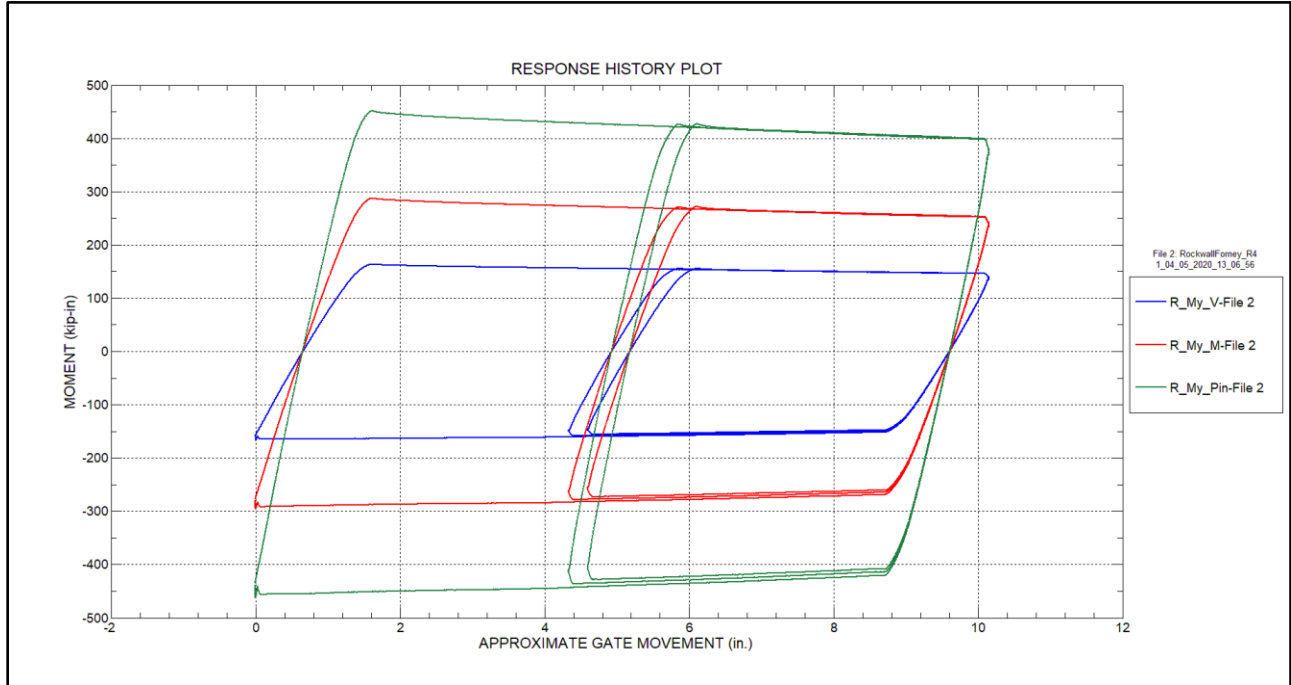
Figure 33 – Pin moment response history – Right arm – Test run 2

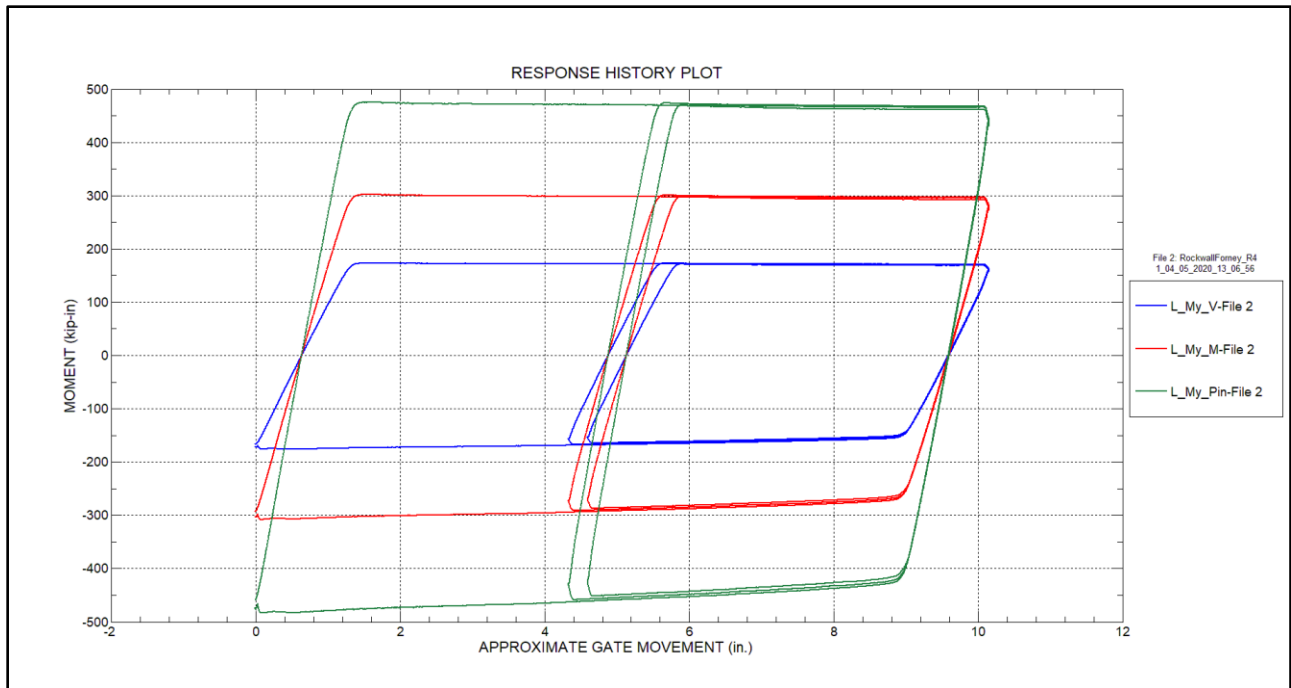
Figure 34 – Pin moment response history – Left arm – Test run 2

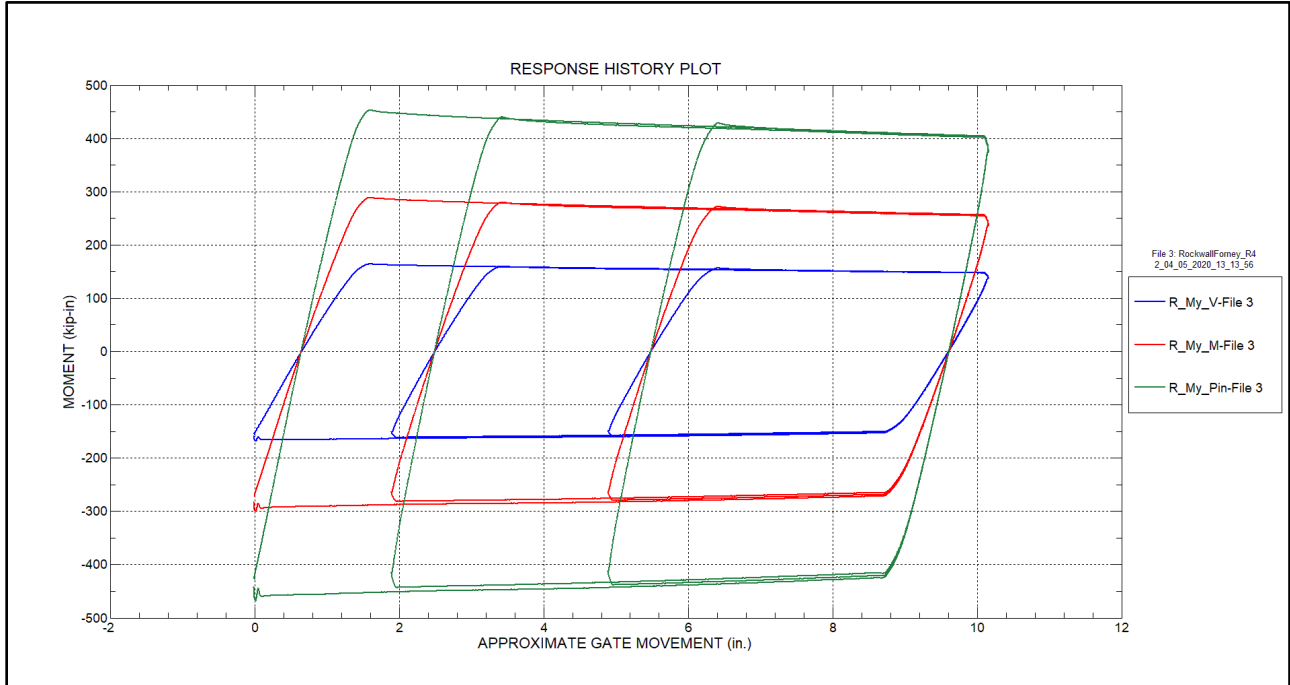
Figure 35 – Pin moment response history – Right arm – Test run 3

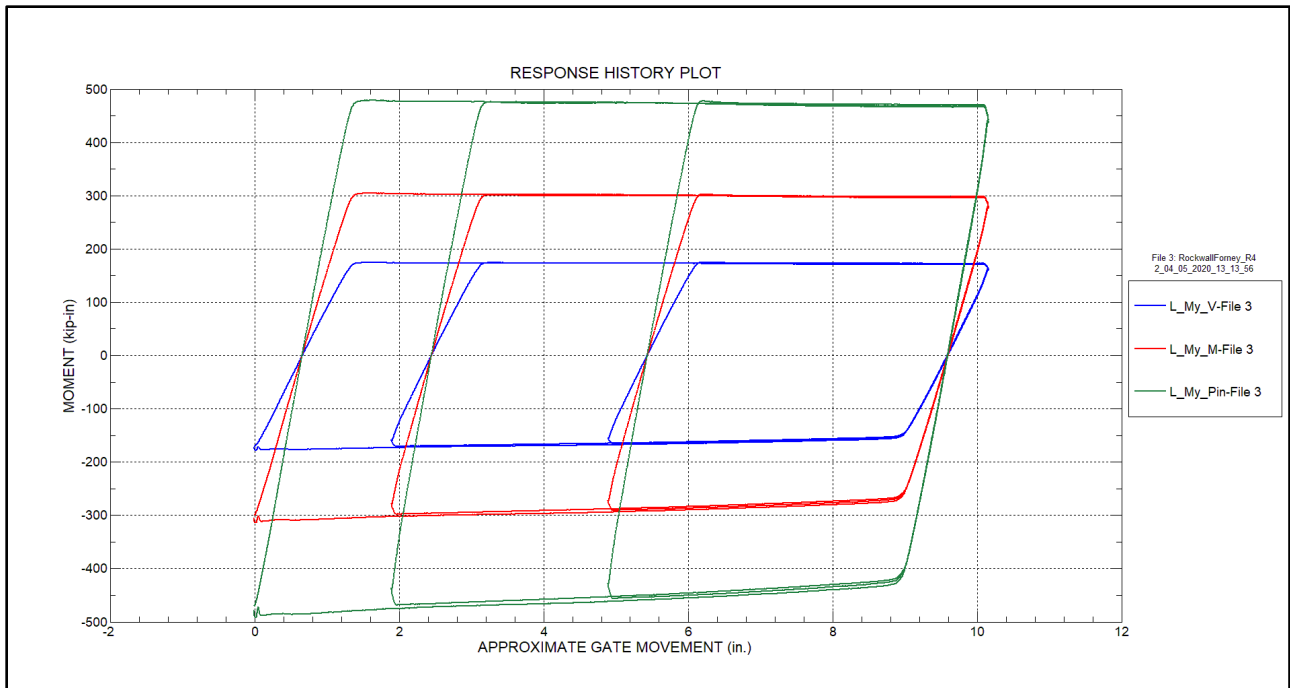
Figure 36 – Pin moment response history – Left arm – Test run 3

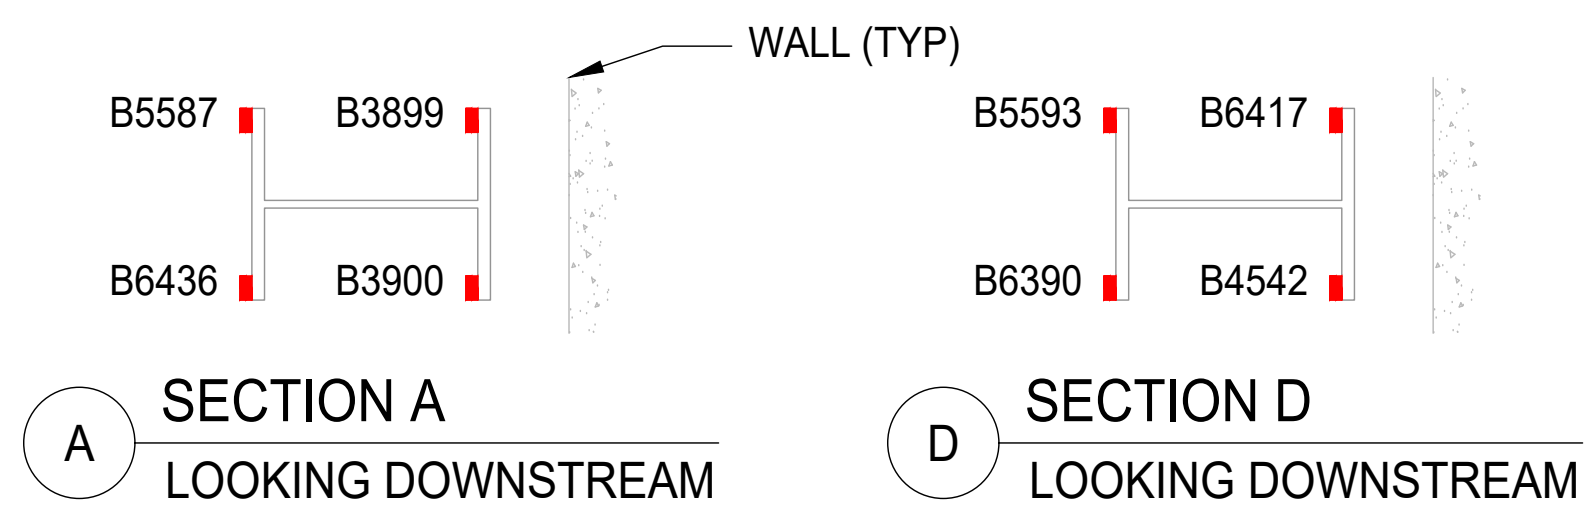
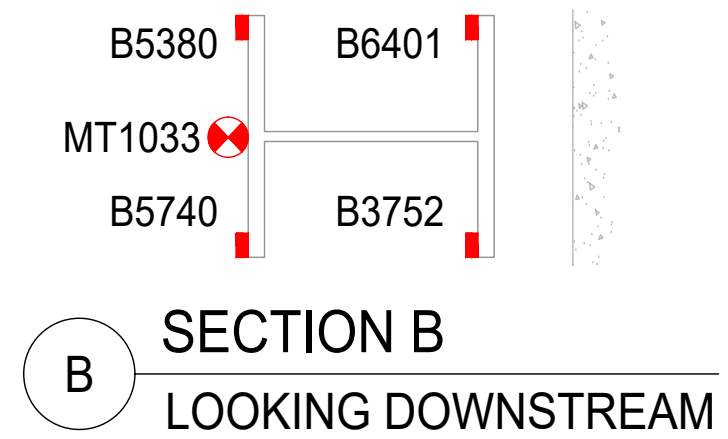
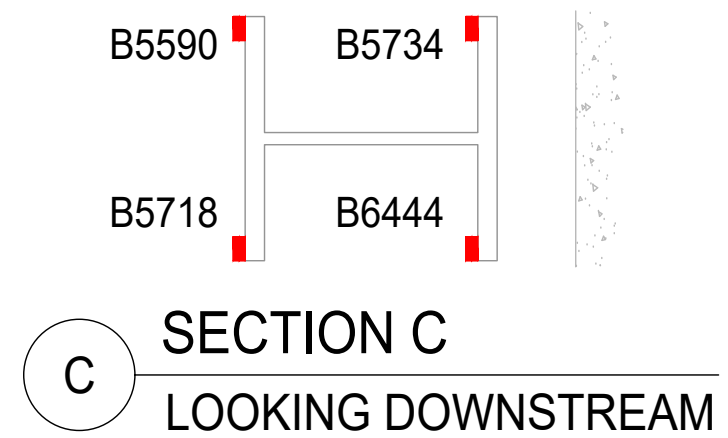
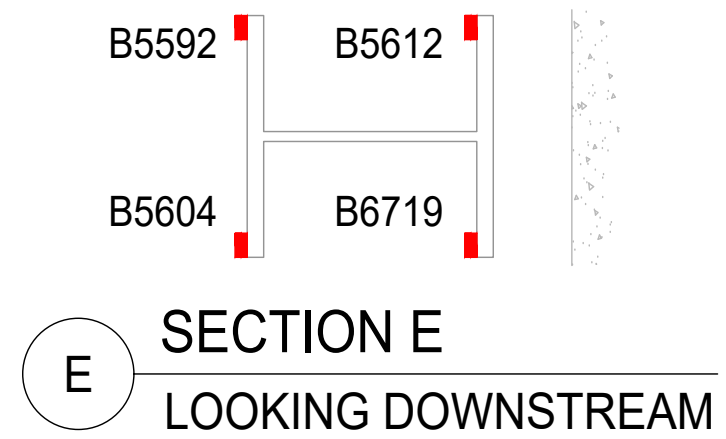
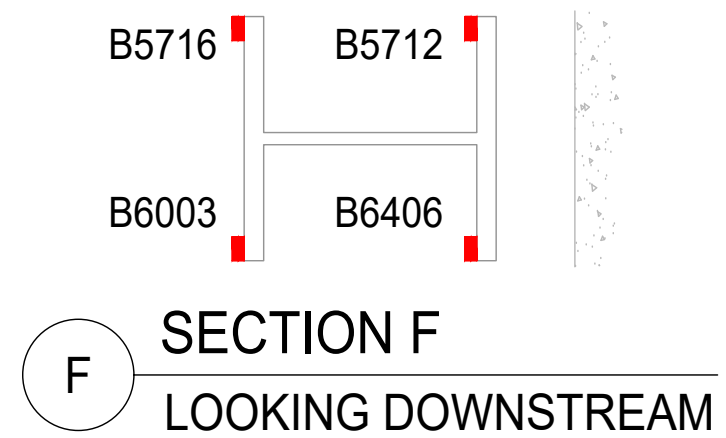
1 GATE 4
RIGHT ARM

- NOTES:
1. SECTIONS A, B, & C SHALL BE INSTALLED 15 INCHES AWAY FROM TRUNNION PLATE.
 2. TILTMETERS SHALL BE INSTALLED CENTERED ON THE MIDDLE STRUT FLANGE.
 3. SECTION G'S TILTMETER SHALL BE INSTALLED AS CLOSE TO THE SKINPLATE AS POSSIBLE.

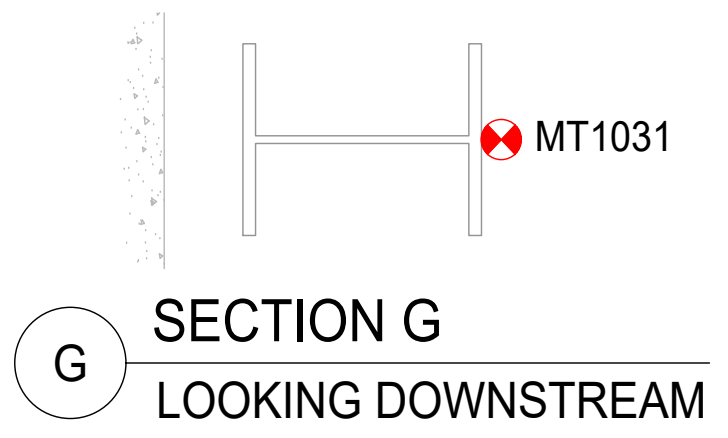
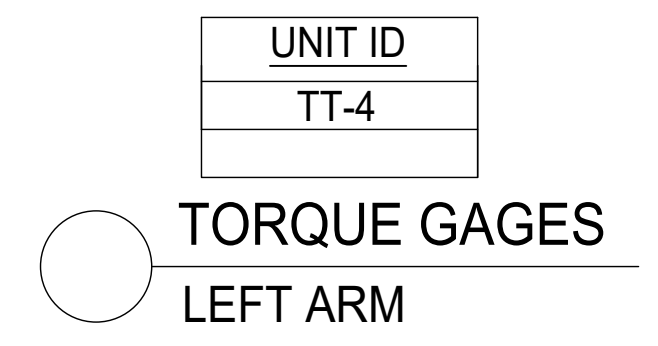
2 GATE 4
LEFT ARM

1. SECTIONS A, B, & C SHALL BE INSTALLED 15 INCHES AWAY FROM TRUNNION PLATE.
2. TILTMETERS SHALL BE INSTALLED CENTERED ON THE MIDDLE STRUT FLANGE.
3. SECTION G'S TILTMETER SHALL BE INSTALLED AS CLOSE TO THE SKINPLATE AS POSSIBLE.

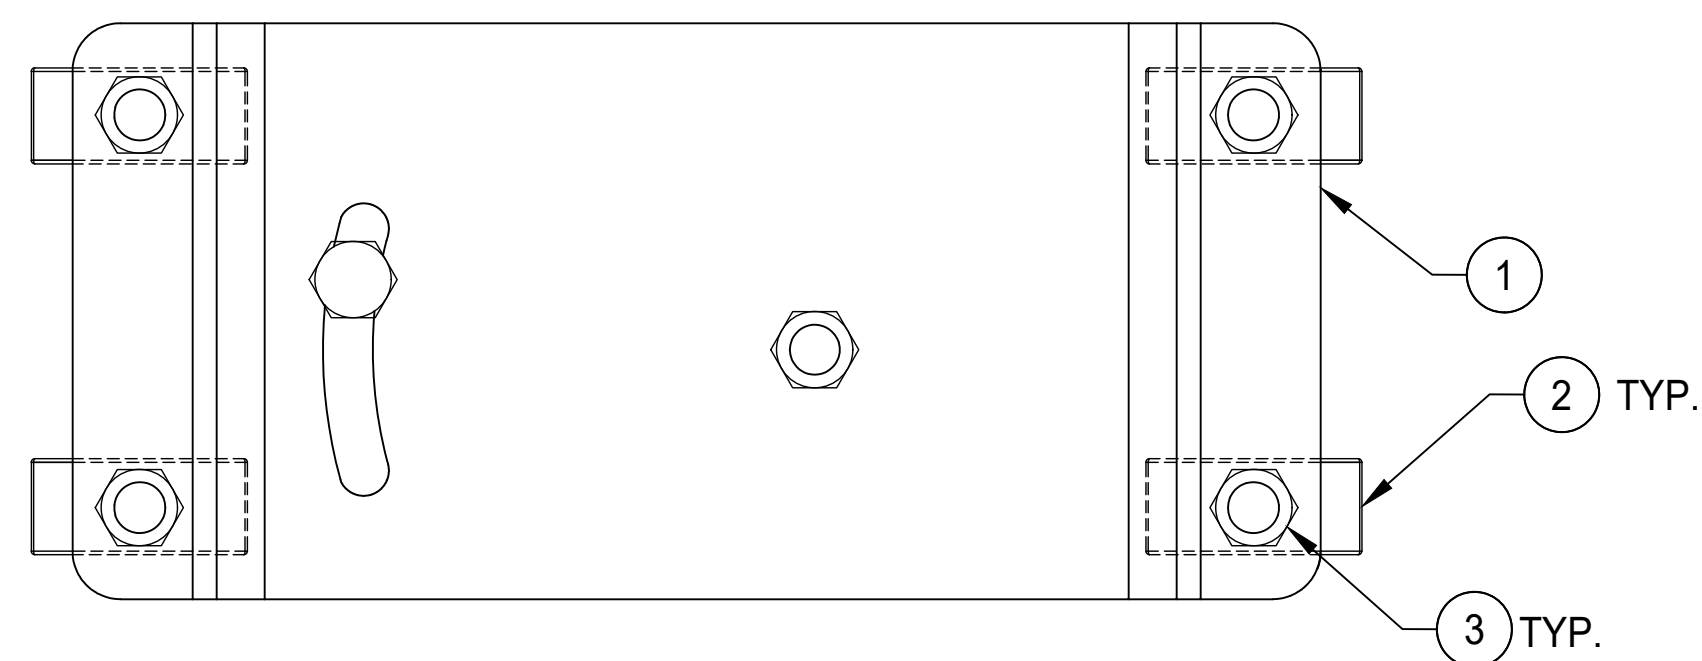
2 TYPICAL BDI TILTMETER INSTALLATION

1. BDI +/- 15 DEGREE TILTMETER WITH COVER AND ADJUSTMENT BOLTS
2. 1/4"-20 THREADED MOUNTING TAB
3. 1/4"-20 STAINLESS STEEL NUT
4. TYPICAL SURFACE PREP REQUIRED TO MOUNT TILTMETERS
5. TYPICAL MOUNTING SURFACE

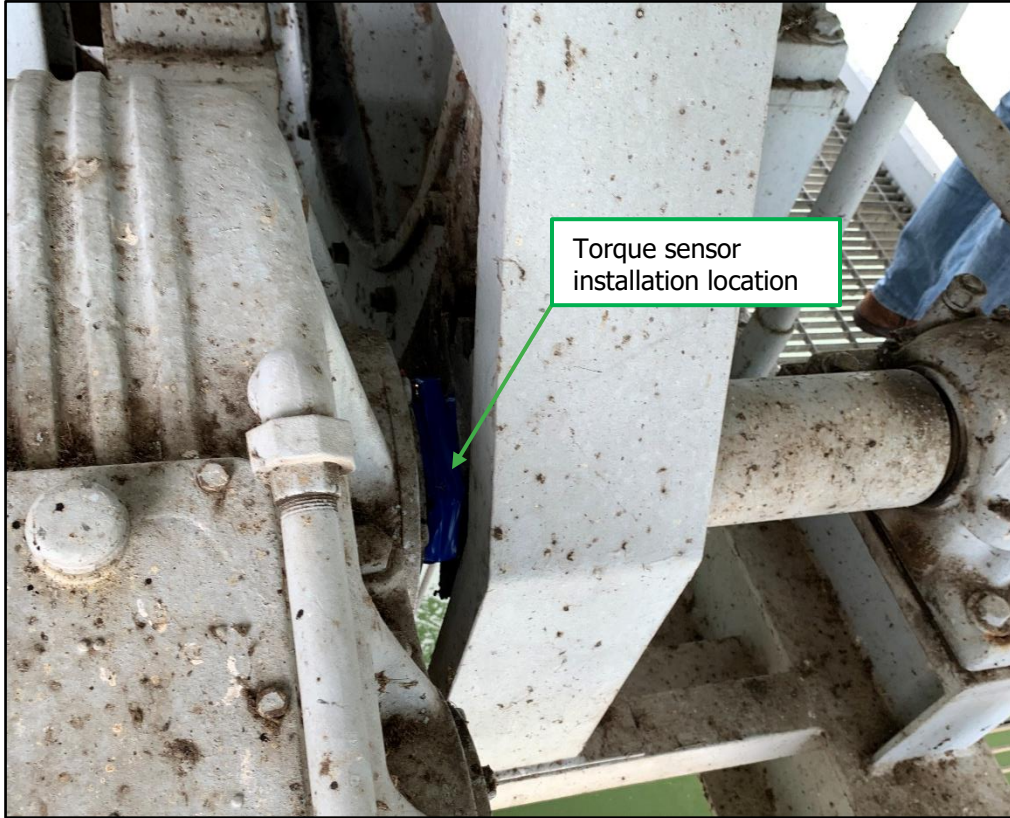
Figure 3 – Torque sensor installation on hoist pinion shaft (Typical)

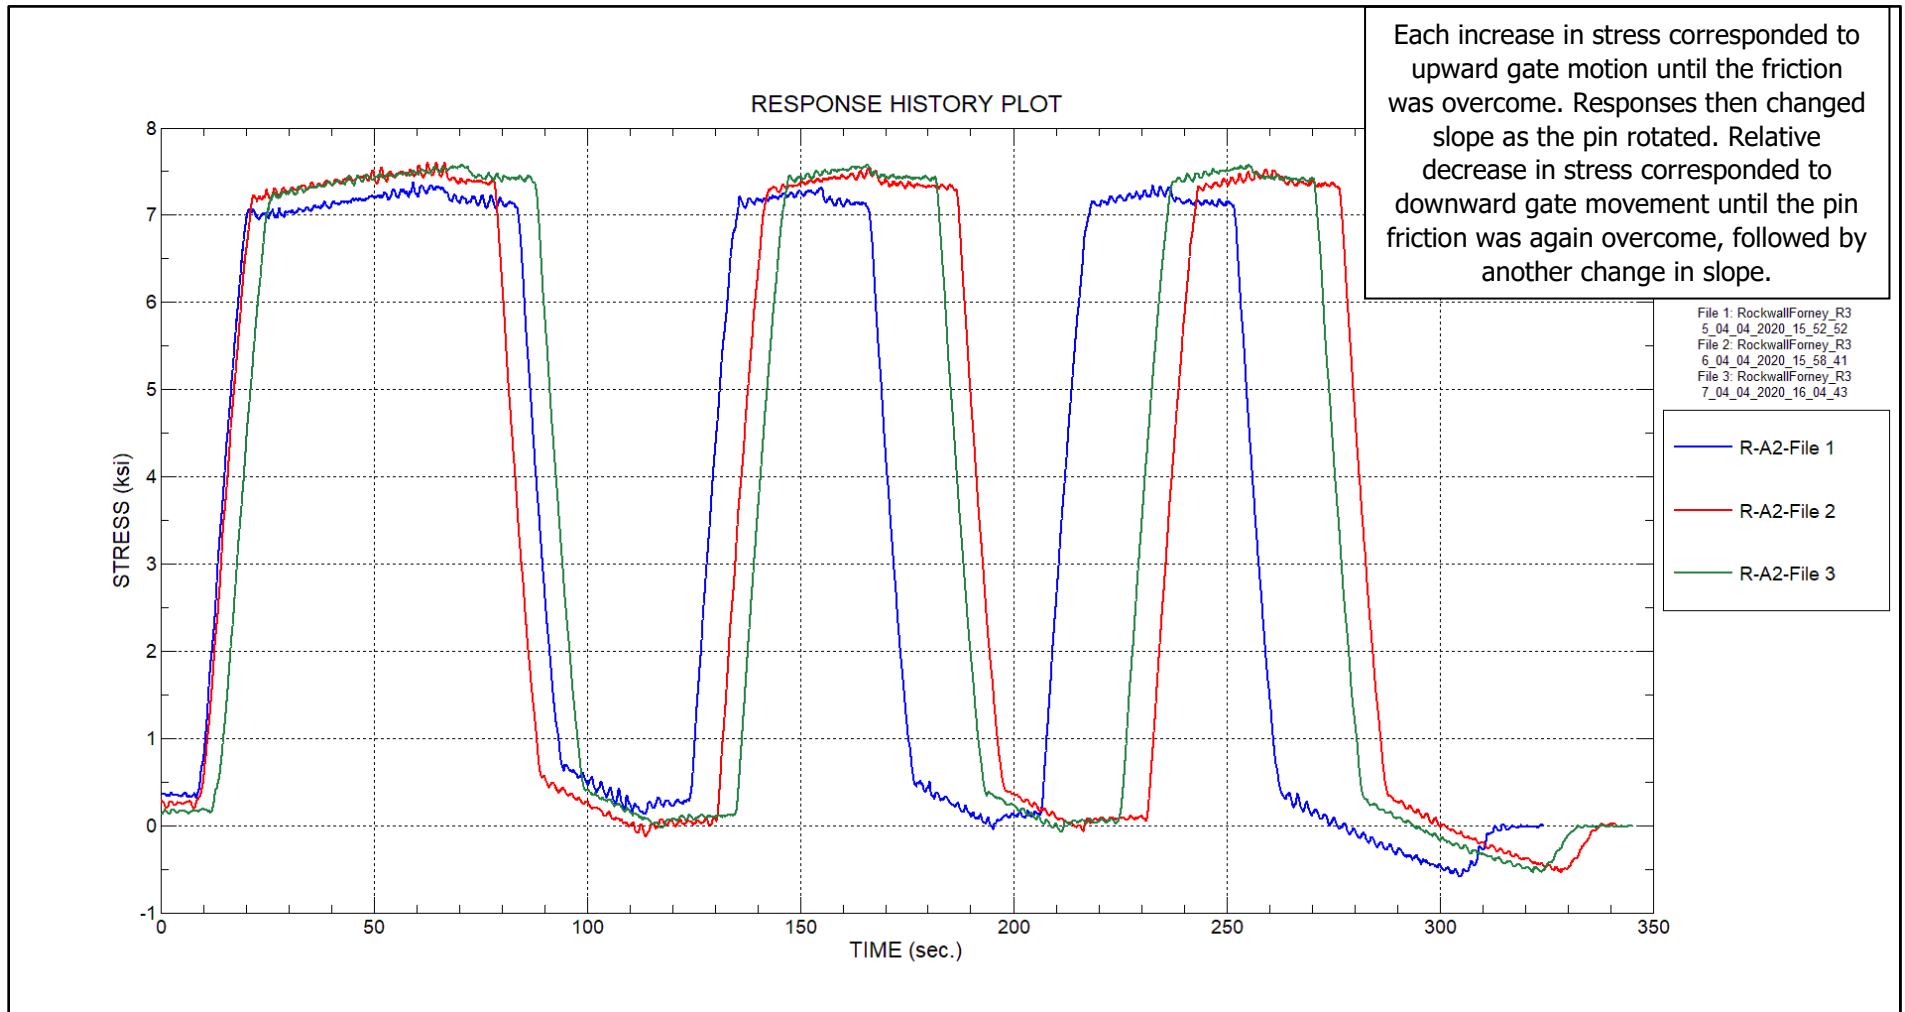
Figure 6 – Stress response history – Right arm – Gage A2 – Time based
File 1 = test run 1, File 2 = test run 2, File 3 = test run 3
(Section A along top strut near pin – Sensor location 2 along bottom of inner flange)

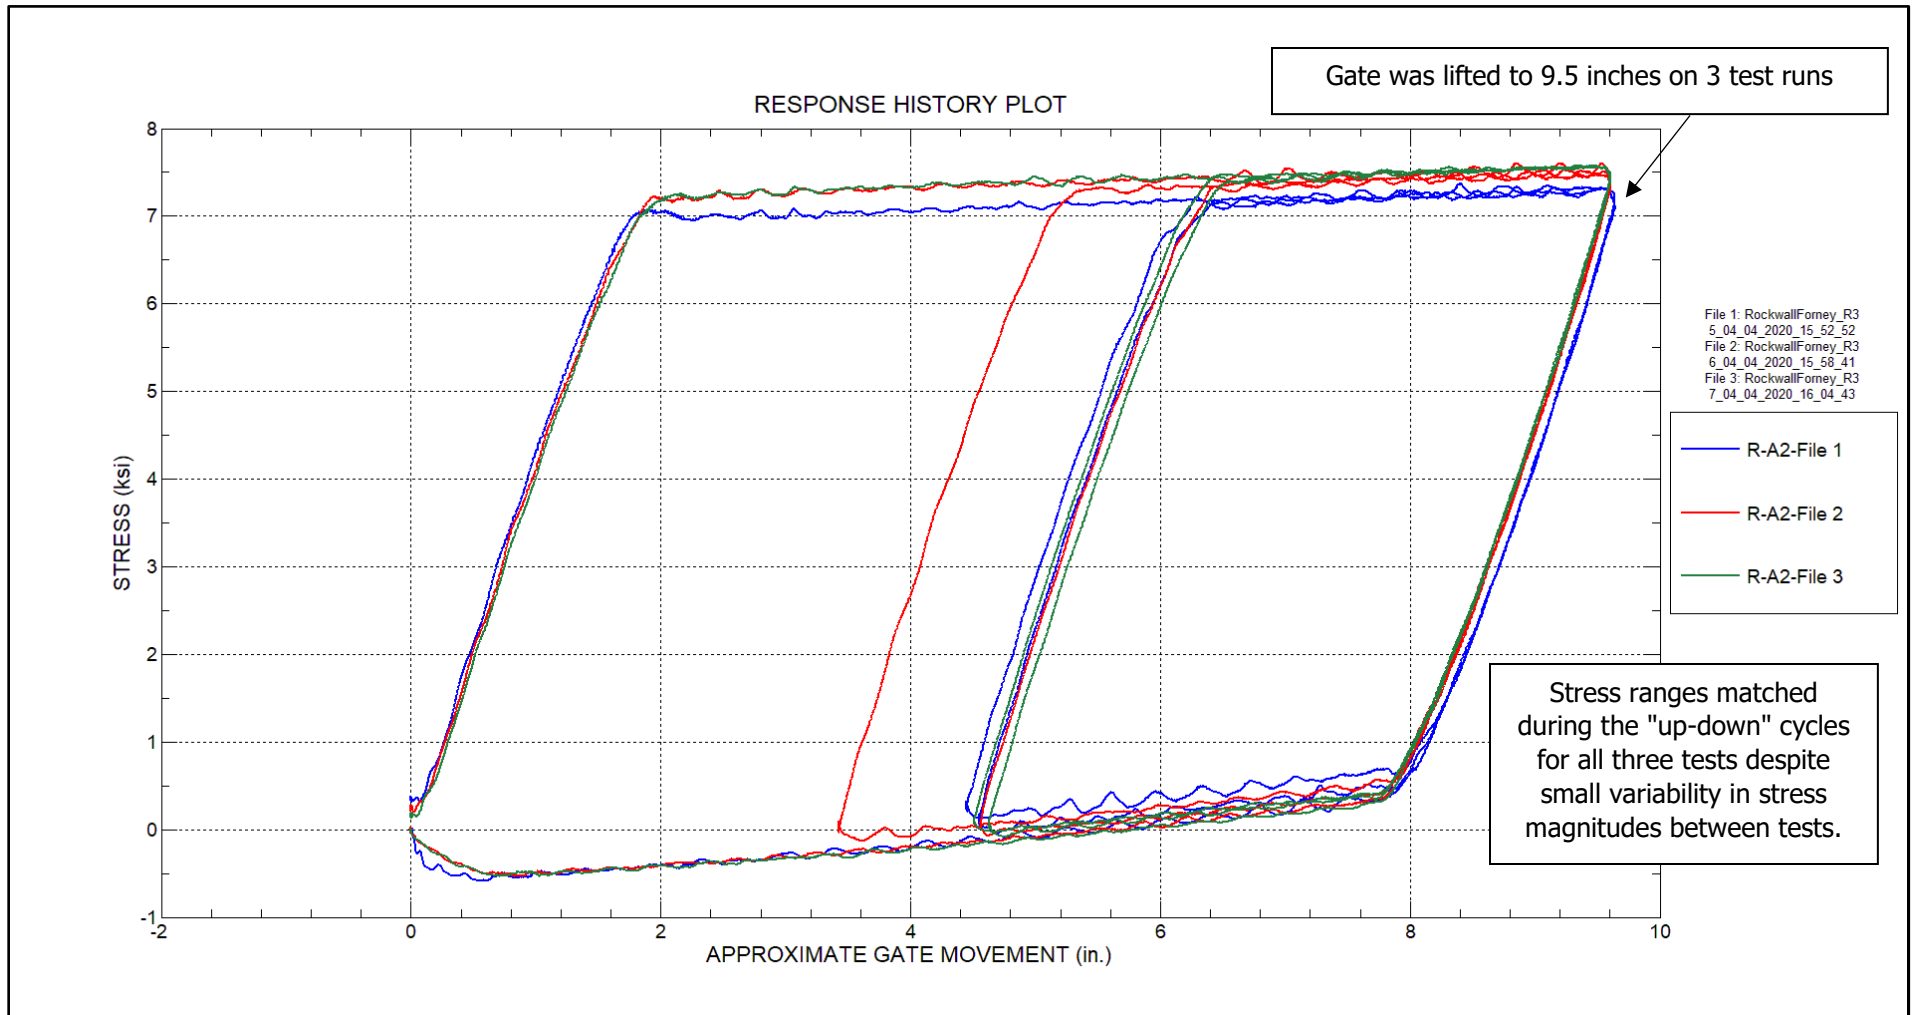
Figure 7 – Stress response history – Right arm – Gage A2 – Function of gate movement
 File 1 = test run 1, File 2 = test run 2, File 3 = test run 3
 (Section A along top strut near pin – Sensor location 2 along bottom of inner flange)

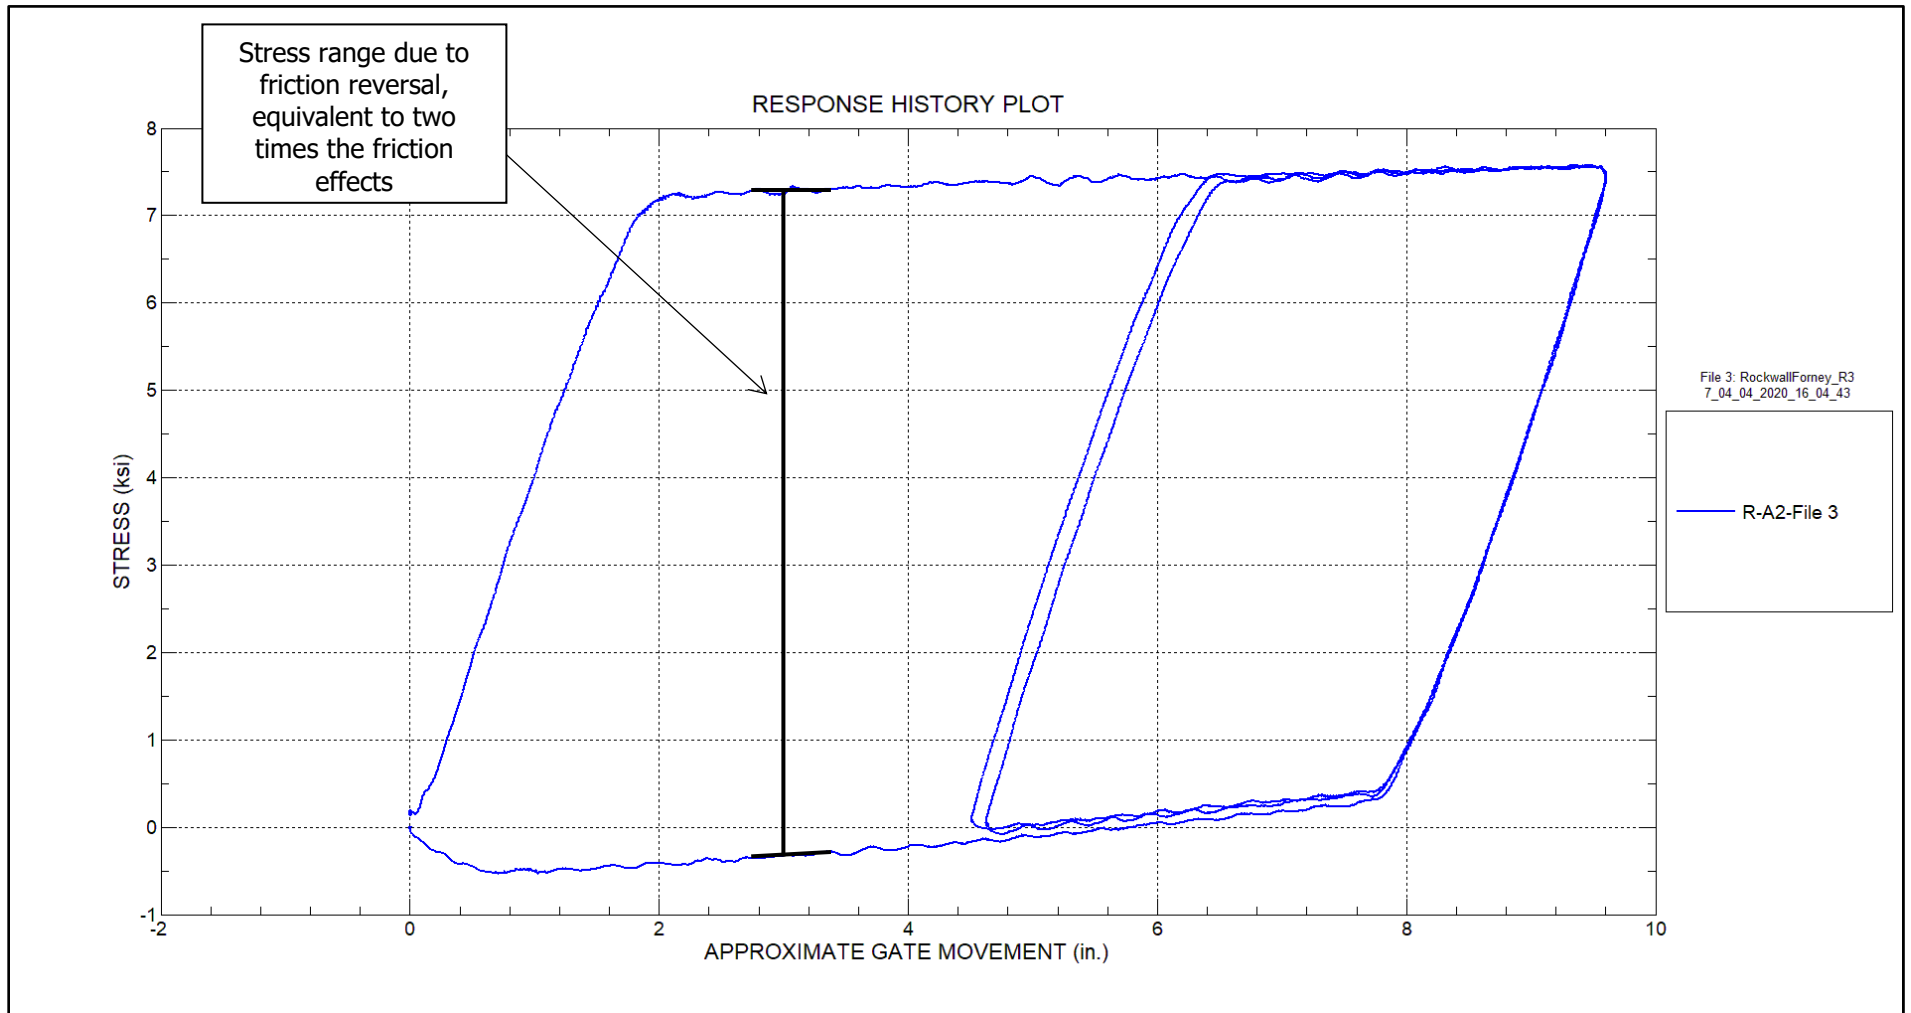
Figure 8 – Stress response history – Right arm – Gage A2 – Friction effect in stress responses
(Section A along top strut near pin – Sensor location 2 along bottom of inner flange)

- + **DIRECTION/FRICTION REVERSAL IN RESPONSES:** The difference in stress during gate opening and closing for a given position is shown in Figure 8. The stress variation at any given gate position was a result of direction reversal and in turn due to trunnion friction reversal. This statement is true since all other loads such as dead-load and hydrostatic pressure were essentially constant barring small changes in hydrostatic pressure due to slight changes in head. This direction/friction reversal is depicted in Figure 9, with deflected shape renderings from a gate arm finite element model under lifting and lowering loads. Note that this figure shows an arm configuration that does not match this gate, but the concept of the direction/friction reversal still applies.

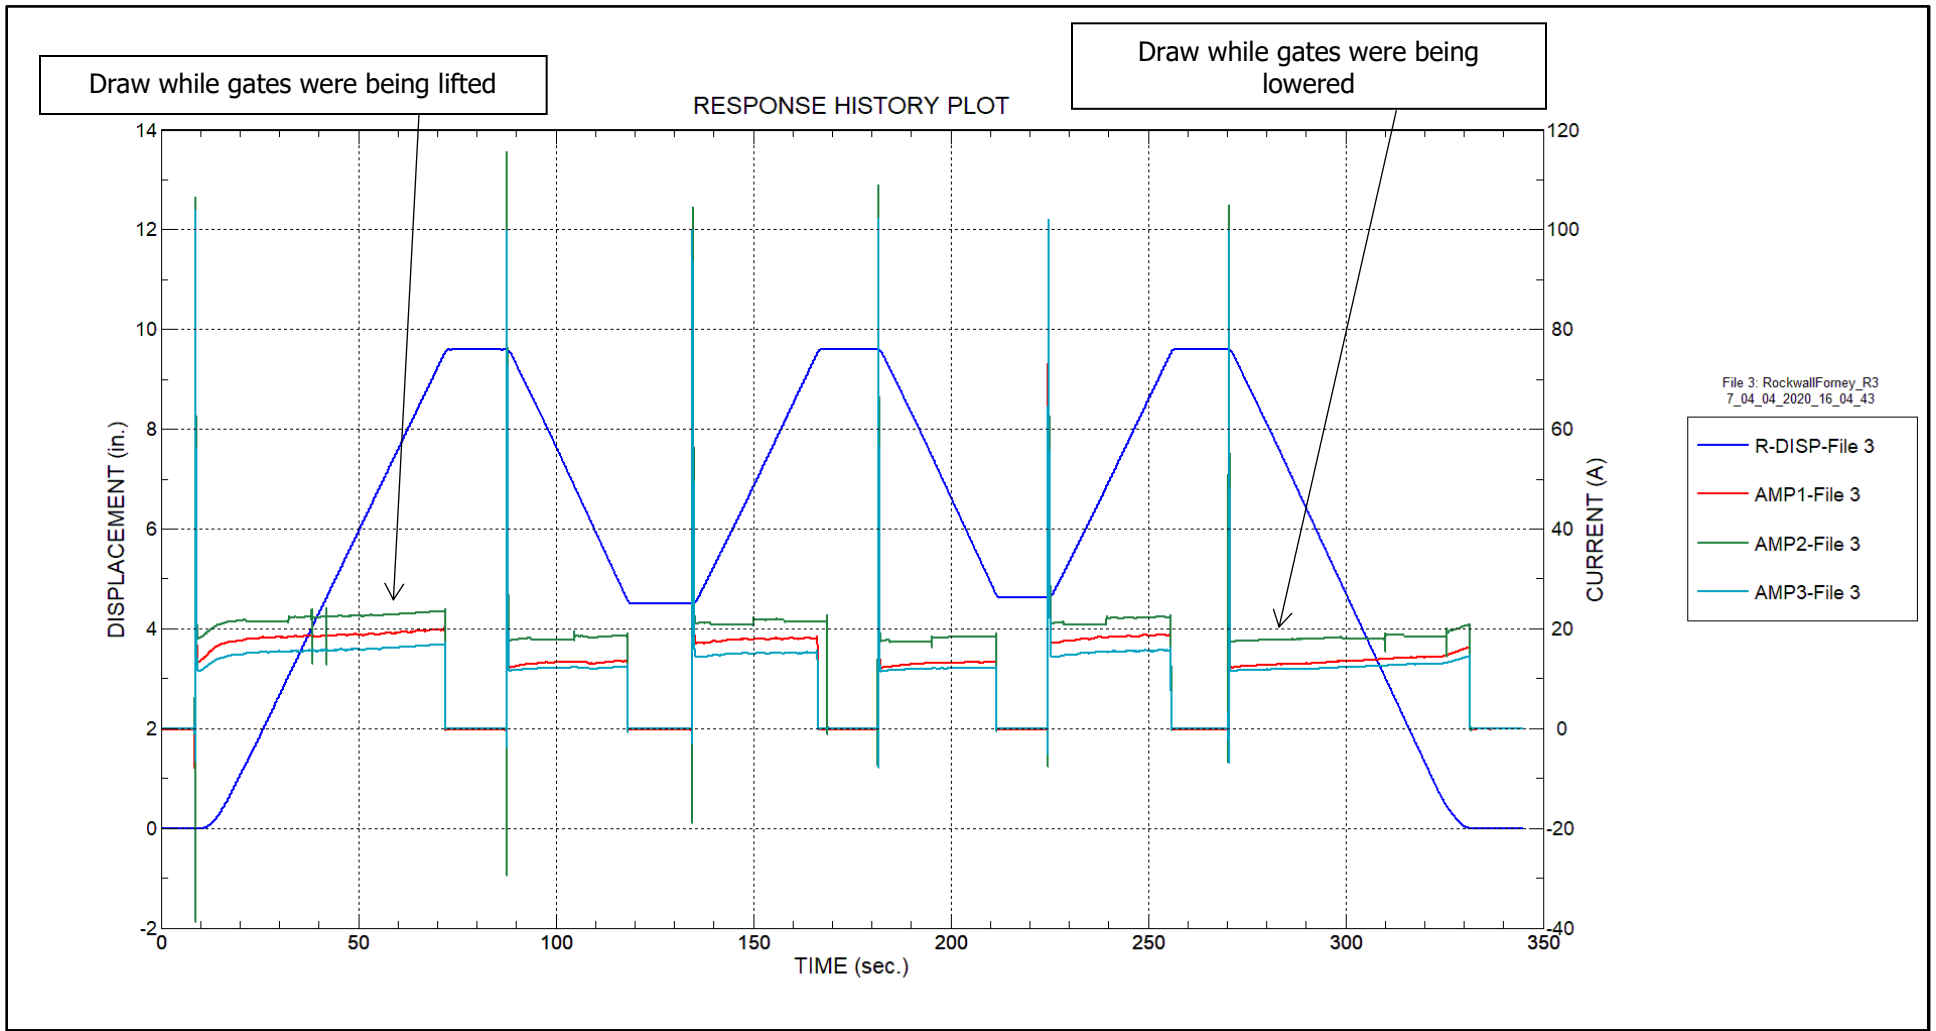
Figure 10 – Motor current & gate movement response history – Lift motor – Highlighting motor draw during lift and lower cycles

- + **MOTOR PERFORMANCE:** Current measurements taken at the hoist motor indicated steady and stable current draws during the lifting and lowering portions. An example plot of current draw and gate position is provided in Figure 10. Current draw ranges during lifting were higher than the ranges during lowering, which is common due to gravity/dead load. These results are summarized along with recorded peak in-rush current in Table 2. Note that the sample rates used during testing were set for collecting gate responses and may not have been appropriate to fully capture the in-rush current. The readings should be evaluated by a licensed electrician with knowledge of the operating parameters.

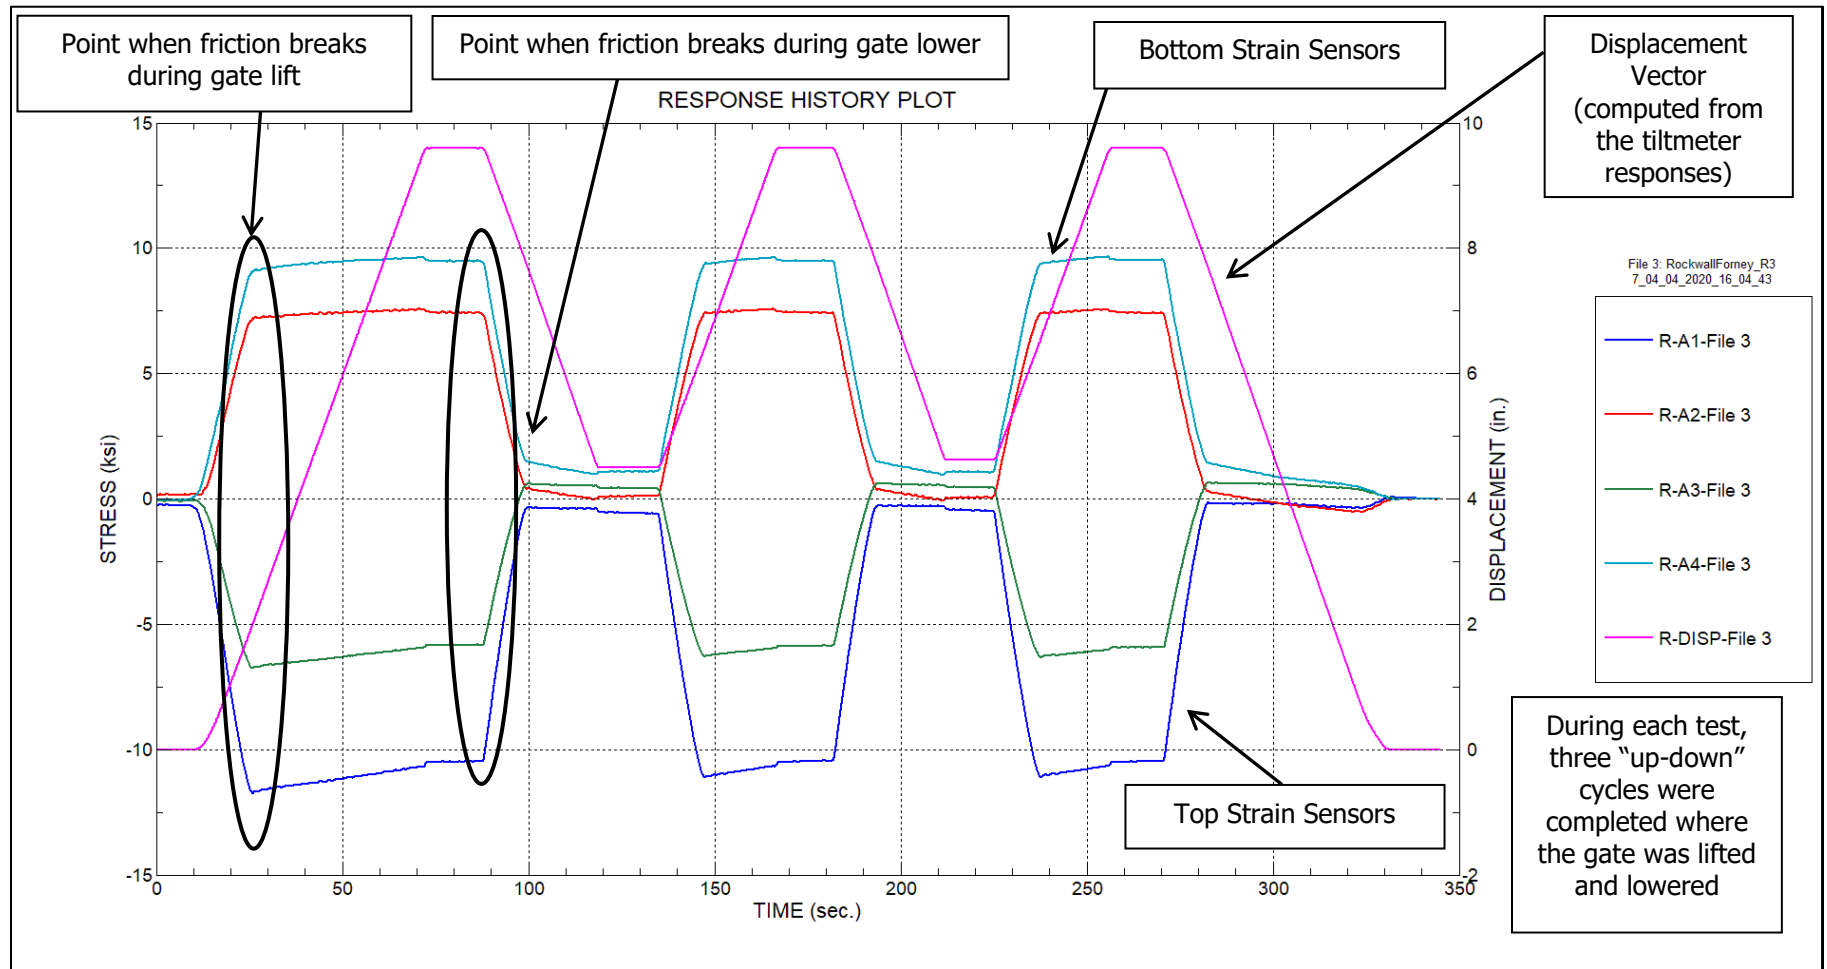
Figure 11 – Stress response & gate movement history – Right arm – Section A - Highlighting friction behavior (Section A along top strut near pin)
