VISUAL INSPECTION AND EVALUATION REPORT

Rockwall-Forney Dam
Dallas Water Utilities
Dallas/Kaufman Counties, Texas

Schnabel Reference #20C22001.00
July 30, 2021

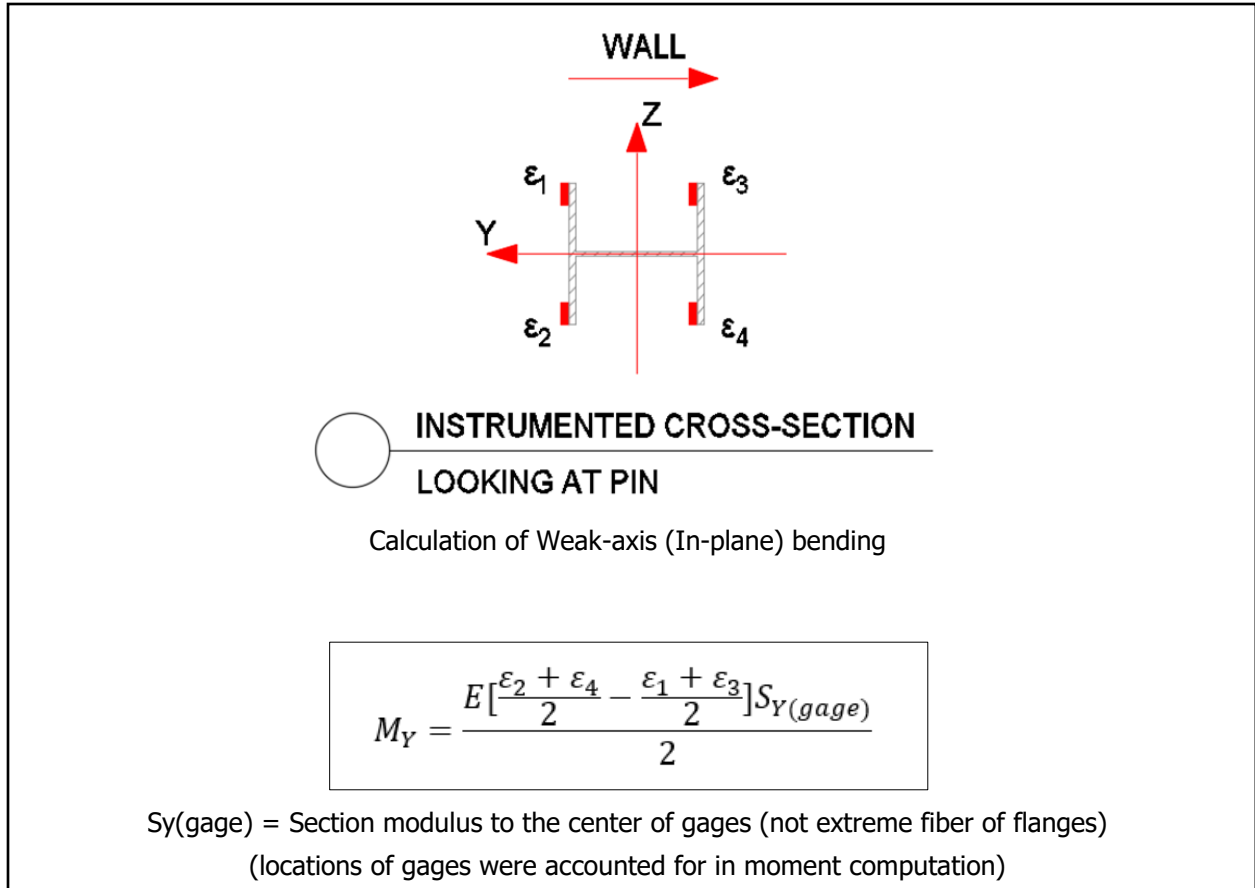
Figure 12 – Basic mechanic equation used to calculate moment

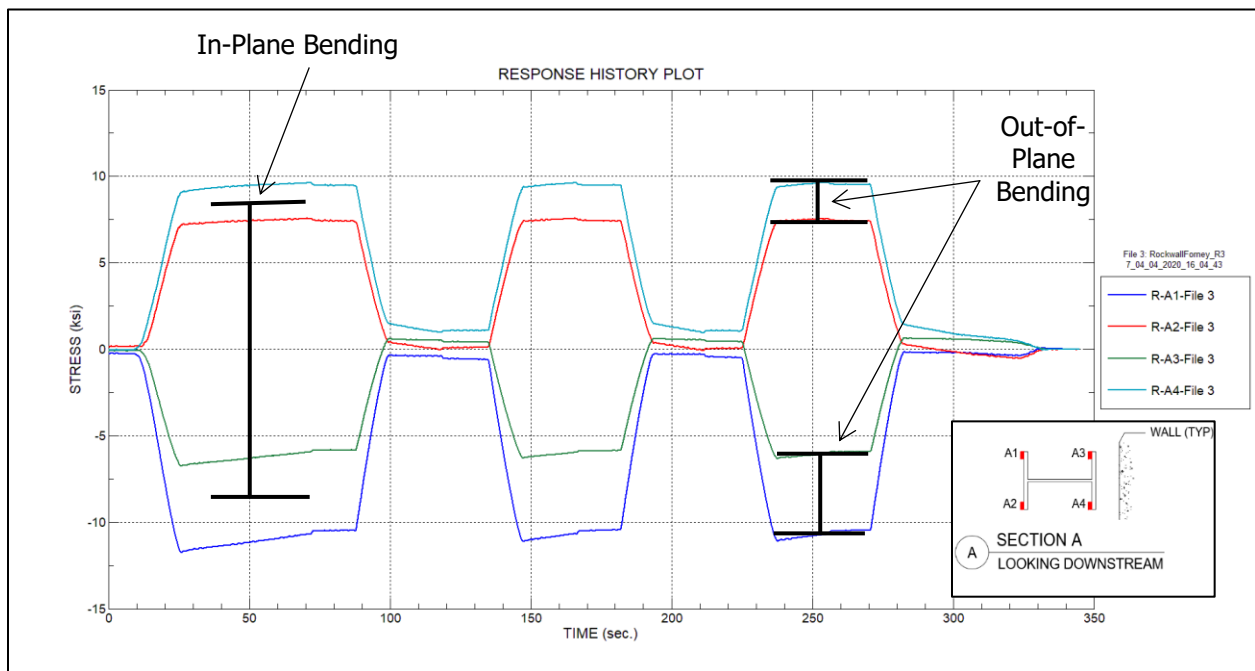
Figure 13 – Stress response history – Right arm – Section A – Bending components
(Section A along top strut near pin)

In-plane or weak-axis flexure refers to bending about a given strut's web. This designation is consistent with typical nomenclature. In-plane bending can be observed visually from the strain response histories as a difference between the top and bottom stresses, whereas out-of-plane or strong-axis bending is visualized as the difference in stress from side to side. Figure 13 provides a visual reference for both types of strut flexure.

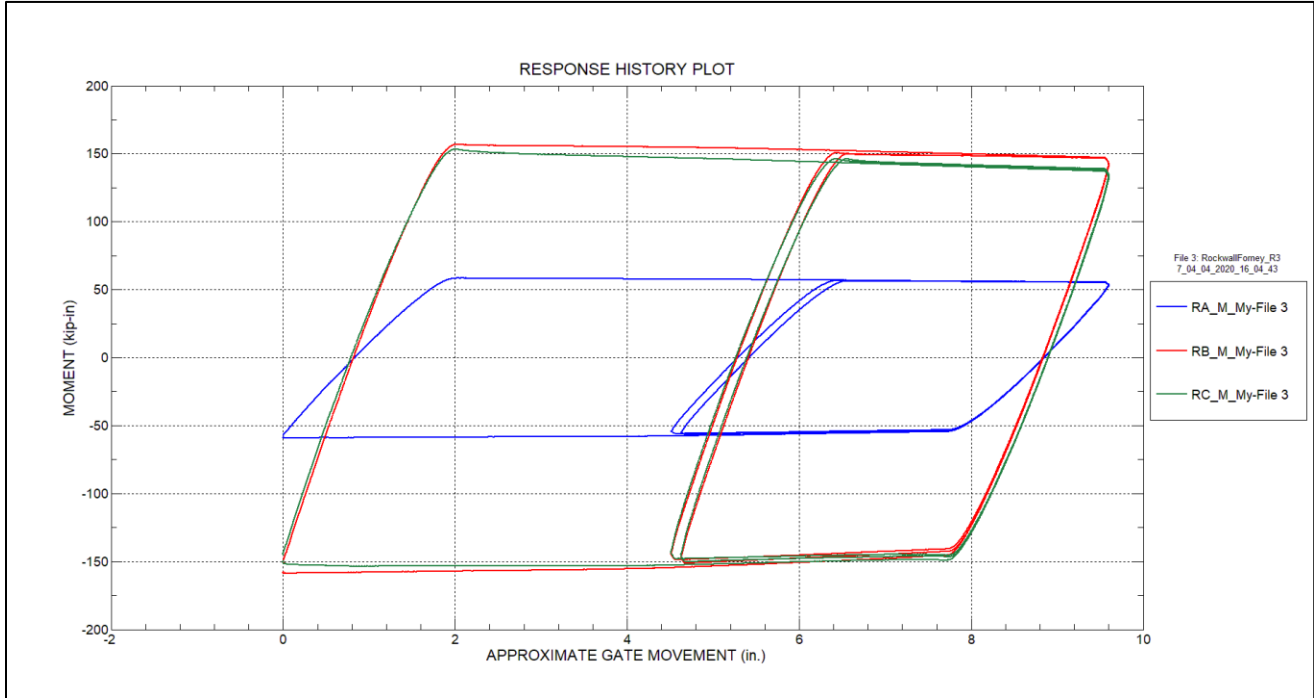
Figure 14 – In-plane moment response history – Right arm – Sections near pin
(RA = Right Arm Top Strut, RB = Right Arm Middle Strut, RC = Right Arm Bottom Strut)

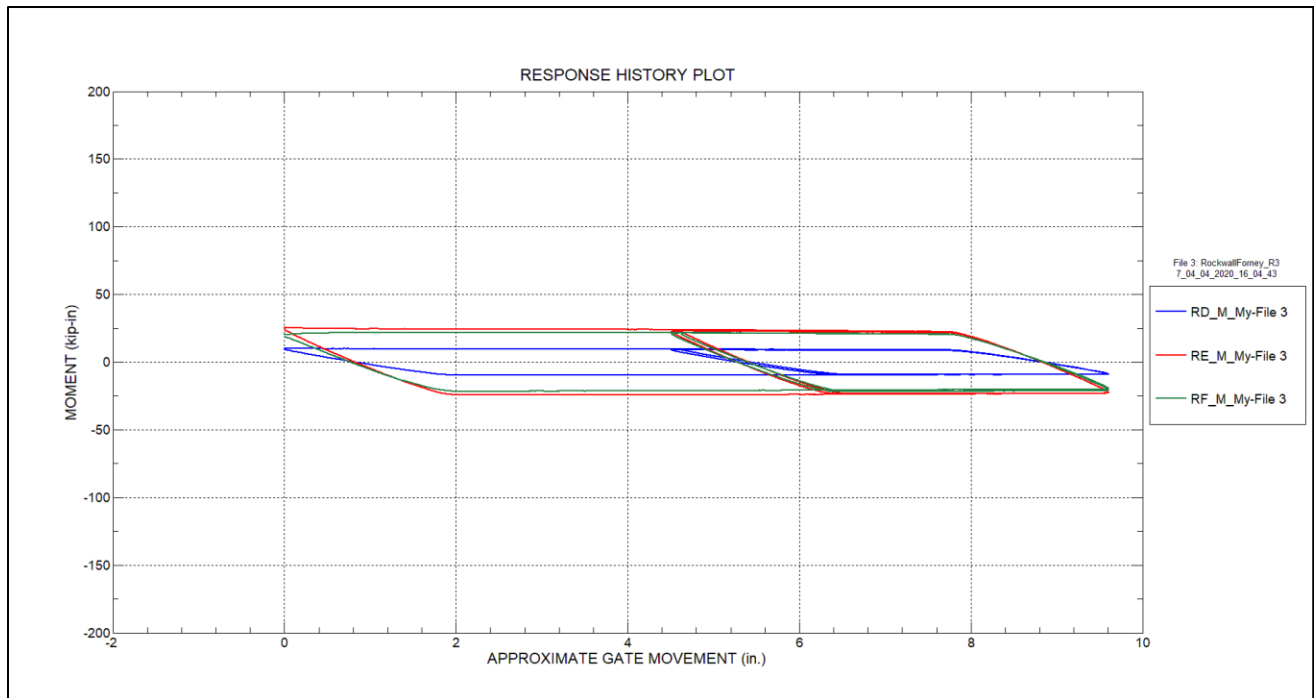
Figure 15 – In-plane moment response history – Right arm – Sections away from pin
(RD = Right Arm Top Strut, RE = Right Arm Middle Strut, RF = Right Arm Bottom Strut)

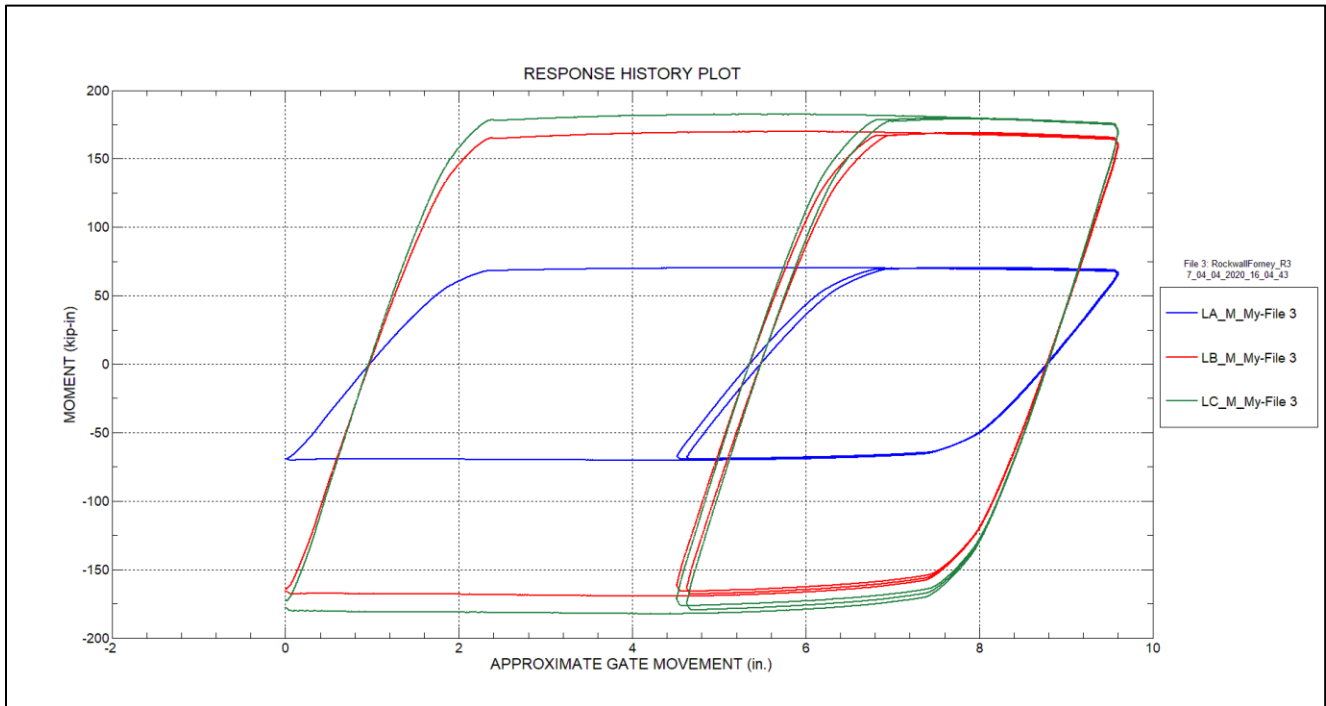
Figure 16 – In-plane moment response history – Left arm – Sections near pin
(LA = Left Arm Top Strut, LB = Left Arm Middle Strut, LC = Left Arm Bottom Strut)

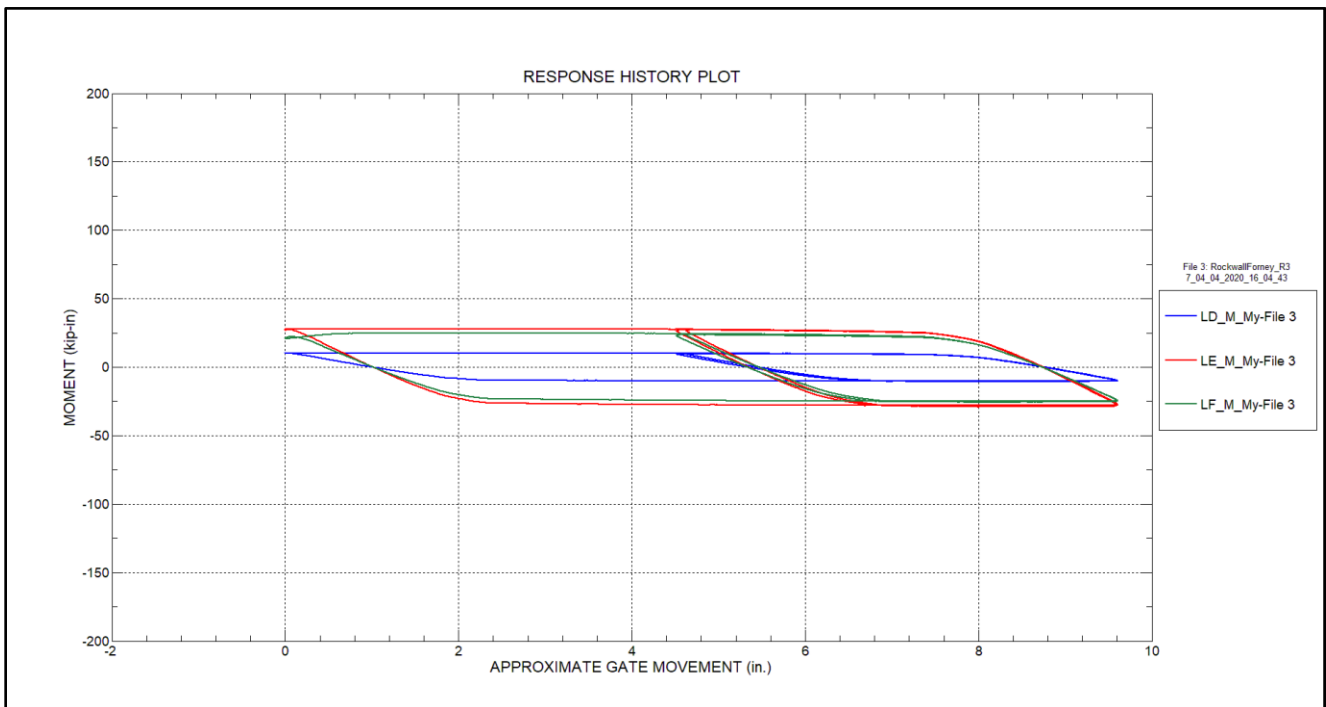
Figure 17 - In-plane moment response history – Left arm – Sections away from pin
(LD = Left Arm Top Strut, LE = Left Arm Middle Strut, LF = Left Arm Bottom Strut)

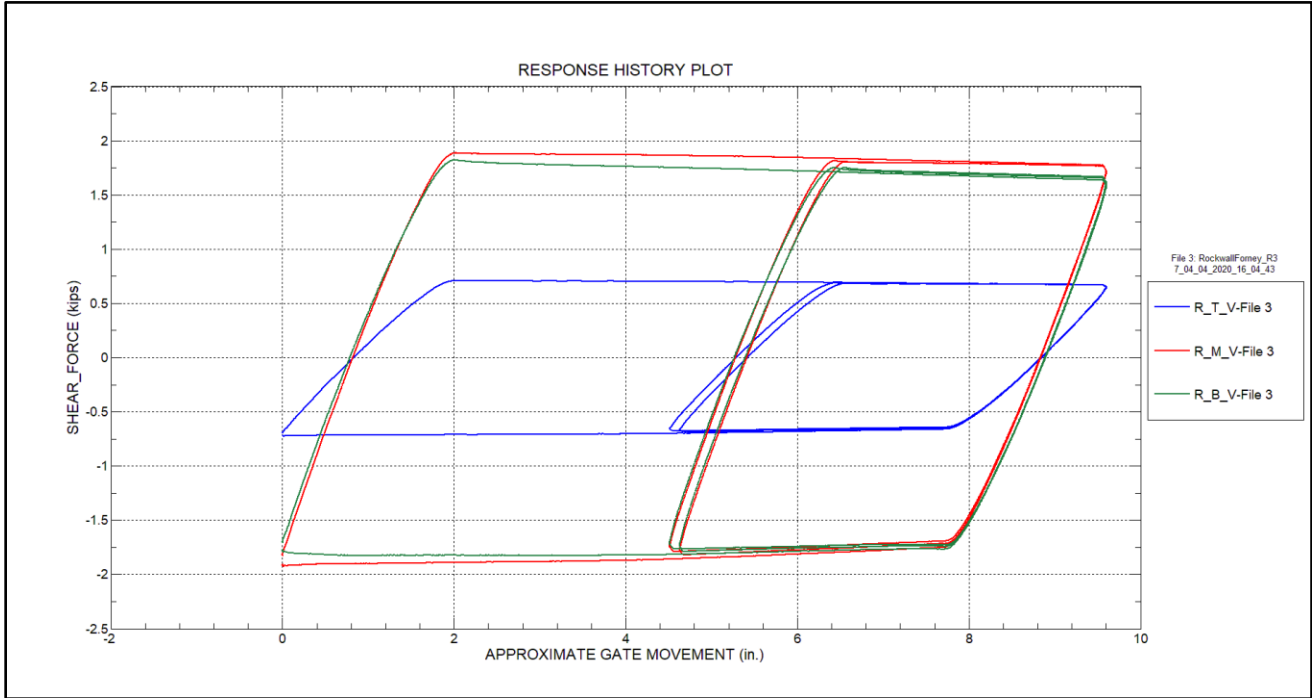
Figure 19 – Strut shear response history – Right arm

(R_T = Right Arm Top Strut, R_M = Right Arm Middle Strut, R_B = Right Arm Bottom Strut)

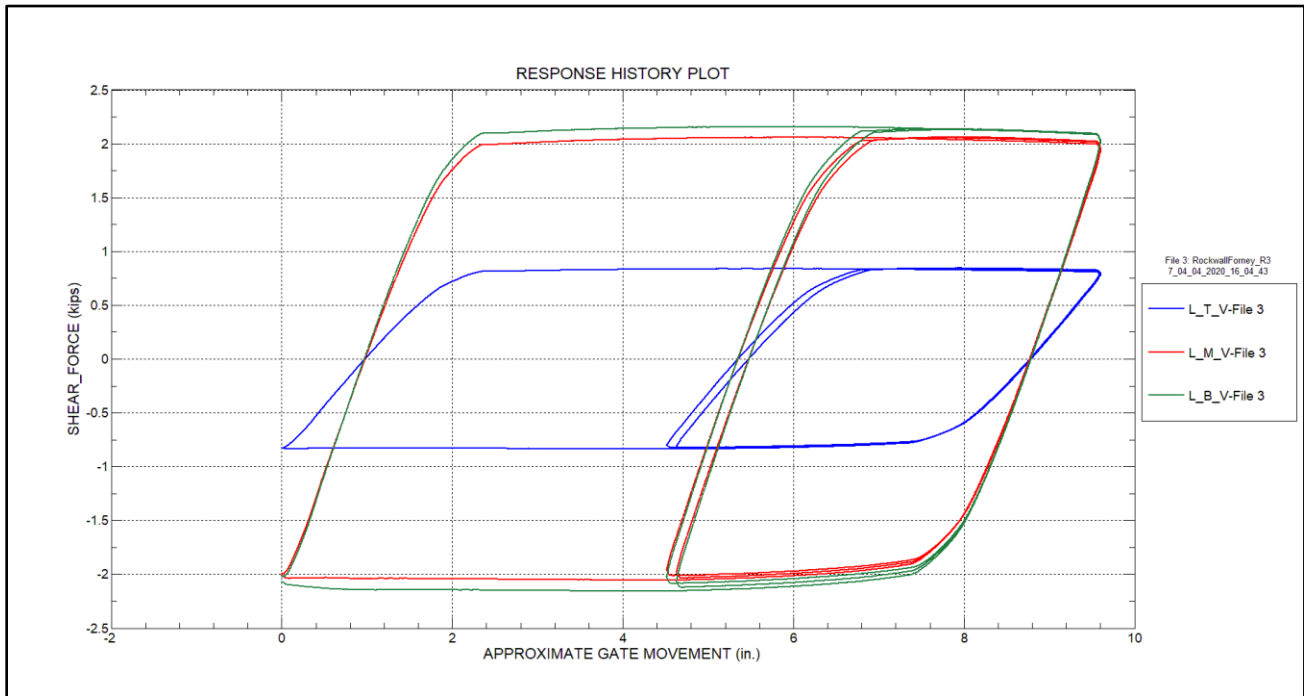
Figure 20 – Strut shear response history – Left arm

(L_T = Left Arm Top Strut, L_M = Left Arm Middle Strut, L_B = Left Arm Bottom Strut)

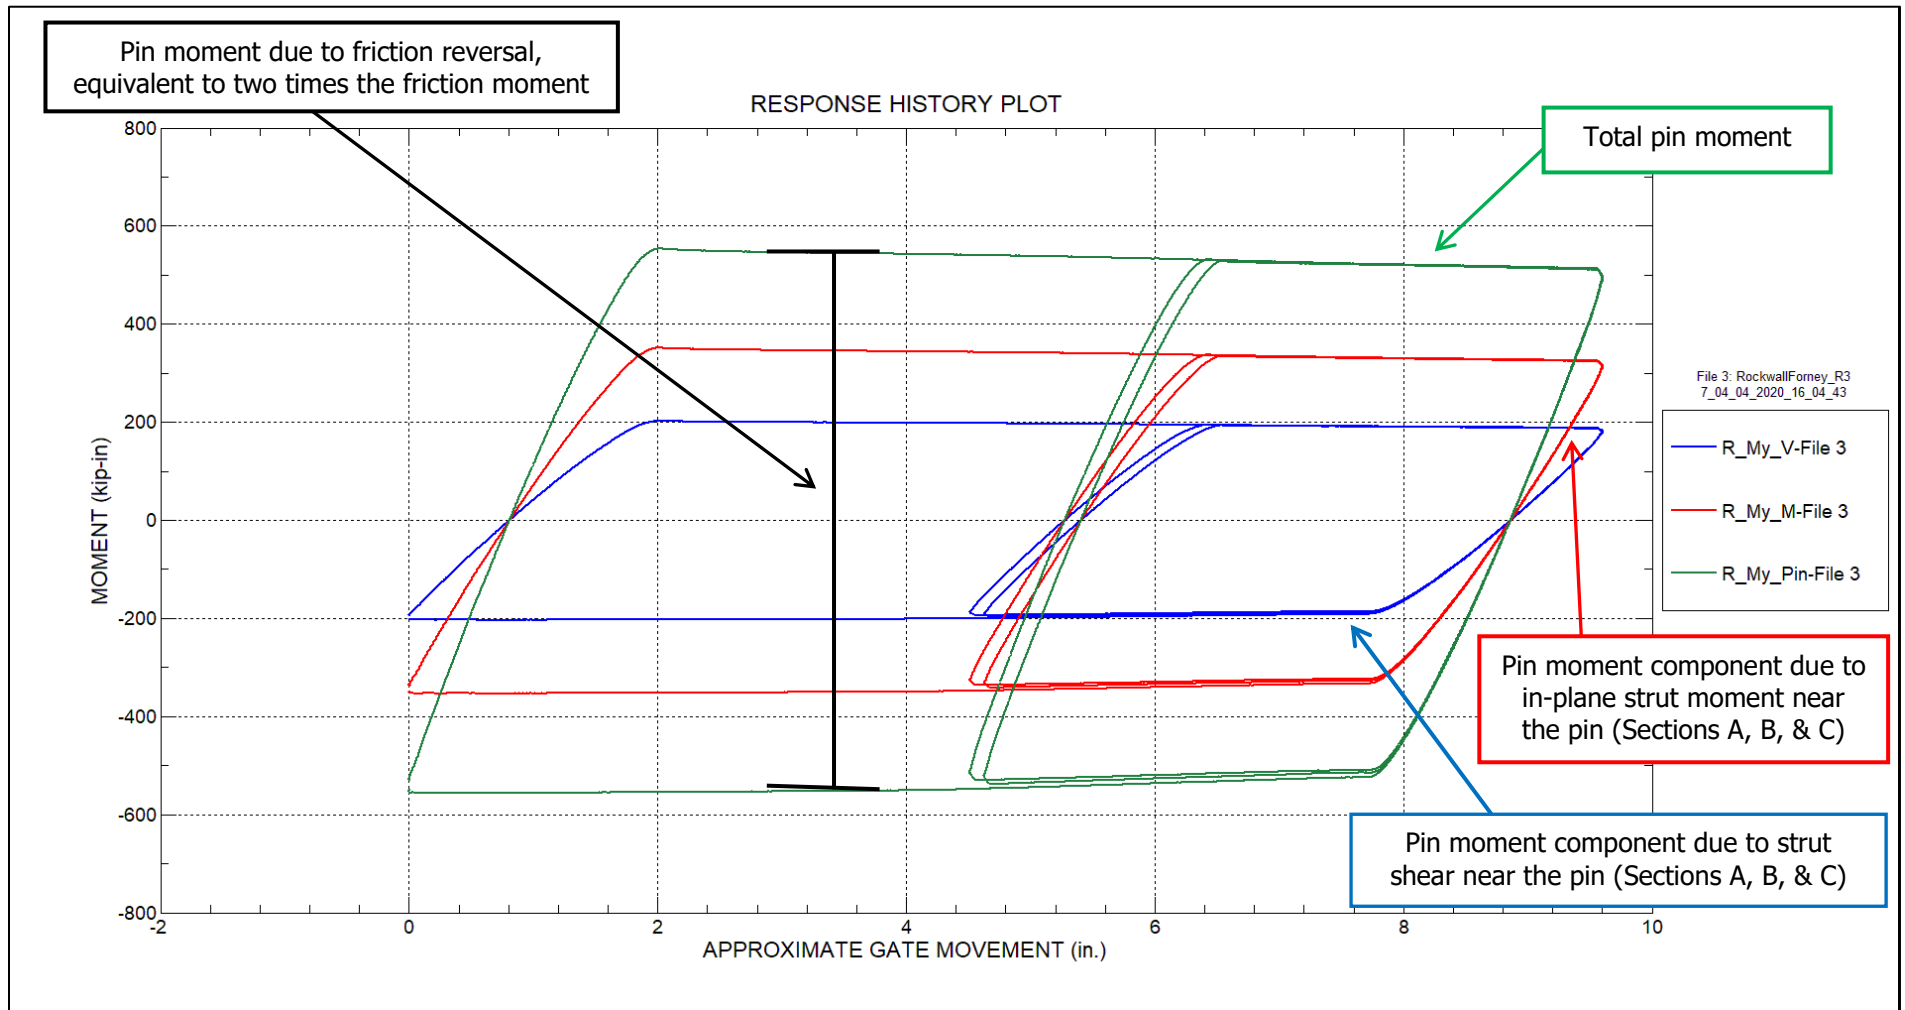
Figure 21 – Pin moment response history – Right arm

The resulting pin friction moments were used to compute friction coefficients from Eq. 4, given the pin radius and the applied thrust. The thrust used in this calculation consisted of the calculated resultant hydrostatic load based on the measured water elevation and was adjusted to account for the loss of head as the gate was lifted. This thrust adjustment was based on the recorded gate movement and was performed in order to calculate more accurate friction coefficients. The water elevation during testing was nearly constant throughout each gate test and was documented during each "up-down" cycle. It should be noted that the minor thrust due to cable wrapping, which was minimal compared to hydrostatic thrust, was not included in the thrust calculation. This assumption resulted in slightly conservative friction coefficients.

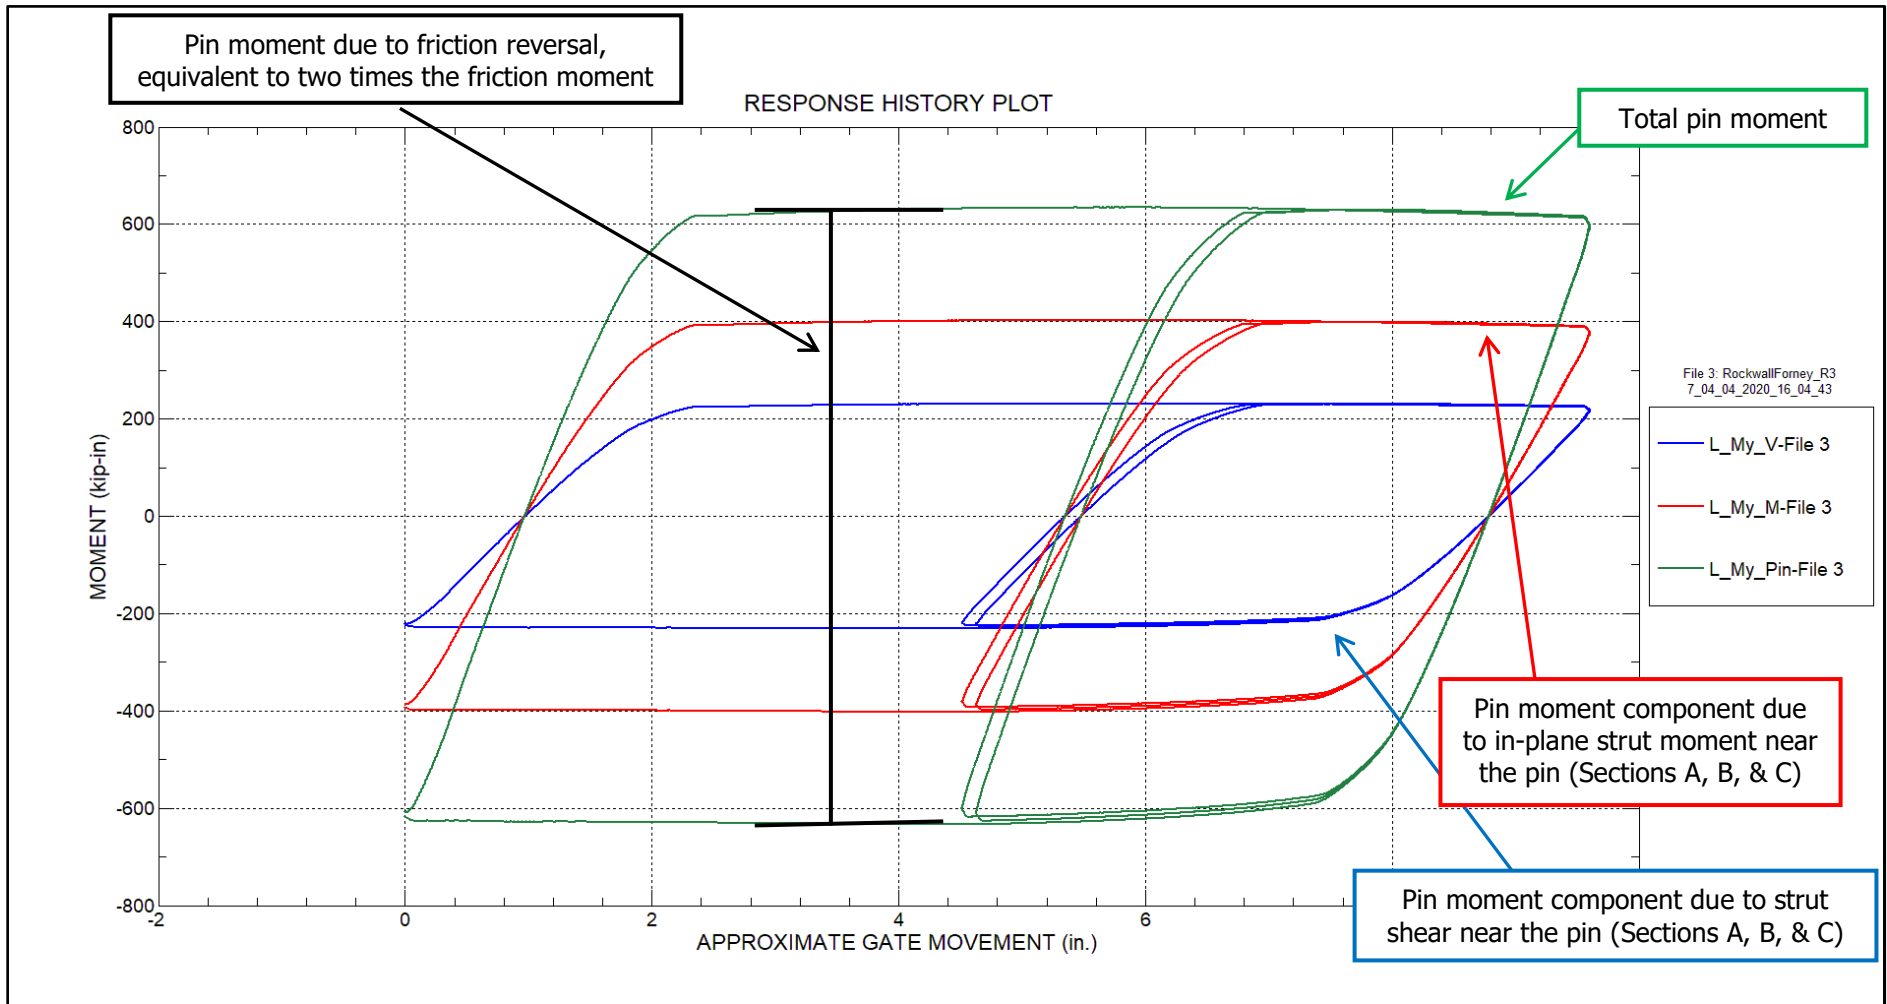
Figure 22 – Pin moment response history – Left arm

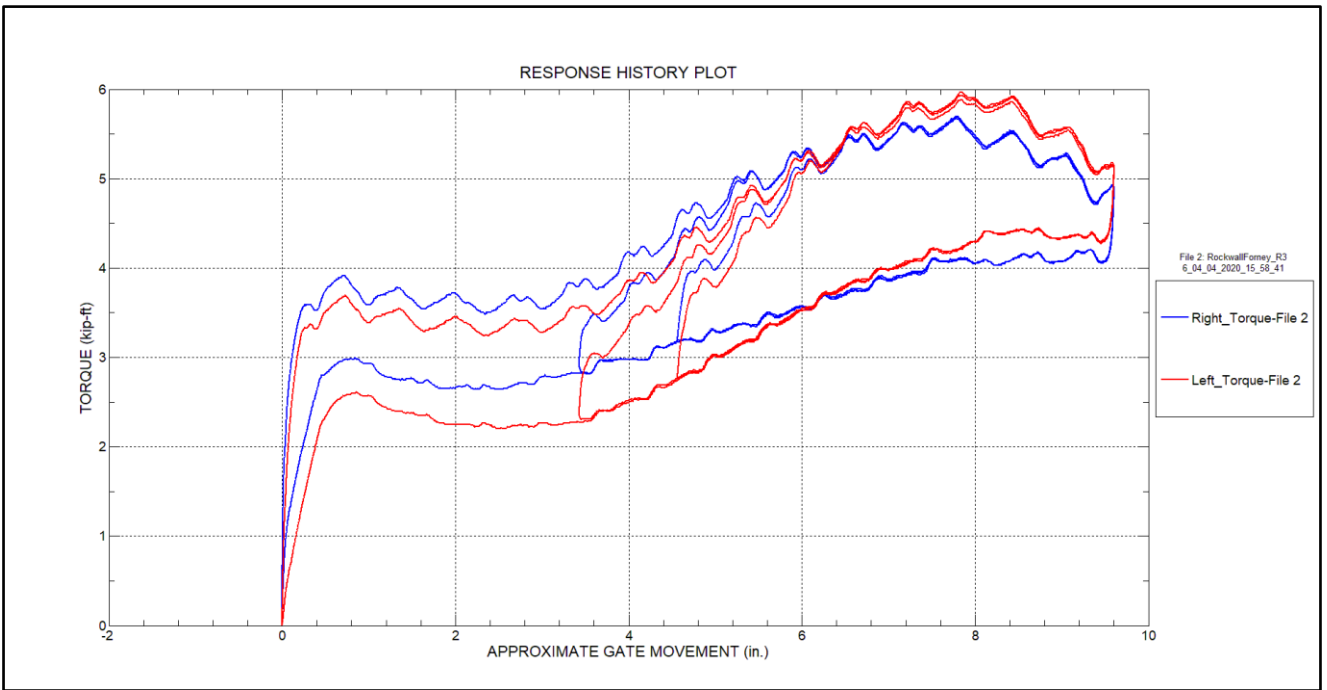
Figure 23 – Hoist torque response history – Gate 5 – Test 2

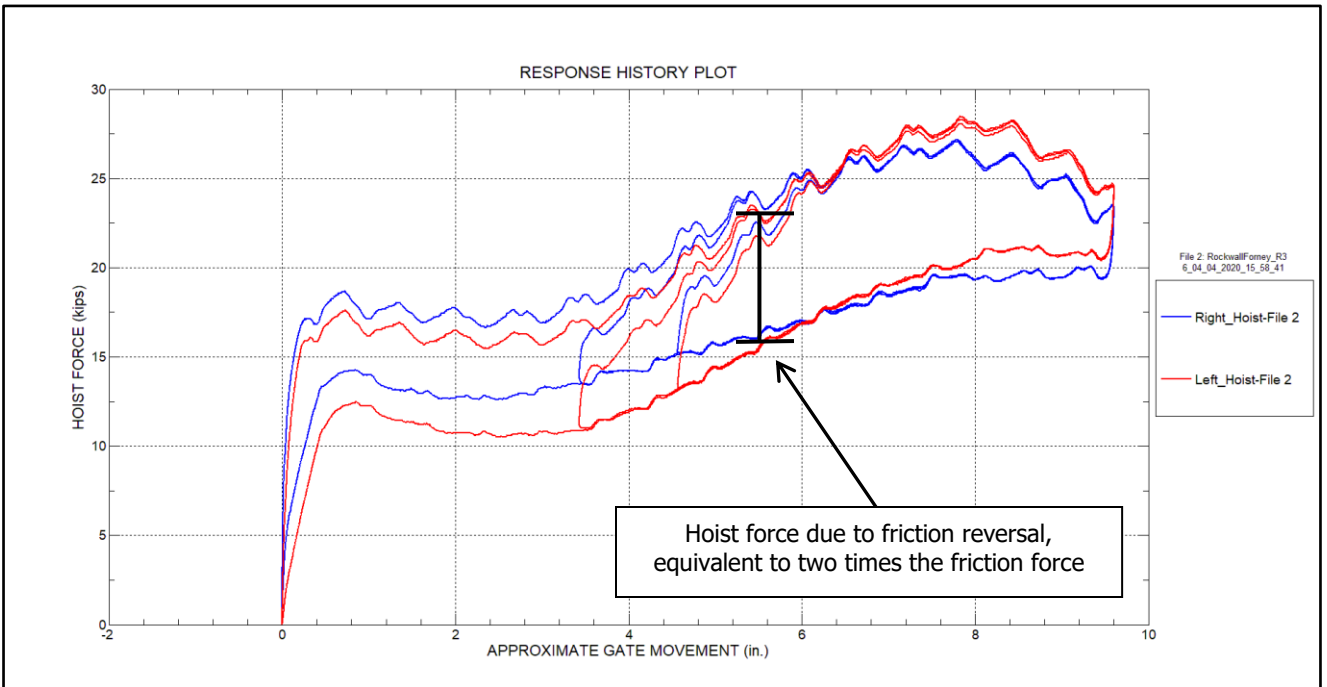
Figure 24 – Hoist force response history – Gate 5 – Test 2

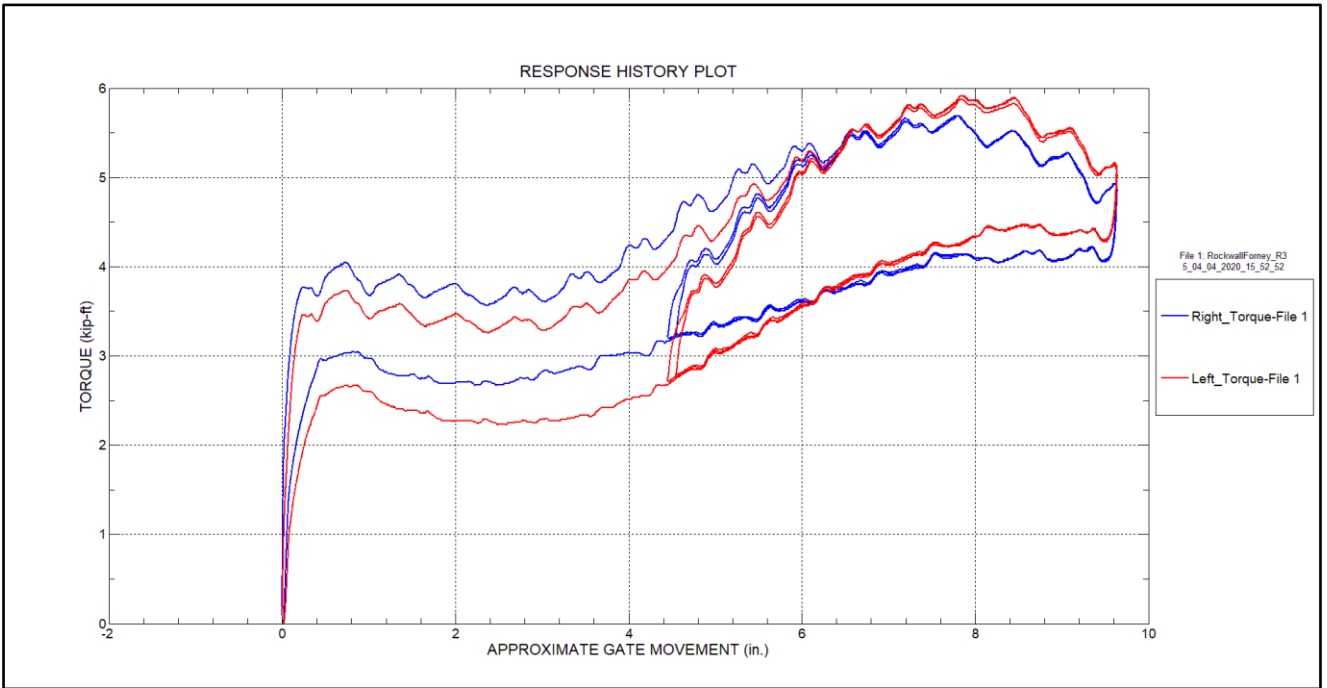
Figure 25 – Hoist torque response history – Gate 5 – Test 1

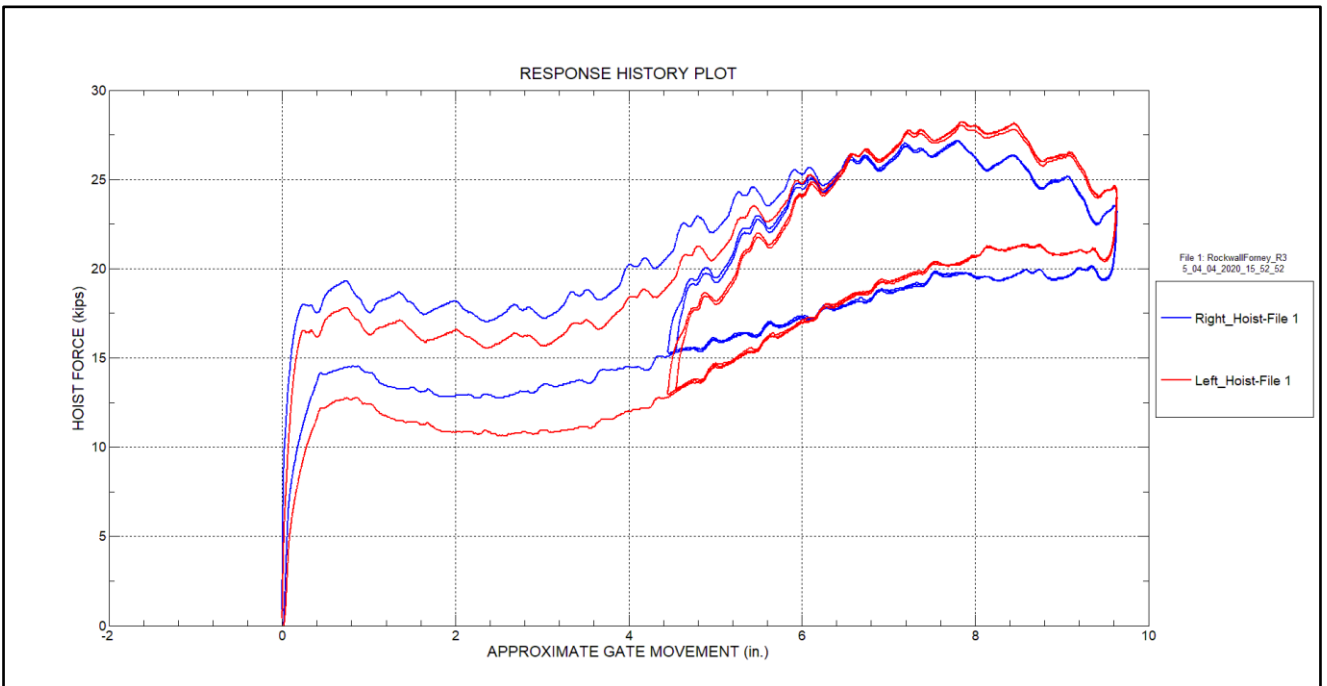
Figure 26 – Hoist force response history – Gate 5 – Test 1

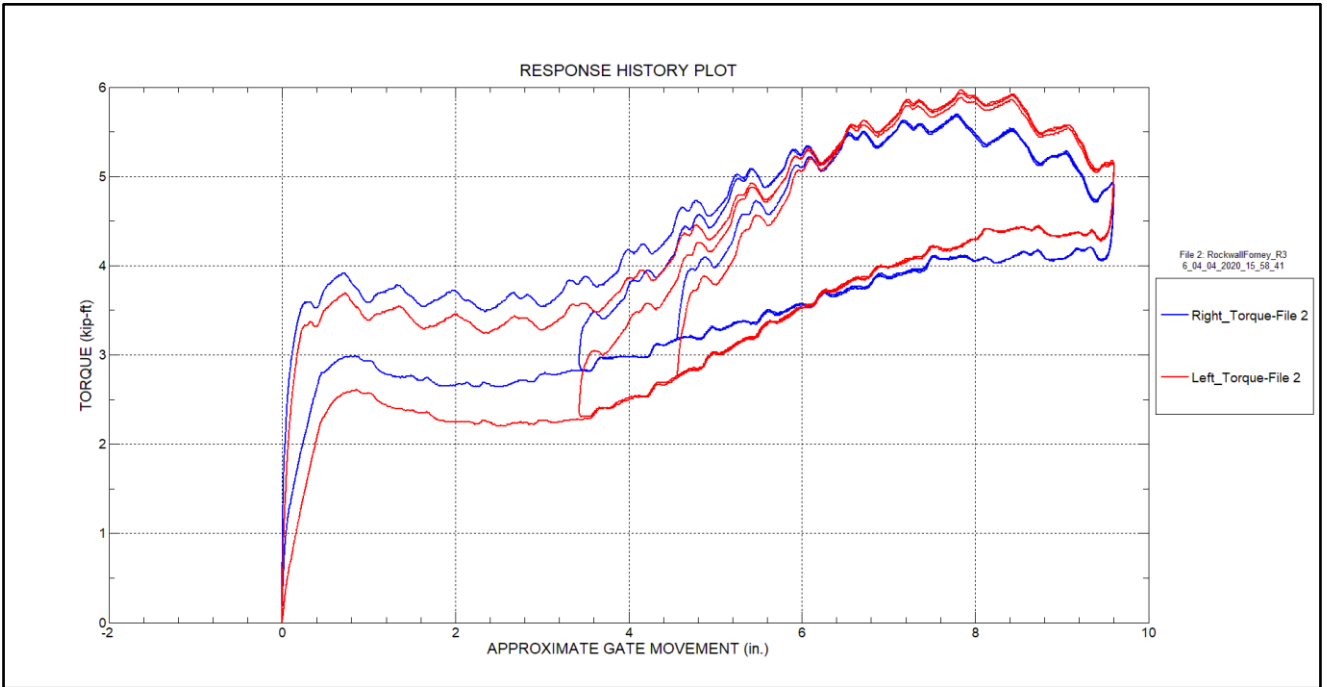
Figure 27 – Hoist torque response history – Gate 5 – Test 2

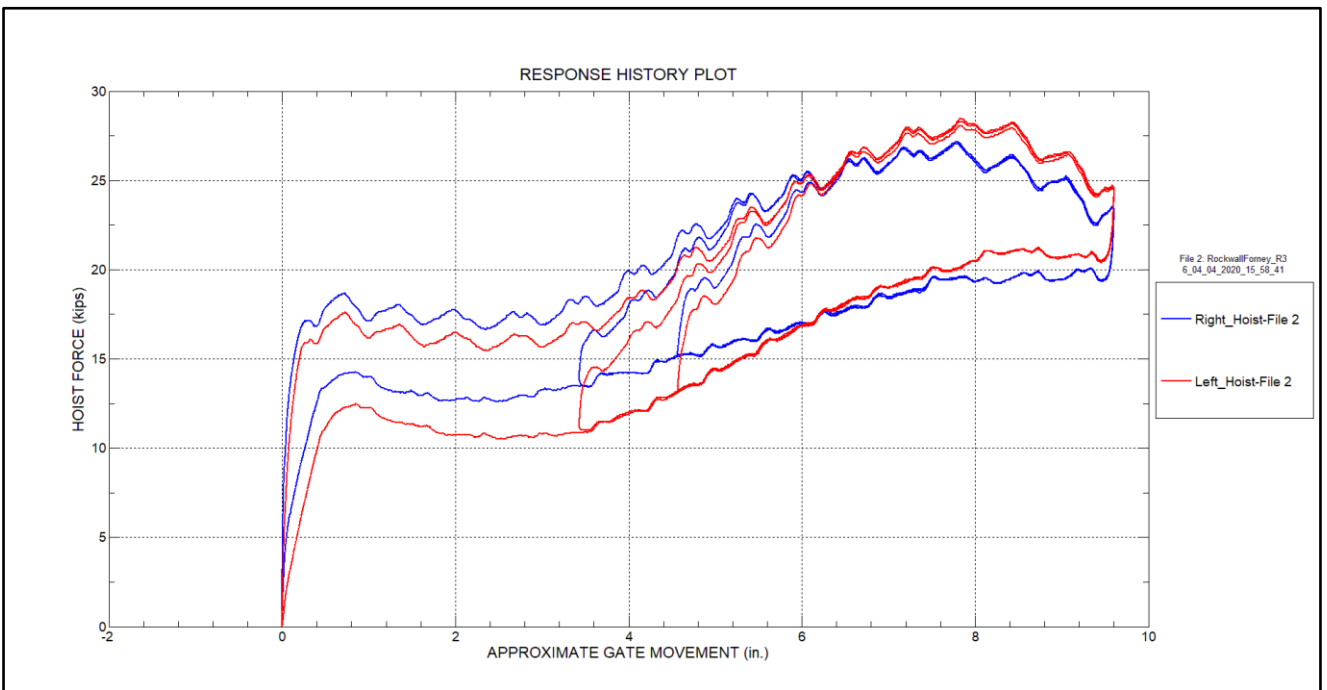
Figure 28 – Hoist force response history – Gate 5 – Test 2

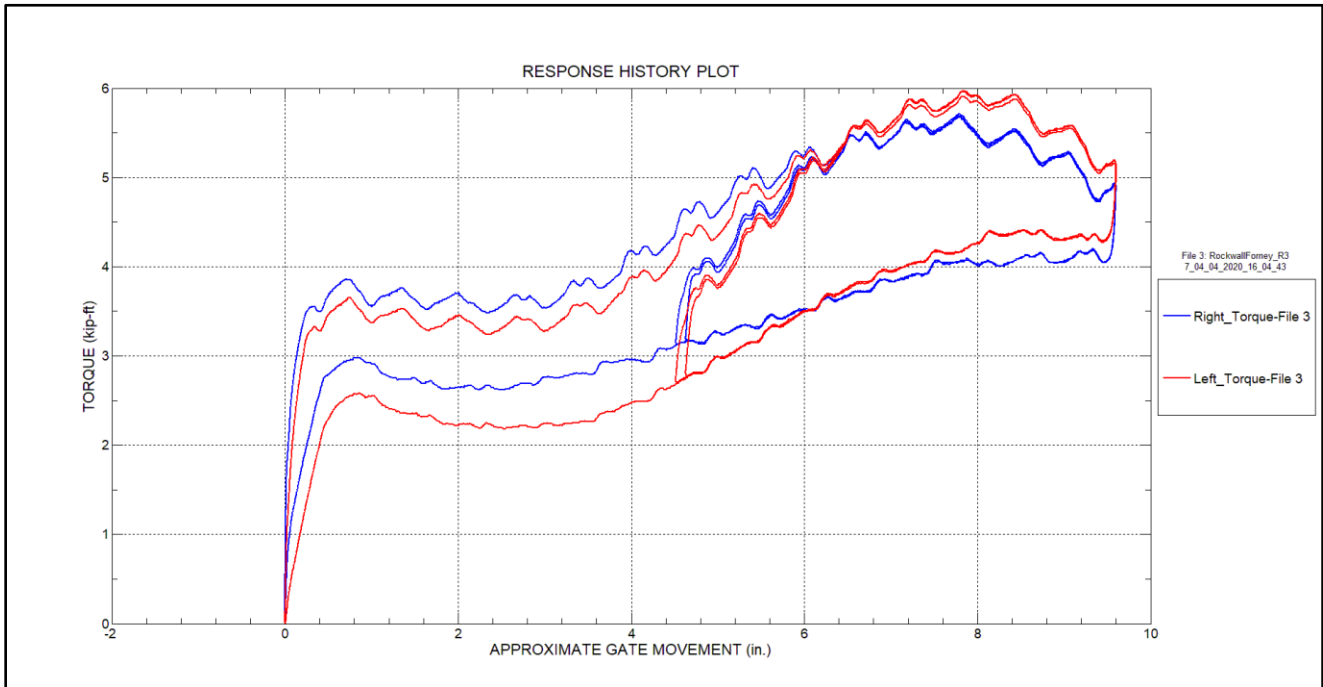
Figure 29 – Hoist torque response history – Gate 5 – Test 3

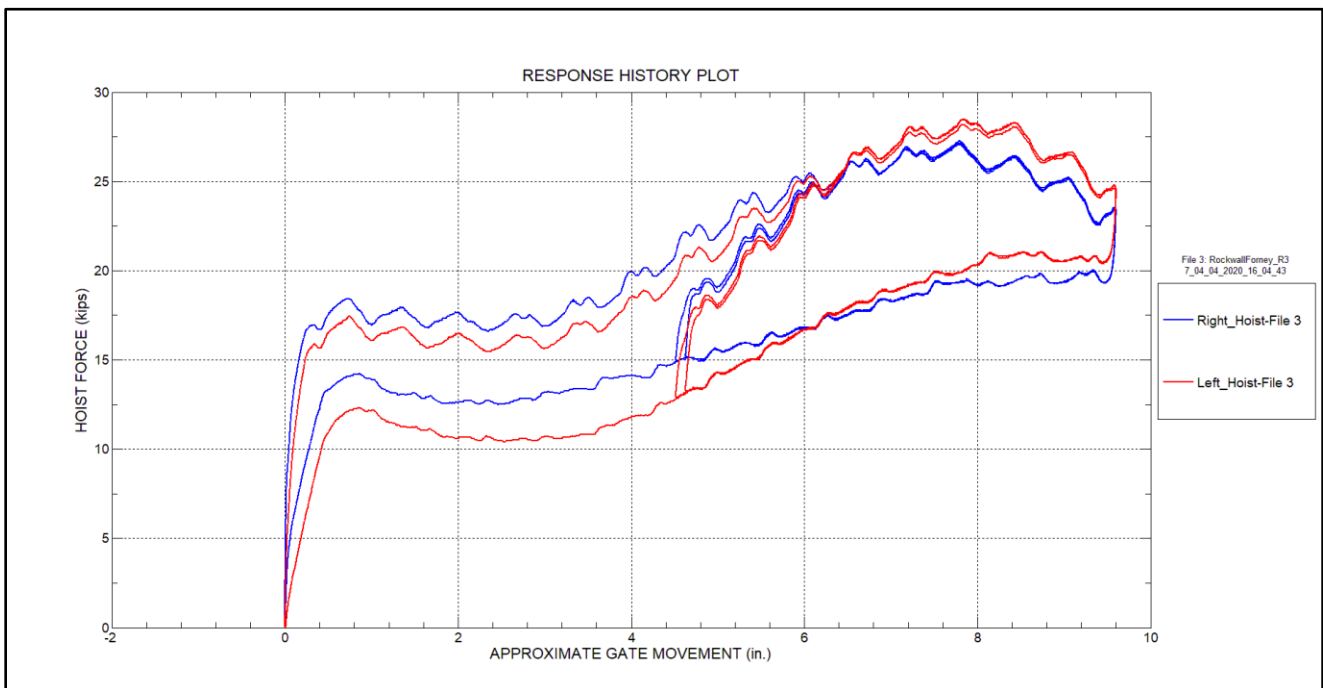
Figure 30 – Hoist force response history – Gate 5 – Test 3

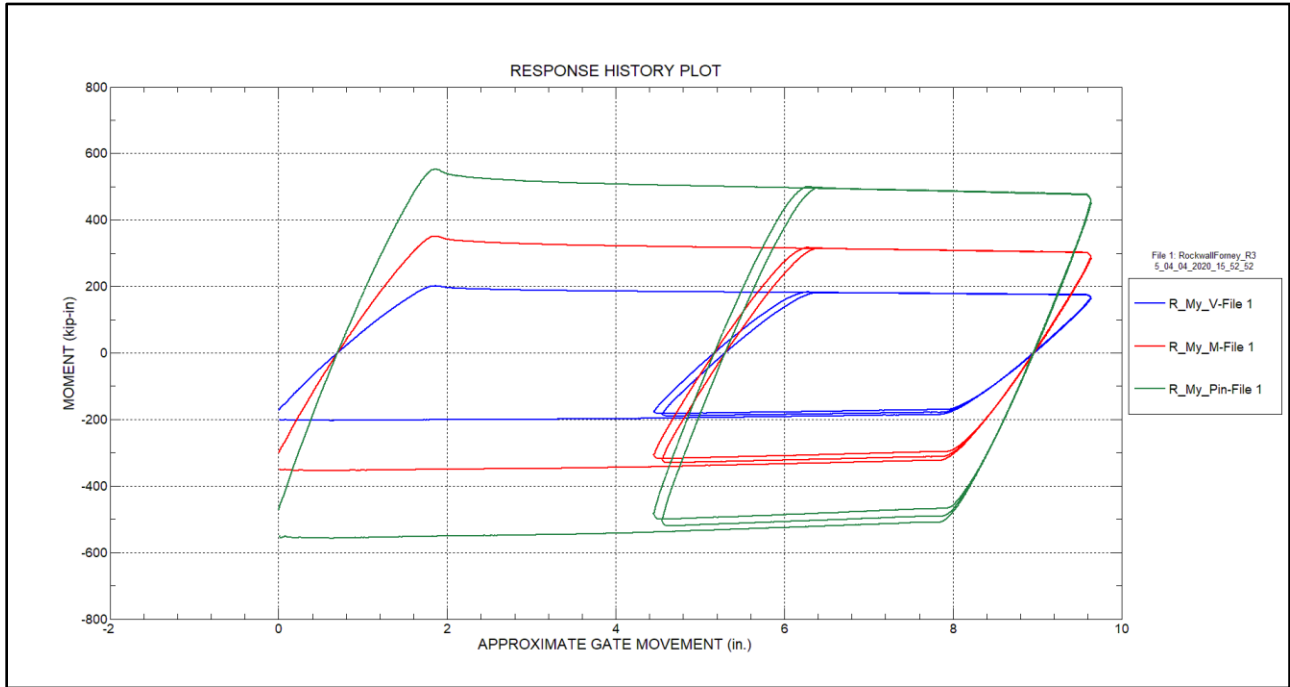
Figure 31 – Pin moment response history – Right arm – Test run 1

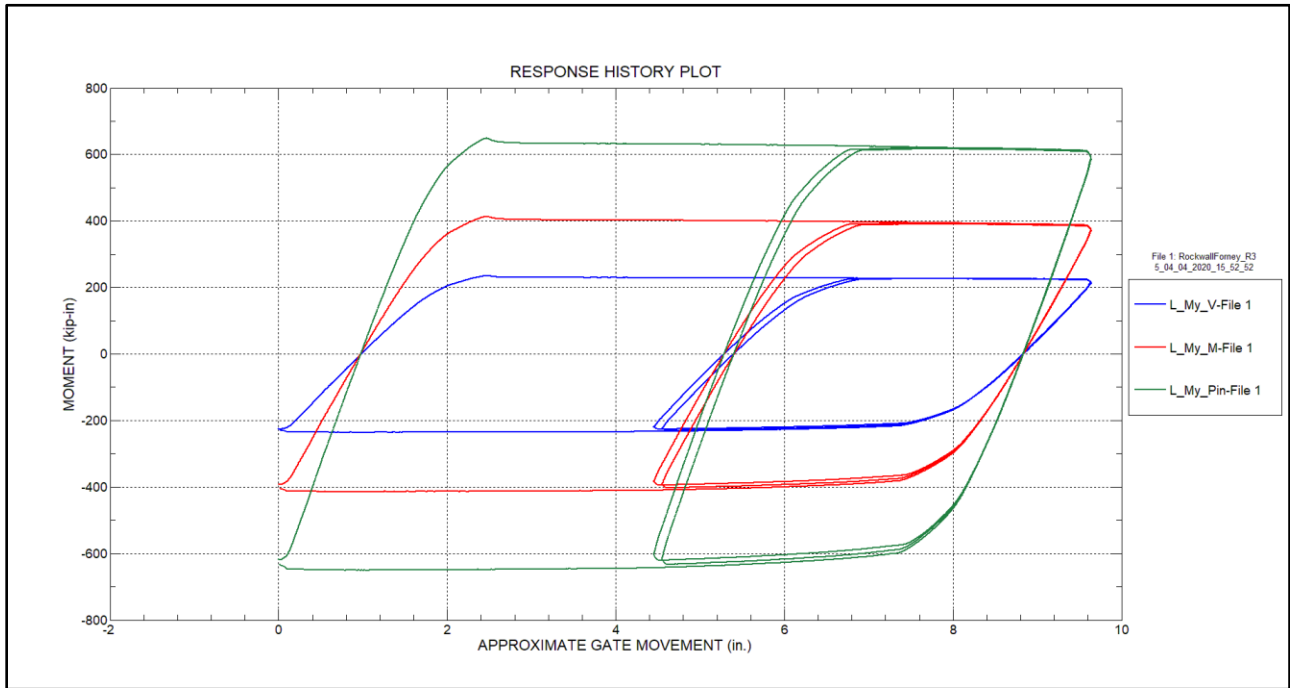
Figure 32 – Pin moment response history – Left arm – Test run 1

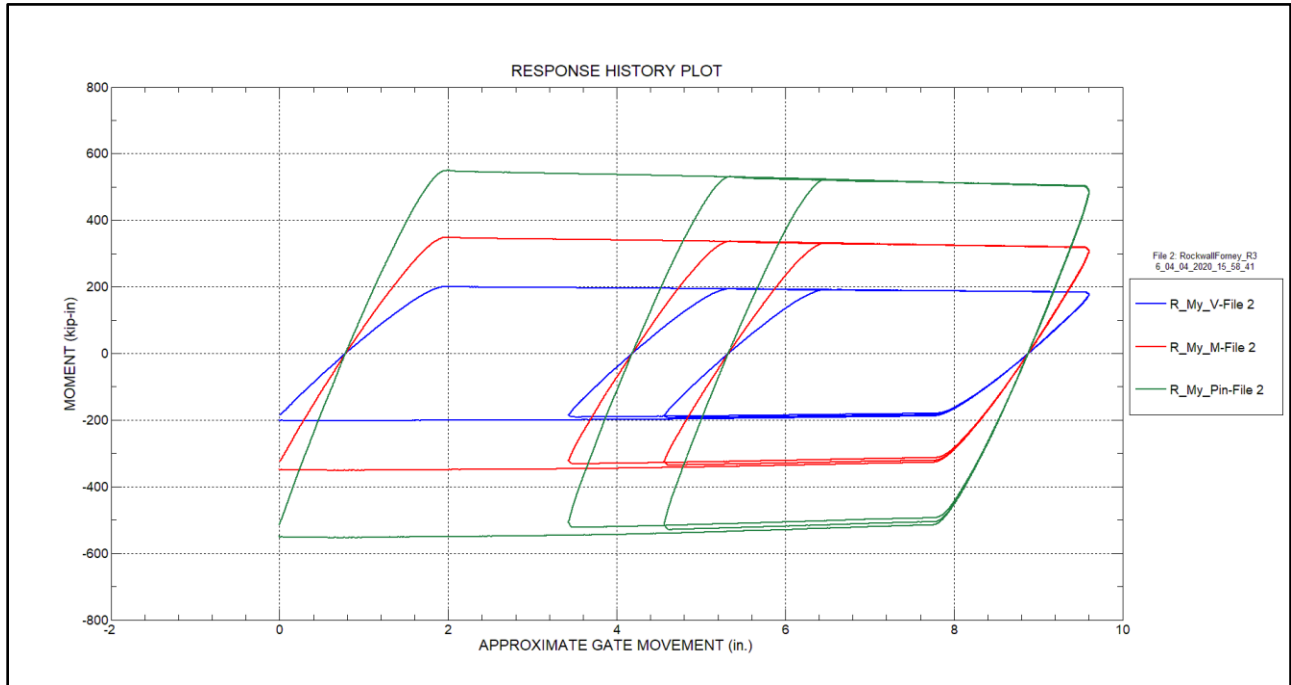
Figure 33 – Pin moment response history – Right arm – Test run 2

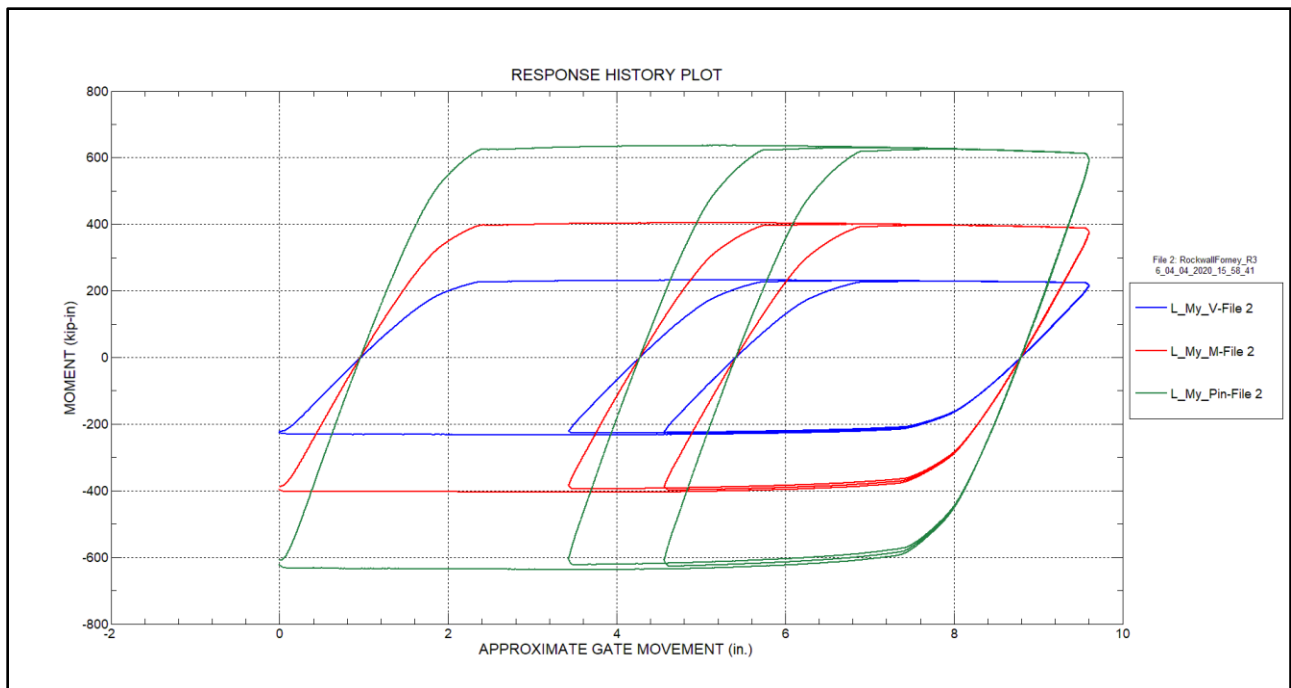
Figure 34 – Pin moment response history – Left arm – Test run 2
