VISUAL INSPECTION AND EVALUATION REPORT

Rockwall-Forney Dam
Dallas Water Utilities
Dallas/Kaufman Counties, Texas

Schnabel Reference #20C22001.00
July 30, 2021

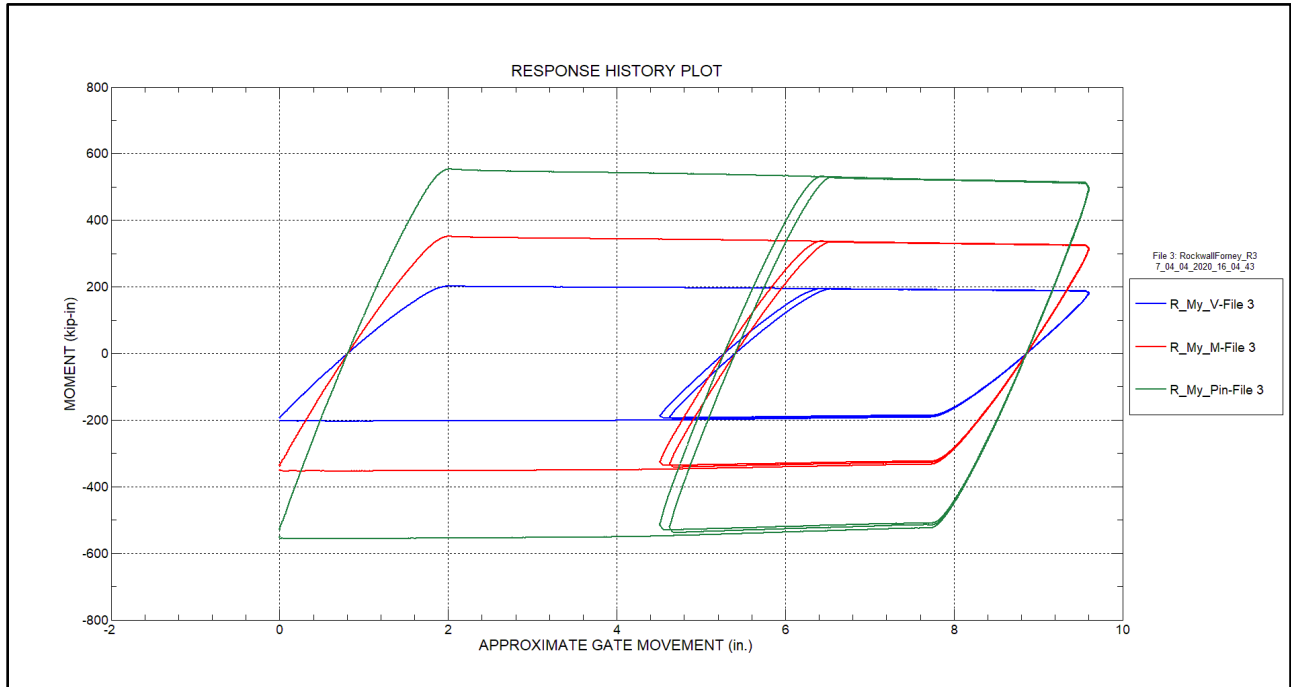
Figure 35 – Pin moment response history – Right arm – Test run 3

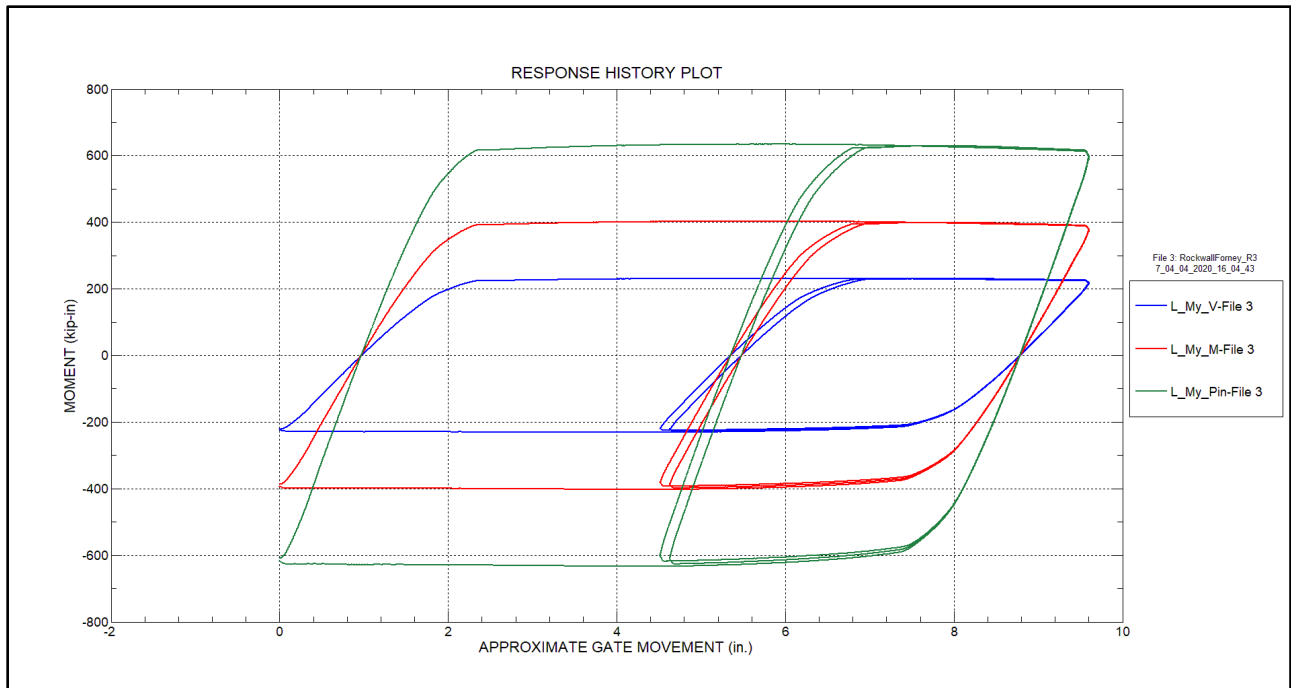
Figure 36 – Pin moment response history – Left arm – Test run 3

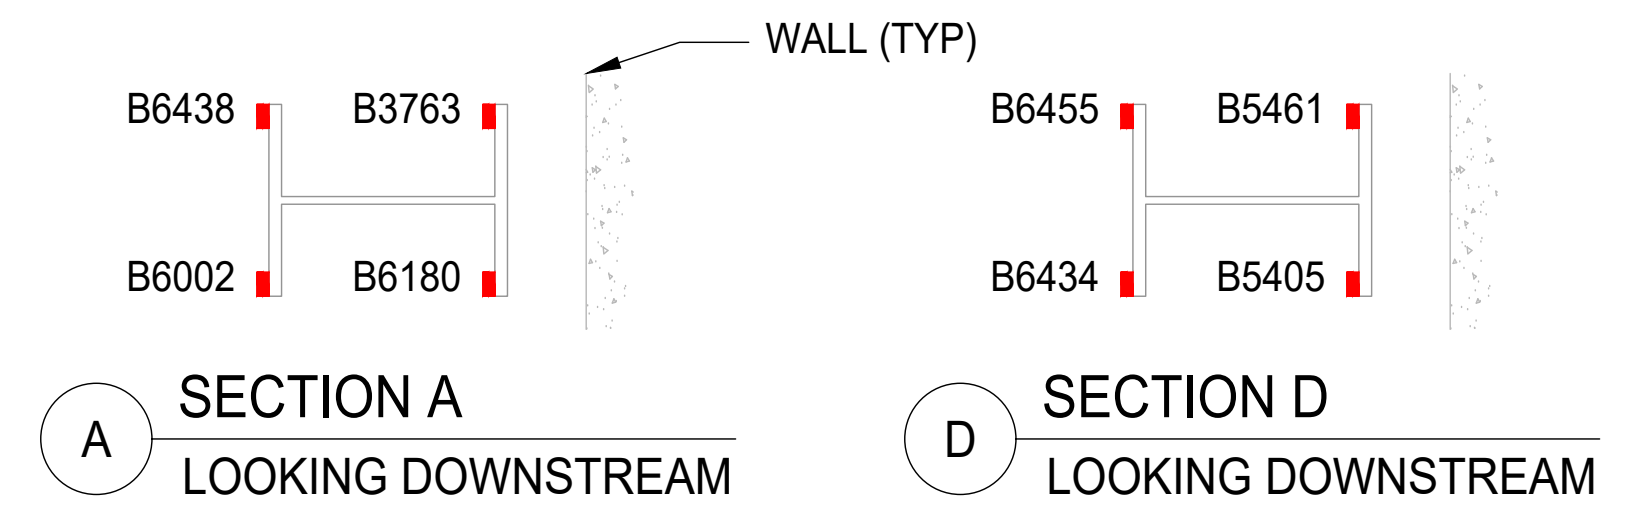
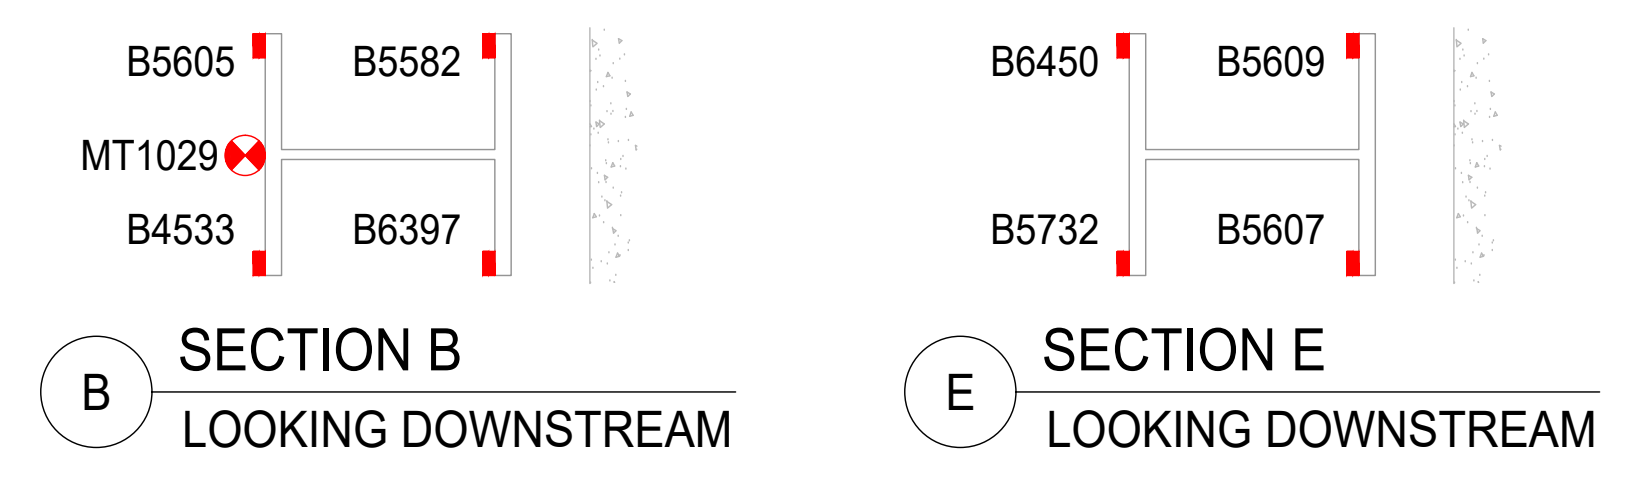
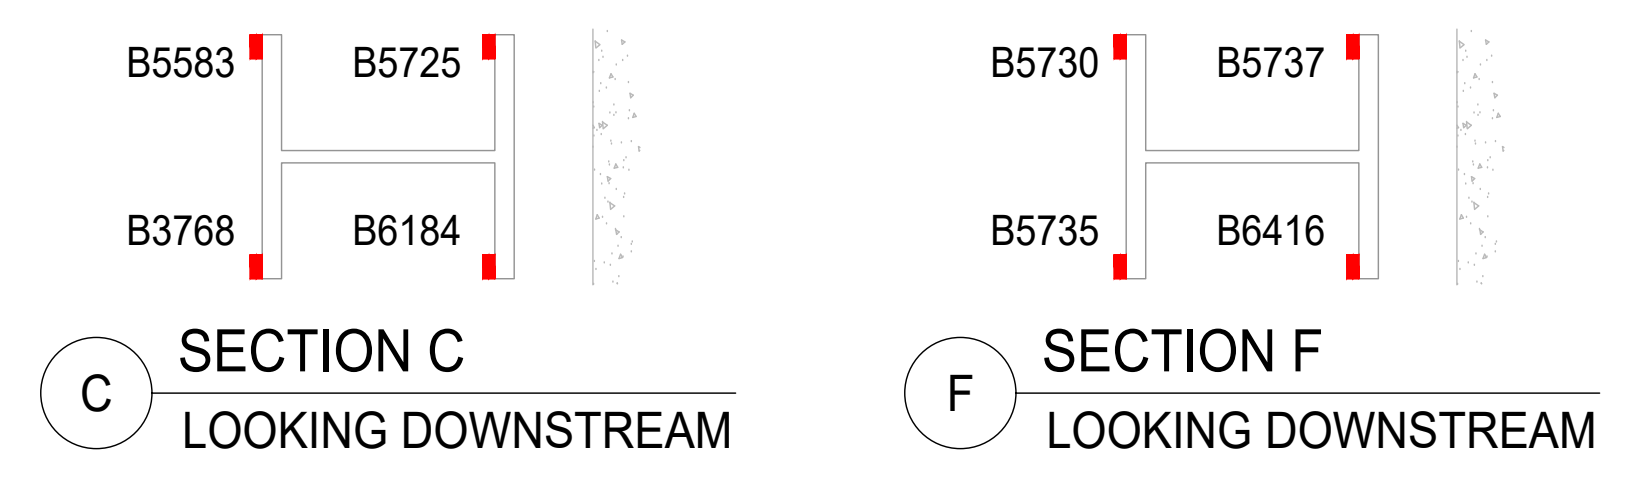
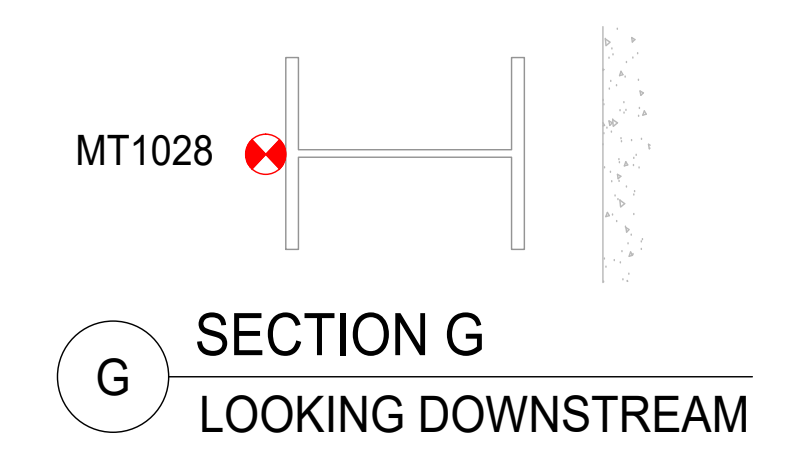
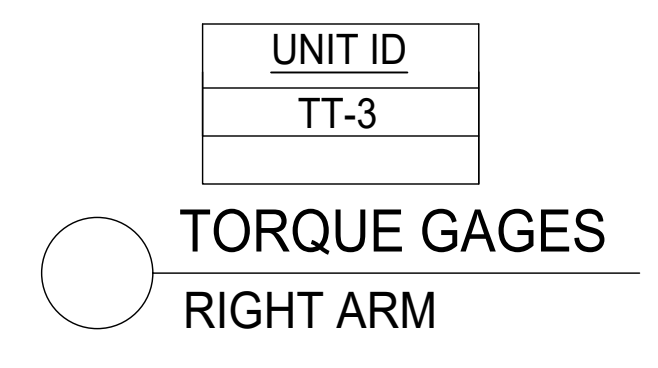
- NOTES:**
- SECTIONS A, B, & C SHALL BE INSTALLED 15 INCHES AWAY FROM TRUNNION PLATE.
 - TILTMETERS SHALL BE INSTALLED CENTERED ON THE MIDDLE STRUT FLANGE.
 - SECTION G'S TILTMETER SHALL BE INSTALLED AS CLOSE TO THE SKINPLATE AS POSSIBLE.

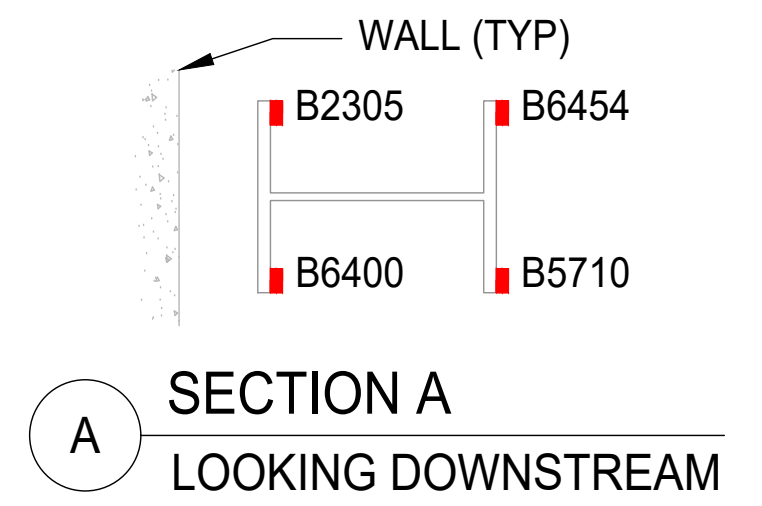
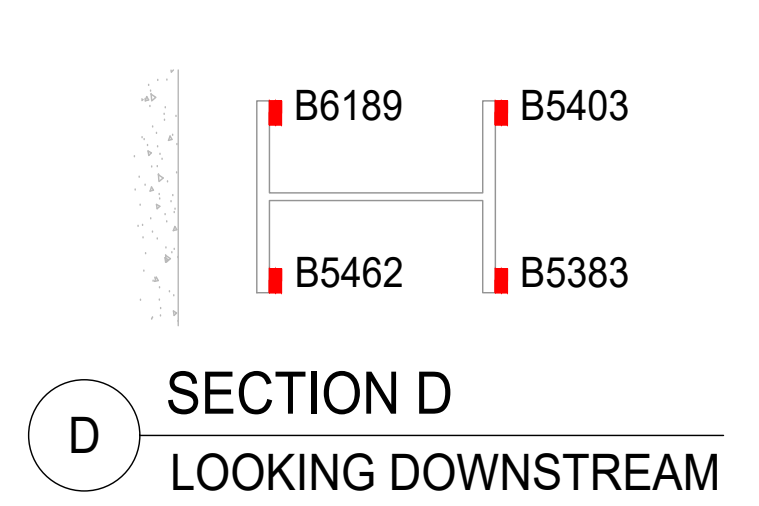
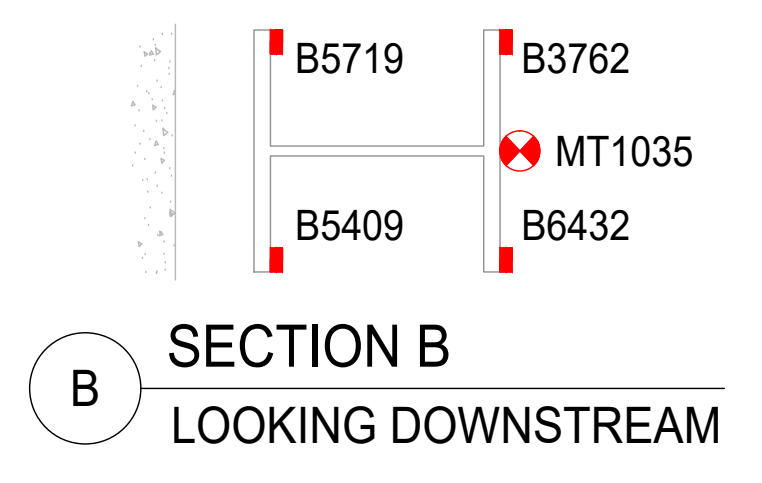
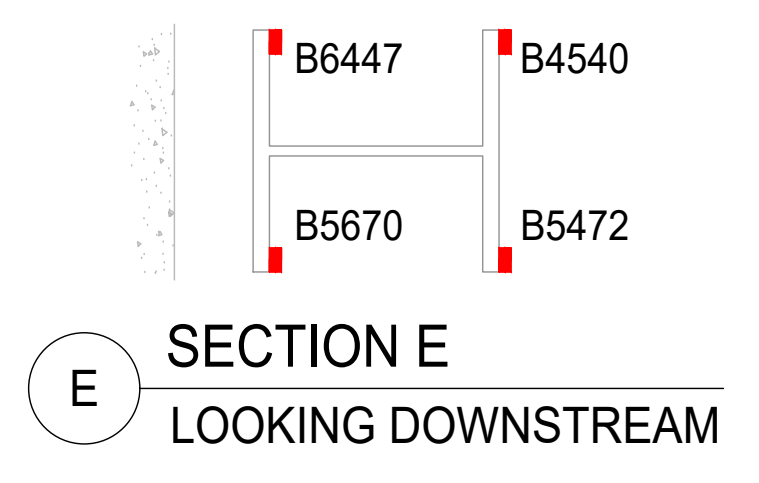
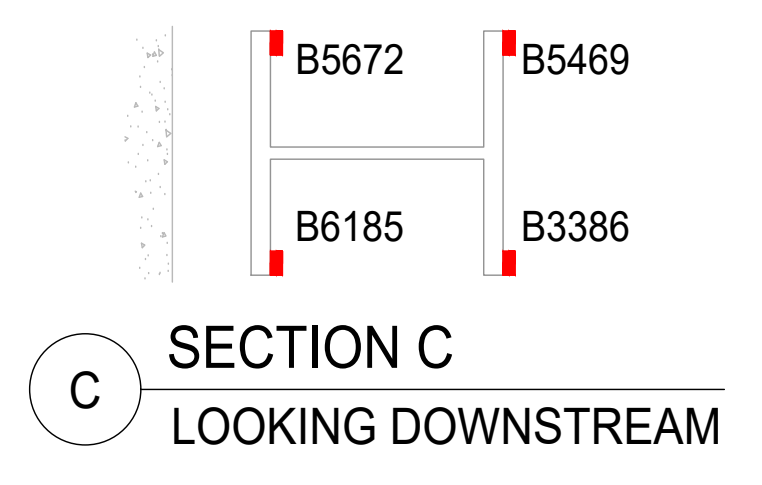
2 GATE 5
LEFT ARM

1. SECTIONS A, B, & C SHALL BE INSTALLED 15 INCHES AWAY FROM TRUNNION PLATE.
2. TILTMETERS SHALL BE INSTALLED CENTERED ON THE MIDDLE STRUT FLANGE.
3. SECTION G'S TILTMETER SHALL BE INSTALLED AS CLOSE TO THE SKINPLATE AS POSSIBLE.

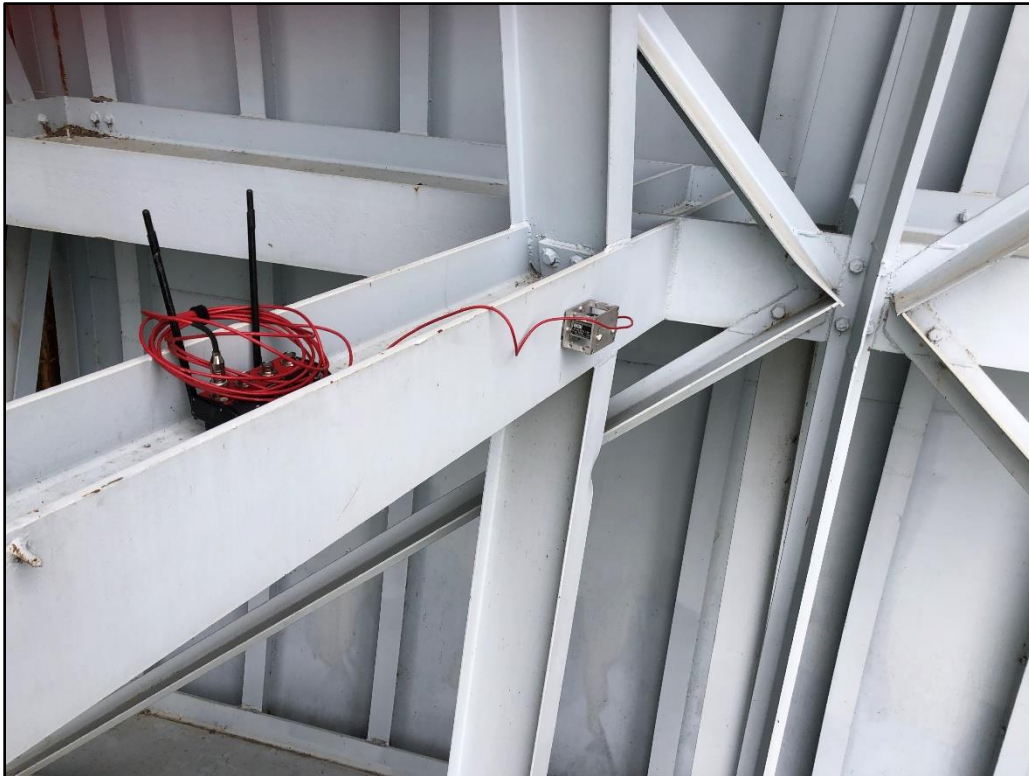
Figure 2 – BDI tiltmeter rotation sensor installed near skin plate (Typical)

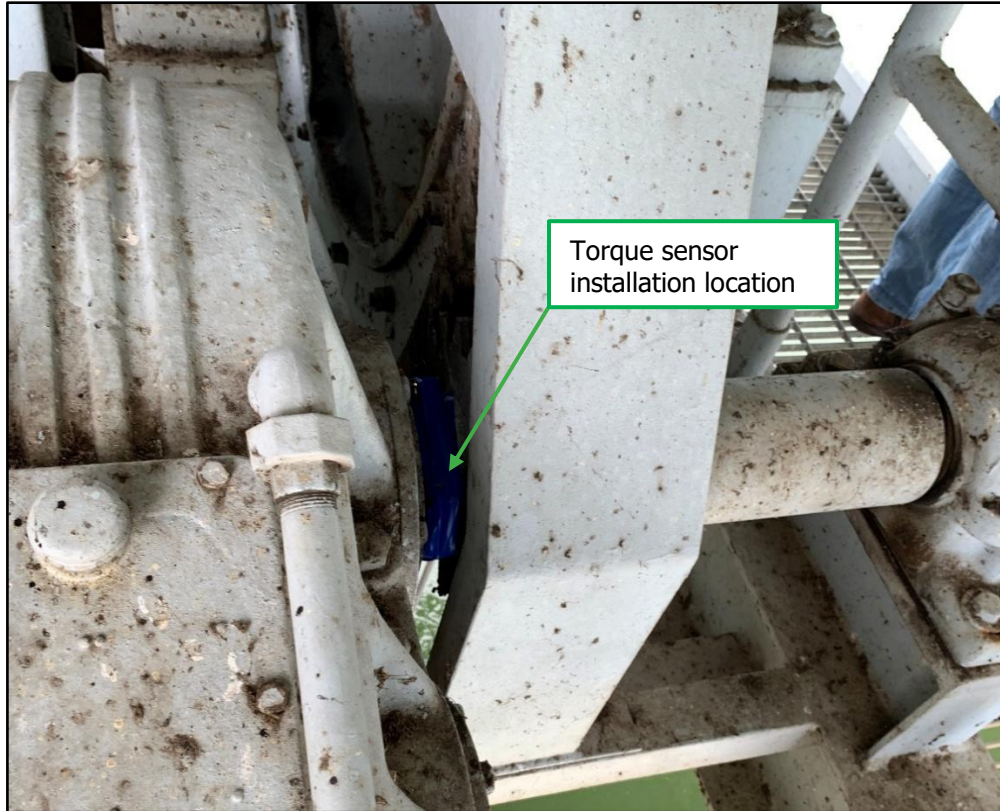
Figure 3 – Torque sensor installation on hoist pinion shaft (Typical)

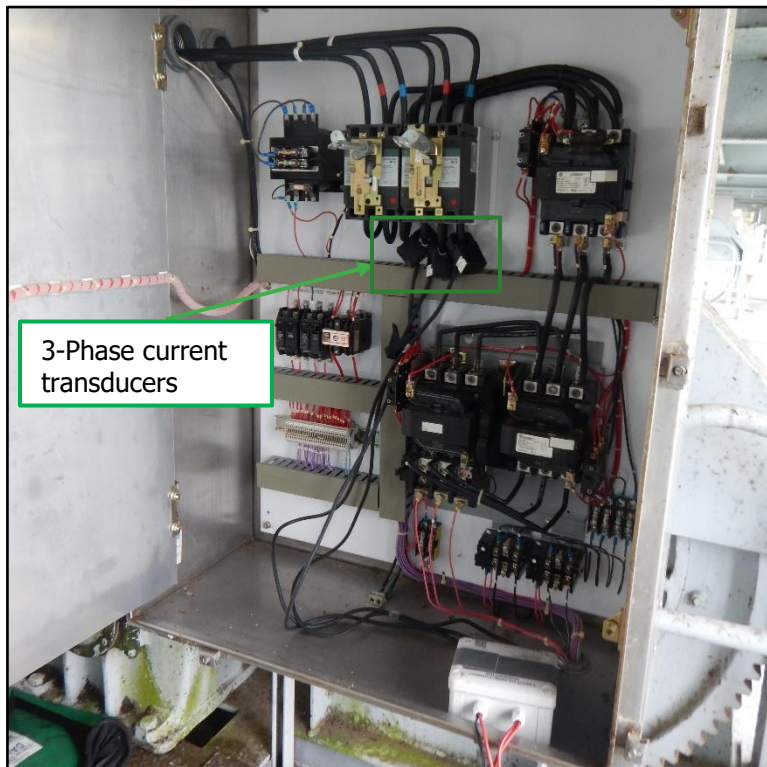
Figure 4 – Current transducers installed on hoist motor controls (Typical)

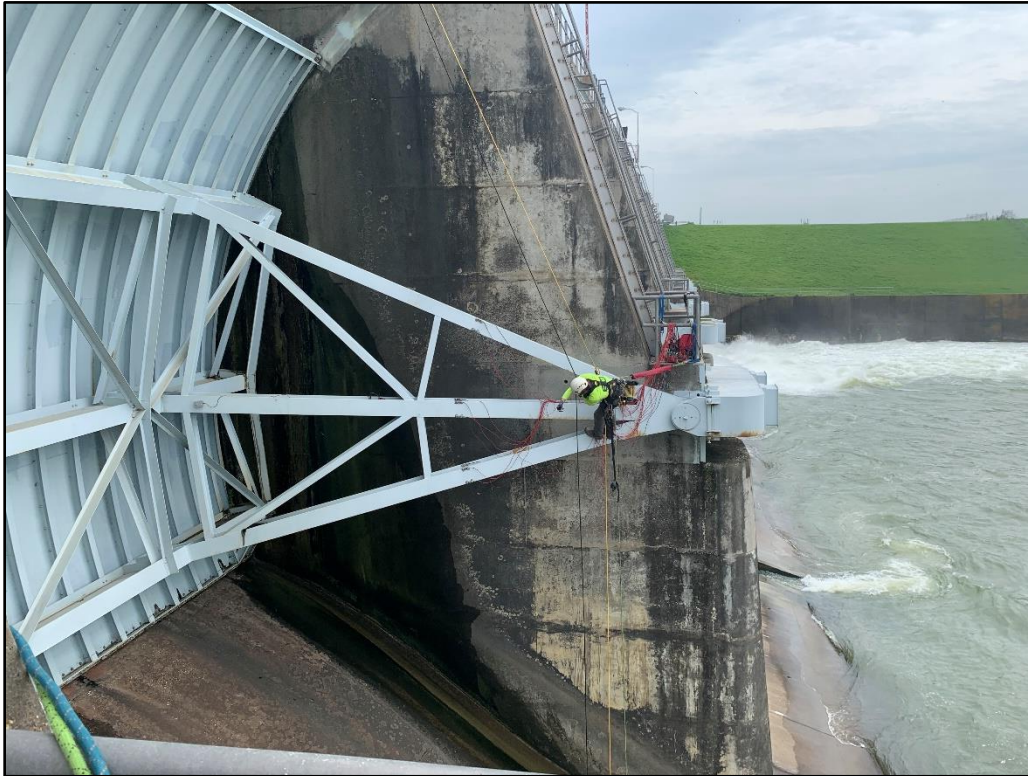
Figure 5 – BDI personnel installing instrumentation on the gate arm

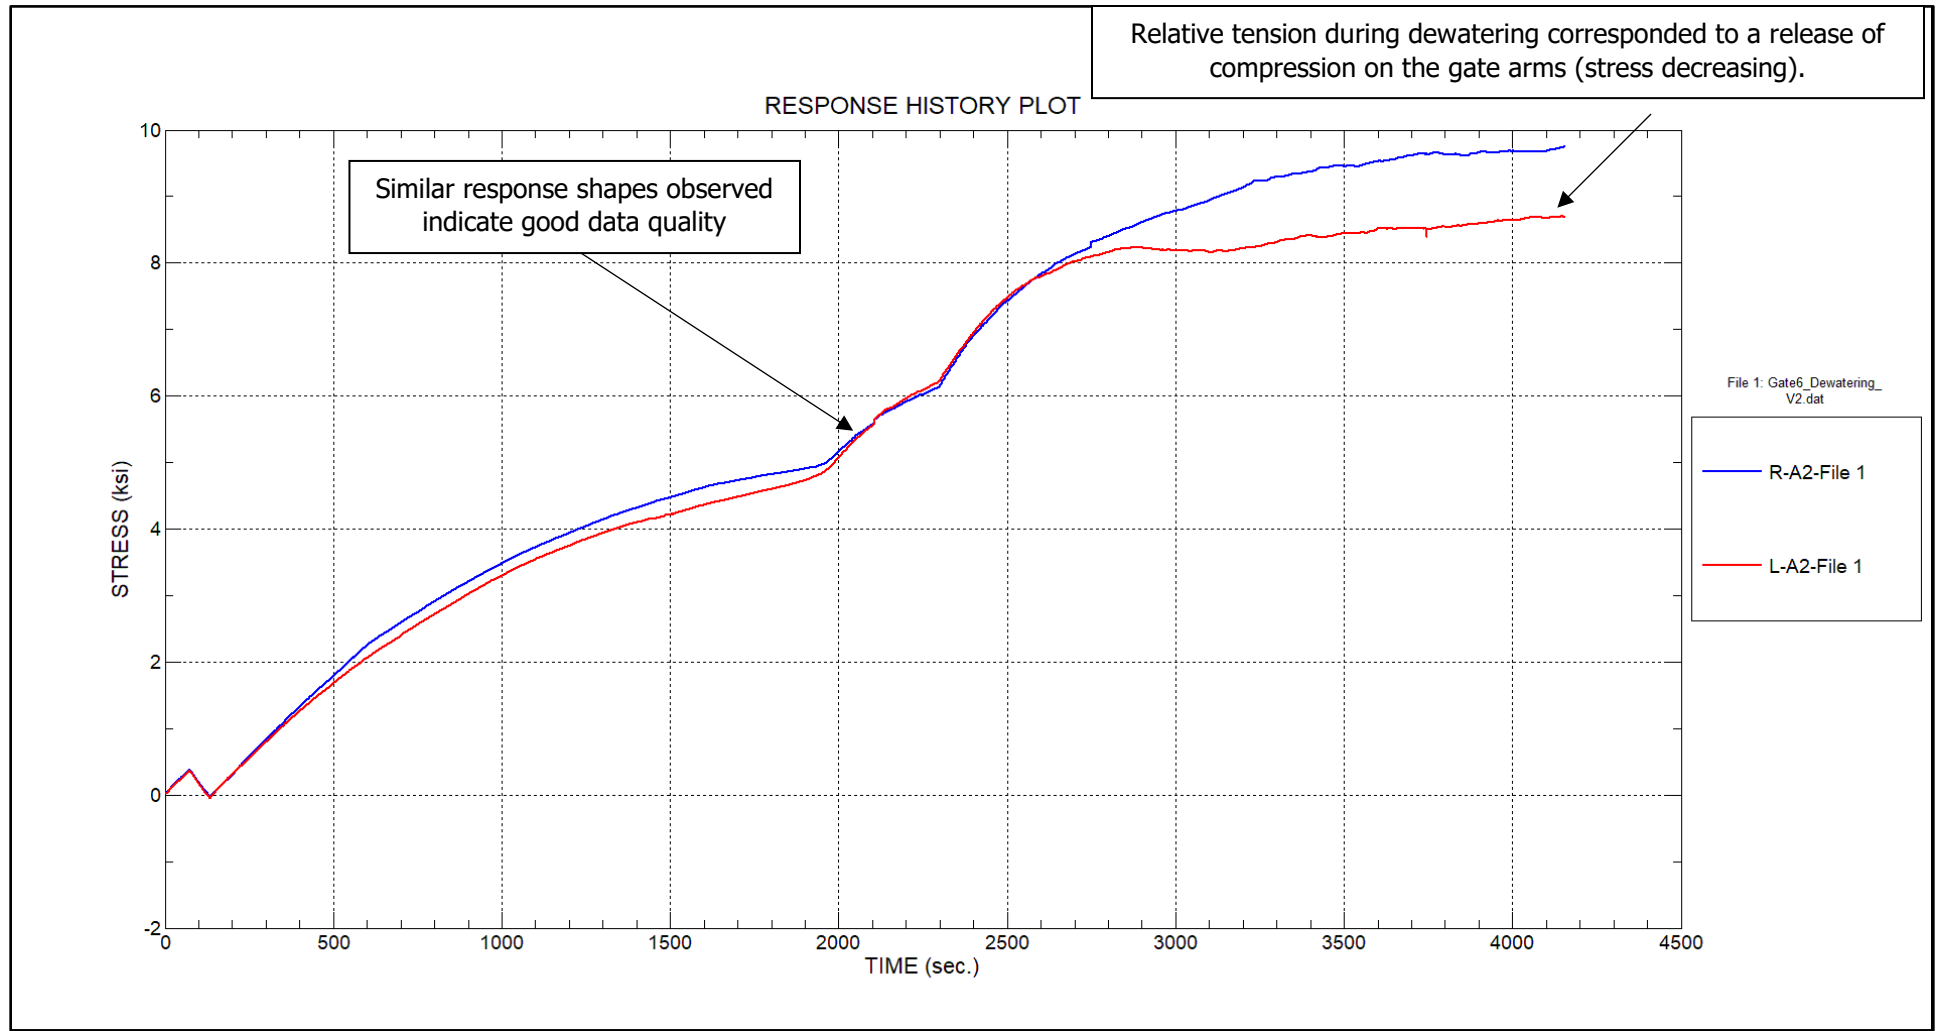
Figure 6 – Stress response history during dewatering – Right and left arms – Gage A2 – Time based
(Section A along top strut near pin – Sensor location 2 along bottom of flange)

- + **QUALITATIVE DATA REVIEW:** Review of the response data indicated good data quality. During the dewatering of the gate, responses along the gate arms were recorded (no hoist operation performed). Dewatering stress magnitudes observed in the left and right arms followed similar response shapes as shown in Figure 6. In this figure, the observed increase in stress during dewatering corresponded to a release of compression on the gate arms. During the gate operation in the dry-state, motor amperage and hoist force measurements were recorded in addition to the gate arm stresses. Gate operation did not follow BDI's typical lift and lower cycles, so response reproducibility could not be verified directly. Instead, data quality was assessed by comparing response shapes and magnitudes between the exploratory tests. During gate operation, stress magnitudes reached similar peak values as shown in Figure 7. All recorded response data was found to be valid and of good quality for use in strut force and moment calculations.

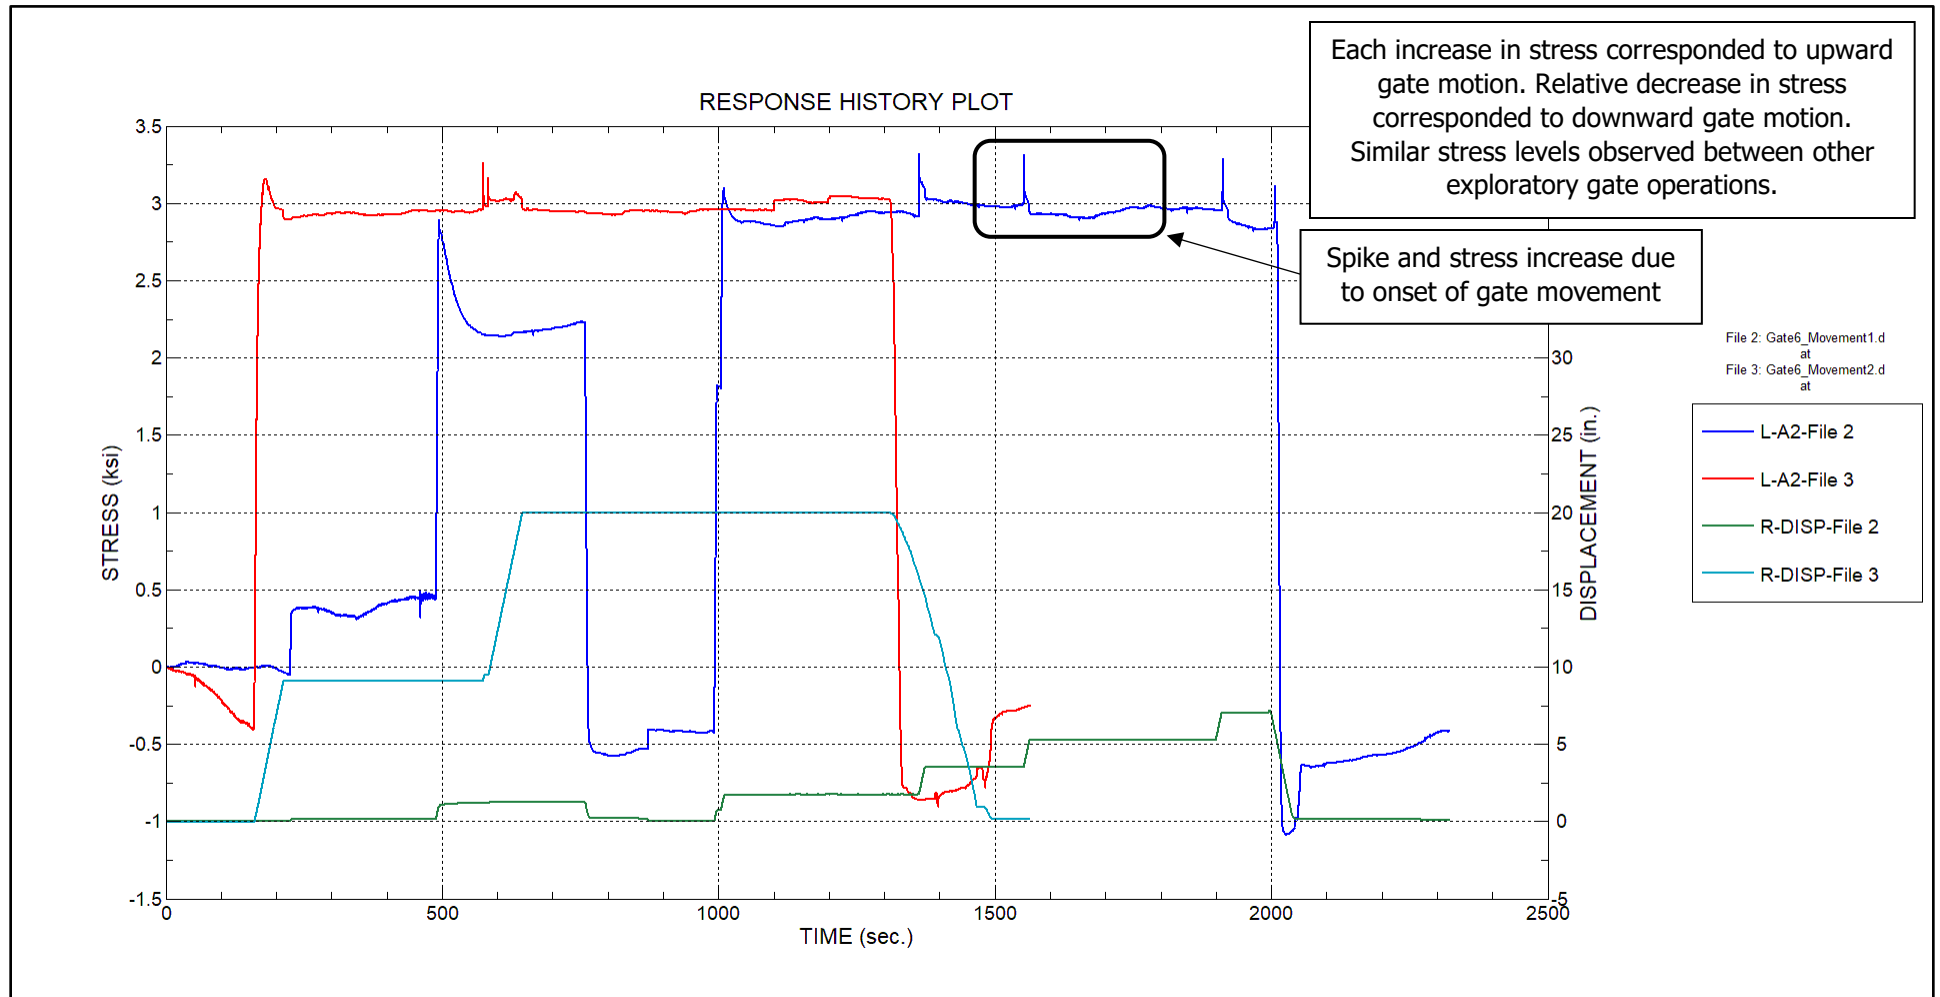
Figure 7 – Stress and displacement response history during gate operation – Left arm – Gage A2 – Time based
 File 1 = Gate operation prior to log removal , File 2 = Gate operation during removal of log
 (Section A along top strut near pin – Sensor location 2 along bottom of inner flange)

- + Prior to removal of the discovered log, the gate was lowered back onto the log resulting in a spike in out-of-plane flexure in the left arm. This captured behavior is likely related to the observed issues.

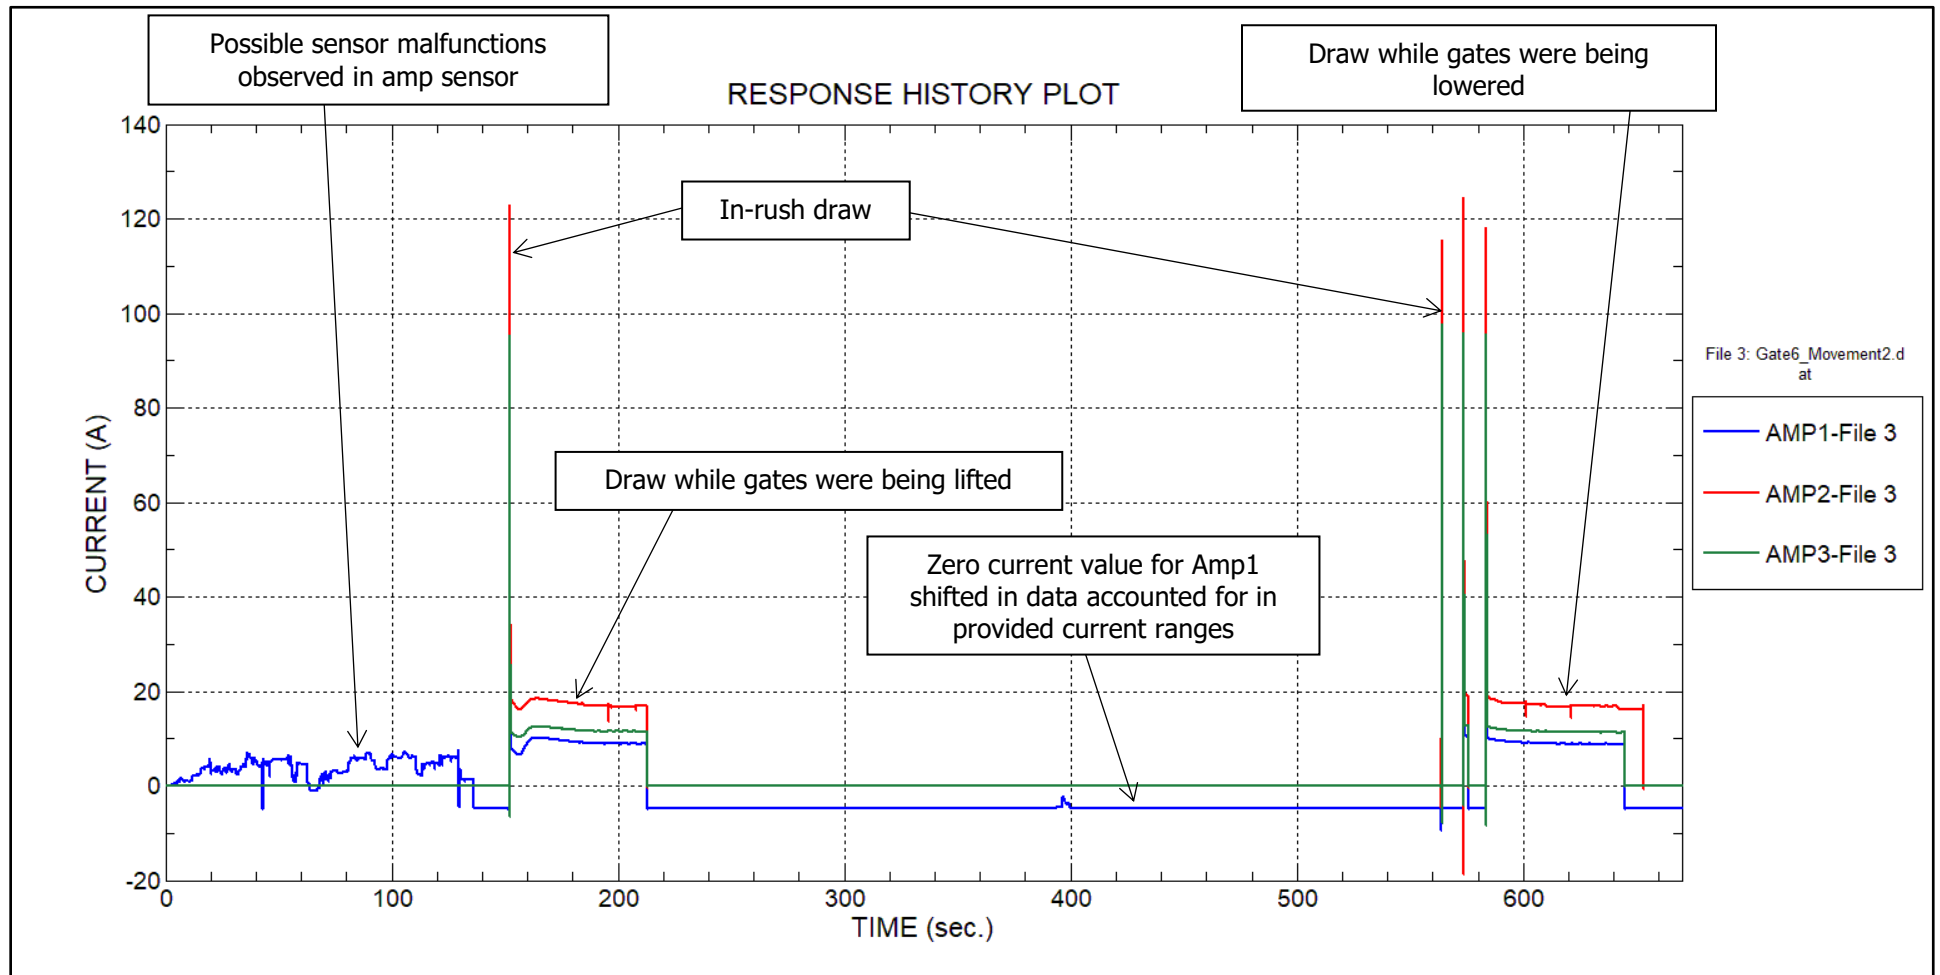
Figure 8 – Motor current & gate movement response history – Highlighting motor draw during lift and lower cycles

- + **MOTOR PERFORMANCE:** Current measurements taken at the hoist motor indicated relatively stable current draws during the lifting and lowering portions of gate operation. However, some anomalies were observed in the current data during both operational tests, including high levels of noise and response spikes. It should be noted that wet site conditions likely played a part in the anomalies observed during response collection. An example plot of current draw and gate position is provided in Figure 8.

Current draw ranges during lifting were higher than the ranges during lowering, which is common due to gravity/dead load. Note that the sample rates used during testing were set for collecting gate responses and may not have been appropriate to fully capture the in-rush current. The readings should be evaluated by a licensed electrician with knowledge of the operating parameters.

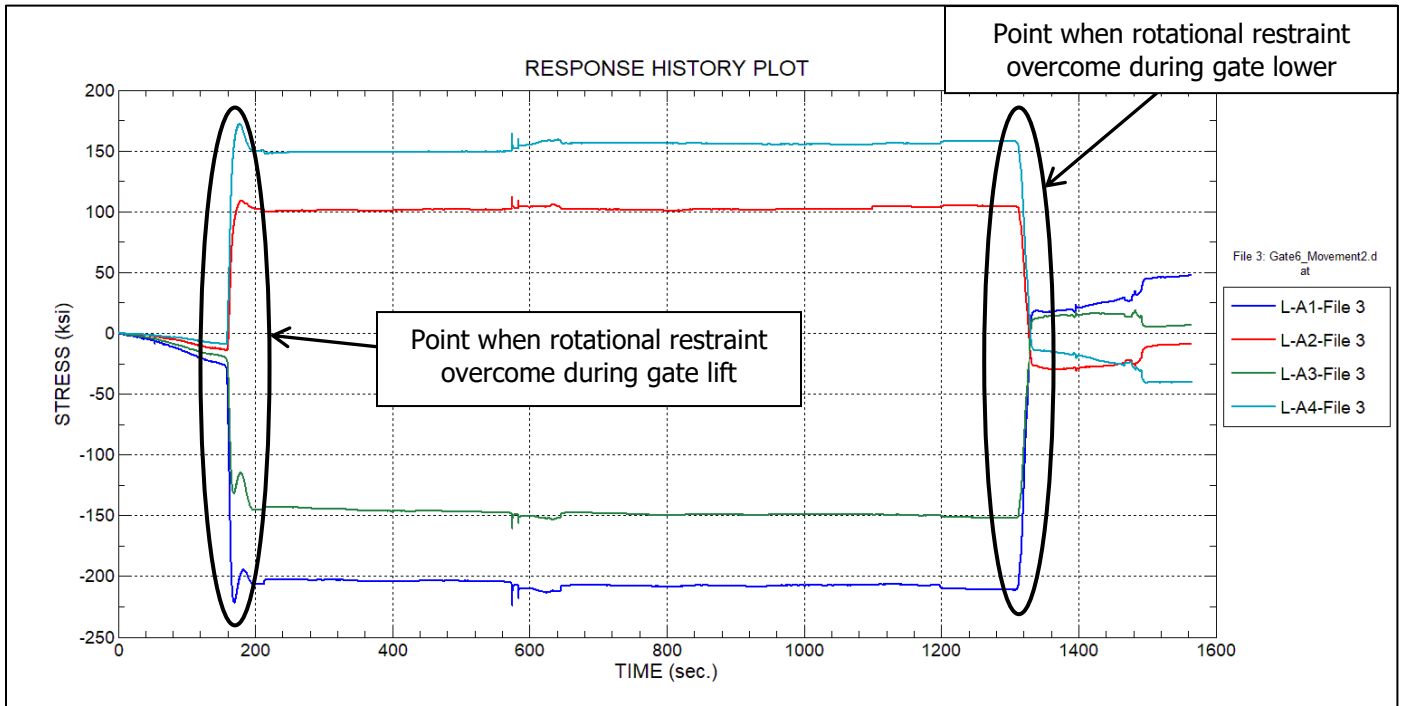
Figure 10 – Stress response history – Left arm – Section A

- + Computed strut moments showed a much higher level of bending in the left arm compared to the right during dry gate operation. Bending behavior also showed a friction-like rotational resistance, as shown in Figure 10, despite no hydrostatic load being present during gate operation. This behavior may be related to the observed issues in the gate and should be further investigated.

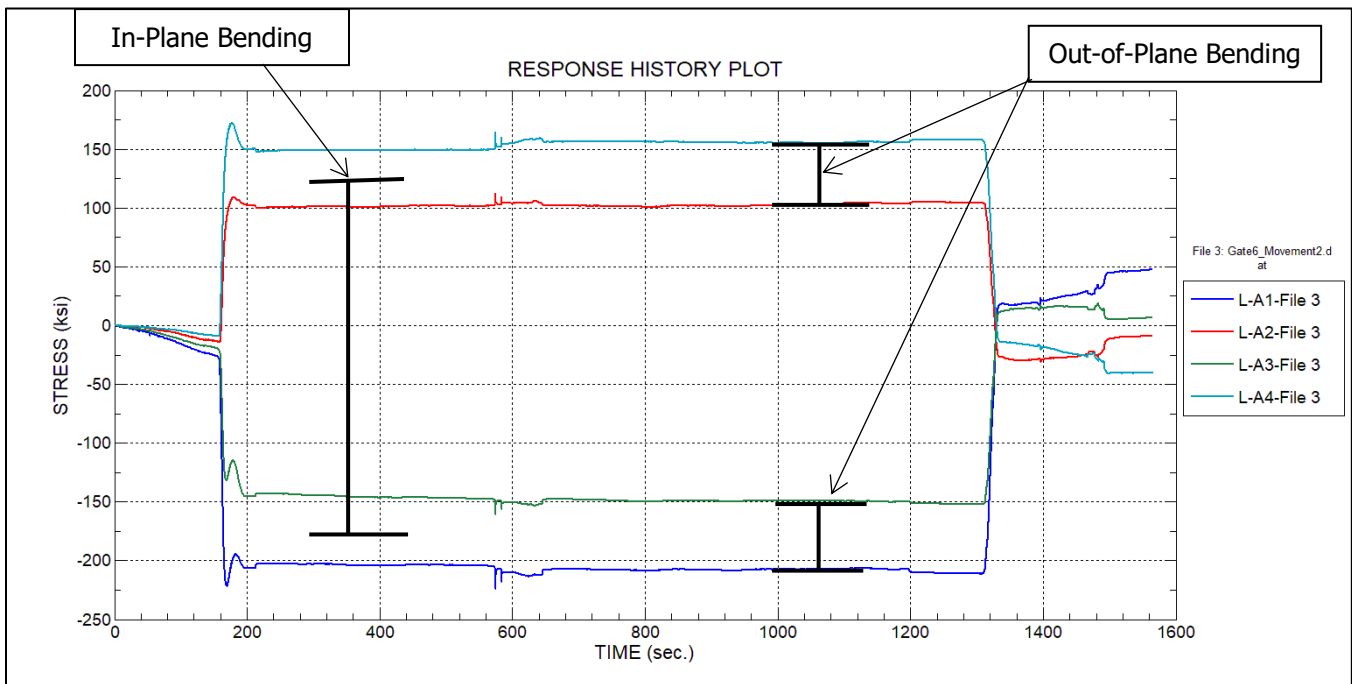
Figure 11 – Stress response history – Left arm – Section A – Bending components

In-plane or weak-axis flexure refers to bending about a given strut's web. This designation is consistent with typical nomenclature. In-plane bending can be observed visually from the strain response histories as a difference between the top and bottom stresses, whereas out-of-plane or strong-axis bending is visualized as the difference in stress from side to side. Figure 11 provides a visual reference for both types of strut flexure.

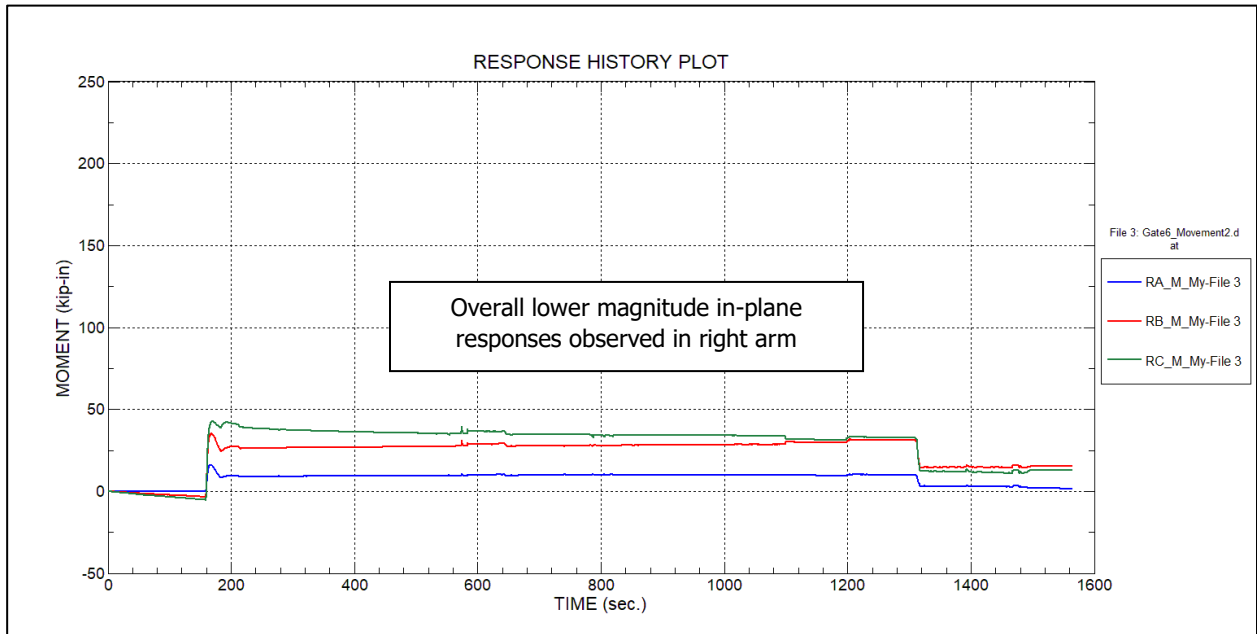
Figure 12 – Moment response history – Right arm – In-plane bending – Gate operation during log removal
(RA = Right Arm Top Strut, RB = Right Arm Middle Strut, RC = Right Arm Bottom Strut)

- + **OBSERVED FLEXURAL BEHAVIOR:** Example plots of strut in-plane and out-of-plane moments for instrumented sections near the pin (Sections A, B, and C) for both left and right arms have been provided in Figure 12 through Figure 15. Again, the gate was operated without any hydrostatic load applied; therefore, normal pin friction was not likely the cause of the observed rotational resistance. The presence of moment resistance without thrust likely indicate the trunnion bearing was binding, likely due to misalignment between the pin and hub.

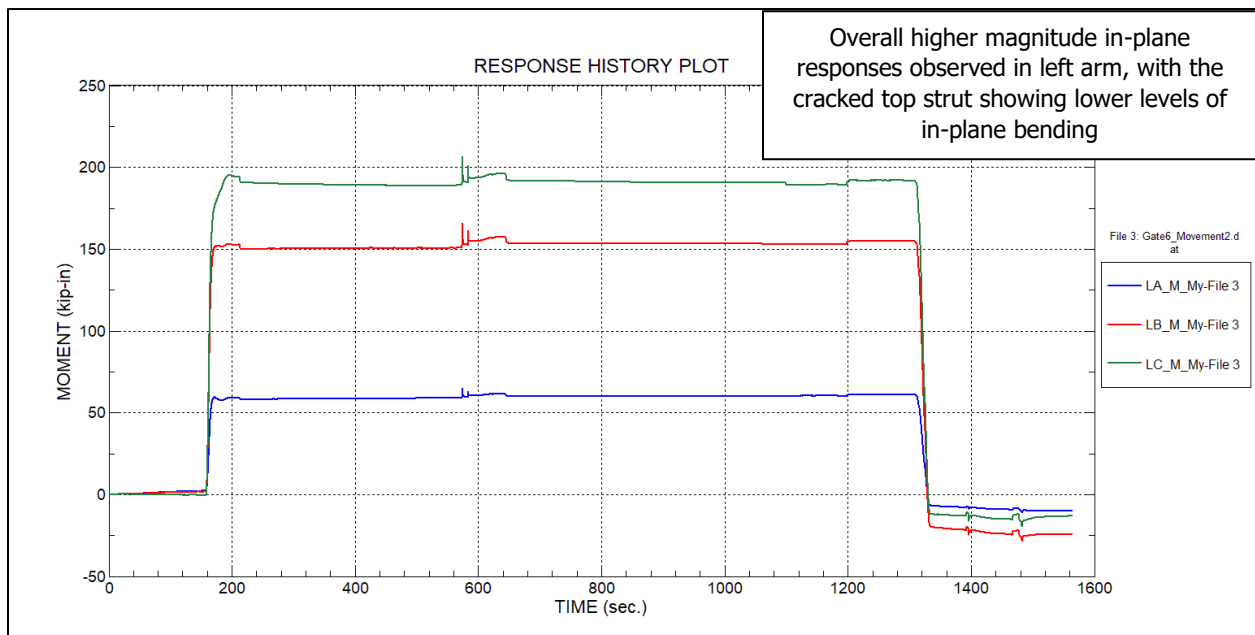
Figure 13 – Moment response history – Left arm – In-plane bending – Gate operation during log removal
(LA = Left Arm Top Strut, LB = Left Arm Middle Strut, LC = Left Arm Bottom Strut)

In general, the computed left arm struts' in-plane moments were significantly larger than the in-plane moments in the right arm struts. Additionally, the left and right arms were observed to bend out-of-plane in the same direction, towards the right wall. This behavior also indicates some level of misalignment in the gate due to the observed flexure imbalance.

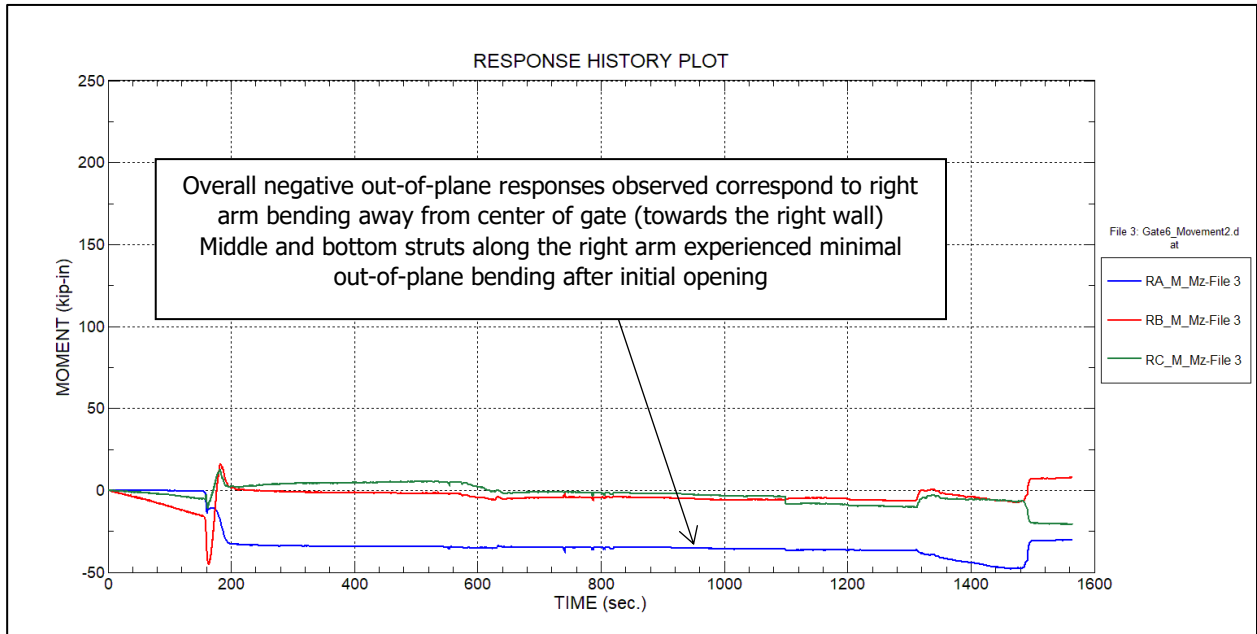
Figure 14 – Moment response history – Right arm – Out-of-plane bending – Gate operation during log removal
(RA = Right Arm Top Strut, RB = Right Arm Middle Strut, RC = Right Arm Bottom Strut)

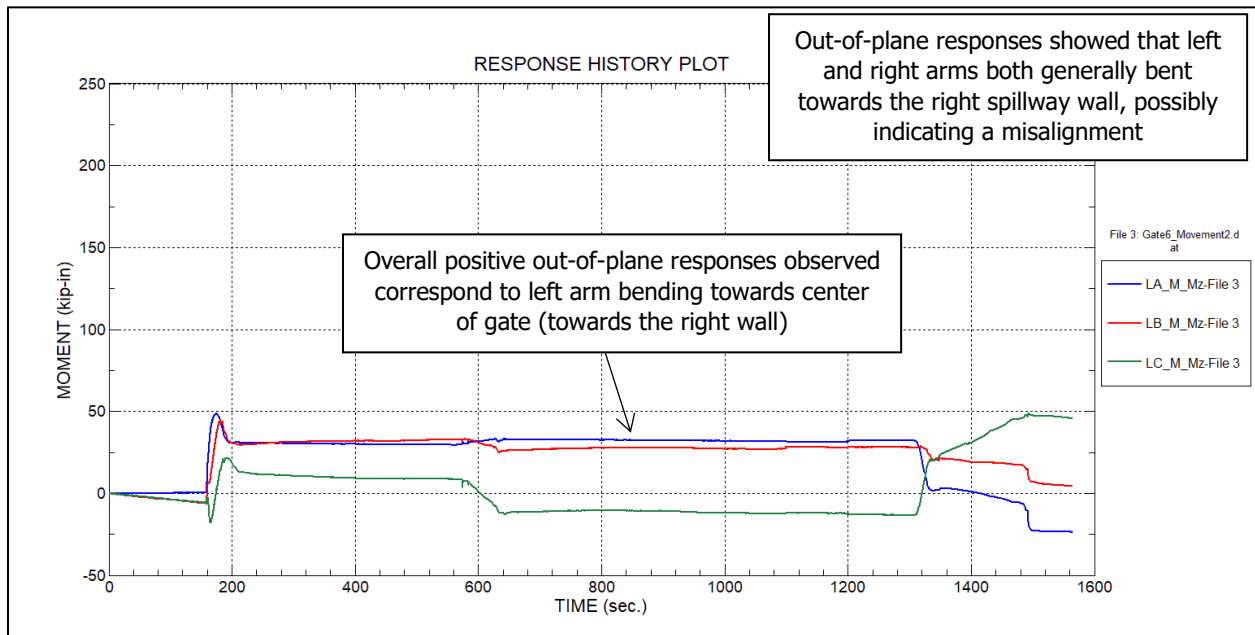
Figure 15 – Moment response history – Left arm – Out-of-plane bending – Gate operation during log removal
(LA = Left Arm Top Strut, LB = Left Arm Middle Strut, LC = Left Arm Bottom Strut)

During the data review, an unusual response was also found in the left arm. During gate operation it was discovered that a log had been lodged under the right side of the skin plate. Before the log was removed, the gate was lowered back on to the log, causing a spike in out-of-plane moment primarily in the left arm. An example plot of this response has been provided in Figure 15.
