VISUAL INSPECTION AND EVALUATION REPORT

Rockwall-Forney Dam
Dallas Water Utilities
Dallas/Kaufman Counties, Texas

Schnabel Reference #20C22001.00
July 30, 2021

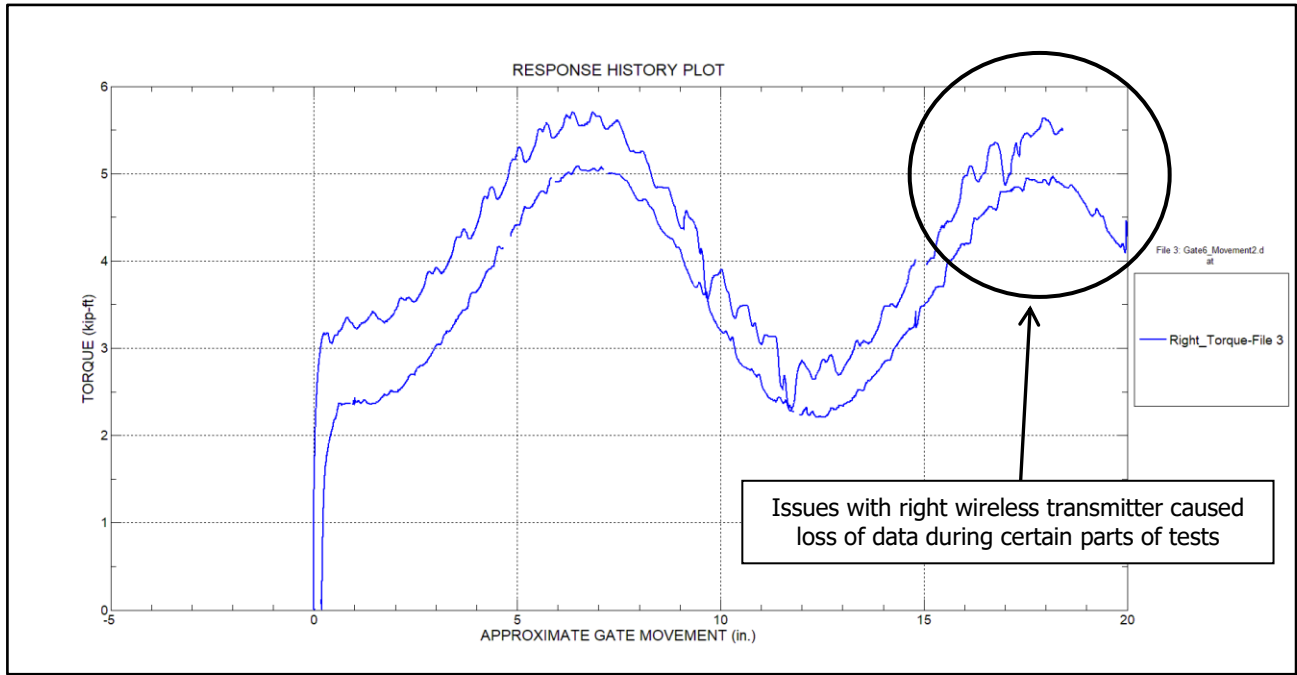
Figure 16 – Hoist torque response history – Gate 6
Note: left hoist data was not collected due to wireless connectivity issues

Figure 16 shows example torque measurements, recorded on the Gate 6 torque shafts. Best practices for torque measurements is to measure torque on opposite sides of the shaft so that any bending in the shaft can be removed by averaging the two responses. Due to access limitations, only one gage at each location could be installed. Therefore, any bending in the shaft may be reflected in the torque measurements and may be related to the peaks and valleys observed in the torque responses.

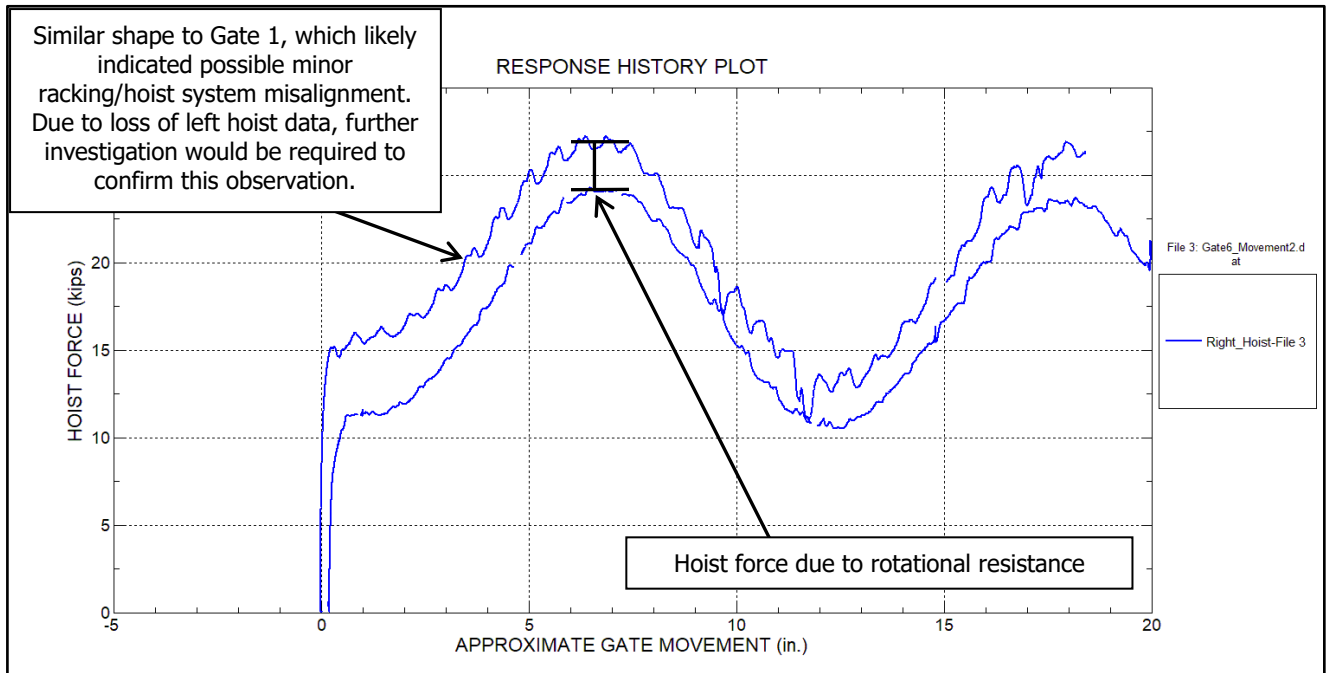
Figure 17 – Hoist force response history – Gate 6
Note: left hoist data was not collected due to wireless connectivity issues

- + **TORQUE AND HOIST FORCE:** Torque measurements taken at the hoist pinion shafts, and the derived hoist forces, indicate a shifting/force reversal between the left and right hoists, as shown in Figure 17. This observed behavior indicates possible minor racking or hoist system misalignment in the gate as it was operated. Note that issues with the wireless transmitter connected to the left gate hoist gages caused total loss of data from the left hoist. This connectivity issue is likely related to the wet site conditions encountered during testing.

Torque values were converted to force in the hoist cables per gate arm using the gear ratio and drum radius, as shown in Figure 17. The gear ratio and drum radius were 5.182 and 1.086 feet respectively, as defined in the provided as-built shop drawings. The hoist force calculated may be smaller than the actual hoist force applied, due to the limit switch engaging the brake before the hoist cable was fully slacked, resulting in an initial force in the cable.

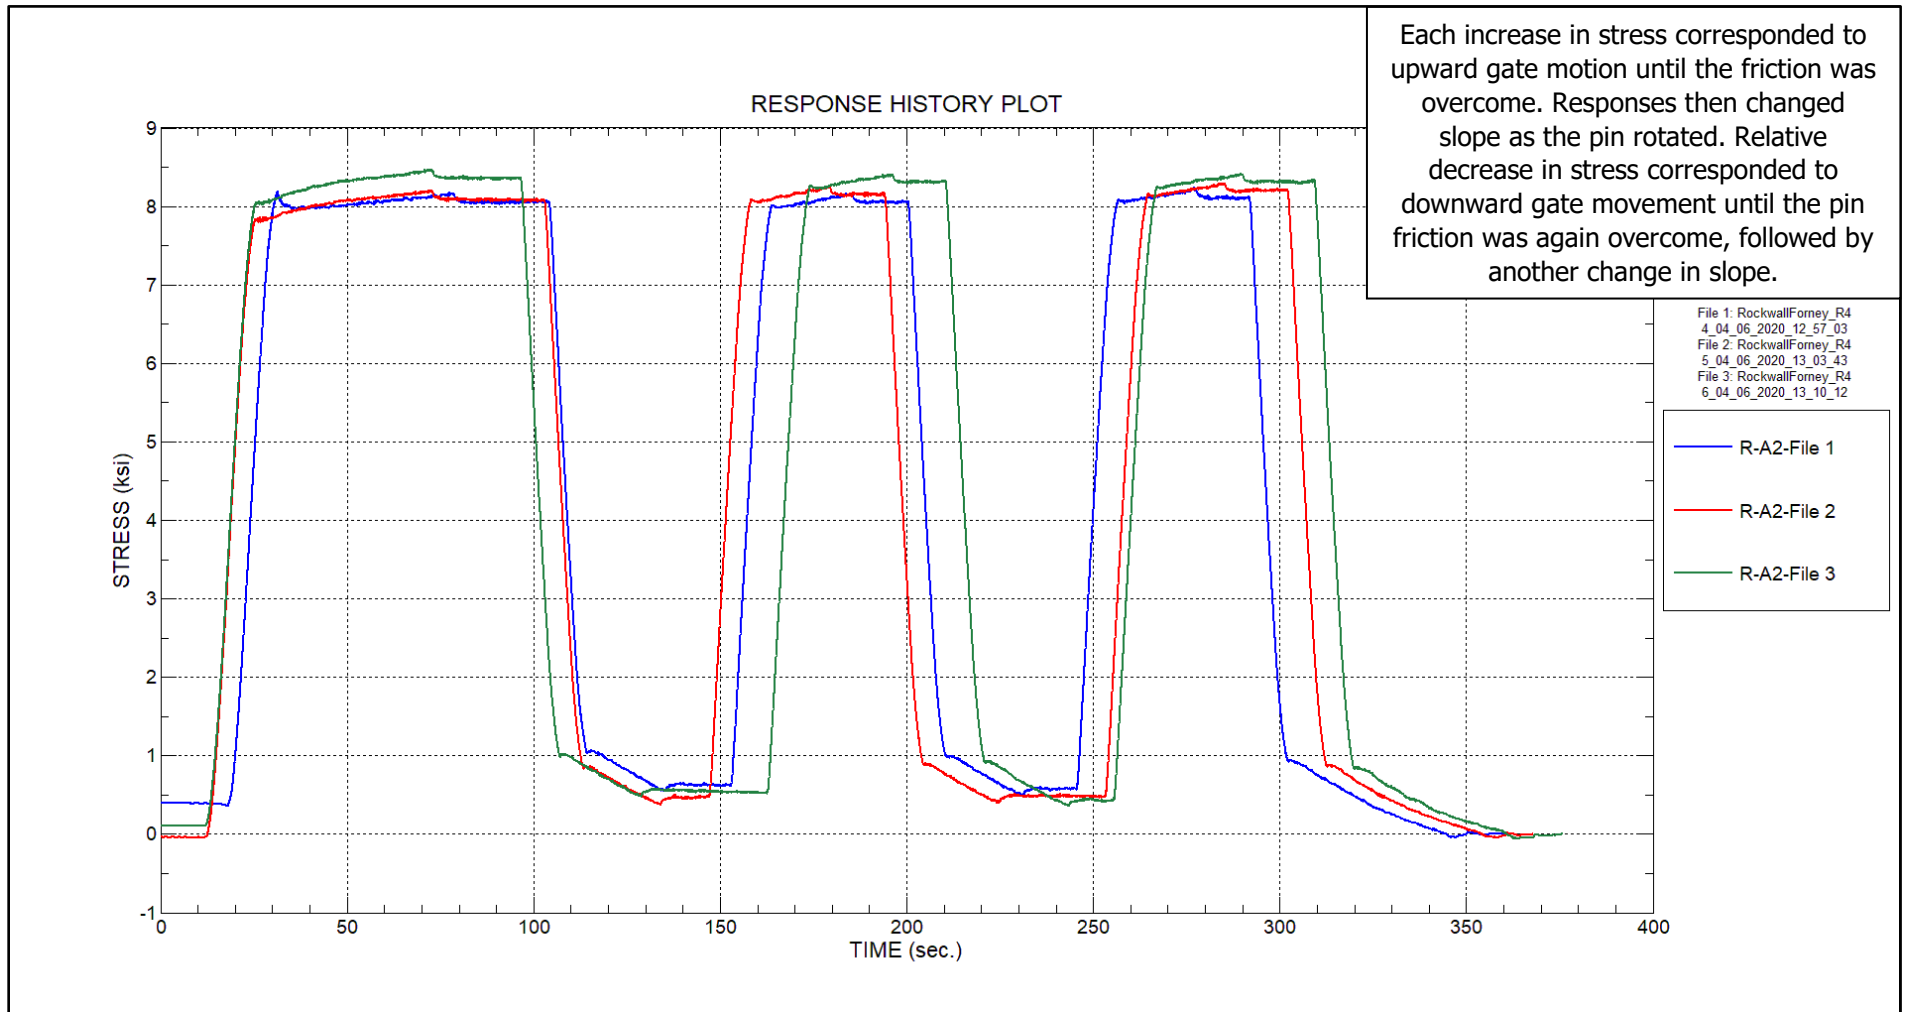
Figure 6 – Stress response history – Right arm – Gage A2 – Time based
File 1 = test run 1, File 2 = test run 2, File 3 = test run 3
(Section A along top strut near pin – Sensor location 2 along bottom of inner flange)

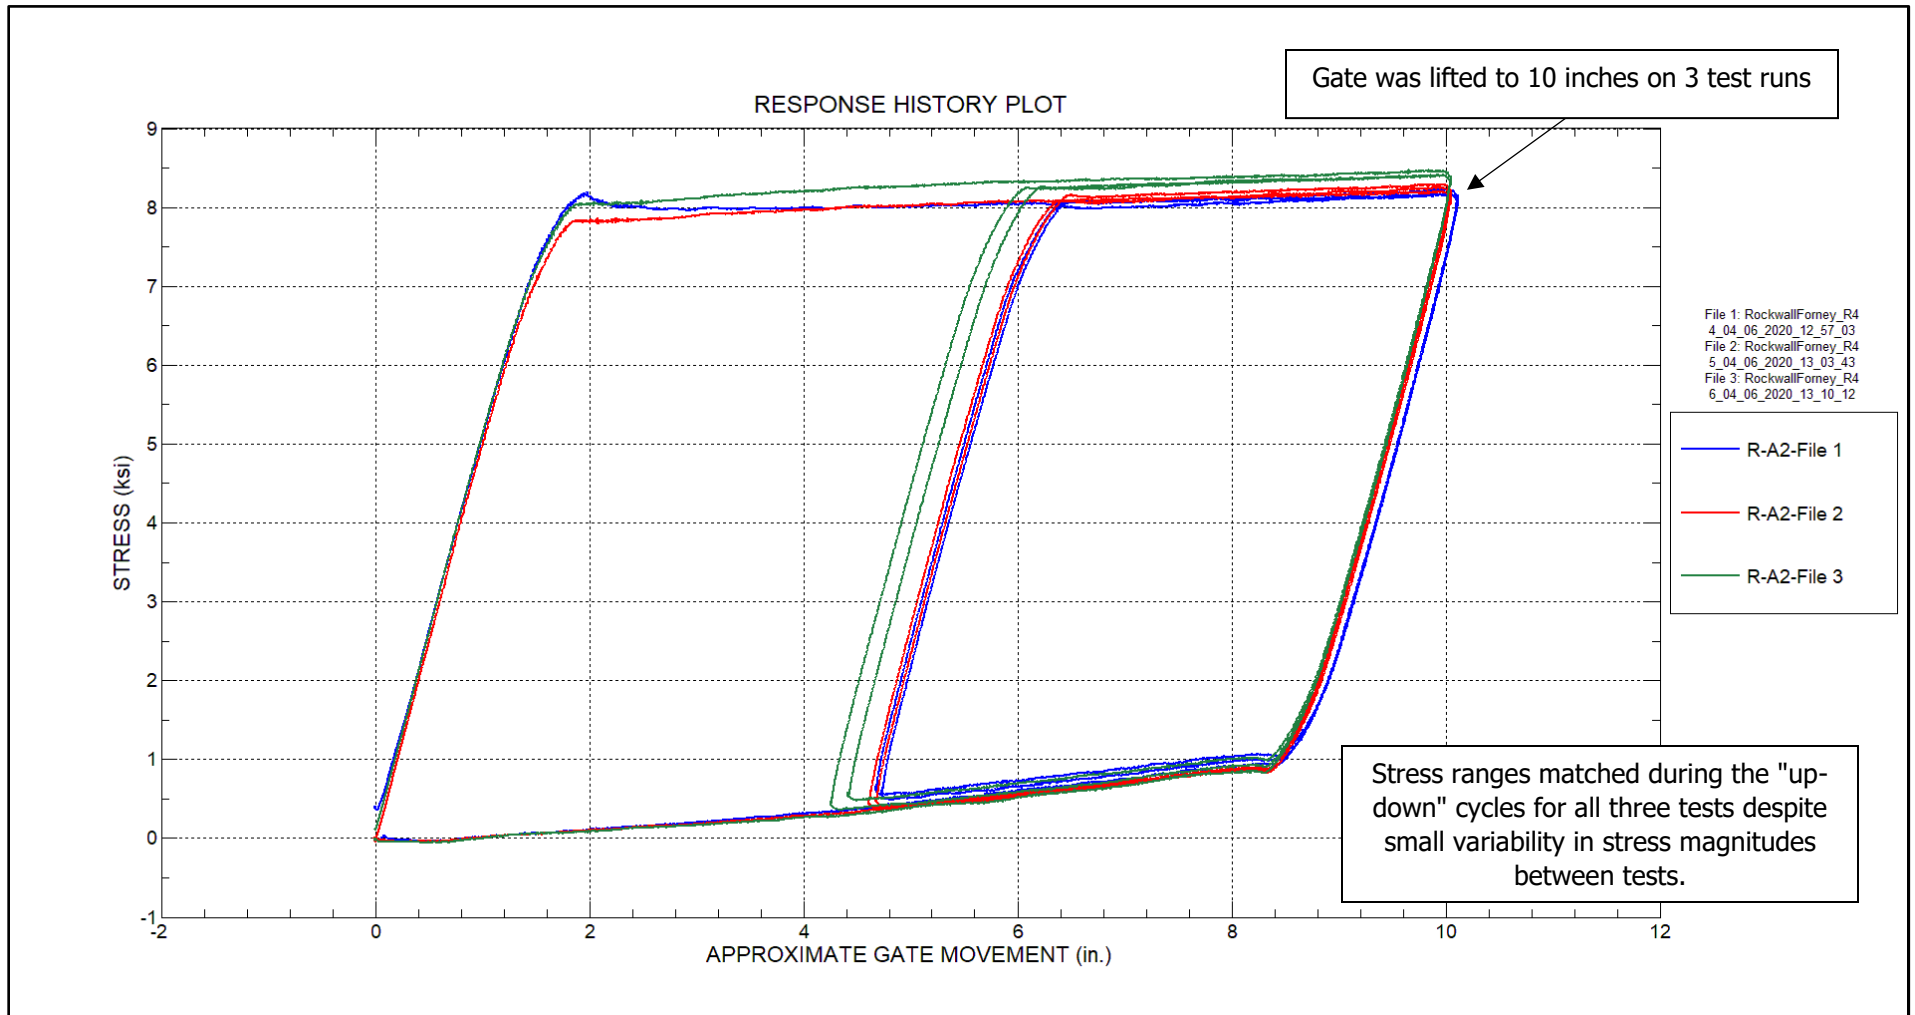
Figure 7 – Stress response history – Right arm – Gage A2 – Function of gate movement
File 1 = test run 1, File 2 = test run 2, File 3 = test run 3
(Section A along top strut near pin – Sensor location 2 along bottom of inner flange)

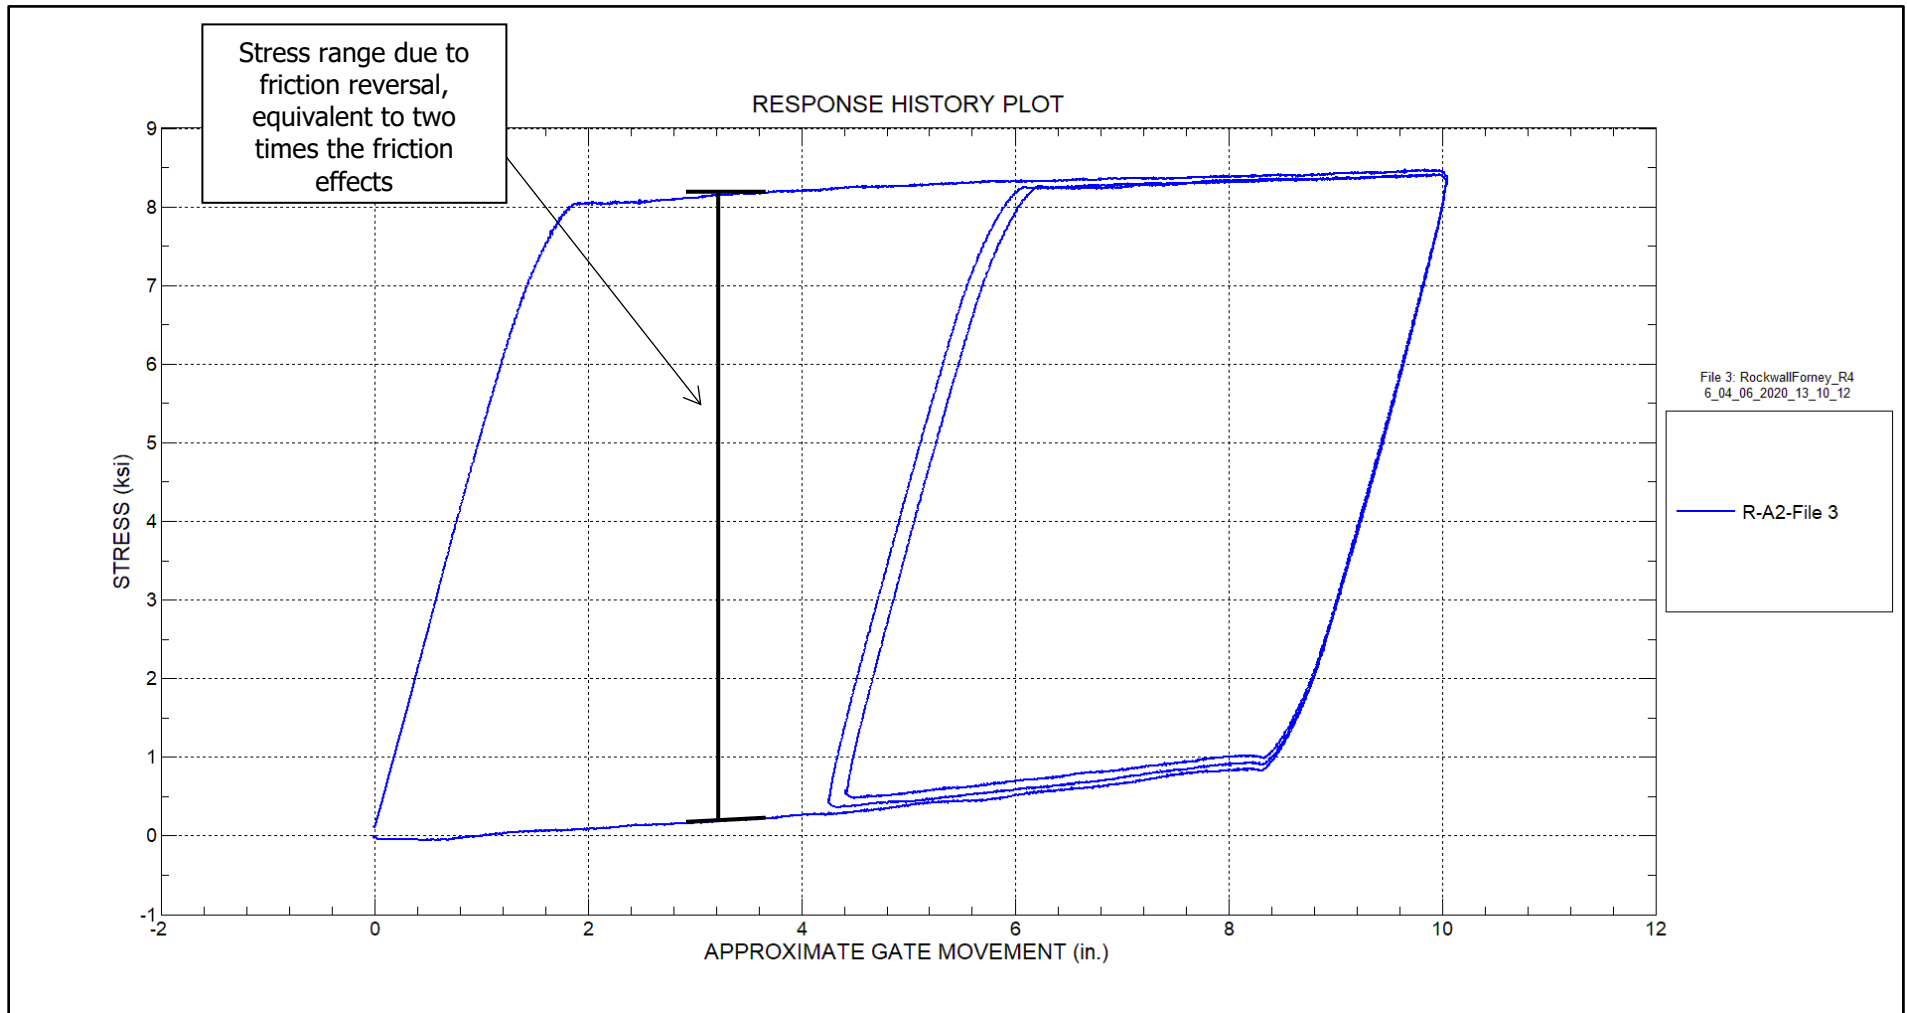
Figure 8 – Stress response history – Right arm – Gage A2 – Friction effect in stress responses
(Section A along top strut near pin – Sensor location 2 along bottom of inner flange)

- + **DIRECTION/FRICTION REVERSAL IN RESPONSES:** The difference in stress during gate opening and closing for a given position is shown in Figure 8. The stress variation at any given gate position was a result of direction reversal and in turn due to trunnion friction reversal. This statement is true since all other loads such as dead-load and hydrostatic pressure were essentially constant barring small changes in hydrostatic pressure due to slight changes in head. This direction/friction reversal is depicted in Figure 9, with deflected shape renderings from a gate arm finite element model under lifting and lowering loads. Note that this figure shows an arm configuration that does not match this gate, but the concept of the direction/friction reversal still applies.

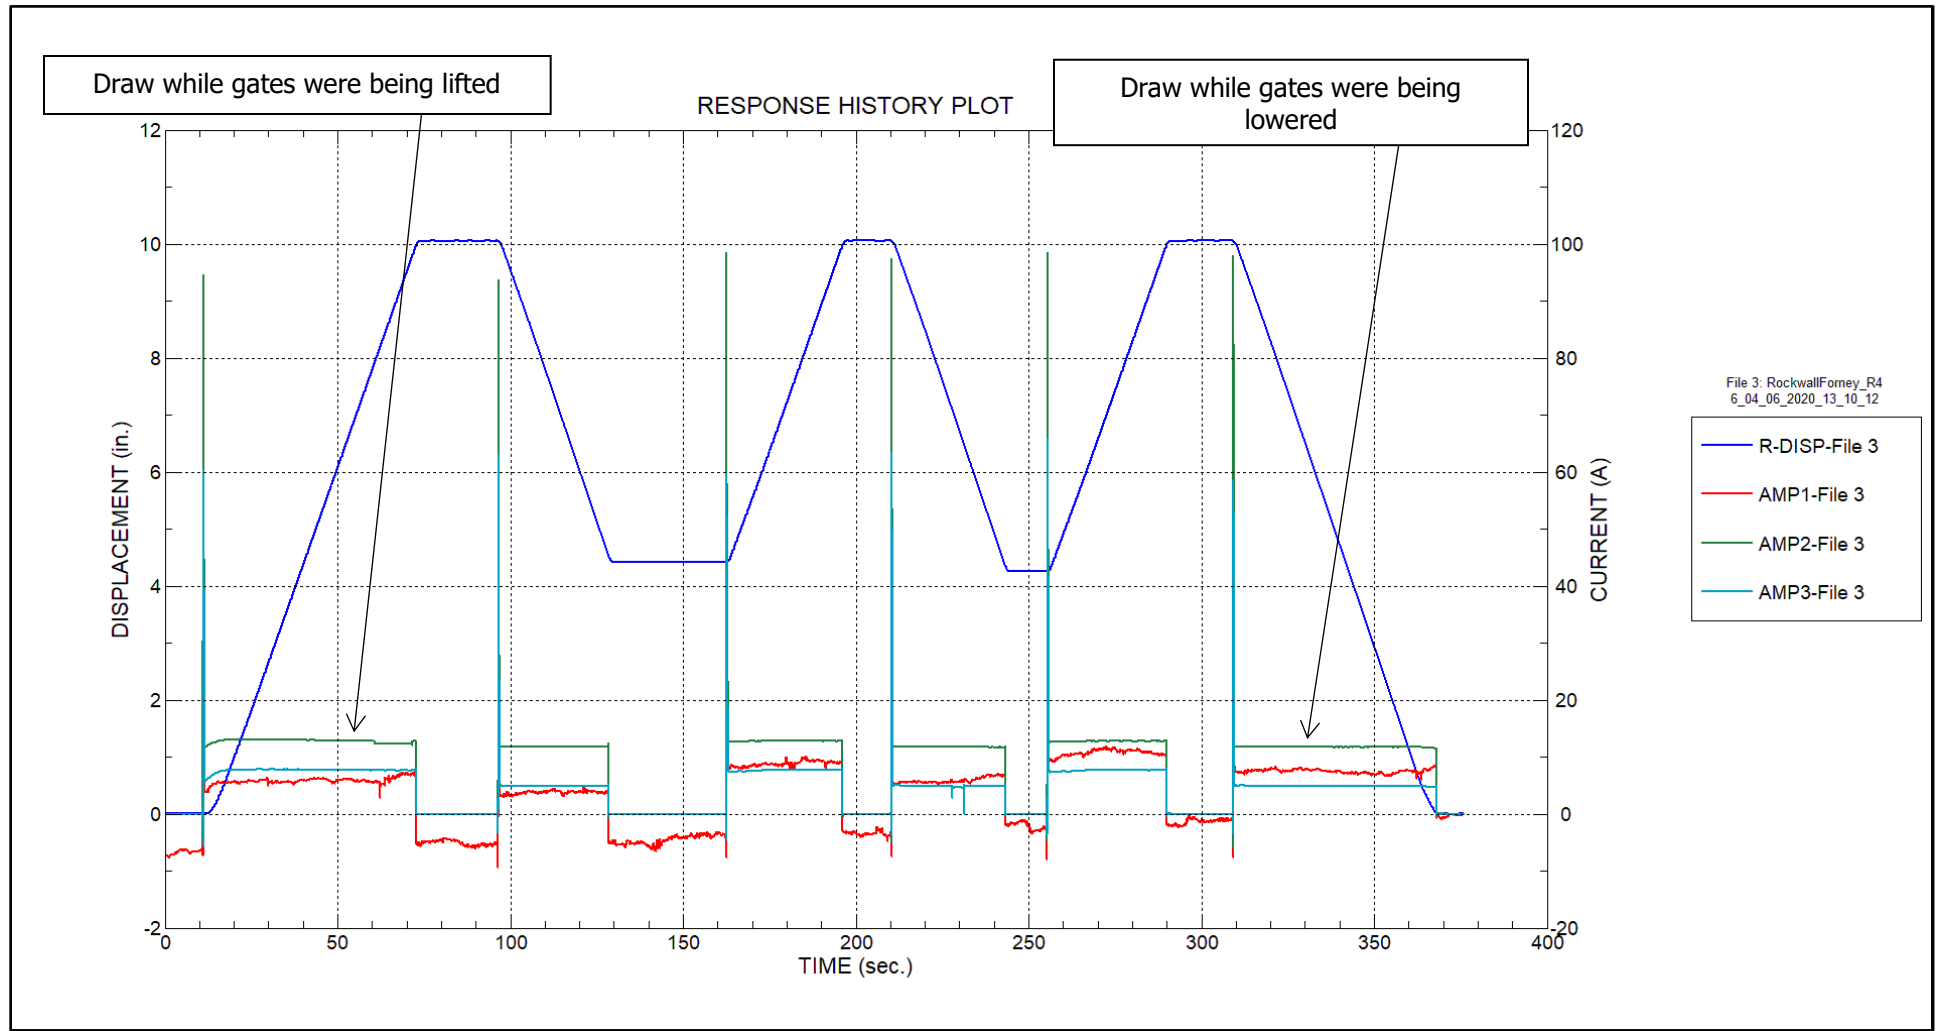
Figure 10 – Motor current & gate movement response history – Lift motor – Highlighting motor draw during lift and lower cycles

- + **MOTOR PERFORMANCE:** Current measurements taken at the hoist motor indicated steady and stable current draws during the lifting and lowering portions. An example plot of current draw and gate position is provided in Figure 10. Current draw ranges during lifting were higher than the ranges during lowering, which is common due to gravity/dead load. These results are summarized along with recorded peak in-rush current in Table 2. Note that the sample rates used during testing were set for collecting gate responses and may not have been appropriate to fully capture the in-rush current. The readings should be evaluated by a licensed electrician with knowledge of the operating parameters.

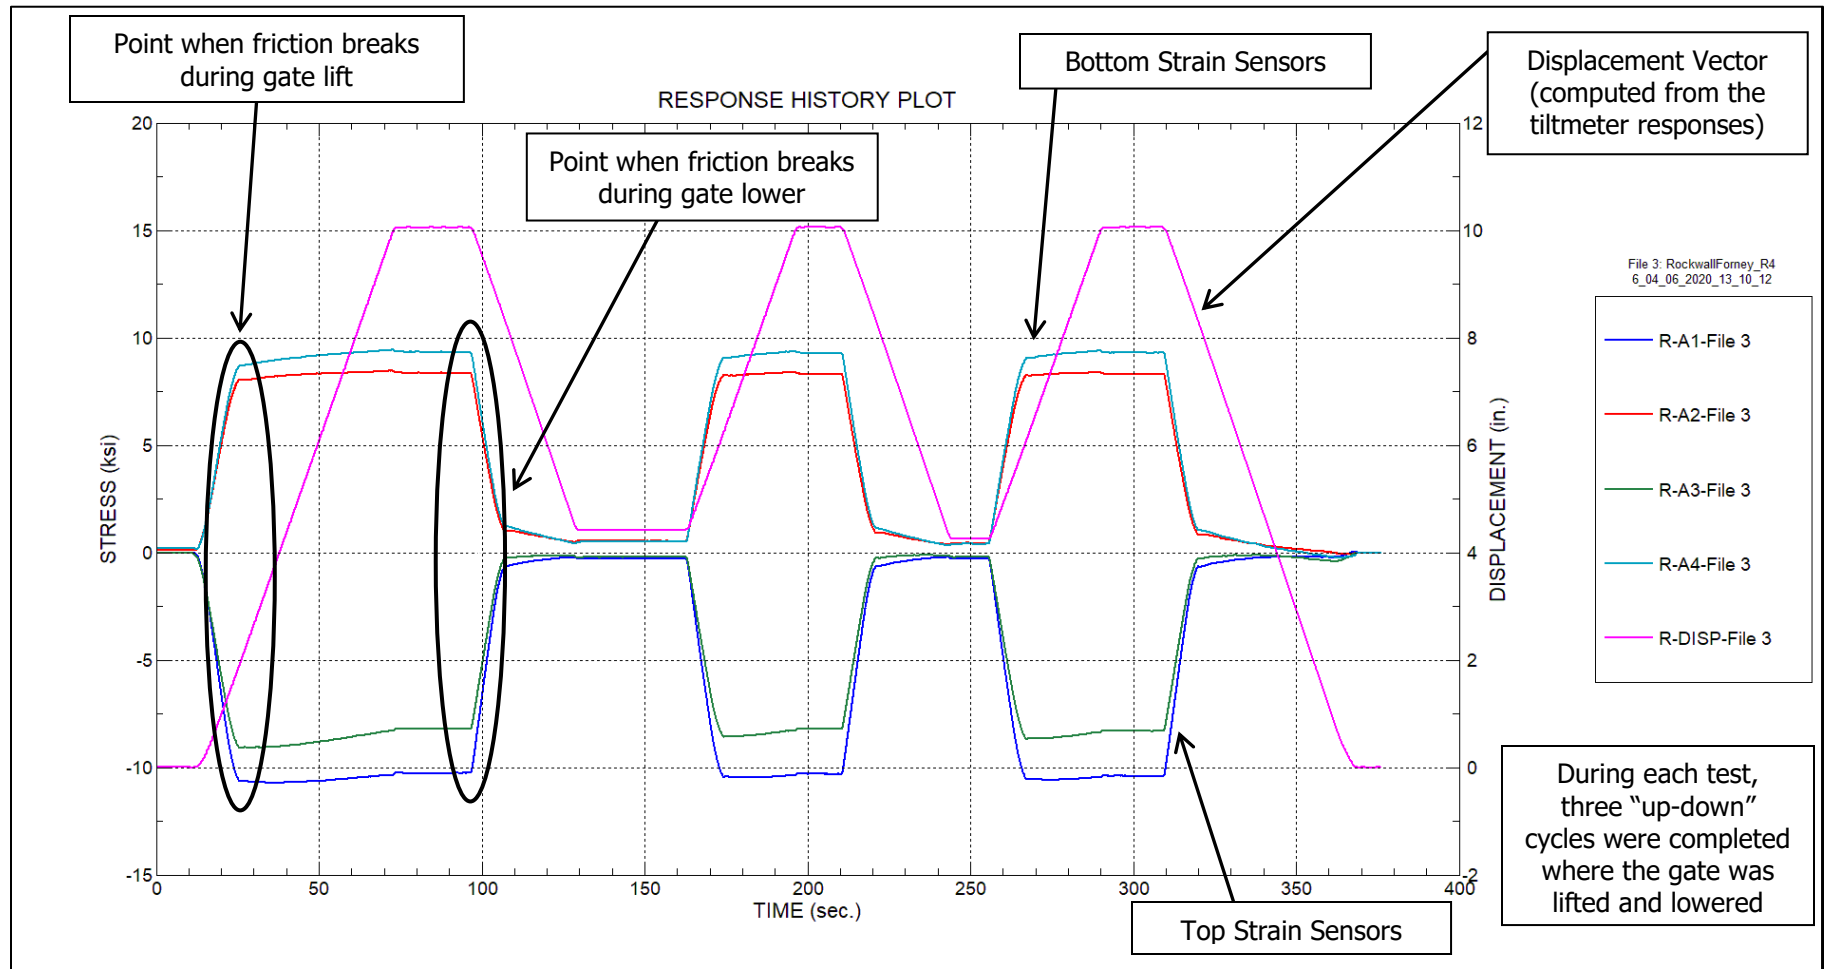
Figure 11 – Stress response & gate movement history – Right arm – Section A - Highlighting friction behavior (Section A along top strut near pin)

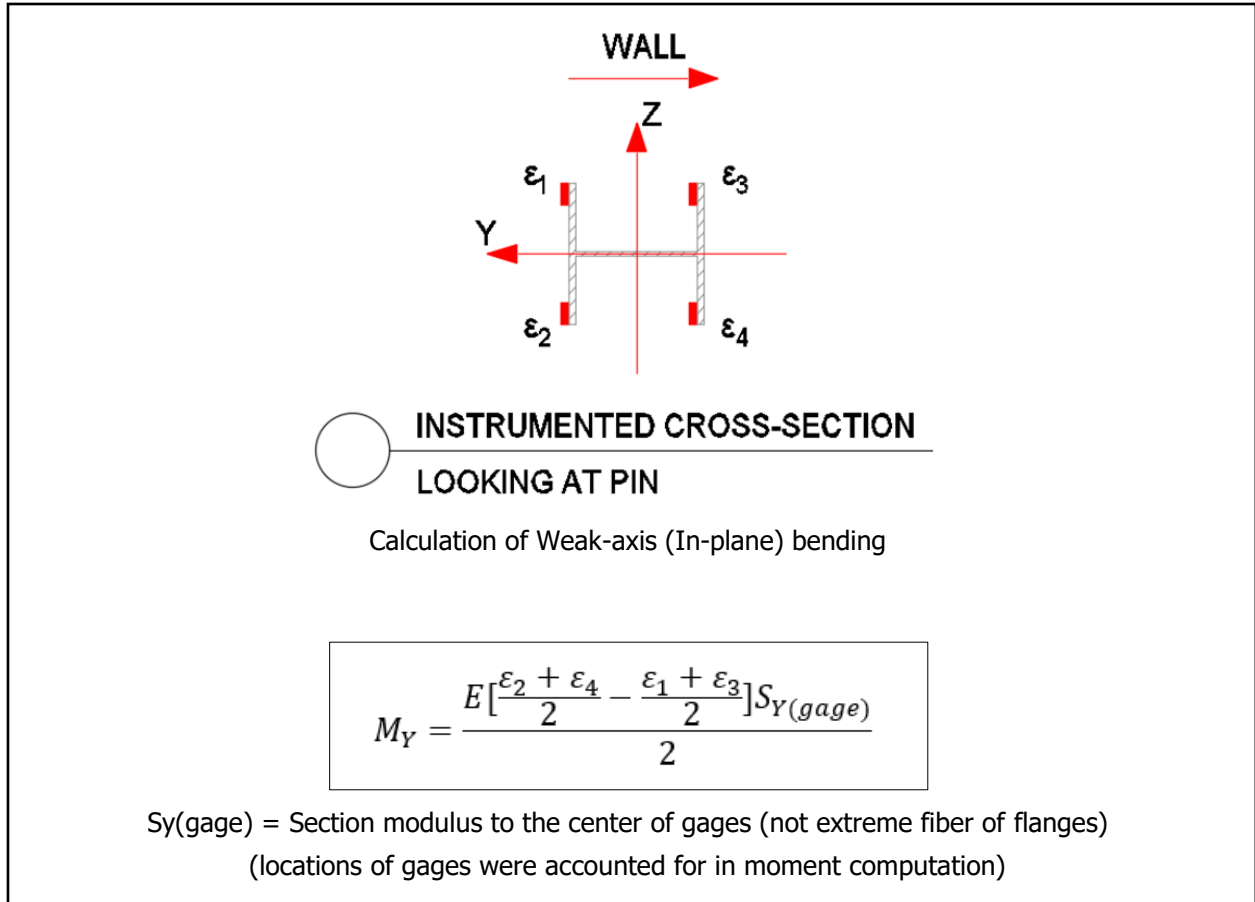
Figure 12 – Basic mechanic equation used to calculate moment

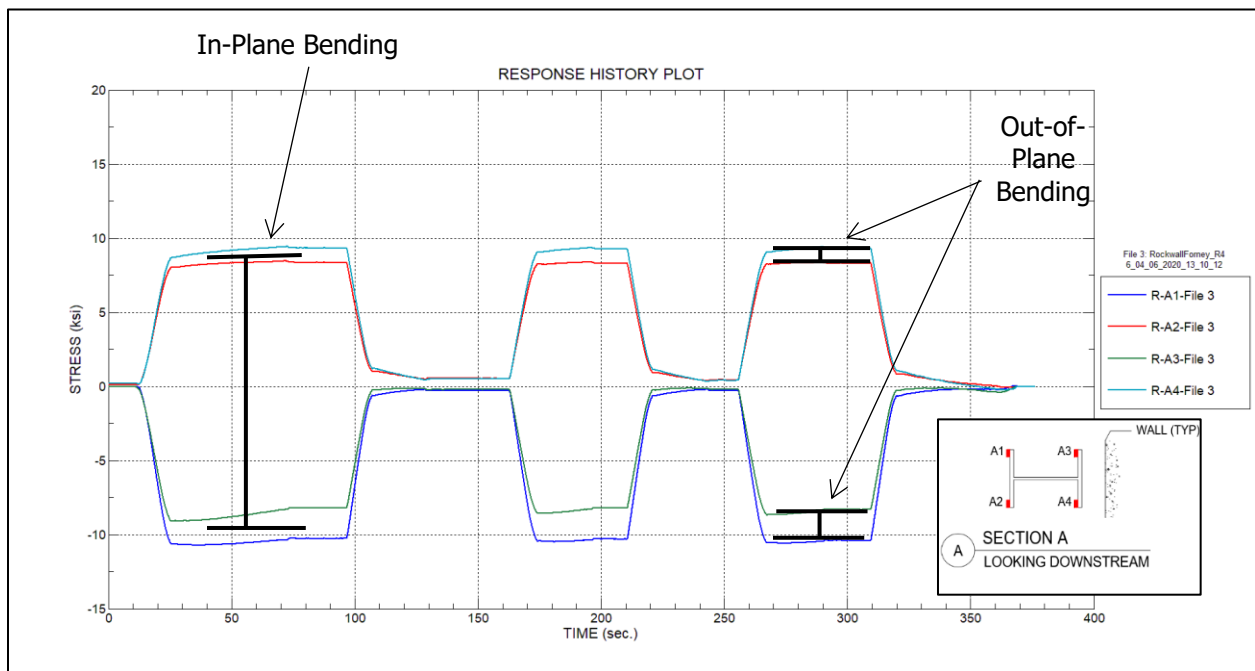
Figure 13 – Stress response history – Right arm – Section A – Bending components
(Section A along top strut near pin)

In-plane or weak-axis flexure refers to bending about a given strut's web. This designation is consistent with typical nomenclature. In-plane bending can be observed visually from the strain response histories as a difference between the top and bottom stresses, whereas out-of-plane or strong-axis bending is visualized as the difference in stress from side to side. Figure 13 provides a visual reference for both types of strut flexure.

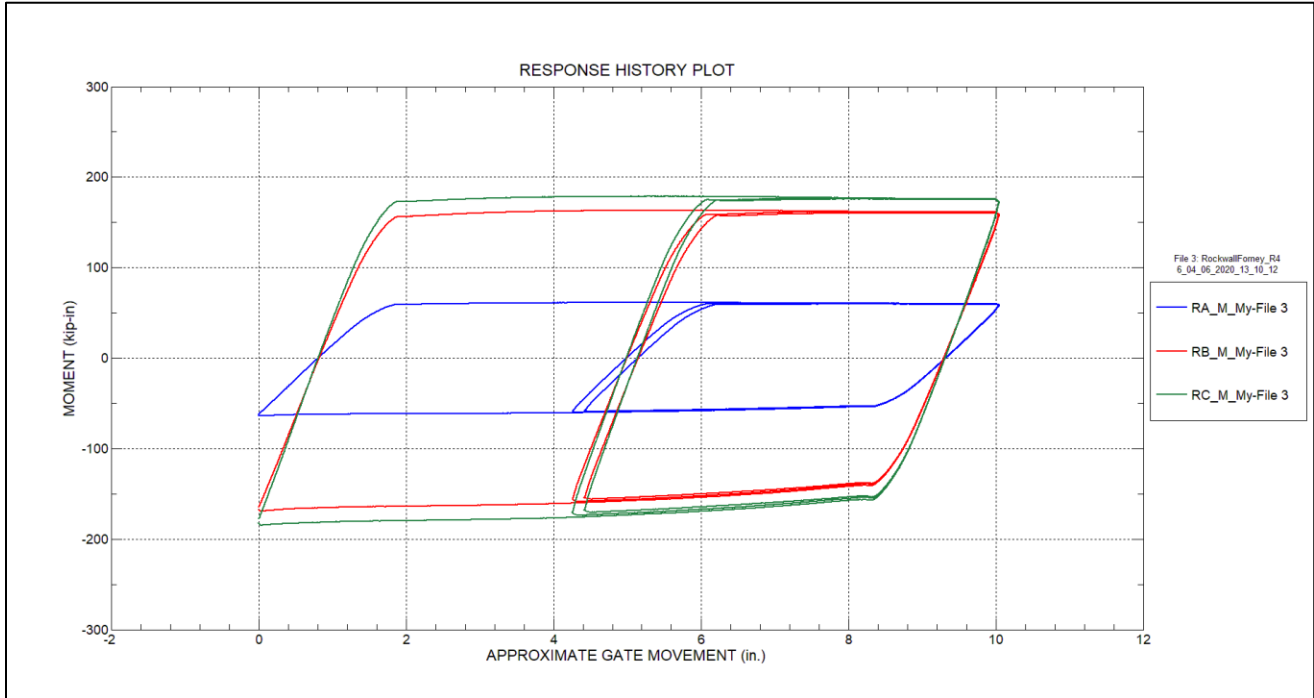
Figure 14 – In-plane moment response history – Right arm – Sections near pin
(RA = Right Arm Top Strut, RB = Right Arm Middle Strut, RC = Right Arm Bottom Strut)

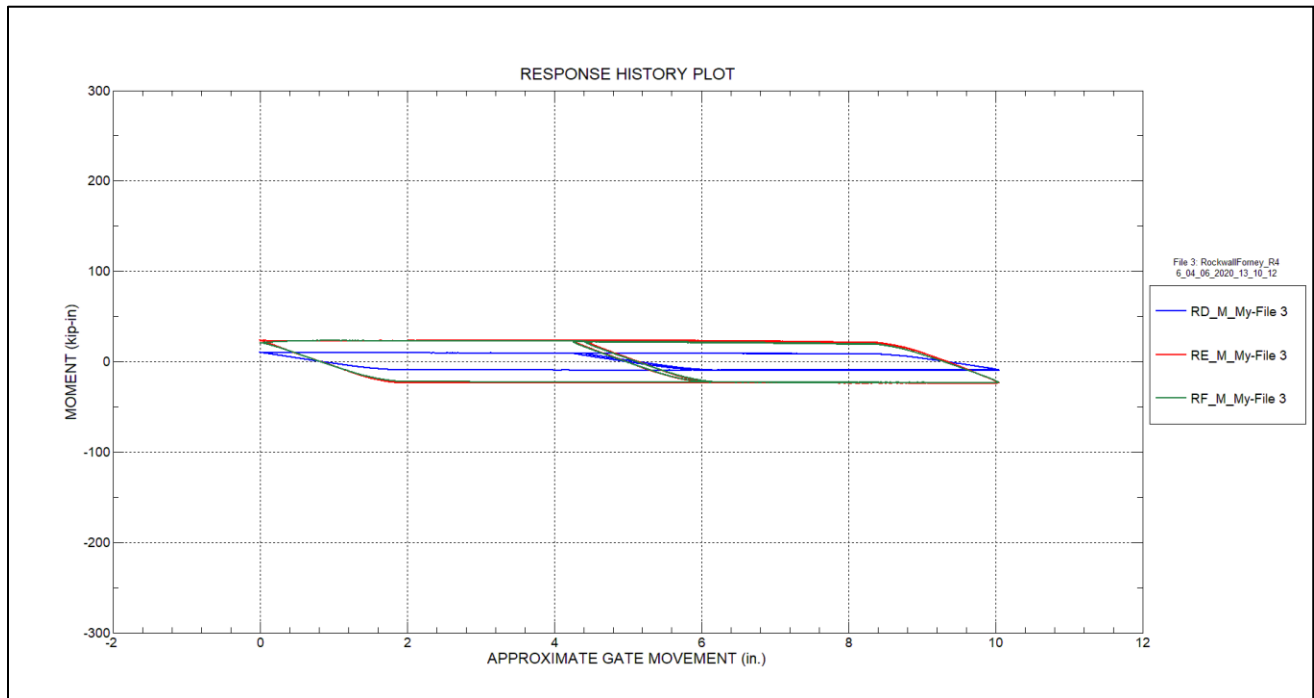
Figure 15 – In-plane moment response history – Right arm – Sections away from pin
(RD = Right Arm Top Strut, RE = Right Arm Middle Strut, RF = Right Arm Bottom Strut)

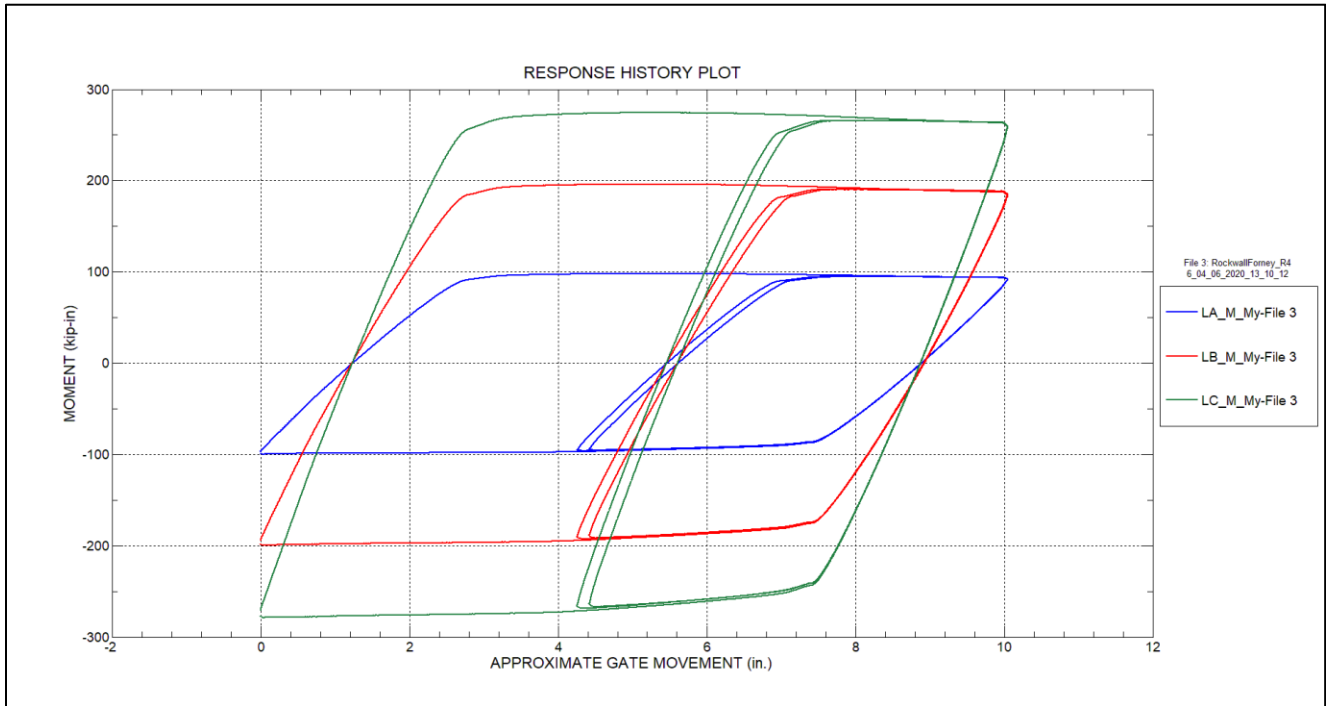
Figure 16 – In-plane moment response history – Left arm – Sections near pin
(LA = Left Arm Top Strut, LB = Left Arm Middle Strut, LC = Left Arm Bottom Strut)

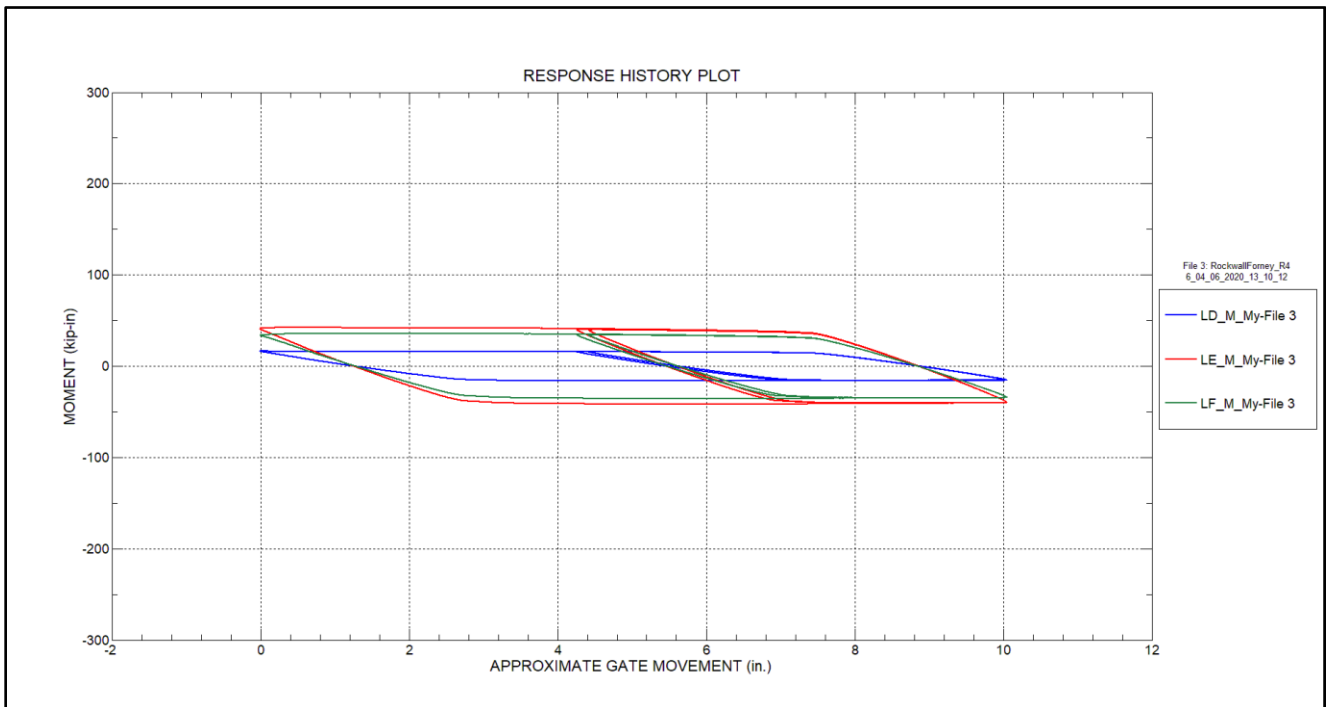
Figure 17 - In-plane moment response history – Left arm – Sections away from pin
(LD = Left Arm Top Strut, LE = Left Arm Middle Strut, LF = Left Arm Bottom Strut)

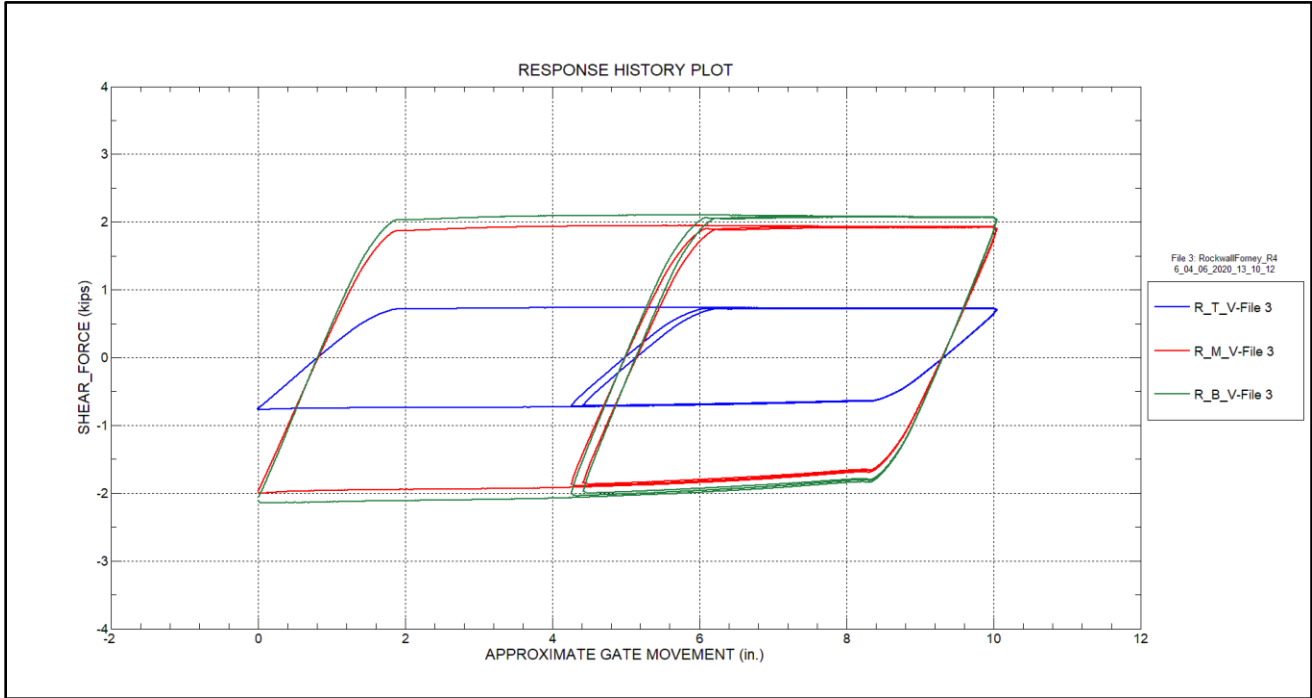
Figure 19 – Strut shear response history – Right arm

(R_T = Right Arm Top Strut, R_M = Right Arm Middle Strut, R_B = Right Arm Bottom Strut)

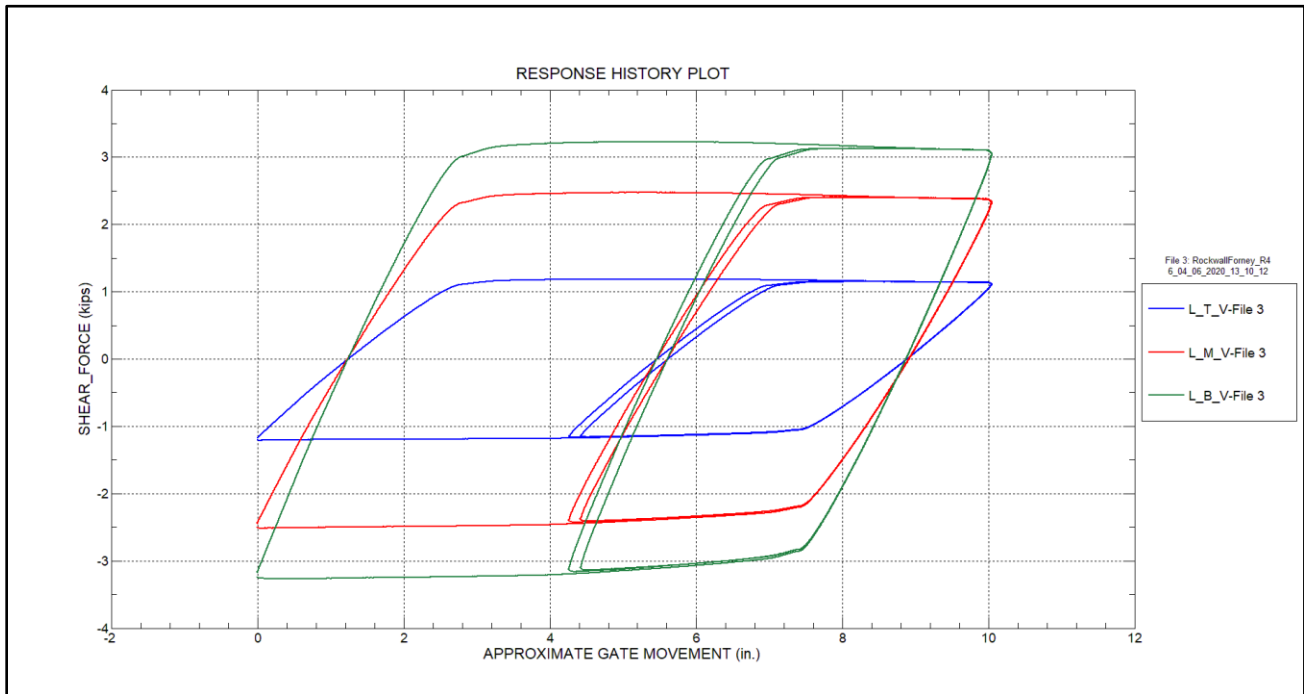
Figure 20 – Strut shear response history – Left arm

(L_T = Left Arm Top Strut, L_M = Left Arm Middle Strut, L_B = Left Arm Bottom Strut)

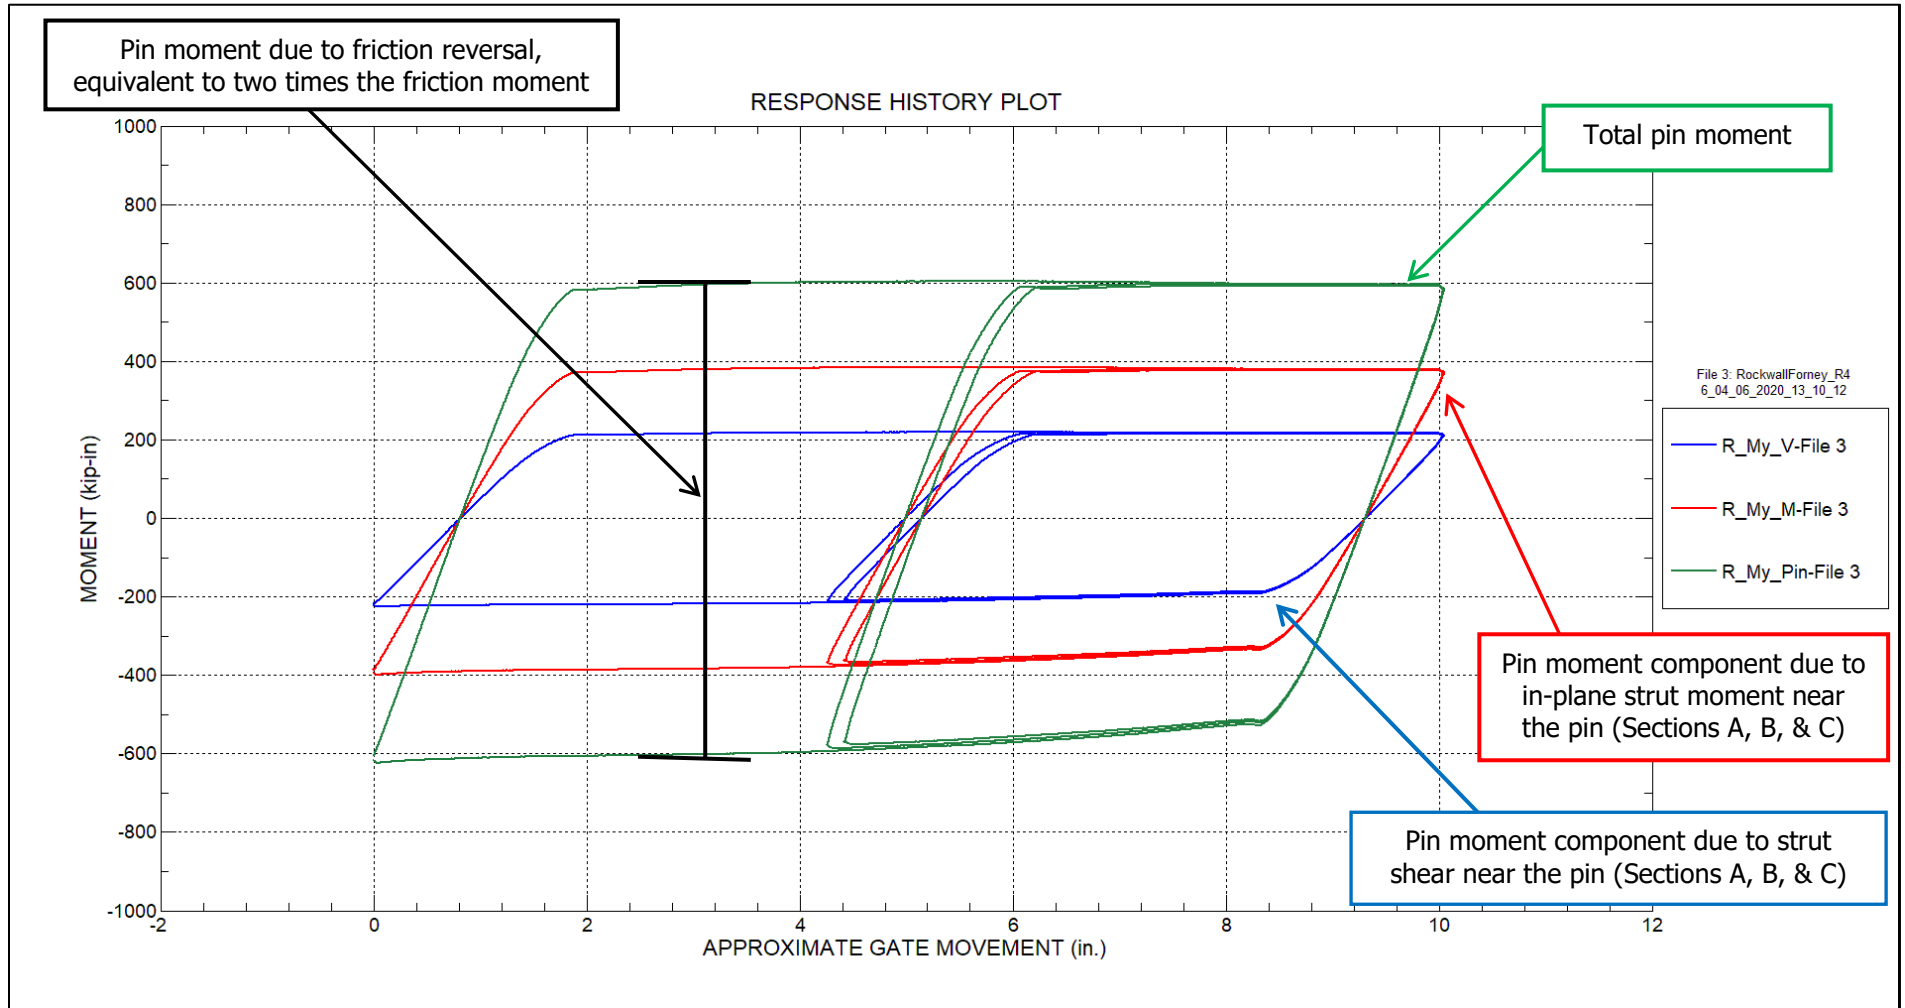
Figure 21 – Pin moment response history – Right arm
