VISUAL INSPECTION AND EVALUATION REPORT

Rockwall-Forney Dam
Dallas Water Utilities
Dallas/Kaufman Counties, Texas

Schnabel Reference #20C22001.00
July 30, 2021

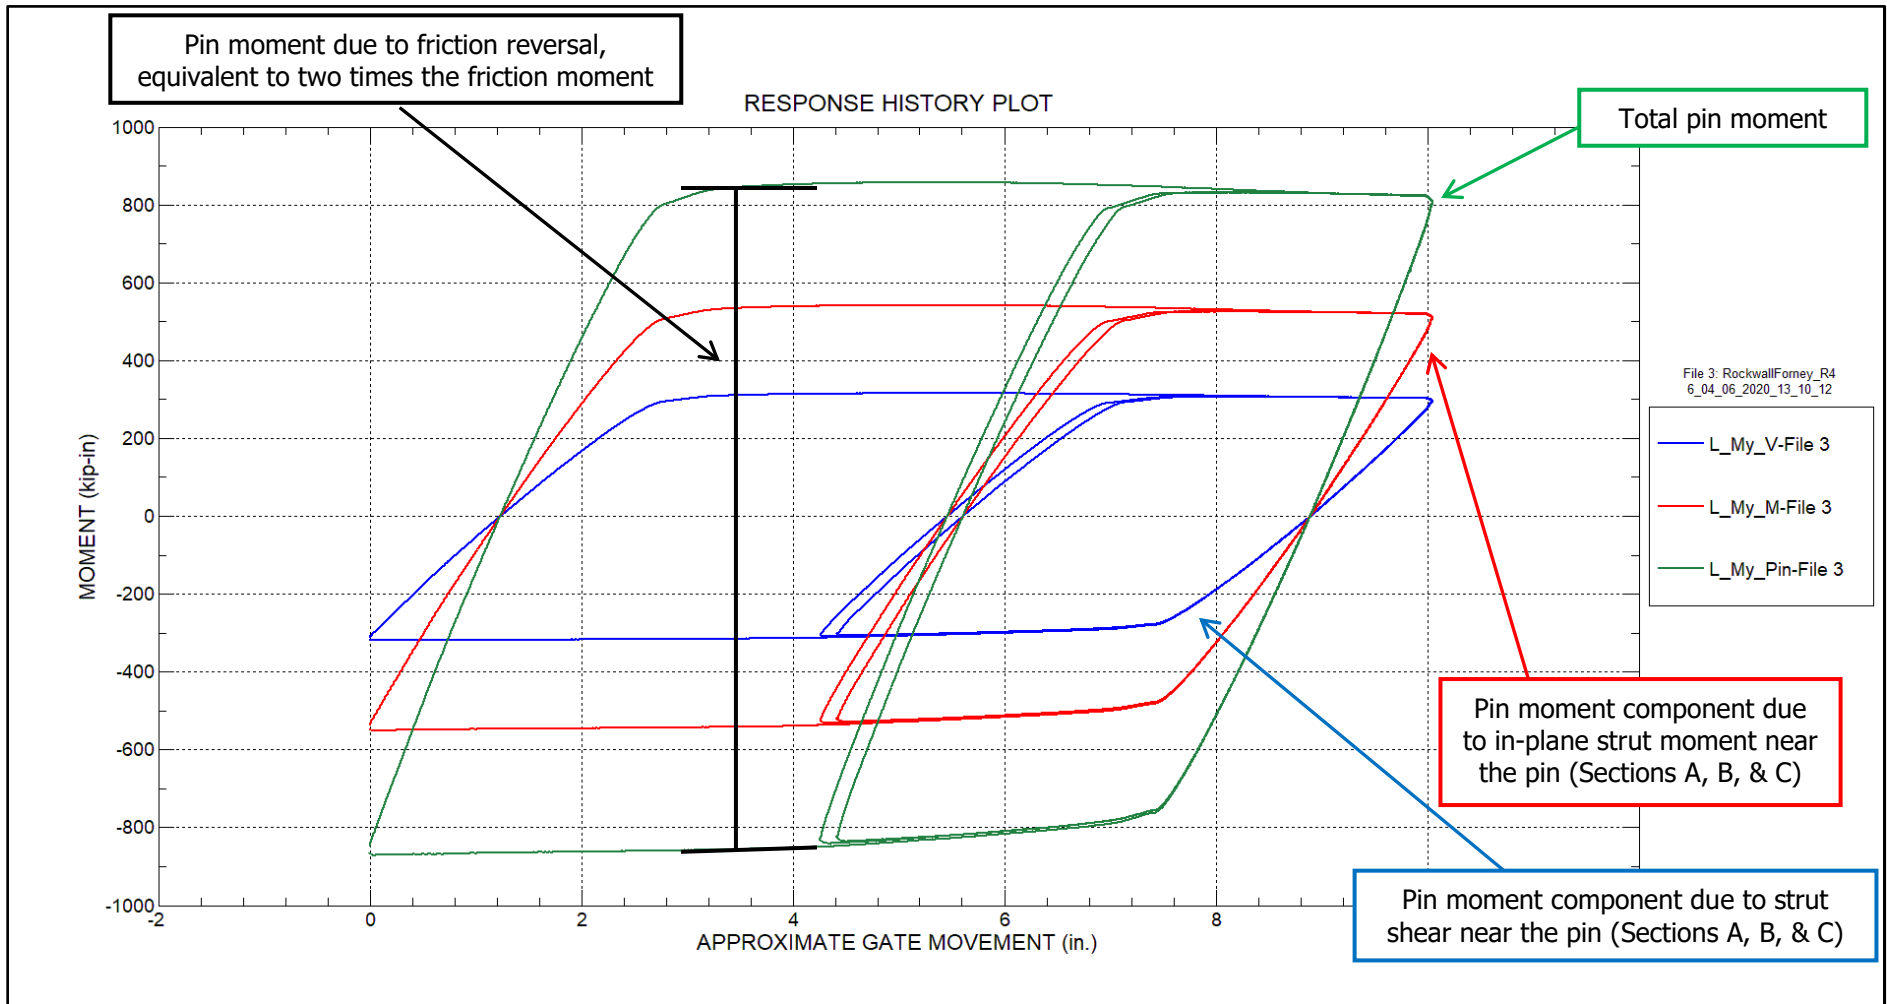
Figure 22 – Pin moment response history – Left arm

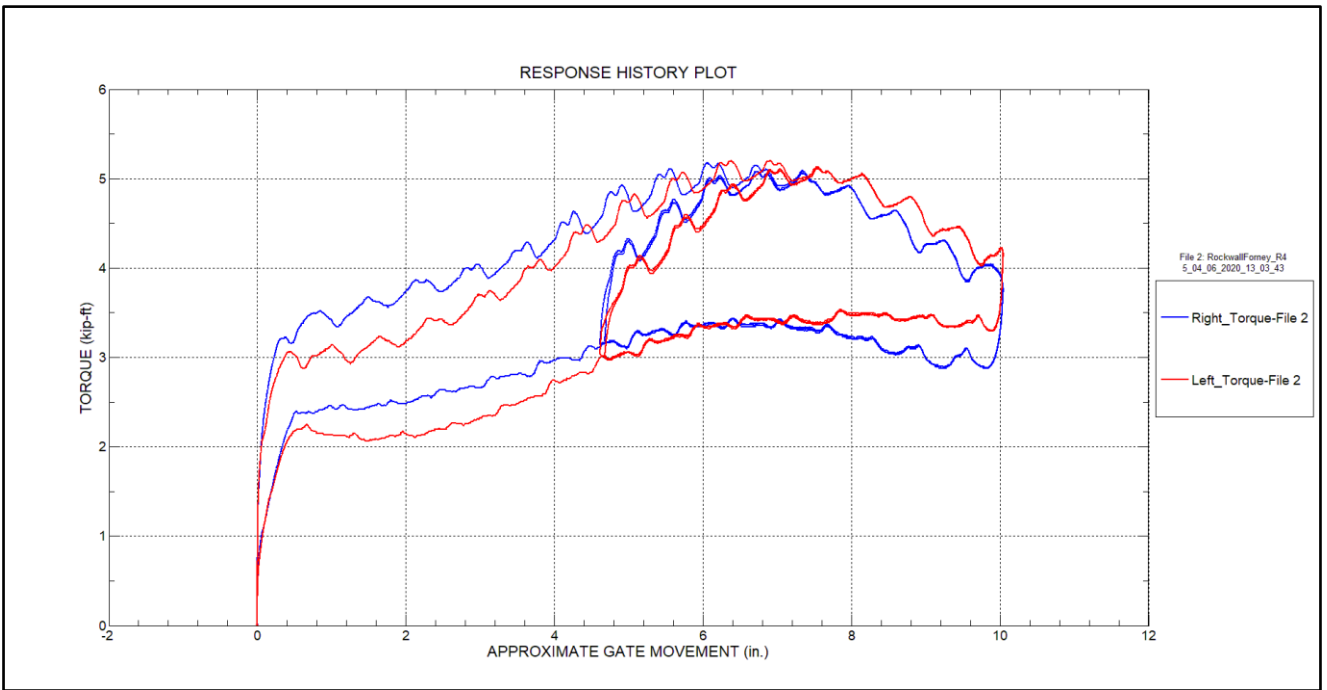
Figure 23 – Hoist torque response history – Gate 7 – Test 2

Figure 23 shows example torque measurements, recorded on the Gate 7 torque shafts. Best practices for torque measurements is to measure torque on opposite sides of the shaft so that any bending in the shaft can be removed by averaging the two responses. Due to access limitations, only one gage at each location could be installed. Therefore, any bending in the shaft may be reflected in the torque measurements and may be related to the peaks and valleys observed in the torque responses.

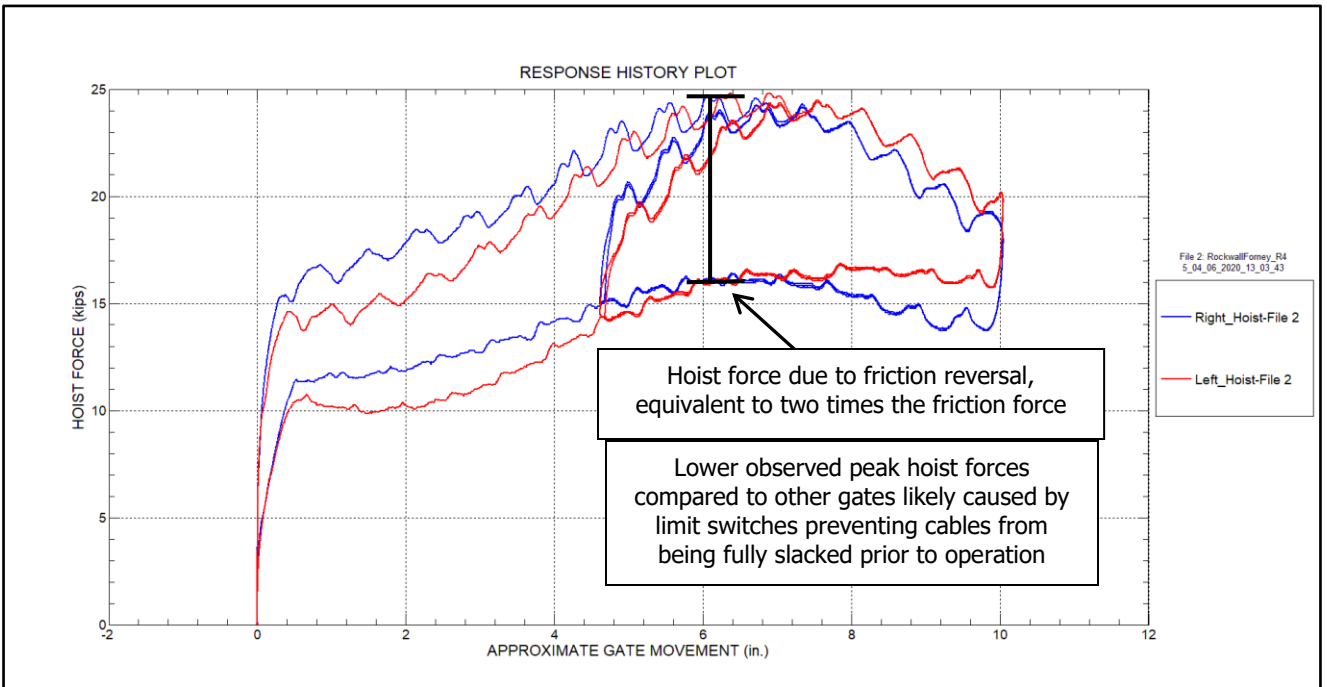
Figure 24 – Hoist force response history – Gate 7 – Test 2

Torque values were converted to force in the hoist cables per gate arm using the gear ratio and drum radius, as shown in Figure 24. The gear ratio and drum radius were 5.182 and 1.086 feet respectively, as defined in the provided as-built shop drawings. It should be noted that the hoist force calculated may be smaller than the actual hoist force applied. This difference is due to the limit switch engaging the brake before the hoist cable was fully slacked, resulting in an initial force in the cable. A hoist force due to total gate friction was then calculated. This friction hoist force was equal to half the differential in force measured during the lifting and lowering of the gate (similar to the pin friction calculations). As shown in Table 3, the change in cable force due to friction was generally consistent between tests. Note that the total hoist force was due to the total friction effects, including side seal, hoist bearings, trunnion friction effects, etc. It is difficult to determine the exact proportion and composition of the total friction sources. Additional torque and hoist force plots for all collected data files are provided in Appendix A – Gate 7 Torque and Hoist Force Plots.

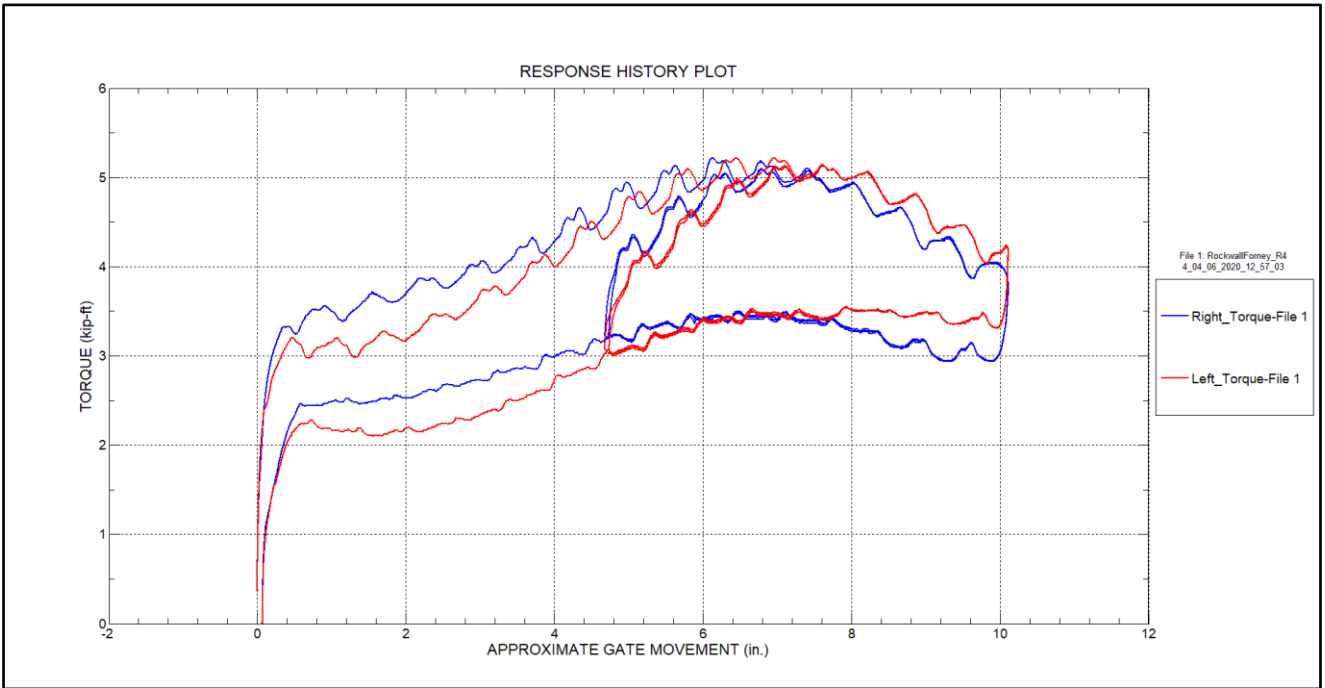
Figure 25 – Hoist torque response history – Gate 7 – Test 1

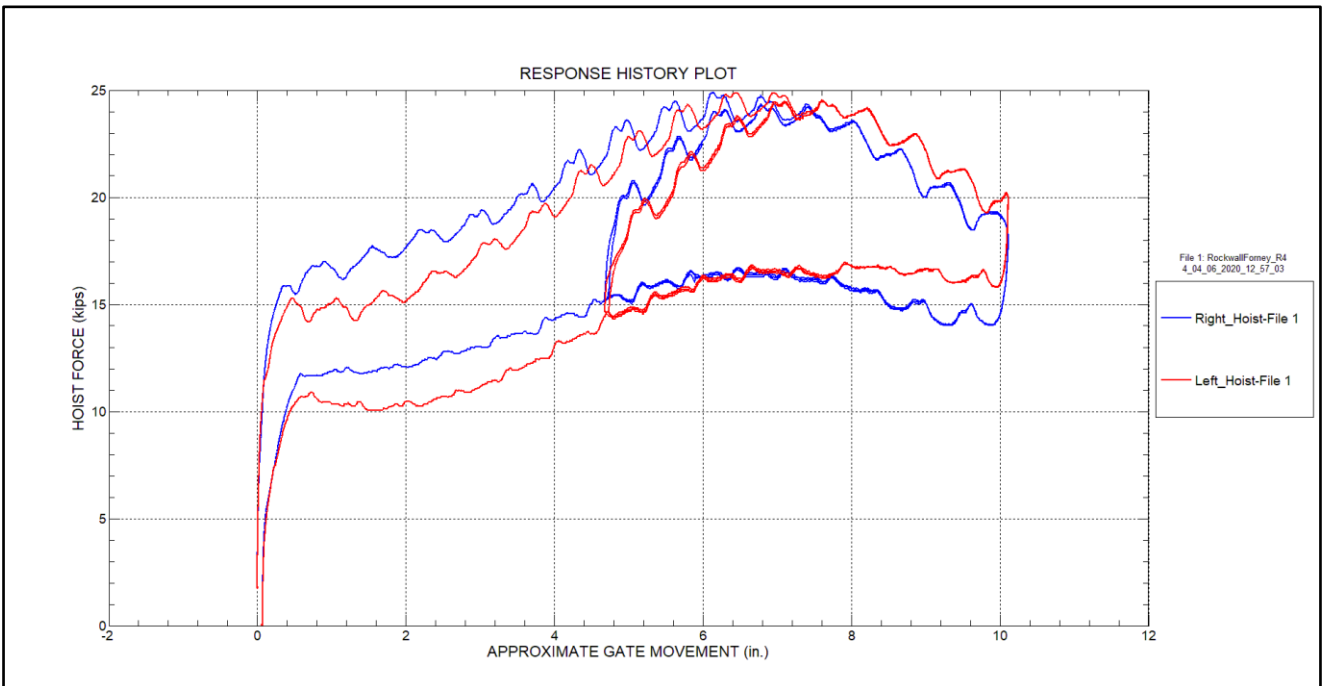
Figure 26 – Hoist force response history – Gate 7 – Test 1

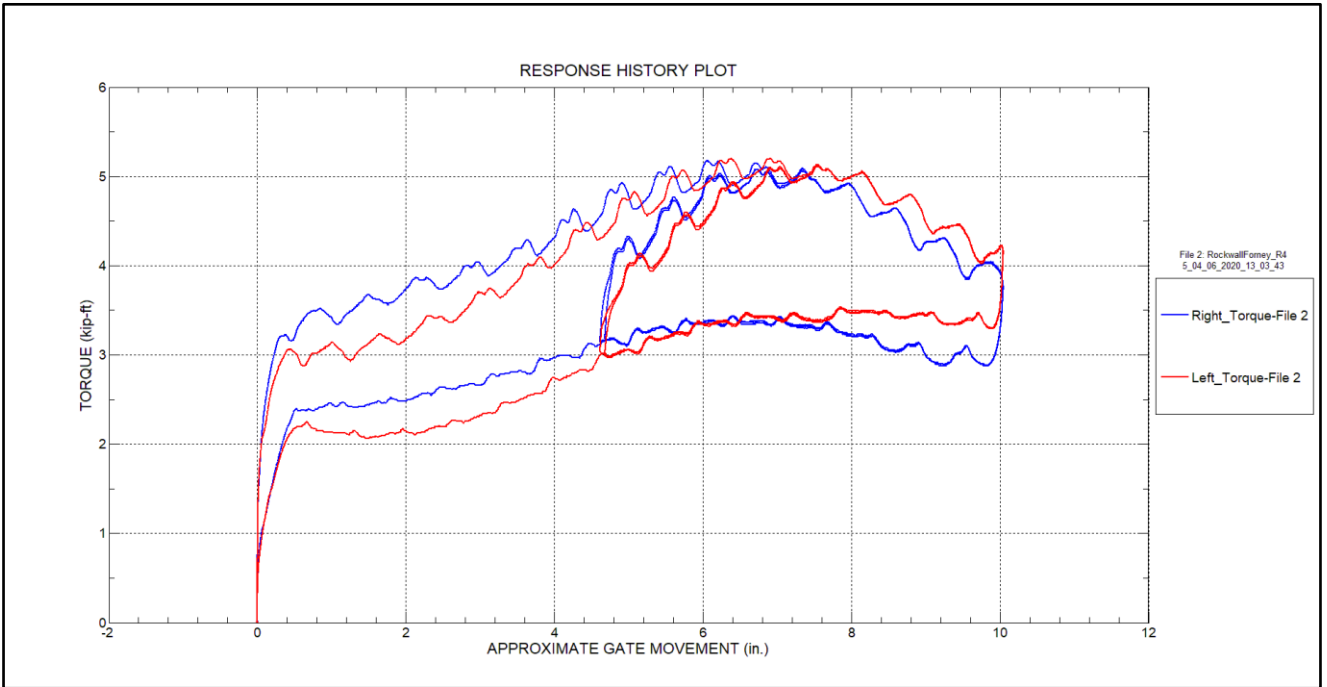
Figure 27 – Hoist torque response history – Gate 7 – Test 2

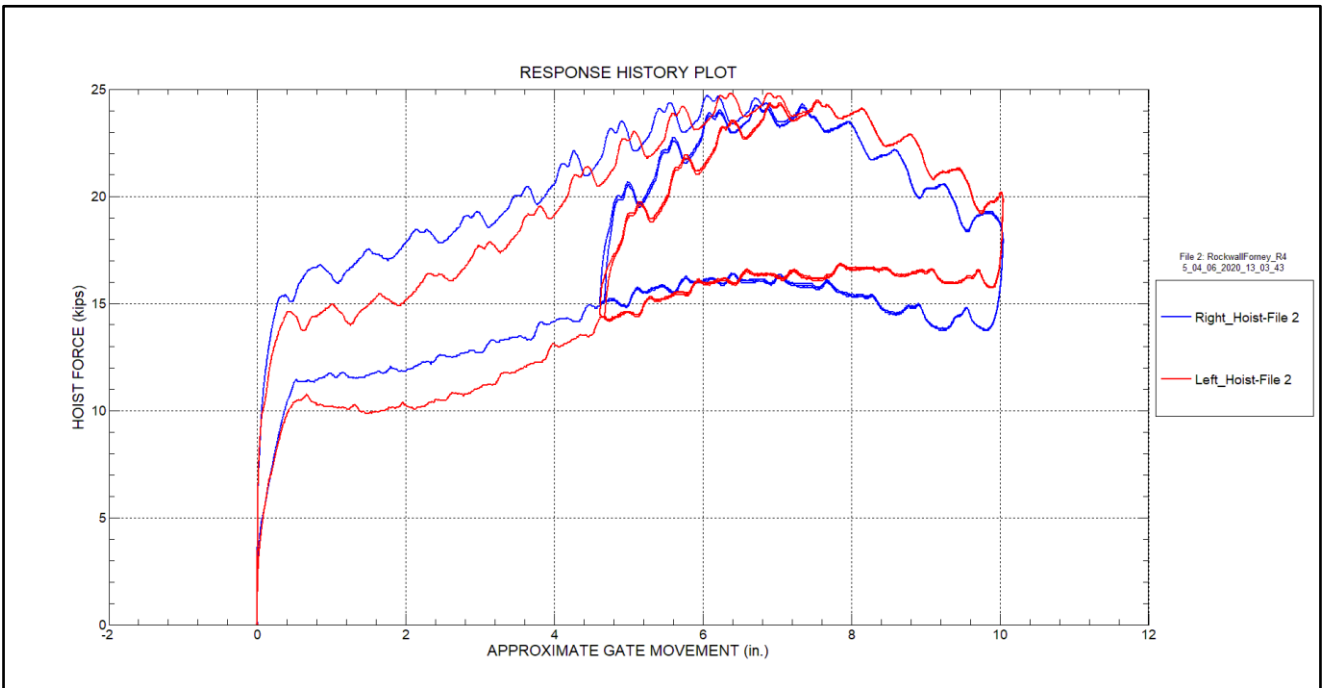
Figure 28 – Hoist force response history – Gate 7 – Test 2

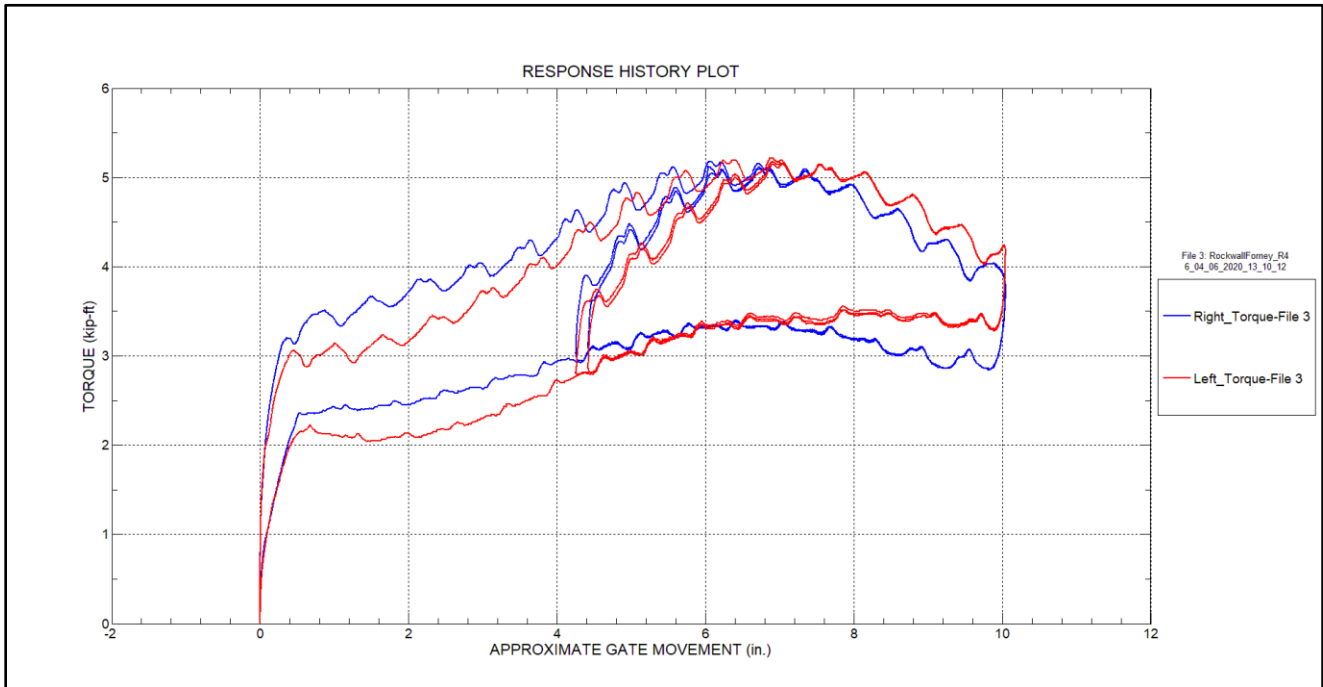
Figure 29 – Hoist torque response history – Gate 7 – Test 3

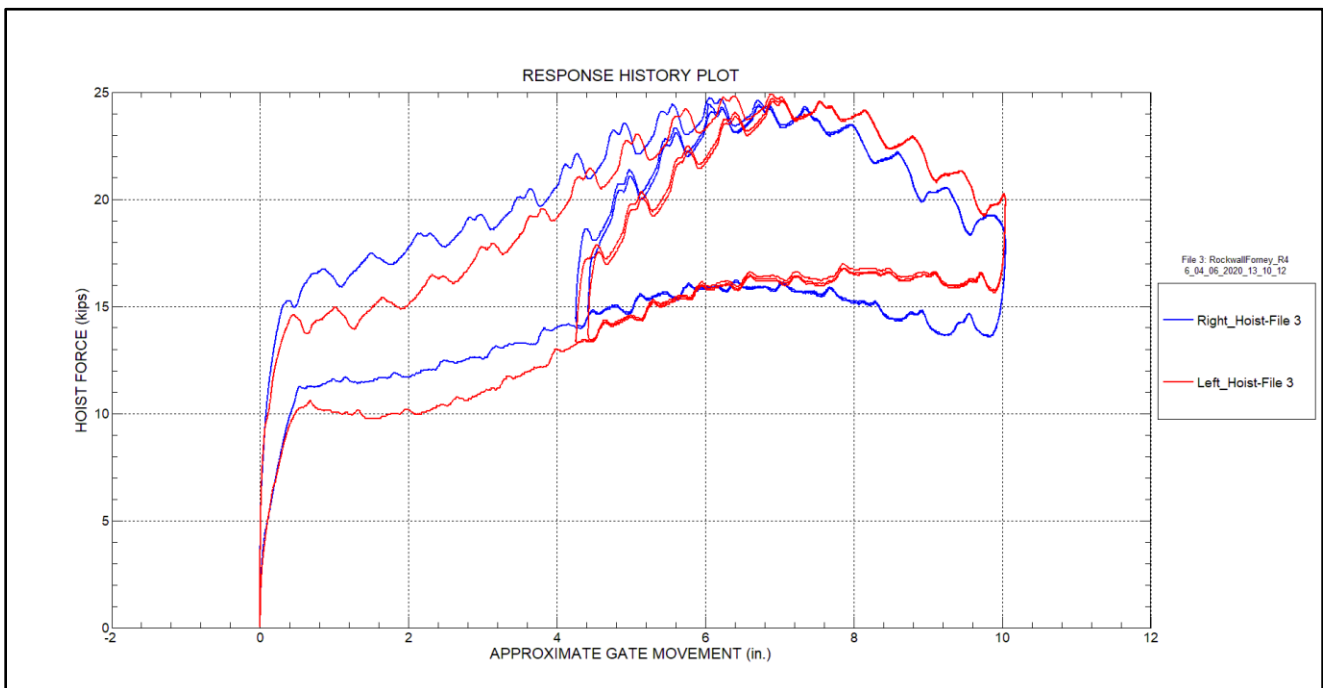
Figure 30 – Hoist force response history – Gate 7 – Test 3

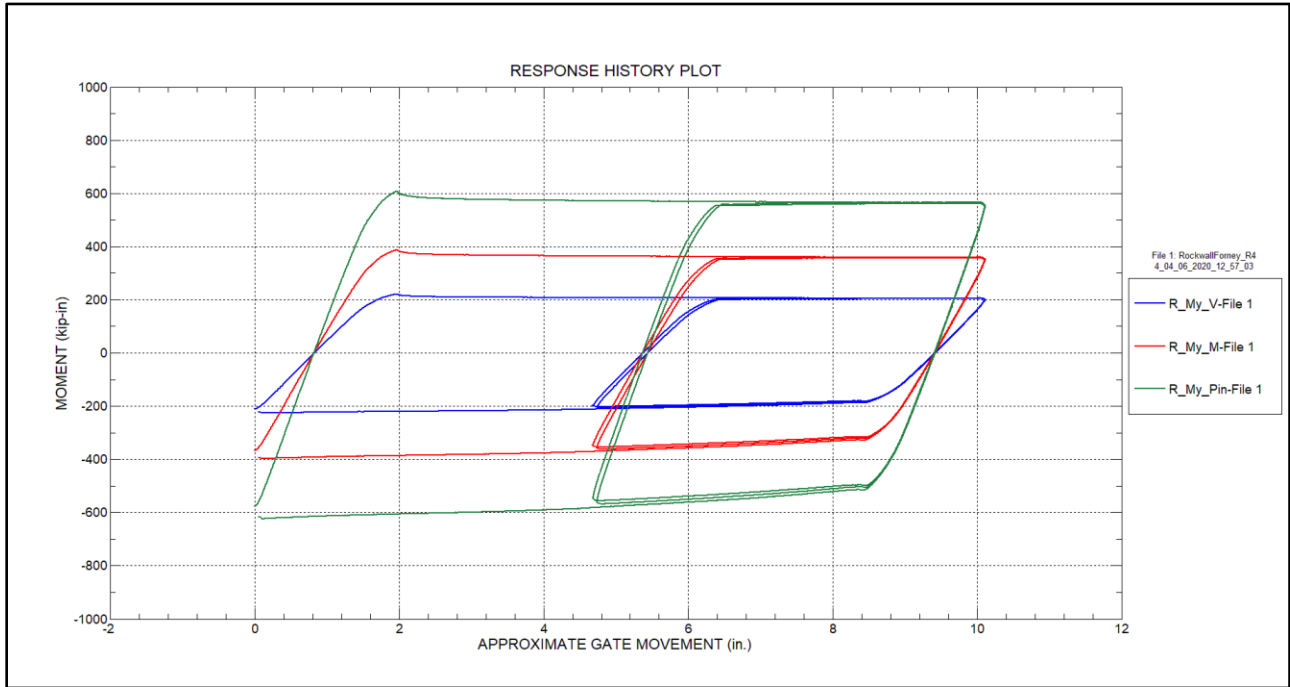
Figure 31 – Pin moment response history – Right arm – Test run 1

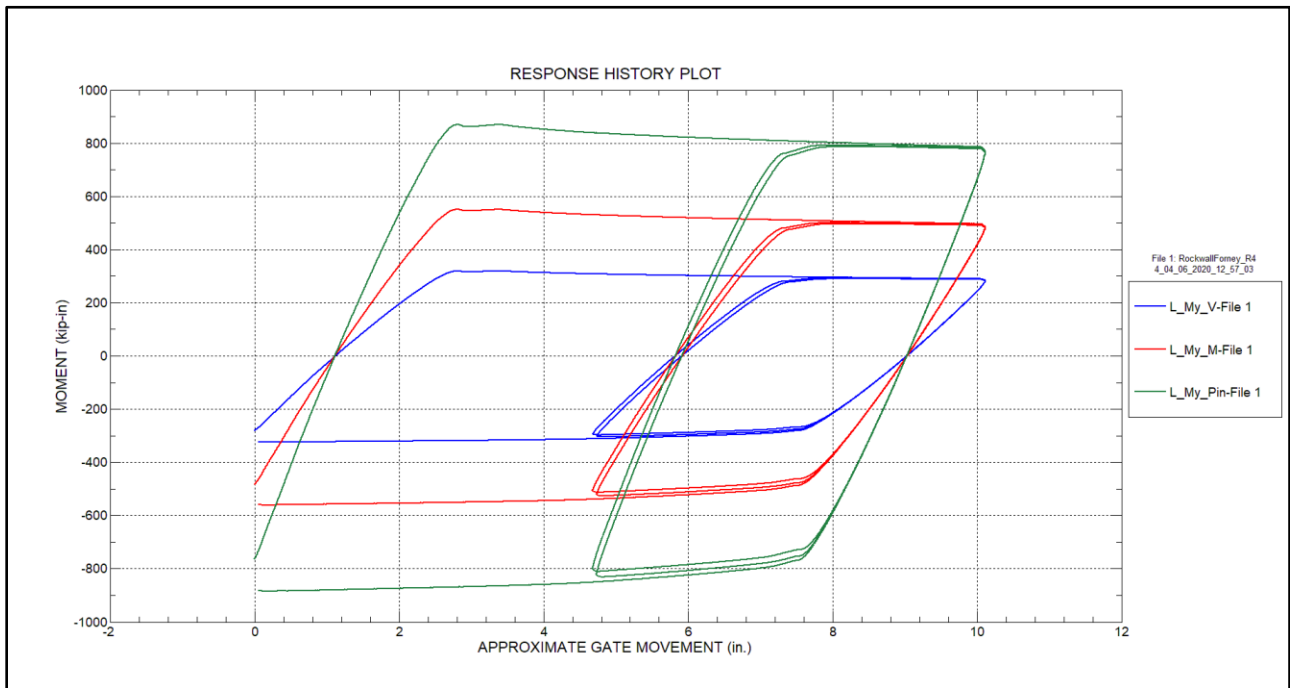
Figure 32 – Pin moment response history – Left arm – Test run 1

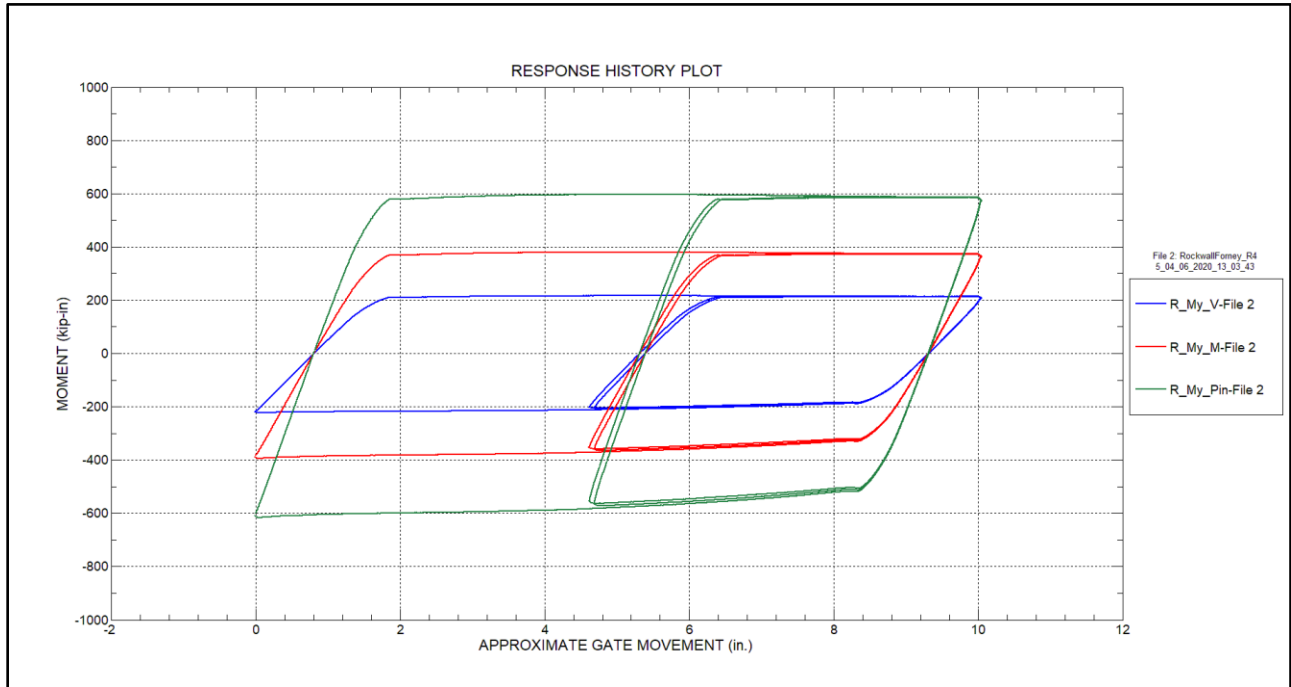
Figure 33 – Pin moment response history – Right arm – Test run 2

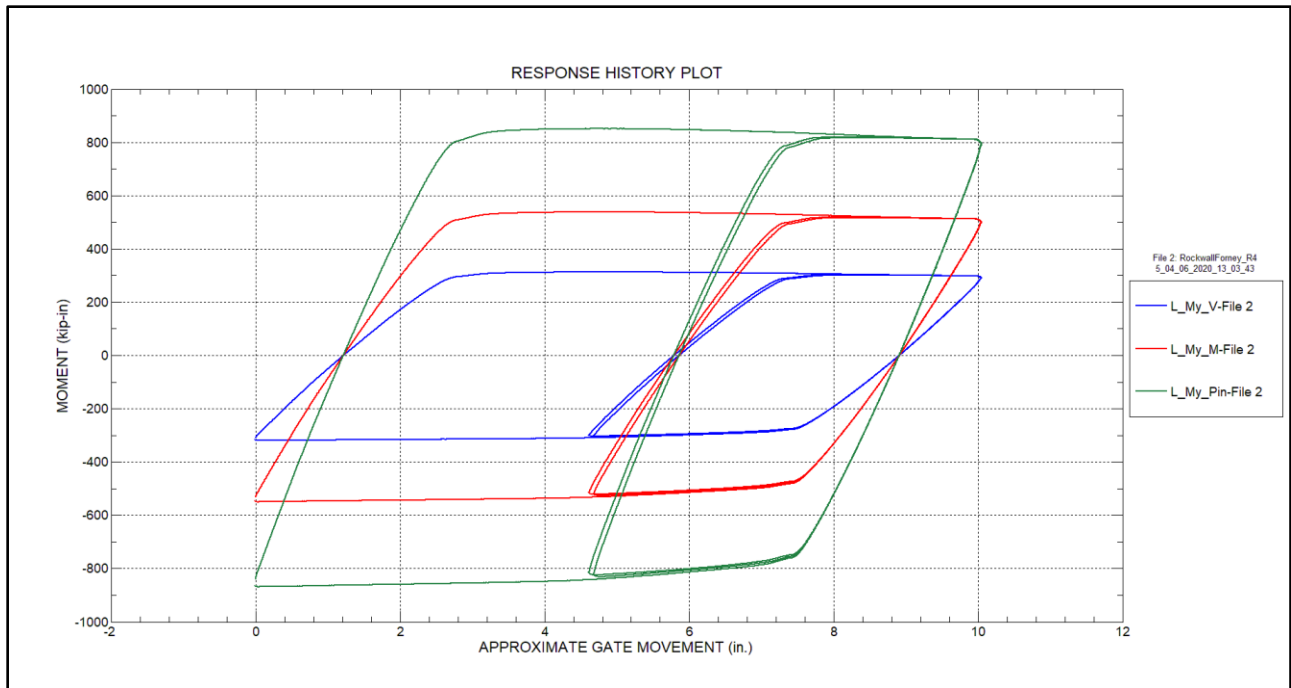
Figure 34 – Pin moment response history – Left arm – Test run 2

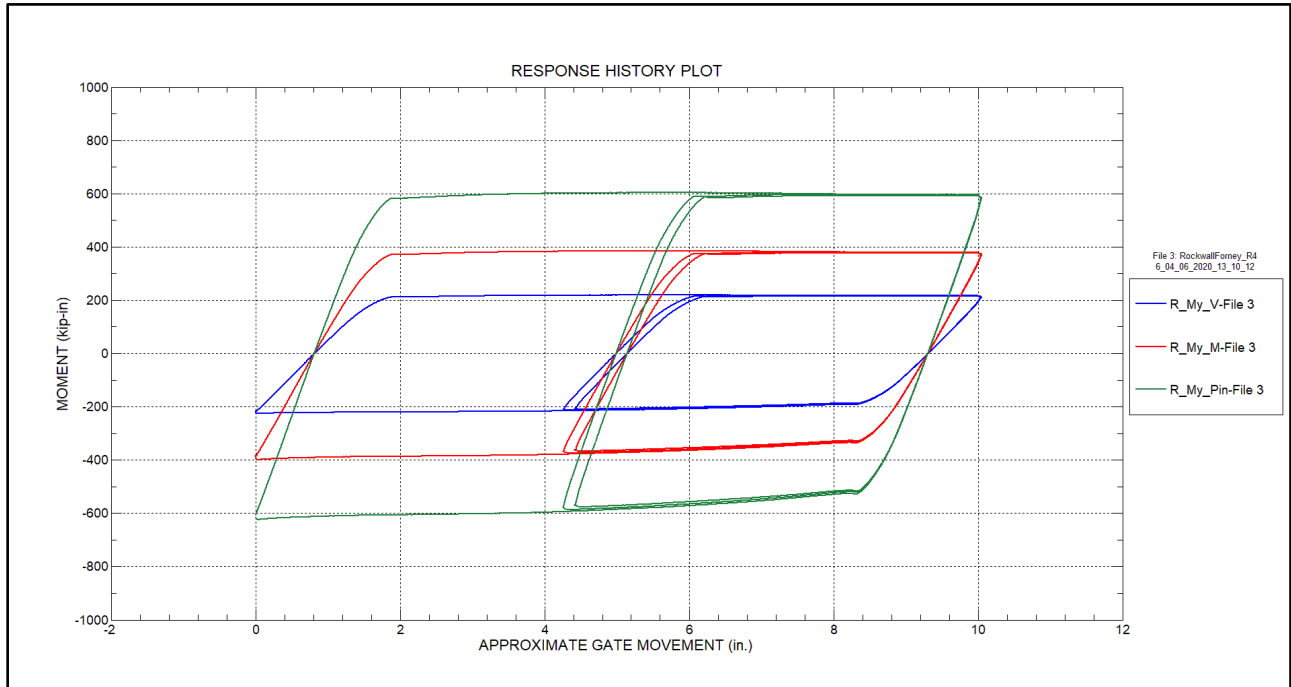
Figure 35 – Pin moment response history – Right arm – Test run 3

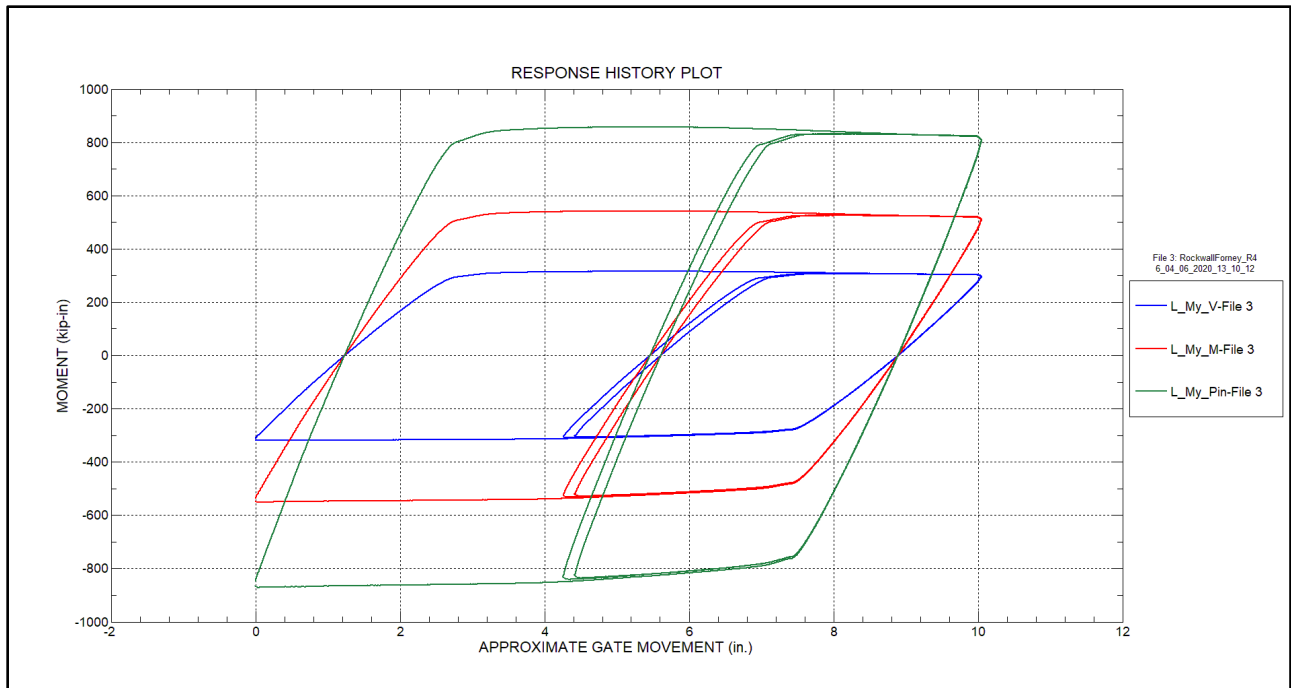
Figure 36 – Pin moment response history – Left arm – Test run 3

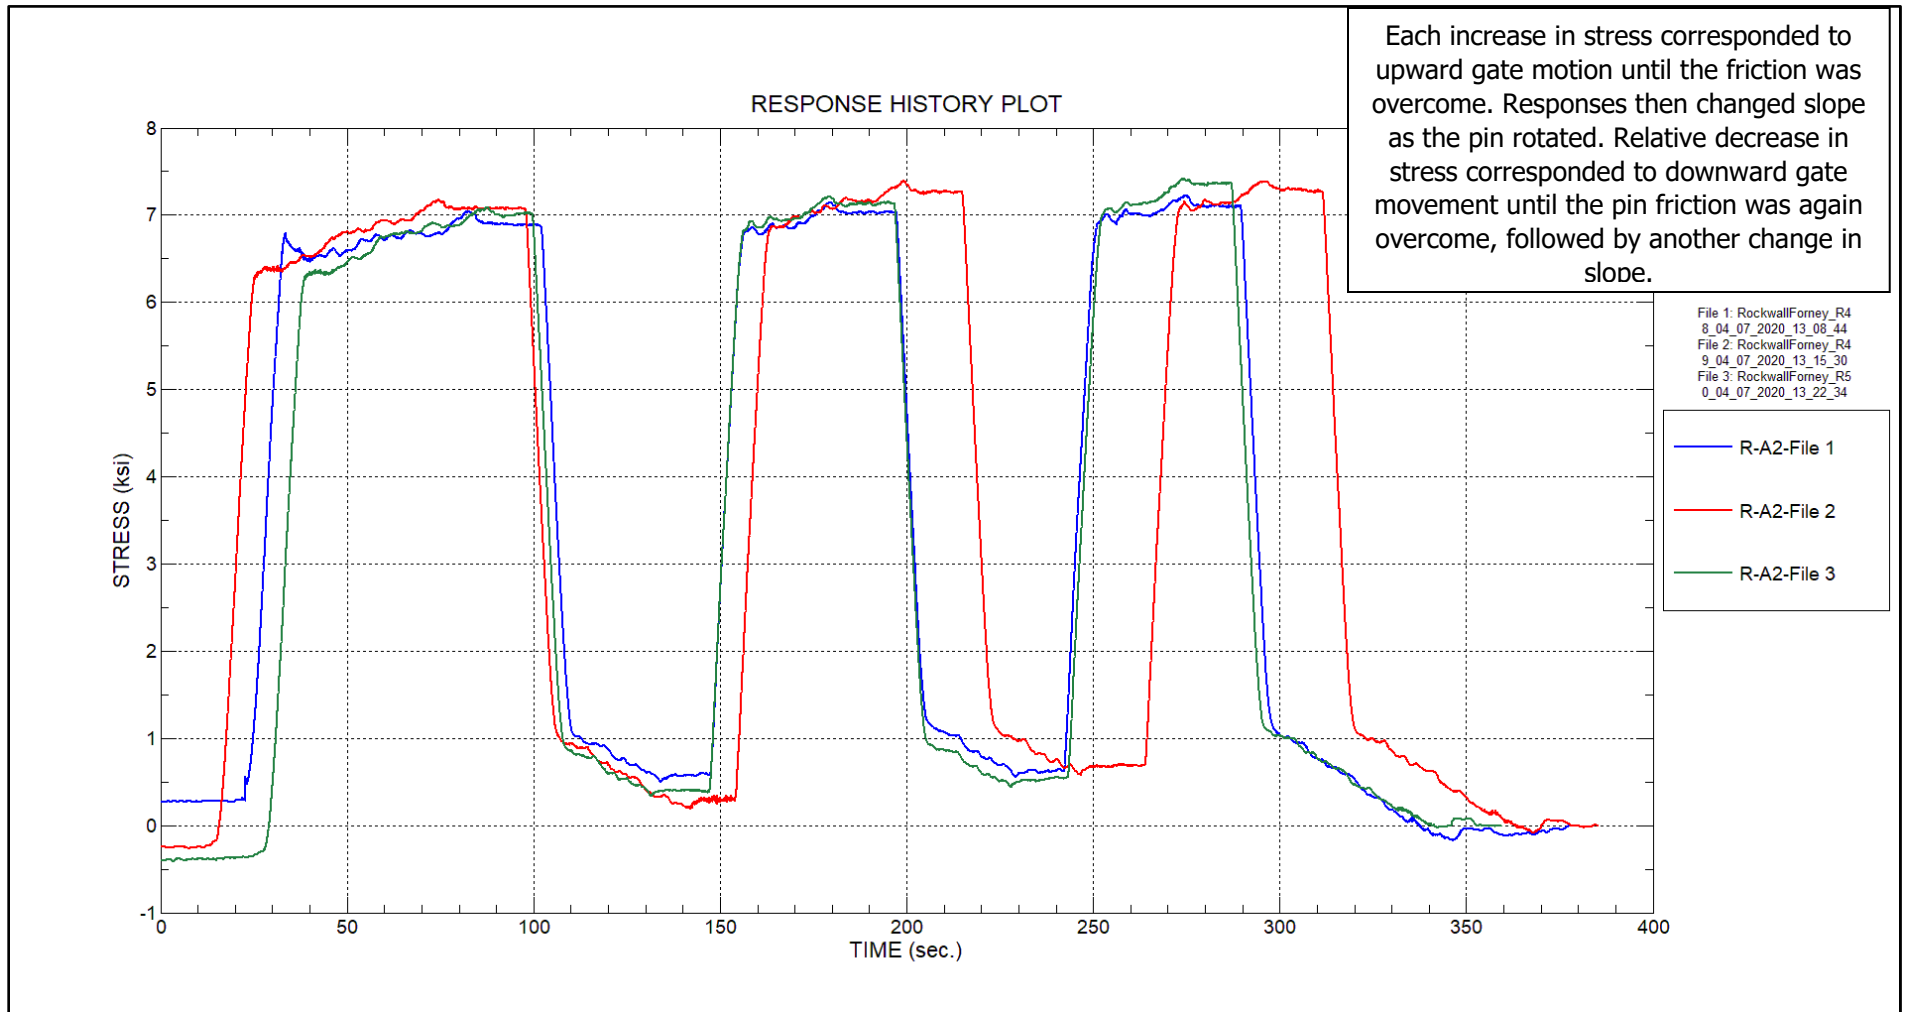
Figure 6 – Stress response history – Right arm – Gage A2 – Time based
File 1 = test run 1, File 2 = test run 2, File 3 = test run 3
(Section A along top strut near pin – Sensor location 2 along bottom of inner flange)

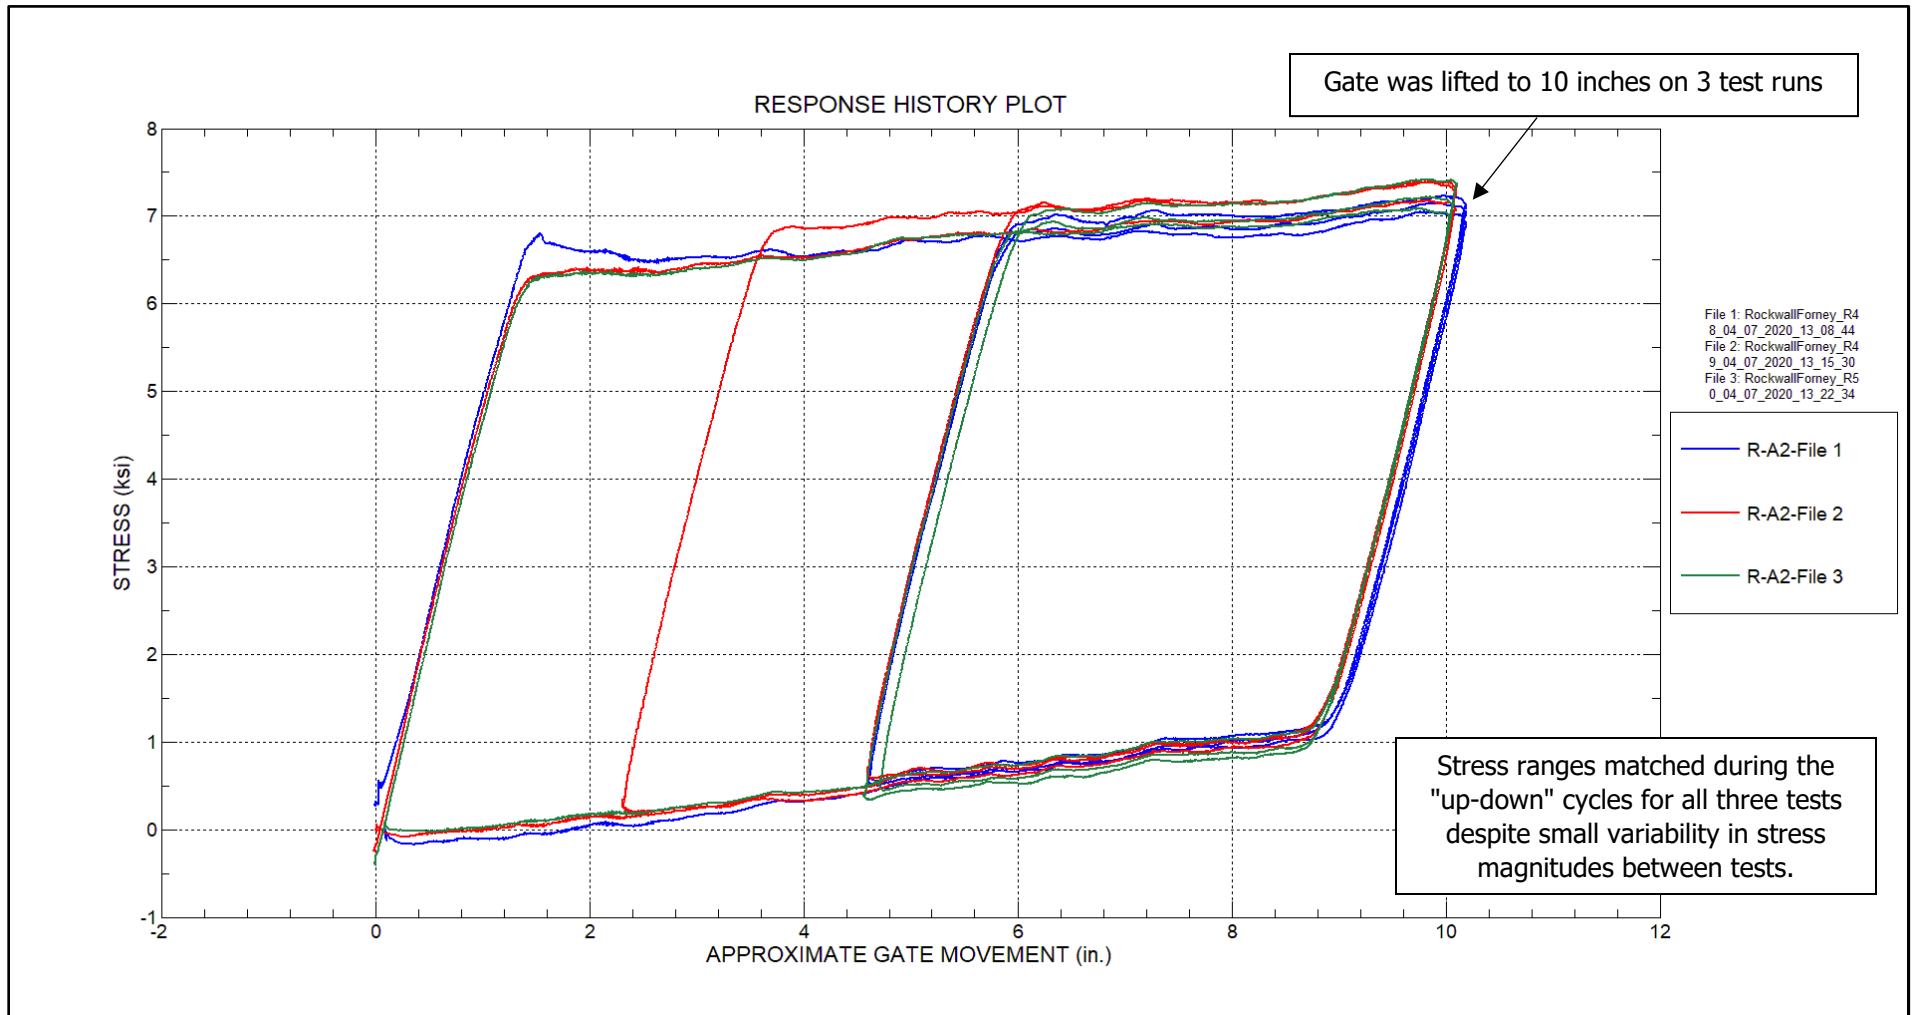
Figure 7 – Stress response history – Right arm – Gage A2 – Function of gate movement
 File 1 = test run 1, File 2 = test run 2, File 3 = test run 3
 (Section A along top strut near pin – Sensor location 2 along bottom of inner flange)

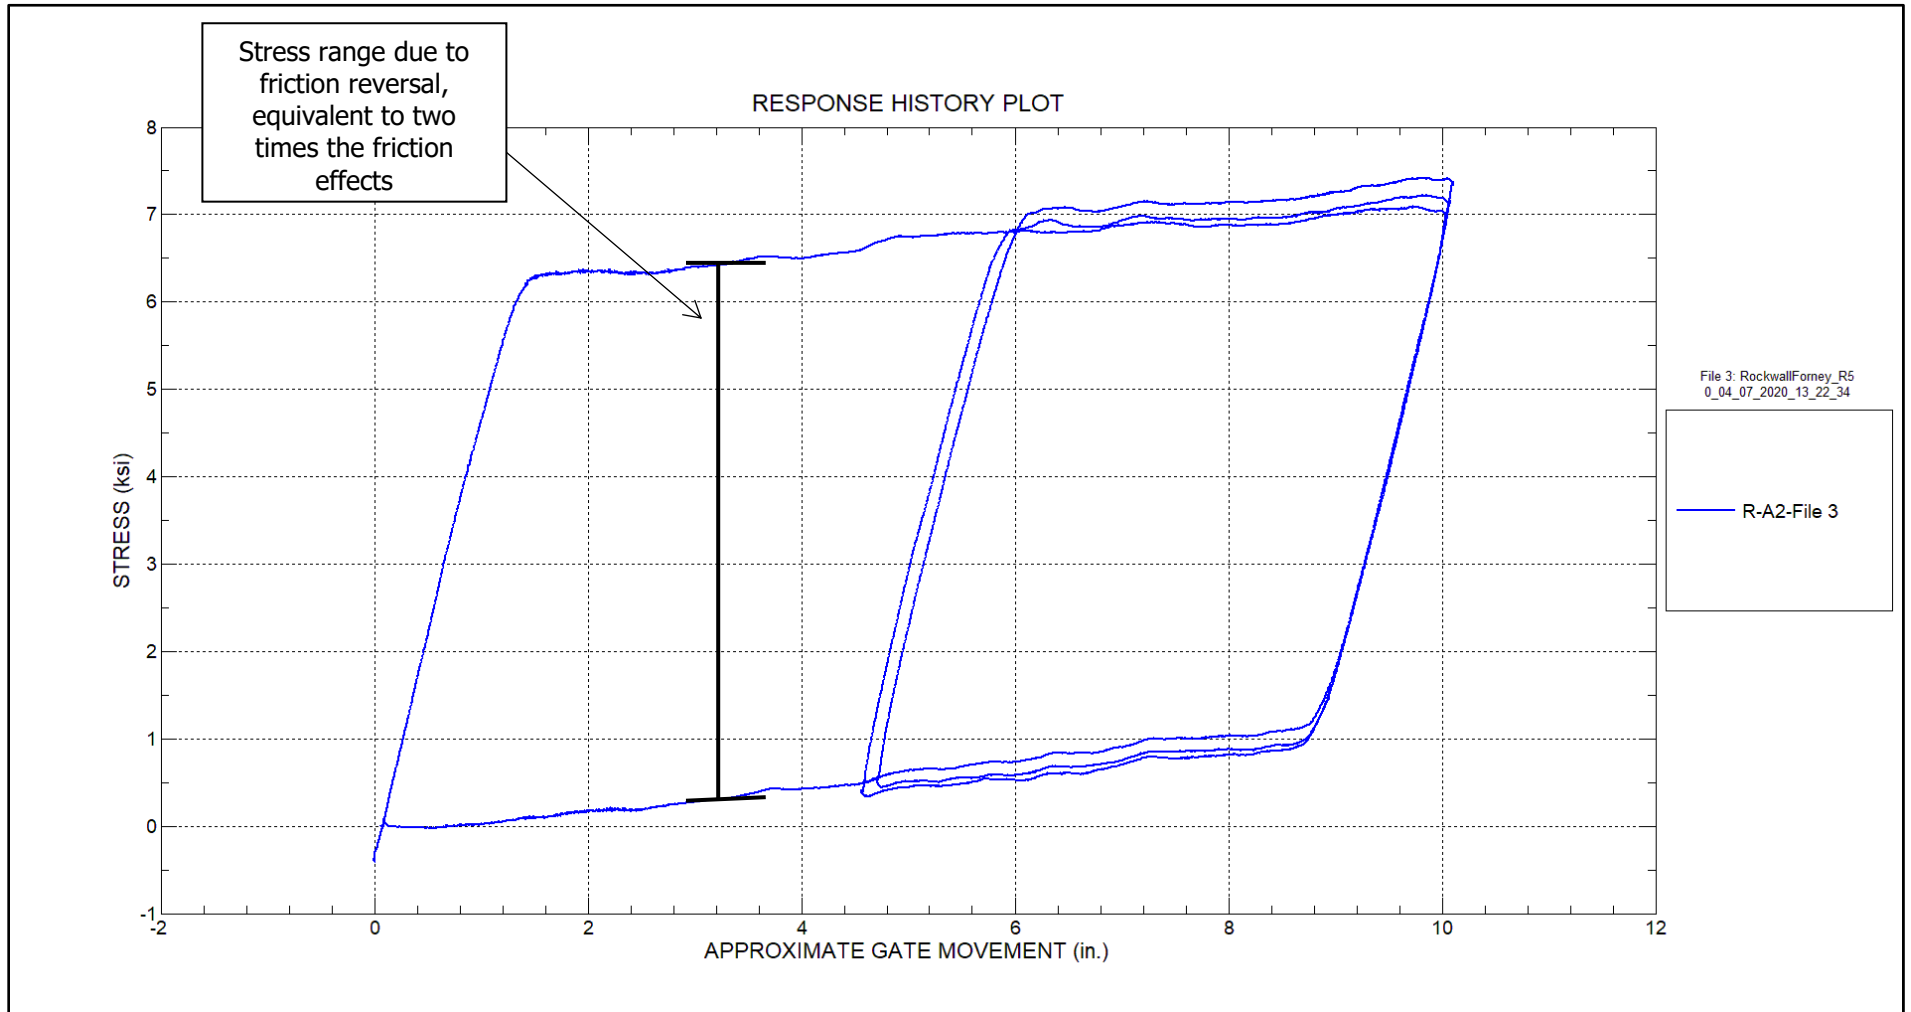
Figure 8 – Stress response history – Right arm – Gage A2 – Friction effect in stress responses
(Section A along top strut near pin – Sensor location 2 along bottom of inner flange)

- + **DIRECTION/FRICTION REVERSAL IN RESPONSES:** The difference in stress during gate opening and closing for a given position is shown in Figure 8. The stress variation at any given gate position was a result of direction reversal and in turn due to trunnion friction reversal. This statement is true since all other loads such as dead-load and hydrostatic pressure were essentially constant barring small changes in hydrostatic pressure due to slight changes in head. This direction/friction reversal is depicted in Figure 9, with deflected shape renderings from a gate arm finite element model under lifting and lowering loads. Note that this figure shows an arm configuration that does not match this gate, but the concept of the direction/friction reversal still applies.
