VISUAL INSPECTION AND EVALUATION REPORT

Rockwall-Forney Dam
Dallas Water Utilities
Dallas/Kaufman Counties, Texas

Schnabel Reference #20C22001.00
July 30, 2021

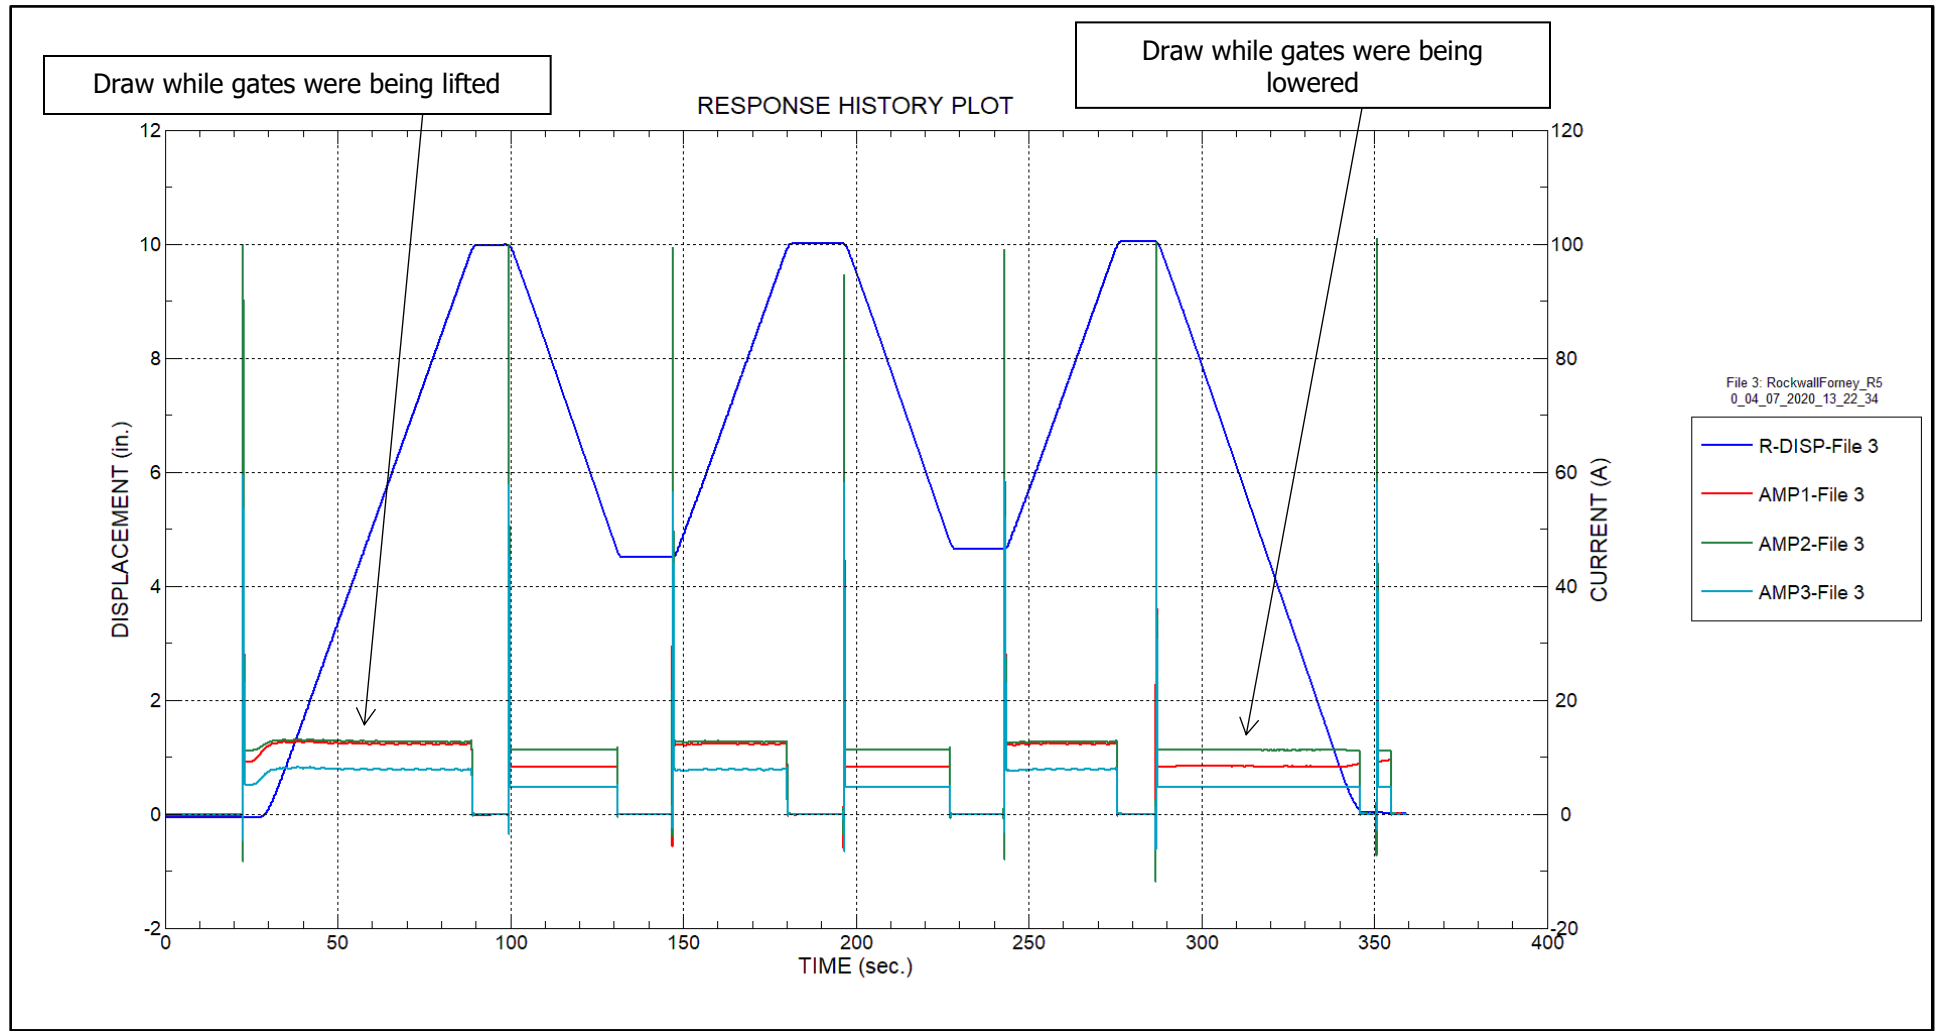
Figure 10 – Motor current & gate movement response history – Lift motor – Highlighting motor draw during lift and lower cycles

- + **MOTOR PERFORMANCE:** Current measurements taken at the hoist motor indicated steady and stable current draws during the lifting and lowering portions. An example plot of current draw and gate position is provided in Figure 10. Current draw ranges during lifting were higher than the ranges during lowering, which is common due to gravity/dead load. These results are summarized along with recorded peak in-rush current in Table 2. Note that the sample rates used during testing were set for collecting gate responses and may not have been appropriate to fully capture the in-rush current. The readings should be evaluated by a licensed electrician with knowledge of the operating parameters.

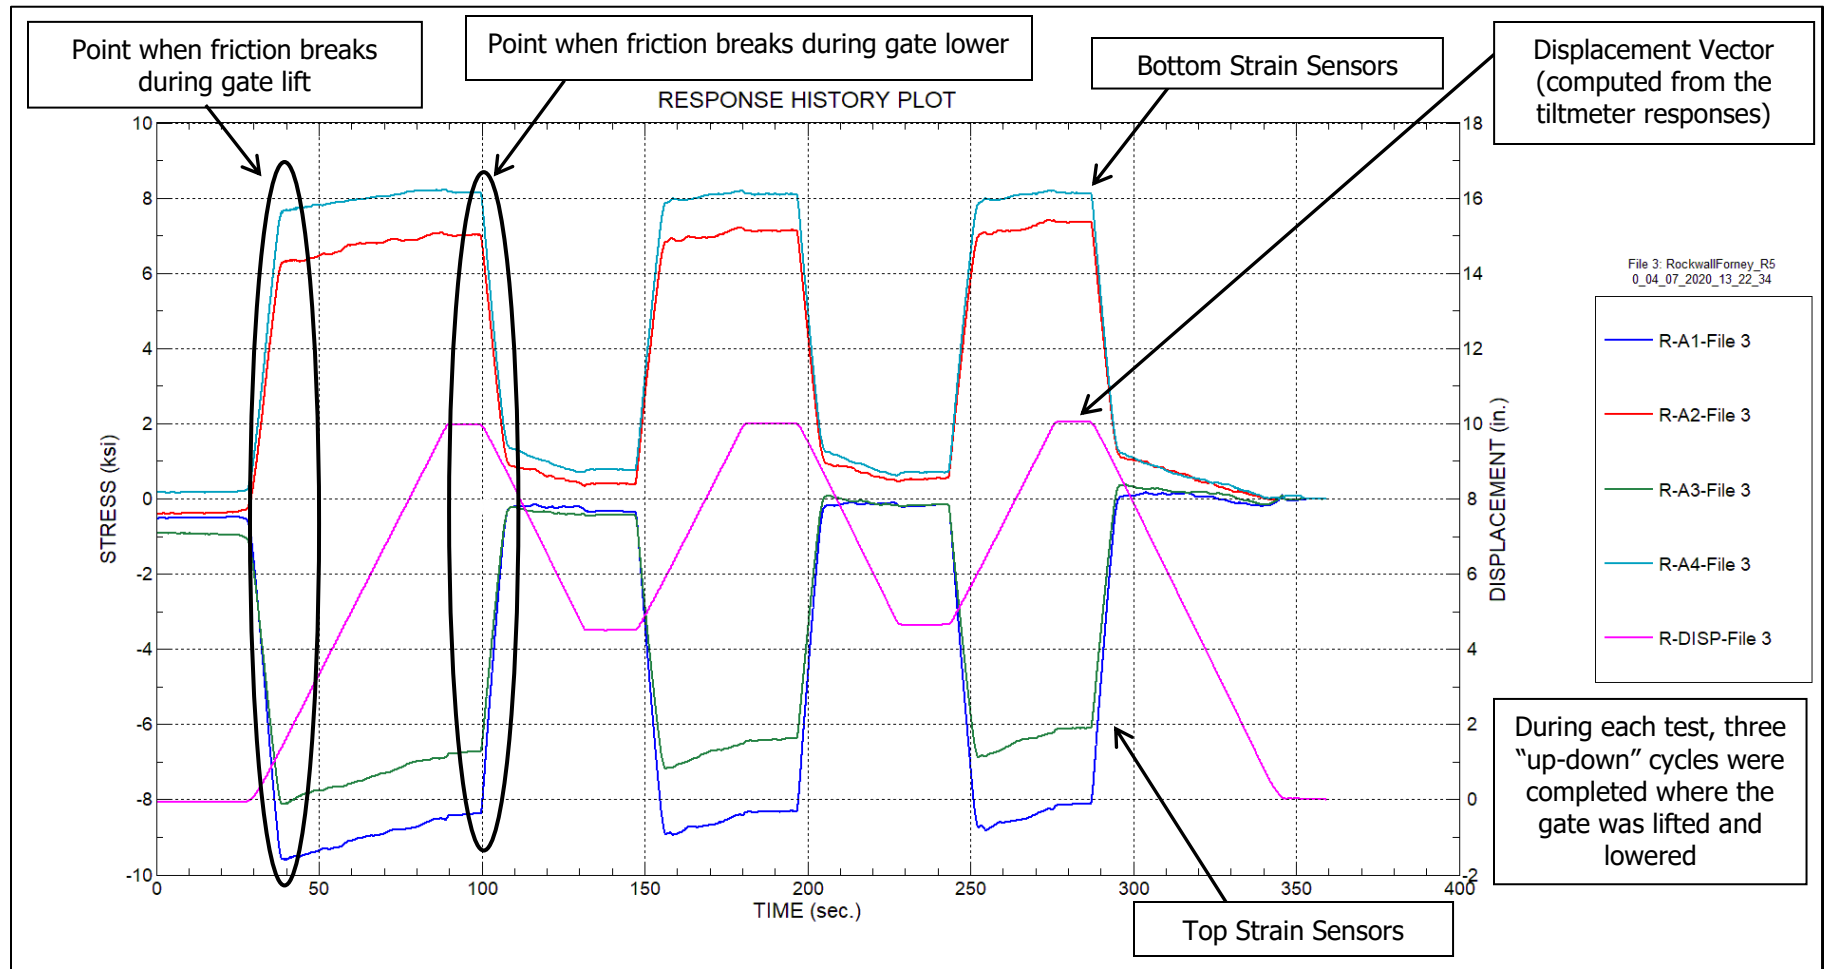
Figure 11 – Stress response & gate movement history – Right arm – Section A - Highlighting friction behavior (Section A along top strut near pin)

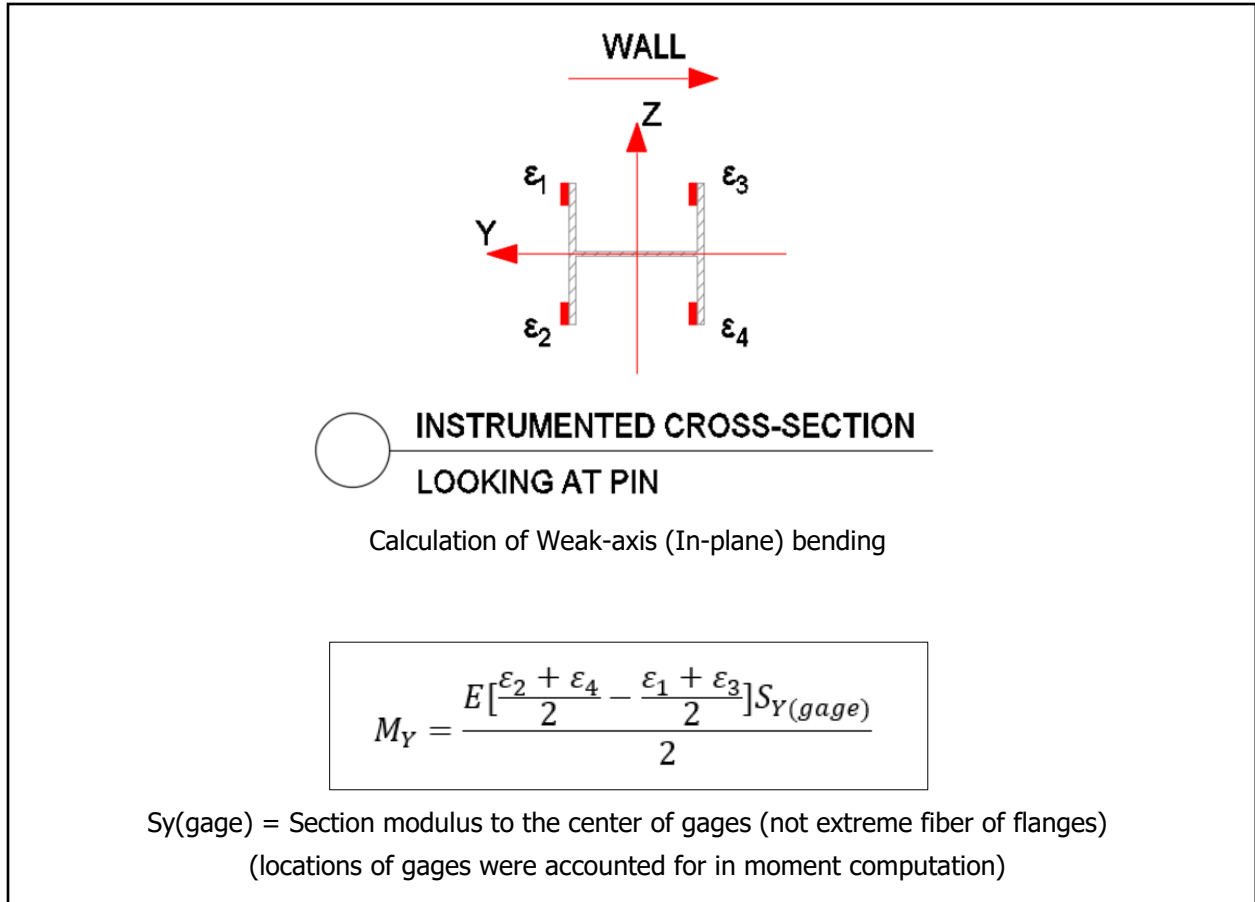
Figure 12 – Basic mechanic equation used to calculate moment

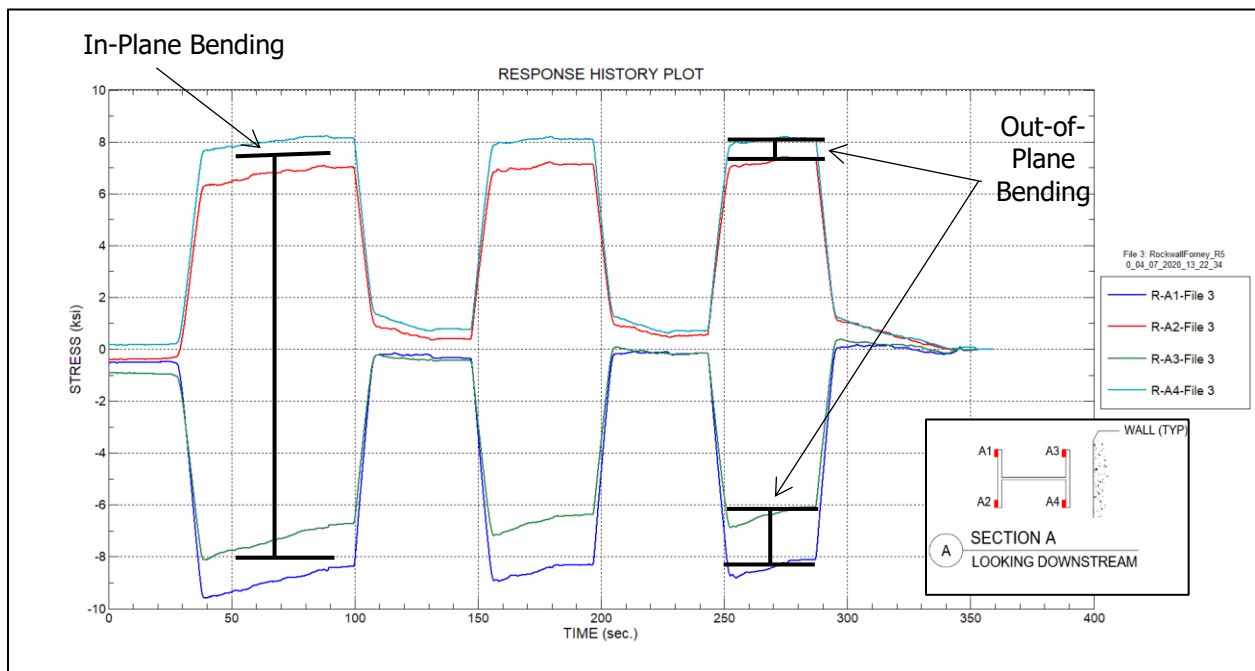
Figure 13 – Stress response history – Right arm – Section A – Bending components
(Section A along top strut near pin)

In-plane or weak-axis flexure refers to bending about a given strut's web. This designation is consistent with typical nomenclature. In-plane bending can be observed visually from the strain response histories as a difference between the top and bottom stresses, whereas out-of-plane or strong-axis bending is visualized as the difference in stress from side to side. Figure 13 provides a visual reference for both types of strut flexure.

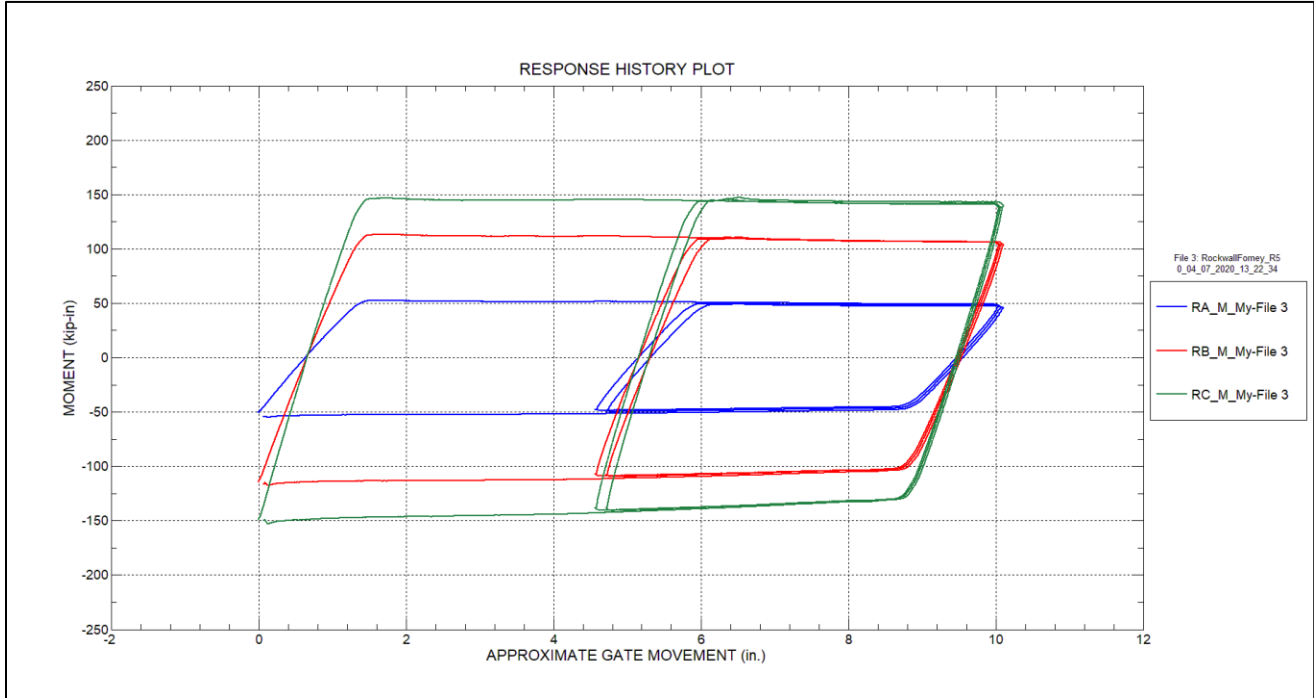
Figure 14 – In-plane moment response history – Right arm – Sections near pin
(RA = Right Arm Top Strut, RB = Right Arm Middle Strut, RC = Right Arm Bottom Strut)

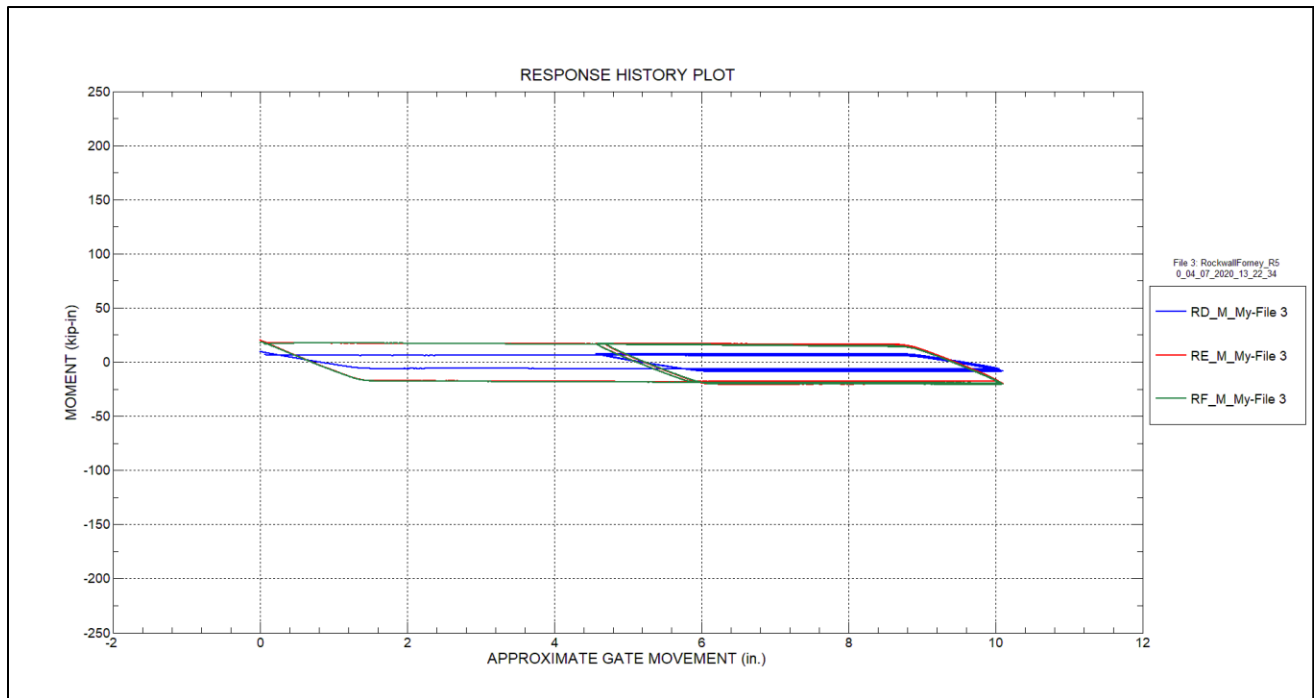
Figure 15 – In-plane moment response history – Right arm – Sections away from pin
(RD = Right Arm Top Strut, RE = Right Arm Middle Strut, RF = Right Arm Bottom Strut)

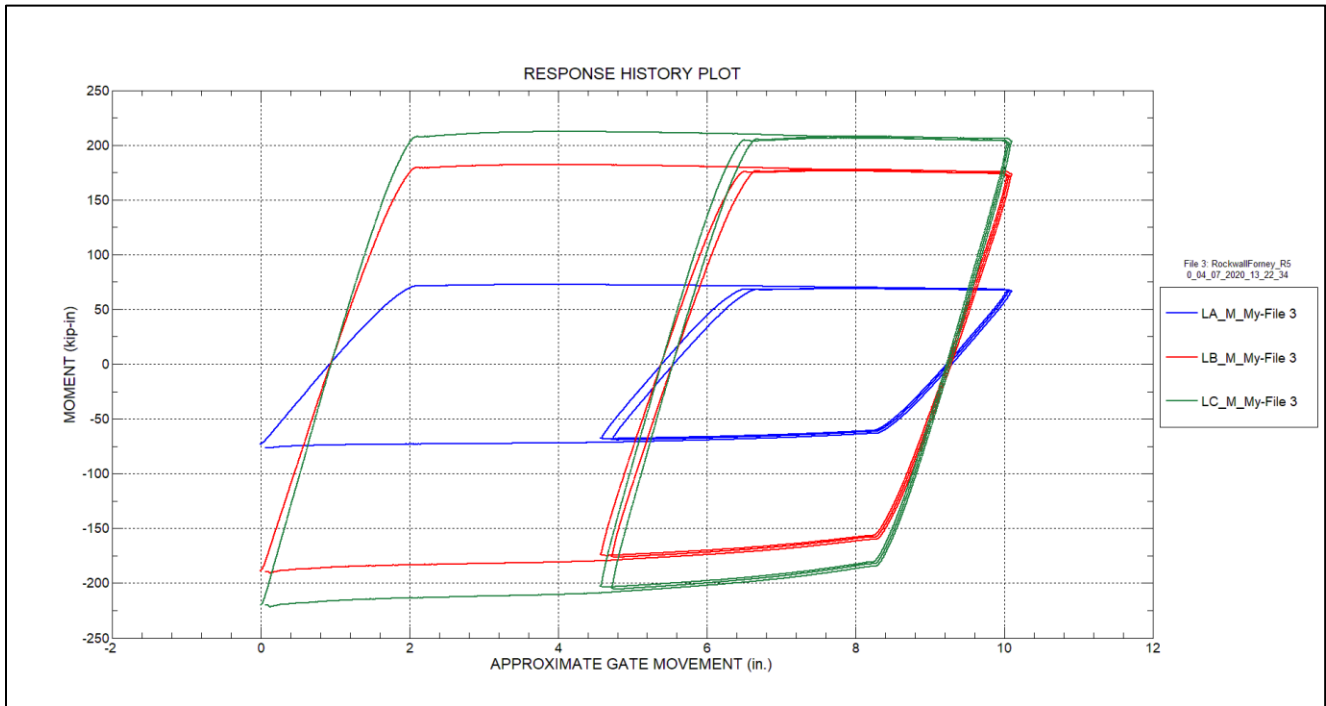
Figure 16 – In-plane moment response history – Left arm – Sections near pin
(LA = Left Arm Top Strut, LB = Left Arm Middle Strut, LC = Left Arm Bottom Strut)

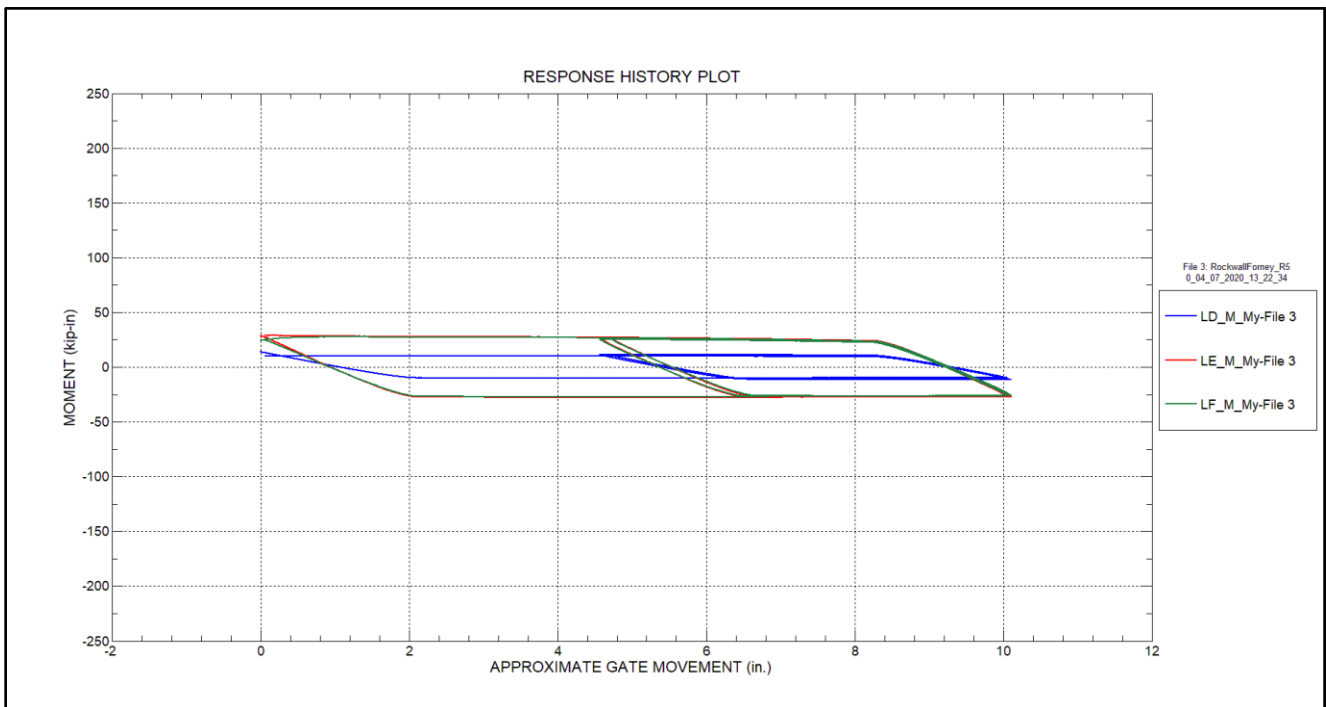
Figure 17 - In-plane moment response history – Left arm – Sections away from pin
(LD = Left Arm Top Strut, LE = Left Arm Middle Strut, LF = Left Arm Bottom Strut)

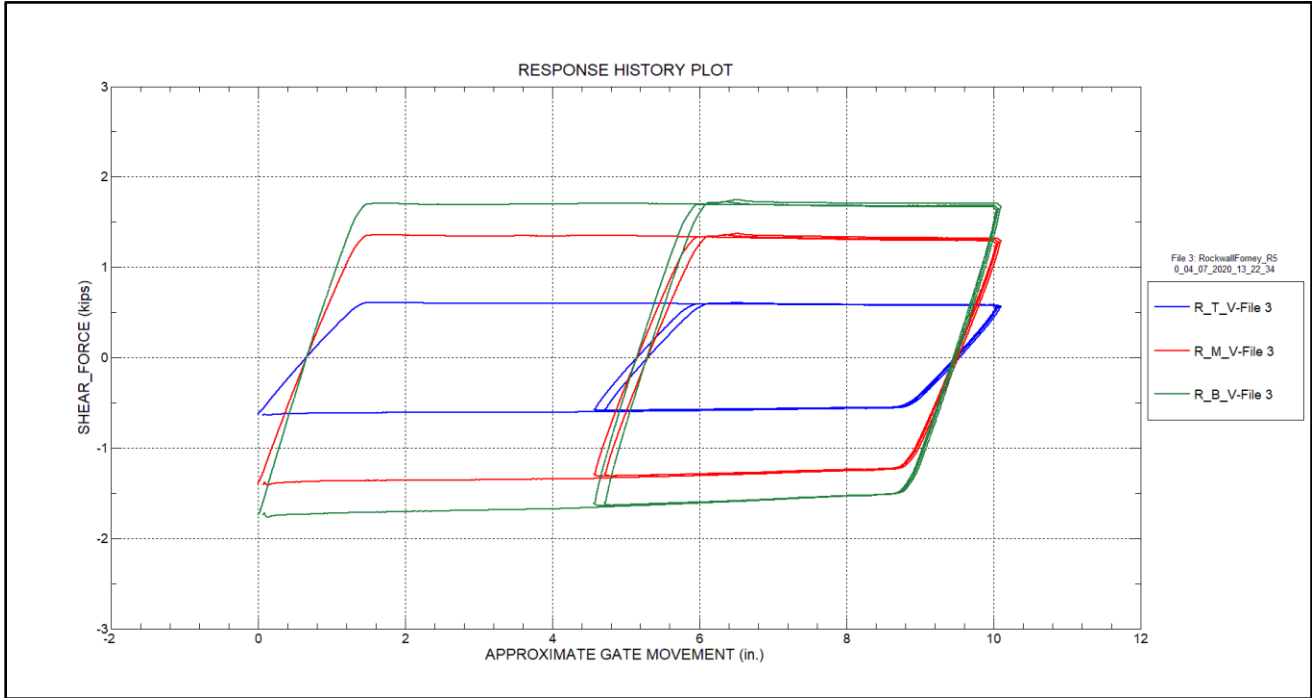
Figure 19 – Strut shear response history – Right arm

(R_T = Right Arm Top Strut, R_M = Right Arm Middle Strut, R_B = Right Arm Bottom Strut)

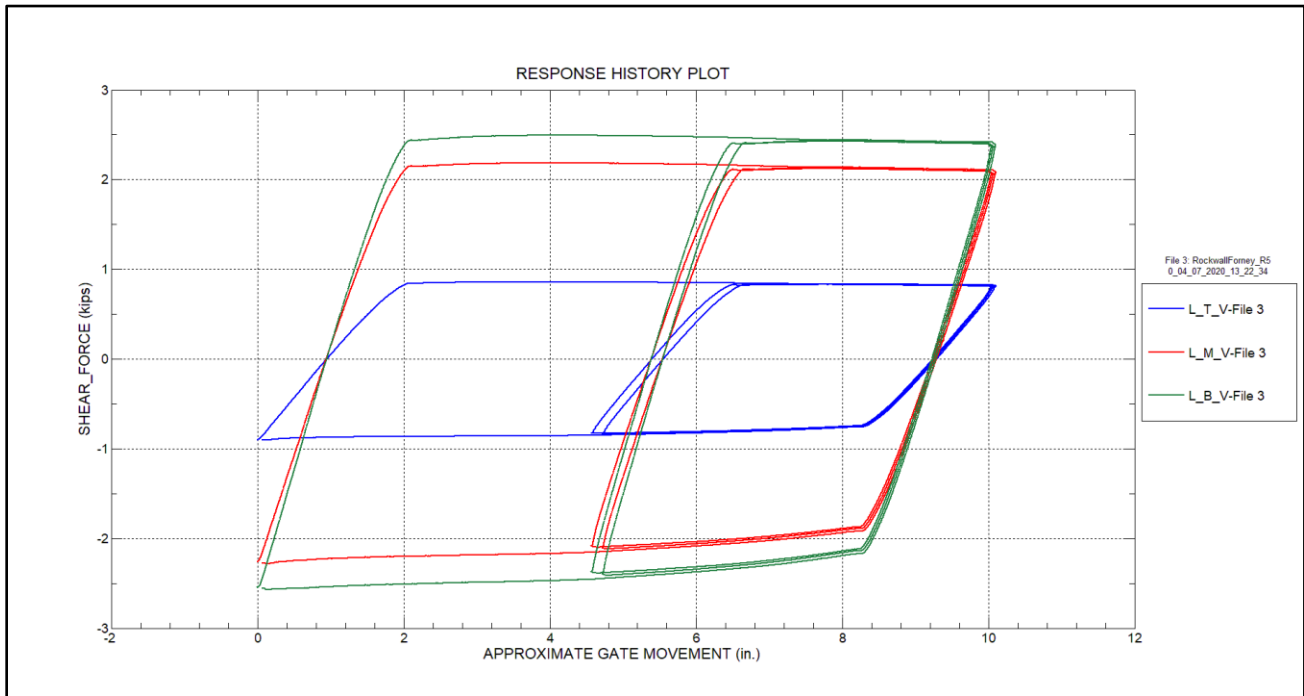
Figure 20 – Strut shear response history – Left arm

(L_T = Left Arm Top Strut, L_M = Left Arm Middle Strut, L_B = Left Arm Bottom Strut)

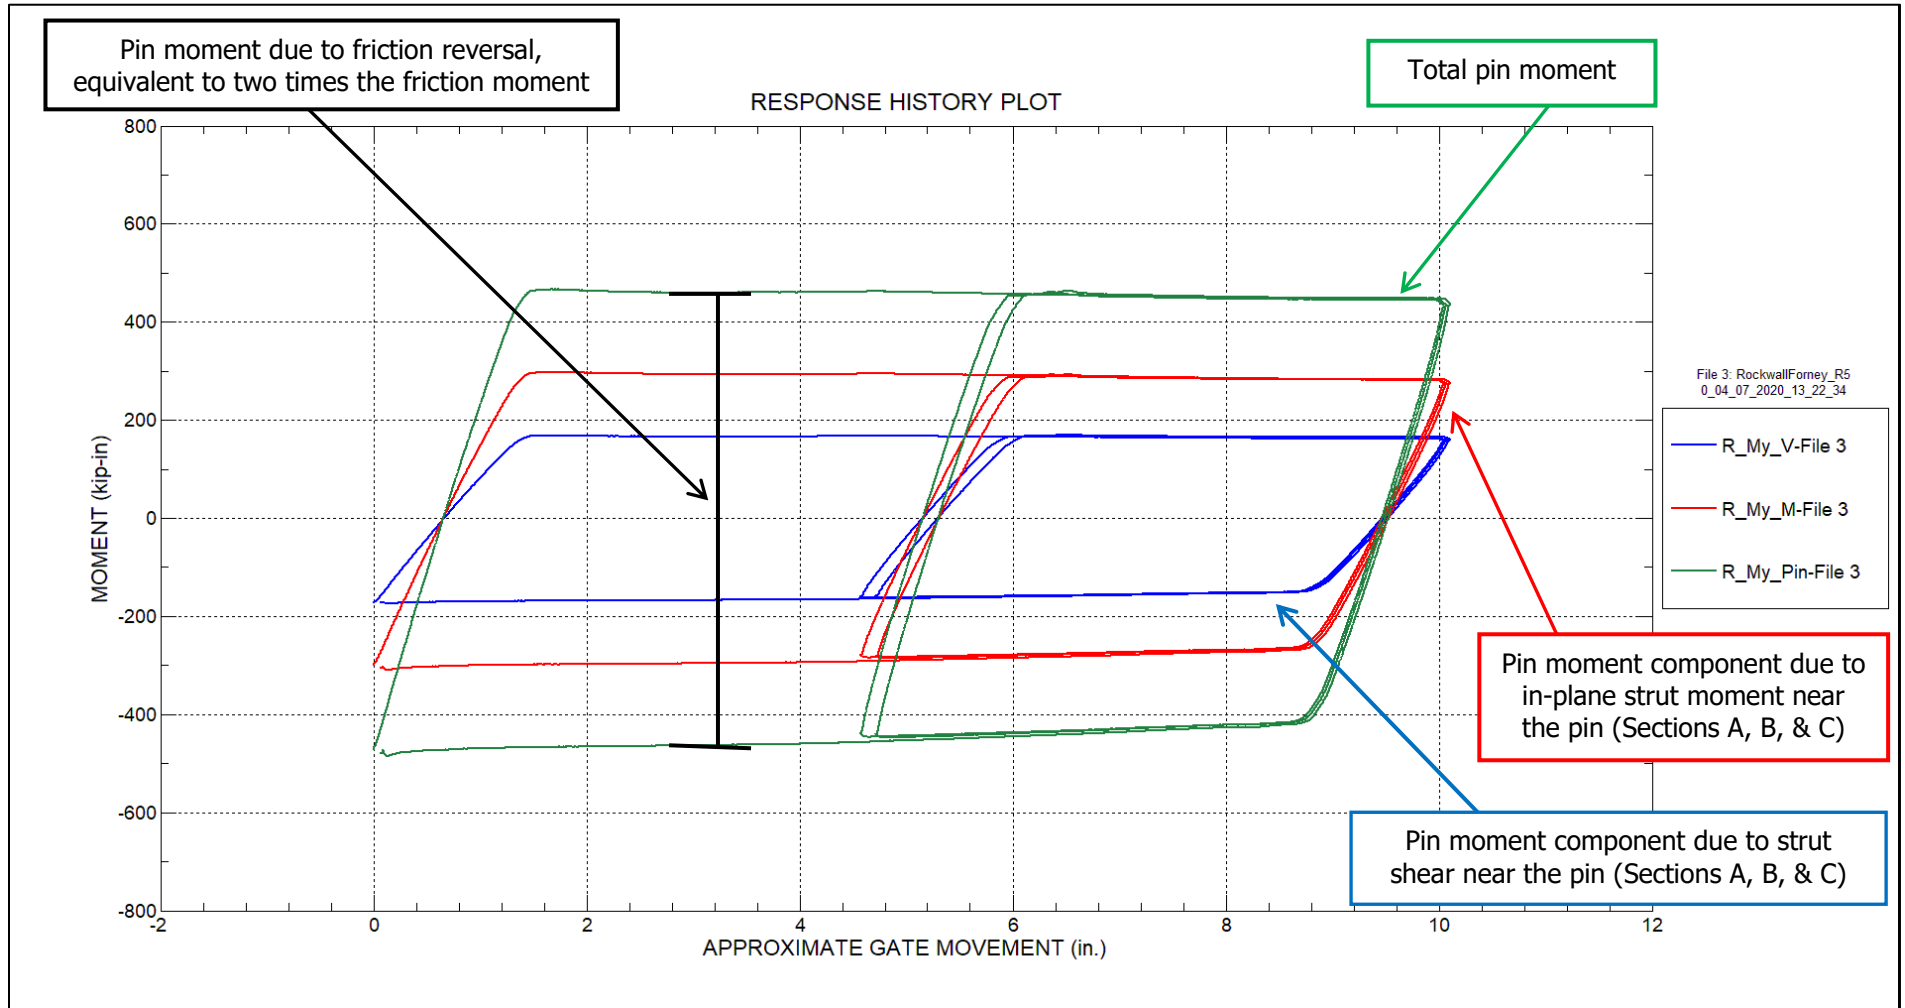
Figure 21 – Pin moment response history – Right arm

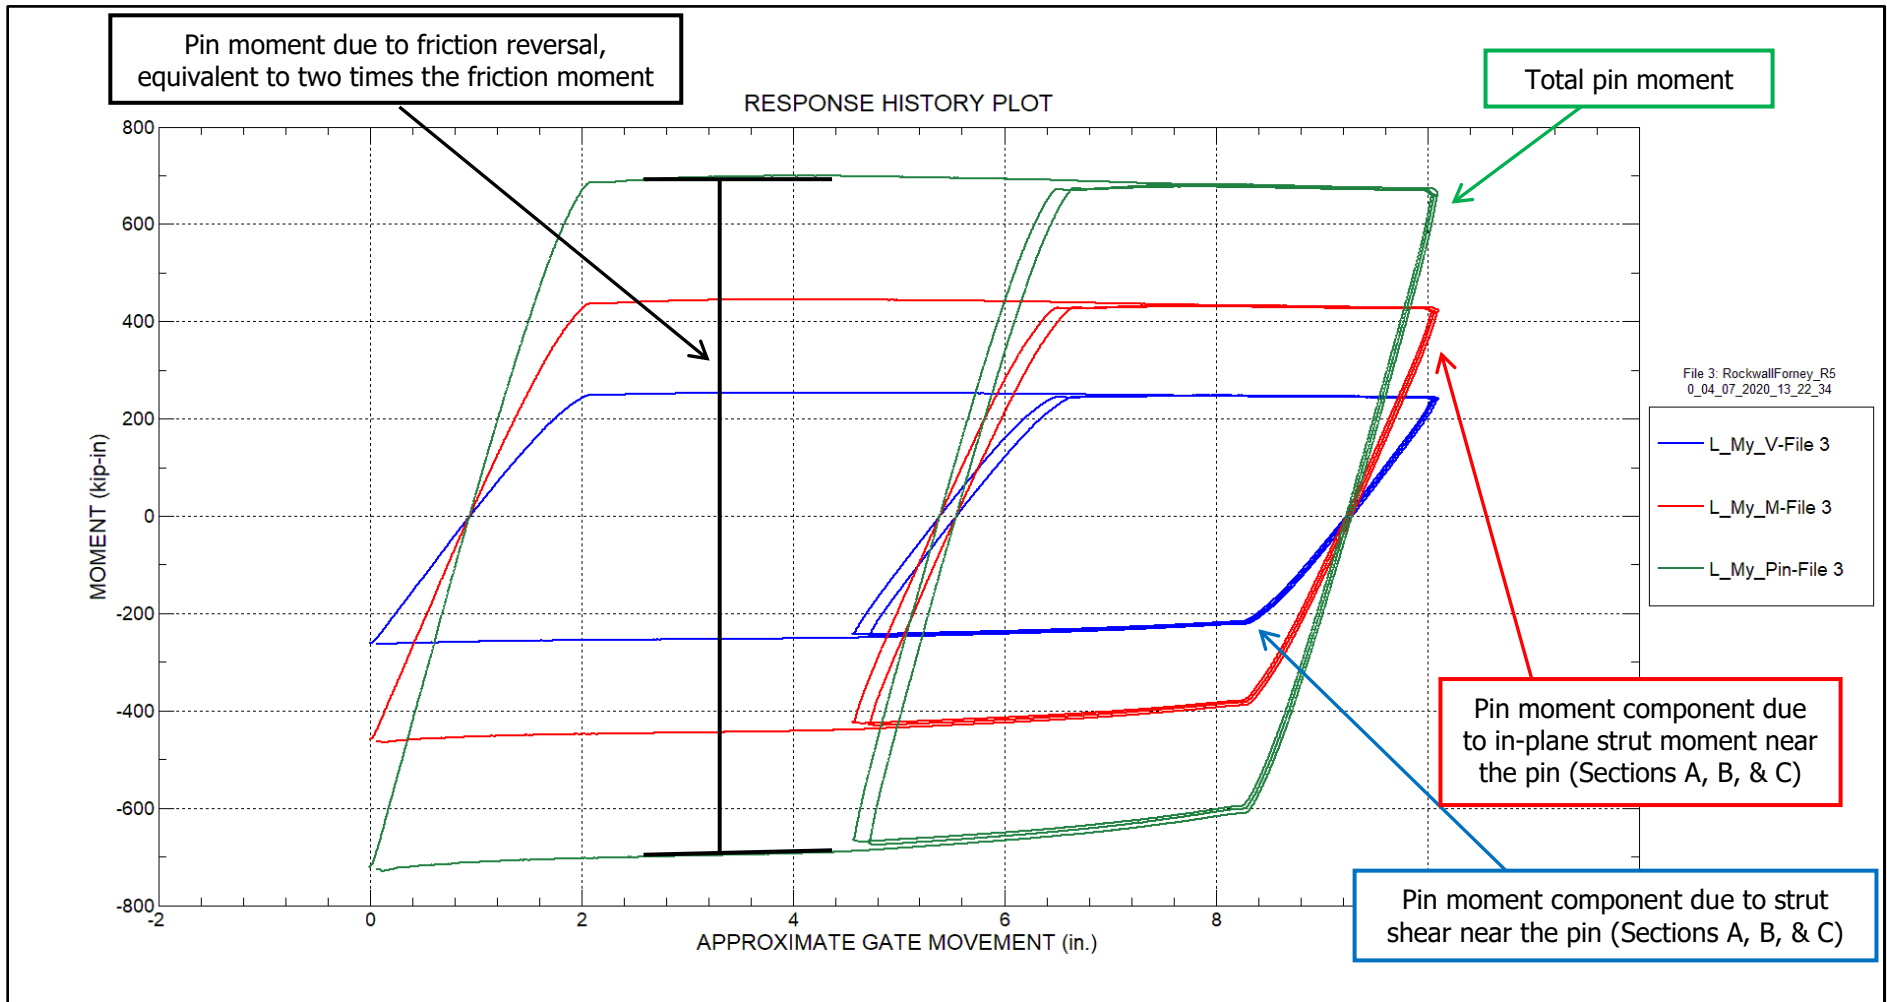
Figure 22 – Pin moment response history – Left arm

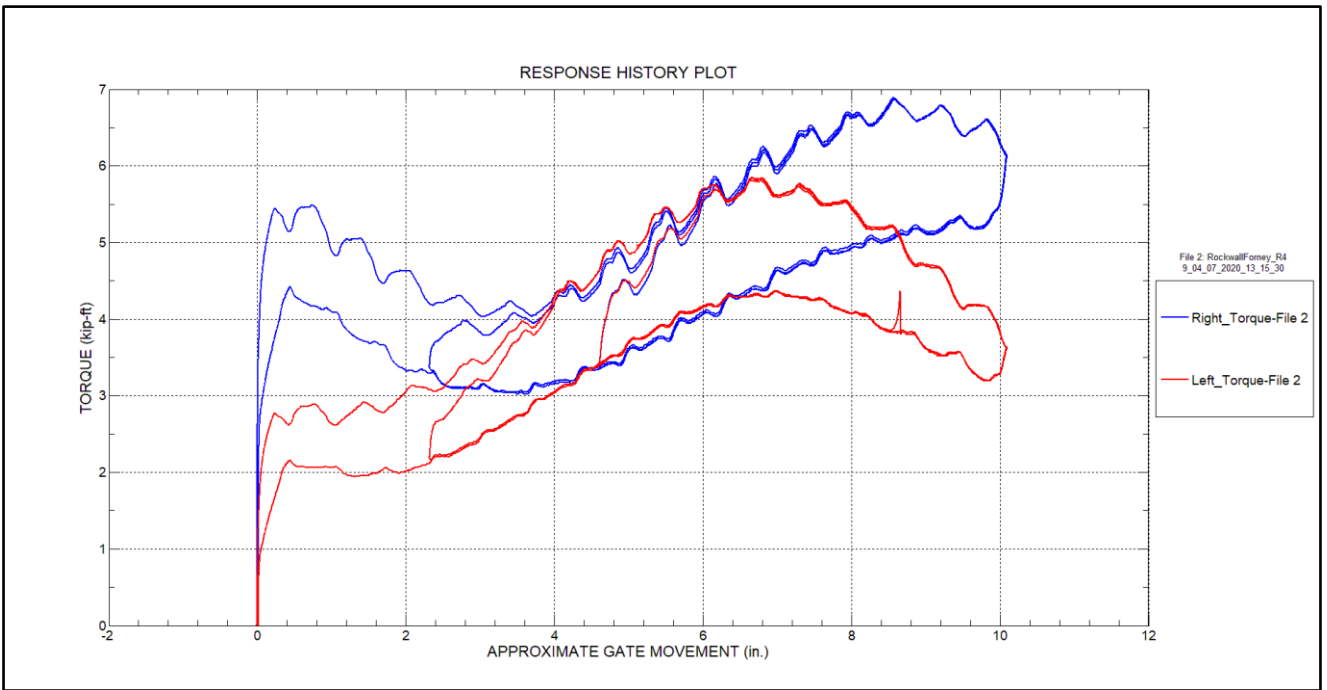
Figure 23 – Hoist torque response history – Gate 8 – Test 2

Figure 23 shows example torque measurements, recorded on the Gate 8 torque shafts. Best practices for torque measurements is to measure torque on opposite sides of the shaft so that any bending in the shaft can be removed by averaging the two responses. Due to access limitations, only one gage at each location could be installed. Therefore, any bending in the shaft may be reflected in the torque measurements and may be related to the peaks and valleys observed in the torque responses.

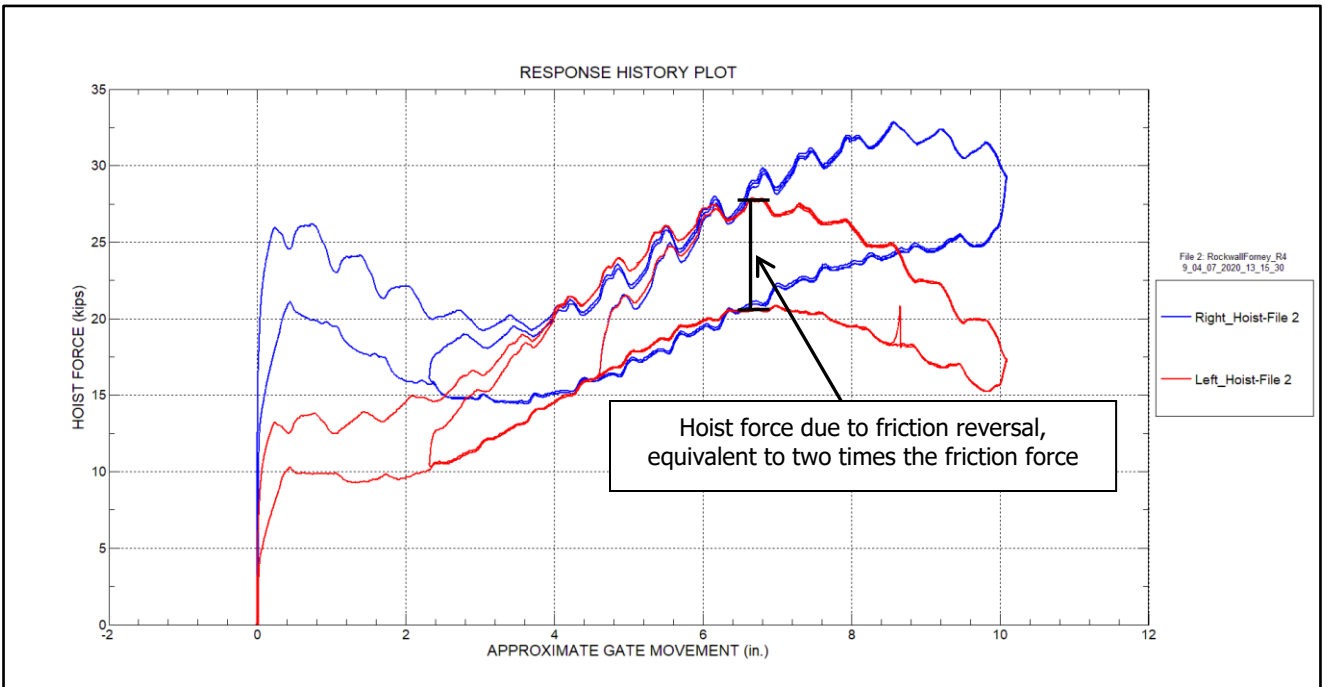
Figure 24 – Hoist force response history – Gate 8 – Test 2

Torque values were converted to force in the hoist cables per gate arm using the gear ratio and drum radius, as shown in Figure 24. The gear ratio and drum radius were 5.182 and 1.086 feet respectively, as defined in the provided as-built shop drawings. It should be noted that the hoist force calculated may be smaller than the actual hoist force applied. This difference is due to the limit switch engaging the brake before the hoist cable was fully slacked, resulting in an initial force in the cable. A hoist force due to total gate friction was then calculated. This friction hoist force was equal to half the differential in force measured during the lifting and lowering of the gate (similar to the pin friction calculations). As shown in Table 3, the change in cable force due to friction was generally consistent between tests. Note that the total hoist force was due to the total friction effects, including side seal, hoist bearings, trunnion friction effects, etc. It is difficult to determine the exact proportion and composition of the total friction sources. Additional torque and hoist force plots for all collected data files are provided in Appendix A – Gate 8 Torque and Hoist Force Plots.

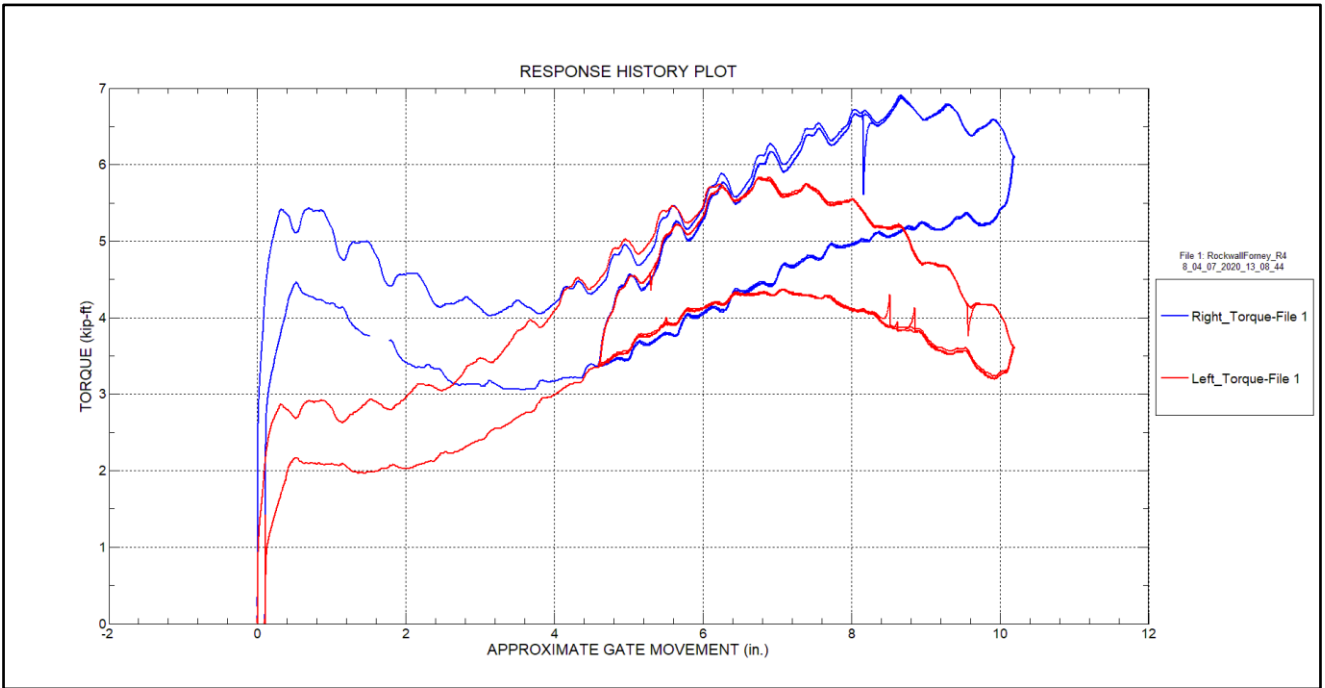
Figure 25 – Hoist torque response history – Gate 8 – Test 1

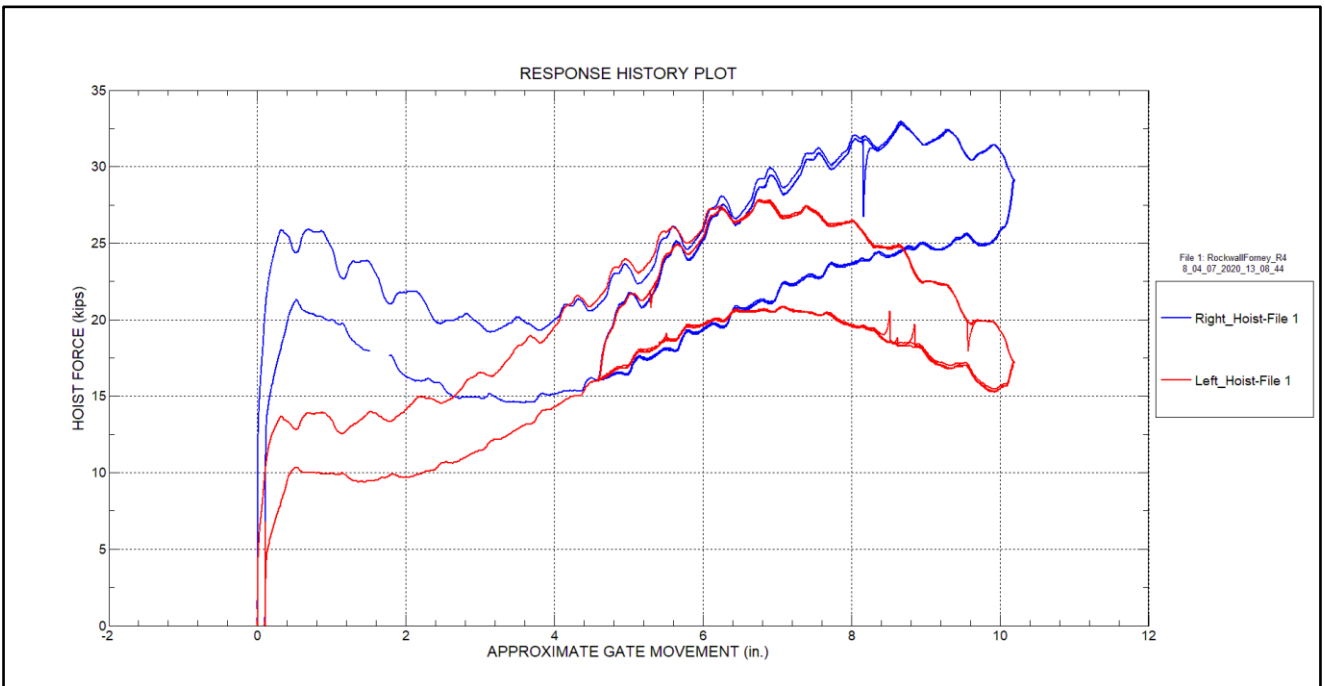
Figure 26 – Hoist force response history – Gate 8 – Test 1

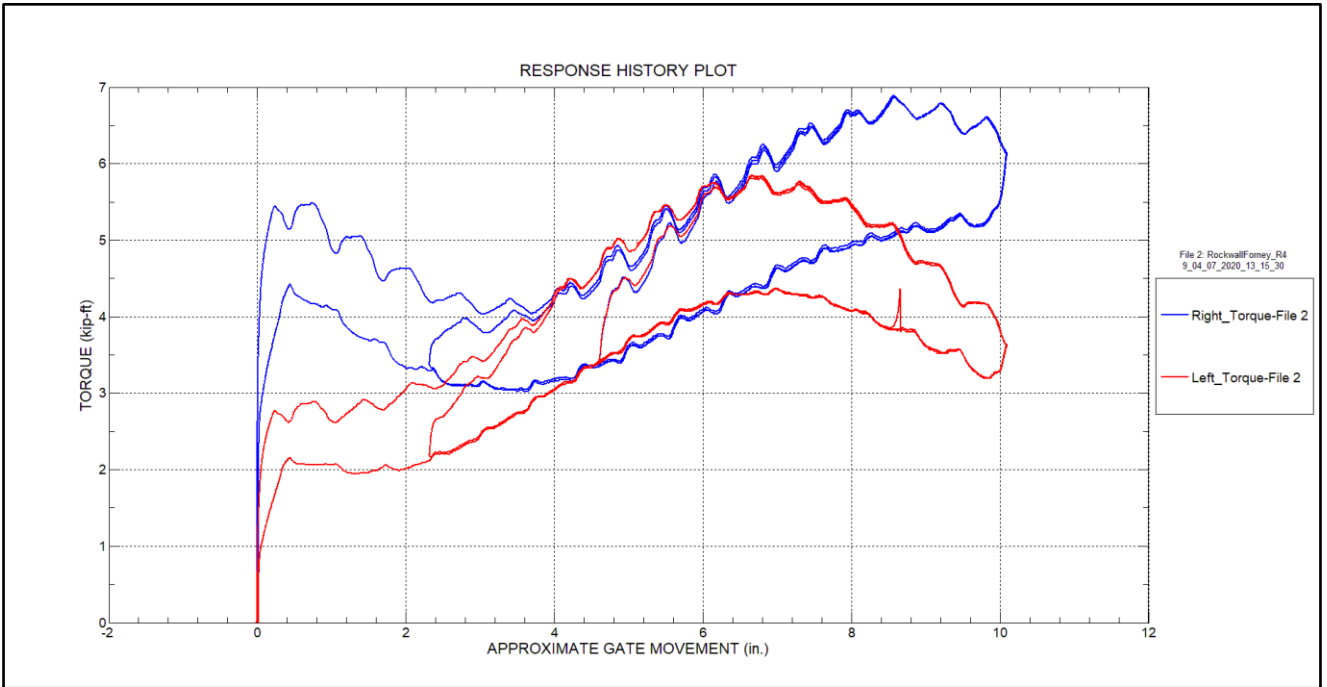
Figure 27 – Hoist torque response history – Gate 8 – Test 2

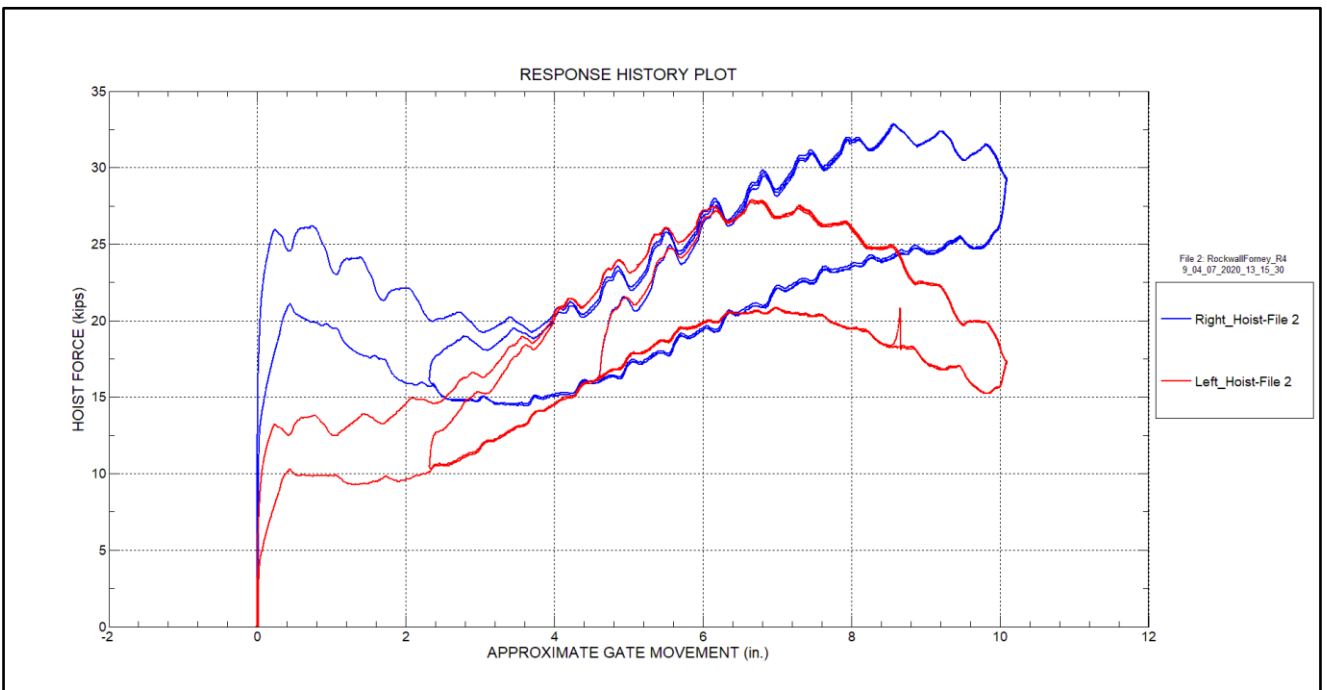
Figure 28 – Hoist force response history – Gate 8 – Test 2

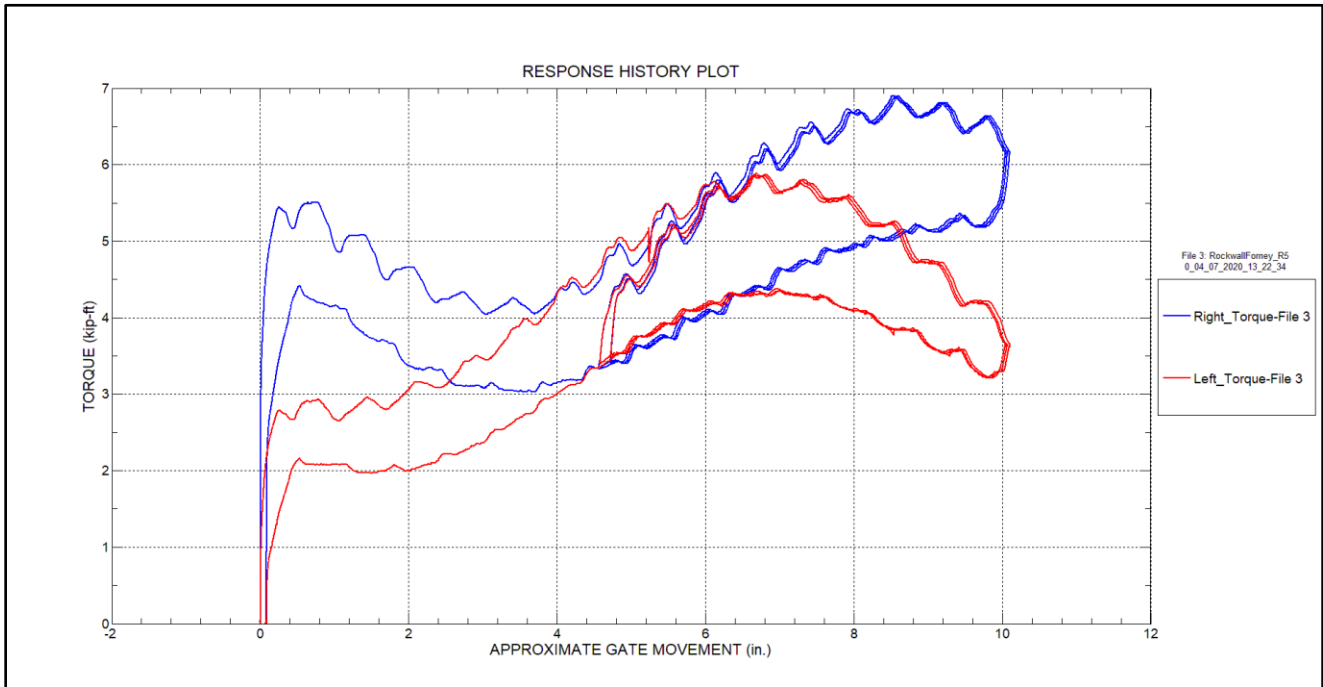
Figure 29 – Hoist torque response history – Gate 8 – Test 3
