VISUAL INSPECTION AND EVALUATION REPORT

Rockwall-Forney Dam
Dallas Water Utilities
Dallas/Kaufman Counties, Texas

Schnabel Reference #20C22001.00
July 30, 2021

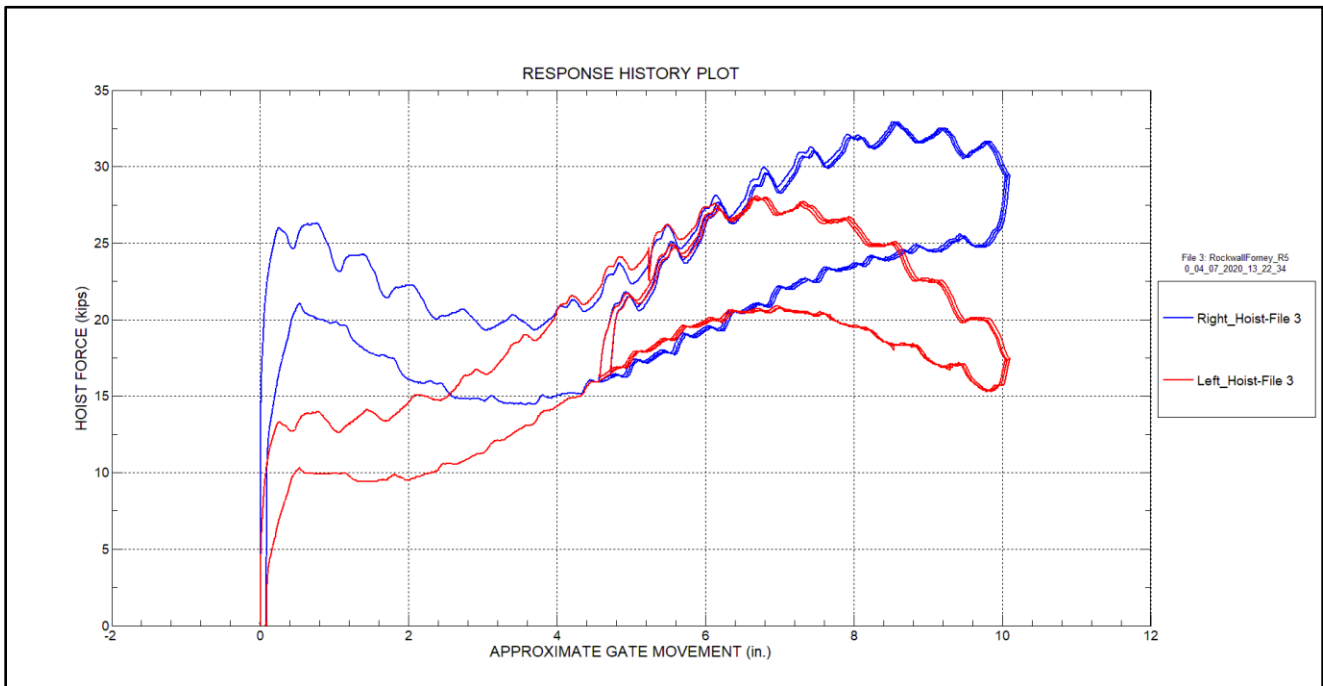
Figure 30 – Hoist force response history – Gate 8 – Test 3

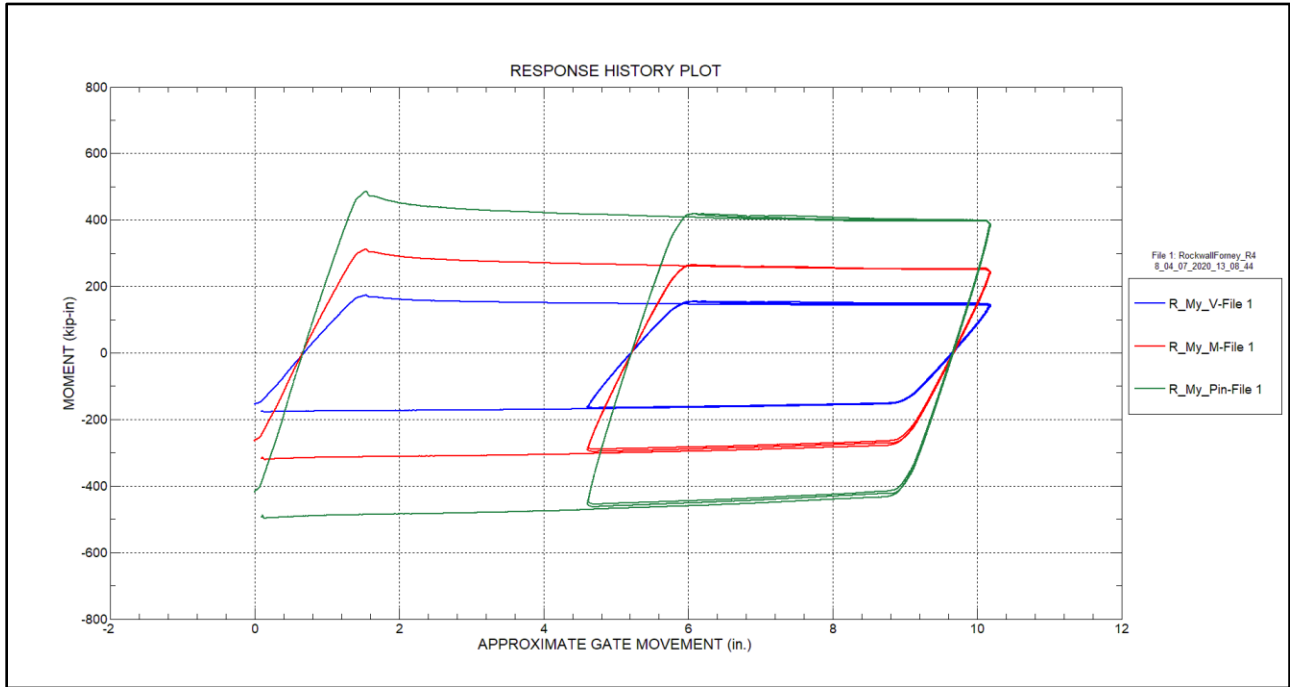
Figure 31 – Pin moment response history – Right arm – Test run 1

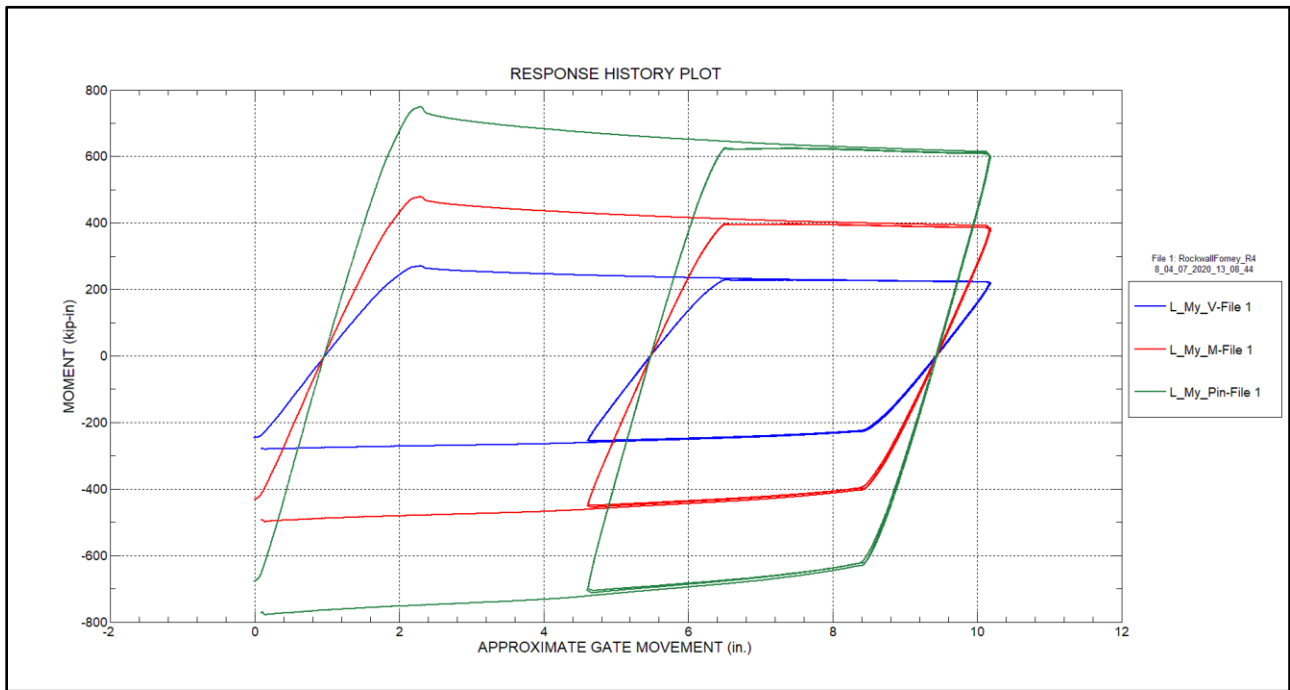
Figure 32 – Pin moment response history – Left arm – Test run 1

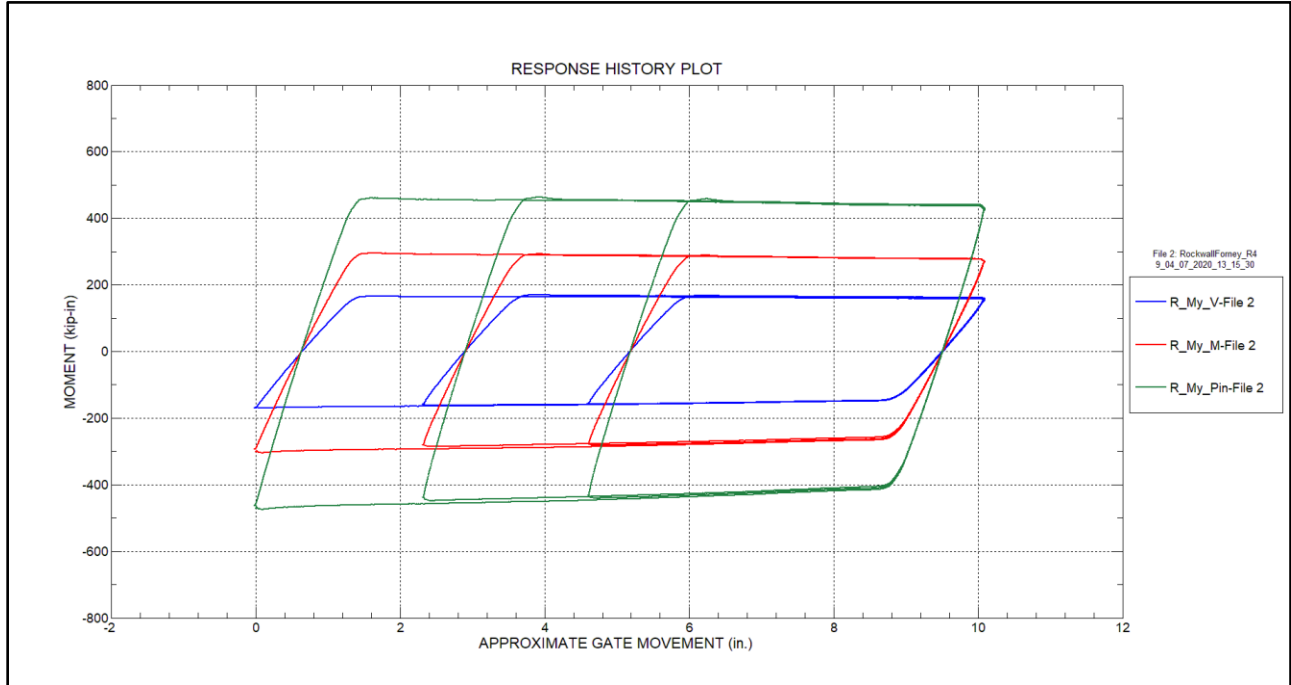
Figure 33 – Pin moment response history – Right arm – Test run 2

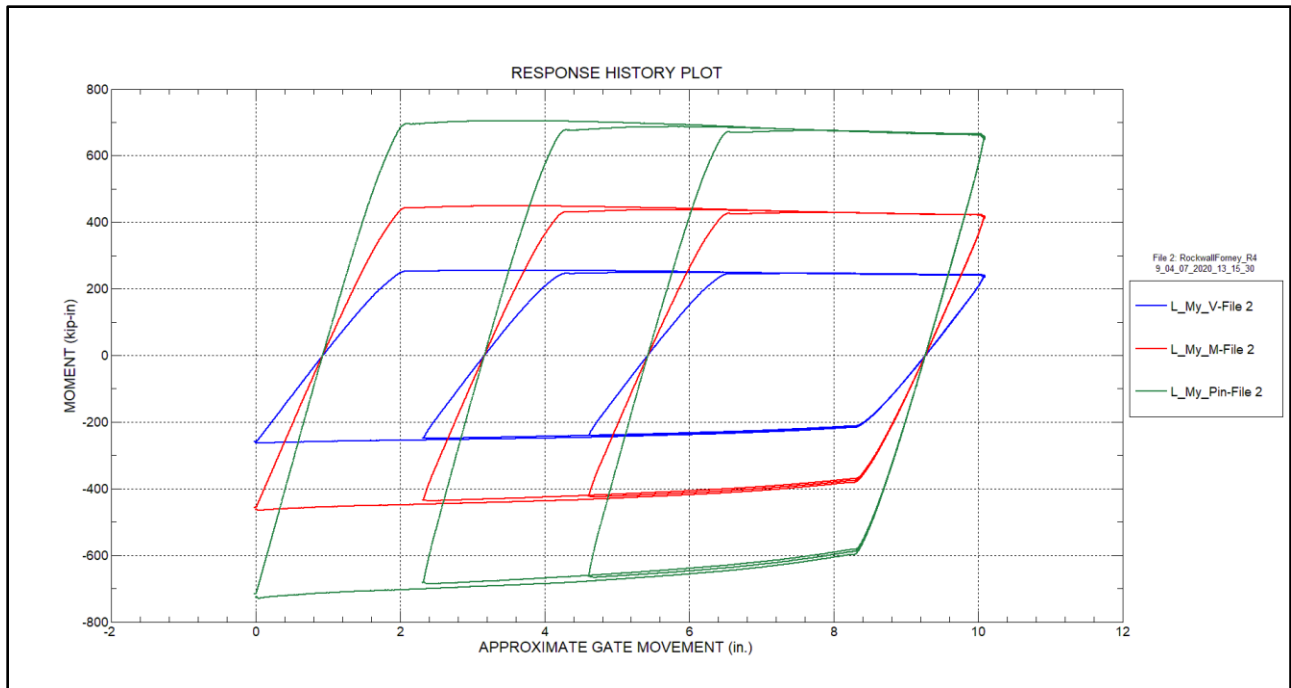
Figure 34 – Pin moment response history – Left arm – Test run 2

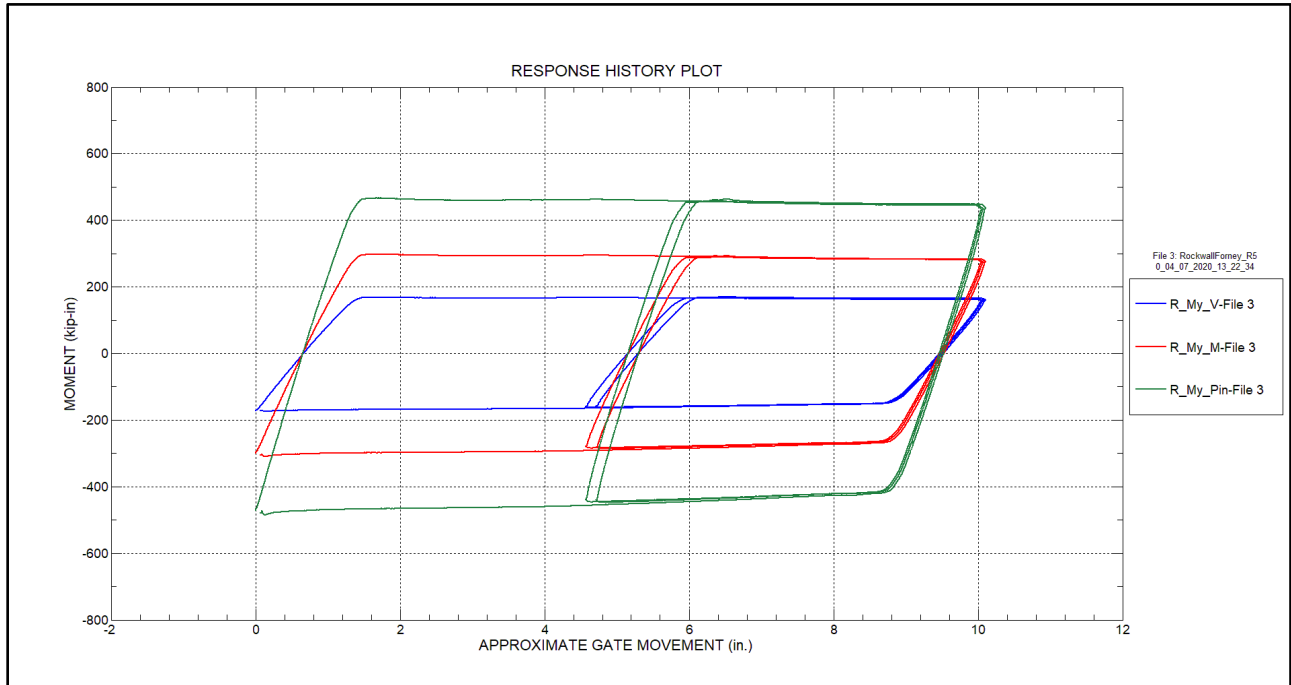
Figure 35 – Pin moment response history – Right arm – Test run 3

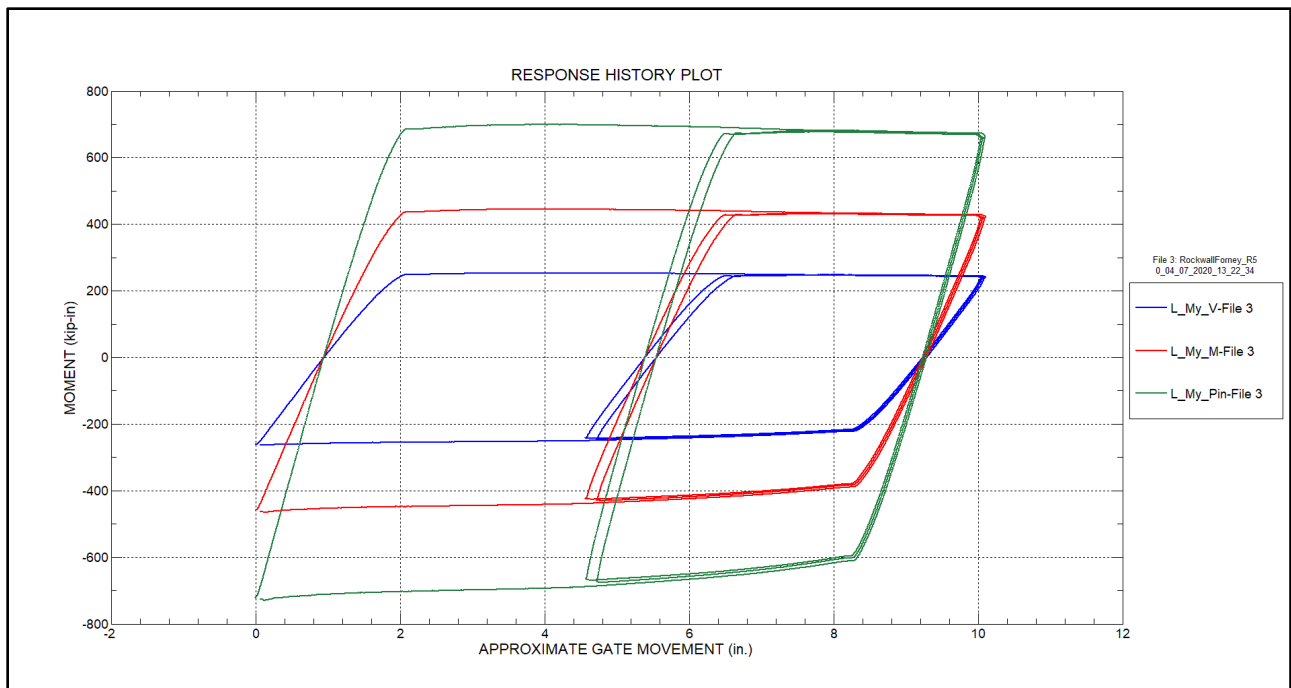
Figure 36 – Pin moment response history – Left arm – Test run 3

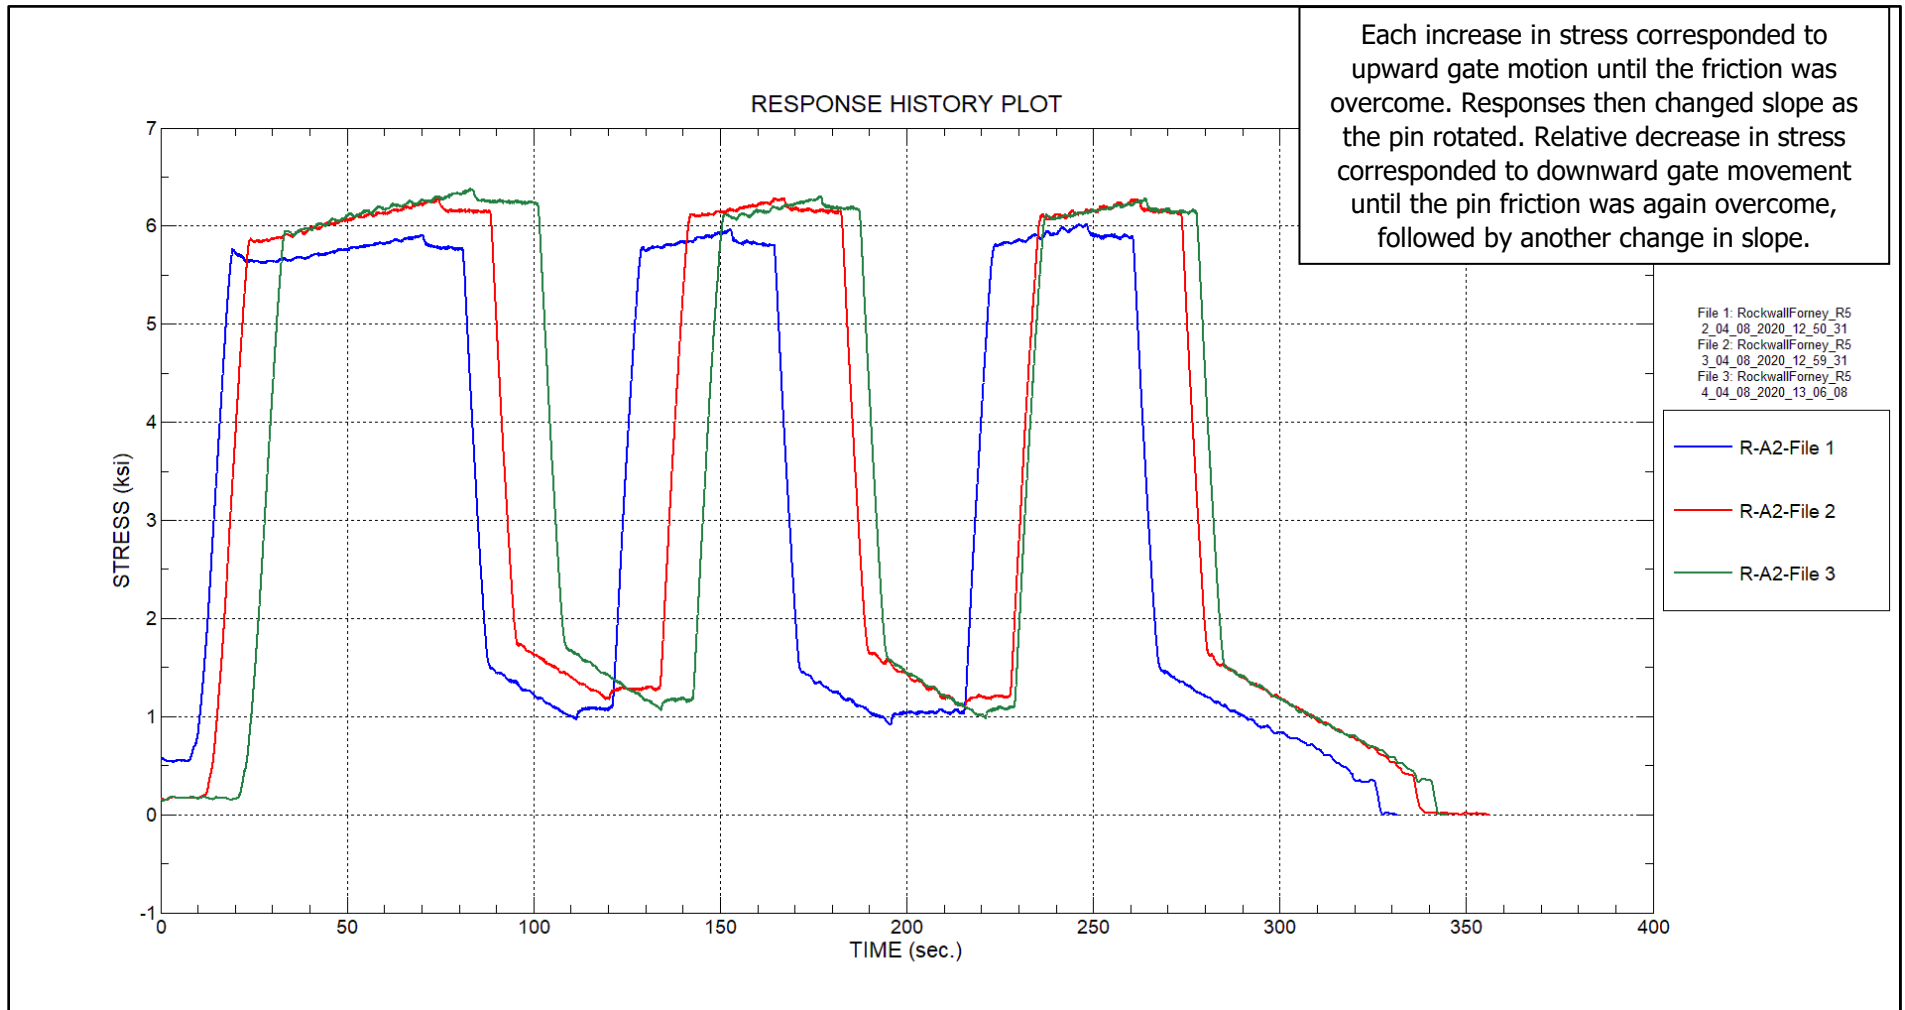
Figure 6 – Stress response history – Right arm – Gage A2 – Time based
File 1 = test run 1, File 2 = test run 2, File 3 = test run 3
(Section A along top strut near pin – Sensor location 2 along bottom of inner flange)

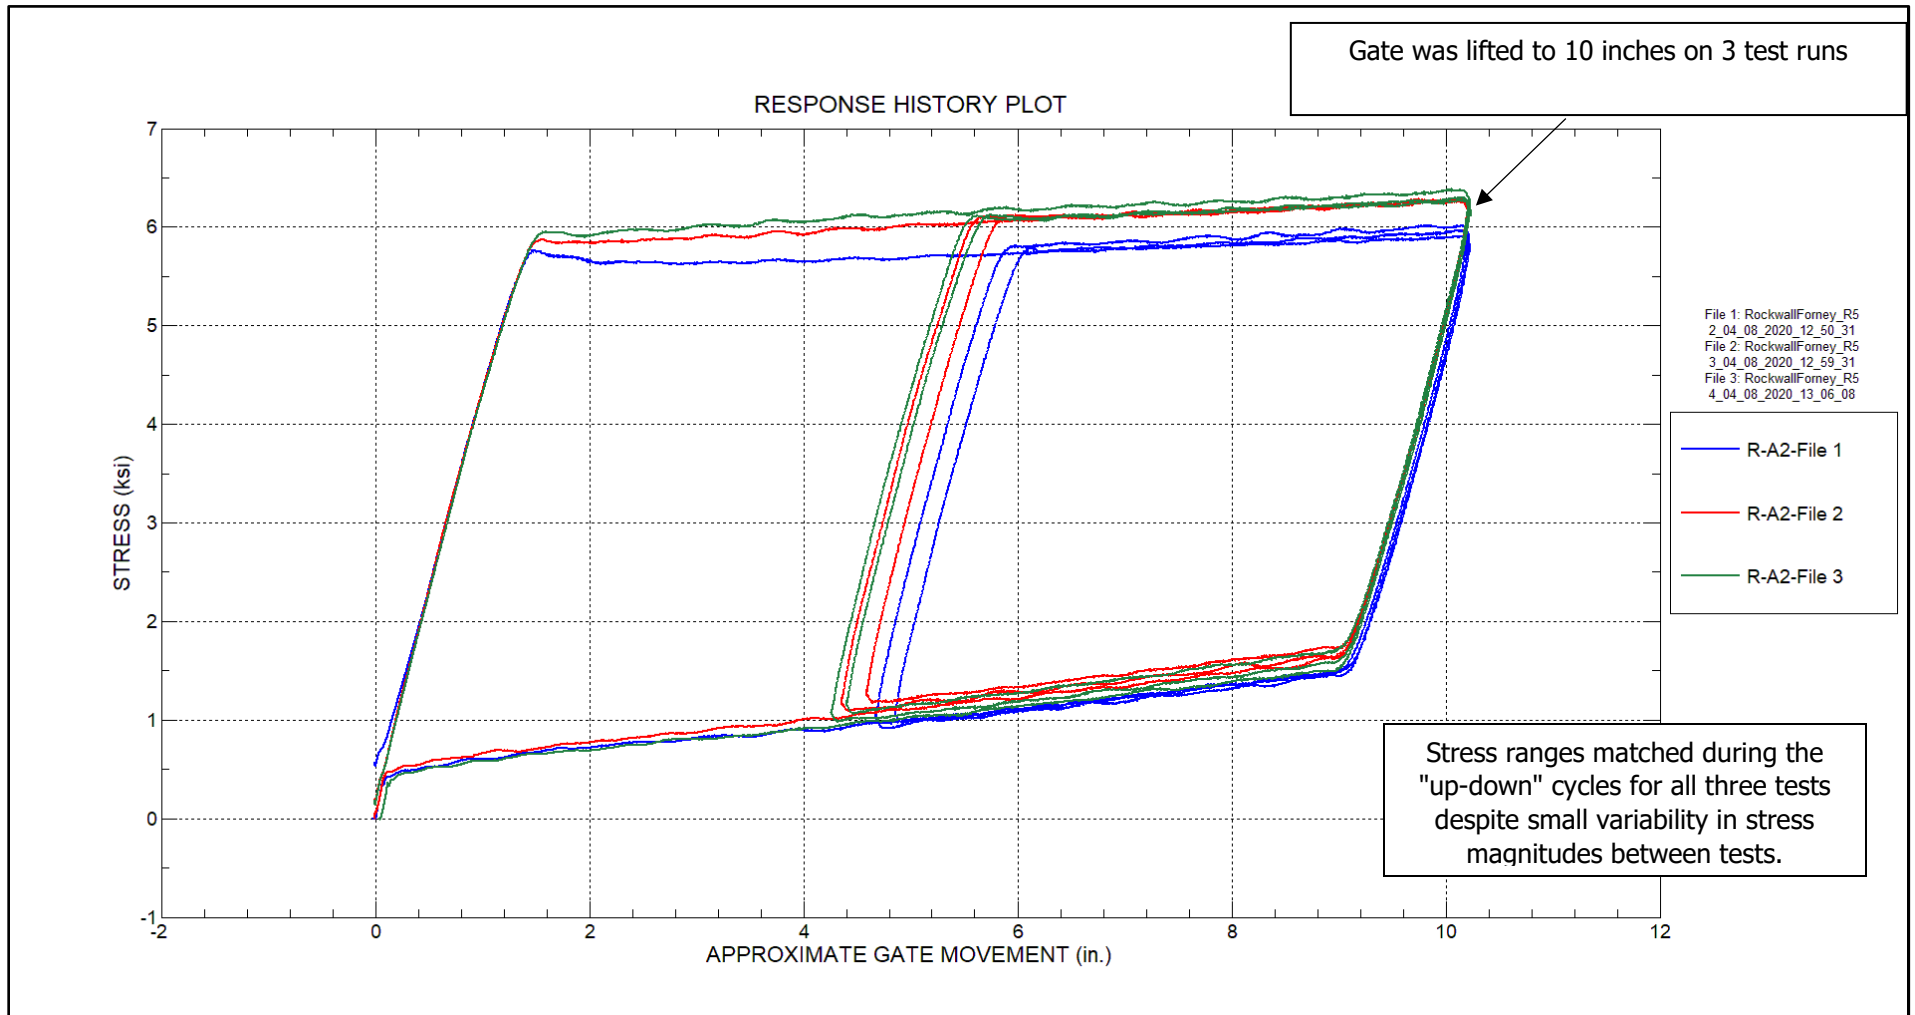
Figure 7 – Stress response history – Right arm – Gage A2 – Function of gate movement
 File 1 = test run 1, File 2 = test run 2, File 3 = test run 3
 (Section A along top strut near pin – Sensor location 2 along bottom of inner flange)

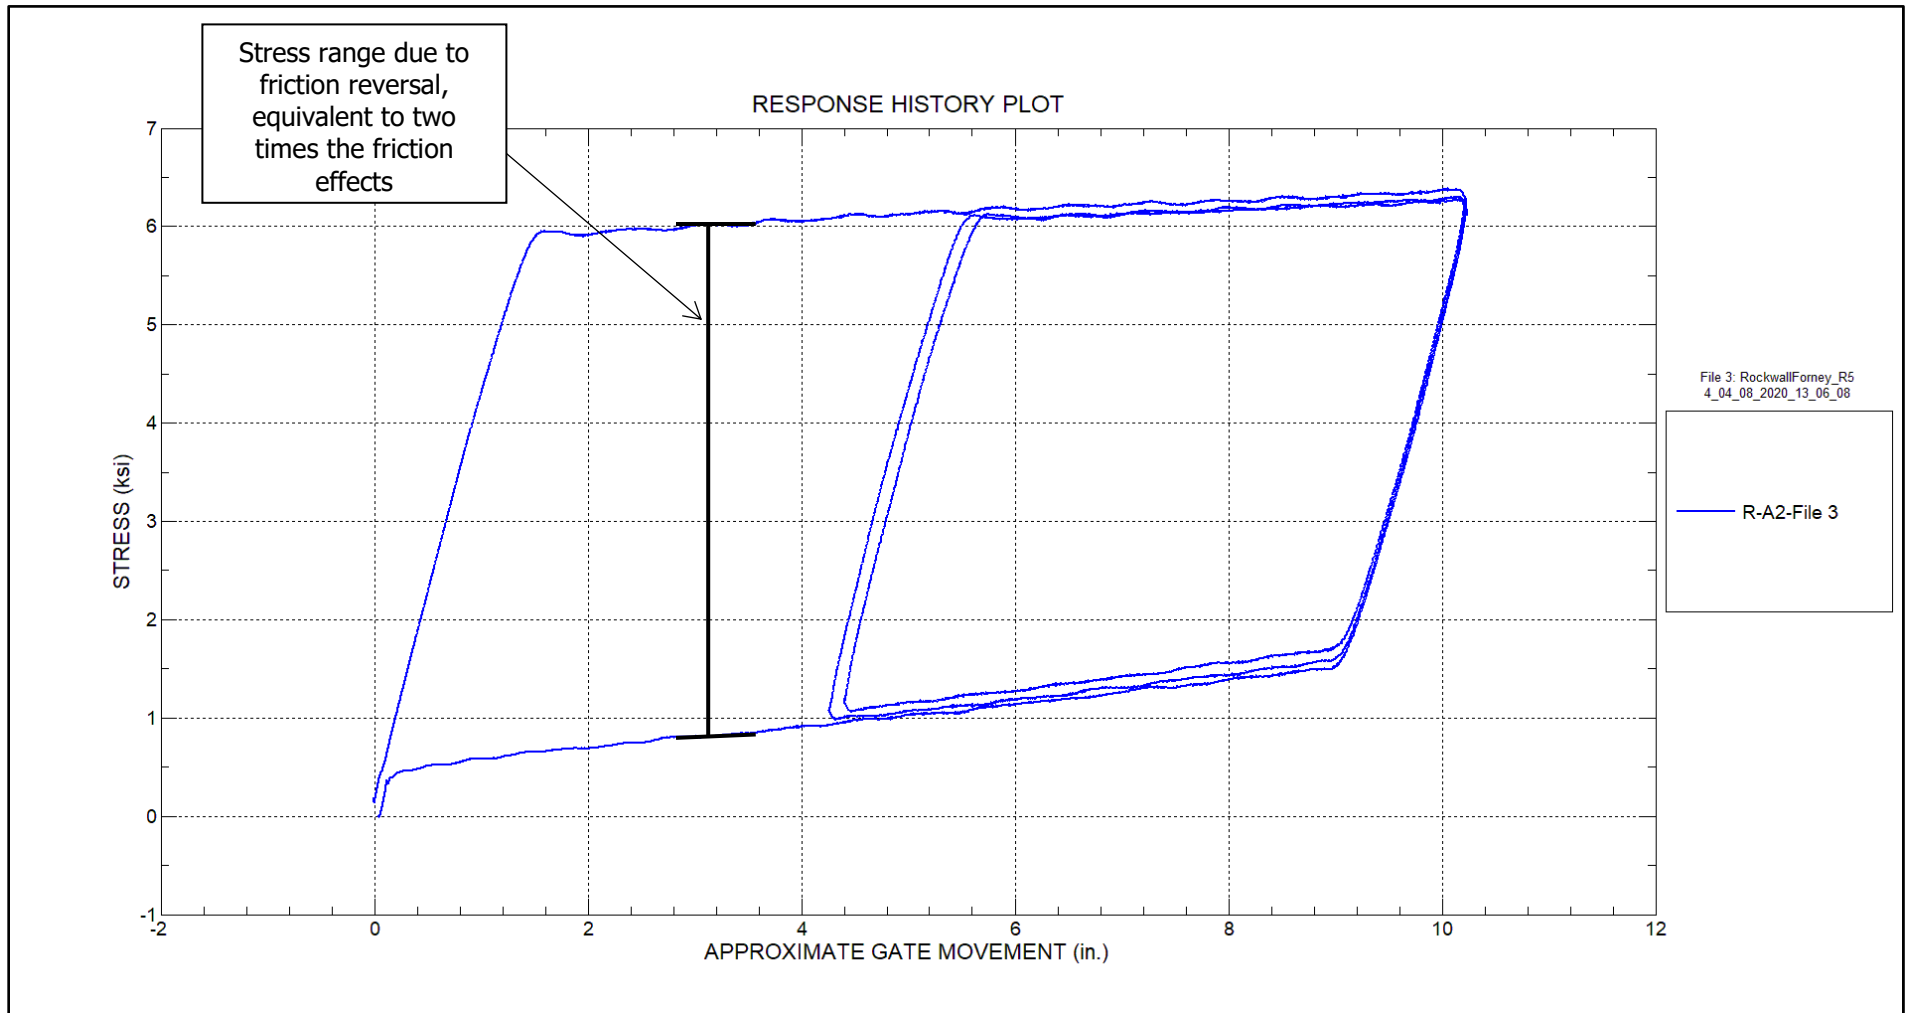
Figure 8 – Stress response history – Right arm – Gage A2 – Friction effect in stress responses
(Section A along top strut near pin – Sensor location 2 along bottom of inner flange)

- + **DIRECTION/FRICTION REVERSAL IN RESPONSES:** The difference in stress during gate opening and closing for a given position is shown in Figure 8. The stress variation at any given gate position was a result of direction reversal and in turn due to trunnion friction reversal. This statement is true since all other loads such as dead-load and hydrostatic pressure were essentially constant barring small changes in hydrostatic pressure due to slight changes in head. This direction/friction reversal is depicted in Figure 9, with deflected shape renderings from a gate arm finite element model under lifting and lowering loads. Note that this figure shows an arm configuration that does not match this gate, but the concept of the direction/friction reversal still applies.

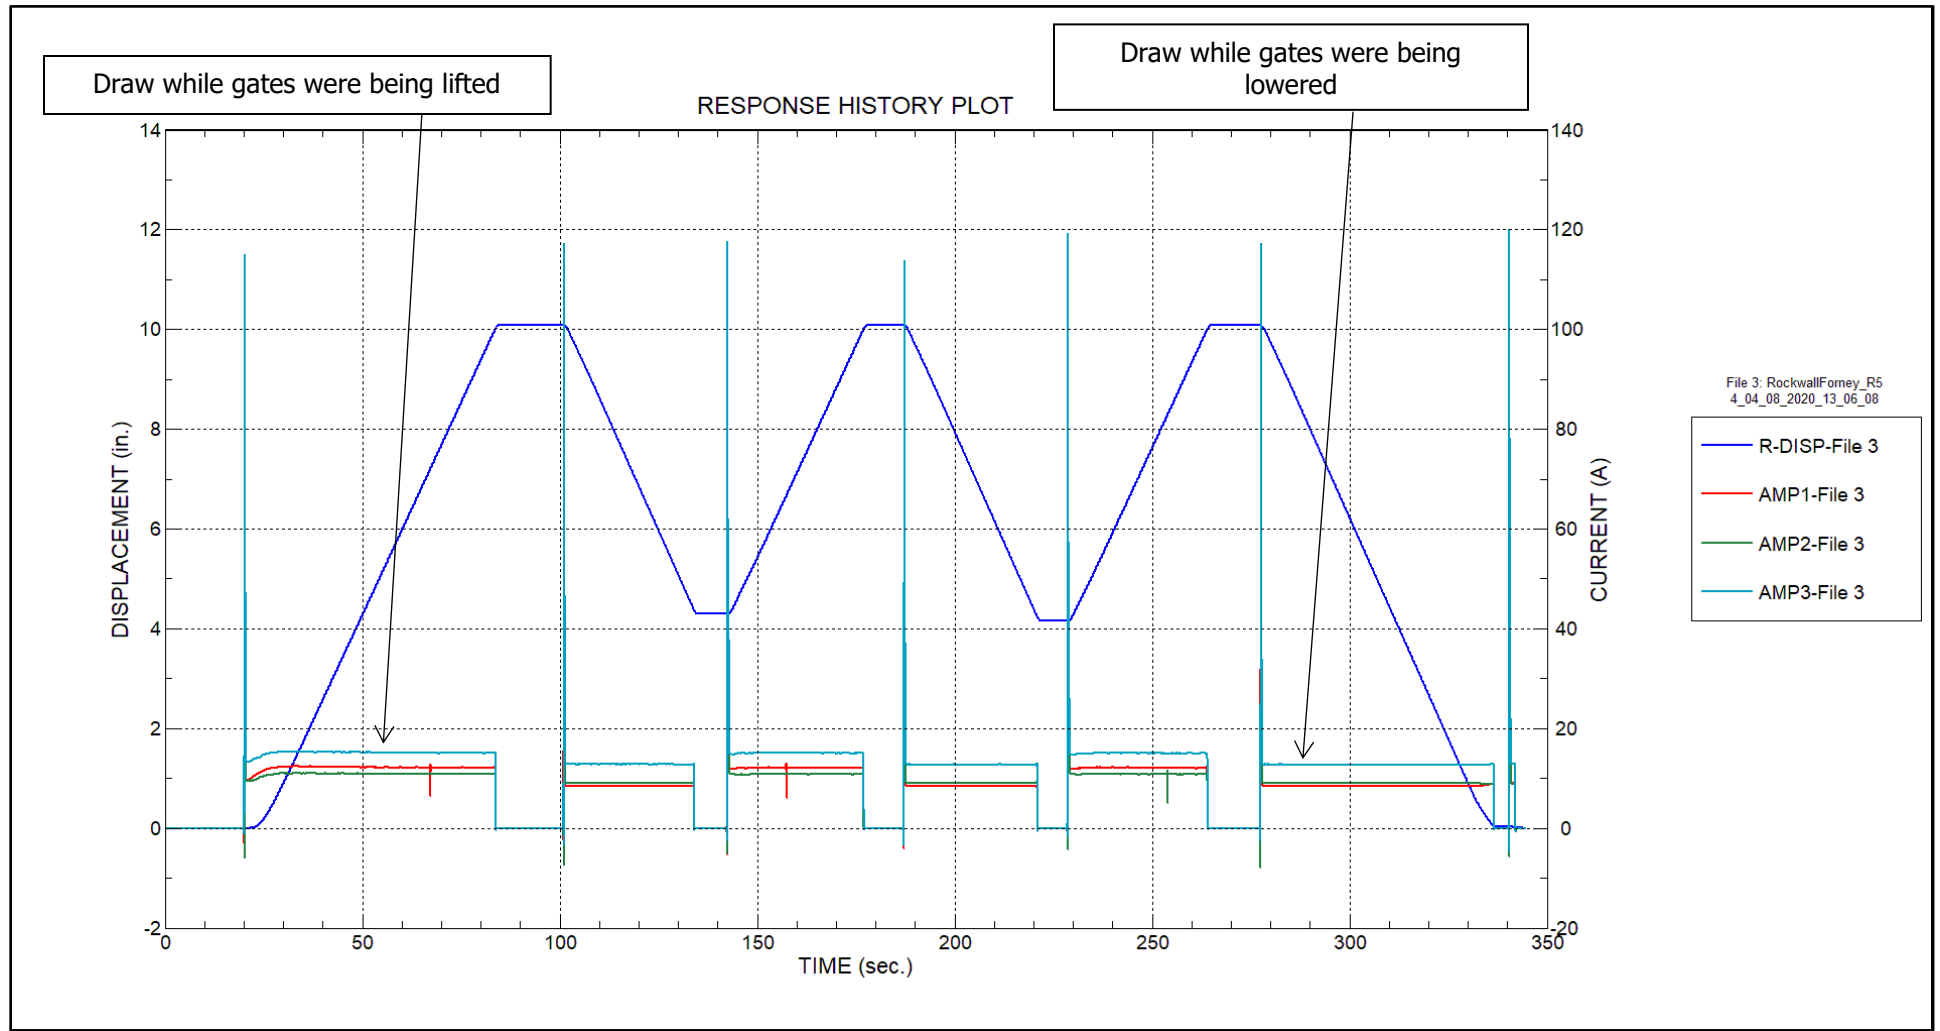
Figure 10 – Motor current & gate movement response history – Lift motor – Highlighting motor draw during lift and lower cycles

- + **MOTOR PERFORMANCE:** Current measurements taken at the hoist motor indicated steady and stable current draws during the lifting and lowering portions. An example plot of current draw and gate position is provided in Figure 10. Current draw ranges during lifting were higher than the ranges during lowering, which is common due to gravity/dead load. These results are summarized along with recorded peak in-rush current in Table 2. Note that the sample rates used during testing were set for collecting gate responses and may not have been appropriate to fully capture the in-rush current. The readings should be evaluated by a licensed electrician with knowledge of the operating parameters. Note: Test 1 amperage data did not match the other two tests, with lower amperage levels and noisy responses from the Phase 2 sensor while the gate was lowered. Given the amperage responses from tests 2 & 3 were reproducible, it is possible that the unexpected responses from test 1 were due to an issue with the amperage sensors.

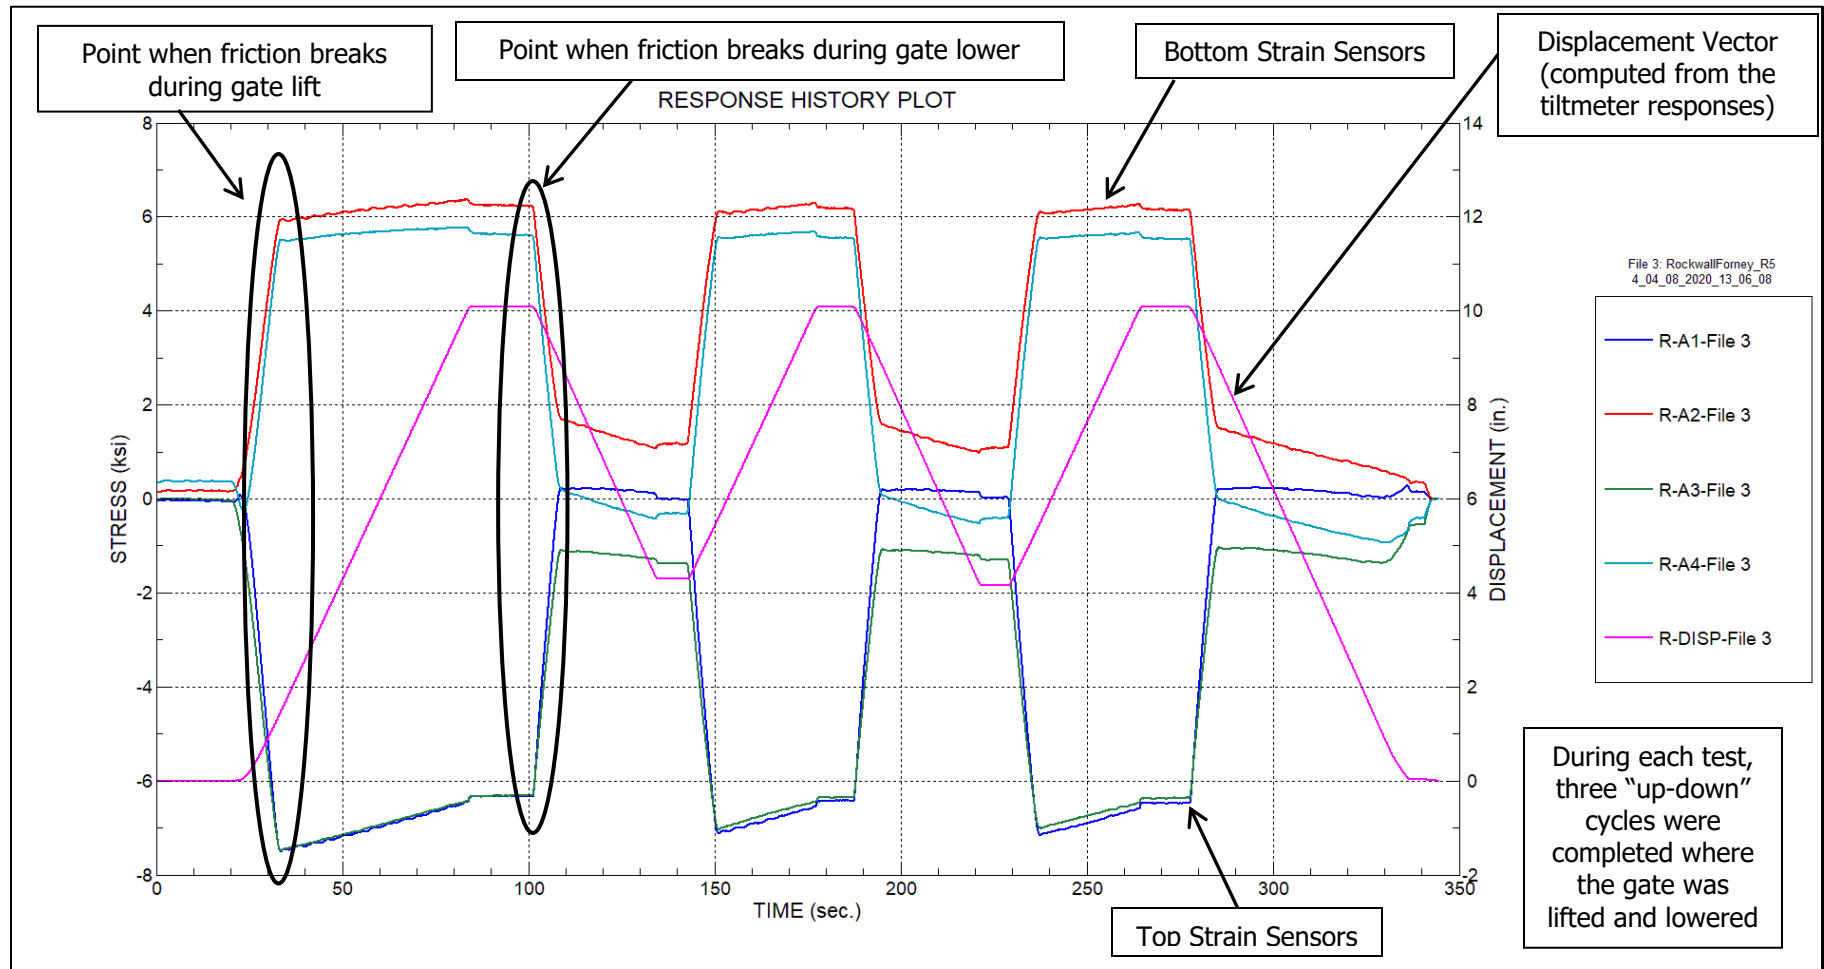
Figure 11 – Stress response & gate movement history – Right arm – Section A - Highlighting friction behavior (Section A along top strut near pin)

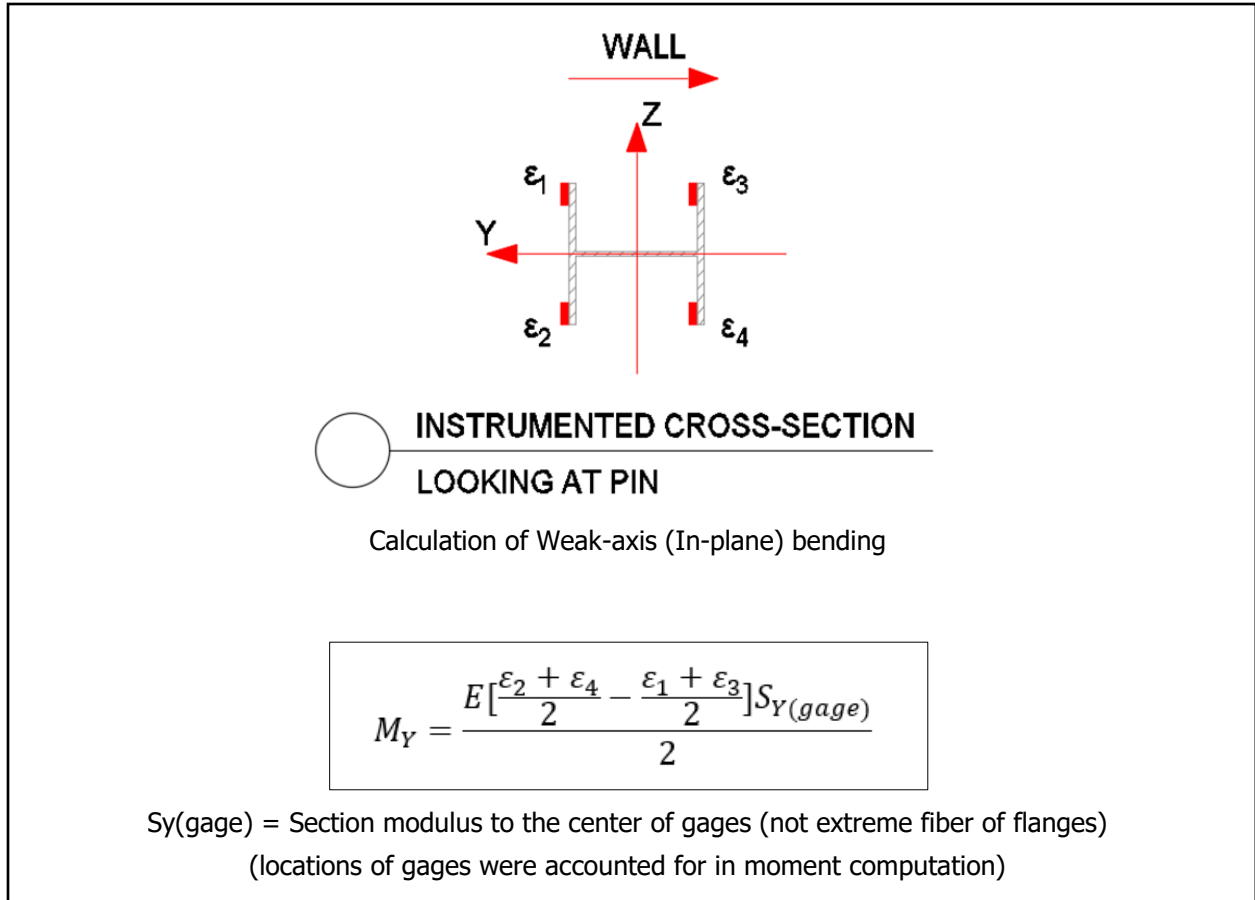
Figure 12 – Basic mechanic equation used to calculate moment

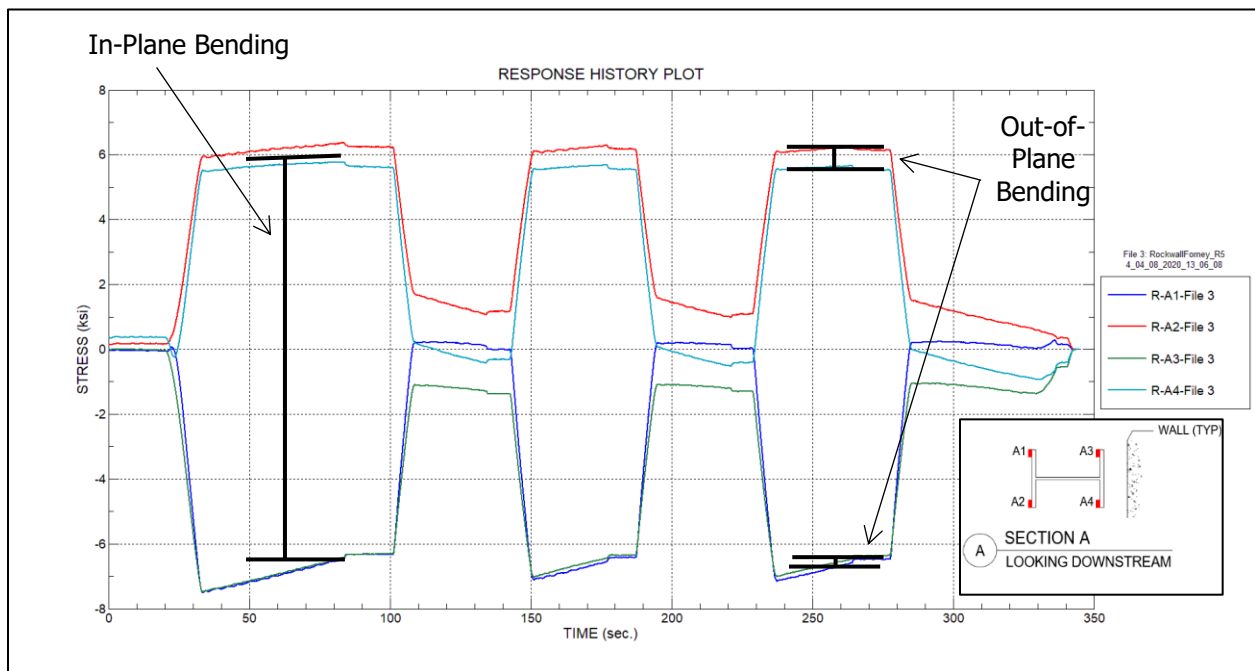
Figure 13 – Stress response history – Right arm – Section A – Bending components
(Section A along top strut near pin)

In-plane or weak-axis flexure refers to bending about a given strut's web. This designation is consistent with typical nomenclature. In-plane bending can be observed visually from the strain response histories as a difference between the top and bottom stresses, whereas out-of-plane or strong-axis bending is visualized as the difference in stress from side to side. Figure 13 provides a visual reference for both types of strut flexure.

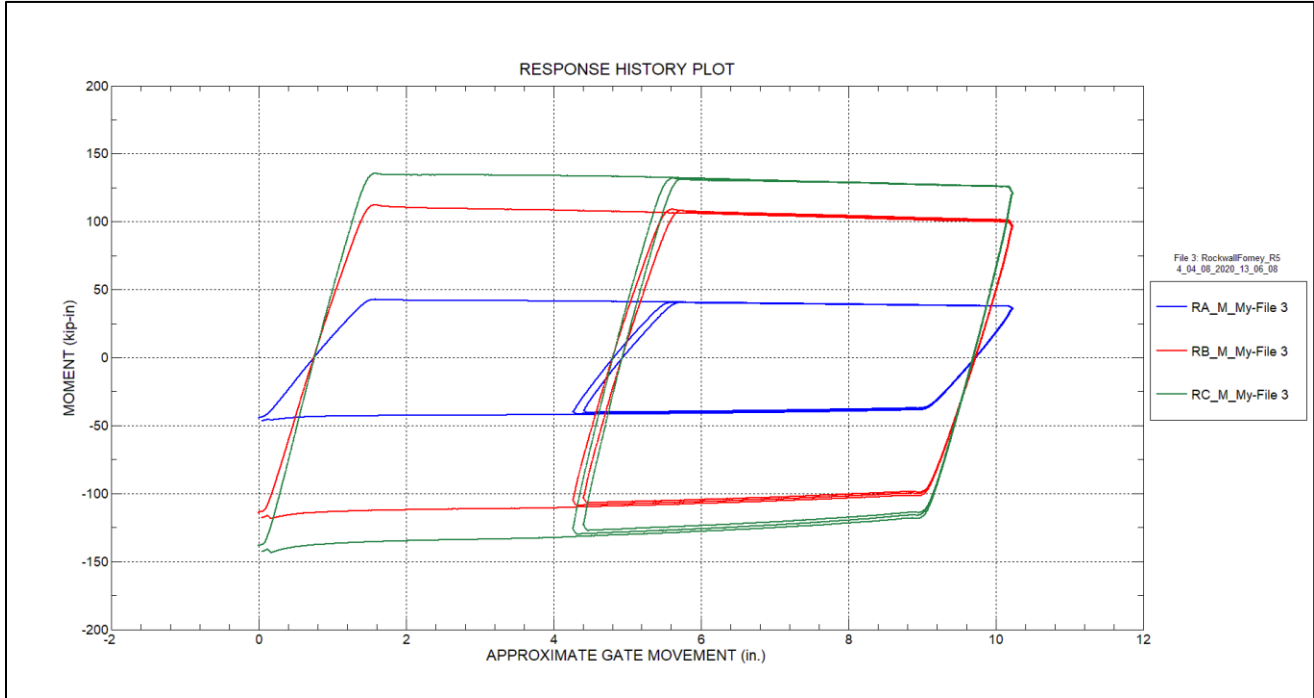
Figure 14 – In-plane moment response history – Right arm – Sections near pin
(RA = Right Arm Top Strut, RB = Right Arm Middle Strut, RC = Right Arm Bottom Strut)

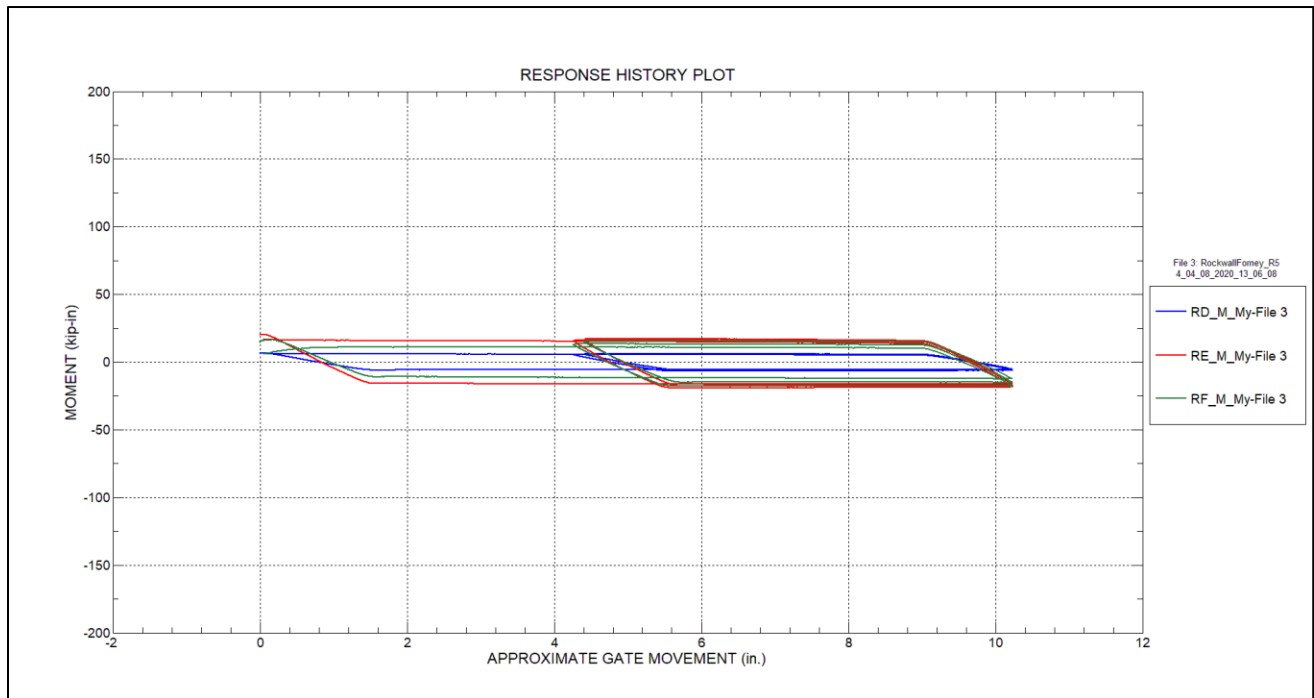
Figure 15 – In-plane moment response history – Right arm – Sections away from pin
(RD = Right Arm Top Strut, RE = Right Arm Middle Strut, RF = Right Arm Bottom Strut)

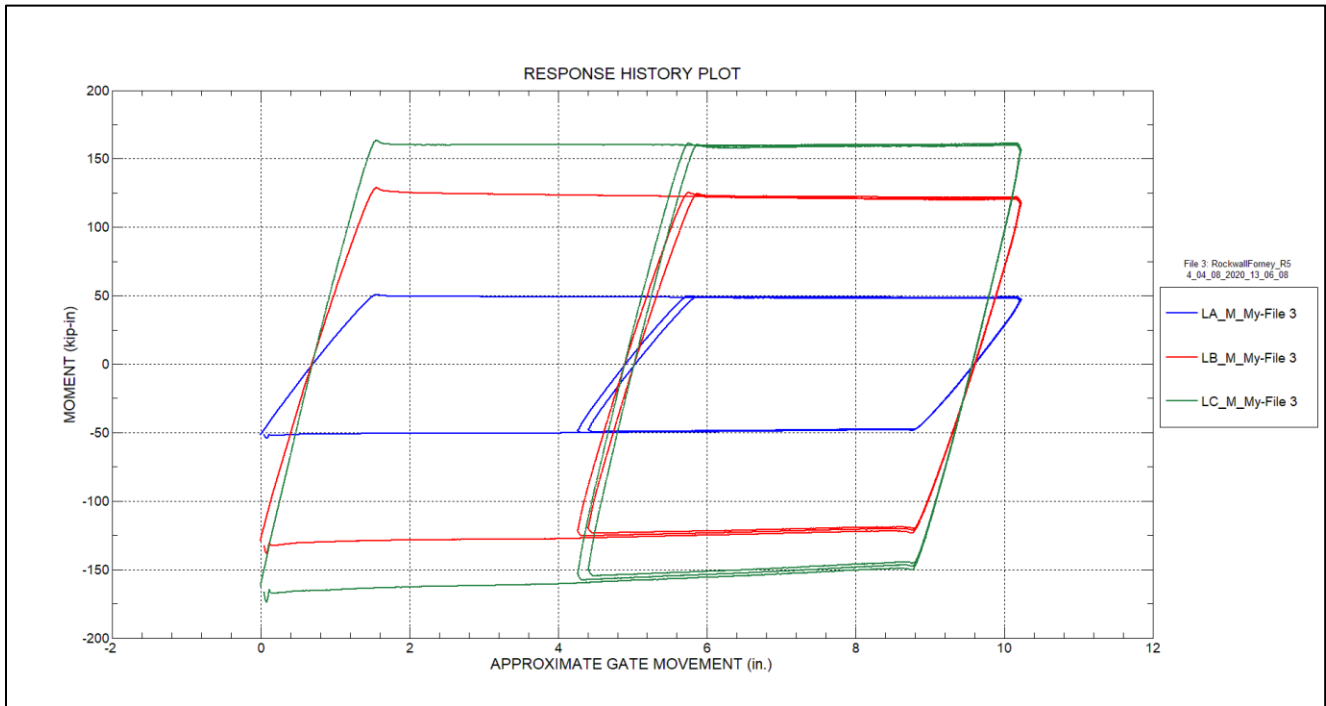
Figure 16 – In-plane moment response history – Left arm – Sections near pin
(LA = Left Arm Top Strut, LB = Left Arm Middle Strut, LC = Left Arm Bottom Strut)

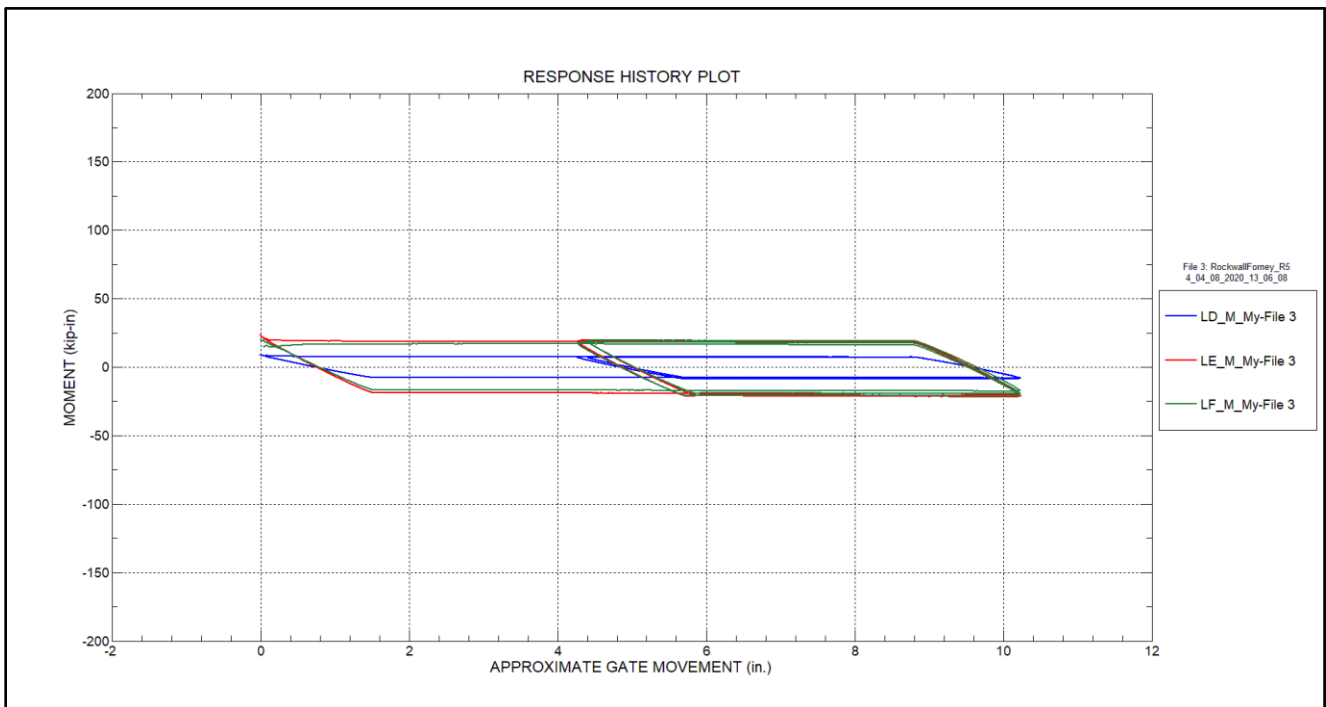
Figure 17 - In-plane moment response history – Left arm – Sections away from pin
(LD = Left Arm Top Strut, LE = Left Arm Middle Strut, LF = Left Arm Bottom Strut)
