VISUAL INSPECTION AND EVALUATION REPORT

Rockwall-Forney Dam
Dallas Water Utilities
Dallas/Kaufman Counties, Texas

Schnabel Reference #20C22001.00
July 30, 2021

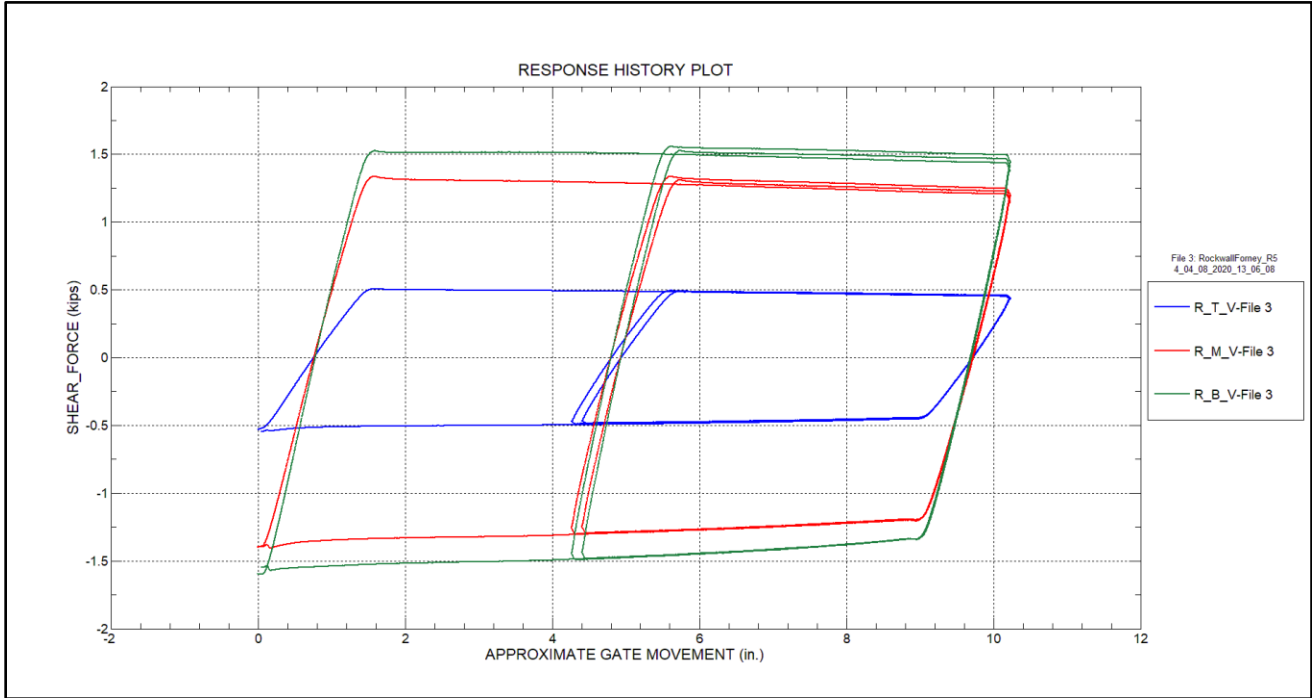
Figure 19 – Strut shear response history – Right arm

(R_T = Right Arm Top Strut, R_M = Right Arm Middle Strut, R_B = Right Arm Bottom Strut)

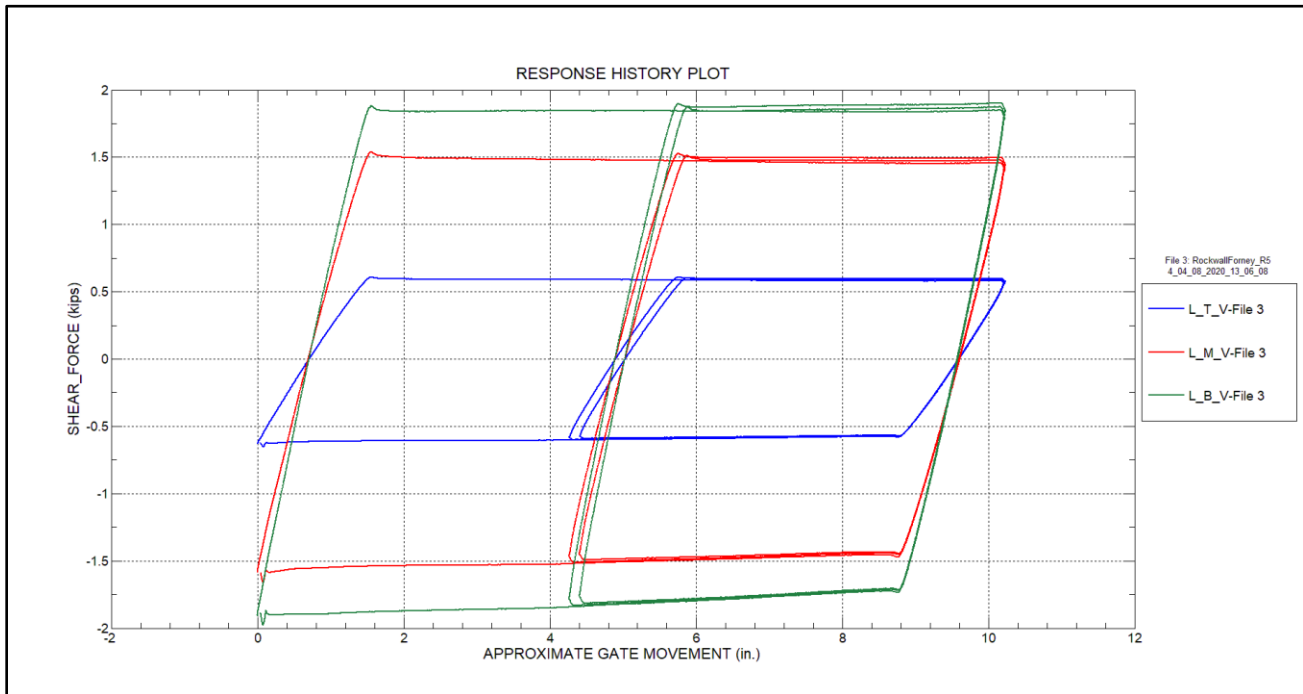
Figure 20 – Strut shear response history – Left arm

(L_T = Left Arm Top Strut, L_M = Left Arm Middle Strut, L_B = Left Arm Bottom Strut)

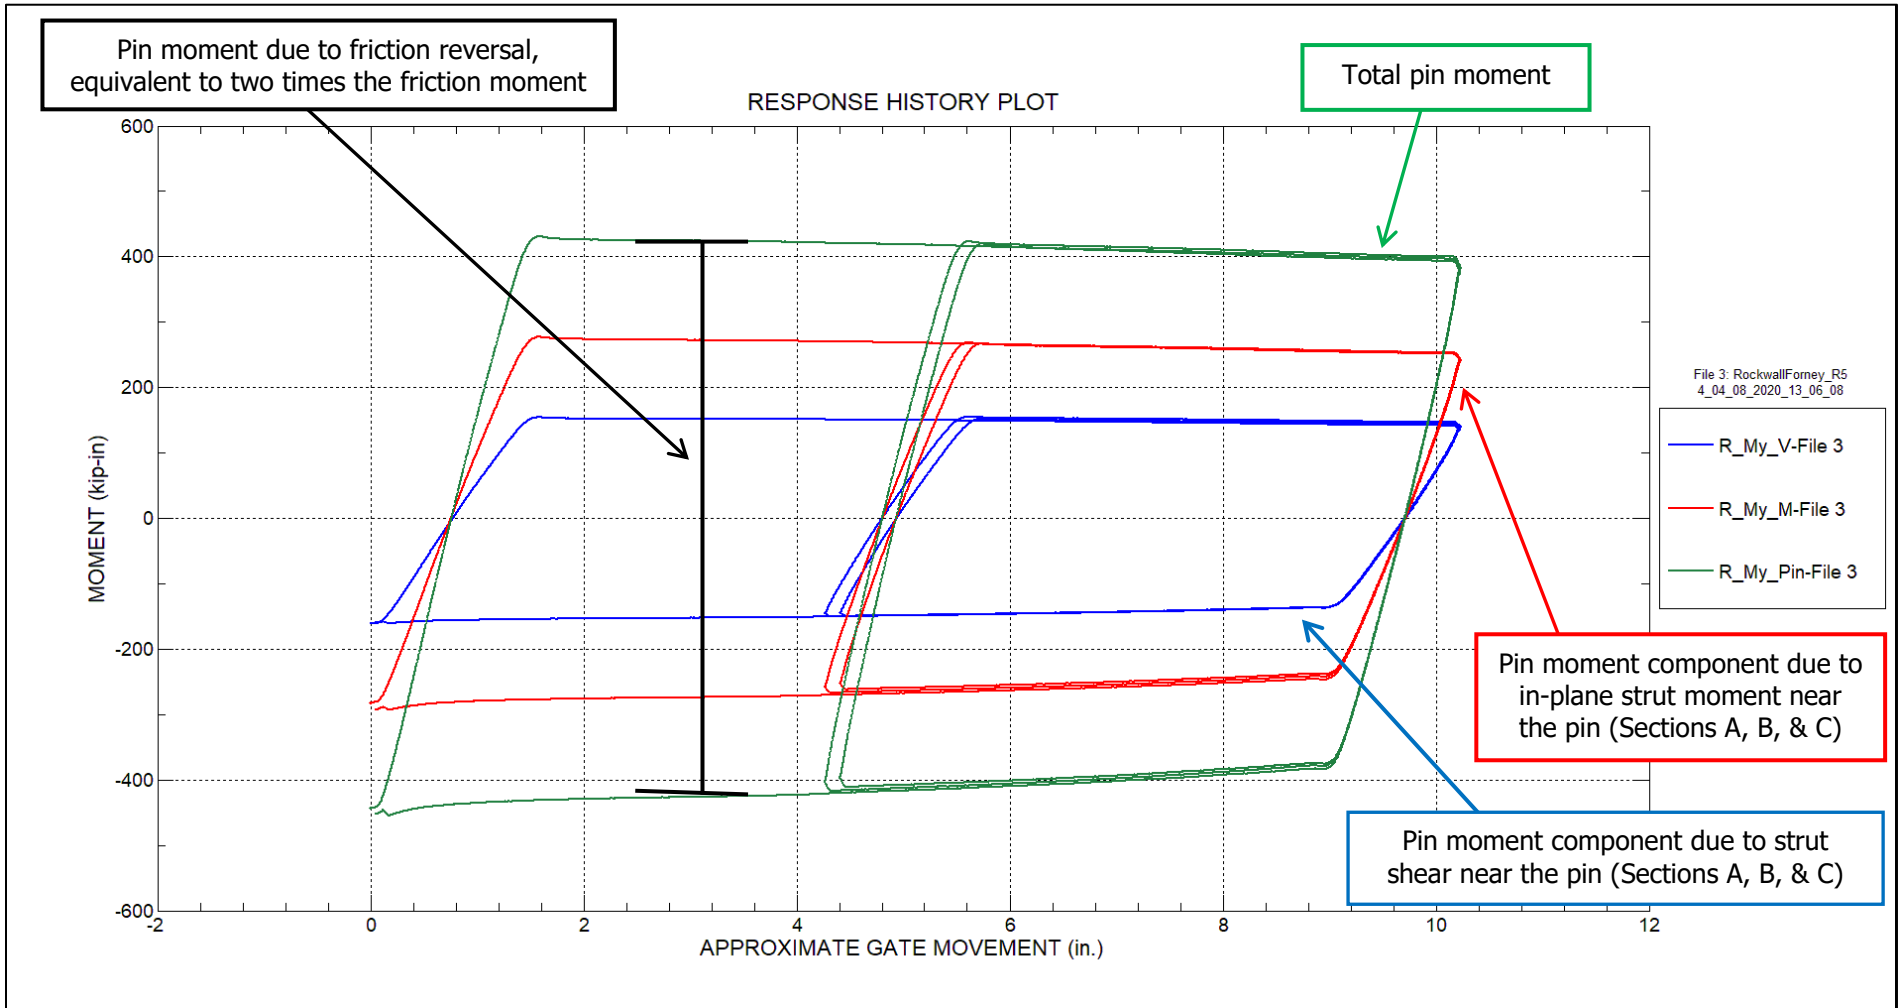
Figure 21 – Pin moment response history – Right arm

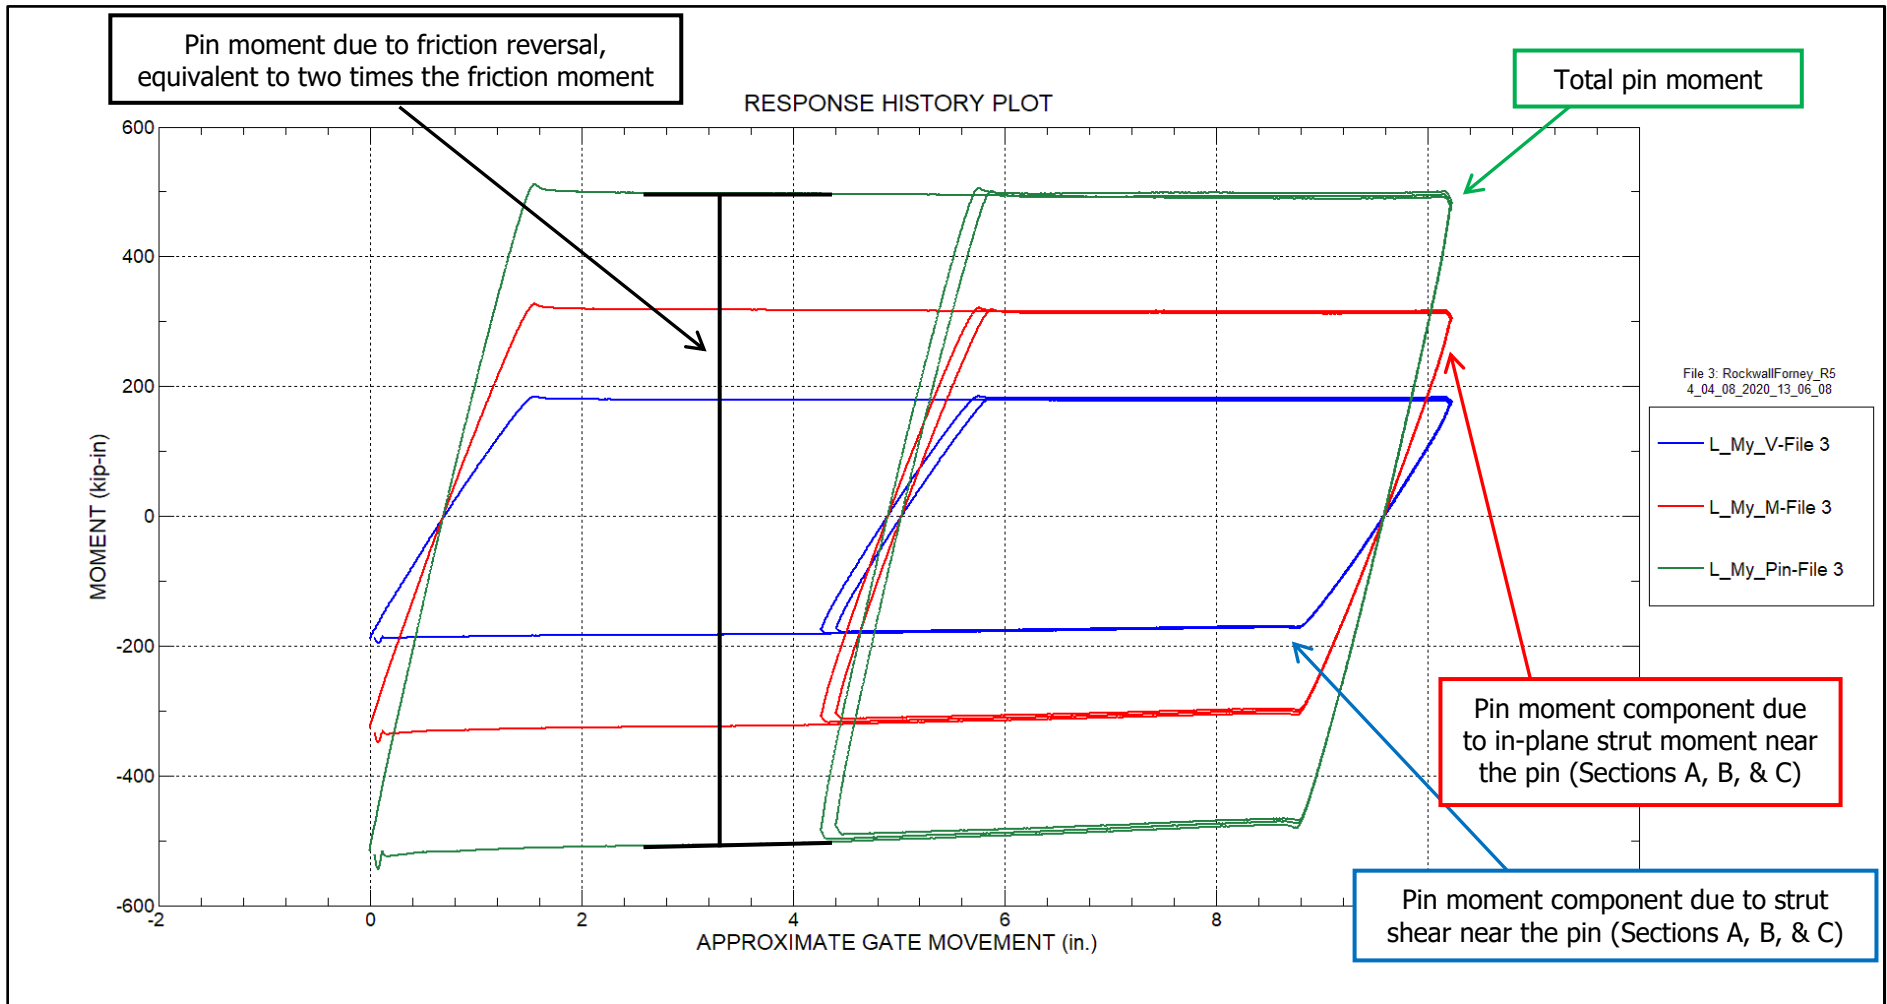
Figure 22 – Pin moment response history – Left arm

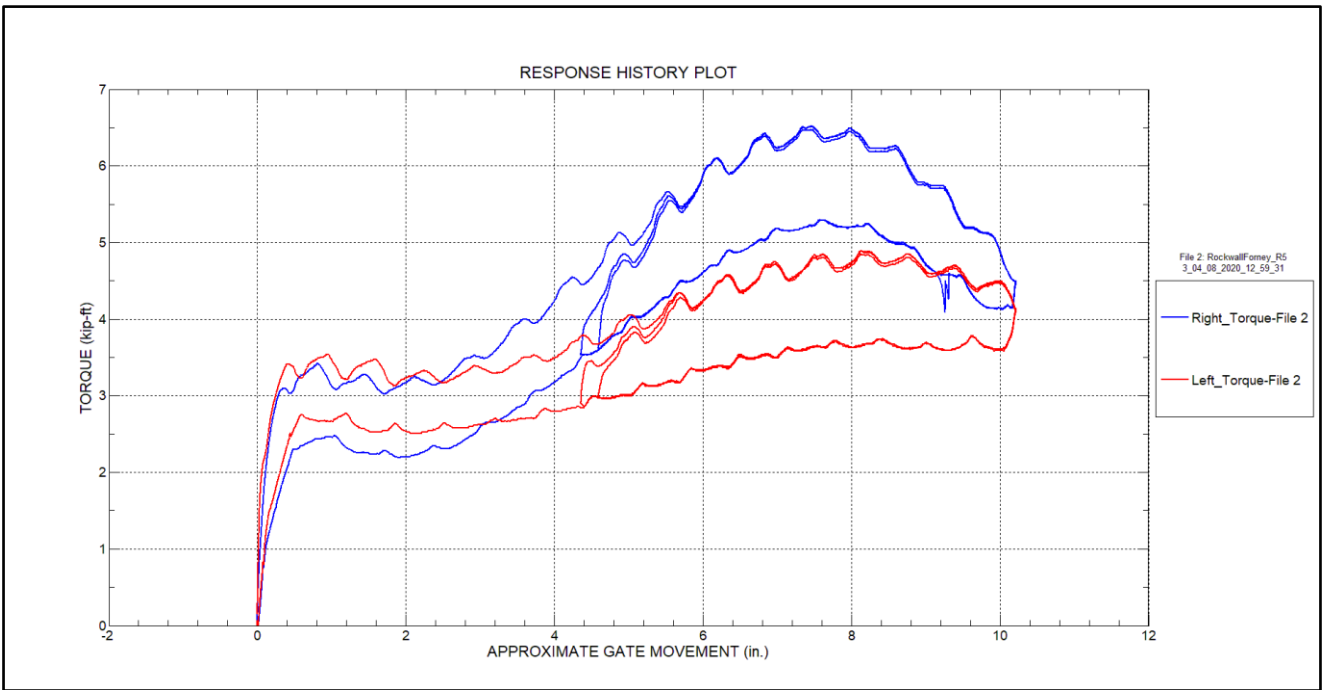
Figure 23 – Hoist torque response history – Gate 9 – Test 2

Figure 23 shows example torque measurements, recorded on the Gate 9 torque shafts. Best practices for torque measurements is to measure torque on opposite sides of the shaft so that any bending in the shaft can be removed by averaging the two responses. Due to access limitations, only one gage at each location could be installed. Therefore, any bending in the shaft may be reflected in the torque measurements and may be related to the peaks and valleys observed in the torque responses.

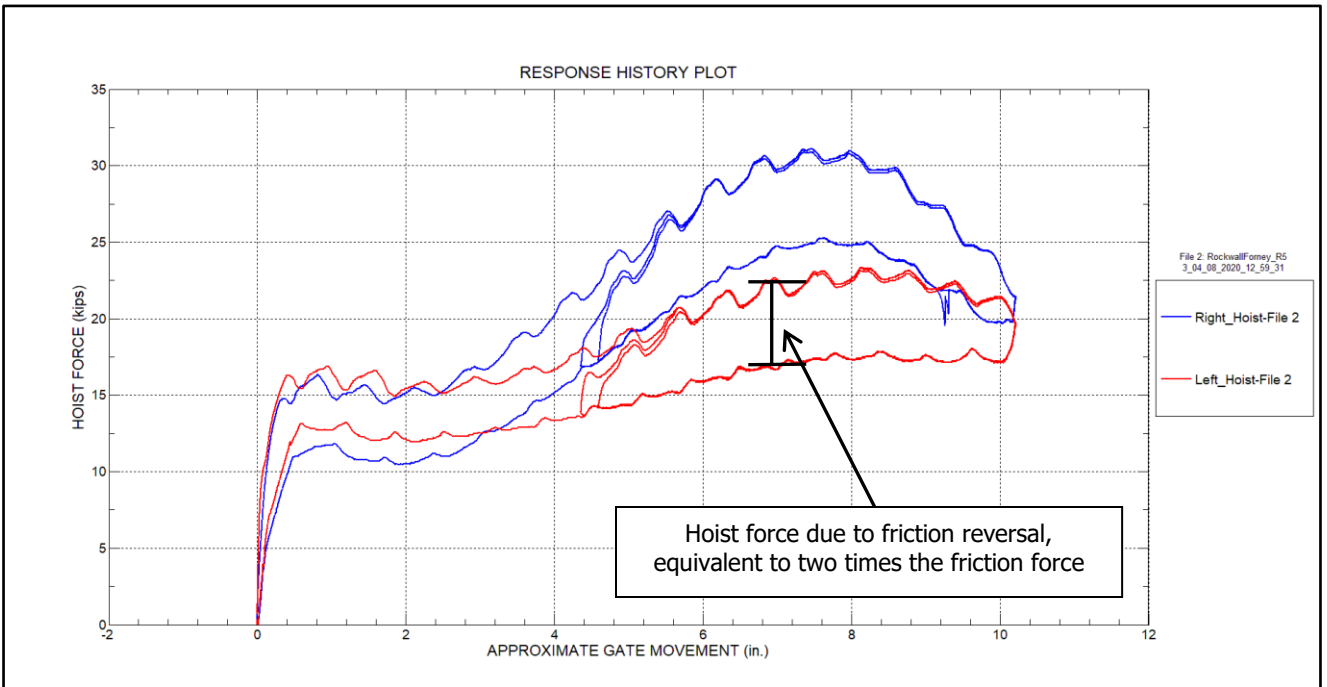
Figure 24 – Hoist force response history – Gate 9 – Test 2

Torque values were converted to force in the hoist cables per gate arm using the gear ratio and drum radius, as shown in Figure 24. The gear ratio and drum radius were 5.182 and 1.086 feet respectively, as defined in the provided as-built shop drawings. It should be noted that the hoist force calculated may be smaller than the actual hoist force applied. This difference is due to the limit switch engaging the brake before the hoist cable was fully slacked, resulting in an initial force in the cable. A hoist force due to total gate friction was then calculated. This friction hoist force was equal to half the differential in force measured during the lifting and lowering of the gate (similar to the pin friction calculations). As shown in Table 3, the change in cable force due to friction was generally consistent between tests. Note that the total hoist force was due to the total friction effects, including side seal, hoist bearings, trunnion friction effects, etc. It is difficult to determine the exact proportion and composition of the total friction sources. Additional torque and hoist force plots for all collected data files are provided in Appendix A – Gate 9 Torque and Hoist Force Plots.

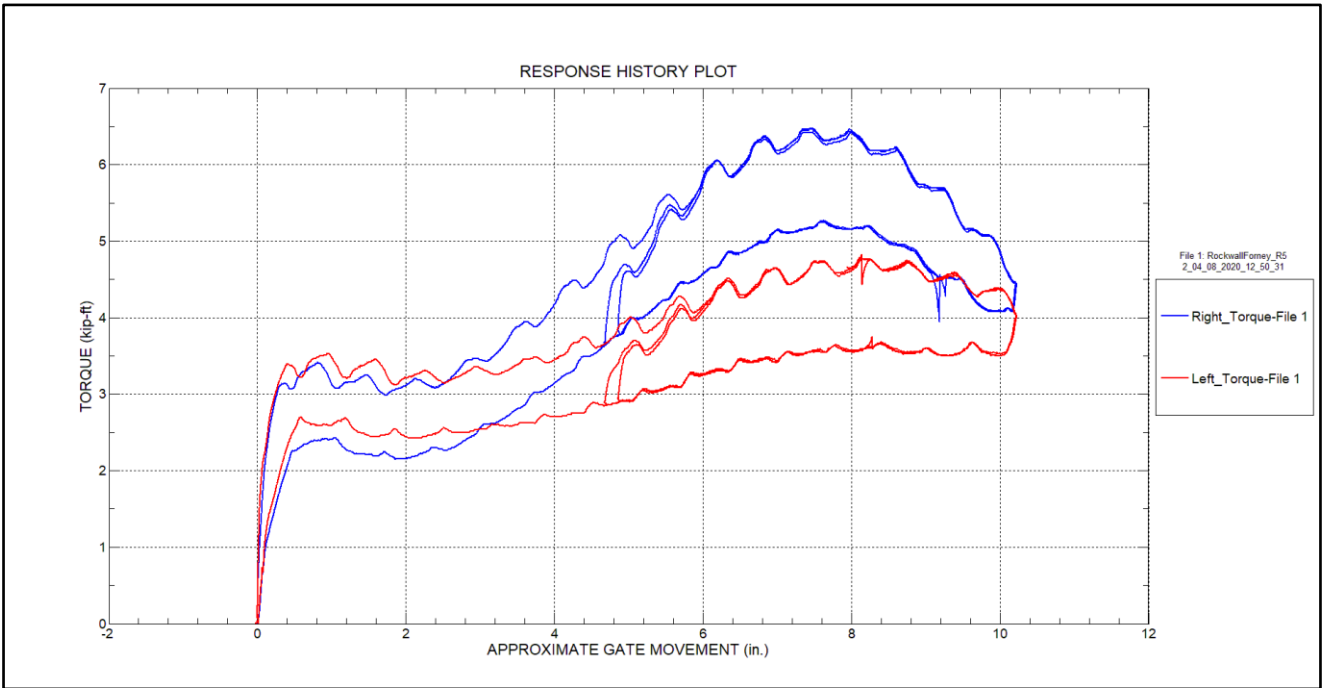
Figure 25 – Hoist torque response history – Gate 9 – Test 1

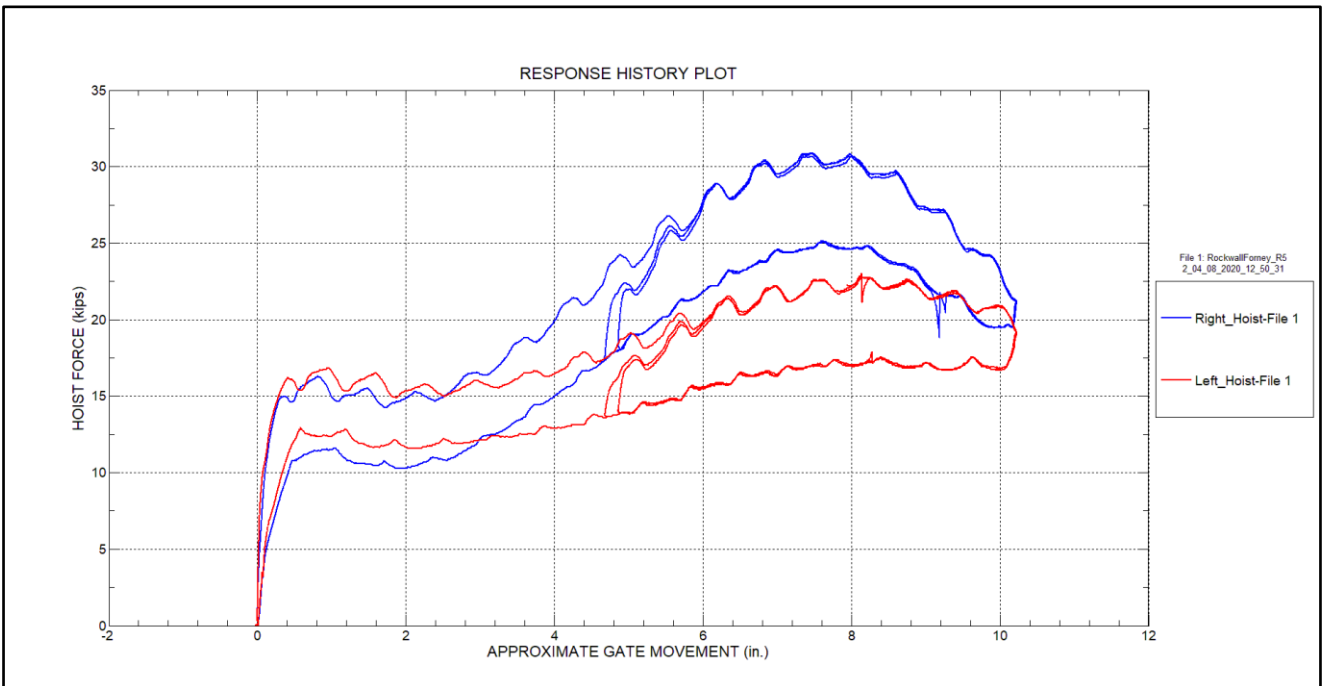
Figure 26 – Hoist force response history – Gate 9 – Test 1

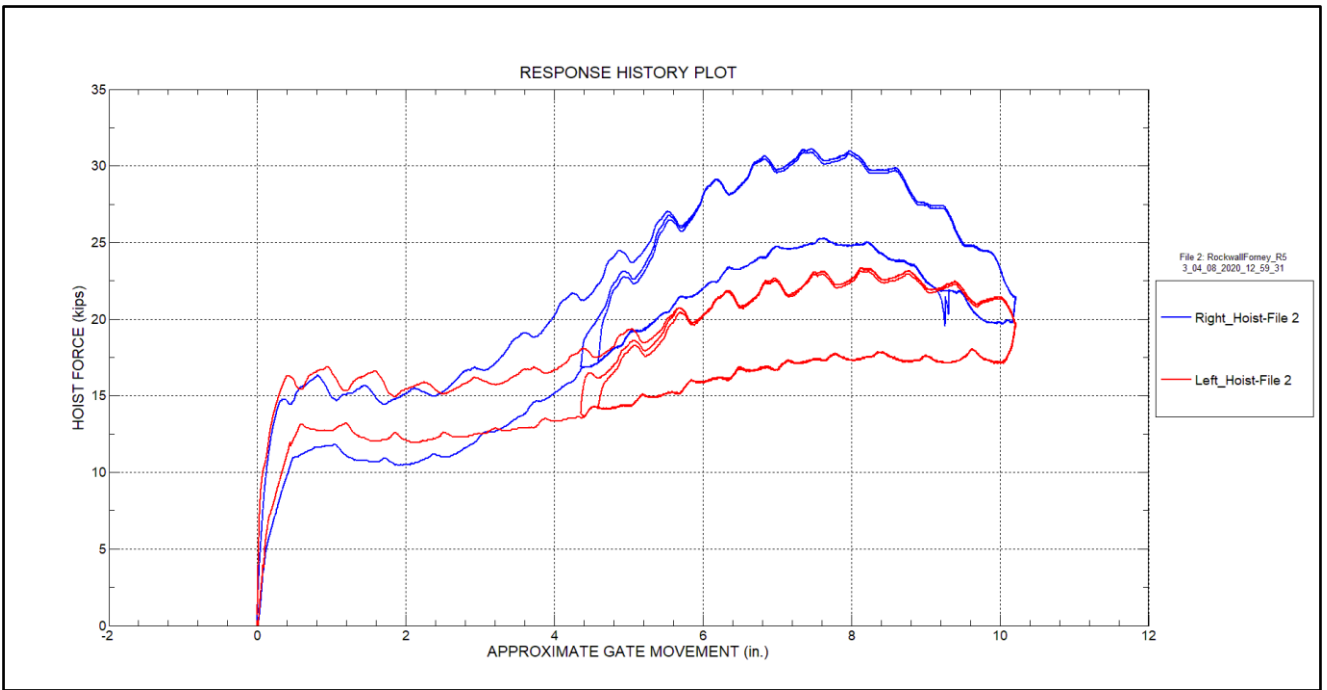
Figure 28 – Hoist force response history – Gate 9 – Test 2

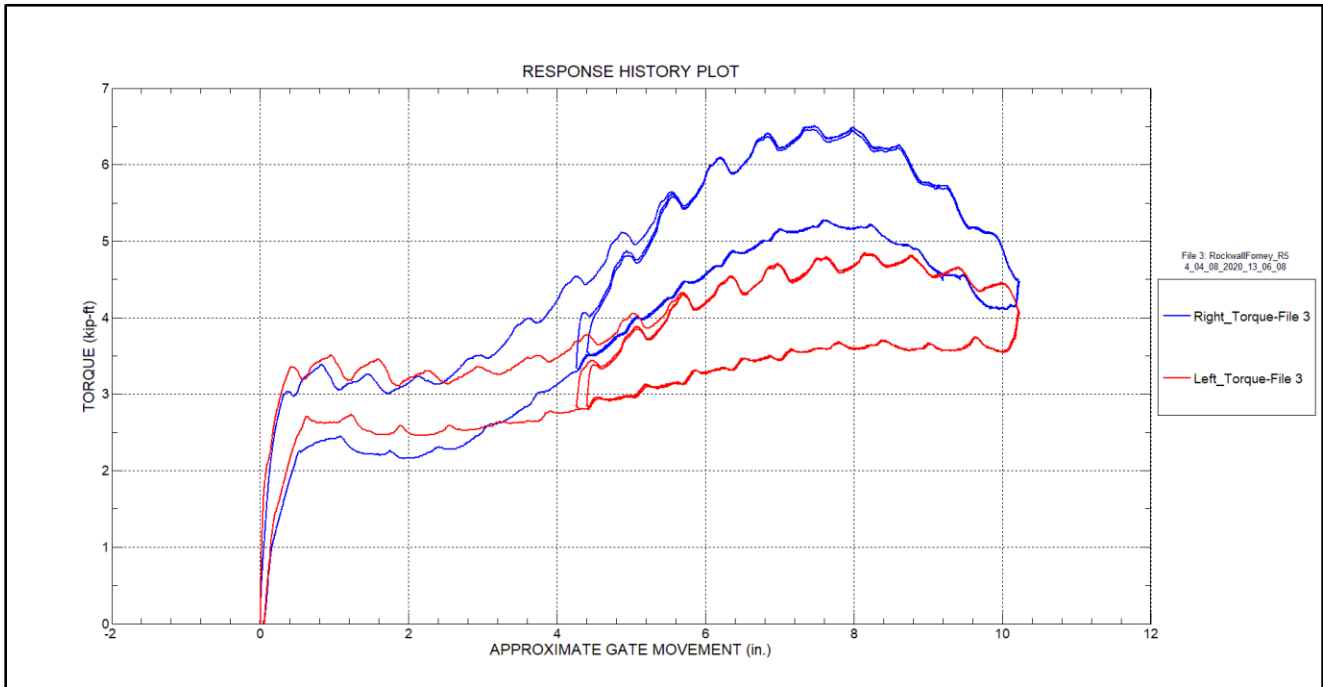
Figure 29 – Hoist torque response history – Gate 9 – Test 3

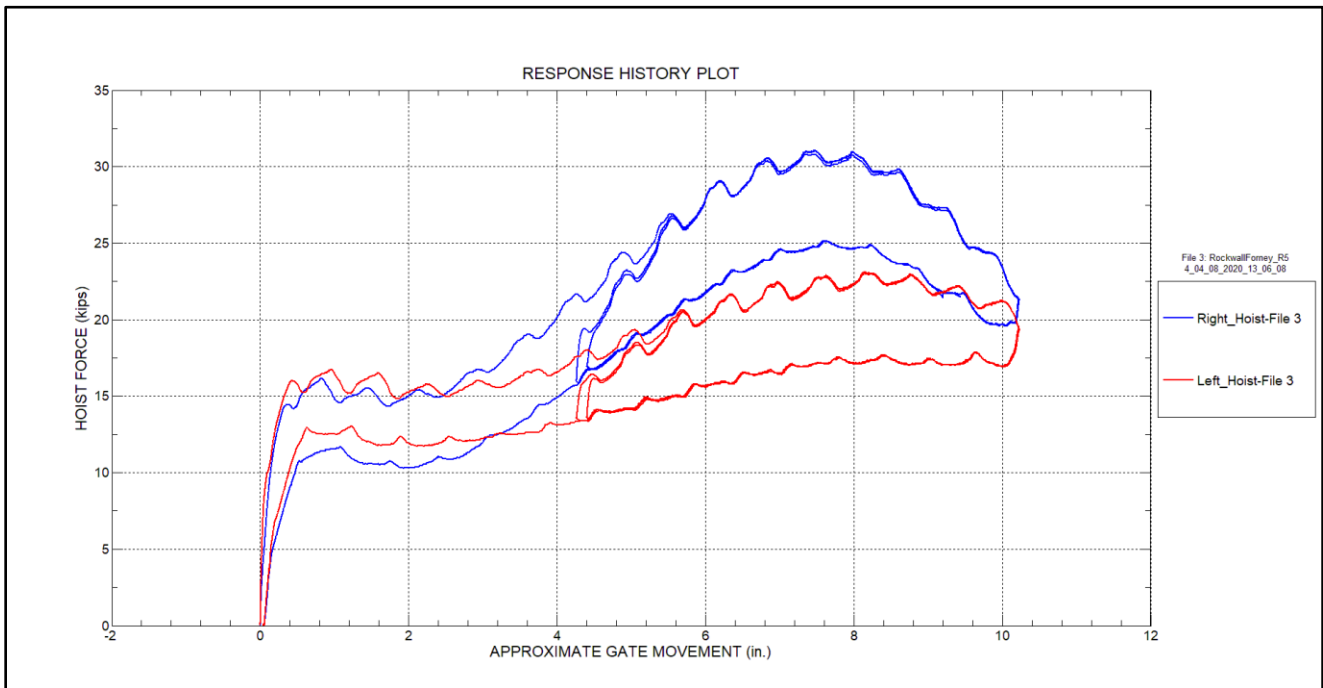
Figure 30 – Hoist force response history – Gate 9 – Test 3

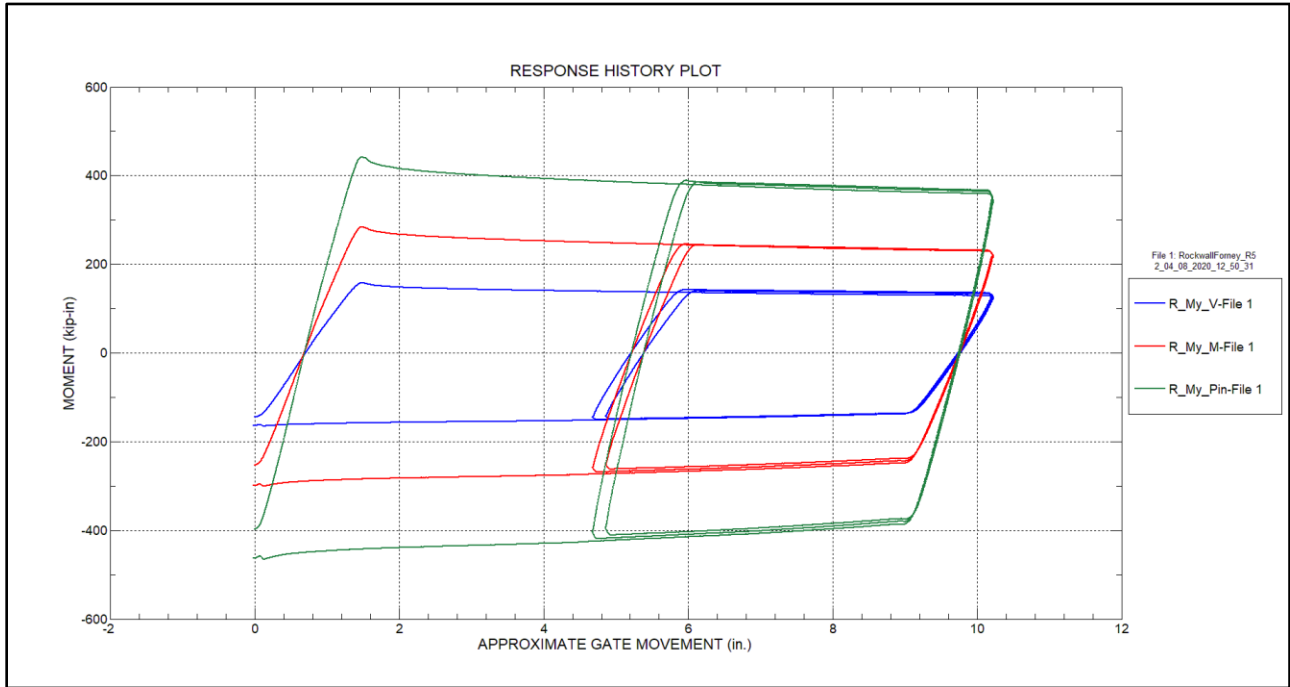
Figure 31 – Pin moment response history – Right arm – Test run 1

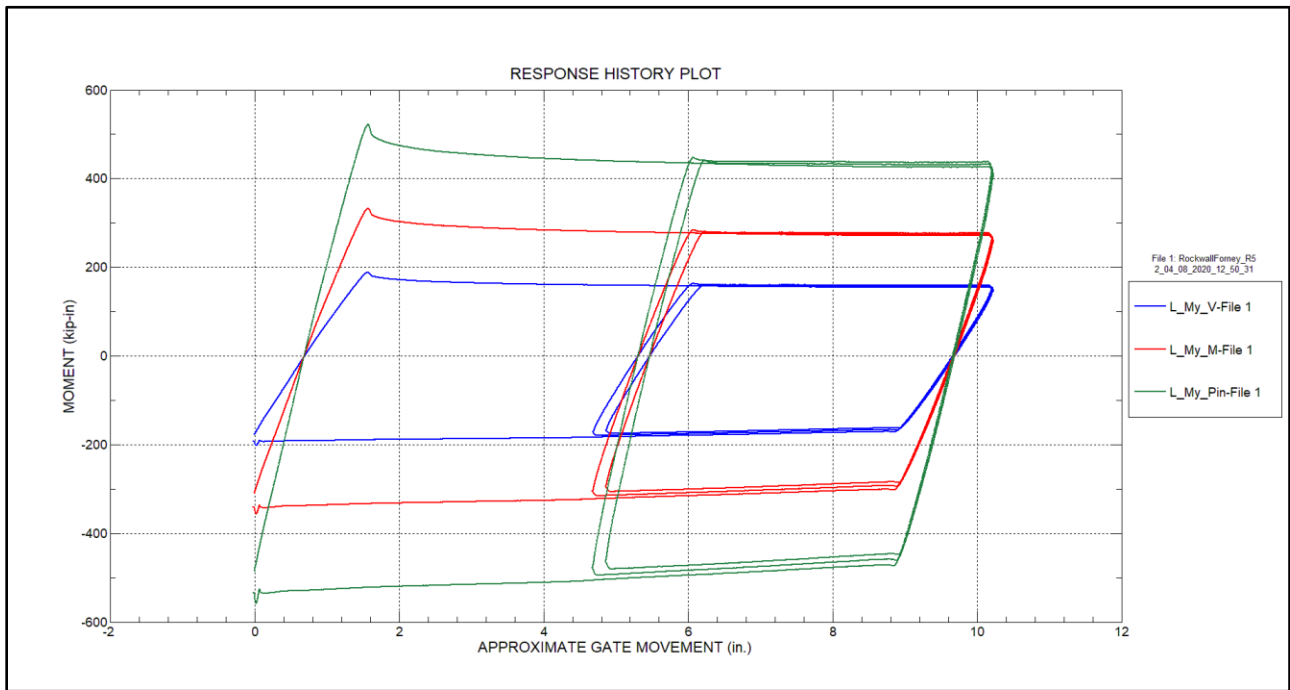
Figure 32 – Pin moment response history – Left arm – Test run 1

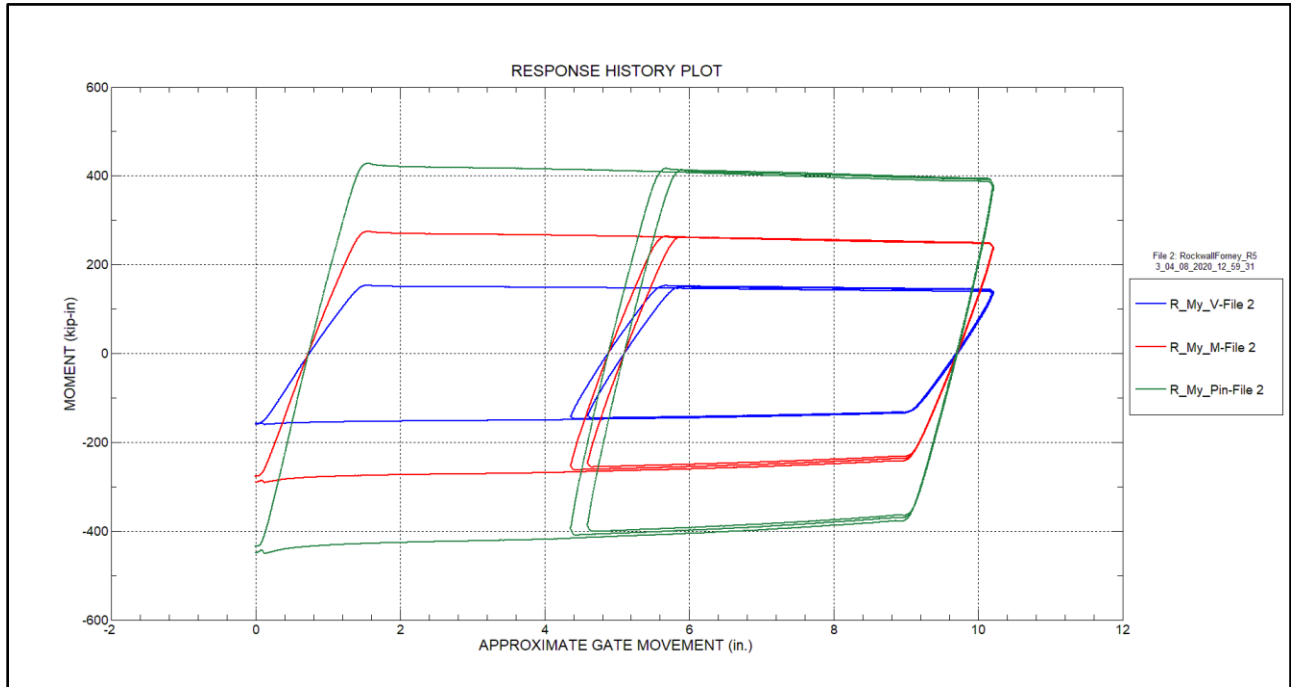
Figure 33 – Pin moment response history – Right arm – Test run 2

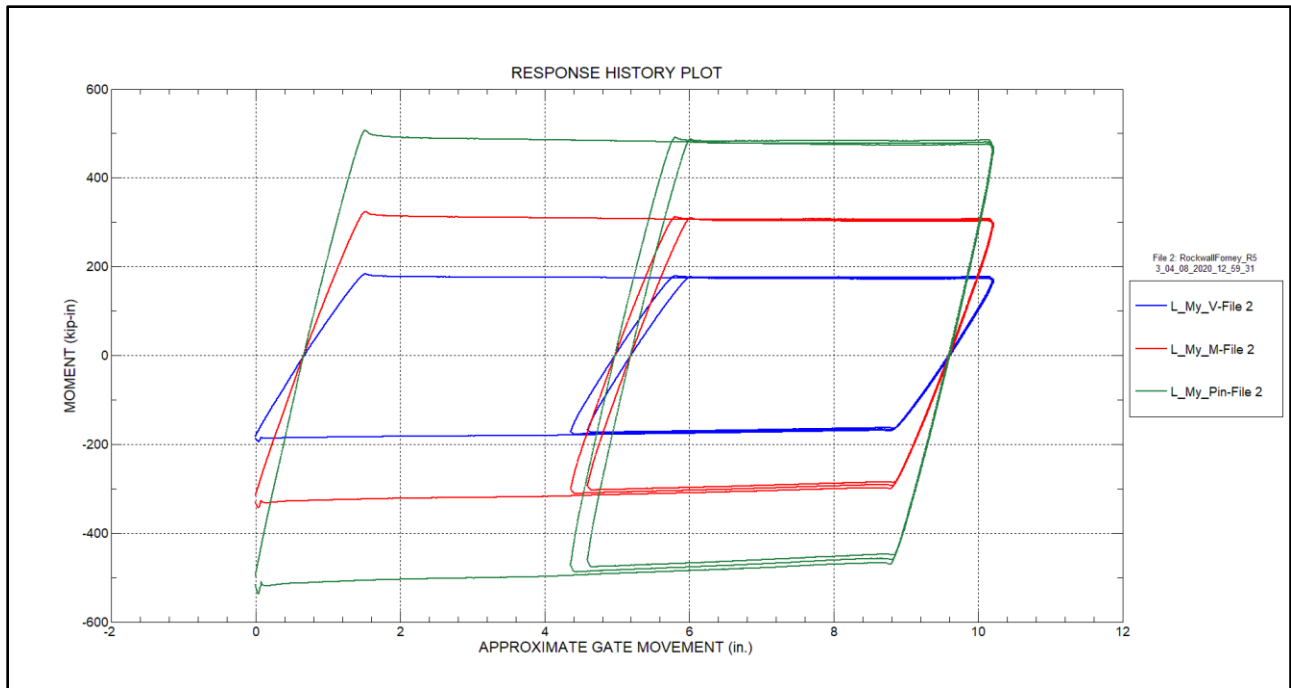
Figure 34 – Pin moment response history – Left arm – Test run 2

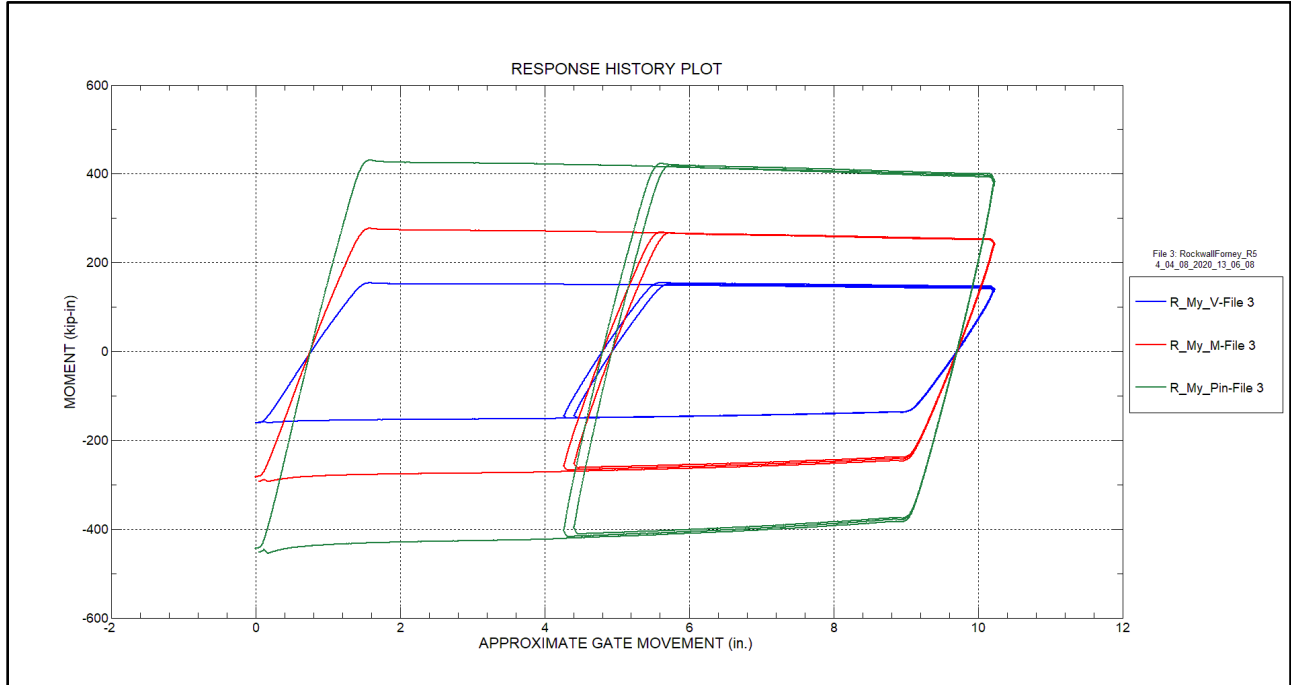
Figure 35 – Pin moment response history – Right arm – Test run 3

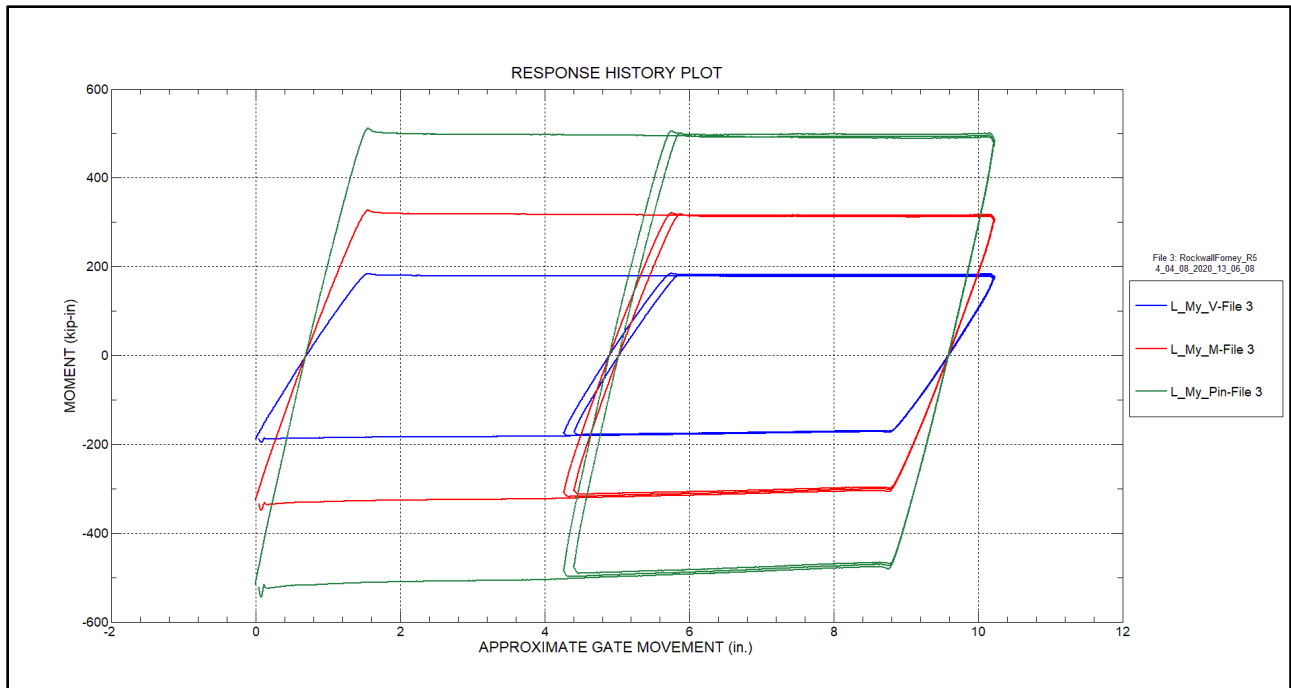
Figure 36 – Pin moment response history – Left arm – Test run 3

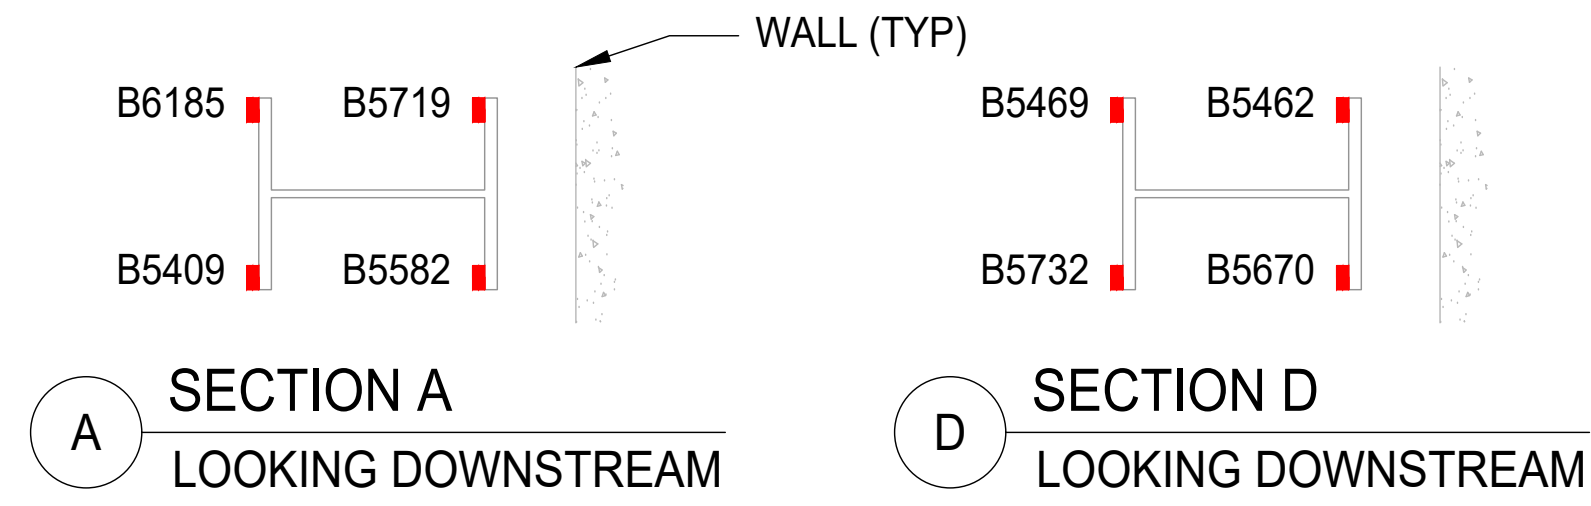
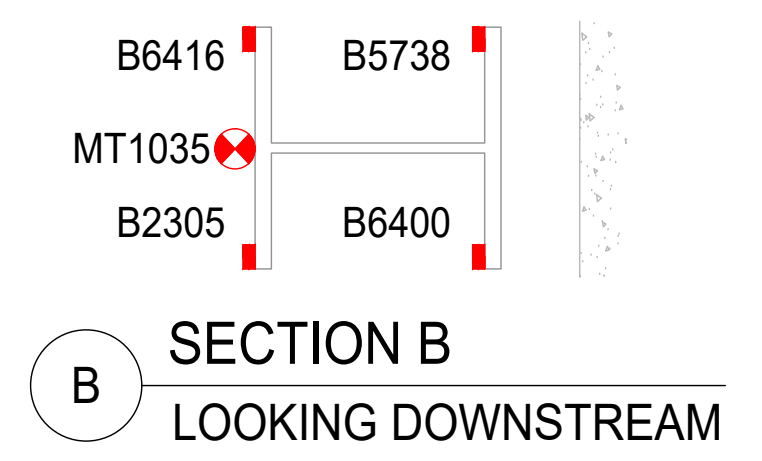
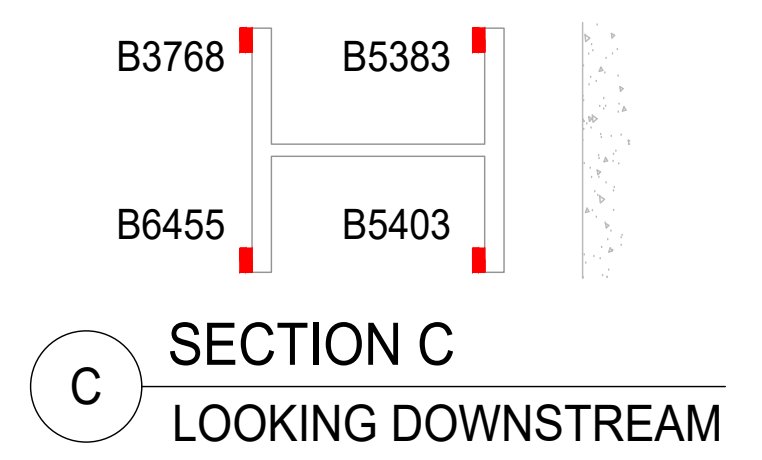
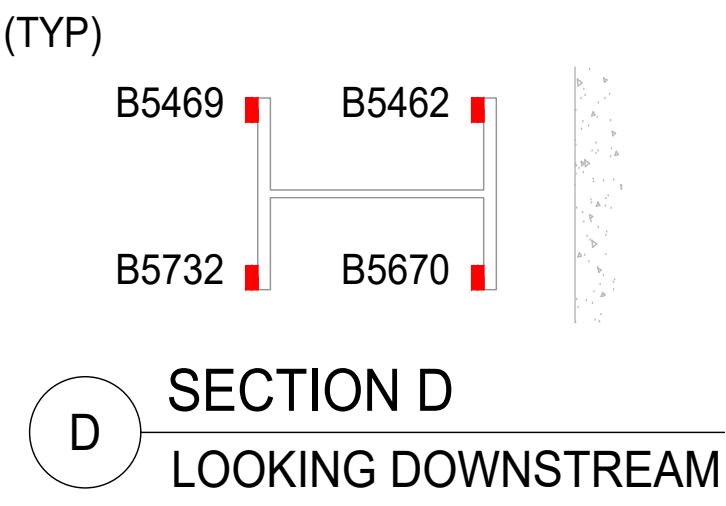
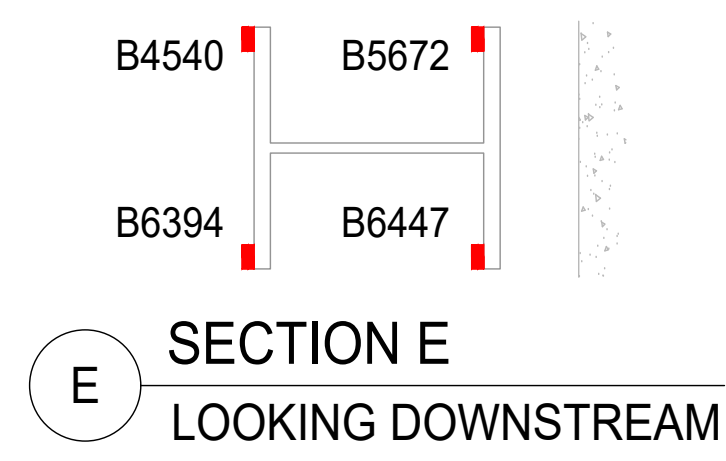
1 GATE 9
RIGHT ARM

- NOTES:
1. SECTIONS A, B, & C SHALL BE INSTALLED 15 INCHES AWAY FROM TRUNNION PLATE.
 2. TILTMETERS SHALL BE INSTALLED CENTERED ON THE MIDDLE STRUT FLANGE.
 3. SECTION G'S TILTMETER SHALL BE INSTALLED AS CLOSE TO THE SKINPLATE AS POSSIBLE.

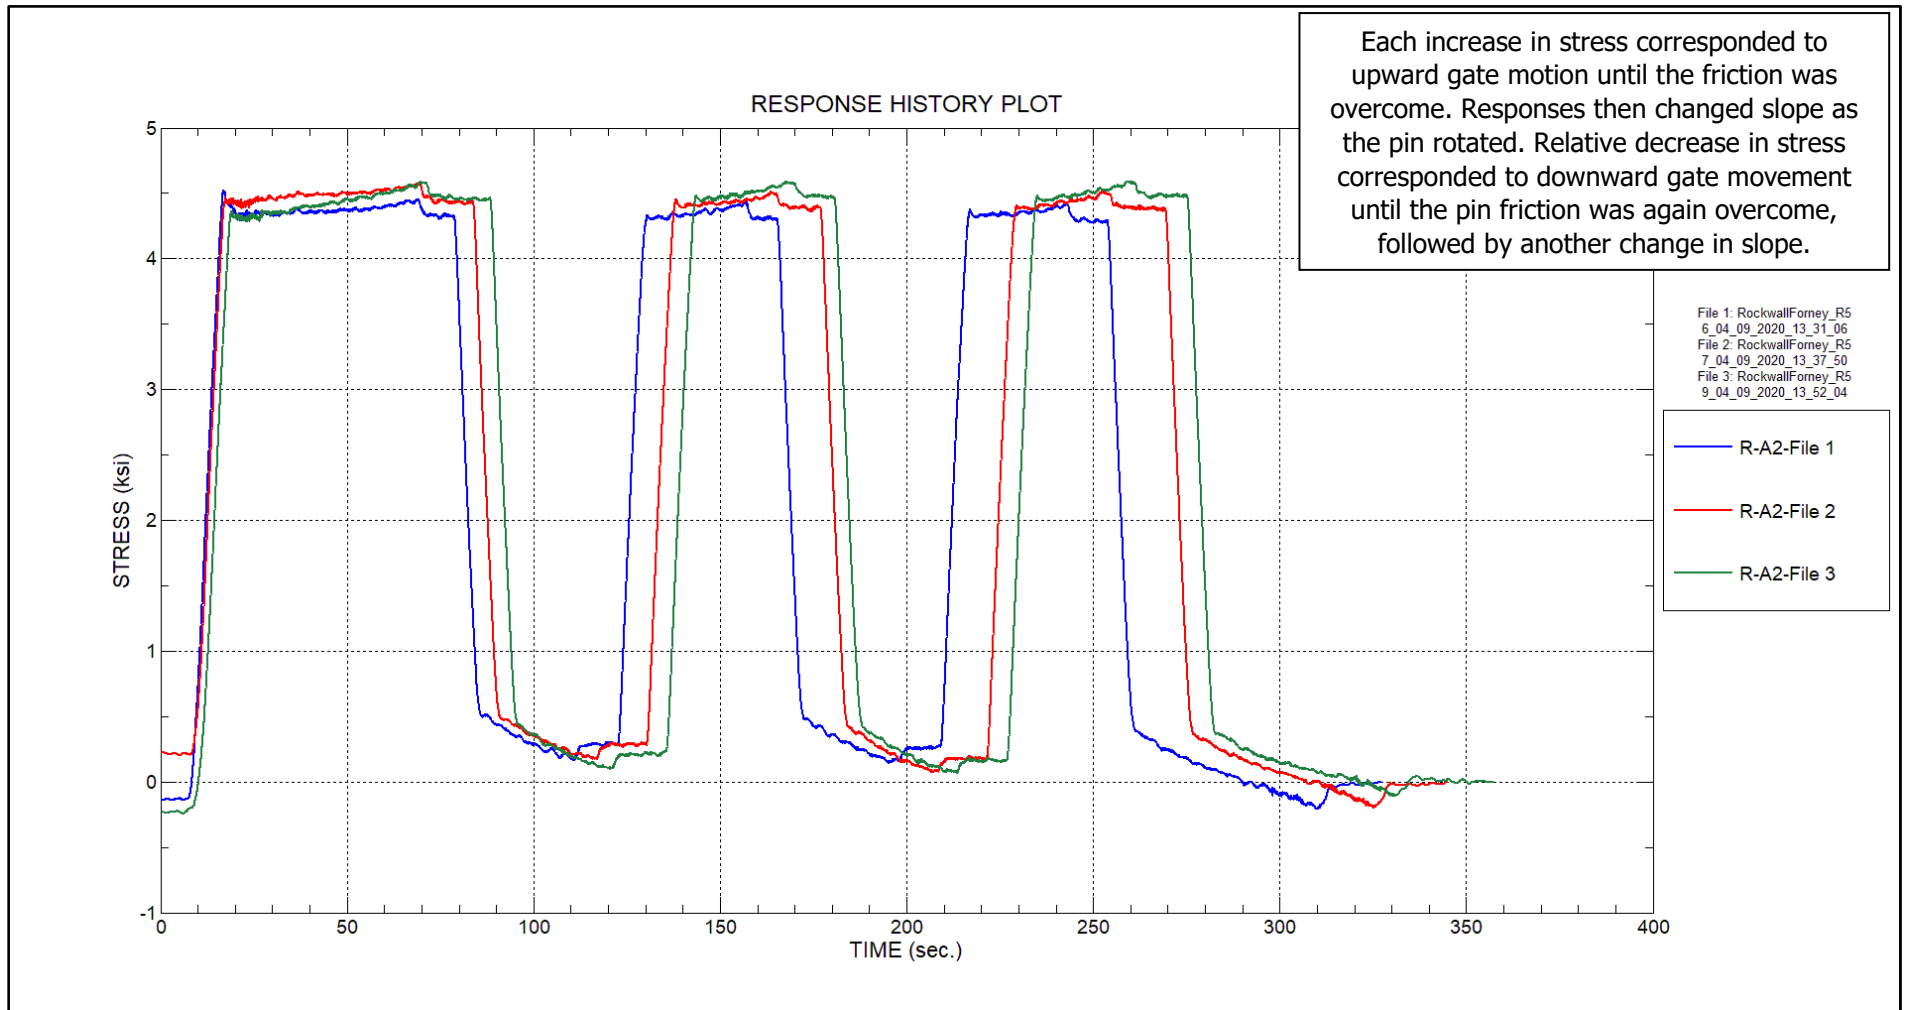
Figure 6 – Stress response history – Right arm – Gage A2 – Time based
File 1 = test run 1, File 2 = test run 2, File 3 = test run 3
(Section A along top strut near pin – Sensor location 2 along bottom of inner flange)
