VISUAL INSPECTION AND EVALUATION REPORT

Rockwall-Forney Dam
Dallas Water Utilities
Dallas/Kaufman Counties, Texas

Schnabel Reference #20C22001.00
July 30, 2021

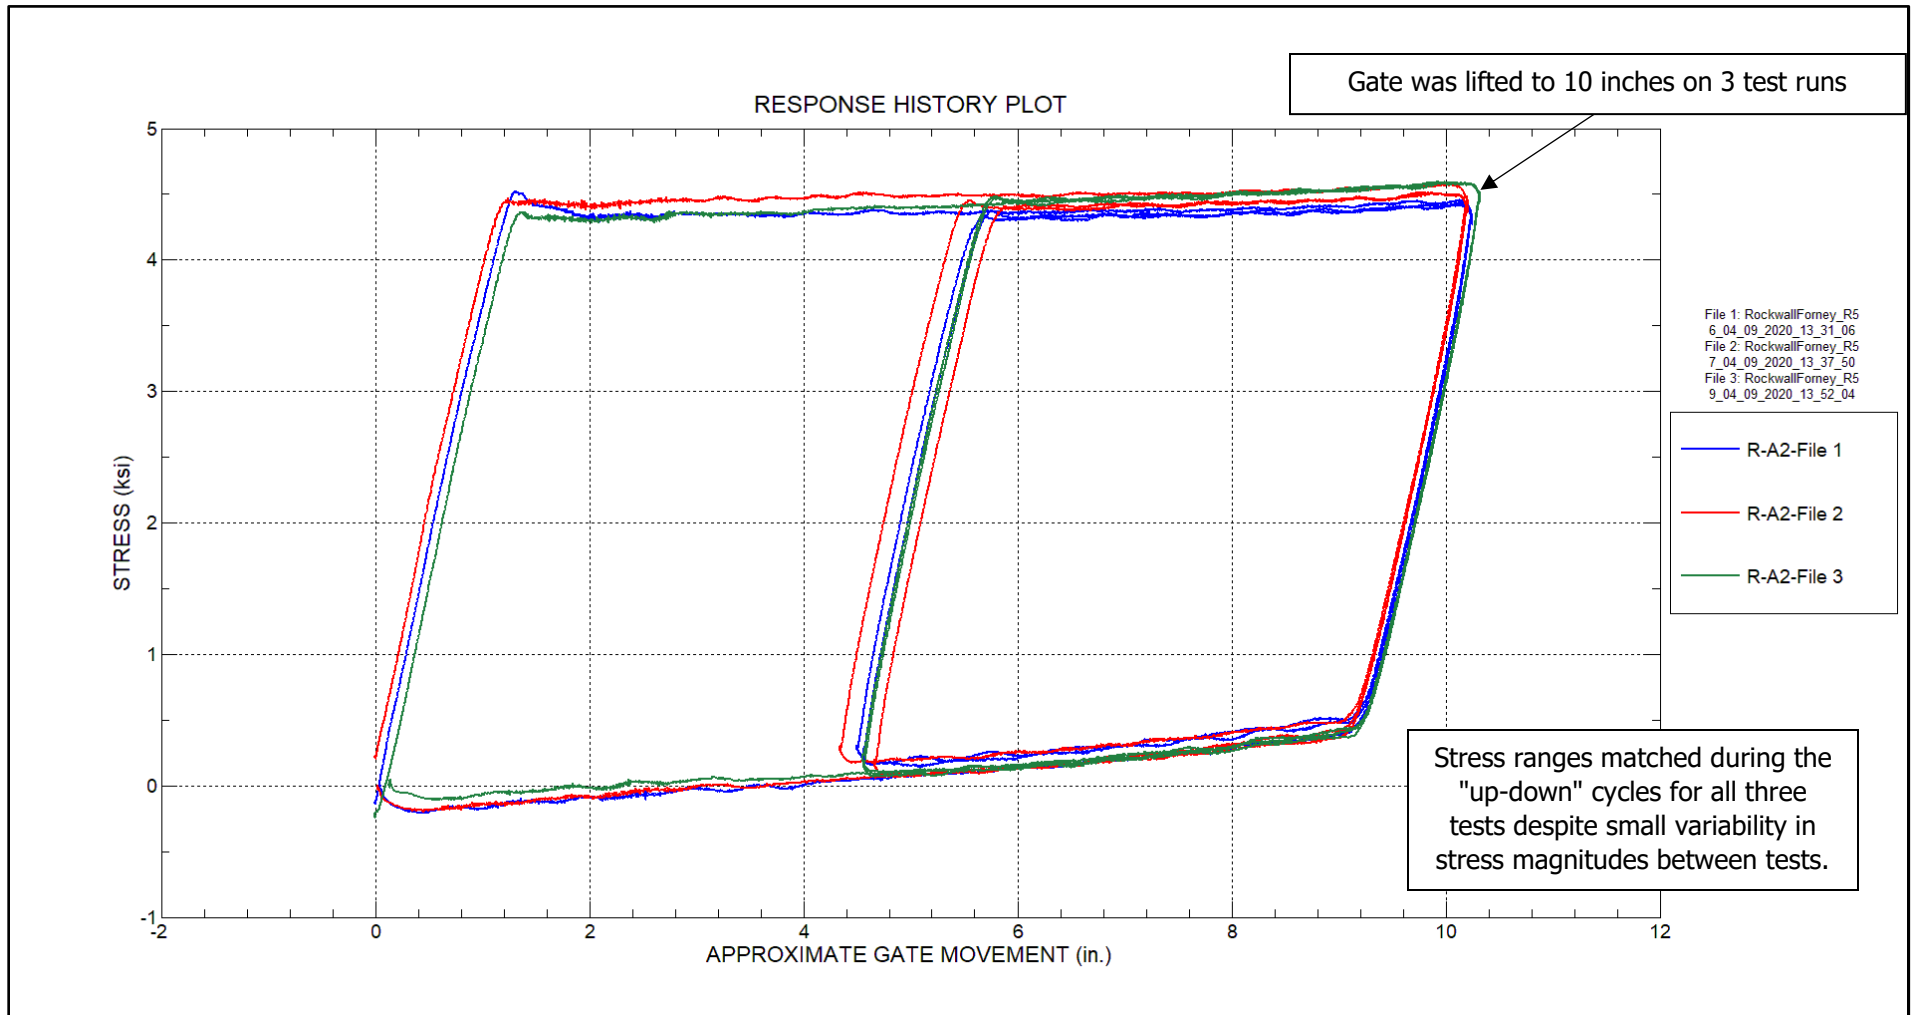
Figure 7 – Stress response history – Right arm – Gage A2 – Function of gate movement
File 1 = test run 1, File 2 = test run 2, File 3 = test run 3
(Section A along top strut near pin – Sensor location 2 along bottom of inner flange)

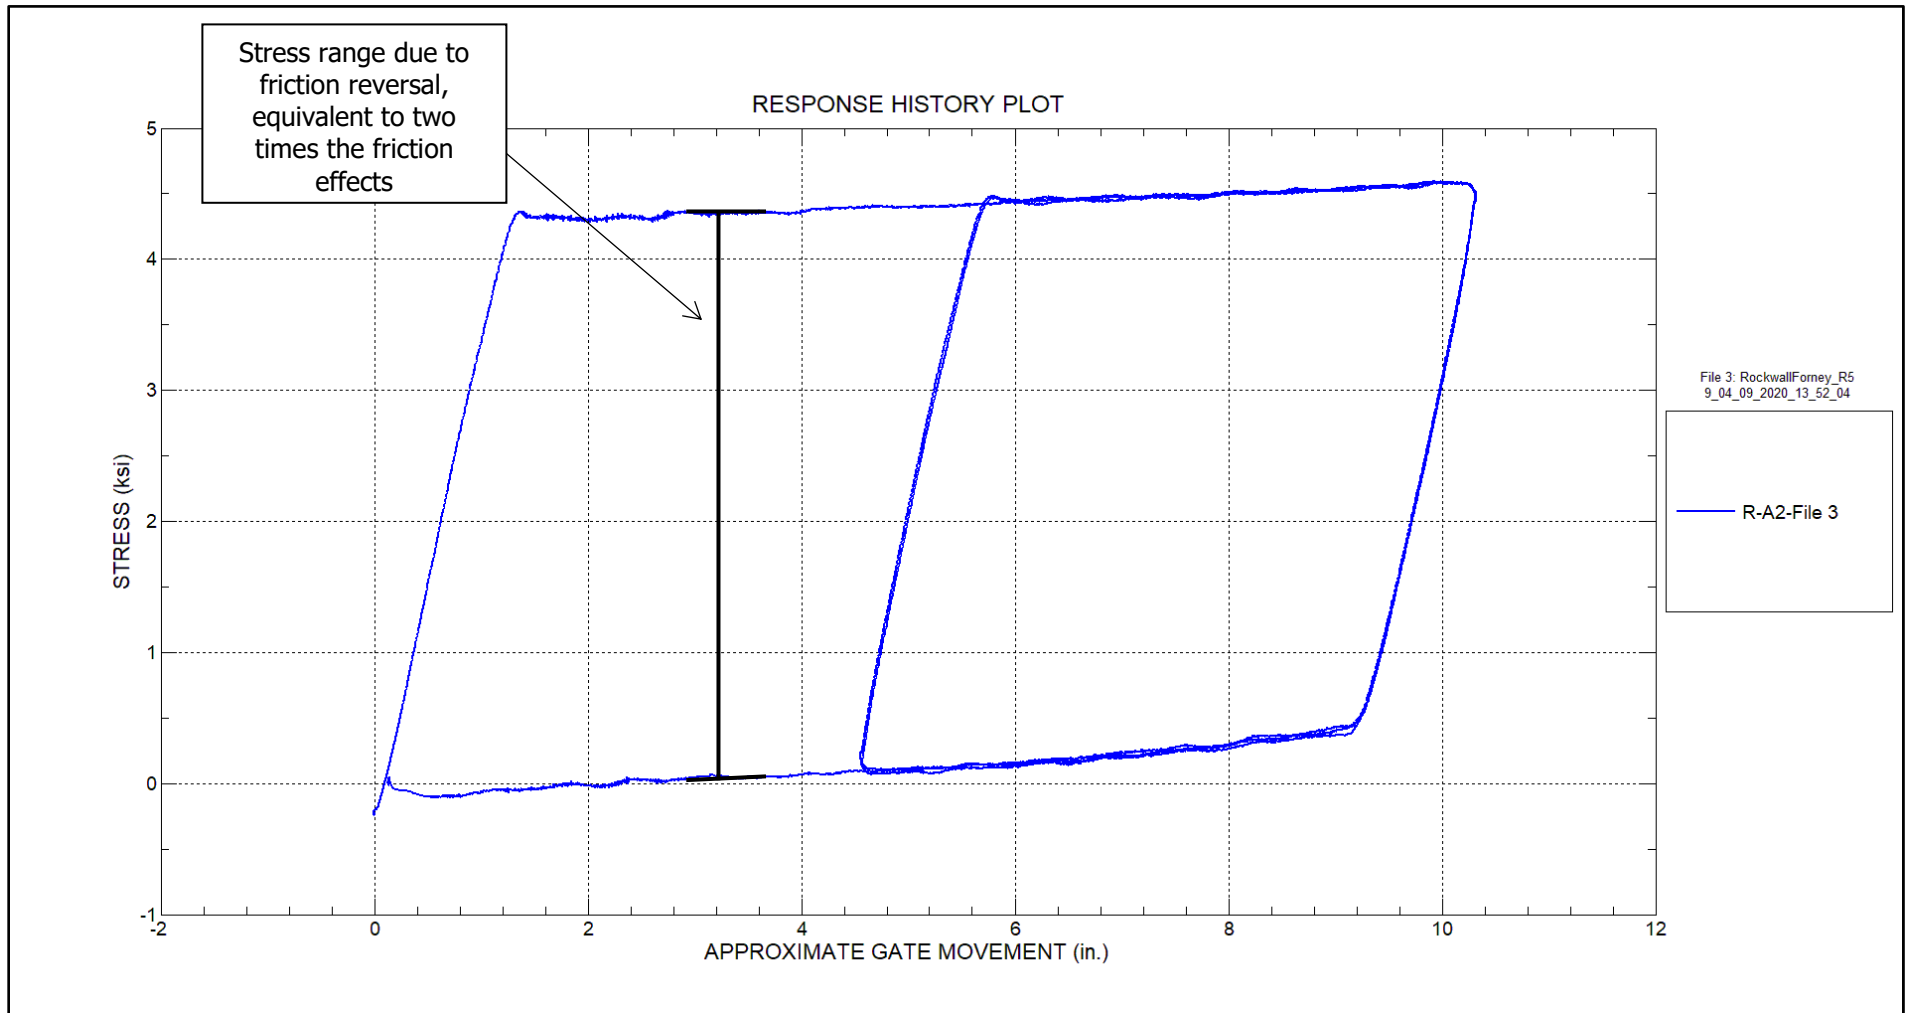
Figure 8 – Stress response history – Right arm – Gage A2 – Friction effect in stress responses
(Section A along top strut near pin – Sensor location 2 along bottom of inner flange)

- + **DIRECTION/FRICTION REVERSAL IN RESPONSES:** The difference in stress during gate opening and closing for a given position is shown in Figure 8. The stress variation at any given gate position was a result of direction reversal and in turn due to trunnion friction reversal. This statement is true since all other loads such as dead-load and hydrostatic pressure were essentially constant barring small changes in hydrostatic pressure due to slight changes in head. This direction/friction reversal is depicted in Figure 9, with deflected shape renderings from a gate arm finite element model under lifting and lowering loads. Note that this figure shows an arm configuration that does not match this gate, but the concept of the direction/friction reversal still applies.

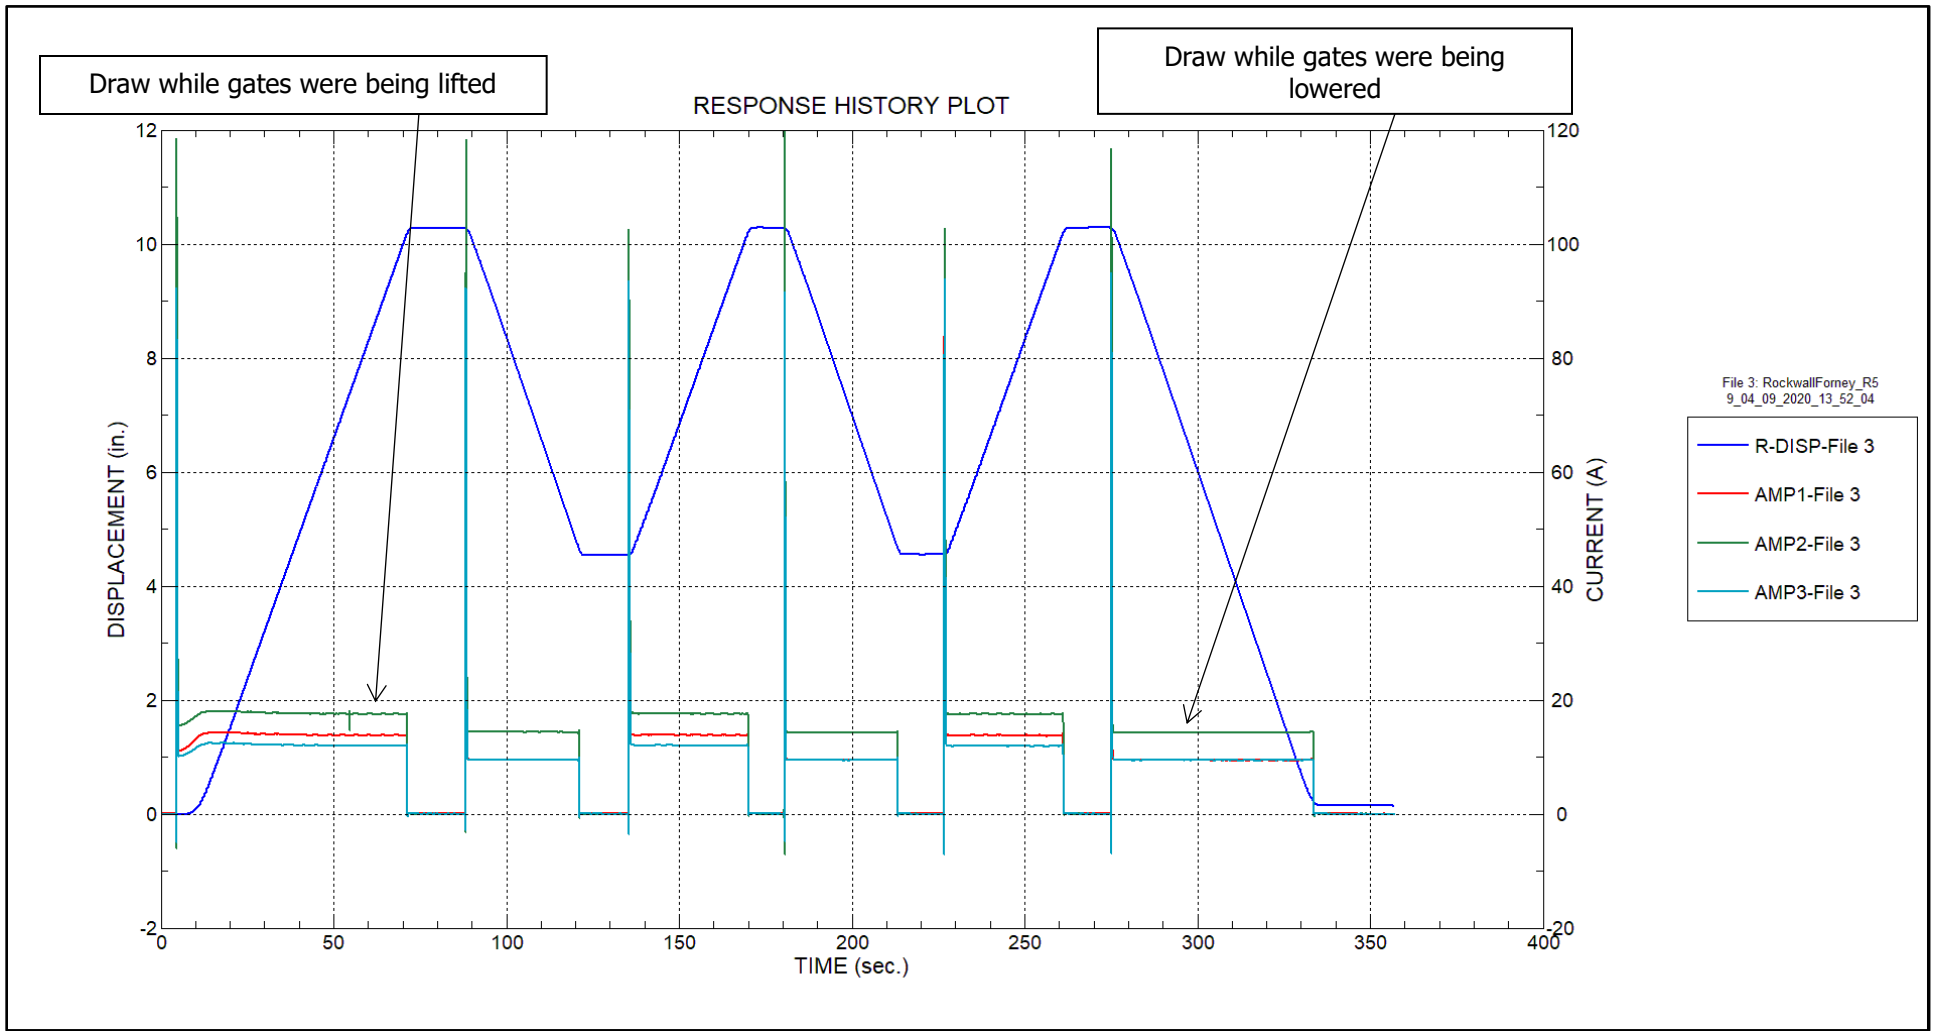
Figure 10 – Motor current & gate movement response history – Lift motor – Highlighting motor draw during lift and lower cycles

- + **MOTOR PERFORMANCE:** Current measurements taken at the hoist motor indicated steady and stable current draws during the lifting and lowering portions. An example plot of current draw and gate position is provided in Figure 10. Current draw ranges during lifting were higher than the ranges during lowering, which is common due to gravity/dead load. These results are summarized along with recorded peak in-rush current in Table 2. Note that the sample rates used during testing were set for collecting gate responses and may not have been appropriate to fully capture the in-rush current. The readings should be evaluated by a licensed electrician with knowledge of the operating parameters.

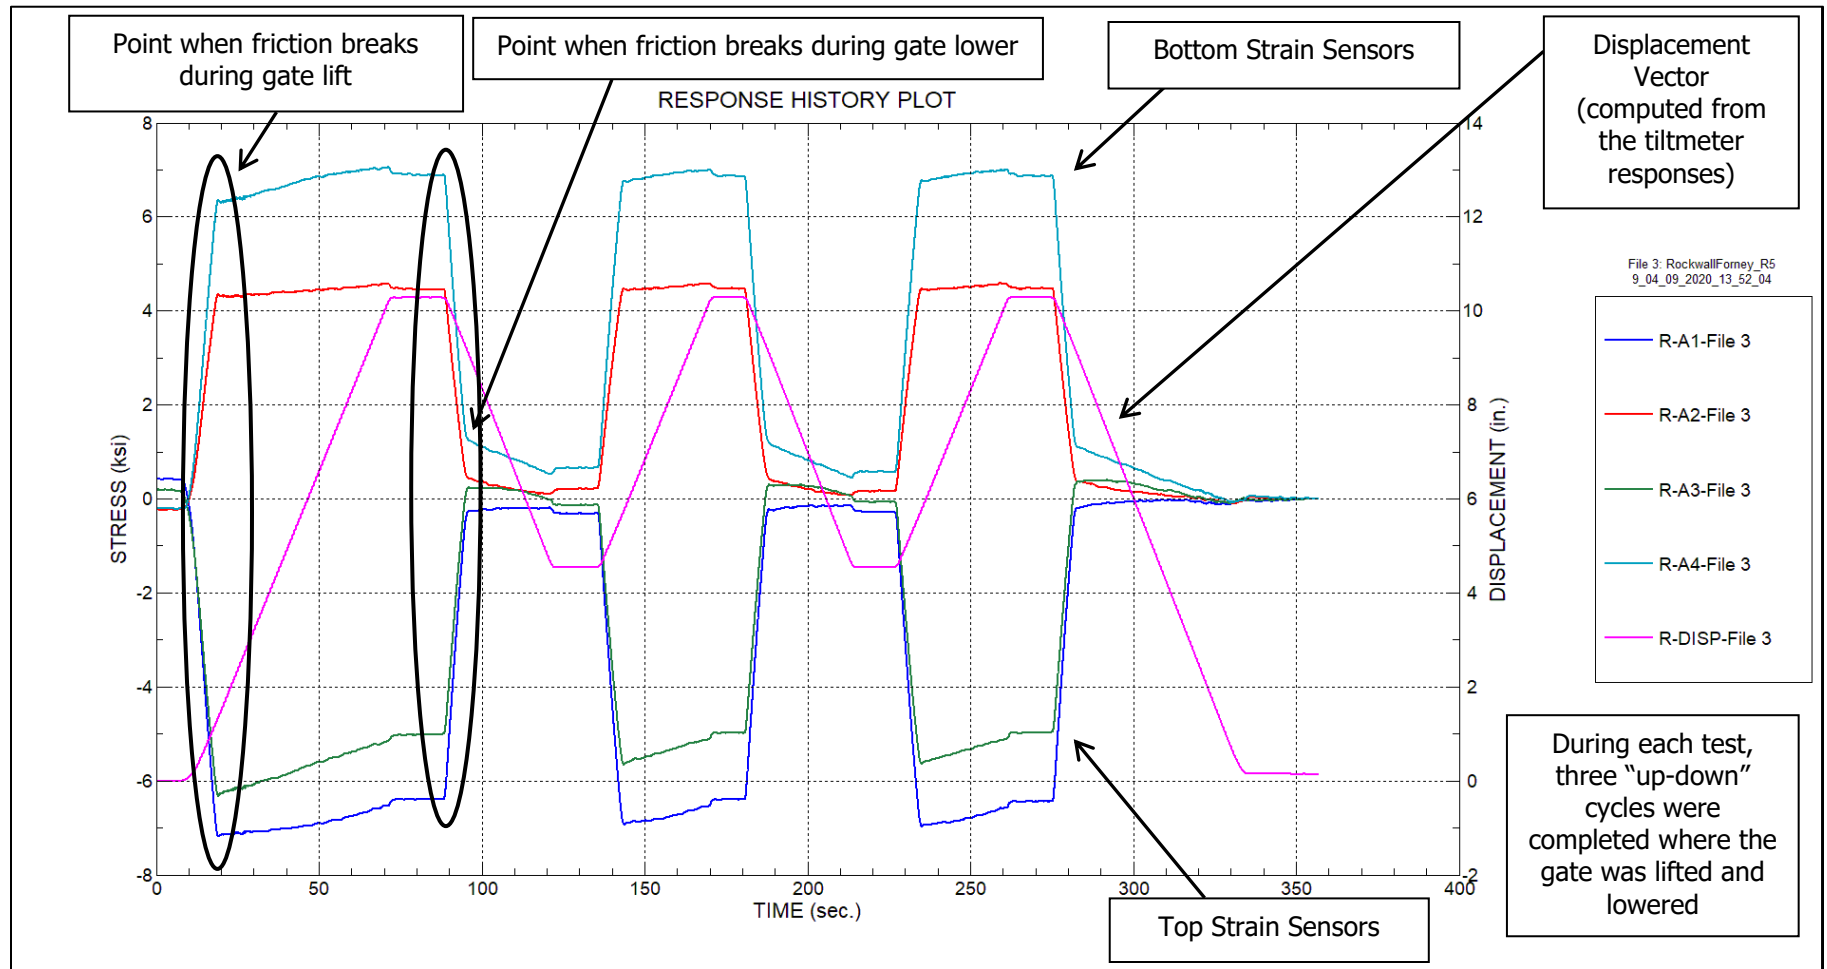
Figure 11 – Stress response & gate movement history – Right arm – Section A - Highlighting friction behavior (Section A along top strut near pin)

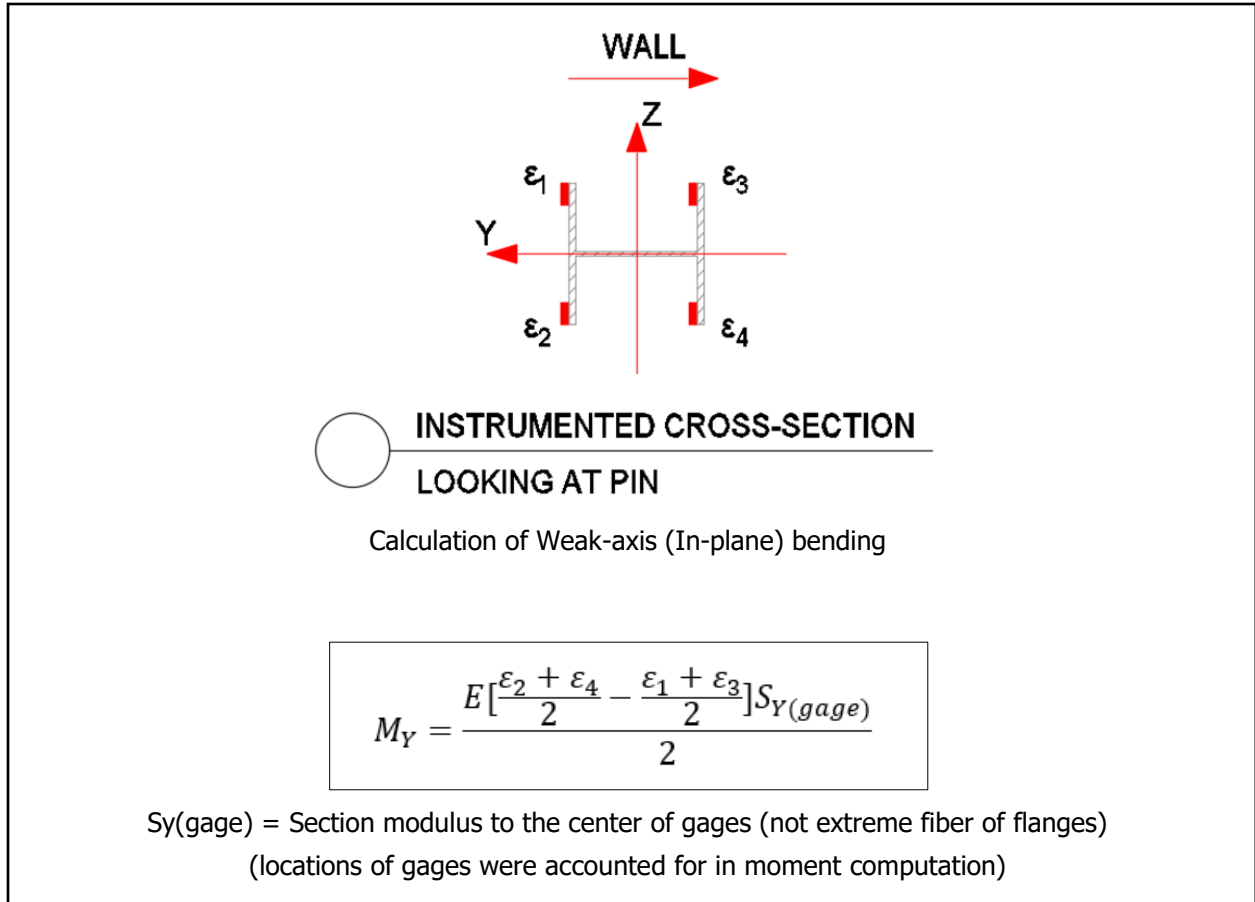
Figure 12 – Basic mechanic equation used to calculate moment

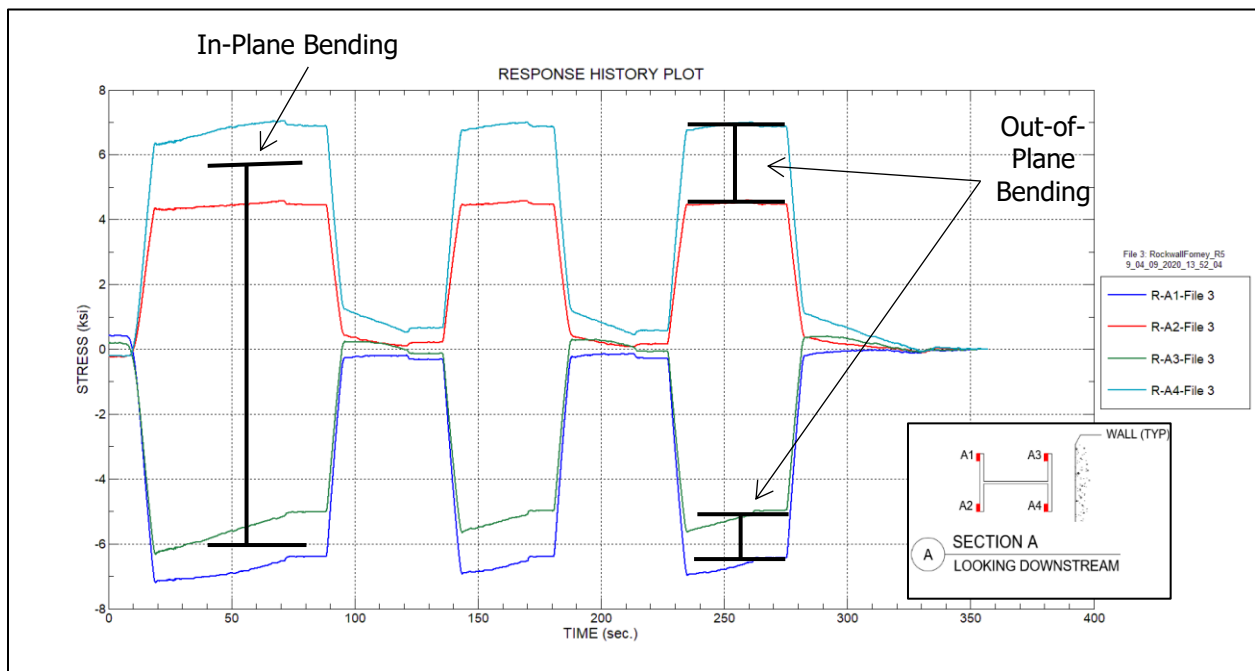
Figure 13 – Stress response history – Right arm – Section A – Bending components
(Section A along top strut near pin)

In-plane or weak-axis flexure refers to bending about a given strut's web. This designation is consistent with typical nomenclature. In-plane bending can be observed visually from the strain response histories as a difference between the top and bottom stresses, whereas out-of-plane or strong-axis bending is visualized as the difference in stress from side to side. Figure 13 provides a visual reference for both types of strut flexure.

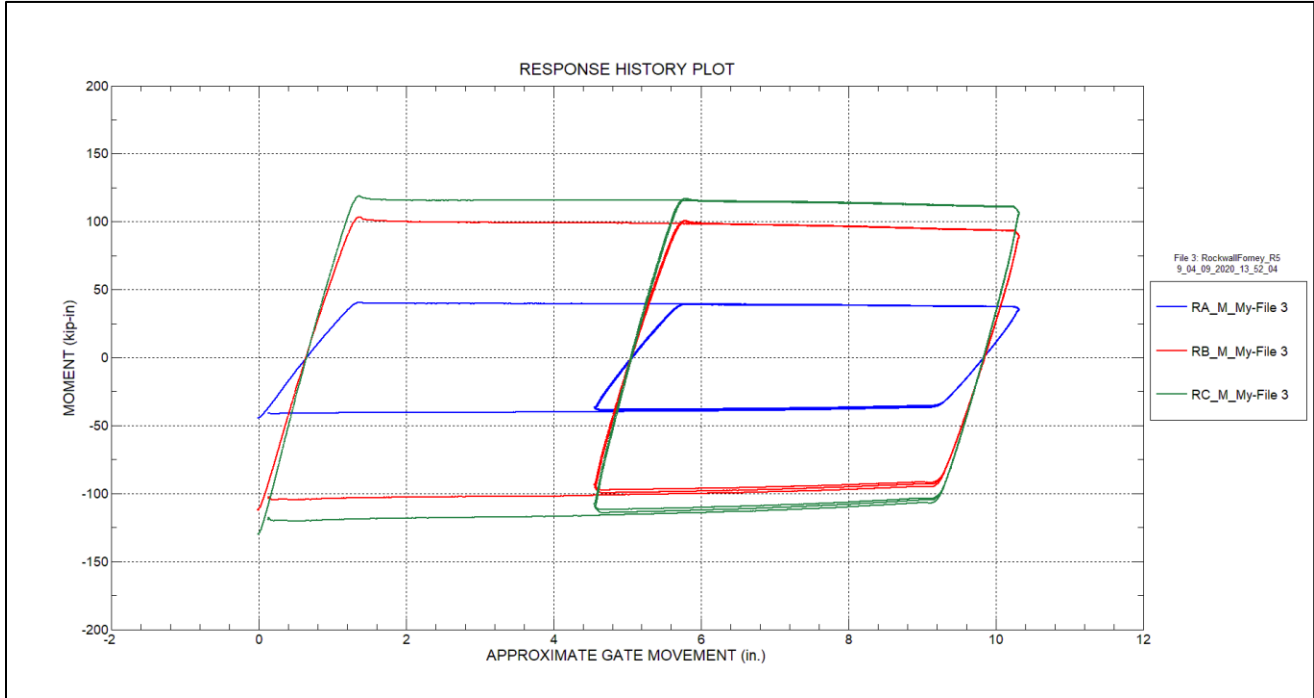
Figure 14 – In-plane moment response history – Right arm – Sections near pin
(RA = Right Arm Top Strut, RB = Right Arm Middle Strut, RC = Right Arm Bottom Strut)

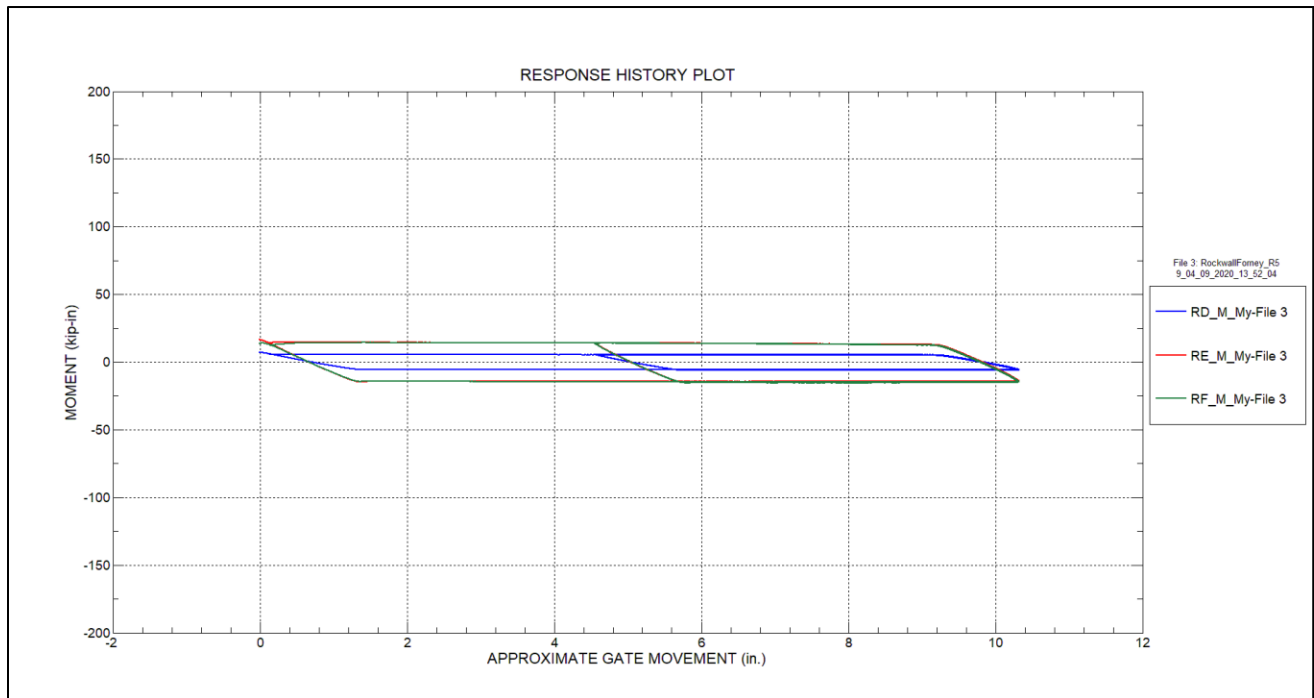
Figure 15 – In-plane moment response history – Right arm – Sections away from pin
(RD = Right Arm Top Strut, RE = Right Arm Middle Strut, RF = Right Arm Bottom Strut)

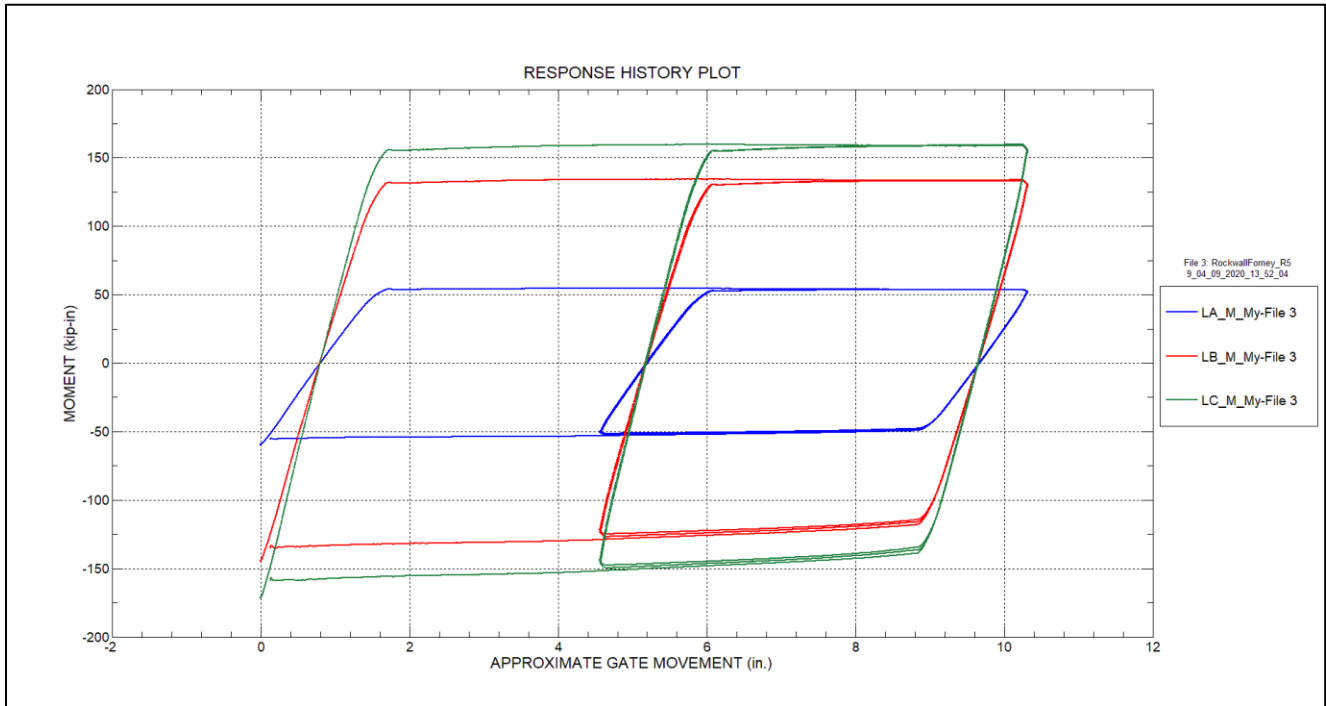
Figure 16 – In-plane moment response history – Left arm – Sections near pin
(LA = Left Arm Top Strut, LB = Left Arm Middle Strut, LC = Left Arm Bottom Strut)

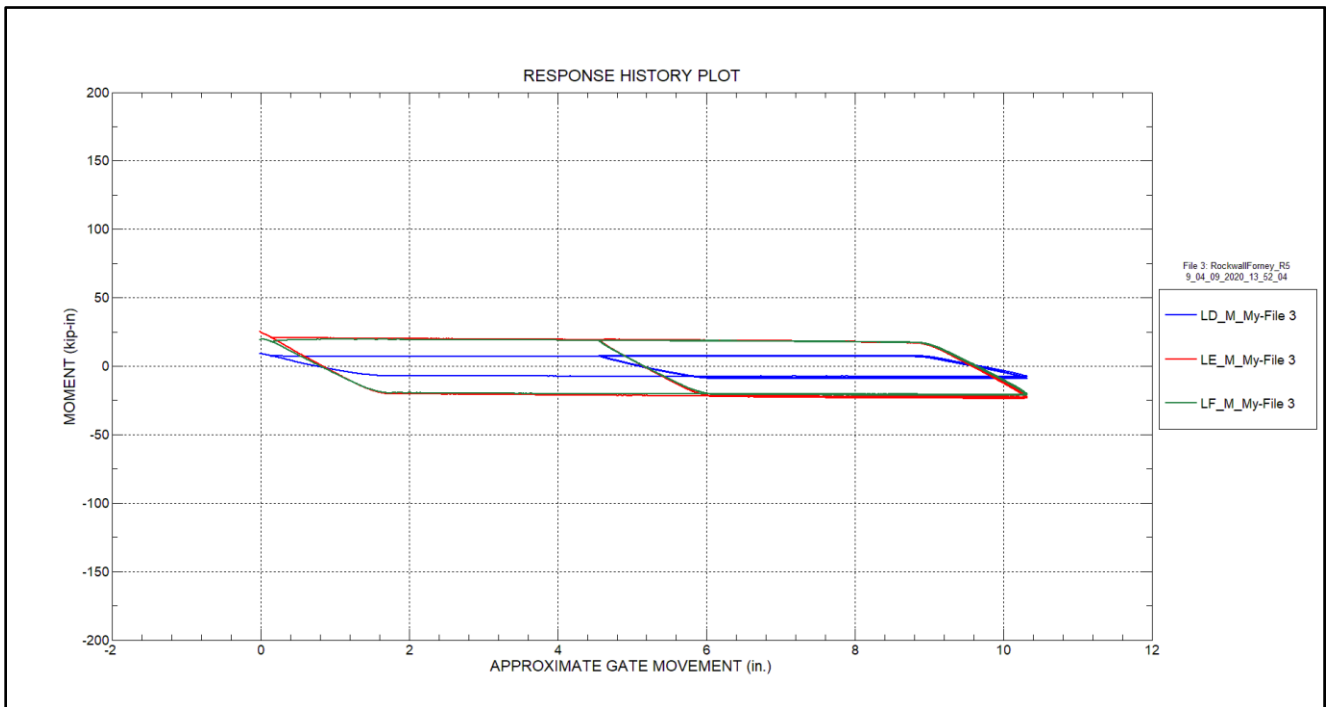
Figure 17 - In-plane moment response history – Left arm – Sections away from pin
(LD = Left Arm Top Strut, LE = Left Arm Middle Strut, LF = Left Arm Bottom Strut)

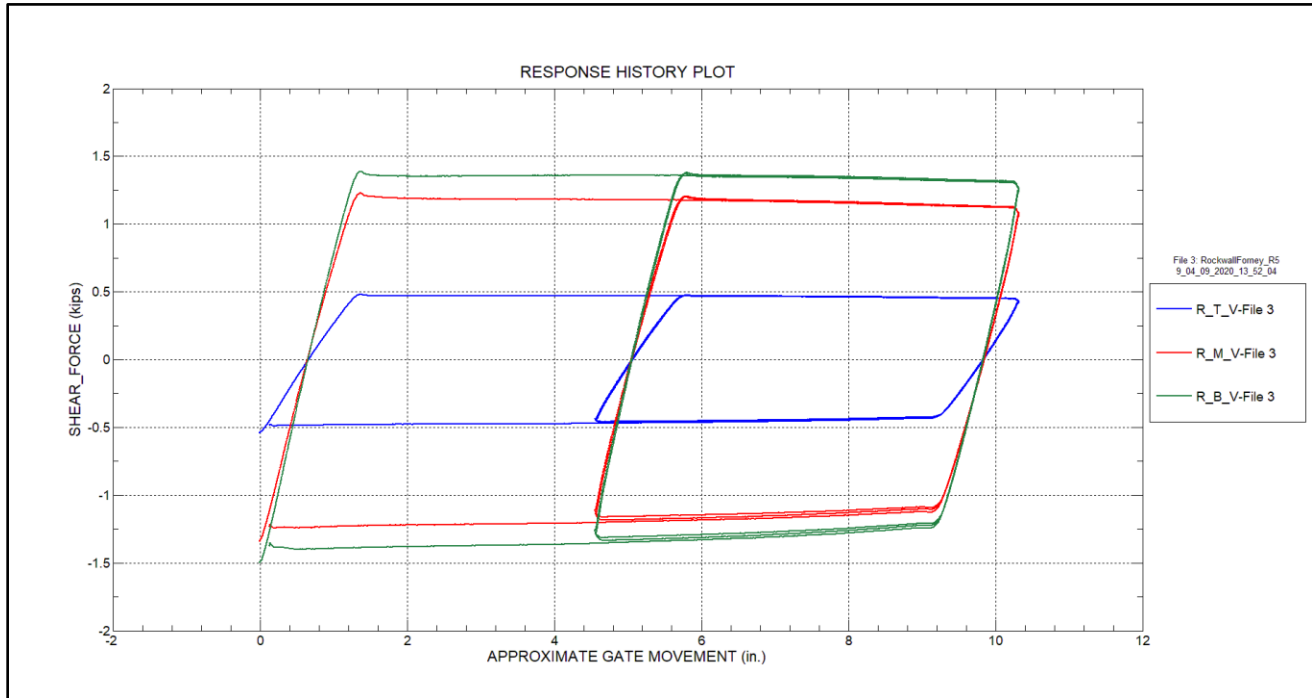
Figure 19 – Strut shear response history – Right arm

(R_T = Right Arm Top Strut, R_M = Right Arm Middle Strut, R_B = Right Arm Bottom Strut)

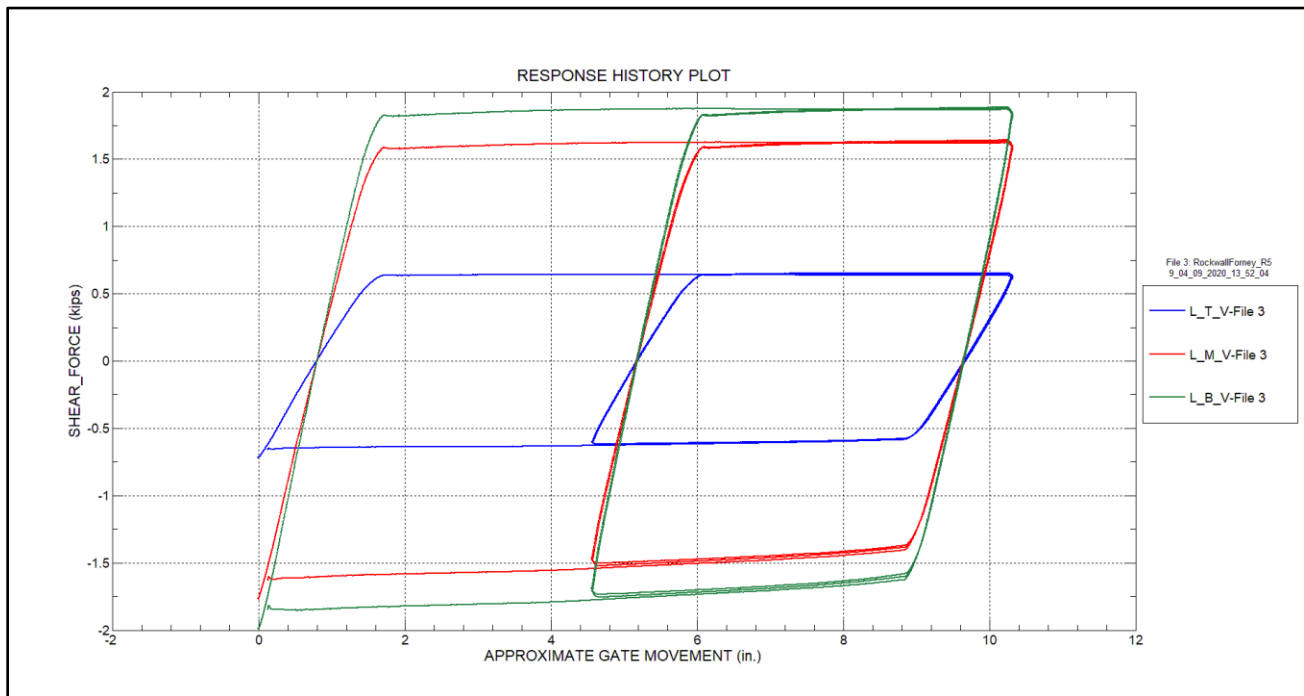
Figure 20 – Strut shear response history – Left arm

(L_T = Left Arm Top Strut, L_M = Left Arm Middle Strut, L_B = Left Arm Bottom Strut)

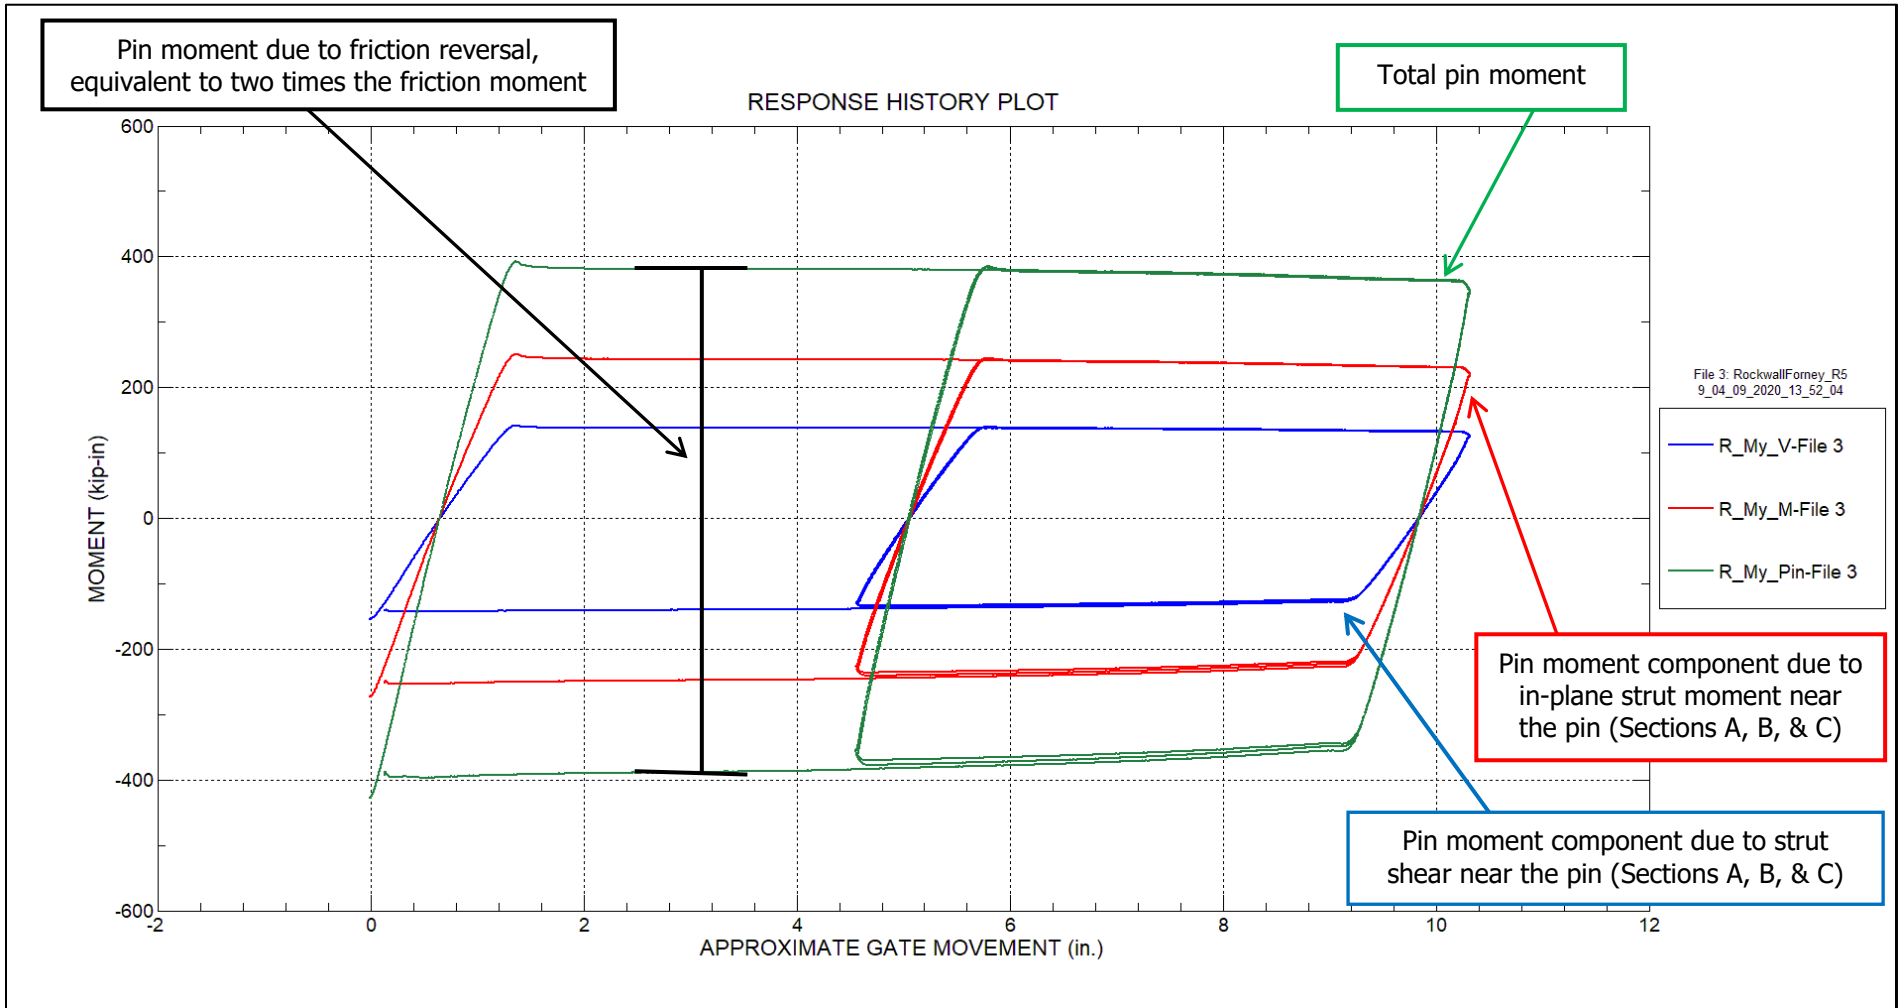
Figure 21 – Pin moment response history – Right arm

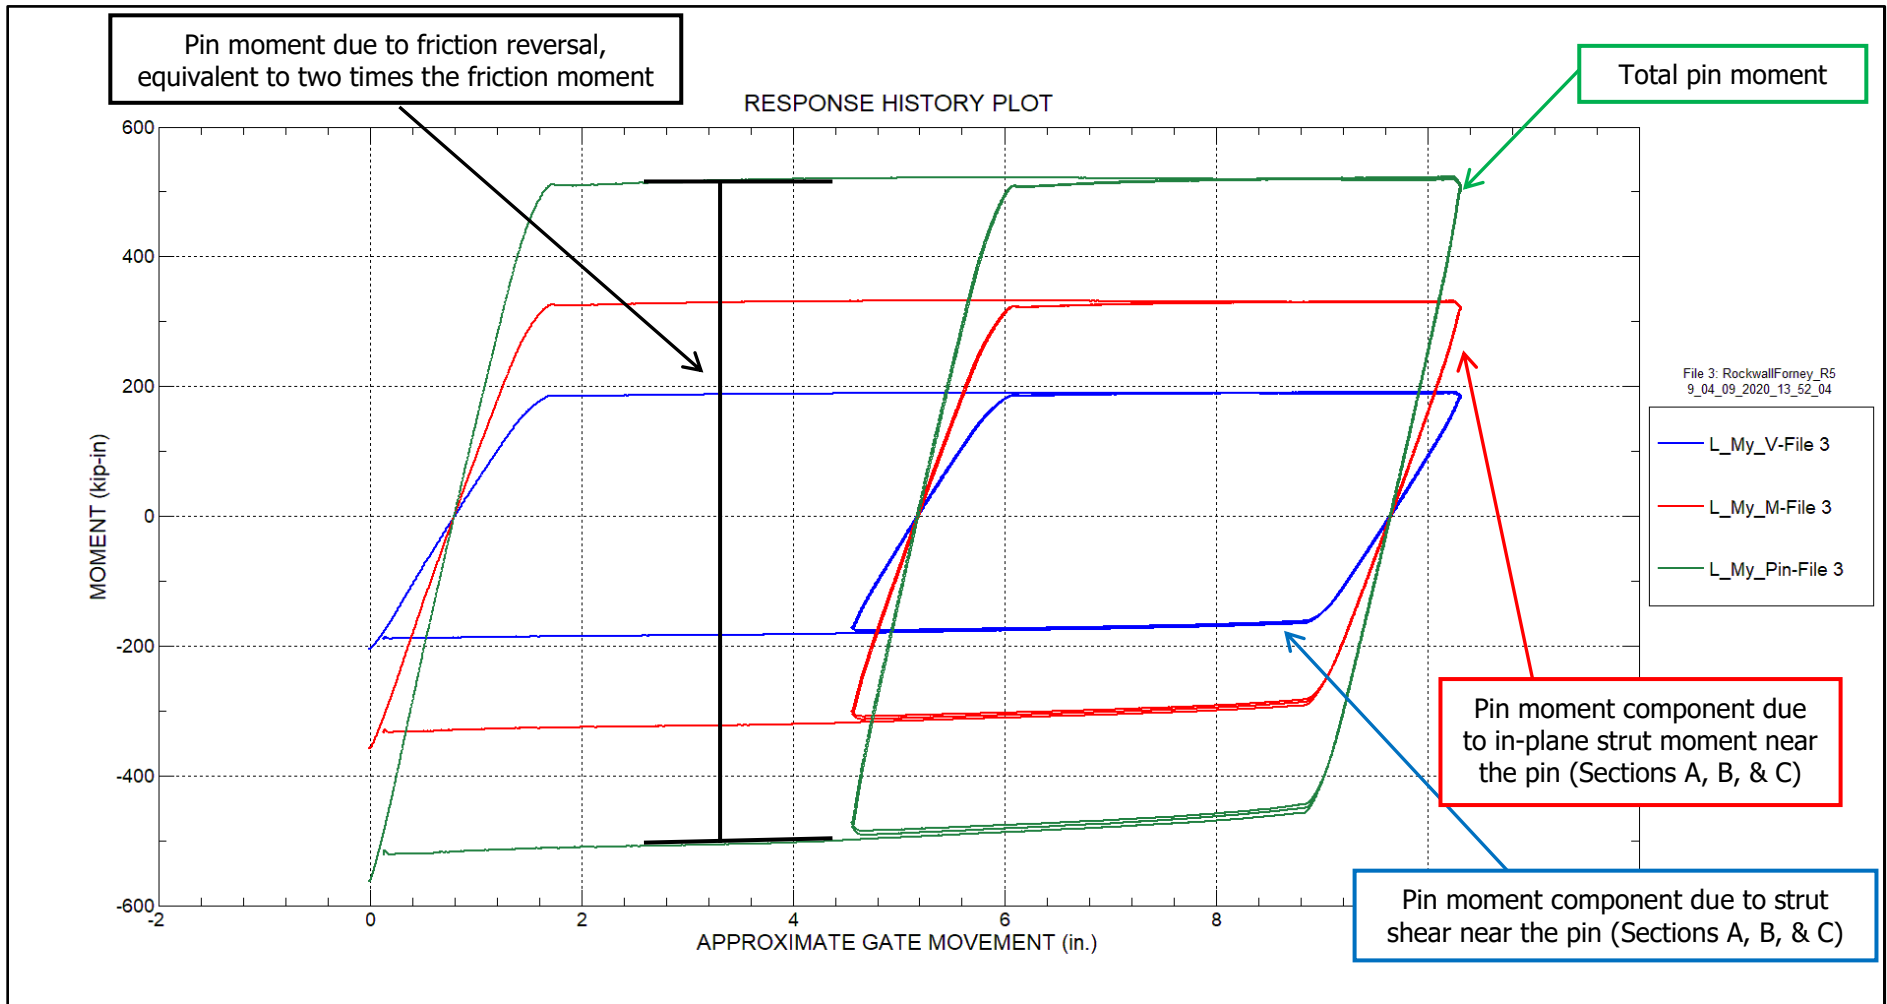
Figure 22 – Pin moment response history – Left arm

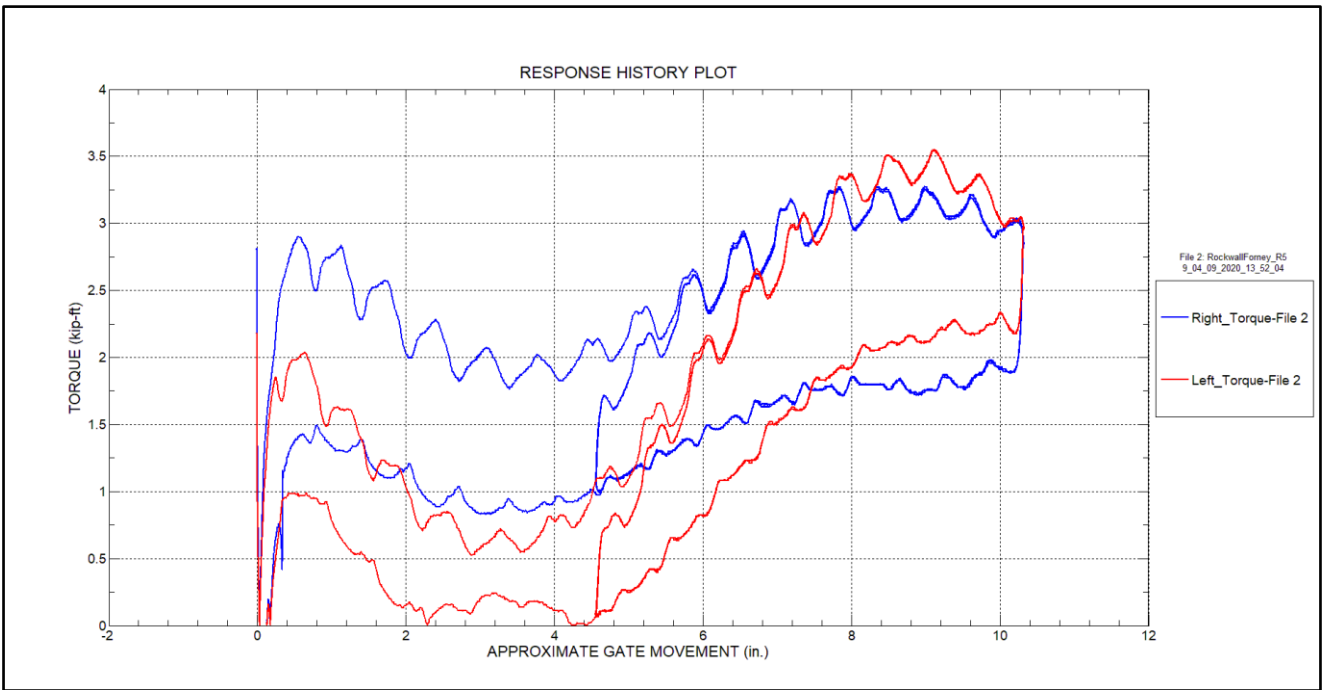
Figure 23 – Hoist torque response history – Gate 10 – Test 2

Figure 23 shows example torque measurements, recorded on the Gate 10 torque shafts. Best practices for torque measurements is to measure torque on opposite sides of the shaft so that any bending in the shaft can be removed by averaging the two responses. Due to access limitations, only one gage at each location could be installed. Therefore, any bending in the shaft may be reflected in the torque measurements and may be related to the peaks and valleys observed in the torque responses.

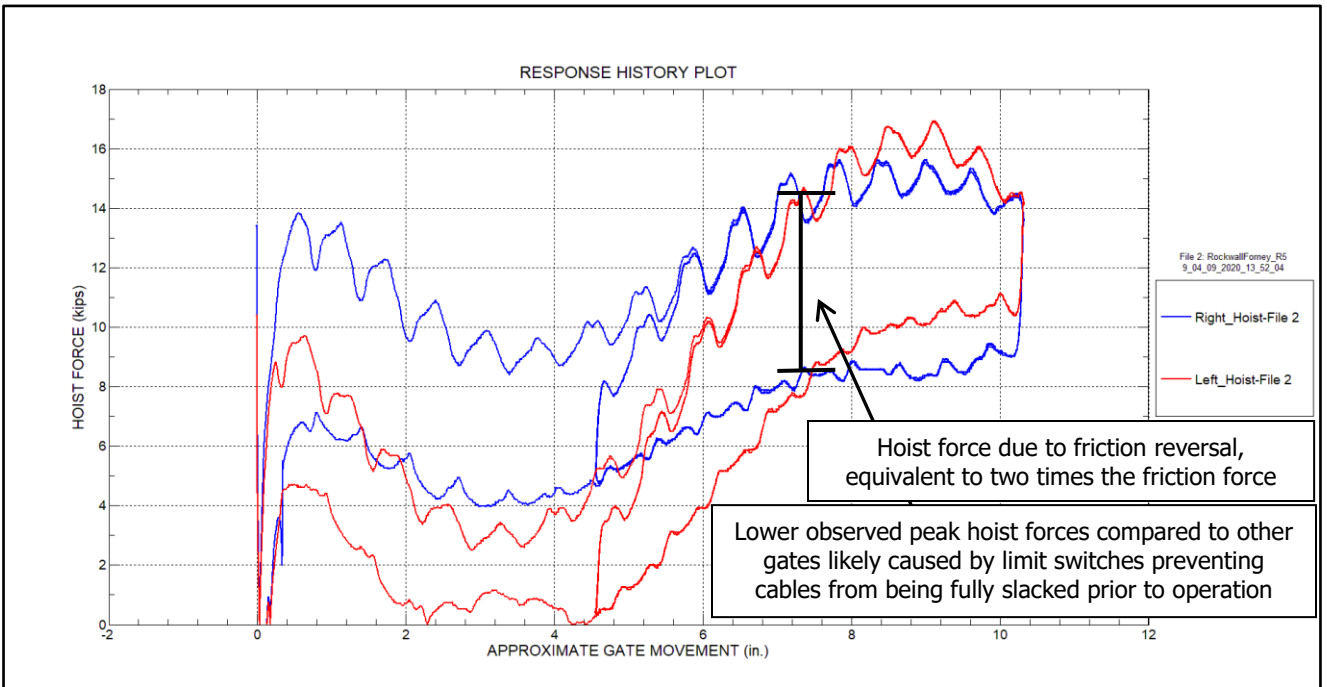
Figure 24 – Hoist force response history – Gate 10 – Test 2

Torque values were converted to force in the hoist cables per gate arm using the gear ratio and drum radius, as shown in Figure 24. The gear ratio and drum radius were 5.182 and 1.086 feet respectively, as defined in the provided as-built shop drawings. It should be noted that the hoist force calculated may be smaller than the actual hoist force applied. This difference is due to the limit switch engaging the brake before the hoist cable was fully slacked, resulting in an initial force in the cable. A hoist force due to total gate friction was then calculated. This friction hoist force was equal to half the differential in force measured during the lifting and lowering of the gate (similar to the pin friction calculations). As shown in Table 3, the change in cable force due to friction was generally consistent between tests. Note that the total hoist force was due to the total friction effects, including side seal, hoist bearings, trunnion friction effects, etc. It is difficult to determine the exact proportion and composition of the total friction sources. Additional torque and hoist force plots for all collected data files are provided in Appendix A – Gate 10 Torque and Hoist Force Plots.
