VISUAL INSPECTION AND EVALUATION REPORT

Rockwall-Forney Dam
Dallas Water Utilities
Dallas/Kaufman Counties, Texas

Schnabel Reference #20C22001.00
July 30, 2021

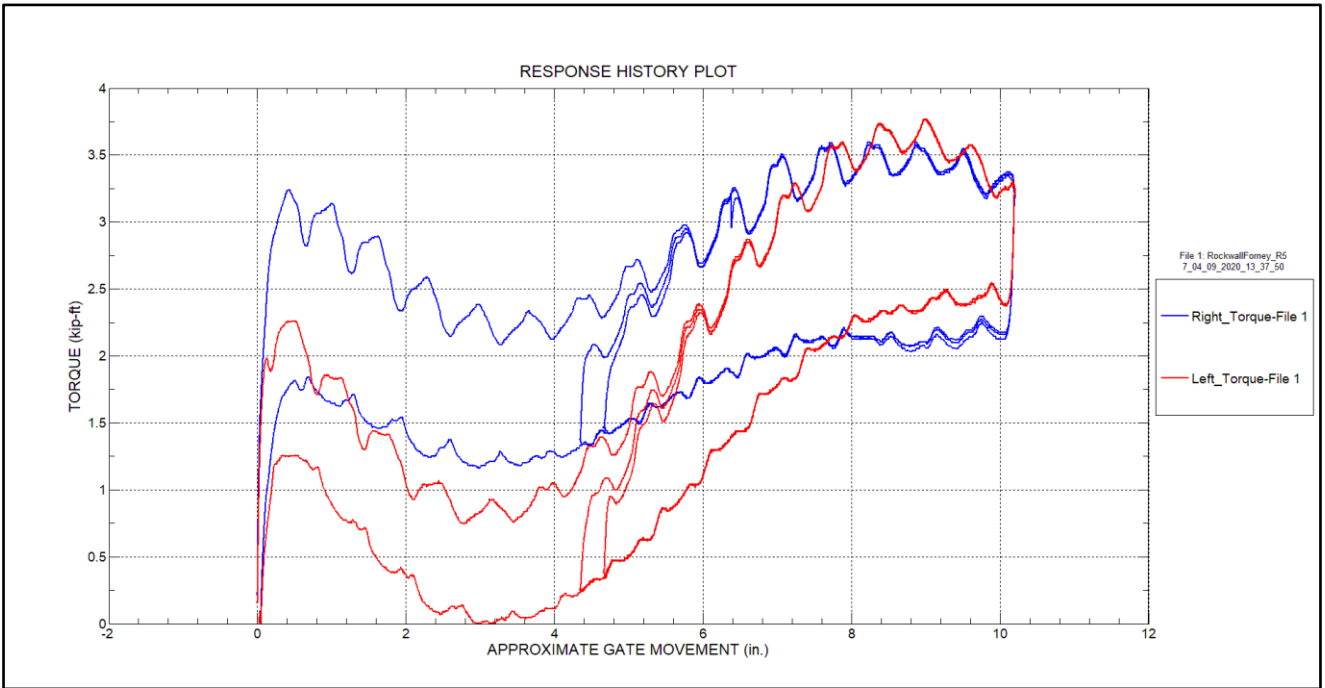
Figure 25 – Hoist torque response history – Gate 10 – Test 1

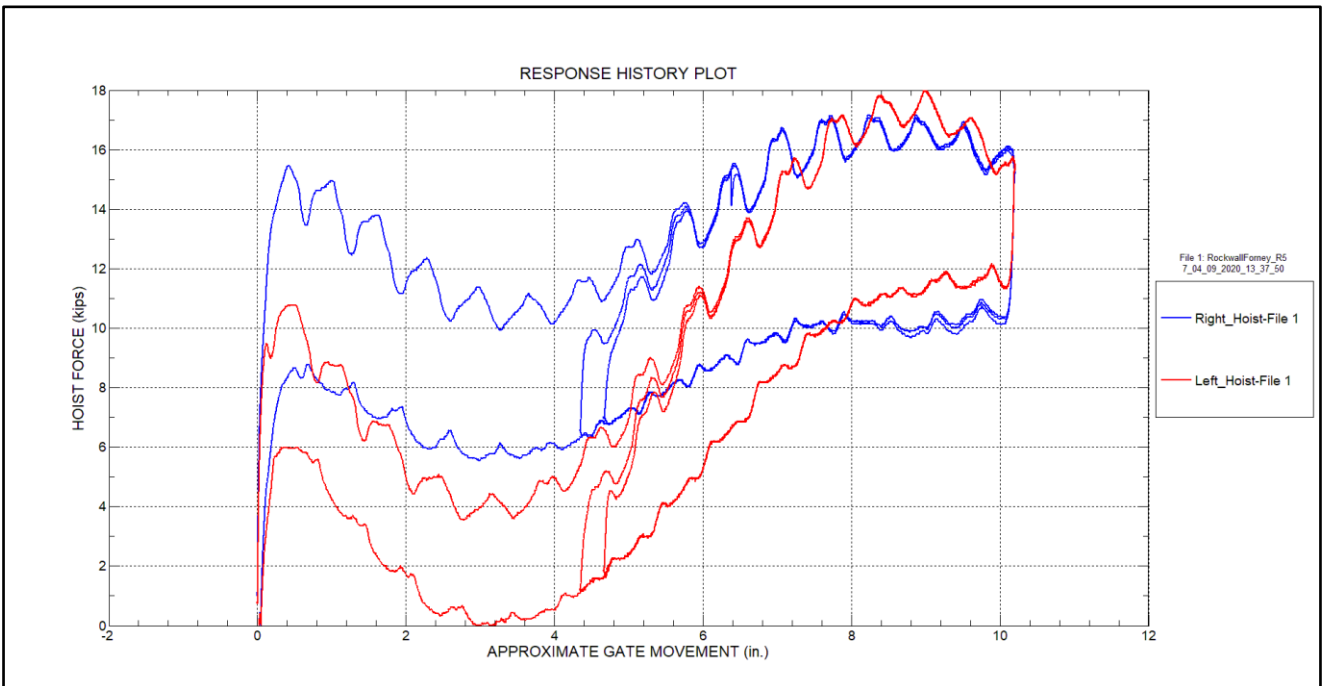
Figure 26 – Hoist force response history – Gate 10 – Test 1

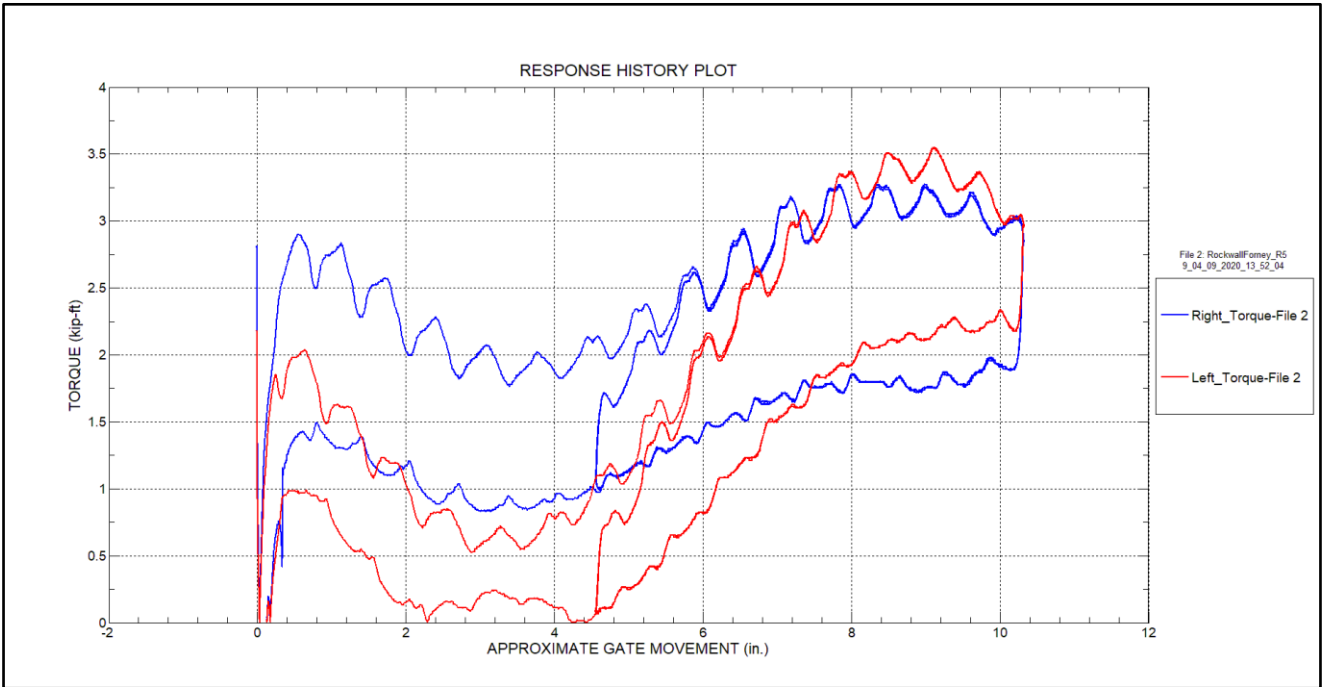
Figure 27 – Hoist torque response history – Gate 10 – Test 2

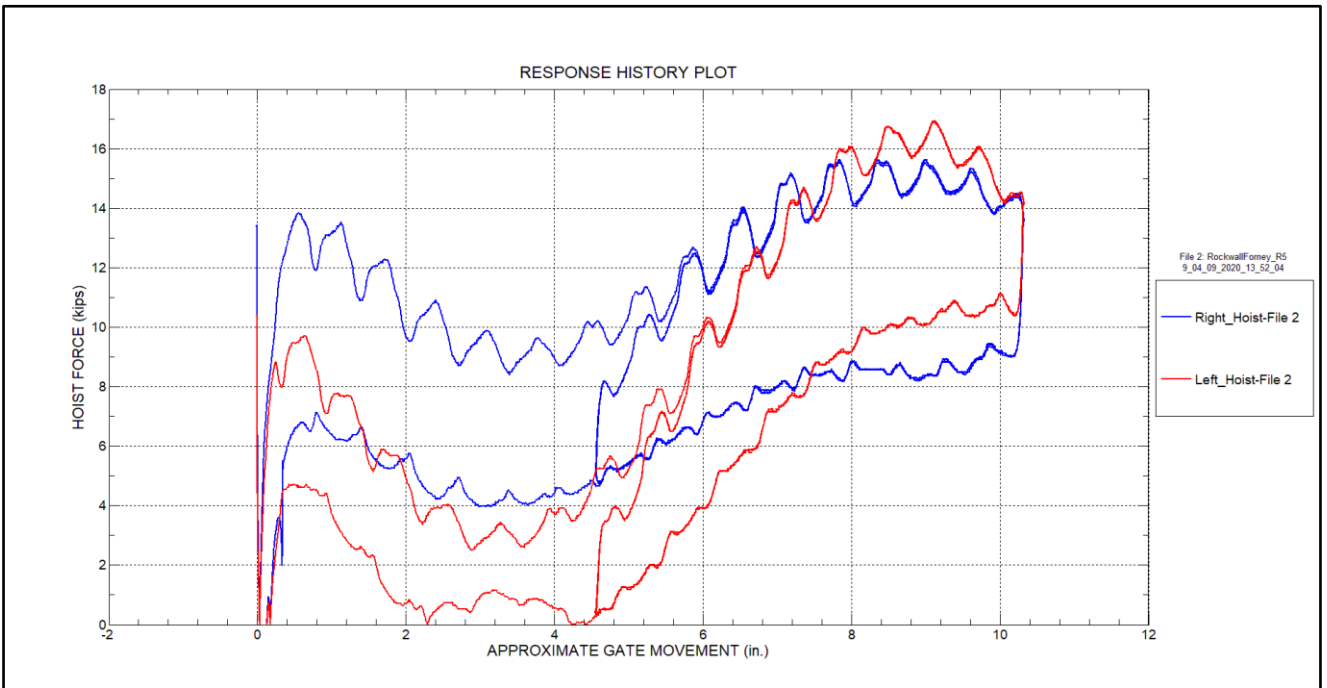
Figure 28 – Hoist force response history – Gate 10 – Test 2

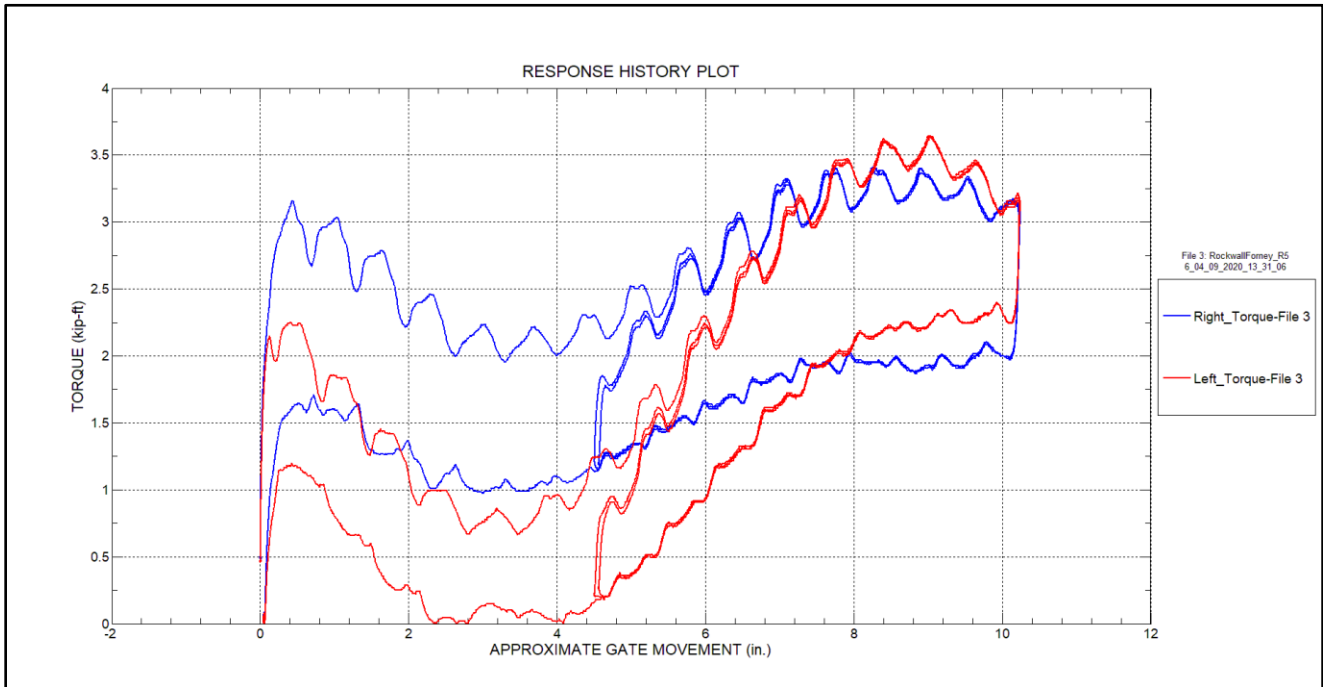
Figure 29 – Hoist torque response history – Gate 10 – Test 3

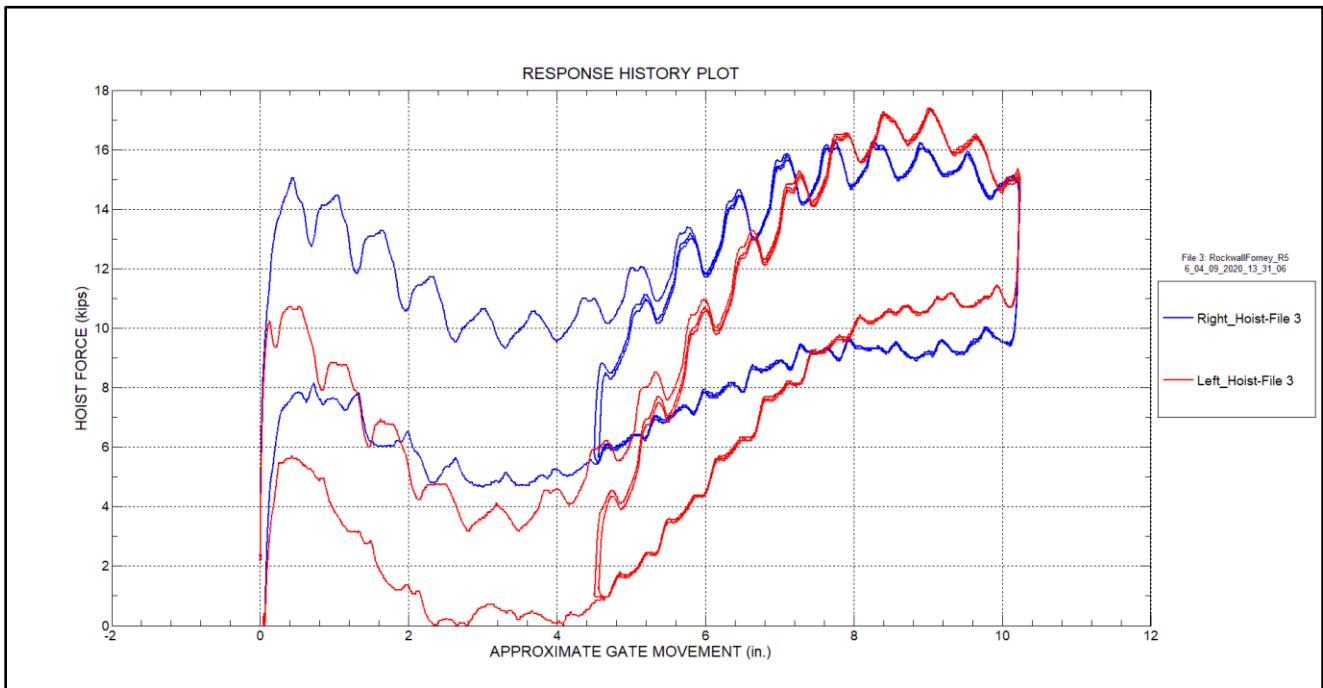
Figure 30 – Hoist force response history – Gate 10 – Test 3

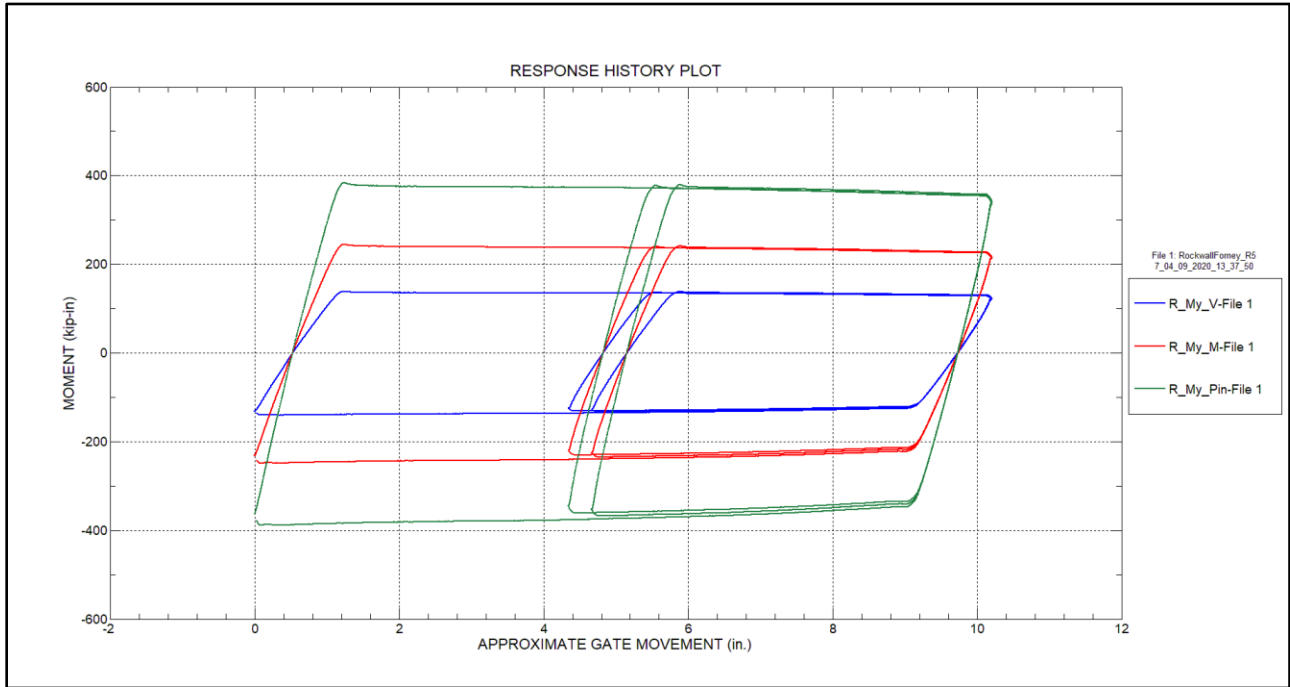
Figure 31 – Pin moment response history – Right arm – Test run 1

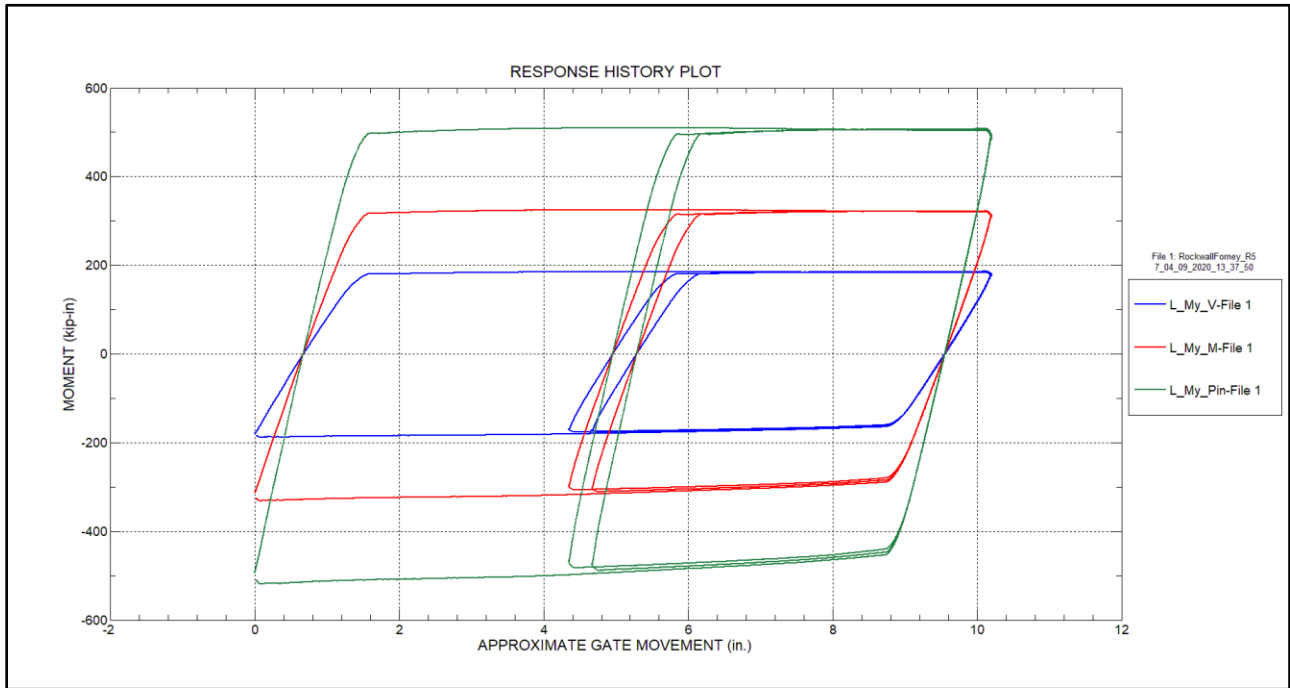
Figure 32 – Pin moment response history – Left arm – Test run 1

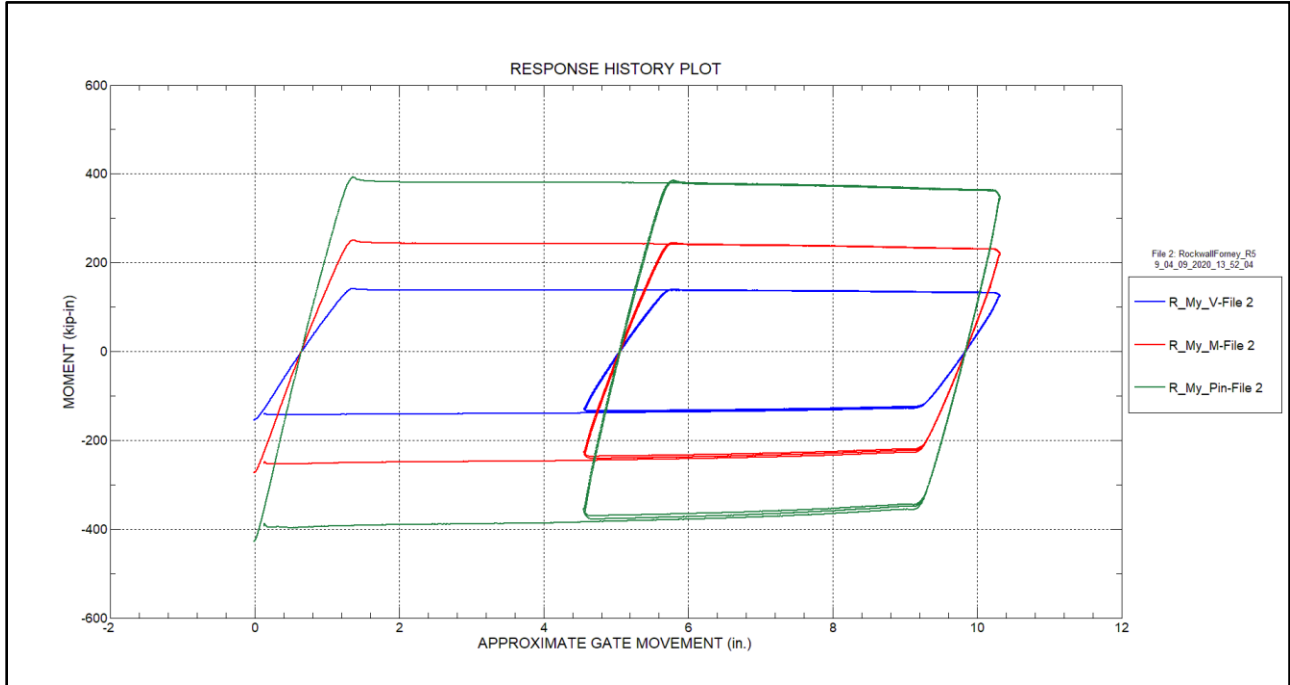
Figure 33 – Pin moment response history – Right arm – Test run 2

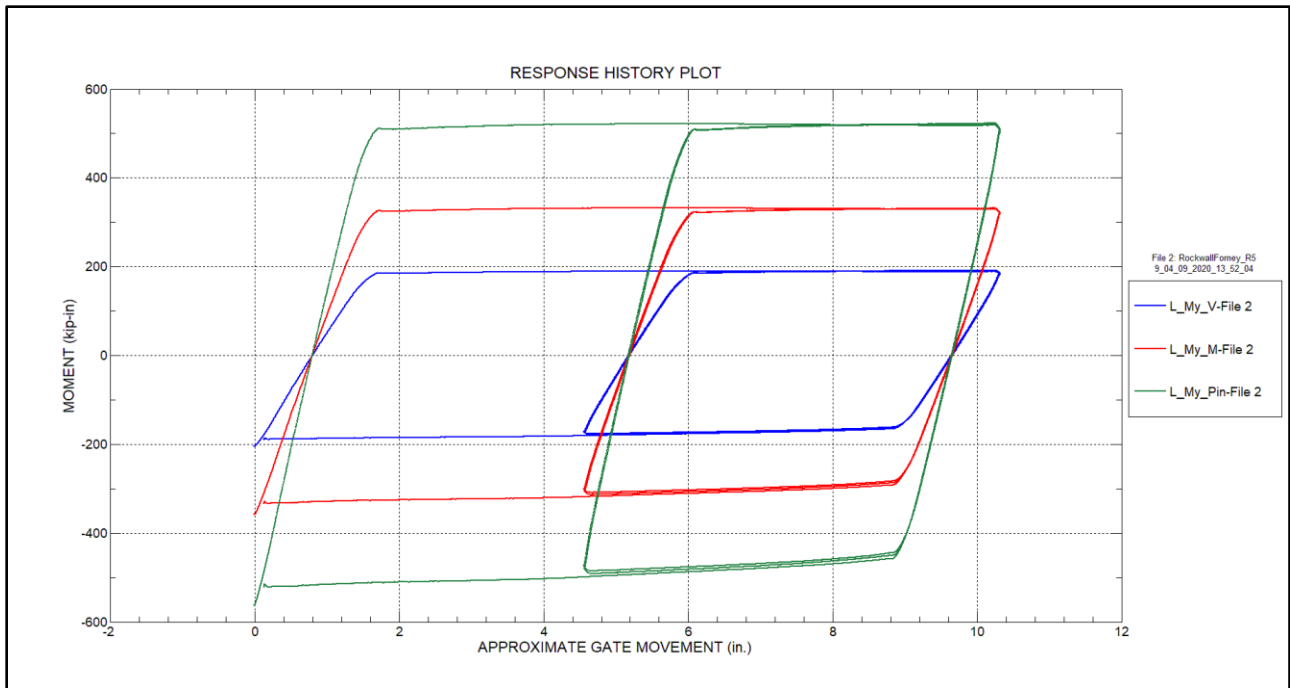
Figure 34 – Pin moment response history – Left arm – Test run 2

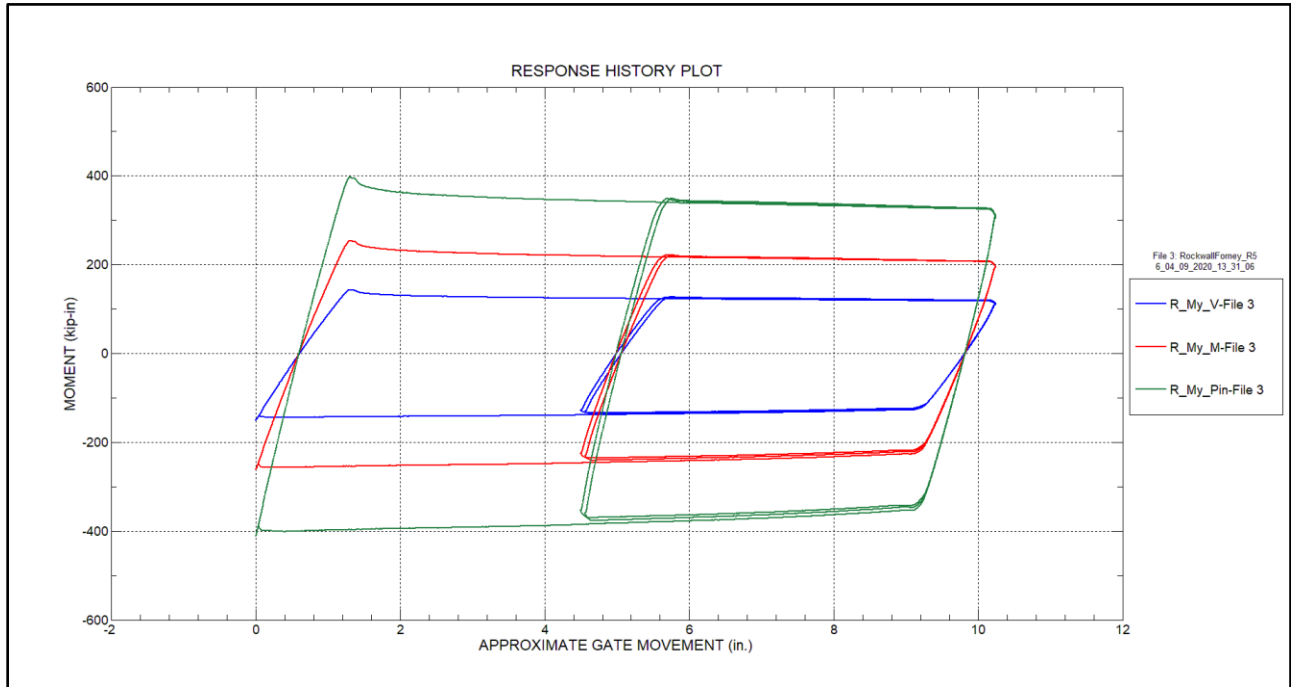
Figure 35 – Pin moment response history – Right arm – Test run 3

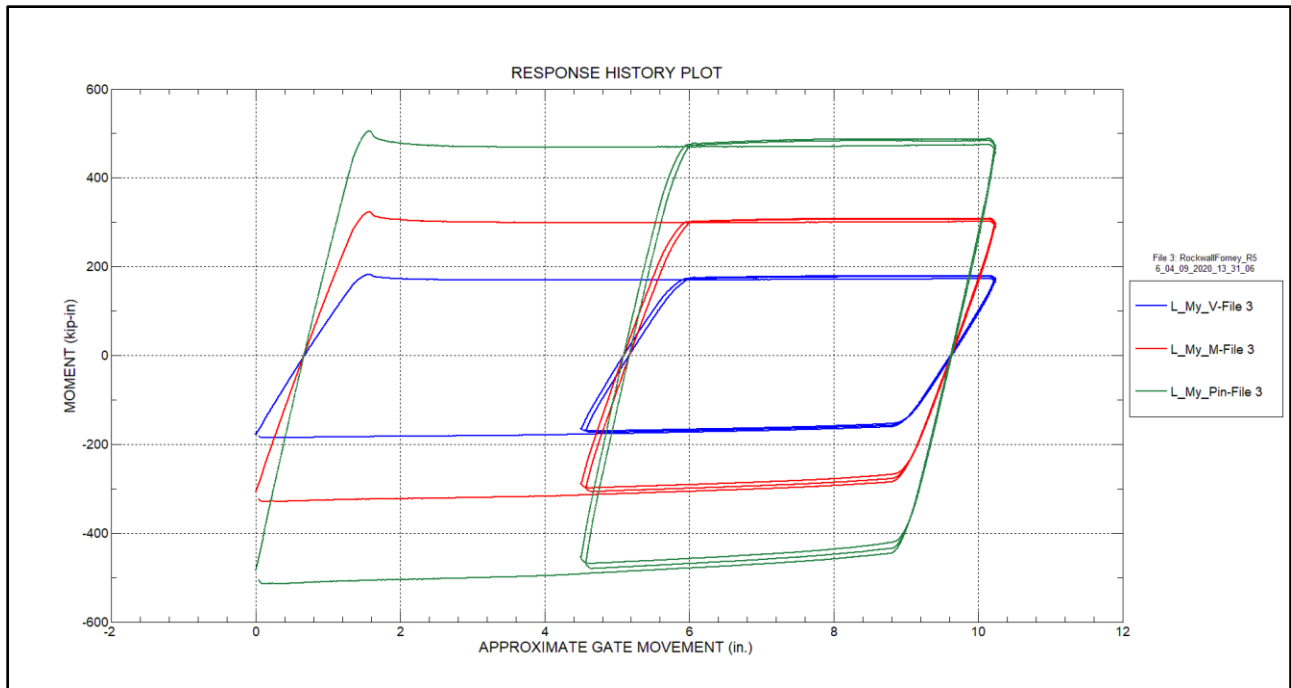
Figure 36 – Pin moment response history – Left arm – Test run 3

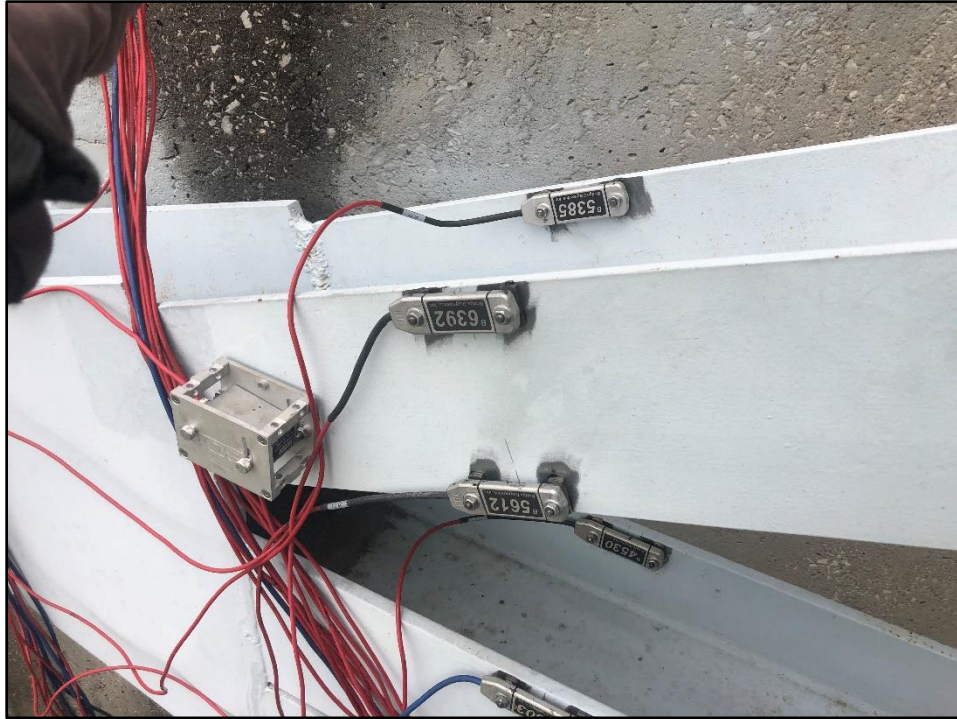
Figure 1 – BDI tiltmeter rotation sensor and reusable strain transducers installed near trunnion hub (Typical)

A typical installation has been shown in Figure 1 through Figure 4. Access to all the sensor locations was provided by BDI's own SPRAT certified rope access technicians and engineers as shown in Figure 5.

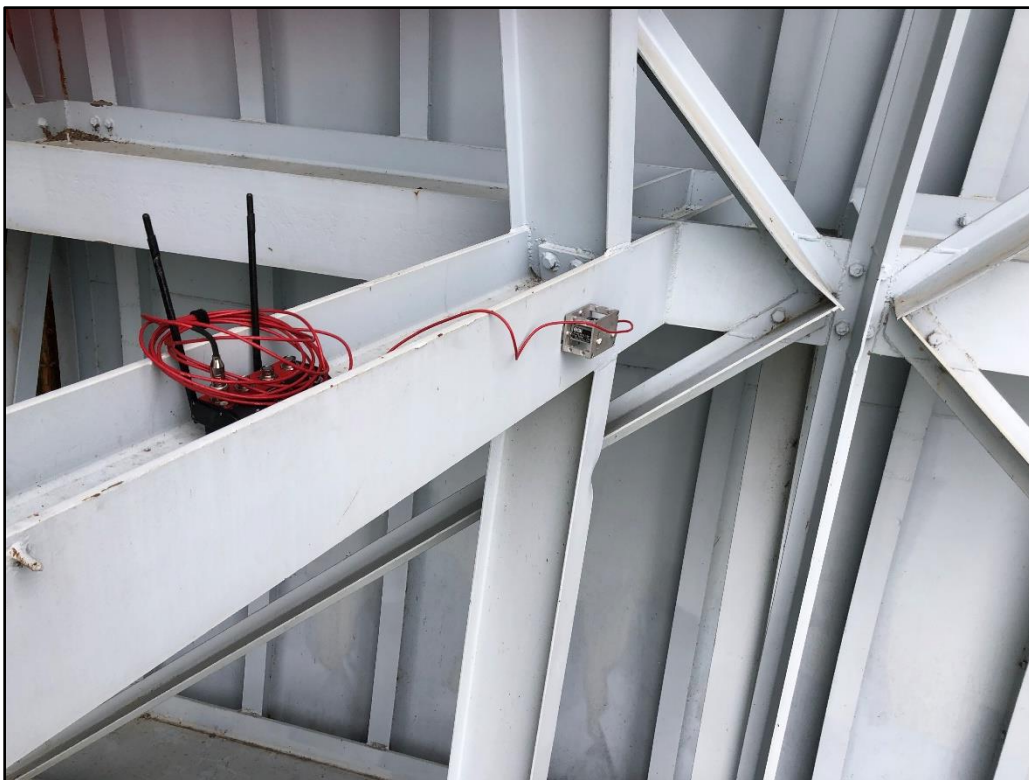
Figure 2 – BDI tiltmeter rotation sensor installed near skin plate (Typical)

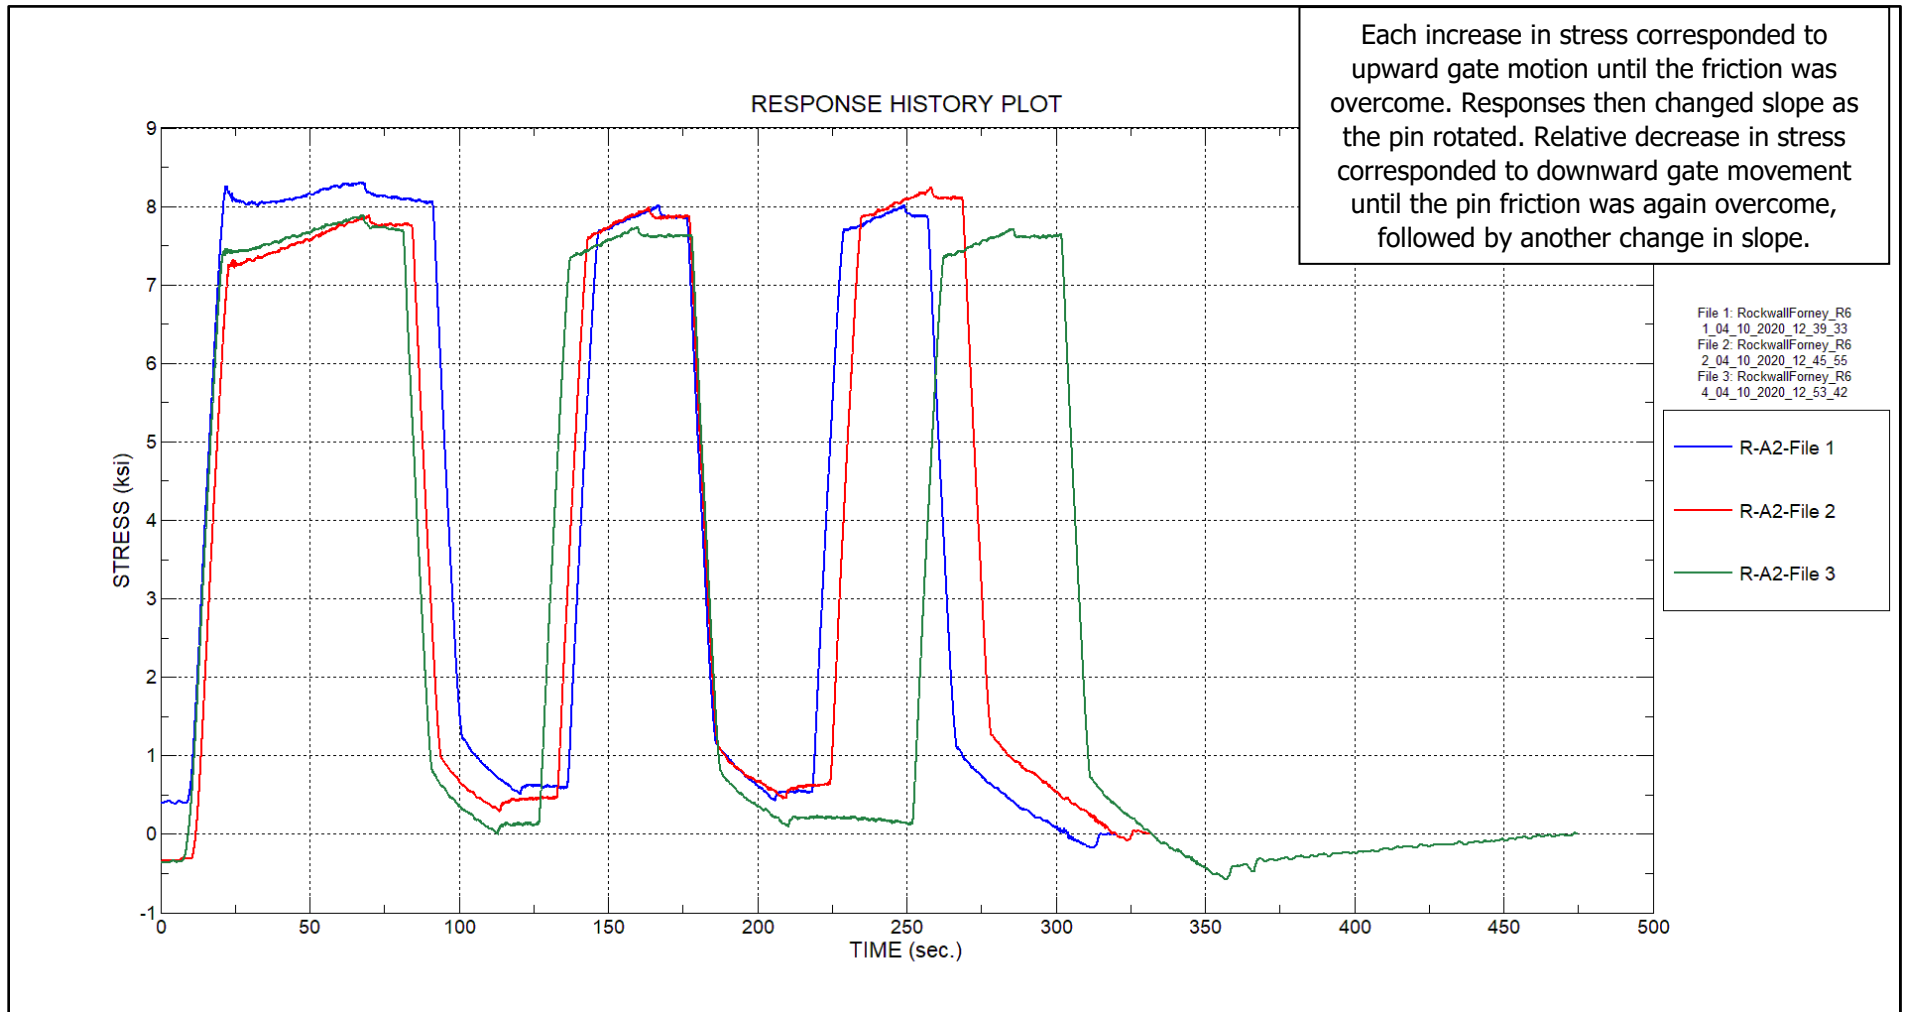
Figure 6 – Stress response history – Right arm – Gage A2 – Time based
File 1 = test run 1, File 2 = test run 2, File 3 = test run 3
(Section A along top strut near pin – Sensor location 2 along bottom of inner flange)

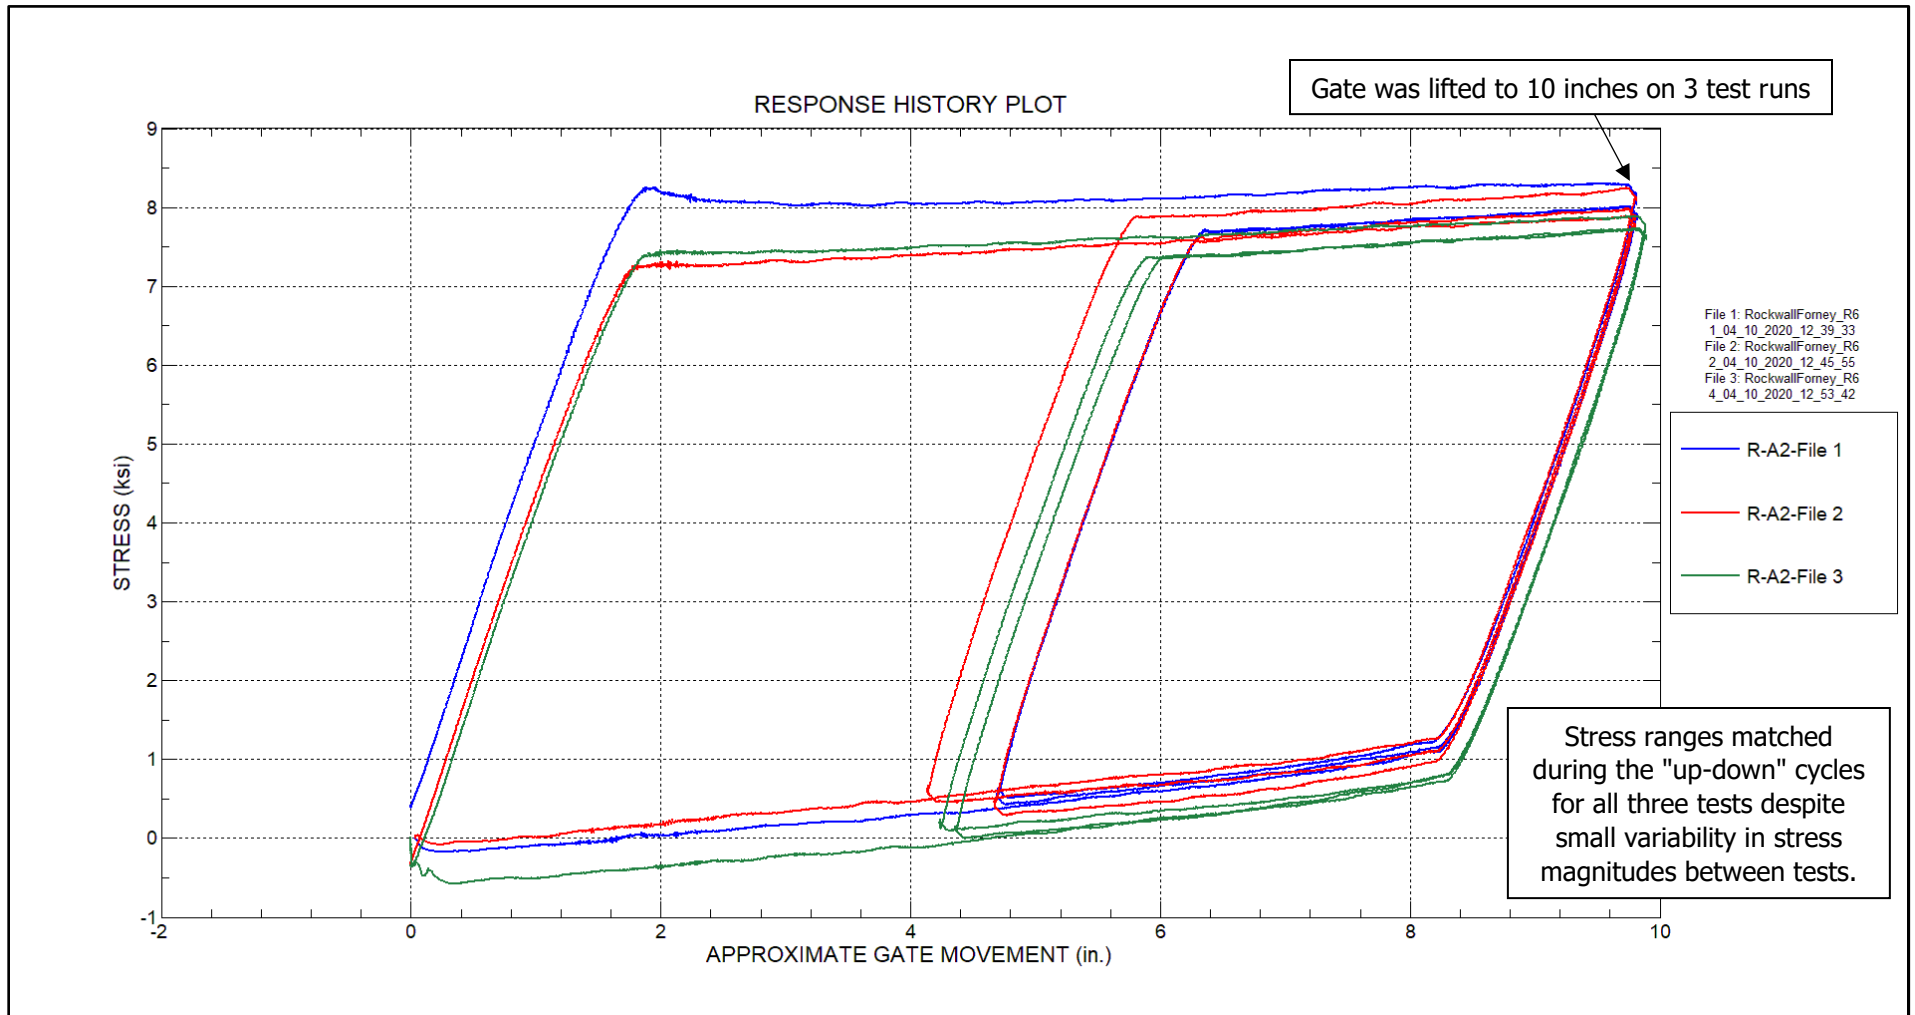
Figure 7 – Stress response history – Right arm – Gage A2 – Function of gate movement
File 1 = test run 1, File 2 = test run 2, File 3 = test run 3
(Section A along top strut near pin – Sensor location 2 along bottom of inner flange)

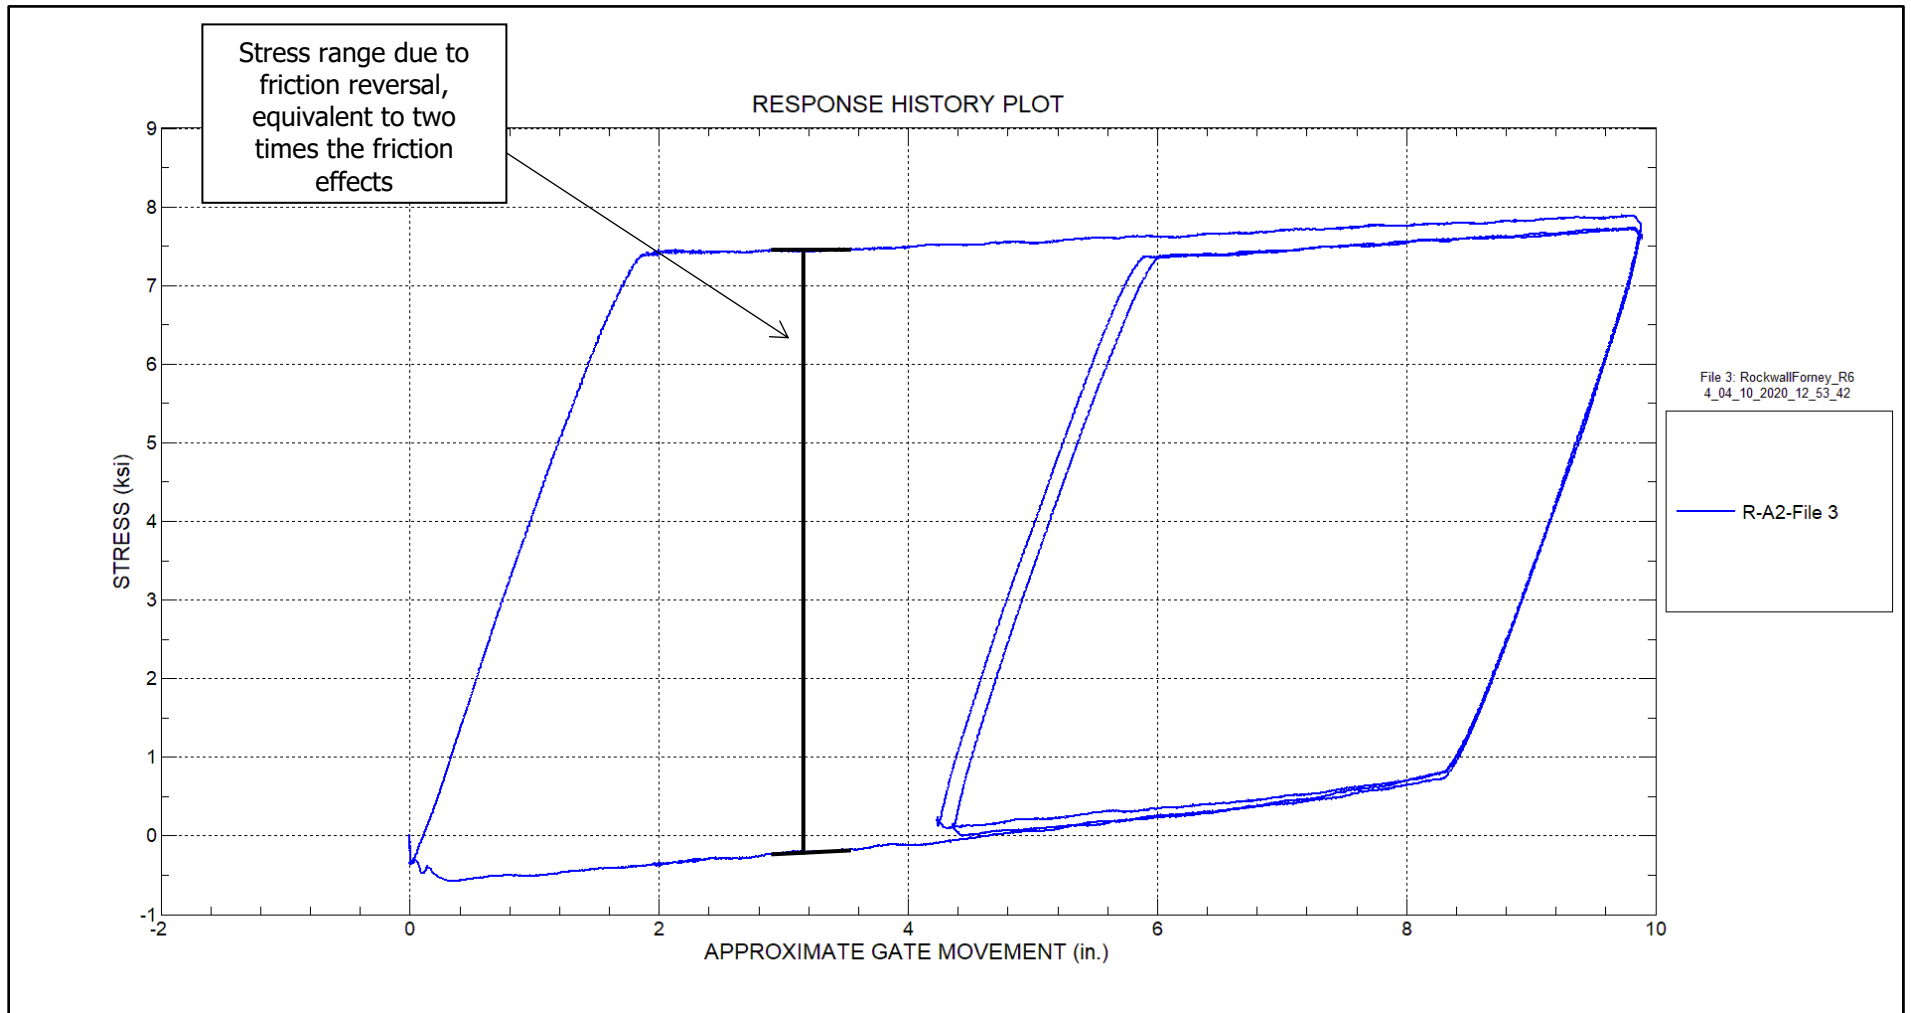
Figure 8 – Stress response history – Right arm – Gage A2 – Friction effect in stress responses
(Section A along top strut near pin – Sensor location 2 along bottom of inner flange)

- + **DIRECTION/FRICTION REVERSAL IN RESPONSES:** The difference in stress during gate opening and closing for a given position is shown in Figure 8. The stress variation at any given gate position was a result of direction reversal and in turn due to trunnion friction reversal. This statement is true since all other loads such as dead-load and hydrostatic pressure were essentially constant barring small changes in hydrostatic pressure due to slight changes in head. This direction/friction reversal is depicted in Figure 9, with deflected shape renderings from a gate arm finite element model under lifting and lowering loads. Note that this figure shows an arm configuration that does not match this gate, but the concept of the direction/friction reversal still applies.

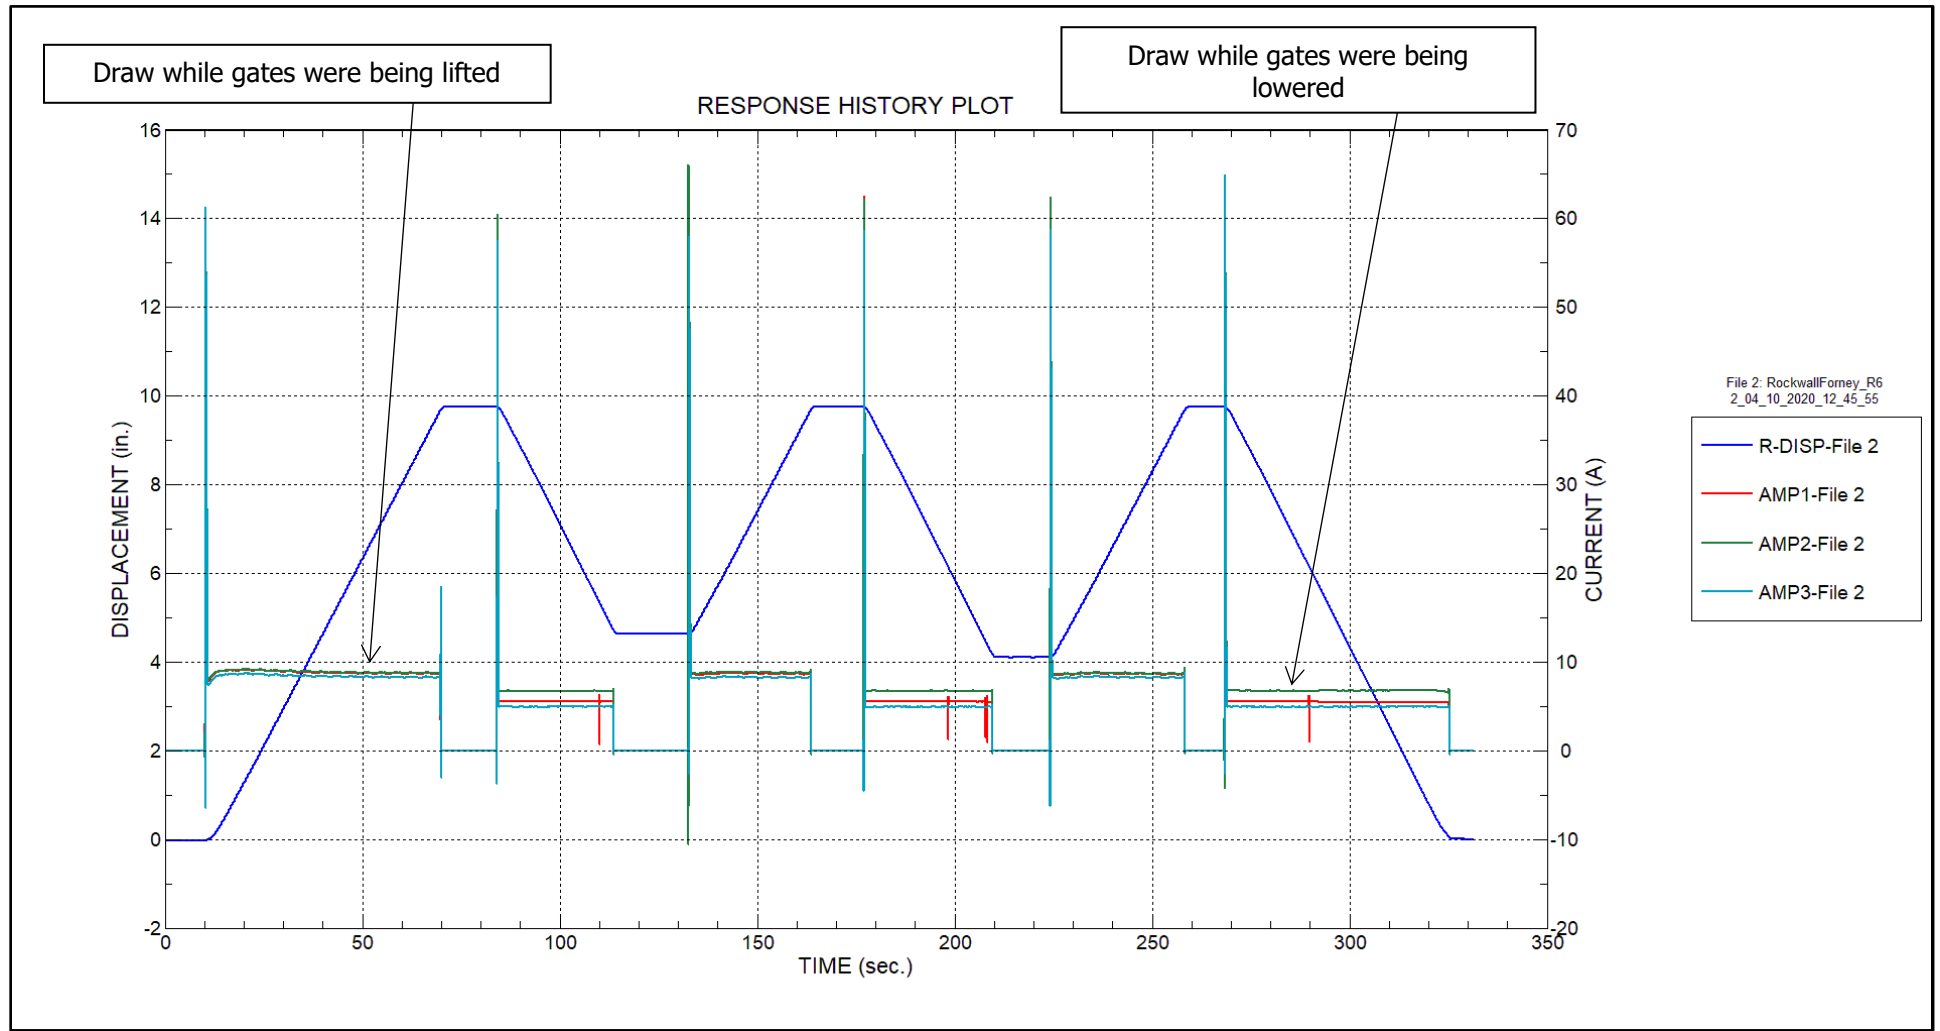
Figure 10 – Motor current & gate movement response history – Lift motor – Highlighting motor draw during lift and lower cycles

- + **MOTOR PERFORMANCE:** Current measurements taken at the hoist motor indicated steady and stable current draws during the lifting and lowering portions. An example plot of current draw and gate position is provided in Figure 10. Current draw ranges during lifting were higher than the ranges during lowering, which is common due to gravity/dead load. These results are summarized along with recorded peak in-rush current in Table 2. Note that the sample rates used during testing were set for collecting gate responses and may not have been appropriate to fully capture the in-rush current. The readings should be evaluated by a licensed electrician with knowledge of the operating parameters.

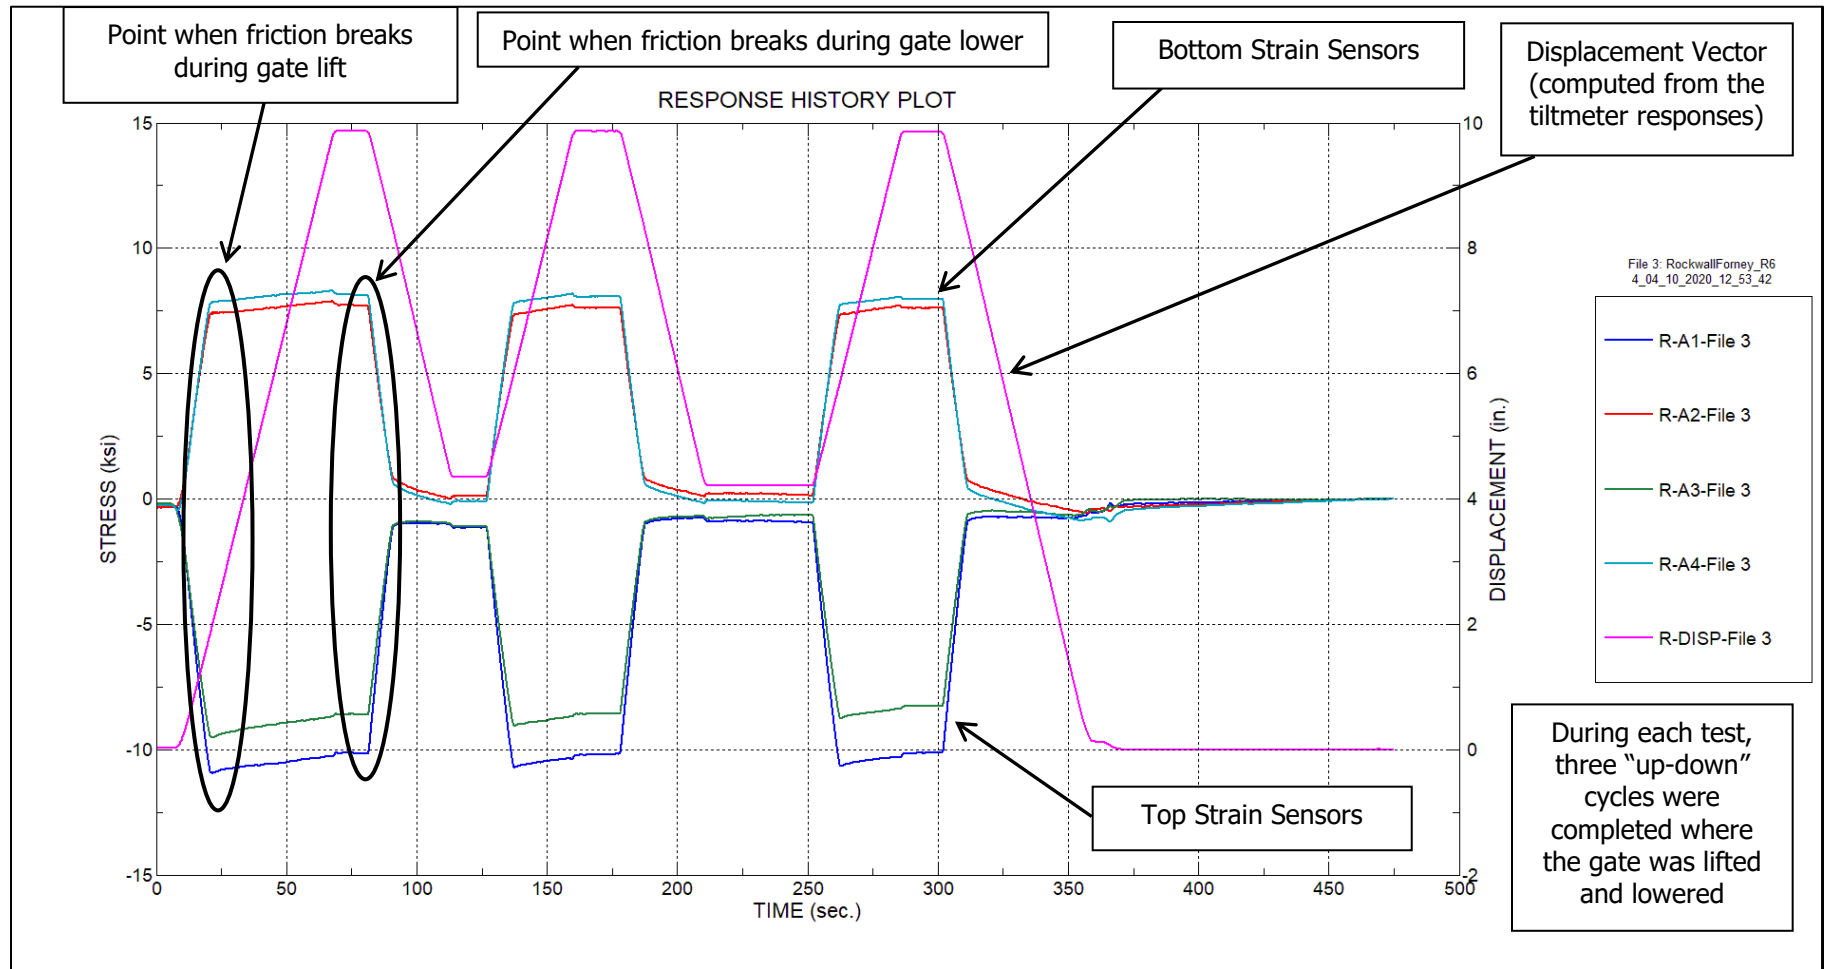
Figure 11 – Stress response & gate movement history – Right arm – Section A - Highlighting friction behavior (Section A along top strut near pin)
