VISUAL INSPECTION AND EVALUATION REPORT

Rockwall-Forney Dam
Dallas Water Utilities
Dallas/Kaufman Counties, Texas

Schnabel Reference #20C22001.00
July 30, 2021

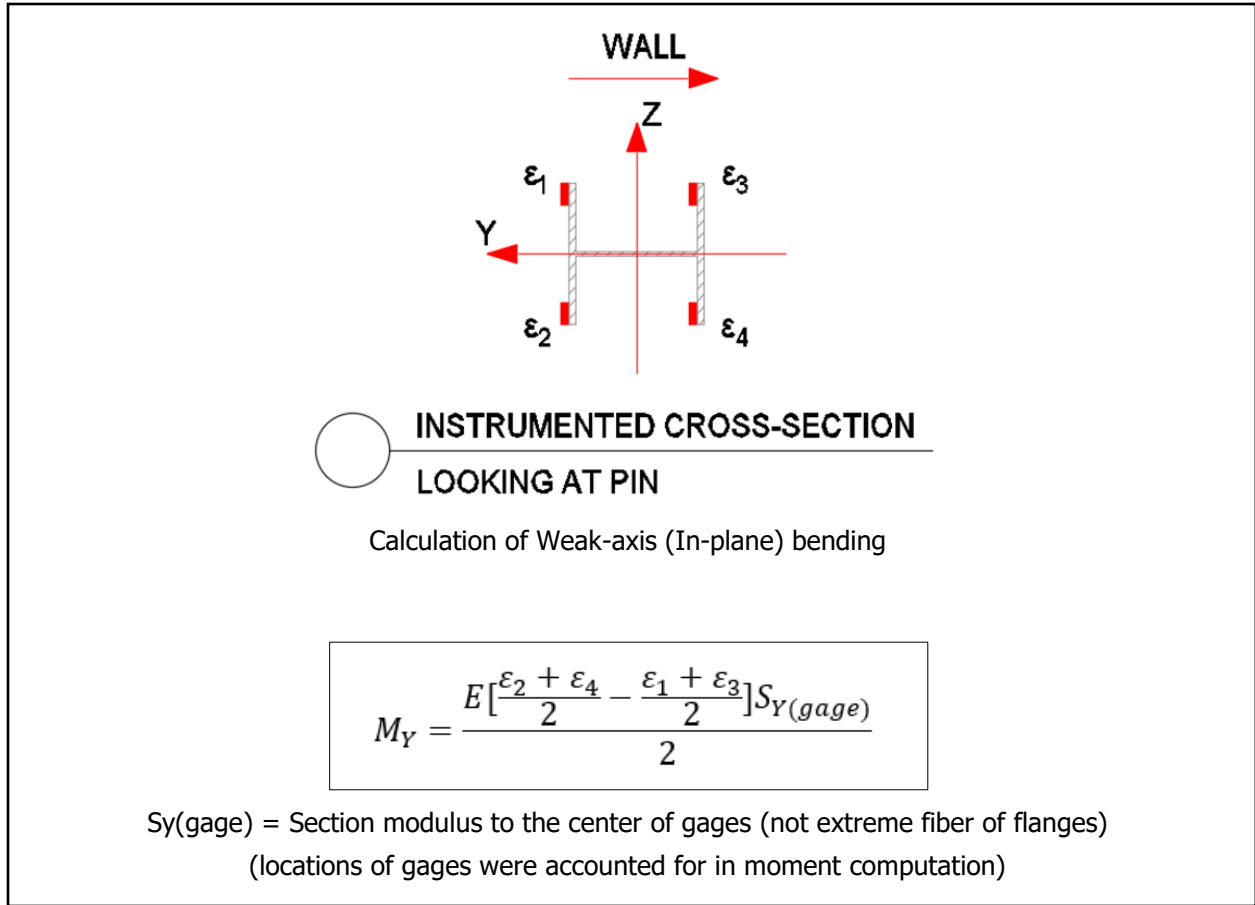
Figure 12 – Basic mechanic equation used to calculate moment

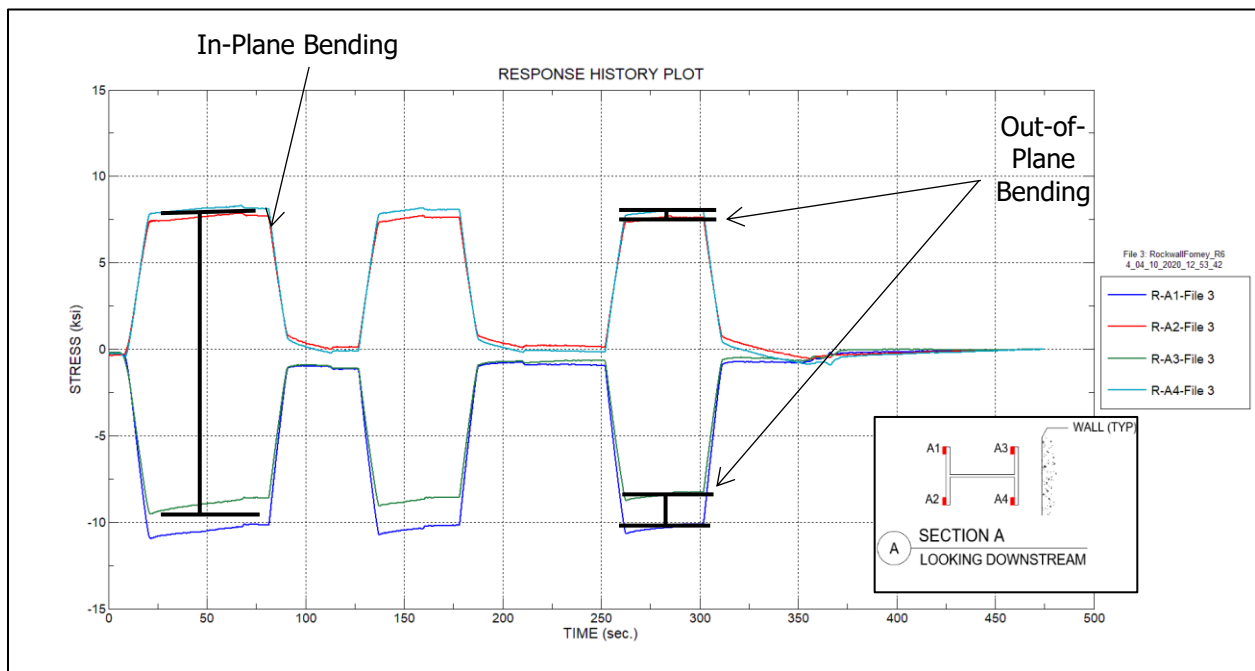
Figure 13 – Stress response history – Right arm – Section A – Bending components
(Section A along top strut near pin)

In-plane or weak-axis flexure refers to bending about a given strut's web. This designation is consistent with typical nomenclature. In-plane bending can be observed visually from the strain response histories as a difference between the top and bottom stresses, whereas out-of-plane or strong-axis bending is visualized as the difference in stress from side to side. Figure 13 provides a visual reference for both types of strut flexure.

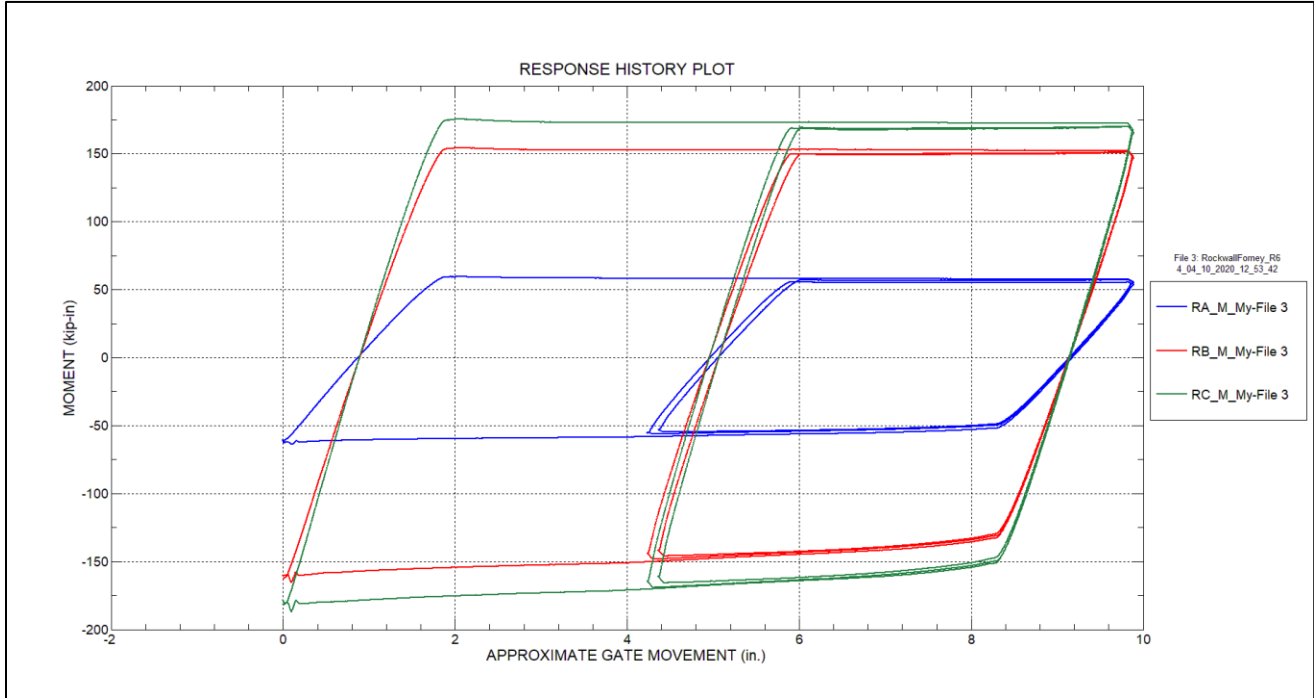
Figure 14 – In-plane moment response history – Right arm – Sections near pin
(RA = Right Arm Top Strut, RB = Right Arm Middle Strut, RC = Right Arm Bottom Strut)

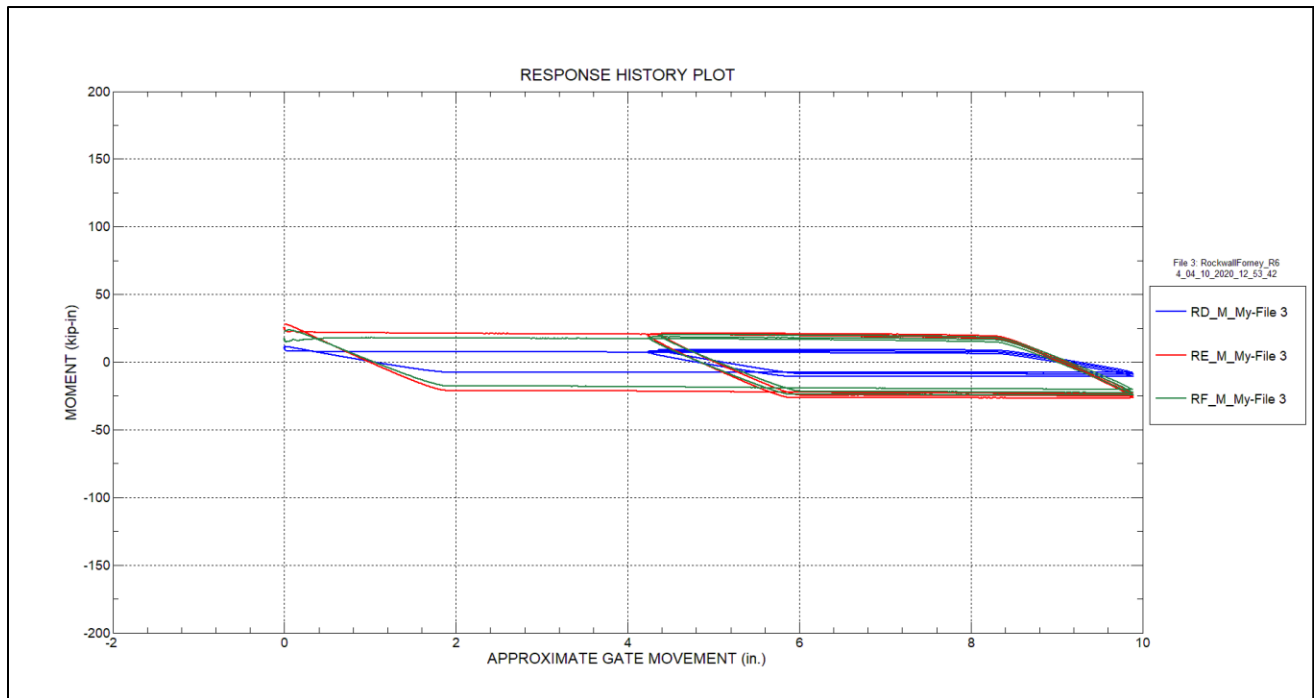
Figure 15 – In-plane moment response history – Right arm – Sections away from pin
(RD = Right Arm Top Strut, RE = Right Arm Middle Strut, RF = Right Arm Bottom Strut)

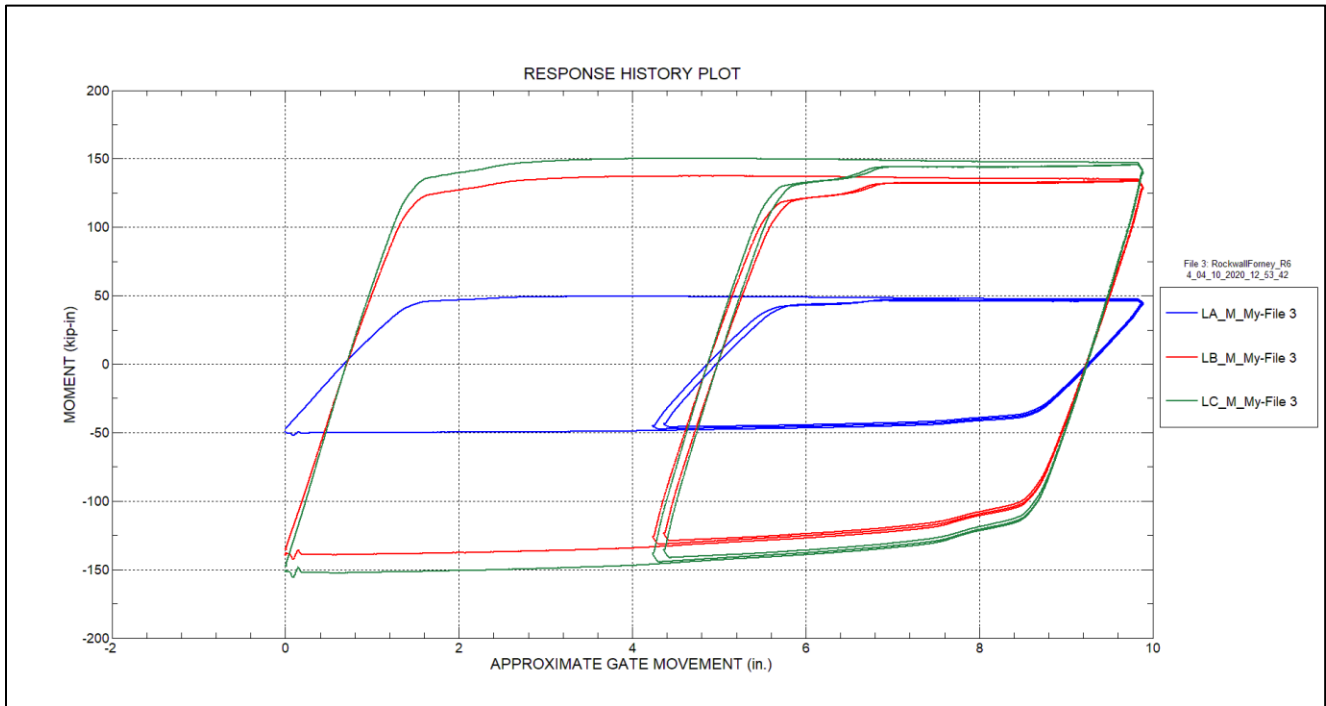
Figure 16 – In-plane moment response history – Left arm – Sections near pin
(LA = Left Arm Top Strut, LB = Left Arm Middle Strut, LC = Left Arm Bottom Strut)

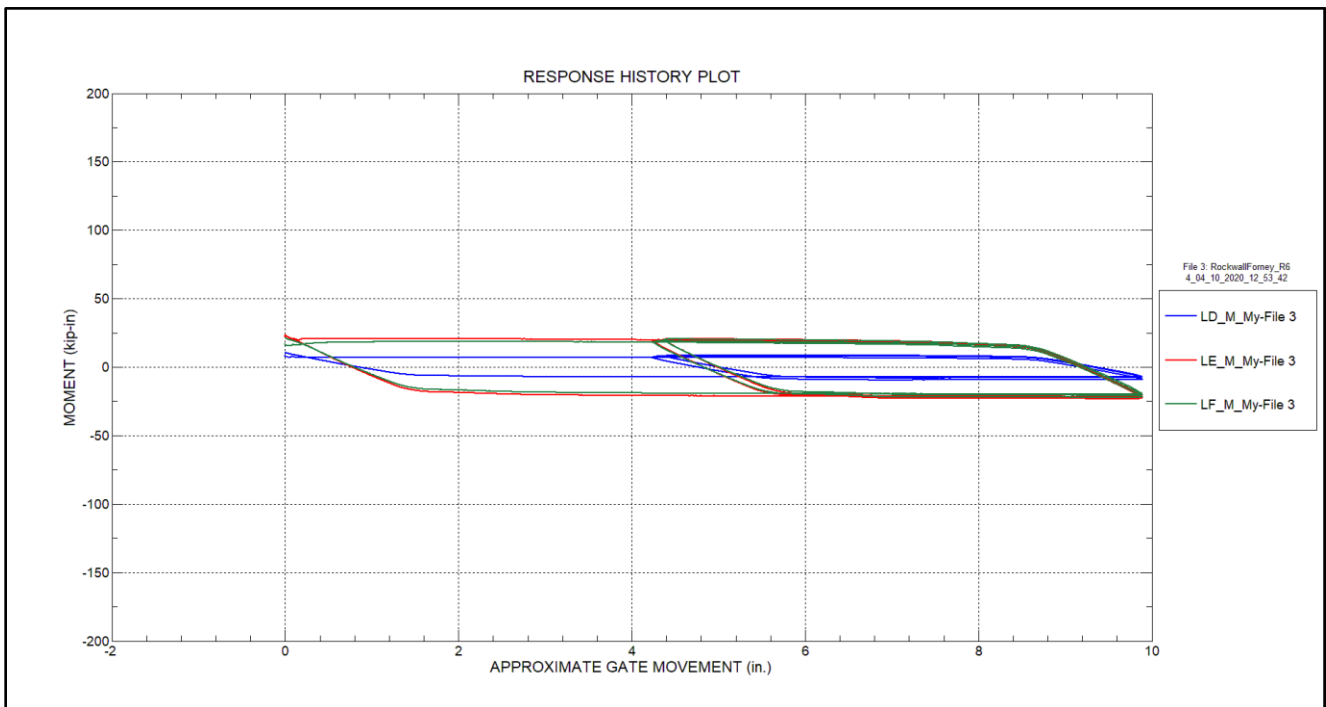
Figure 17 - In-plane moment response history – Left arm – Sections away from pin
(LD = Left Arm Top Strut, LE = Left Arm Middle Strut, LF = Left Arm Bottom Strut)

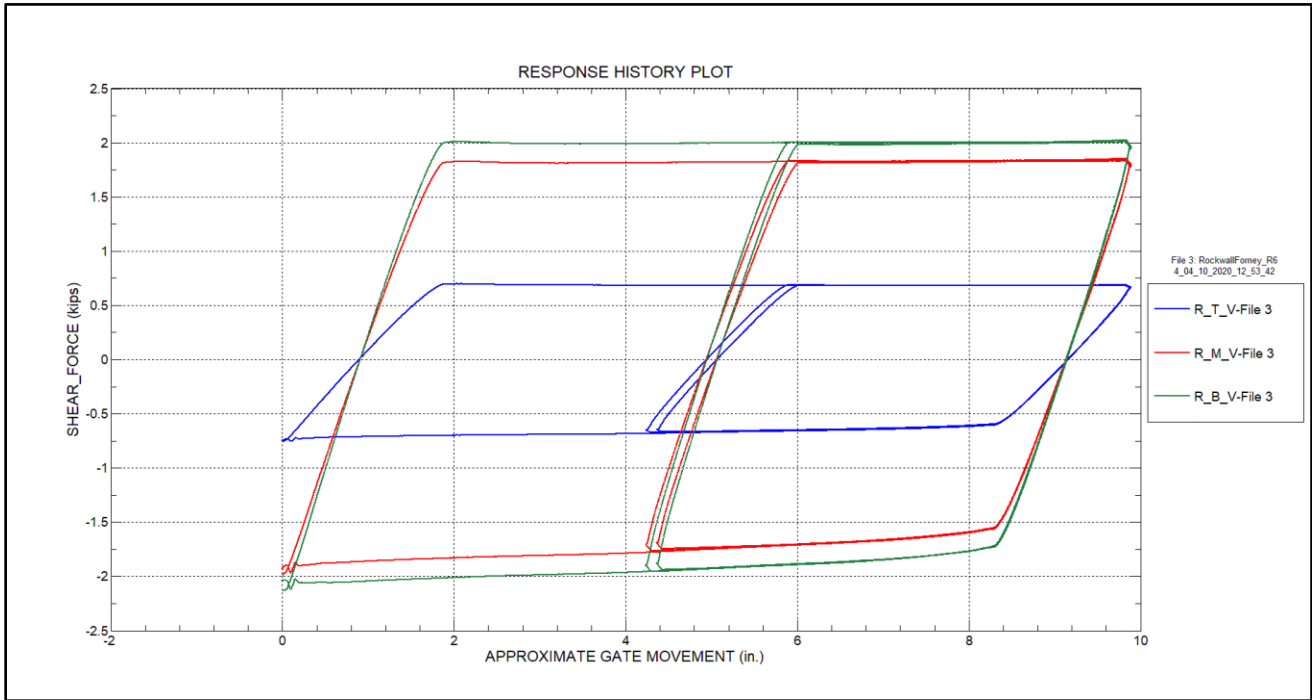
Figure 19 – Strut shear response history – Right arm

(R_T = Right Arm Top Strut, R_M = Right Arm Middle Strut, R_B = Right Arm Bottom Strut)

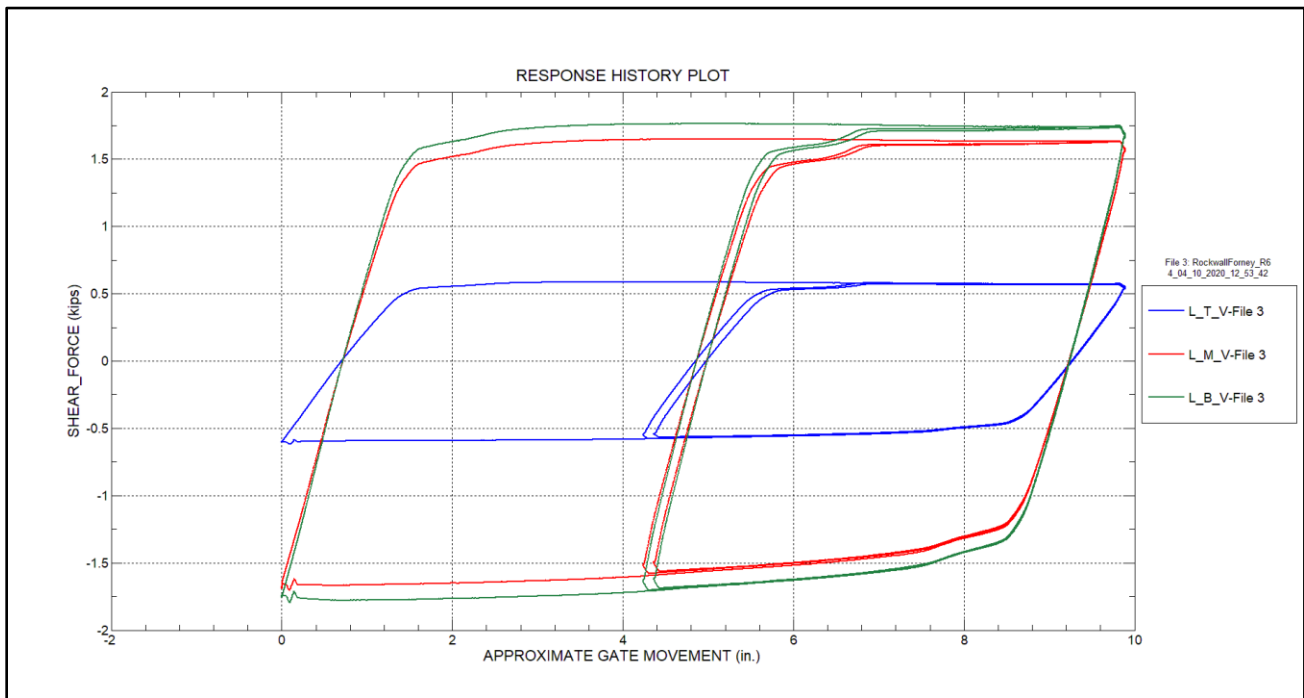
Figure 20 – Strut shear response history – Left arm

(L_T = Left Arm Top Strut, L_M = Left Arm Middle Strut, L_B = Left Arm Bottom Strut)

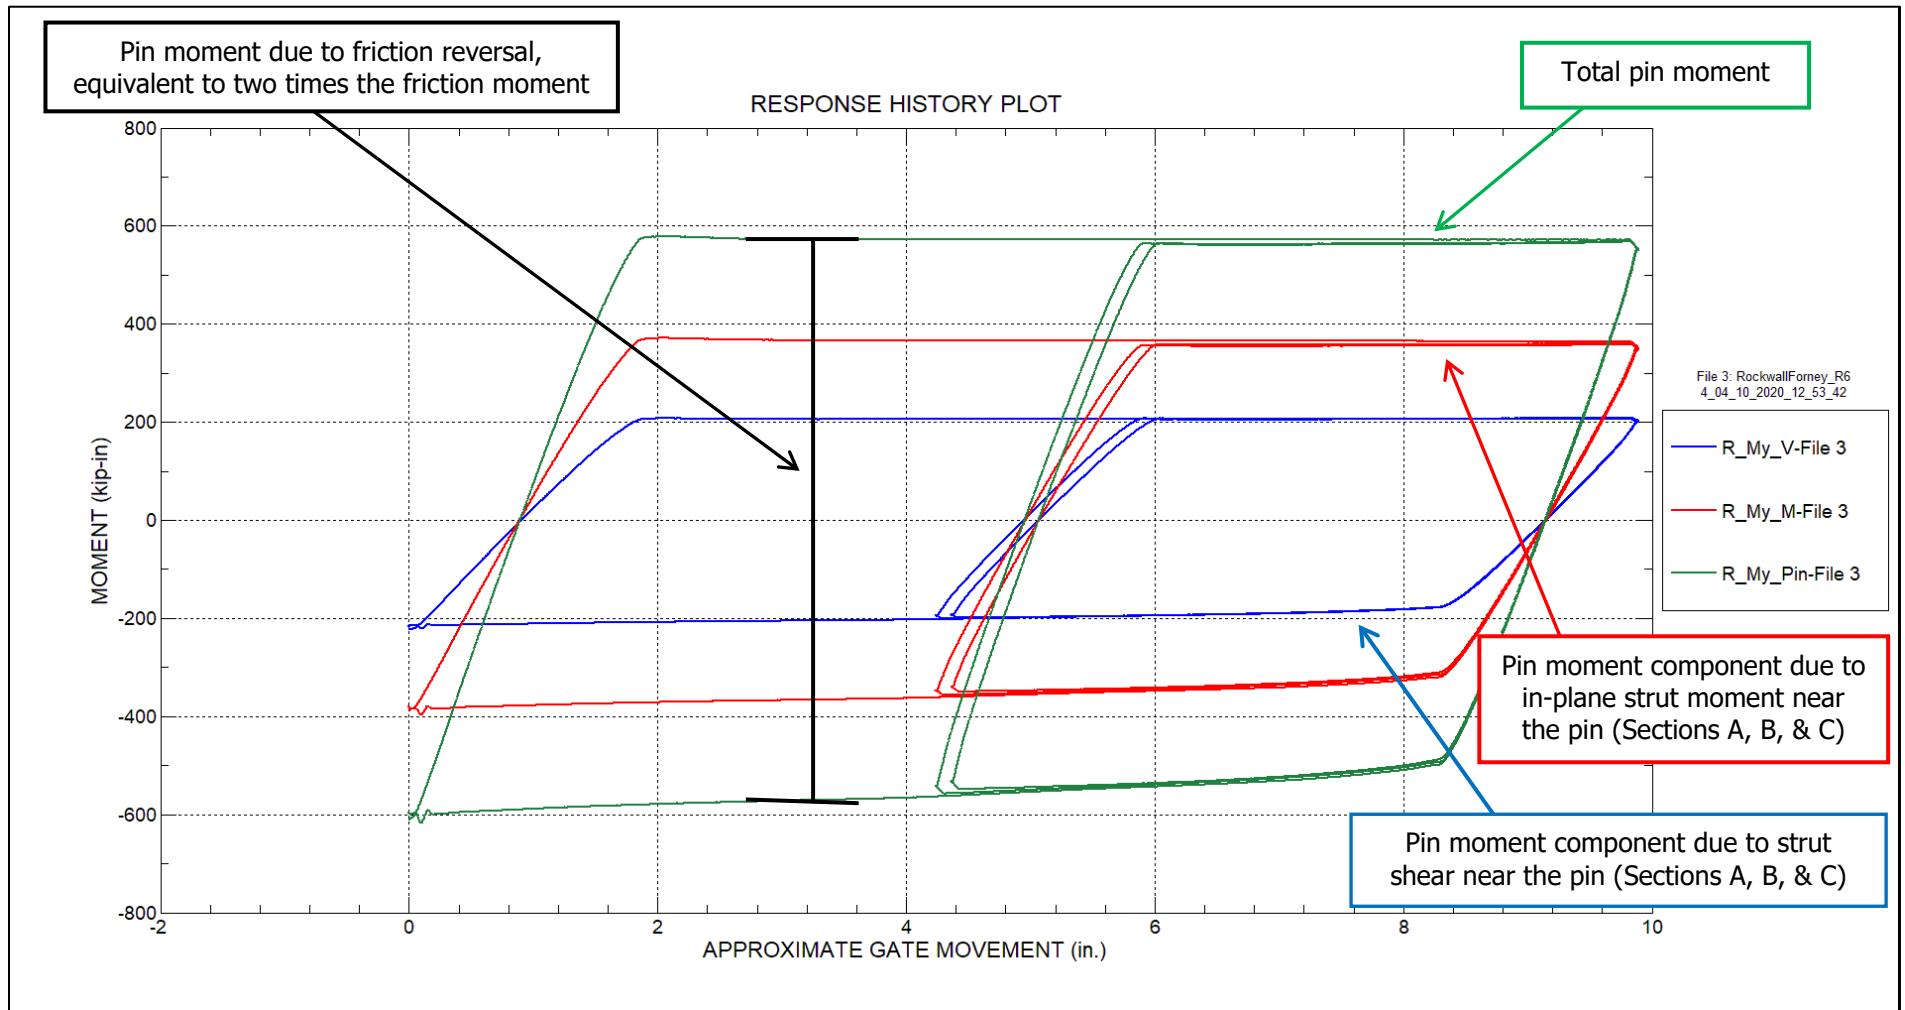
Figure 21 – Pin moment response history – Right arm

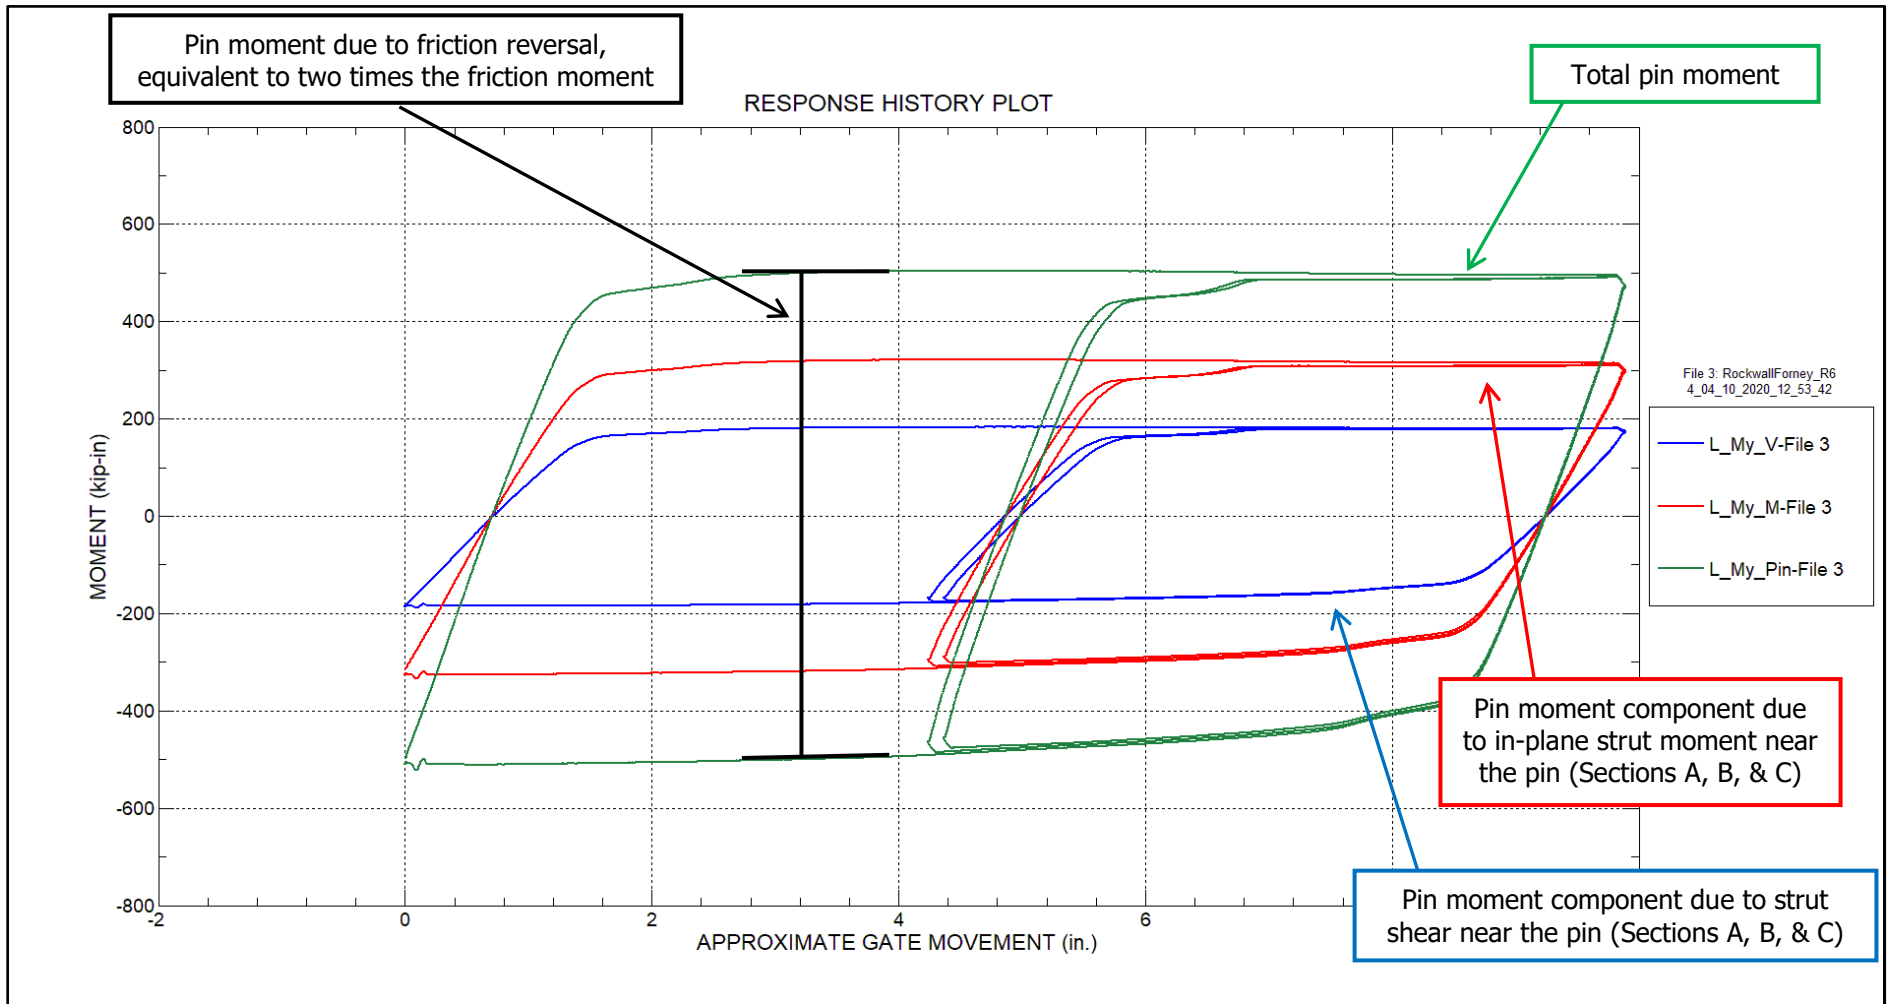
Figure 22 – Pin moment response history – Left arm

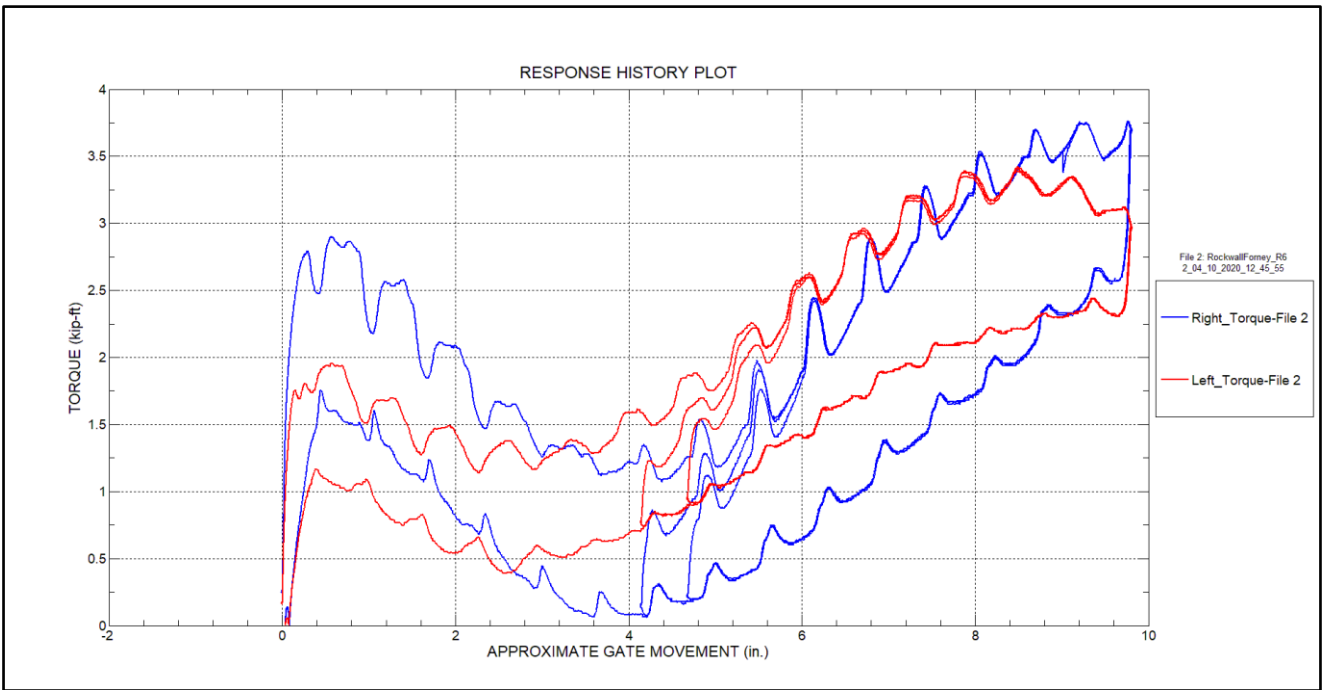
Figure 23 – Hoist torque response history – Gate 11 – Test 2

Figure 23 shows example torque measurements, recorded on the Gate 11 torque shafts. Best practices for torque measurements is to measure torque on opposite sides of the shaft so that any bending in the shaft can be removed by averaging the two responses. Due to access limitations, only one gage at each location could be installed. Therefore, any bending in the shaft may be reflected in the torque measurements and may be related to the peaks and valleys observed in the torque responses.

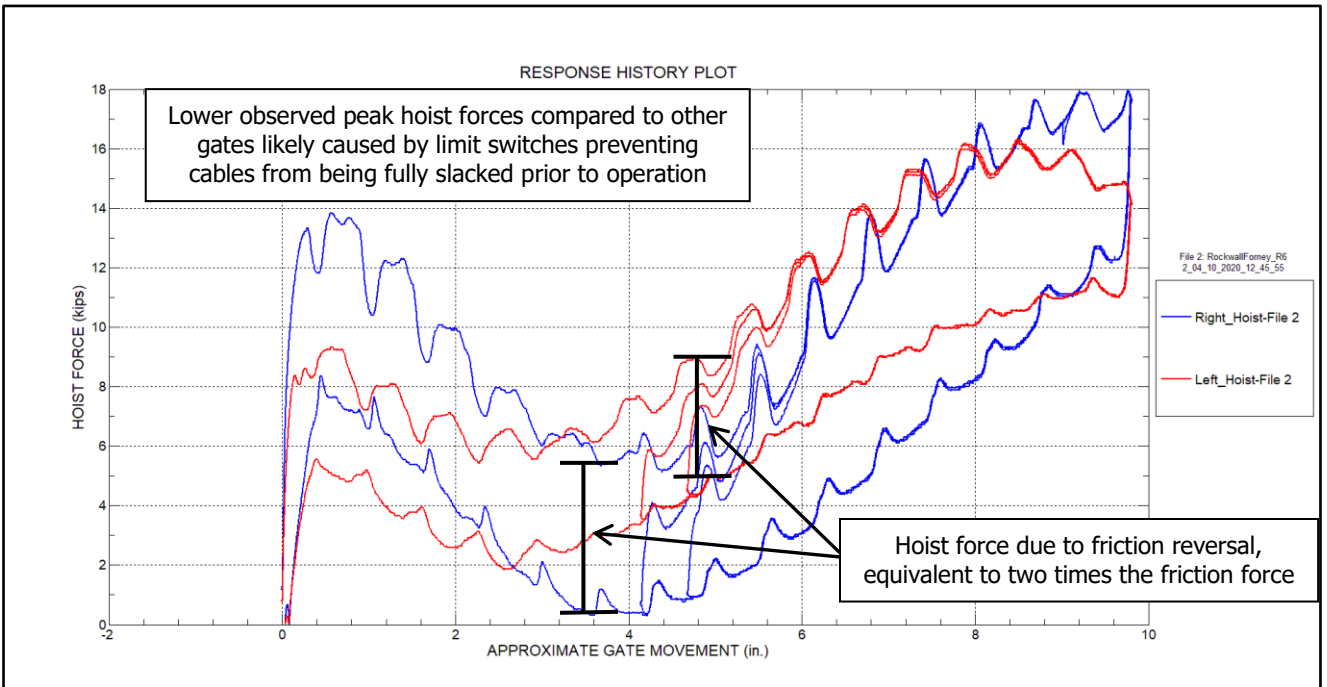
Figure 24 – Hoist force response history – Gate 11 – Test 2

Torque values were converted to force in the hoist cables per gate arm using the gear ratio and drum radius, as shown in Figure 24. The gear ratio and drum radius were 5.182 and 1.086 feet respectively, as defined in the provided as-built shop drawings. It should be noted that the hoist force calculated may be smaller than the actual hoist force applied. This difference is due to the limit switch engaging the brake before the hoist cable was fully slacked, resulting in an initial force in the cable. A hoist force due to total gate friction was then calculated. This friction hoist force was equal to half the differential in force measured during the lifting and lowering of the gate (similar to the pin friction calculations). As shown in Table 3, the change in cable force due to friction was generally consistent between tests. Note that the total hoist force was due to the total friction effects, including side seal, hoist bearings, trunnion friction effects, etc. It is difficult to determine the exact proportion and composition of the total friction sources. Additional torque and hoist force plots for all collected data files are provided in Appendix A – Gate 11 Torque and Hoist Force Plots.

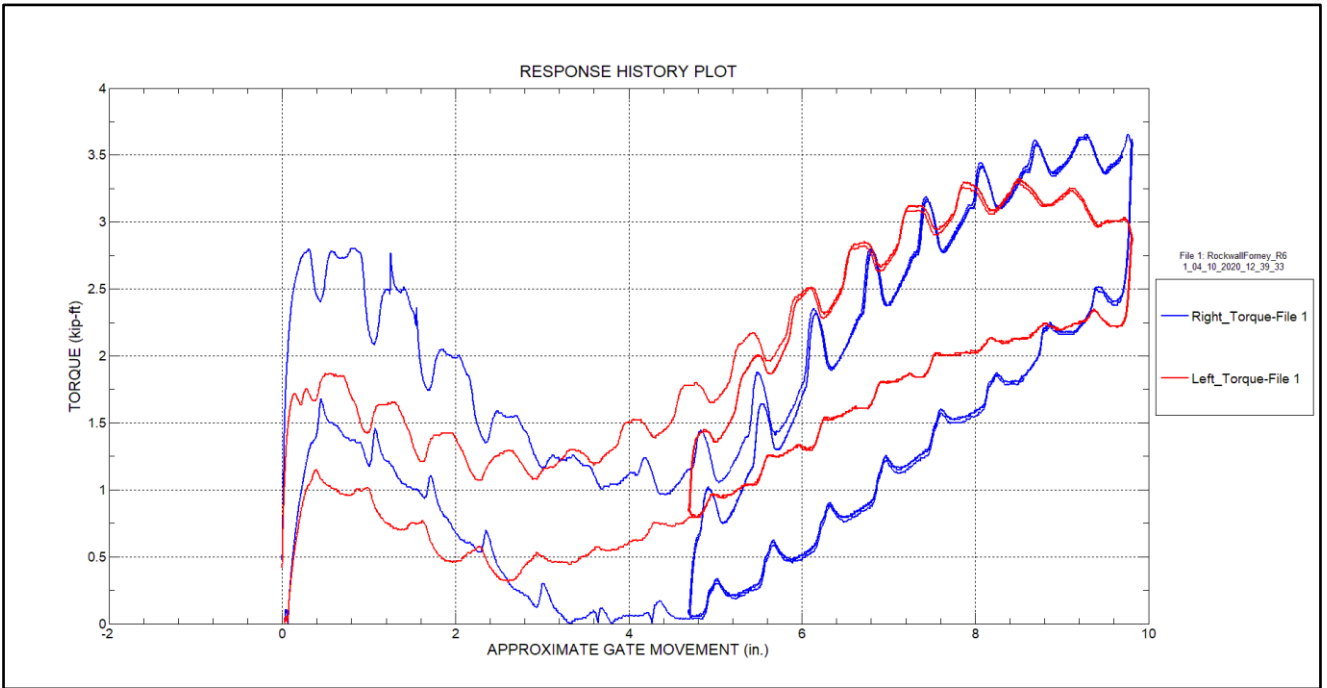
Figure 25 – Hoist torque response history – Gate 11 – Test 1

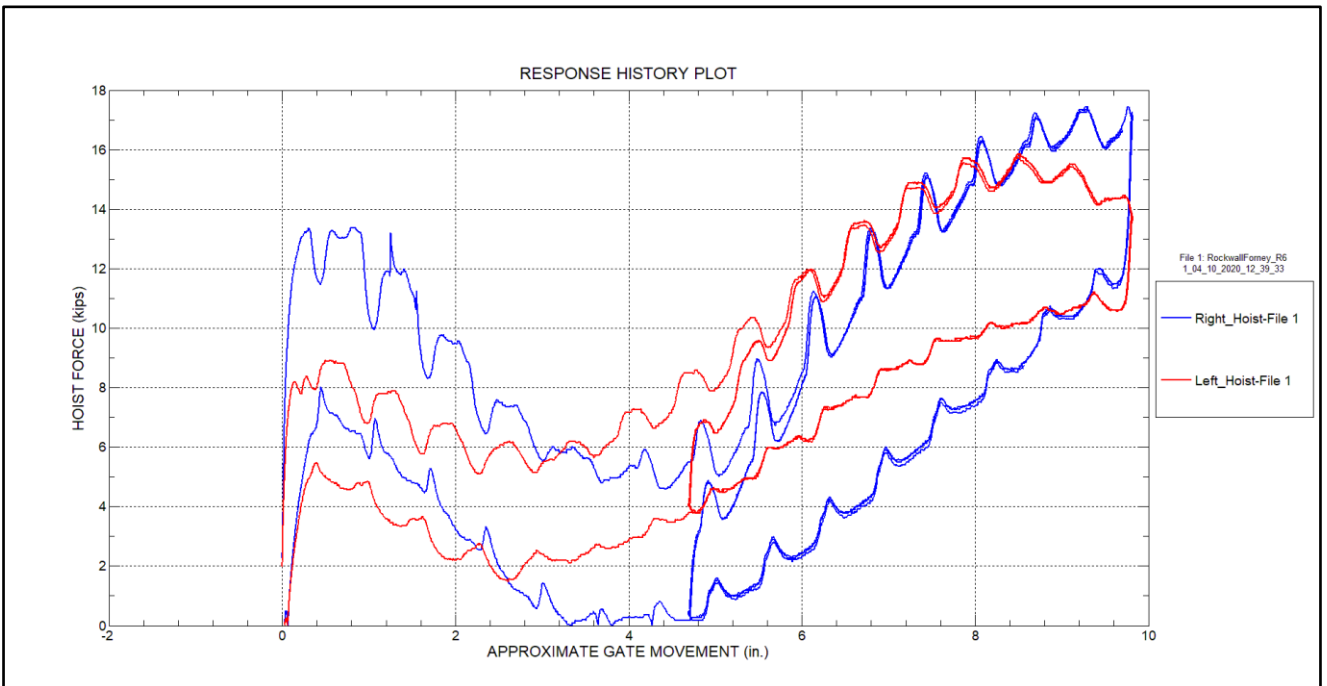
Figure 26 – Hoist force response history – Gate 11 – Test 1

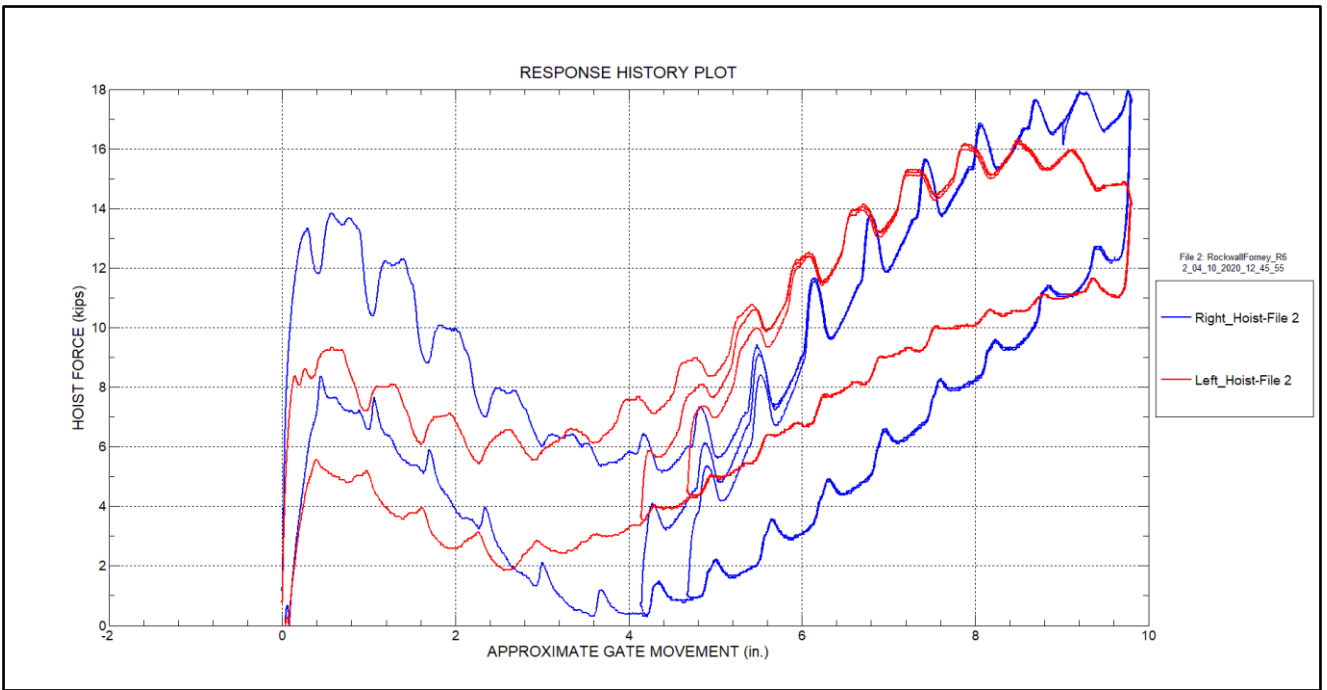
Figure 28 – Hoist force response history – Gate 11 – Test 2

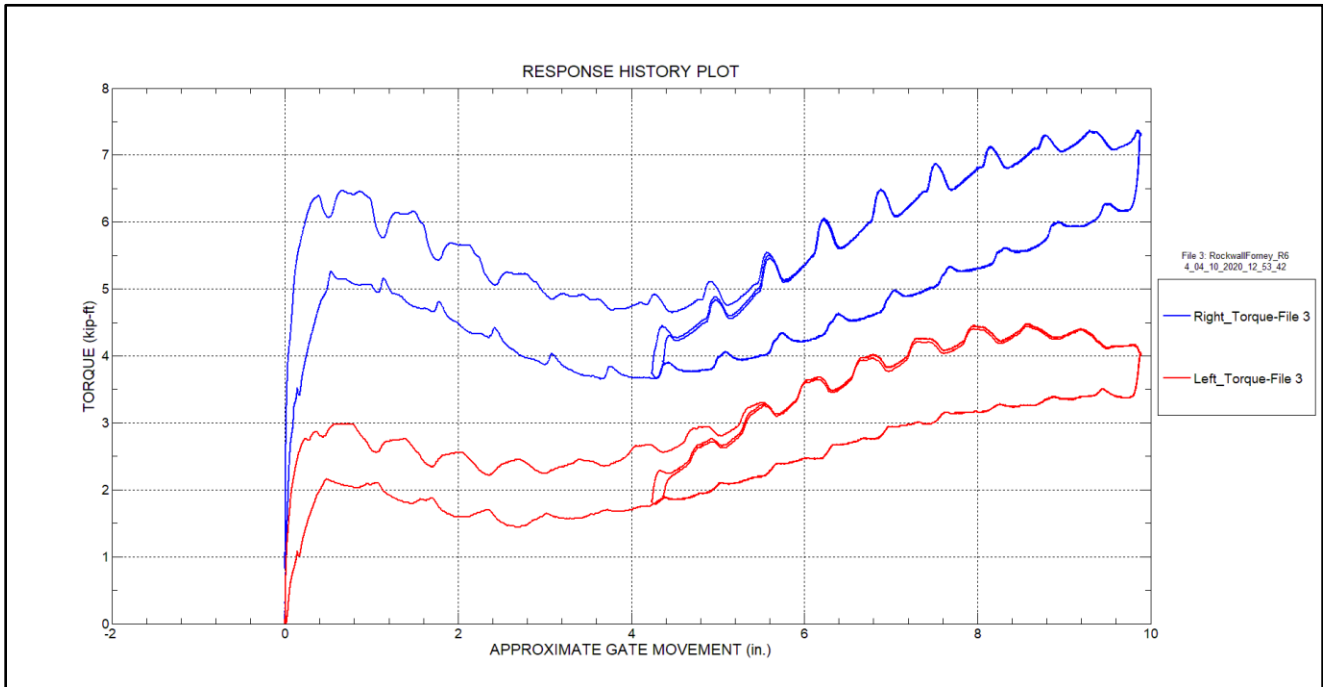
Figure 29 – Hoist torque response history – Gate 11 – Test 3

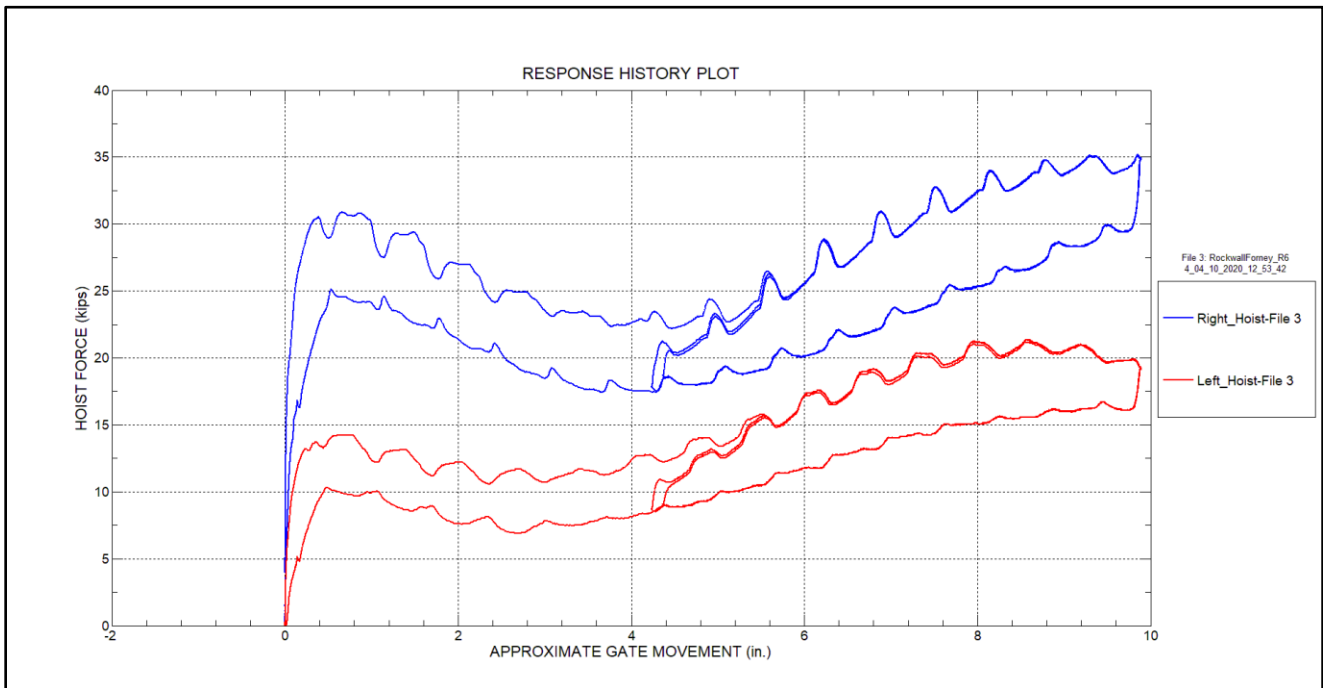
Figure 30 – Hoist force response history – Gate 11 – Test 3

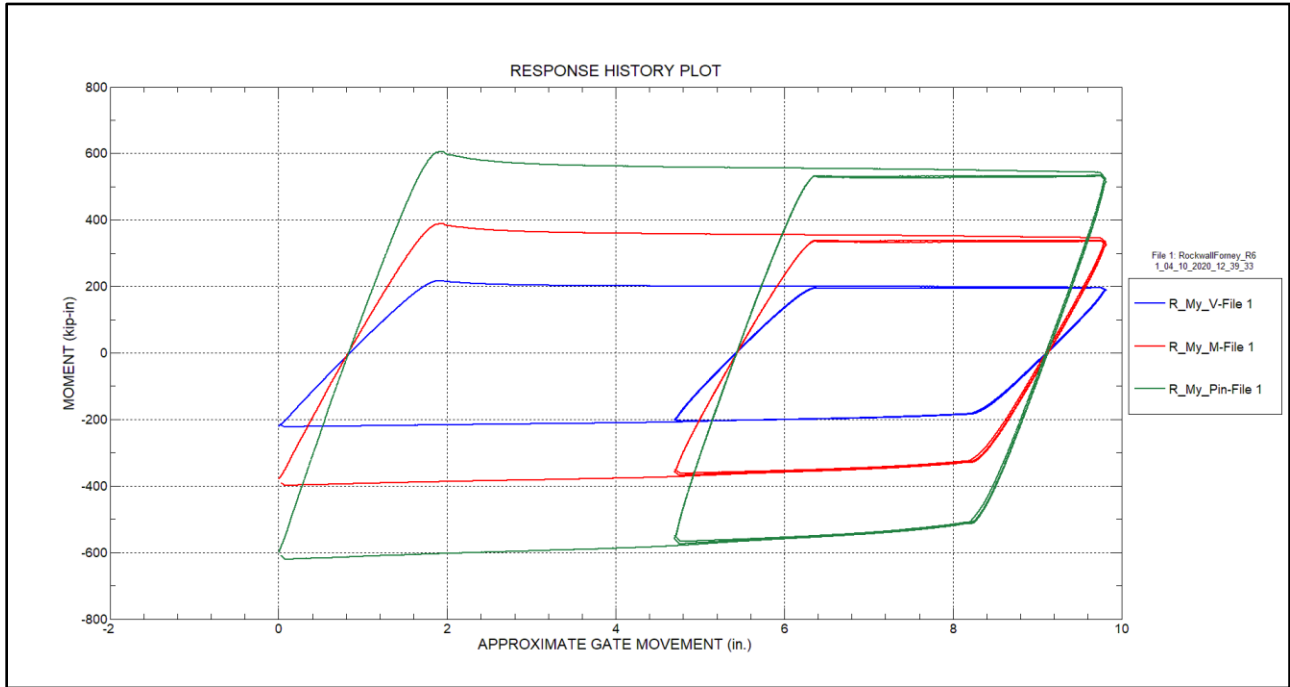
Figure 31 – Pin moment response history – Right arm – Test run 1

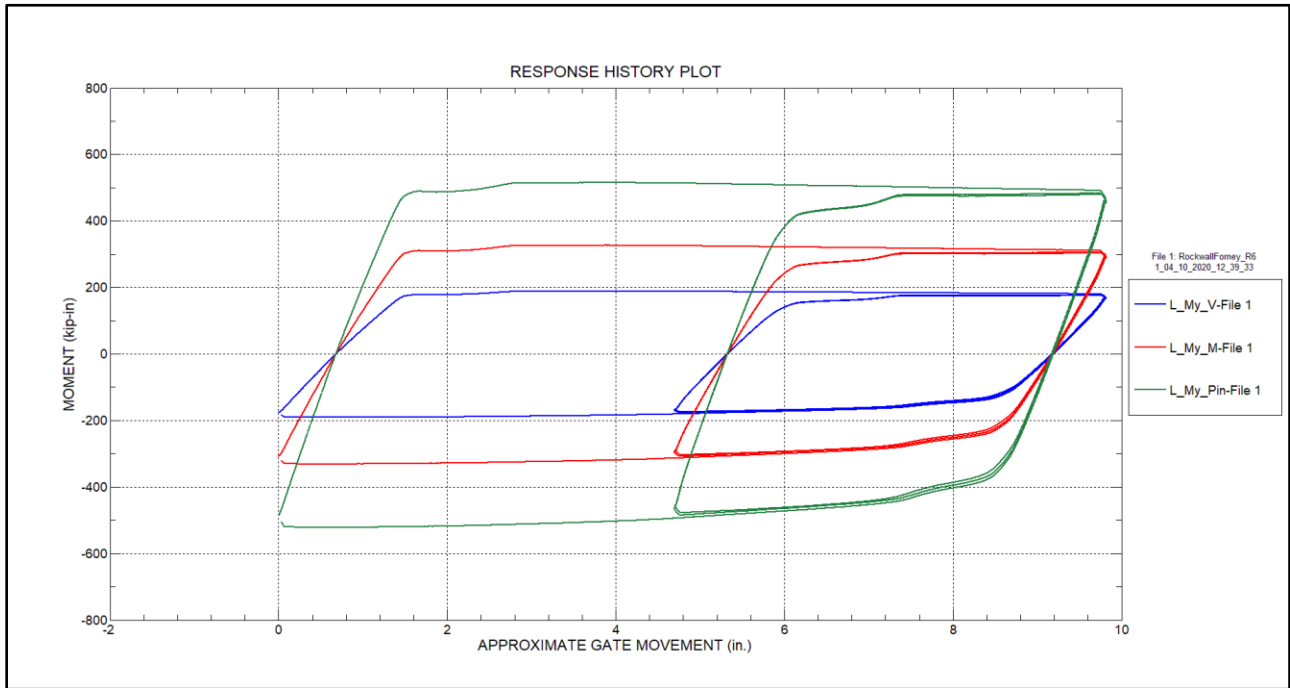
Figure 32 – Pin moment response history – Left arm – Test run 1

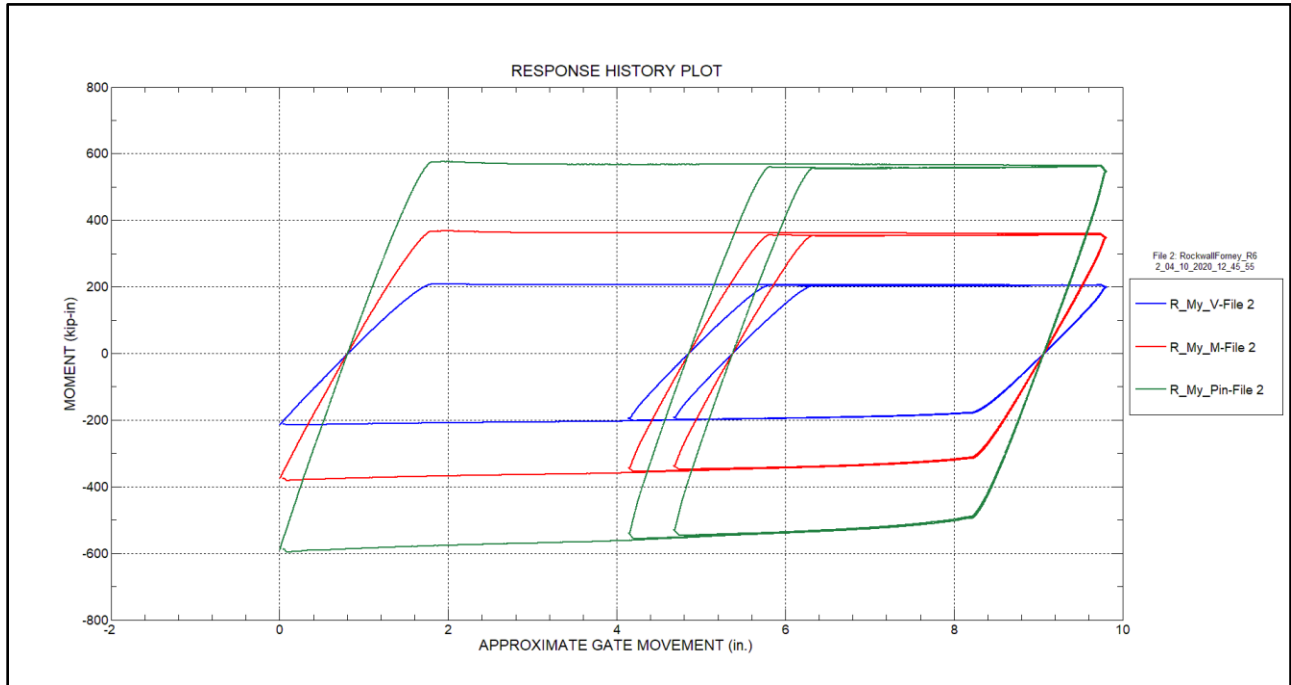
Figure 33 – Pin moment response history – Right arm – Test run 2

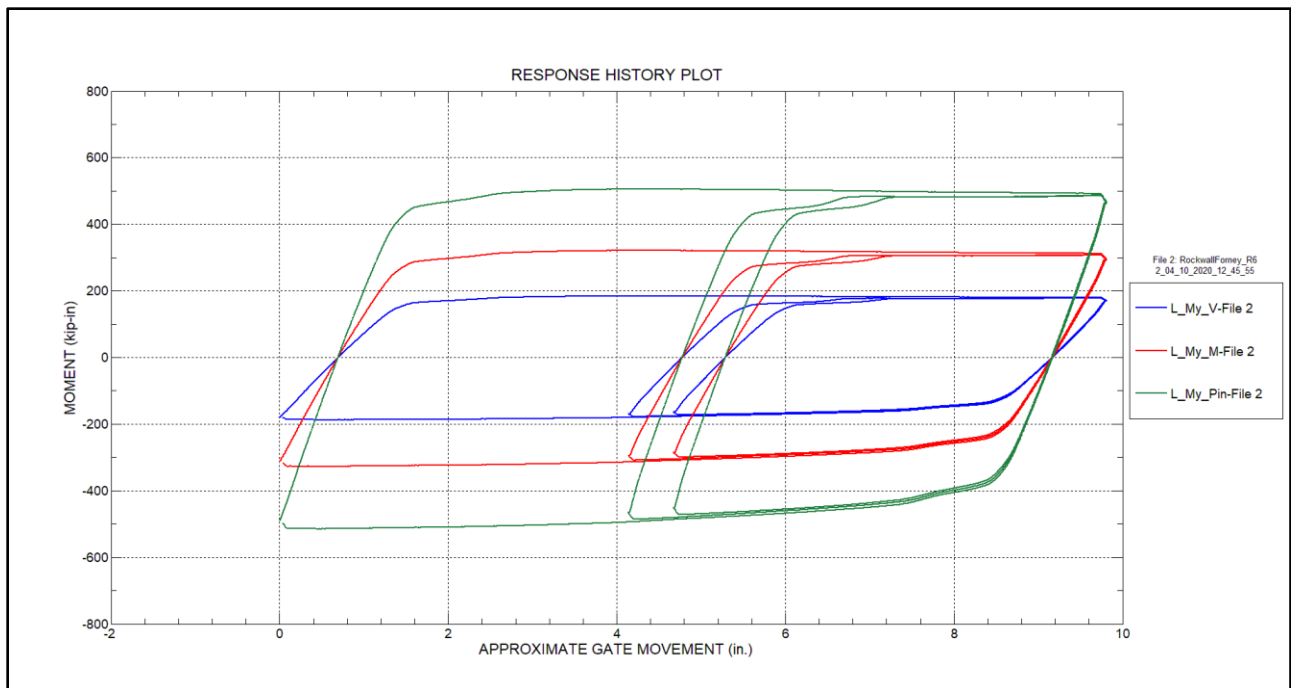
Figure 34 – Pin moment response history – Left arm – Test run 2

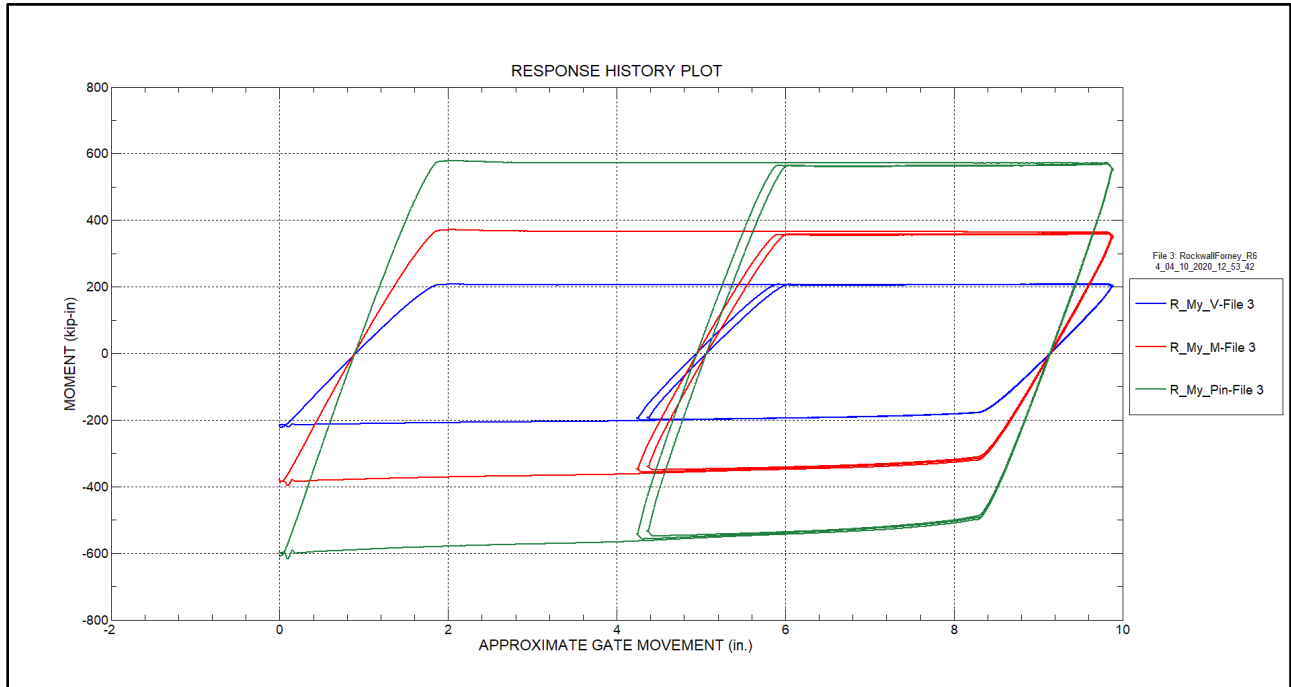
Figure 35 – Pin moment response history – Right arm – Test run 3
