VISUAL INSPECTION AND EVALUATION REPORT

Rockwall-Forney Dam
Dallas Water Utilities
Dallas/Kaufman Counties, Texas

Schnabel Reference #20C22001.00
July 30, 2021

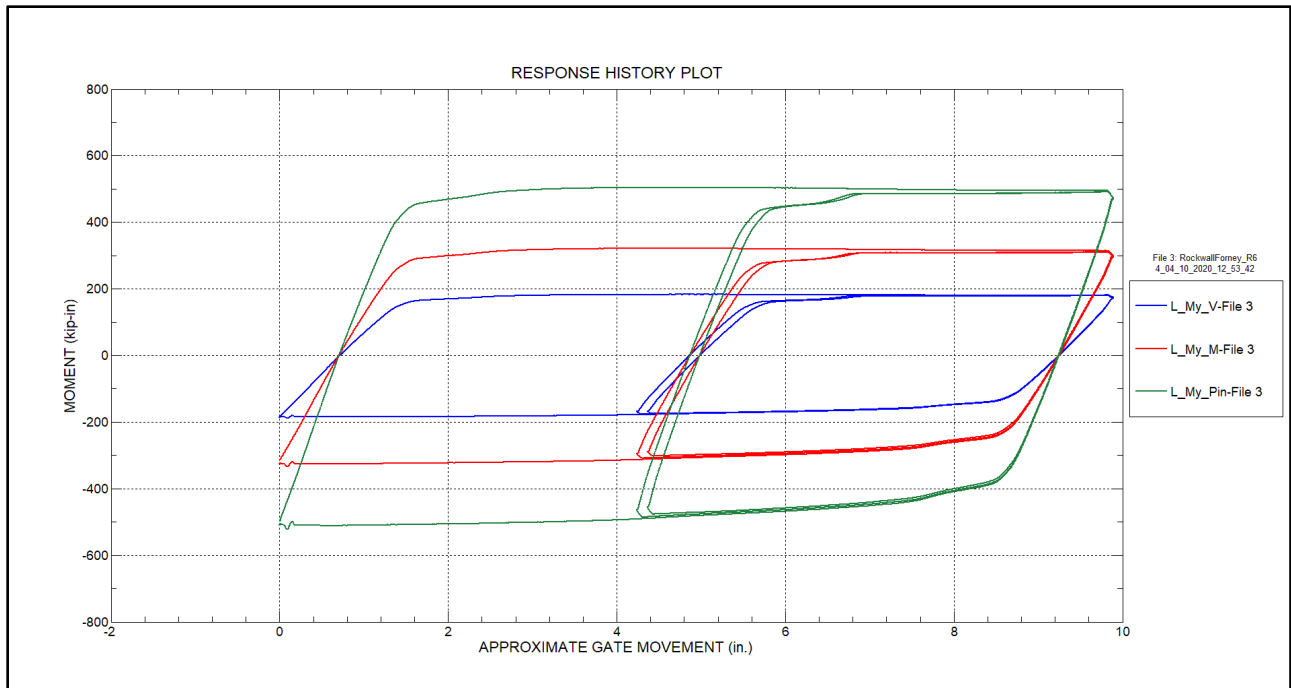
Figure 36 – Pin moment response history – Left arm – Test run 3

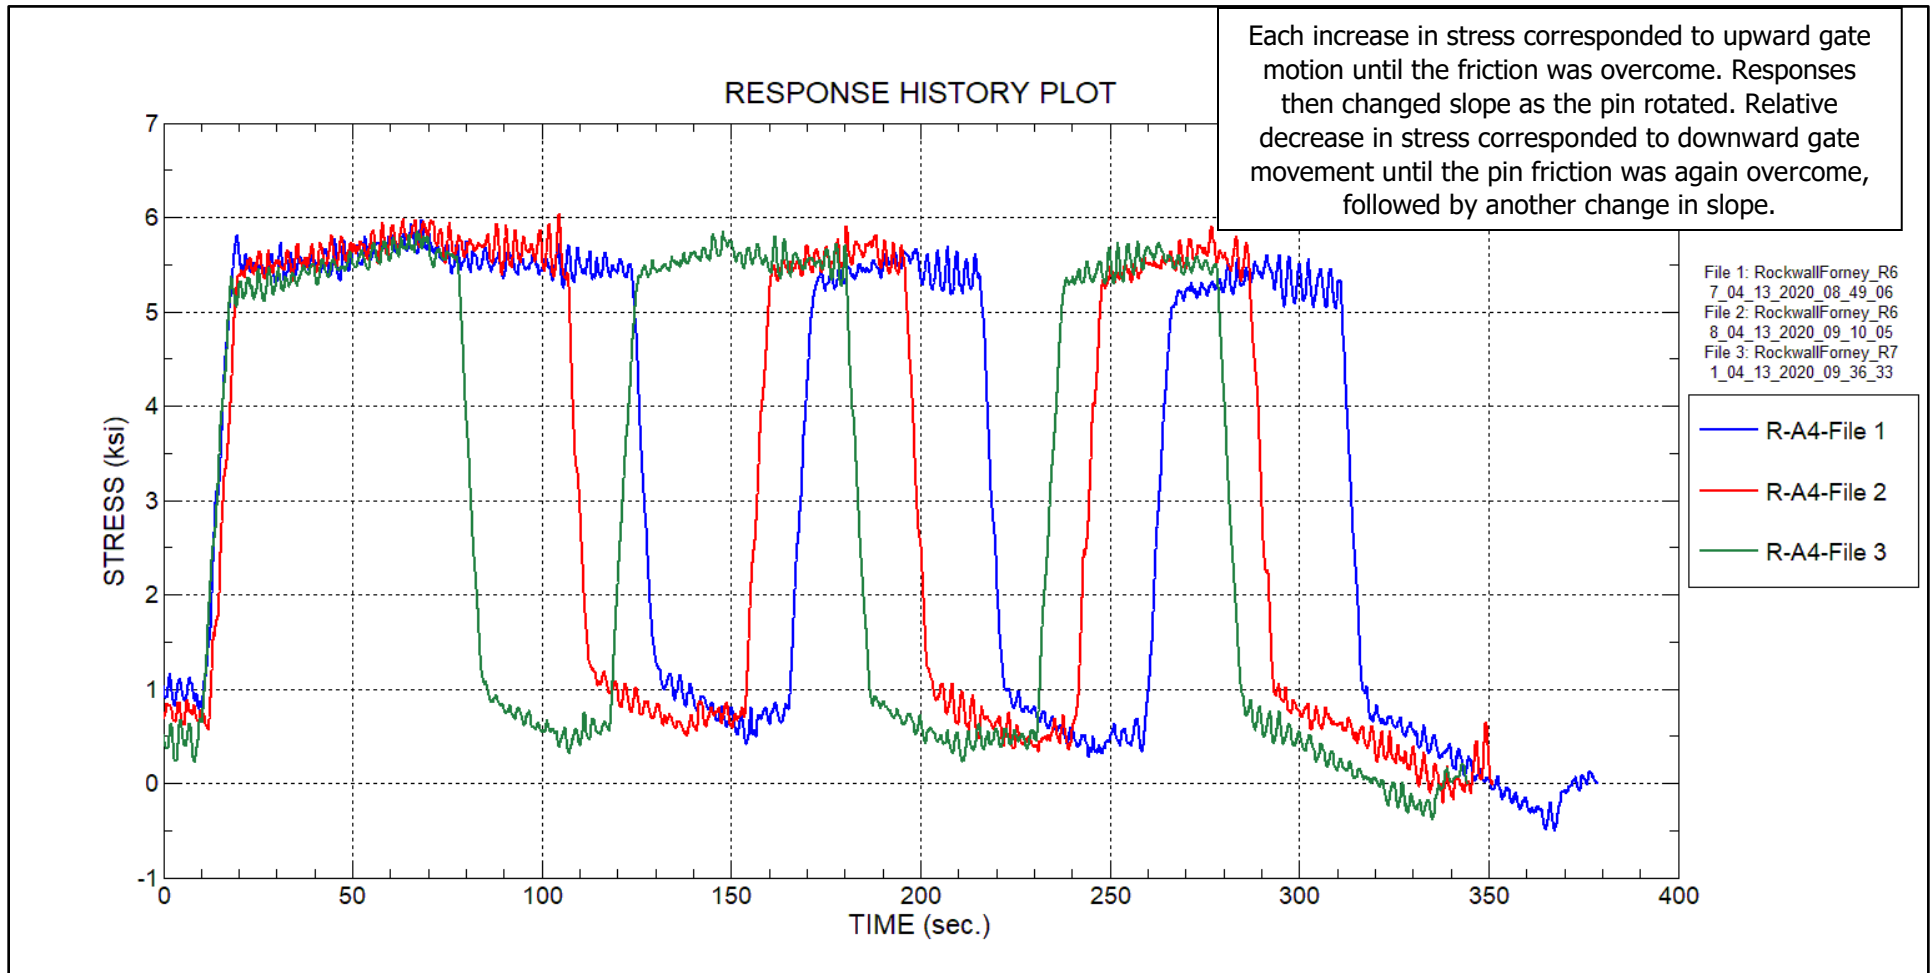
Figure 6 – Stress response history – Right arm – Gage A4 – Time based
File 1 = test run 1, File 2 = test run 2, File 3 = test run 3
(Section A along top strut near pin – Sensor location 4 along bottom of outer flange)

- + **DESCRIPTIONS OF RESPONSE MEASUREMENTS:** All sensor readings were zeroed at the end of each test (which consisted of three cycles of direction reversals) so that each measurement corresponded to response change relative to the final gate position as shown in Figure 6 (gates in the downward “closed” position with the hoist cables slacked as much as possible). It is also worth noting that the stresses did not always start and end at the same levels between tests. This variation in behavior is due to small changes in the flexed gate condition between the start and end of tests. It is common for the flex in the gate, caused by pin friction, to slowly release as it rests on the sill. The purpose of the three up-down cycles per test, prior to sitting the gate back onto the sill, is to ensure that these changes in boundary conditions, including gate flexure due to friction, did not affect BDI’s trunnion friction results. ***It is important to note that the recorded measurements were changes in structural response due to gate movement, and do not include the in-situ stresses due to the dead load, cable wrap, and hydrostatic loads present prior to testing.***

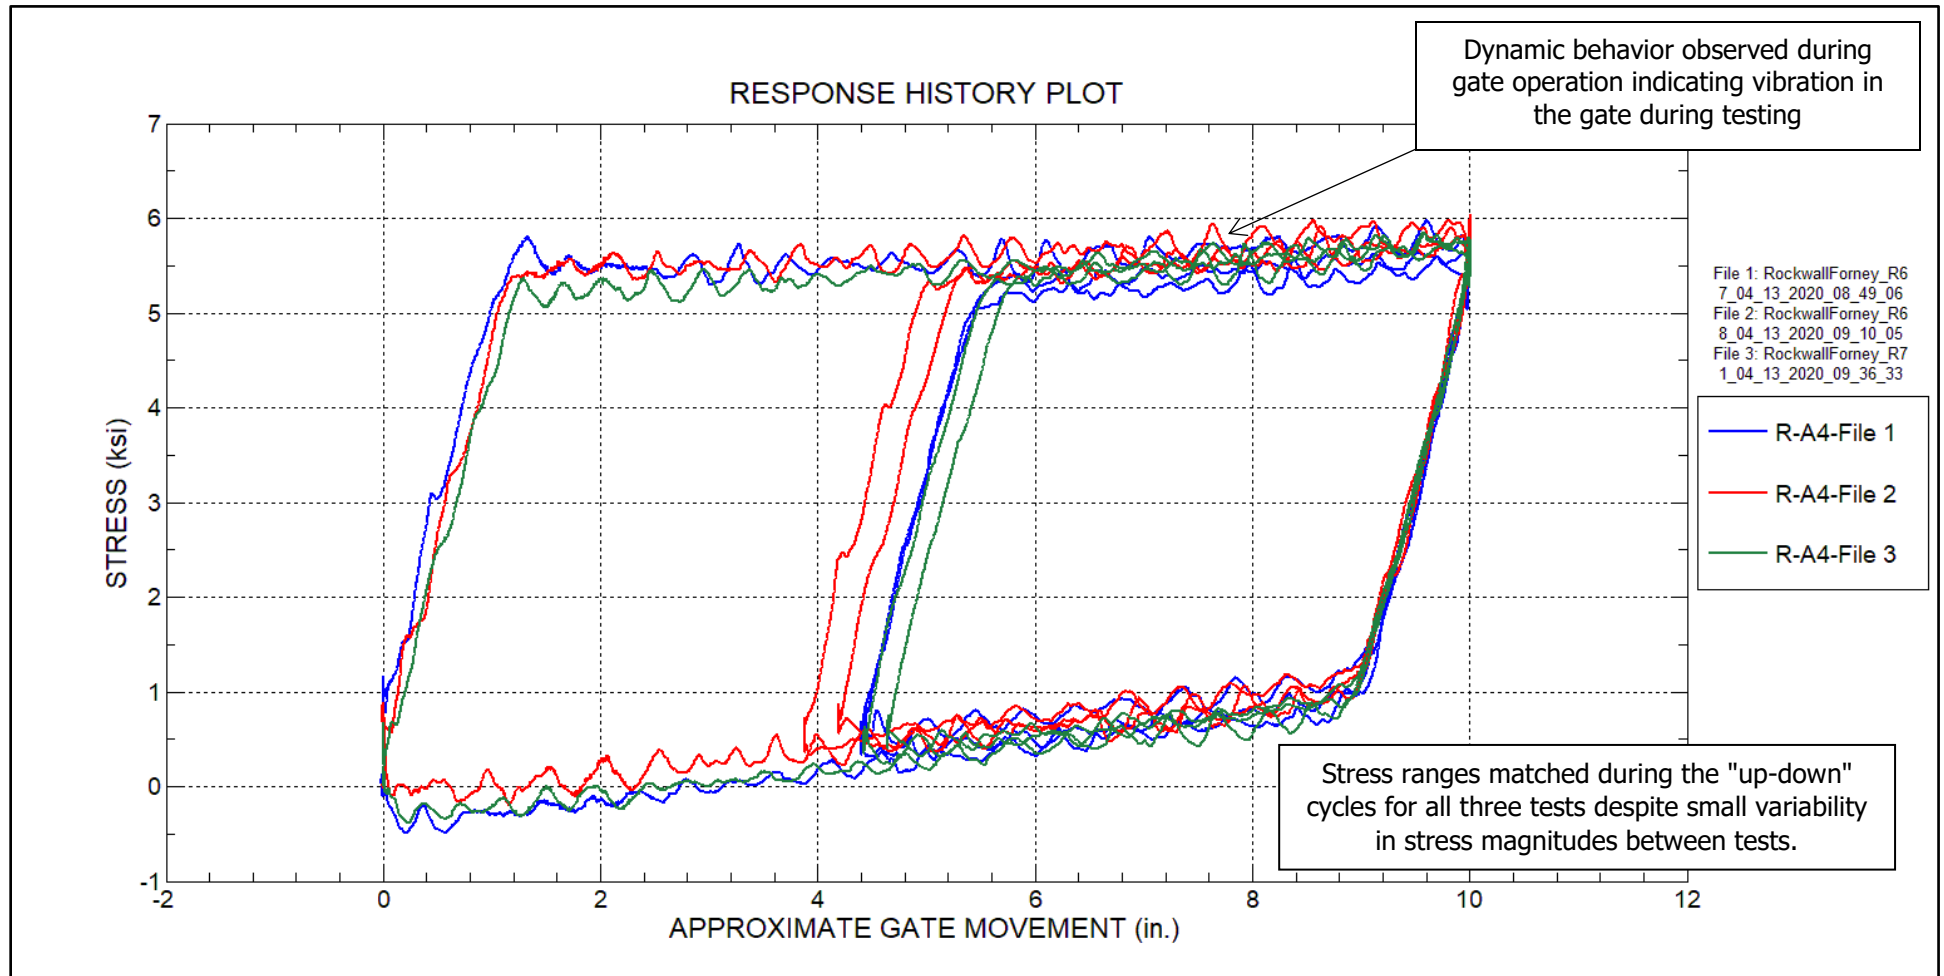
Figure 7 – Stress response history – Right arm – Gage A4 – Function of gate movement
File 1 = test run 1, File 2 = test run 2, File 3 = test run 3

(Section A along top strut near pin – Sensor location 4 along bottom of outer flange)

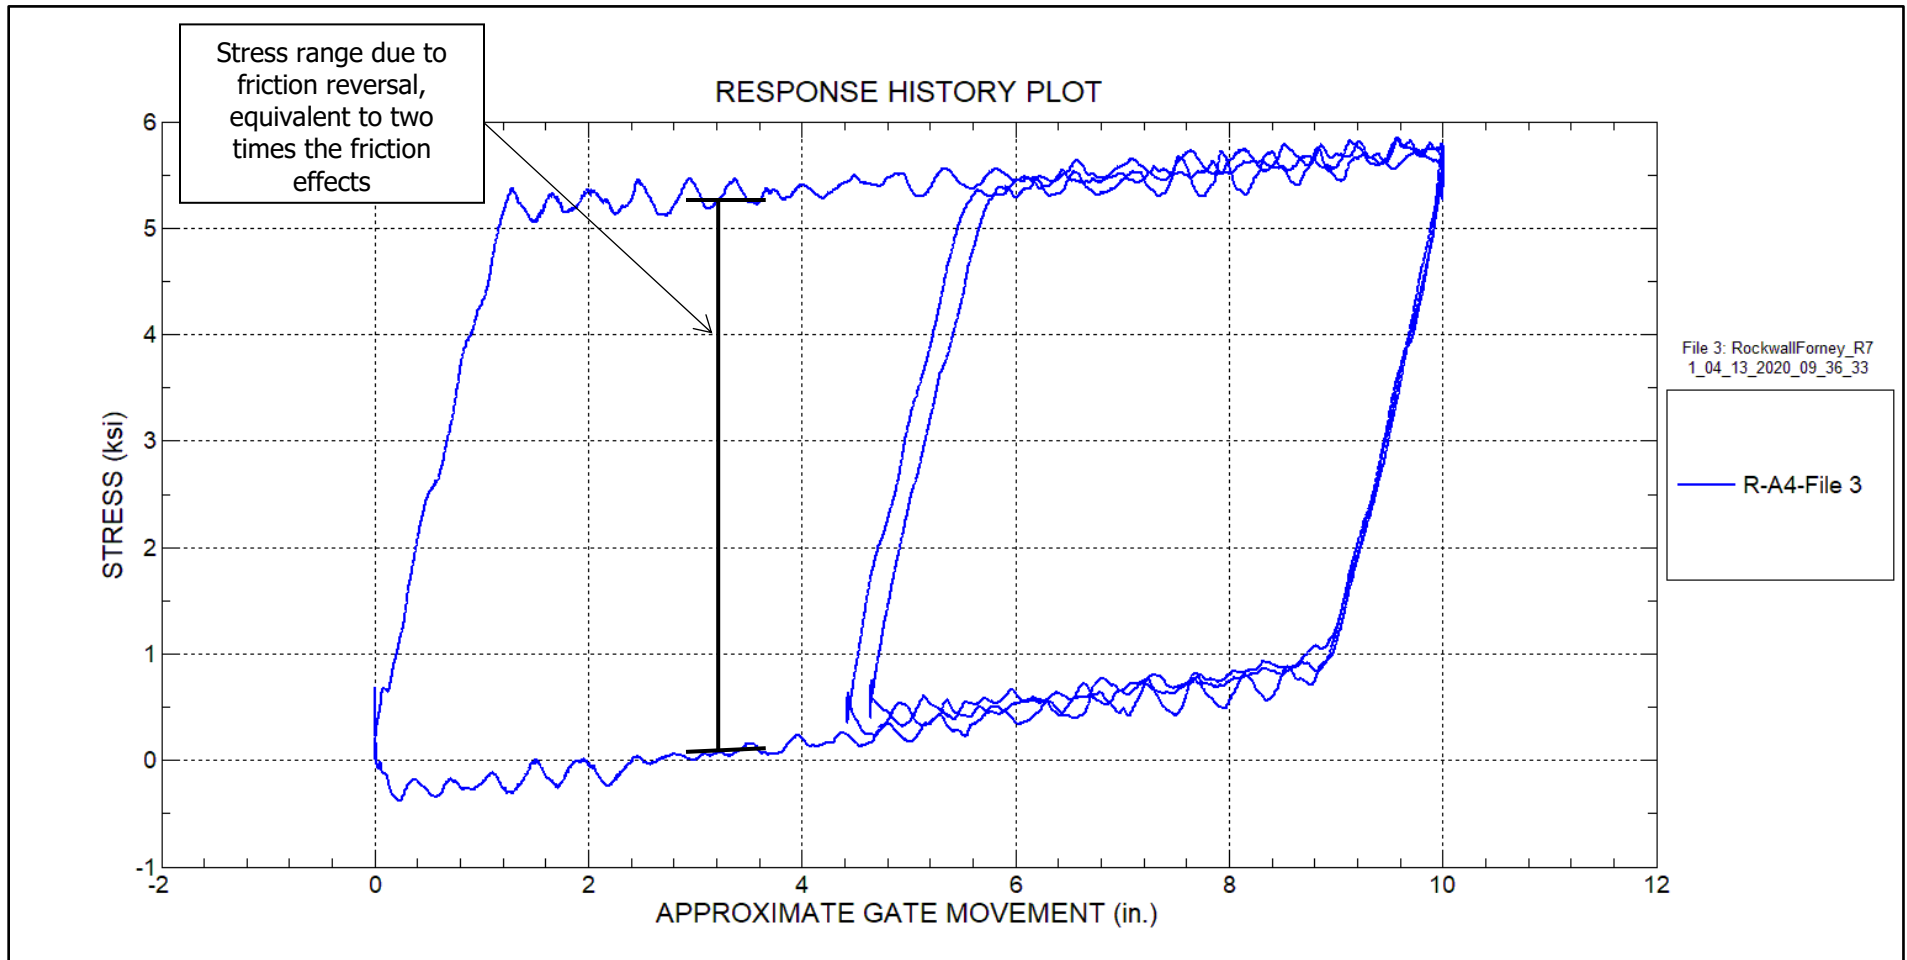
Figure 8 – Stress response history – Right arm – Gage A4 – Friction effect in stress responses
(Section A along top strut near pin – Sensor location 4 along bottom of outer flange)

- + **DIRECTION/FRICTION REVERSAL IN RESPONSES:** The difference in stress during gate opening and closing for a given position is shown in Figure 8. The stress variation at any given gate position was a result of direction reversal and in turn due to trunnion friction reversal. This statement is true since all other loads such as dead-load and hydrostatic pressure were essentially constant barring small changes in hydrostatic pressure due to slight changes in head. This direction/friction reversal is depicted in Figure 9, with deflected shape renderings from a gate arm finite element model under lifting and lowering loads. Note that this figure shows an arm configuration that does not match this gate, but the concept of the direction/friction reversal still applies.

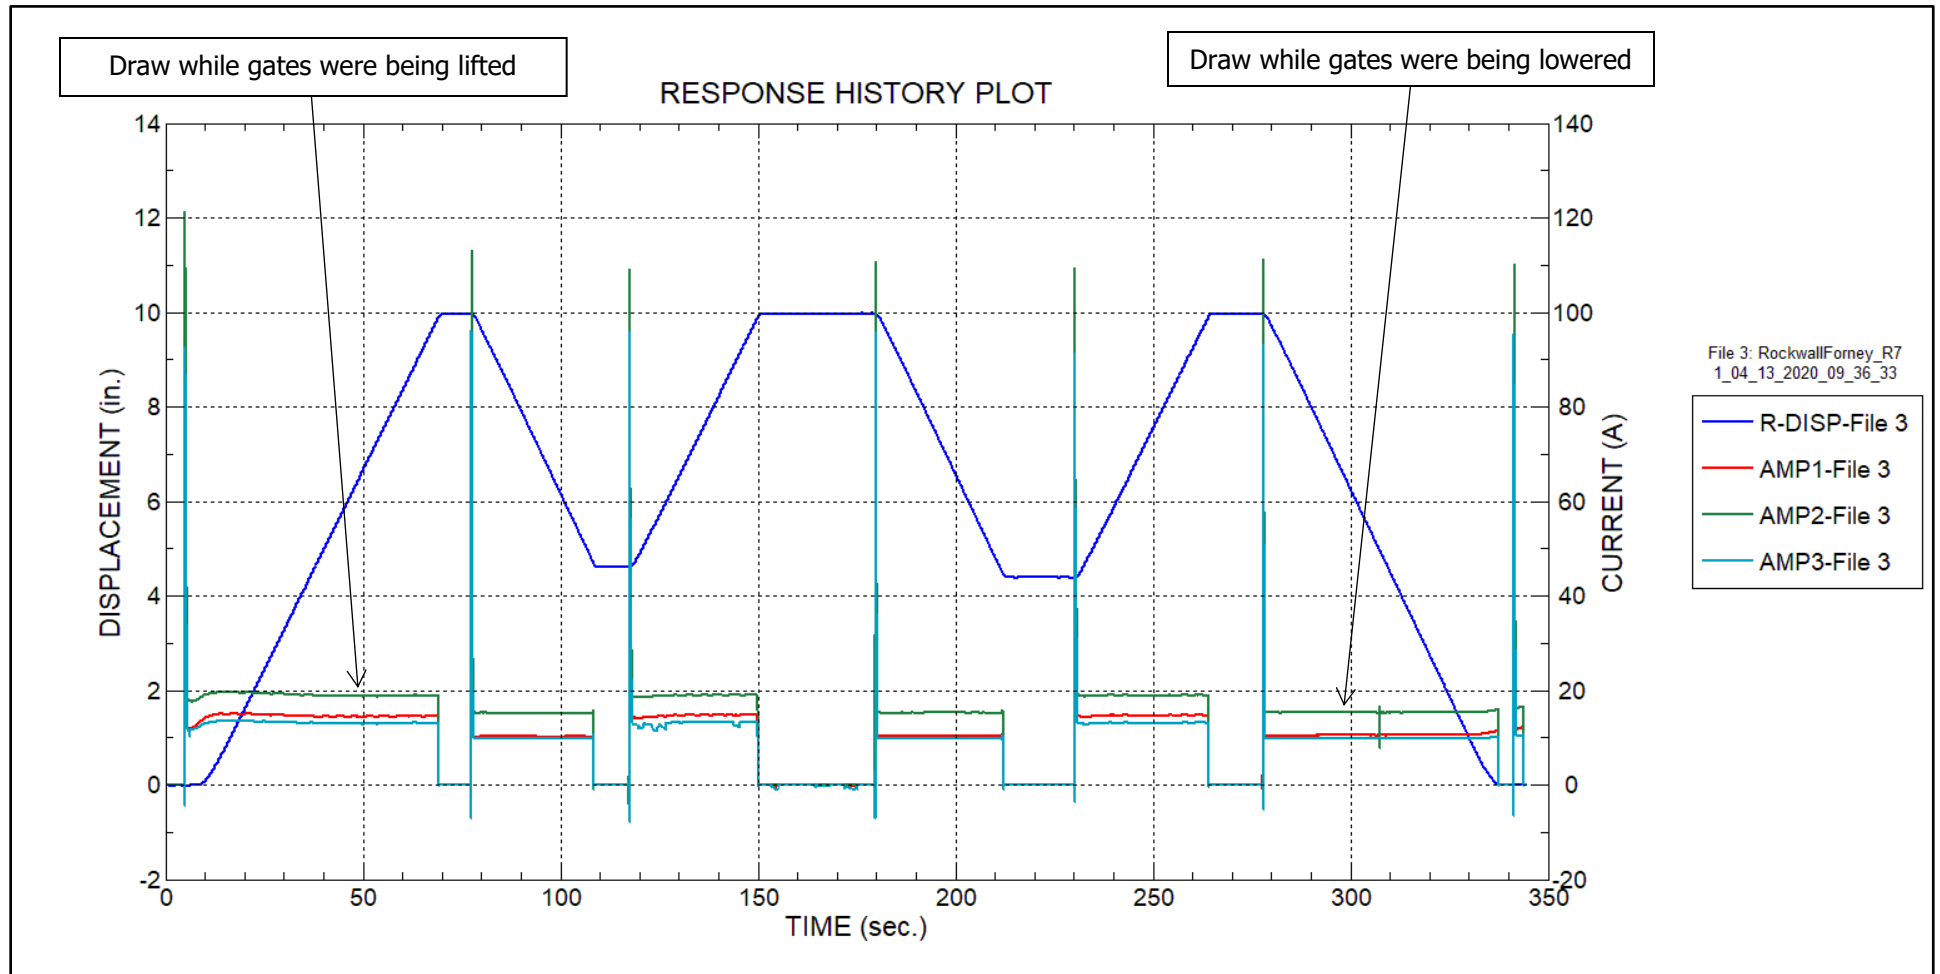
Figure 10 – Motor current & gate movement response history – Lift motor – Highlighting motor draw during lift and lower cycles

- + **MOTOR PERFORMANCE:** Current measurements taken at the hoist motor indicated steady and stable current draws during the lifting and lowering portions. An example plot of current draw and gate position is provided in Figure 10. Current draw ranges during lifting were higher than the ranges during lowering, which is common due to gravity/dead load. These results are summarized along with recorded peak in-rush current in Table 2. Note that the sample rates used during testing were set for collecting gate responses and may not have been appropriate to fully capture the in-rush current. The readings should be evaluated by a licensed electrician with knowledge of the operating parameters.

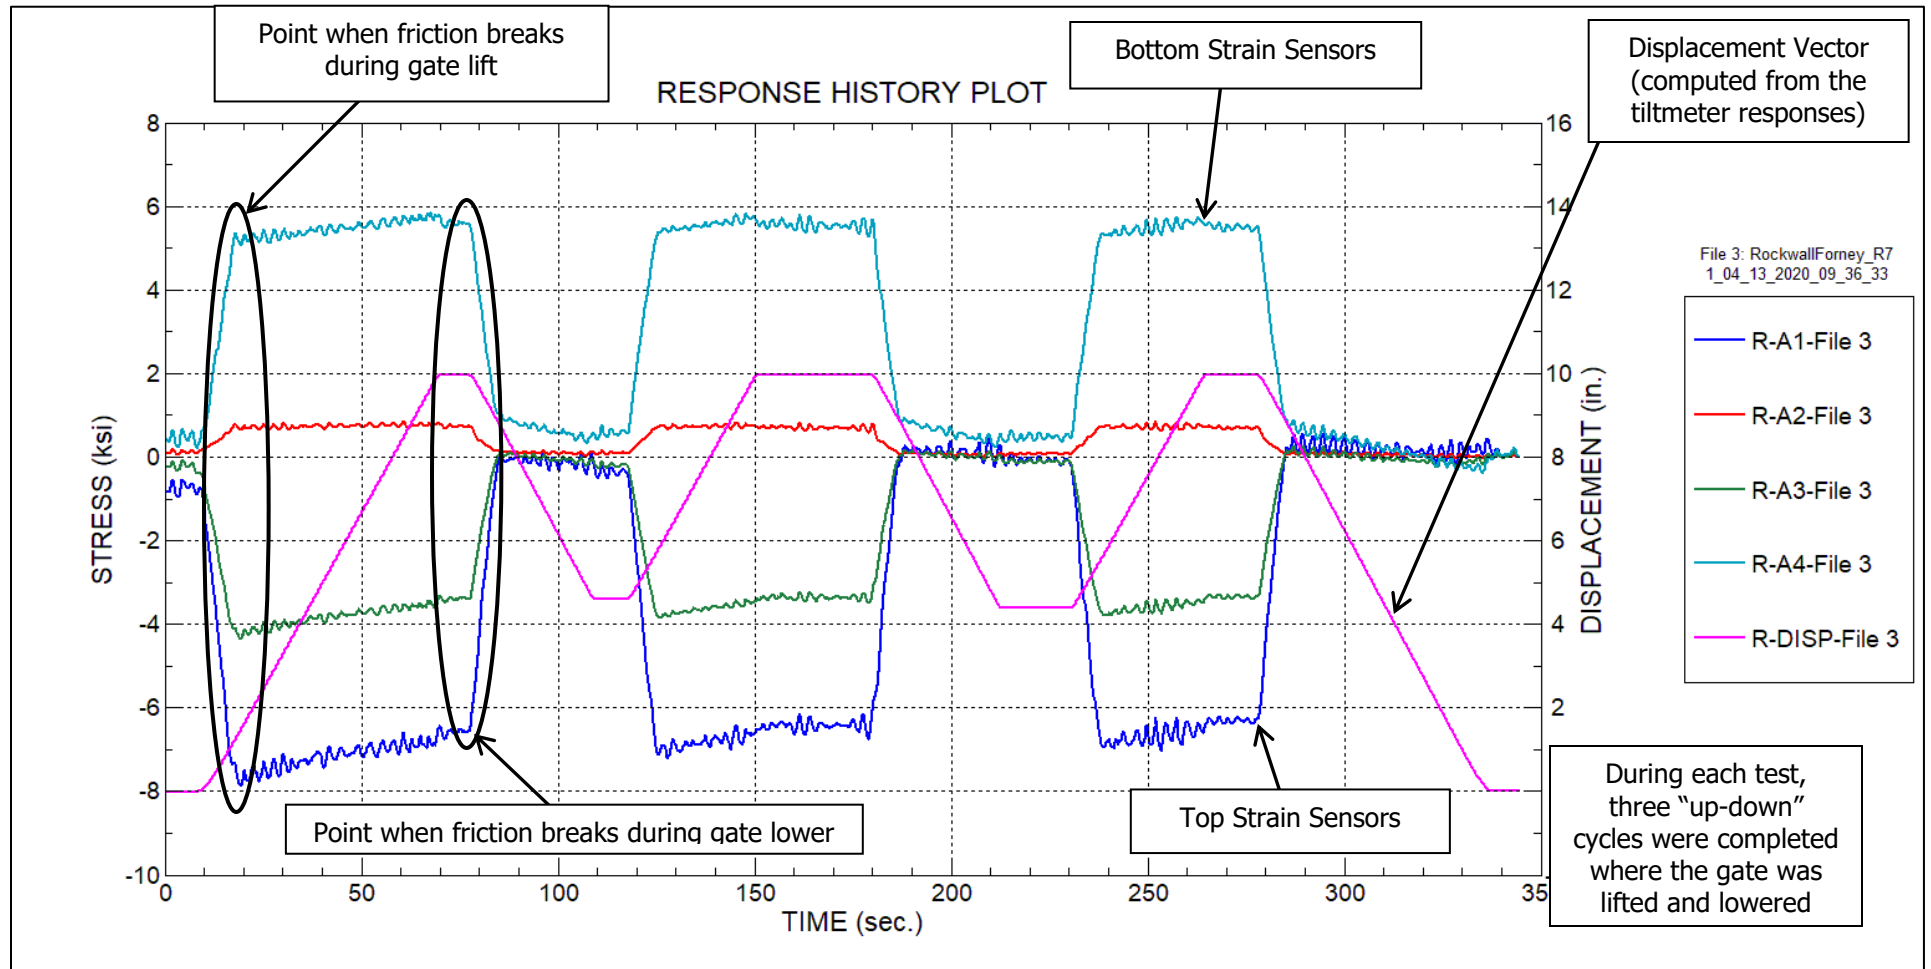
Figure 11 – Stress response & gate movement history – Right arm – Section A - Highlighting friction behavior (Section A along top strut near pin)

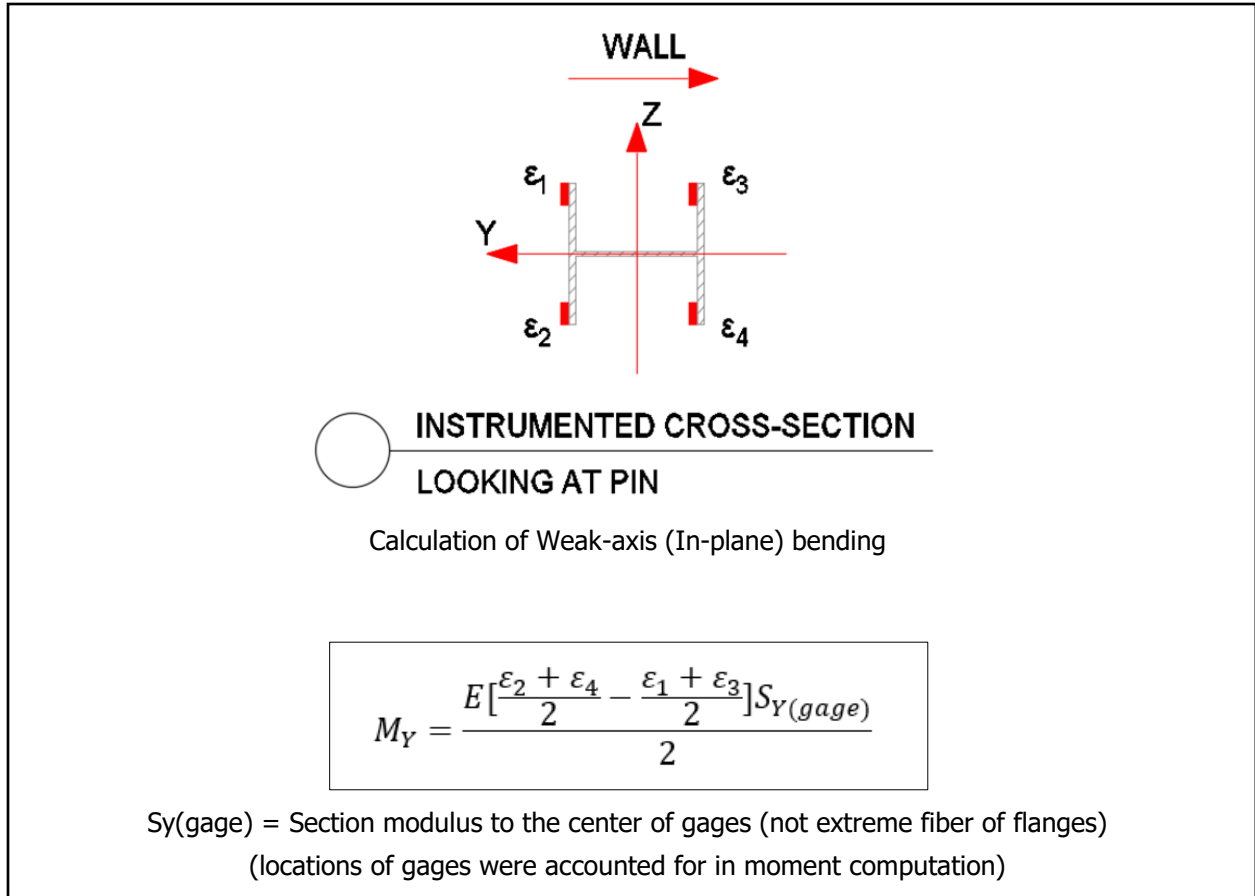
Figure 12 – Basic mechanic equation used to calculate moment

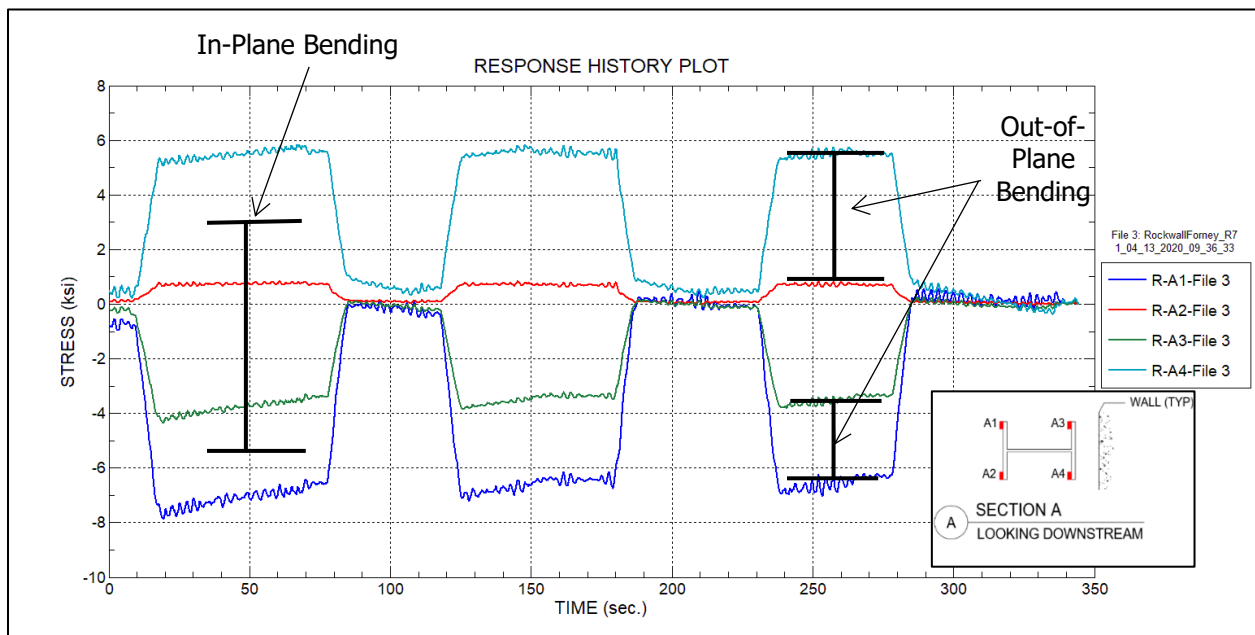
Figure 13 – Stress response history – Right arm – Section A – Bending components
(Section A along top strut near pin)

In-plane or weak-axis flexure refers to bending about a given strut's web. This designation is consistent with typical nomenclature. In-plane bending can be observed visually from the strain response histories as a difference between the top and bottom stresses, whereas out-of-plane or strong-axis bending is visualized as the difference in stress from side to side. Figure 13 provides a visual reference for both types of strut flexure.

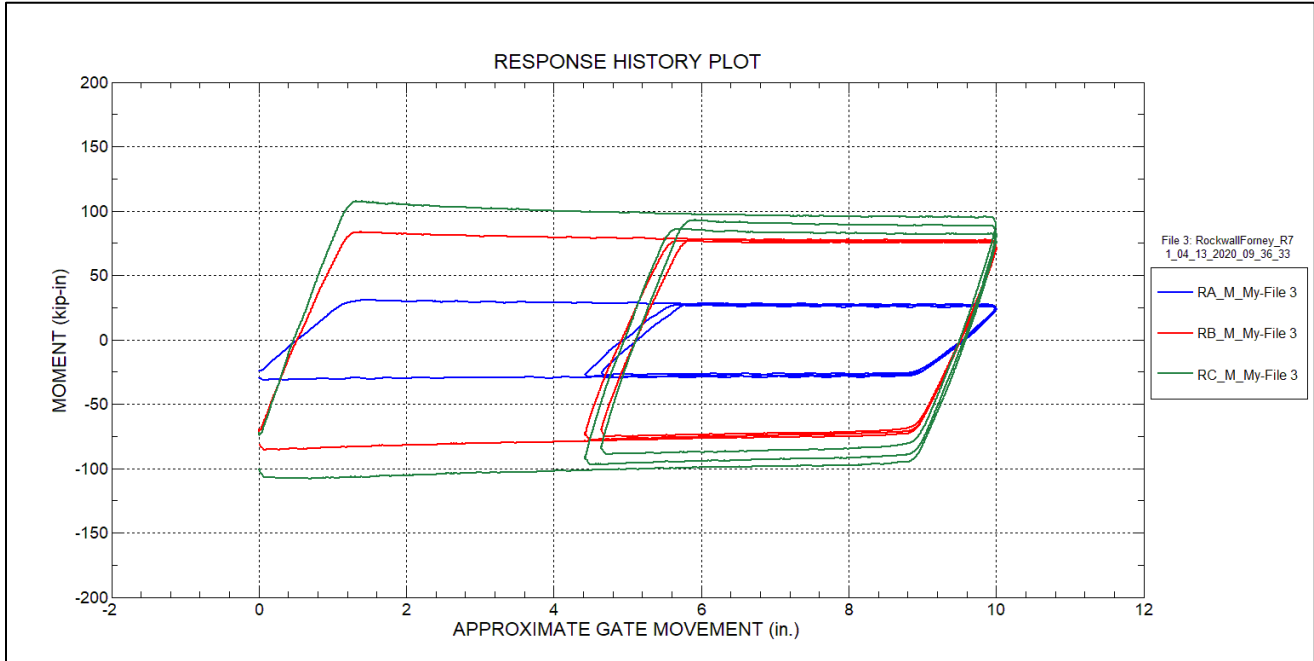
Figure 14 – In-plane moment response history – Right arm – Sections near pin
(RA = Right Arm Top Strut, RB = Right Arm Middle Strut, RC = Right Arm Bottom Strut)

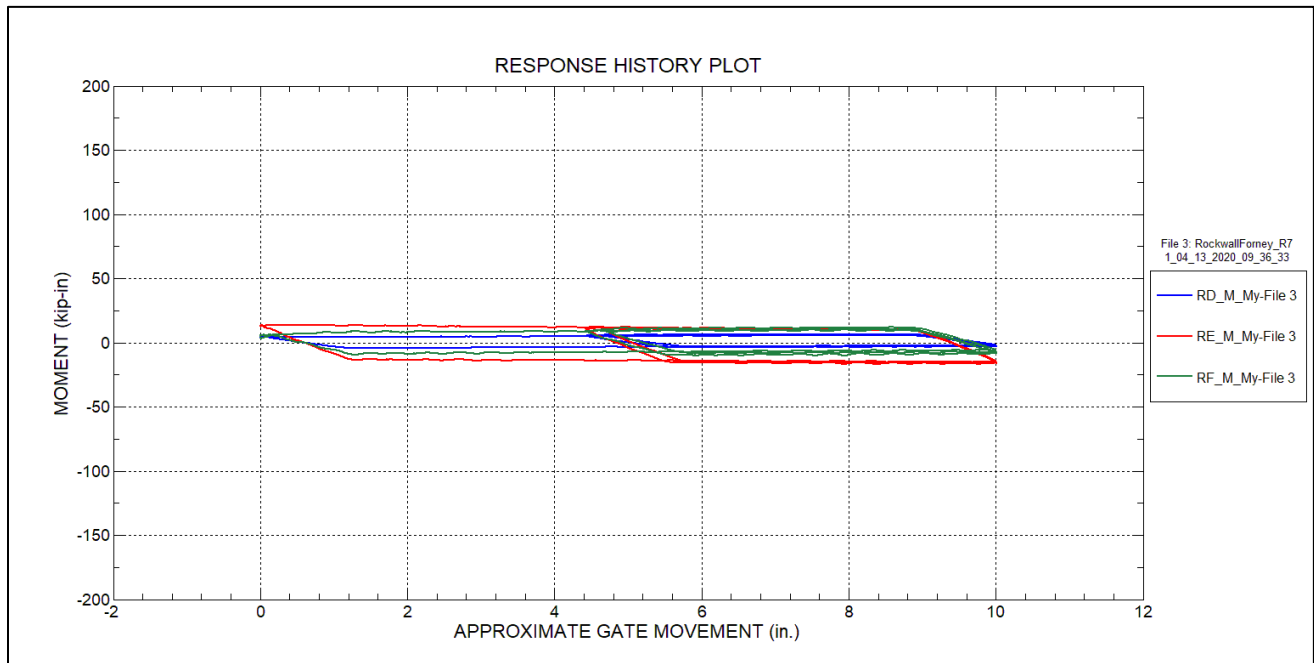
Figure 15 – In-plane moment response history – Right arm – Sections away from pin
(RD = Right Arm Top Strut, RE = Right Arm Middle Strut, RF = Right Arm Bottom Strut)

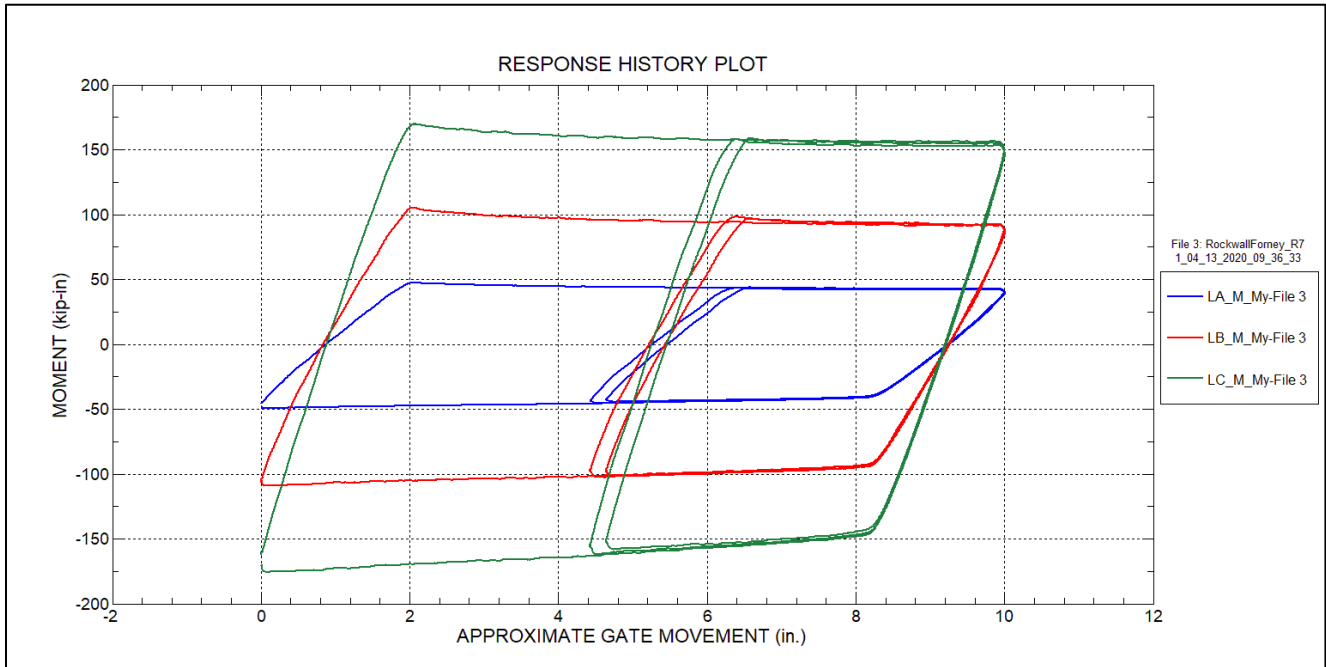
Figure 16 – In-plane moment response history – Left arm – Sections near pin
(LA = Left Arm Top Strut, LB = Left Arm Middle Strut, LC = Left Arm Bottom Strut)

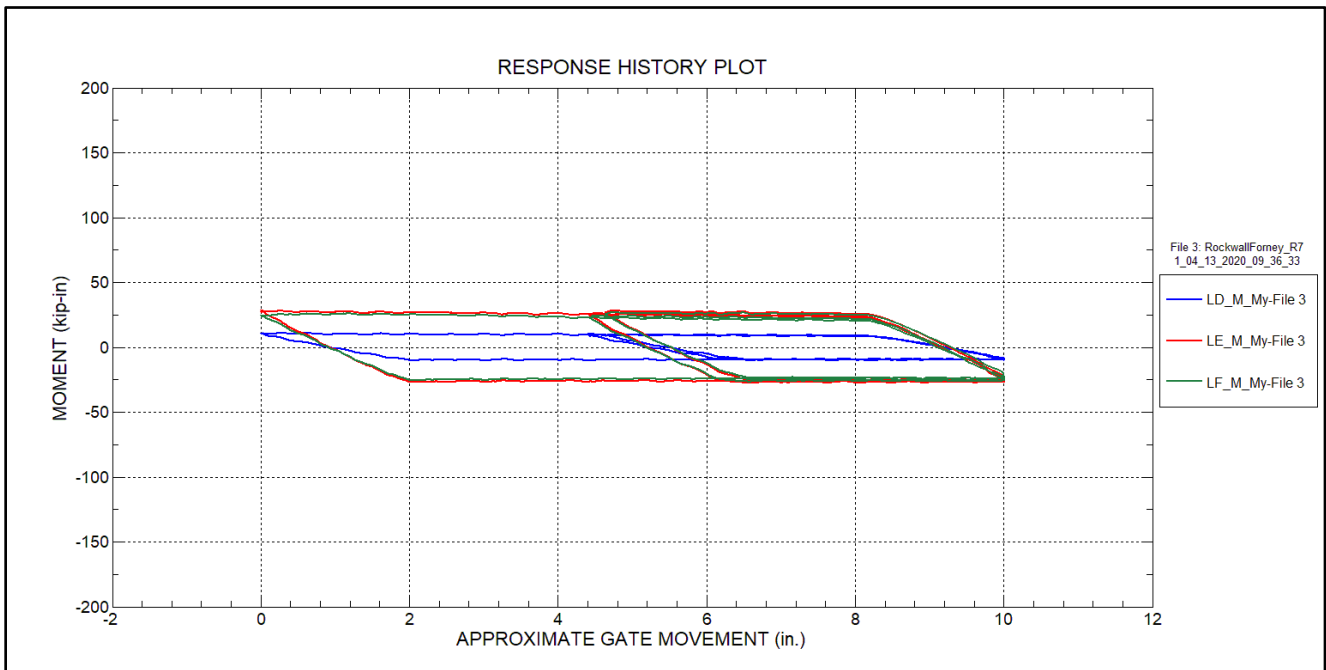
Figure 17 - In-plane moment response history – Left arm – Sections away from pin
(LD = Left Arm Top Strut, LE = Left Arm Middle Strut, LF = Left Arm Bottom Strut)

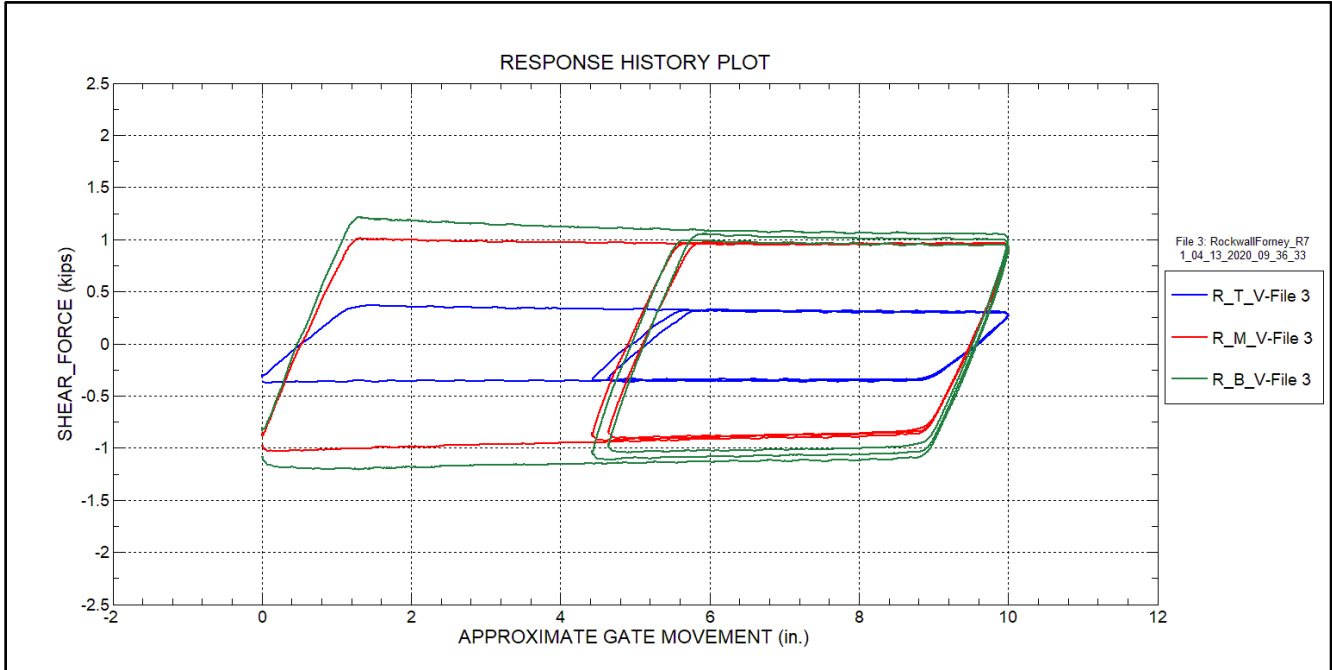
Figure 19 – Strut shear response history – Right arm

(R_T = Right Arm Top Strut, R_M = Right Arm Middle Strut, R_B = Right Arm Bottom Strut)

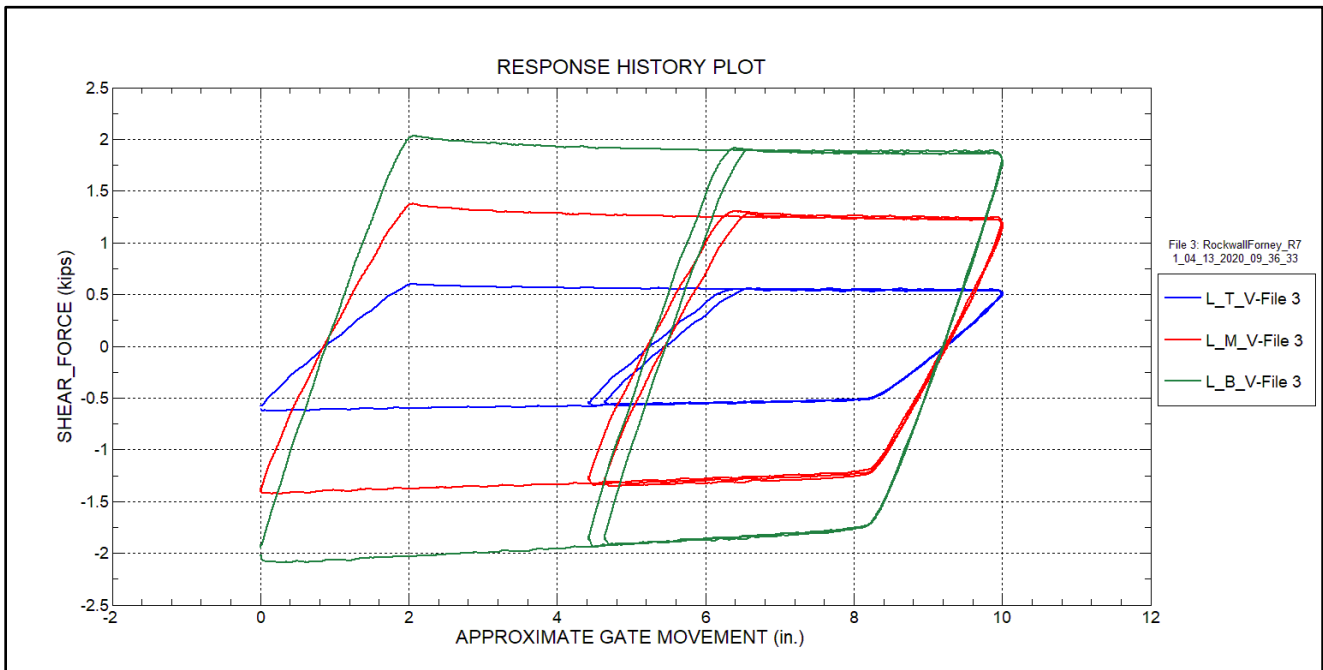
Figure 20 – Strut shear response history – Left arm

(L_T = Left Arm Top Strut, L_M = Left Arm Middle Strut, L_B = Left Arm Bottom Strut)

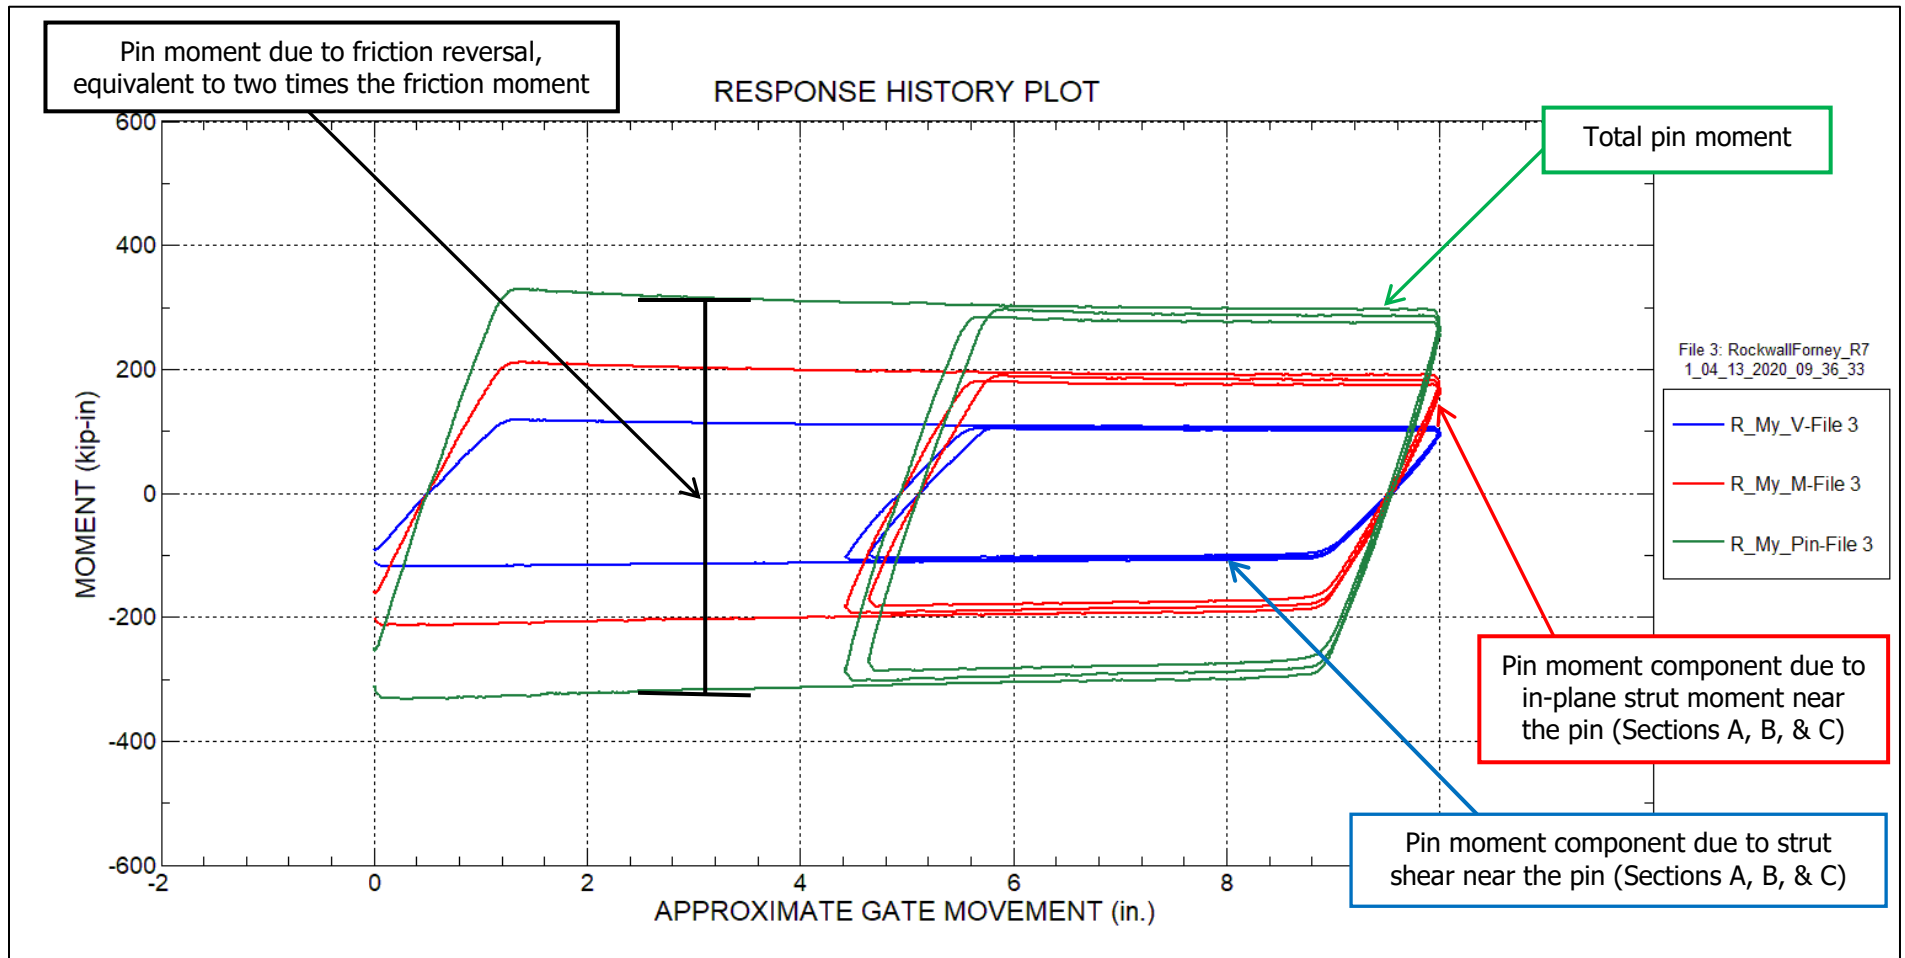
Figure 21 – Pin moment response history – Right arm

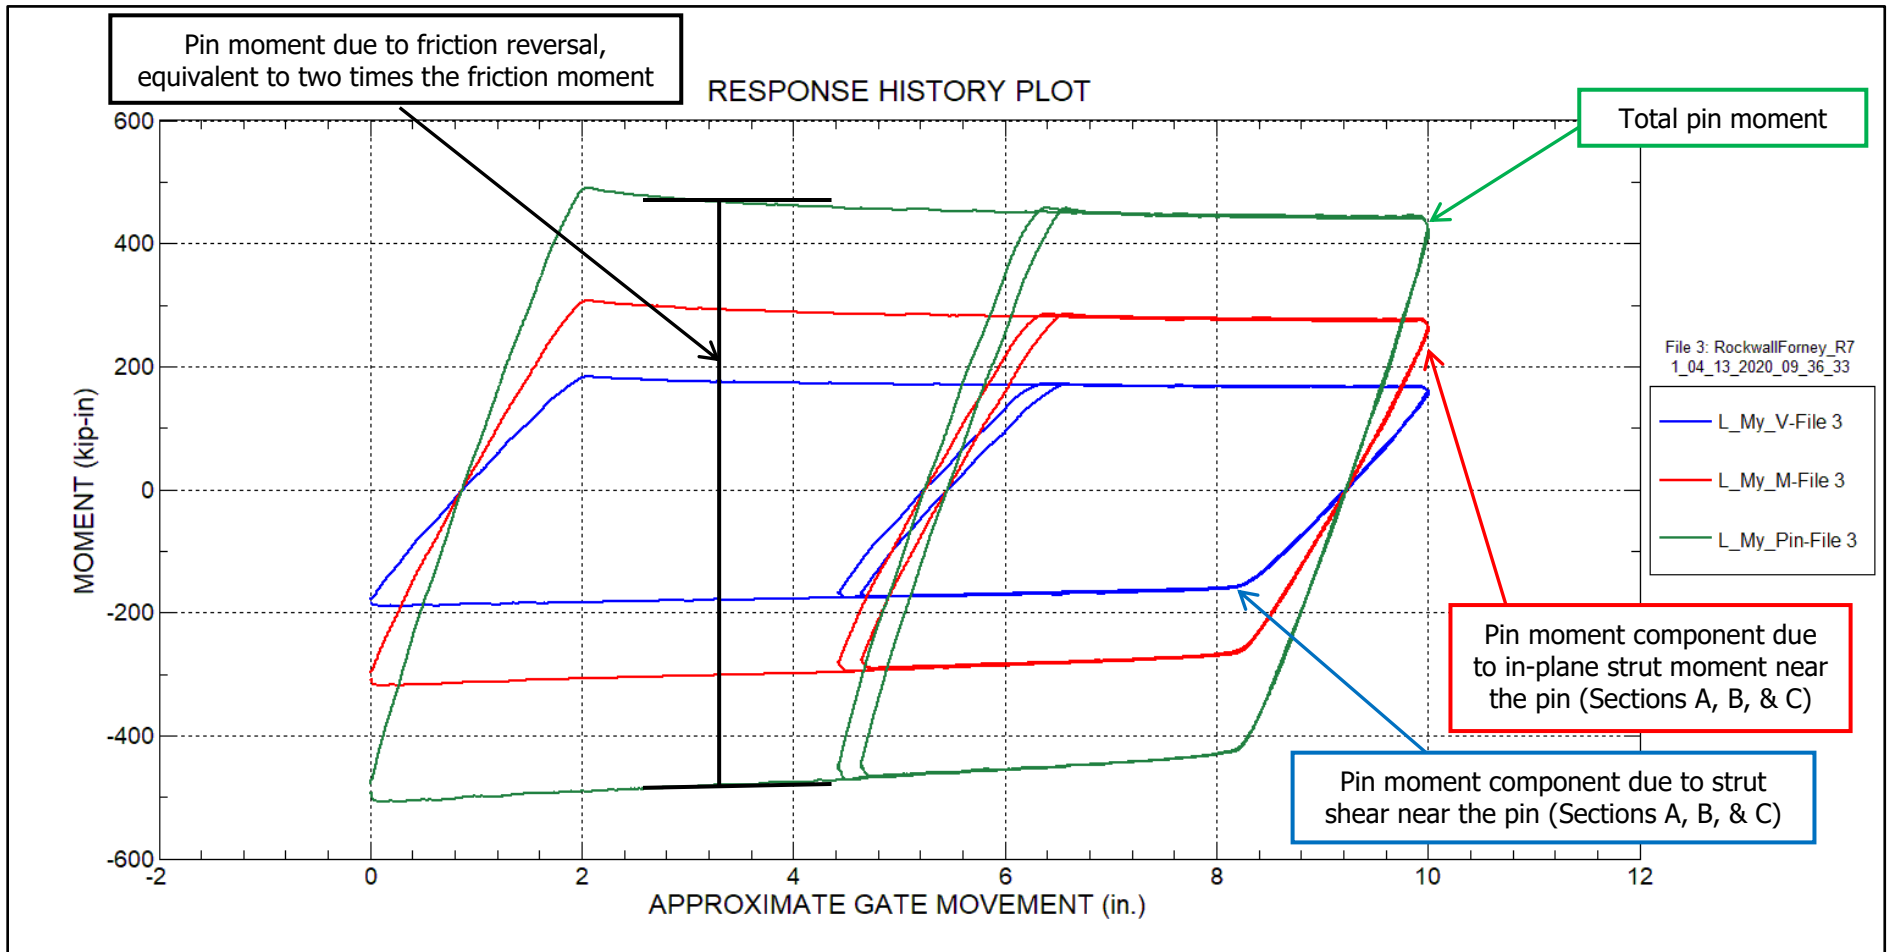
Figure 22 – Pin moment response history – Left arm
