VISUAL INSPECTION AND EVALUATION REPORT

Rockwall-Forney Dam
Dallas Water Utilities
Dallas/Kaufman Counties, Texas

Schnabel Reference #20C22001.00
July 30, 2021

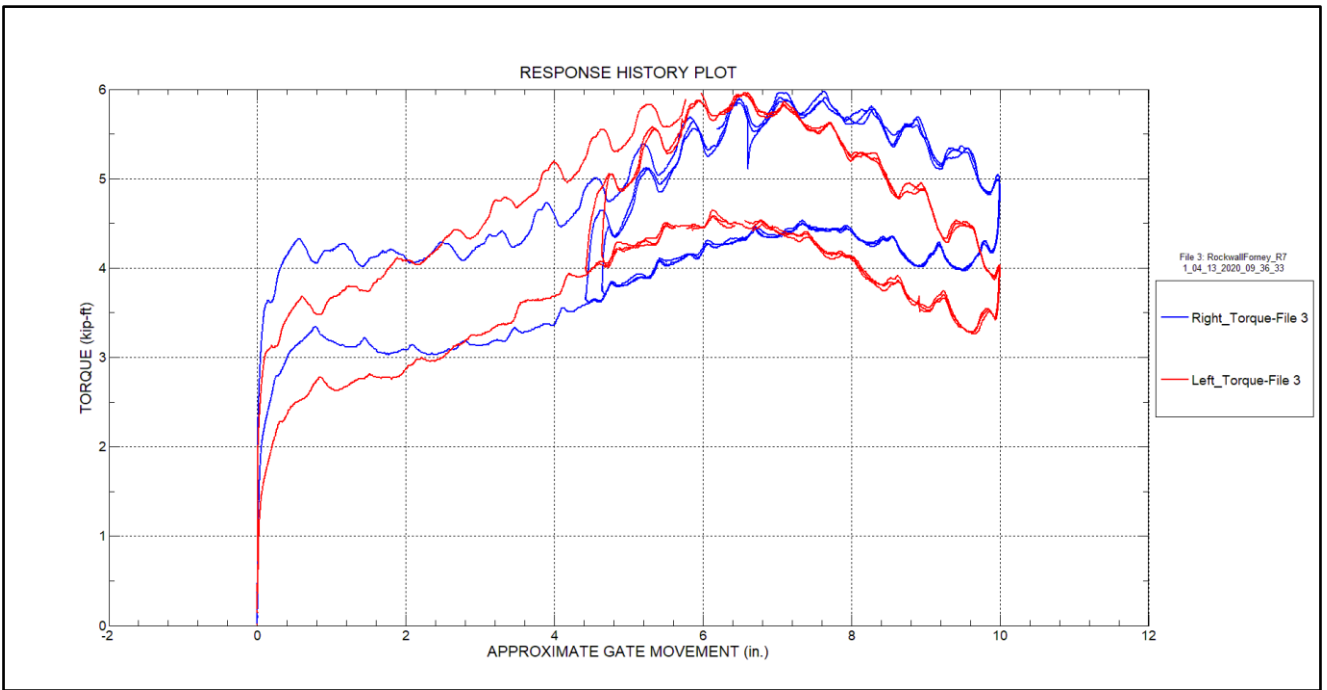
Figure 23 – Hoist torque response history – Gate 12 – Test 2

Note: missing data due to wireless connectivity issues as the sensor rotates with the pinion shaft

Figure 23 shows example torque measurements, recorded on the Gate 12 torque shafts. Best practices for torque measurements is to measure torque on opposite sides of the shaft so that any bending in the shaft can be removed by averaging the two responses. Due to access limitations, only one gage at each location could be installed. Therefore, any bending in the shaft may be reflected in the torque measurements and may be related to the peaks and valleys observed in the torque responses.

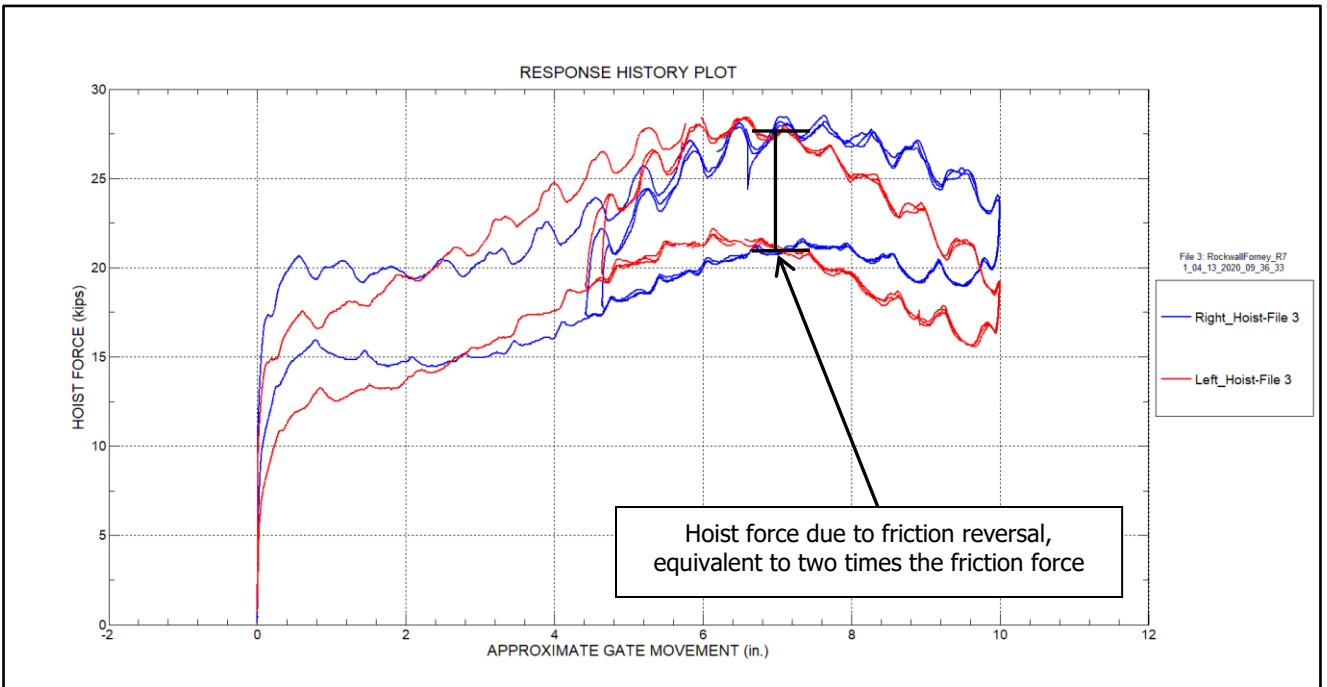
Figure 24 – Hoist force response history – Gate 12 – Test 2

Note: missing data due to wireless connectivity issues as the sensor rotated with the pinion shaft

Torque values were converted to force in the hoist cables per gate arm using the gear ratio and drum radius, as shown in Figure 24. The gear ratio and drum radius were 5.182 and 1.086 feet respectively, as defined in the provided as-built shop drawings. It should be noted that the hoist force calculated may be smaller than the actual hoist force applied. This difference is due to the limit switch engaging the brake before the hoist cable was fully slacked, resulting in an initial force in the cable. A hoist force due to total gate friction was then calculated. This friction hoist force was equal to half the differential in force measured during the lifting and lowering of the gate (similar to the pin friction calculations). As shown in Table 3, the change in cable force due to friction was generally consistent between tests. Note that the total hoist force was due to the total friction effects, including side seal, hoist bearings, trunnion friction effects, etc . It is difficult to determine the exact proportion and composition of the total friction sources. Additional torque and hoist force plots for all collected data files are provided in Appendix A – Gate 12 Torque and Hoist Force Plots.

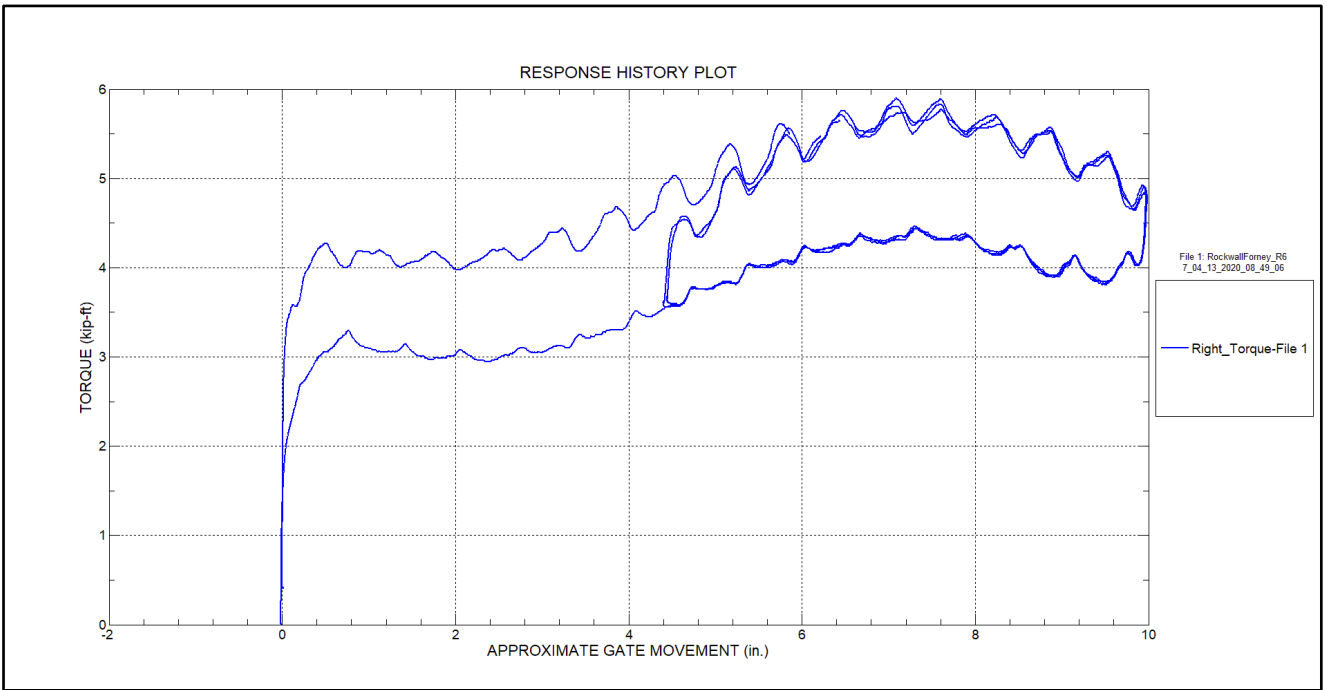
Figure 25 – Hoist torque response history – Gate 12 – Test 1

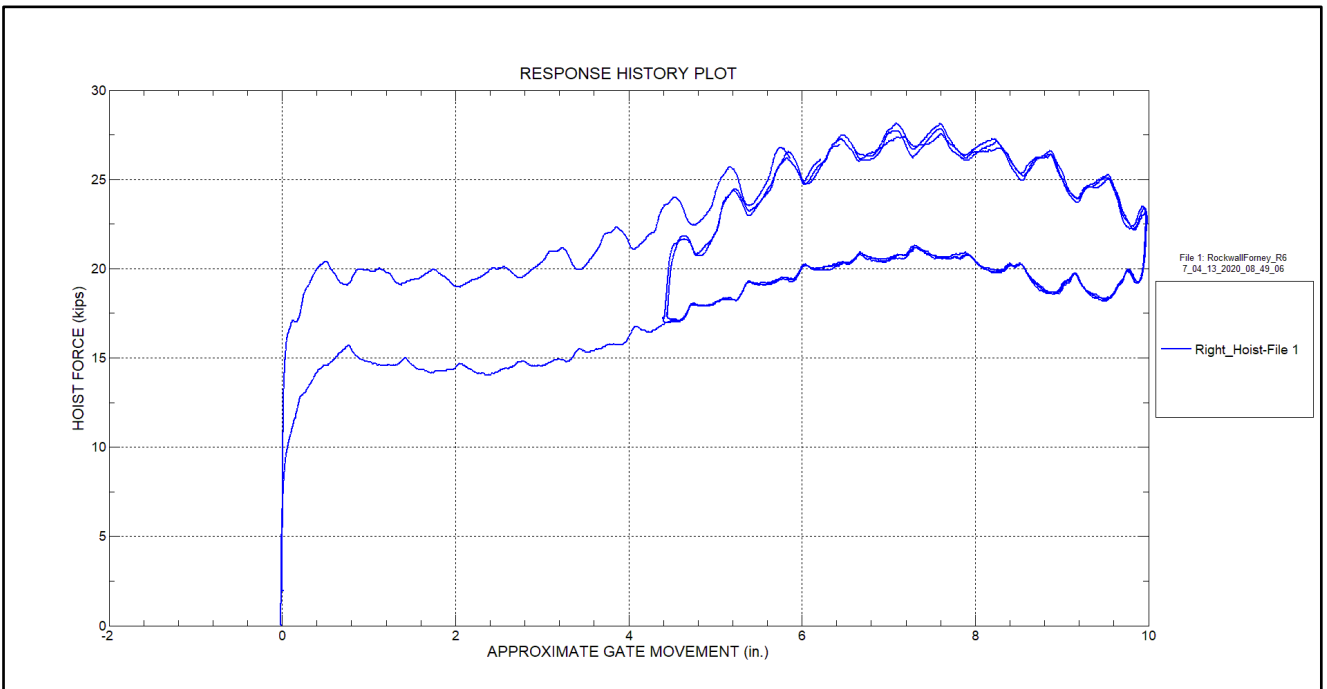
Figure 26 – Hoist force response history – Gate 12 – Test 1

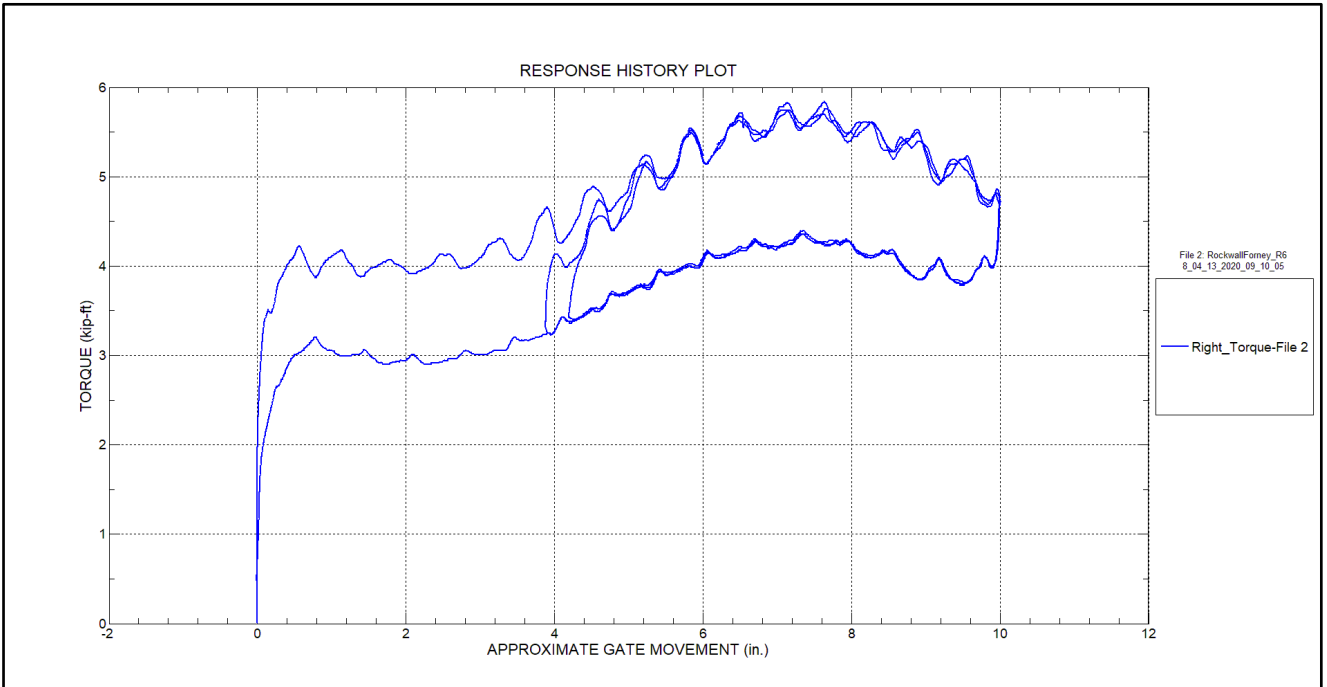
Figure 27 – Hoist torque response history – Gate 12 – Test 2

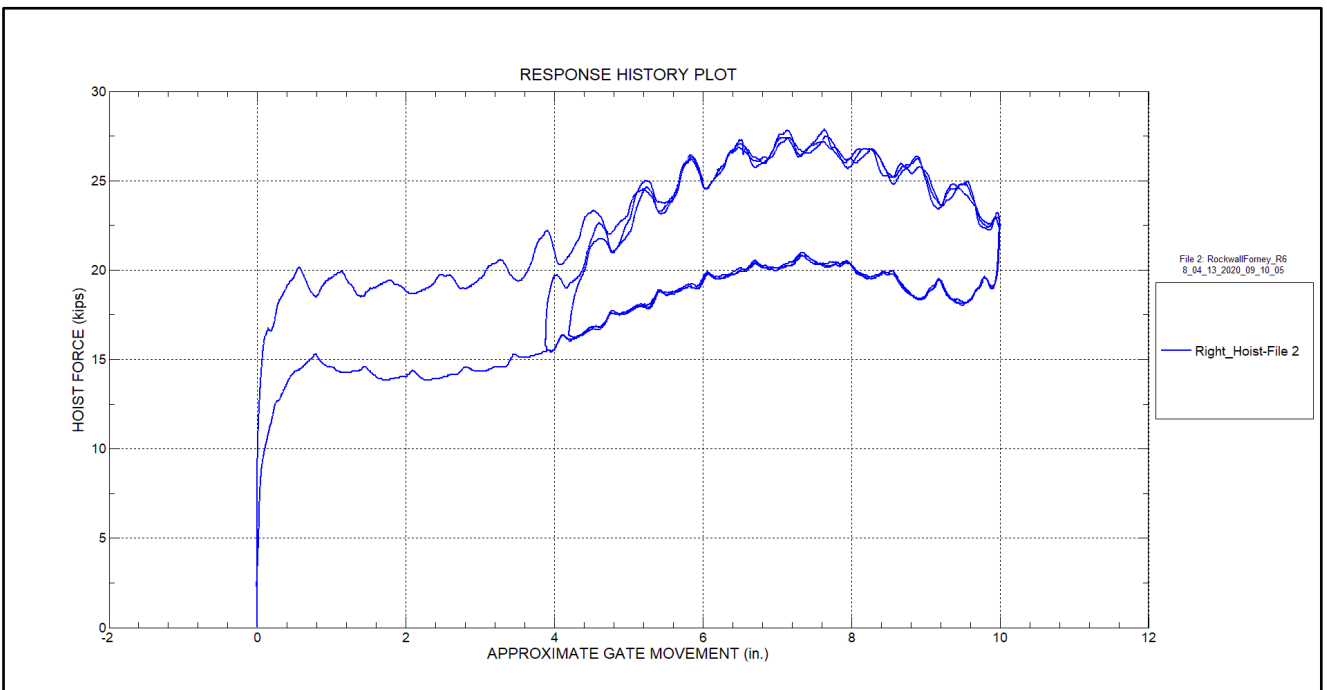
Figure 28 – Hoist force response history – Gate 12 – Test 2

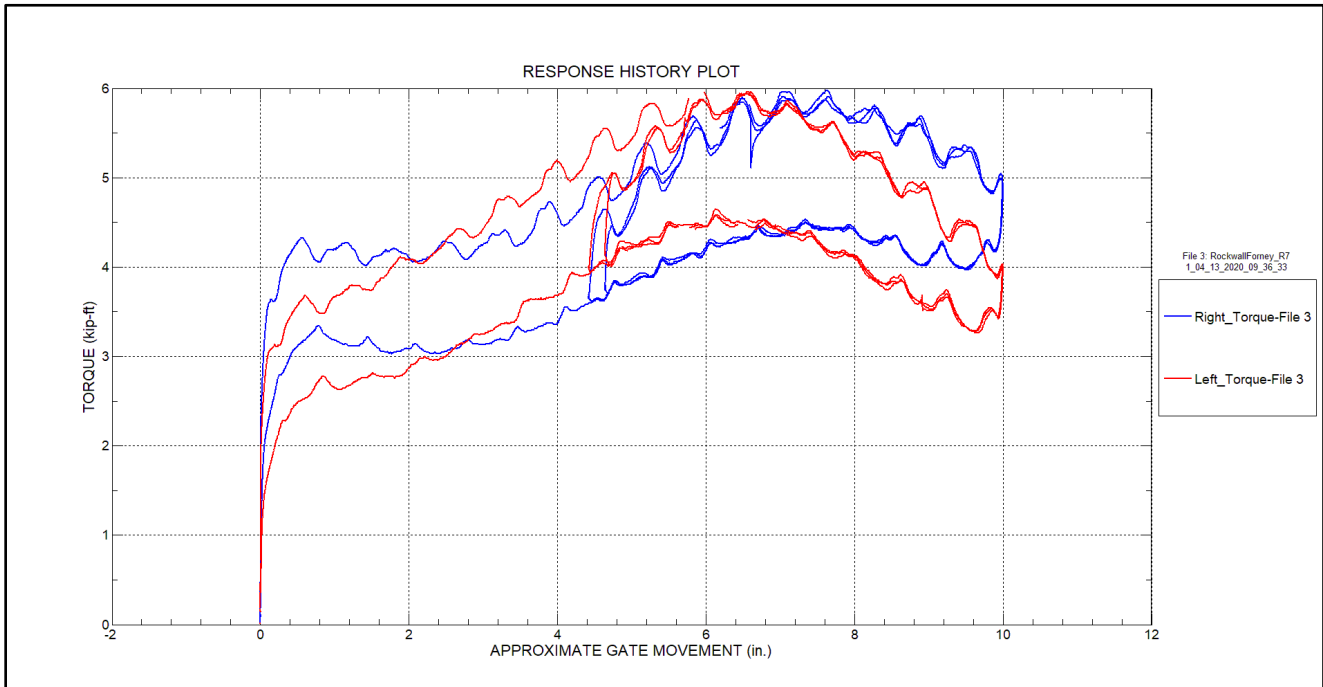
Figure 29 – Hoist torque response history – Gate 12 – Test 3

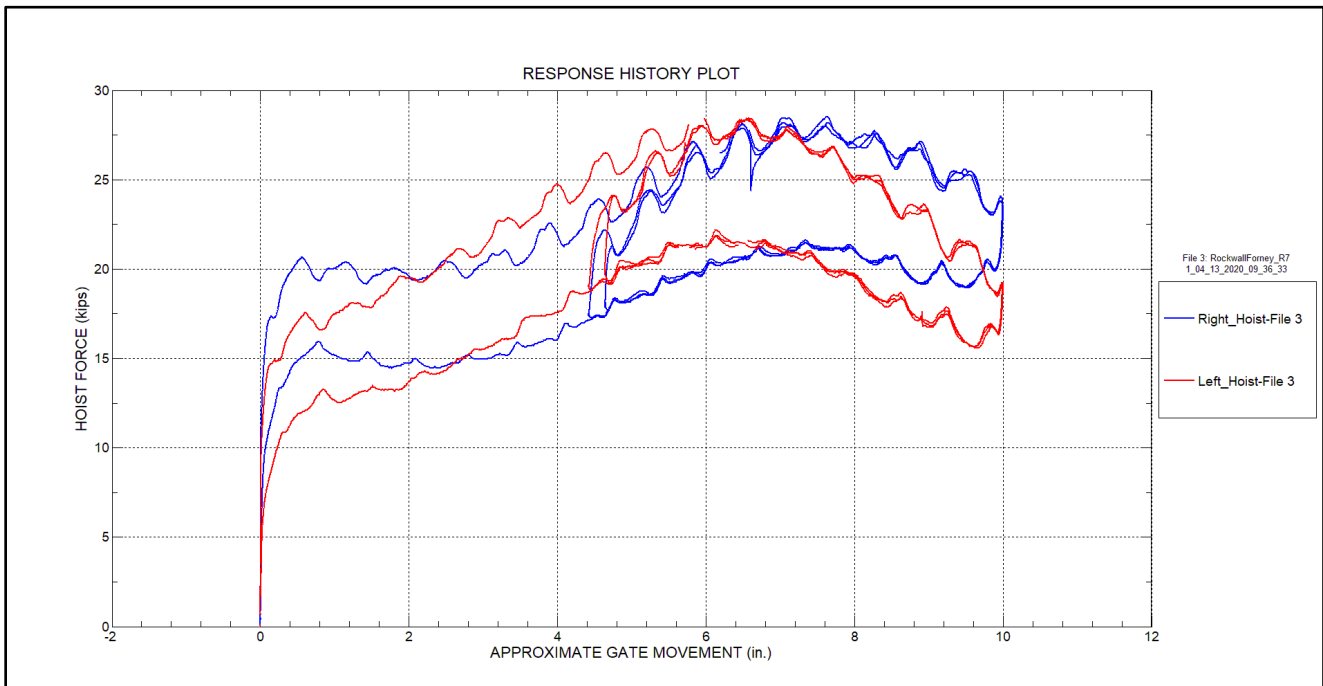
Figure 30 – Hoist force response history – Gate 12 – Test 3

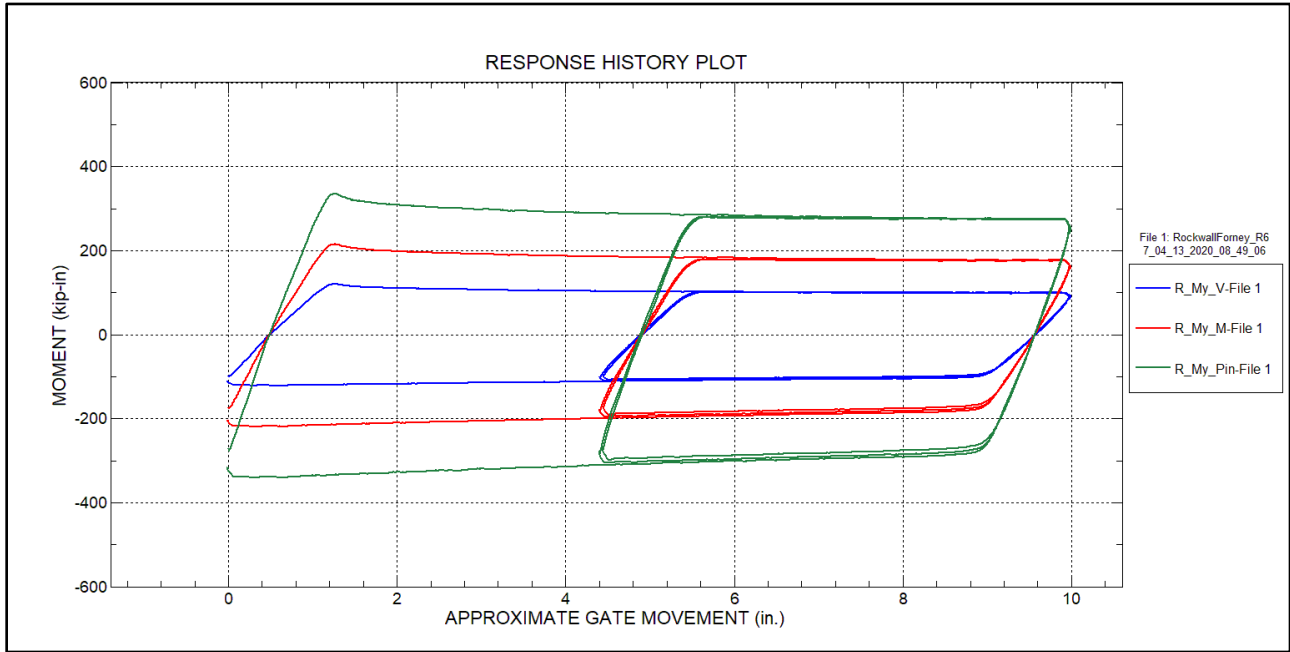
Figure 31 – Pin moment response history – Right arm – Test run 1

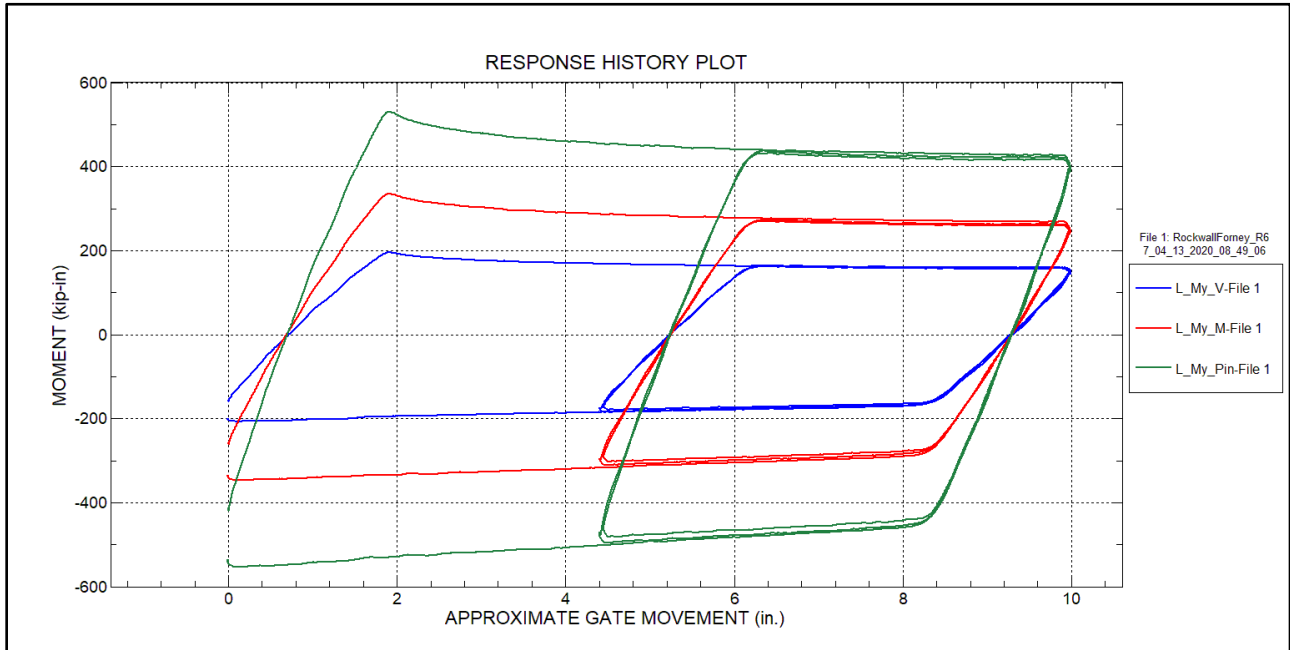
Figure 32 – Pin moment response history – Left arm – Test run 1

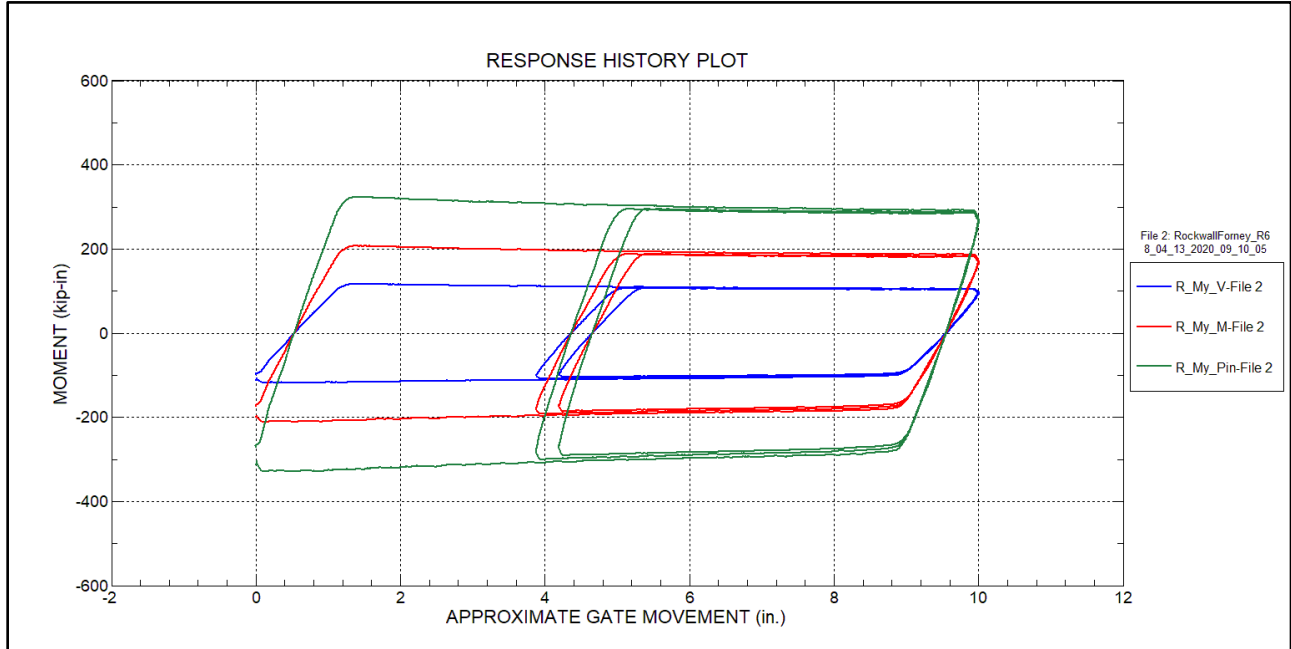
Figure 33 – Pin moment response history – Right arm – Test run 2

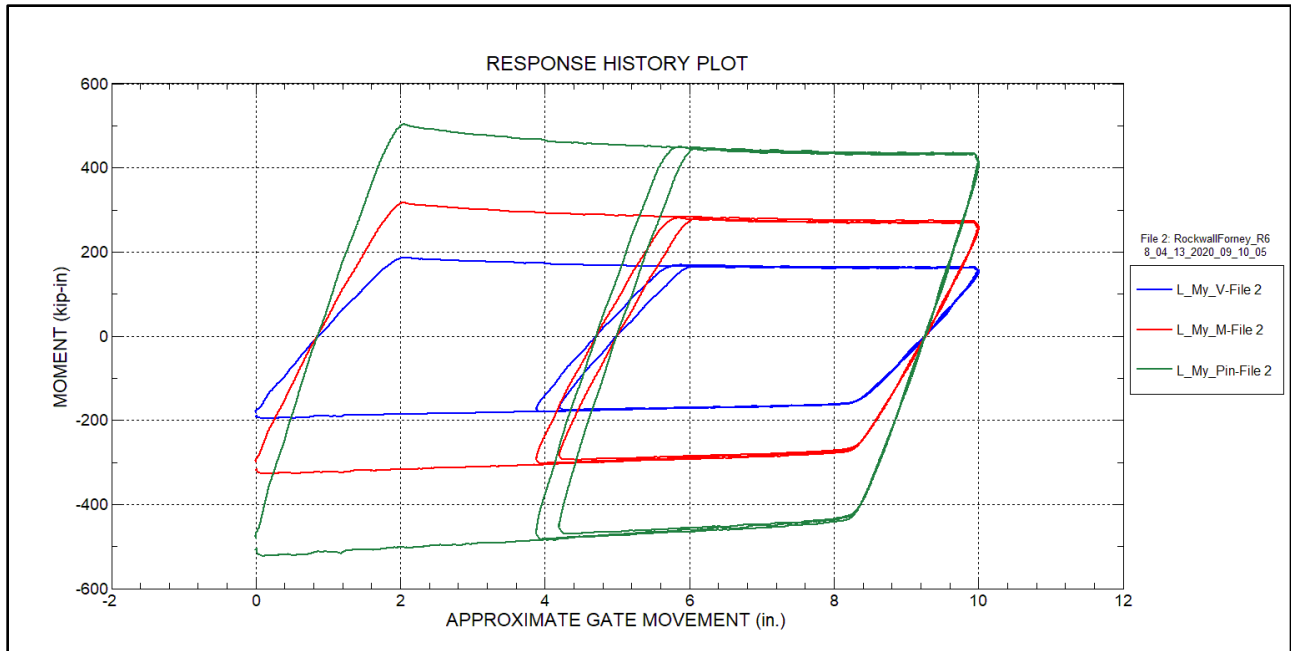
Figure 34 – Pin moment response history – Left arm – Test run 2

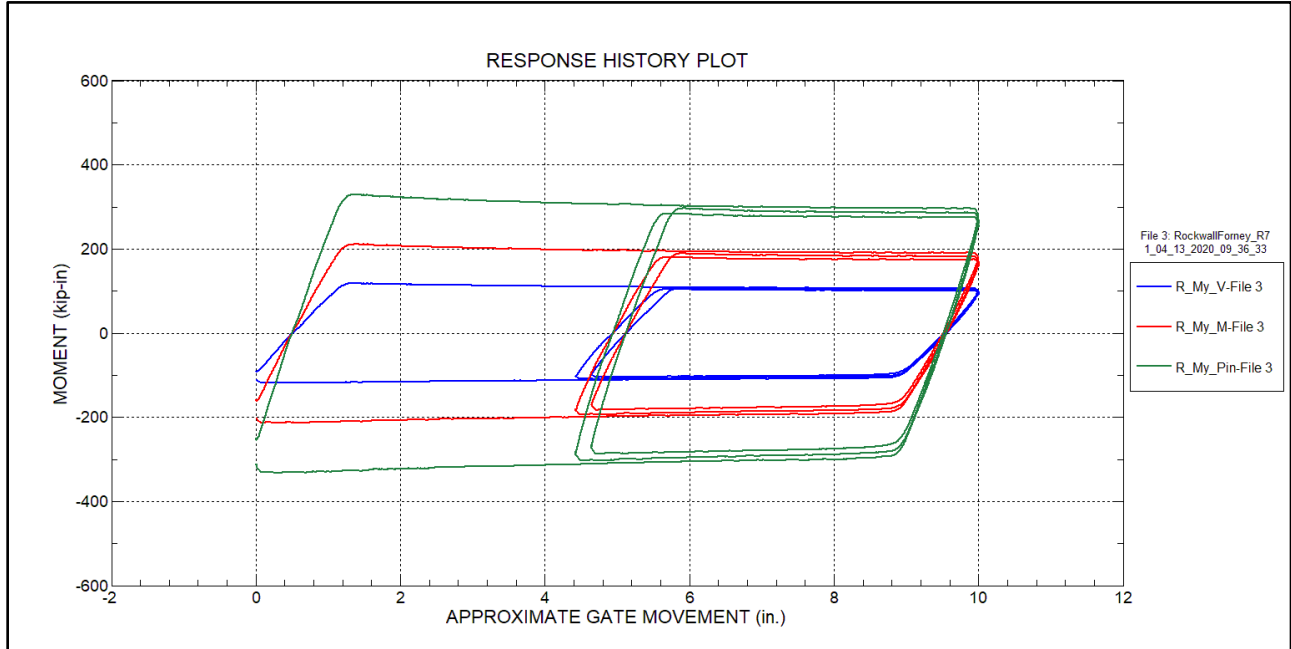
Figure 35 – Pin moment response history – Right arm – Test run 3

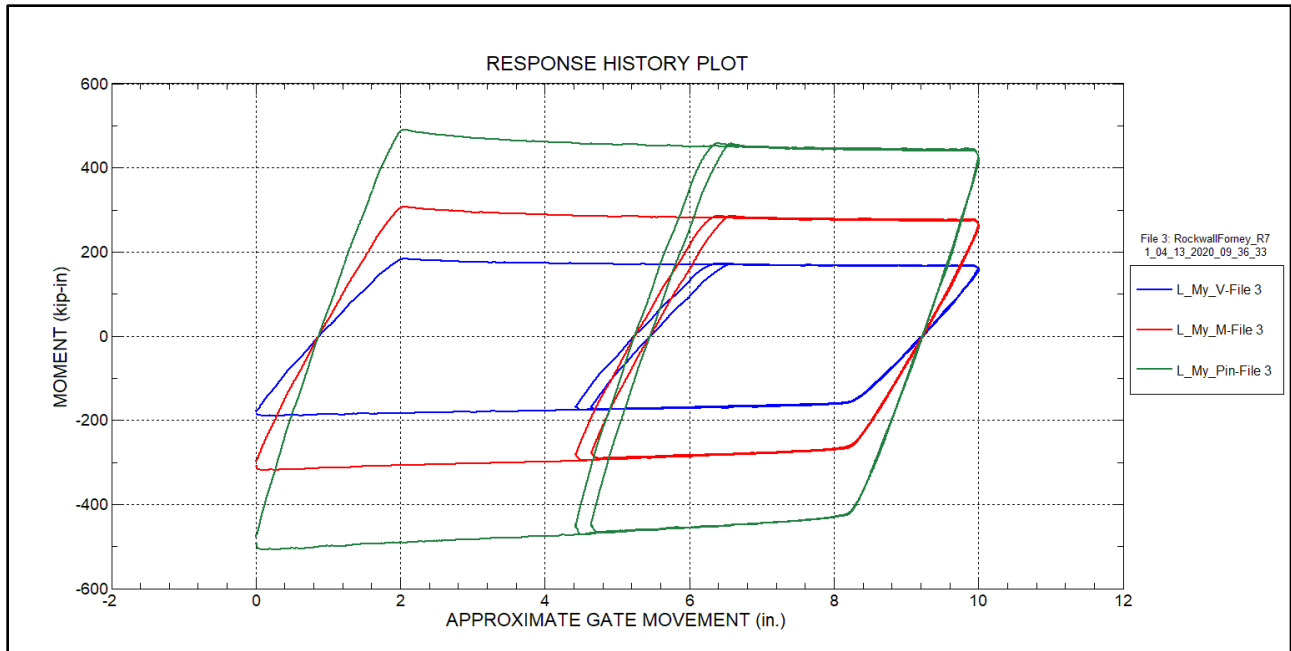
Figure 36 – Pin moment response history – Left arm – Test run 3

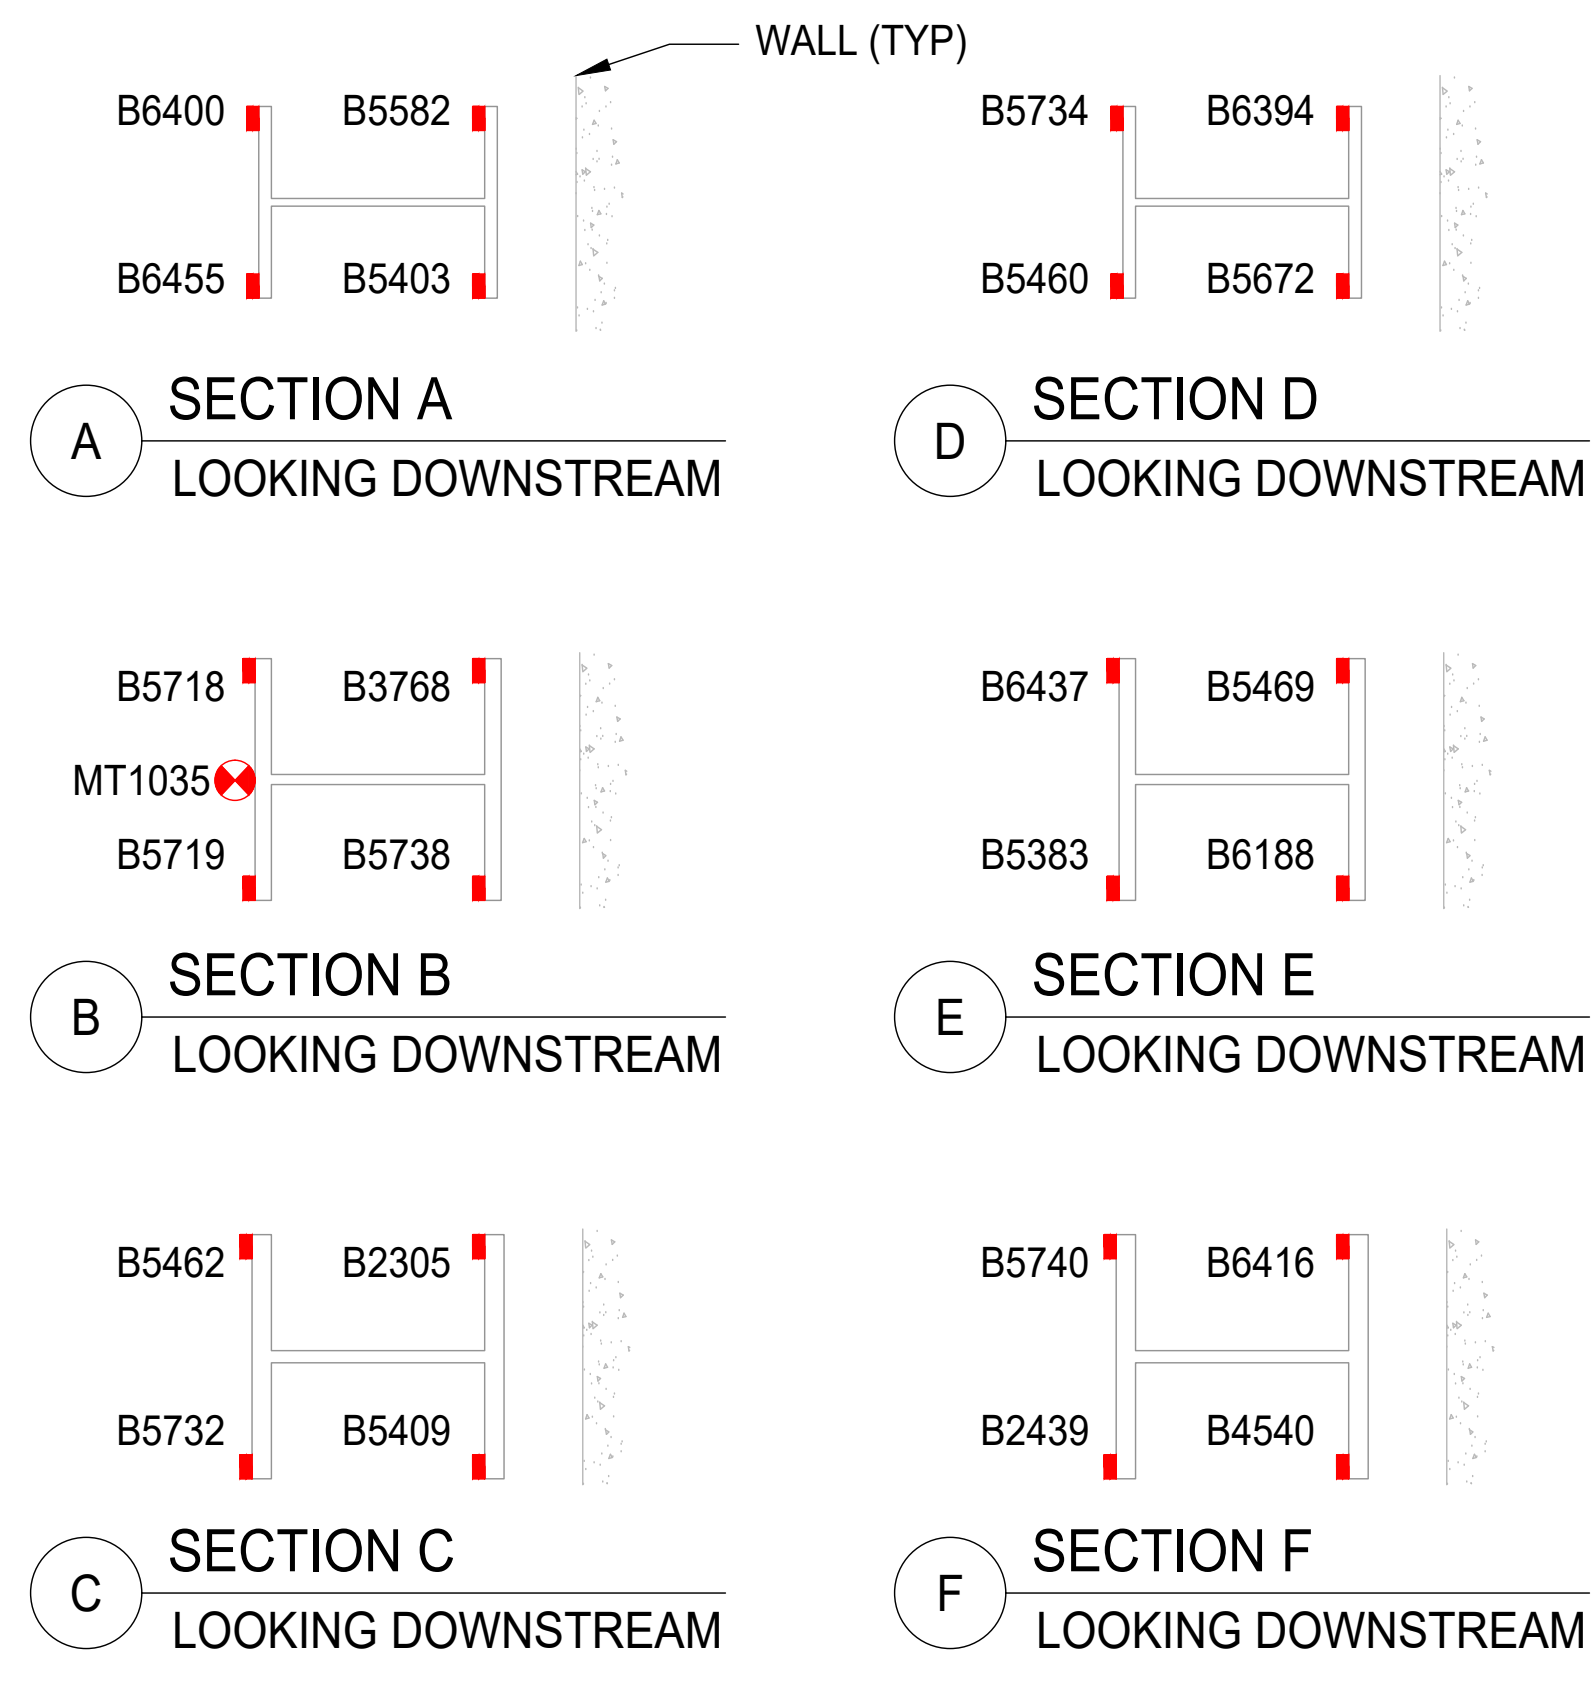
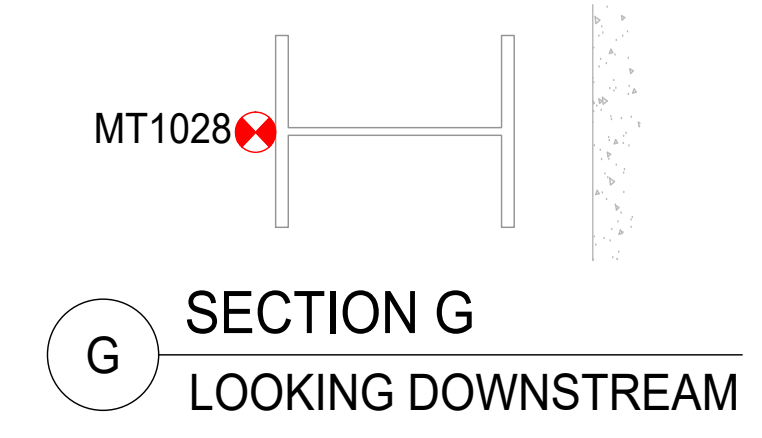
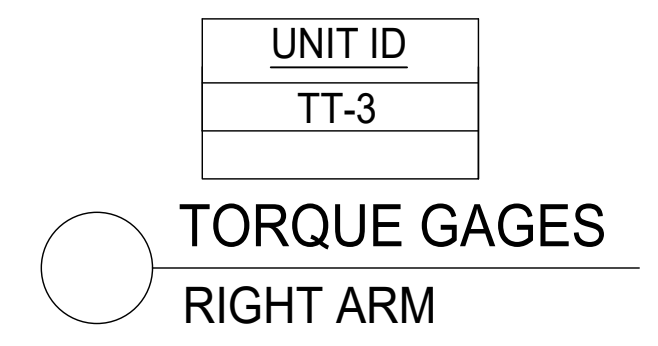
1 GATE 12
RIGHT ARM

- NOTES:
1. SECTIONS A, B, & C SHALL BE INSTALLED 15 INCHES AWAY FROM TRUNNION PLATE.
 2. TILTMETERS SHALL BE INSTALLED CENTERED ON THE MIDDLE STRUT FLANGE.
 3. SECTION G'S TILTMETER SHALL BE INSTALLED AS CLOSE TO THE SKINPLATE AS POSSIBLE.

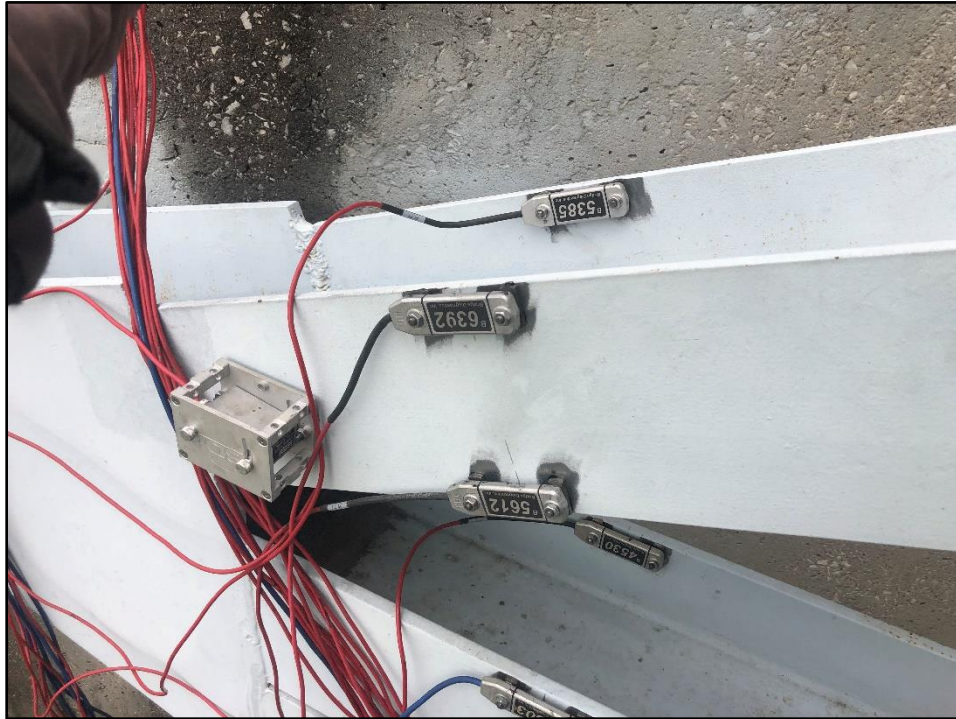
Figure 1 – BDI tiltmeter rotation sensor and reusable strain transducers installed near trunnion hub (Typical)

A typical installation has been shown in Figure 1 through Figure 4. Access to all the sensor locations was provided by BDI's own SPRAT certified rope access technicians and engineers as shown in Figure 5.

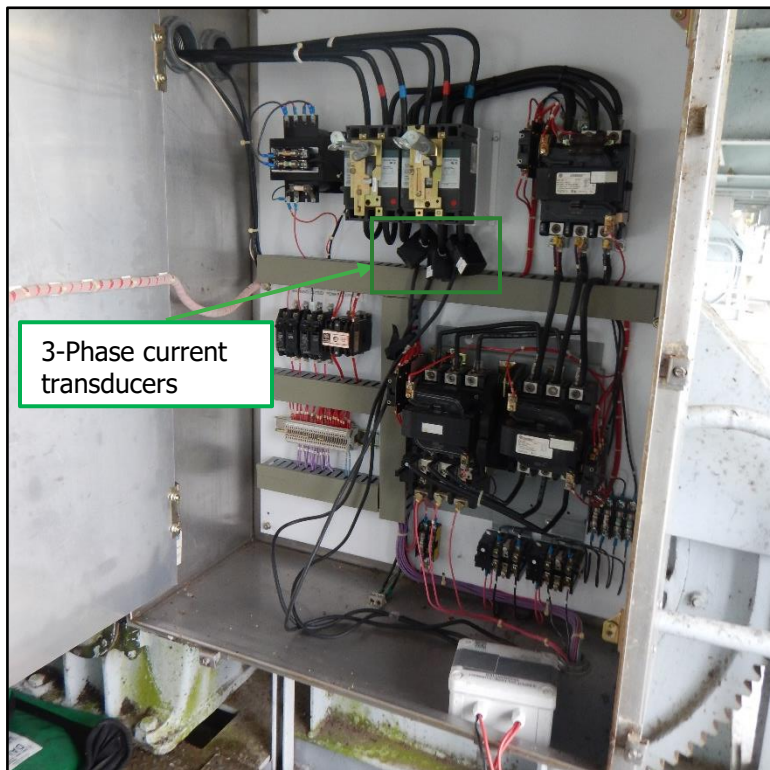
Figure 4 – Current transducers installed on hoist motor controls (Typical)

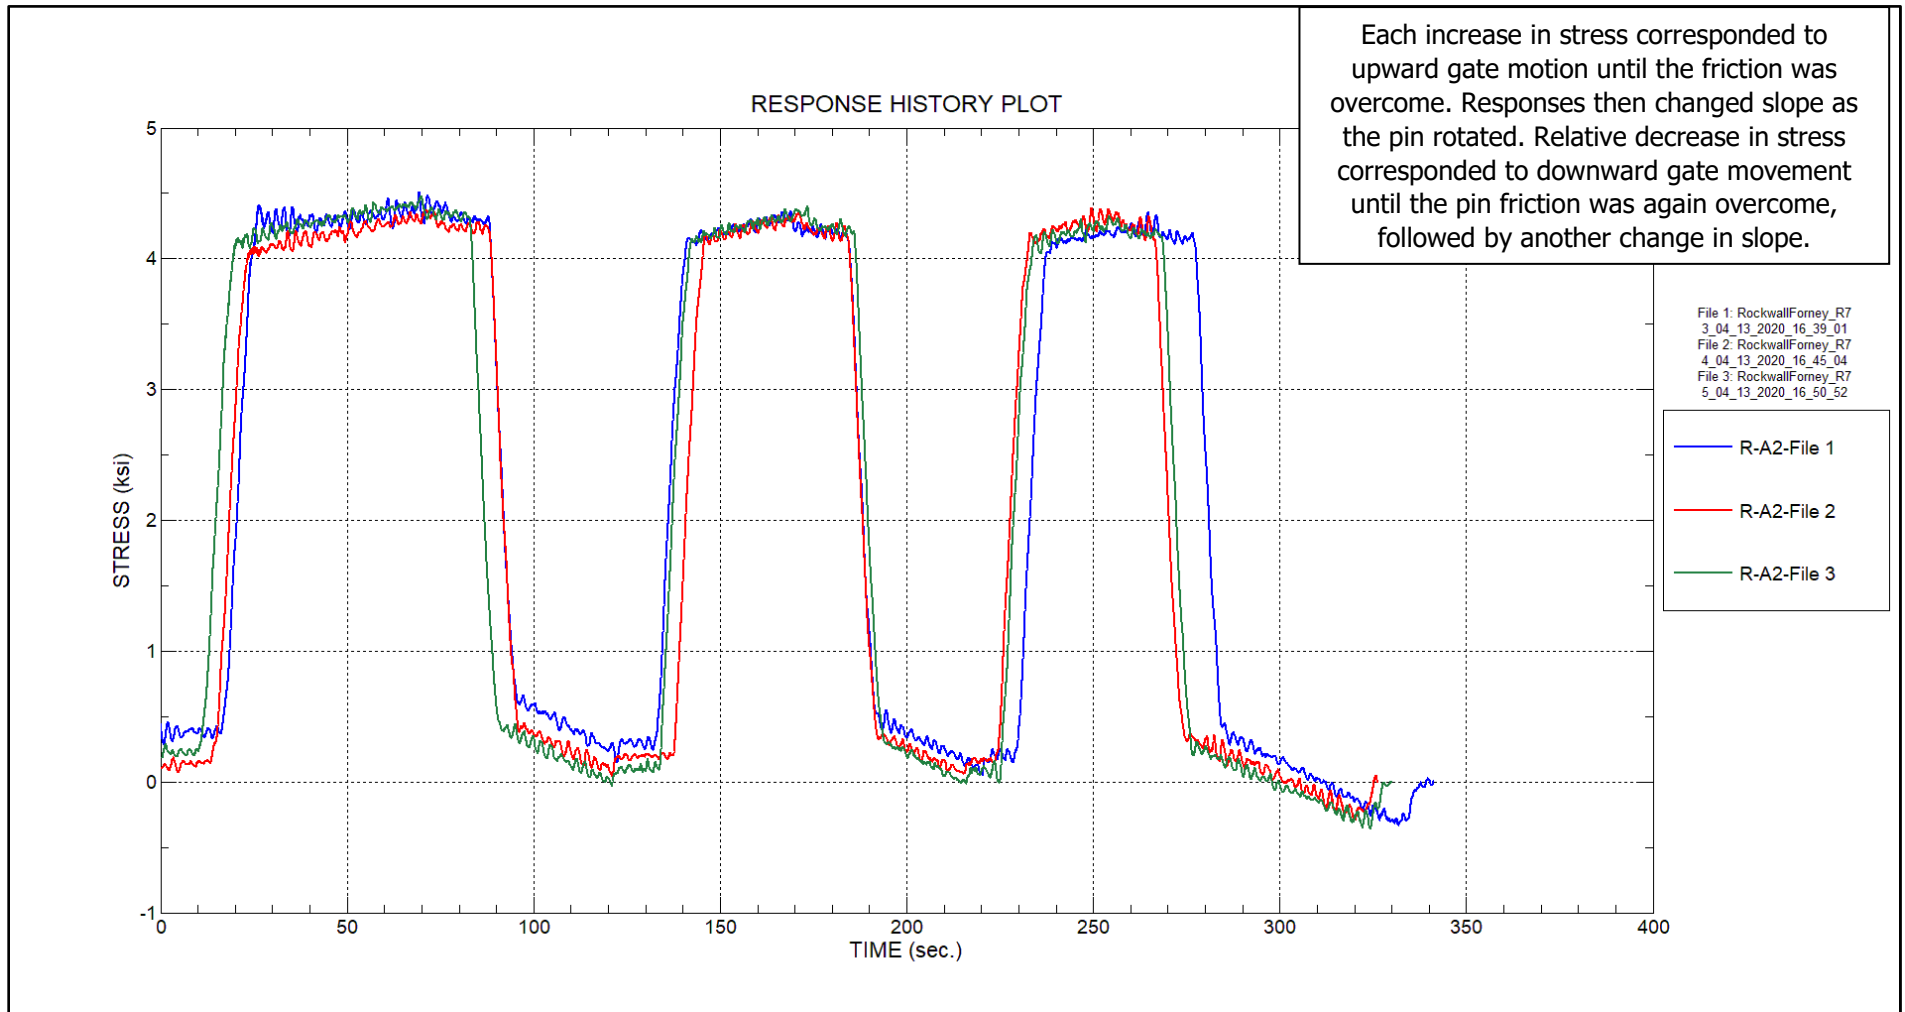
Figure 6 – Stress response history – Right arm – Gage A2 – Time based
File 1 = test run 1, File 2 = test run 2, File 3 = test run 3

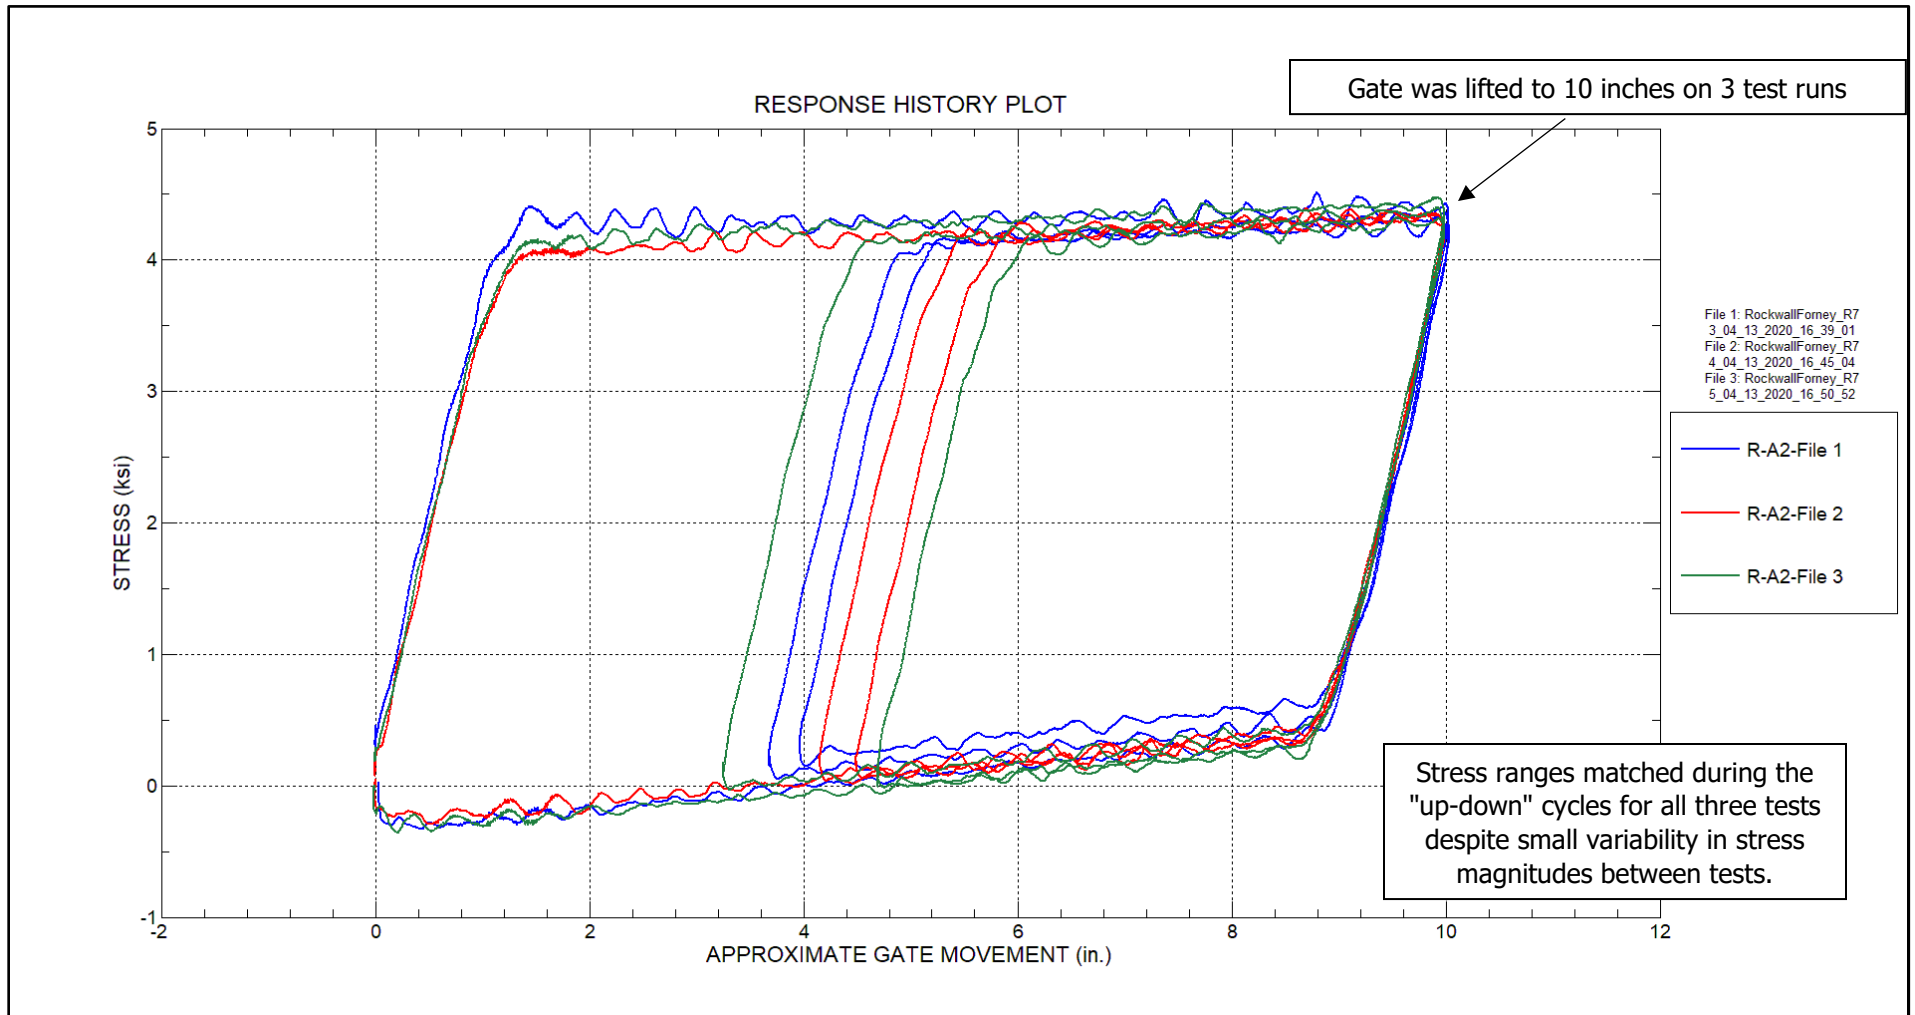
Figure 7 – Stress response history – Right arm – Gage A2 – Function of gate movement
File 1 = test run 1, File 2 = test run 2, File 3 = test run 3
(Section A along top strut near pin – Sensor location 2 along bottom of inner flange)
