VISUAL INSPECTION AND EVALUATION REPORT

Rockwall-Forney Dam
Dallas Water Utilities
Dallas/Kaufman Counties, Texas

Schnabel Reference #20C22001.00
July 30, 2021

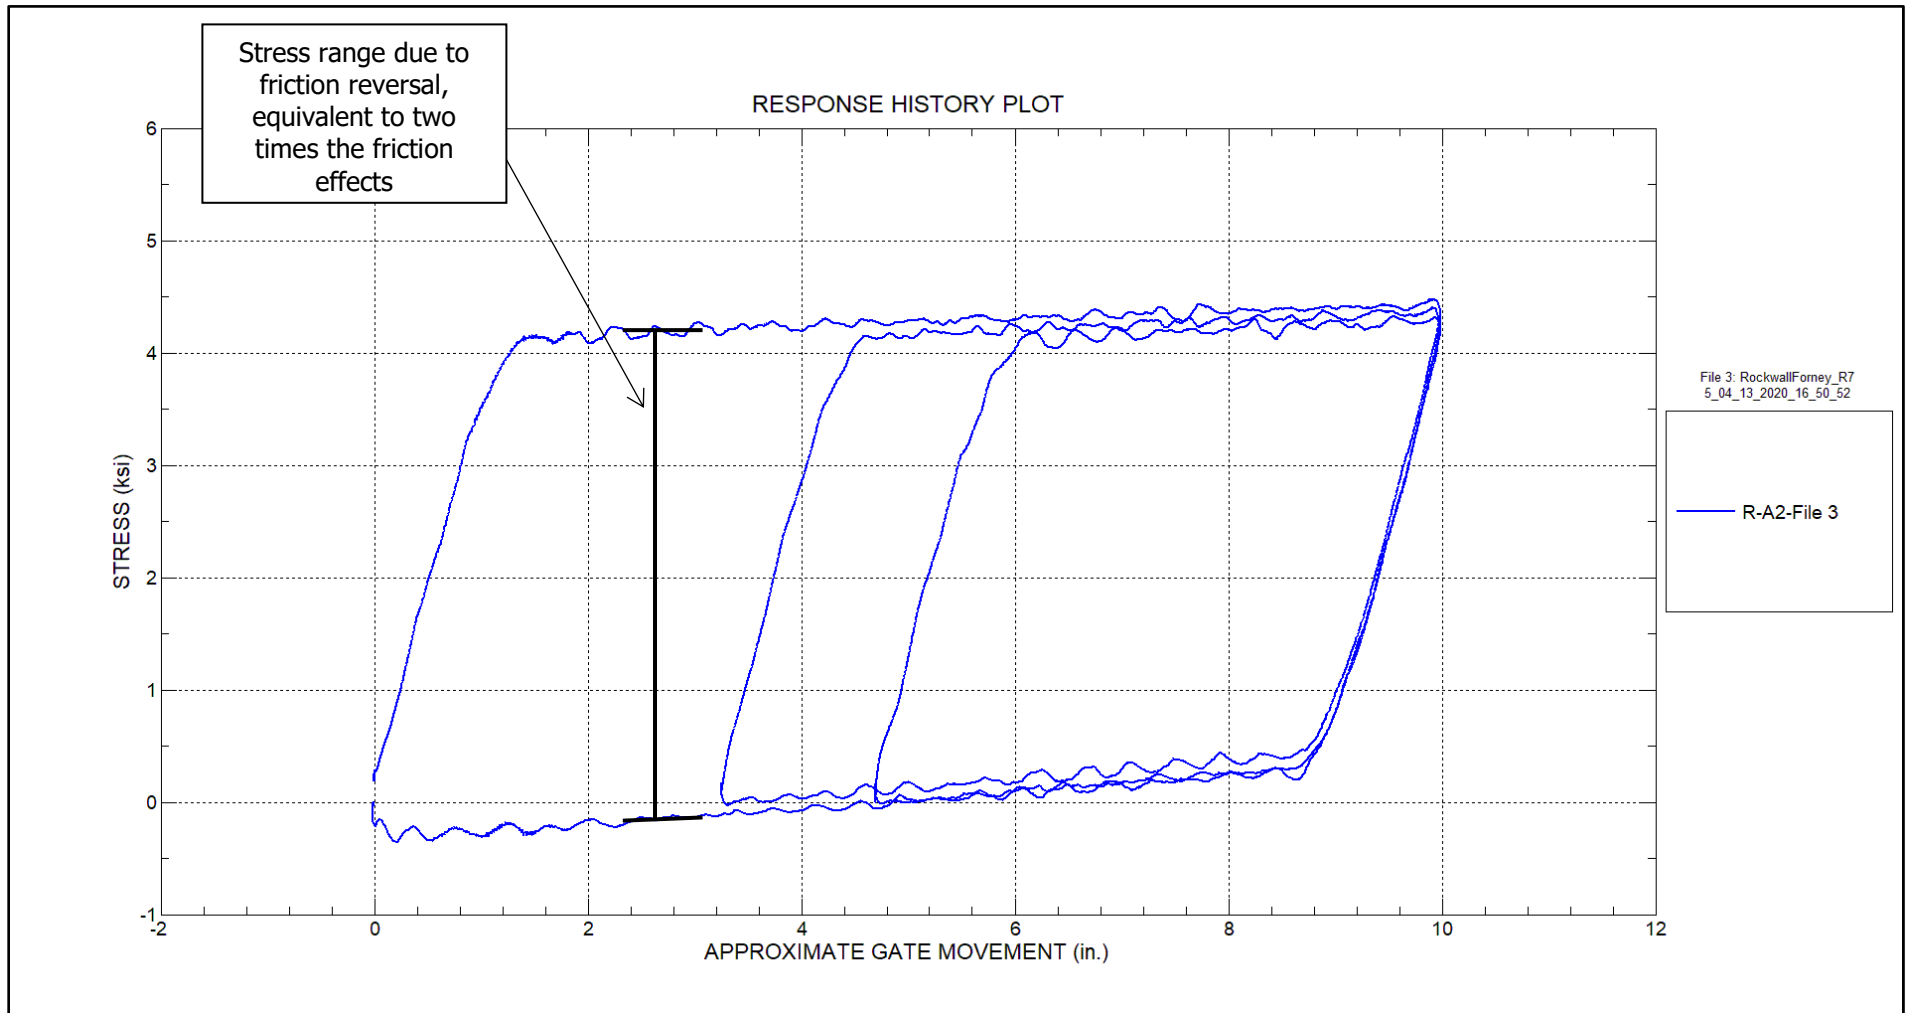
Figure 8 – Stress response history – Right arm – Gage A2 – Friction effect in stress responses
(Section A along top strut near pin – Sensor location 2 along bottom of inner flange)

- + **DIRECTION/FRICTION REVERSAL IN RESPONSES:** The difference in stress during gate opening and closing for a given position is shown in Figure 8. The stress variation at any given gate position was a result of direction reversal and in turn due to trunnion friction reversal. This statement is true since all other loads such as dead-load and hydrostatic pressure were essentially constant barring small changes in hydrostatic pressure due to slight changes in head. This direction/friction reversal is depicted in Figure 9, with deflected shape renderings from a gate arm finite element model under lifting and lowering loads. Note that this figure shows an arm configuration that does not match this gate, but the concept of the direction/friction reversal still applies.

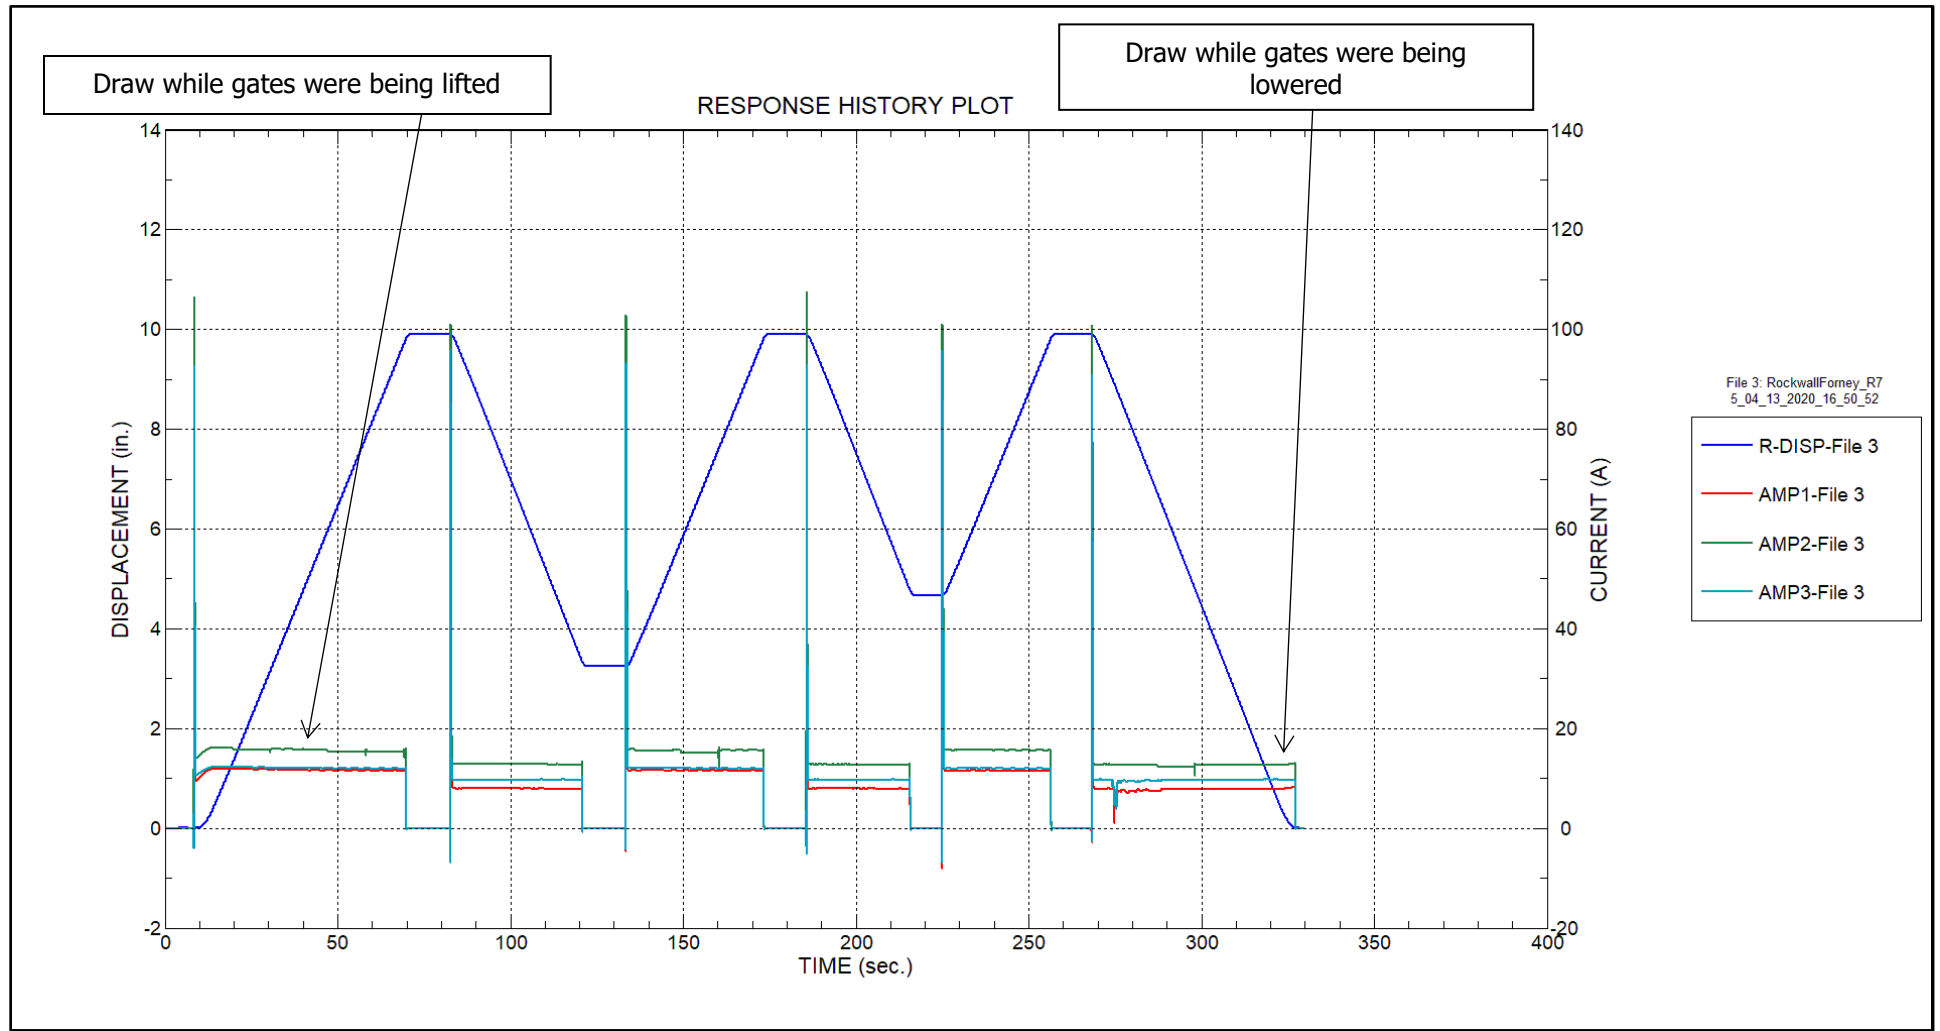
Figure 10 – Motor current & gate movement response history – Lift motor – Highlighting motor draw during lift and lower cycles

- + **MOTOR PERFORMANCE:** Current measurements taken at the hoist motor indicated steady and stable current draws during the lifting and lowering portions. An example plot of current draw and gate position is provided in Figure 10. Current draw ranges during lifting were higher than the ranges during lowering, which is common due to gravity/dead load. These results are summarized along with recorded peak in-rush current in Table 2. Note that the sample rates used during testing were set for collecting gate responses and may not have been appropriate to fully capture the in-rush current. The readings should be evaluated by a licensed electrician with knowledge of the operating parameters.

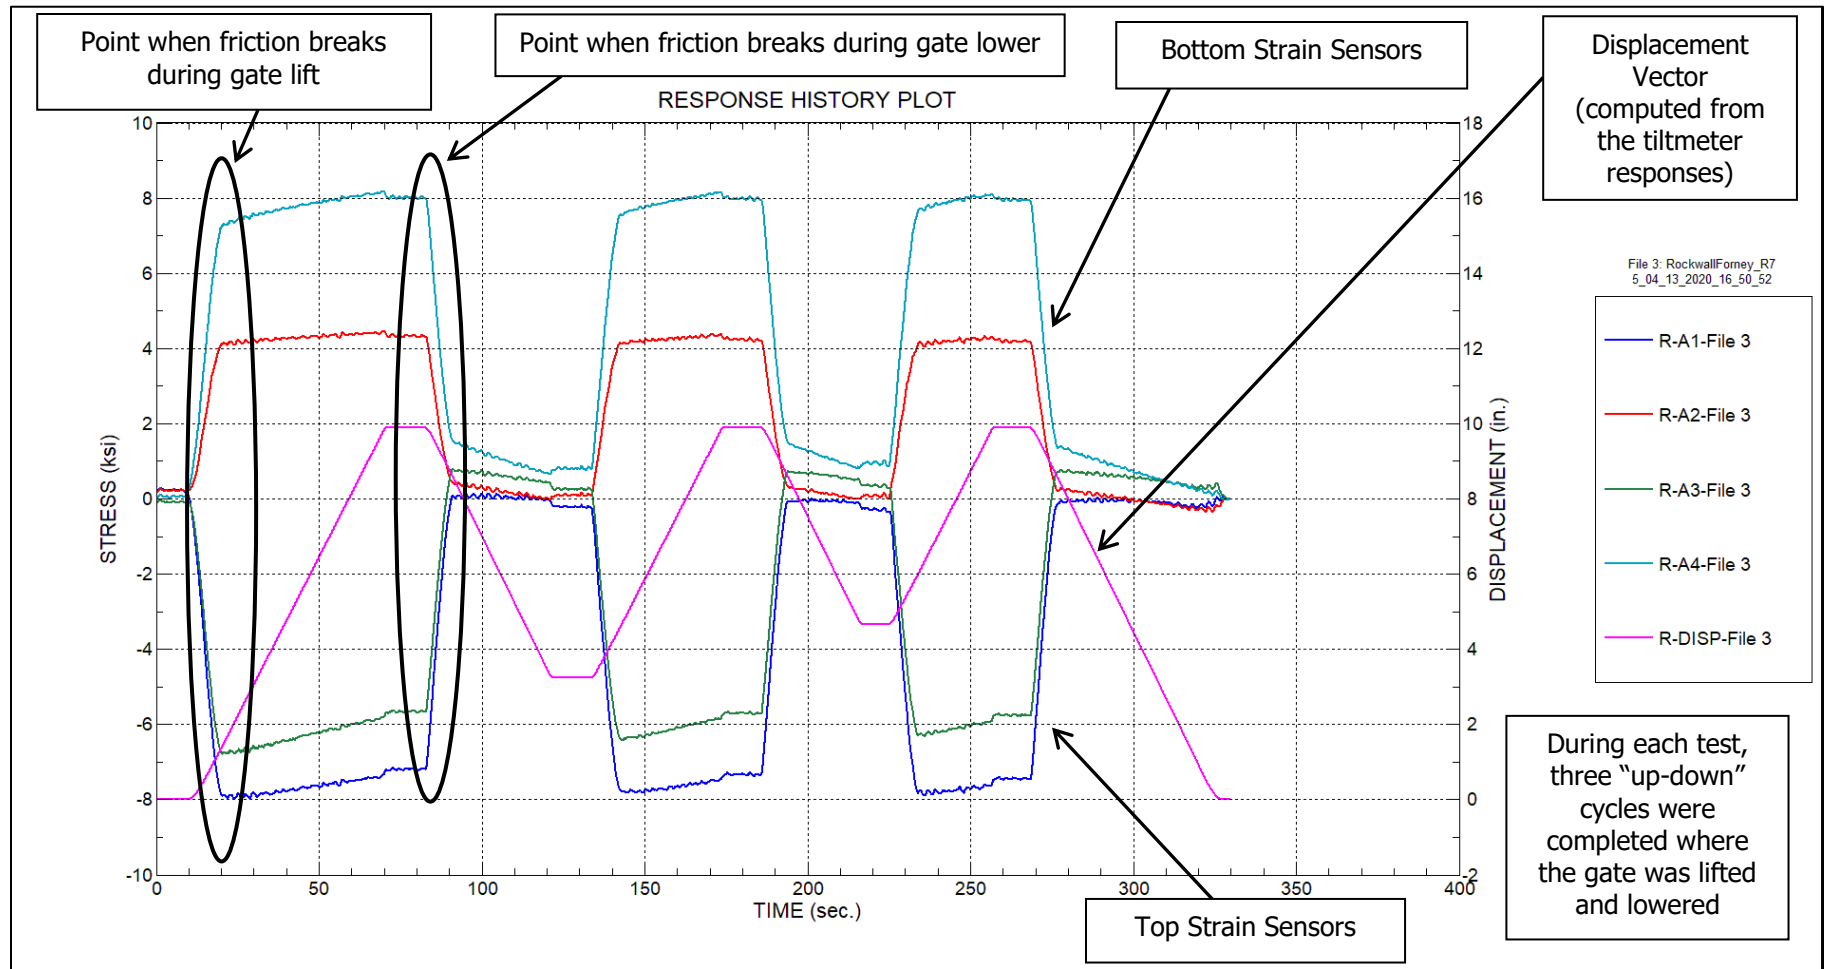
Figure 11 – Stress response & gate movement history – Right arm – Section A - Highlighting friction behavior (Section A along top strut near pin)

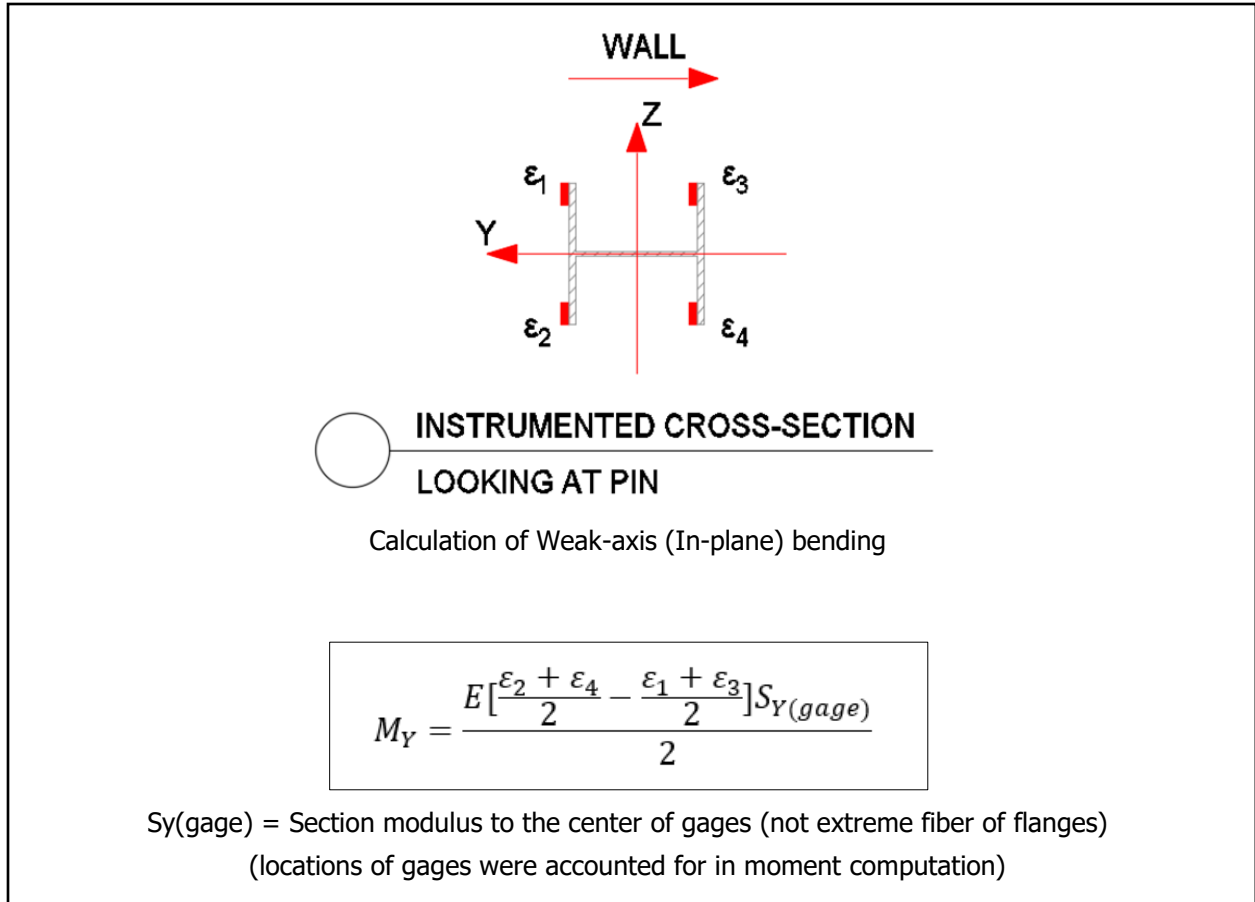
Figure 12 – Basic mechanic equation used to calculate moment

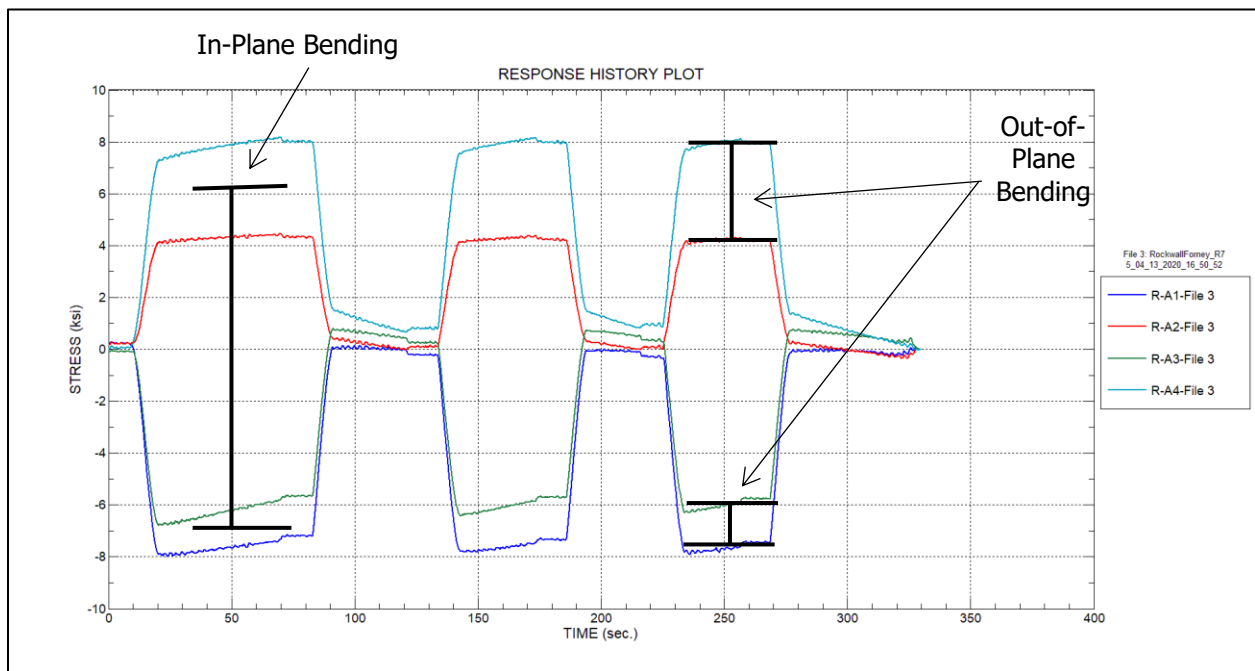
Figure 13 – Stress response history – Right arm – Section A – Bending components
(Section A along top strut near pin)

In-plane or weak-axis flexure refers to bending about a given strut's web. This designation is consistent with typical nomenclature. In-plane bending can be observed visually from the strain response histories as a difference between the top and bottom stresses, whereas out-of-plane or strong-axis bending is visualized as the difference in stress from side to side. Figure 13 provides a visual reference for both types of strut flexure.

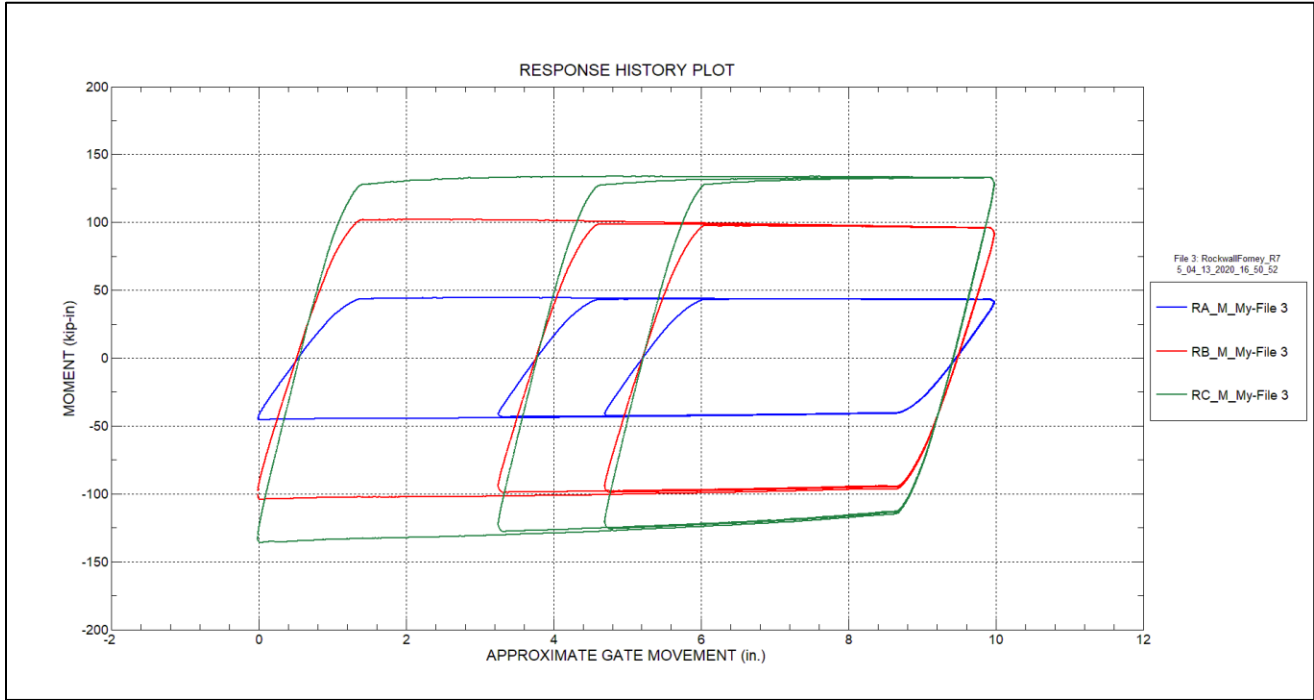
Figure 14 – In-plane moment response history – Right arm – Sections near pin
(RA = Right Arm Top Strut, RB = Right Arm Middle Strut, RC = Right Arm Bottom Strut)

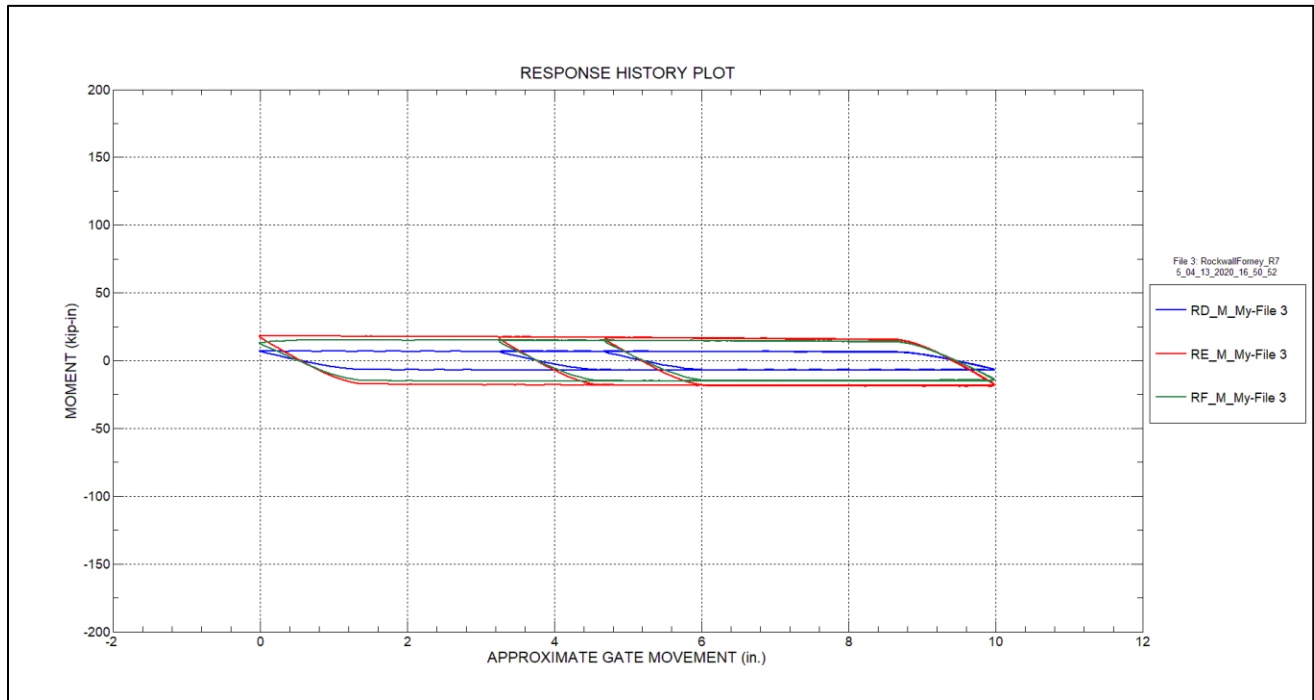
Figure 15 – In-plane moment response history – Right arm – Sections away from pin
(RD = Right Arm Top Strut, RE = Right Arm Middle Strut, RF = Right Arm Bottom Strut)

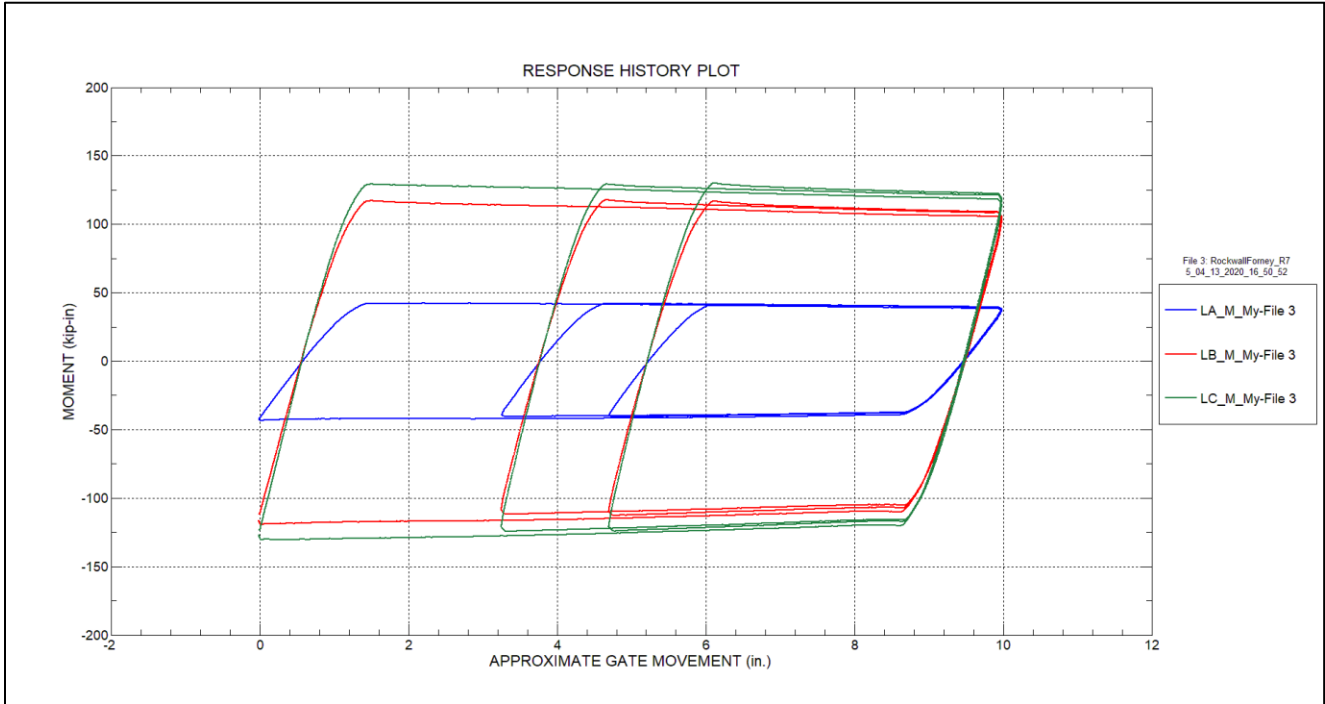
Figure 16 – In-plane moment response history – Left arm – Sections near pin
(LA = Left Arm Top Strut, LB = Left Arm Middle Strut, LC = Left Arm Bottom Strut)

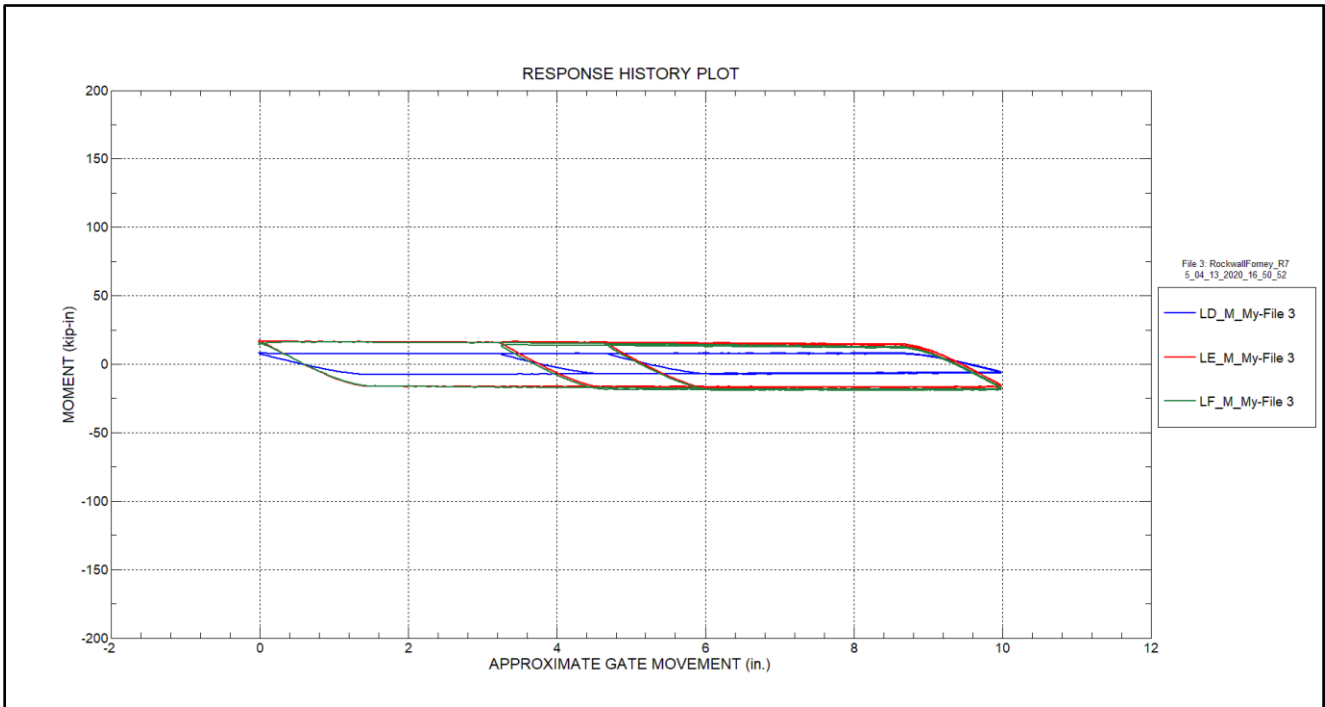
Figure 17 - In-plane moment response history – Left arm – Sections away from pin
(LD = Left Arm Top Strut, LE = Left Arm Middle Strut, LF = Left Arm Bottom Strut)

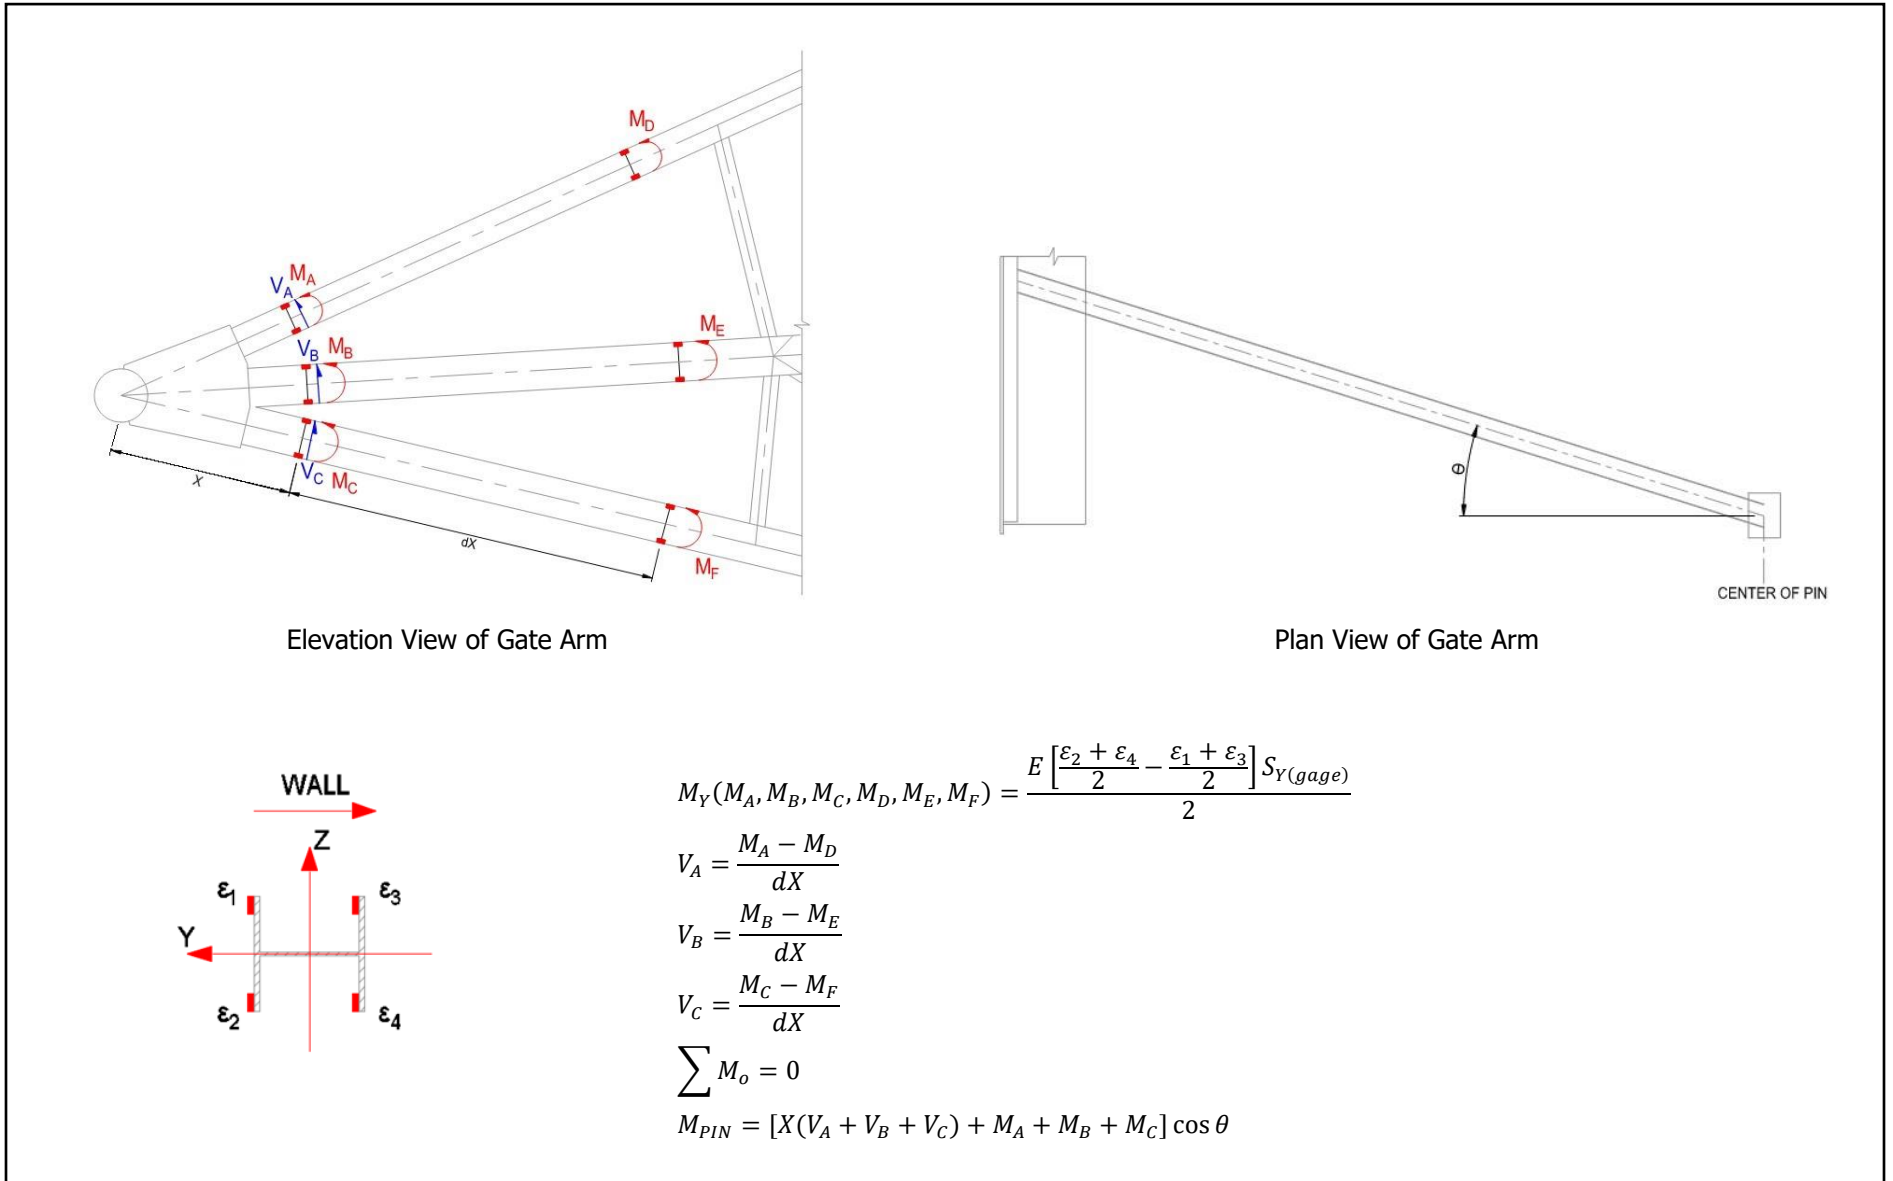
Figure 18 – Direct calculation of pin moment from strain measurements

- + **TRUNNION FREE-BODY-DIAGRAM & PIN MOMENT CALCULATION:** Figure 18 shows the instrumented member cross-sections and shows how the measured cross-sectional flexural responses were used to compute pin moment. The in-plane moment values used in these calculations were determined directly from the strain measurements at each cross-section using the provided mechanics equations. It should be noted that the out-of-plane moments were not considered in the calculation of pin moment since they were orthogonal to the axis of the pin rotation. Total pin moment was then determined by summing all the moment components about the pin, which included the in-plane moment and the shear components at the strut cross-sections nearest the pin.

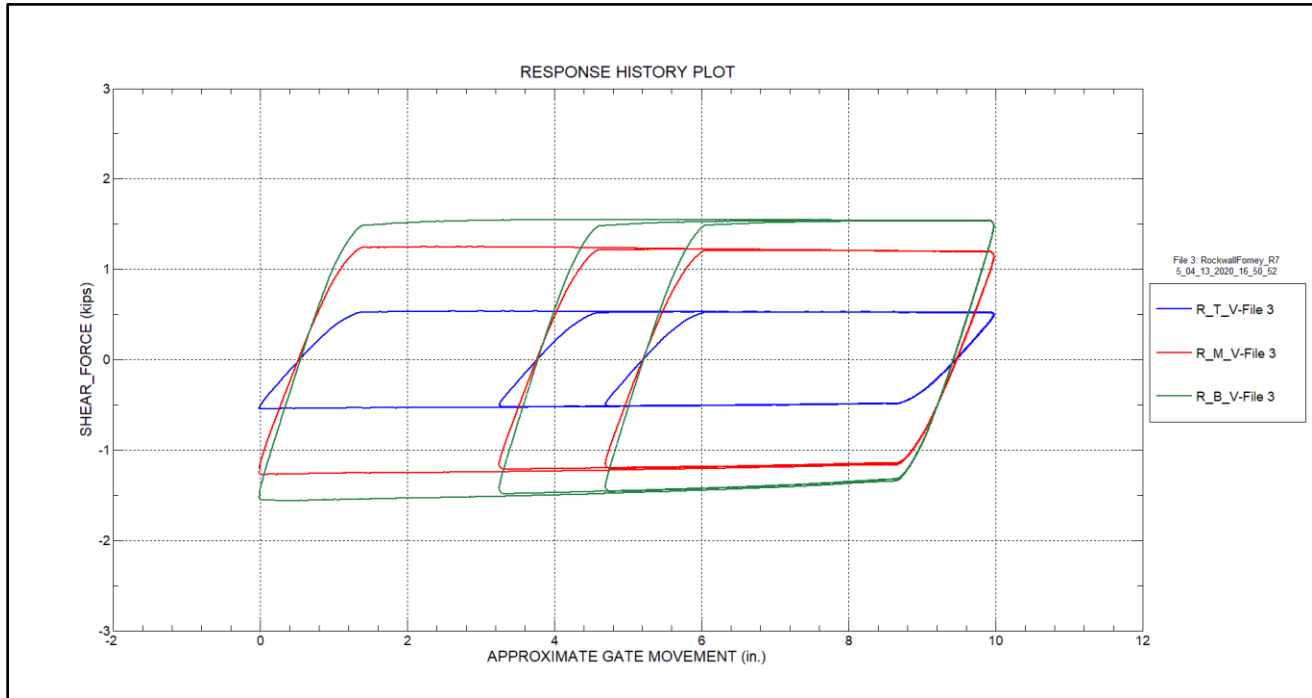
Figure 19 – Strut shear response history – Right arm

(R_T = Right Arm Top Strut, R_M = Right Arm Middle Strut, R_B = Right Arm Bottom Strut)

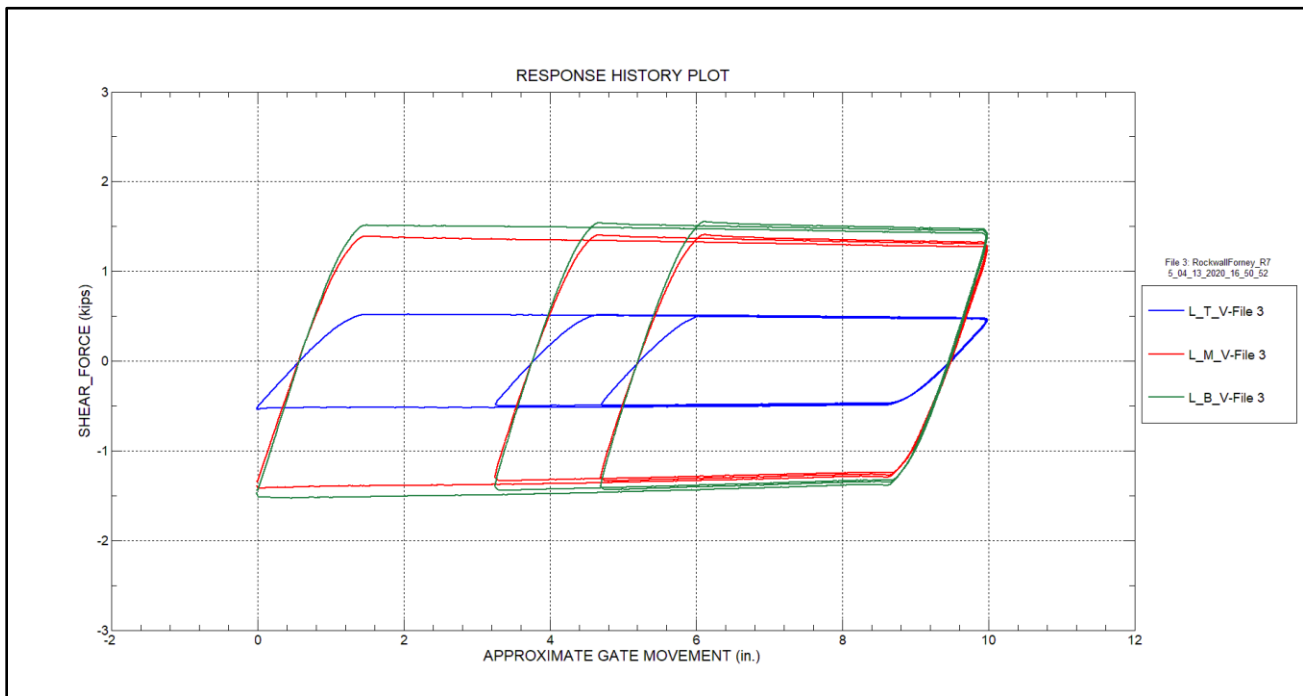
Figure 20 – Strut shear response history – Left arm

(L_T = Left Arm Top Strut, L_M = Left Arm Middle Strut, L_B = Left Arm Bottom Strut)

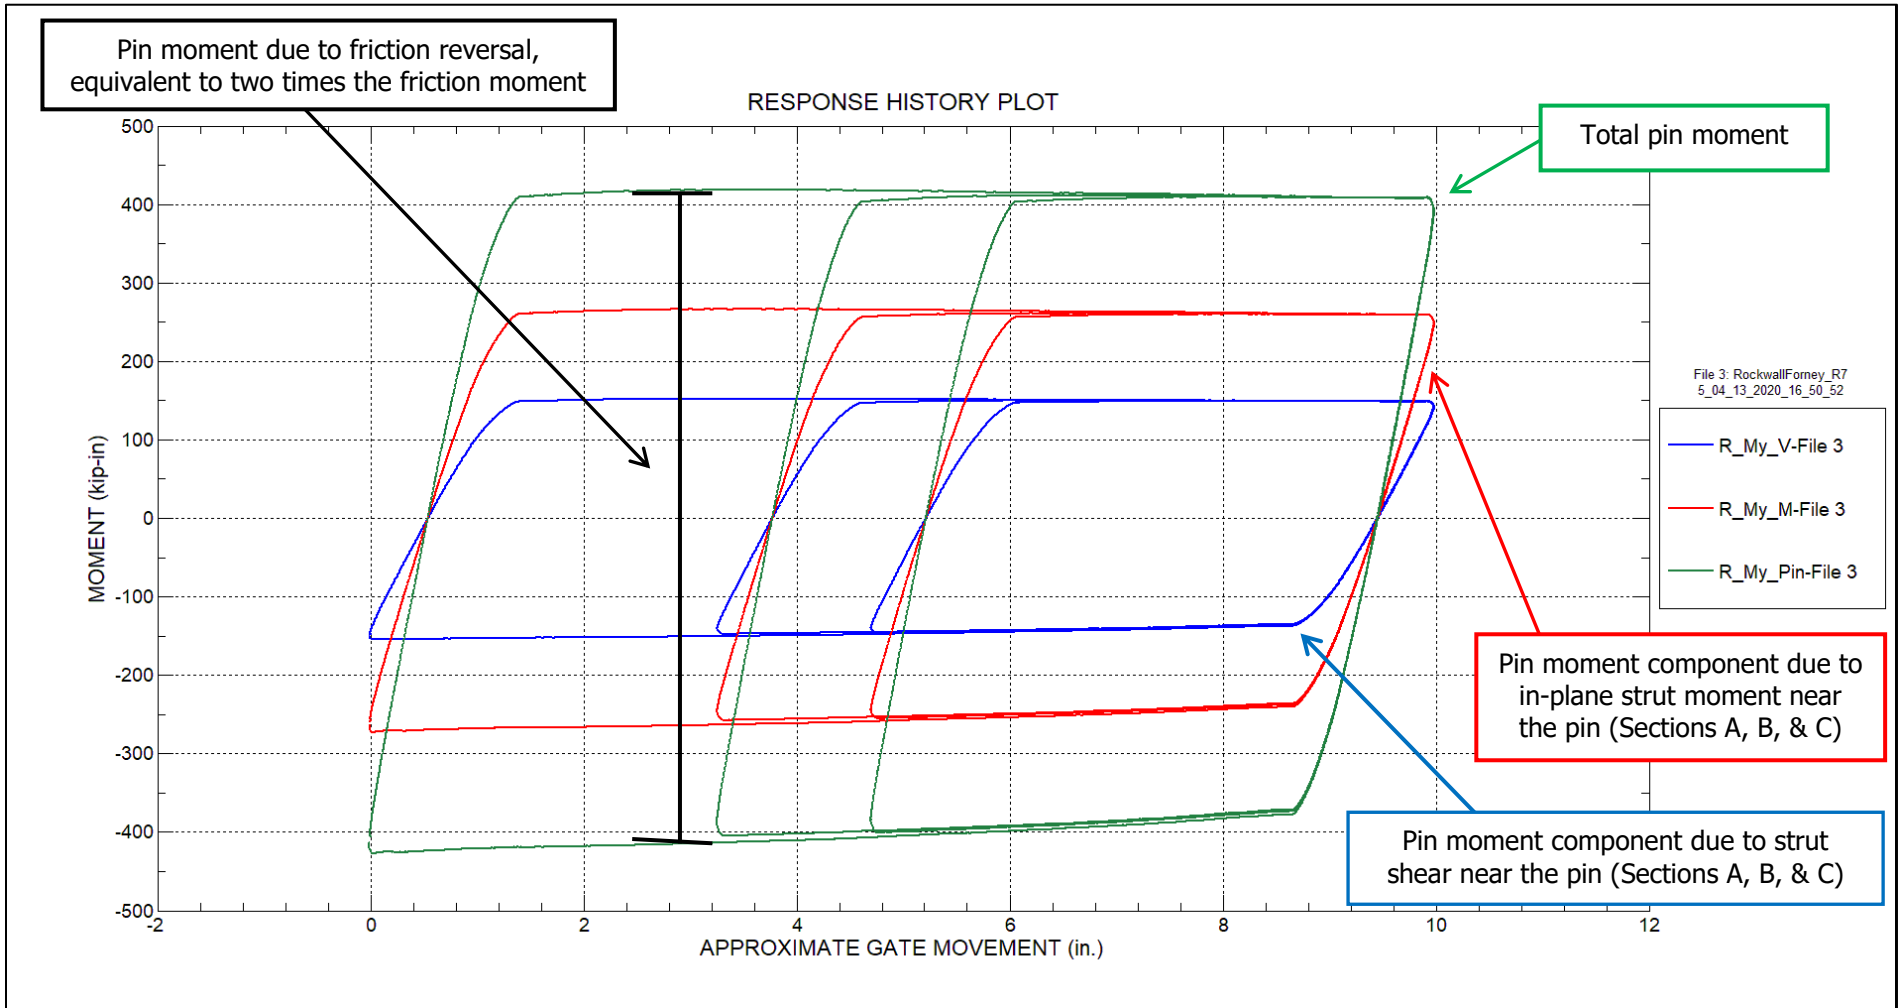
Figure 21 – Pin moment response history – Right arm

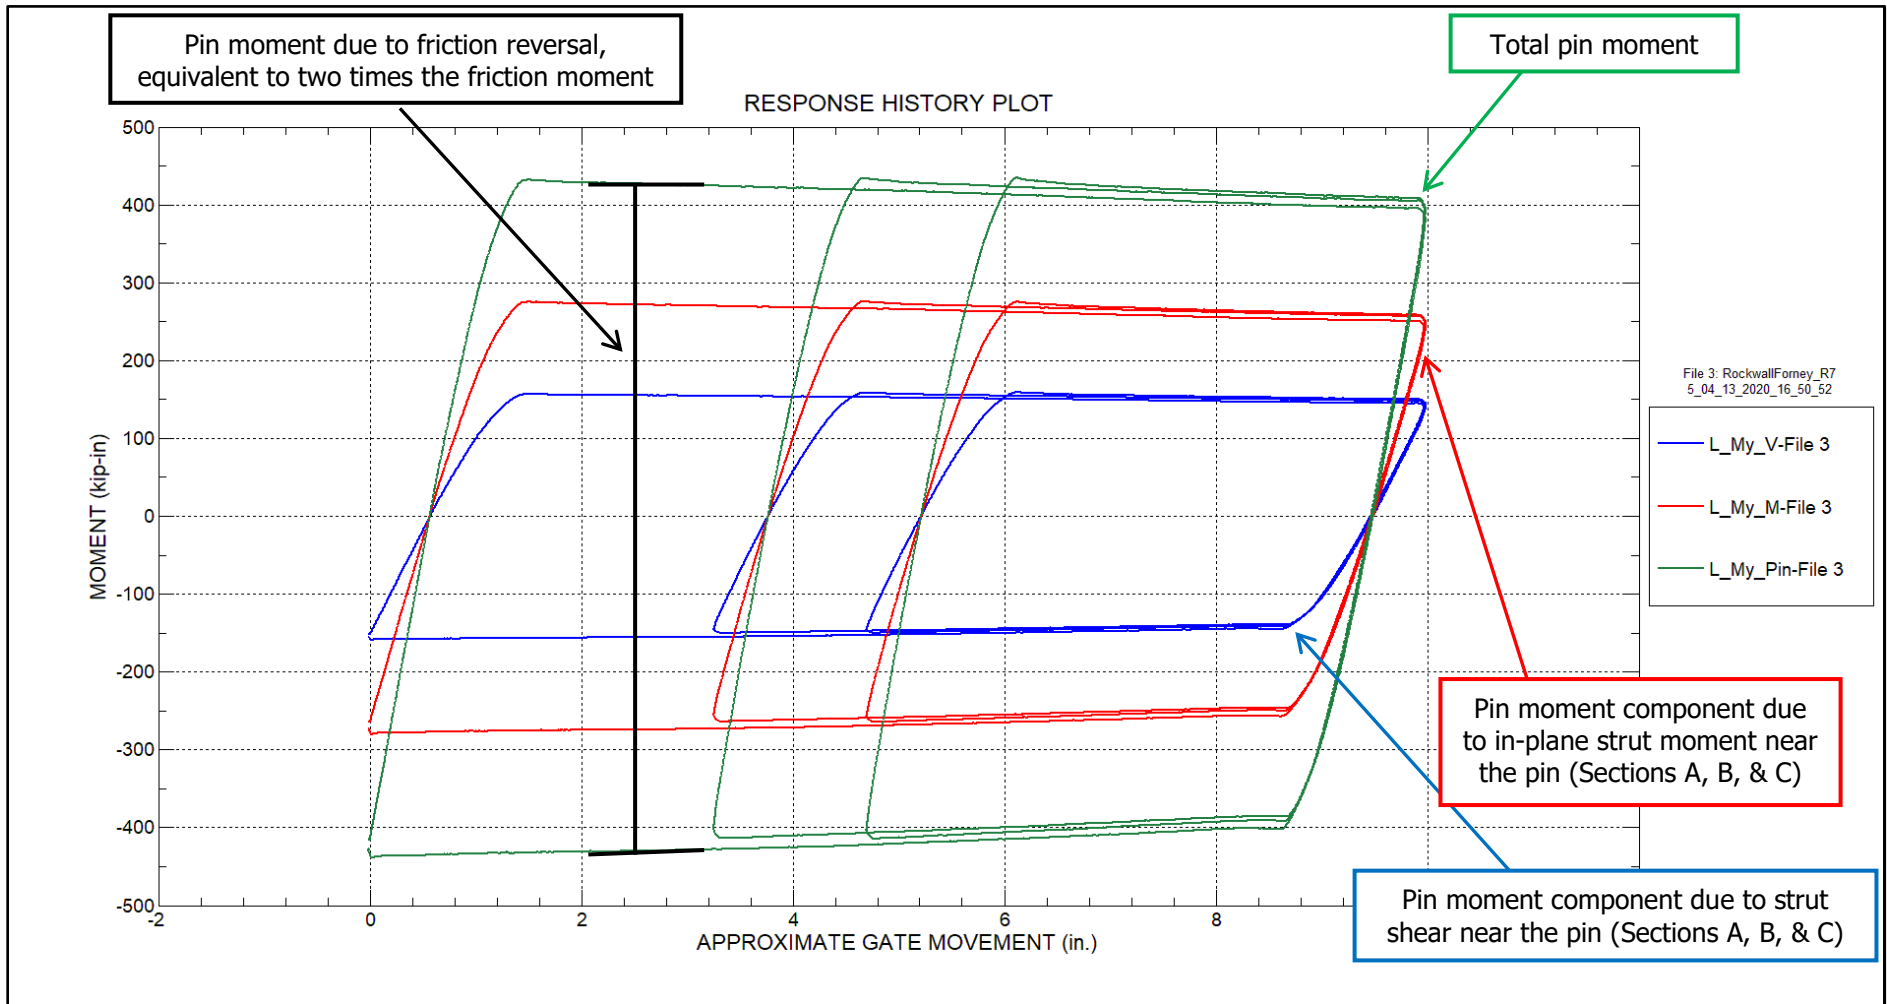
Figure 22 – Pin moment response history – Left arm

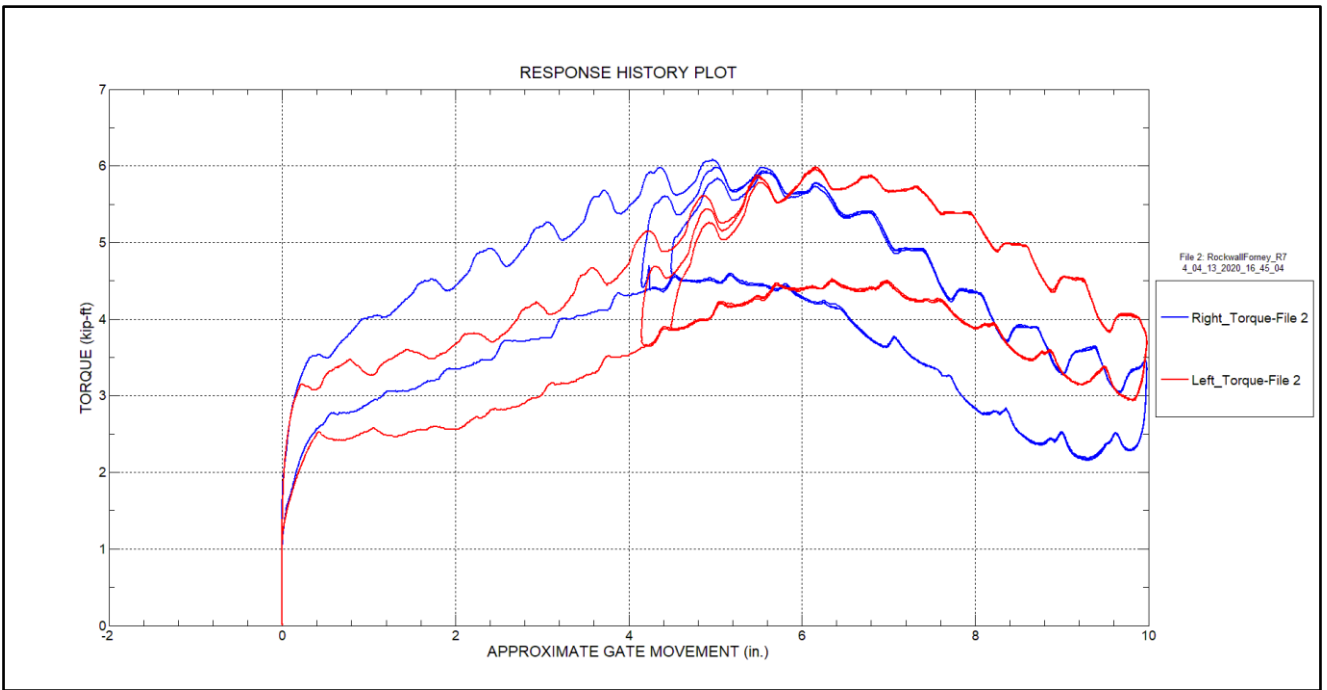
Figure 23 – Hoist torque response history – Gate 13 – Test 2

Figure 23 shows example torque measurements, recorded on the Gate 13 torque shafts. Best practices for torque measurements is to measure torque on opposite sides of the shaft so that any bending in the shaft can be removed by averaging the two responses. Due to access limitations, only one gage at each location could be installed. Therefore, any bending in the shaft may be reflected in the torque measurements and may be related to the peaks and valleys observed in the torque responses.

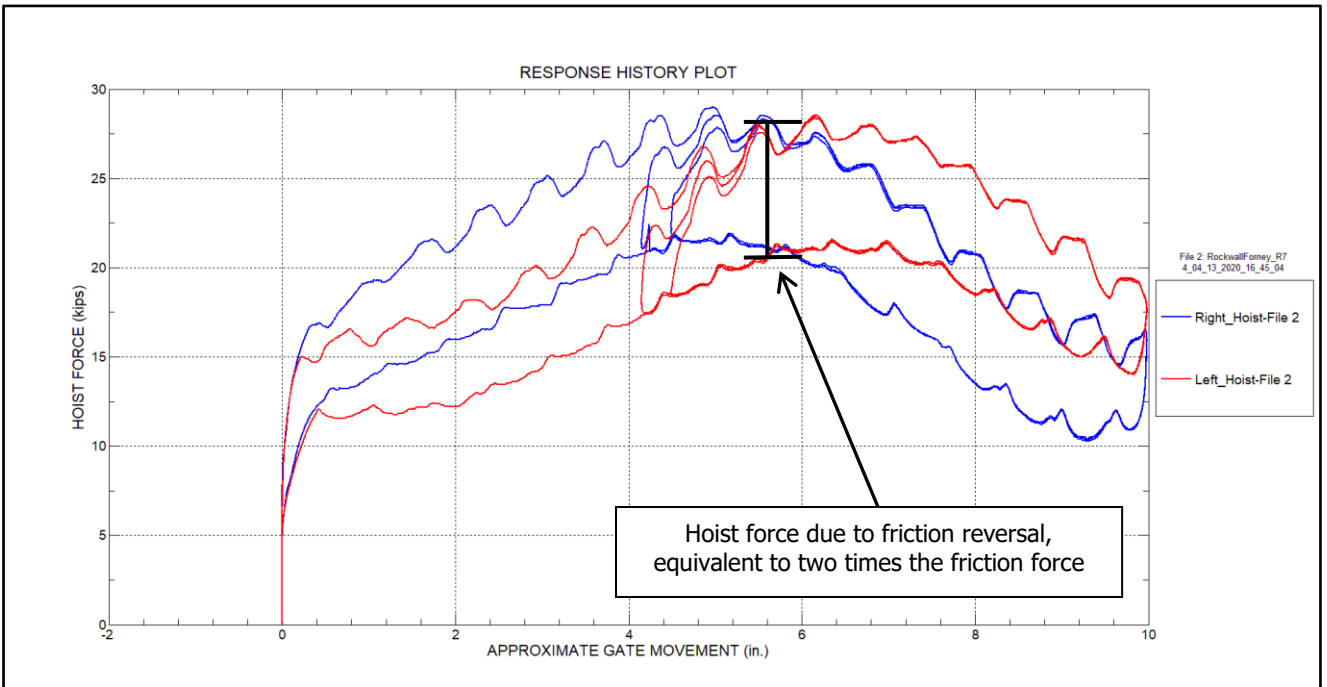
Figure 24 – Hoist force response history – Gate 13 – Test 2

Torque values were converted to force in the hoist cables per gate arm using the gear ratio and drum radius, as shown in Figure 24. The gear ratio and drum radius were 5.182 and 1.086 feet respectively, as defined in the provided as-built shop drawings. It should be noted that the hoist force calculated may be smaller than the actual hoist force applied. This difference is due to the limit switch engaging the brake before the hoist cable was fully slacked, resulting in an initial force in the cable. A hoist force due to total gate friction was then calculated. This friction hoist force was equal to half the differential in force measured during the lifting and lowering of the gate (similar to the pin friction calculations). As shown in Table 3, the change in cable force due to friction was generally consistent between tests. Note that the total hoist force was due to the total friction effects, including side seal, hoist bearings, trunnion friction effects, etc. It is difficult to determine the exact proportion and composition of the total friction sources. Additional torque and hoist force plots for all collected data files are provided in Appendix A – Gate 13 Torque and Hoist Force Plots.
