VISUAL INSPECTION AND EVALUATION REPORT

Rockwall-Forney Dam
Dallas Water Utilities
Dallas/Kaufman Counties, Texas

Schnabel Reference #20C22001.00
July 30, 2021

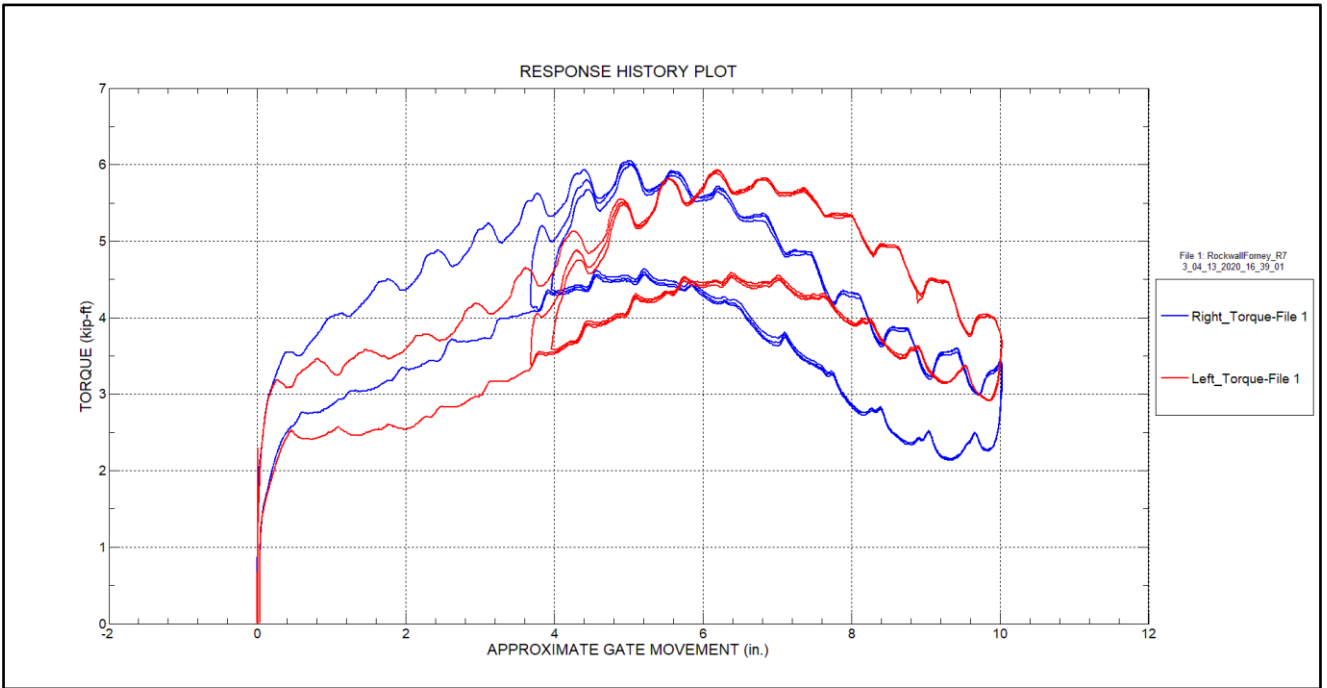
Figure 25 – Hoist torque response history – Gate 13 – Test 1

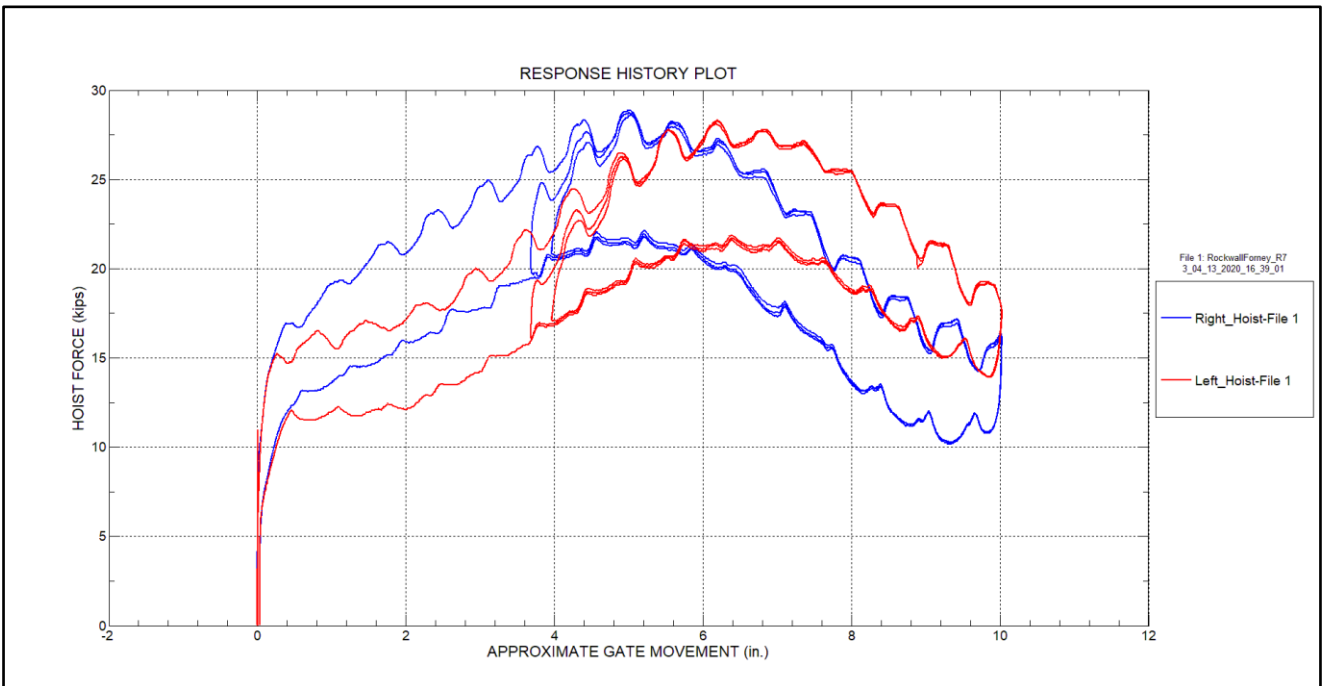
Figure 26 – Hoist force response history – Gate 13 – Test 1

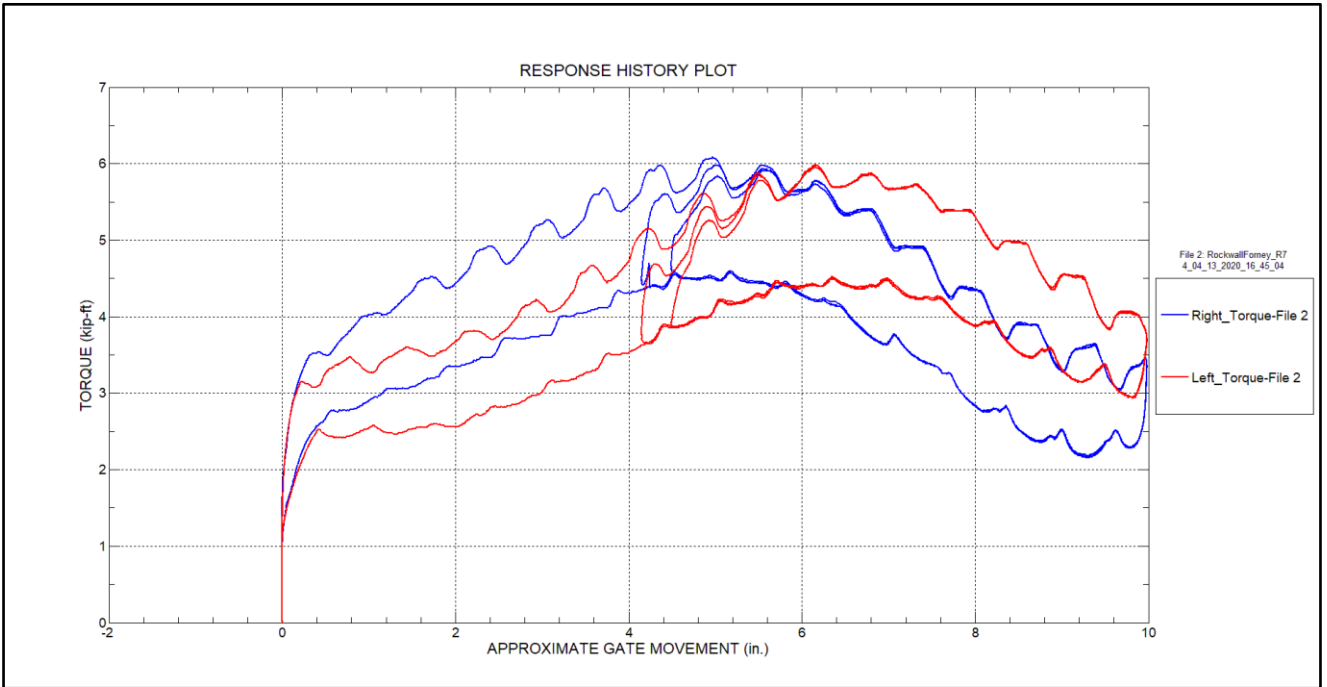
Figure 27 – Hoist torque response history – Gate 13 – Test 2

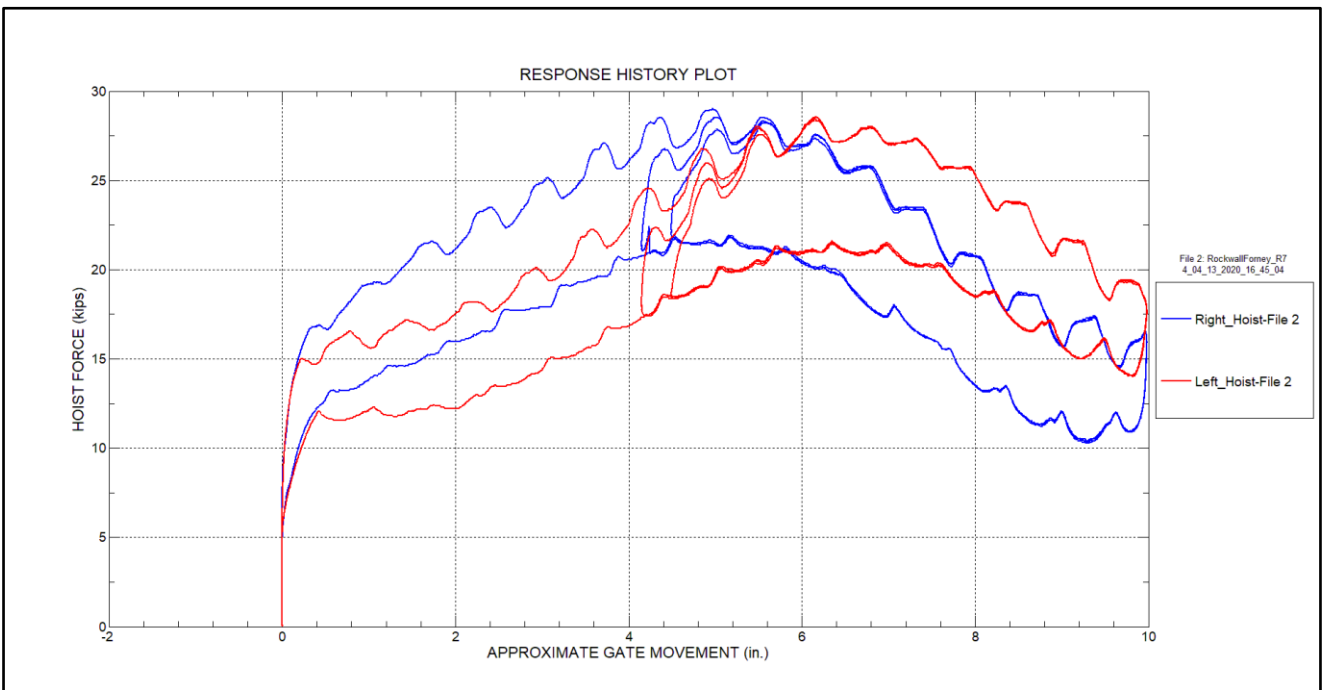
Figure 28 – Hoist force response history – Gate 13 – Test 2

Torque values were converted to force in the hoist cables per gate arm using the gear ratio and drum radius, as shown in Figure 24. The gear ratio and drum radius were 5.182 and 1.086 feet respectively, as defined in the provided as-built shop drawings. It should be noted that the hoist force calculated may be smaller than the actual hoist force applied. This difference is due to the limit switch engaging the brake before the hoist cable was fully slacked, resulting in an initial force in the cable. A hoist force due to total gate friction was then calculated. This friction hoist force was equal to half the differential in force measured during the lifting and lowering of the gate (similar to the pin friction calculations). As shown in Table 3, the change in cable force due to friction was generally consistent between tests. Note that the total hoist force was due to the total friction effects, including side seal, hoist bearings, trunnion friction effects, etc. It is difficult to determine the exact proportion and composition of the total friction sources. Additional torque and hoist force plots for all collected data files are provided in Appendix A – Gate 13 Torque and Hoist Force Plots.

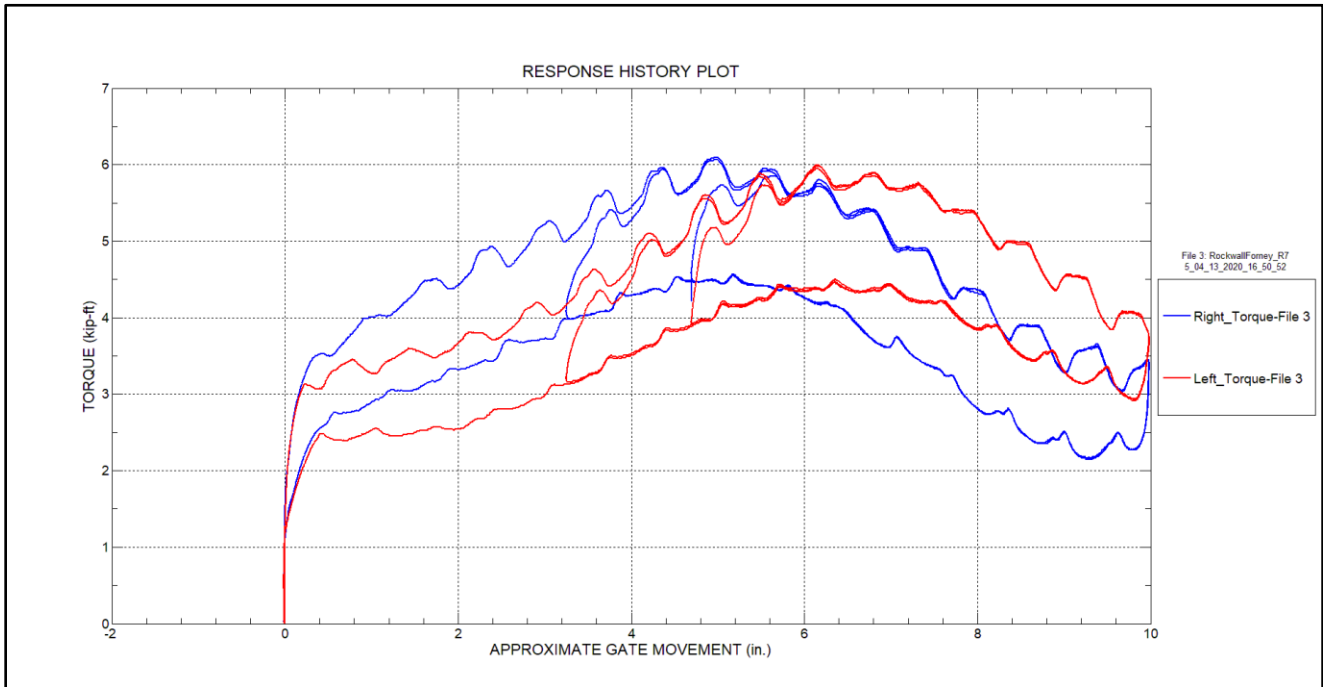
Figure 29 – Hoist torque response history – Gate 13 – Test 3

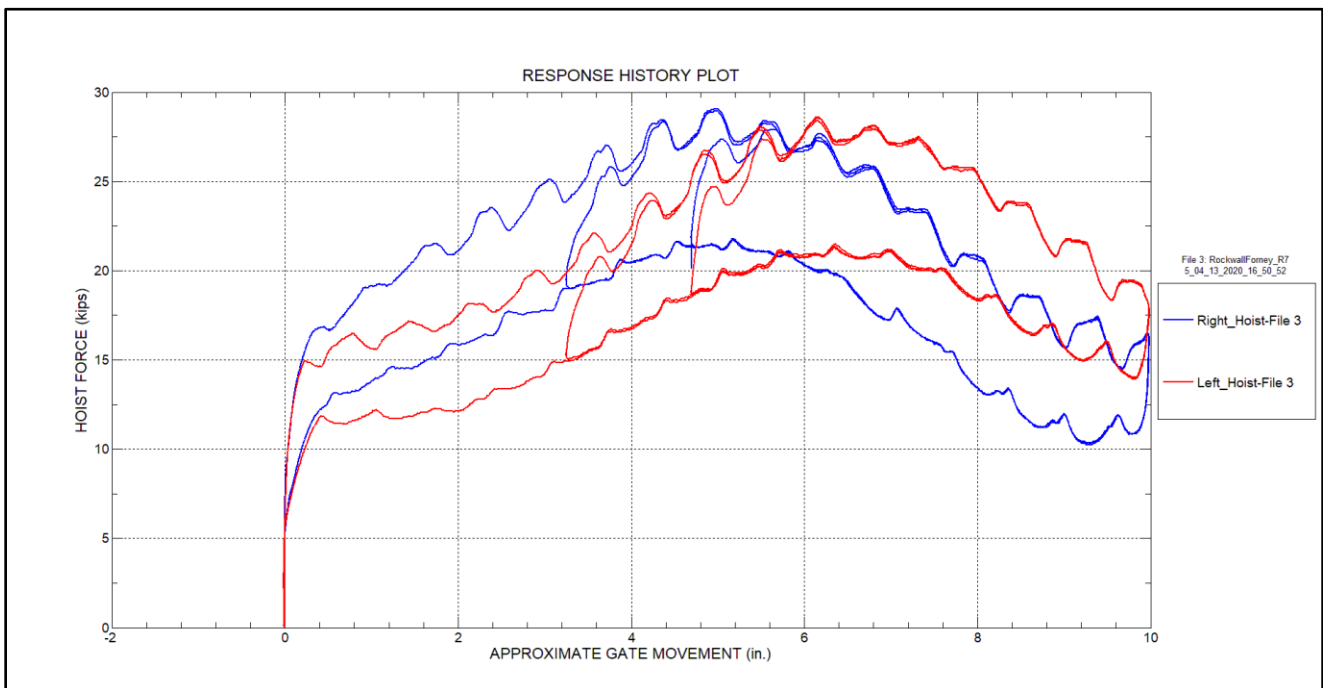
Figure 30 – Hoist force response history – Gate 13 – Test 3

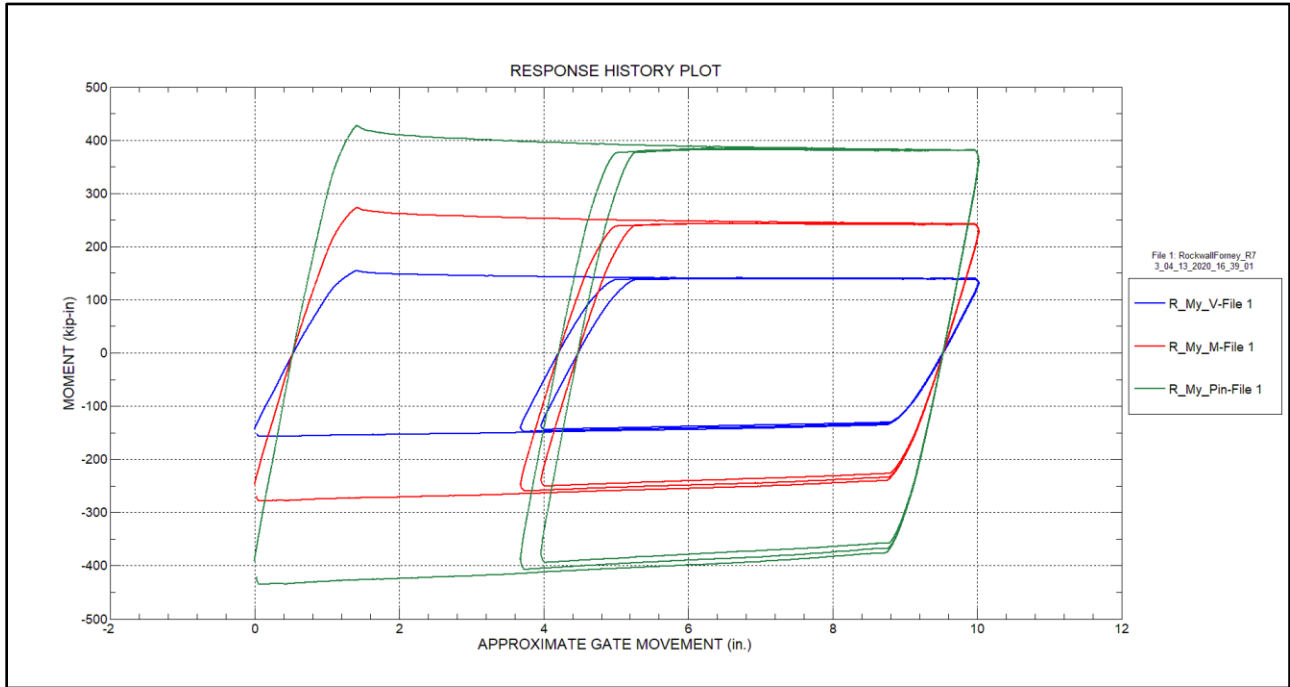
Figure 31 – Pin moment response history – Right arm – Test run 1

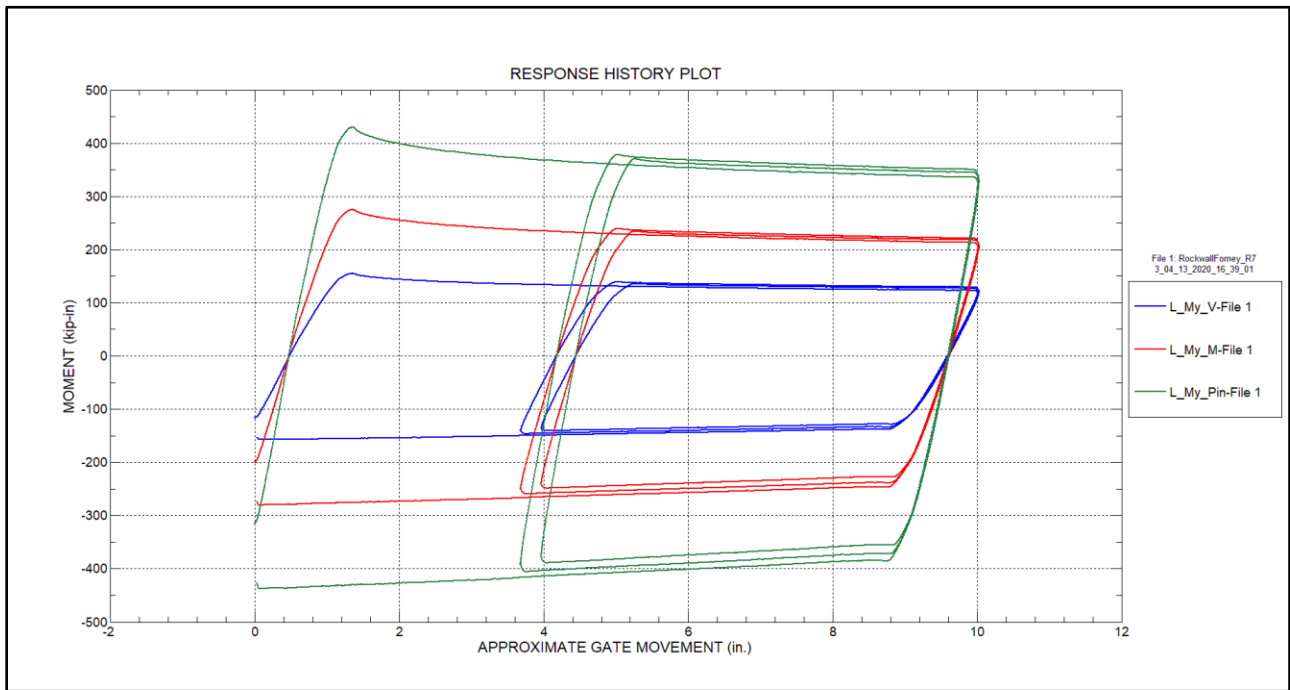
Figure 32 – Pin moment response history – Left arm – Test run 1

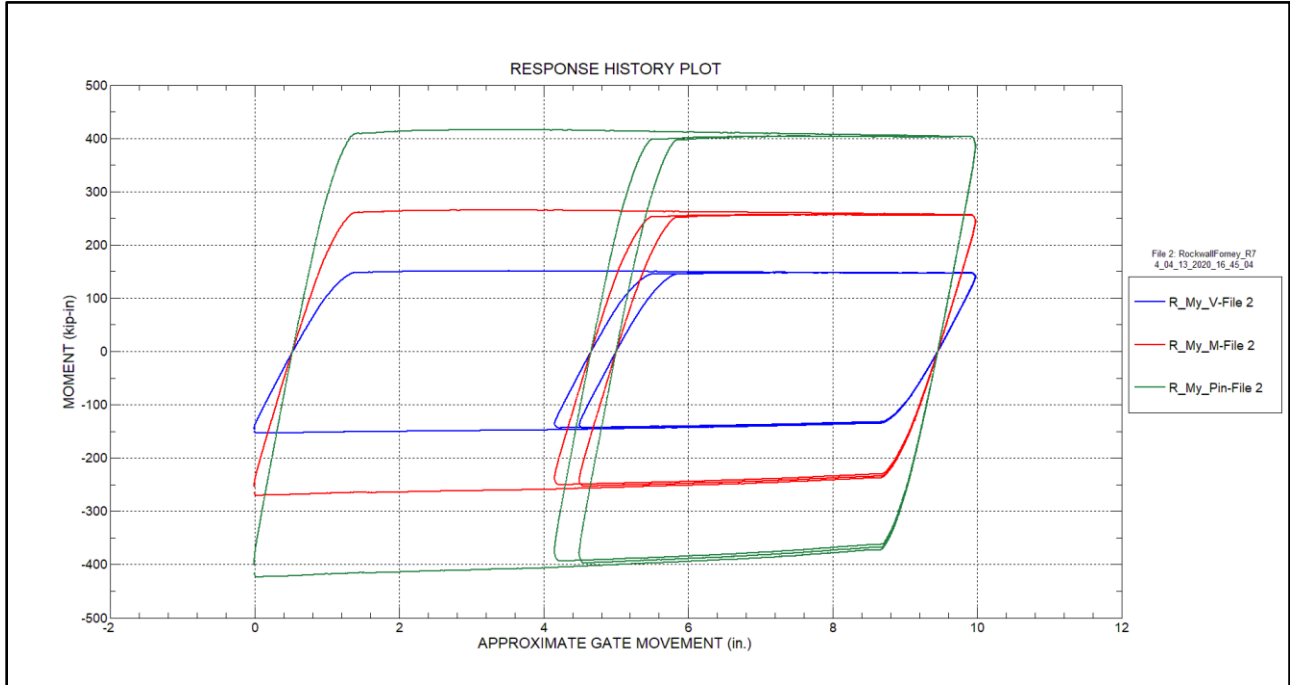
Figure 33 – Pin moment response history – Right arm – Test run 2

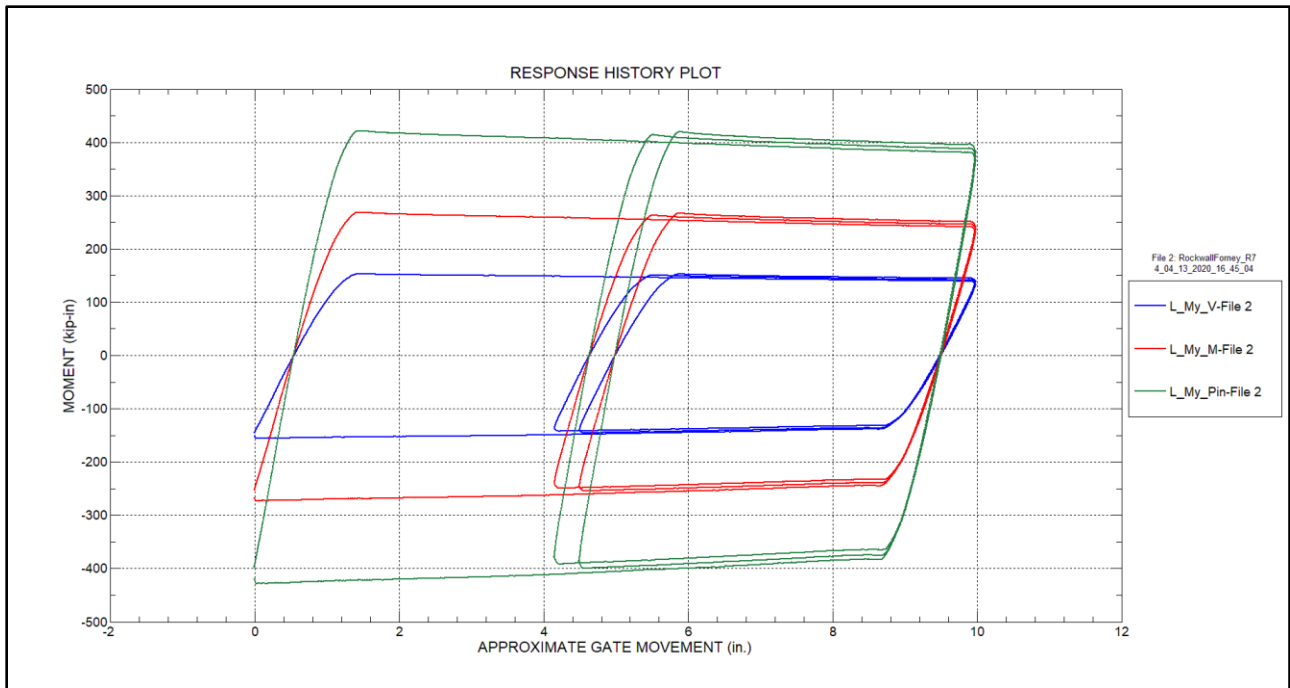
Figure 34 – Pin moment response history – Left arm – Test run 2

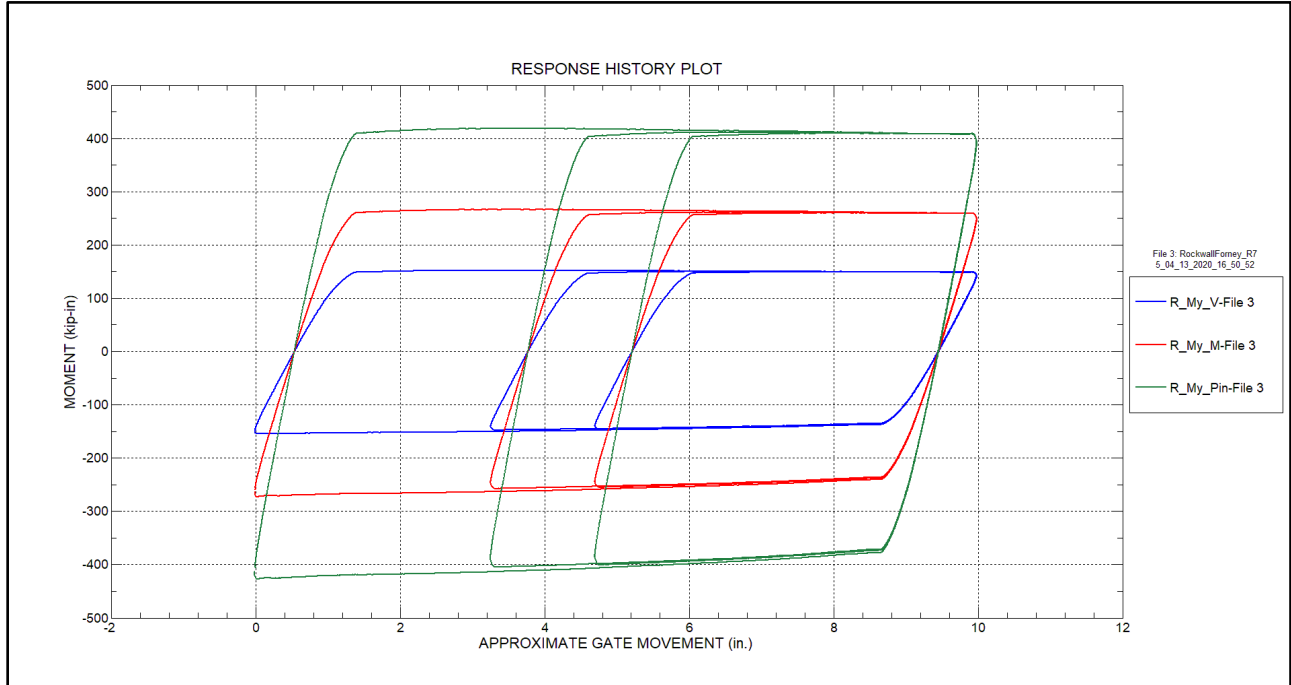
Figure 35 – Pin moment response history – Right arm – Test run 3

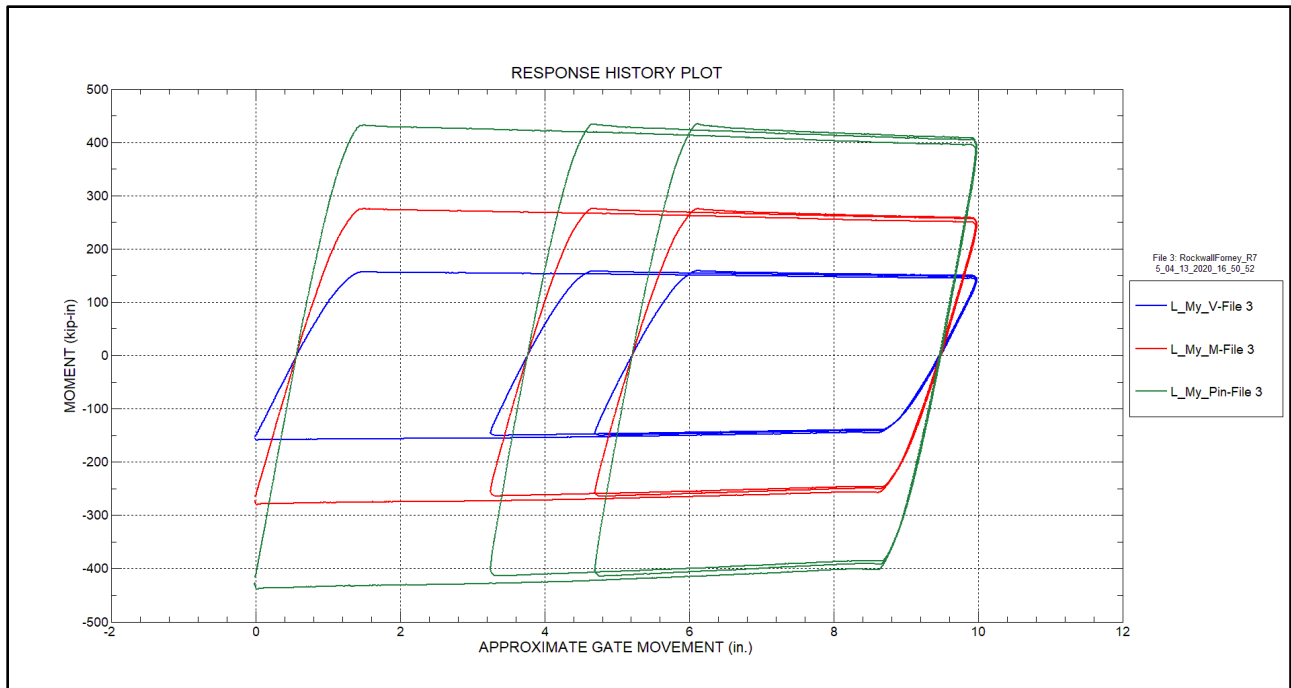
Figure 36 – Pin moment response history – Left arm – Test run 3

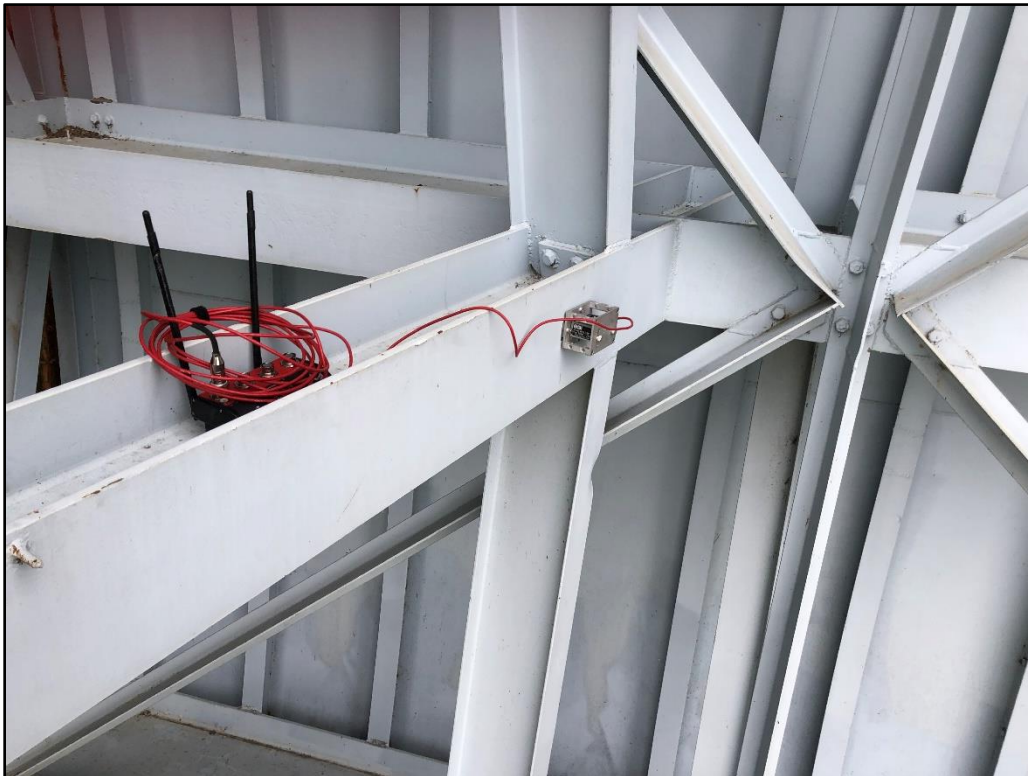
Figure 2 – BDI tiltmeter rotation sensor installed near skin plate (Typical)

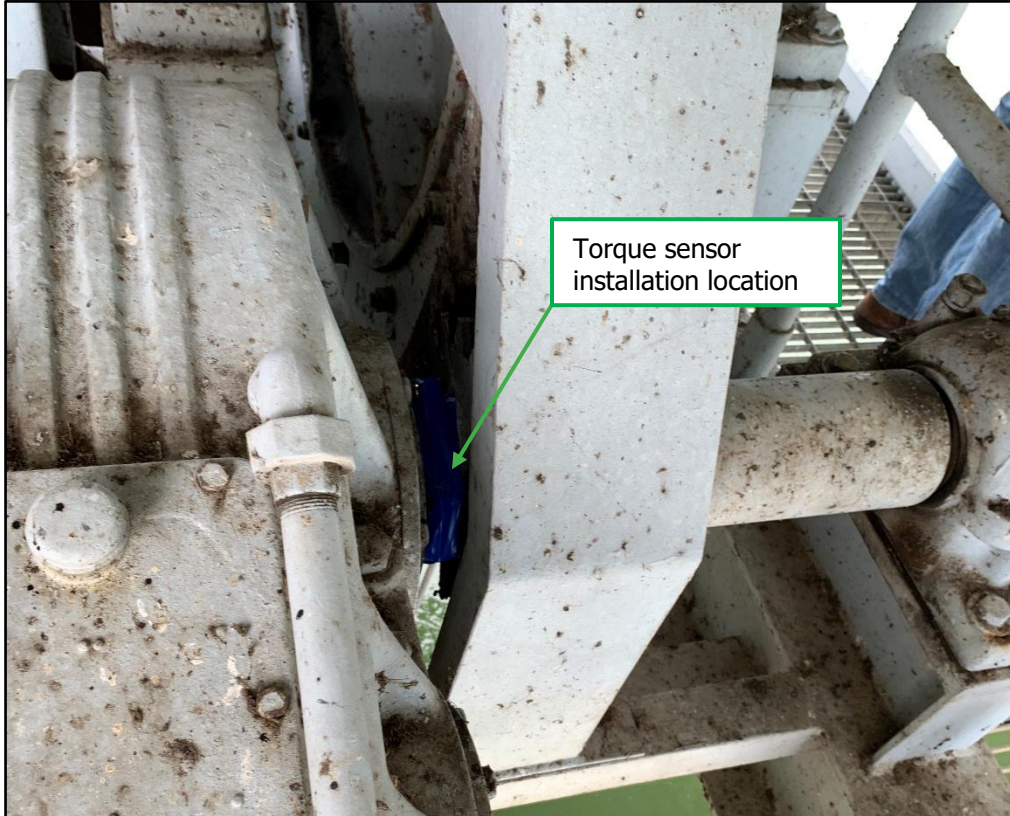
Figure 3 – Torque sensor installation on hoist pinion shaft (Typical)

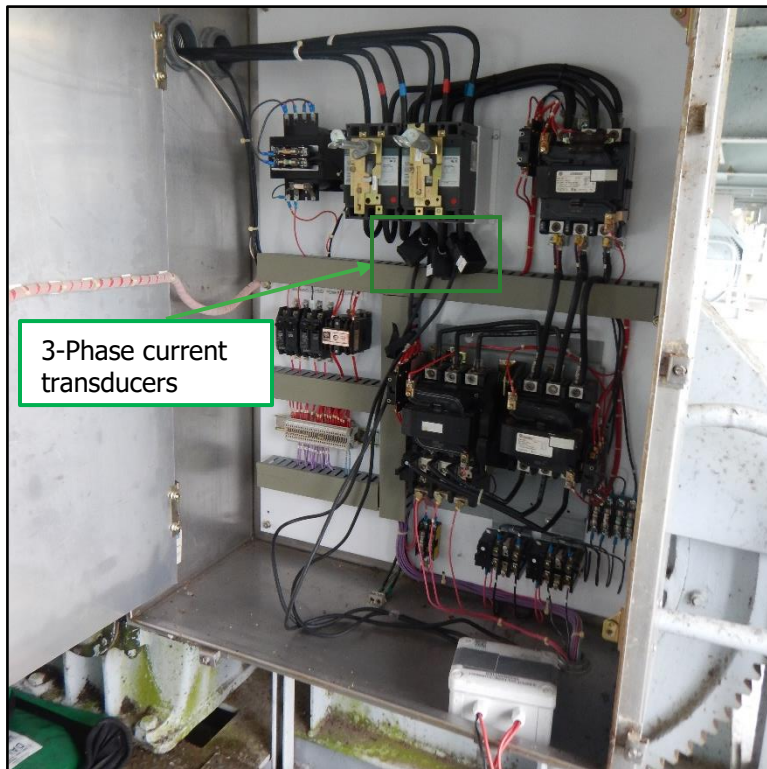
Figure 4 – Current transducers installed on hoist motor controls (Typical)

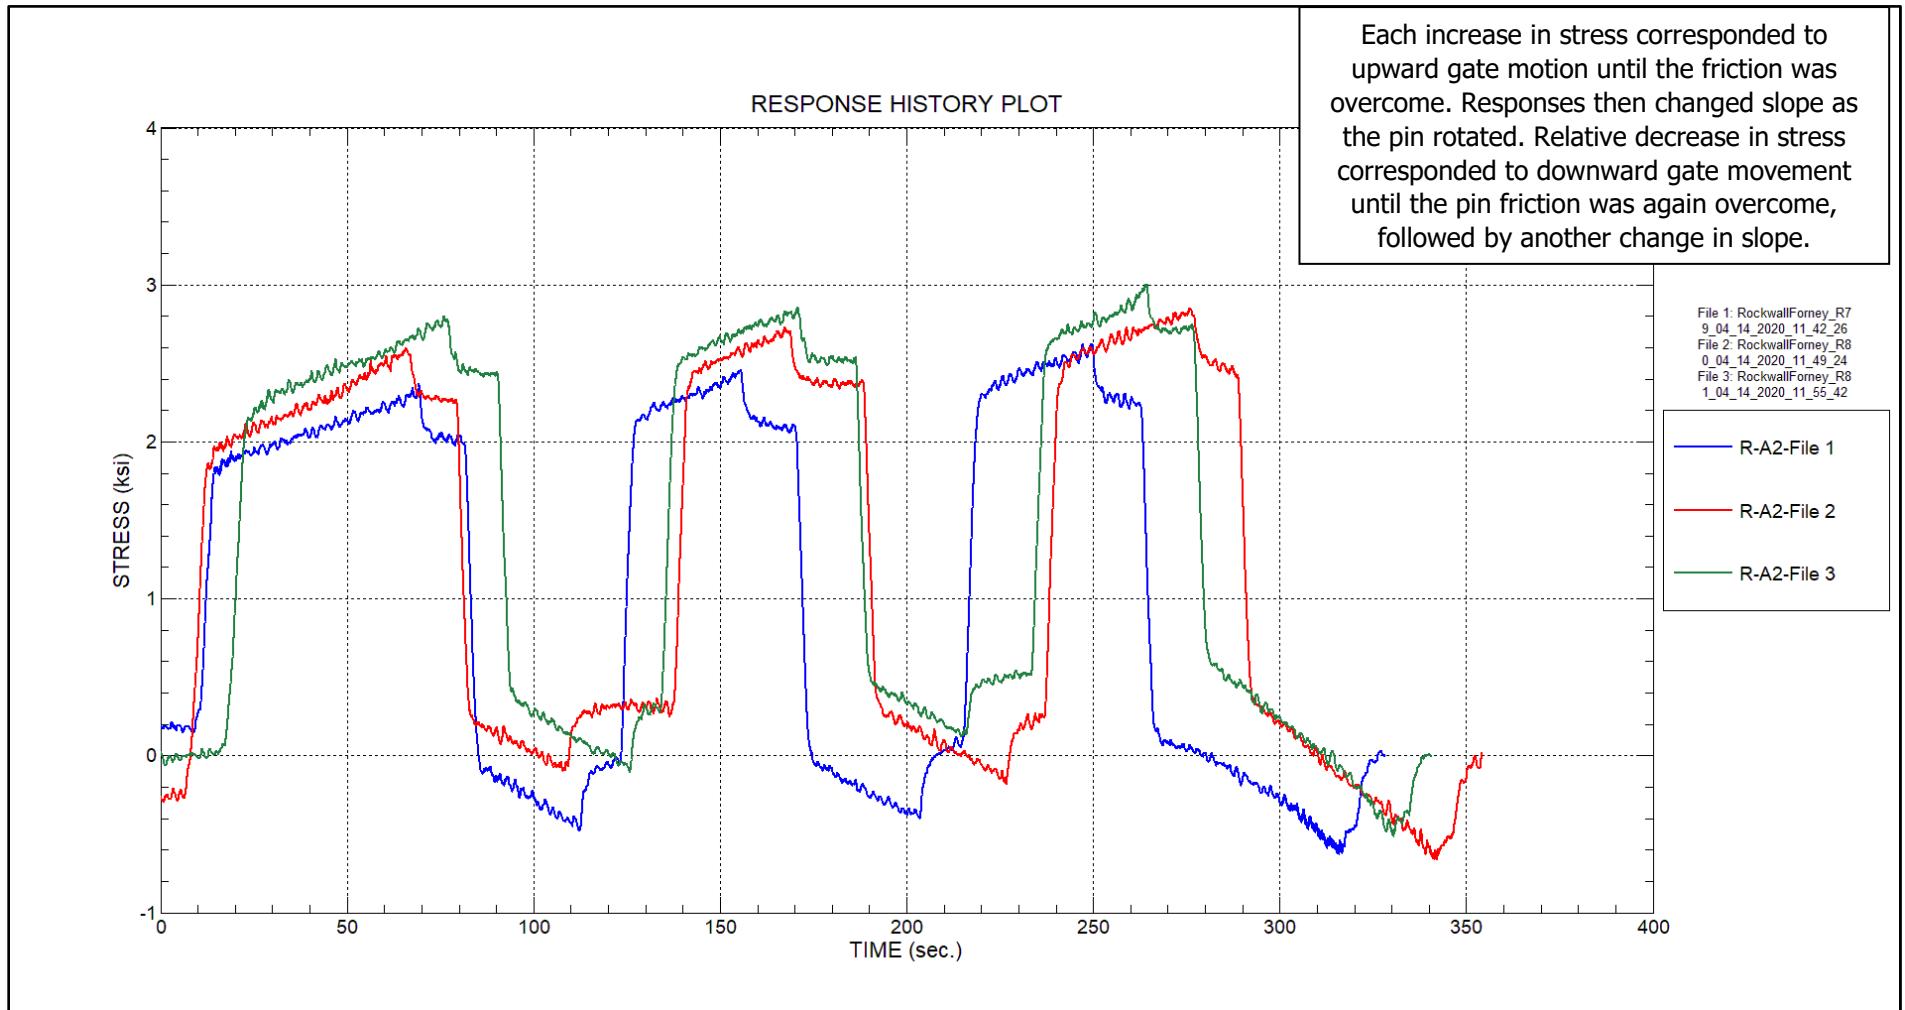
Figure 6 – Stress response history – Right arm – Gage A2 – Time based
File 1 = test run 1, File 2 = test run 2, File 3 = test run 3
(Section A along top strut near pin – Sensor location 2 along bottom of inner flange)

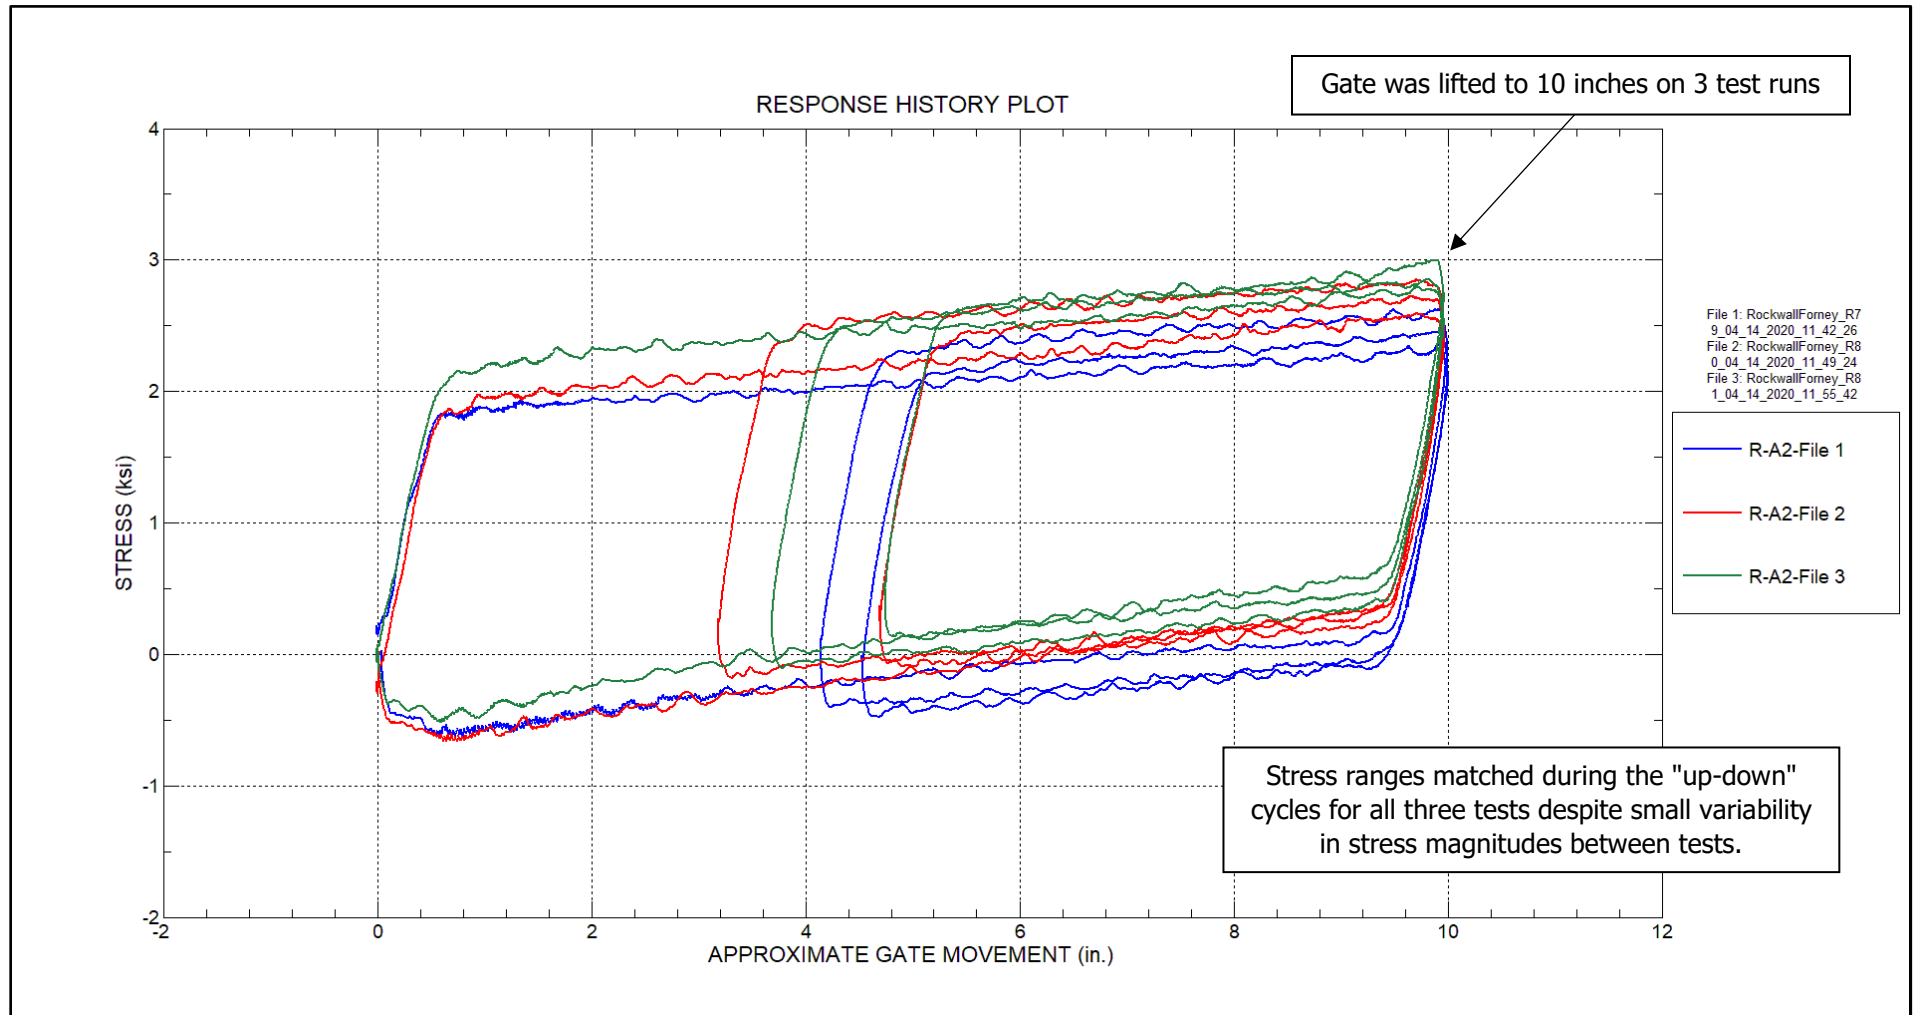
Figure 7 – Stress response history – Right arm – Gage A2 – Function of gate movement
File 1 = test run 1, File 2 = test run 2, File 3 = test run 3
(Section A along top strut near pin – Sensor location 2 along bottom of inner flange)

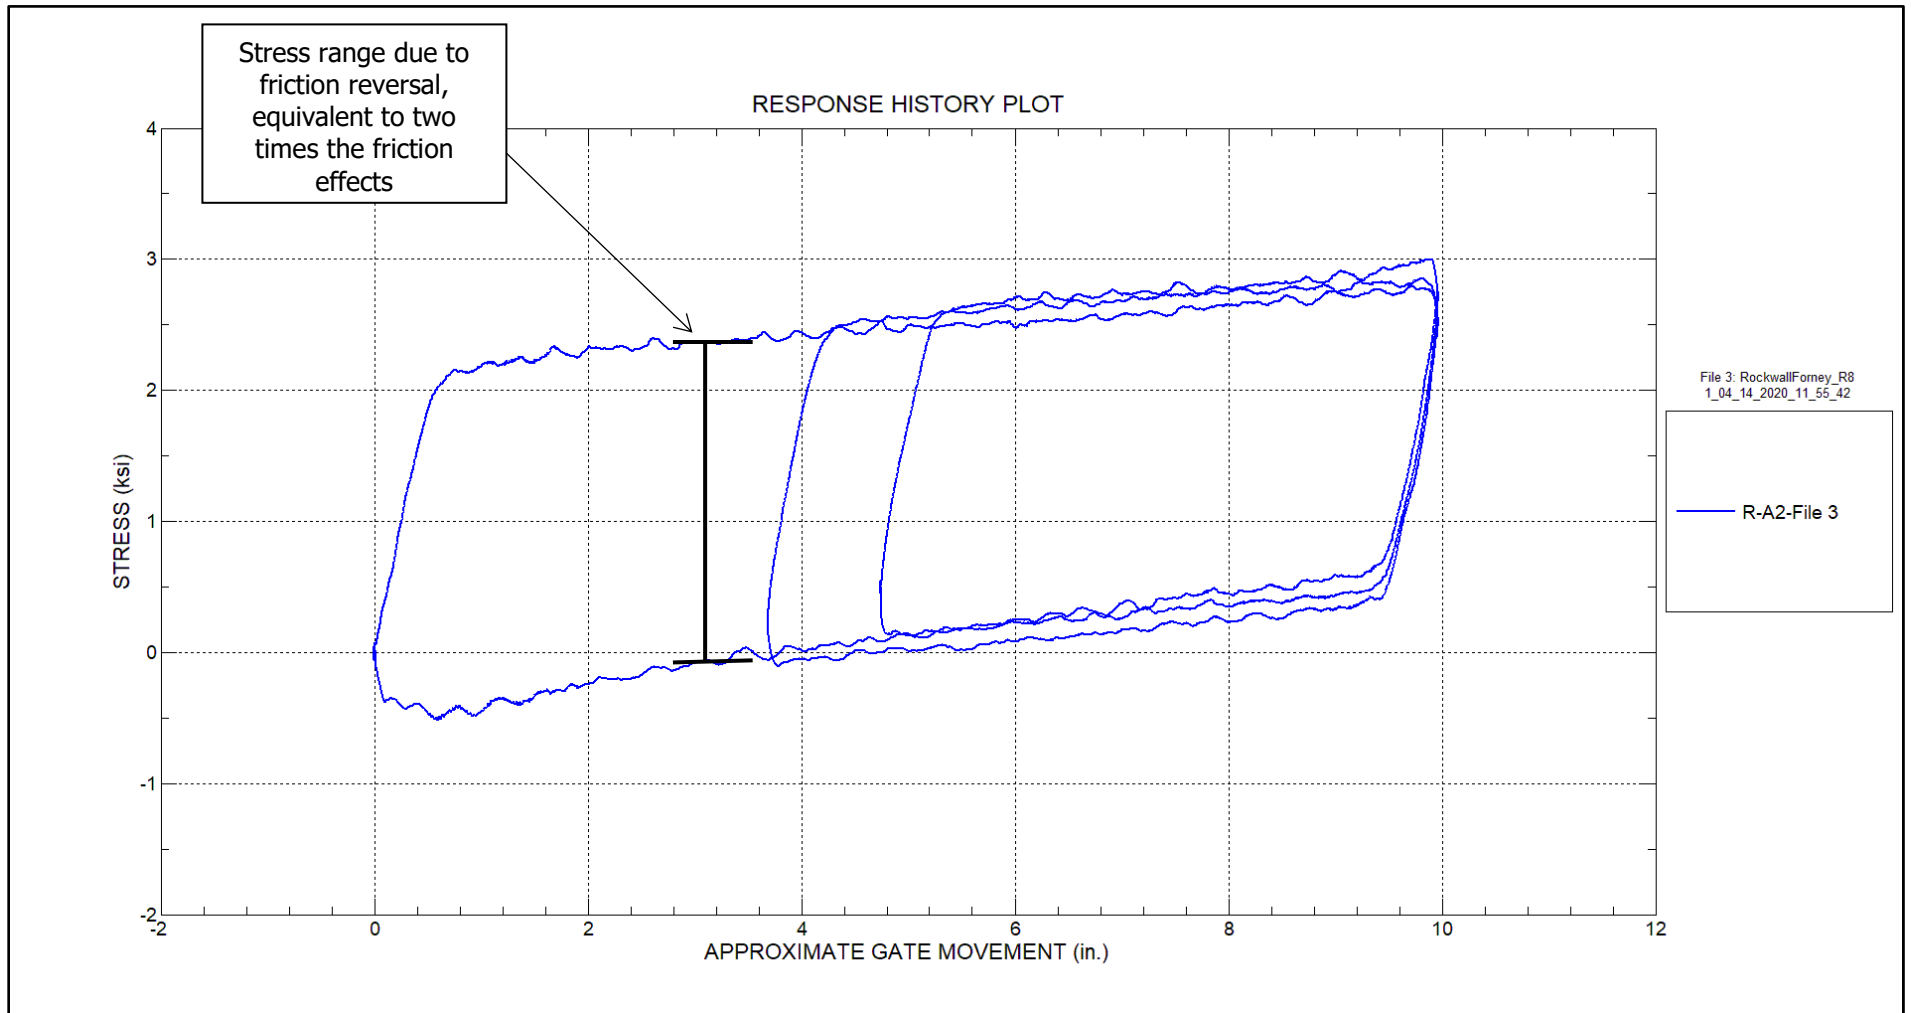
Figure 8 – Stress response history – Right arm – Gage A2 – Friction effect in stress responses
(Section A along top strut near pin – Sensor location 2 along bottom of inner flange)

- + **DIRECTION/FRICTION REVERSAL IN RESPONSES:** The difference in stress during gate opening and closing for a given position is shown in Figure 8. The stress variation at any given gate position was a result of direction reversal and in turn due to trunnion friction reversal. This statement is true since all other loads such as dead-load and hydrostatic pressure were essentially constant barring small changes in hydrostatic pressure due to slight changes in head. This direction/friction reversal is depicted in Figure 9, with deflected shape renderings from a gate arm finite element model under lifting and lowering loads. Note that this figure shows an arm configuration that does not match this gate, but the concept of the direction/friction reversal still applies.

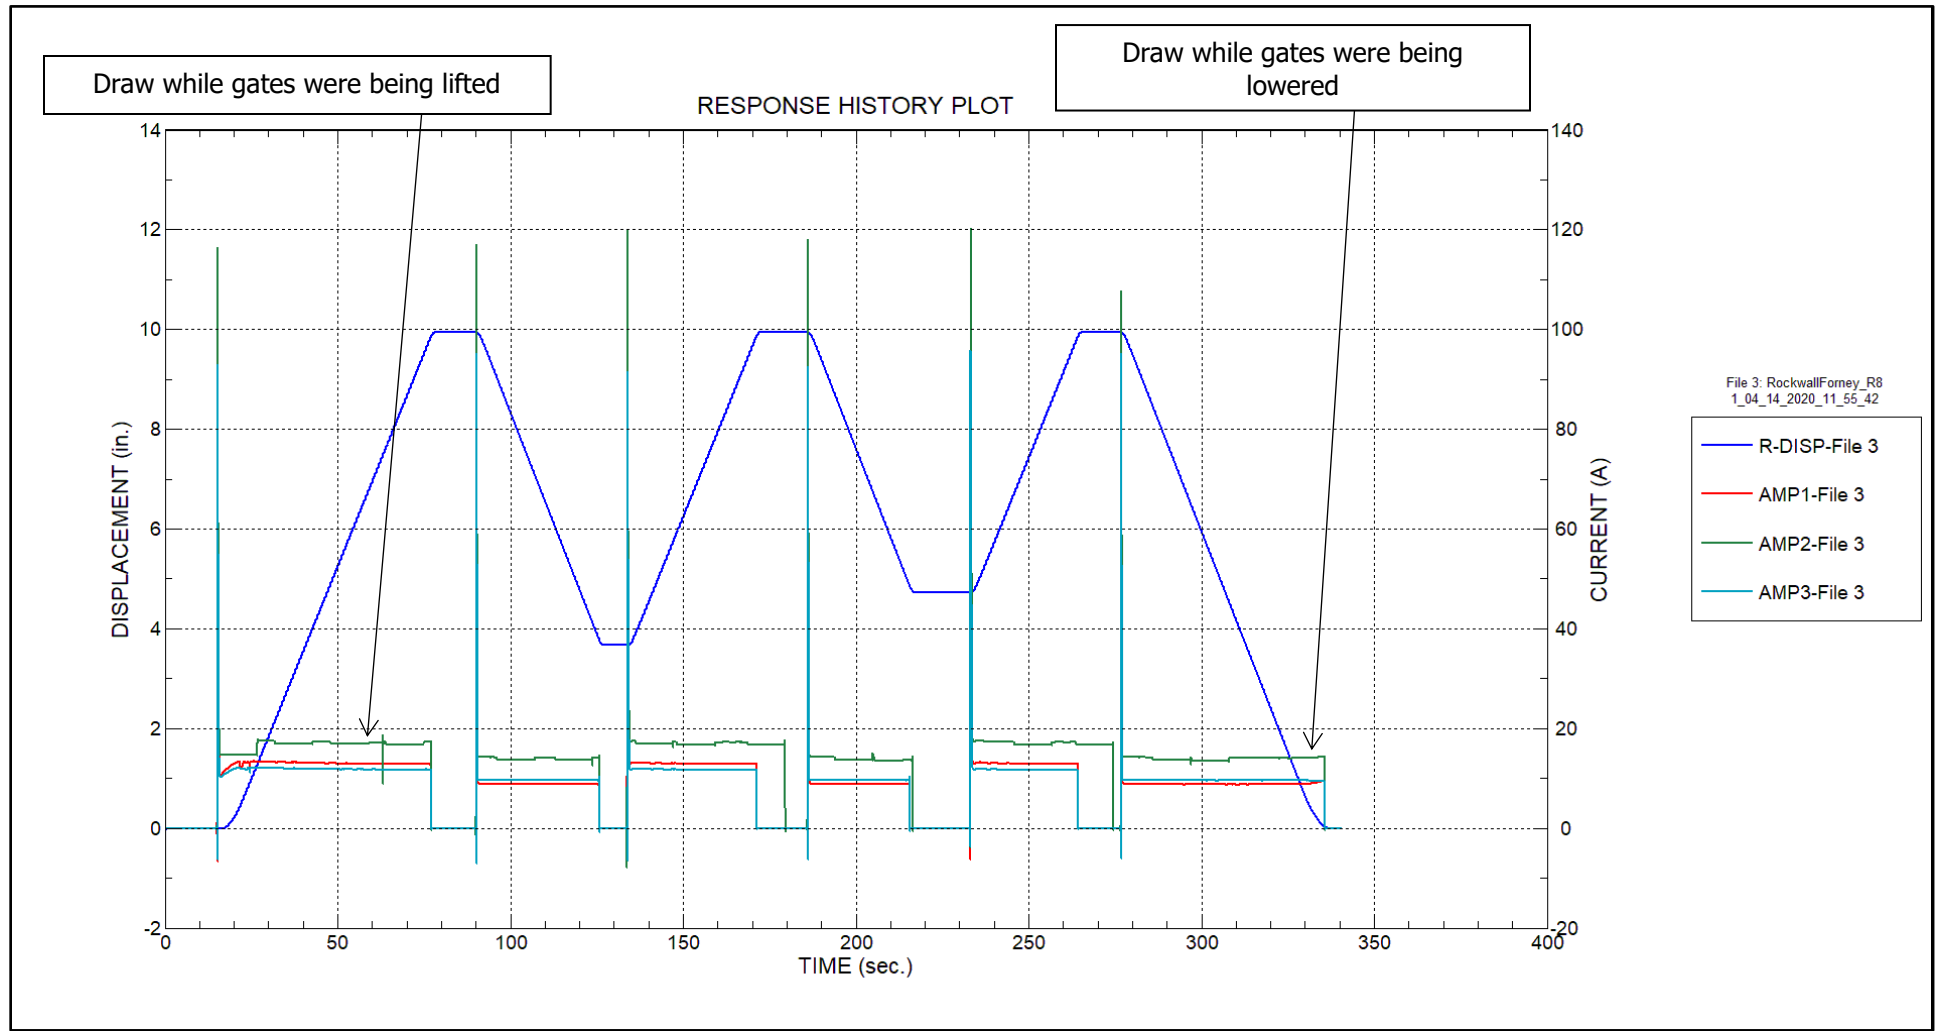
Figure 10 – Motor current & gate movement response history – Lift motor – Highlighting motor draw during lift and lower cycles

- + **MOTOR PERFORMANCE:** Current measurements taken at the hoist motor indicated steady and stable current draws during the lifting and lowering portions. An example plot of current draw and gate position is provided in Figure 10. Current draw ranges during lifting were higher than the ranges during lowering, which is common due to gravity/dead load. These results are summarized along with recorded peak in-rush current in Table 2. Note that the sample rates used during testing were set for collecting gate responses and may not have been appropriate to fully capture the in-rush current. The readings should be evaluated by a licensed electrician with knowledge of the operating parameters.
