VISUAL INSPECTION AND EVALUATION REPORT

Rockwall-Forney Dam
Dallas Water Utilities
Dallas/Kaufman Counties, Texas

Schnabel Reference #20C22001.00
July 30, 2021

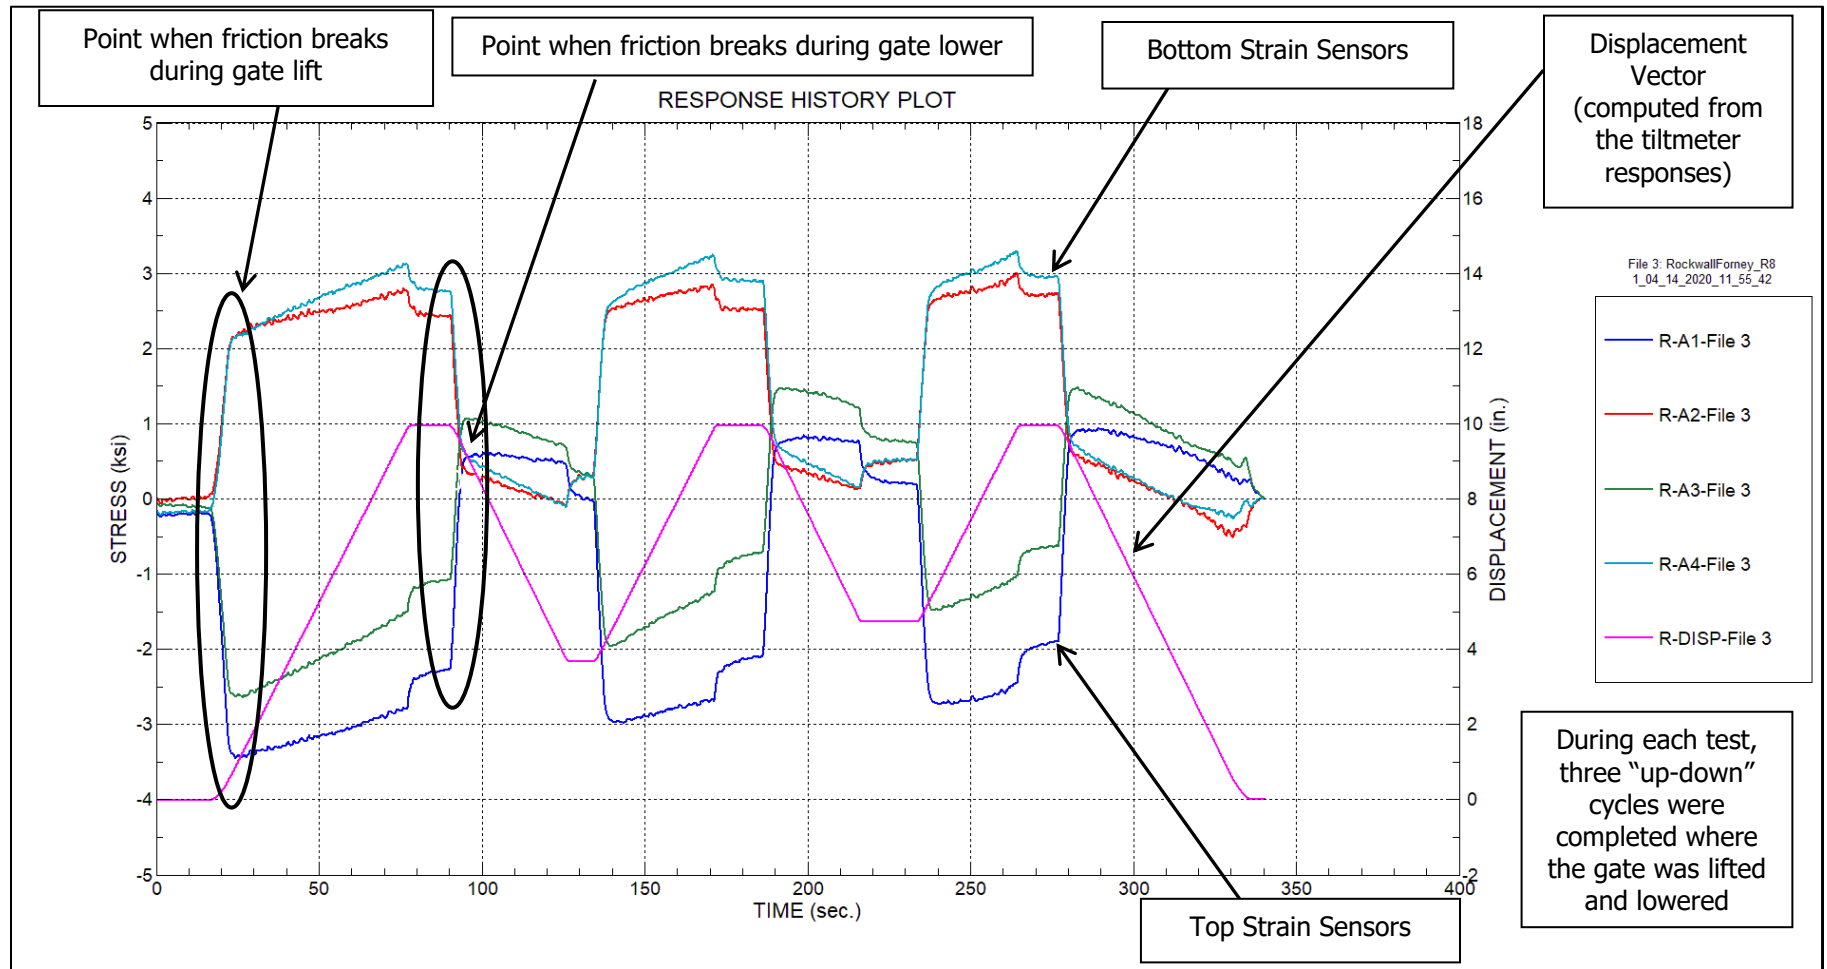
Figure 11 – Stress response & gate movement history – Right arm – Section A - Highlighting friction behavior (Section A along top strut near pin)

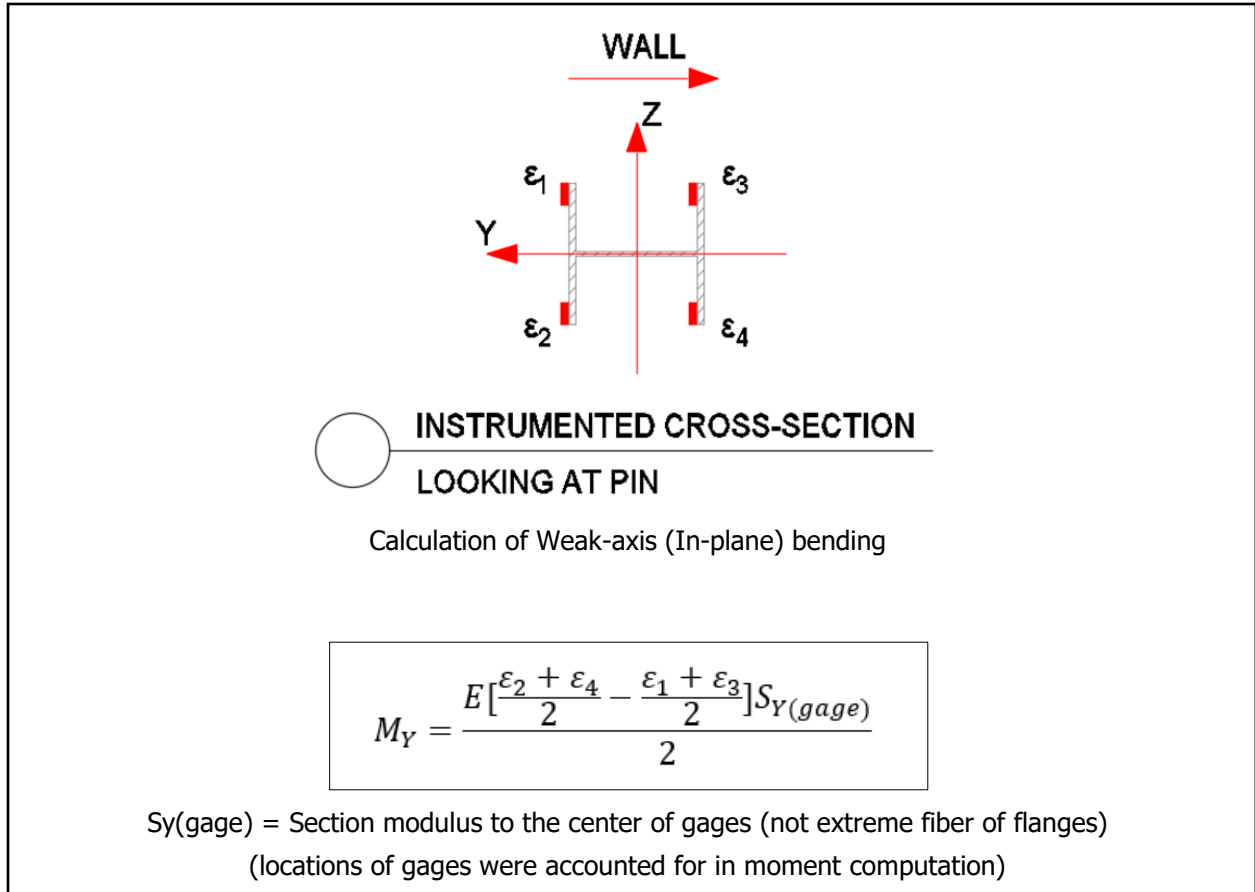
Figure 12 – Basic mechanic equation used to calculate moment

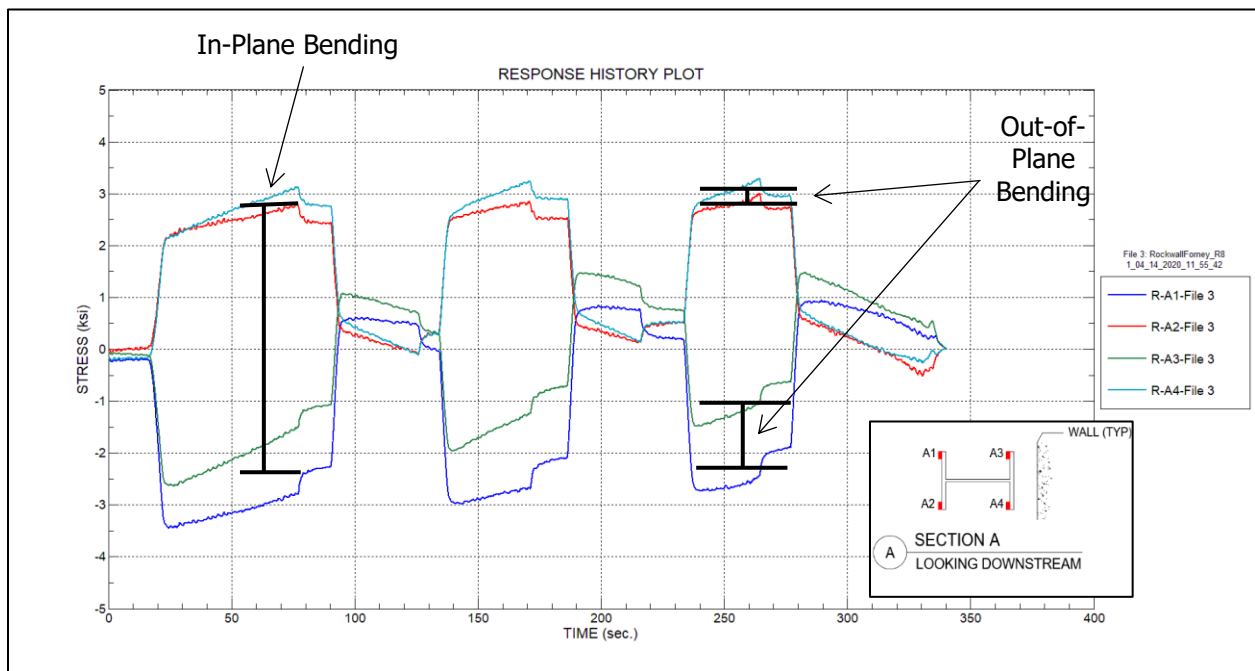
Figure 13 – Stress response history – Right arm – Section A – Bending components (Section A along top strut near pin)

In-plane or weak-axis flexure refers to bending about a given strut's web. This designation is consistent with typical nomenclature. In-plane bending can be observed visually from the strain response histories as a difference between the top and bottom stresses, whereas out-of-plane or strong-axis bending is visualized as the difference in stress from side to side. Figure 13 provides a visual reference for both types of strut flexure.

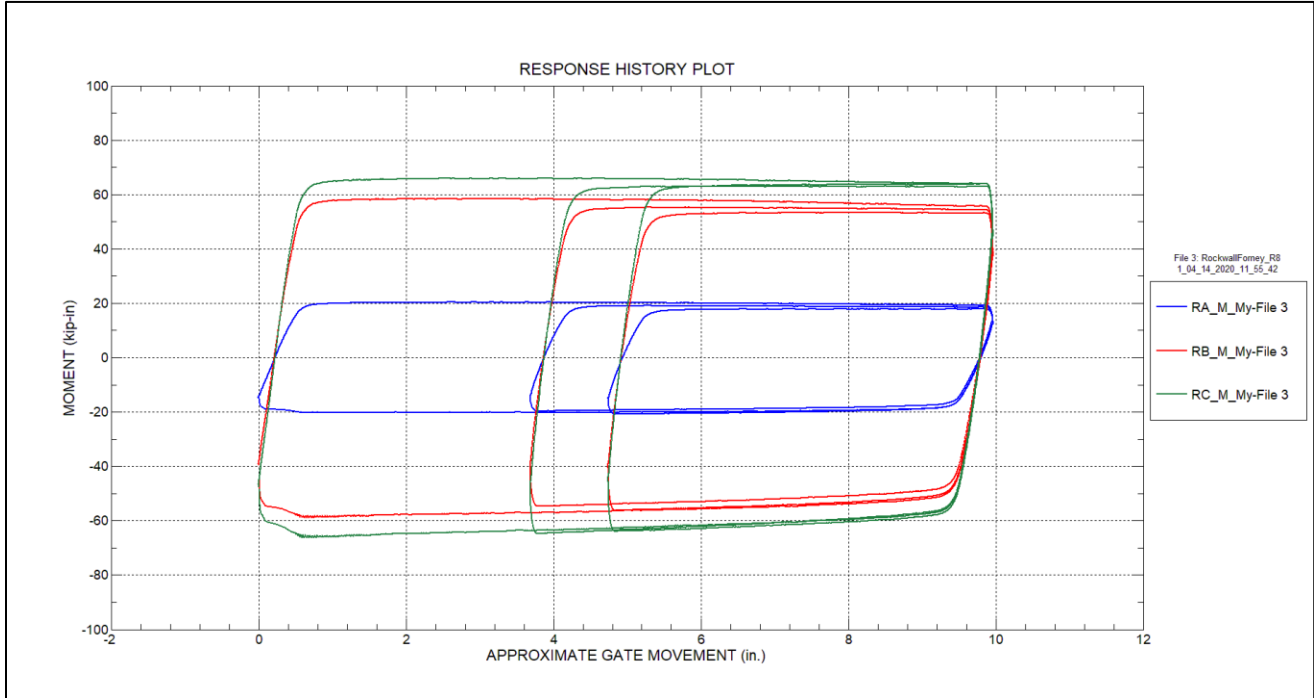
Figure 14 – In-plane moment response history – Right arm – Sections near pin
(RA = Right Arm Top Strut, RB = Right Arm Middle Strut, RC = Right Arm Bottom Strut)

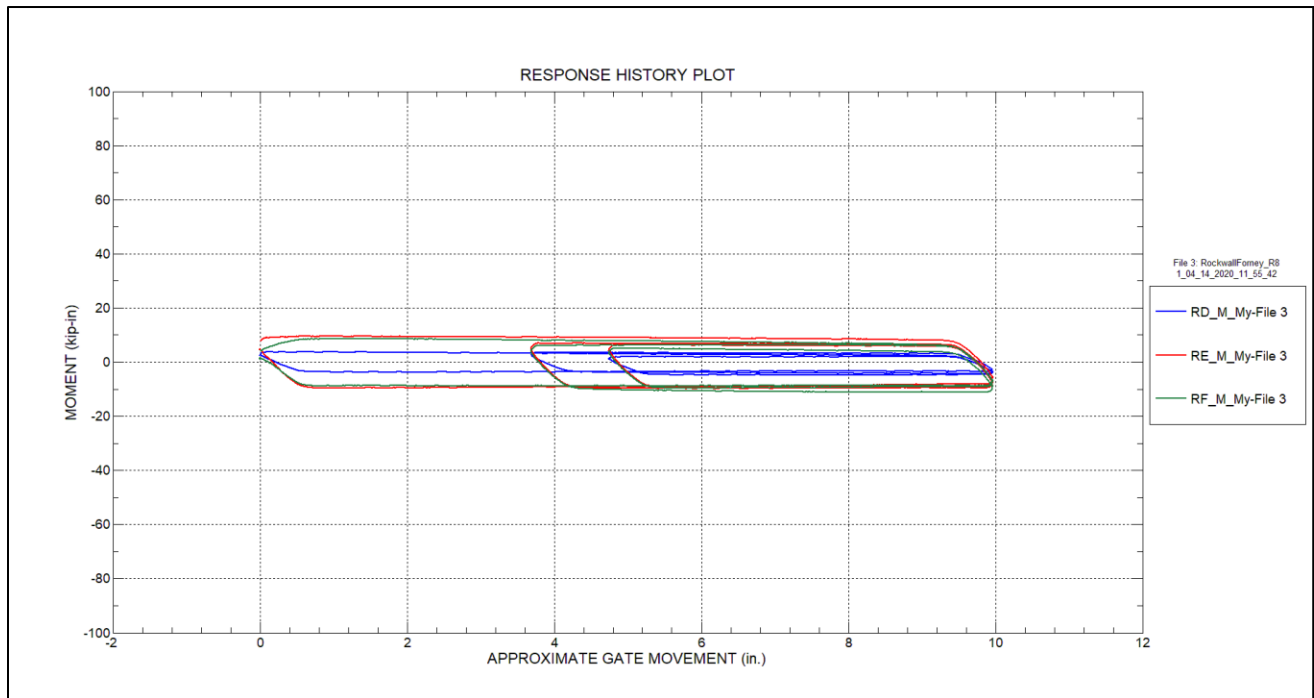
Figure 15 – In-plane moment response history – Right arm – Sections away from pin
(RD = Right Arm Top Strut, RE = Right Arm Middle Strut, RF = Right Arm Bottom Strut)

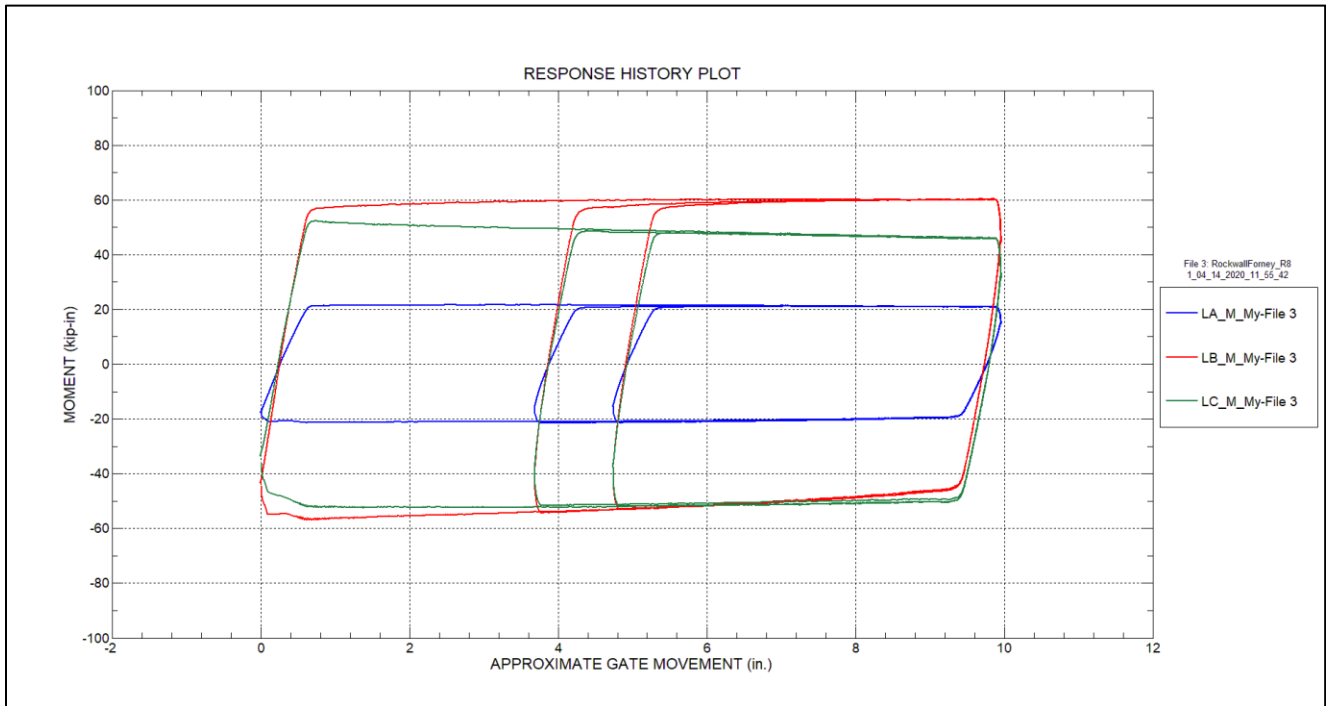
Figure 16 – In-plane moment response history – Left arm – Sections near pin
(LA = Left Arm Top Strut, LB = Left Arm Middle Strut, LC = Left Arm Bottom Strut)

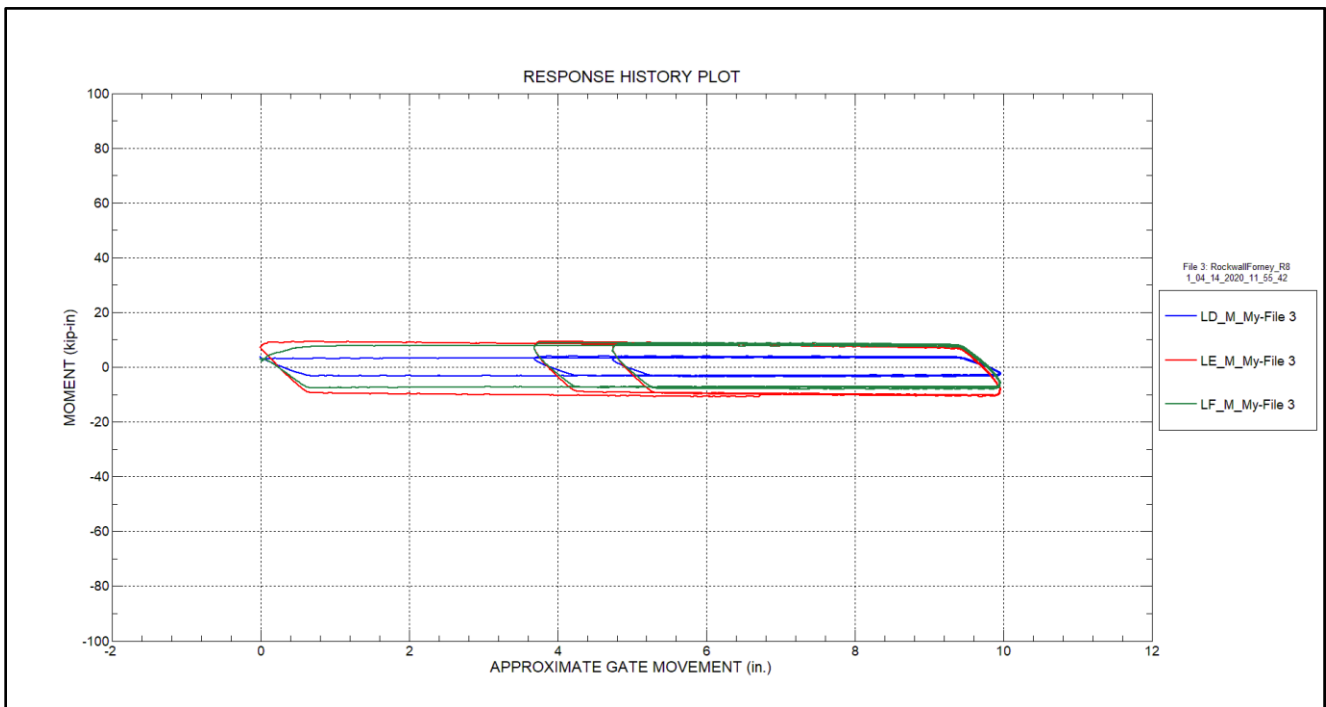
Figure 17 - In-plane moment response history – Left arm – Sections away from pin
(LD = Left Arm Top Strut, LE = Left Arm Middle Strut, LF = Left Arm Bottom Strut)

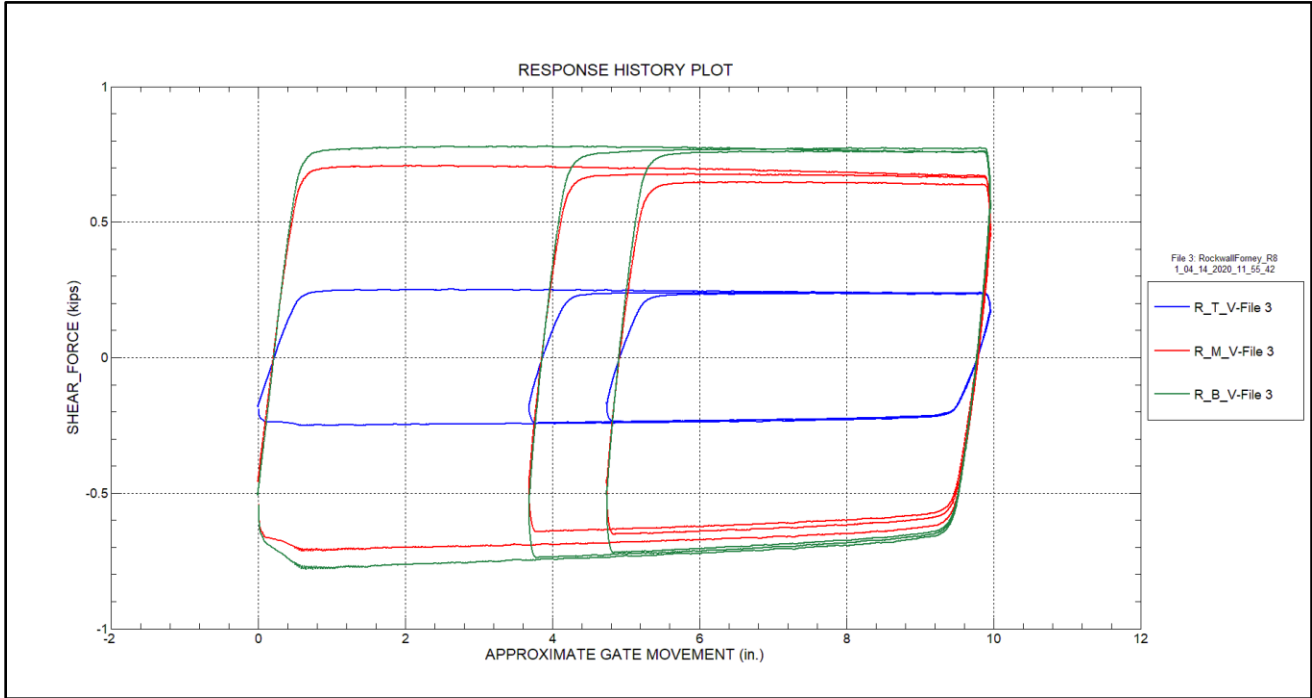
Figure 19 – Strut shear response history – Right arm

(R_T = Right Arm Top Strut, R_M = Right Arm Middle Strut, R_B = Right Arm Bottom Strut)

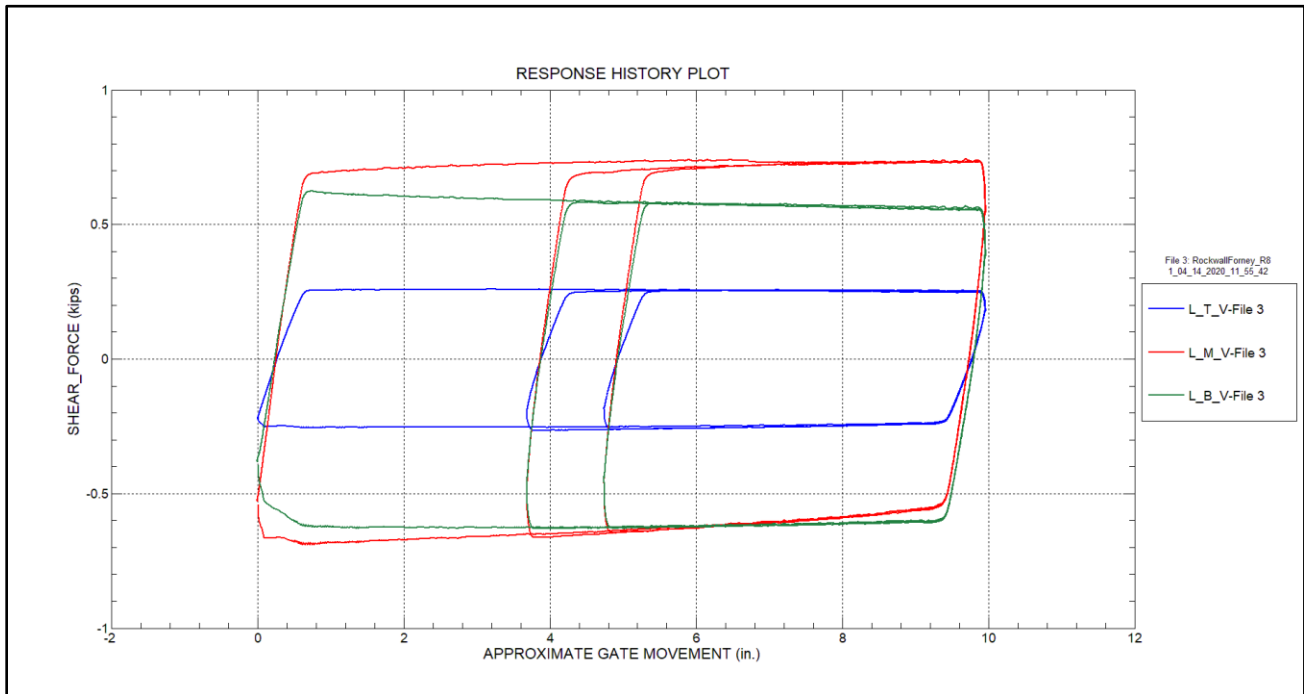
Figure 20 – Strut shear response history – Left arm

(L_T = Left Arm Top Strut, L_M = Left Arm Middle Strut, L_B = Left Arm Bottom Strut)

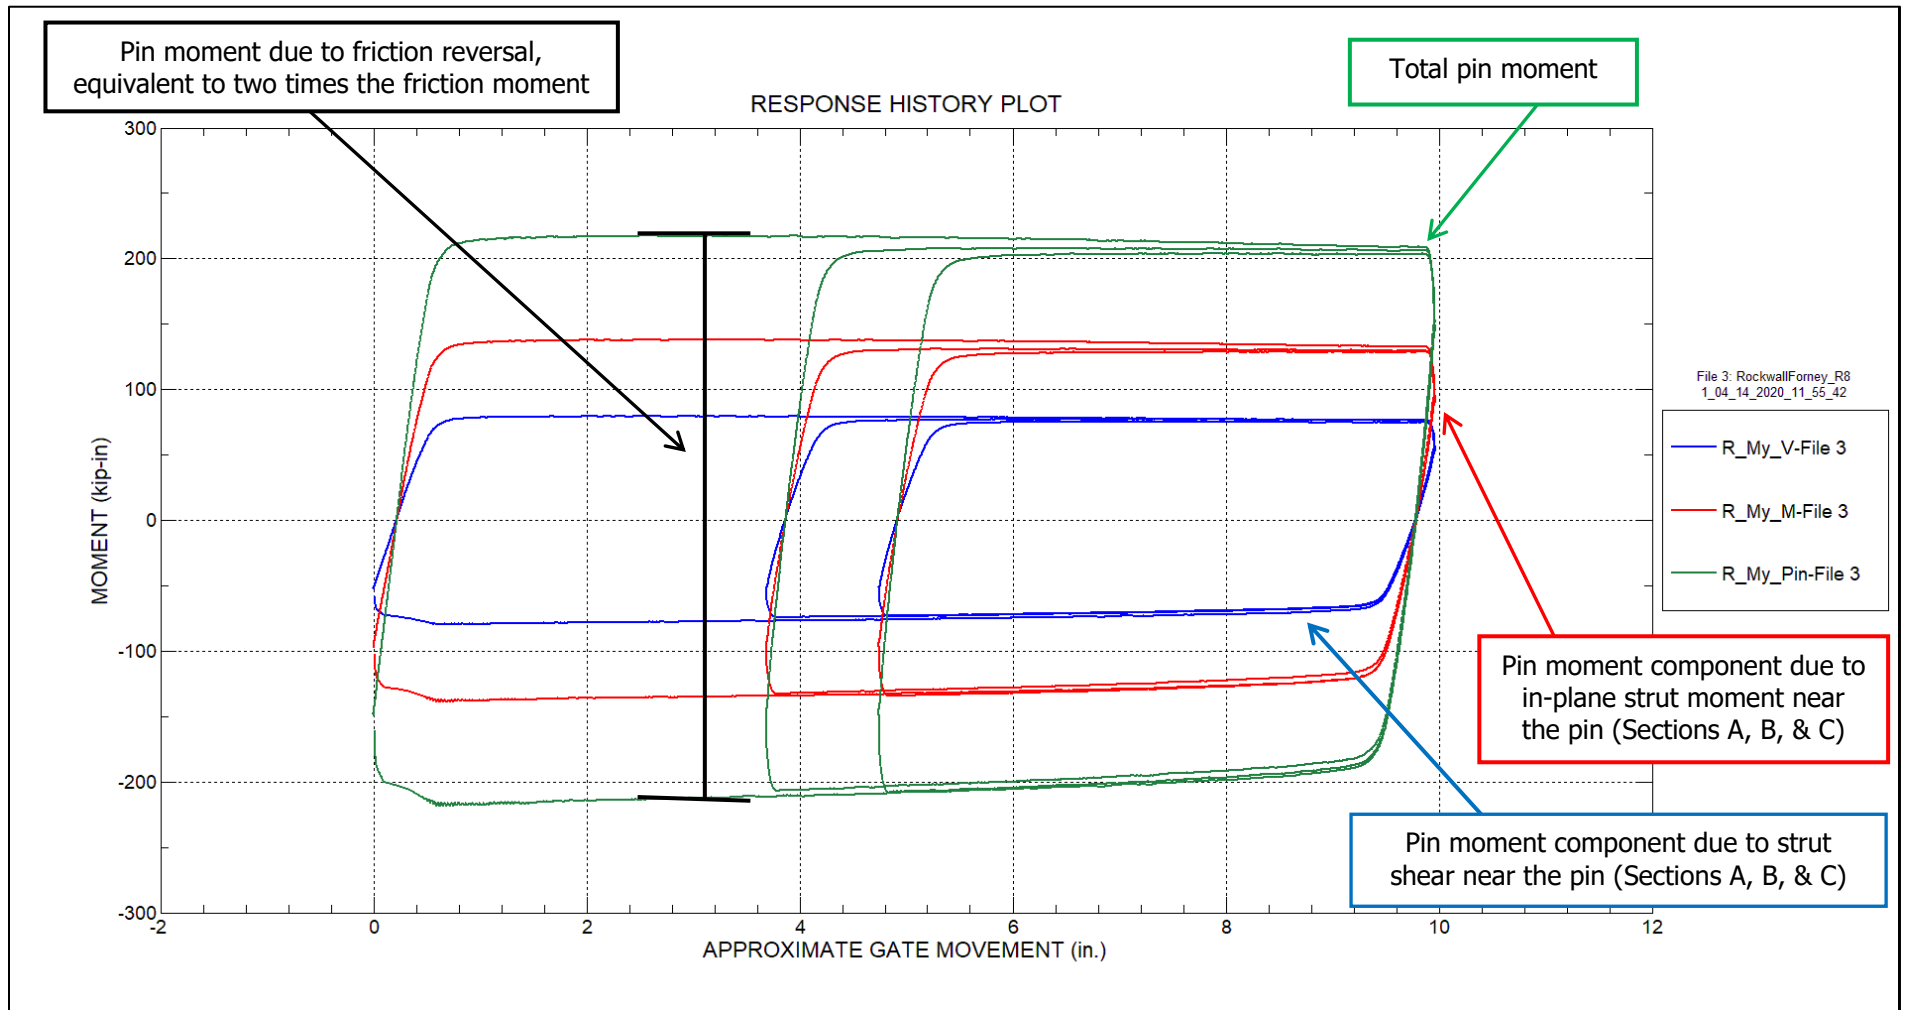
Figure 21 – Pin moment response history – Right arm

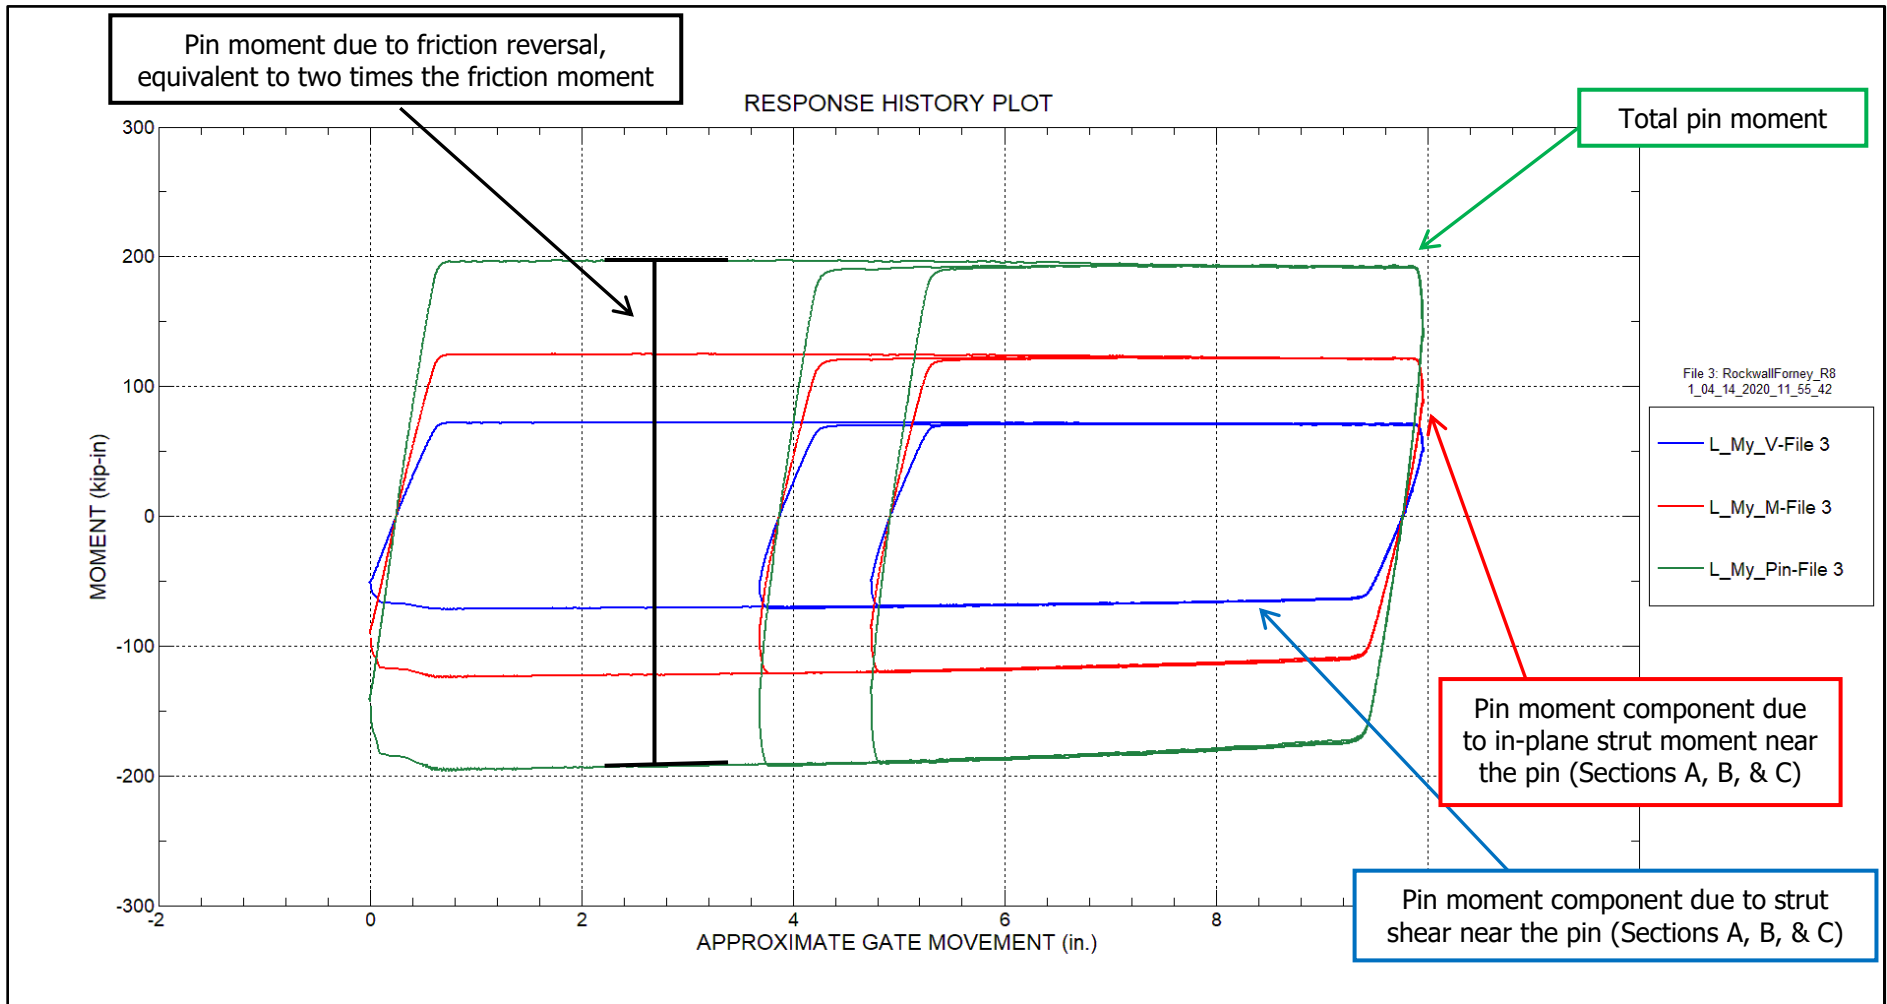
Figure 22 – Pin moment response history – Left arm

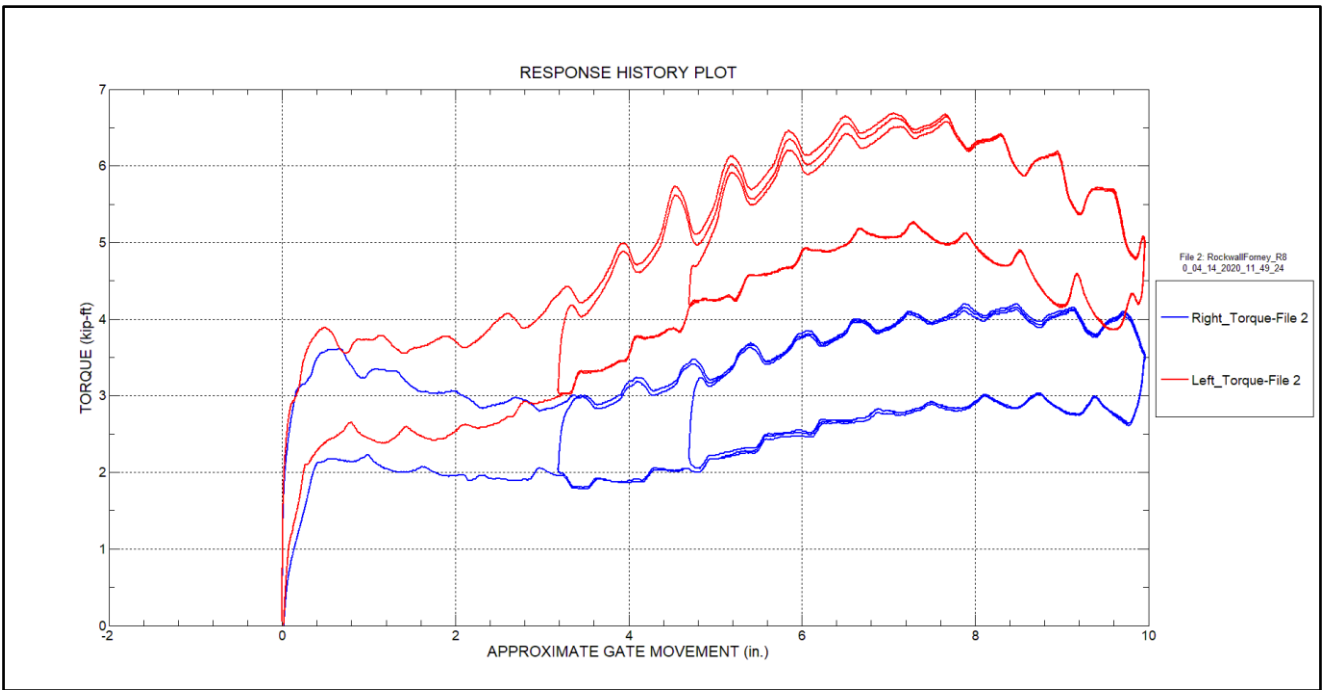
Figure 23 – Hoist torque response history – Gate 14 – Test 2

Figure 23 shows example torque measurements, recorded on the Gate 14 torque shafts. Best practices for torque measurements is to measure torque on opposite sides of the shaft so that any bending in the shaft can be removed by averaging the two responses. Due to access limitations, only one gage at each location could be installed. Therefore, any bending in the shaft may be reflected in the torque measurements and may be related to the peaks and valleys observed in the torque responses.

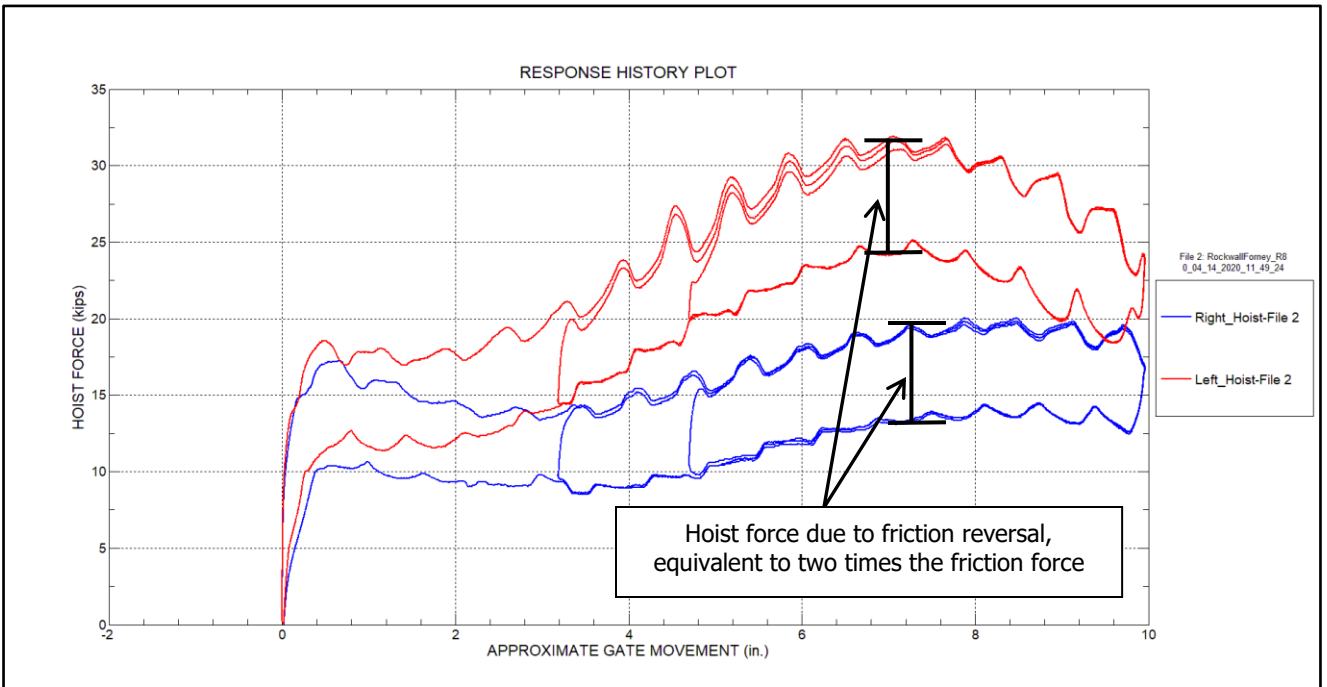
Figure 24 – Hoist force response history – Gate 14 – Test 2

Torque values were converted to force in the hoist cables per gate arm using the gear ratio and drum radius, as shown in Figure 24. The gear ratio and drum radius were 5.182 and 1.086 feet respectively, as defined in the provided as-built shop drawings. It should be noted that the hoist force calculated may be smaller than the actual hoist force applied. This difference is due to the limit switch engaging the brake before the hoist cable was fully slacked, resulting in an initial force in the cable. A hoist force due to total gate friction was then calculated. This friction hoist force was equal to half the differential in force measured during the lifting and lowering of the gate (similar to the pin friction calculations). As shown in Table 3, the change in cable force due to friction was generally consistent between tests. Note that the total hoist force was due to the total friction effects, including side seal, hoist bearings, trunnion friction effects, etc. It is difficult to determine the exact proportion and composition of the total friction sources. Additional torque and hoist force plots for all collected data files are provided in Appendix A – Gate 14 Torque and Hoist Force Plots.

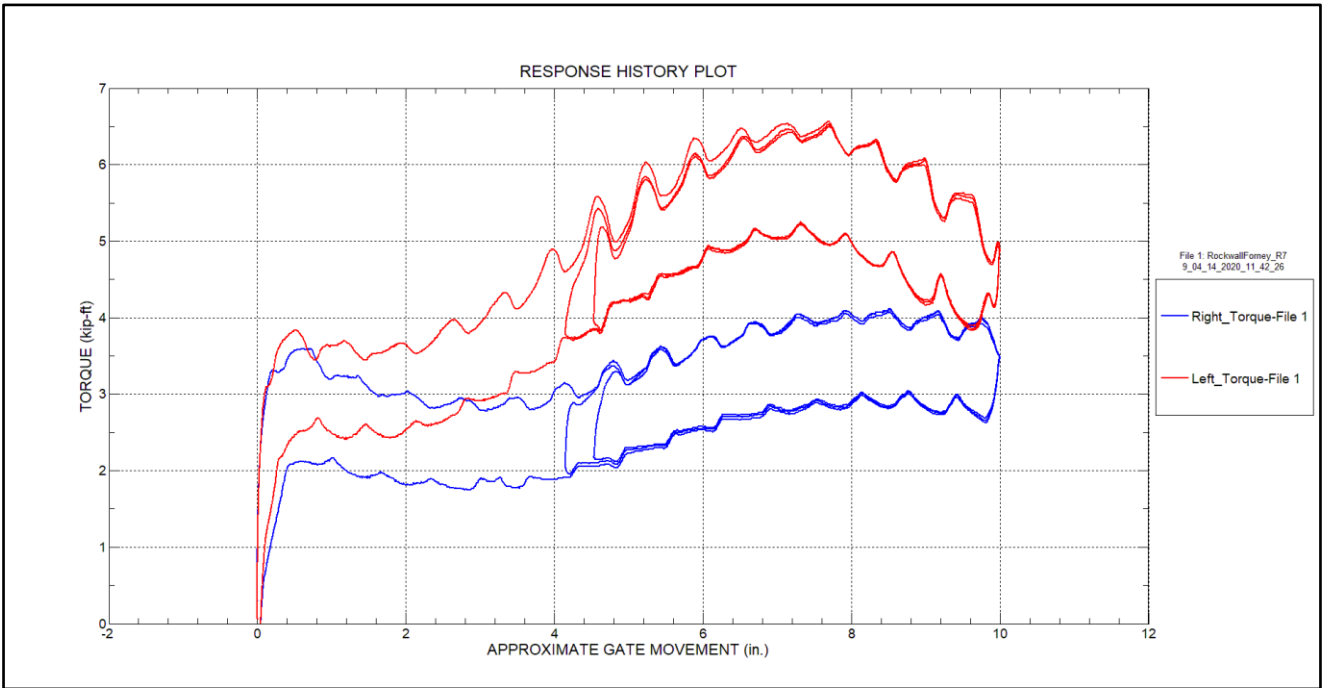
Figure 25 – Hoist torque response history – Gate 14 – Test 1

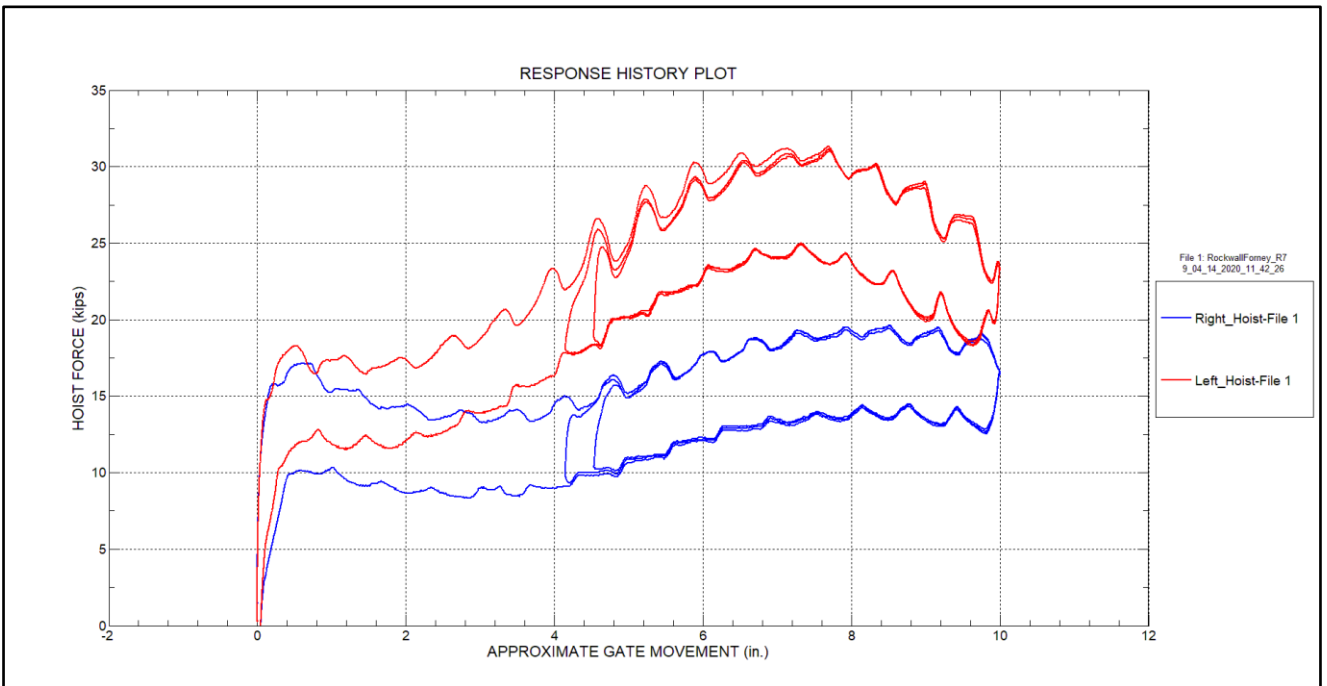
Figure 26 – Hoist force response history – Gate 14 – Test 1

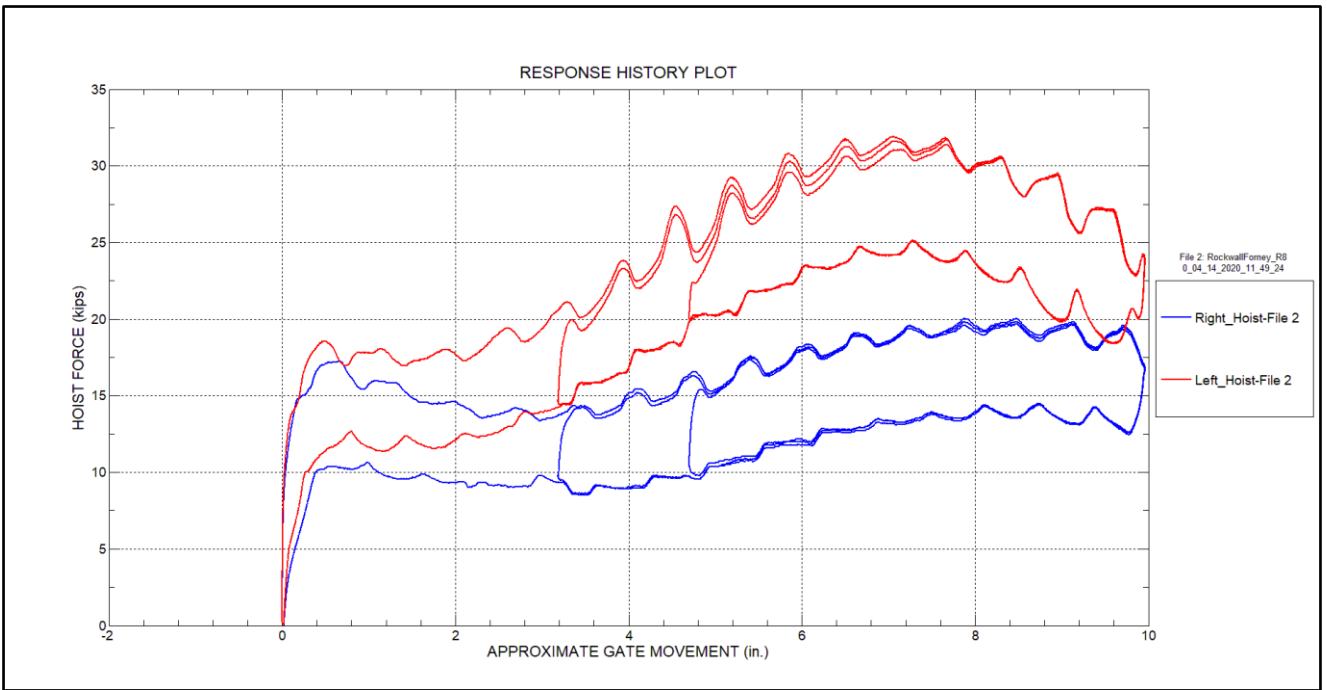
Figure 28 – Hoist force response history – Gate 14 – Test 2

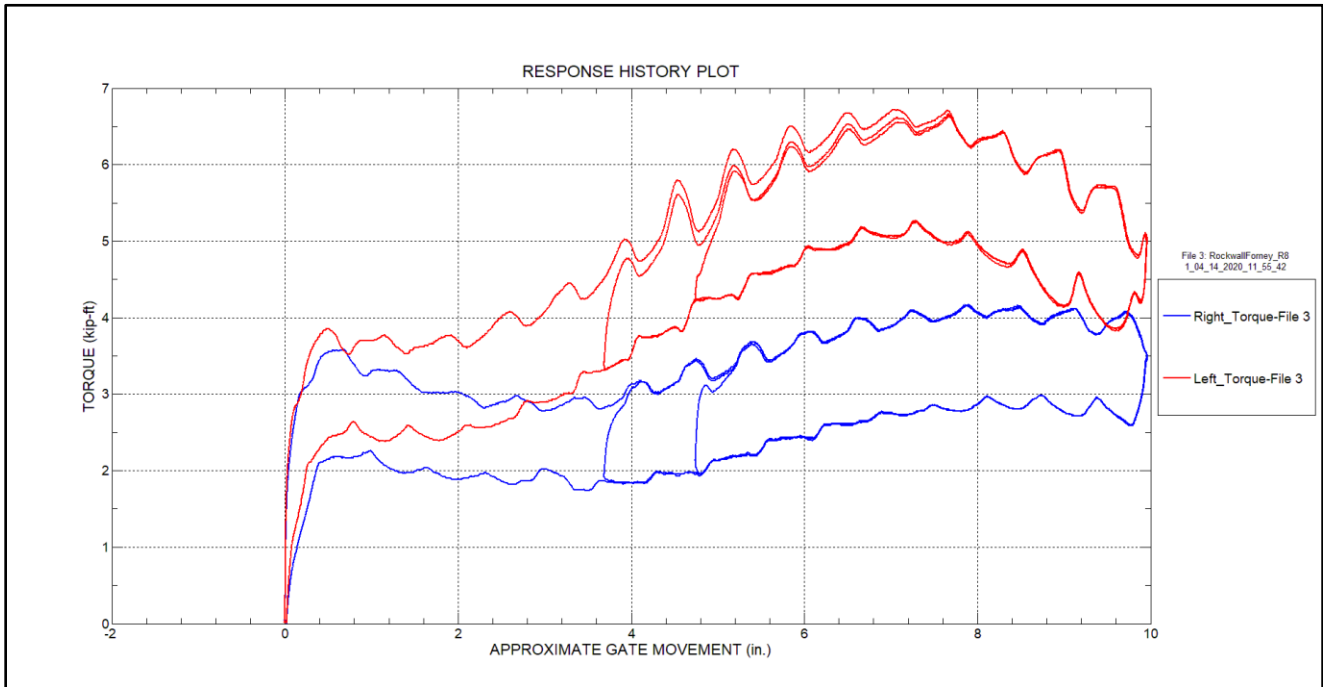
Figure 29 – Hoist torque response history – Gate 14 – Test 3
