VISUAL INSPECTION AND EVALUATION REPORT

Rockwall-Forney Dam
Dallas Water Utilities
Dallas/Kaufman Counties, Texas

Schnabel Reference #20C22001.00
July 30, 2021

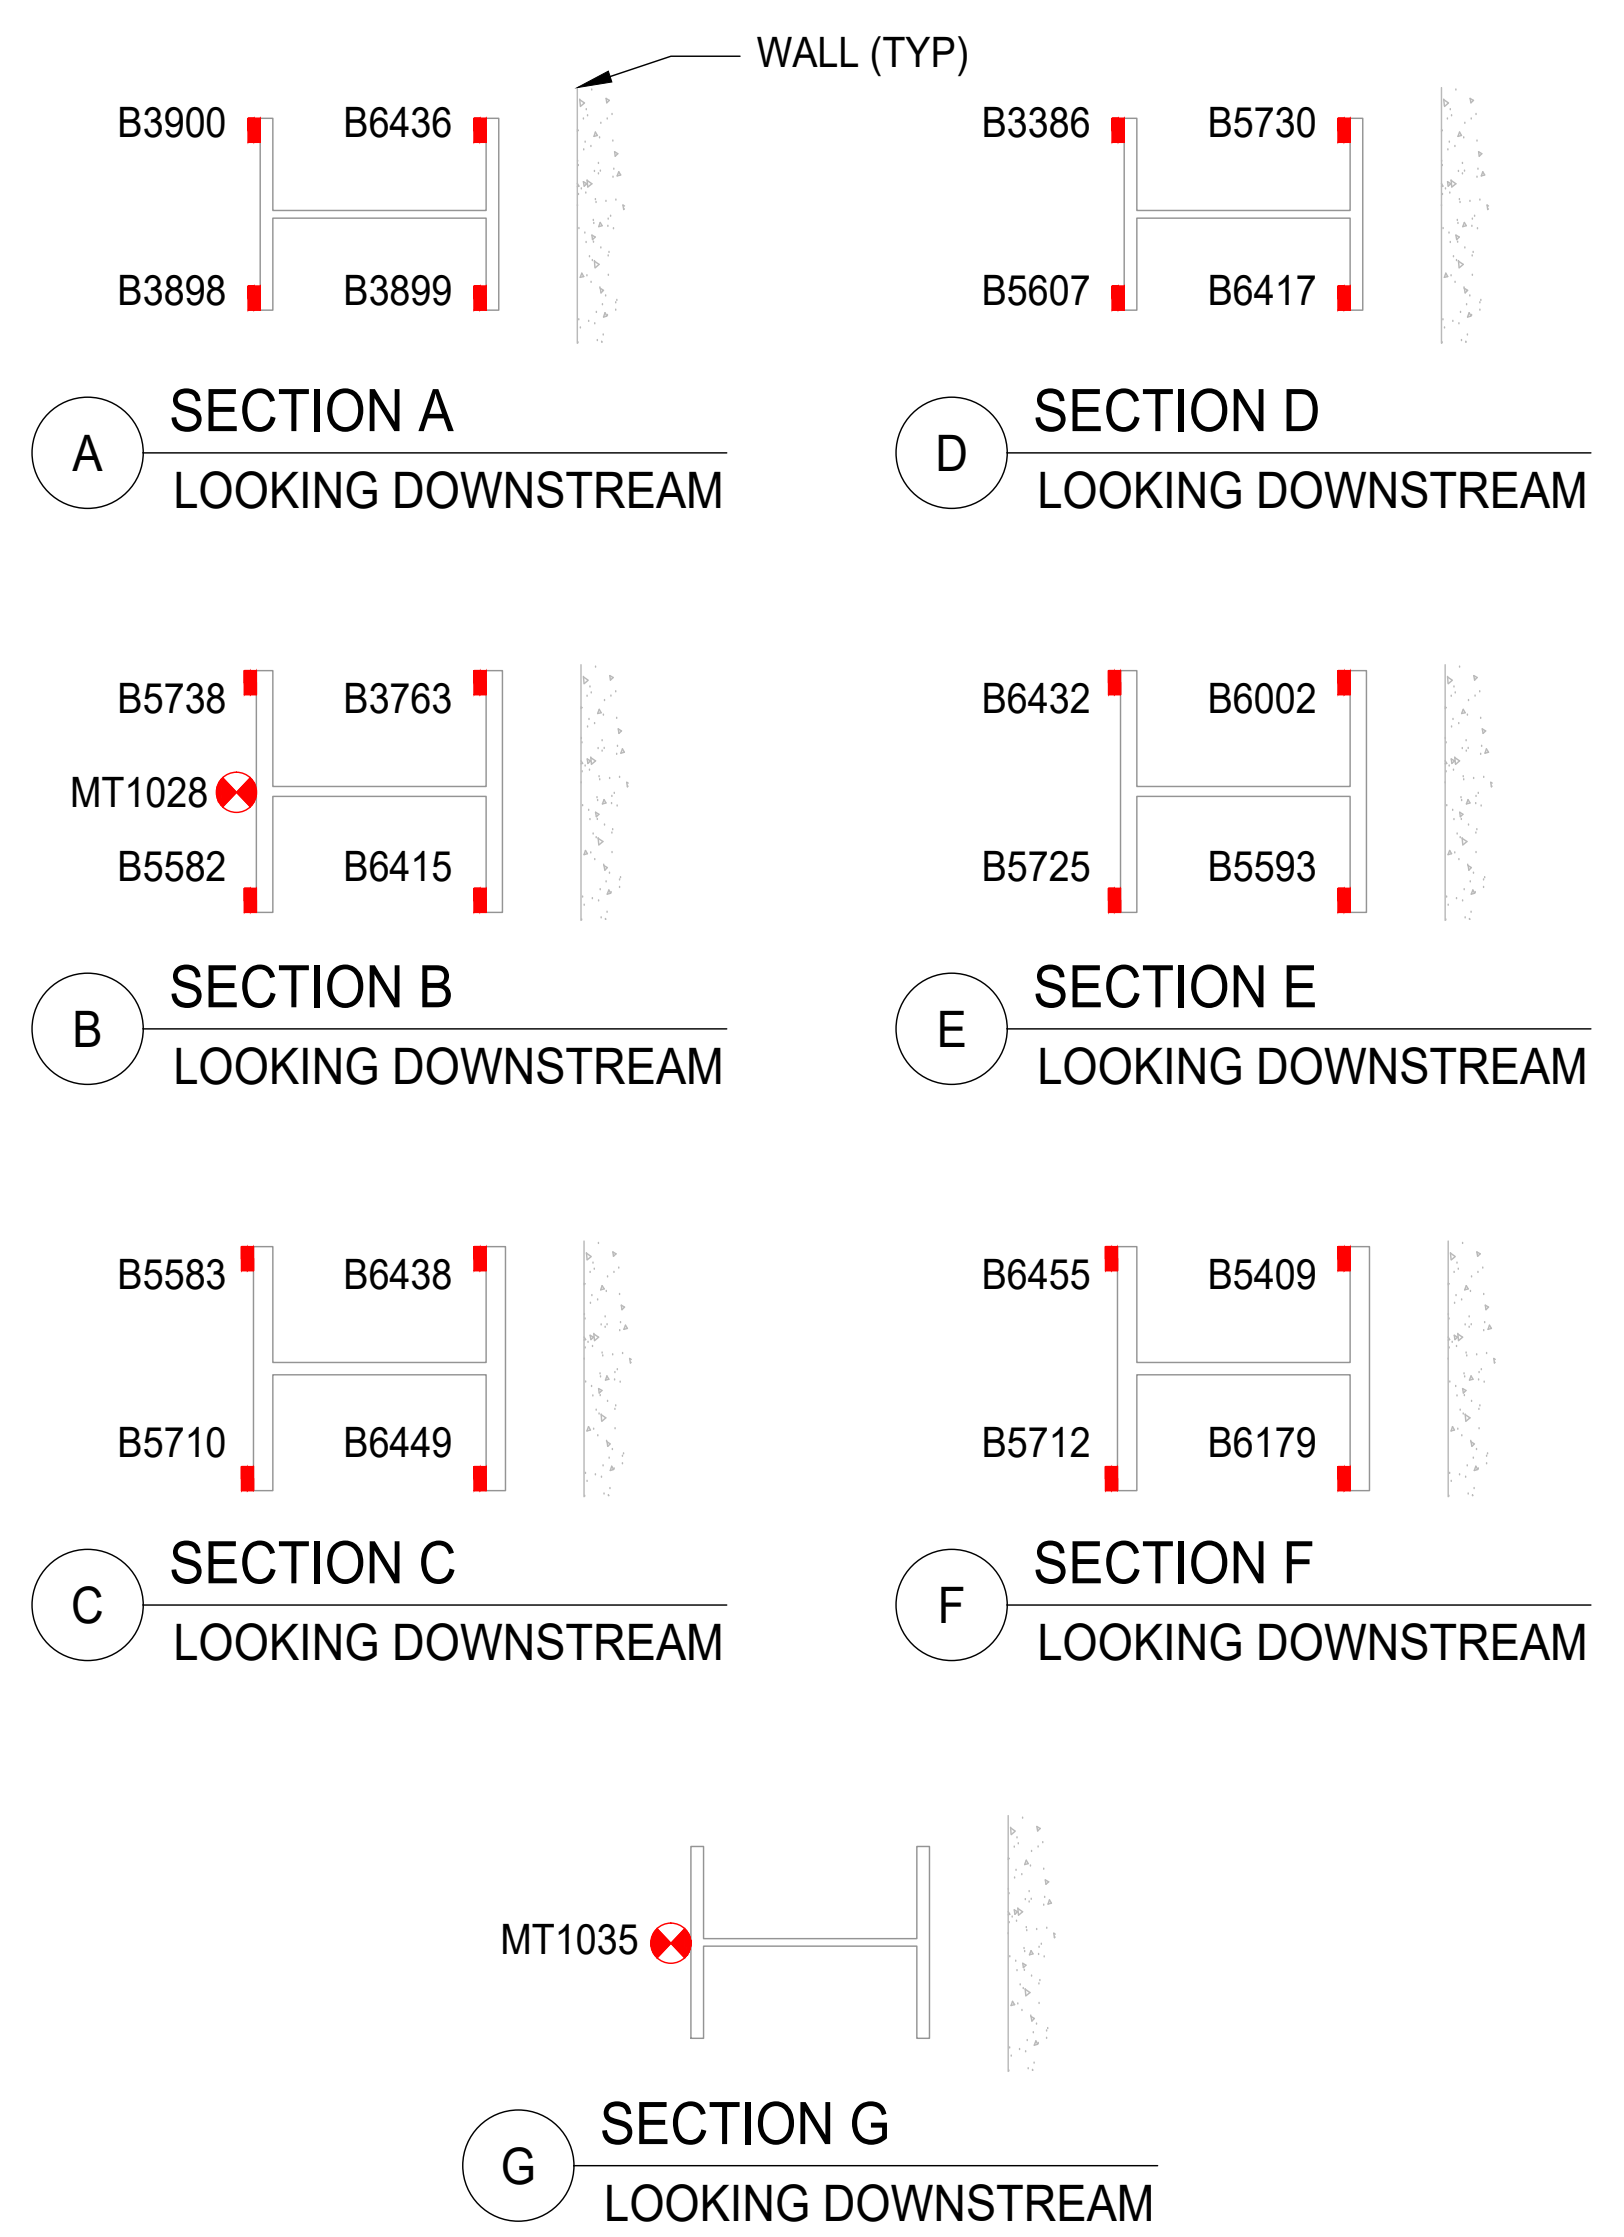
1 GATE 14
RIGHT ARM

1. SECTIONS A, B, & C SHALL BE INSTALLED 15 INCHES AWAY FROM TRUNNION PLATE.
2. TILTMETERS SHALL BE INSTALLED CENTERED ON THE MIDDLE STRUT FLANGE.
3. SECTION G'S TILTMETER SHALL BE INSTALLED AS CLOSE TO THE SKINPLATE AS POSSIBLE.

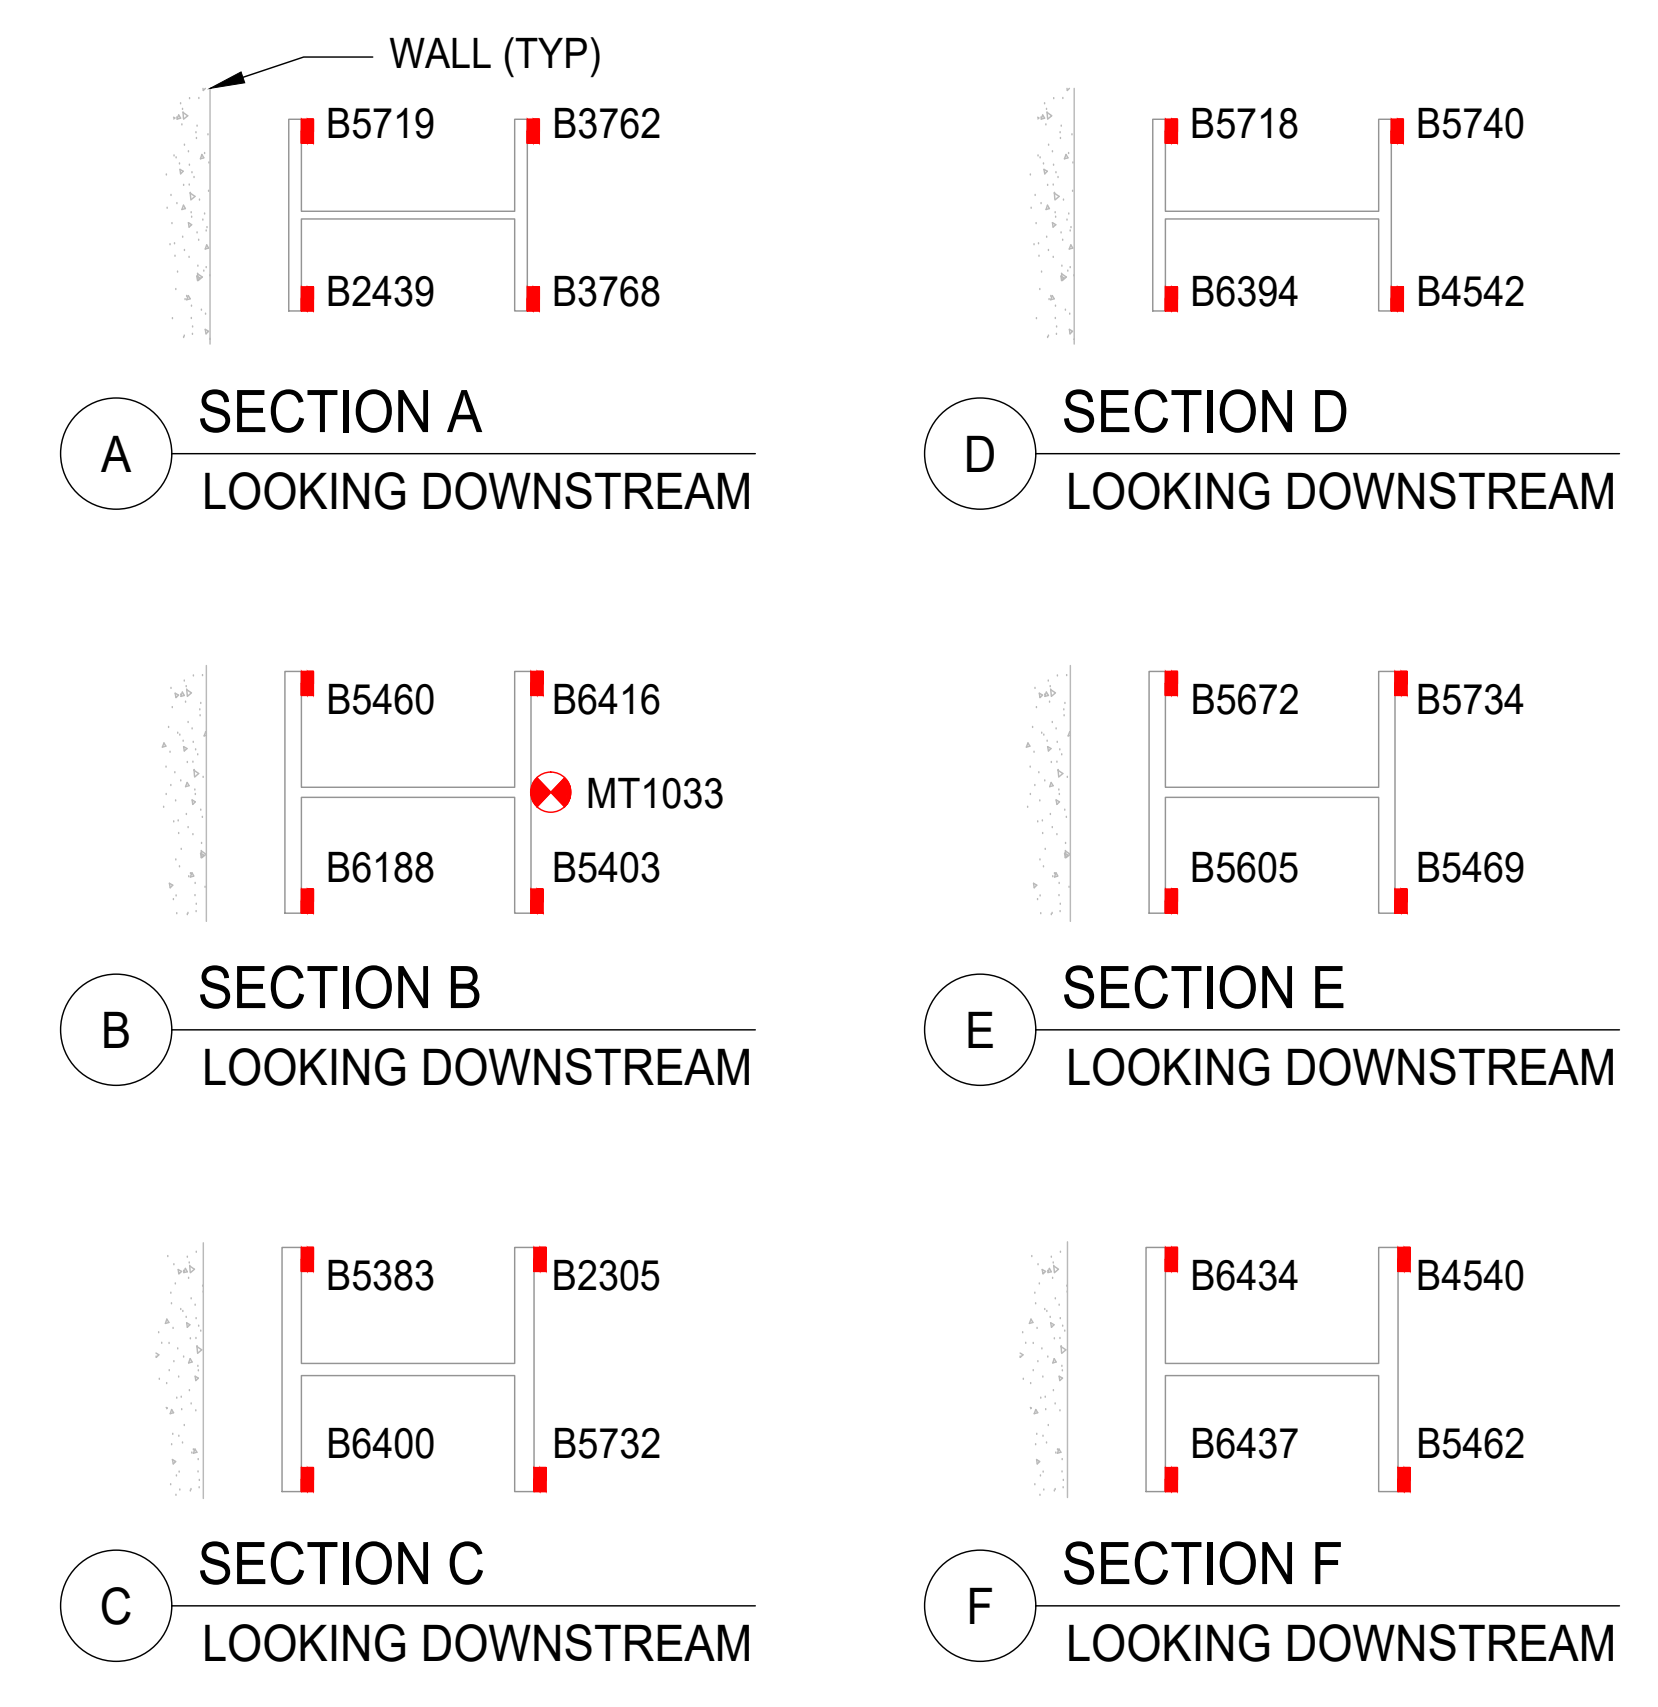
2 GATE 14
LEFT ARM

1. SECTIONS A, B, & C SHALL BE INSTALLED 15 INCHES AWAY FROM TRUNNION PLATE.
2. TILTMETERS SHALL BE INSTALLED CENTERED ON THE MIDDLE STRUT FLANGE.
3. SECTION G'S TILTMETER SHALL BE INSTALLED AS CLOSE TO THE SKINPLATE AS POSSIBLE.

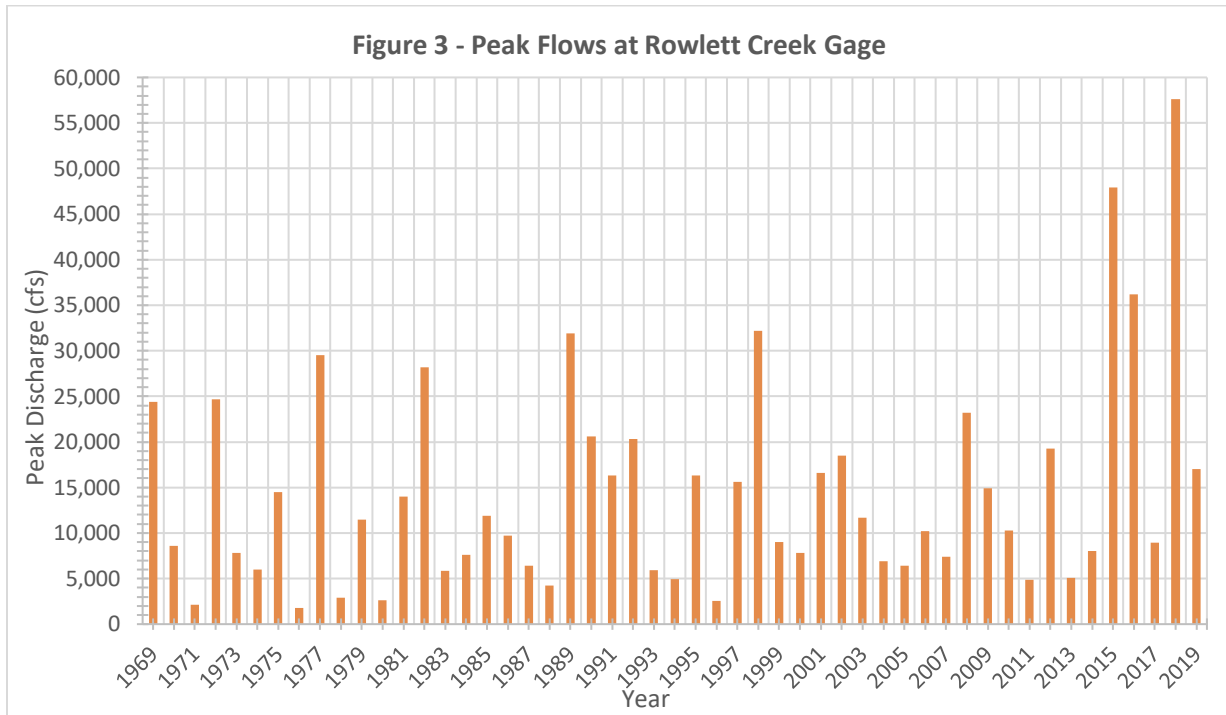
As previously mentioned, the Rowlett Creek gauge represents about 40% of the Lake Ray Hubbard local drainage basin (i.e. downstream of Lake Lavon Dam), and current operation procedures estimate that inflows to Lake Ray Hubbard could be as high as 2.5 times the recorded flow at Rowlett Creek. Figure 3 depicts the recorded peak flows during the period of record for the Rowlett Creek gauge.

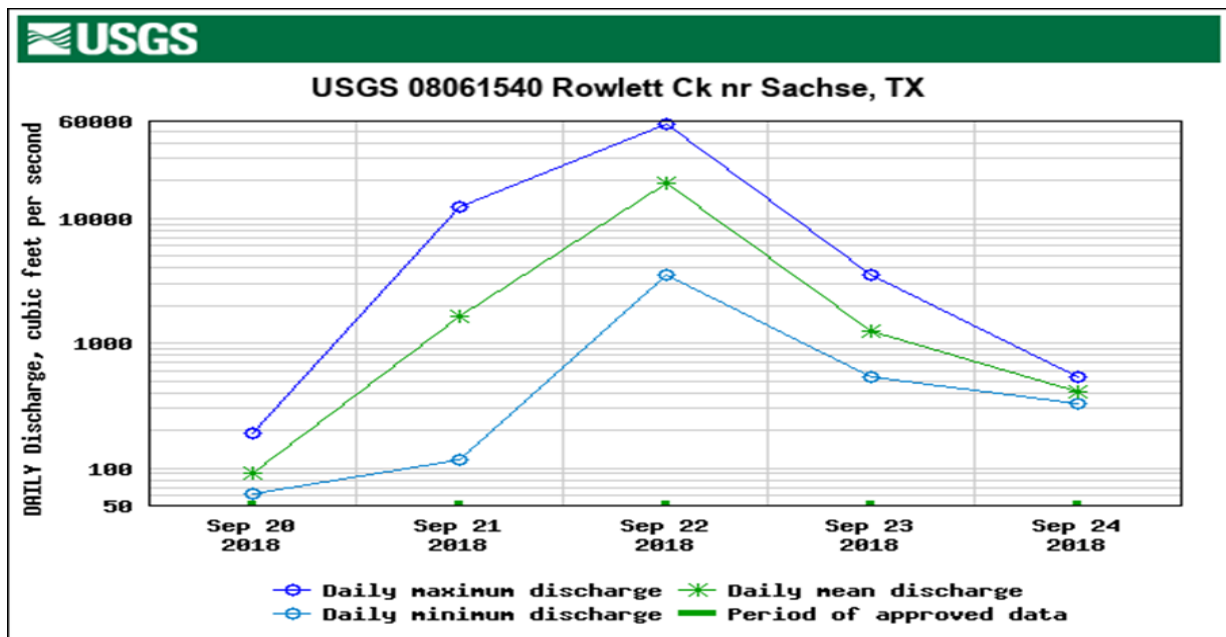
Figure 4 – Record Peak Flow at Rowlett Gauge in 2018

Figure 4 depicts the maximum, minimum, and mean daily discharges at the Rowlett Creek gauge over the 5-day period of September 20, 2018 through September 24, 2018, when the largest recorded flow occurred. The figure illustrates the wide variance between the maximum and minimum flows throughout the days, and further illustrates the importance of timely gauge information.

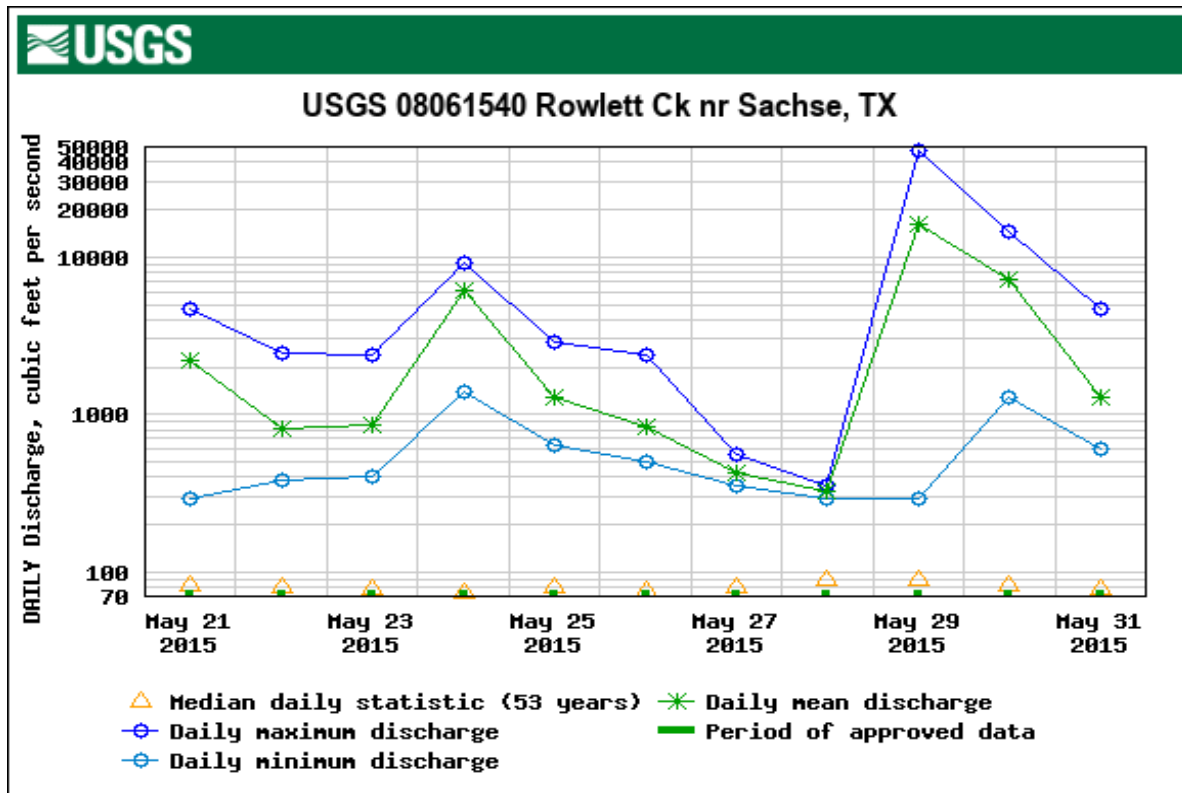
Figure 5 – Rowlett Creek Response to May 2015 Storm

The second highest recorded flow occurred on May 29, 2015 with a peak flow of 47,900 cfs. For the period of May 21, 2015 to May 26, 2015, the precipitation totals were 0.57, 0.55, 0.73, 3.30, 0.42, and 0.43 inches per day, respectively. Trace amounts of rainfall were recorded on May 27, 2015, followed by daily precipitation totals of 1.56, 2.20, and 0.89 inches for May 28, 2015 through May 30, 2015. Figure 5 shows the streamflow response for this period.

The relative streamflow response can be seen on May 24, 2015, with a rainfall total of 3.30 inches throughout the day and a corresponding increase in flow on the same day. A similar sharp increase in flow can be seen on May 29, 2015 when the daily total rainfall was 2.20 inches. While these correlations use daily, rather than hourly, data, the rapid variance in flow during relatively short periods can be seen from the graph.

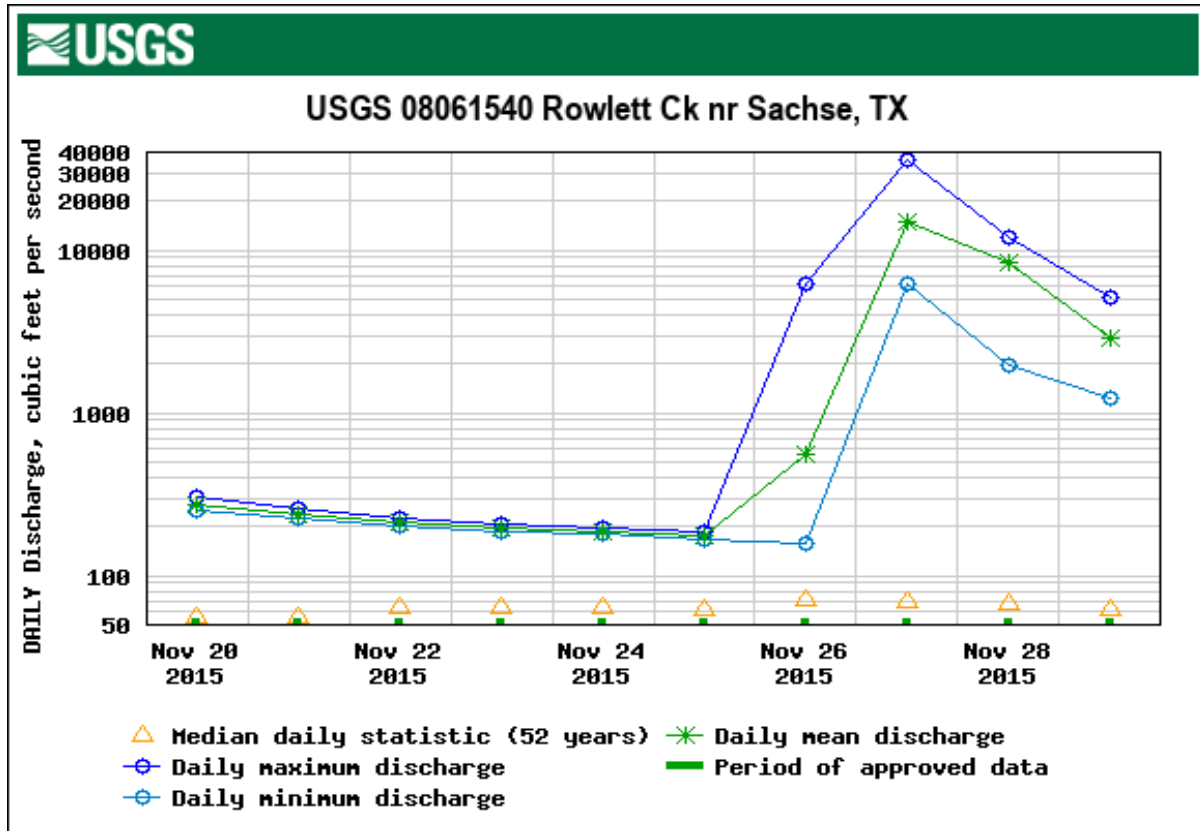
Figure 6 – Rowlett Creek Response to May 2015 Storm

The third highest recorded flow occurred on November 27, 2015 with a peak flow of 36,200 cfs. About a week preceded this flood event without any rainfall. The initial recorded daily precipitation was 2.71 inches on November 26, 2015, followed by 3.45 inches on the November 27, 2015. The following two days had rainfall totals of 0.99 and 0.88 inches per day. Figure 6 shows the streamflow response for this period.

As with the previous storm, the rapid response to the rainfall is apparent. Again, the correlation is only an approximation as daily totals may not reflect the timing of high intensity rainfall or any localized discrepancy between rainfall at the NWS Fort Worth/Dallas, TX station and the actual site conditions.
