Independent Seismic Risk Advice on the Acute Services Buildings at Hawke's Bay Hospital

This report reviews and summarises the report recently prepared by WSP on the current seismic status of the acute services buildings at the Hawke's Bay Fallen Soldiers' Memorial Hospital, and provides additional risk commentary and recommendations.

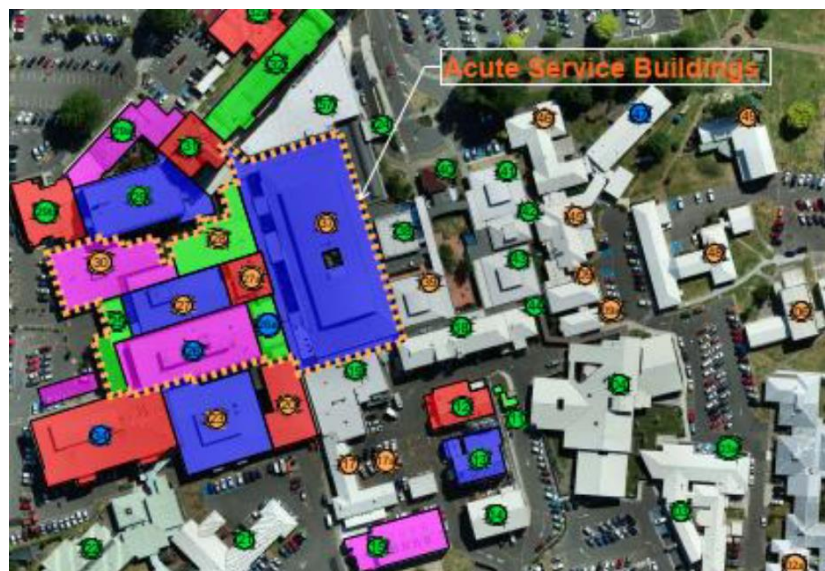
While the WSP report focused on the acute services buildings clustered around Radiology as indicated in the following figure, they also provided relevant commentary in relation to other IL4 buildings across the campus.
