Economic Benefits of Code Compliant Non-Structural Elements in New Buildings

Ministry of Business, Innovation & Employment

Date: 20 March 2017
Reference: 6-DP292.01
Status: Final

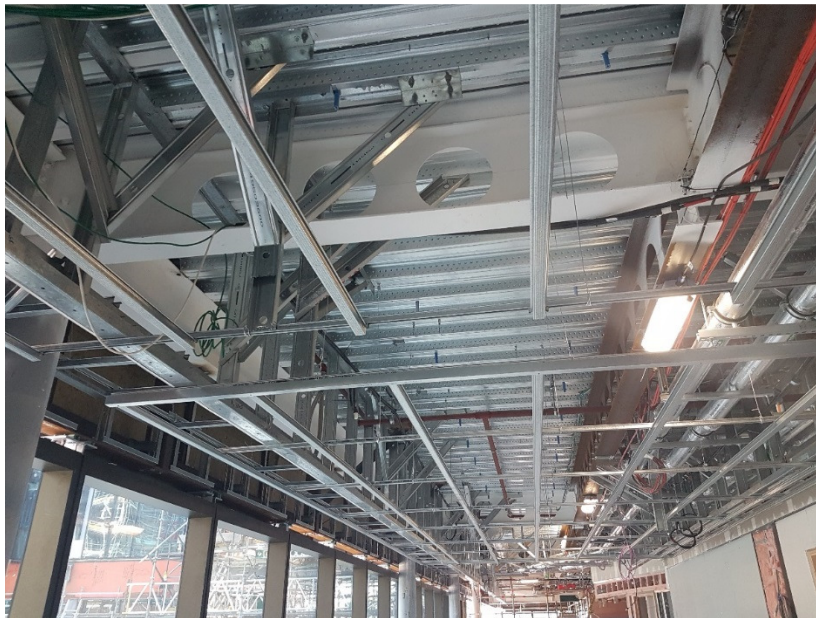
Figure 2: Seismic Restraint of Services and Ceilings

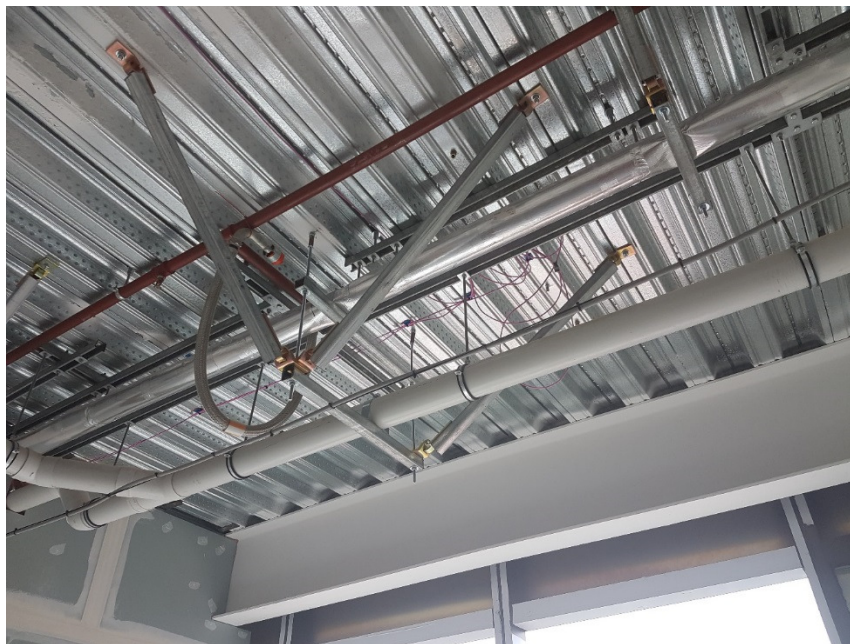
Figure 3: Seismic Restraint of services

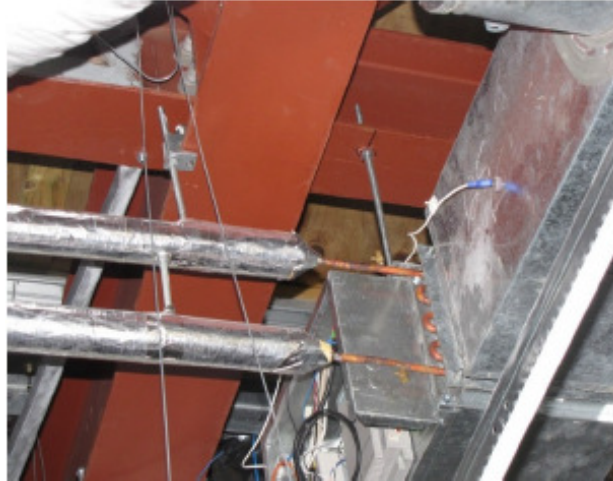
Figure 5: Lack of flexible connections to mechanical plant

- Equipment suspended within ceiling voids was, in some cases, found to not comply with Clause 5.2.2 of NZS 4219 which requires flexible connections when services and ceilings are not supported together. Examples of non-compliance included unrestrained pipe branches connecting to unrestrained ventilation equipment, without a flexible connection.
- Mechanical equipment weighing in excess of 10kg was found to be unrestrained. This does not comply with Clause 5.9 of NZS 4219.

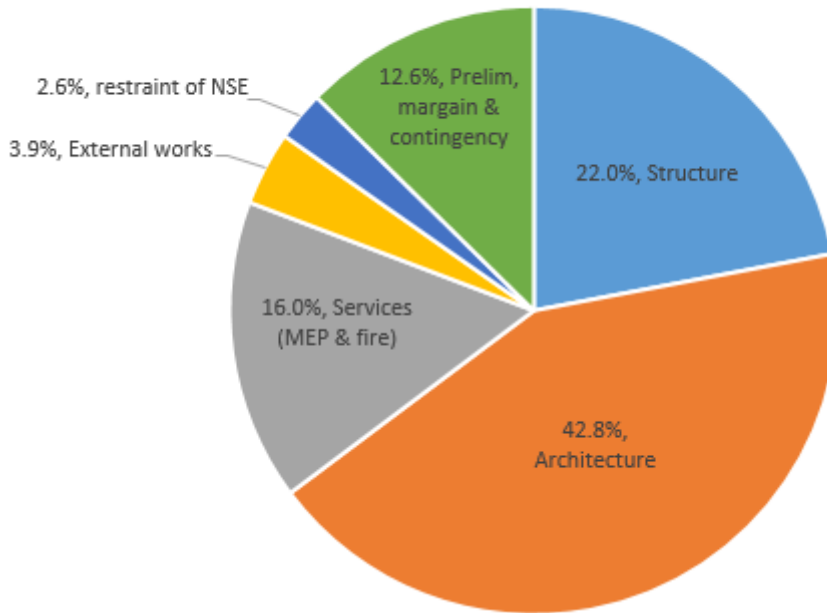
Fire Station - single storey

The following charts show the cost breakdown of building elements for each of the chosen study buildings. The dark blue pieces represents the cost to provide seismic restraints to the ceilings, partitions, mechanical, electrical, plumbing and pipework and sprinkler systems.

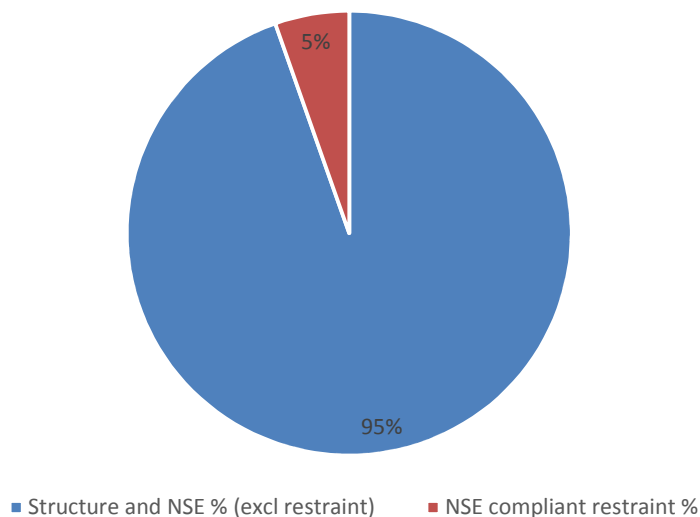
Average annual NZ Construction value (2016)

While the minor ‘Heavy Industry / Energy’ and ‘Sports’ categories are not covered in the table above these account for only \$700m. For the remainder of the \$8.7b of non-residential building construction in New Zealand the cost of NSE restraint can therefore be extrapolated be in the order of \$423m or around an average of 4.9% of the total annual construction spend.

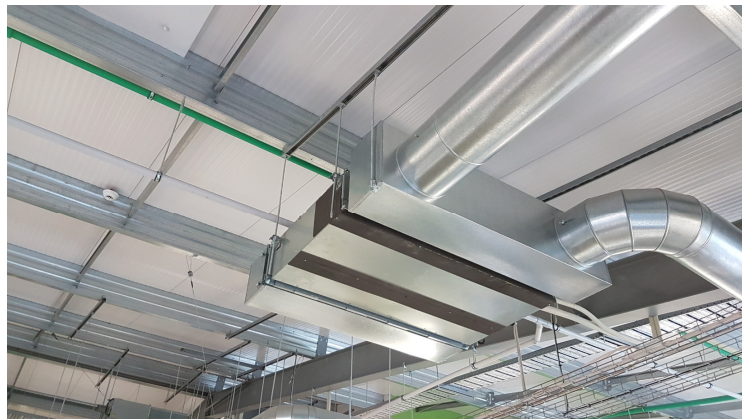
Figure 16: Non-compliant installation of overhead mechanical plant (no lateral restraint provided) – building completed and received Code Compliance Certificate 2015
