#### Memo from DTS is in black

#### MxV Rail (TTCI) responses are in blue.

Flange-Bearing Frog Long Term Solution

Date: June 9, 2022

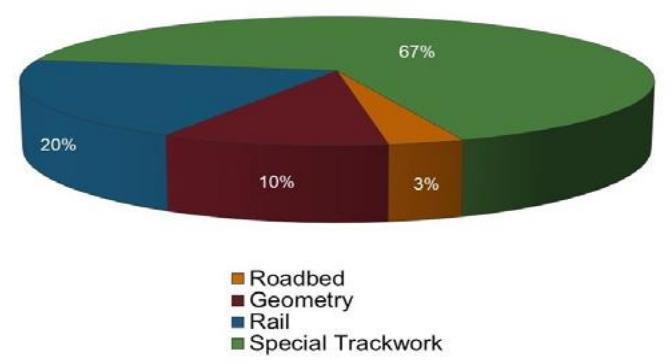
Figure 2-7 Track-caused derailments by sub-group (NTD)

Sixty-seven percent of derailments occur at switches and we are heading down a path that no one has ever done before (see figure 2-7 below from the FTA's latest report). DTS will be the first system owner to operate at 55MPH over FBFs and the first system to possess an entire mainline network of FBFs. **Even the MBTA doesn't have an entire network of FBFs on their mainline tracks (MBTA has a few FBFs on their mainline).** TTCI says there is not safety issue and that is fine for now based off of their study, but Ben Holland, Rolling Stock Compliance Officer (RSCO) believes that TTCI used design simulations versus as-built simulations and that is why TTCI never identified the wheel tread top of frog interference strikes near the frog point, where each frog is only supposed to only be flange-bearing. This same concern was voiced to me by our TCO weeks prior.

Sixty-seven percent of derailments occur at switches and we are heading down a path that no one has ever done before (see figure 2-7 below from the FTA's latest report). DTS will be the first system owner to operate at 55MPH over FBFs and the first system to possess an entire mainline network of FBFs. Even the MBTA doesn't have an entire network of FBFs on their mainline tracks (MBTA has a few FBFs on their mainline). TTCI says there is not safety issue and that is fine for now based off of their study, but Ben Holland, Rolling Stock Compliance Officer (RSCO) believes that TTCI used design simulations versus as-built simulations and that is why TTCI never identified the wheel tread top of frog interference strikes near the frog point, where each frog is only supposed to only be flange-bearing. This same concern was voiced to me by our TCO weeks prior.
