### Dalton Highway MP 362-414

QAP paves the northern section of the project

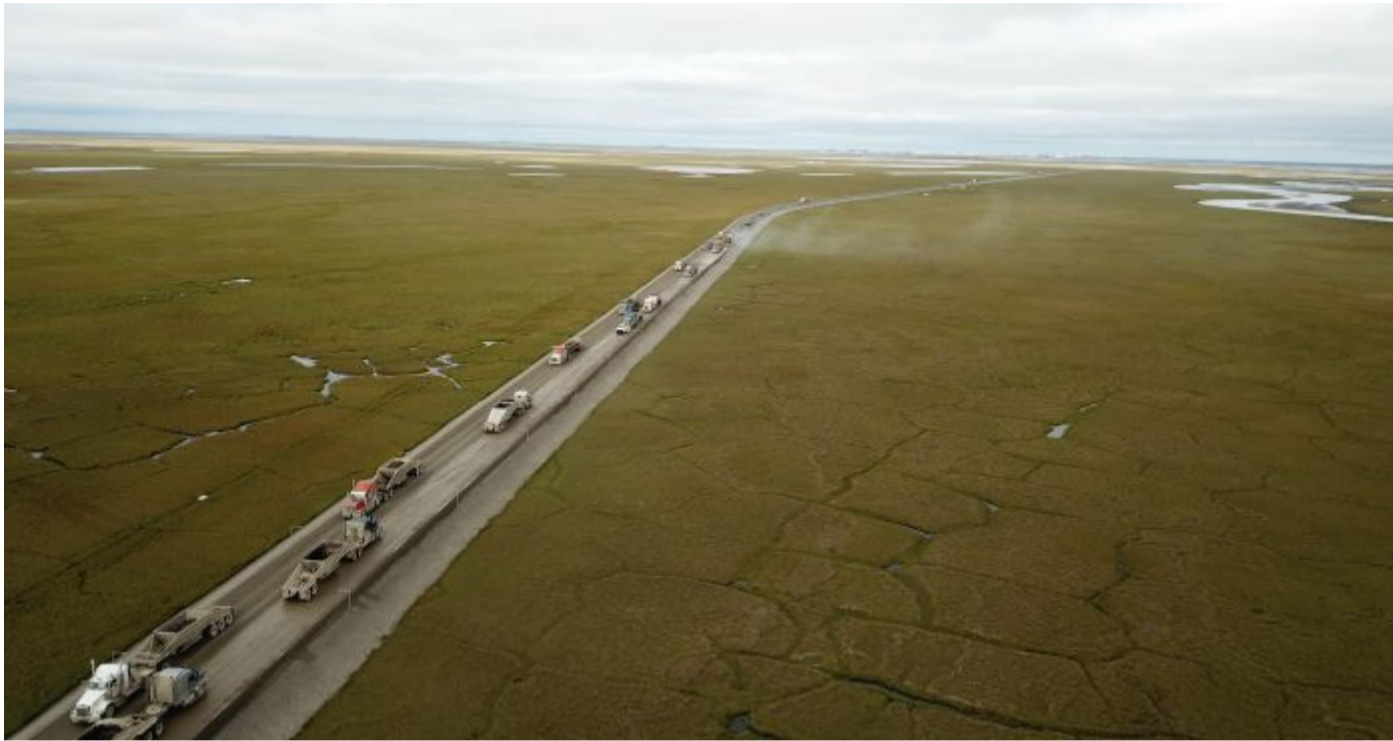
with Deadhorse on the horizon.

The Alaska Department of Transportation & Public Facilities (DOT&PF) and contractor Quality Asphalt Paving (QAP) are paving the last fifty miles of the Dalton Highway in a two-year project that is being constructed in 2020 and 2021. This is the largest, farthest north highway paving job our department and the State of Alaska have ever undertaken. The purpose of the project is to improve the driving surface of the Dalton Highway as it makes its final stretch across the tundra into Deadhorse and the Prudhoe Bay oil fields.

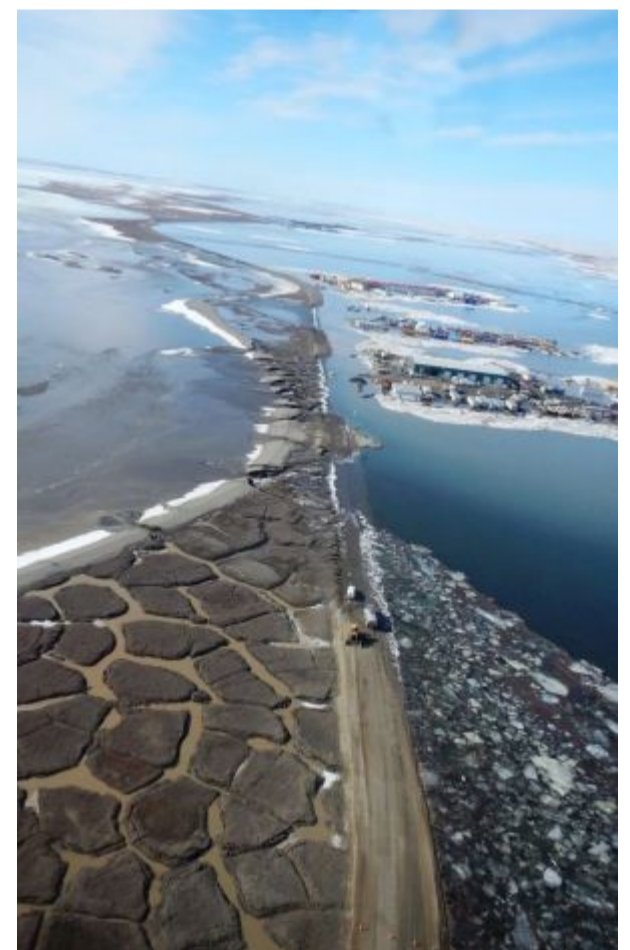
Catastrophic flooding in 2015 shut down the Dalton Highway for 28 days, prompting two state disaster declarations to be issued. Photo taken in May 2015

In the spring of 2015, massive overflow and flooding of the Sagavanirktok (Sag) River [washed out several sections of the Dalton Highway](#) in the area where this project is being constructed. The floods closed the road for 28 days and prompted two disaster declarations by Alaska's governor. After the waters receded, a project that was already underway in this section of the highway was modified to raise the road seven to ten feet above the tundra to reduce the possibility of a road under water and an emergency closure during flooding events like 2015.

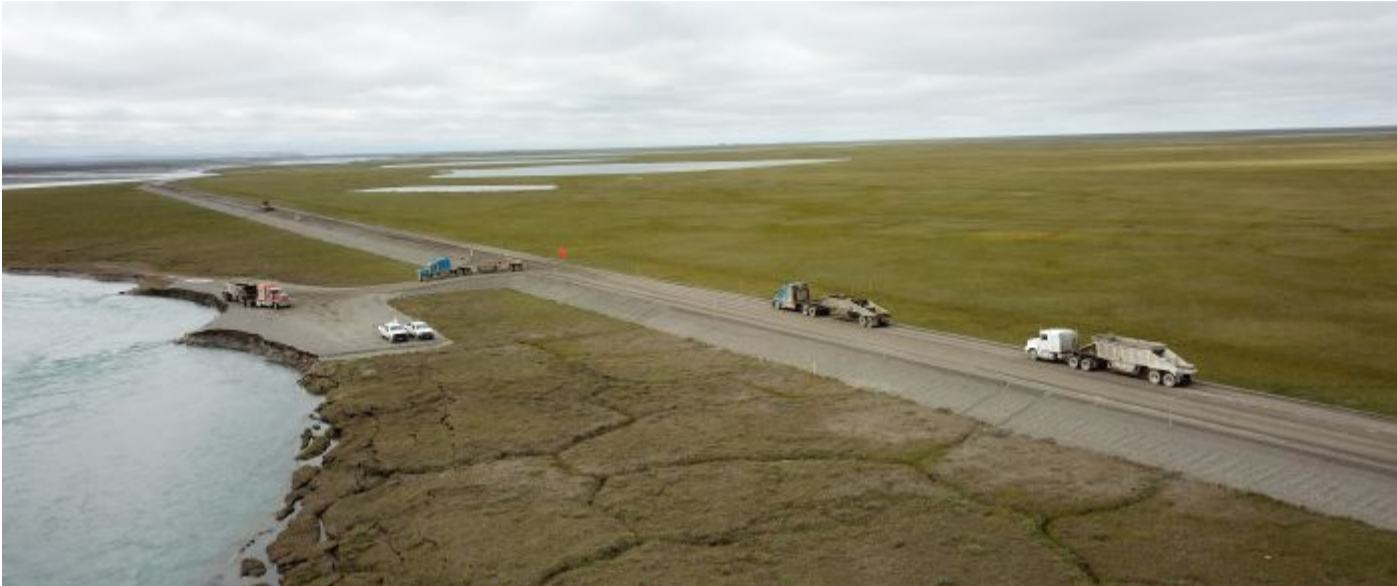
Trucks haul material in preparation for paving.

Paving creates another set of challenges. The lack of fine materials to get the right mix for the asphalt is as big a problem for paving as it is for gravel maintenance. And then there's logistics. Contractor QAP transported its asphalt hot plant 850 miles from Anchorage to the northern edge of the project at the beginning of the 2020 season. That's like driving from Atlanta to New York City on a two-lane highway, and north of Richmond there's only one restaurant, you've got to bring your own gas, and your cell phone doesn't work—oh, and you're hauling an asphalt plant. In the 2021 construction season, they may move the plant to the southern end of the project. After the project is constructed, the asphalt plant will be demobilized from the Dalton Highway and head back south. This brings us to the next phase.

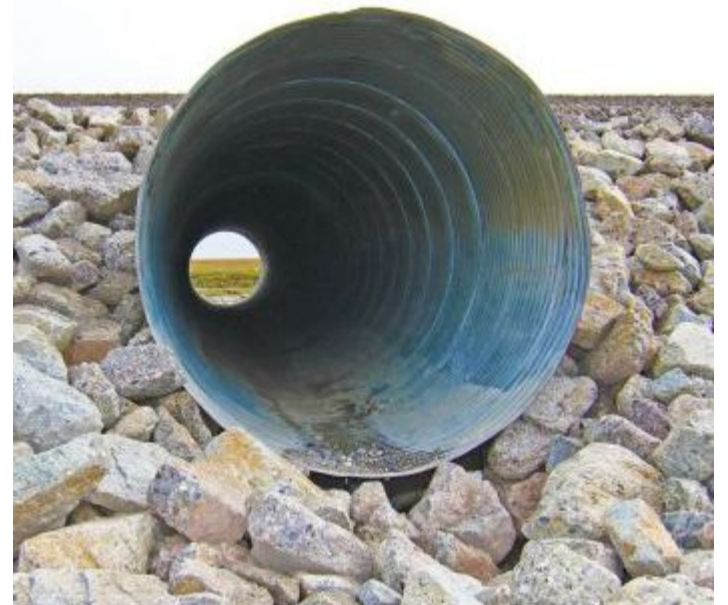
A culvert under the Dalton Highway provides a window to the tundra. Photo taken August 2018 by Alaska DOT&PF staff
