CIT-210803-119

REPORT OF INVESTIGATION

Report as prepared by EPT CIT including all facts pertaining to the case listed above

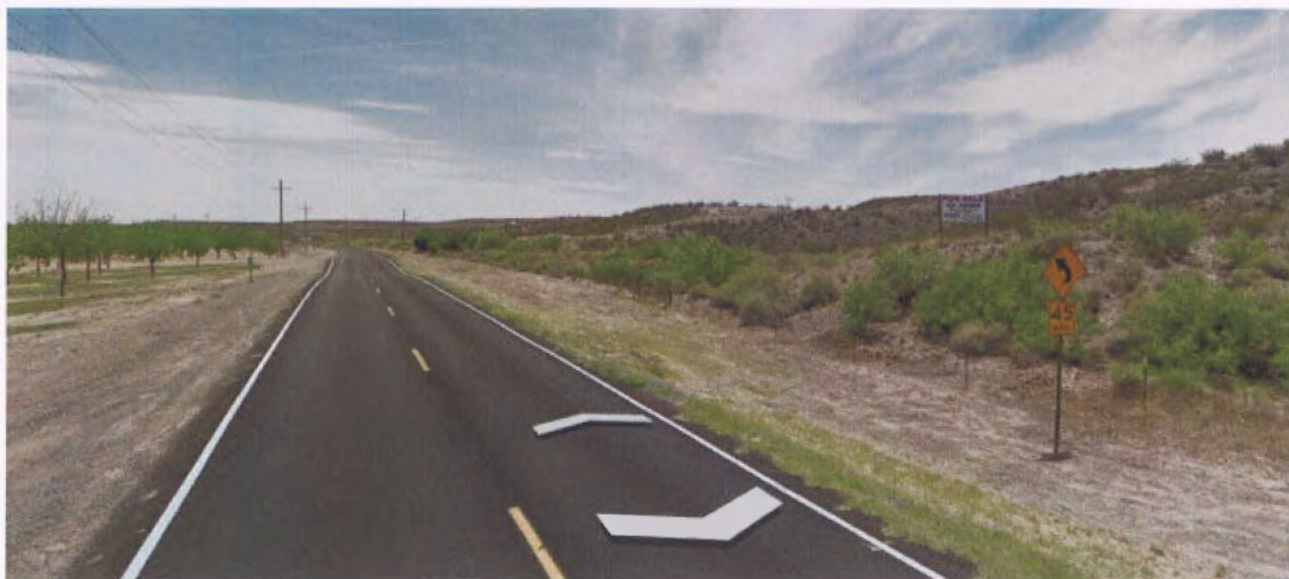
Based on the above information, CIT Investigator [REDACTED] determined that the minimum speed of VEH at the time it went into a critical speed yaw, was approximately 69 MPH. The posted speed limit for this area of highway is 55 MPH and the posted recommended speed for this curve is 45 MPH.

View: Close-Up
Description: Recommended Speed for Curve

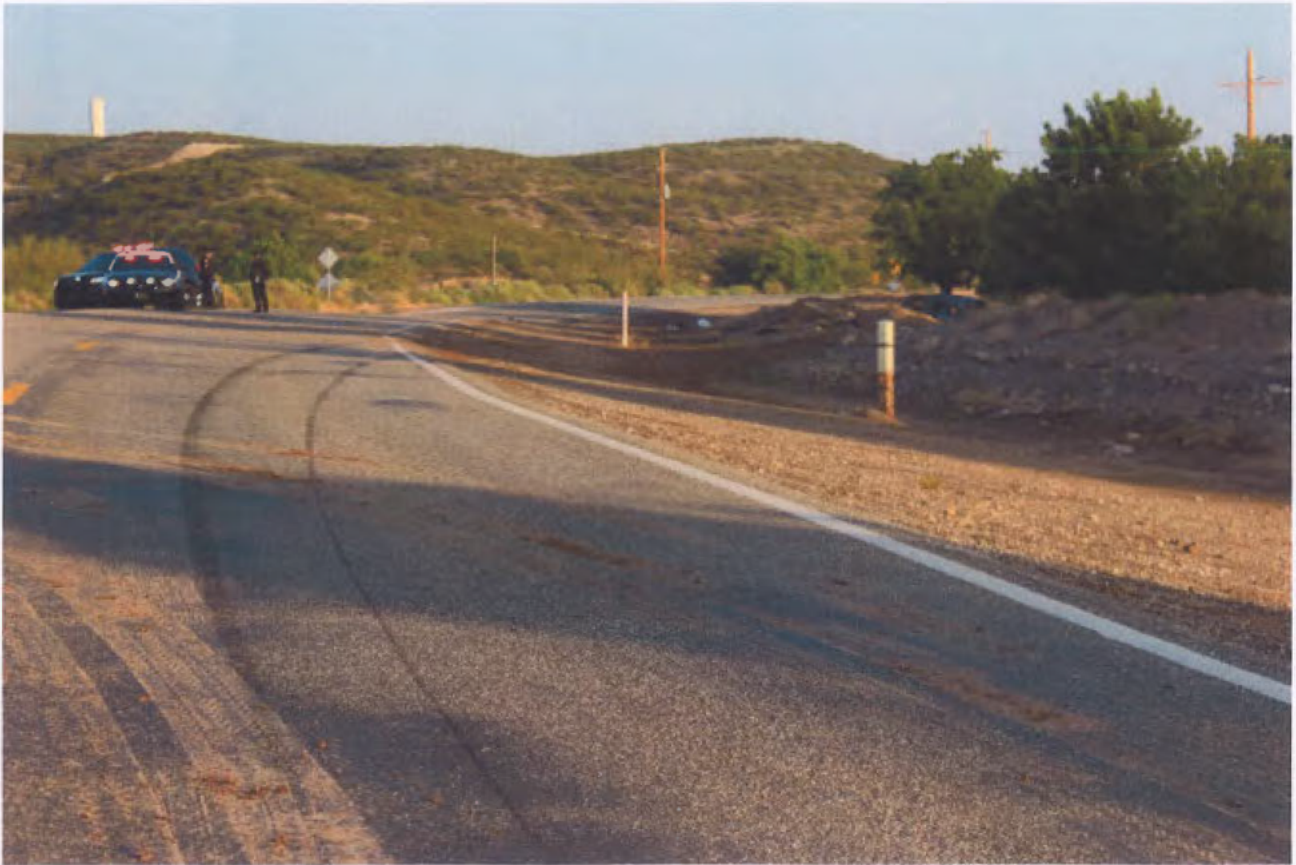
View: Midrange
Description: VEH Skids

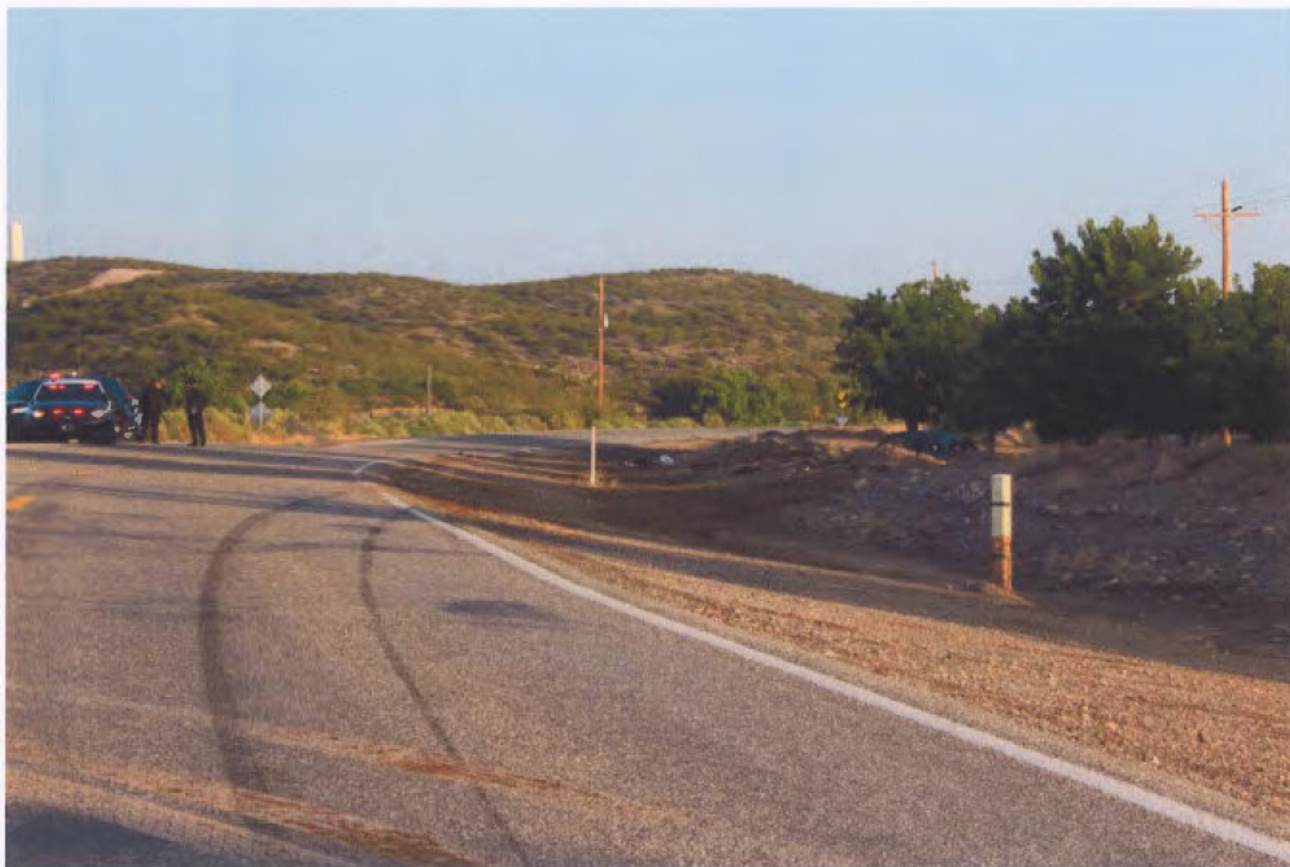
View: Midrange
Description: VEH Skids

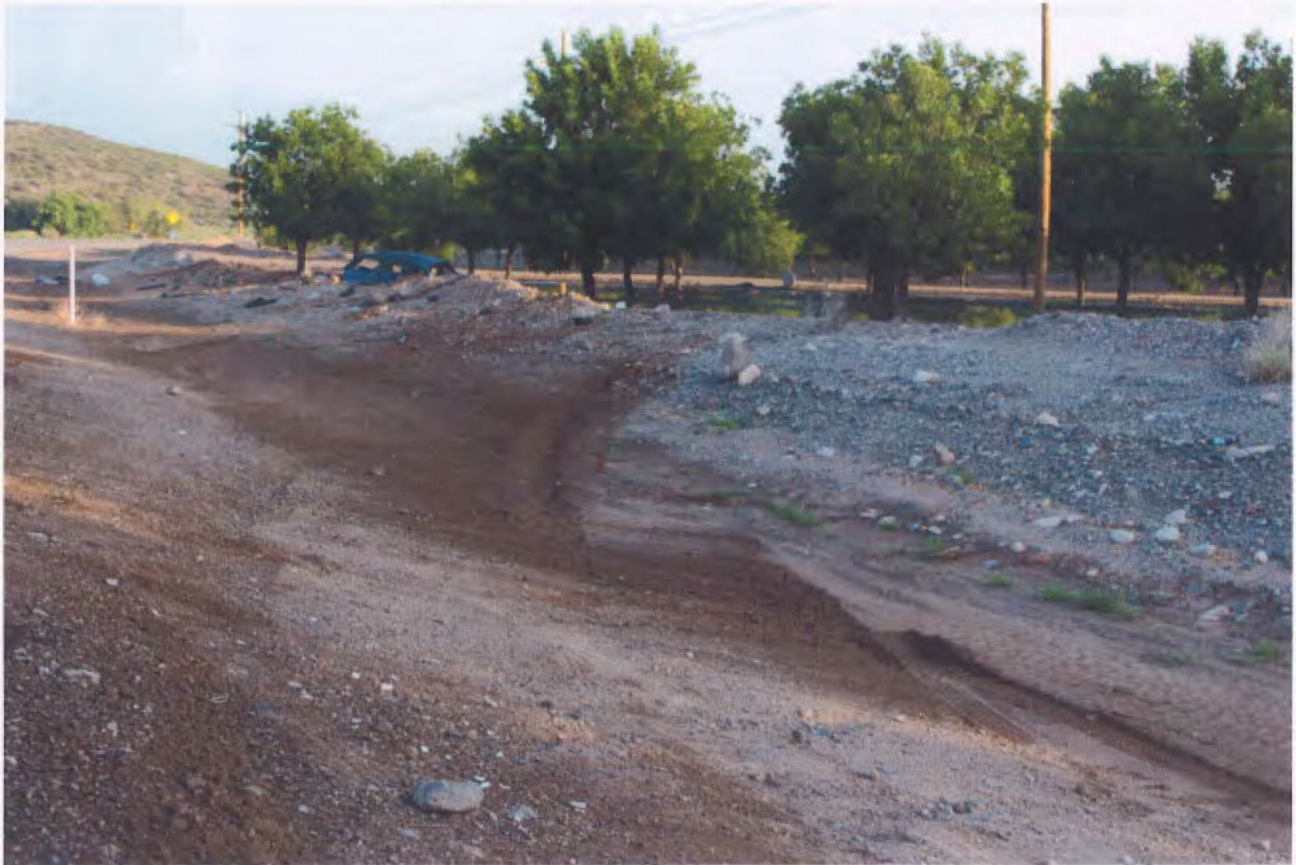
View: Close-Up
Description: VEH Skids

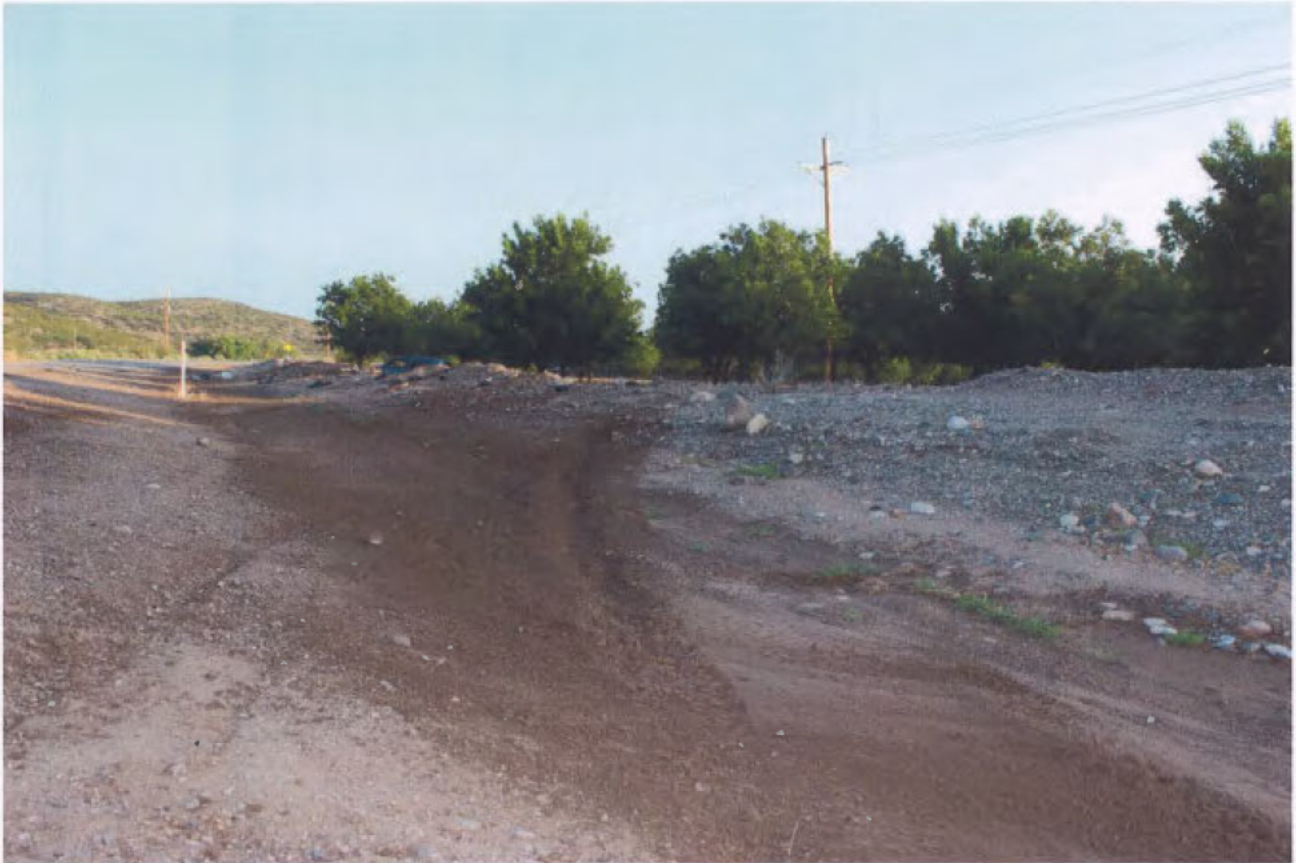
View: Midrange
Description: VEH Skids

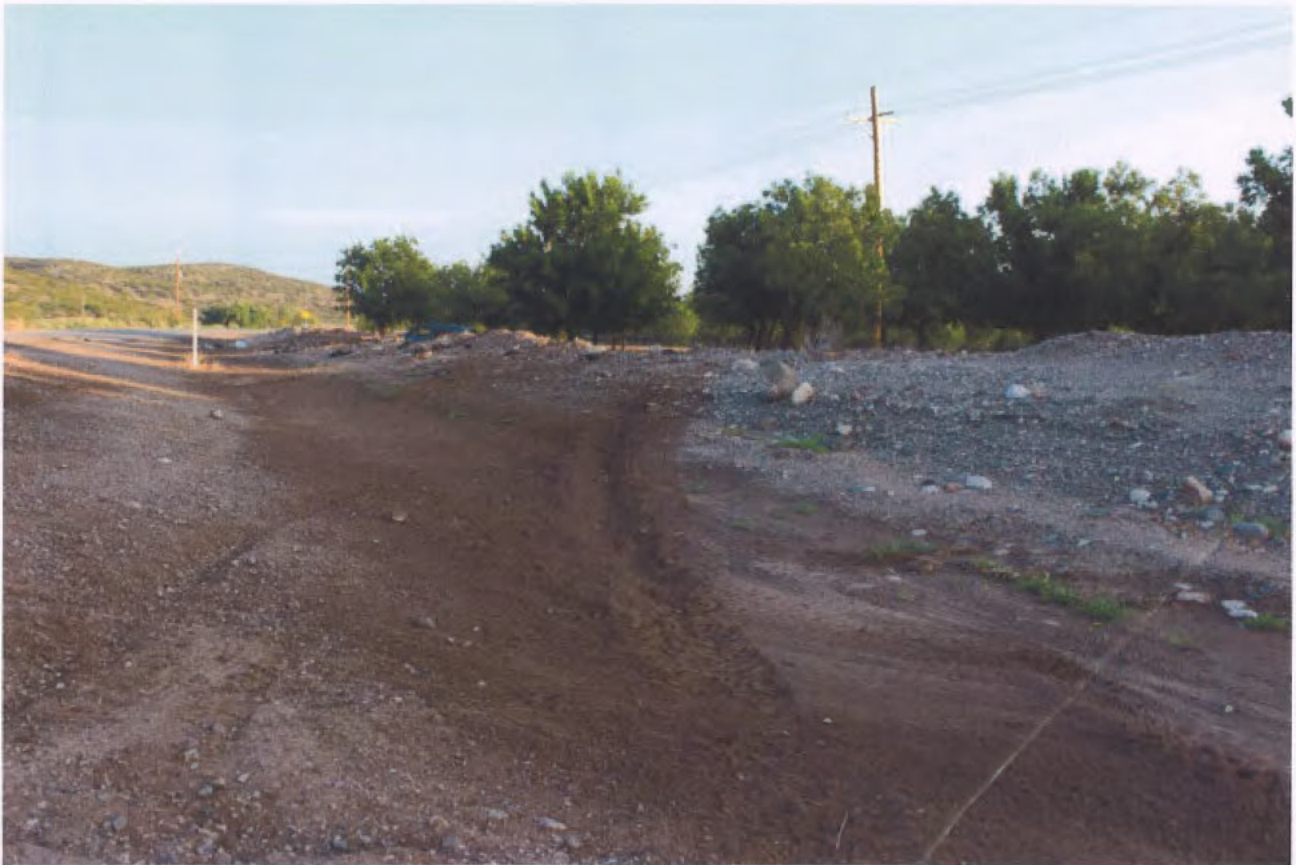
View: Close-Up
Description: VEH Skids

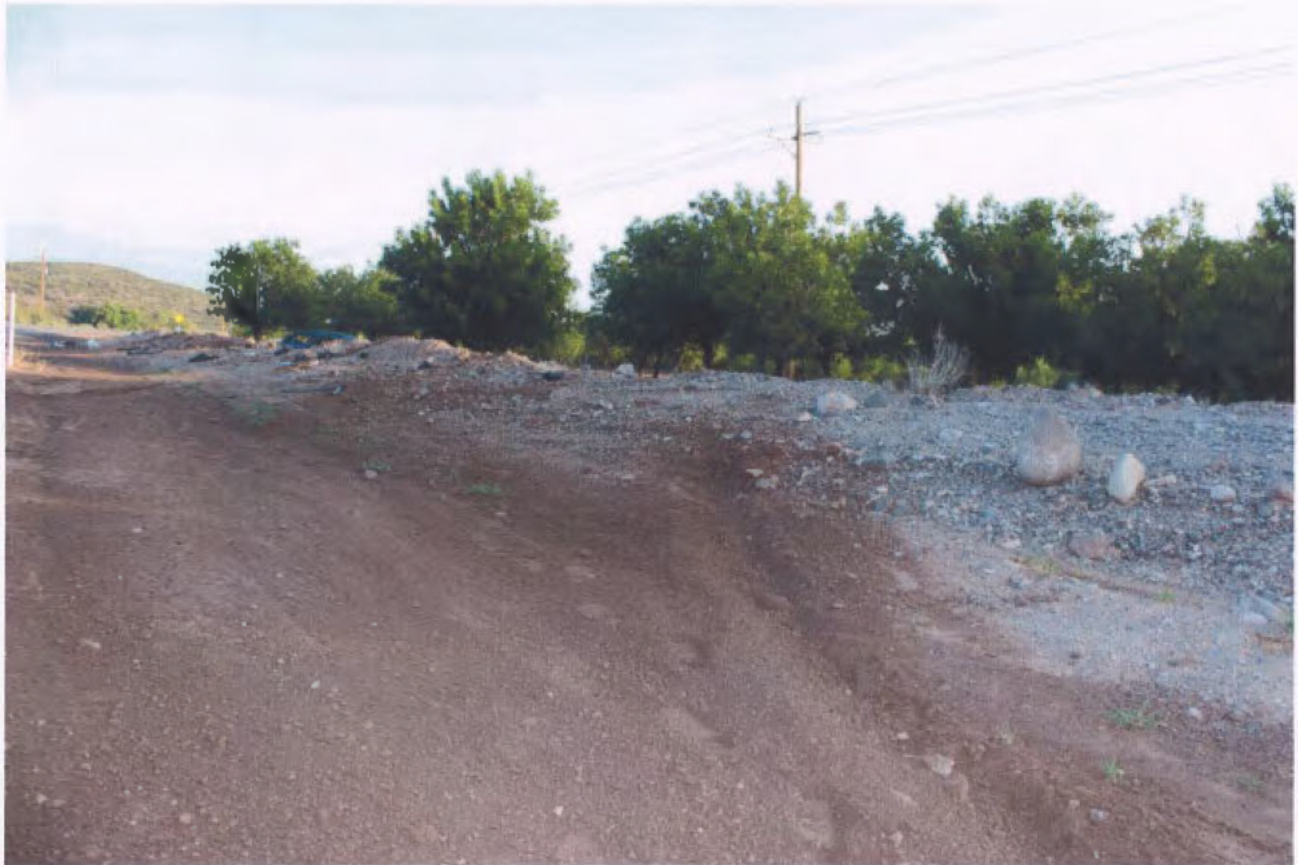
View: Close-Up
Description: VEH Skids

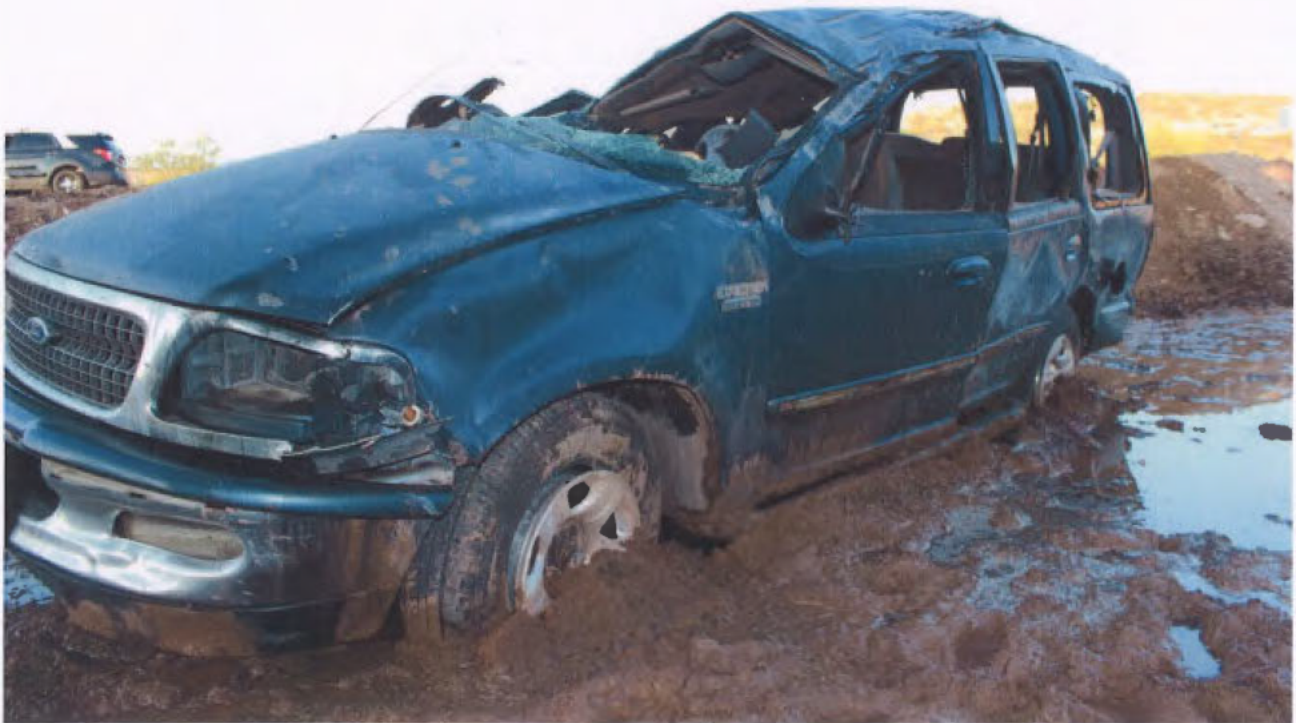
View: Close-Up
Description: VEH Damage

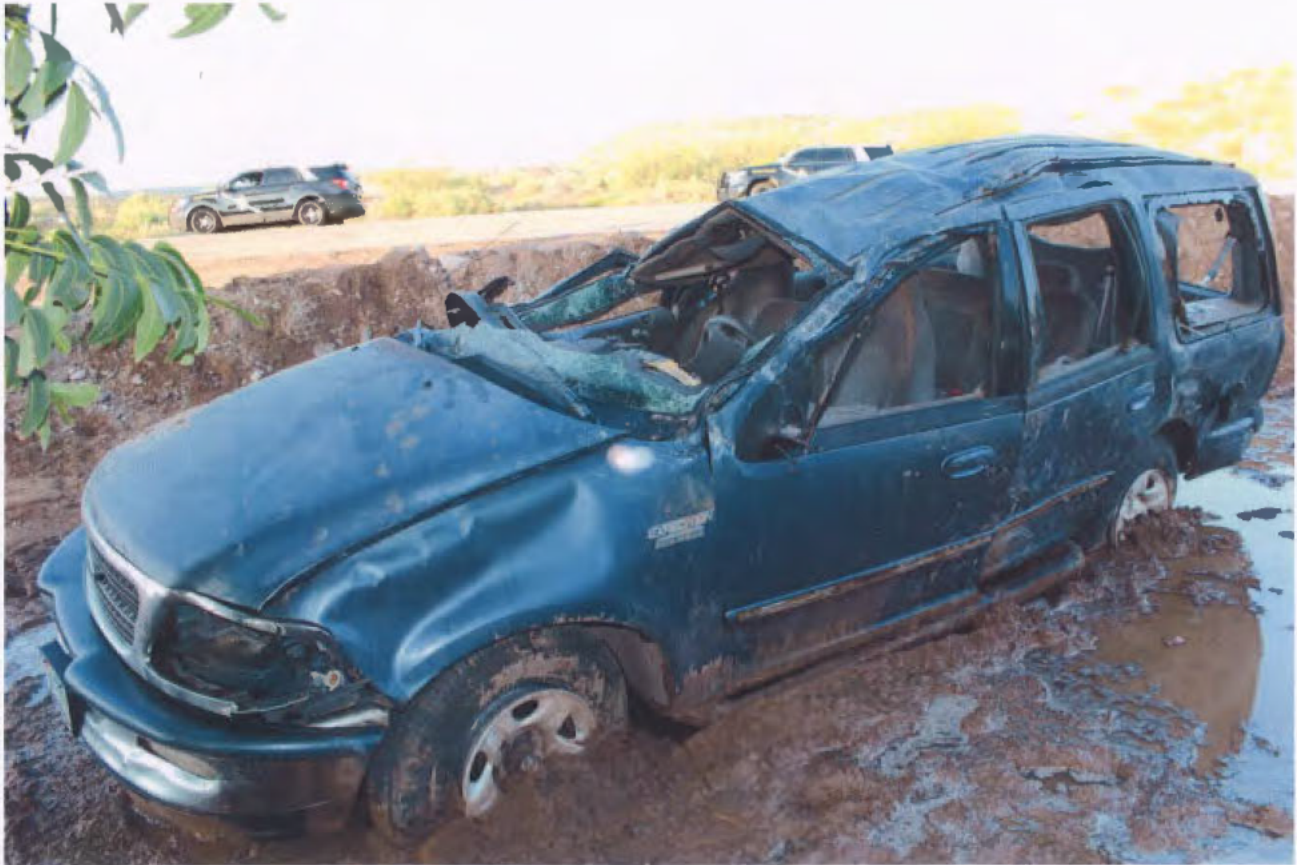
View: Close-Up
Description: VEH Damage

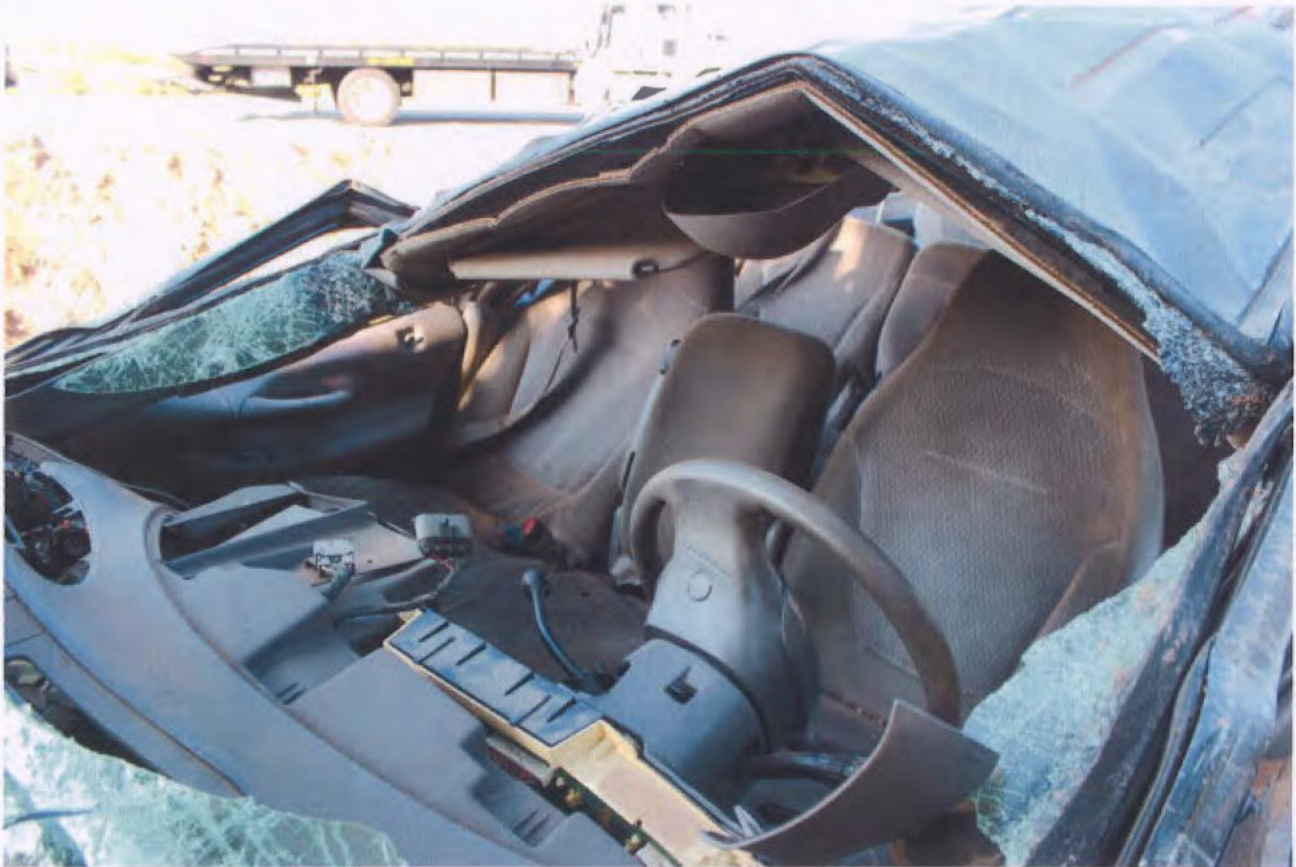
View: Close-Up
Description: VEH Damage

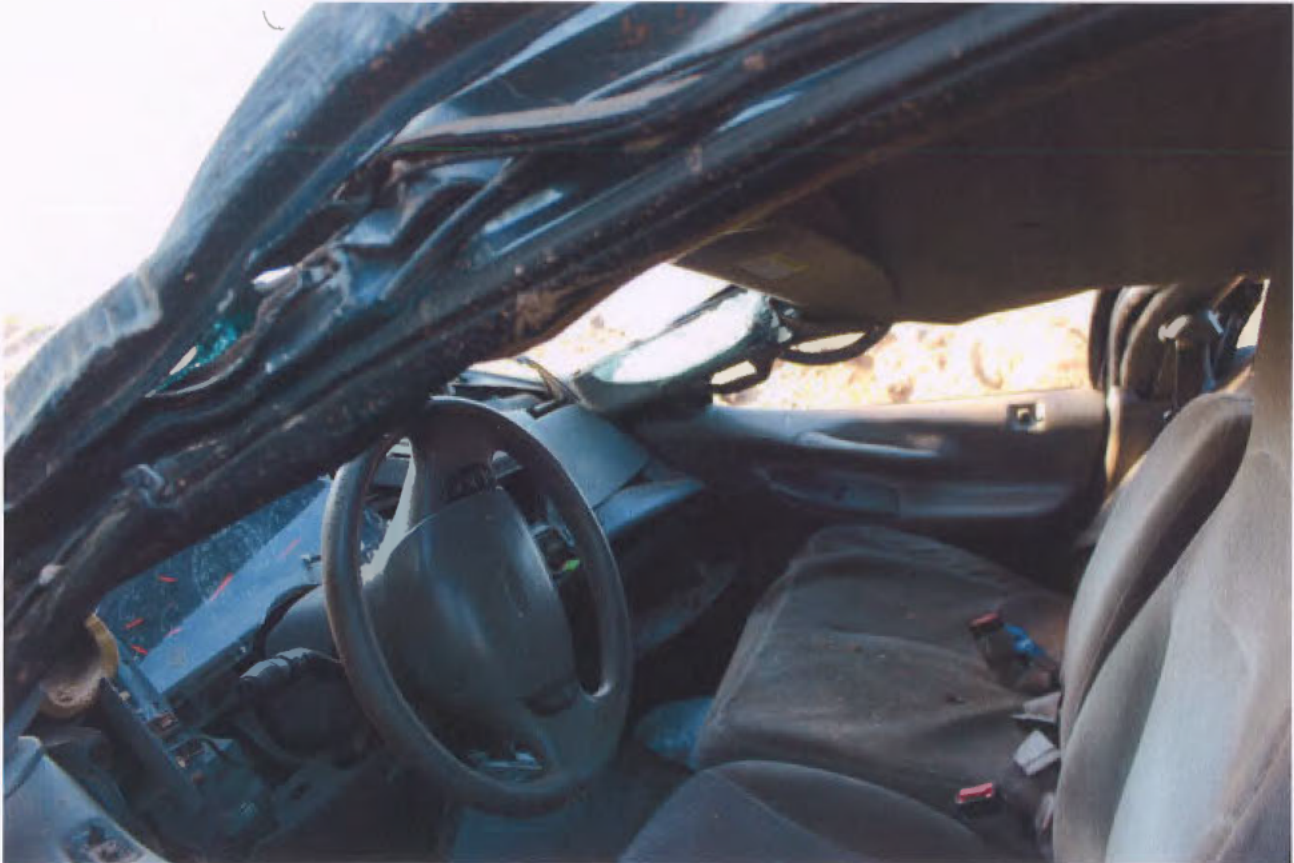
View: Close-Up
Description: VEH Damage

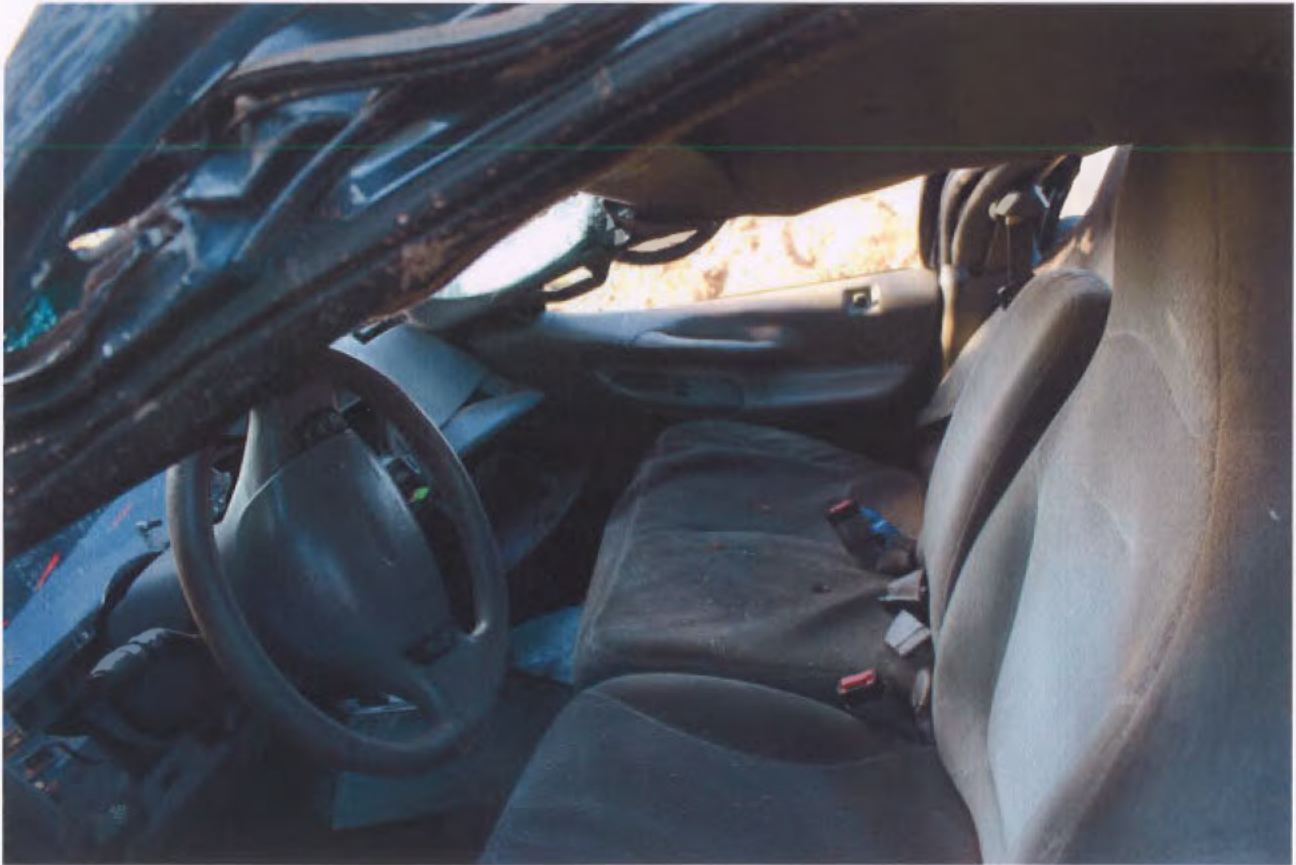
View: Close-Up
Description: VEH Damage

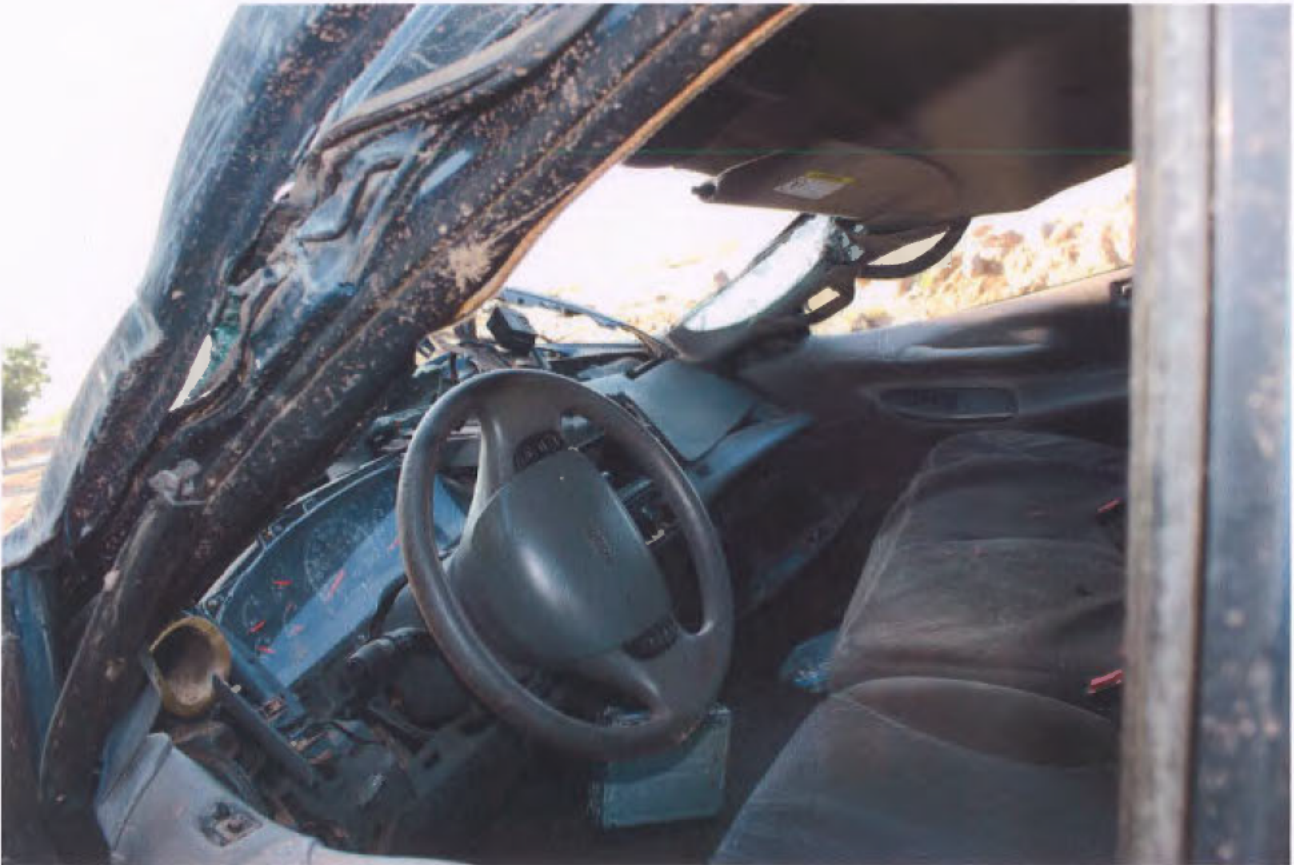
View: Close-Up
Description: VEH Damage

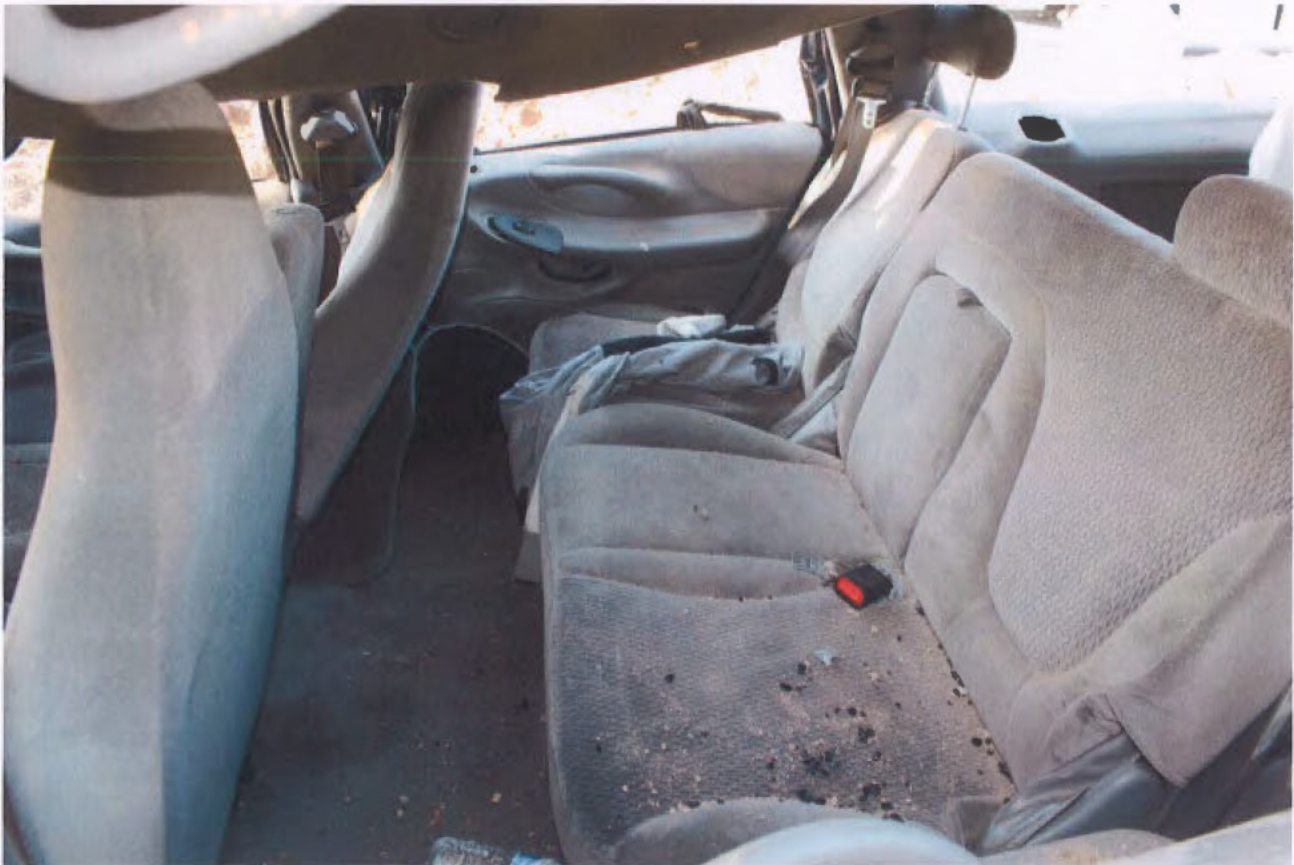
View: Close-Up
Description: VEH Damage

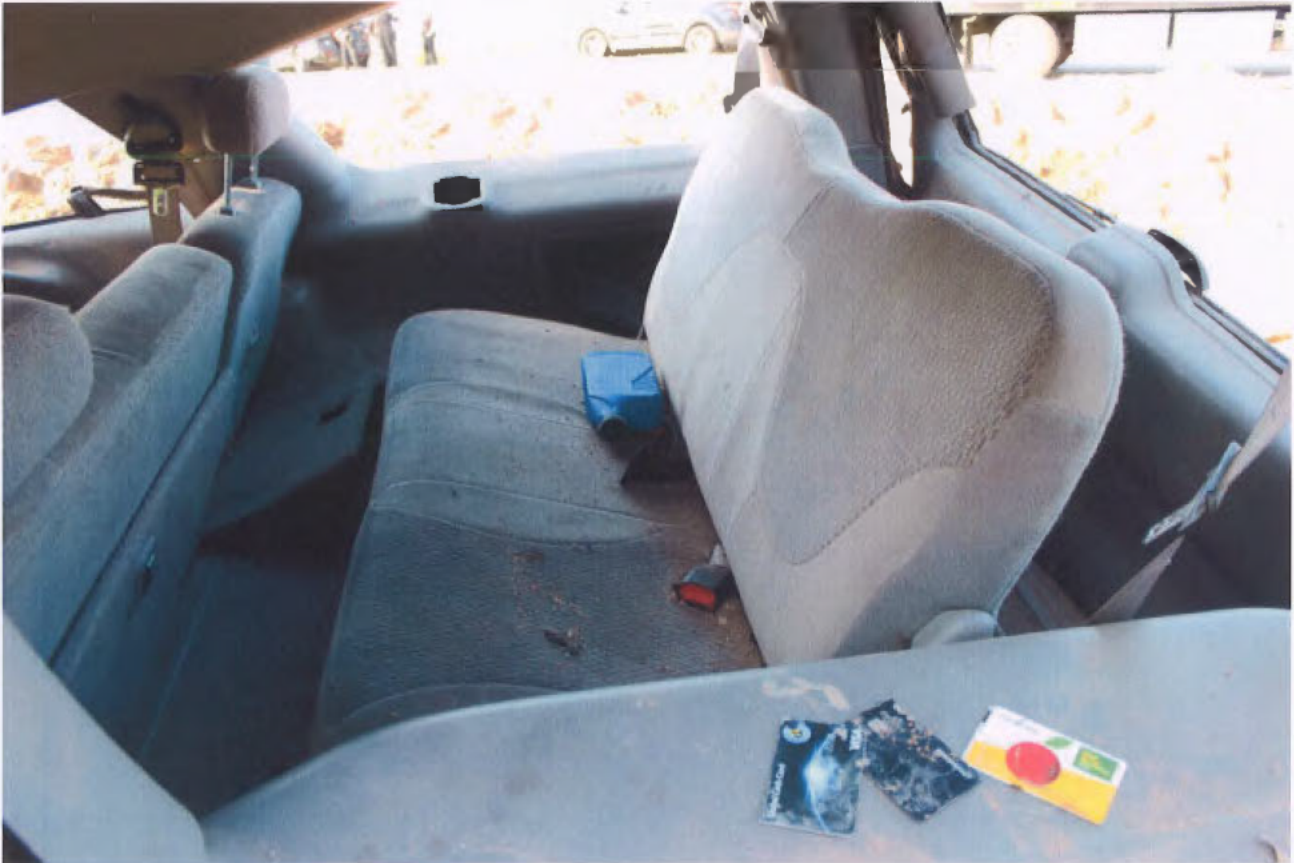
View: Close-Up
Description: VEH Damage

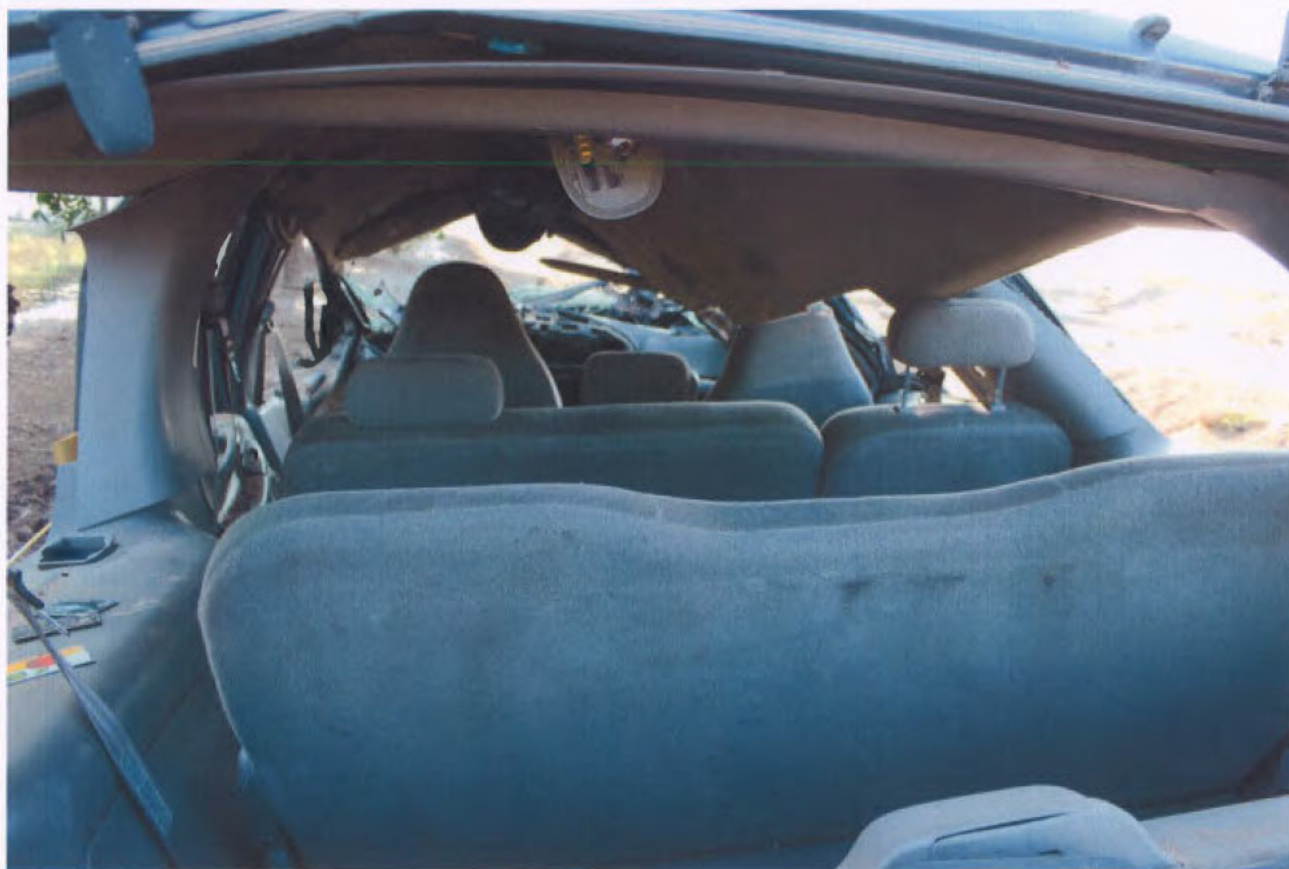
View: Close-Up
Description: VEH Damage

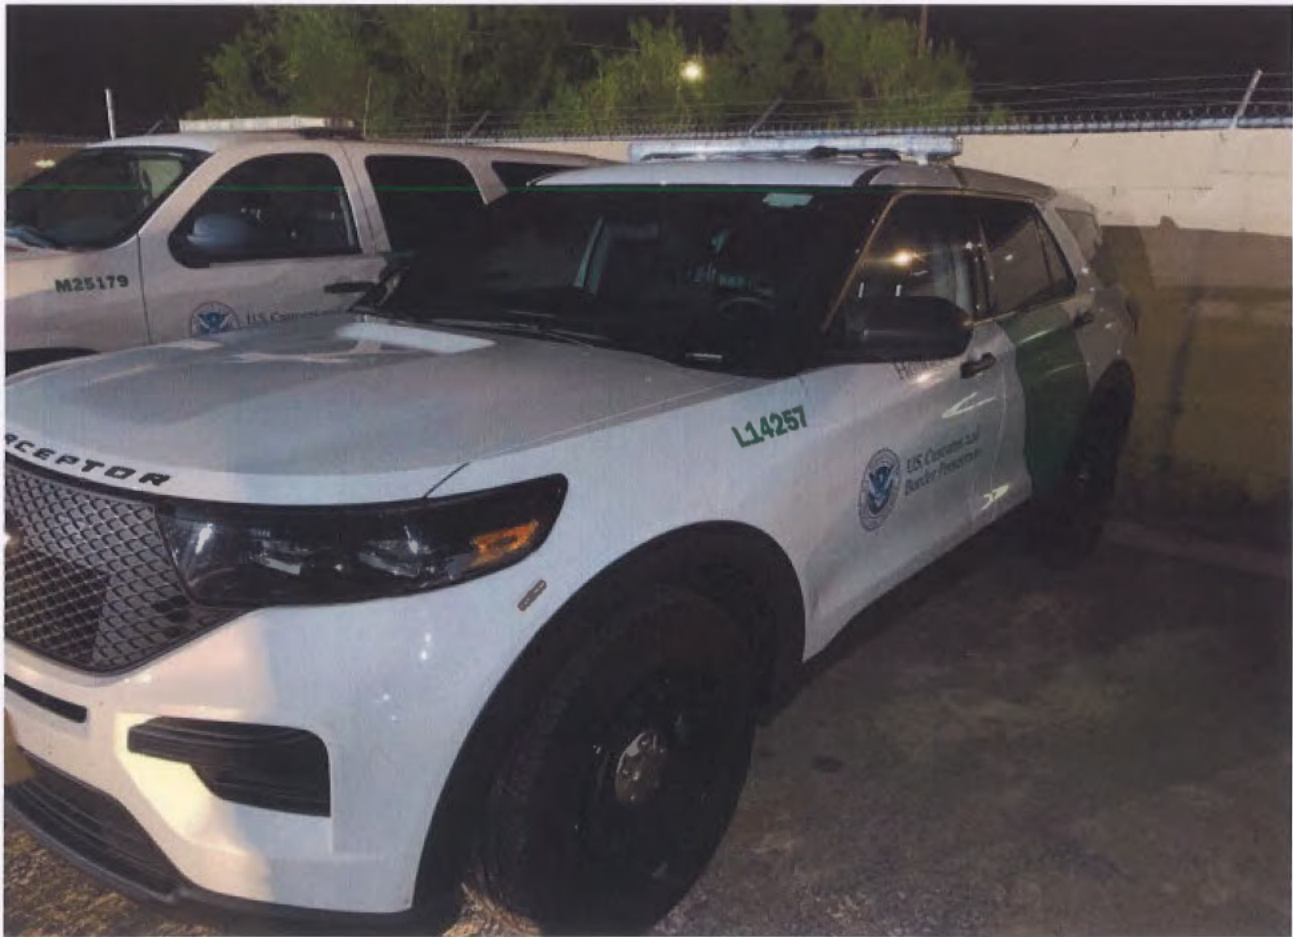
On August 9, 2021, CIT Investigator [REDACTED] reached out to WC [REDACTED] to request photographs of the Government Owned Vehicles (GOVs) BPAs [REDACTED] were driving. Photographs of both GOVs show no damage and indicate no contact was made between GOVs and VEH. **(See Section H; Scene Photographs).**

Description: GOV-1

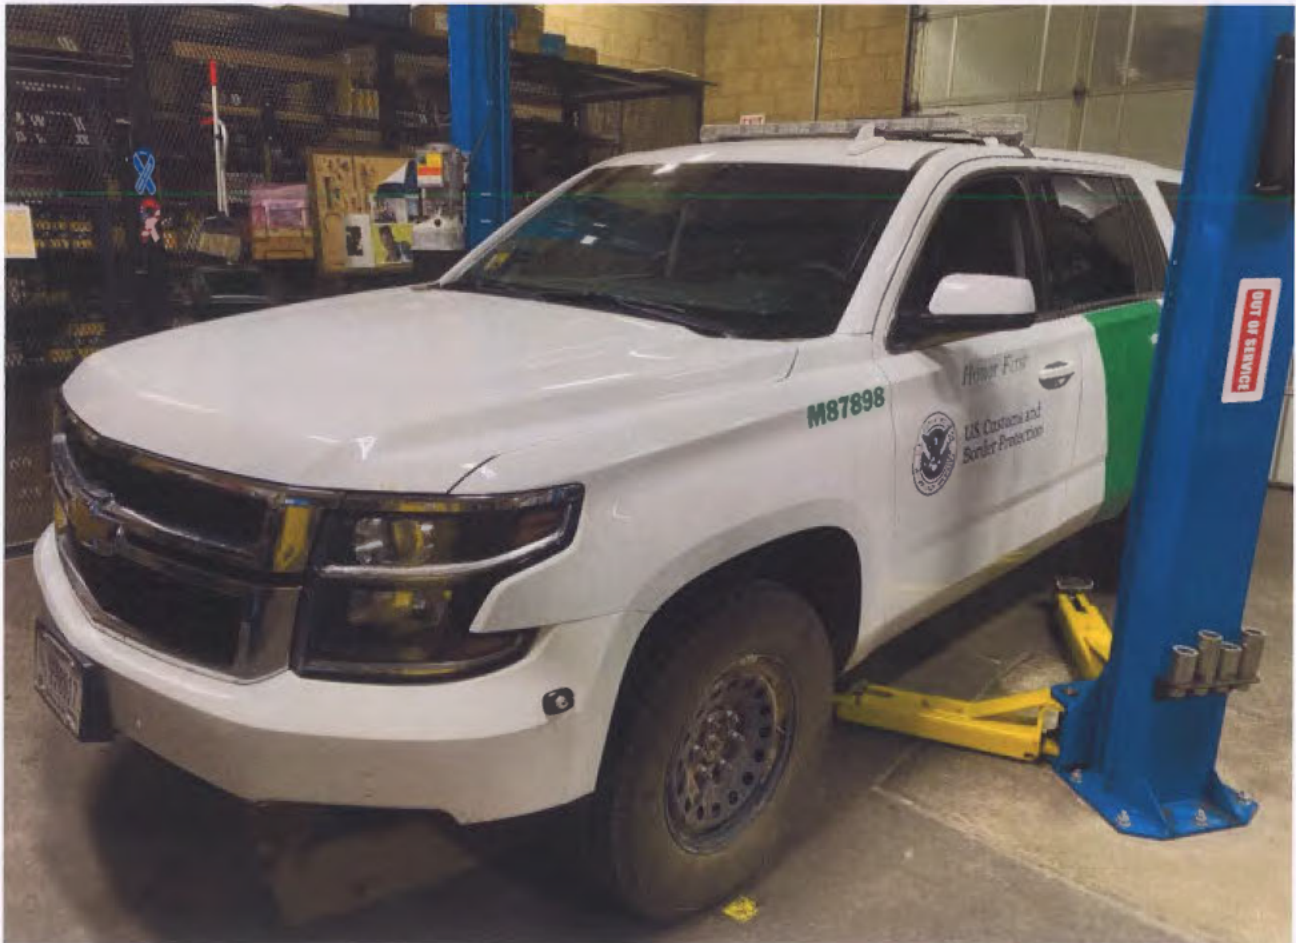
Description: GOV-2

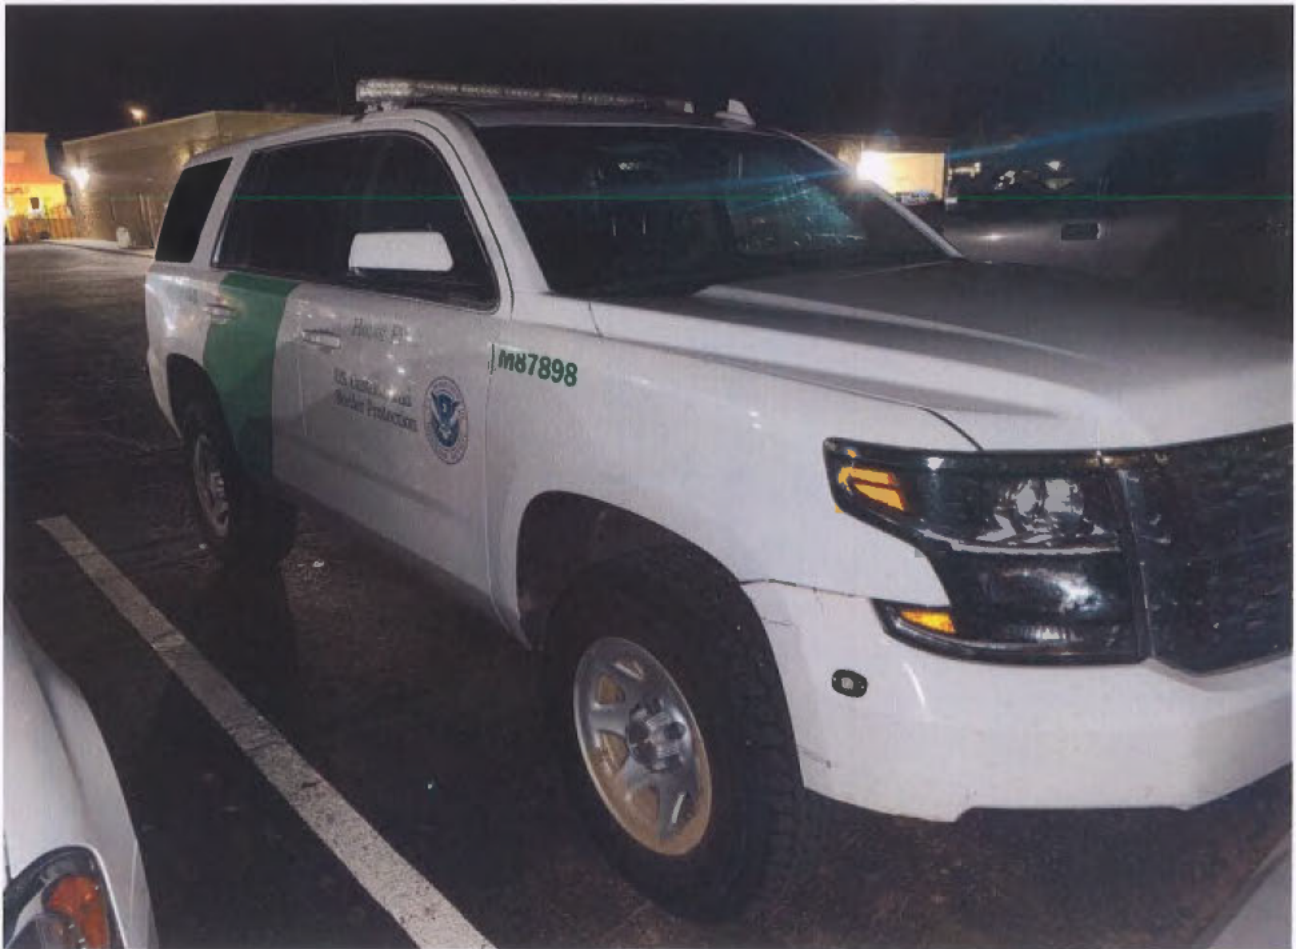
Description: GOV-2

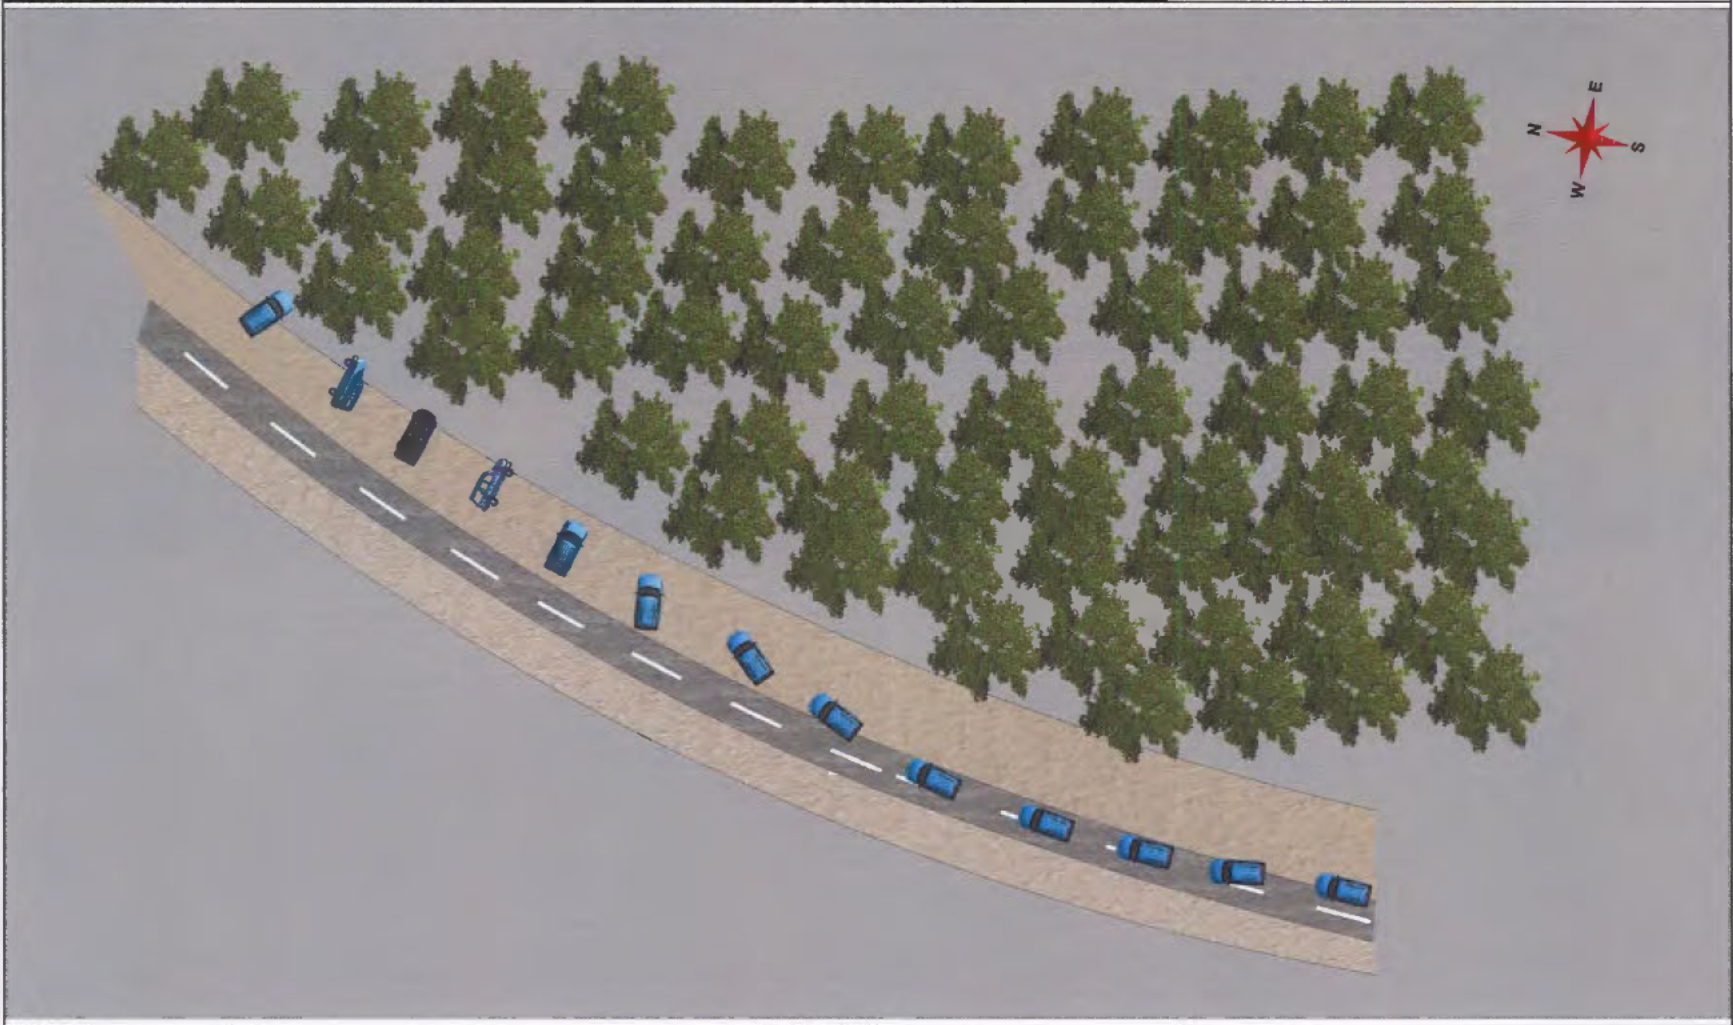
CIT Investigators [REDACTED] documented the scene by measuring and diagramming the scene with the use of the Canon Total Station. **(See Section I; Scene Diagram).**

NMSP Patrolman [REDACTED] investigation found that VEH drifted off the right side of the roadway. Driver jerked steering wheel to the left causing VEH to enter a counterclockwise critical speed yaw. VEH slid off the right side of the roadway where wheels furrowed into the dirt shoulder causing VEH to roll at least one full rotation before coming to rest on its wheels facing east. **(See Section G; Other Agency Reports).**

Drawn By:	Location:
[REDACTED]	NM HWY-185, Mile Marker 29
Date Drawn:	Incident Date:
08/23/2021	08/03/2021
Scale	Case
Not to Scale	CIT-210803-119
