Memorandum

Date: April 25, 2022

Subject: Champlain Towers South Condominium Collapse
Victim Identification Report:
Theresa Velasquez
Valeria G. Barth

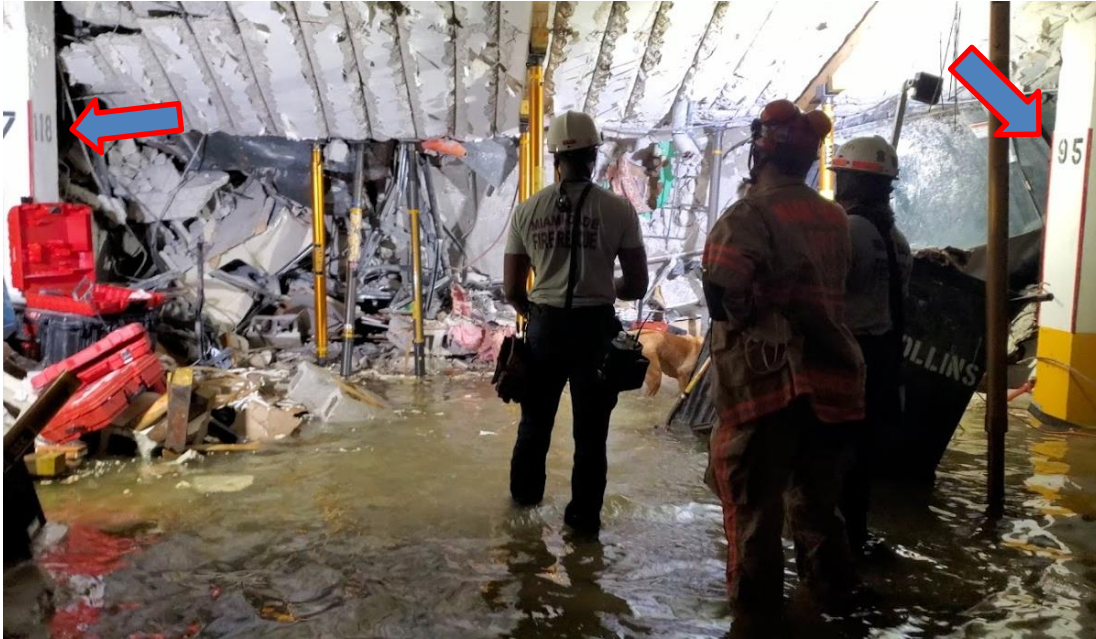
Image 1: Rescue Crew operating between parking columns 95 and 118

minutes. According to the technical rescue crews, the power generator's closest location was on the south side of the Champlain Towers South building, approximately 300'-400' from where the work was conducted. According to rescue crews, their operation was located on the extreme far north side of the building. As seen in *Image 1*, the area our rescue crews were working was between parking spots 95 and 118, as seen on the vertical columns.

5. On July 8th, Ms. Velasquez's remains were located and removed by one of the FEMA taskforces. On July 12th, FEMA taskforce crews were able to retrieve two Paratech pneumatic shores that were left underneath the parking garage where initial rescue crews made entry to conduct operations, as seen in *Image 1*. These two Paratechs were too risky to remove on June 24th, and

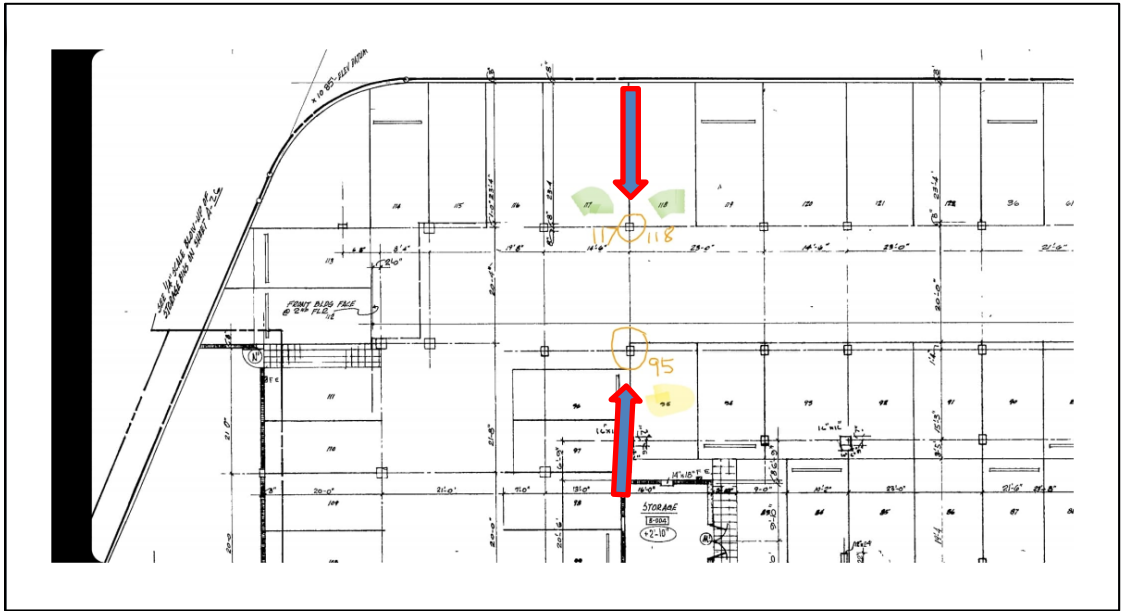
Illustration 1: Location of parking columns 95 and 118 in the parking garage.

By reviewing *Illustration 1*, a floor plan of the garage area, the two vertical columns are noted as being on the far north side of the property. As a result of the distance, crews exceeded the tool manufacturer's recommended cord length at times by 300'. However, our rescue crews would adapt and overcome.

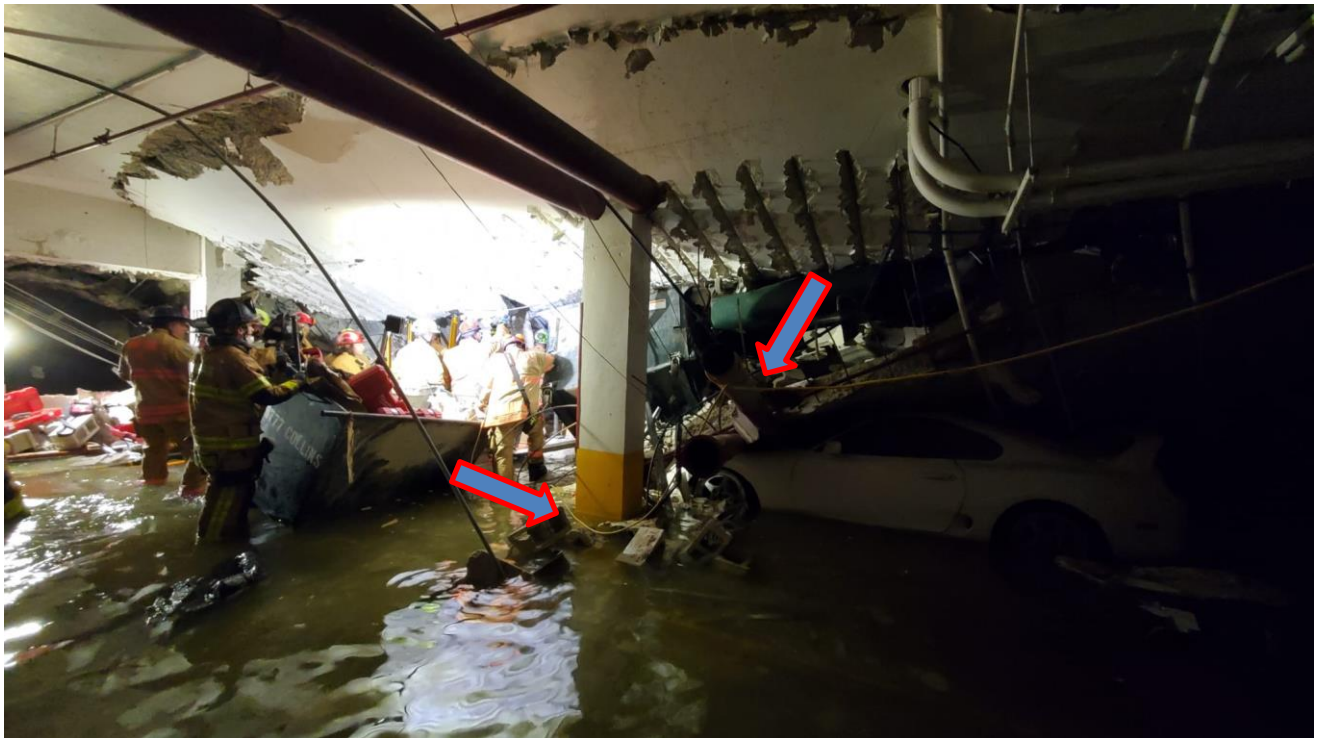
Image 3 - Electrical cords were daisy-chained

In addition, electrical cords were daisy-chained on hanging rebar and on top of vehicles to avoid the cords from getting wet, as seen in *Image 3*.

While working in standing water, rescue crews were electrically shocked as they operated the jackhammers due to the moisture in the electrical lines. These issues were one of many complexities

that rescuers constantly encountered as water and moisture continued to affect electrical cords further tripping the ground fault circuit indicators (GFCI). The GFCI could not be reset until the electrical cords were dry or moisture-free. Though the USA Today article correctly identified some issues that rescuers encountered, as noted above; however, the reasons why our rescue crews had these issues, as stated in the newspaper article, are not factual.

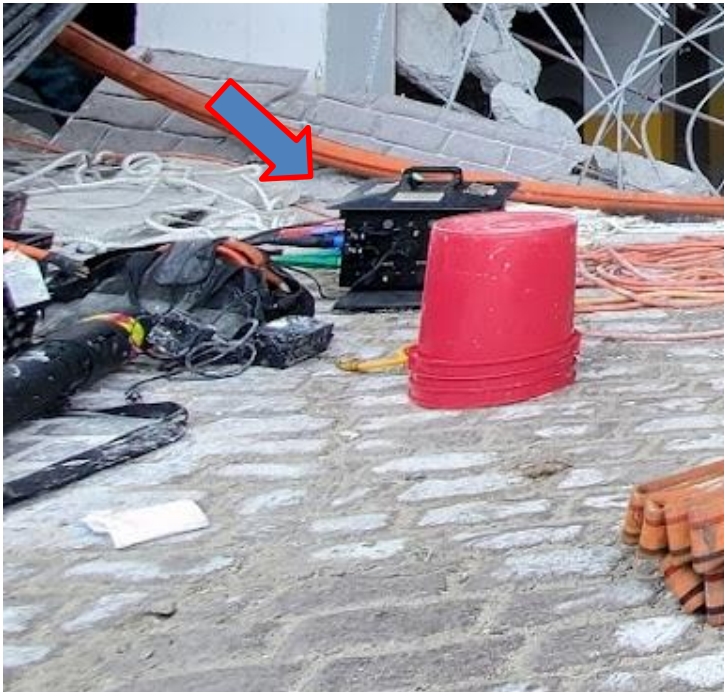
Image 3: Portable distribution box

The rescuers advised that the claim made by the reporter that the rescuers lacked proper tools to handle the search and rescue operations is baseless and nonfactual. According to the rescuers, all technical rescue equipment necessary for immediate breaching and breaking was available at their request, in excellent working order. The interviewed rescuers advised that the USAR Hackney apparatus was onsite with the necessary heavy hand tools (to view the cache in the Hackney, click this [Hackney Equipment List link](#)). As the rescuers explained repeatedly, it was not an equipment issue but rather a moisture and voltage issue that could not be resolved due to the conditions of the collapse that were not in the control of the rescuers. The power cords, at times were beyond the manufacturer's recommendation, reducing the necessary voltage needed for the tool to run optimally, and moisture continued to trip the GFCI. A search for openings on the west and north sides of the building to bring the generators closer to the working area and reduce the length of power cords were unsuccessful. Several portable distribution boxes, as seen in *Image 3*, were used to safely distribute electricity from the generator to other devices in a circuit. It typically has one input and multiple outputs, allowing several devices to be connected to the distribution box rather than directly to the power source. This makes things safer, more efficient and more convenient.

Additionally, one of its key advantages is that it reduces the chances of blown fuses or even dangerous short-outs. However, the rescue crews continued to encounter tripped GFCIs as moisture got into the electrical lines. Additionally, the rescuers advised that the search camera batteries did run out momentarily; however, a charged battery was inserted within minutes.

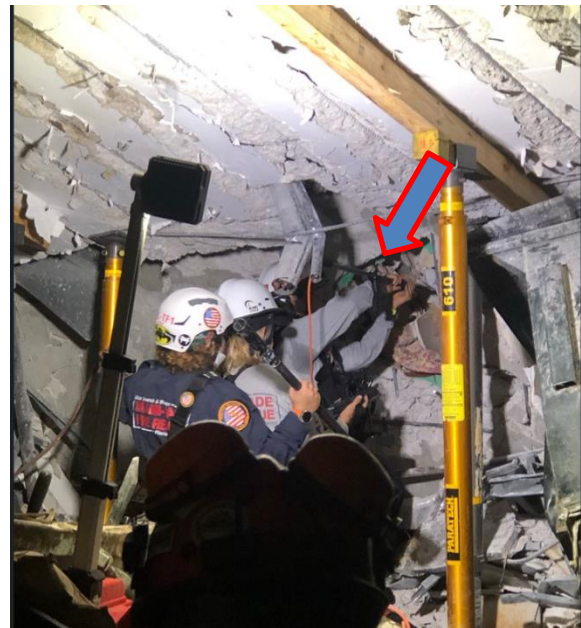
Image 4: Search camera used to view behind the slab.

The slab that the crews were breaching and cutting in *Image 4* shows our rescue crews utilizing cameras to inspect the area behind the slab. Radio communications reported a mattress was behind the slab after the camera inspected the area behind the slab.

There was no report of a victim, alive or deceased. Locating a patient, alive or deceased, is a department benchmark that would have been communicated over the radio. Additionally, the rescue crews reaffirmed that there were no victims behind the slab during the interviews, just a mattress. The circular saws with the water line connection the newspaper reporter claimed that MDRF was lacking are also nonfactual. MDRF had a Stanley Twin Circuit Portable Hydraulic unit on hand, one version of the saw the reporter erroneously reported we were not equipped with. However, the water spigot was 600' away, so a water line was not an option. Additionally, these saws are used to cut concrete in a straight precision line and reduce concrete dust when water is used. Therefore, these saws may be utilized without water connections when necessary. Finally, these saws are not designed for cutting large gauge rebar, as the water would destroy the hot blade. To summarize, even if a water line was used on a Stanley saw, rescue crews would still need to switch saws to utilize a metal cutting blade to cut through the large gauge rebar. The assets of the Hackney may be viewed in the by accessing the [Hackney Equipment List link](#).

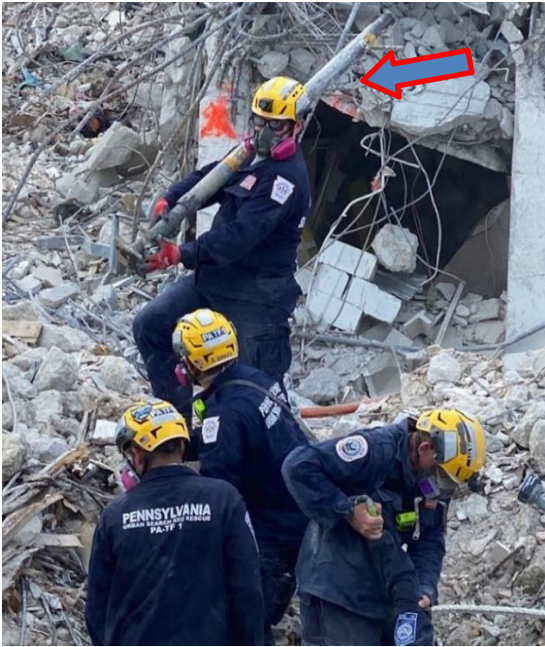
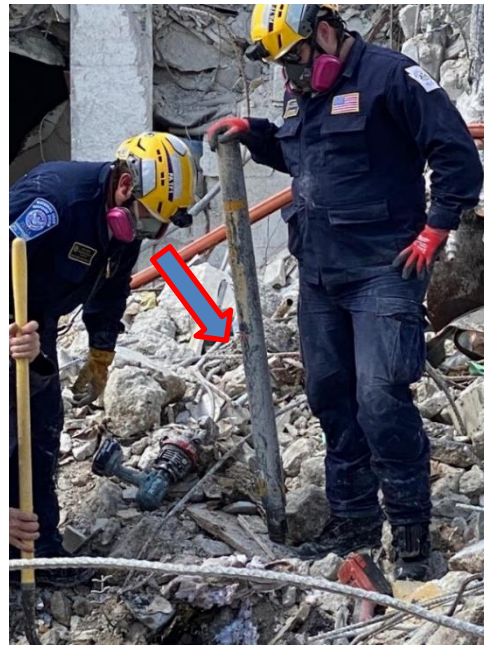
Image 5: Paratech devices removed near Theresa Velasquez. Image 6: Paratech devices removed near Theresa Velasquez

the decision was made to leave them behind. The Paratechs were found approximately 15' from where Ms. Velasquez's remains were found. This is physical evidence that the equipment was located within the boundaries described by the rescuers and in accordance with where Ms. Velasquez remains were ultimately located (see *Image 5 and 6*).
