December 14, 2022

RE: Request for Immediate U.S. Environmental Protection Agency (EPA) Action to Abate Benzene Emissions and Other Toxic Air Pollution in Monongahela River Valley Communities in Allegheny County, Pennsylvania

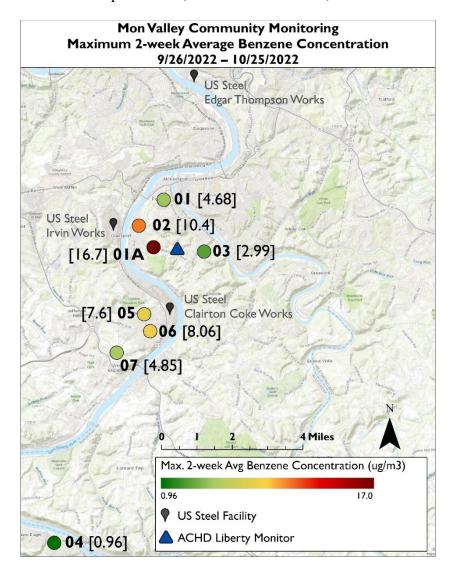
Between September 25, 2022 and October 25, 2022, all eight monitors in the Mon Valley recorded a new peak two-week average concentration compared to prior sampling periods. See Attachment B for laboratory results. During the October 11, 2022 to October 25, 2022 monitoring period, the average concentration of benzene at Monitoring Station 01A was 16.7 μg/m3. Monitoring Station 02 recorded a two-week average concentration of 10.4 μg/m3 for the same period. The map below shows the highest two-week average concentration recorded at each

monitoring station between September 25, 2022 and October 25, 2022.

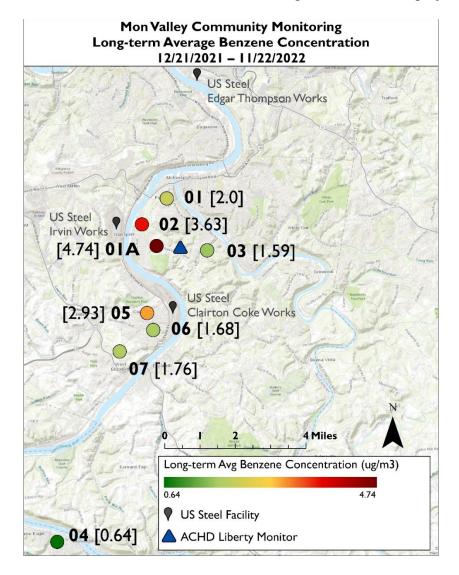
In addition, the long-term two-week average at Monitoring Station 01A and 02 are above 3 $\mu g/m3$, the California Reference Exposure Level (REL) for benzene. Monitoring Station 05 in Clairton is approaching this threshold at 2.93 $\mu g/m3$. The map below shows the long-term average benzene concentration recorded at each Monitoring Station since the project began.

Attachment D also provides the long-term average benzene concentrations at each monitoring station.

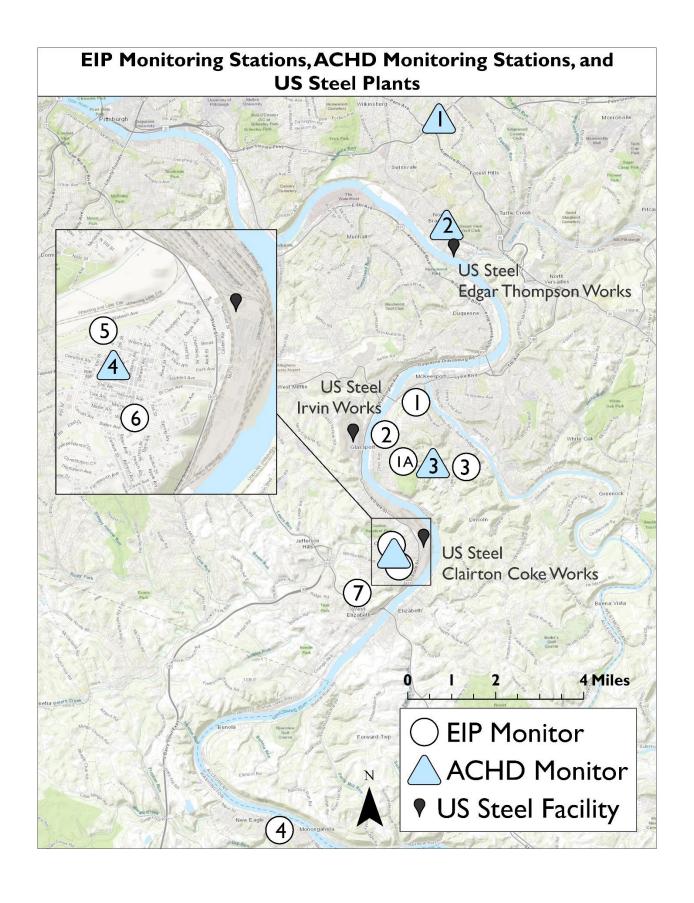
During the month of October while residents were forced to endure high levels of PM2.5 and hydrogen sulfide, passive air monitors located in the community near the U.S. Steel plants recorded alarmingly high concentrations of benzene. EIP, in partnership with the Breathe Project and the Carnegie Mellon University (CMU) Create Lab, installed eight passive benzene monitoring stations in the Mon Valley between 0.6 and 7.25 miles away from the Clairton plant in December of 2021. Six out of the eight monitors are located within two miles of the Clairton and Irvin Works plants. Monitoring Station 01A and 02 in Glassport are located approximately 0.7 and 1.3 miles from the ACHD Liberty Borough monitor, respectively. The passive benzene monitoring tubes are provided and analyzed by Enthalpy Analytical using EPA Method 325A/B. The sampling tubes collect two-week average benzene concentrations and are the same tubes and methods used by refineries to monitor benzene concentrations at fencelines in accordance with federal rules. EIP also collects a blank sample every two-week period. See Attachment A for locations of monitoring stations.

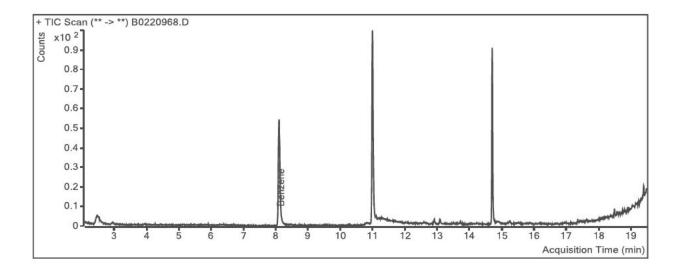
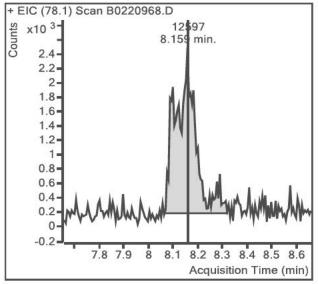
Compound	Retention Time	Response	Flags	
benzene-d6 (IS)	8.10	677,582		
Benzene	8.16	12,597

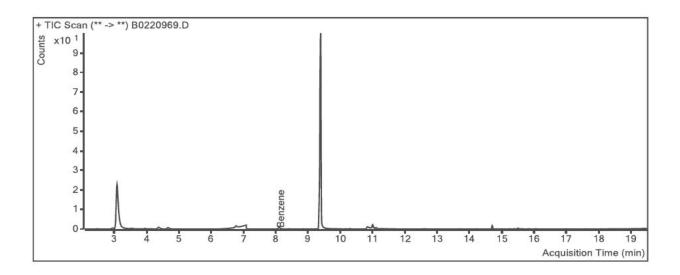
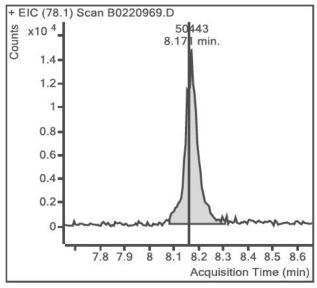
Sample Name : EIMPA-02-B-20220926

Compound	Retention Time	Response	Flags	
benzene-d6 (IS)	8.10	679,813		
Benzene	8.16	50,443

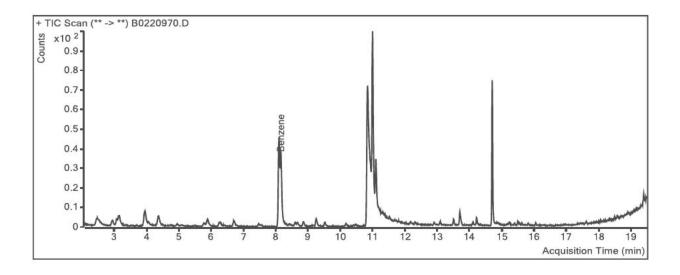
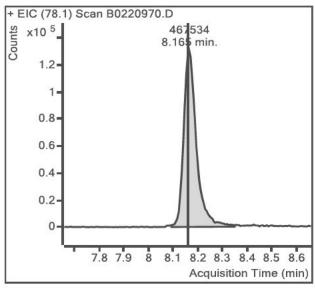
Sample Name : EIMPA-01-S-20220926

Compound	Retention Time	Response	Flags
benzene-d6 (IS)	8.10	690,179	
Benzene	8.16	467,534

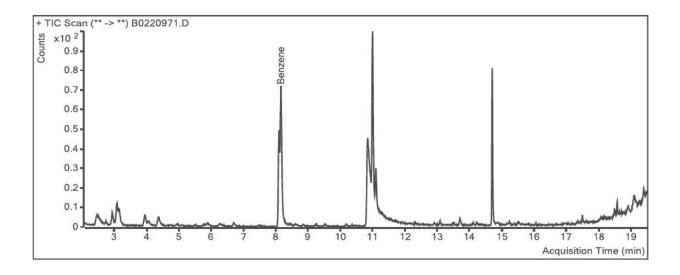
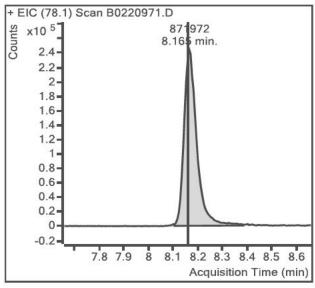
Sample Name : EIMPA-01A-S-20220926

Compound	Retention Time	Response	Flags	
benzene-d6 (IS)	8.10	671,399		
Benzene	8.16	871,972

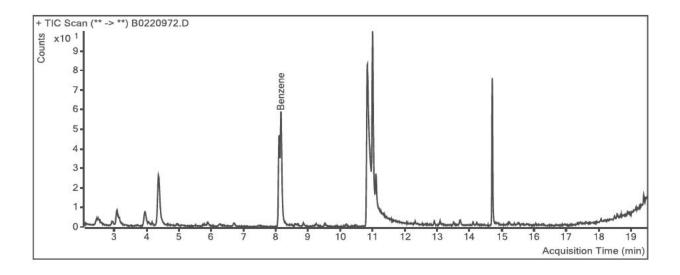
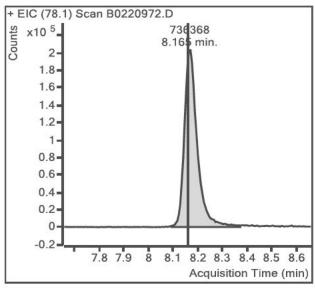
Sample Name : EIMPA-02-S-20220926

Compound	Retention Time	Response	
benzene-d6 (IS)	8.10	664,311	
Benzene	8.16	736,368

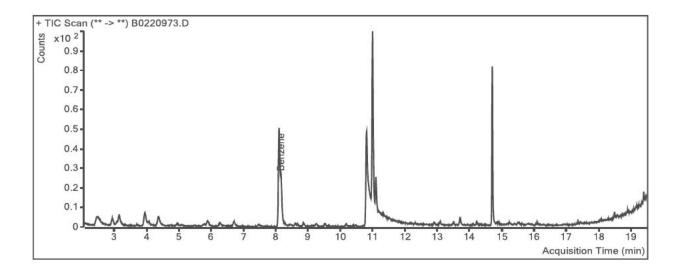
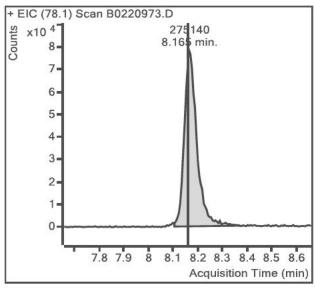
Sample Name : EIMPA-03-S-20220926

Compound	Retention Time	Response	
benzene-d6 (IS)	8.10	668,292	
Benzene	8.16	275,140

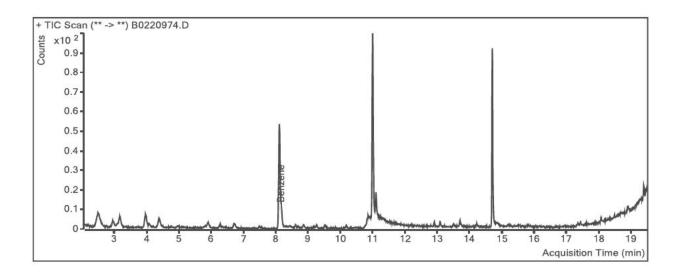
Sample Name : EIMPA-04-S-20220926

Compound	Retention Time	Response	Flags	
benzene-d6 (IS)	8.10	493,262		
Benzene	8.16	74,264

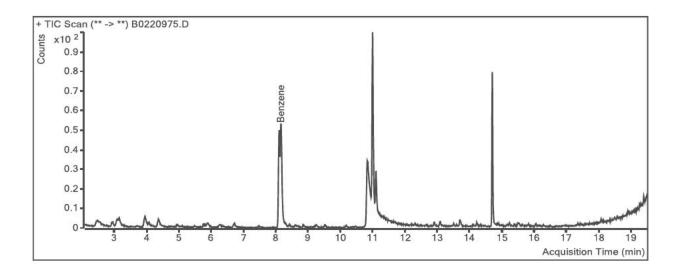
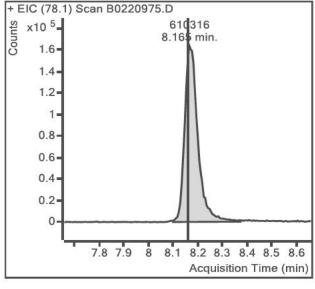
Compound	Retention Time	Response	Flags	
benzene-d6 (IS)	8.10	650,494		
Benzene	8.16	610,316

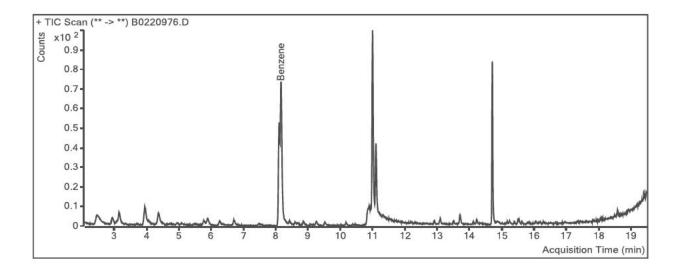
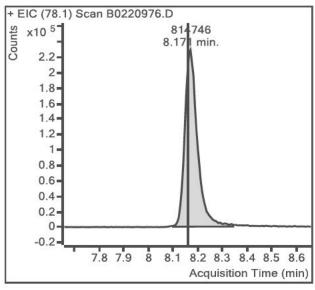
Sample Name : EIMPA-06-S-20220926

Retention Time	Response	Flags	
benzene-d6 (IS)	8.10	644,630		
Benzene	8.16	814,746

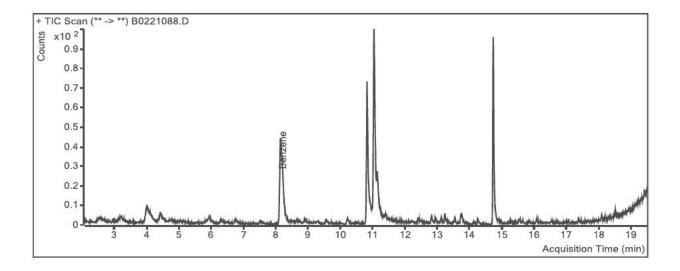
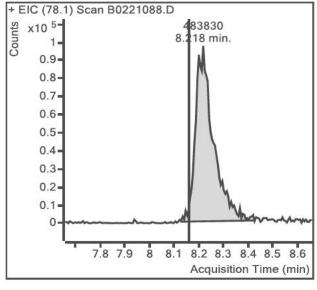
Sample Name : EIMPA-07-S-20220926

Retention Time	Response	Flags
benzene-d6 (IS)	8.10	1,587,558	
Benzene	8.16	483,830

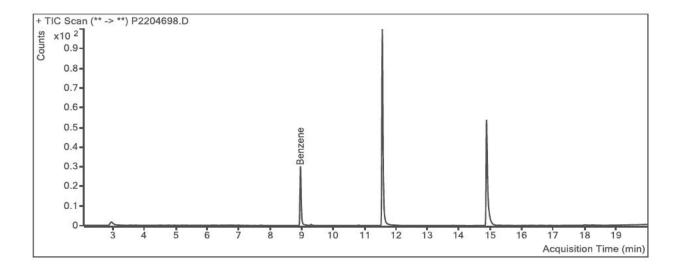
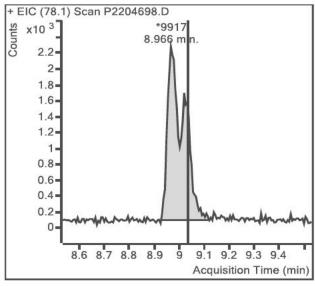
Compound	Retention Time	Response		
benzene-d6 (IS)	8.97	886,282		
Benzene	9.03	9,917	m

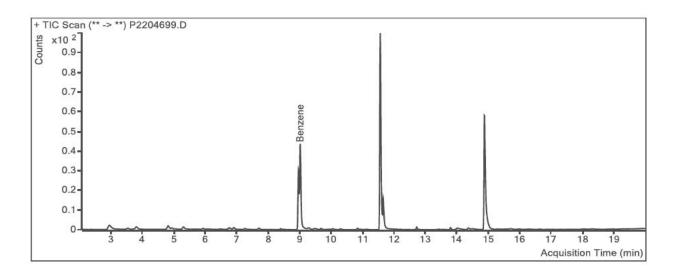
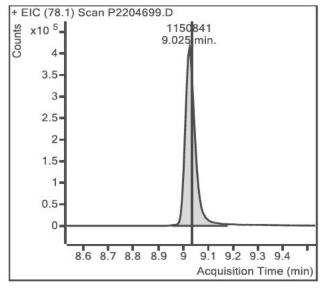
Sample Name : EIMPA-02-S-20221011

Compound	Retention Time	Response	Flags	
benzene-d6 (IS)	8.97	896,543		
Benzene	9.03	1,150,841

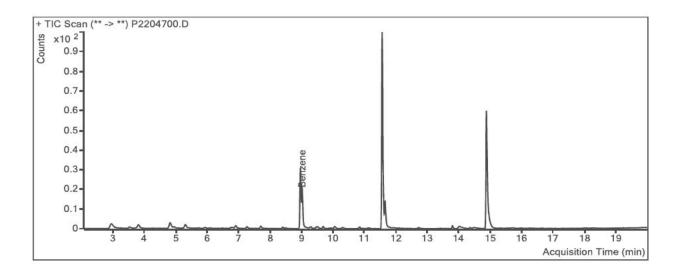
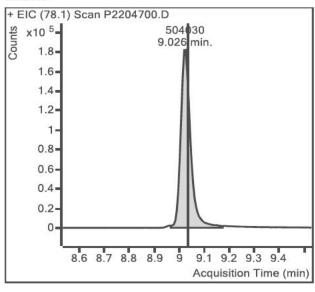
Sample Name : EIMPA-01-S-20221011

Compound	Retention Time	Response	Flags	
benzene-d6 (IS)	8.97	877,902		
Benzene	9.03	504,030

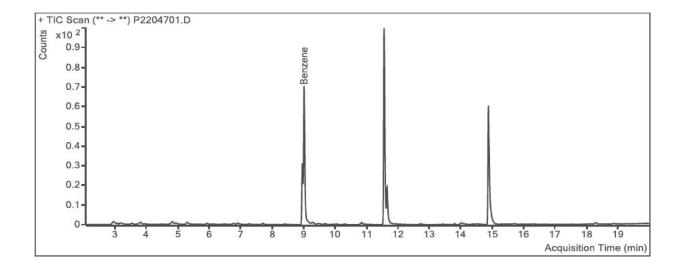
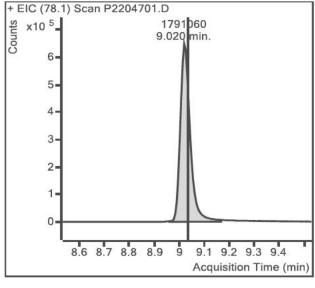
Sample Name : EIMPA-01A-S-20221011

Compound	Retention Time	Response	Flags	
benzene-d6 (IS)	8.97	870,646		
Benzene	9.03	1,791,060

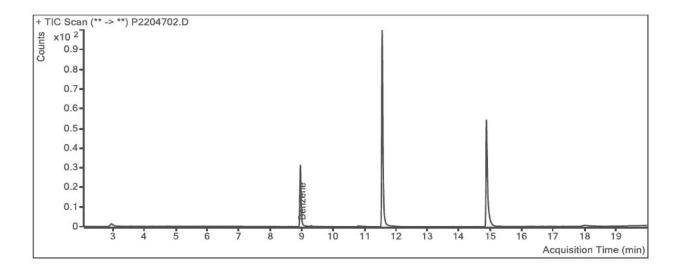
Retention Time	Response		
benzene-d6 (IS)	8.97	879,096		
Benzene	9.03	15,304	m

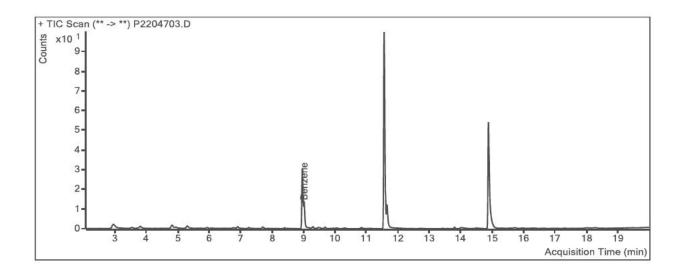
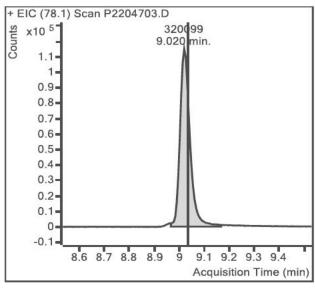
Compound	Retention Time	Response	Flags	
benzene-d6 (IS)	8.97	871,714		
Benzene	9.03	320,099

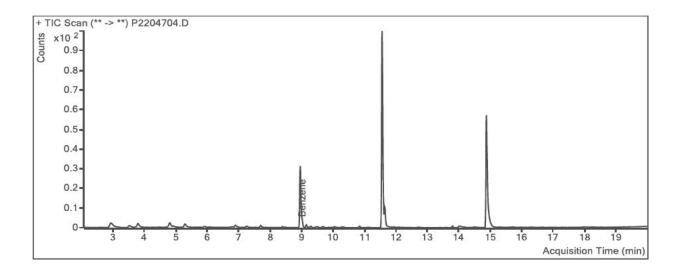
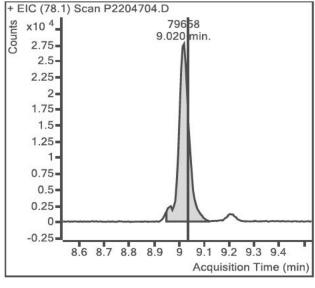
Sample Name : EIMPA-04-S-20221011

Compound	Retention Time	Response	Flags	
benzene-d6 (IS)	8.97	877,234		
Benzene	9.03	79,658

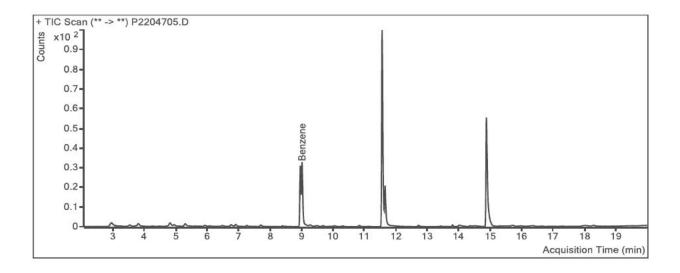
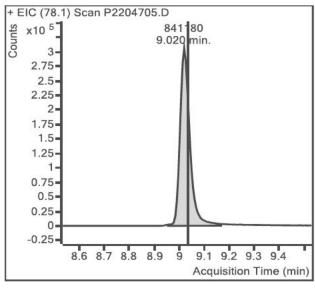
Sample Name : EIMPA-05-S-20221011

Compound	Retention Time	Response	Flags	
benzene-d6 (IS)	8.97	899,922		
Benzene	9.03	841,180

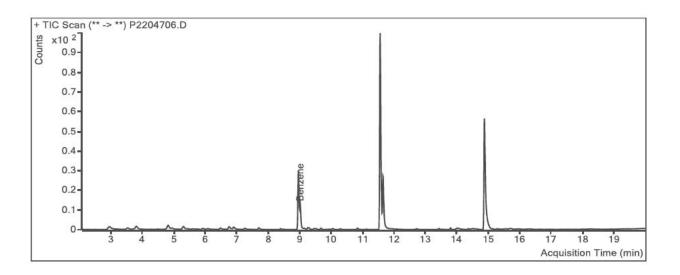
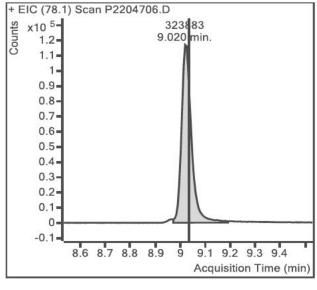
Sample Name : EIMPA-06-S-20221011

Compound	Retention Time	Response	Flags	
benzene-d6 (IS)	8.97	878,031		
Benzene	9.03	323,883

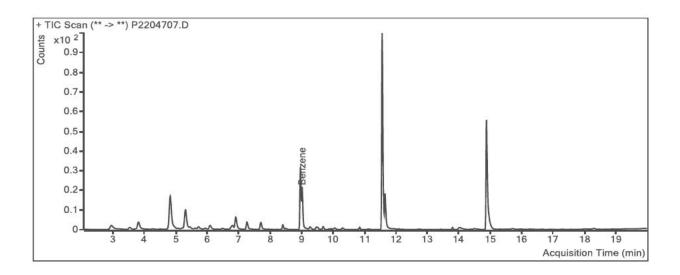
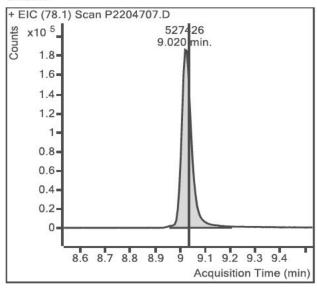
Sample Name : EIMPA-07-S-20221011

Compound	Retention Time	Response	Flags	
benzene-d6 (IS)	8.97	884,550		
Benzene	9.03	527,426

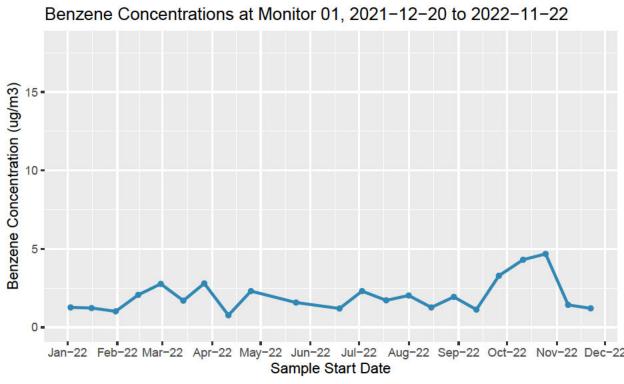
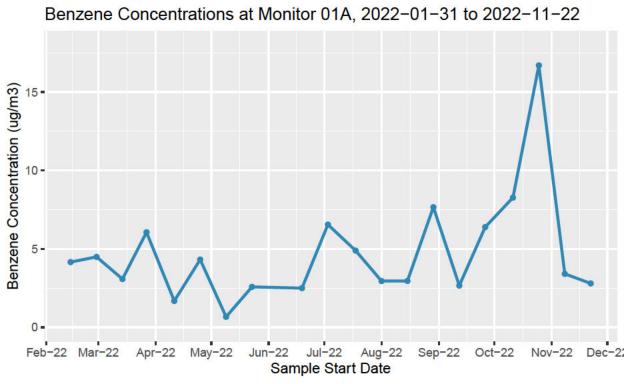
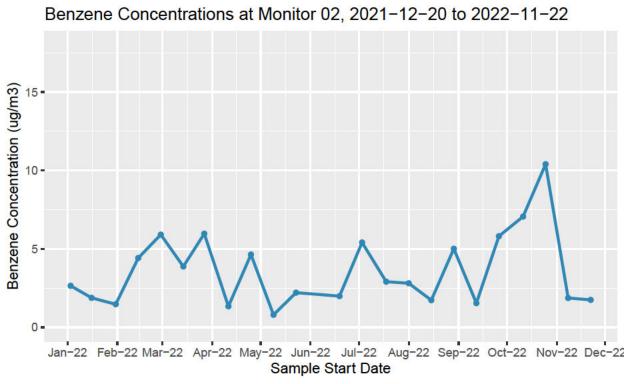
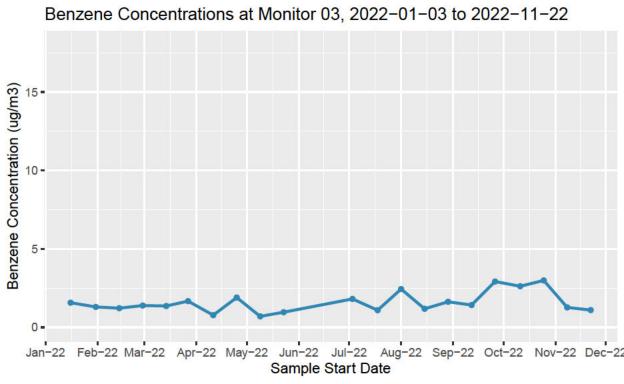
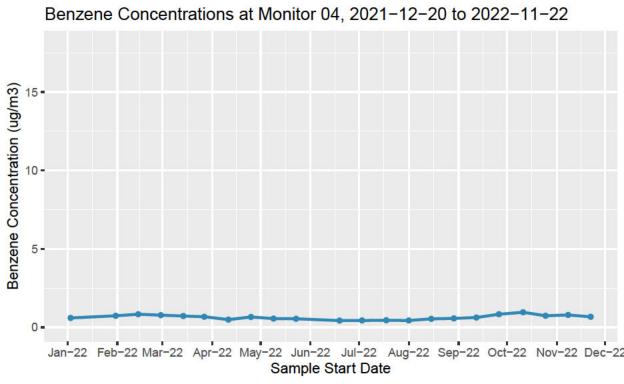
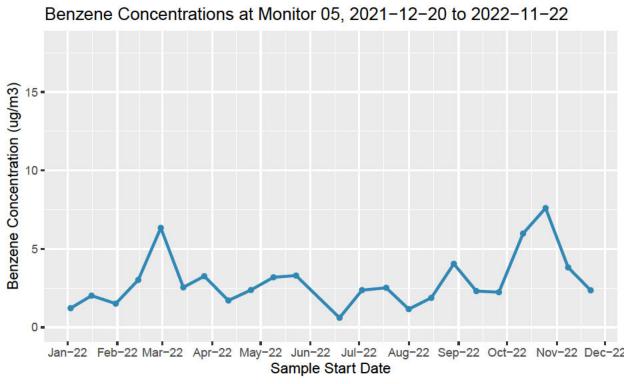
Attachment C provides all two-week average concentrations recorded at each monitoring station since the project began in December of 2021.
