IN THE IOWA DISTRICT COURT FOR SCOTT COUNTY

PETITION AT LAW

1. On May 28, 2023, just before 5:00 p.m., the six-story apartment building known as The Davenport located at 324 N. Main Street in Davenport, Iowa (“The Davenport”) suffered a catastrophic failure and partial collapse, burying multiple residents under a mountain of rubble, inflicting devastating injuries on others, and destroying numerous apartment units. The remaining structure has been deemed dangerously unstable and complete demolition of the structure and all remaining units is imminent.

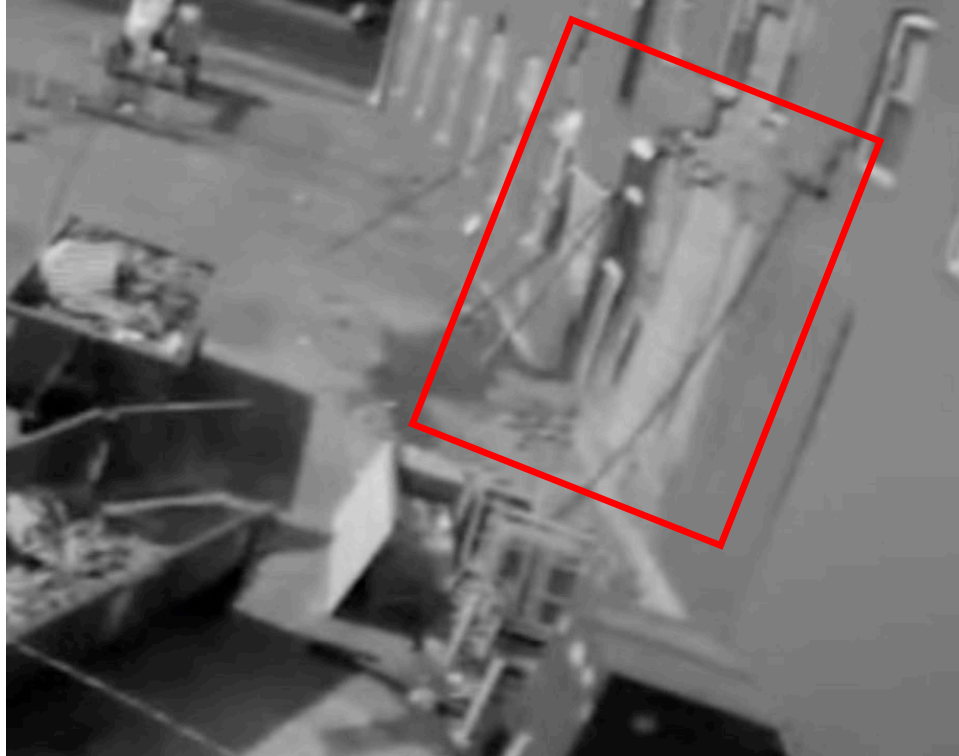
40. The area of the wall that was the subject of numerous warnings, violations, and inspections for years was the portion of brick façade and underlying CMU wall on the first floor of the structure immediately to the right of the entrance door.

41. As shown further in this Petition, this area of the wall was badly deteriorated and imminently dangerous and work was ongoing on this portion of the wall at the time of the collapse. The bracing supports seen in the surveillance footage were completely ineffective and, upon information and belief, were put up to give the appearance of safety than to actually act as proper structural supports.

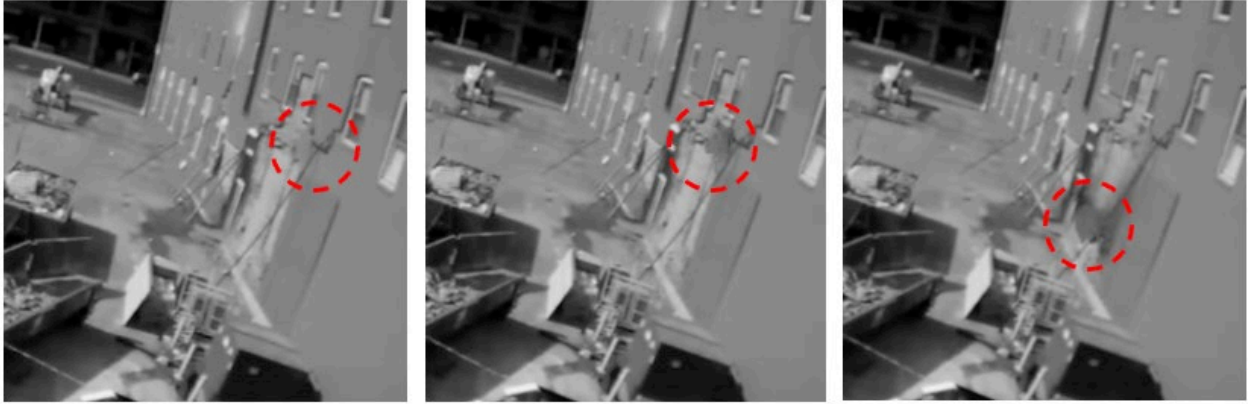
42. Approximately one minute and forty-five seconds before the catastrophic collapse a section of the brick façade that were previously identified as imminently hazardous began to fall away, stripping away the west exterior wall's vertical and lateral support.

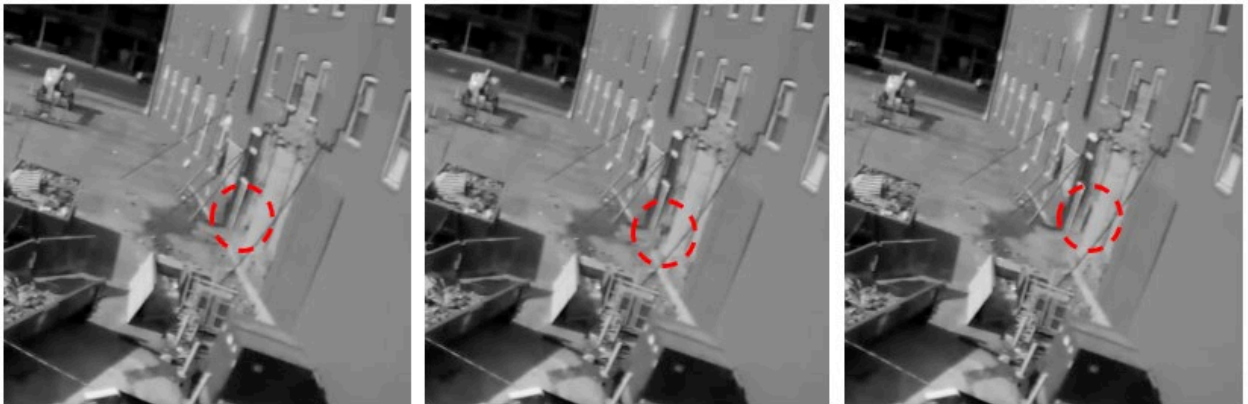
43. Approximately 56 seconds before the catastrophic collapse more bricks crumbled out of the bottom of the wall, stripping away even more of the wall's structural support.

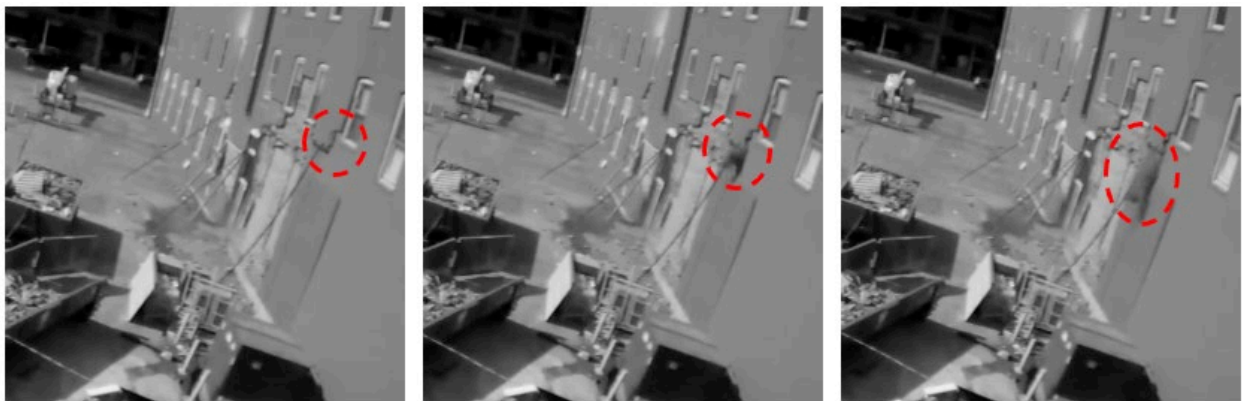
44. Approximately 44 seconds before the catastrophic collapse more bricks from the area previously identified as imminently hazardous fell away.

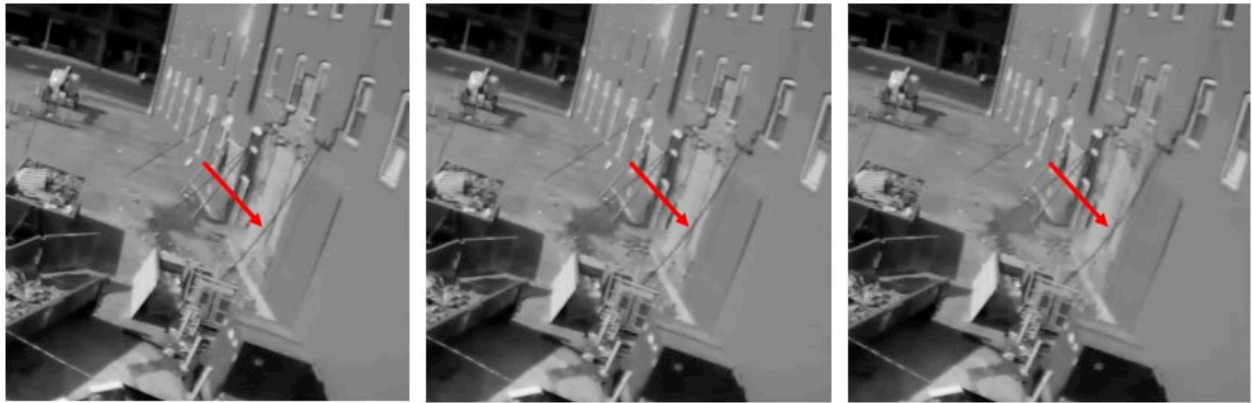
45. As sections of the wall continued to fall out, the wall was gradually robbed of what little structural stability it had left. The ineffective support brace in the area of the collapse can be seen bending more and more under the gradually increasing load that was bearing down upon that section of damaged wall.

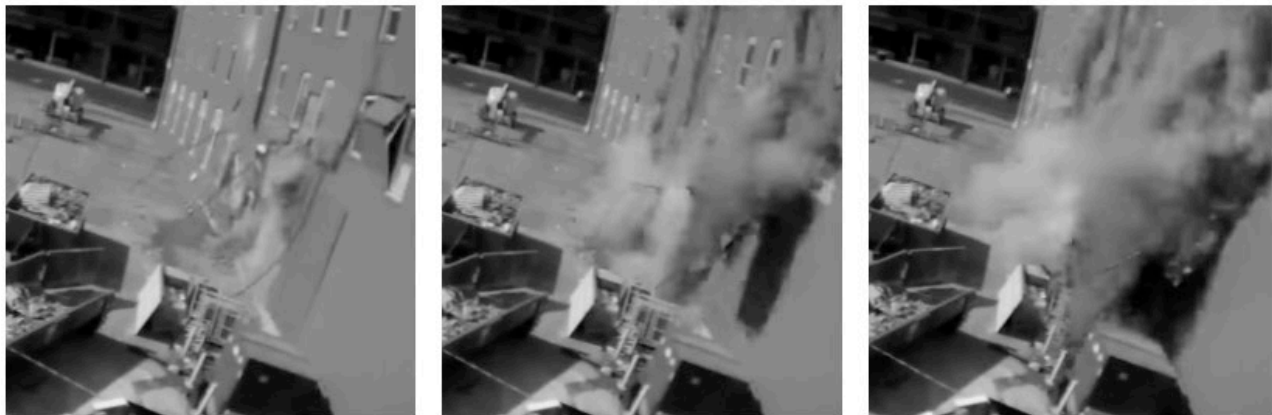
46. After numerous sections of brick had fallen from the wall and it lost its vital structural support, the brick wall catastrophically collapsed, pulling the underlying CMU wall and structural members of the building with it.

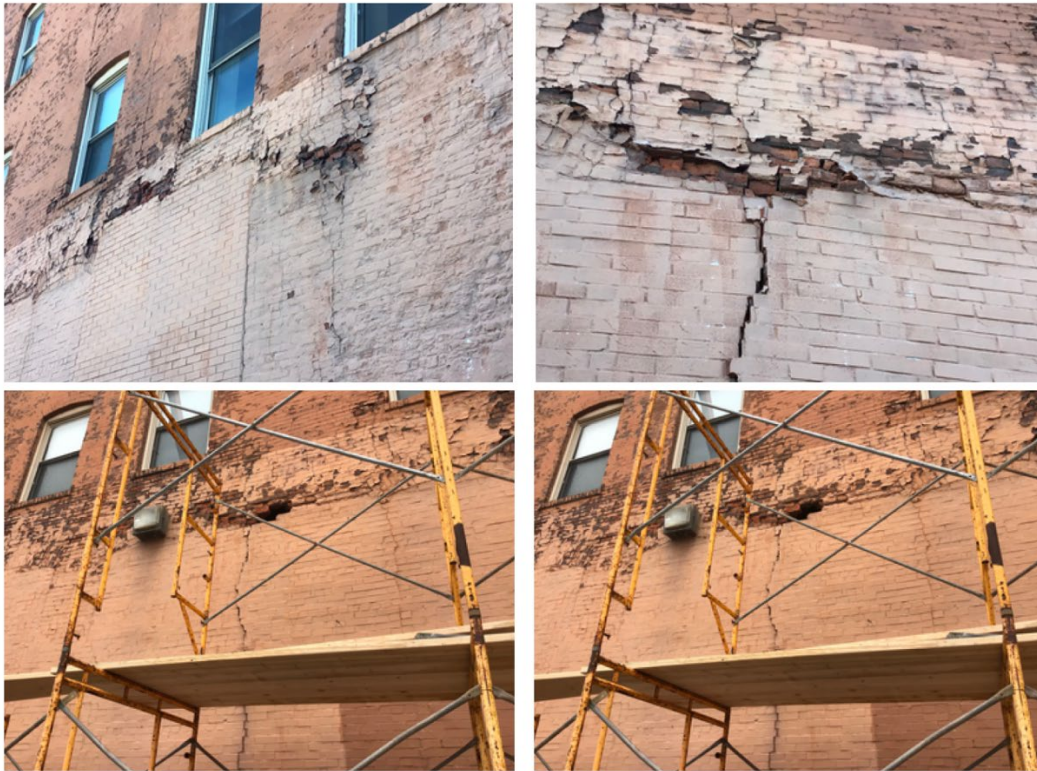
51. At the time the Wold Defendants purchased The Davenport, the exterior west wall was in an obvious state of dangerous dilapidation. Photographs taken by City of Davenport inspectors in November and December 2020 depict the appalling state of the exterior west wall.

53. The brick wall was clearly bulging outward, significantly cracked, and teetering on the edge of disaster, but no action was taken.

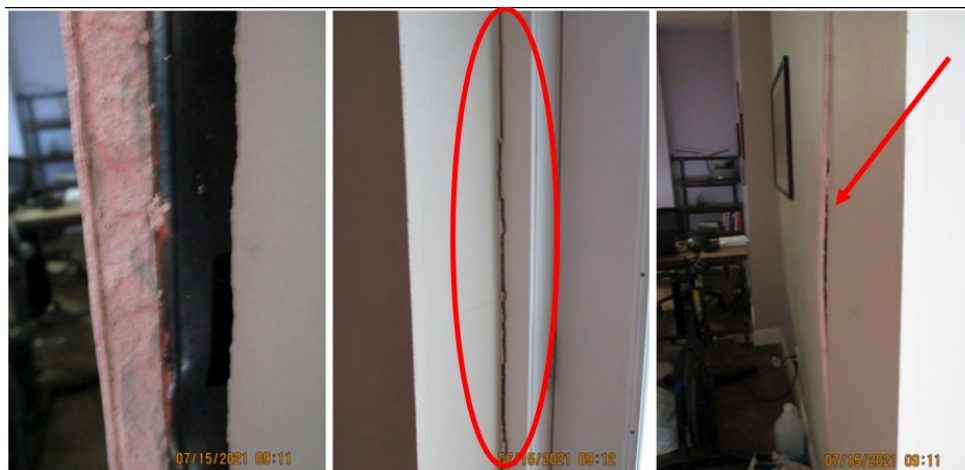
57. Photographs taken during the inspection which resulted in the July 19, 2021 Complaint Notice and Order also reveal that the walls within the building were cracking and bowing, clear indications that the structure was in distress.

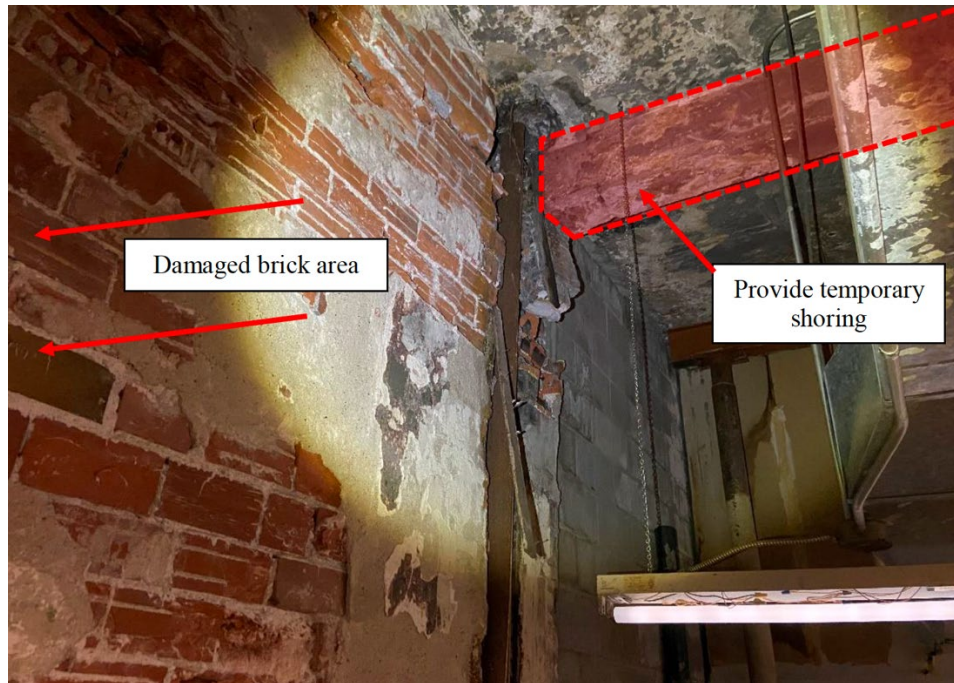
75. Mr. Valliere’s February 2, 2023 emergency site visit also yielded photographs depicting the interior side of the west wall and its severely damaged and deteriorated condition.

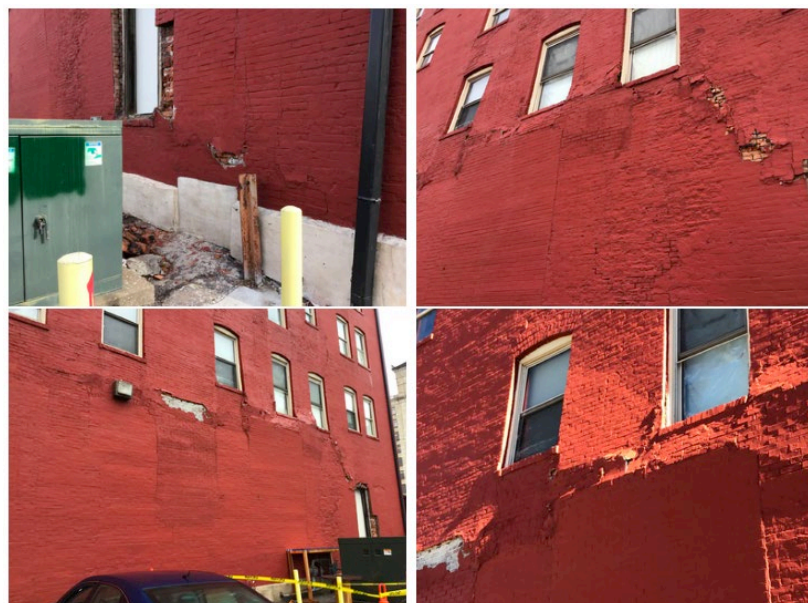
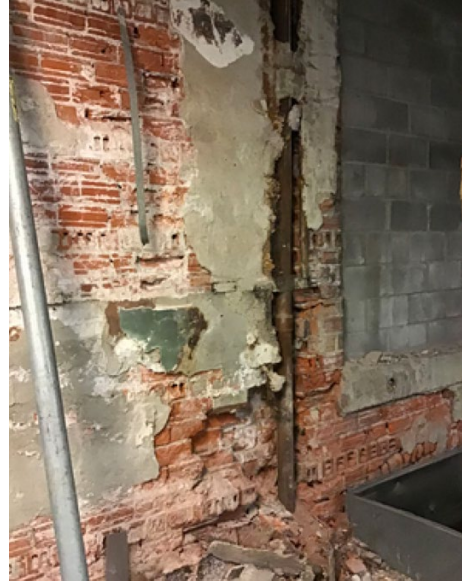
85. While on-site in early February 2023, City of Davenport inspectors took photographs that depict the aggressive and advanced state of deterioration and structural instability of the exterior west wall.

86. The photographs above clearly depict the wall buckling under the load it is supporting and the bricks bulging outward.

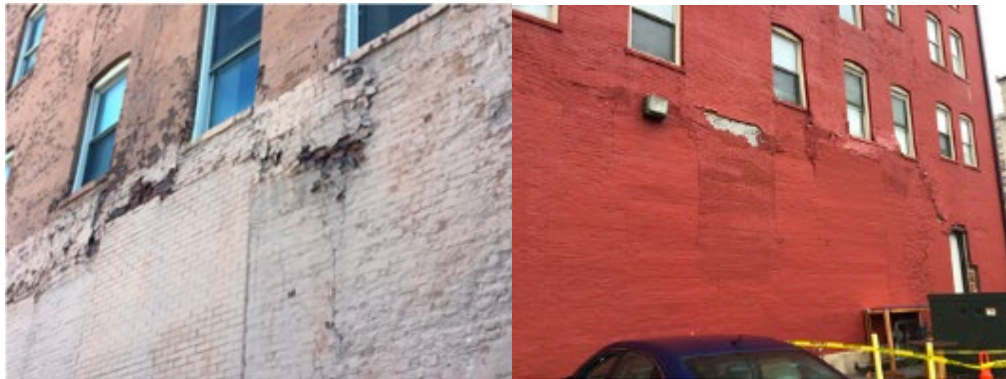
87. The photographs above and other photographs taken earlier in 2022 show that after the Wold Defendants acquired The Davenport, instead of addressing the extremely dangerous and deteriorated condition of the west wall, the Wold Defendants decided to simply paint over the dangerous condition, hoping to conceal the extent of the danger.

88. However, by merely painting over the dangerous condition of the wall, the Wold Defendants not only attempted to conceal the danger, but actually made it worse. Painting over

the bricks acted only to trap moisture and condensation within the bricks and the wall, further damaging the wall and accelerating its deterioration.

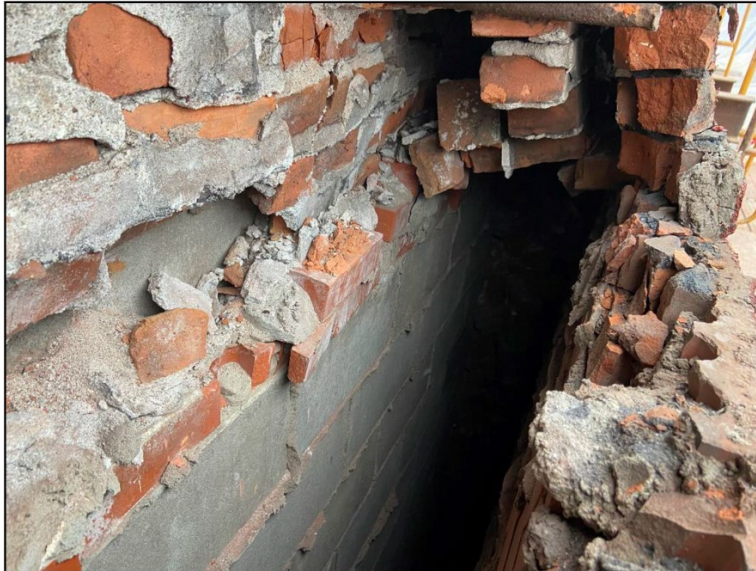
93. Mr. Valliere’s February 28, 2023 report noted that repairs were being made by Bi-State Masonry, but that upon further observation of the area of significant damage, it ***“has recently come [to] the attention of the team is that this area has a large void space...between the clay brick façade and CMU layer.”*** Mr. Valliere concluded that this void space was “caused by the collapse of some mass of clay brick between the façade and CMU.”

94. Mr. Valliere further observed that the collapsed mass of bricks ***“is now settled and piling up against the inside face of the façade, pushing it outward. This will soon cause a large***

A follow-up site visit was performed at the property above on February 23rd. At the meeting, the mason pointed out that the area immediately to the north of the work area has a large and potentially dangerous void beneath the façade wythe of clay brick.

The repairs recommended in the report issued February 8th are being performed by Bi-State Masonry; they appear to be going according to plan. One deviation from the plan is that two layers/wythes of CMU are being installed to replace the clay brick wall segments rather than a single layer with an outer, façade layer of clay brick. This modification is acceptable and will add structural strength to the replaced areas. The original repair area is roughly twelve feet wide, and will abut to an existing wythe of CMU (which is likely a previous repair). What has recently come the attention of the team is that this area has a large void space, roughly 12”-14” wide, between the clay brick façade and CMU layer. This void appears to have been caused by the collapse of some mass of clay brick between the façade and CMU. This collapsed mass is now settled and piling up against the inside face of the façade, pushing it outward. This will soon cause a large panel of façade to also collapse, creating a safety problem and potentially destabilizing the upper areas of brick façade. This condition was not visible in the early

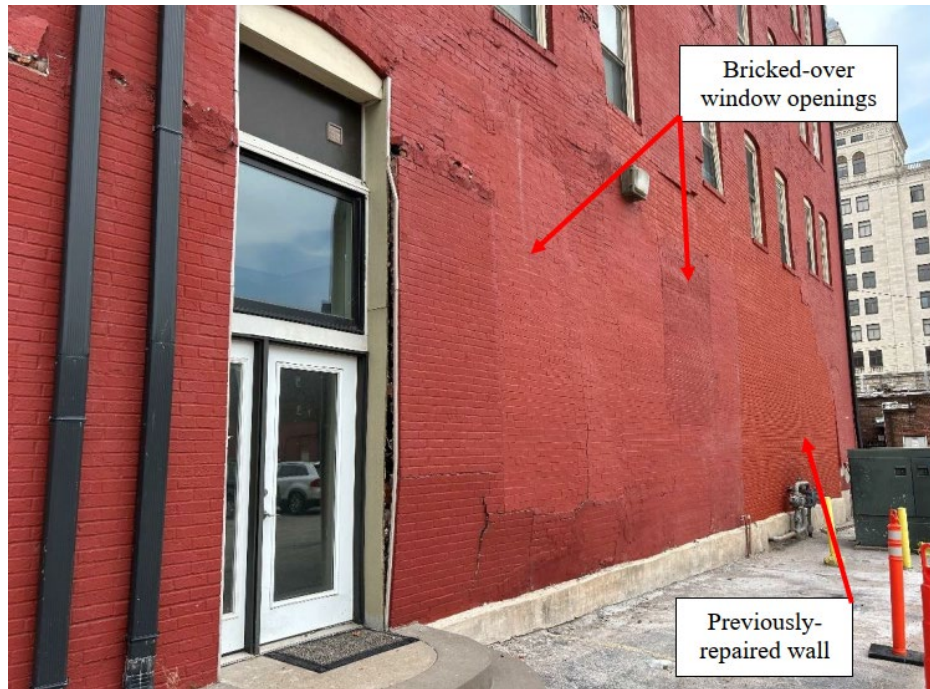
115. Mr. Valliere observed that “there are two former window openings, roughly 12 feet tall by six feet wide, which appear to have been bricked over some years ago. *The clay brick façade on and between these openings is bulging outward by several inches and looks poised to fall. In anticipation of these areas falling, the brick façade above the windows should be secured. This is to keep the entire face of the building from falling away when the bottom area(s) come loose.”*

As viewed from the west exterior, there are two former window openings, roughly 12 feet tall by six feet wide, which appear to have been bricked over some years ago. The clay brick façade on and between these openings is bulging outward by several inches and looks poised to fall. In anticipation of these areas falling, the brick façade above the windows should be secured. This is to keep the entire face of the building from falling away when the bottom area(s) come loose. The same temporary façade support as was recommended on February 9th, 2023, may be used here too. Note that the elevation of the steel angle in the detail shall be at or above the top of the window openings.

116. Mr. Valliere also identified a potential cause of the brick façade’s imminent collapse: the previously bricked-over window openings, shown above, “were never filled with brick or block. Rather, the clay brick façade was just run right over the openings, unsupported.” Mr. Valliere explained that, **“[t]his lack of bracing helps explain why the façade is currently about to topple outward.”**

Inside the first floor, the drywall is being stripped away. This reveals that the window openings were never filled with brick or block. Rather, the clay brick façade was just run right over the openings, unsupported. This lack of bracing helps explain why the façade is currently about to topple outward. The brick façade is unlikely to be preserved in place, but it can be brought down in a safe, controlled manner. The stable sections above will be secured as mentioned previously. With the loose façade

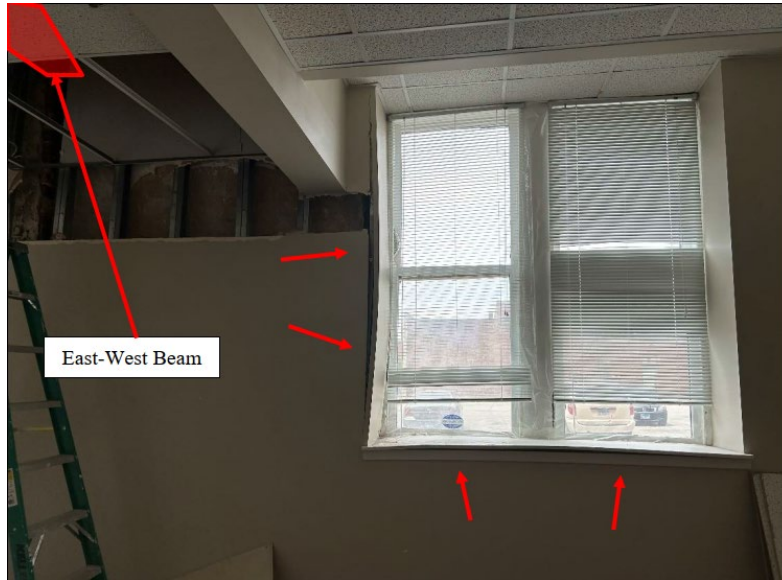
To the north of the two window openings in question, there is another issue. The wall appears to be losing some stability and is causing deformation. This is evidenced by the bowing of the interior light gauge steel furring and drywall; they bulge as if a large downward force is acting upon them. This downward force may be due to the reaction of an east-west beam which bears on the west exterior

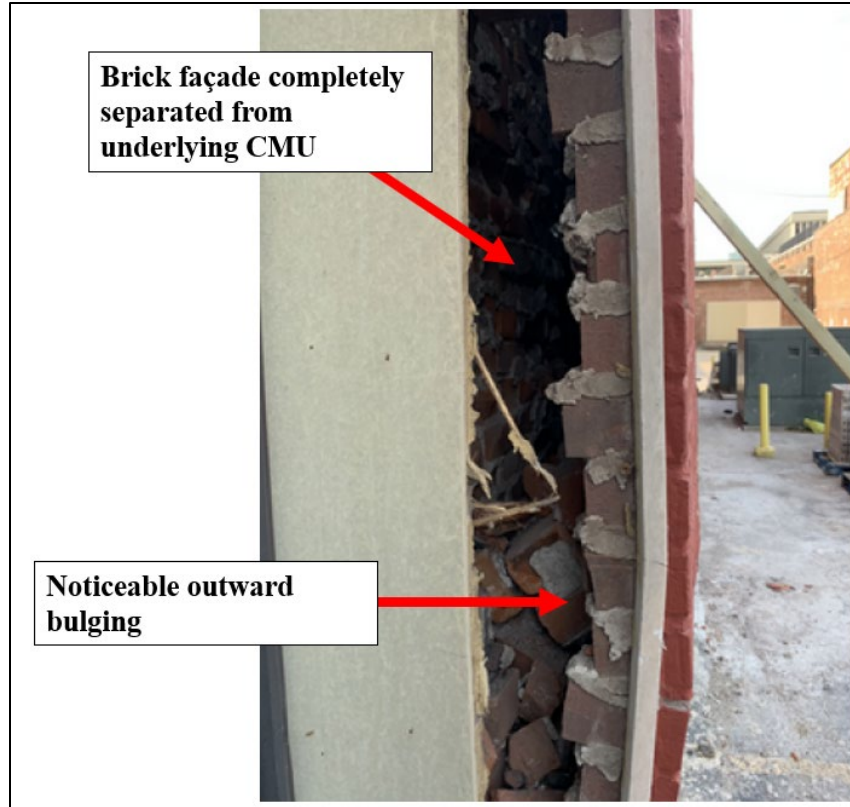
125. Pradhan’s inspection photographs reveal the extent of the structural damage and instability of the exterior west wall. The brick façade had completely separated from the CMU and the gap was filled with already-collapsed bricks. The wall was also noticeably bulging outward and was at risk of an imminent collapse.

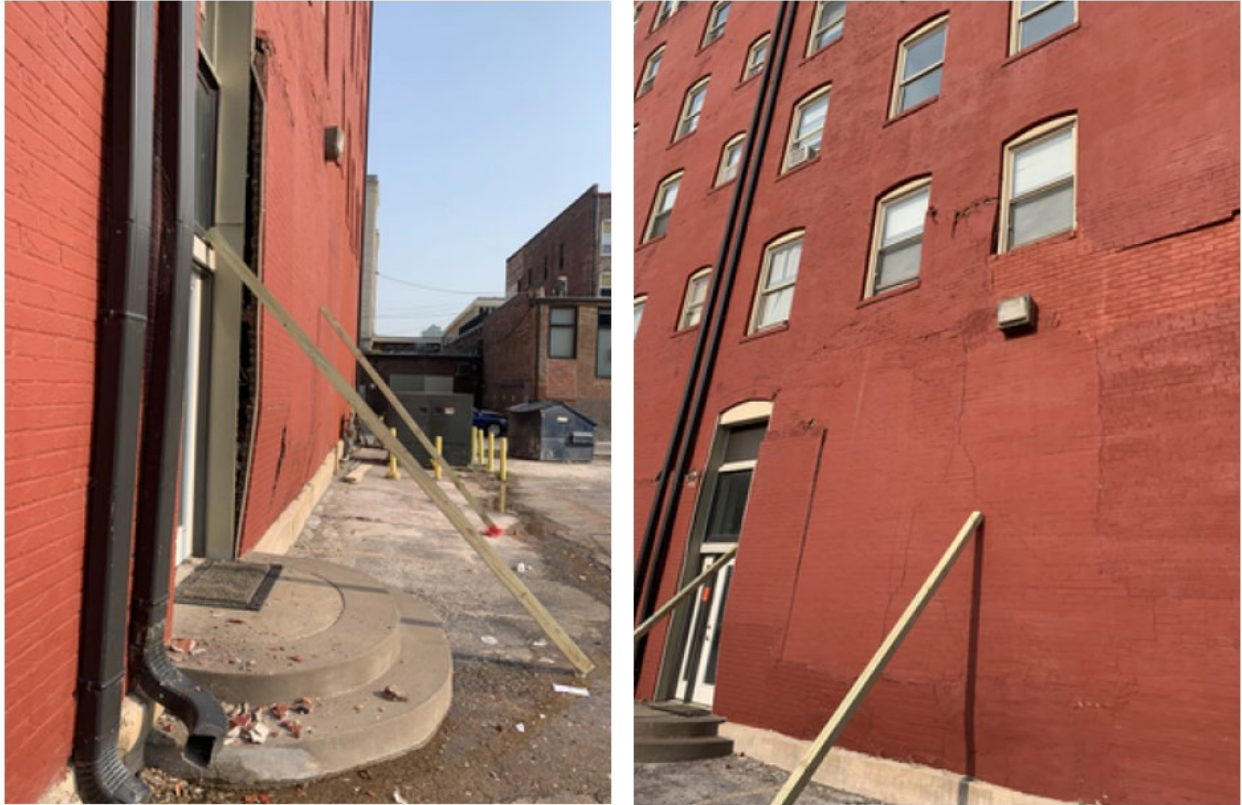
127. *Instead of showing the proper bracing and shoring needed to support the wall, Pradhan's photographs show that the Wold Defendants and/or their workers merely laid some loose two-by-fours against the wall, anchored to nothing.* These two-by-fours provided absolutely no structural support to the wall whatsoever.

128. Upon information and belief, the Wold Defendants had these ineffectual two-by-fours laid against the building to deceitfully give the appearance of the bracing and shoring they knew should have been installed long before but that he didn't want to spend the money to actually install.

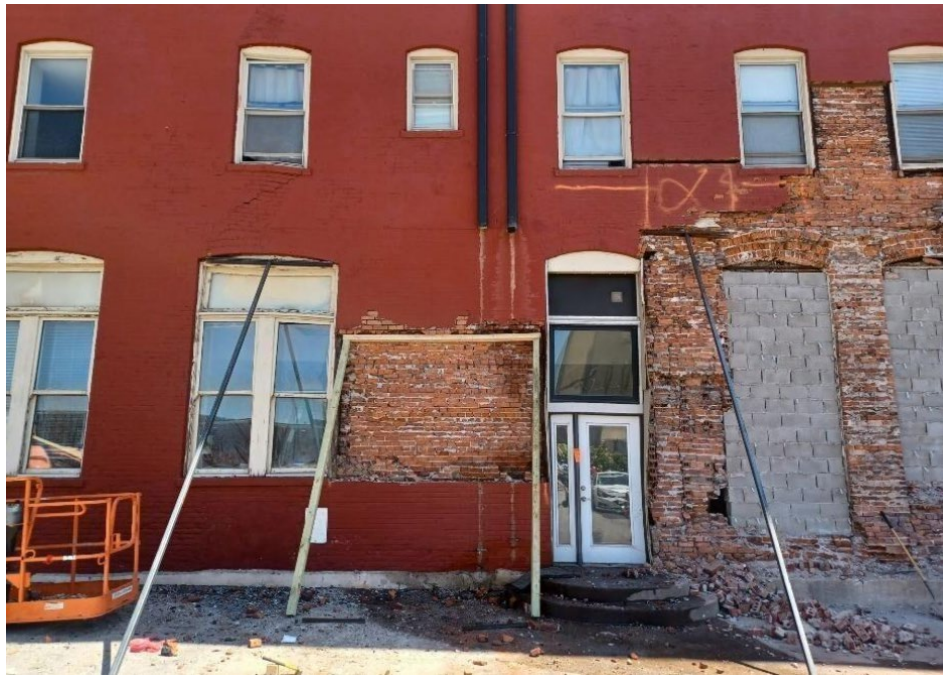
137. On May 28, 2023, just hours before the collapse occurred, Shaffer returned to The Davenport and again warned the workers that they needed to leave. Shaffer also took a photograph which further depicted the outrageously ineffective “bracing” that the Wold Defendants put up.

139. This above photograph also reveals that the workers hired by the Wold Defendants were intentionally removing bricks from the building without having the proper bracing and supports installed due to the fact that the Wold Defendants decided to take the cheap route and not pay for proper and safe bracing.
