Telecommunications Emergency Forum

Cyclone Gabrielle Post Incident Report

May 2023

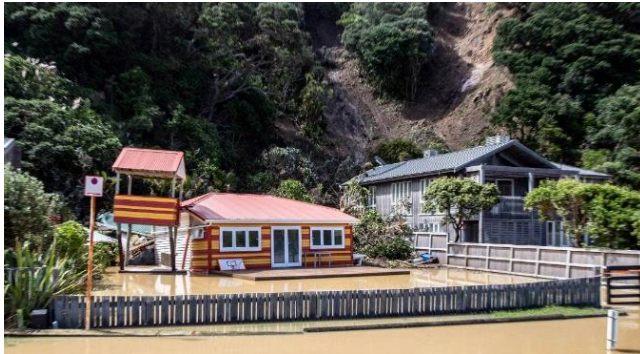
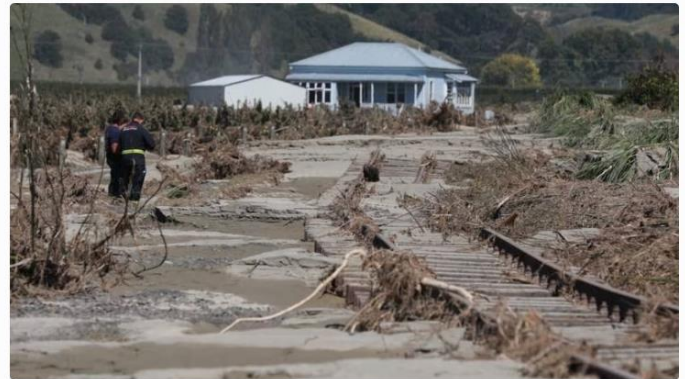
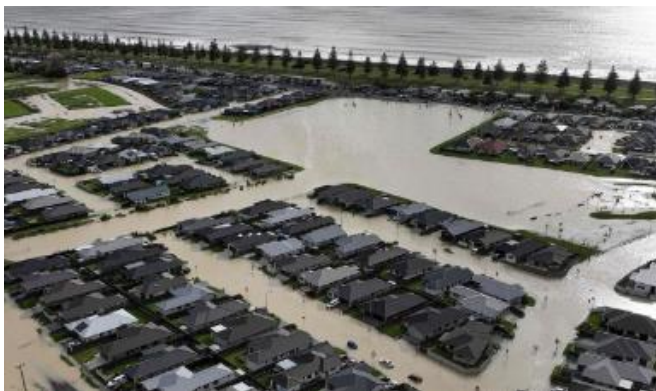
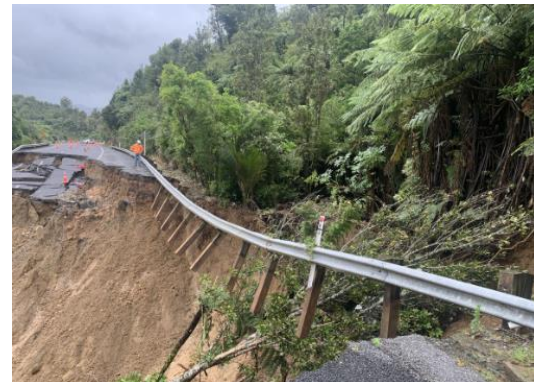
Images of damage caused by Cyclone Gabrielle across the four regions.

Damage in Esk Valley. (Source: rnz.co.nz)

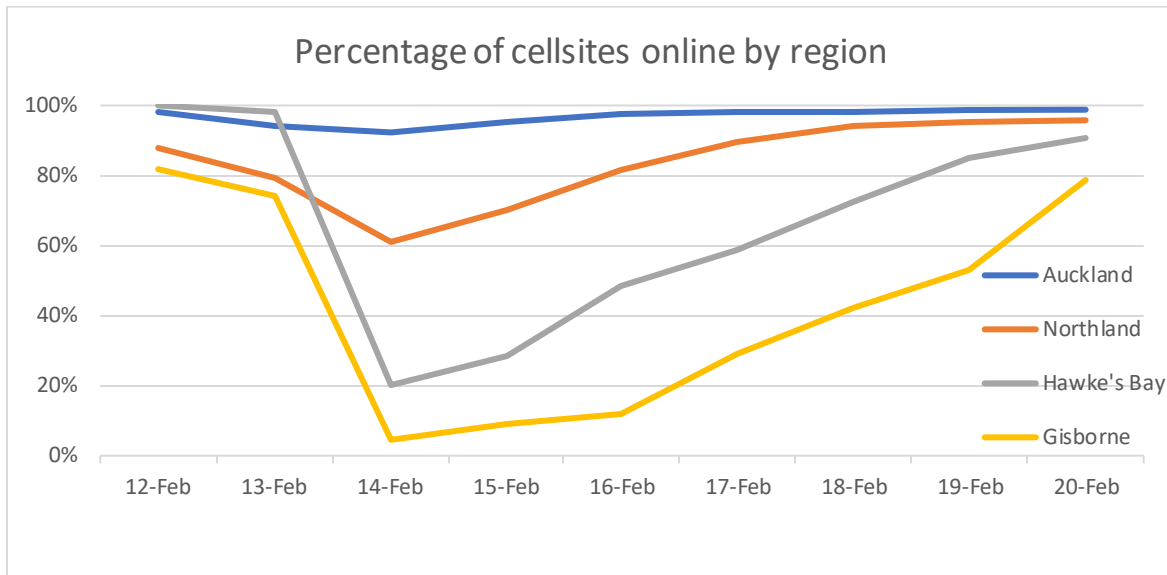
Collated mobile cell site outages over the period 12 – 20 February 2023

All cell sites have battery back-up, the below graph shows the trend as mobile cell sites went offline at the end of their battery life and/or failure of fibre backhaul. Restoration was either through the

installation of a generator or power restoration plus backhaul services restored to bring the cell site back online.

Appendix 1 shows the trend to restore mobile cell sites across the four regions between 12 – 20 February 2023.

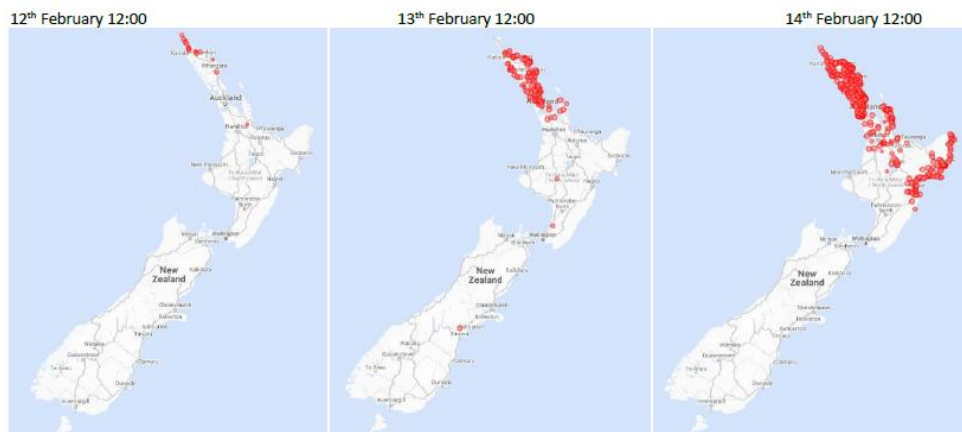
The below shows the geographical spread of Chorus (DSLAM and POLT) outages⁵:

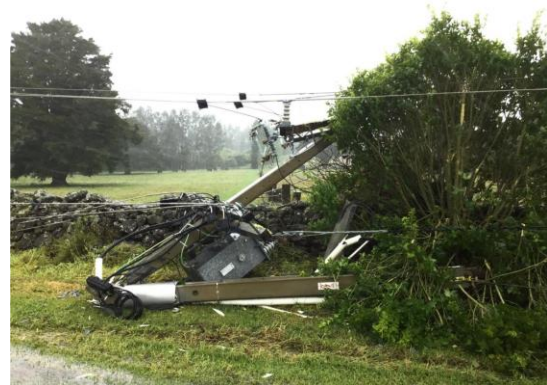
Images below of key infrastructure damage
