General Permit No WV0116815 WEST VIRGINIA DEPARTMENT OF ENVIRONMENTAL PROTECTION WV OIL AND GAS CONSTRUCTION STORMWATER PERMIT

vv	V UIL AND GAS CO	MSIKUUI			
FACILITY NAME:	Mountain Valley Pipeline	e Project	REG. #	EXPIRE DATE:	
PERMITTEE	MOUNTAIN VALLEY	PIPELINE, LLC	WVR310667	12/31/2018	
ADDRESS/PHONE:	Attn: MATTHEW HOOV	VER			
	625 LIBERTY AVE, ST	1700			
	PITTSBURG, PA 15222				
	(724)873-3645				
LOCATION:	CR 4 – Big Elk Creek		Entry Date/Time:	6/6/2018 @ 09:15	
COUNTY:	Harrison			Exit Date/Time:	6/6/2018 @ 11:50
Site Representative	Travis Huskins / (423)930-0422			PHOTOS 🛛	
/Phone					
CO-PERMITTEE:					
SITE OPERATOR:	Precision Pipeline		ADDRESS:	3314 56th Street; E	Eau Claire, WI 54703
PERMITTED ACREAGE	4311	WEATHER:	Cloudy	LAST INSPECTION:	N/D
RECEIVING STREAM	NOV: W18-17- 065-TJC				
Regular Mail 🗖 Ce	rtified Mail 🛛 🛛 Tra	cking #

NOTICE OF VIOLATION

WV Department of Environmental Protection Environmental Enforcement / WW 2031 Pleasant Valley Road; Fairmont, WV 26554 MOUNTAIN VALLEY PIPELINE, LLC, WVR310667, Mountain Valley Pipeline Project – Spread A, 6/6/2018

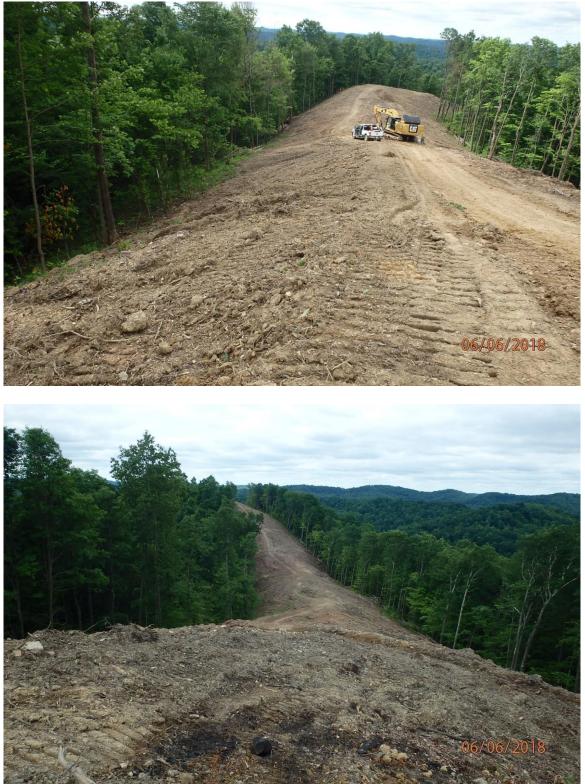
1). (1, 7, 13, 15, 19 & 21) The inspected area from 513+64 to 556+00 was cleared to mineral soil. The perimeter controls that were indicated in the SWPPP were not in place even though it had been approximately two to three weeks prior to the inspection, according to the site representative, since this area was disturbed. The temporary water bars were installed, but there was no compost filter sock at the discharge end as indicated in the SWPPP. The grading crew is lagging behind the mechanical clearing and

grubbing crew and the proposed temporary ROW diversion berm and sediment trap outlets were not in place as a result. The lack of BMPs in this area would allow sediment laden water to leave the site in violation of the permit.

Areas of the project that have been cleared to mineral soil and BMPs are not in place as indicated in the SWPPP. Deficiencies in site evaluation item numbers 1, 7, 8, 13, 15, 19 & 21 pictured.

WARNINGS: Immediately take all measures necessary to comply with all terms and conditions of the WV/NPDES general permit. Section G.4.e.2.A.i.-Stabilize all areas where construction activities have ceased for more than 21 days. Section G.4.c. Modify the SWPPP and install additional BMPs in order to prevent sediment laden water from leaving the site.

The following corrective measures were discussed with you at the time of this inspection: Take measures to correct the aforementioned violations.

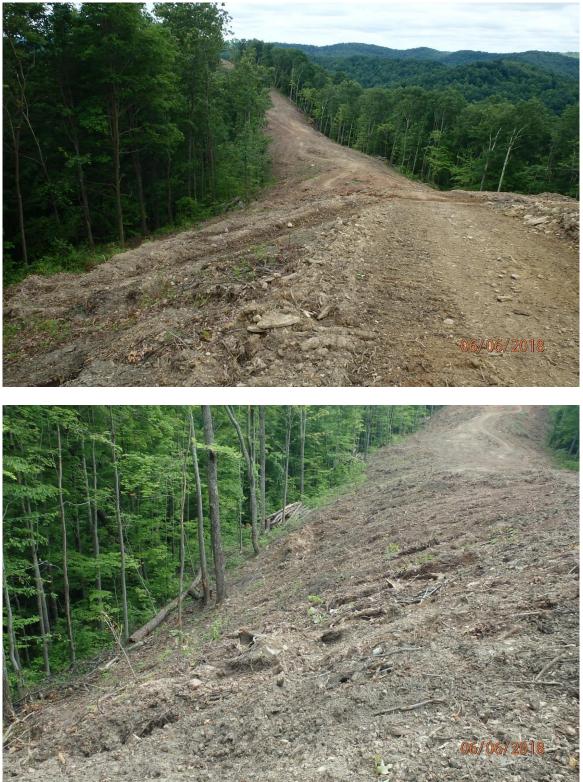
Areas of the project that have been cleared to mineral soil and BMPs are not in place as indicated in the SWPPP. Deficiencies in site evaluation item numbers 1, 7, 8, 13, 15, 19 & 21 pictured.

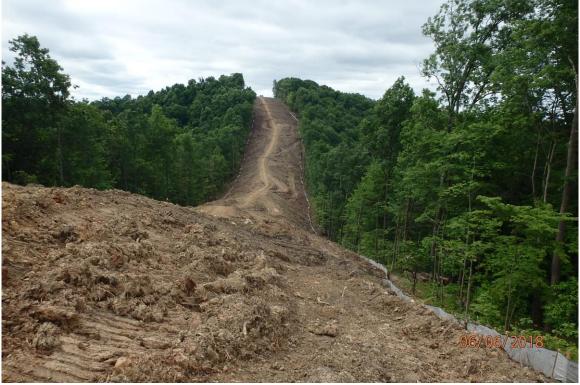
Area adjacent to 498+06 showing controls in place.

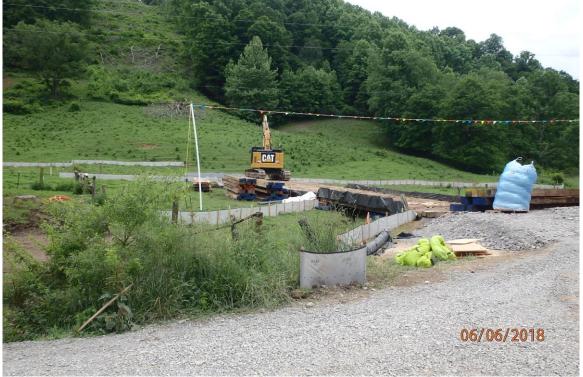
Area adjacent to AR 19 showing BMP installation.
