Re: Mountain Valley Pipeline, LLC
Docket No. CP16-10-000
Confirmation of Notification

**WEST VIRGINIA DEPARTMENT OF ENVIRONMENTAL PROTECTION
WV OIL AND GAS CONSTRUCTION STORMWATER PERMIT**

STATE OF WEST VIRGINIA
Department of Environmental Protection
Environmental Enforcement
NOTICE OF VIOLATION

Violation No W18-09-076-TJC

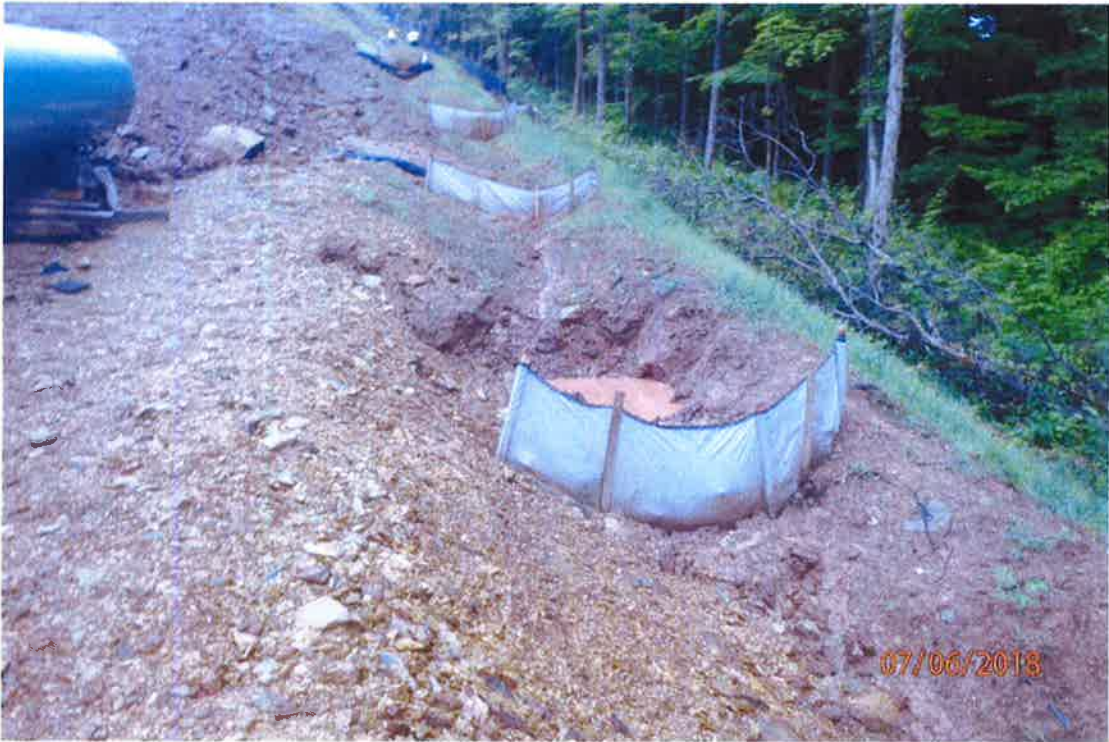
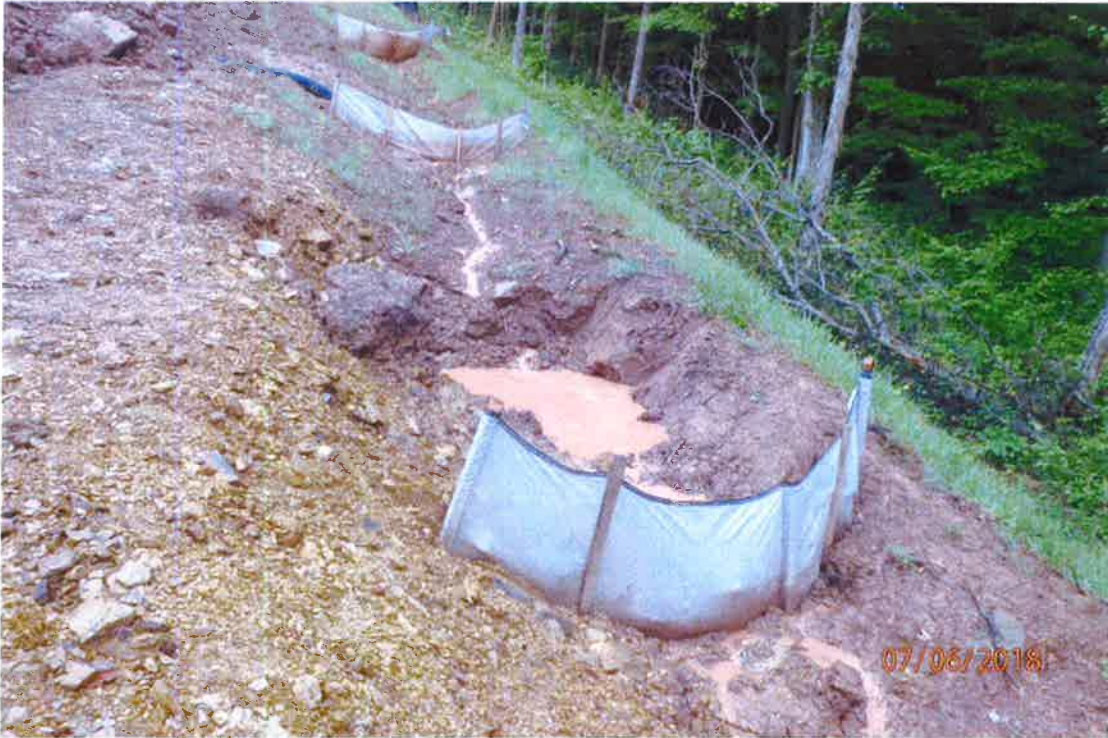
The installed temporary right of way diversion and outlet adjacent to 1851+00 that was collecting stormwater from multiple water bars and it did not have adequate outlets. This caused concentrated flow to overwhelm the installed BMP at the base of the slope. Deficiencies in site evaluation item numbers 2, 6, 7, 19, 20 & 21 pictured.

Take measures to correct the aforementioned violations.

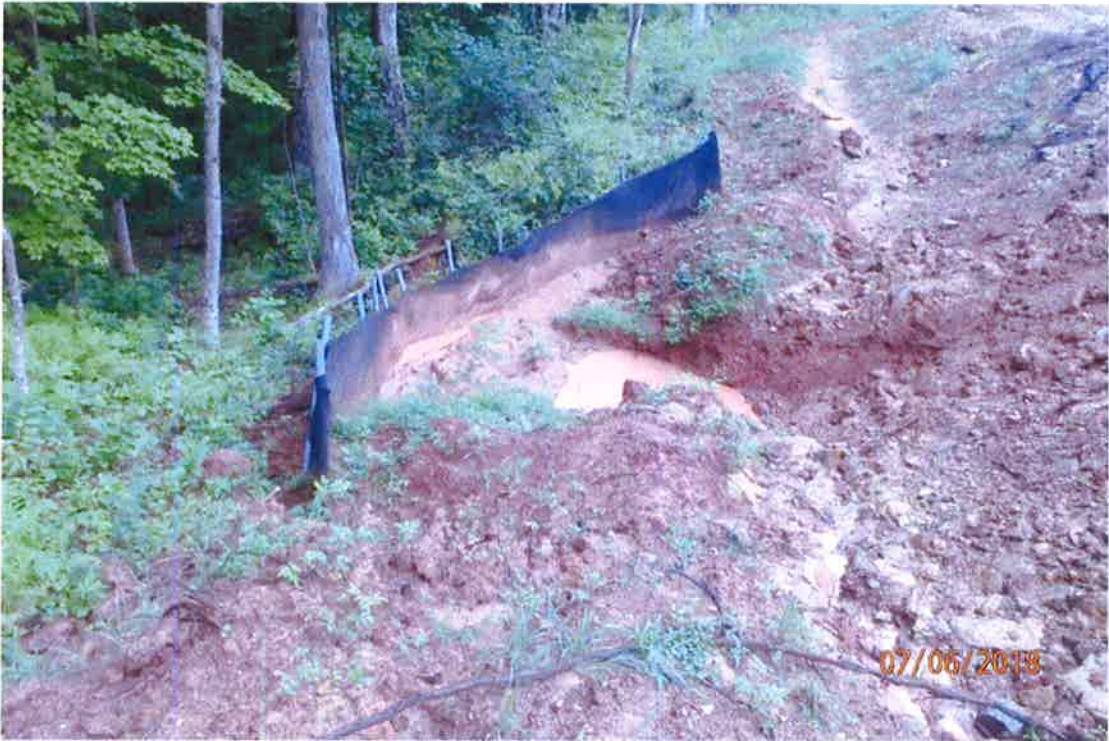
Overwhelmed BMP at the base of the slope adjacent to 1851+00.

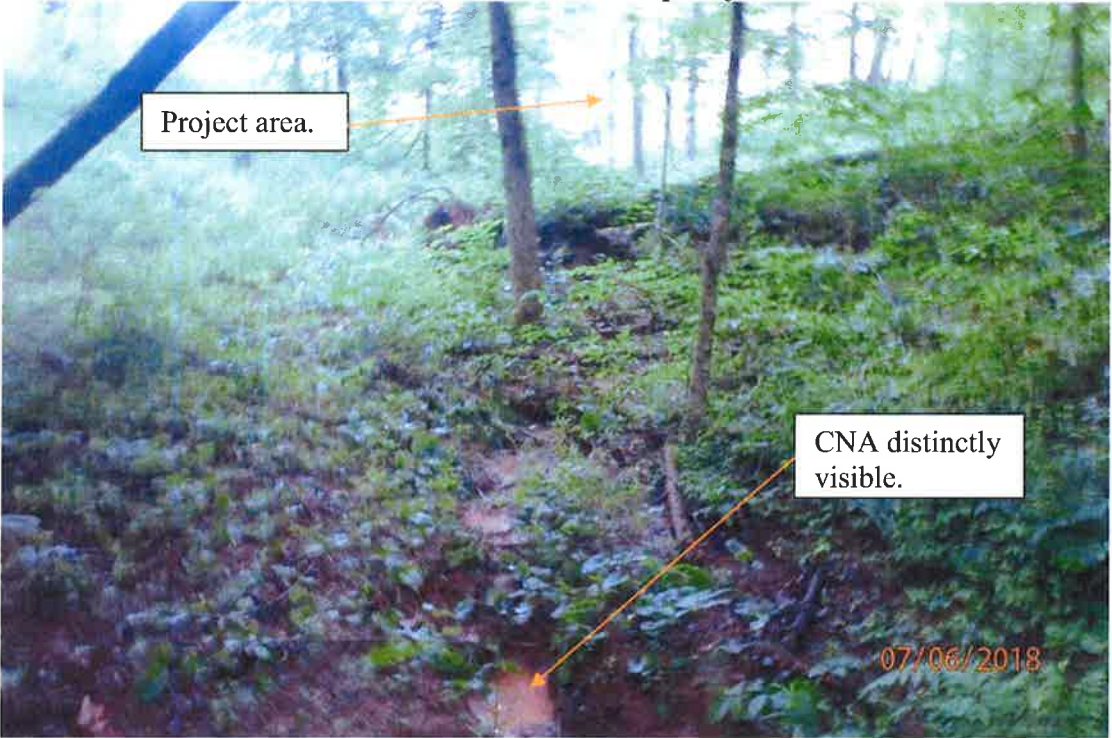
Sediment laden water in UNT Meathouse Fork that originates from site. Deficiencies in site evaluation item numbers 2, 6, 7, 19, 20 & 21 pictured.

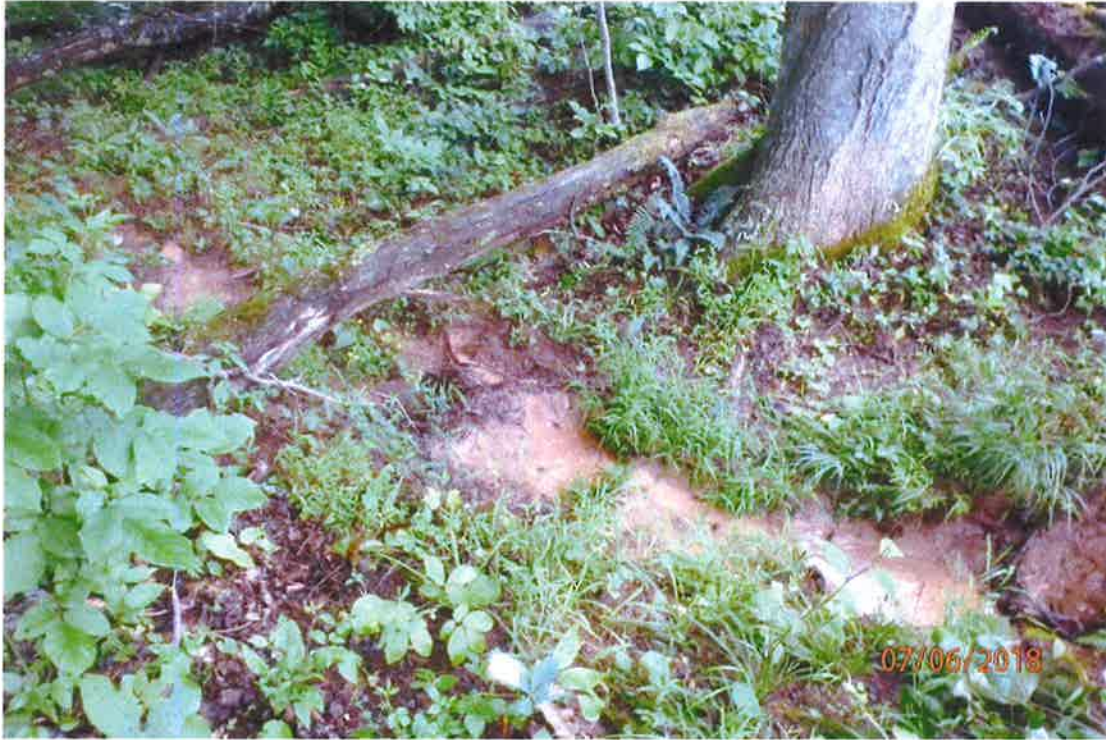
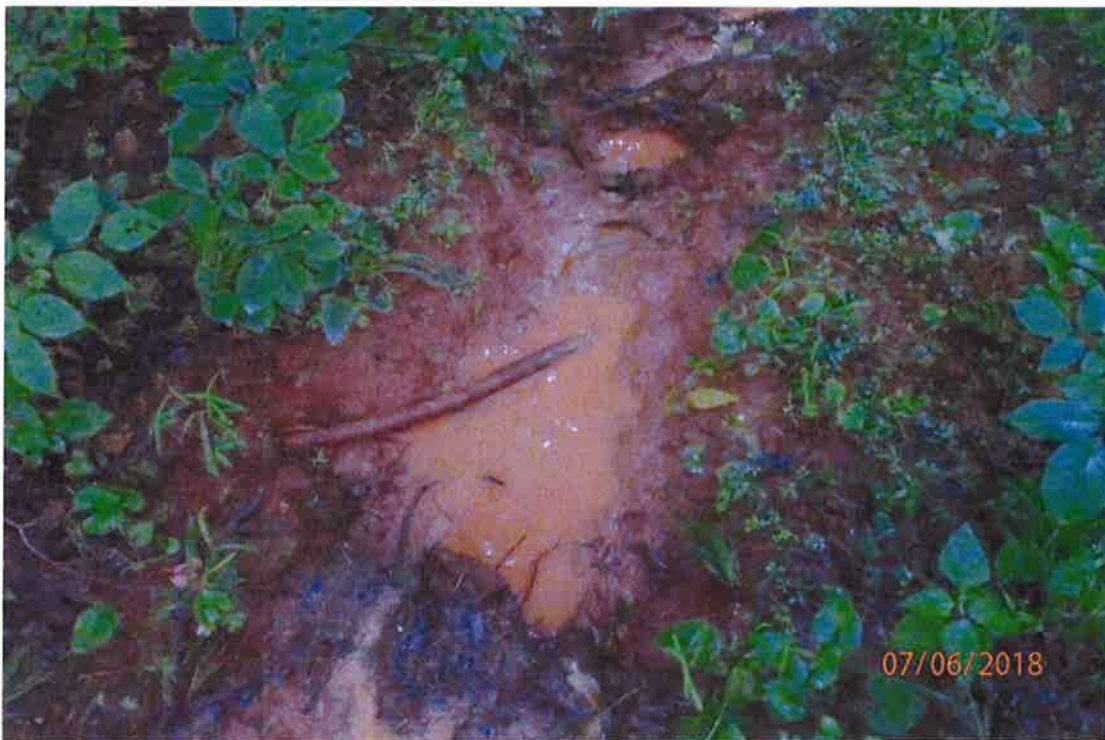
- 1). (1, 7, 19 & 21) Improperly installed water bars were noted in areas scattered throughout the inspected area. Water bars that were installed at steep angles which caused excessive erosion to the BMP were found. Water bars that terminate prior to the installed perimeter controls were also found. Offsite deposits were noted as a result.
- 2). (2, 6, 7, 19, 20 & 21) The installed temporary right of way diversions and outlets adjacent to 1851+00 and 1876+00 were collecting stormwater from multiple water bars and it did not have adequate outlets. This deficiency at 1851+00 caused concentrated flow to overwhelm the installed BMP at the base of the slope which resulted in Conditions Not Allowable (CNA) distinctly visible in UNT Meathouse Fork (39° 11.891' X 80° 33.209').

4. Title 47, Series 2, Section 3.2.a.- caused conditions not allowable in waters of the State by allowing distinctly visible settleable solids in UNT Meathouse Fork (39° 11.891' X 80° 33.209').
5. Title 47, Series 2, Section 3.2.b.-Caused conditions not allowable in waters of the State by allowing sediment deposits on the bottom of UNT Dry Fork (39° 11.384' X 80° 33.554').

Sediment laden water in UNT Meathouse Fork (39° 11.891' X 80° 33.209') that originates from site.
Deficiencies in site evaluation item numbers 2, 6, 7, 19, 20 & 21 pictured.

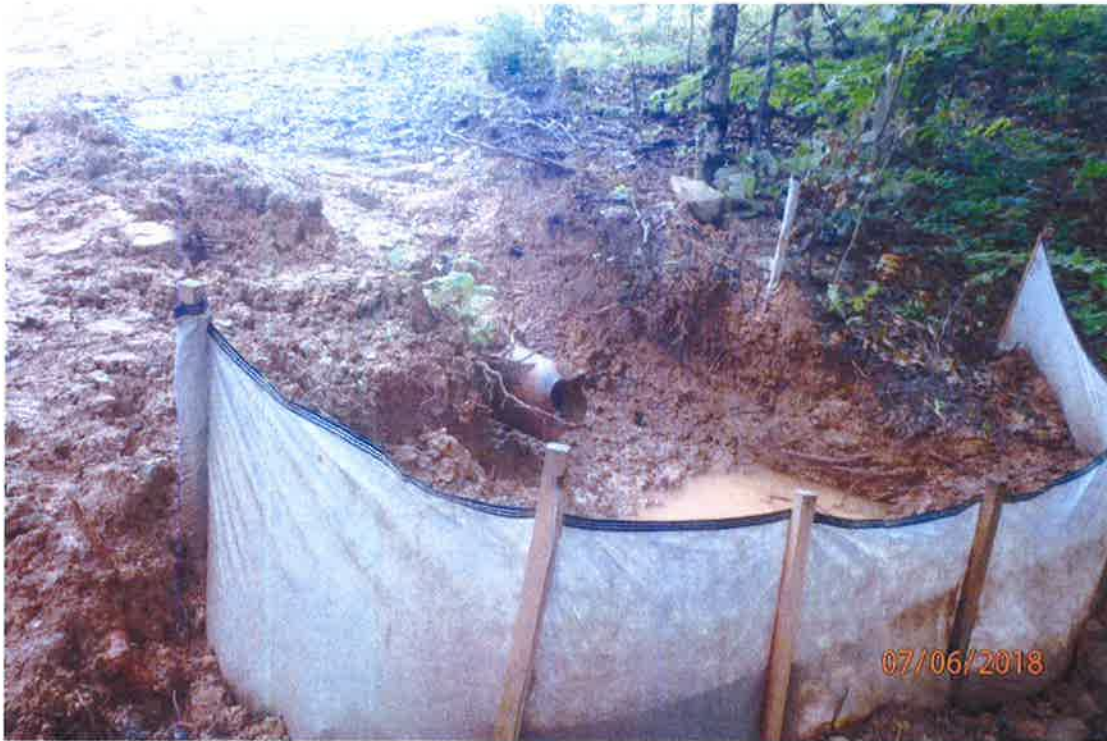
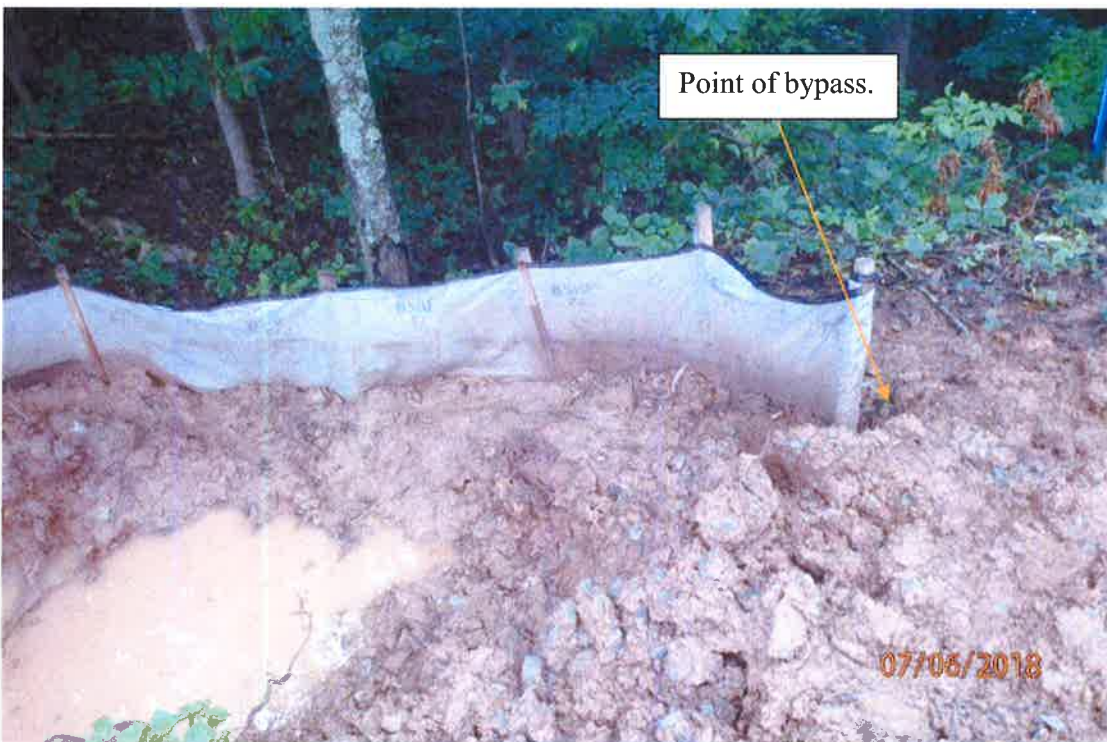
3). (1, 6, 7, 19, 20 & 21) An improperly installed BMP at the terminus of a water bar located adjacent to the Dry Fork access (MVP-DO-049) caused sediment laden water to bypass the device. This resulted in CNA offsite deposits in UNT Dry Fork (39° 11.384' X 80° 33.554').

Improperly installed BMP at the terminus of a water bar adjacent to MVPDO-049 (1891+00) that allowed sediment laden water to leave the site and caused CNA in UNT Dry Fork. Deficiencies in site evaluation item numbers 2, 6, 7, 19, 20 & 21 pictured.

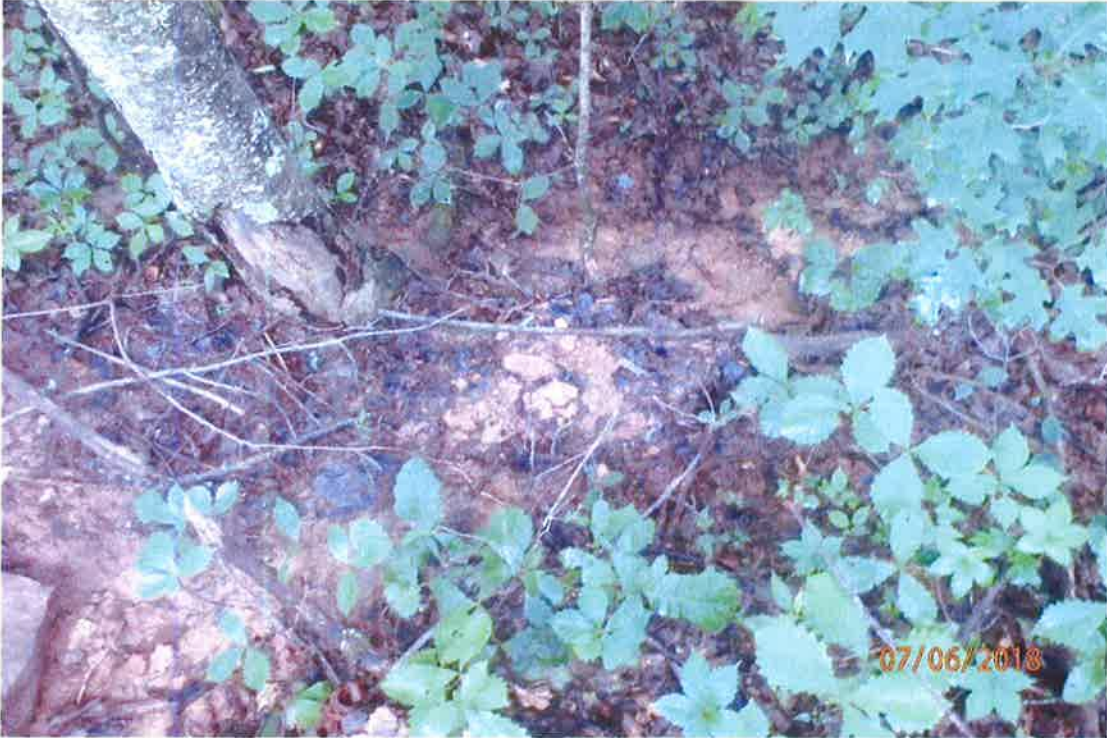
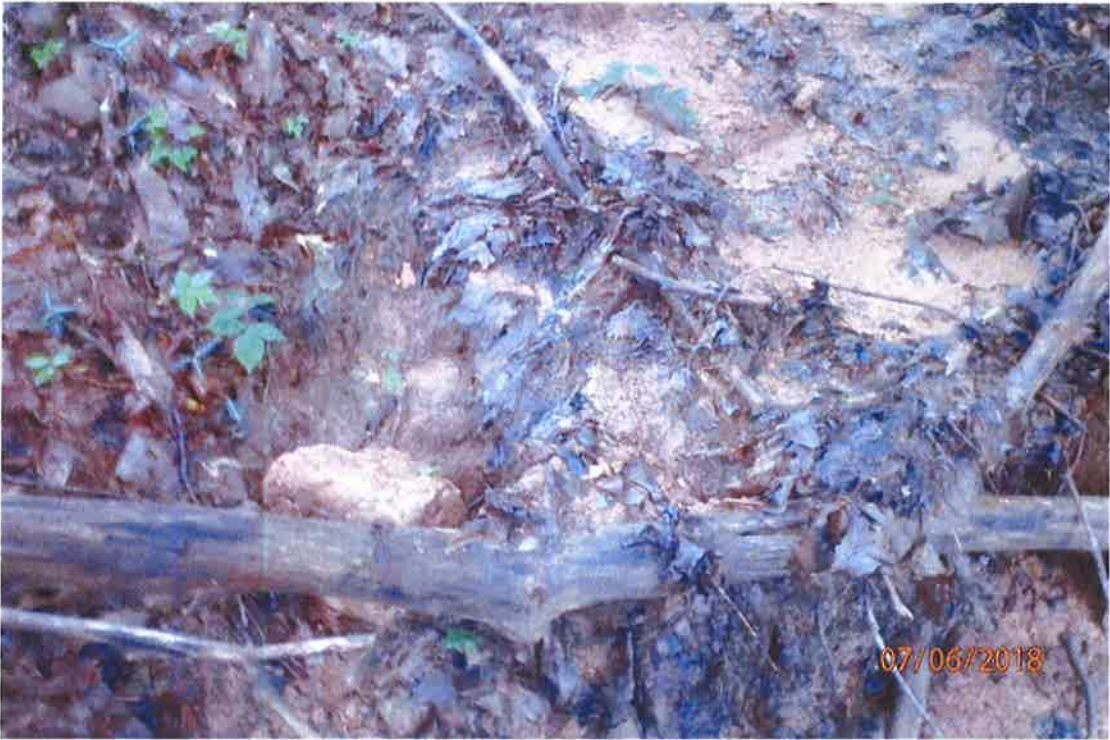
CNA deposits in UNT Dry Fork (39° 11.384' X 80° 33.554'). Deficiencies in site evaluation item numbers 2, 6, 7, 19, 20 & 21 pictured.

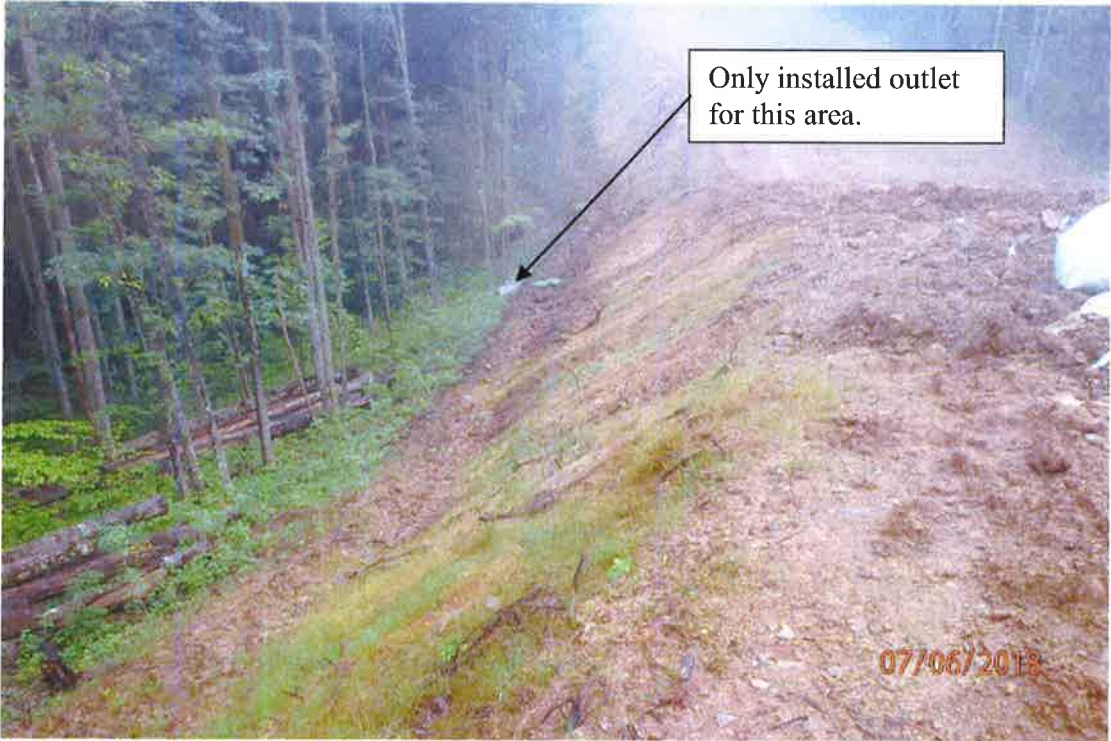
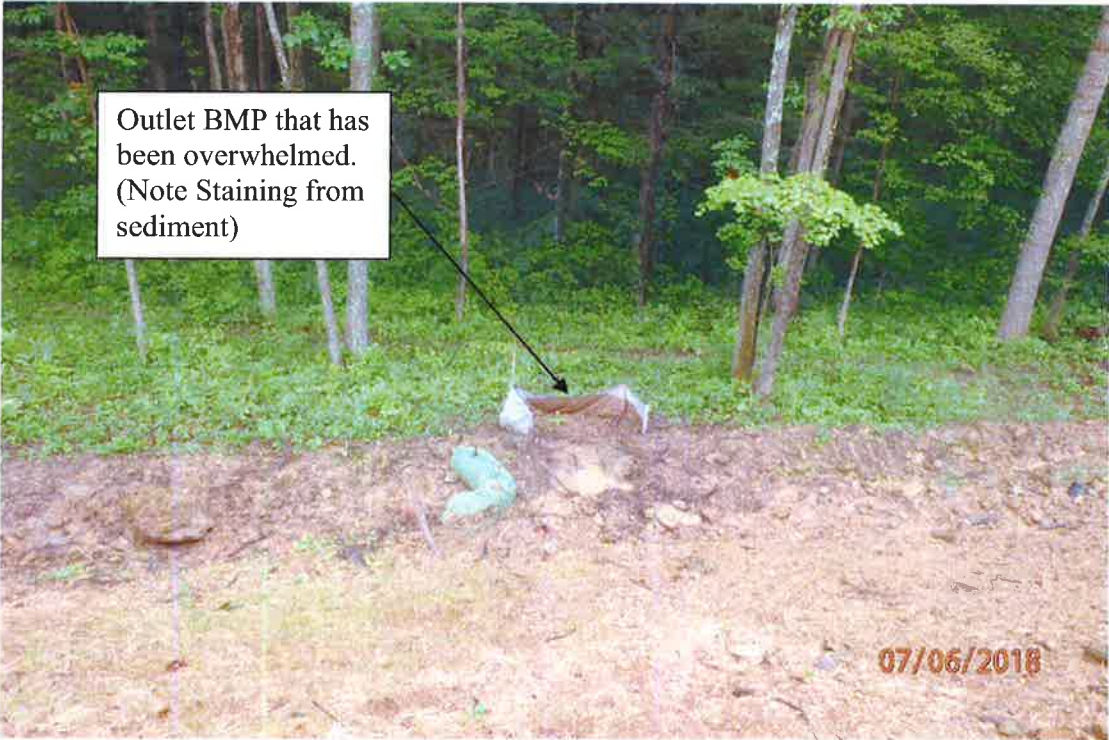
Installed temporary tight of way diversion and outlet that does not have adequate outlets adjacent to 1876+00. Evidence of the terminus BMP being overwhelmed in lower picture. Deficiencies in site evaluation item numbers 2, 6, 7, 19 & 21 pictured.

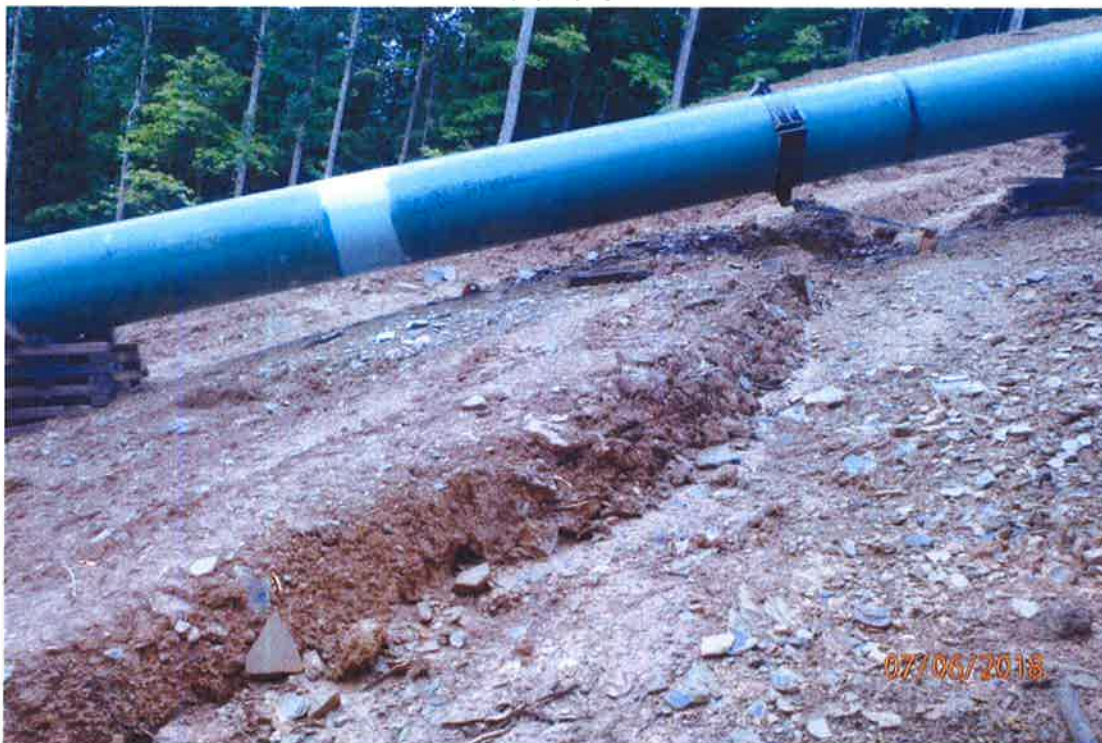
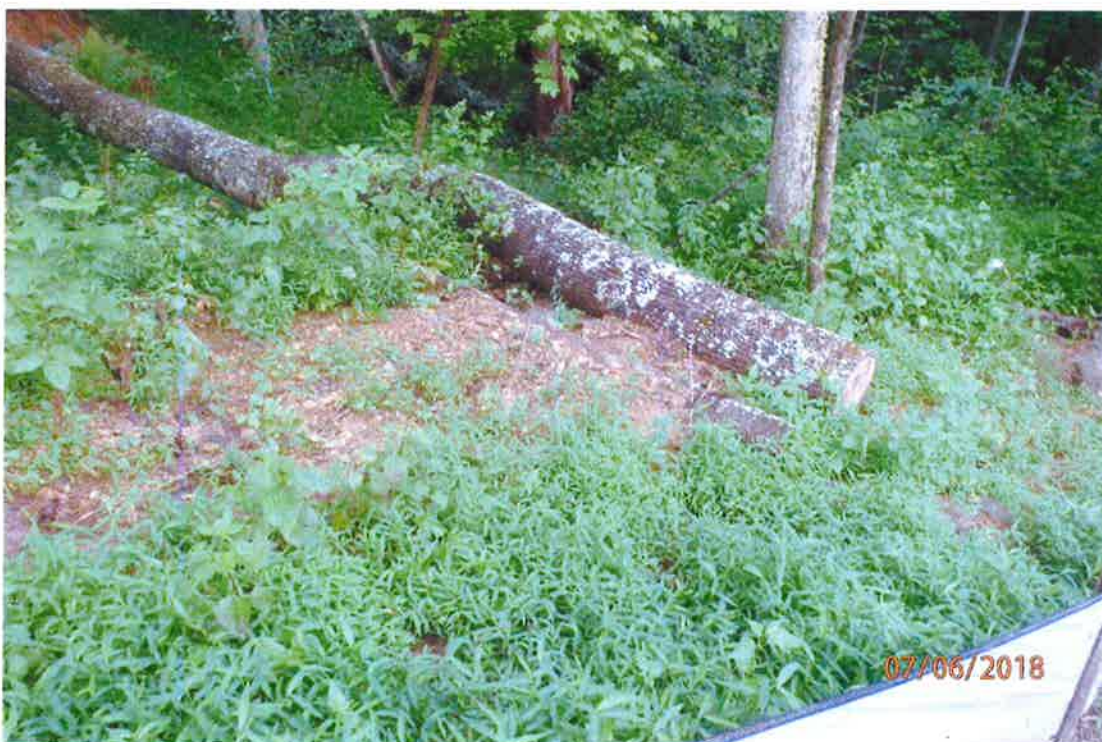
Water bar that has been installed at a steep angle with erosion and the associated offsite sediment deposits. Deficiencies in site evaluation item numbers 1, 7, 19 & 21 pictured.

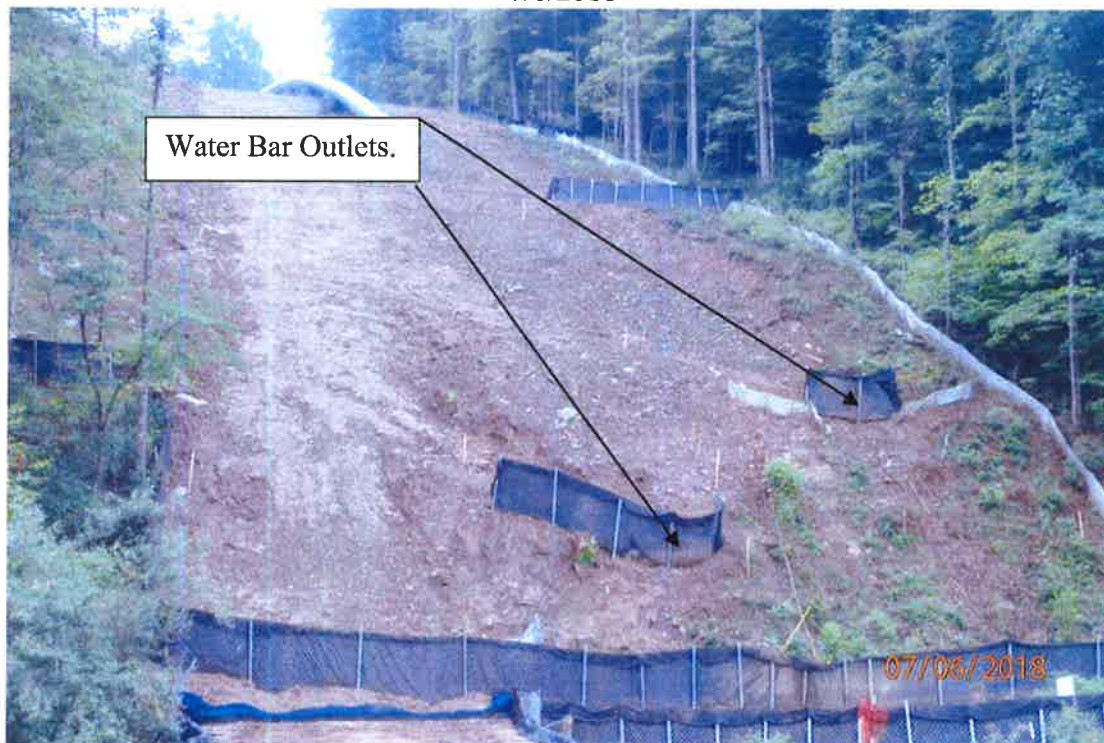
Water bars that are not installed properly and do not shed stormwater off of the LOD in small quantities as designed located adjacent to Laurel Run of Meathouse Fork crossing. Deficiencies in site evaluation item numbers 1, 7, 19 & 21 pictured.
