Expert Evaluation of the D.A. Hughes Collier-Hogan 20-3H

Well Drilling and Workover

Prepared for
Florida Department of Environmental Protection
3900 Commonwealth Blvd. M.S. 35
Tallahassee, FL 32399

December 2014

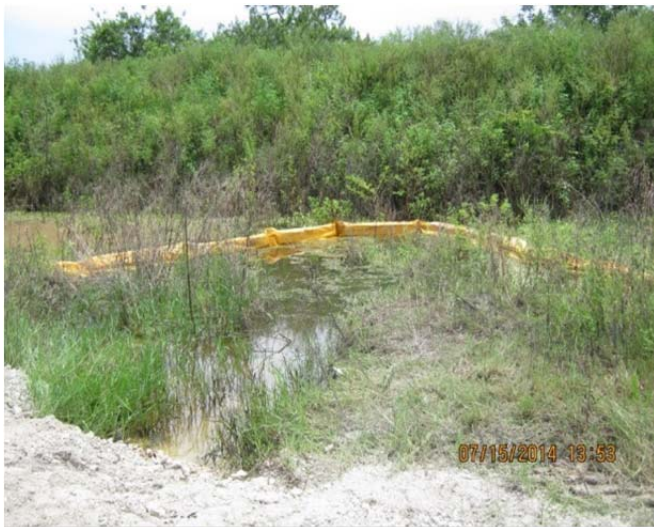
Figure 3: FDEP Photo of Yellow Boom

- One FDEP report mentioned that the liner had been torn. No violations were cited with regards to the spillage or material removal.¹³
- Although there is no mention in the provided material, there may have been a discharge immediately from or outside of the berm as evidenced by the presence of a yellow containment boom in that area (see **Figure 3**).

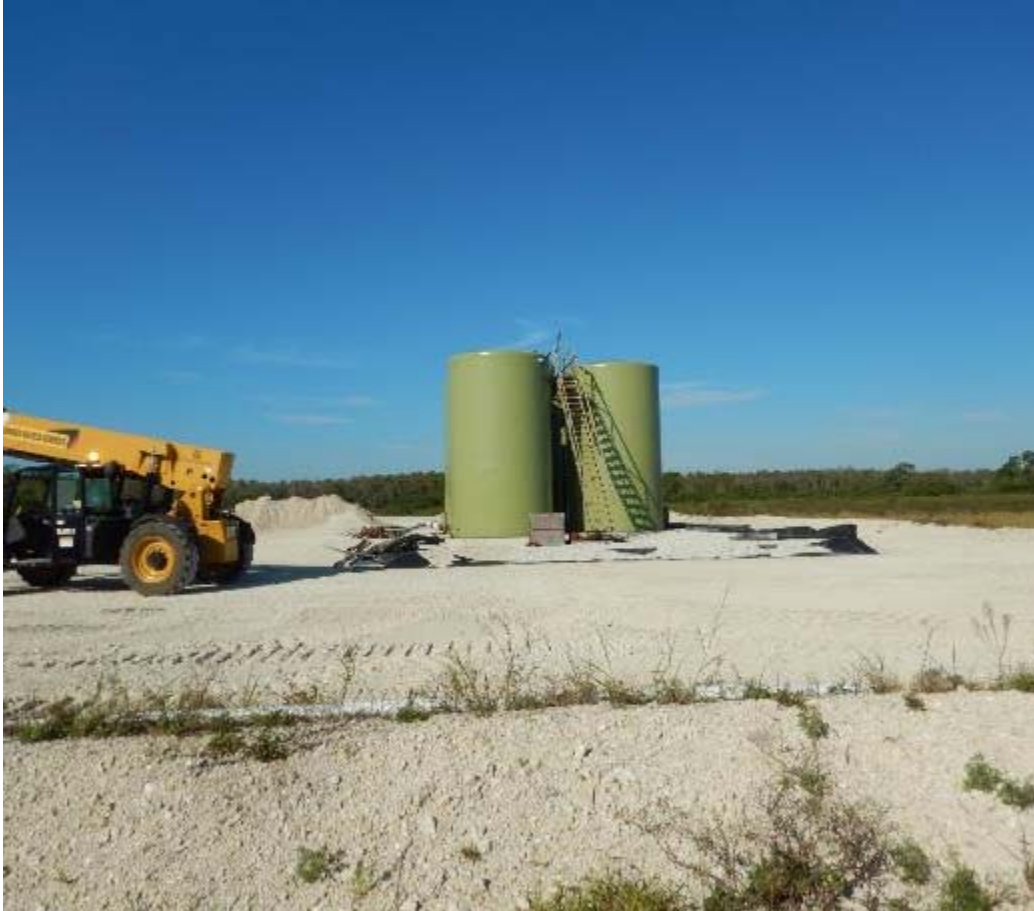
Photograph 11

Notes: Equipment in foreground

Tank Battery at center showing liner and noted recent work

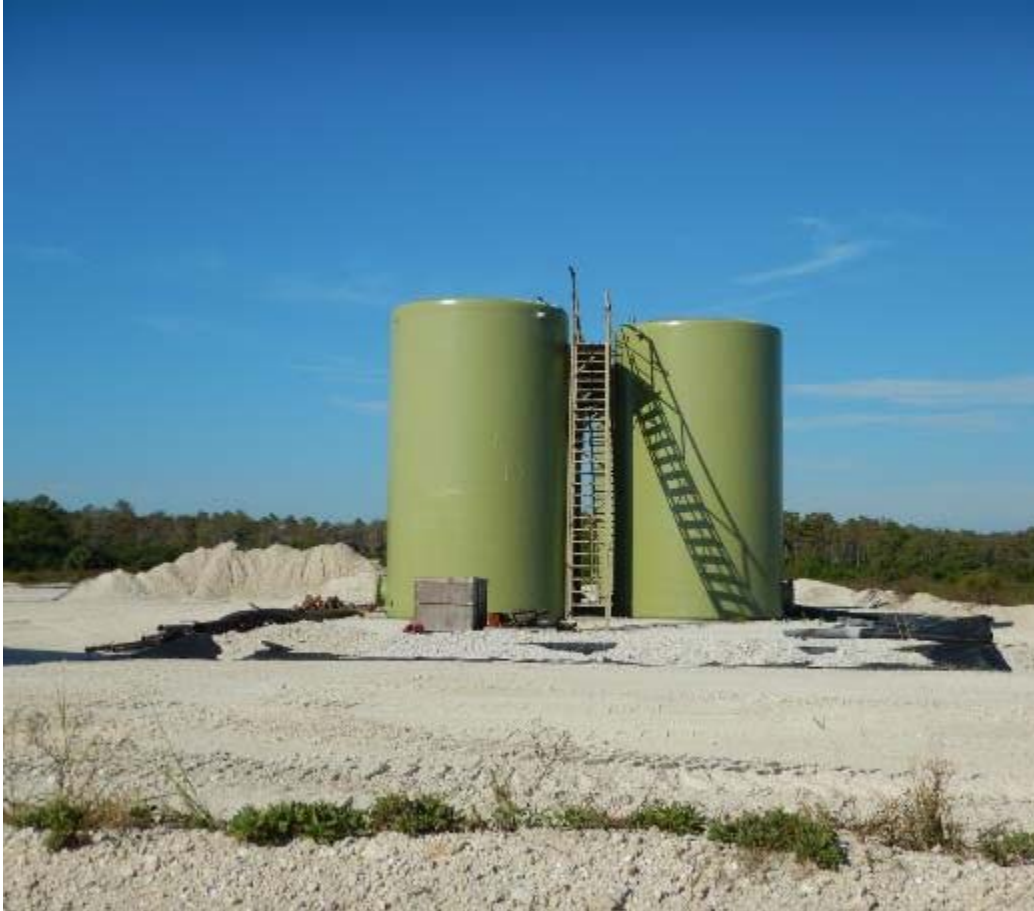
Photograph 12

Notes: Tank Battery at center showing liner and noted recent work

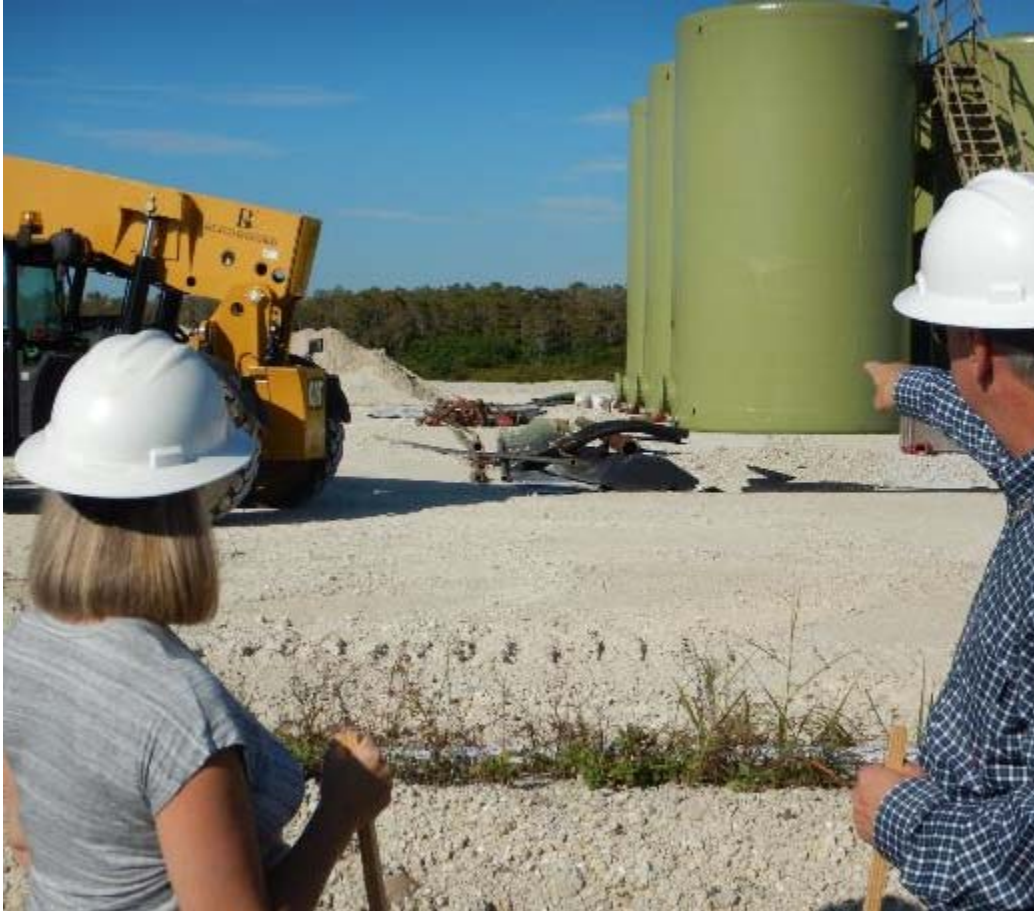
Photograph 15

Notes: Pipe laying on liner and possible damage to same communication to Danielle Irwin

Tank Battery at center showing liner and noted recent work

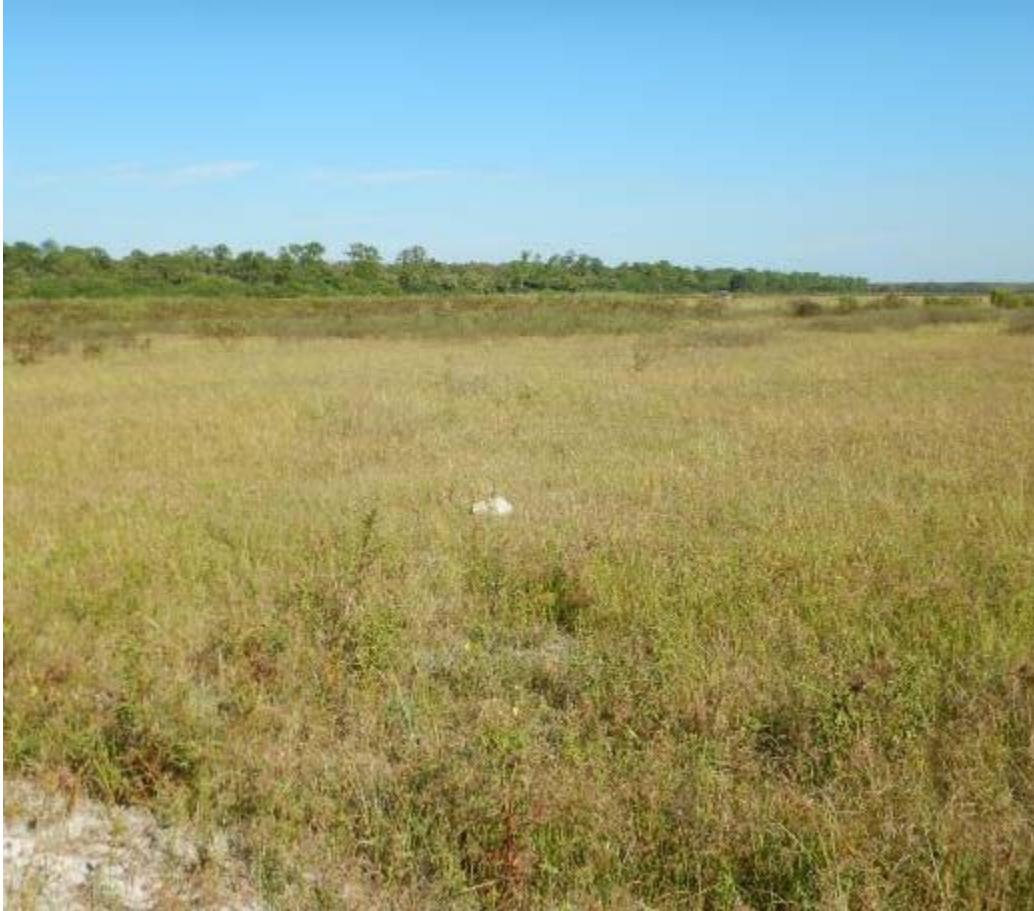
Photograph 35

Notes: No distressed vegetation

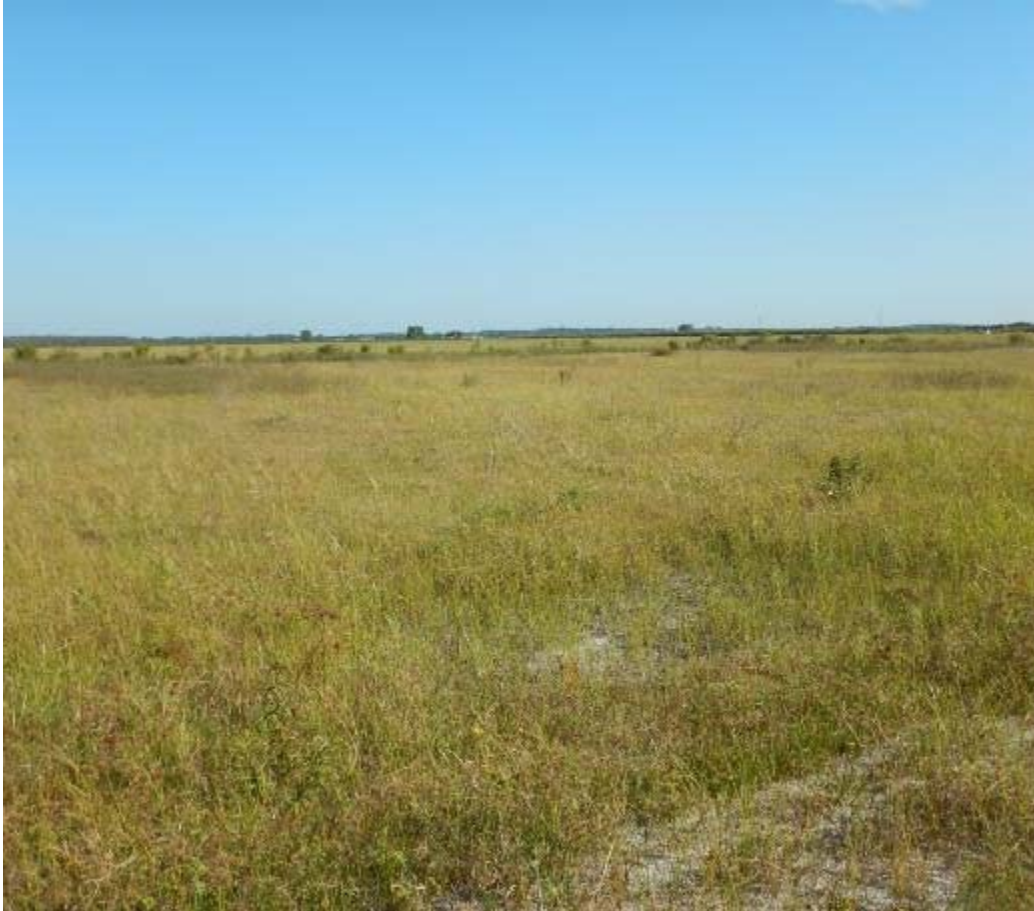
Photograph 36

Notes: No distressed vegetation

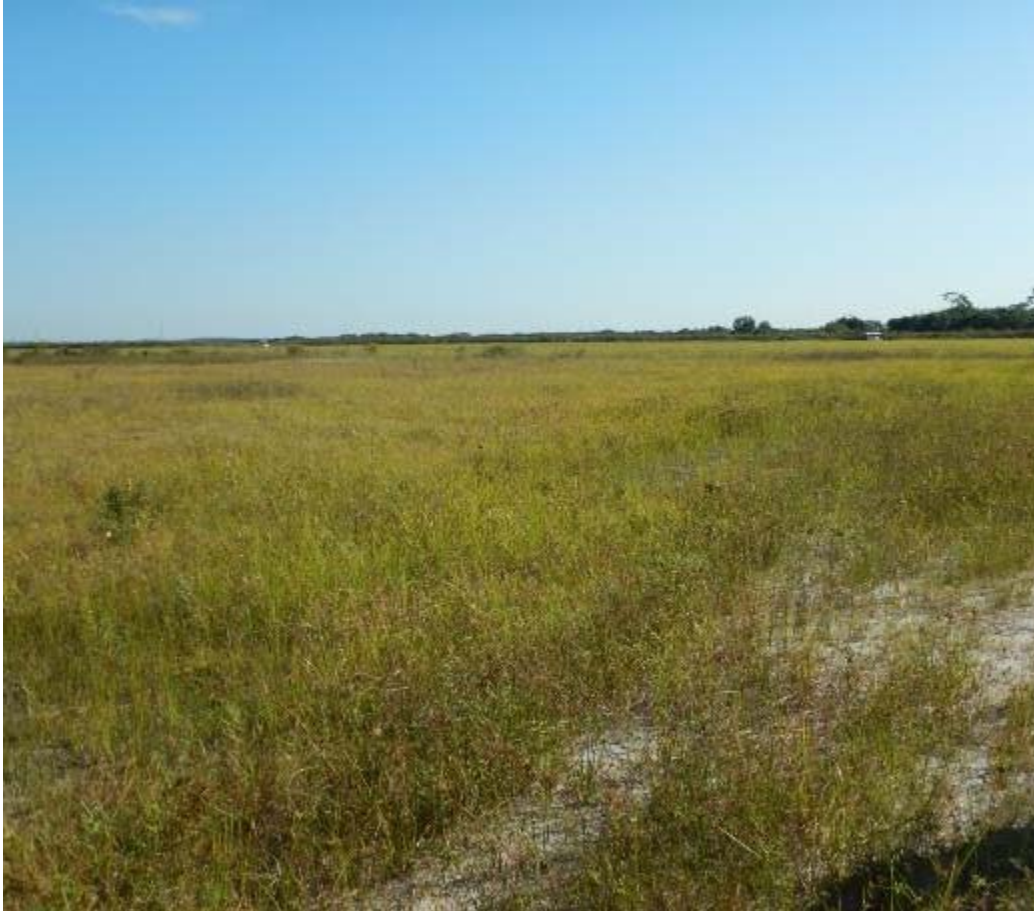
Photograph 37

Notes: No distressed vegetation

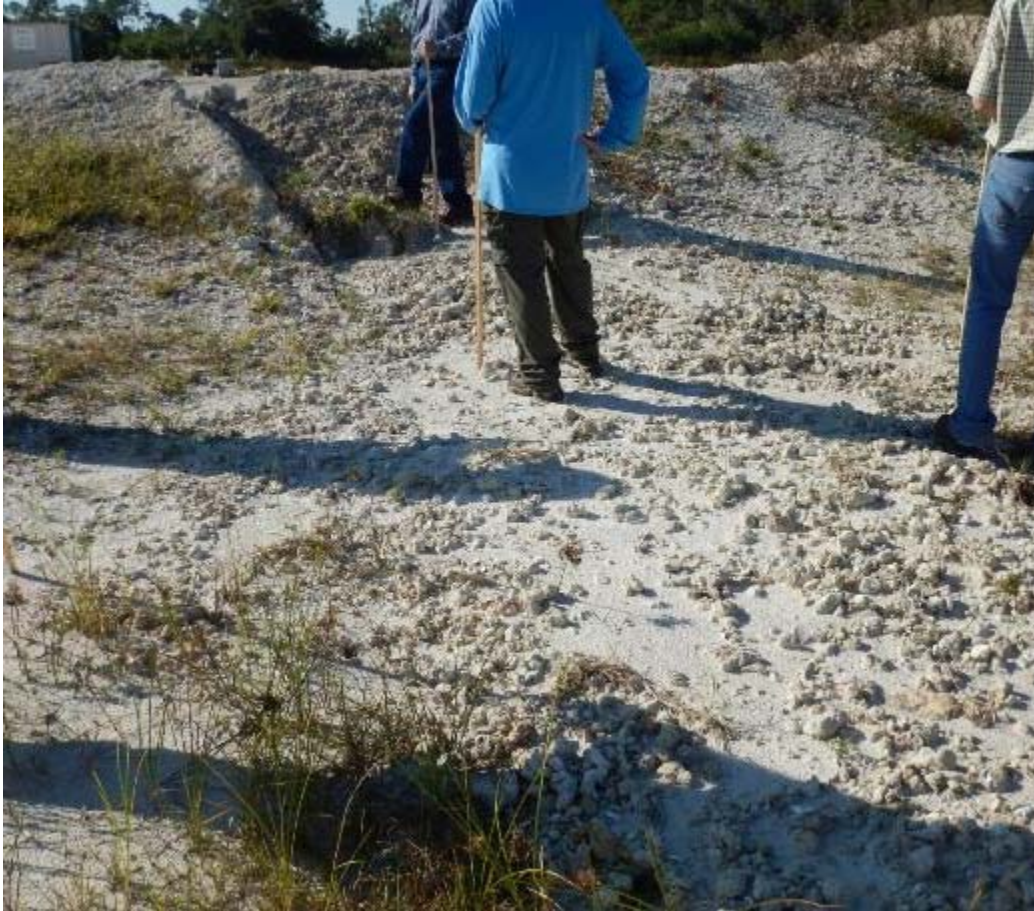
Photograph 40

Notes: Breached berm with subsequent fill

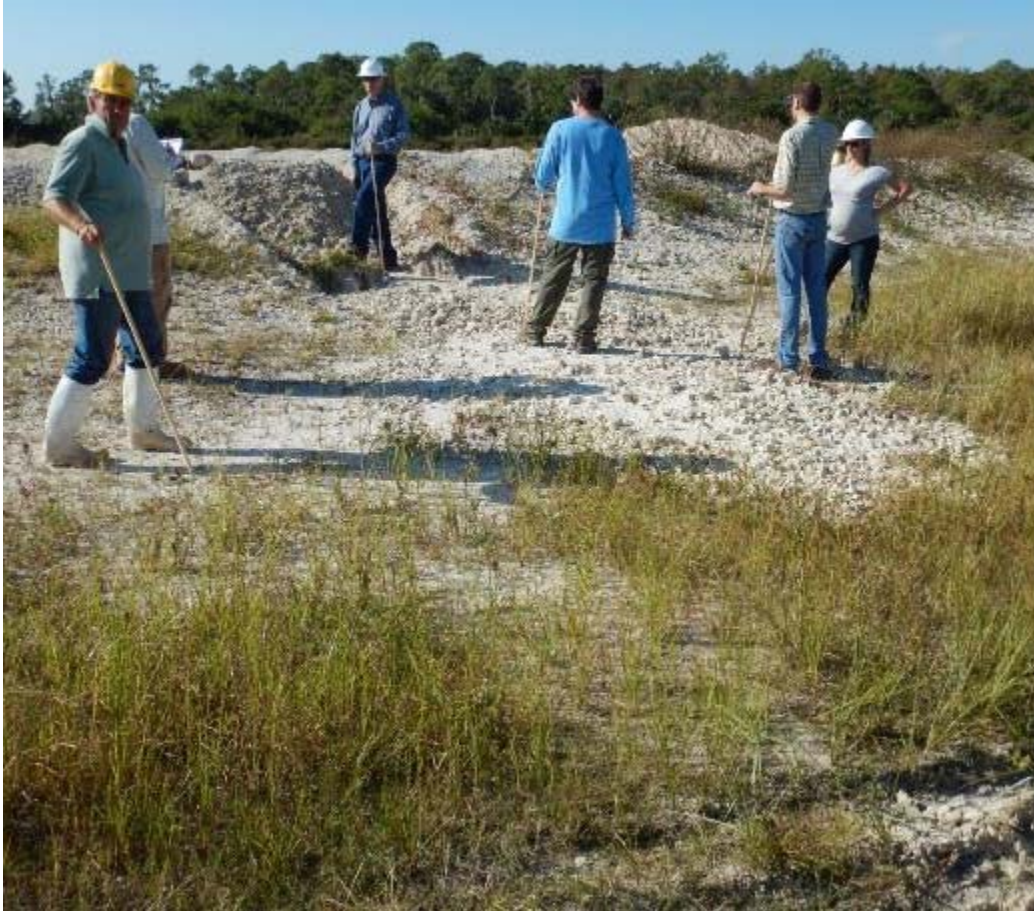
Photograph 41

Notes: Breached berm with subsequent fill

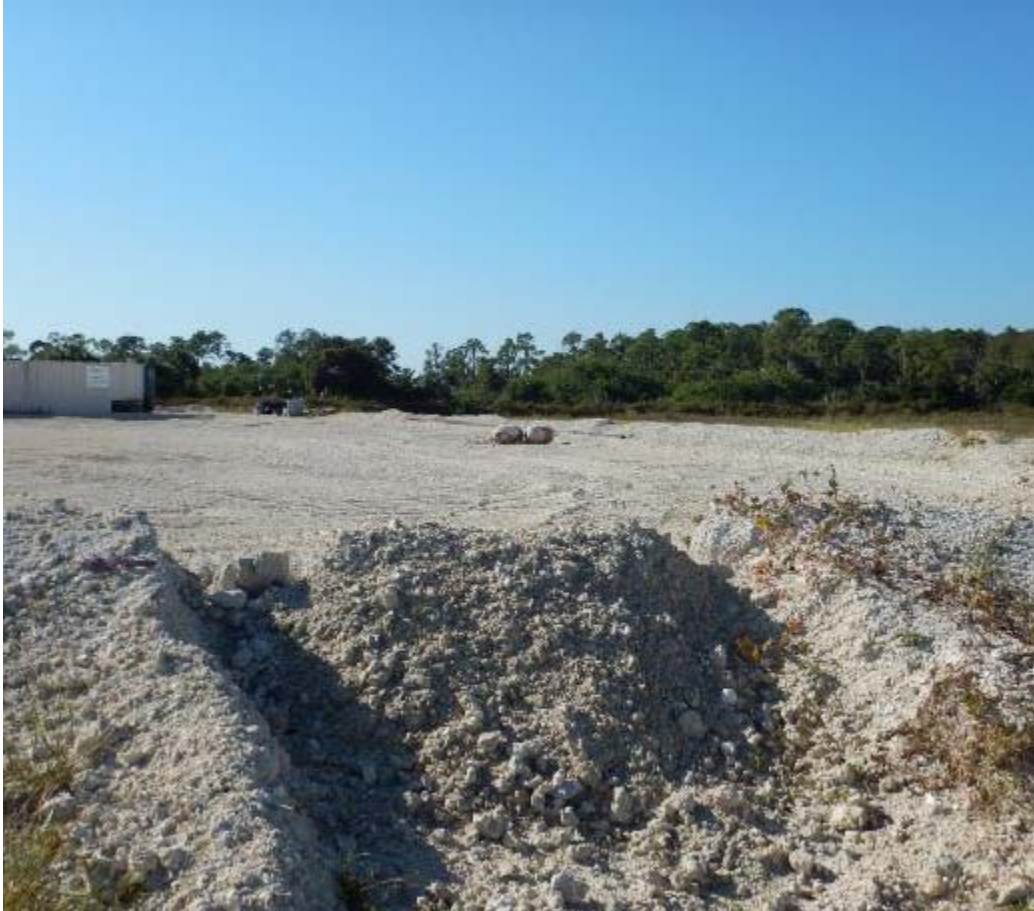
Photograph 42

Notes: Breached berm with subsequent fill

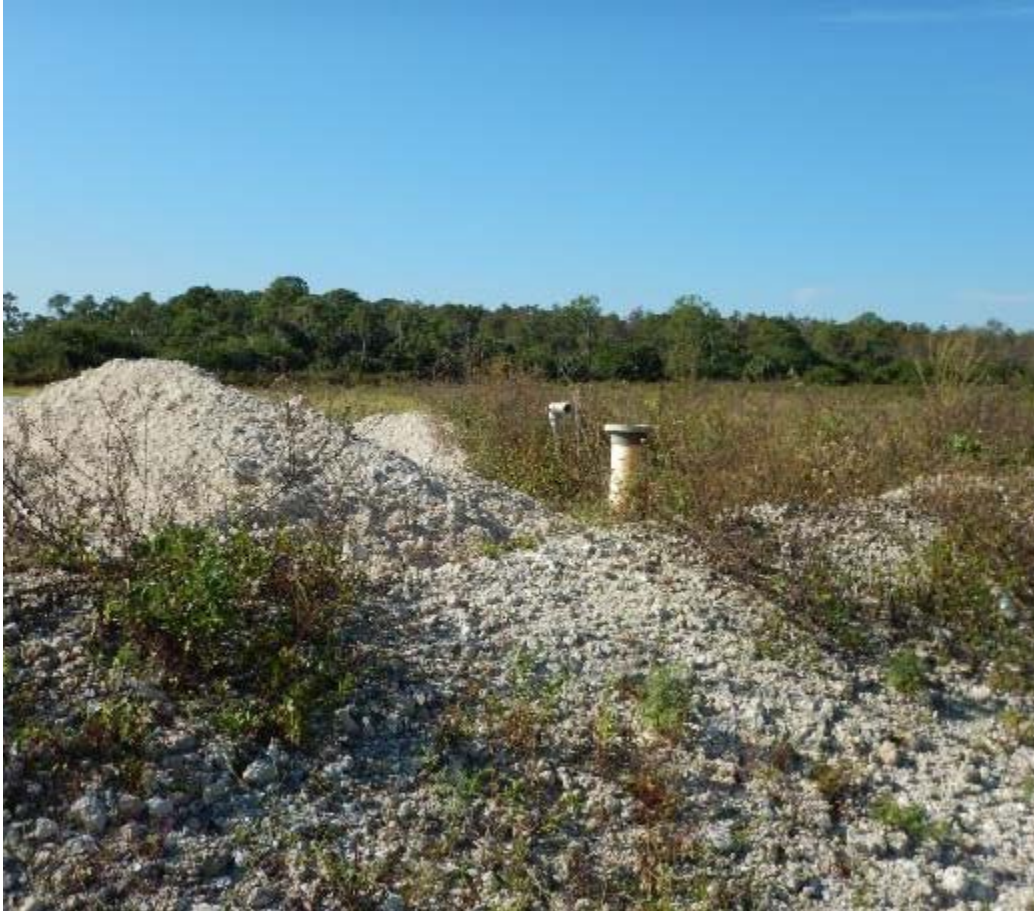
Photograph 43

Notes: Breached berm with subsequent fill

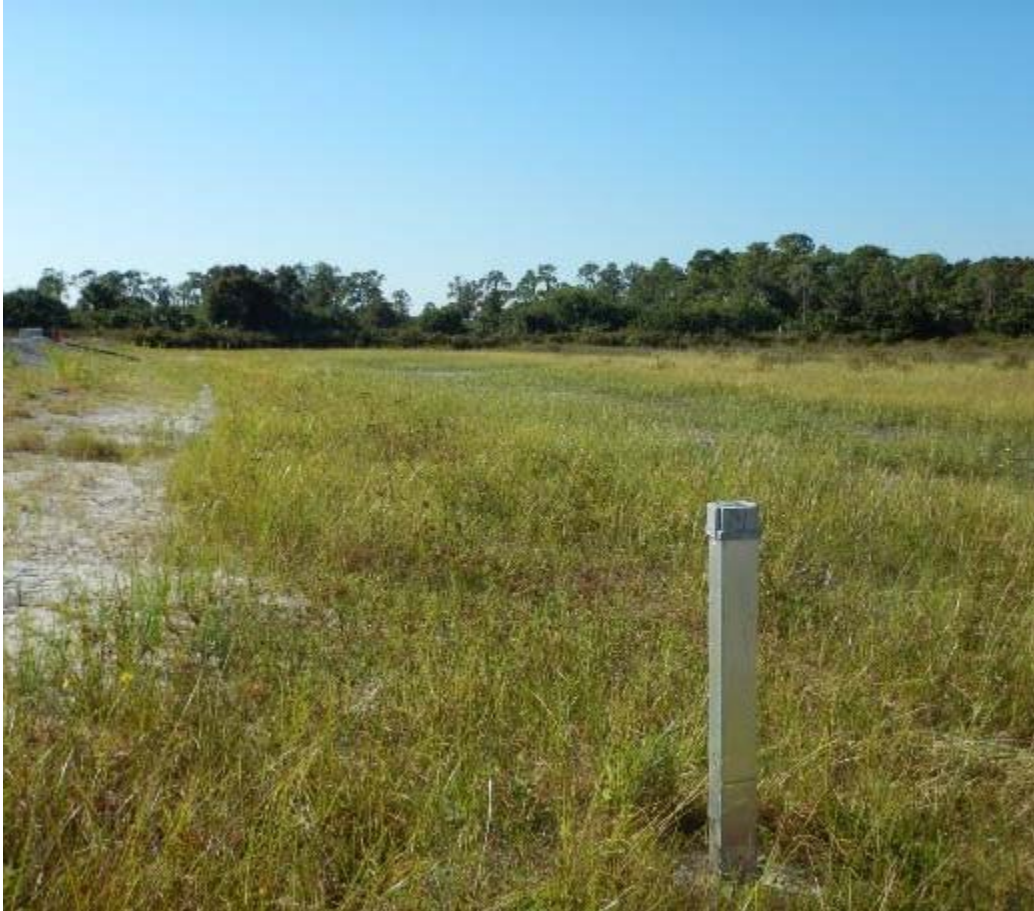
Photograph 48

Notes: Near FDEP monitoring well (low spot with evaporated water/mud)

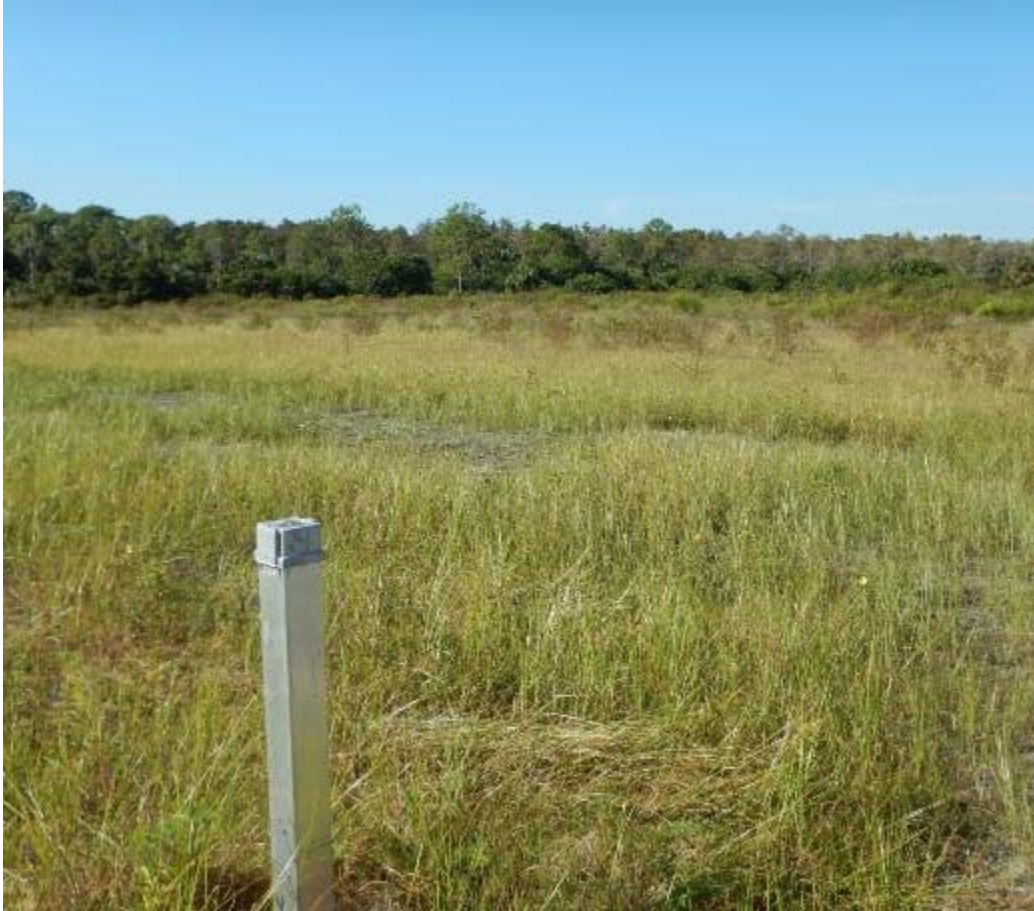
Photograph 49

Vegetation not distressed

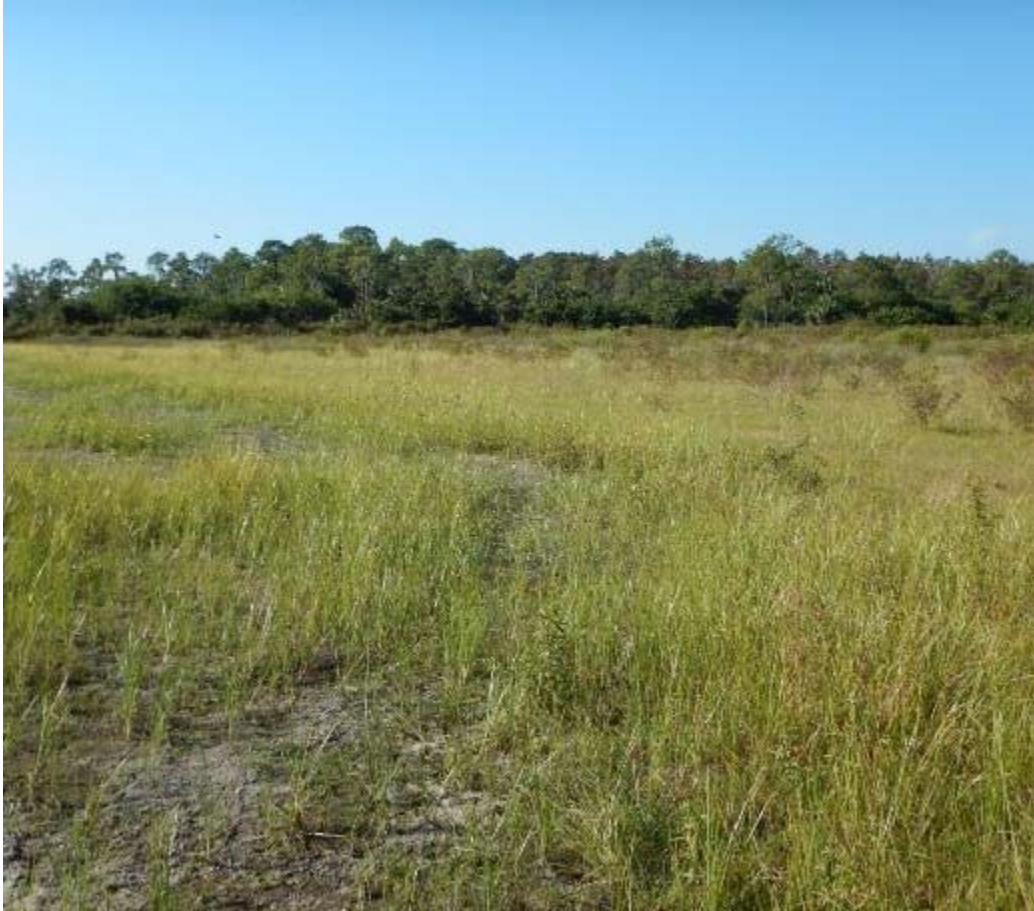
Photograph 50

Vegetation not distressed

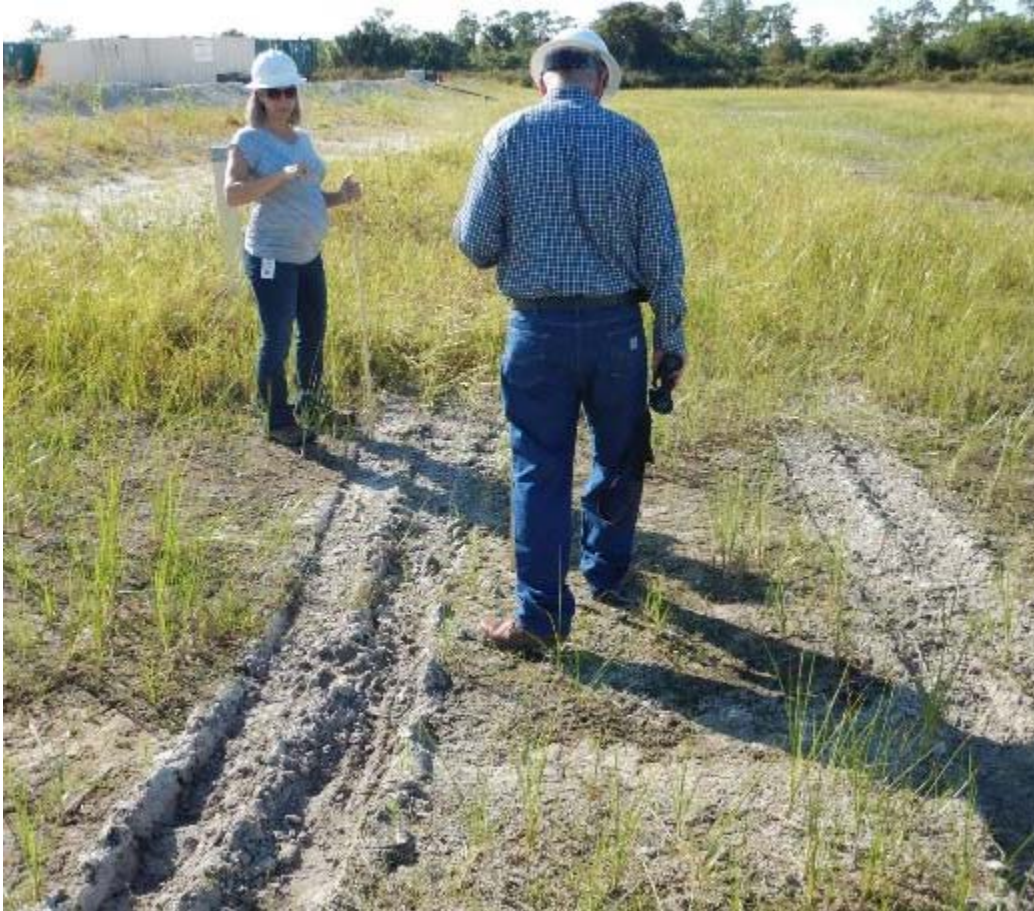
Photograph 51

Notes: Vegetation not distressed (looking NW)

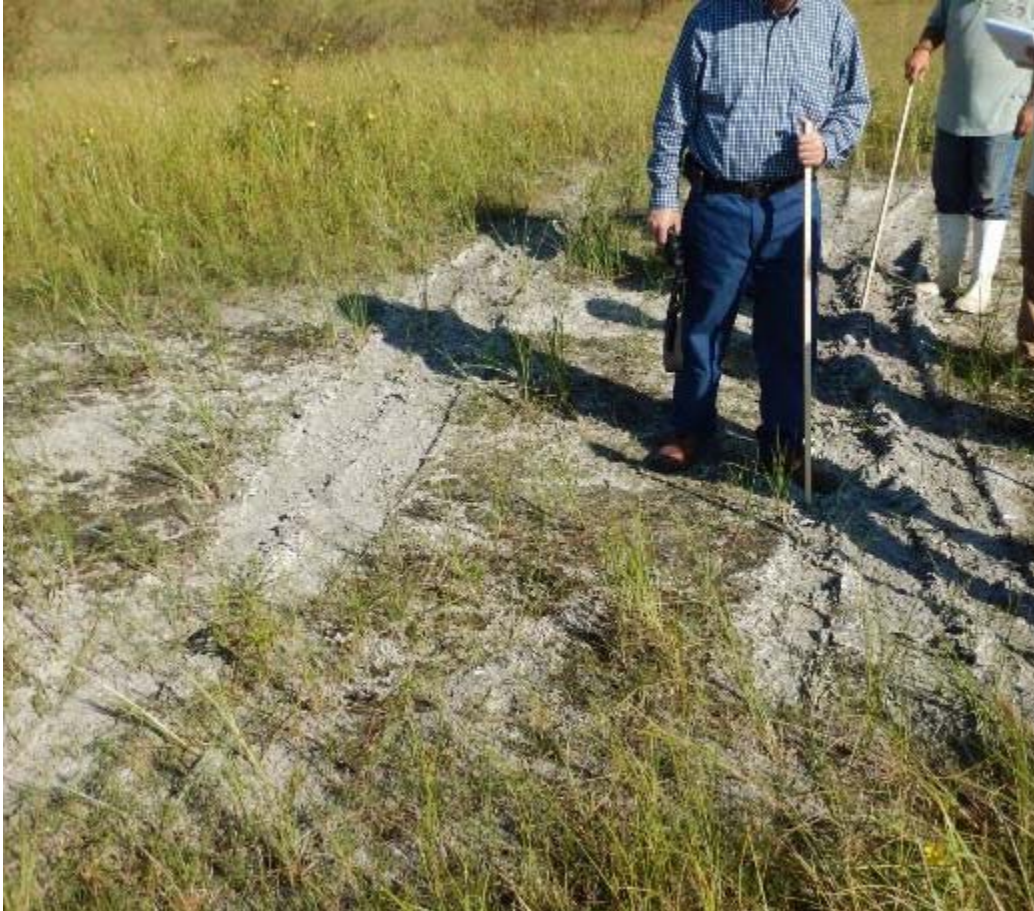
Photograph 52

Notes: Near FDEP monitoring well (low spot with evaporated water/mud tire tracks suspected from monitoring well rig)

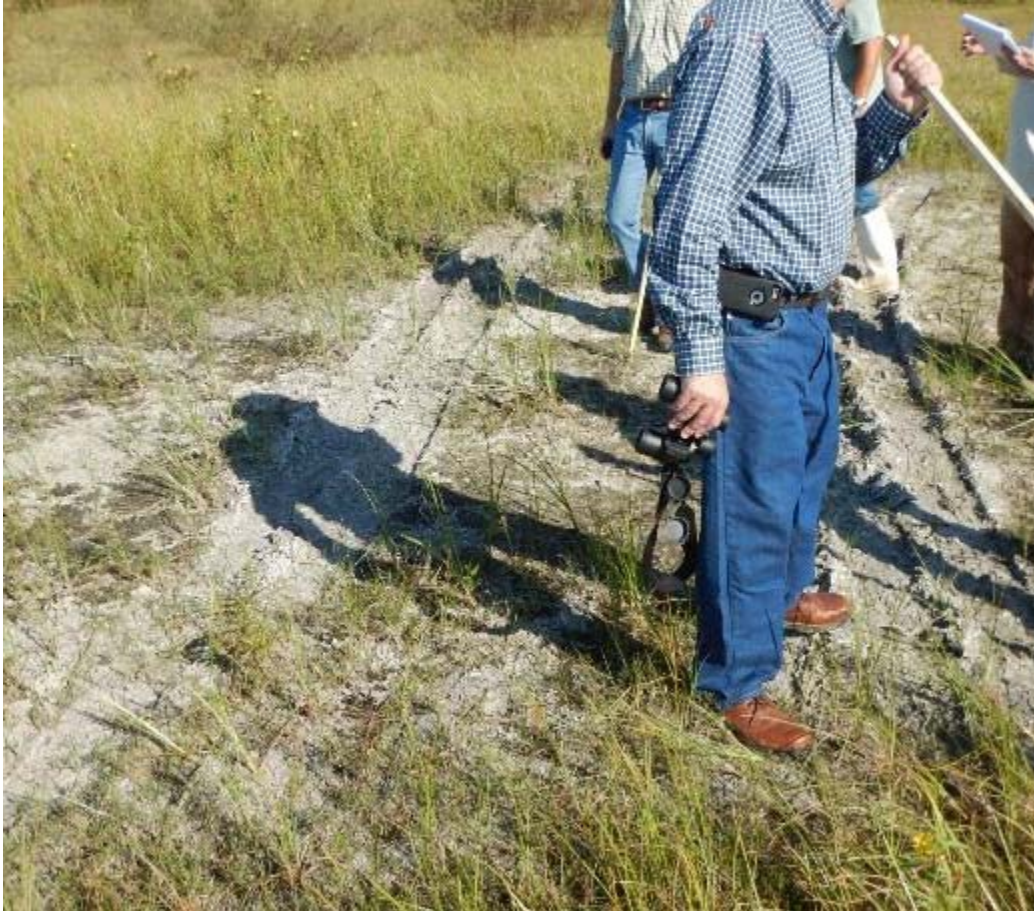
Photograph 53

Notes: Near FDEP monitoring well (low spot with evaporated water/mud tire tracks suspected from monitoring well rig)

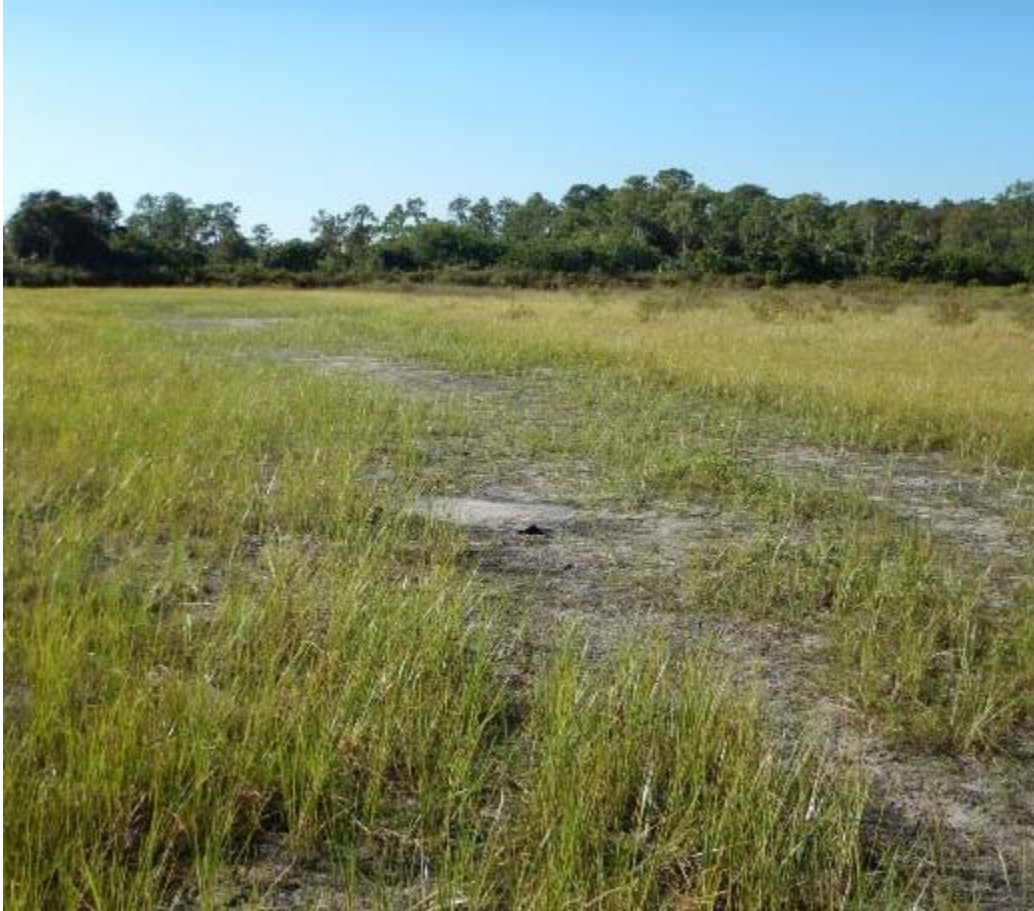
Photograph 54

Notes: Near FDEP monitoring well (low spot with evaporated water/mud tire tracks suspected from monitoring well rig)

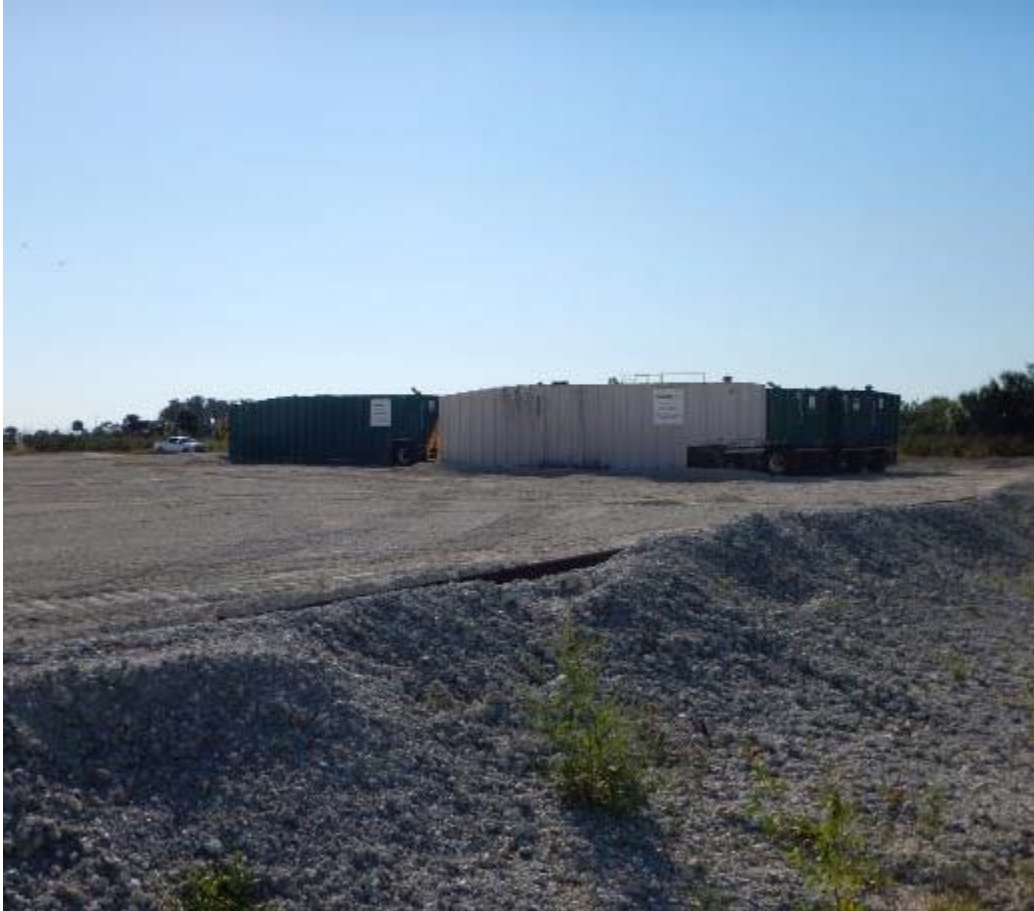
Photograph 58

Notes: Notation of freshly painted tanks (buckets noted, and reference to prior photos and site visit by Danielle Irwin reference notation of PE seal and fiberglass by Levi Sciara. (Holes and tears in plastic on battery from this vantage)

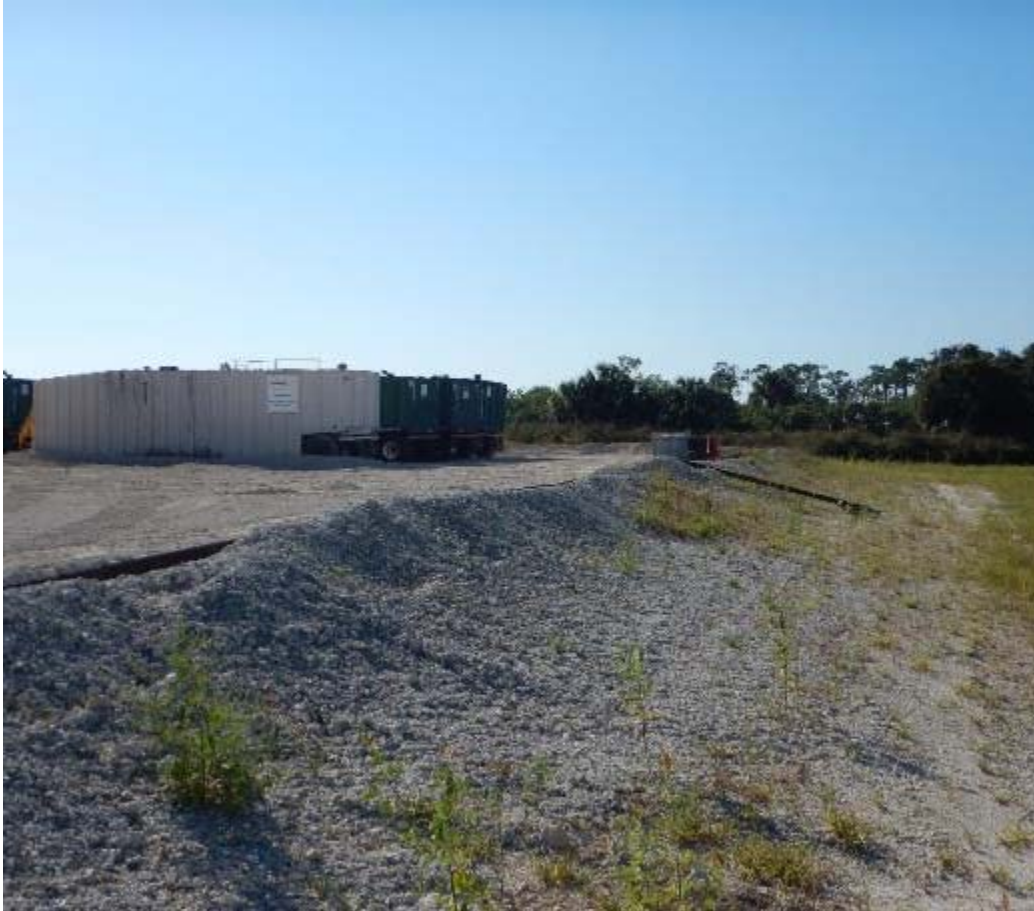
Photograph 59

Notes: Notation of freshly painted tanks (buckets noted, and reference to prior photos and site visit by Danielle Irwin reference notation of PE seal and fiberglass by Levi Sciara. (Holes and tears in plastic on battery from this vantage)

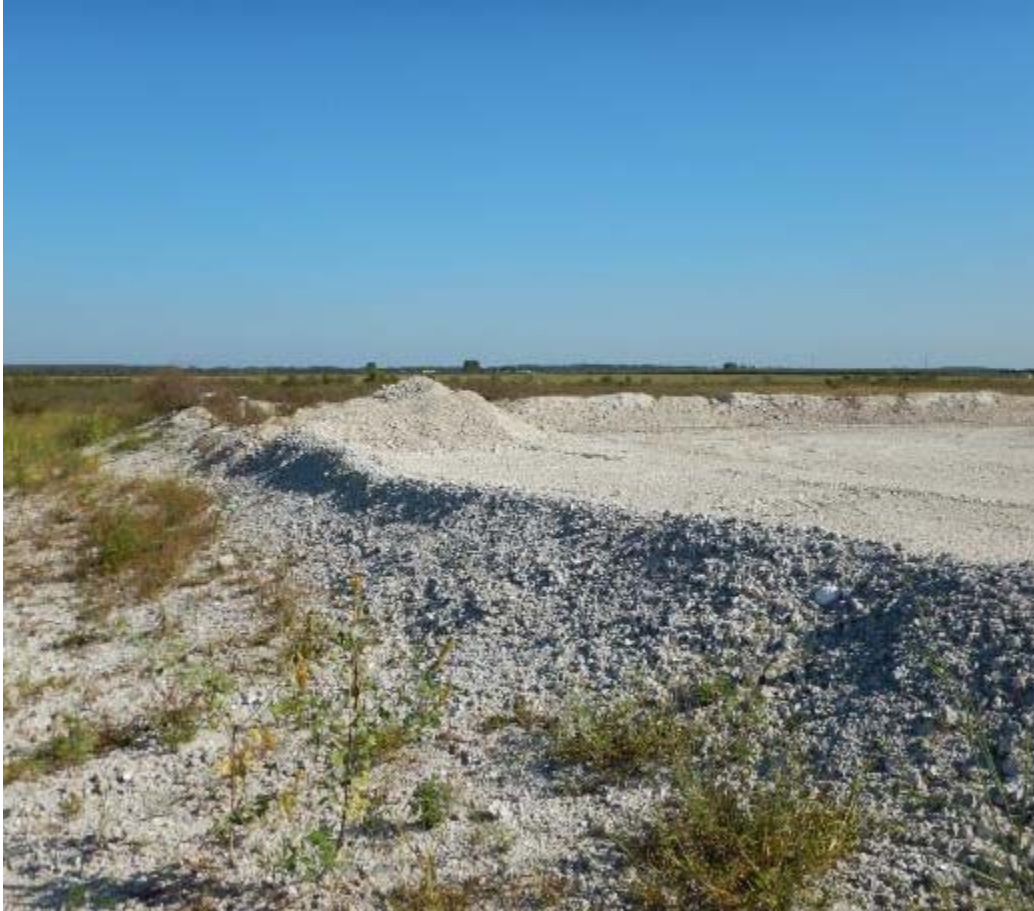
Photograph 60

Frac tanks with tanker/frac loading line draped over berm (disconnected)

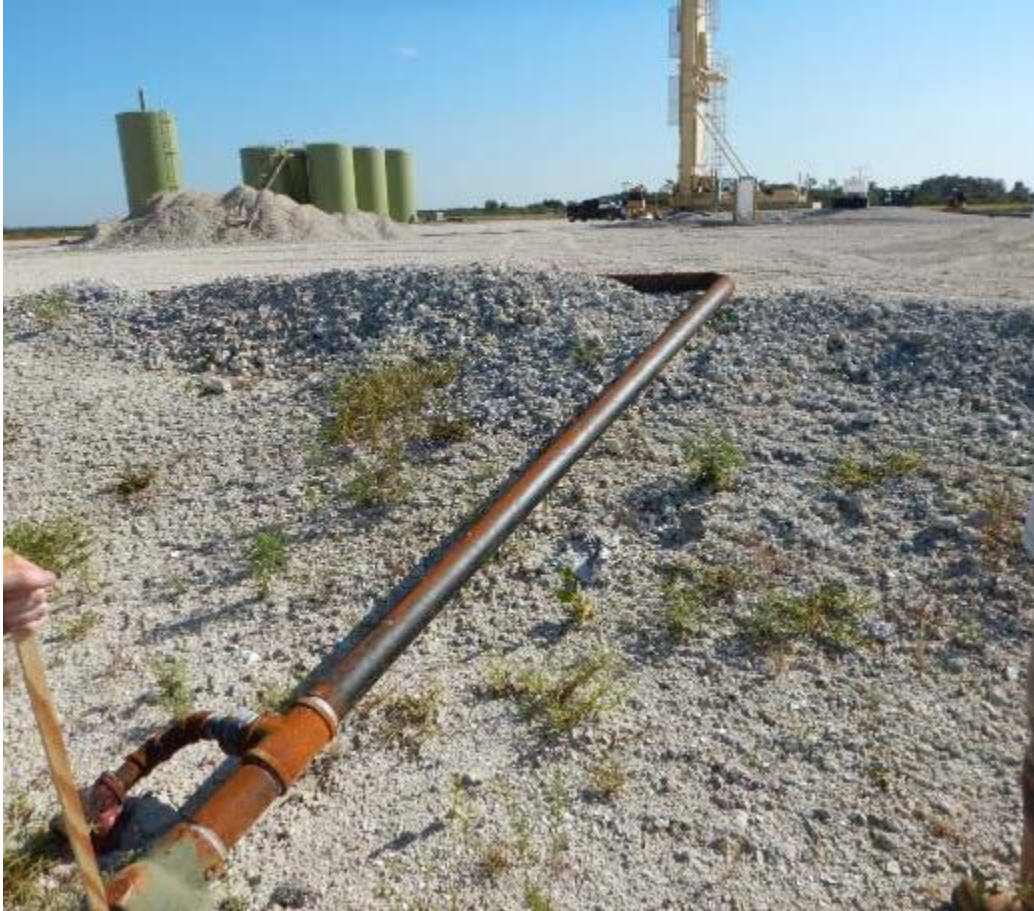
Photograph 63

Notes: Loading line (disconnected)

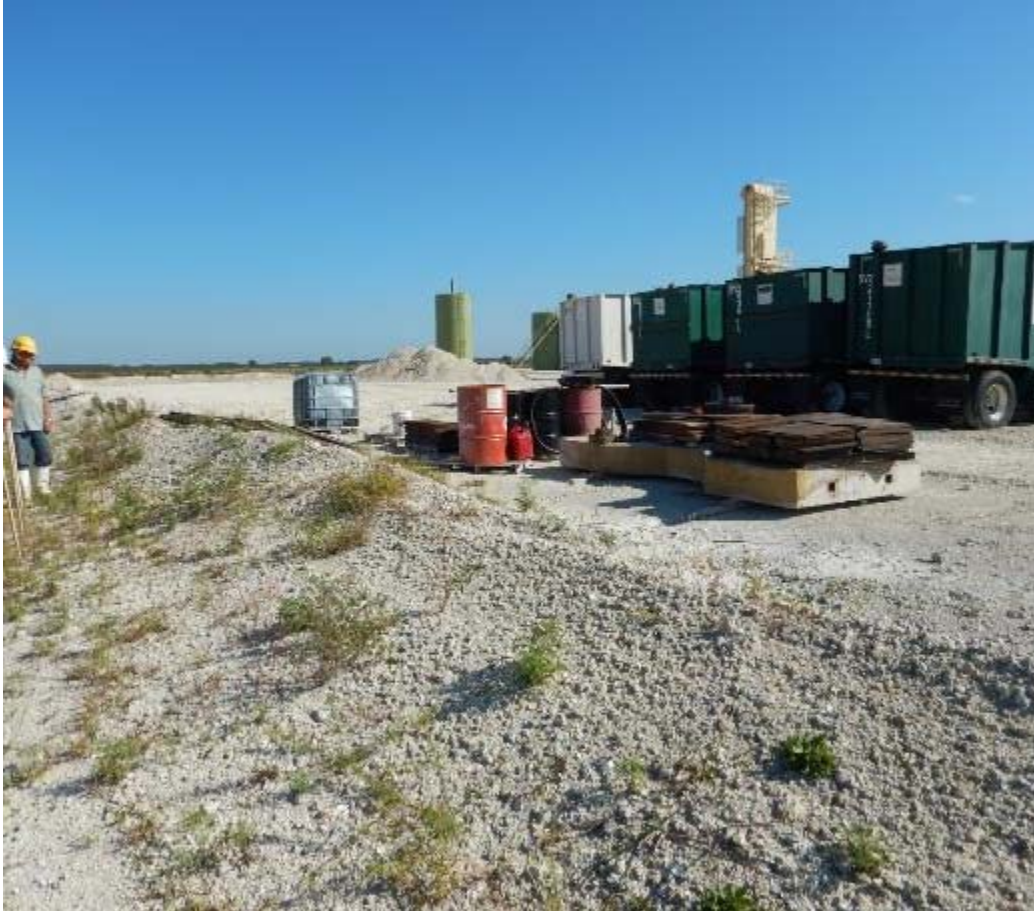
Photograph 69

Notes: Noted no secondary containment for chemical tote.

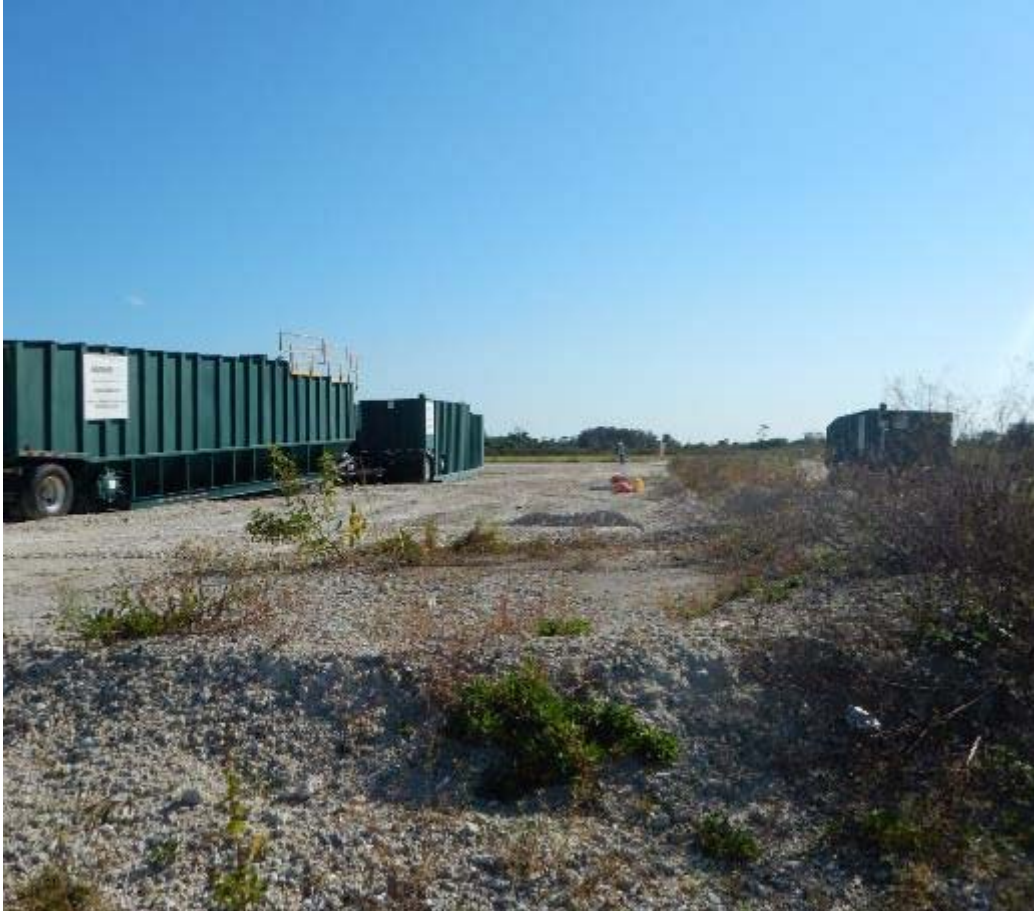
Photograph 70

Notes: Noted no secondary containment for chemical tote or barrels.
