Expert Evaluation of the D.A. Hughes Collier-Hogan 20-3H

Well Drilling and Workover

Prepared for
Florida Department of Environmental Protection
3900 Commonwealth Blvd. M.S. 35
Tallahassee, FL 32399

December 2014

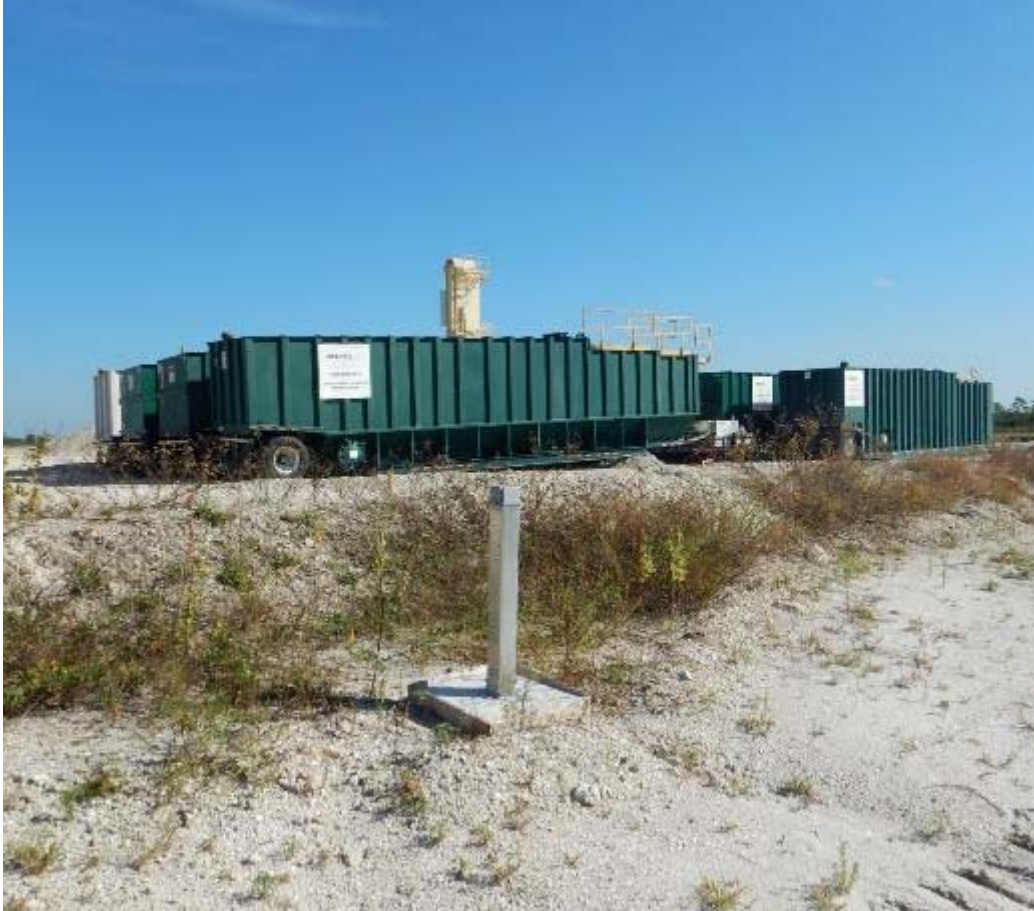
Photograph 72

Notes: 7 frac tanks foreground and 1 off well pad.

Monitoring well on SW corner of well pad installed per direction of FDEP
(monitoring wells on all four corners of site)

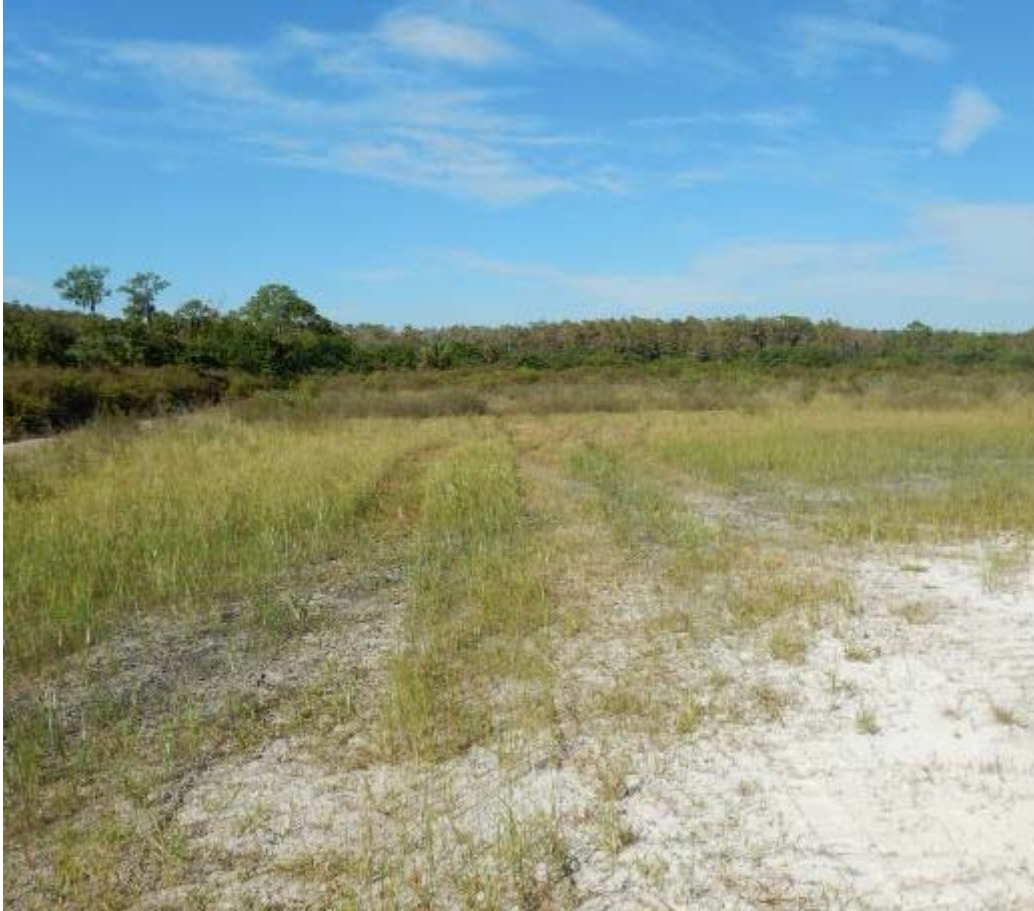
Photograph 73

Notes: Looking west in front of proposed DMW location.

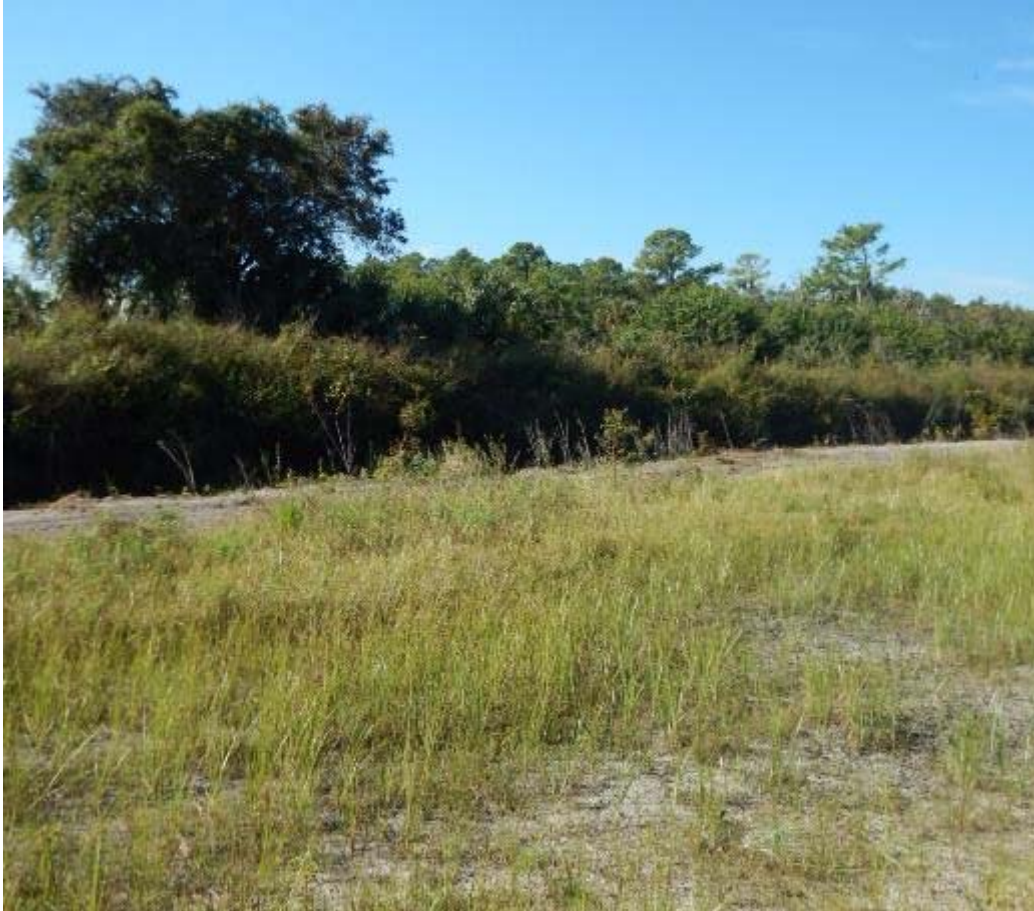
Photograph 74

Notes: Agricultural water drainage/supply/storage next to entrance road.

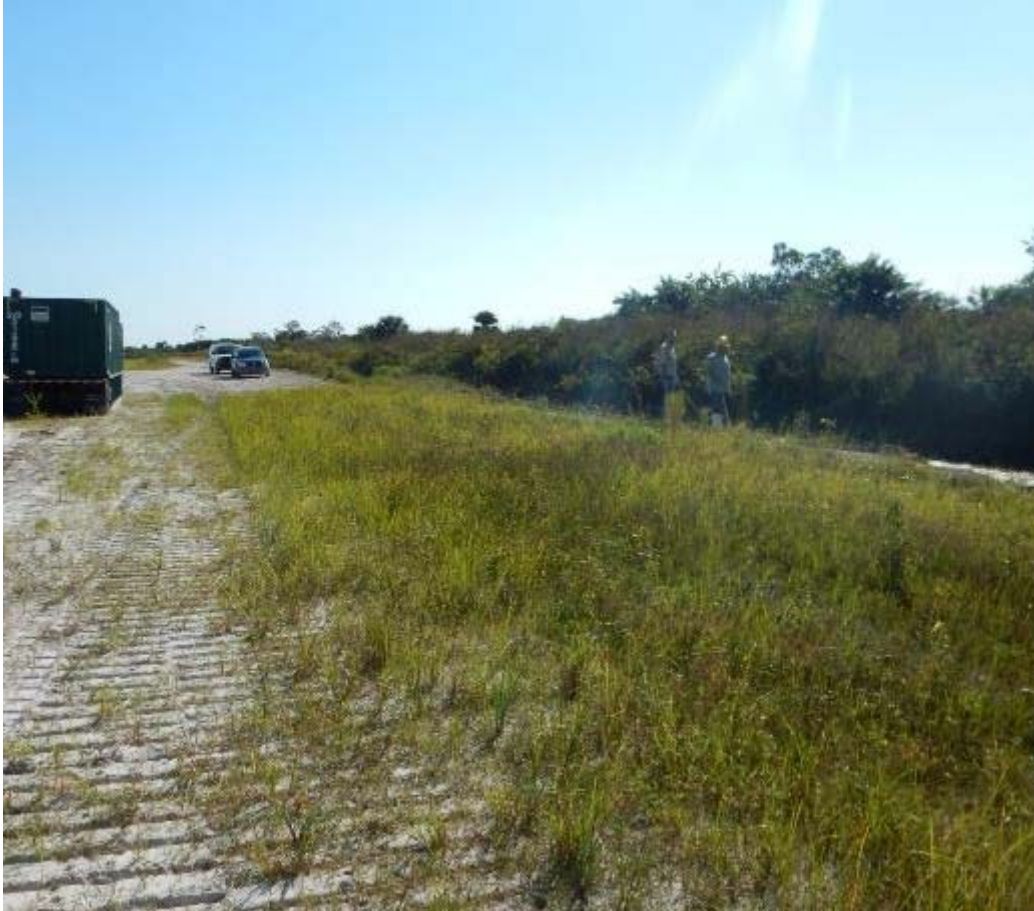
Photograph 75

Notes: Agricultural water drainage/supply/storage next to entrance road. Also boom constructed in ditch adjacent and south of well pad entrance grade to location. Site personnel noting boom installation.

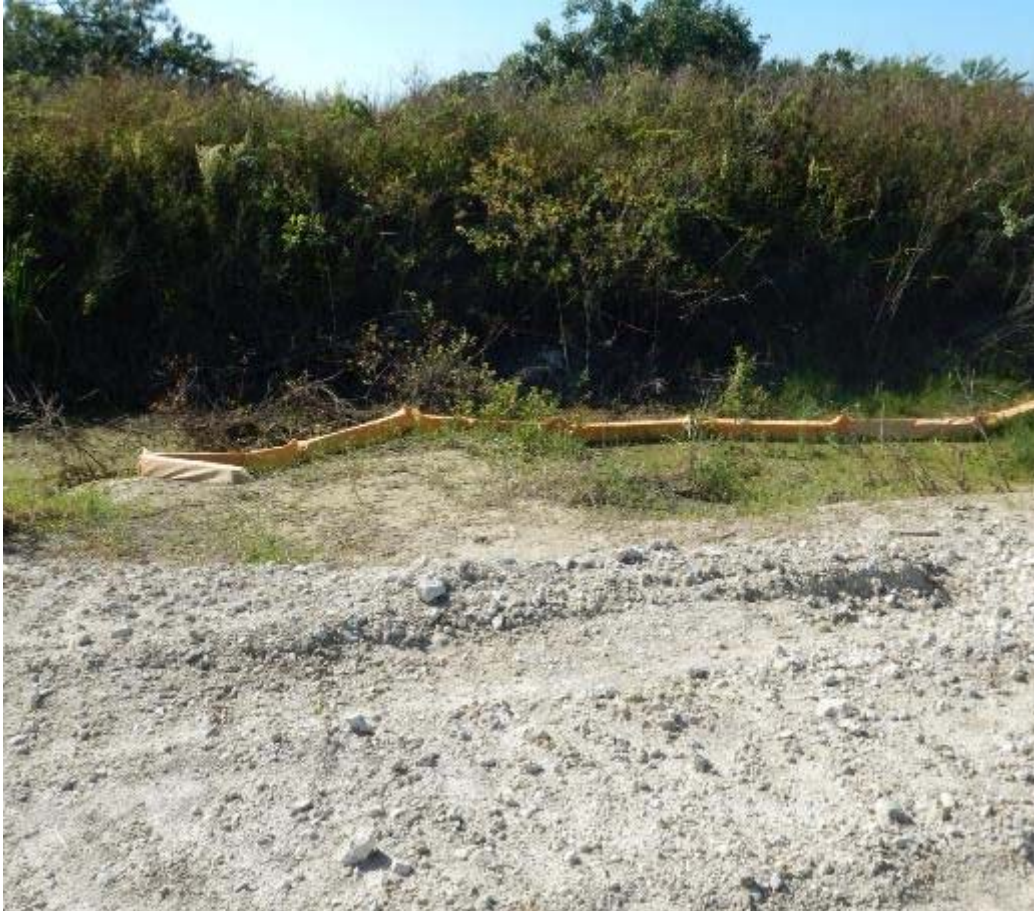
Photograph 81

Notes: Agricultural water drainage/supply/storage next to entrance road. Also note boom constructed in ditch adjacent and south of well pad entrance grade to location.

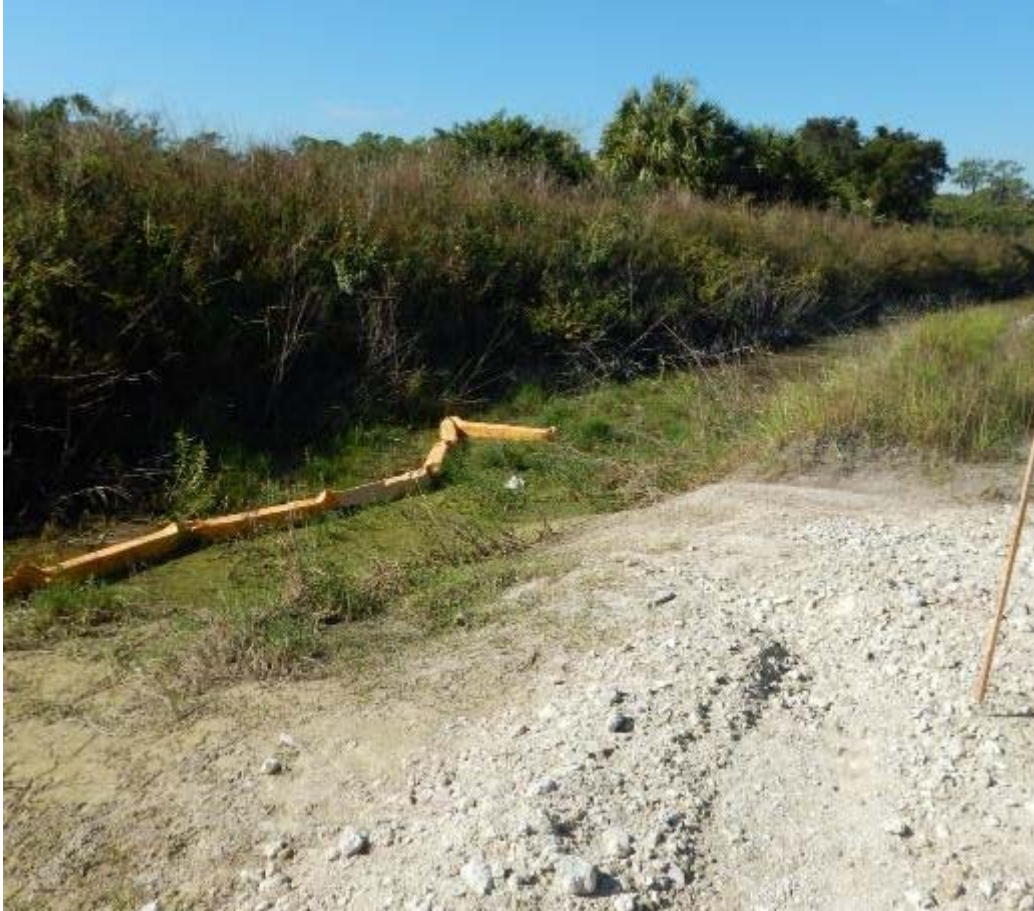
Photograph 82

Notes: Agricultural water drainage/supply/storage next to entrance road. Also note boom constructed in ditch adjacent and south of well pad entrance grade to location.

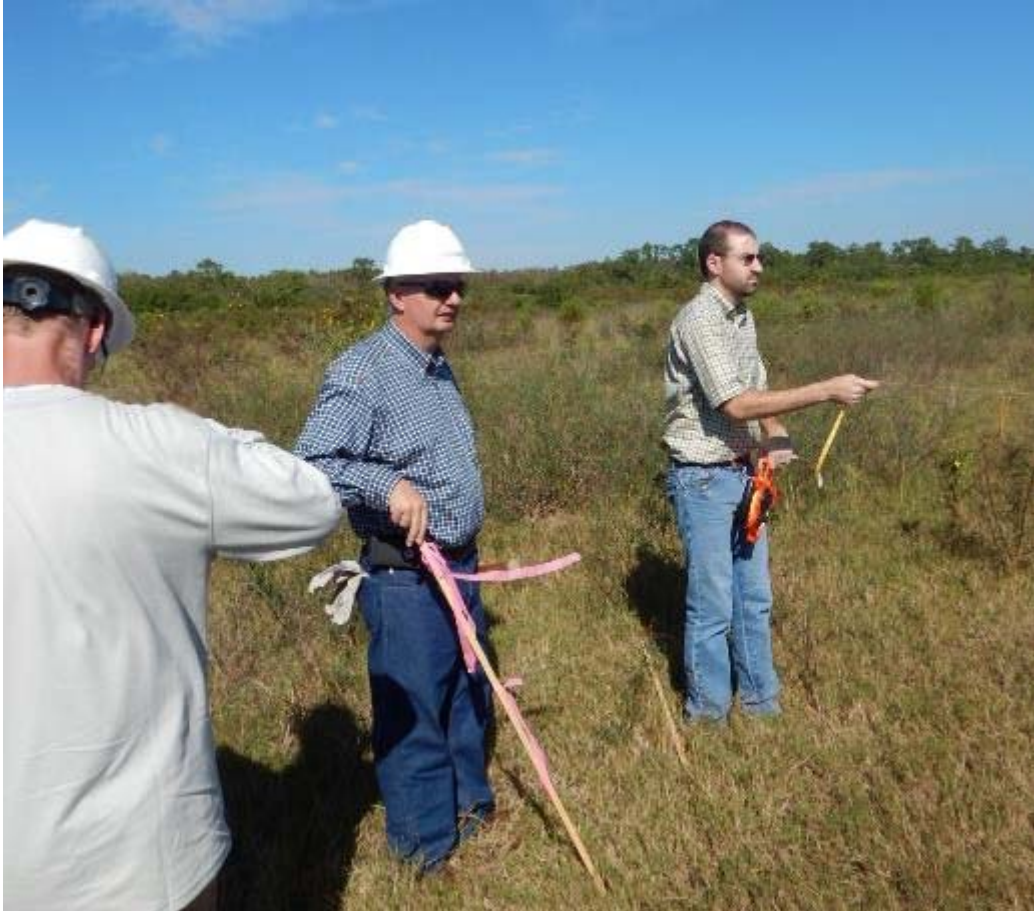
Photograph 83

Notes: Start to stake new Deep Monitoring Well (DMW) location.

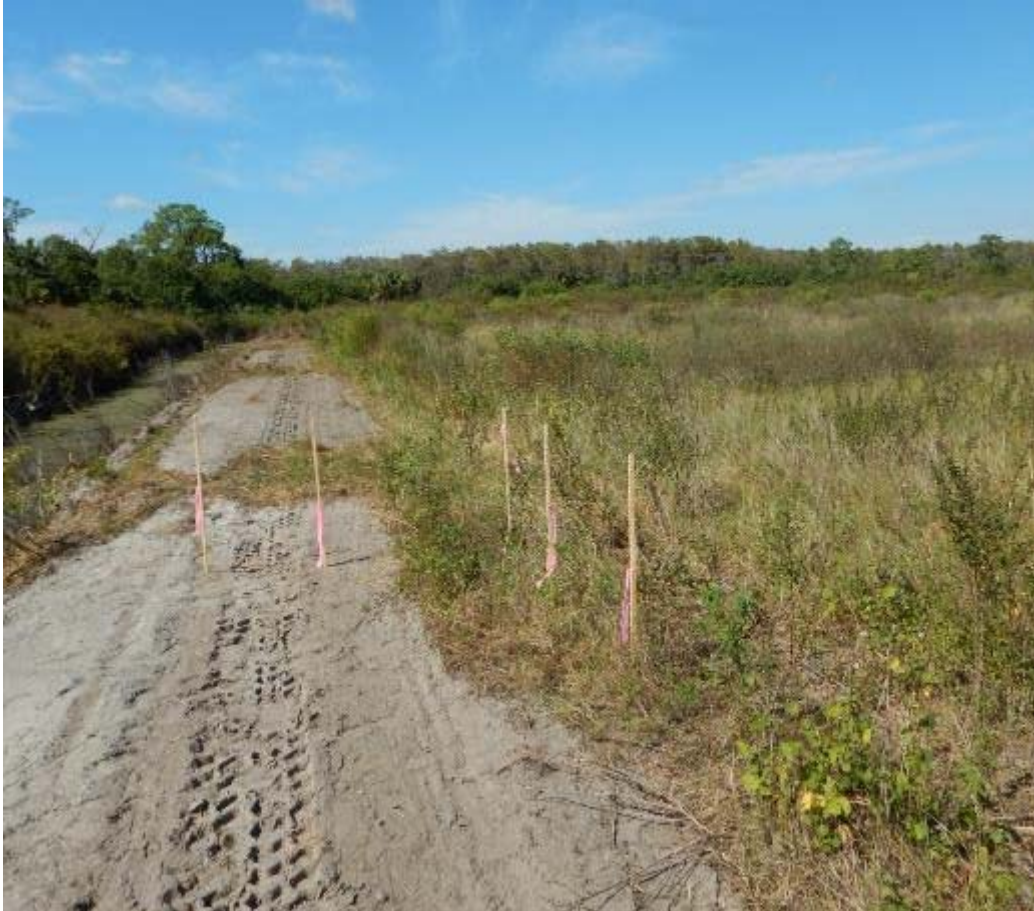
Photograph 90

Location: SE Corner with slit fence and sock install

Notes: Looking west

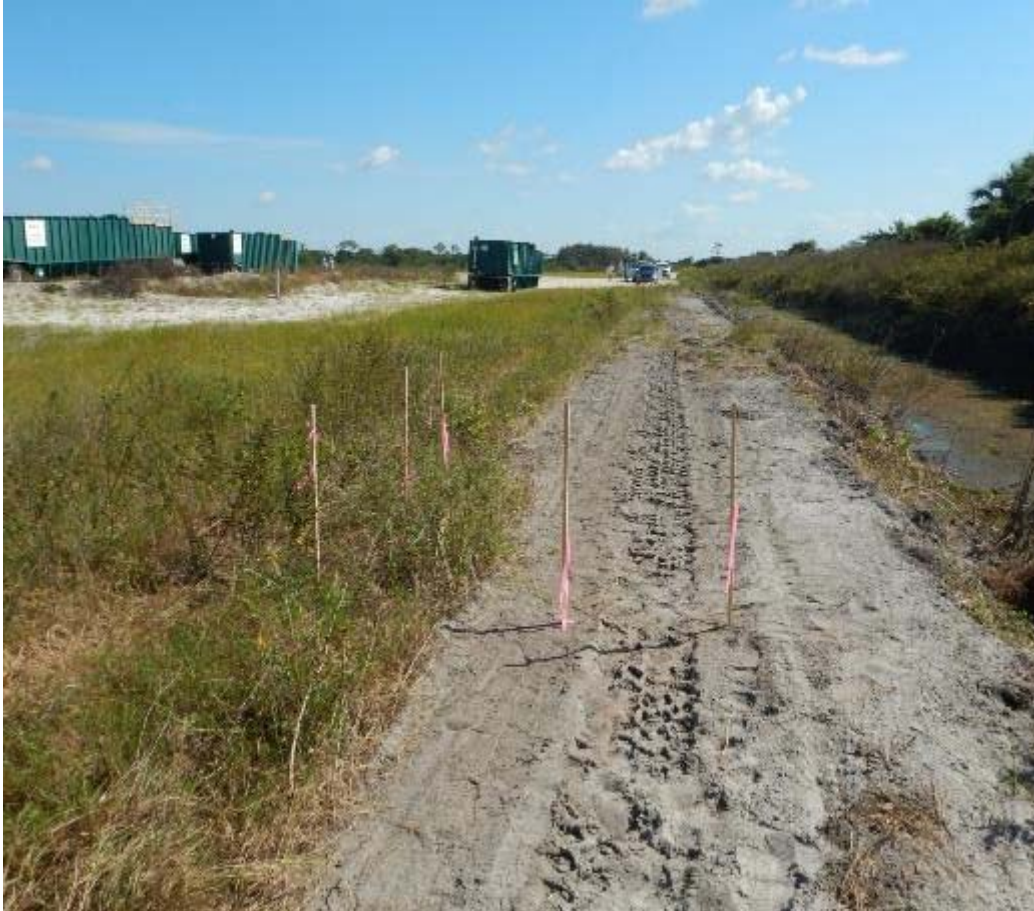
Photograph 91

Location: SE corner stake (silt fence and sock)

Notes: Looking east
