# **Engineering Evaluation of Bollard Fence**

## Rio Grande, Hidalgo County, Texas

United States of America v. Fisher Sand and Gravel Company, Civil Action No. 7:19-CV-403

August 2021

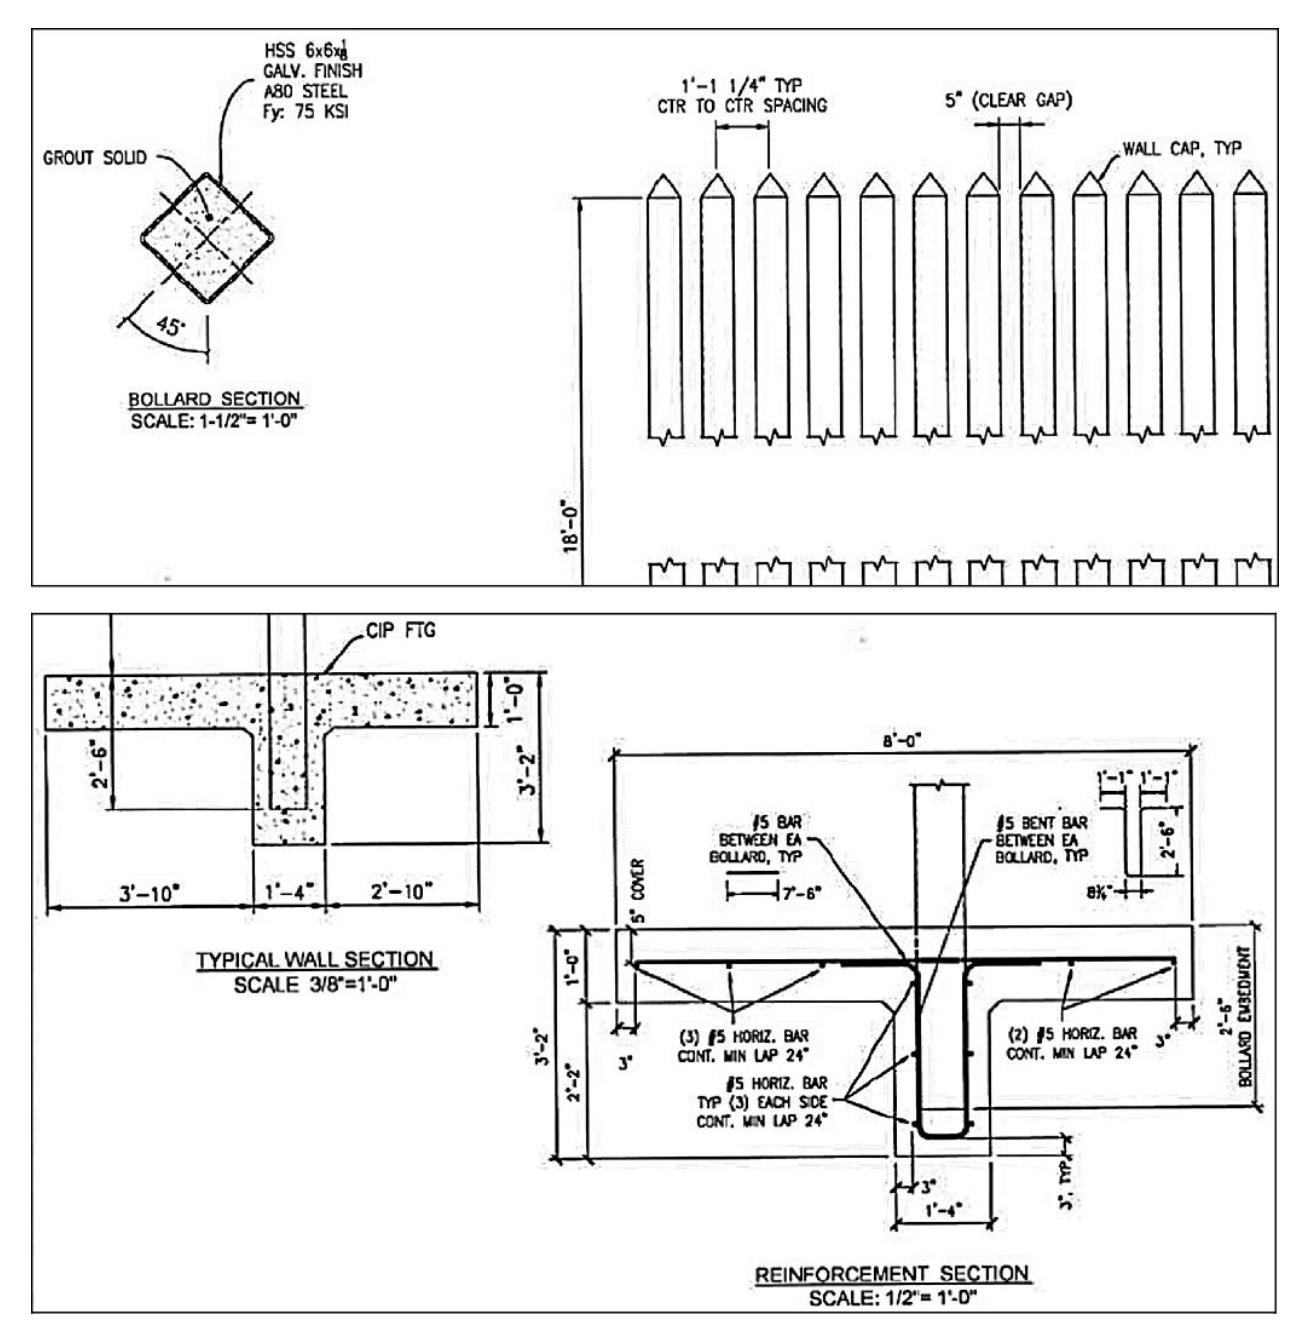
- The plans prepared by TGR Construction, Inc. and dated October 30, 2019 were not signed and sealed by a licensed professional engineer in the State of Texas, and do not include design criteria, concrete notes, reinforcing and structural steel notes, foundation notes, datum, benchmarks, items requiring structural observation and inspection, and other contents considered to meet industry standards.

Figure 1.2. Construction details from plans by TGR, dated October 30, 2019

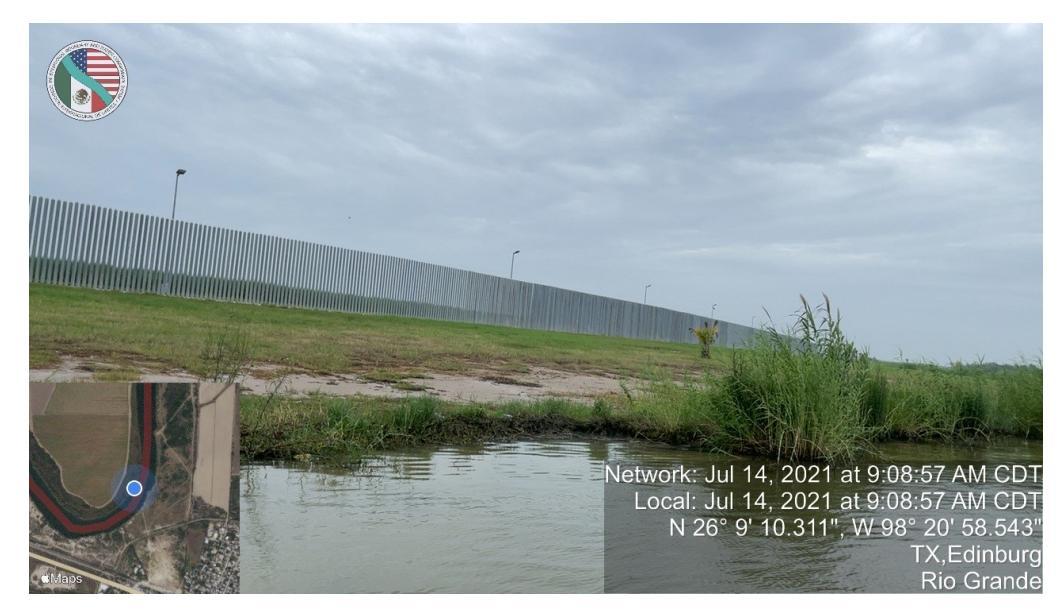
Figure 2.2. Surface erosion, southeast side of fence

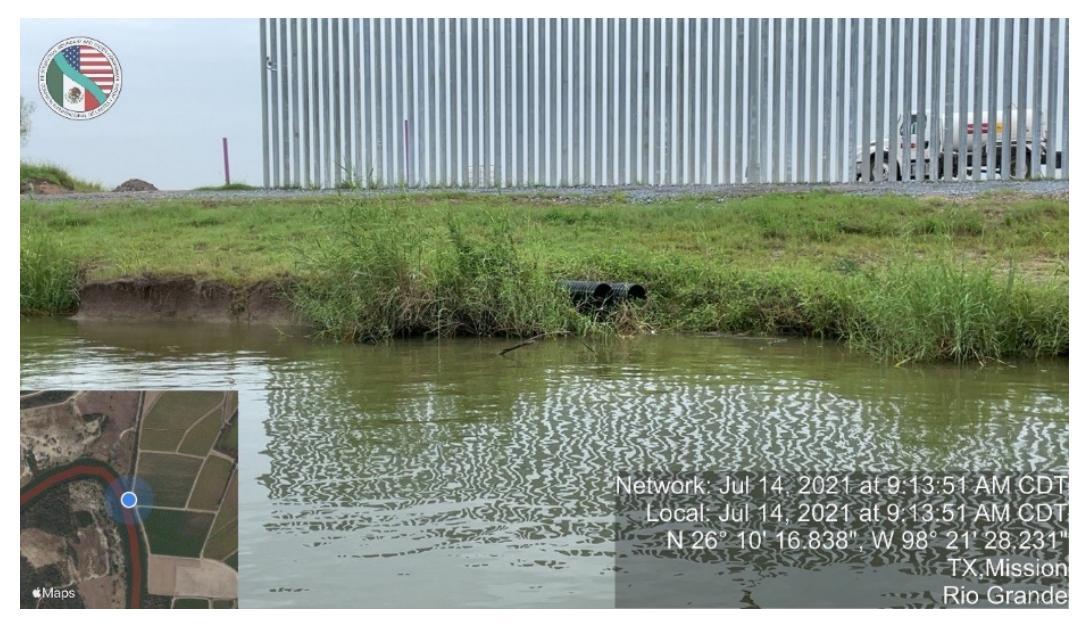
Figure 2.3. Bank caving, northwest side of fence

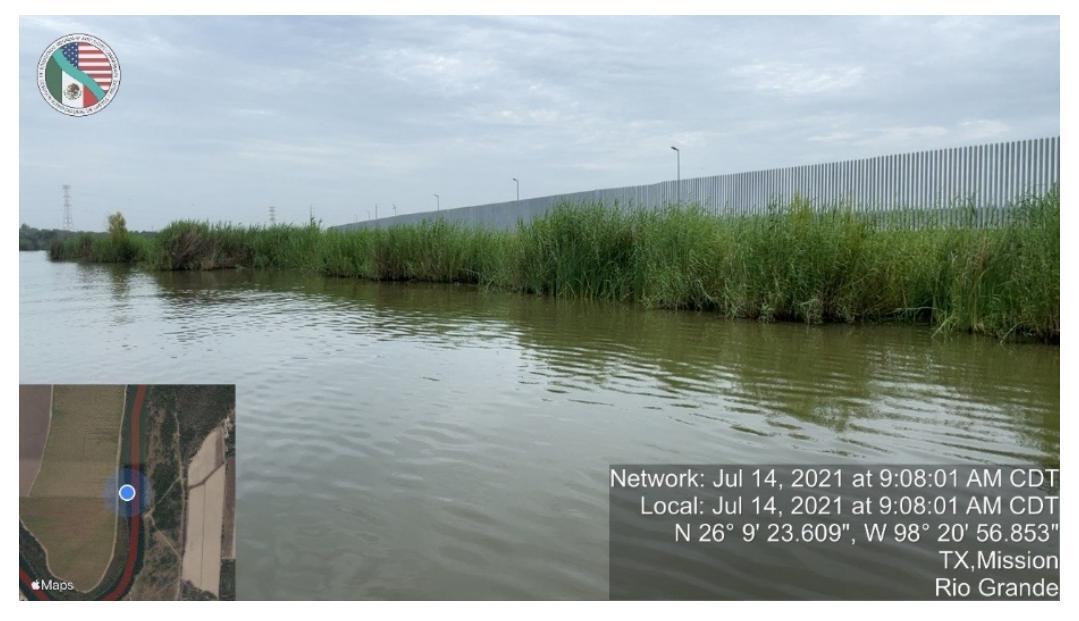
Figure 2.4. Vegetation along eastern side of fence

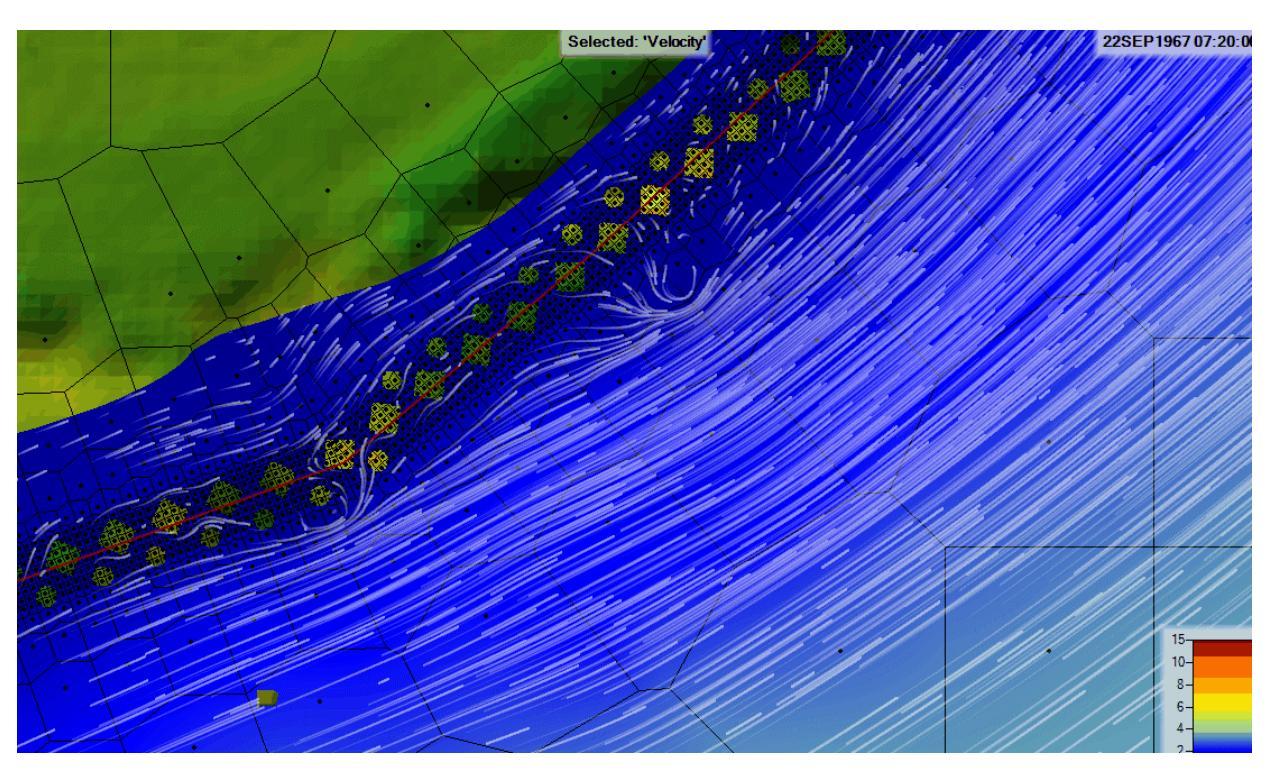
By distorting the horizontal dimensions of the bollard fence by a factor of 12, the 2D TGR model does not preserve hydraulic similitude. For any given river flow depth and velocity, flow and turbulence around 6-foot bollards spaced 5 feet apart are not similar to flow around 6-inch bollards with 5-inch openings. As shown in Figure 4.4, the TGR model simulates large (10 to 20 feet) whirls and eddies along the riverbank and fence, which ordinarily would not be expected to occur with river flow velocities between 2 and 4 fps. In addition, velocities of 8 to 10 fps are shown in Figure 4.5 at the downstream terminus of the fence where velocities would be expected to fall as the reservoir fills. Large-scale turbulence and high velocities simulated by the TGR model do not appear to accurately characterize river and floodplain hydrodynamics with flow velocities averaging less than 4 fps as simulated by the subsequently described Arcadis HEC-RAS model. The TGR report does not disclose high velocities and turbulence simulated by its model and does not propose or discuss mitigation measures.

Figure 4.4. TGR HEC-RAS model-simulated whirls and eddies

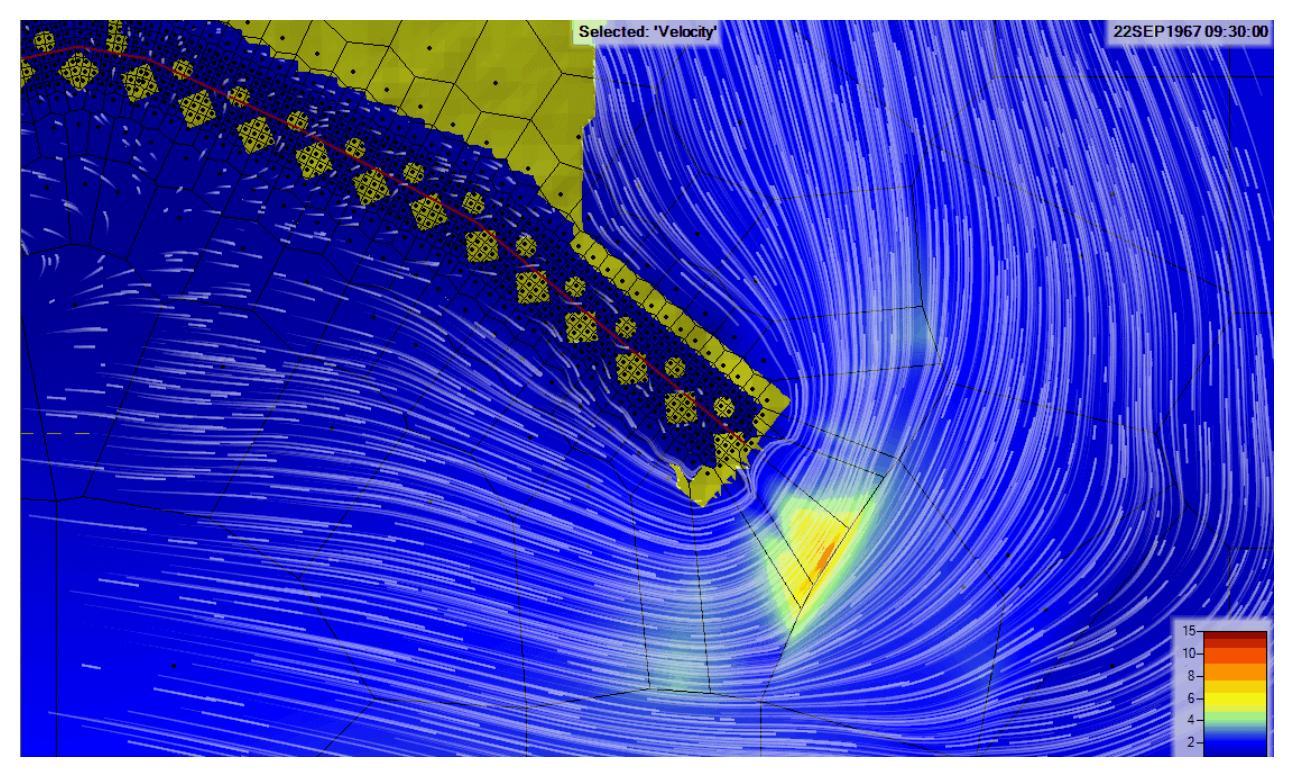
Figure 4.5. TGR HEC-RAS model-simulated velocity at downstream fence terminus

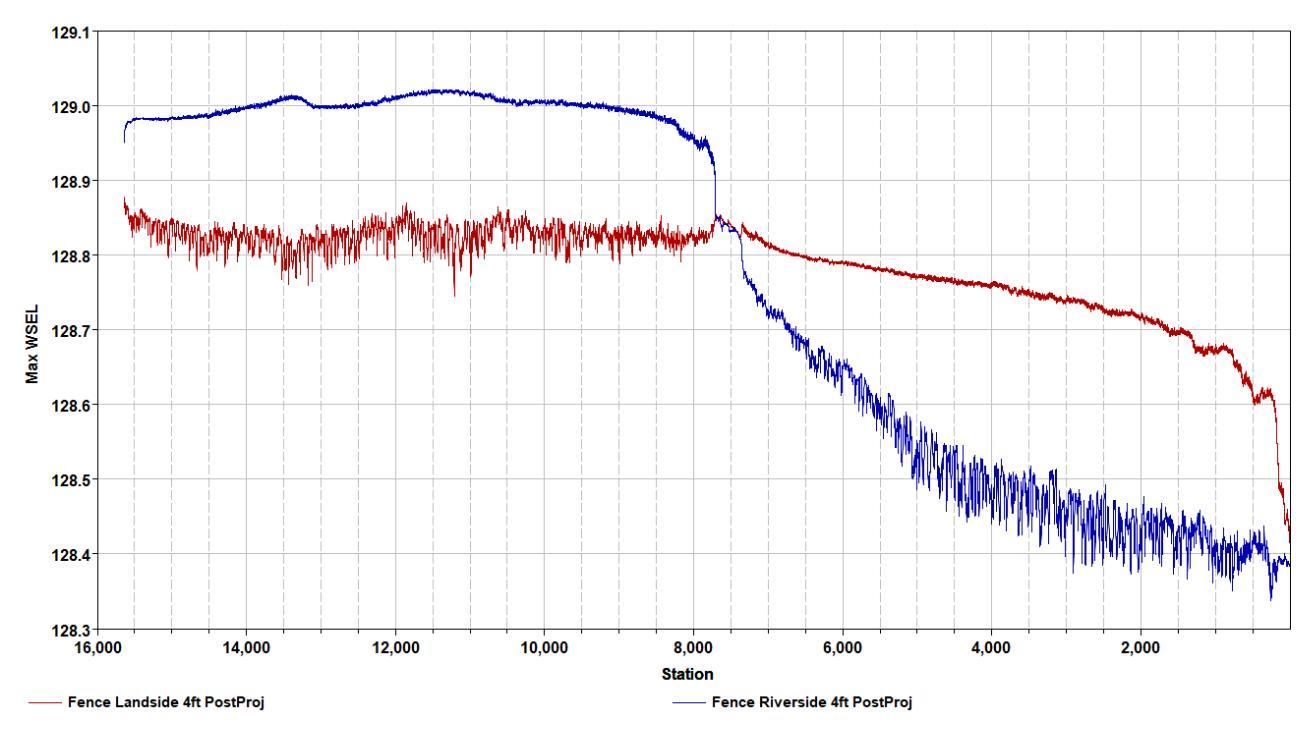
Another indicator of altered circulation caused by the fence is differential WSEL between the land and river sides of the fence. As shown in Figure 4.17, the maximum WSEL is higher in the river than in the floodplain behind the fence on the western portion by about 0.2 feet on average. To the east of the fence midpoint (the southern tip of the peninsula bounded by the fence, shown in Figure 4.17), however, WSEL behind the fence is approximately 0.25 feet on average higher than in the river. The net effect is that movement of water into the floodplain from the west and out of the floodplain to the east is clearly impeded by the fence. By comparison, Figure 4.18 shows peak WSELs on land and river sides of the fence line to be nearly identical and lower overall than the post-project condition. Together these results indicate that the fence significantly reduces flow conveyance from west to east, creating a large ineffective or ponding area behind the fence as a result.

Figure 4.17. Post-project peak water surface elevation profiles on land (red line) and river (blue line) sides of fence

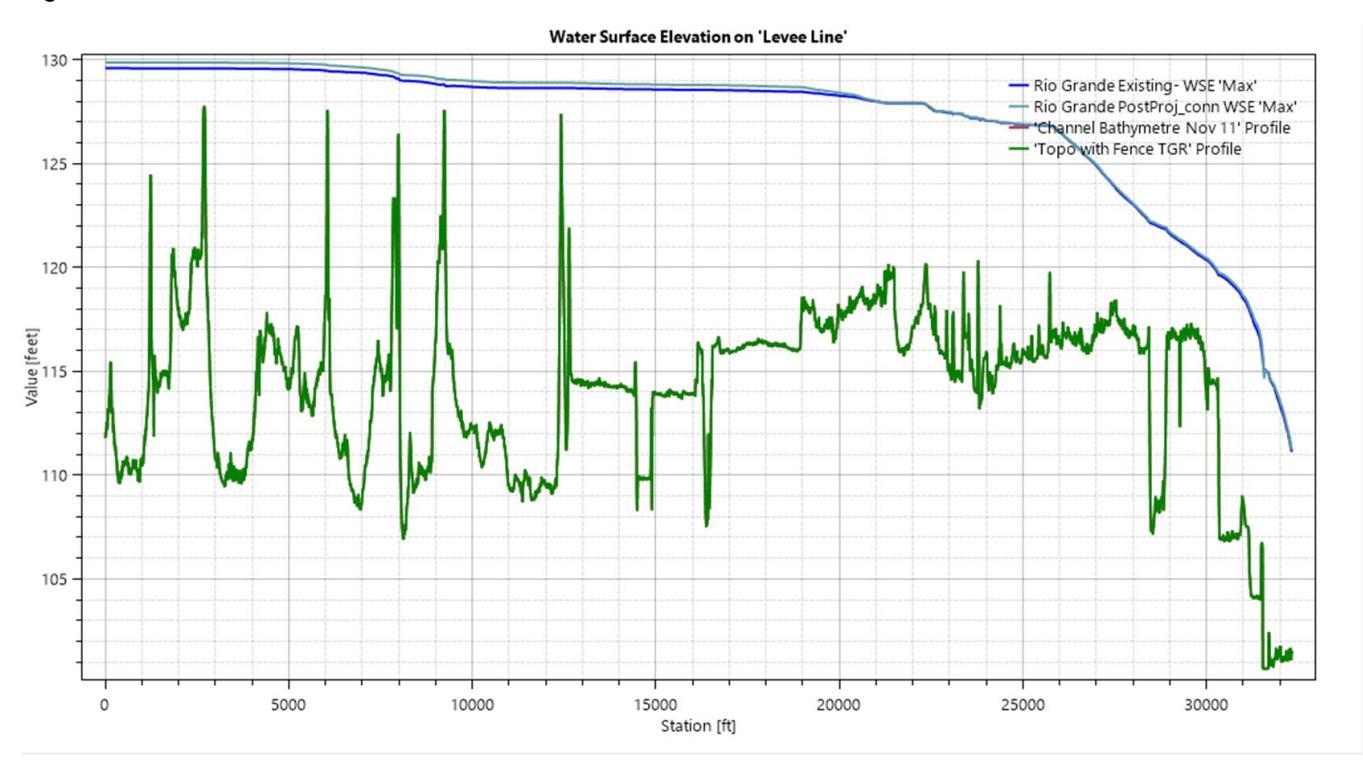
*Figure 4.28. Maximum water surface elevation along Mission Levee (light blue – post-project, blue – pre-project, green – base elevation)*

The data show that freeboard is reduced by up to 0.29 feet on the western and middle portions of the levee (Station 0 - 20000 in Figure 4.28) and by up to 0.06 feet on the eastern portion of the levee (Station 20000 - 32000) due to the fence.

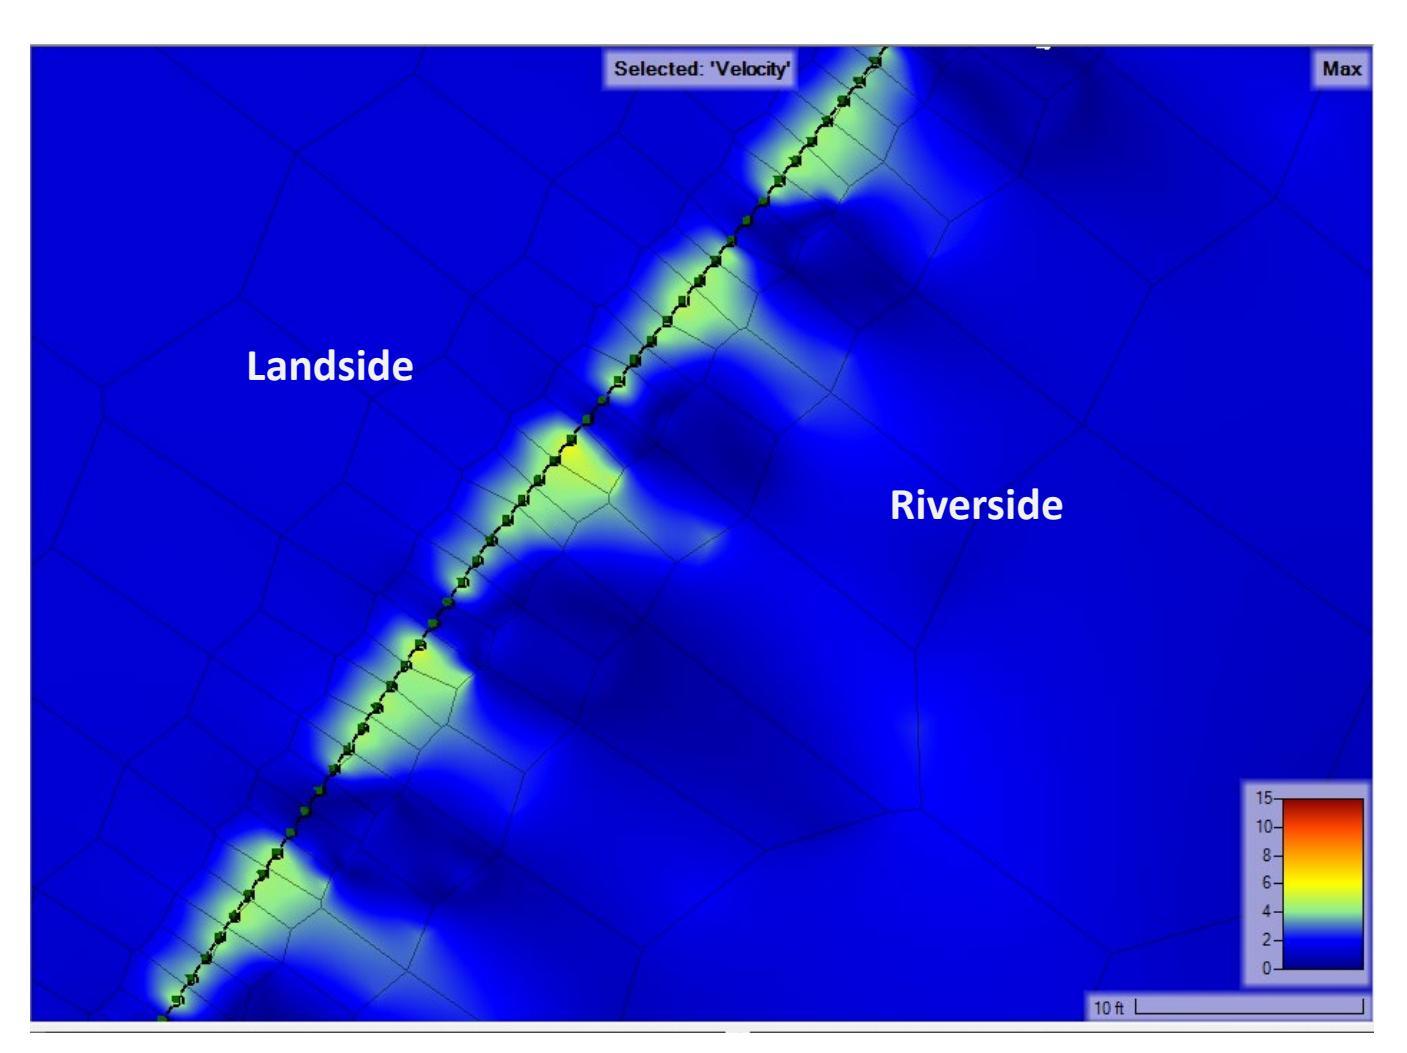
Figure 4.31 shows a color-coded map of maximum velocities through typical unblocked openings on the eastern portion of the fence. Figure 4.32 zooms out, showing the prevalence of high-velocity openings along the eastern fence line. Both figures show high-velocity plumes extending for several feet to the outside (river side) of the fence.

Figure 4.31. Maximum velocity plumes through typical unblocked openings on eastern portion of fence

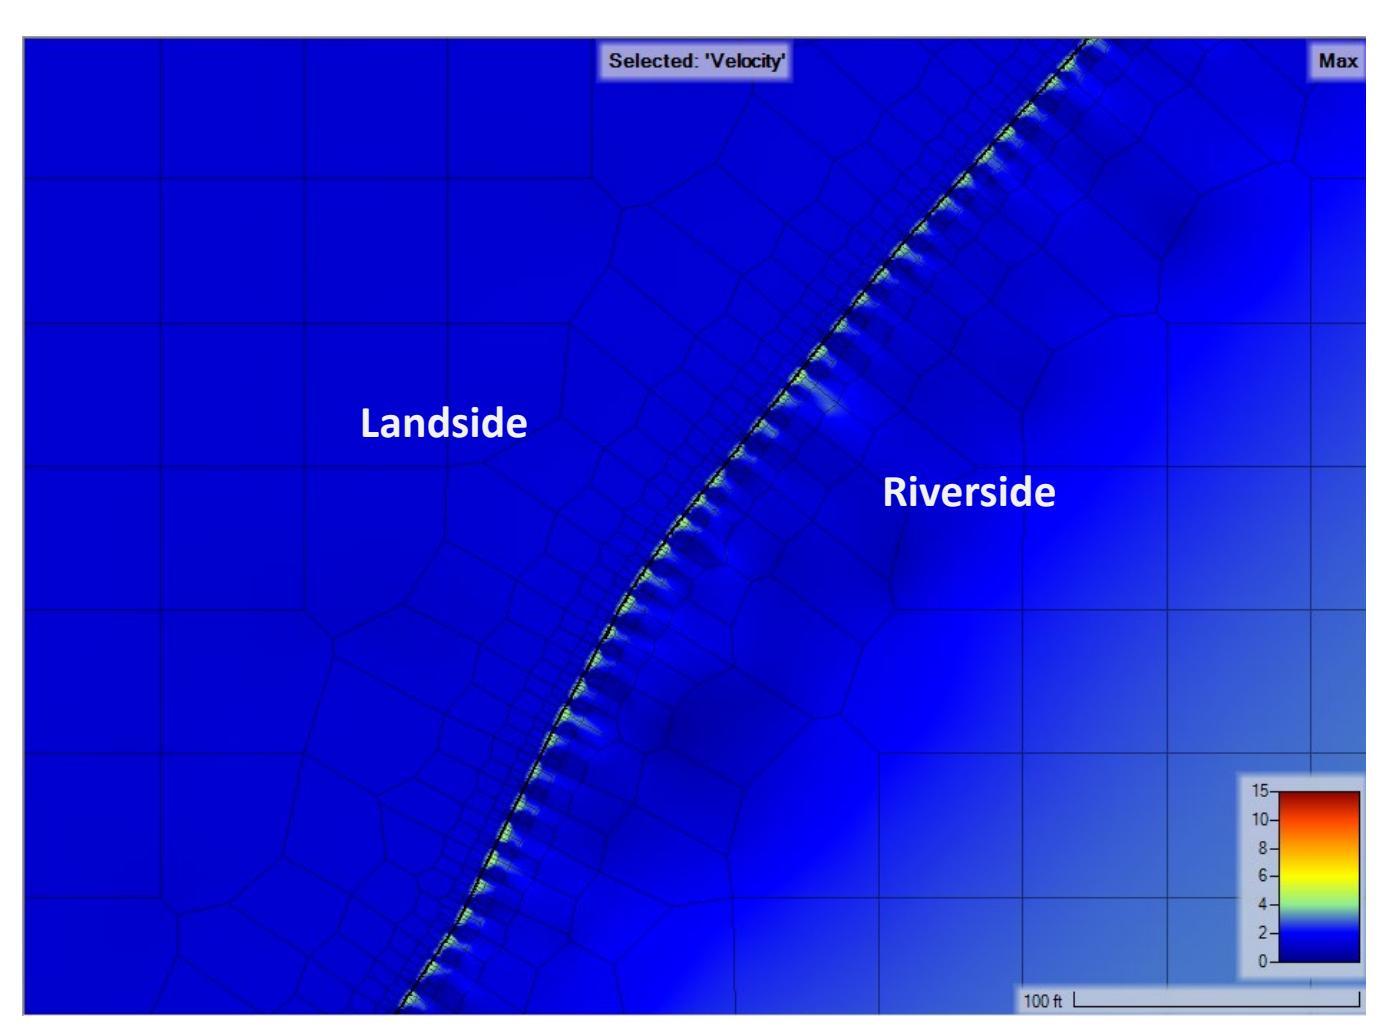
Figure 4.32. Maximum velocity plumes along eastern portion of fence

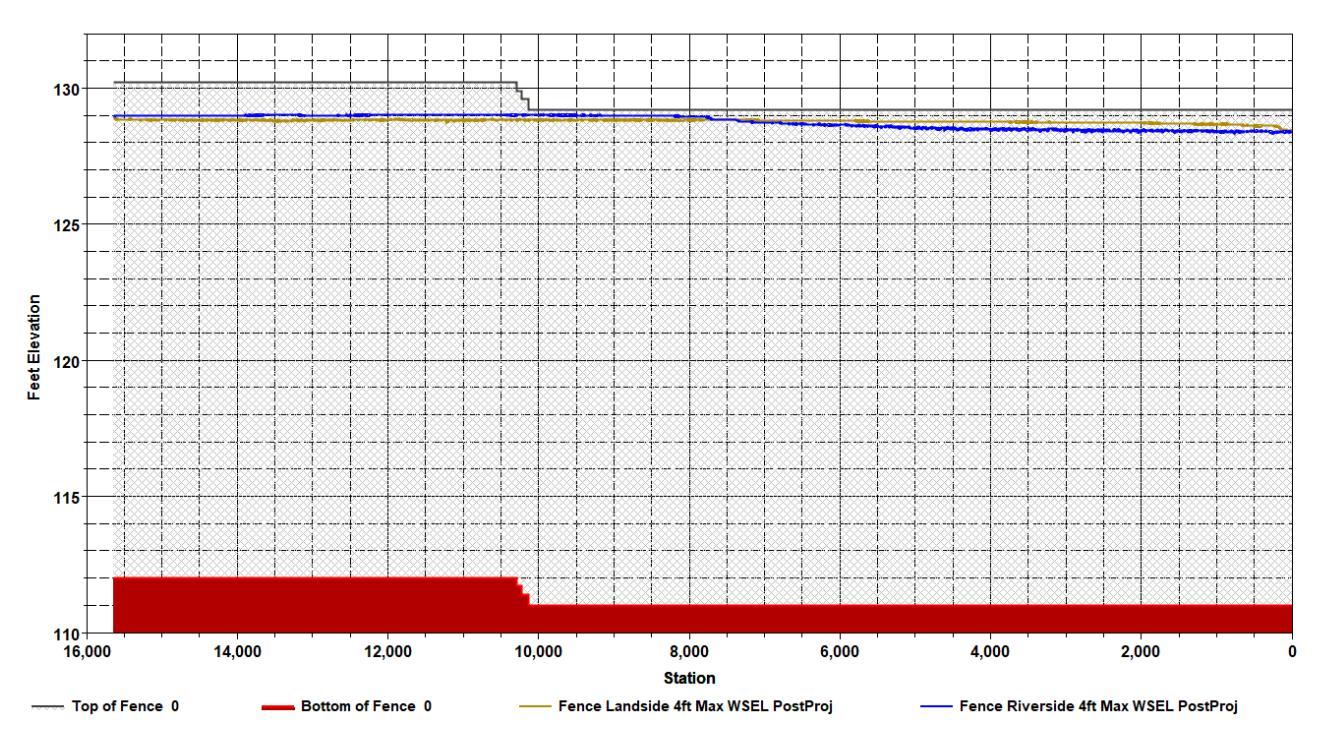
In addition to velocity, other hydraulic parameters for determination of forces and moments on the bollard fence include head difference across the bollards (based on data displayed in Figure 4.17) and depth of flow on both sides of the fence. Figure 4.33 profiles base and top of the fence and maximum WSELs, showing that the fence is mostly submerged at the peak of the flood. Depth of flow and flow velocity affect bottom shear stress and erosion potential at the base of the fence as well.

Figure 4.33. Profile showing fence base (dark red), top of bollards (gray), and maximum water surface elevations on land (orange) and river (blue) sides of fence

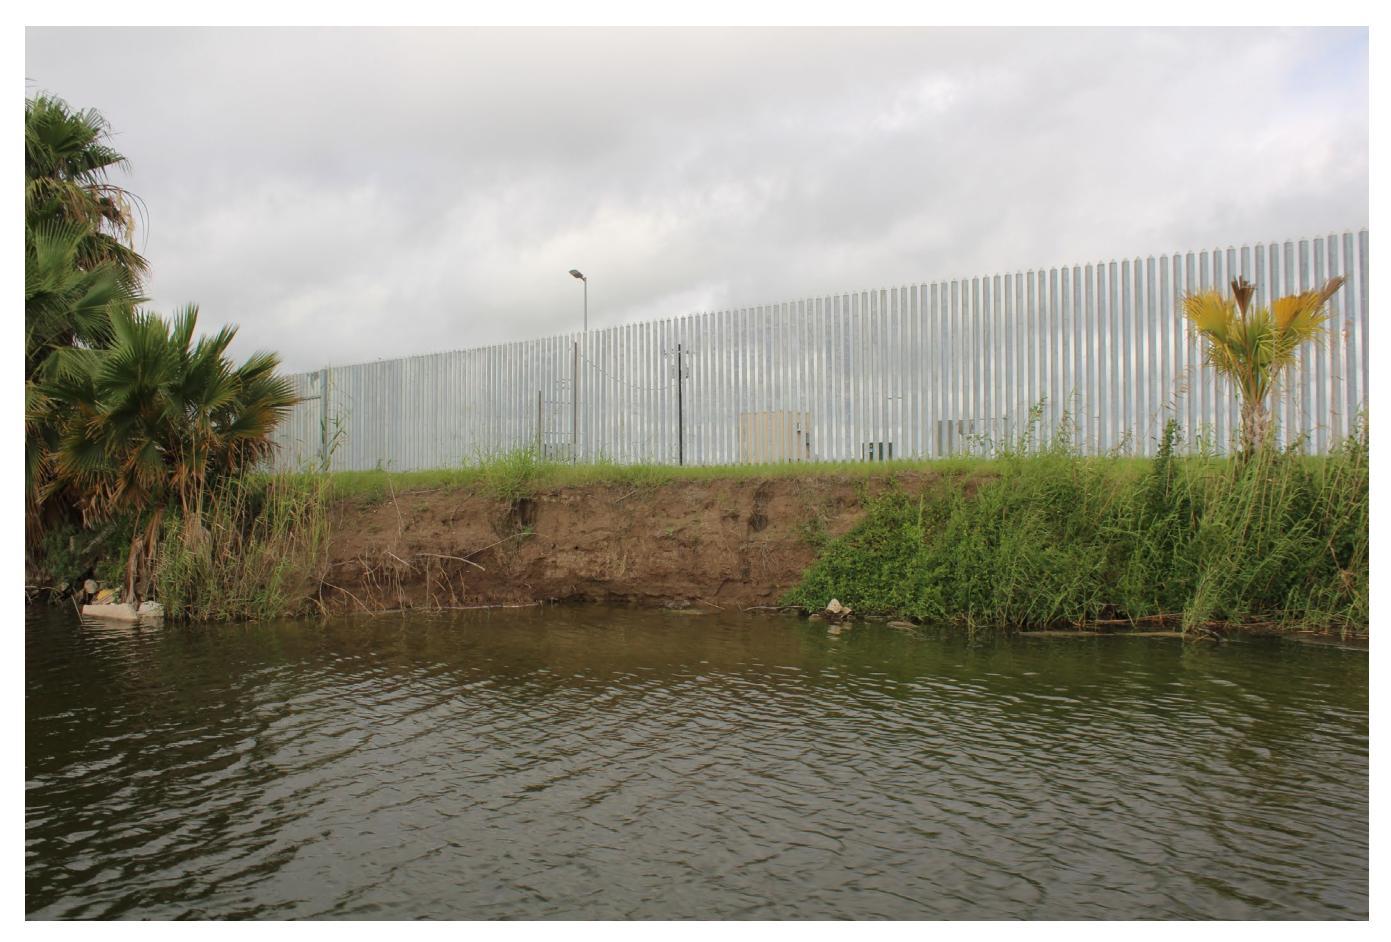
Figure 4.35. Severe bank caving on river side of fence

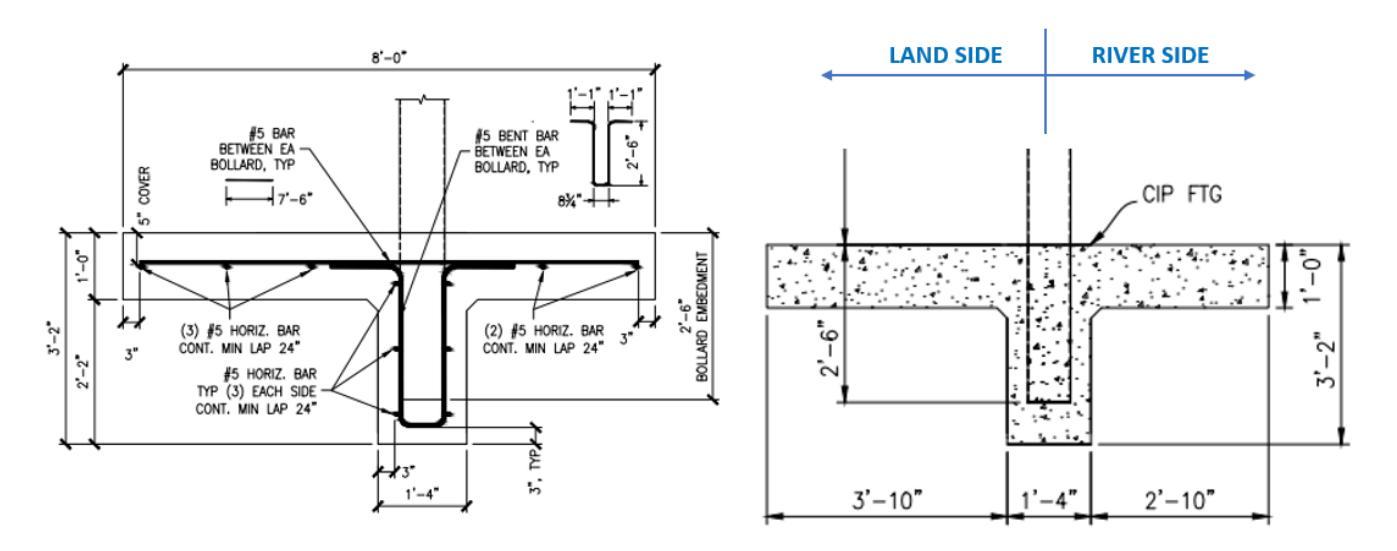
Figure 5.4. Sections of the fence foundation (Fisher 2019)

The foundation system, shown in Figure 5.4, comprises a continuous, T-shaped reinforced concrete footing. The flanges of the T are 8 feet wide by 1 foot deep and the top elevation is at the ground surface. The stem is 1 foot 4 inches wide and extends 2 feet 2 inches deep below the flanges (i.e., 3 feet 2 inches below the existing ground surface). The stem of the T is poured integrally with the flanges and is asymmetrically placed as indicated in Figure 5.4. The bearing area of the shallow foundation is 8 square feet per foot of fence.

As part of our field investigation, we measured the thickness of the flange of the T-shaped footing at five locations along the fence alignment. Near the upstream end of the fence, we observed the flange to be 1 foot thick as indicated by the foundation design in Figure 5.4. However, at four other locations, we measured the flange to vary from 4.5 to 10 inches thick (refer the Site and Subsurface Investigation Report in Appendix B).

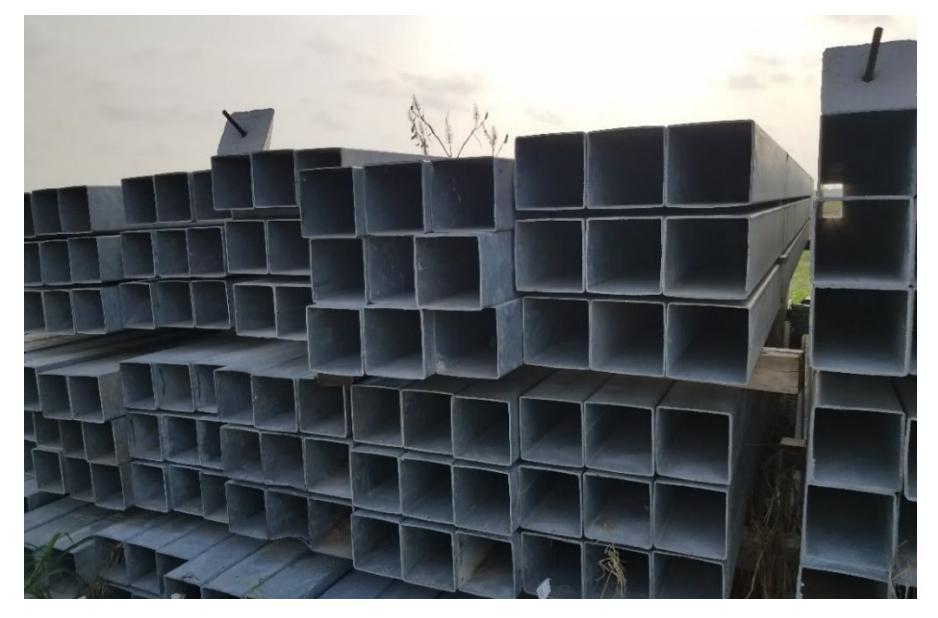
Figure 6.6. Surplus of steel bollards

A surplus of steel bollards used to construct the fence section is stockpiled at the site as shown in Figure 6.6. These bollards were inspected during the investigation.

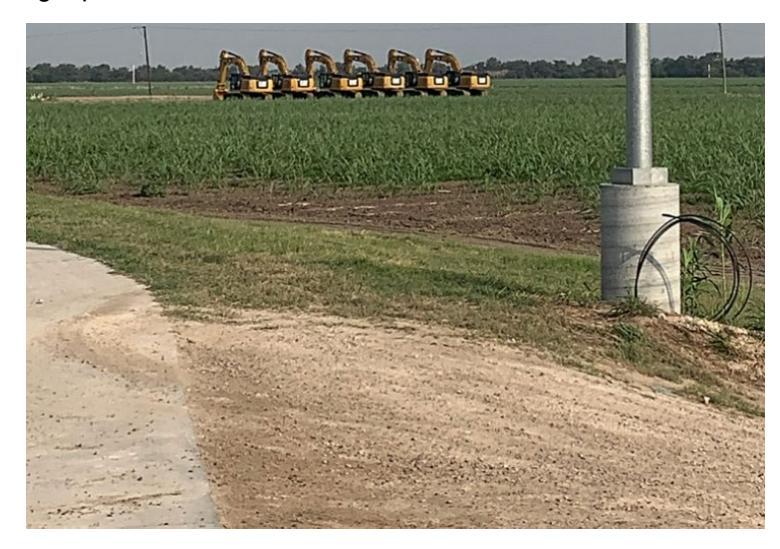
Figure 6.8. Precast shaft founded light/camera monopole

A light/camera monopole founded in a precast concrete shaft foundation is shown in Figure 6.8. The light pole foundation is designed as 4 feet embedded into the ground with 2 feet exposed above ground as shown in Figure 6.1; however, the exposed height was at times higher due to variance in the finished grade with respect to

the typical system cross section. The light/camera pole is also galvanized steel. No details were provided of the light pole anchor detail into the concrete foundation.

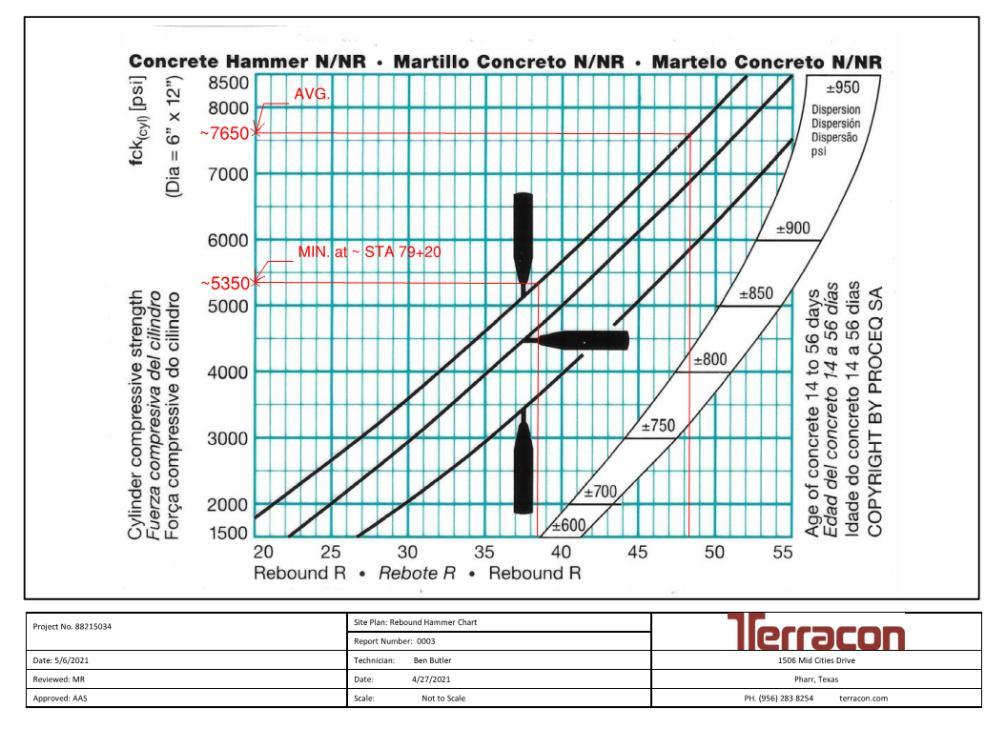
Figure 6.10. Rebound hammer converting chart

Terracon completed NDT to confirm the thickness of steel bollards, the configuration of reinforcing steel, and the compressive strength of the concrete mix used in the footing. A Schmidt rebound hammer was used to verify the compressive strength at 12 distinct locations ¼ mile apart along the 3-mile bollard fence alignment. The rebound hammer tests results are included in Appendix B. Based on the lowest R-value result, the minimum compressive strength is correlated to 5,350 pounds per square inch (psi); based on the average R-value result of all 12 locations, the average compressive strength is correlated to 7,650 psi, as shown in Figure 6.10. Even the minimum correlated value exceeds the specified compressive strength (at 28 days) reported by MEG Engineers as 4,500 psi.

It should be noted that the chart converting rebound number (R-value) to a specific compressive strength does not account for differences in mix design, maturity, surface moisture, surface smoothness, and other factors and is primarily useful to indicate relative strengths between different test locations. Nevertheless, the rebound hammer test provides a practical and cost-effective solution for estimating in-place concrete strength.

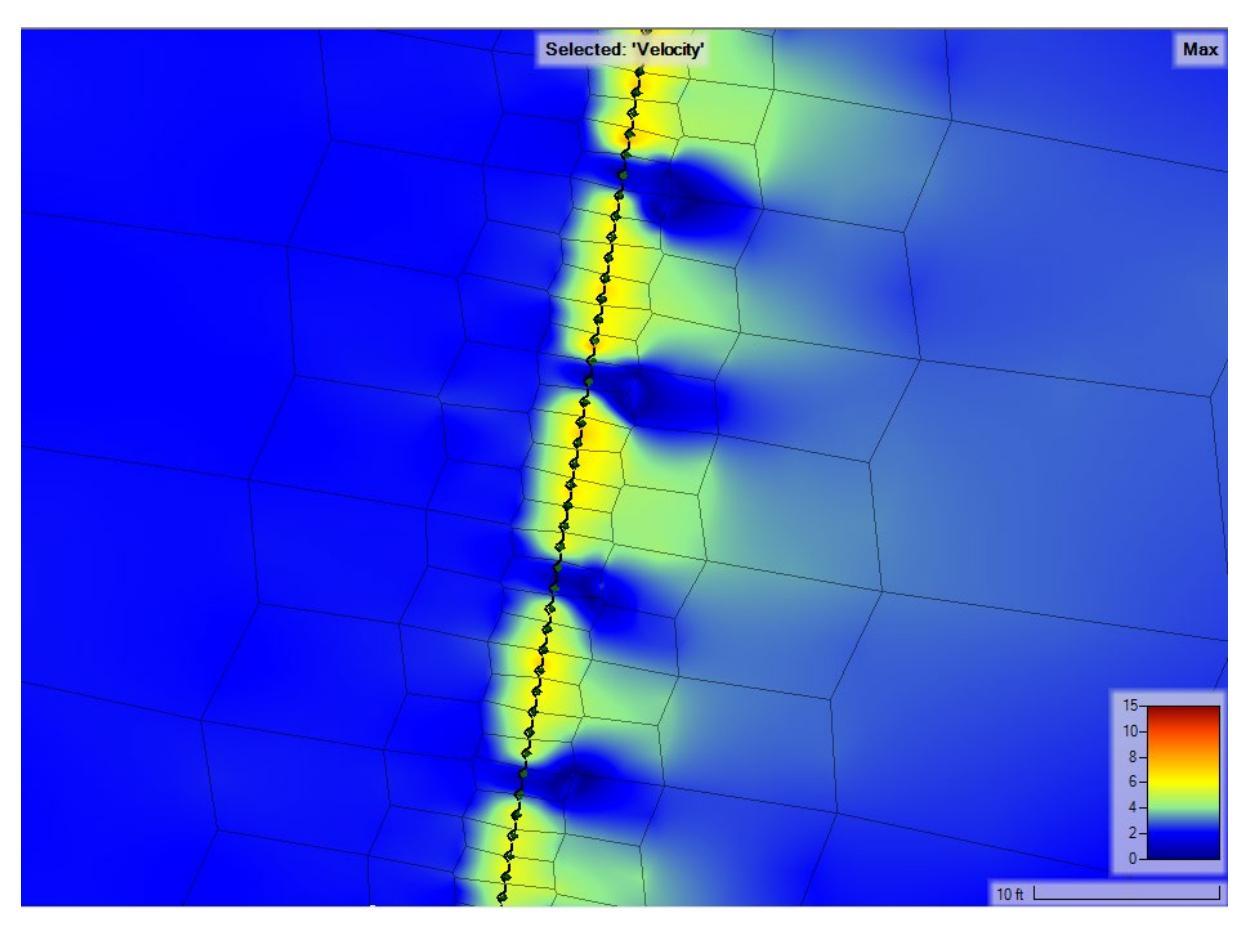
Figure 6.11. Maximum velocity plumes through typical unblocked openings on western portion of fence

- Maximum flow velocity in the bollard fence at any given segment or time: 7.9 fps
- Average flow velocity in the western segment of bollard fence from river side (see Figure 6.11): 7 fps
- Average flow velocity in the eastern segment of bollard fence from land side (see Figure 6.12): 6 fps

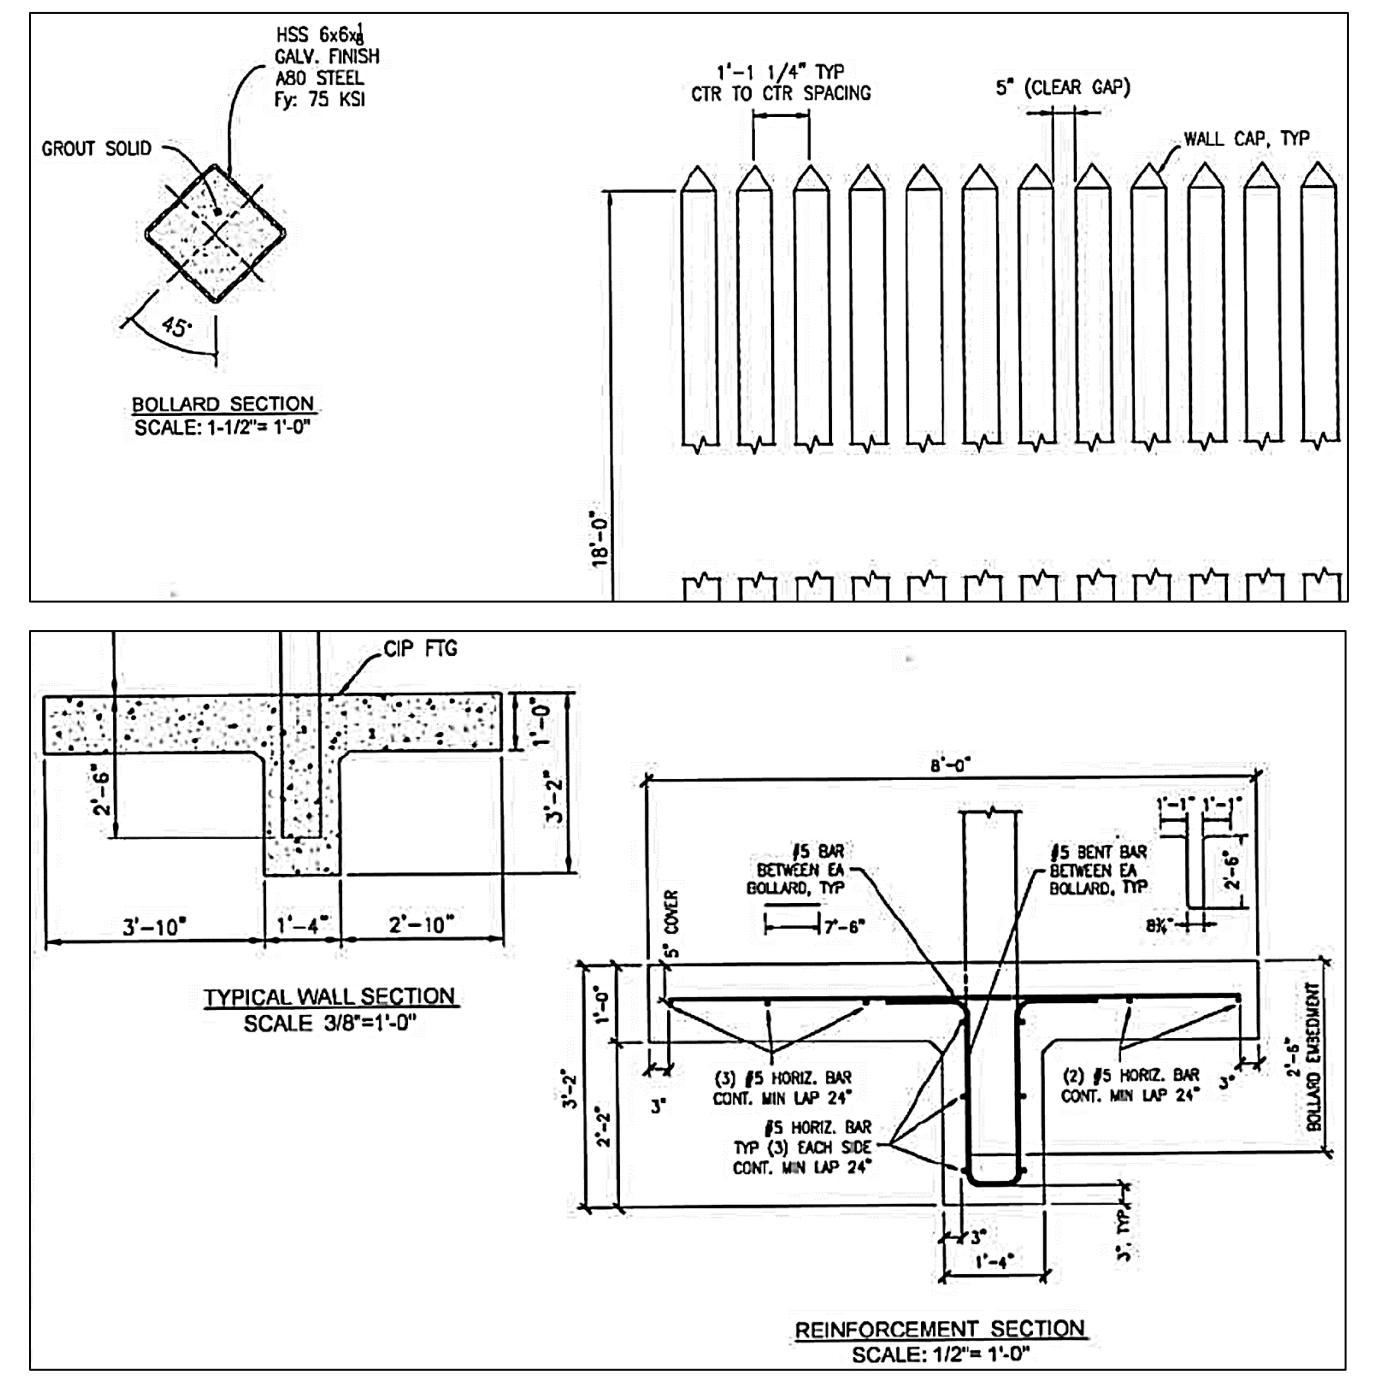
Figure 1: Construction Details from Plans by TGR Dated October 30, 2019

Mr. Fisher reported that the fence was constructed as shown on the plans provided (details shown on Figure 1). An exception is that the bollards were not grouted solid as shown on the plans, and instead were backfilled with an unspecified grade "pea" gravel. No material specifications, quality control test results, or field reports were provided regarding the backfill of the bollards and no field verification was completed for this investigation. Precast concrete caps were grouted to the top of the fence bollards using a rebar dowel. Shop tags providing records of galvanizing and photographs of example materials are shown on Figure 3.

The depth of the concrete footing shown in the design (Figure 1) is 1 foot up to the steel bollards, where the depth increases to 3 feet for the embedment of the bollards. The edge of the footing on the riverside of the fence was evaluated at five locations along the alignment to confirm the depth of the concrete. This evaluation indicated that the edge of the concrete is not a uniform depth of 1 foot, with one location measuring as little as 4.5 inches as shown on Figure 14. One location evaluated near STA 156+00 did measure a full 12 inches as shown on Figure 15.

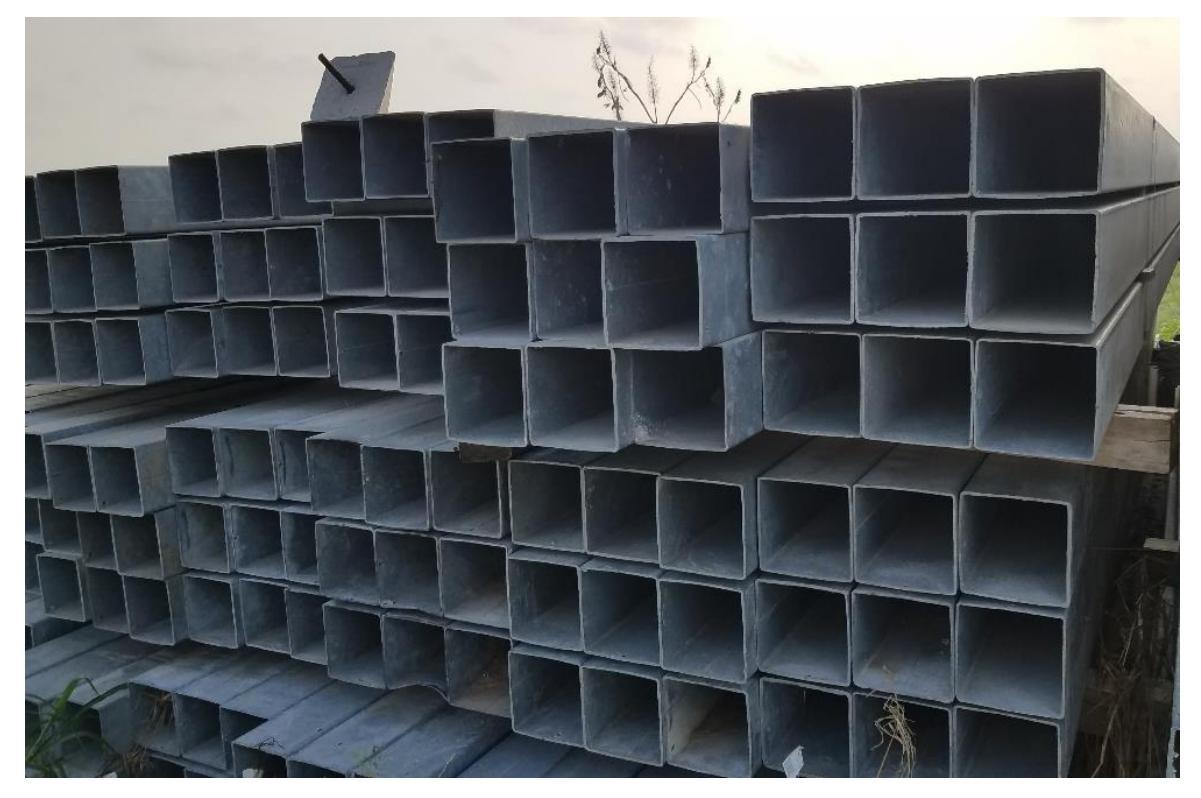
Figure 4: Surplus Steel Bollards Stockpiled on Site

Surplus steel bollards used to construct the fence section are stockpiled at the site as shown on Figure 4, and the dimensions of the 6-inch by 6-inch tube sections were verified. A photograph of typical completed fence near STA 156+00 at the upstream limits is shown on Figure 5.
