# **Engineering Evaluation of Bollard Fence**

## Rio Grande, Hidalgo County, Texas

United States of America v. Fisher Sand and Gravel Company, Civil Action No. 7:19-CV-403

August 2021

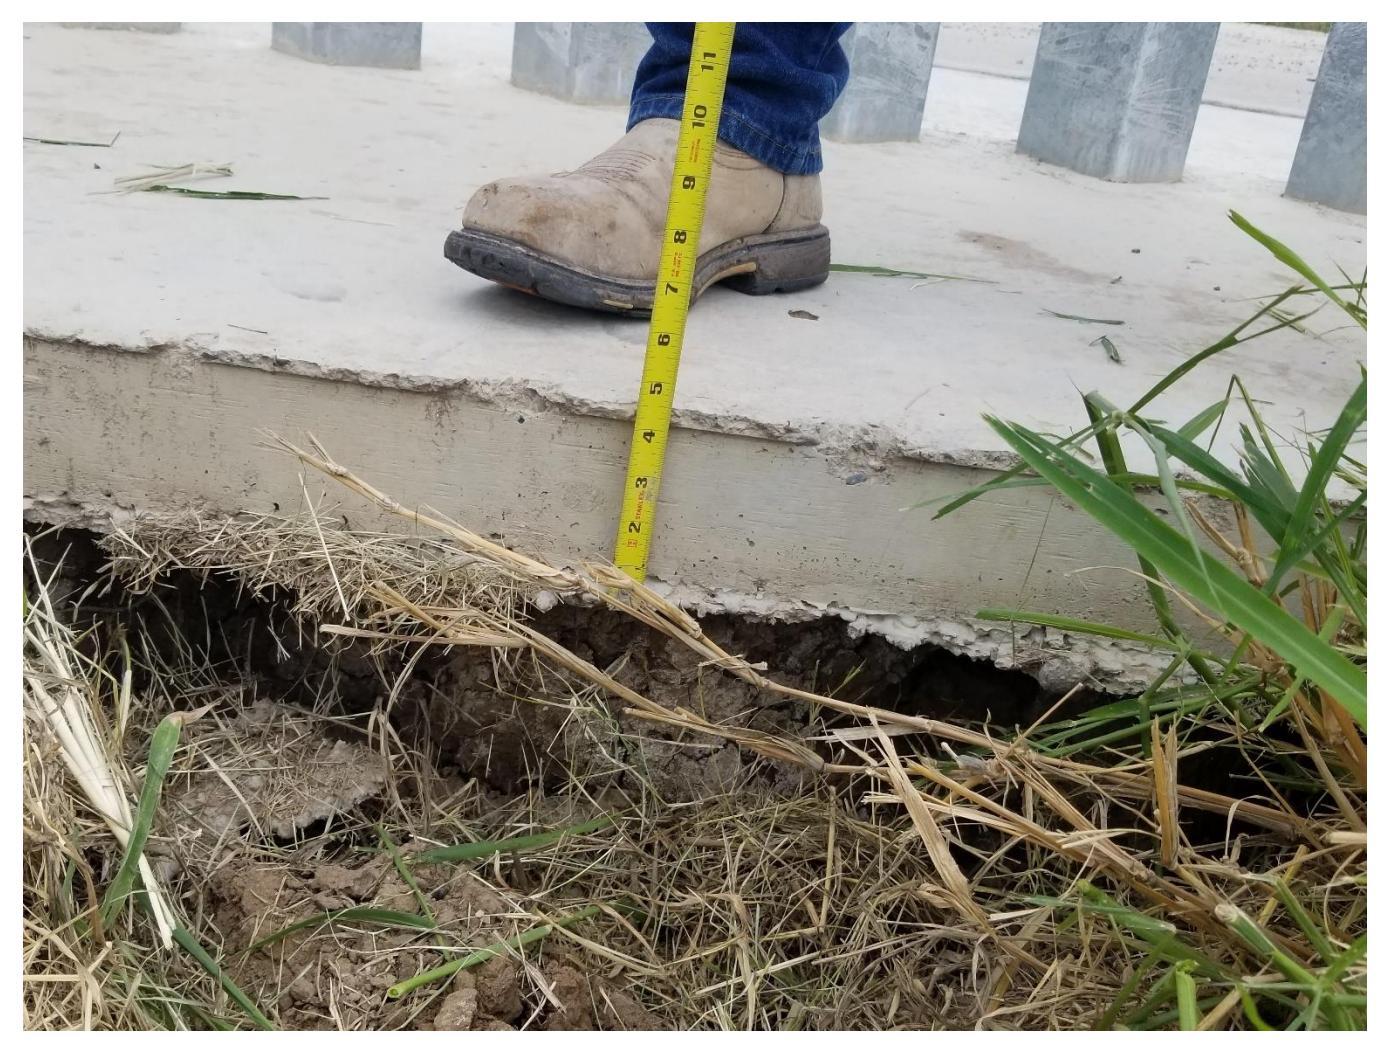
Figure 14: Footing Depth Measurement of Riverside Edge Near STA 0+00

The depth of the concrete footing shown in the design (Figure 1) is 1 foot up to the steel bollards, where the depth increases to 3 feet for the embedment of the bollards. The edge of the footing on the riverside of the fence was evaluated at five locations along the alignment to confirm the depth of the concrete. This evaluation indicated that the edge of the concrete is not a uniform depth of 1 foot, with one location measuring as little as 4.5 inches as shown on Figure 14. One location evaluated near STA 156+00 did measure a full 12 inches as shown on Figure 15.

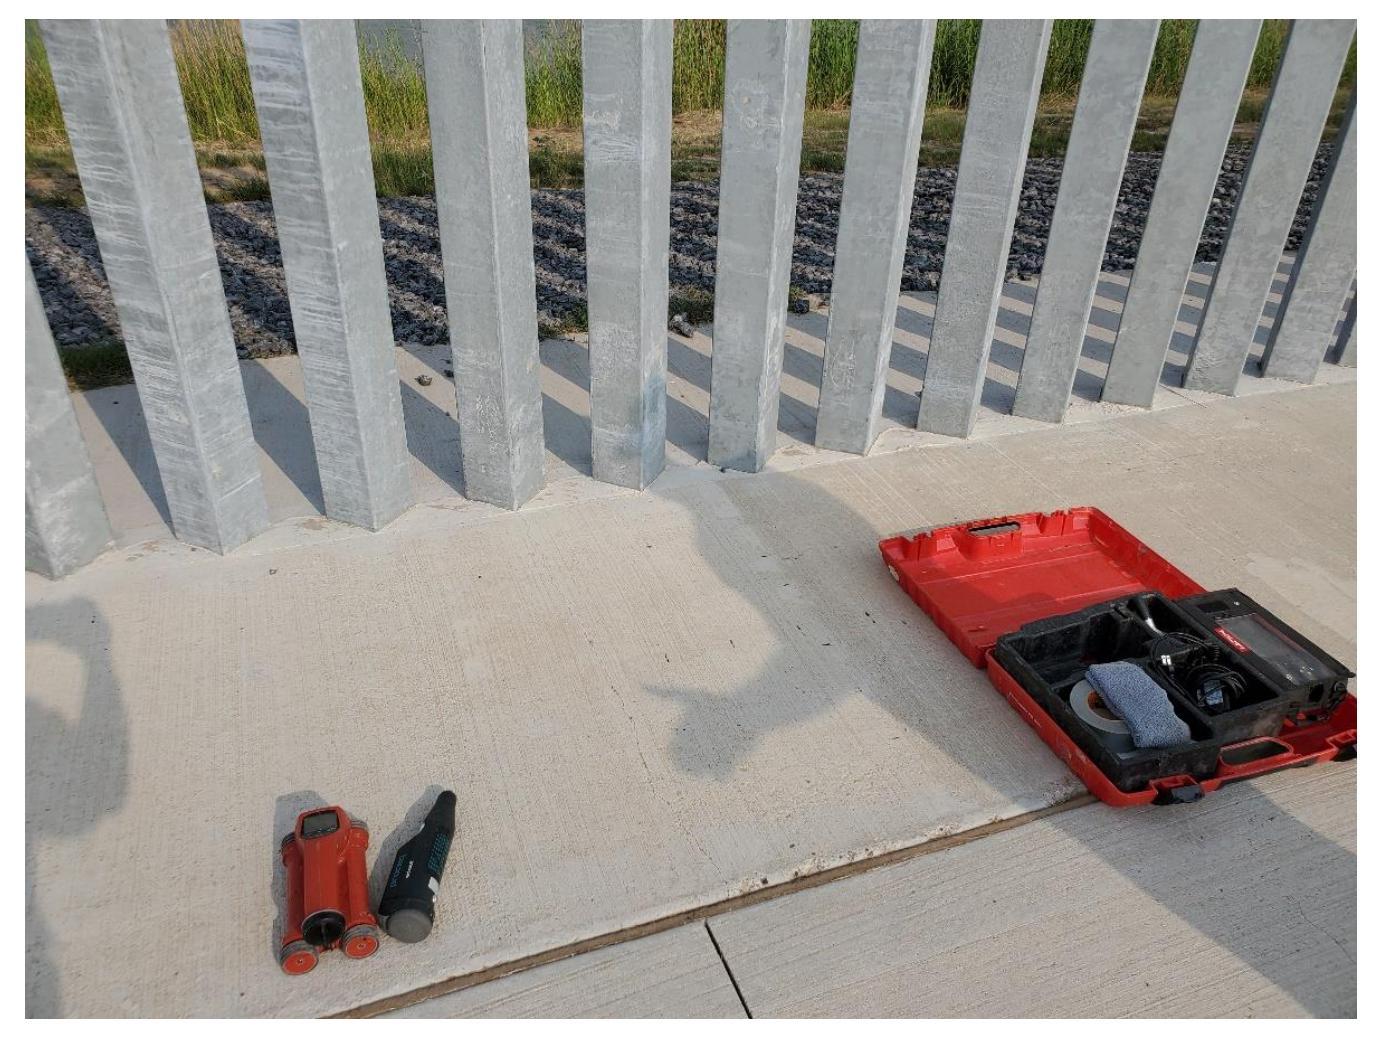
Figure 16: Typical GPR Test Location for Rebar Spacing and Concrete Strength

Terracon used NDT to measure the concrete strength with a rebound hammer and the spacing of reinforcement with a ground-penetrating radar (GPR) as described in Attachment 2. Tests were conducted at approximately every ¼ mile, for a total of 12 test locations. Results indicate that the concrete at test locations has a compressive strength of approximately 4,500 psi per the design. GPR scans indicate that the reinforcement is #5 rebar at approximately 5 inches on center in both directions per the plans, as shown on Figures 16 through 18 and reported in Attachment 2.

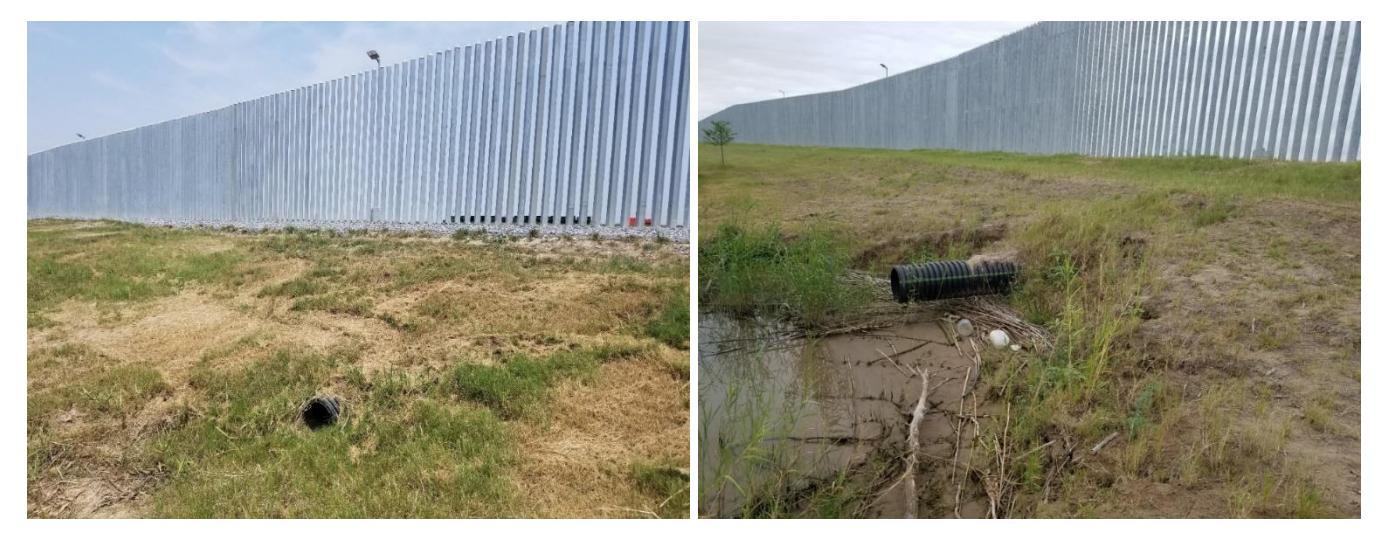
Figure 19: Drainage Culverts Installed for Fence Construction

Surface water is conveyed underneath the fence foundation via corrugated high-density polyethylene (HDPE) pipes as shown on Figure 19. The design details and locations for the drainpipes were not provided for this investigation. Surface water travels as sheet flow across the road and fence footing to drain on the ground surface to the river. This surface flow has caused rills to be formed as observed along the edge of the fill material on the riverside of the fence, as shown on Figure 20. Historical information from August 2020 (included in Attachment 1) documented major rill erosion damage on the riverside of the fence following major storms that caused flooding along the river. At the time of the current investigation, most of the damage had been repaired and covered with grass; however, the rills could be seen as ground surface rutting and bare areas with limited grass cover.

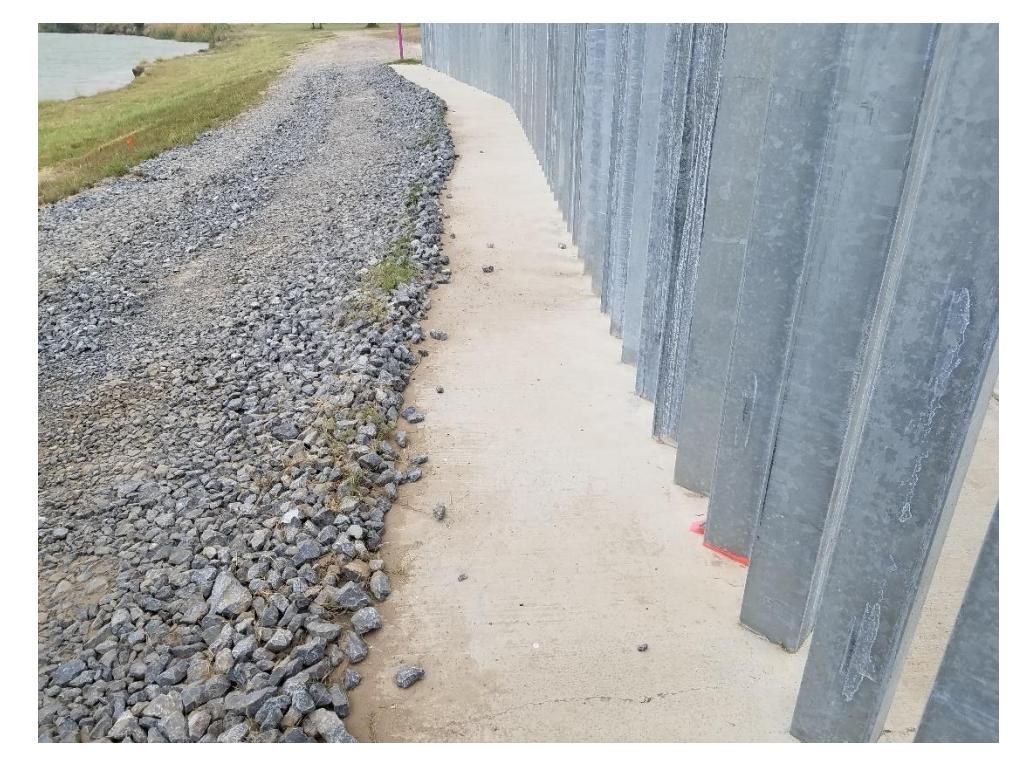
### Photograph: 1

**Description:** TP-1 excavation showing typical soil conditions.

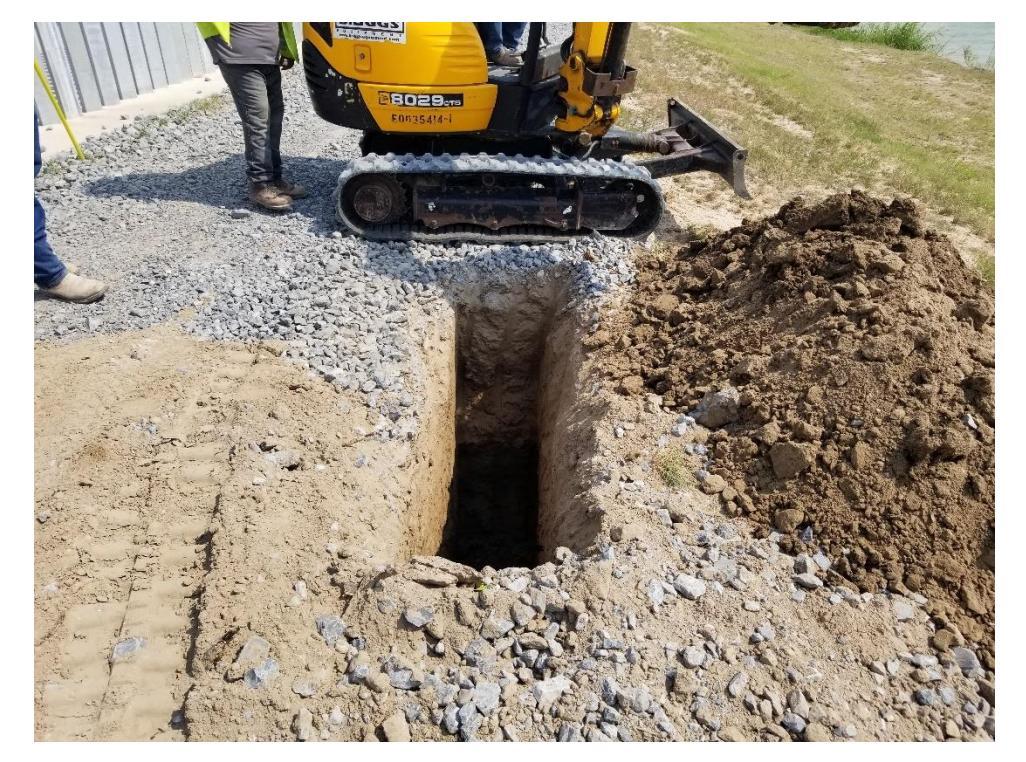
### Photograph: 5

**Description:** TP-1 looking south at excavated trench.

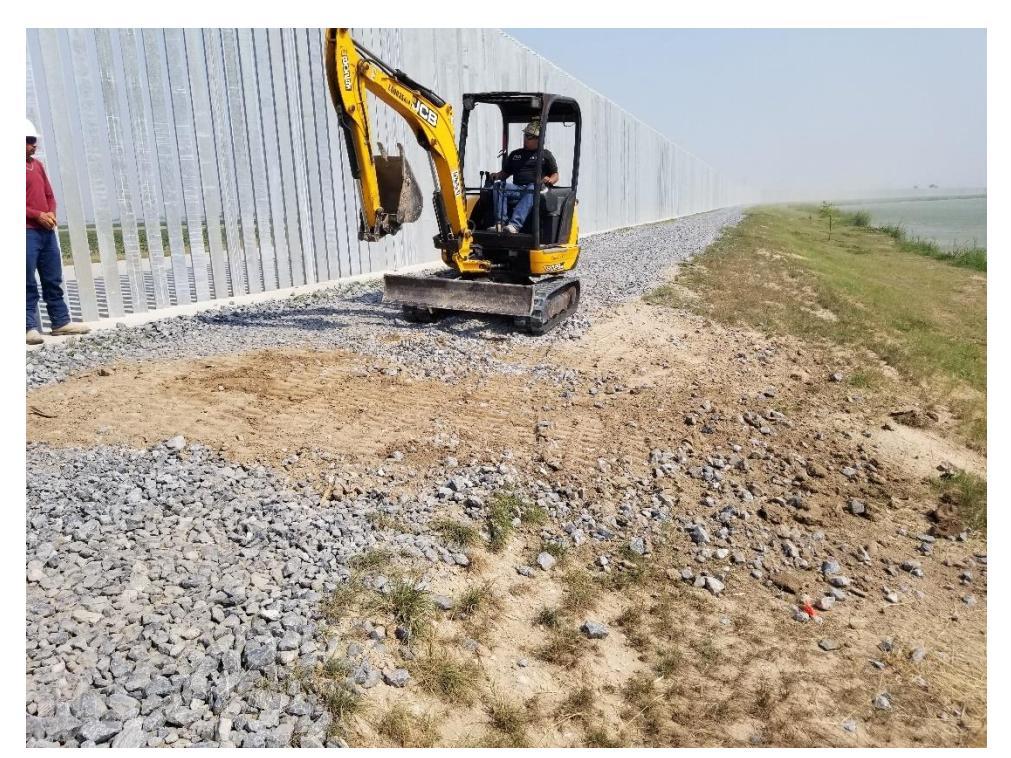
### Photograph: 6

**Description:** TP-1 looking southeast at backfilled trench.

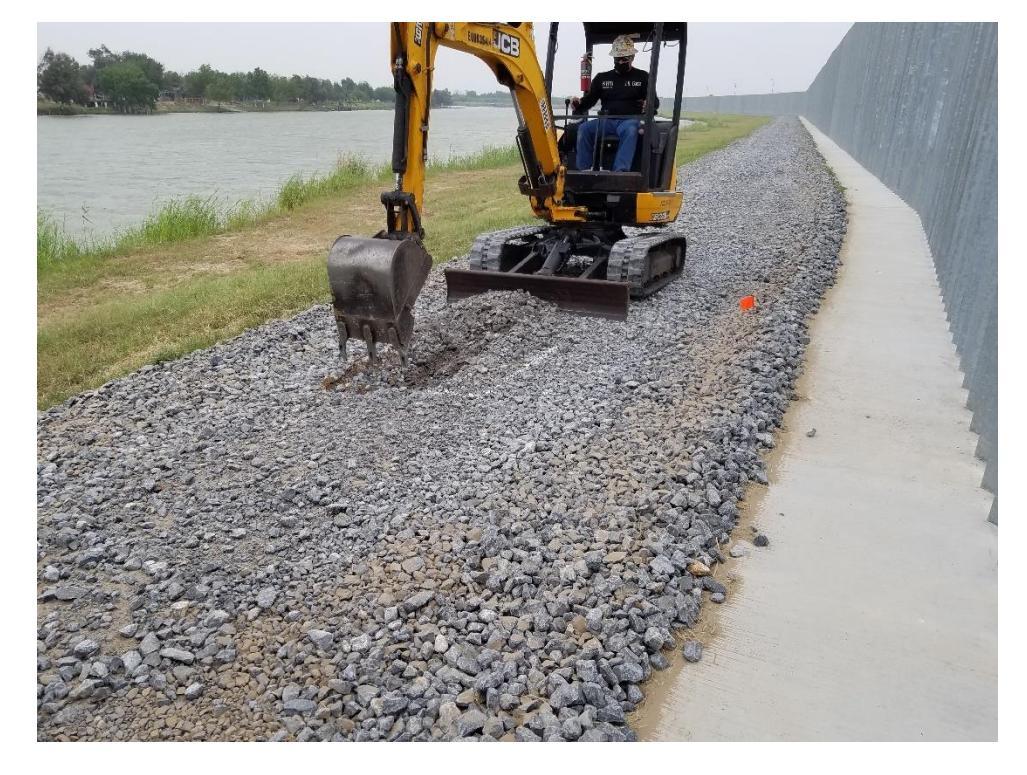
### Photograph: 7

TP-2 excavation near STA 139+50 looking northwest at footing and aggregate base.

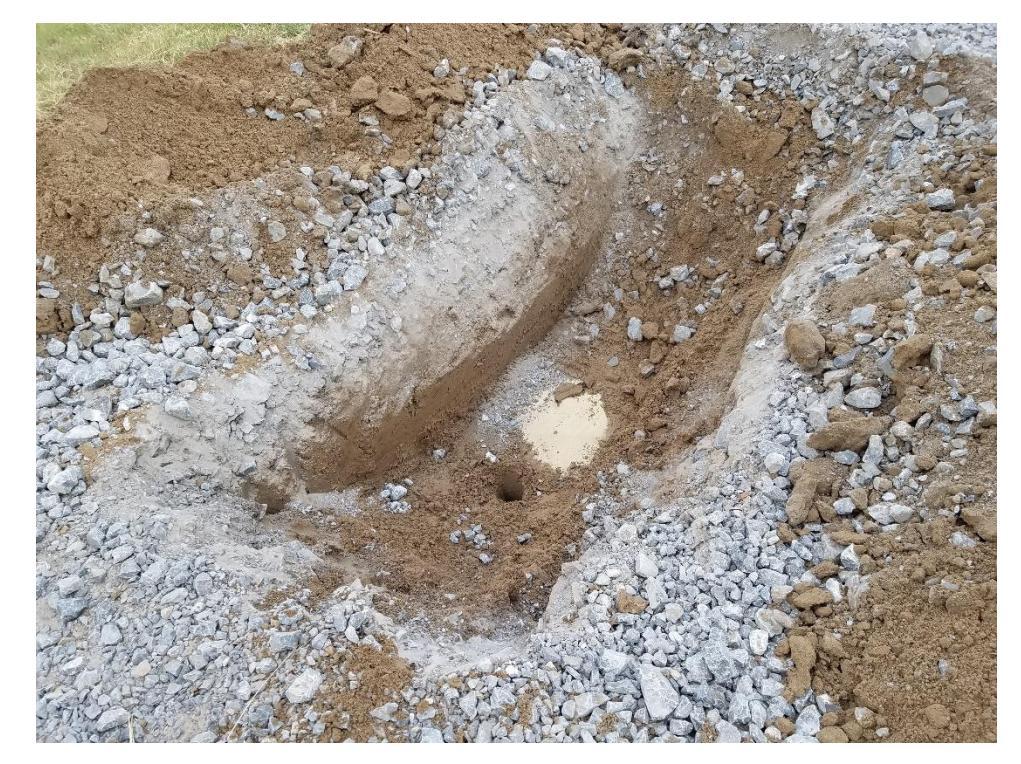
### Photograph: 9

TP-2 excavation showing typical soil conditions at 3 feet after sand cone test.

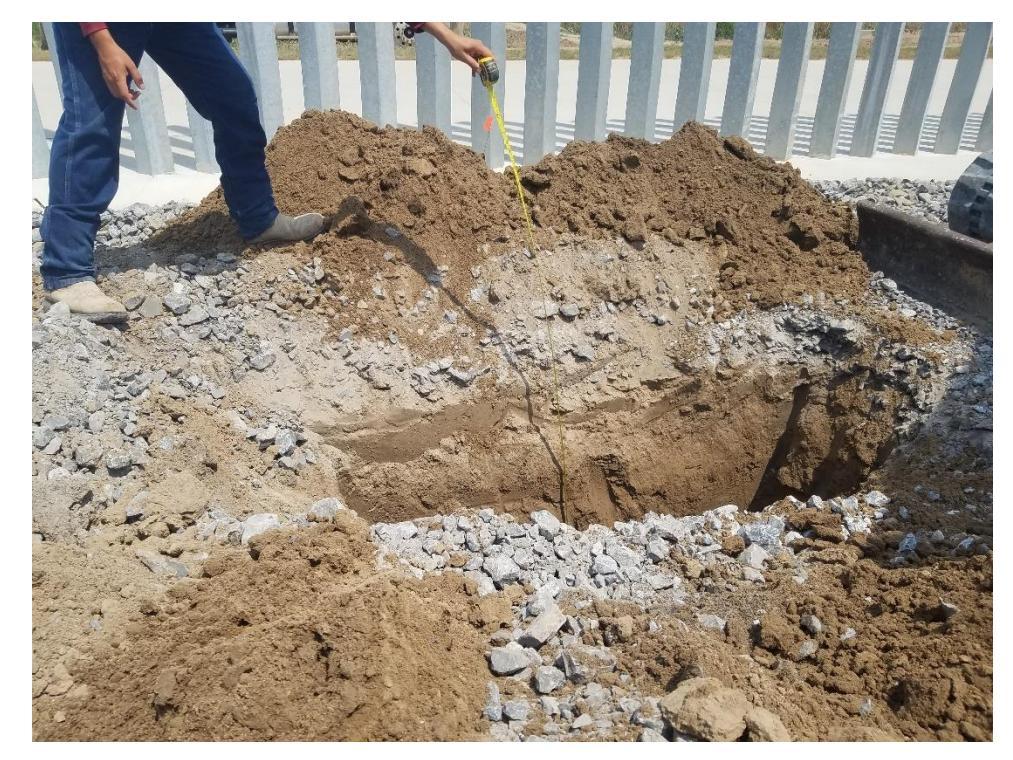
### Photograph: 11

TP-2 excavation showing soil conditions and depth sounding.

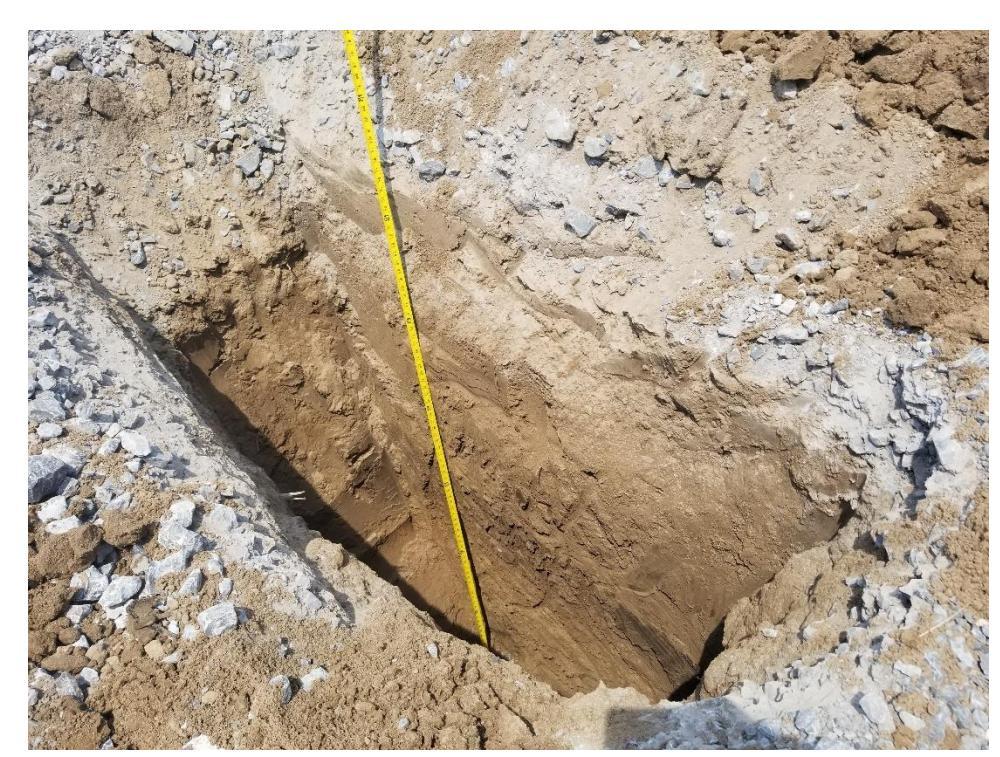
### Photograph: 12

### **Description:** TP-2 excavation showing typical conditions of trench.

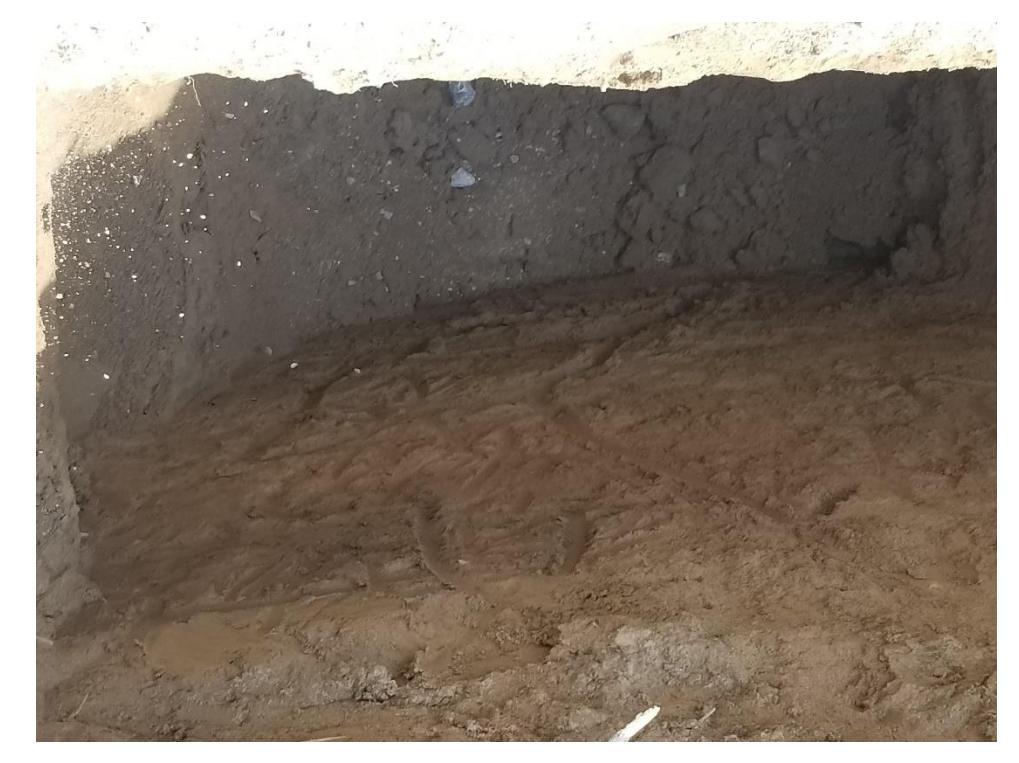
### Photograph: 13

TP-2 excavation at termination depth of 7 feet bgs showing soils and trace groundwater entering trench.

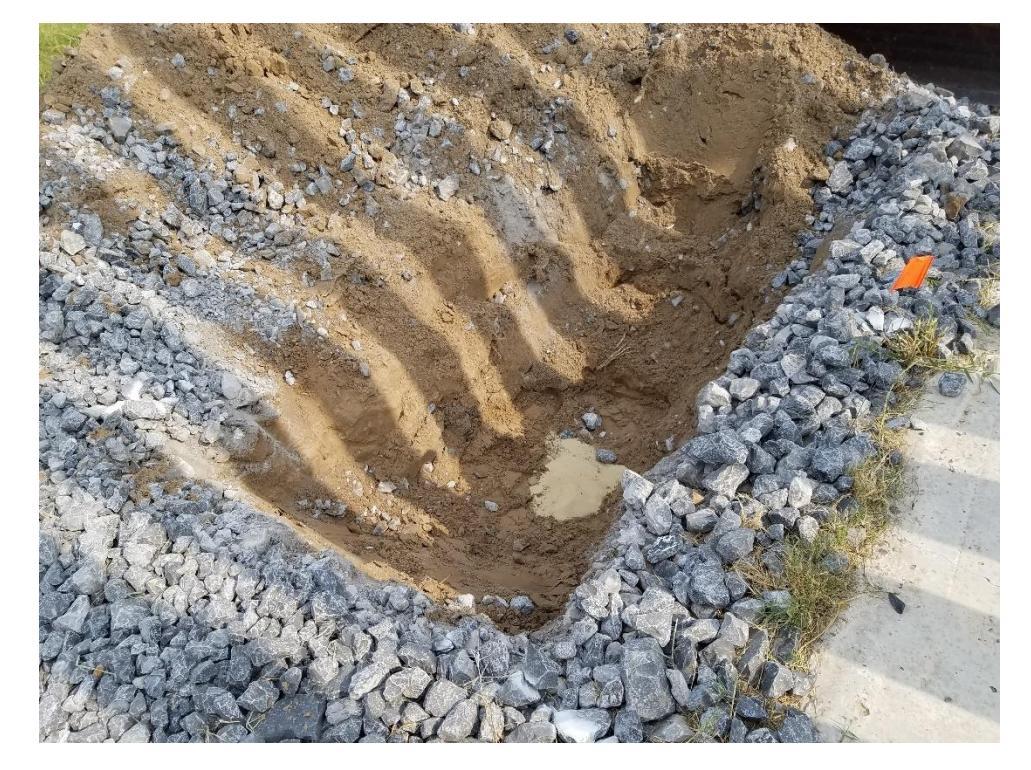
### Photograph: 15

TP-3 excavation at 3' depth showing typical conditions after sand cone test.

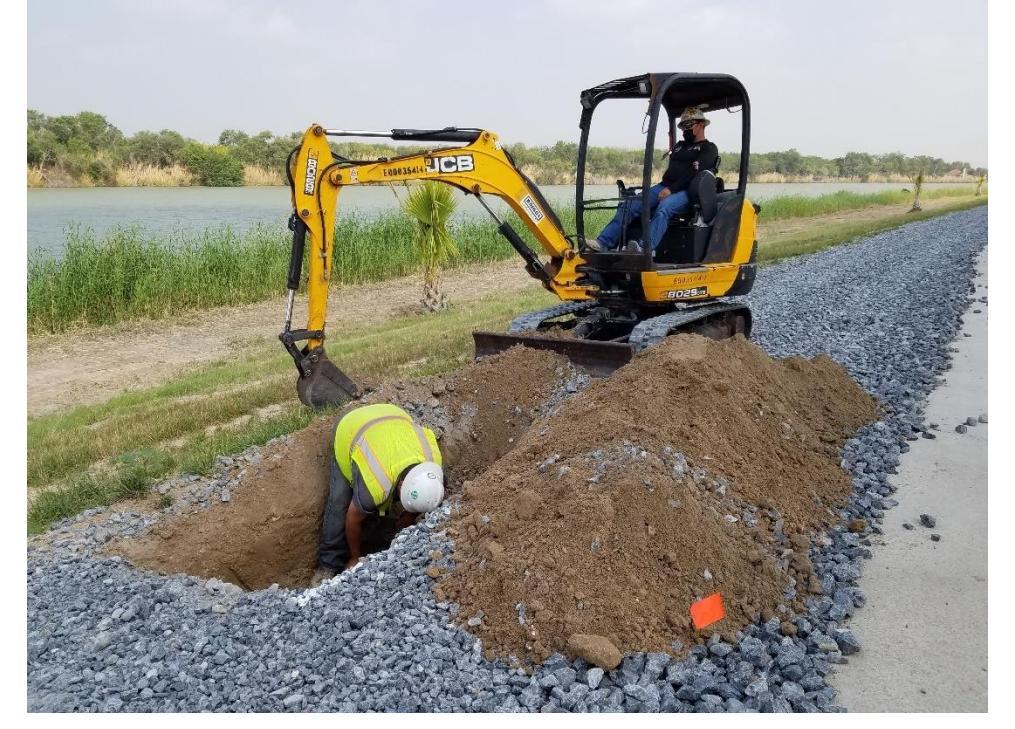
### Photograph: 19

TP-4 excavation near STA 115+00 looking northwest at typical soil conditions at 3 feet bgs.

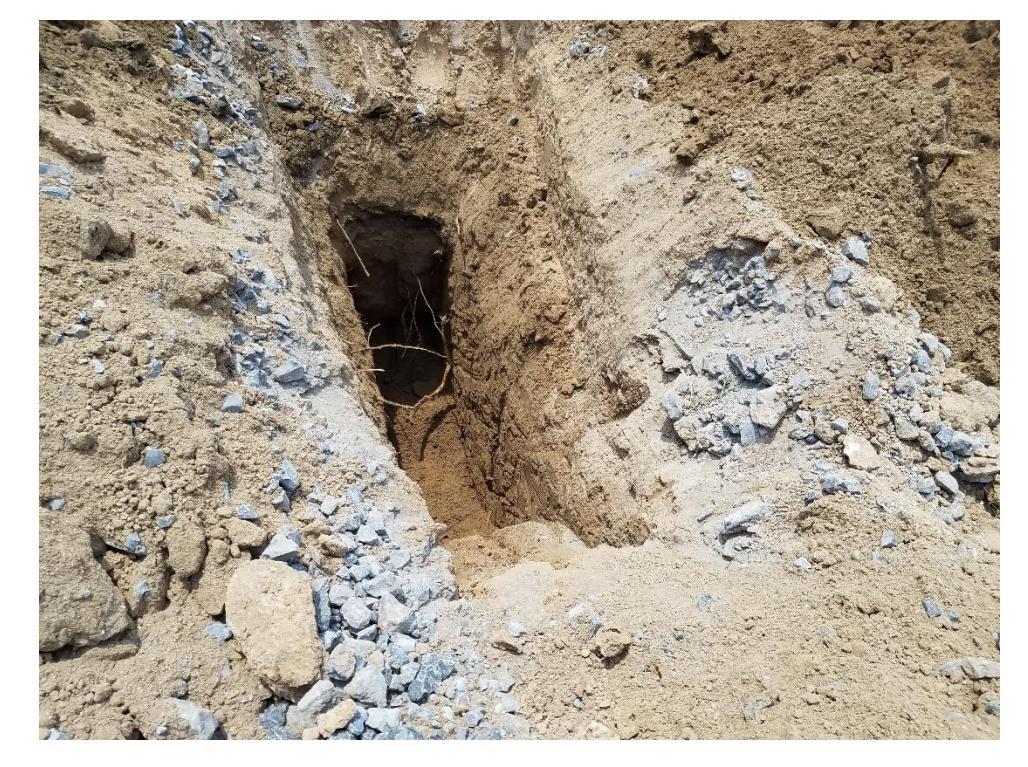
### Photograph: 23

TP-4 showing typical conditions for excavated trench.

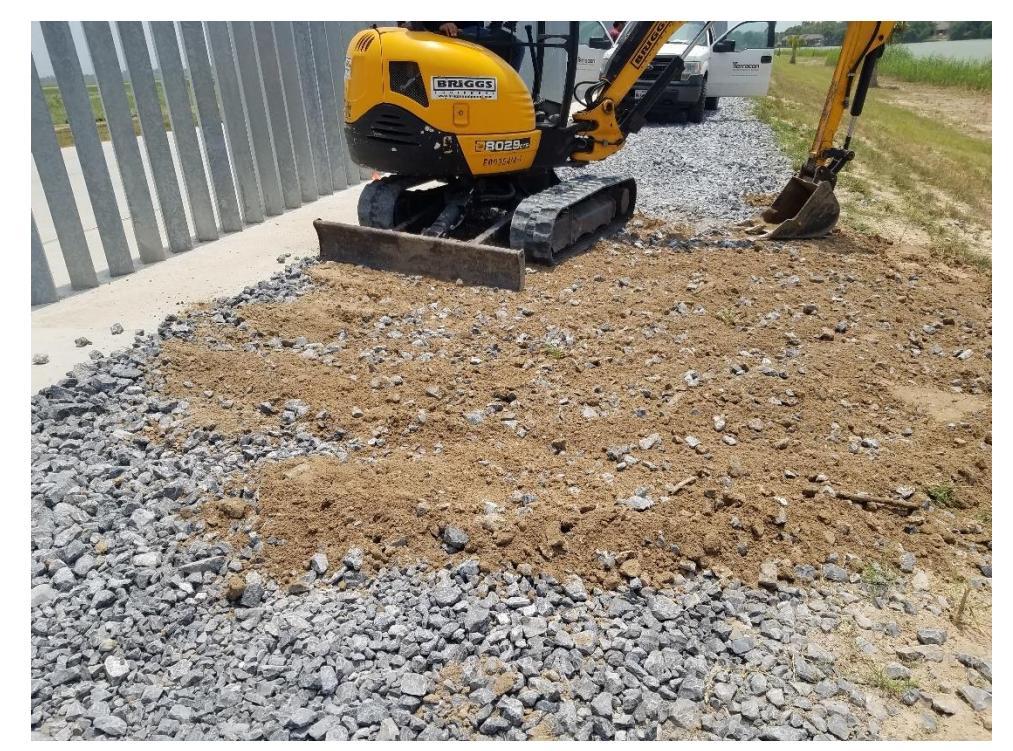
### Photograph: 24

**Description:** TP-4 looking southeast at backfilled trench.

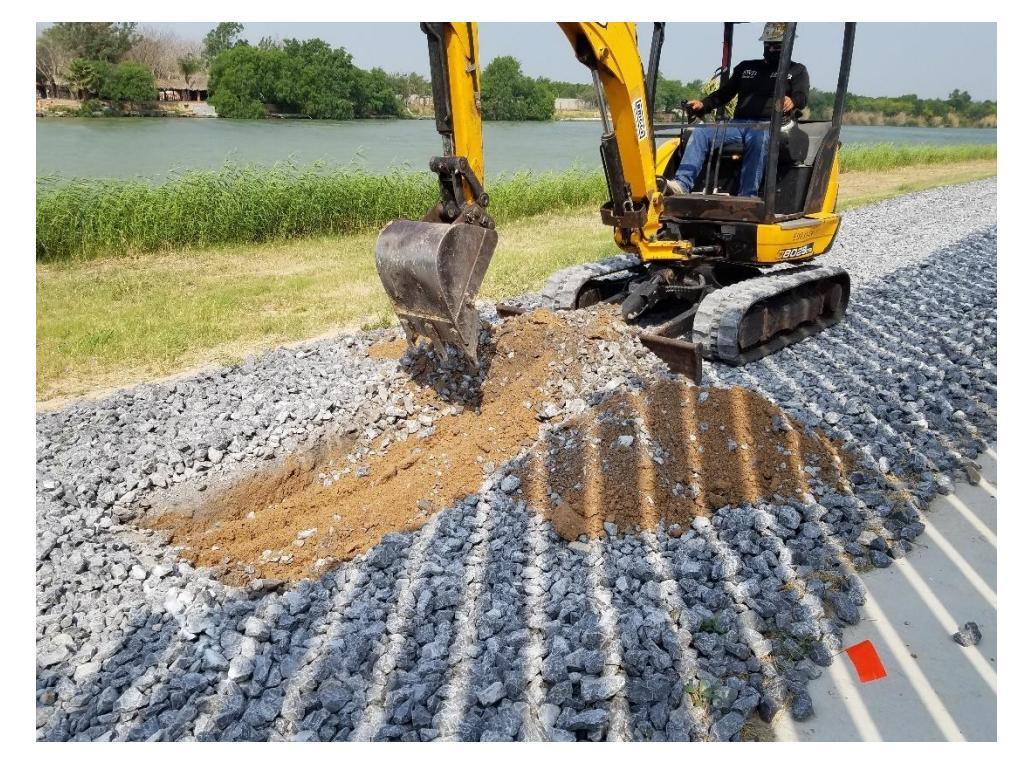
### Photograph: 25

TP-5 excavation near STA 101+00 looking northwest at typical site and soil conditions.

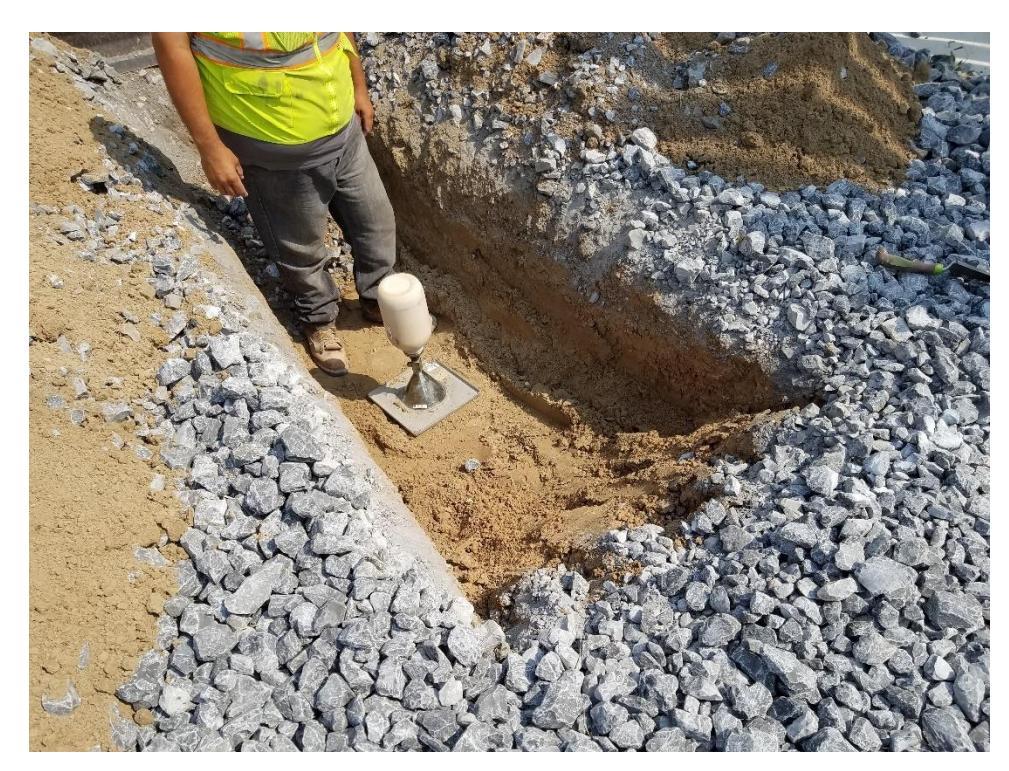
Photograph: 26

**Description:** TP-5 excavation showing sand cone test at depth of 3' bgs.

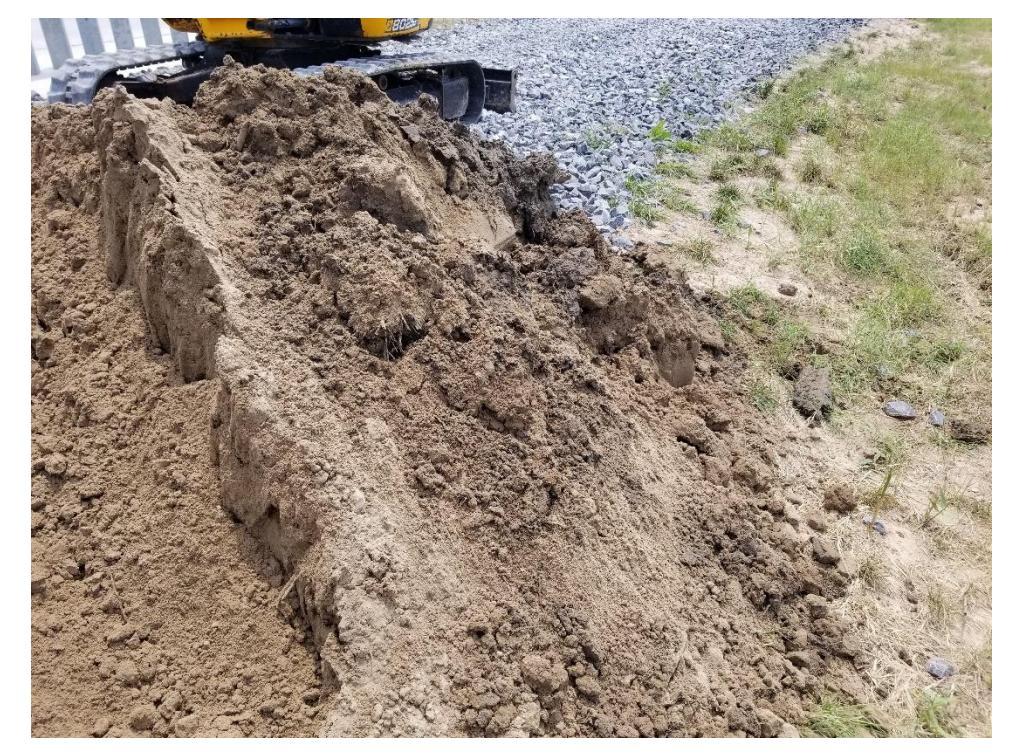
### Photograph: 30

TP-5 excavated materials consisting of silty/sand clay and root matter below fill materials.

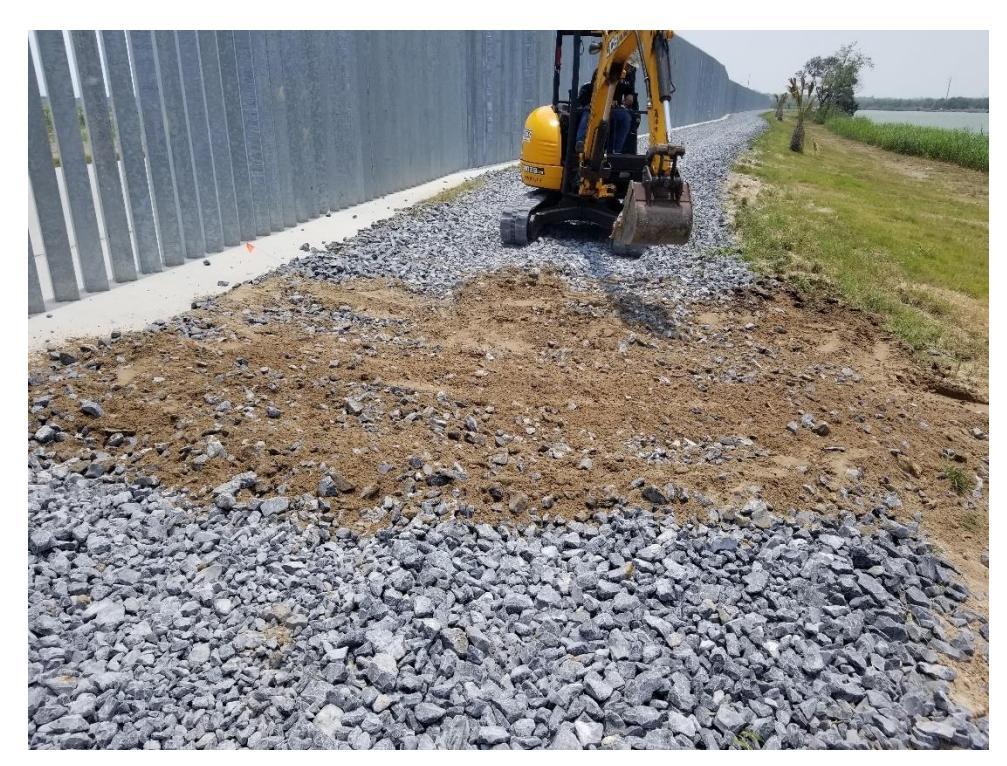
### Photograph: 31

**Description:** TP-5 looking southeast at backfilled trench.

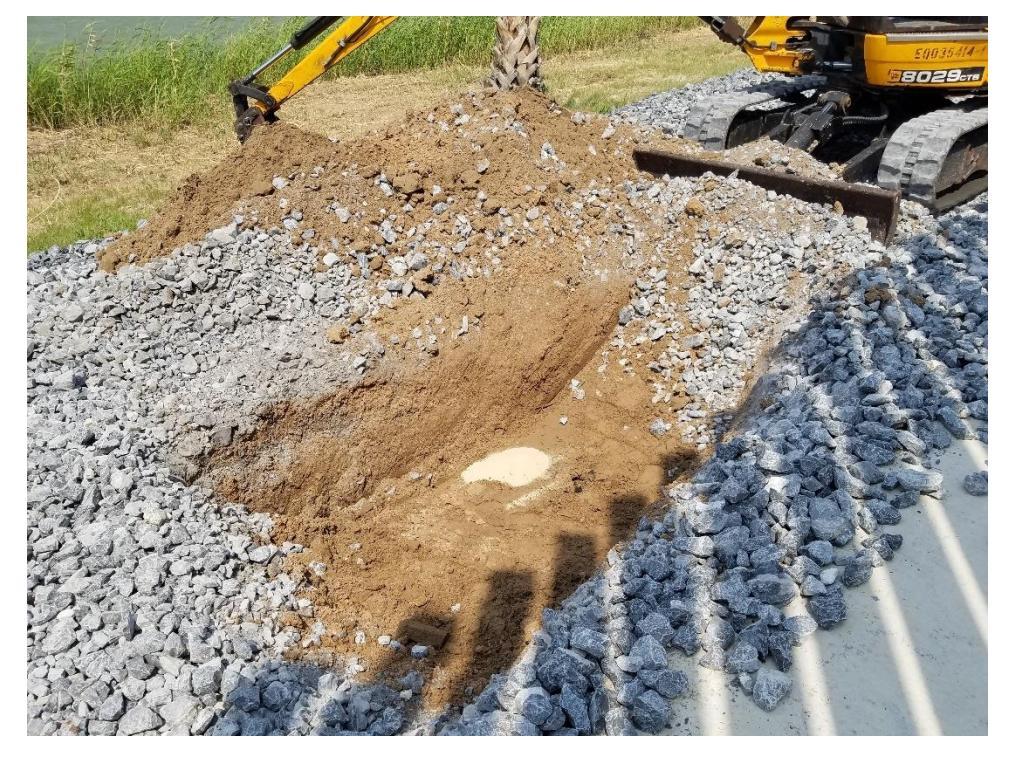
### Photograph: 32

TP-6 excavation near STA 88+50 looking northwest showing typical conditions at 3 feet bgs after sand cone test.

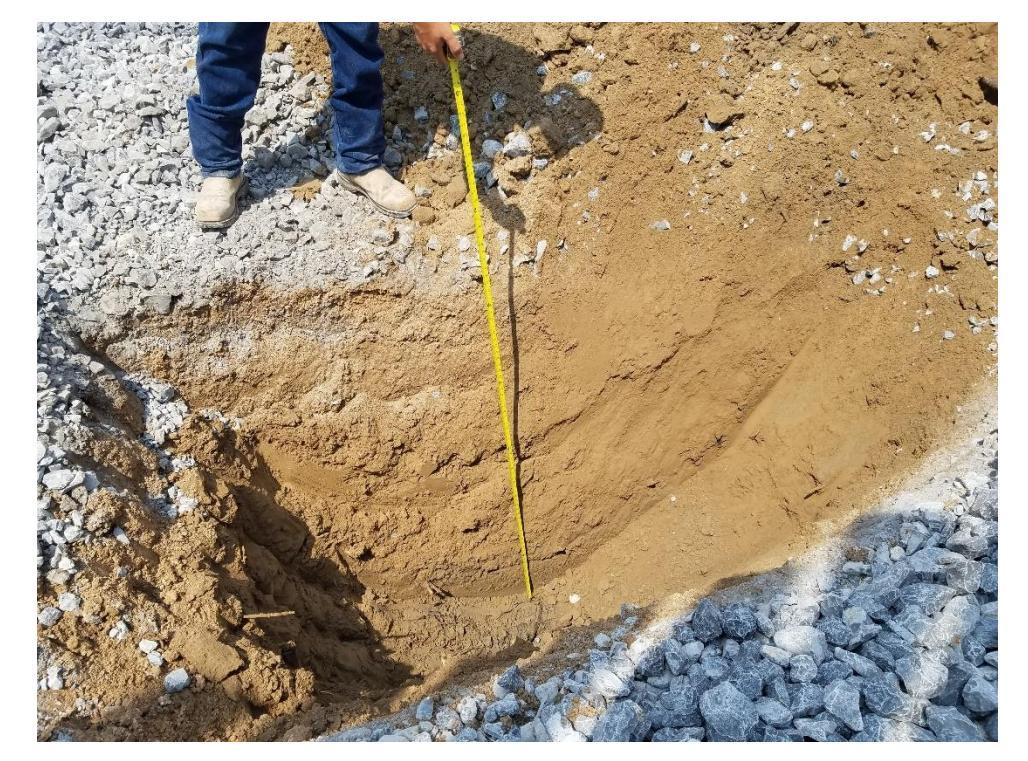
### Photograph: 34

TP-6 excavation sounding at 6 feet bgs for Proctor sample.

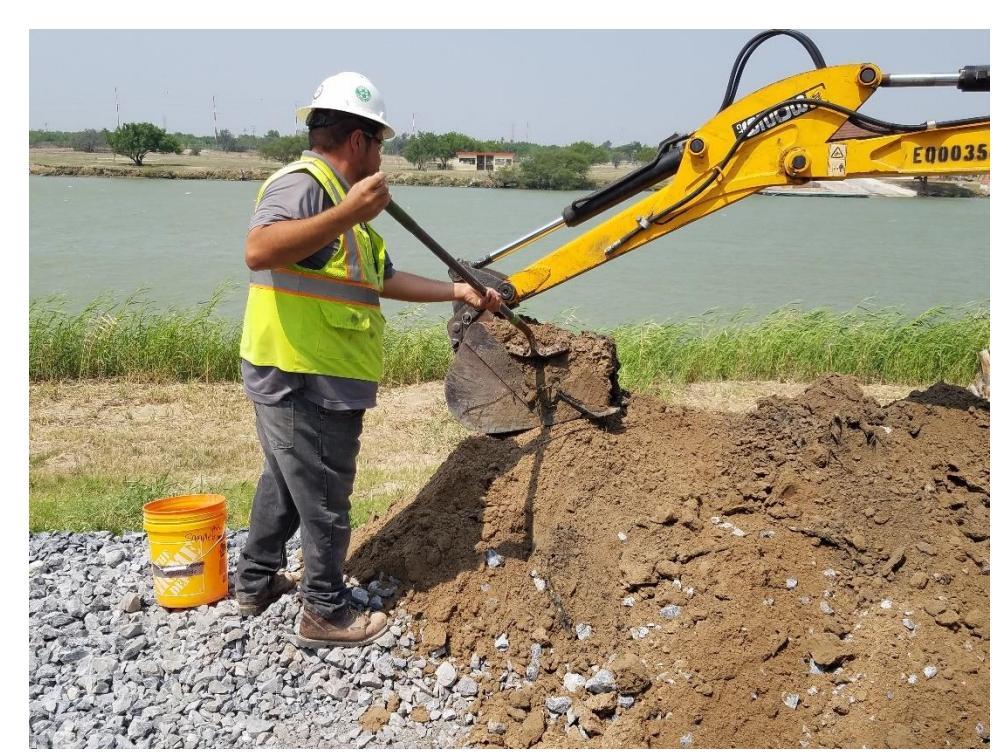
### Photograph: 35

**Description:** TP-6 Proctor sample collection at 6 feet bgs.

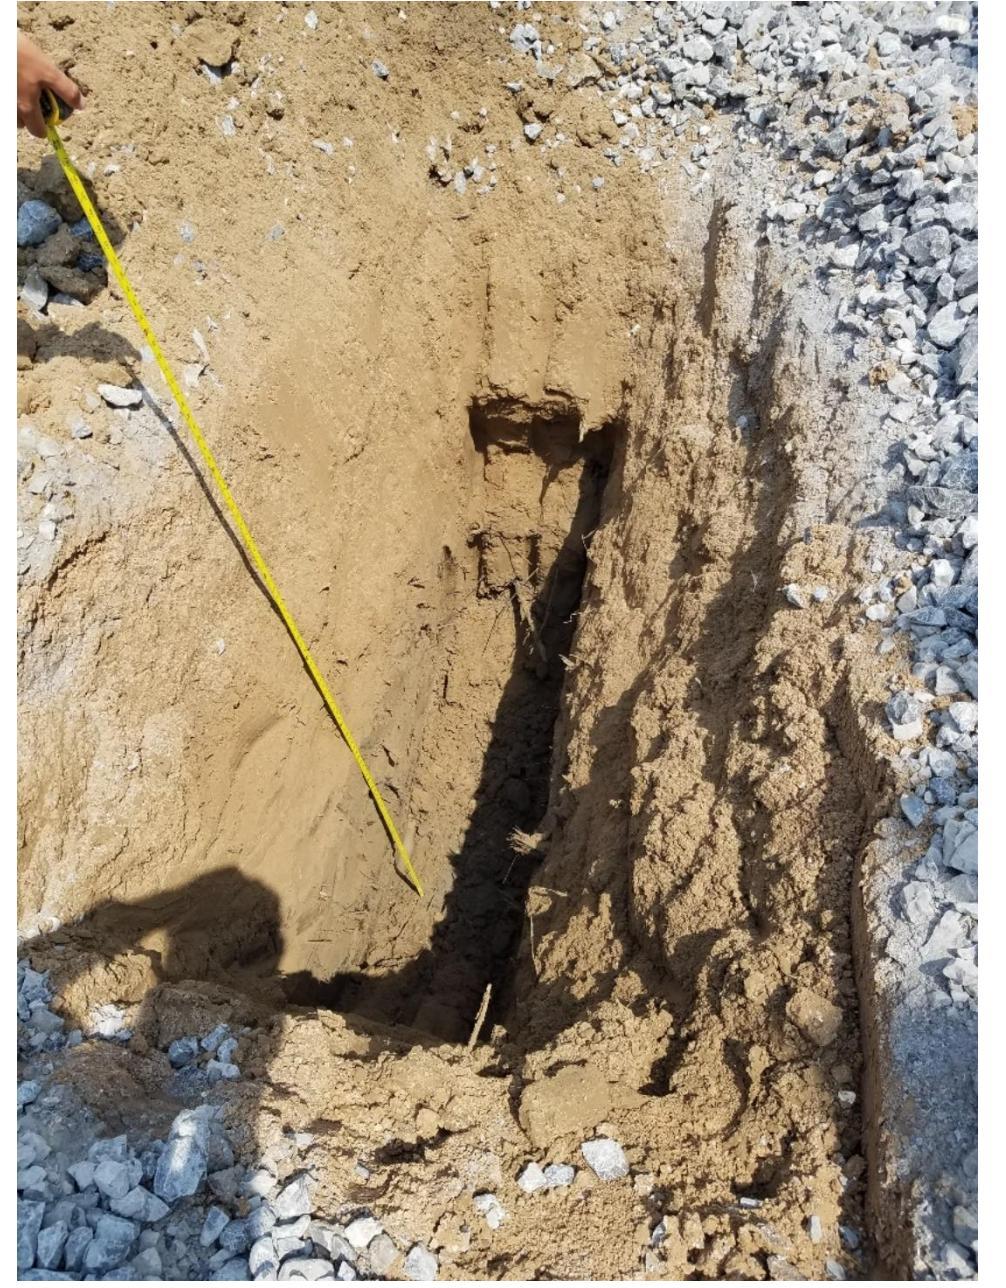
### Photograph: 36

TP-6 excavation sounding showing typical soil conditions.

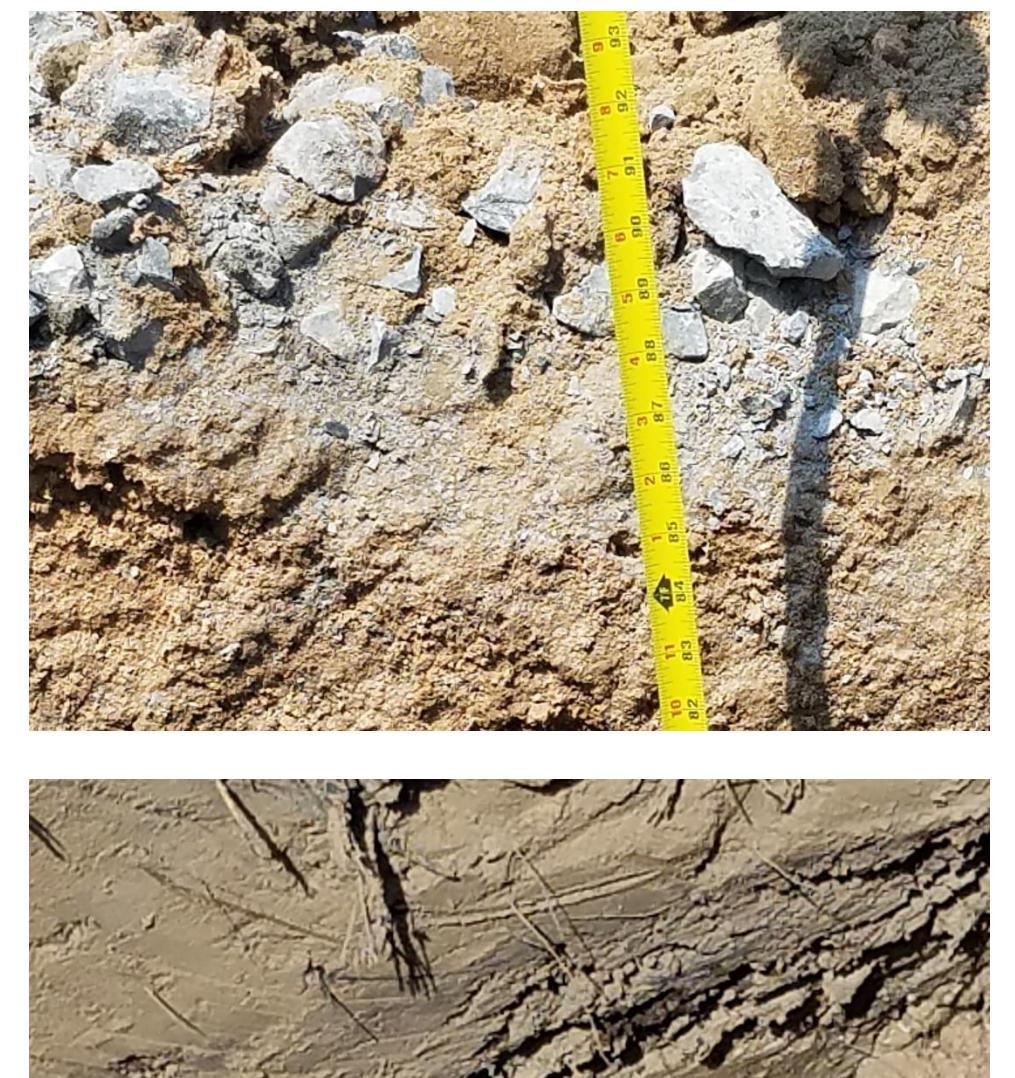
### Photograph: 37

**Description:** TP-6 excavation sounding at 7 feet bgs.

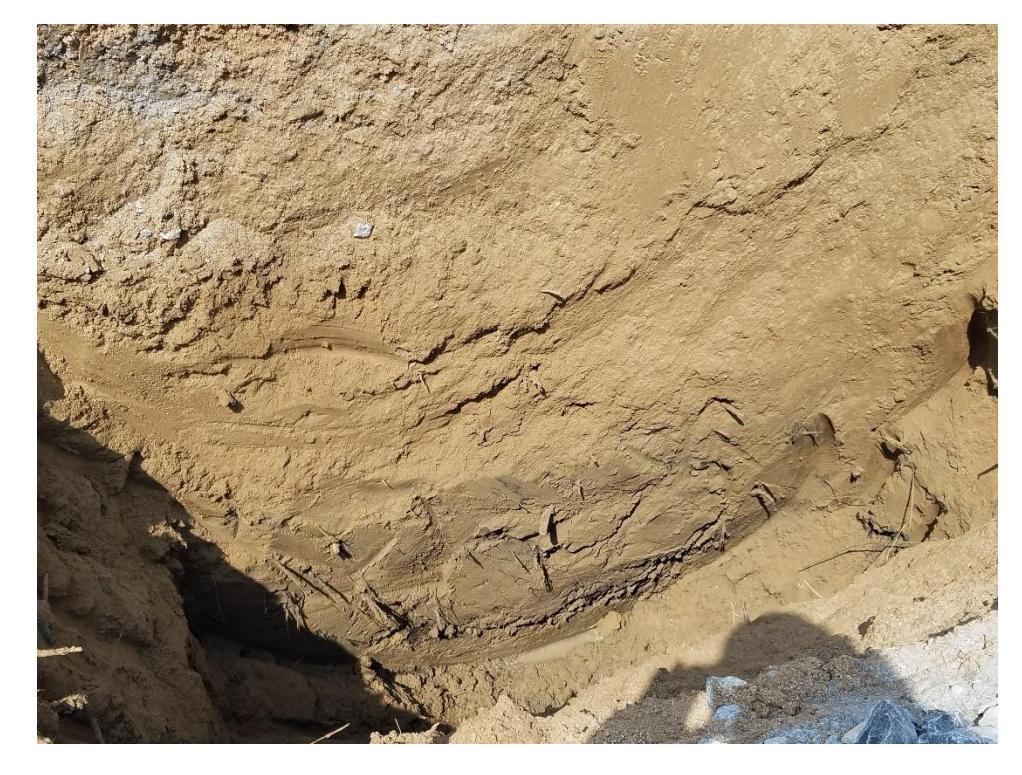
### Photograph: 39

TP-6 excavation showing typical soil conditions with roots and groundwater intrusion to the trench.
