# **Engineering Evaluation of Bollard Fence**

## Rio Grande, Hidalgo County, Texas

United States of America v. Fisher Sand and Gravel Company, Civil Action No. 7:19-CV-403

August 2021

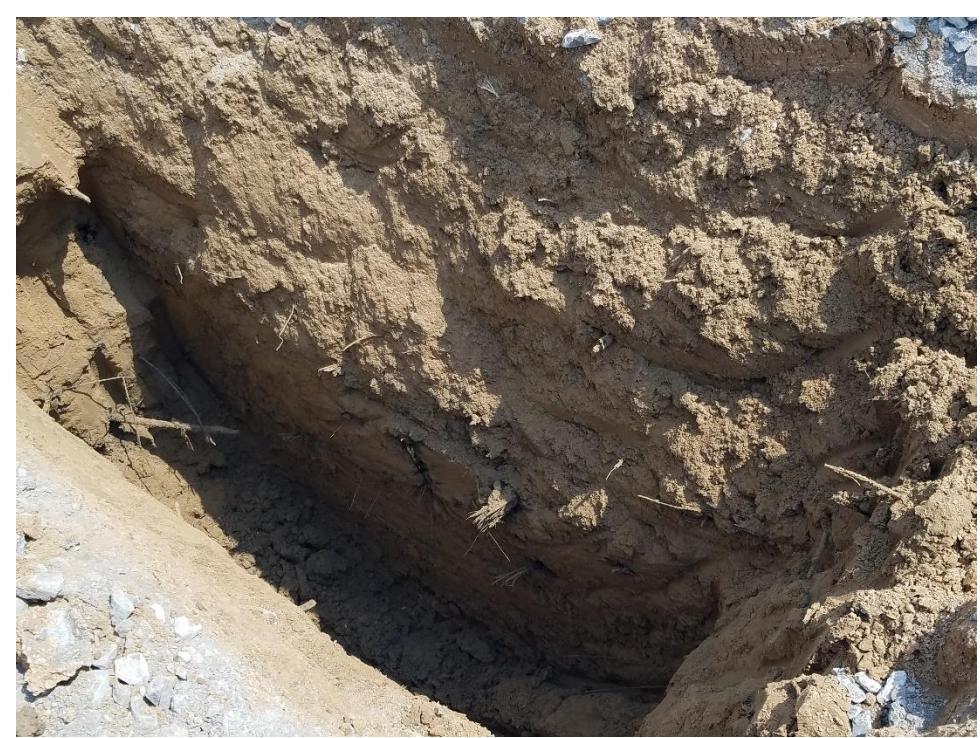
### Photograph: 40

TP-6 excavation showing typical conditions for subgrade soil with roots below fill.

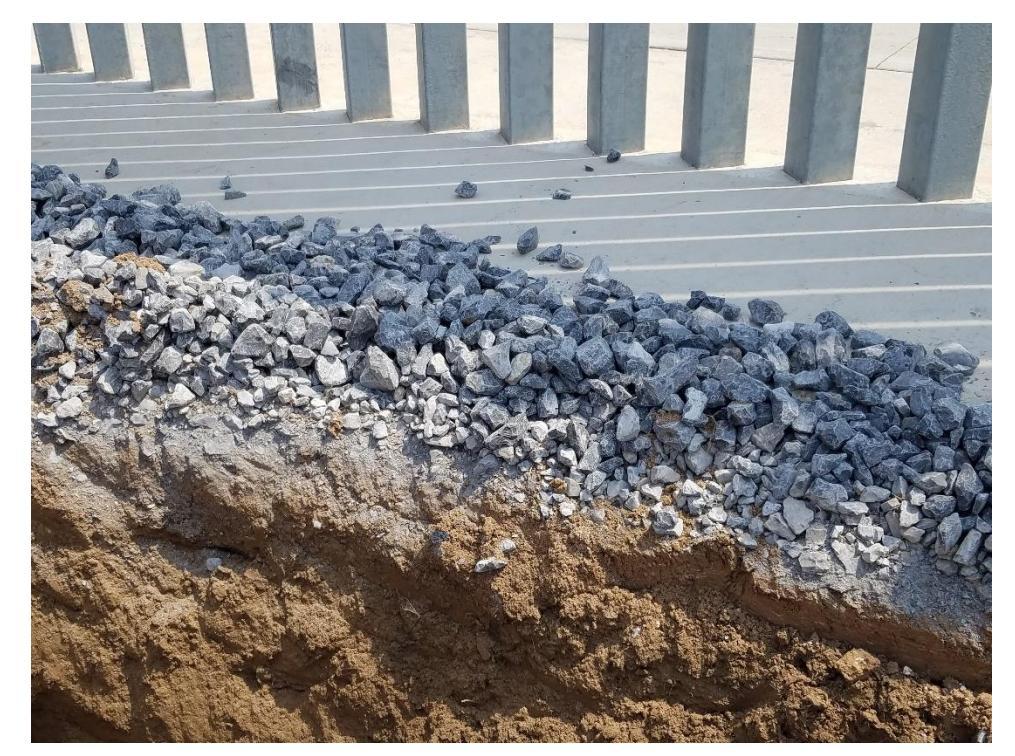
### Photograph: 41

TP-6 excavation showing typical conditions for fill and subgrade soils.

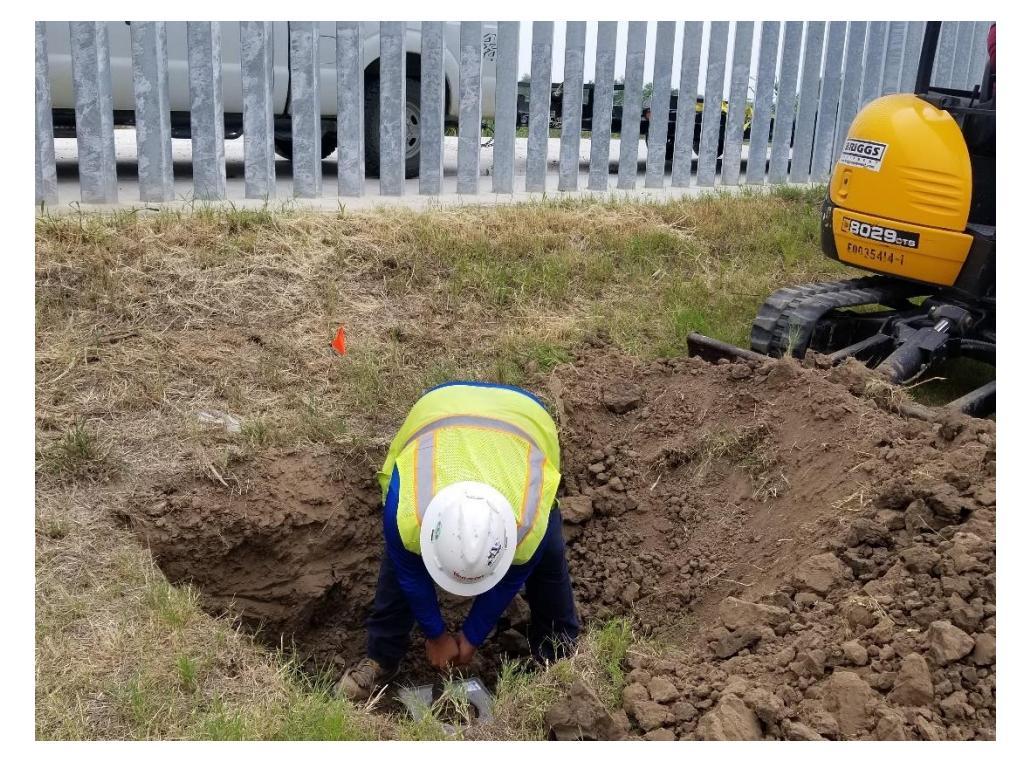
### Photograph: 43

TP-7 excavation showing sand cone test at 3 feet bgs.

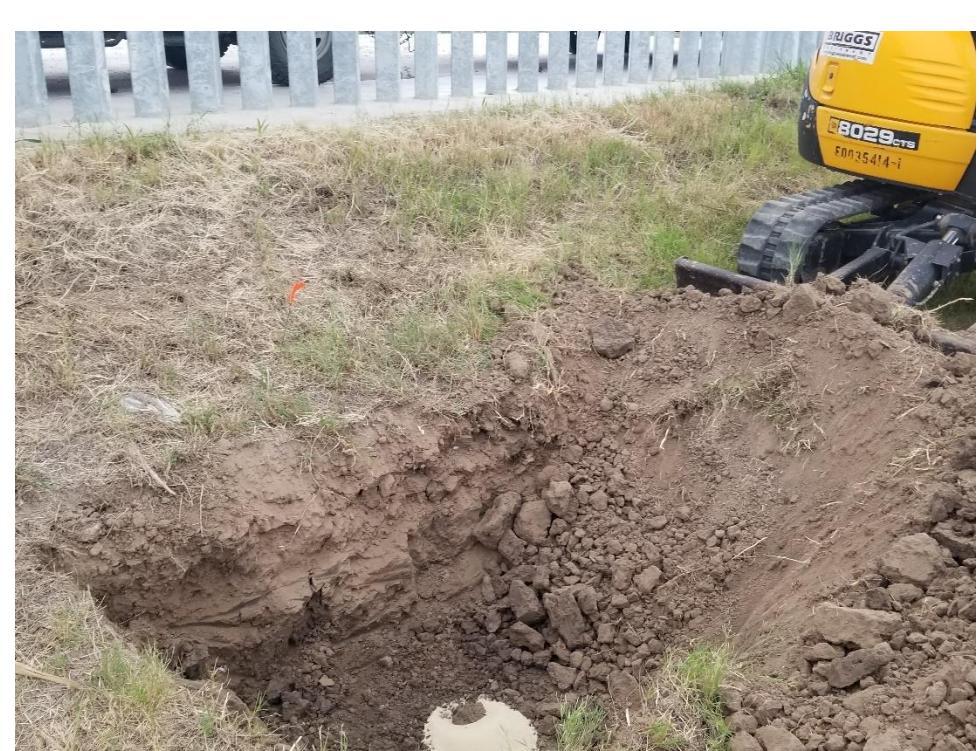
### Photograph: 44

TP-7 showing soil conditions after sand cone test at depth of Proctor sample collection

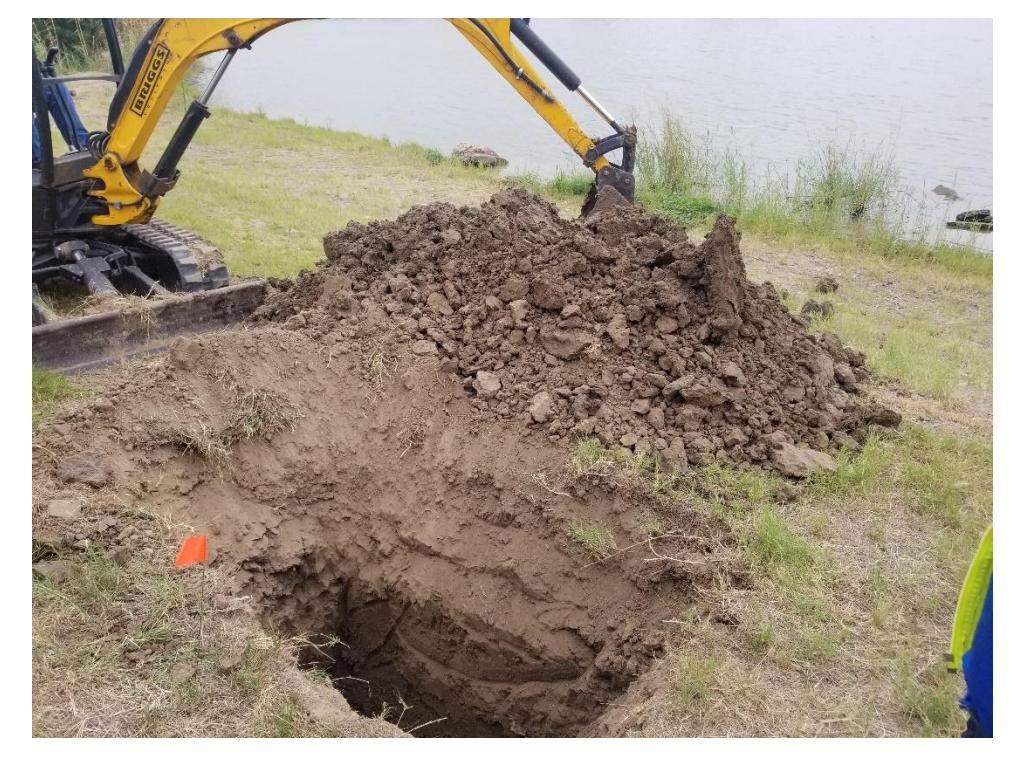
### Photograph: 45

TP-7 excavation looking southeast at clayey soils from trench

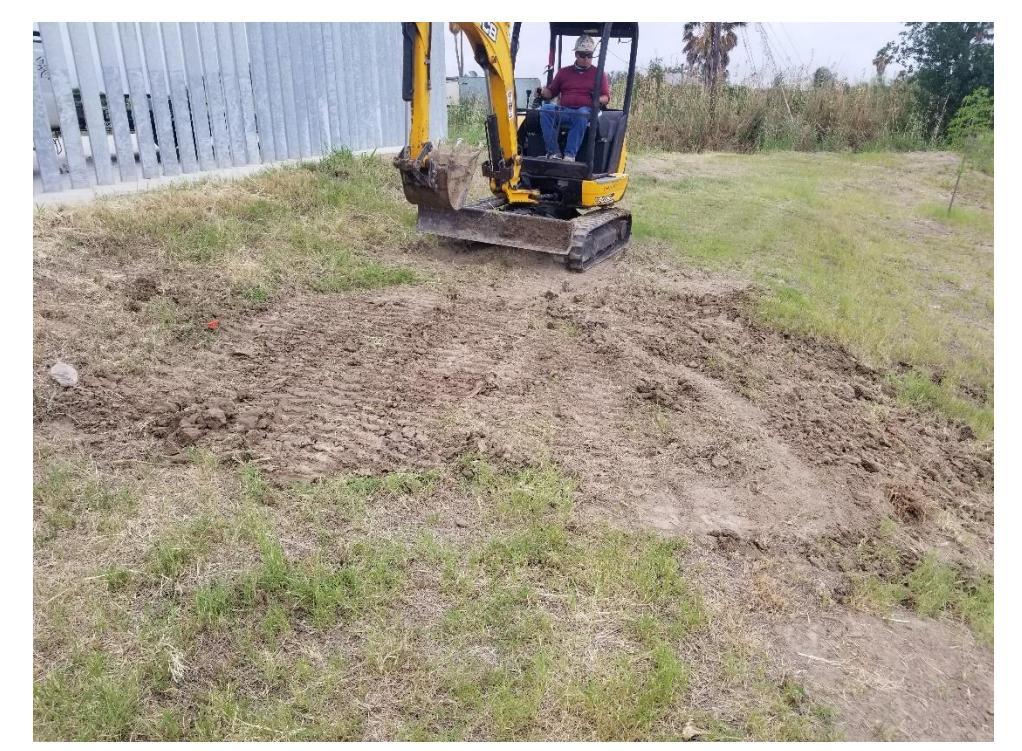
### Photograph: 49

**Description:** TP-7 looking southeast at backfilled trench

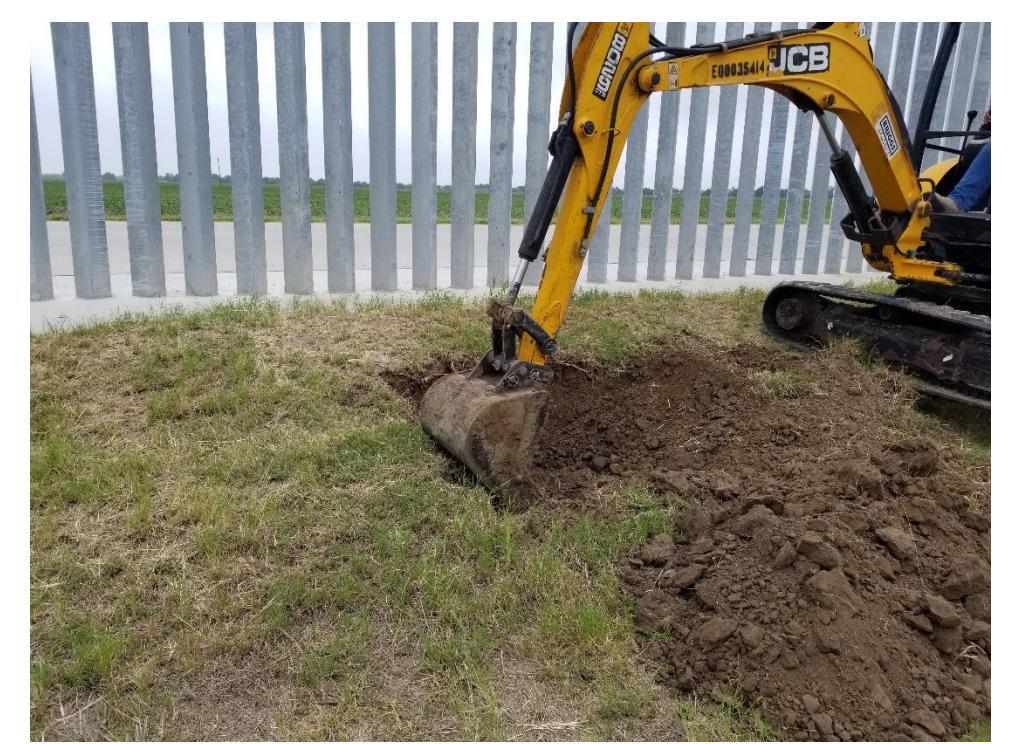
### Photograph: 51

TP-8 excavation looking northeast showing approximate depth of fill materials.

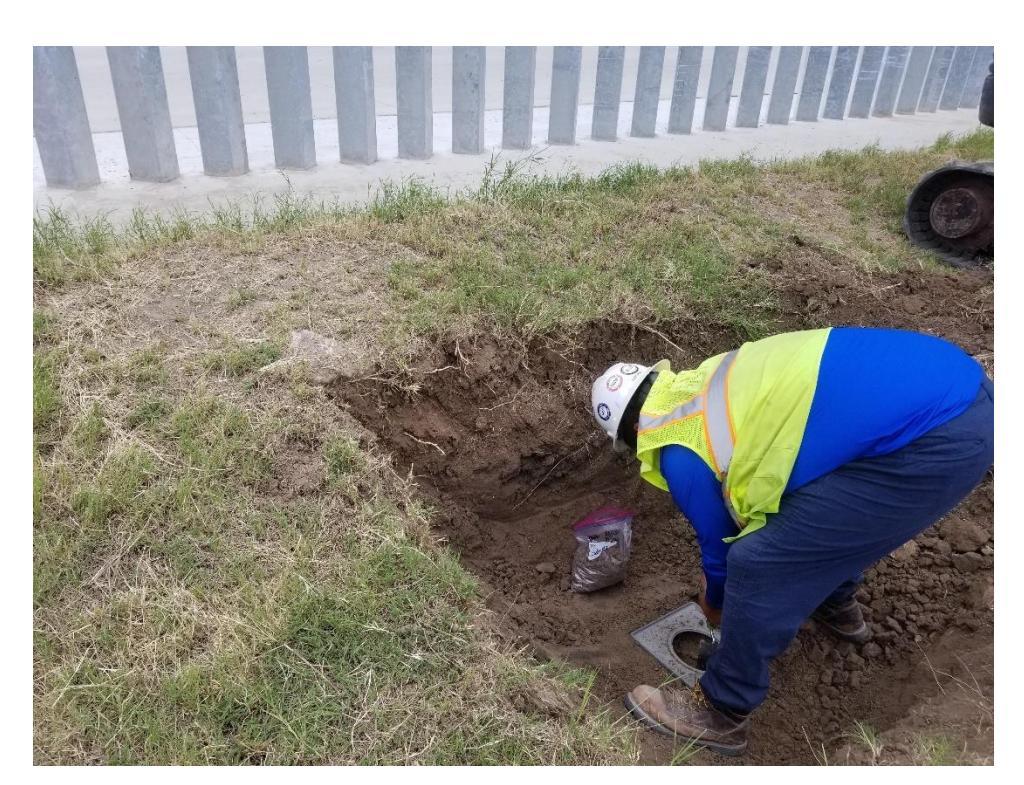
### Photograph: 52

**Description:** TP-8 excavation looking at sand cone test at 3 feet bgs.

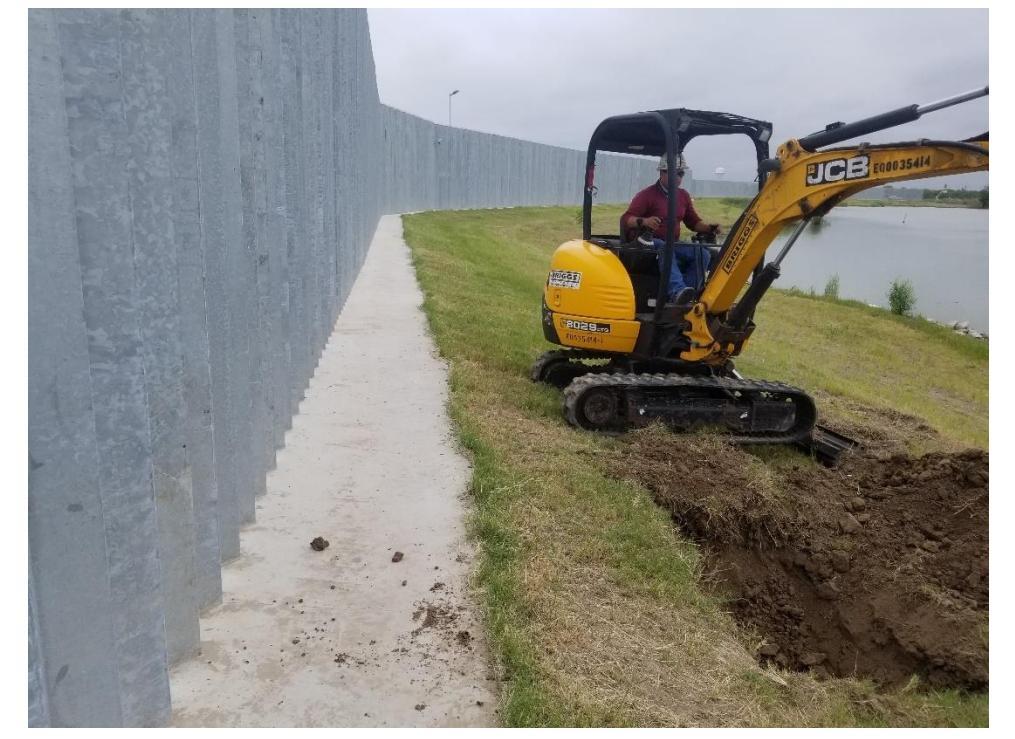
### Photograph: 53

TP-8 excavation looking northeast showing soil conditions

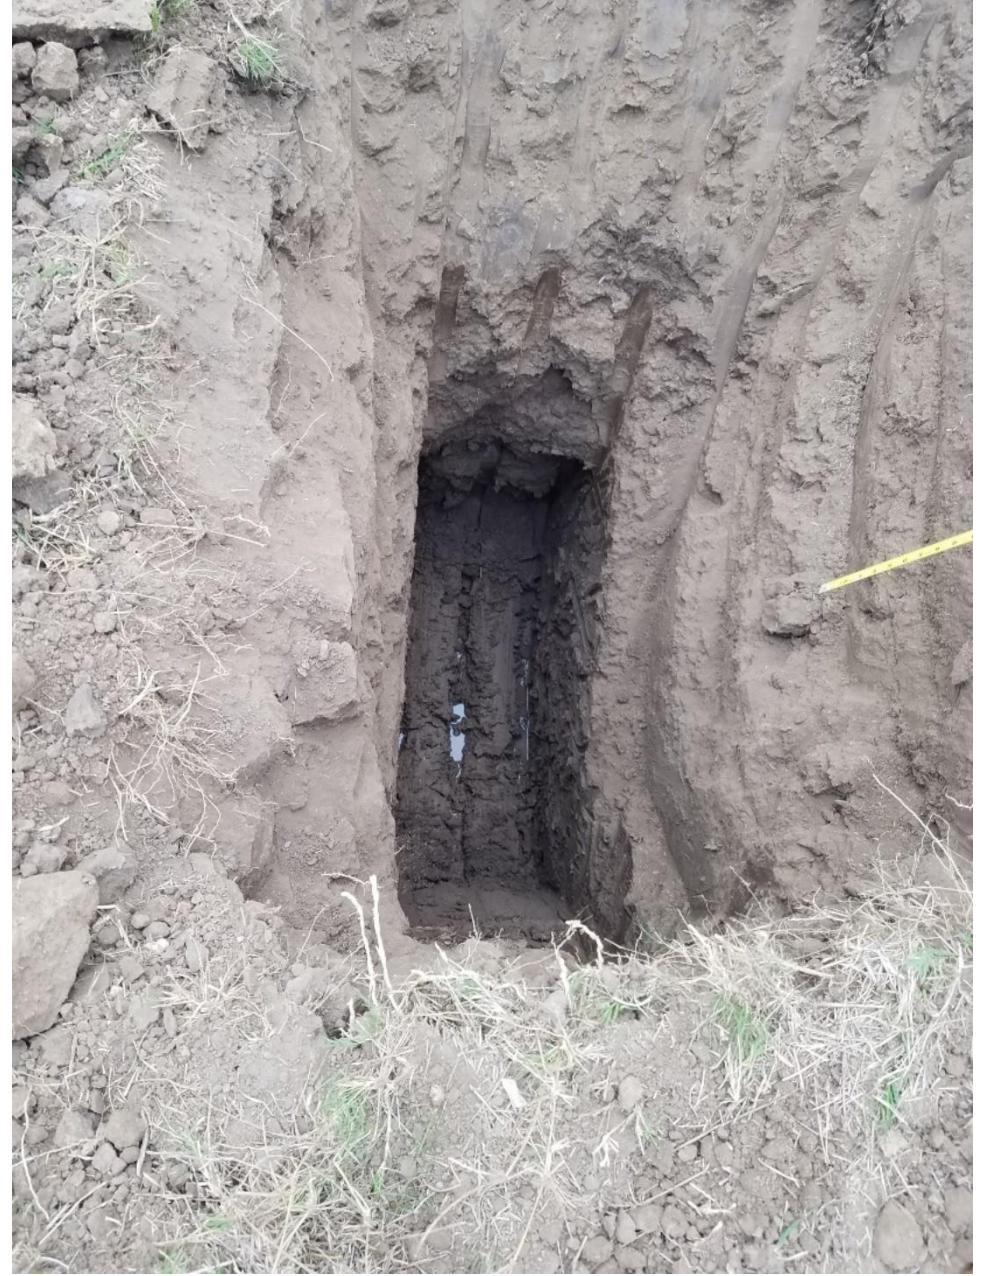
### Photograph: 55

TP-8 excavation showing soil and groundwater conditions at 9 feet bgs.

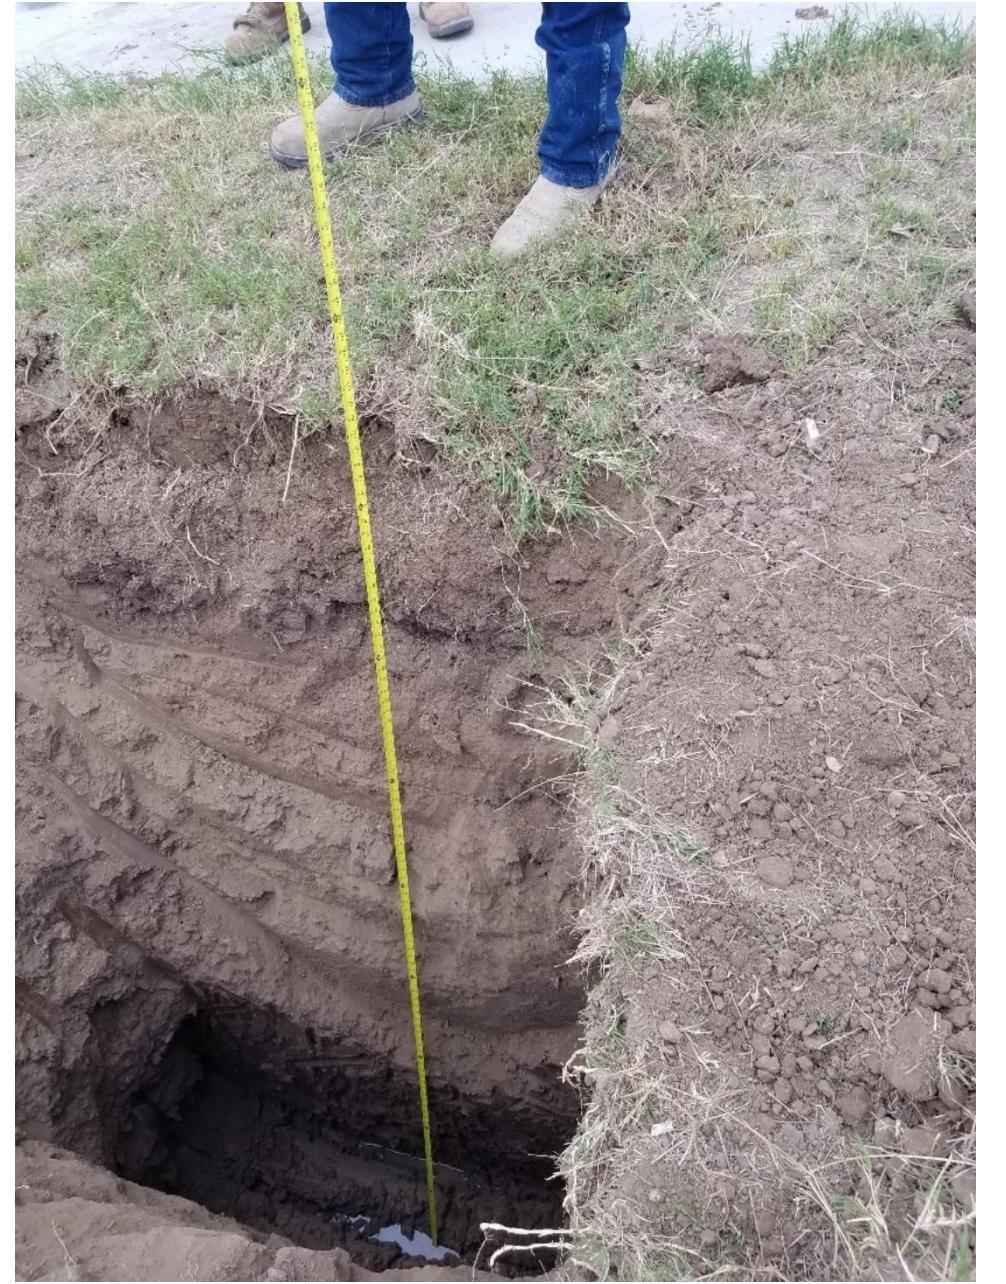
### Photograph: 56

TP-8 excavation showing soil conditions at 9 feet bgs.

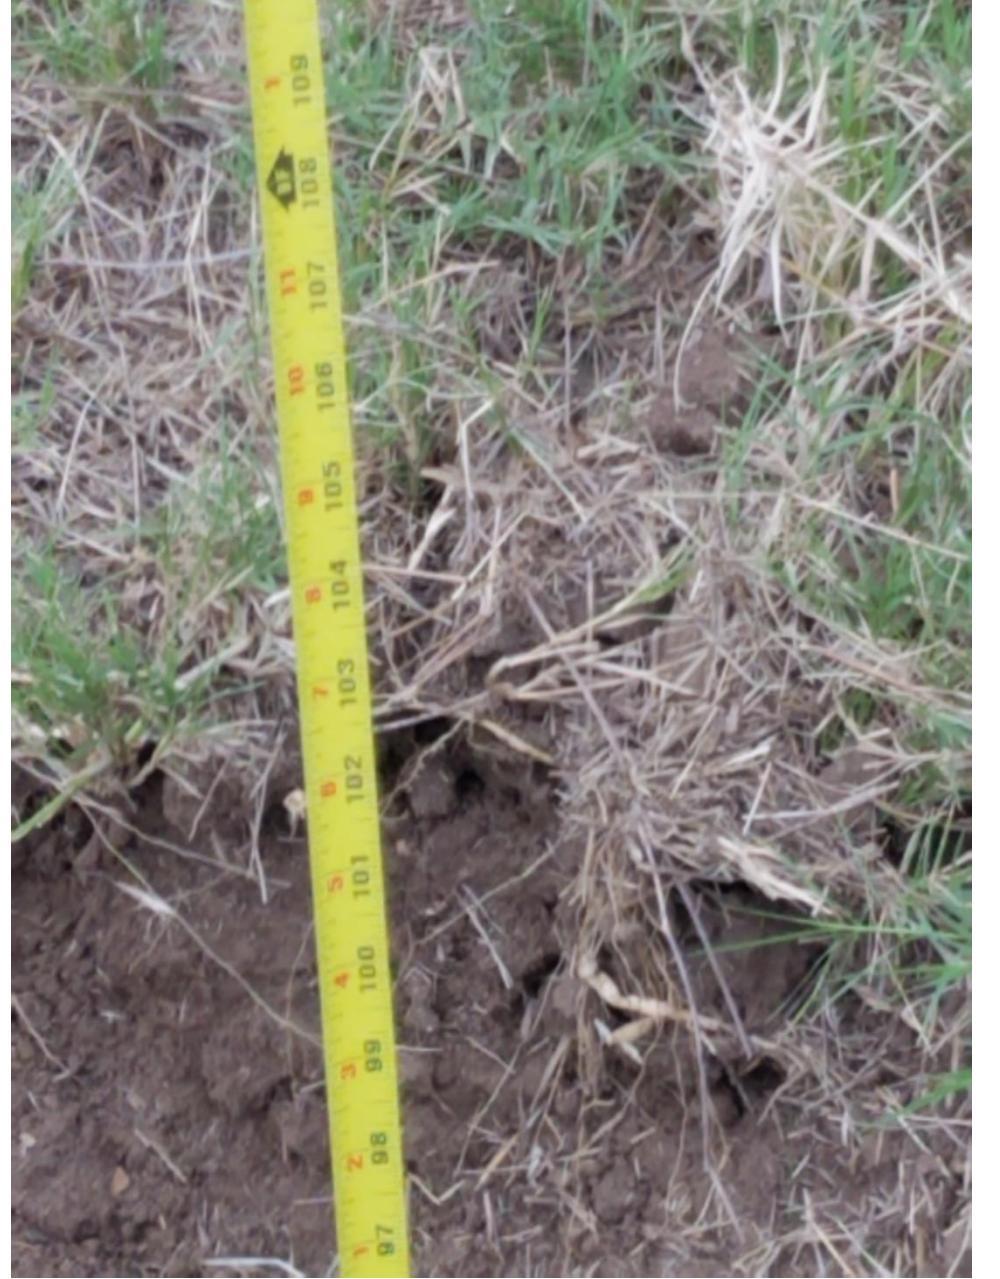
### Photograph: 57

**Description:** TP-8 excavation sounding at 9 feet bgs.

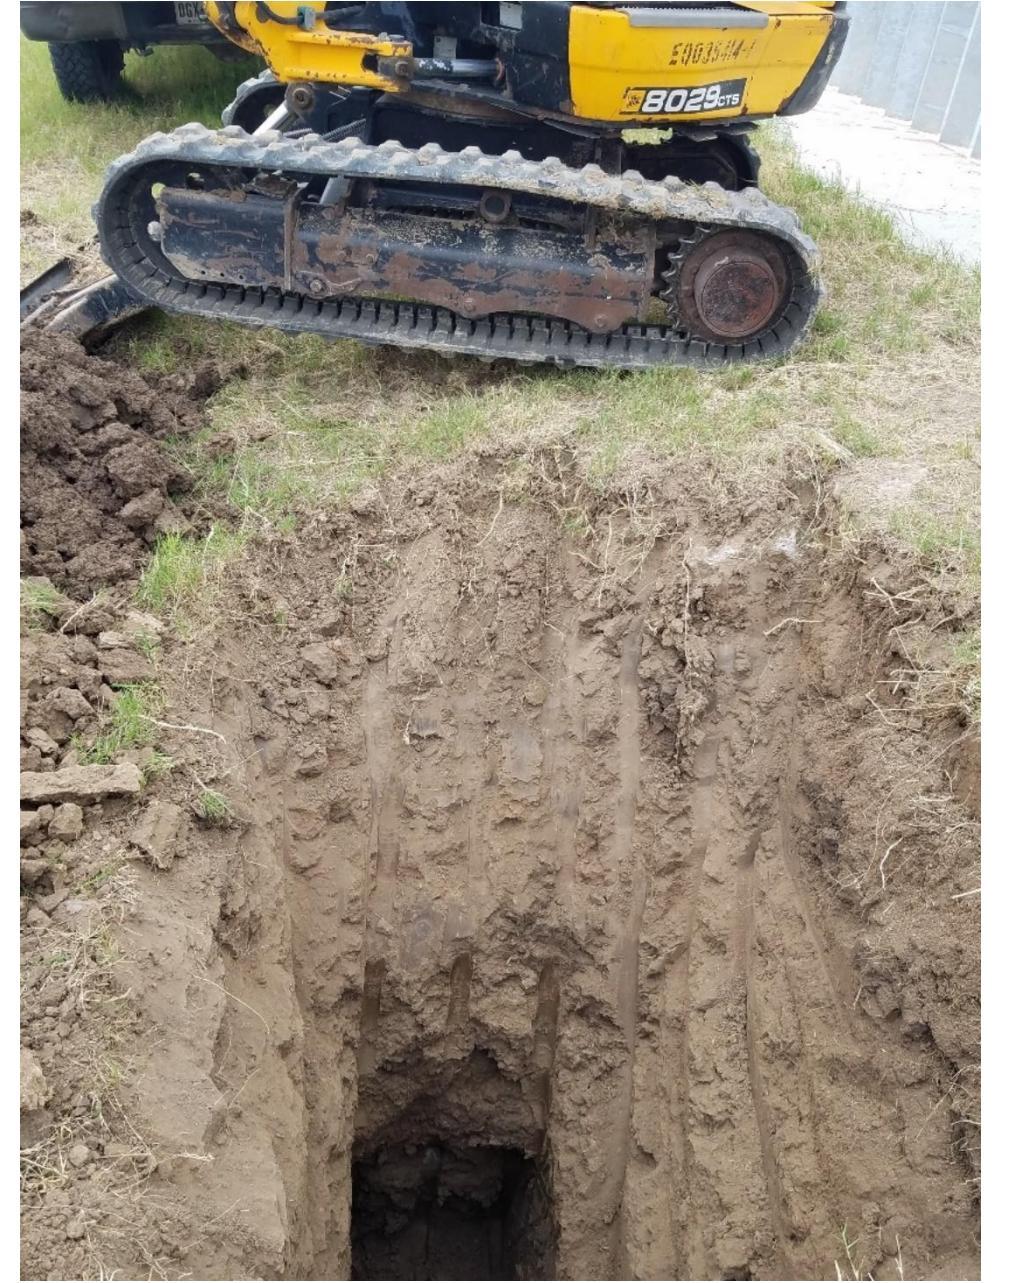
### Photograph: 58

TP-8 excavation showing soil conditions at 9 feet bgs.

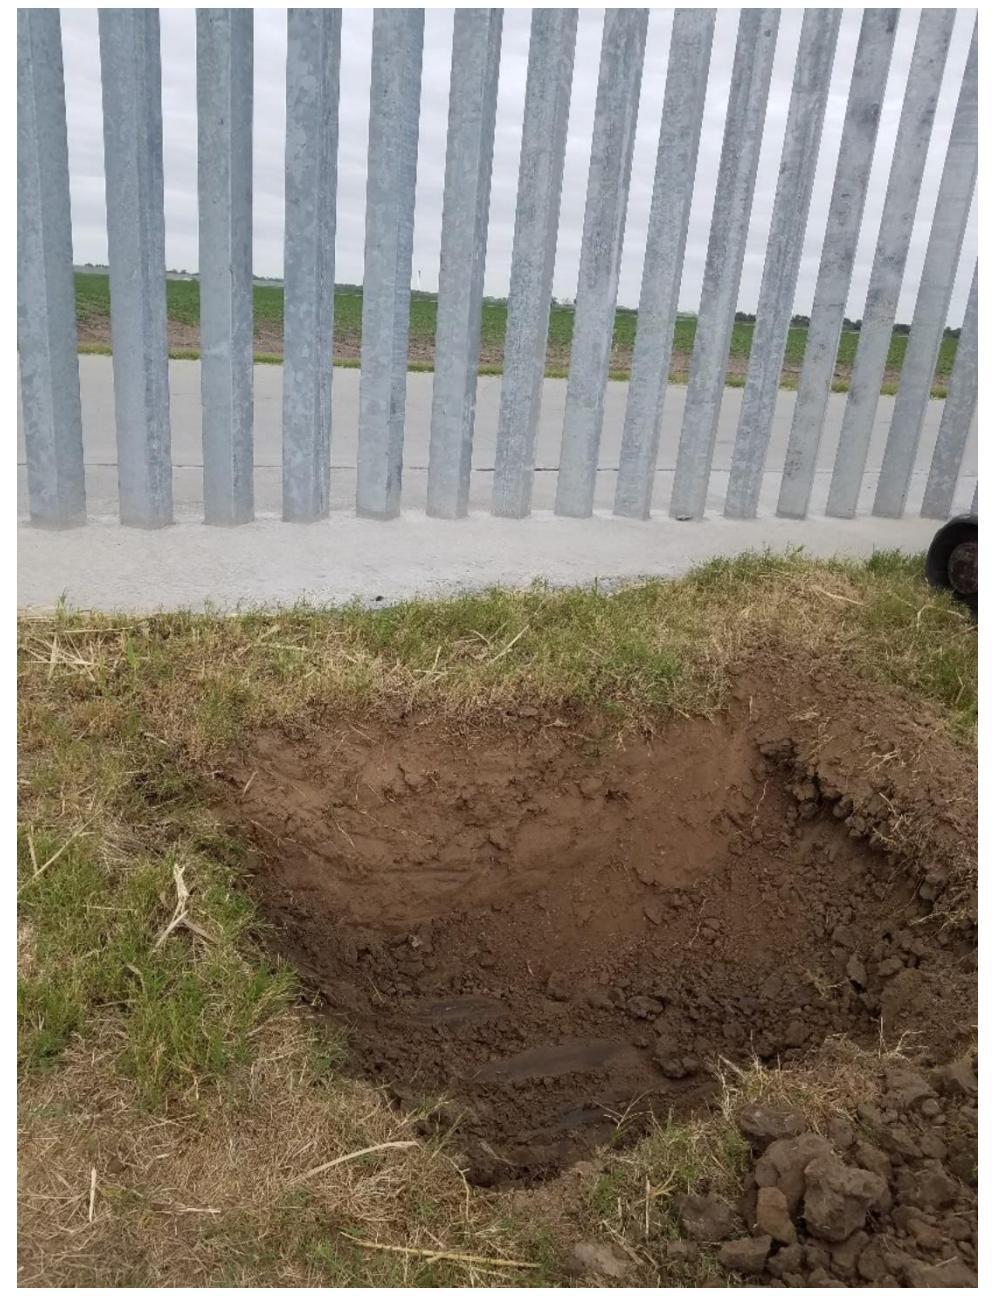
### Photograph: 59

TP-9 excavation looking northwest showing soil conditions at 3 feet bgs

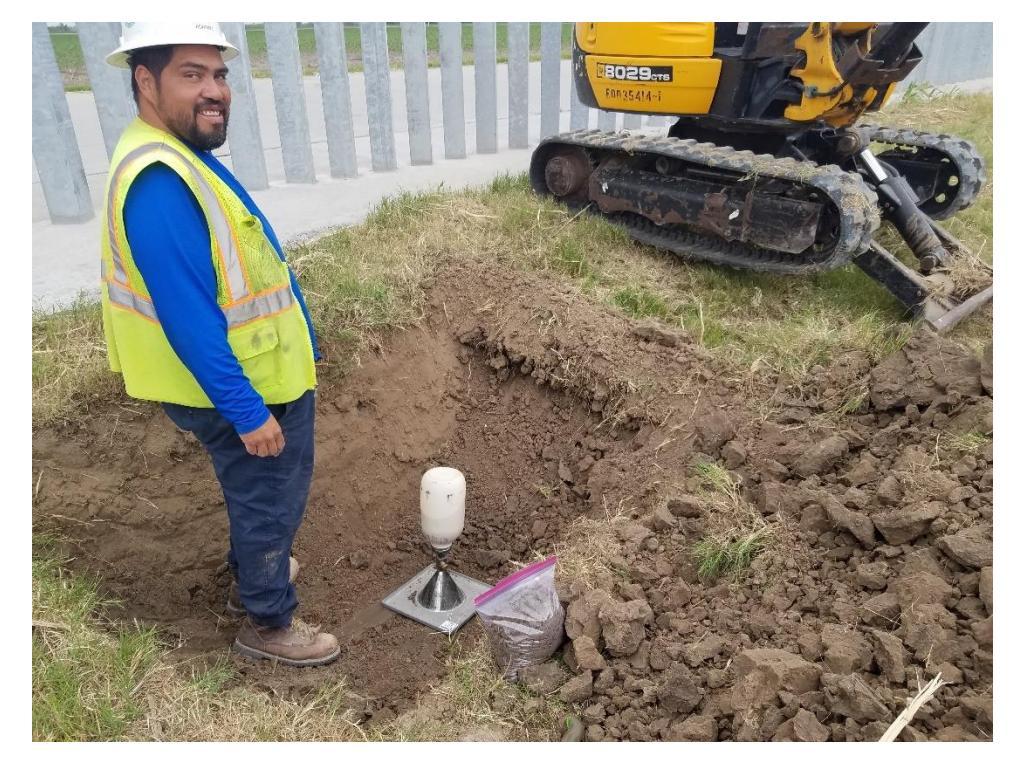
### Photograph: 60

TP-9 excavation at 3 feet bgs showing the sand cone test

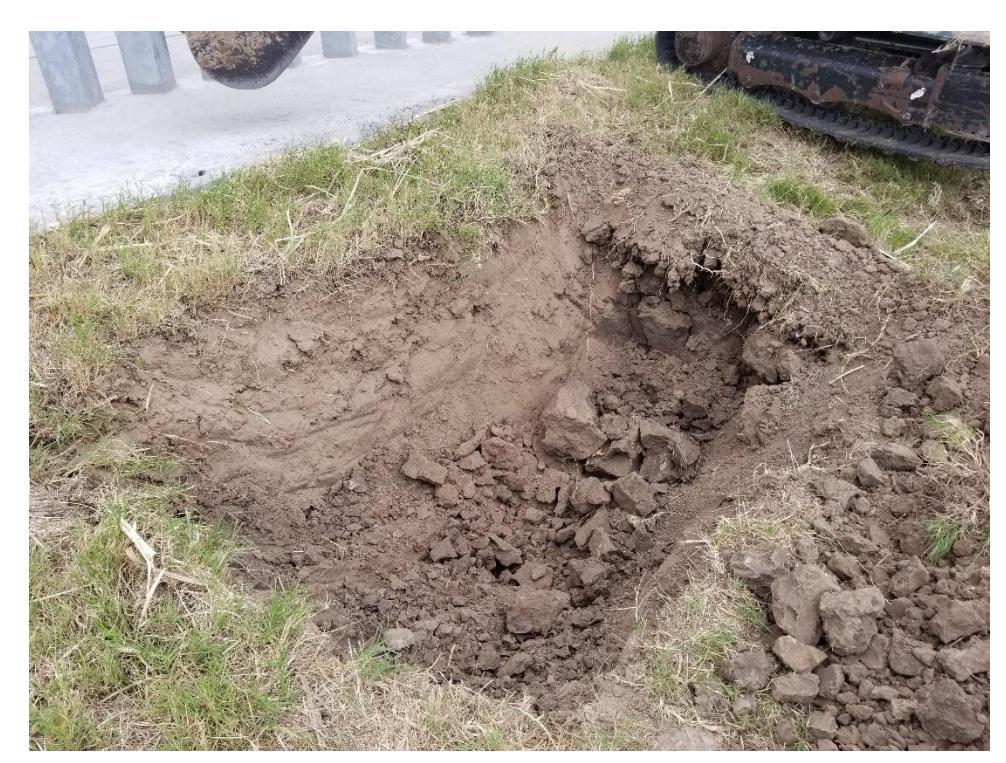
### Photograph: 61

TP-9 excavation at 3 feet bgs showing the soil condition for Proctor sample

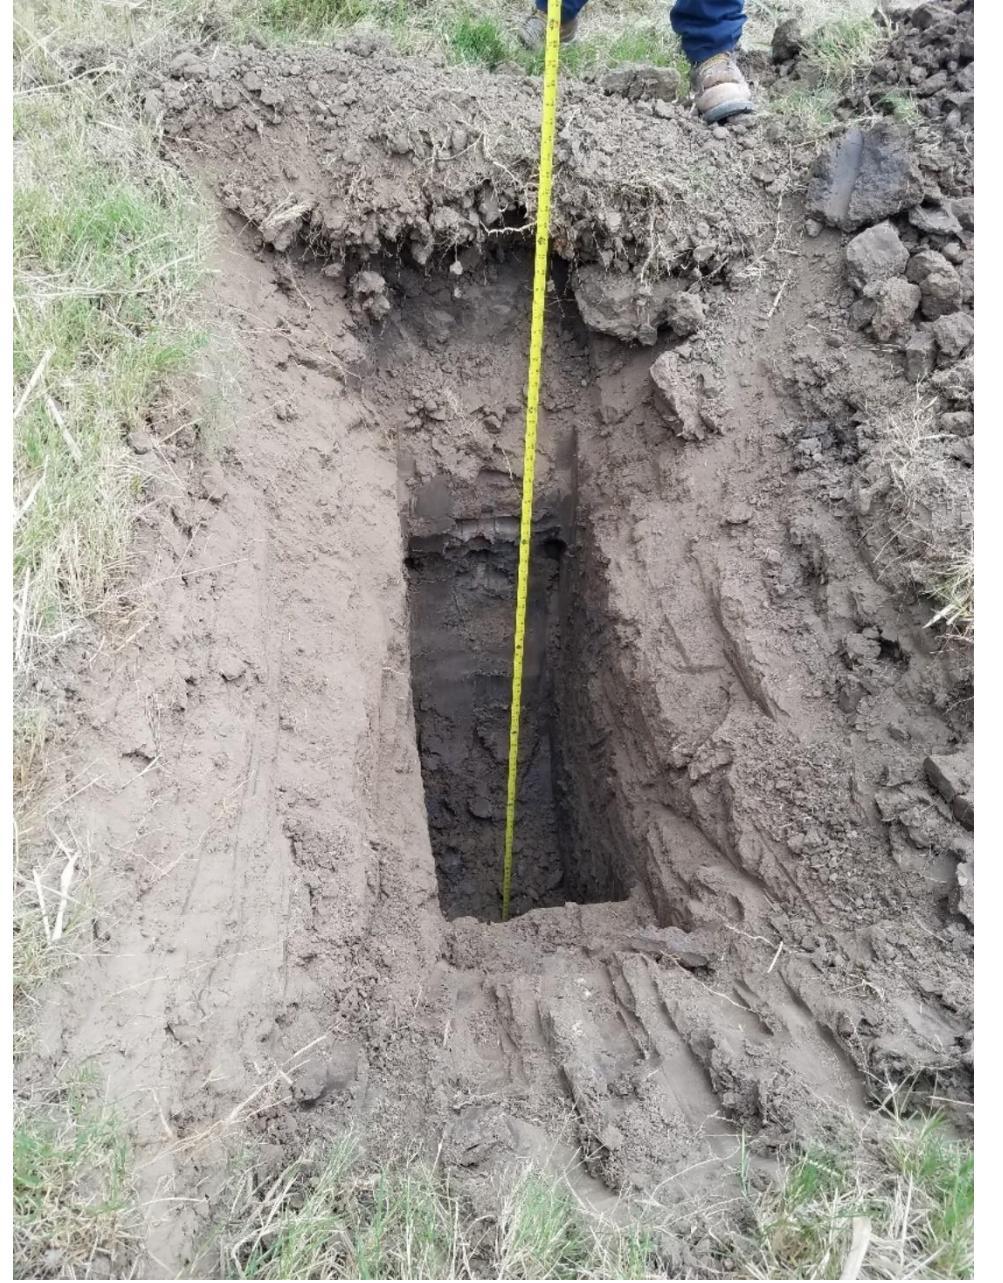
### Photograph: 63

TP-9 excavation at sounding depth of 7.5 feet bgs showing soil conditions.

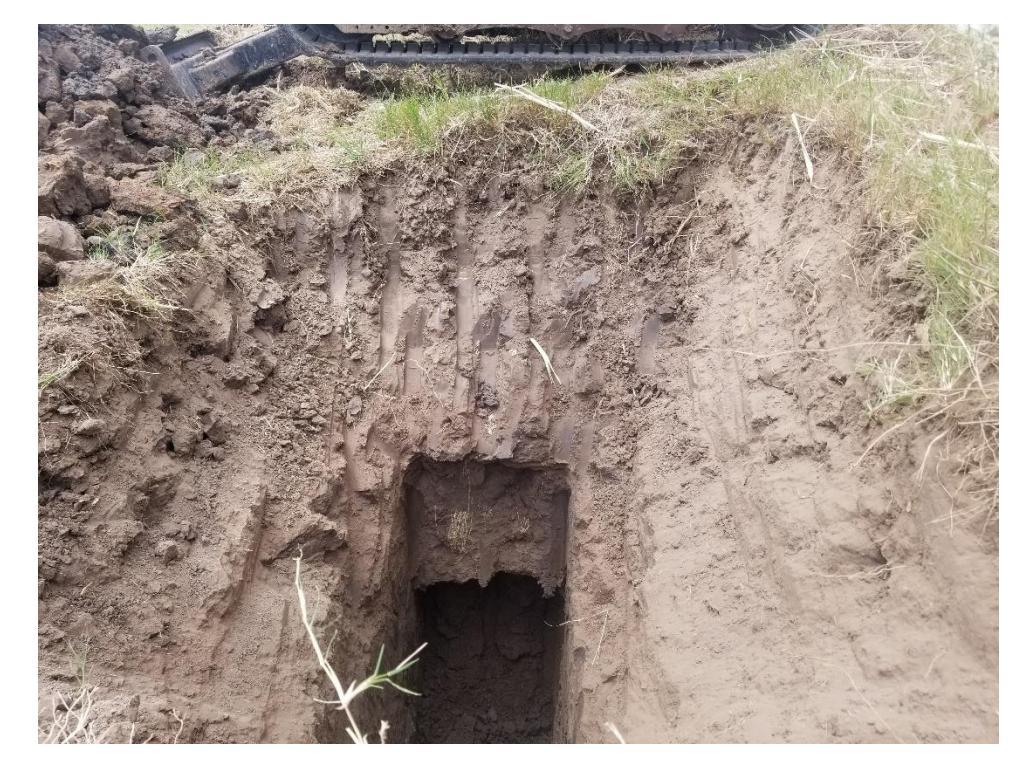
### Photograph: 64

**Description:** TP-9 excavation showing soil conditions.

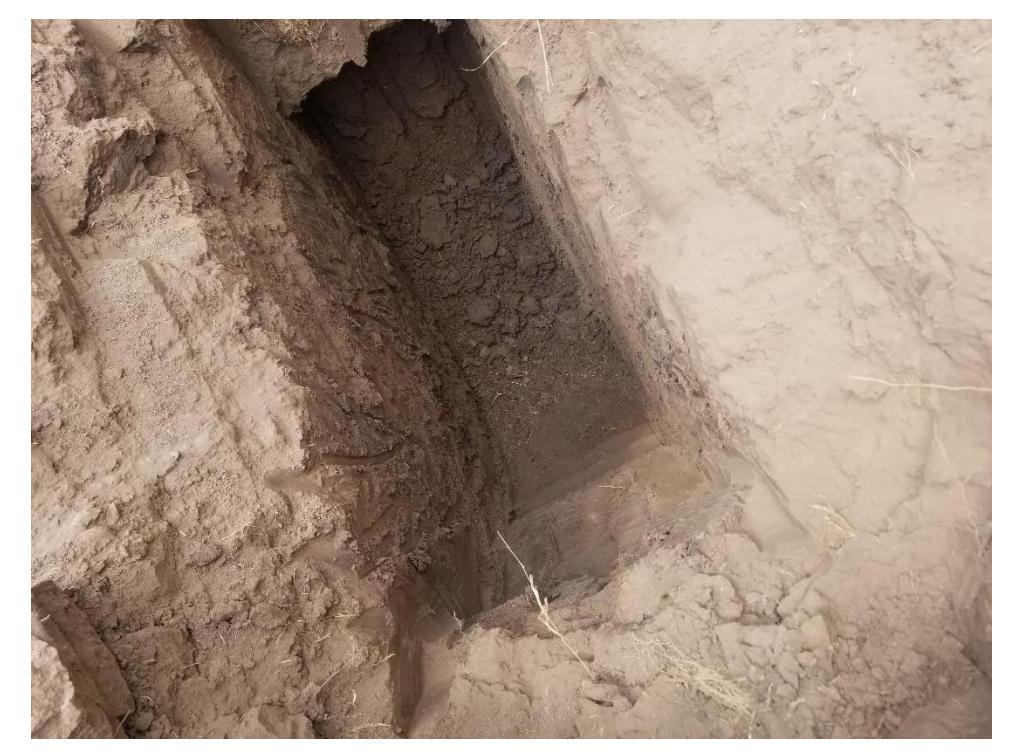
### Photograph: 65

**Description:** TP-9 excavation showing soil conditions.

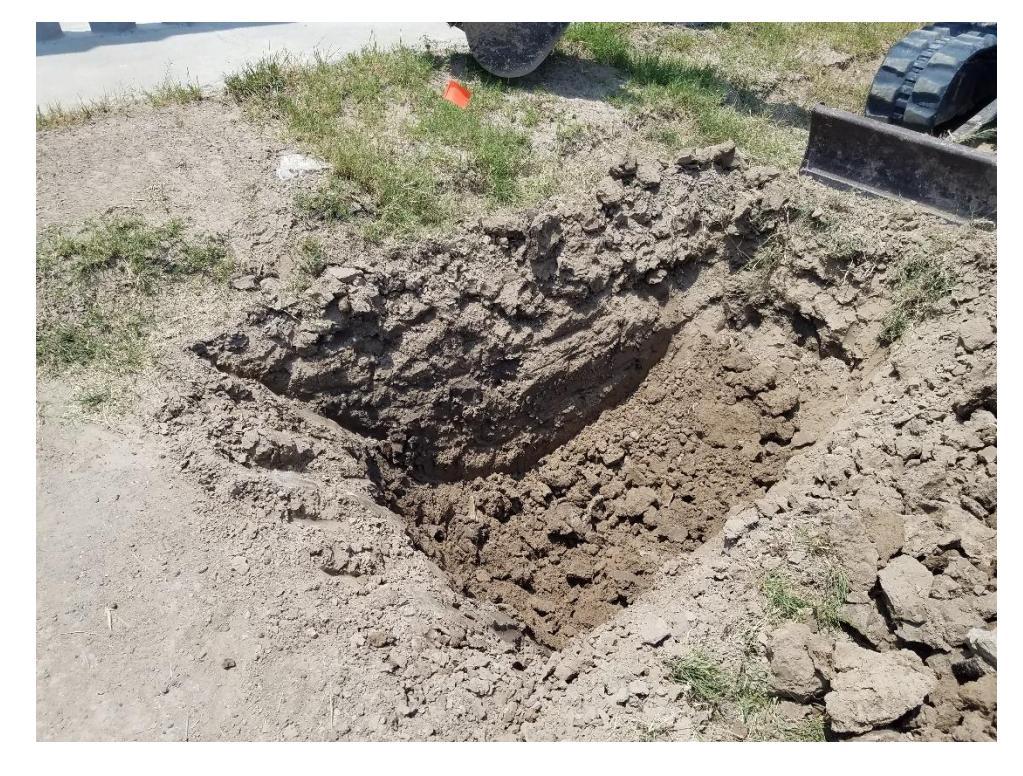
### Photograph: 66

TP-10 excavation at 3 feet bgs showing the soil condition for Proctor sample

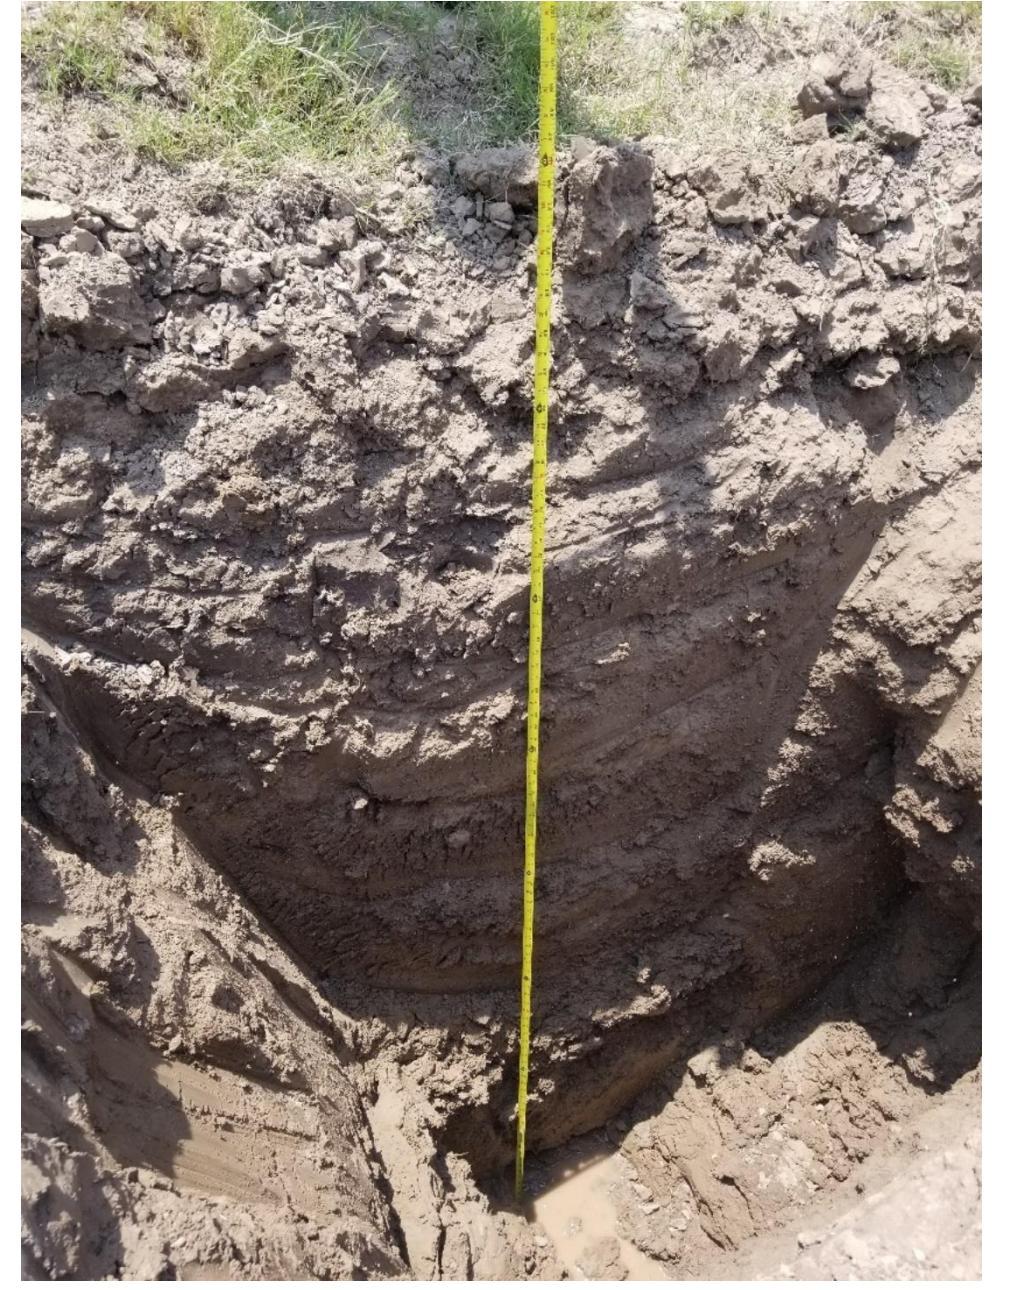
### Photograph: 68

TP-10 excavation at sounding depth of 8 feet bgs showing soil and groundwater conditions

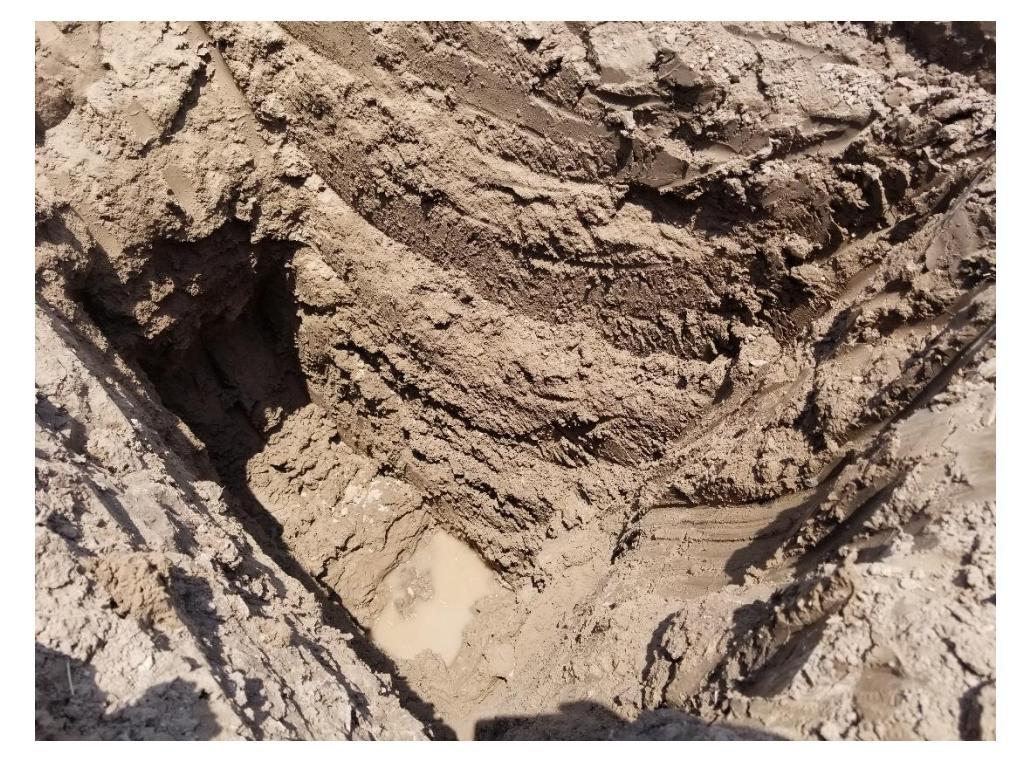
### Photograph: 70

**Description:** TP-10 excavation

showing soil and groundwater conditions

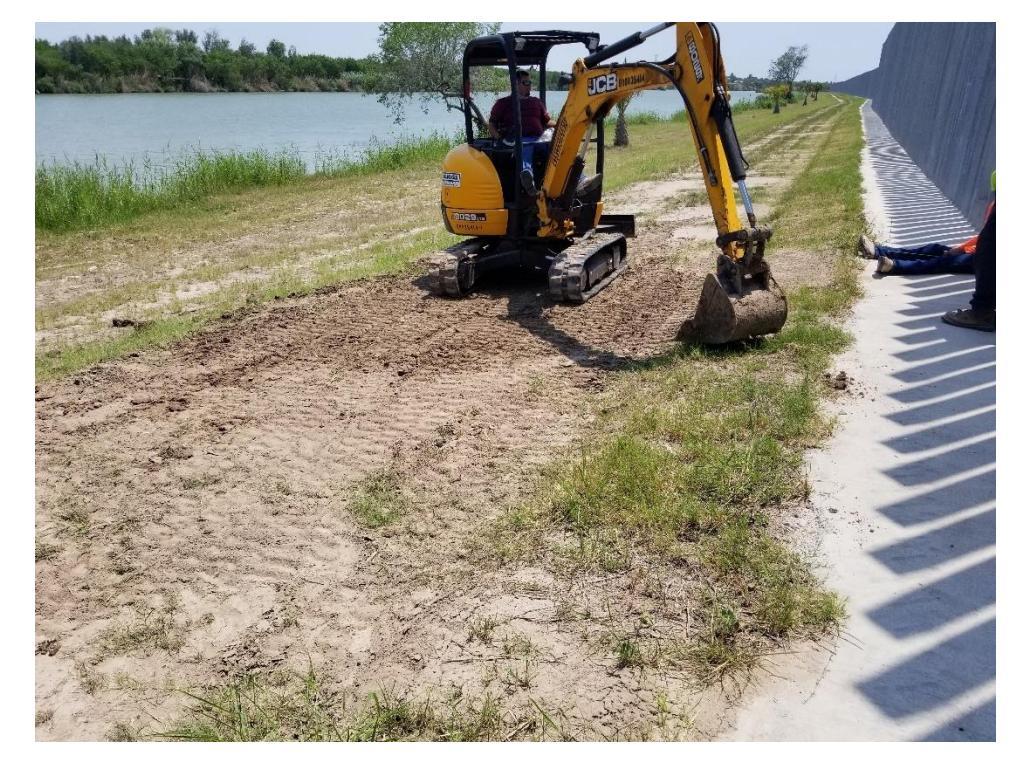
### Photograph: 72

TP-10 looking northwest at backfilled trench

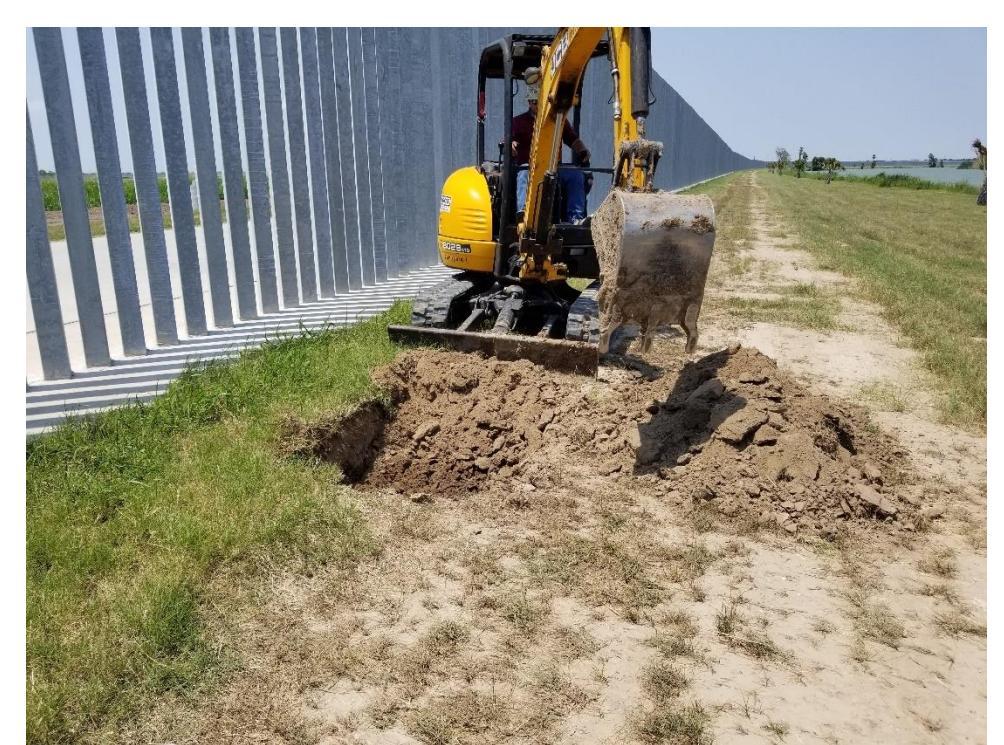
### Photograph: 73

**Description:** TP-11excavation looking northeast
