# **Engineering Evaluation of Bollard Fence**

## Rio Grande, Hidalgo County, Texas

United States of America v. Fisher Sand and Gravel Company, Civil Action No. 7:19-CV-403

August 2021

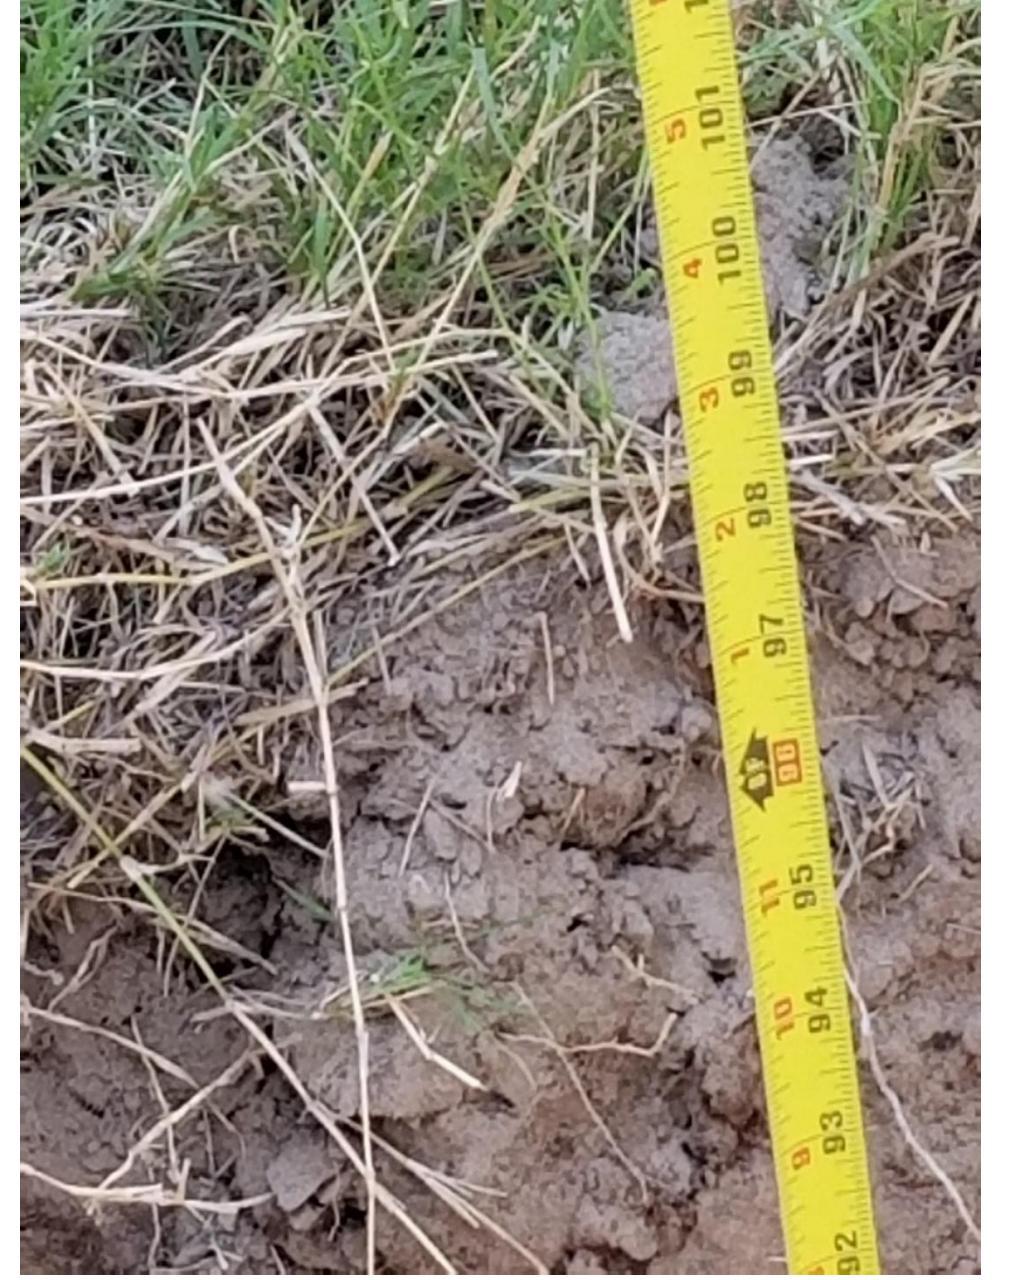
### Photograph: 75

TP-11 excavation at sounding depth of 8.5 feet bgs showing soil conditions

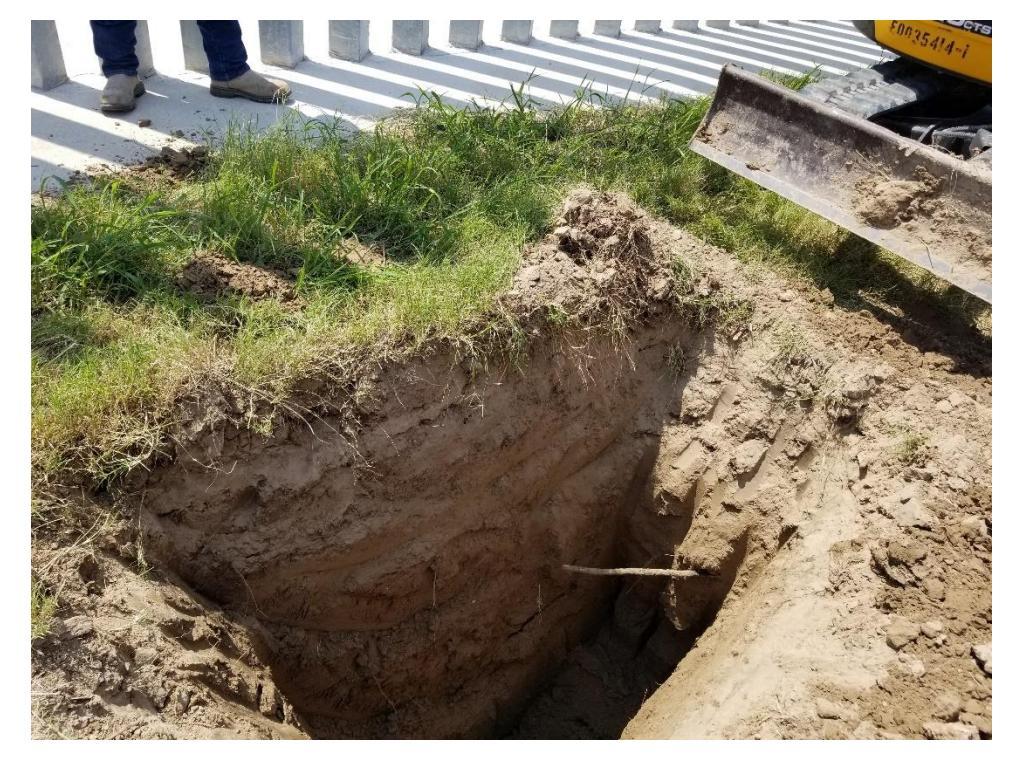
### Photograph: 76

TP-11 excavation looking northwest showing soil conditions.

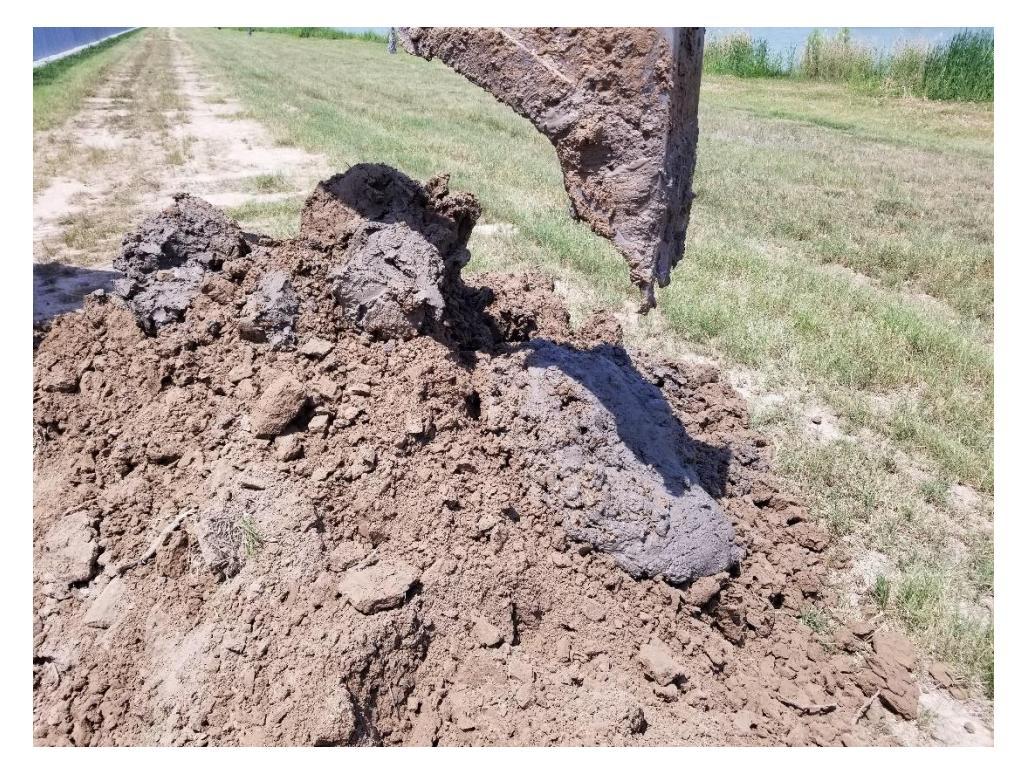
Photograph: 77

TP-11 excavation soil materials show wet condition when groundwater intrudes into trench

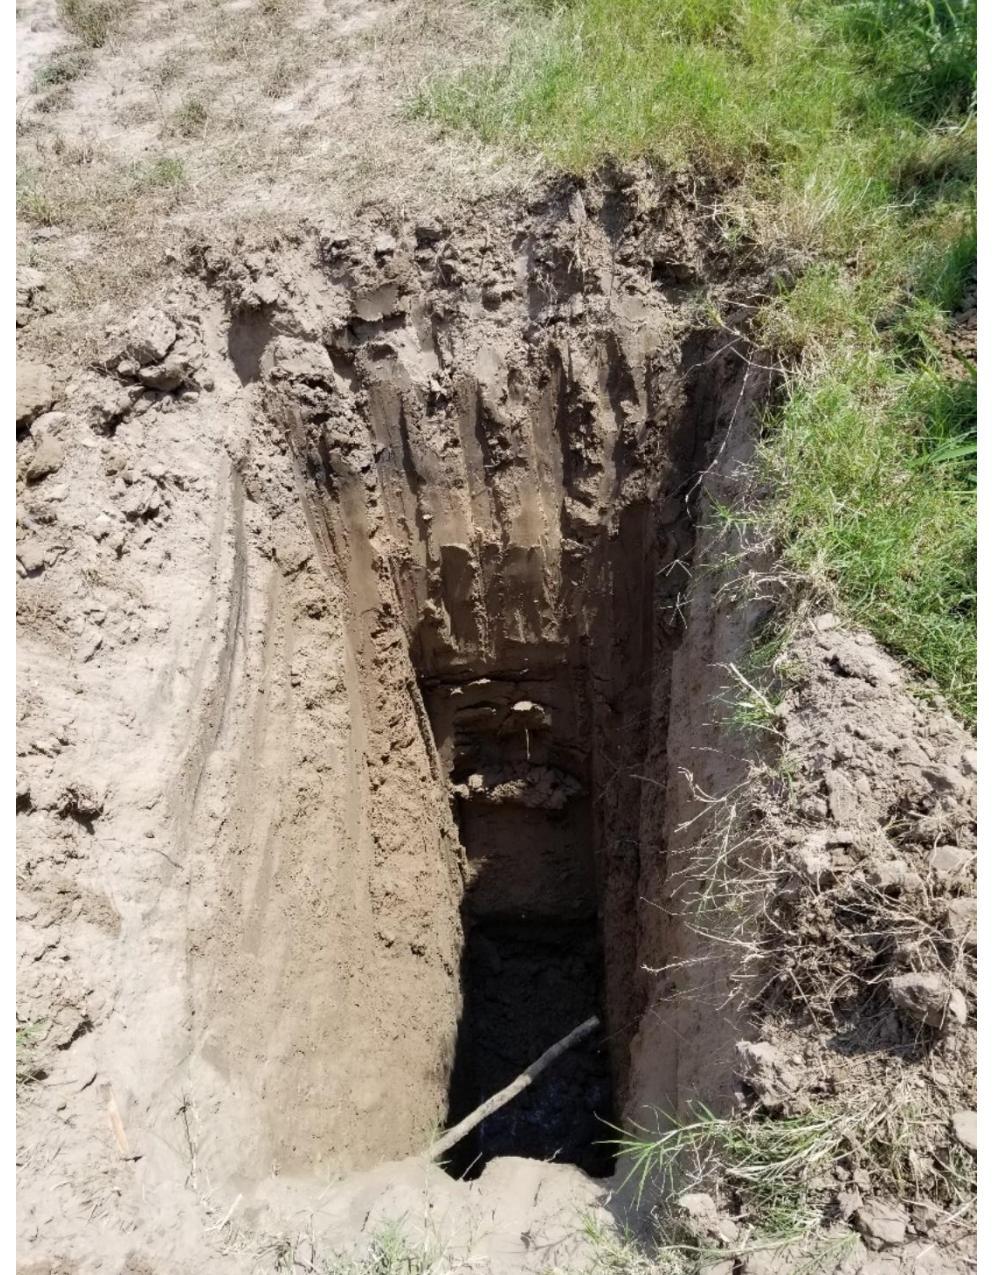
### Photograph: 78

TP-11 excavation showing soil and groundwater conditions.

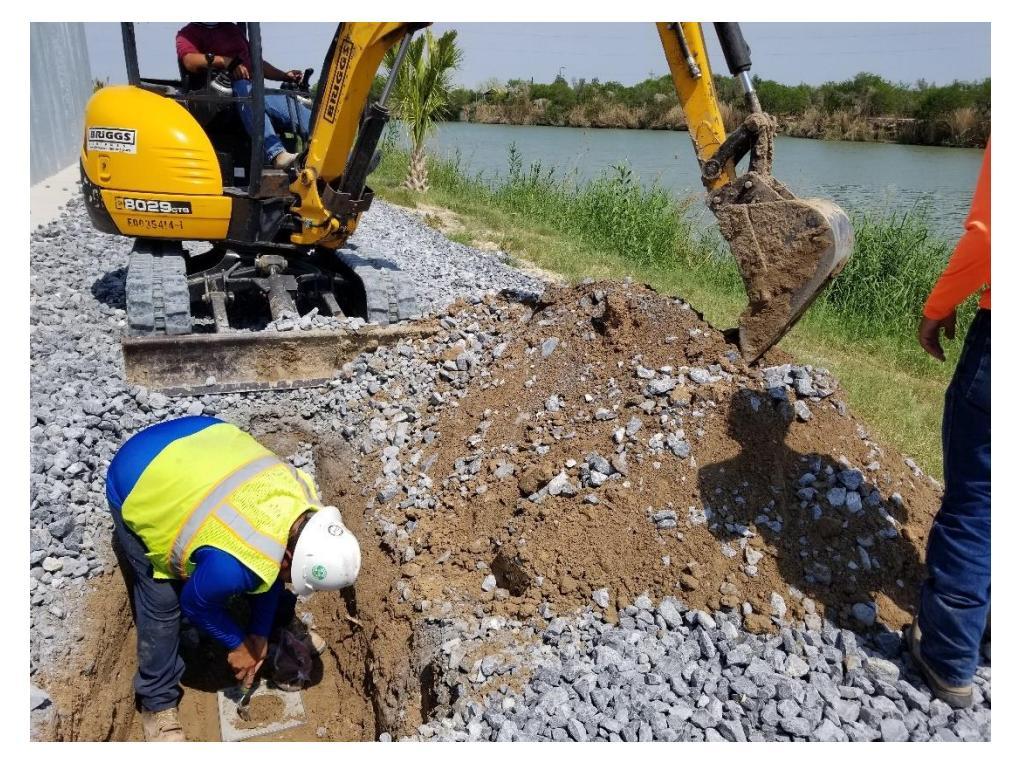
### Photograph: 79

TP-12 excavation at 3 feet bgs showing sand cone test and soil conditions.

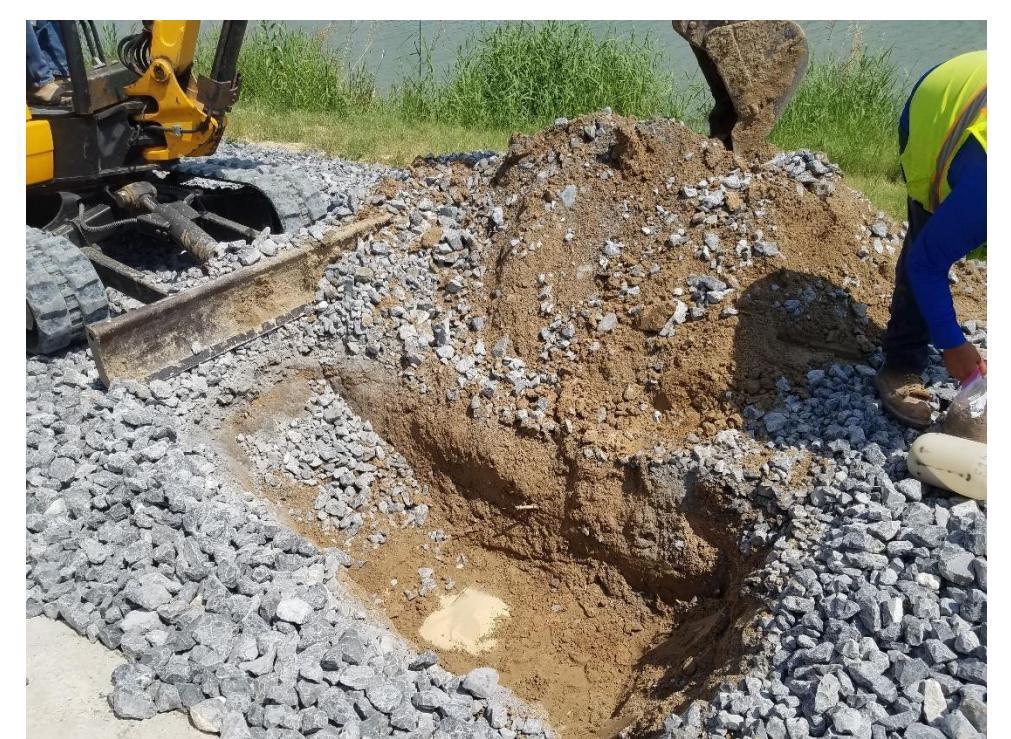
### Photograph: 80

TP-12 excavation at 3 feet bgs showing sand cone test and soil conditions.

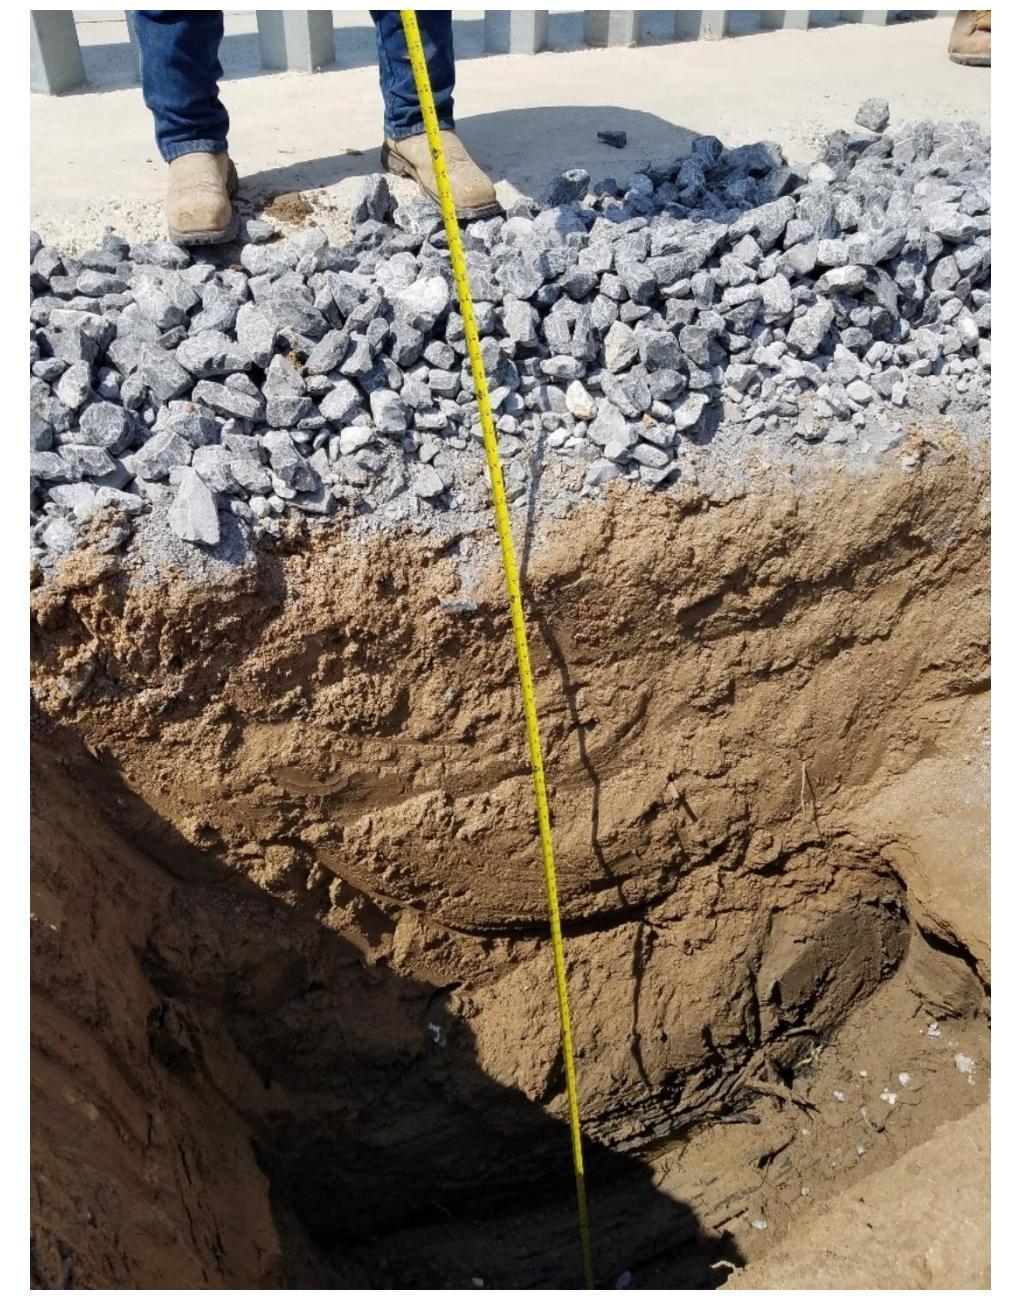
### Photograph: 81

TP-12 excavation at sounding depth of 7.5 feet bgs showing soil conditions.

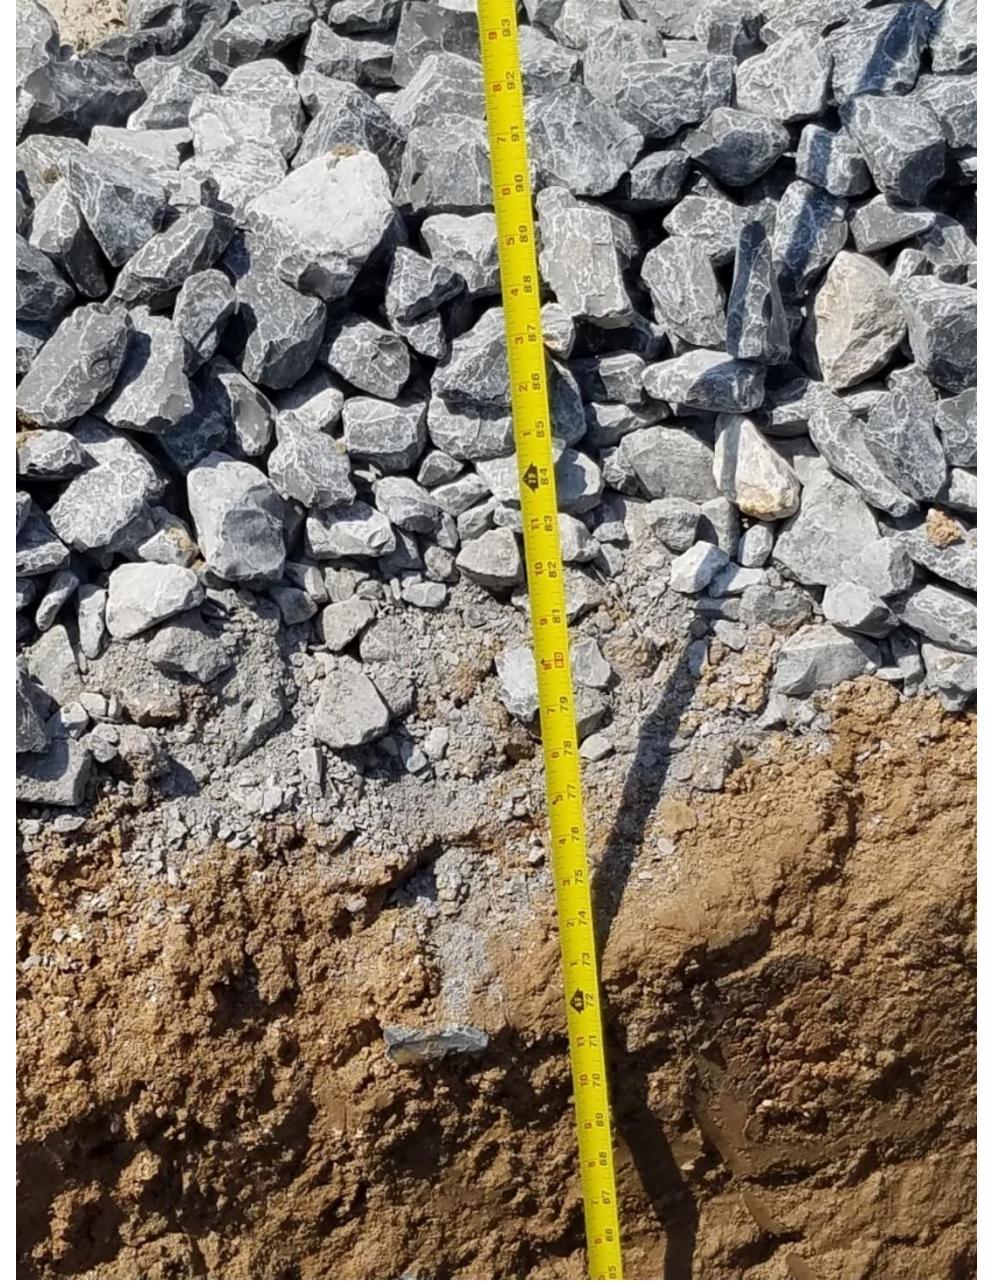
### Photograph: 82

TP-12 excavation at sounding depth of 7.5 feet bgs showing soil conditions.

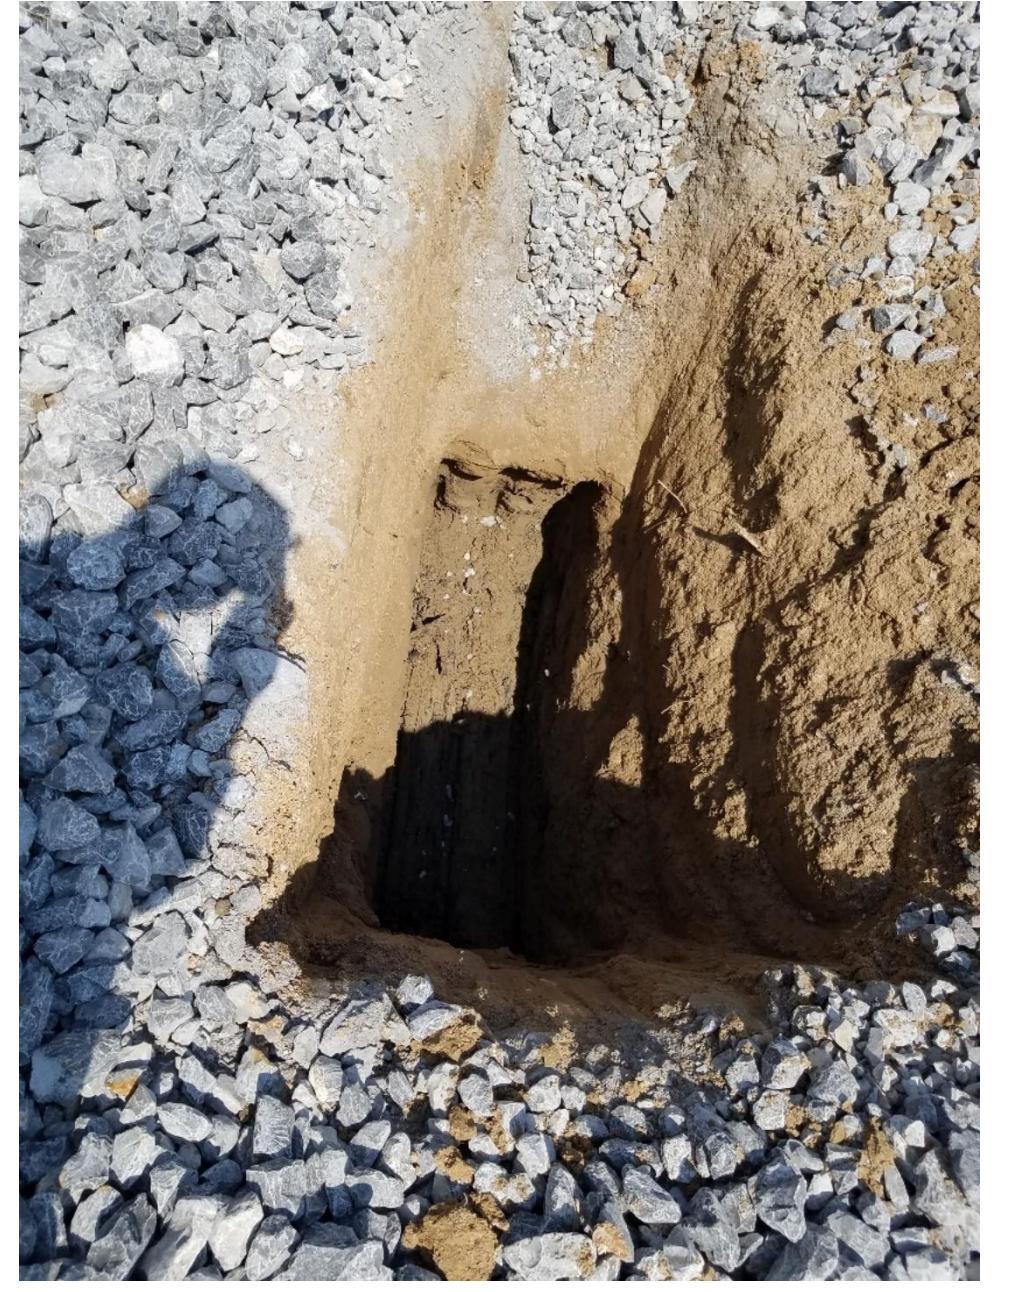
### Photograph: 83

TP-12 excavation showing soil conditions.
