# JLL Valuation Advisory Property Condition Assessment

Property: 7800 Ricchi Tower - 7800 North Stemmons Freeway, Dallas, Texas 75247

Report Date: July 21, 2022

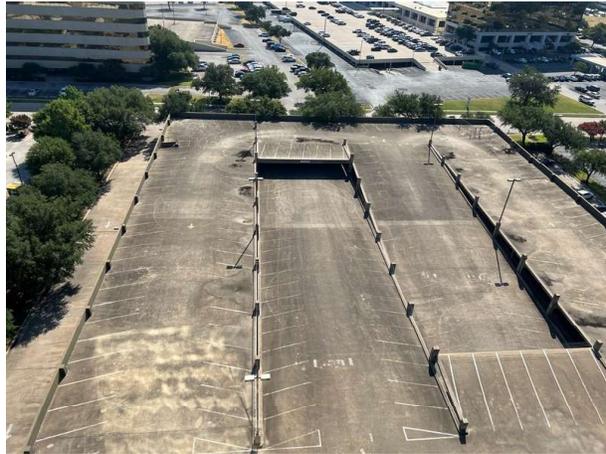
Overall view of parking garage

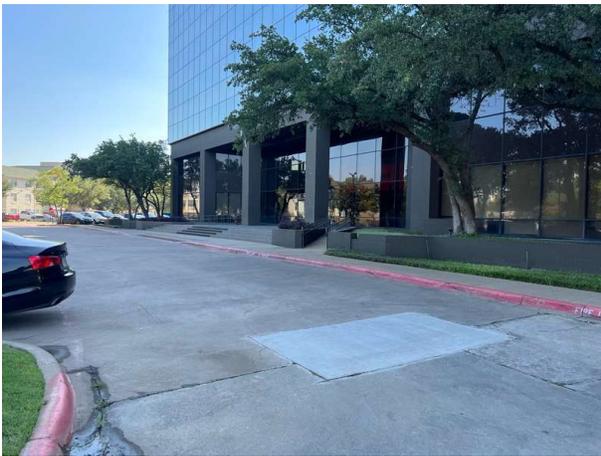
Concrete driveway

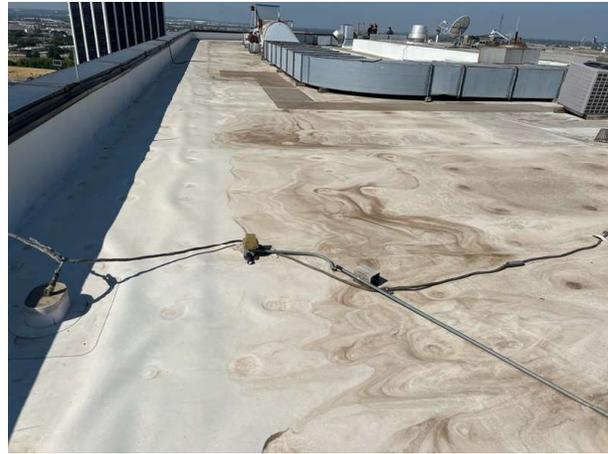
Roof tear

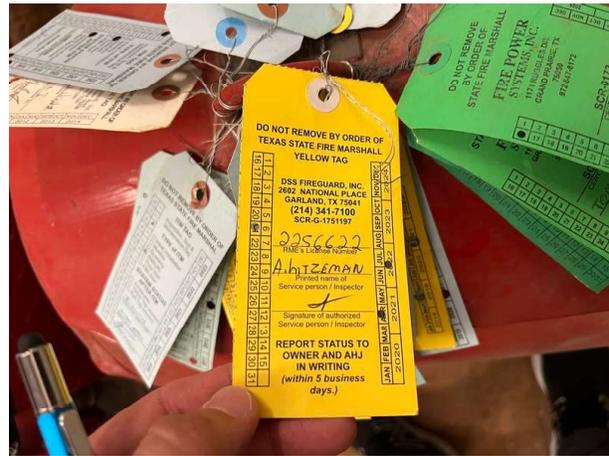
Yellow tags at fire sprinkler system

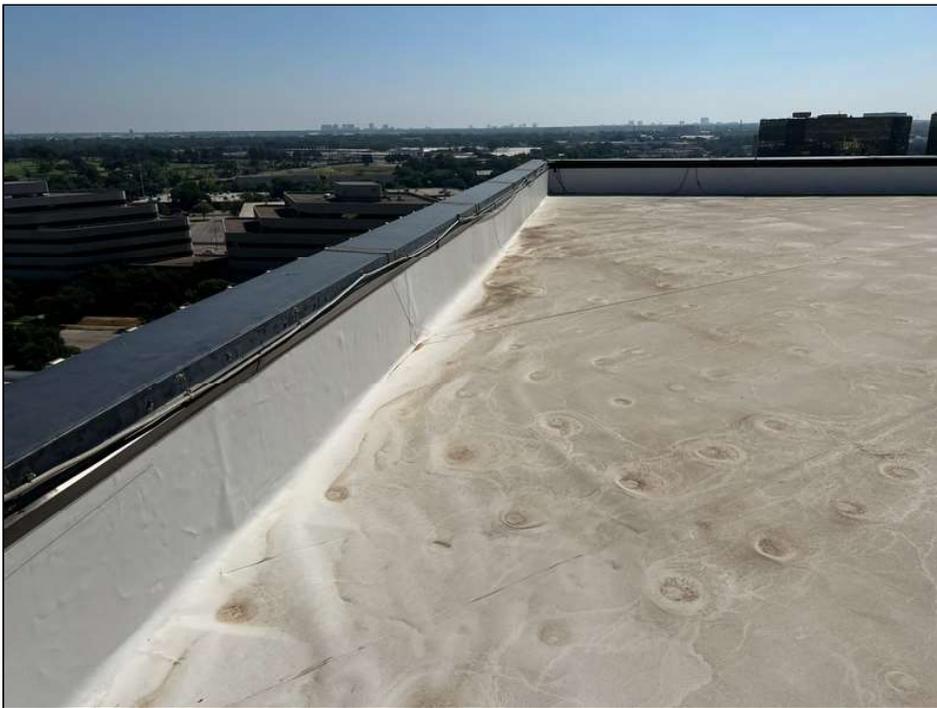
16. Roof parapet and membrane condition

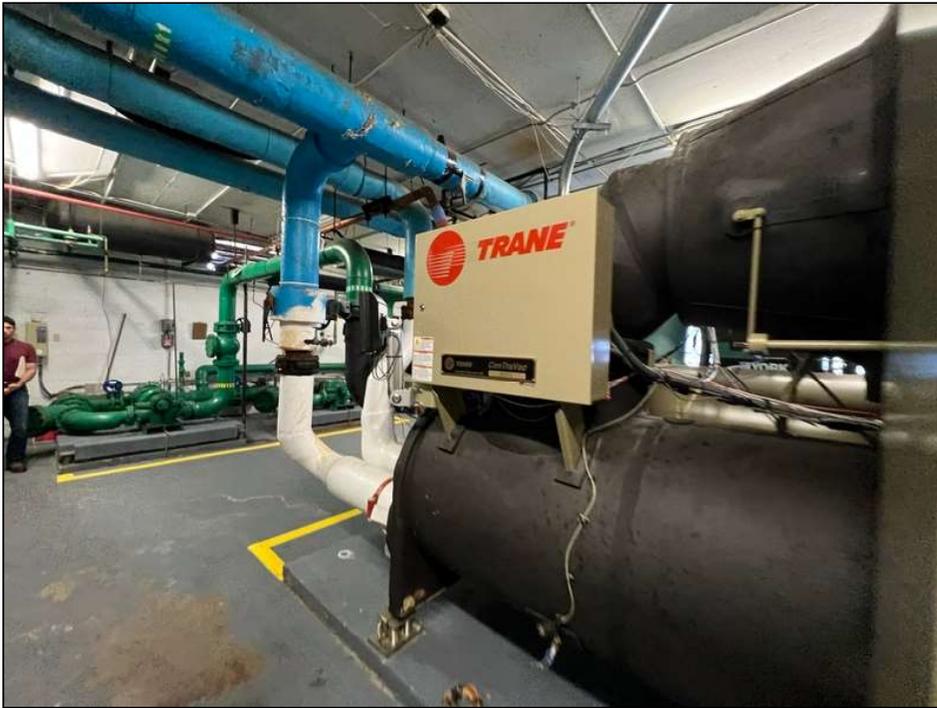
23. Chiller

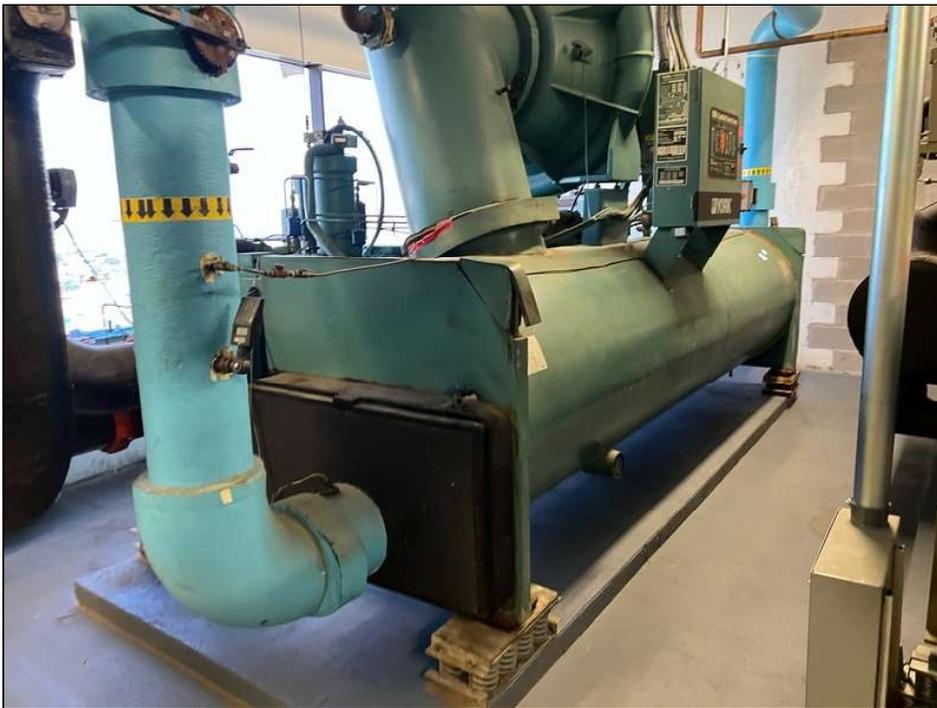
24. Chiller

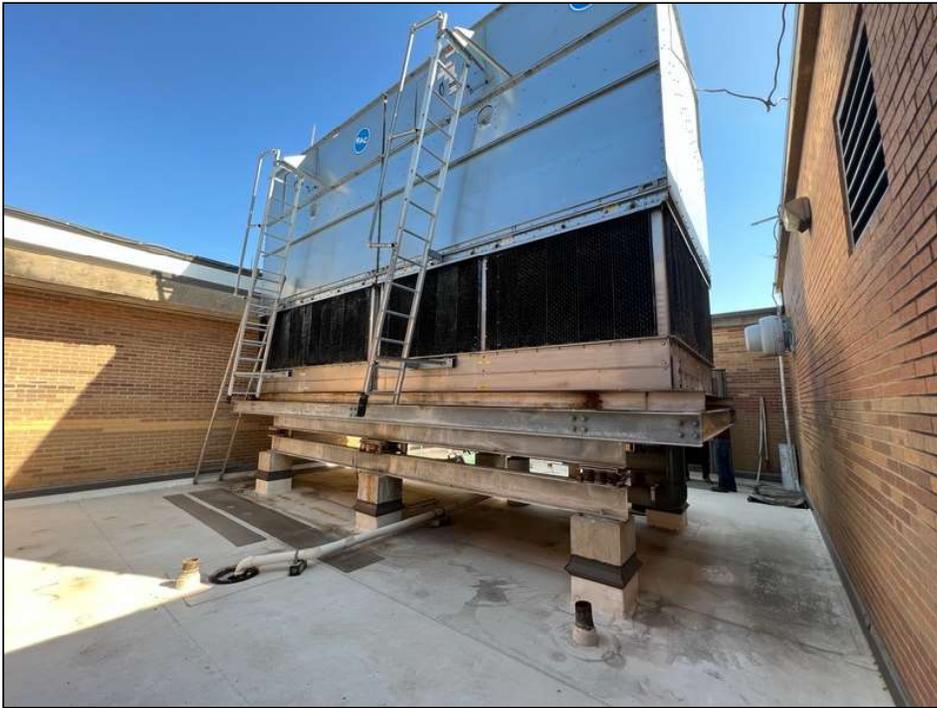
25. Cooling tower

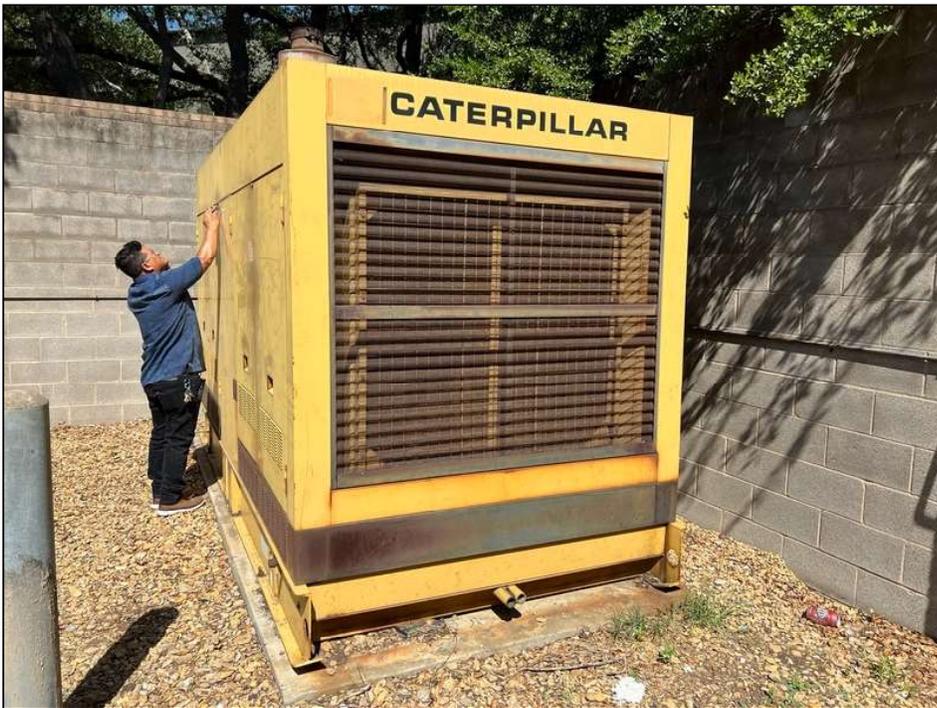
32. Emergency generator

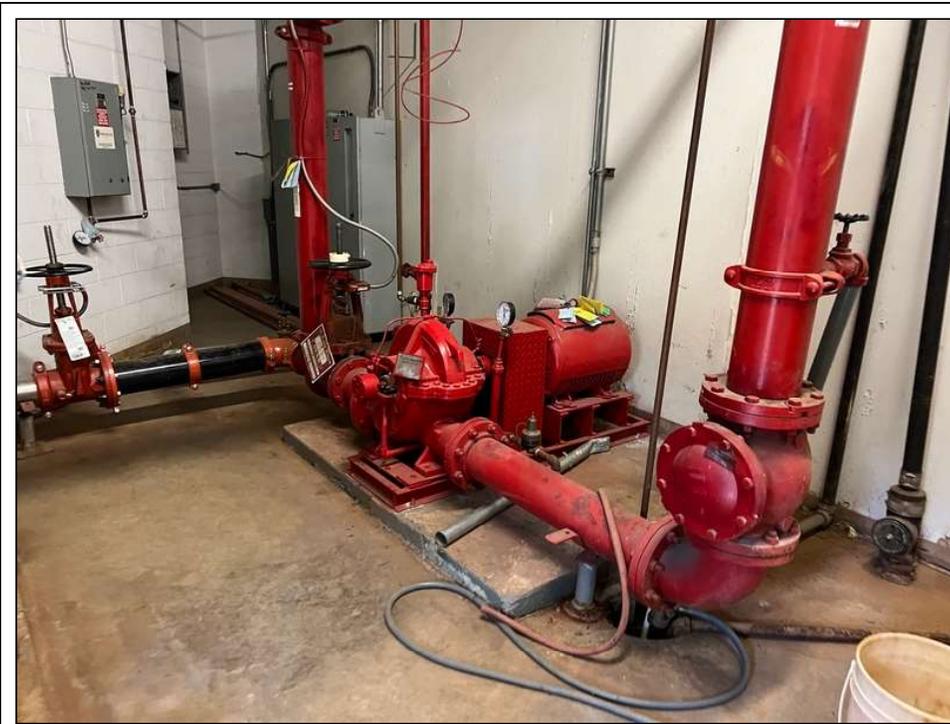
35. Fire pump

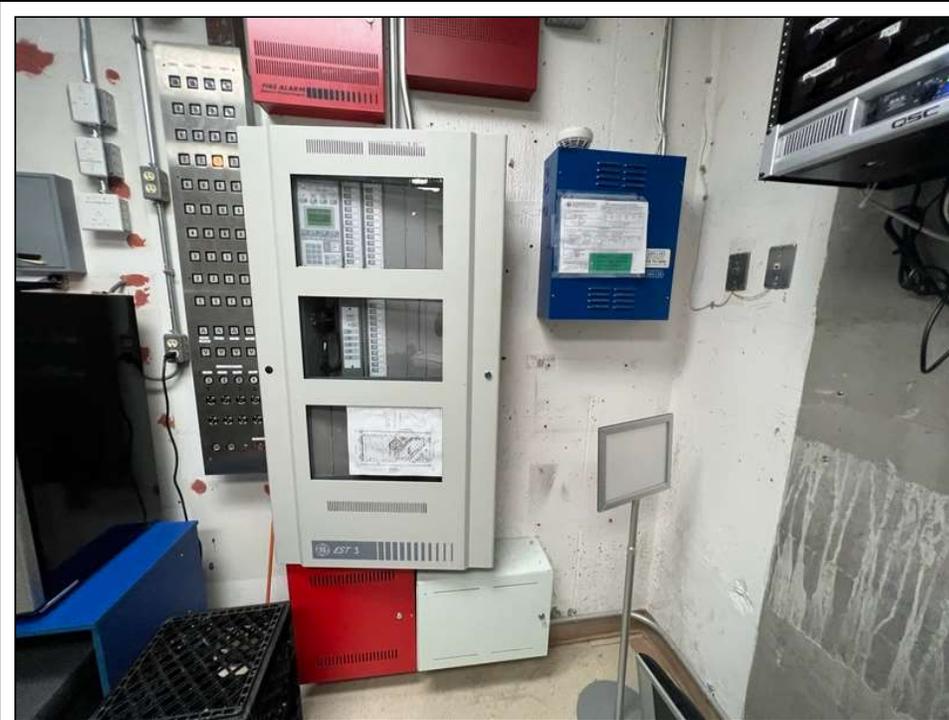
37. Fire alarm panel

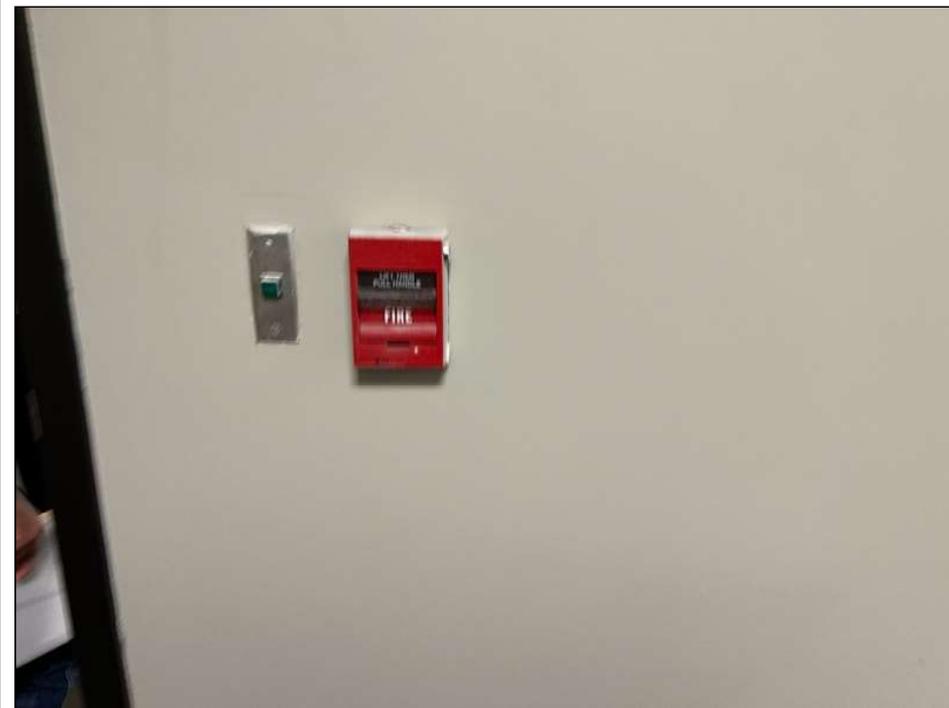
38. Fire pull station

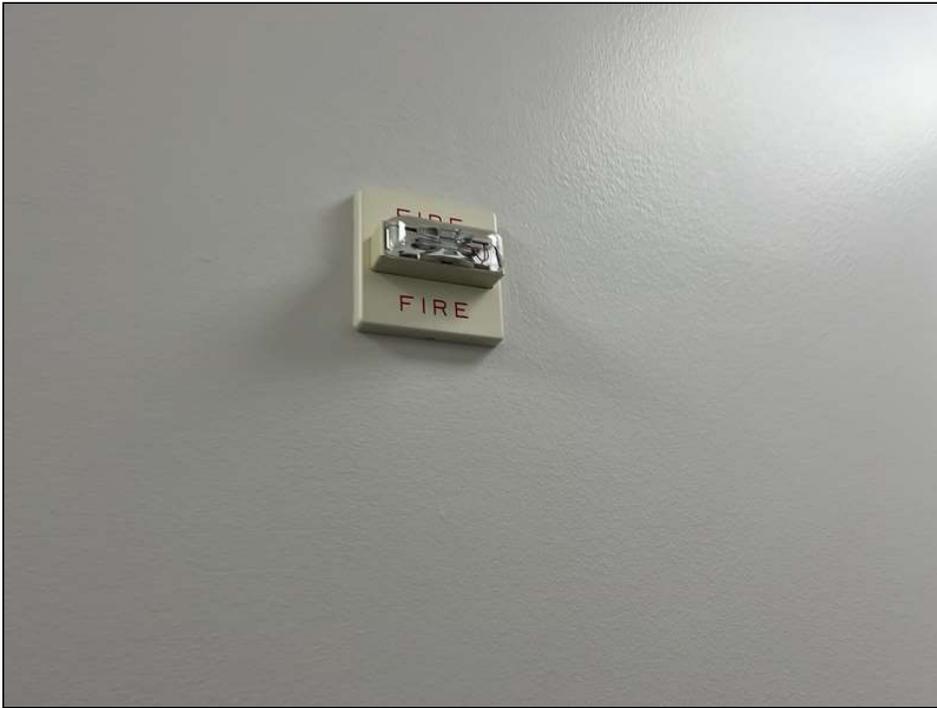
39. Fire strobe

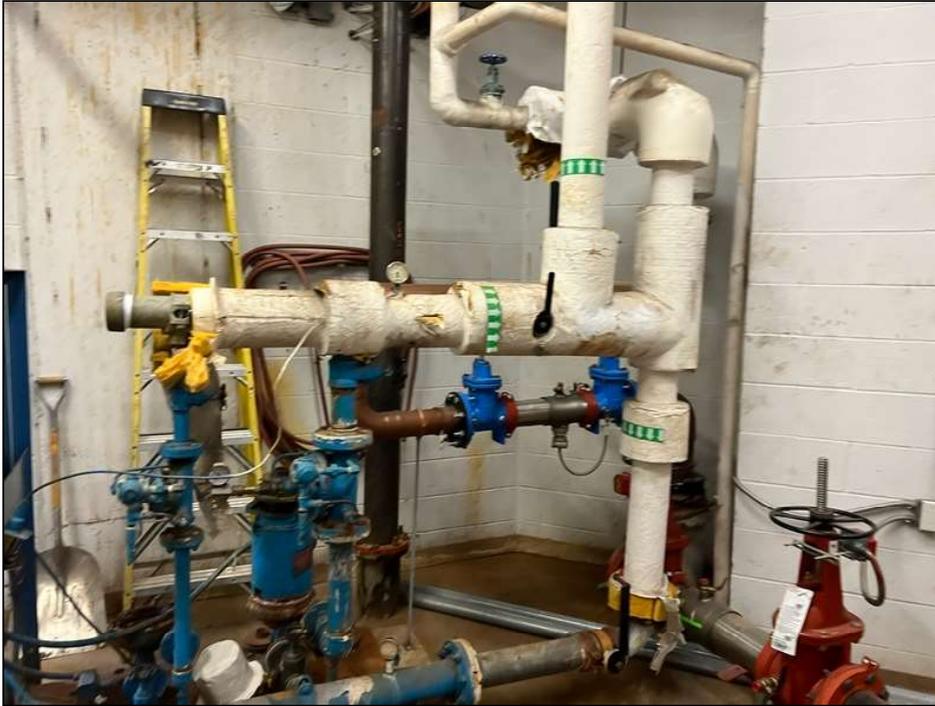
41. Chilled water piping

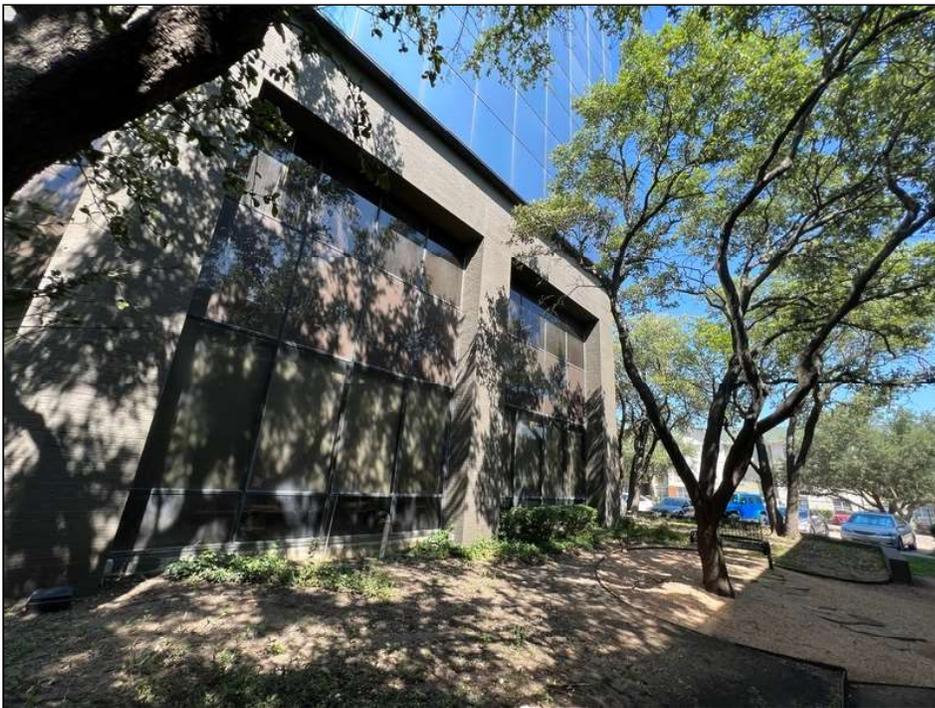
42. Ground floor exterior materials

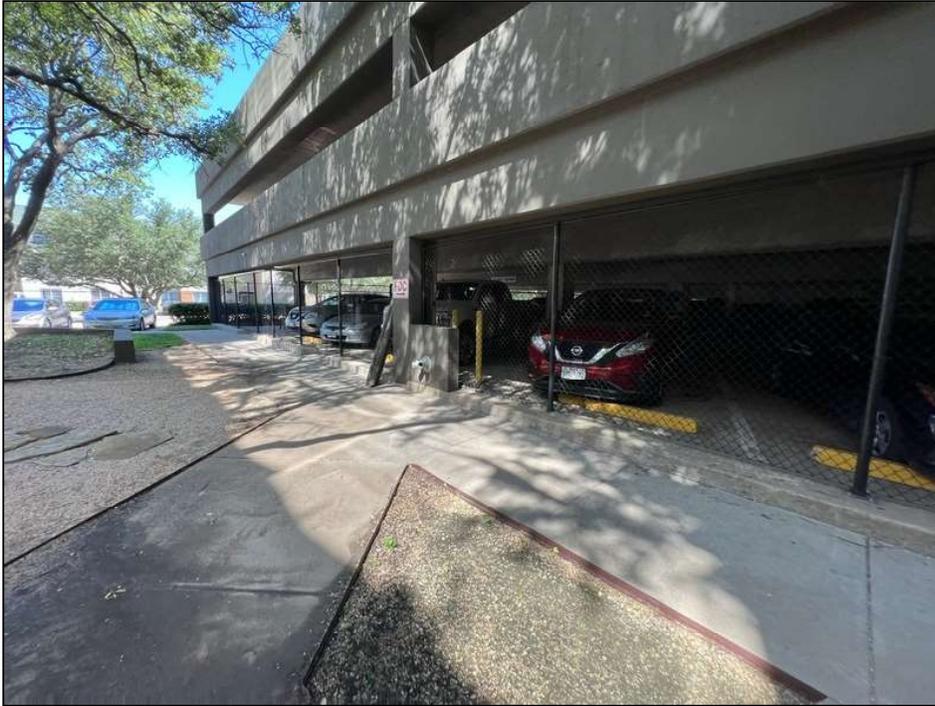
43. Parking garage exterior

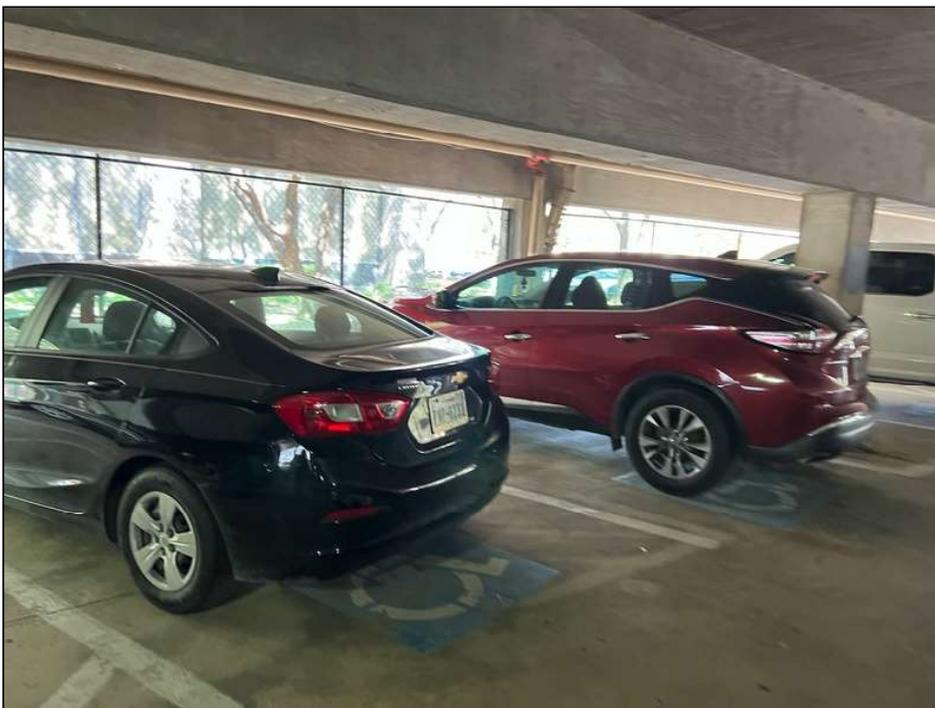
72. Accessible parking at parking garage

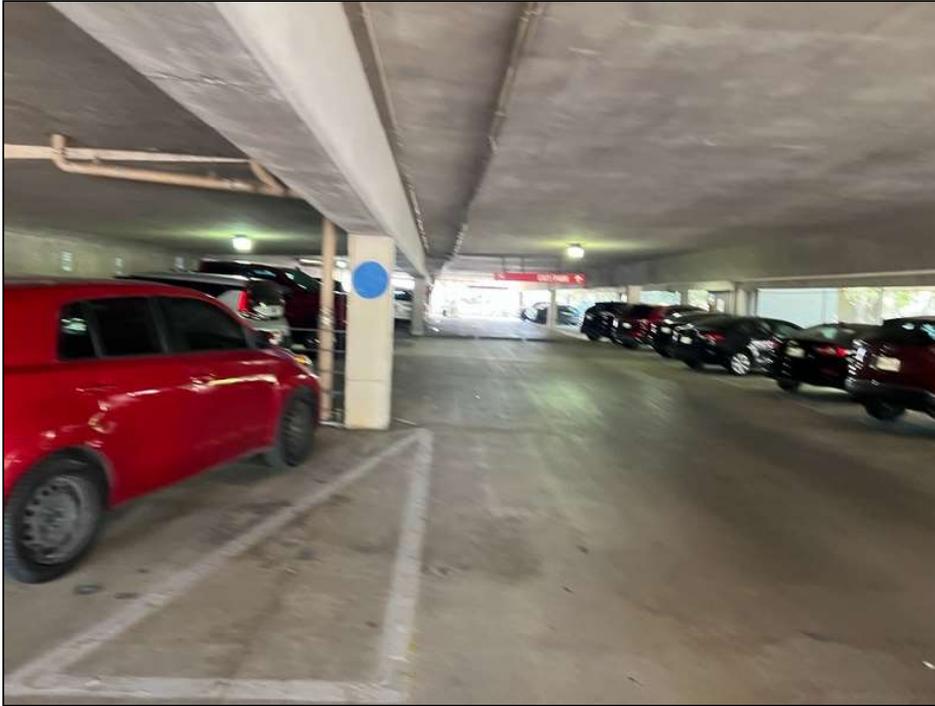
73. Parking garage concrete structure

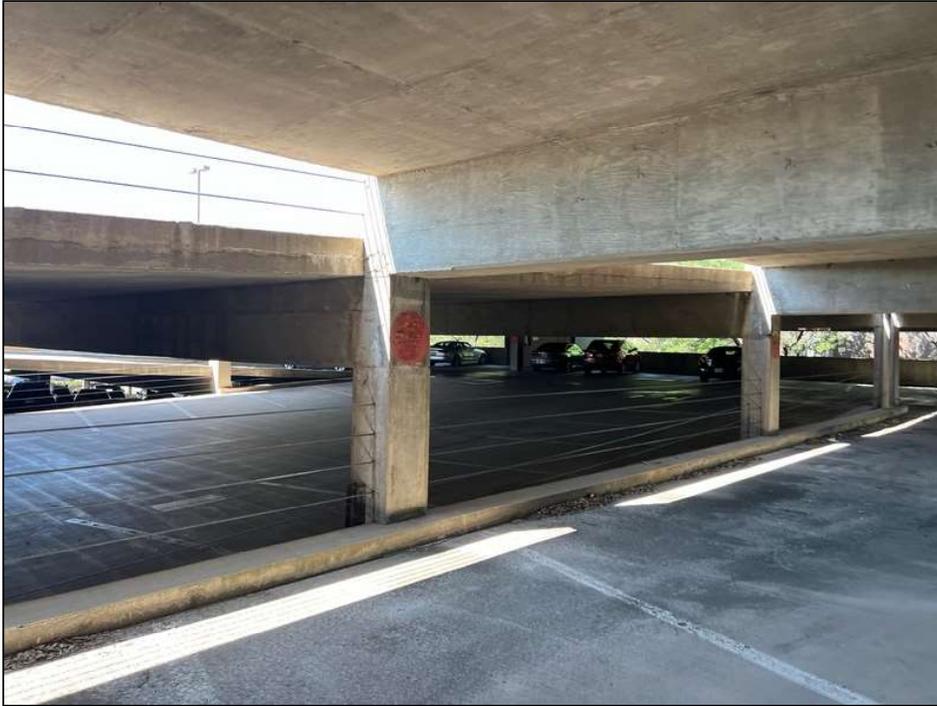
75. Parking garage concrete structure

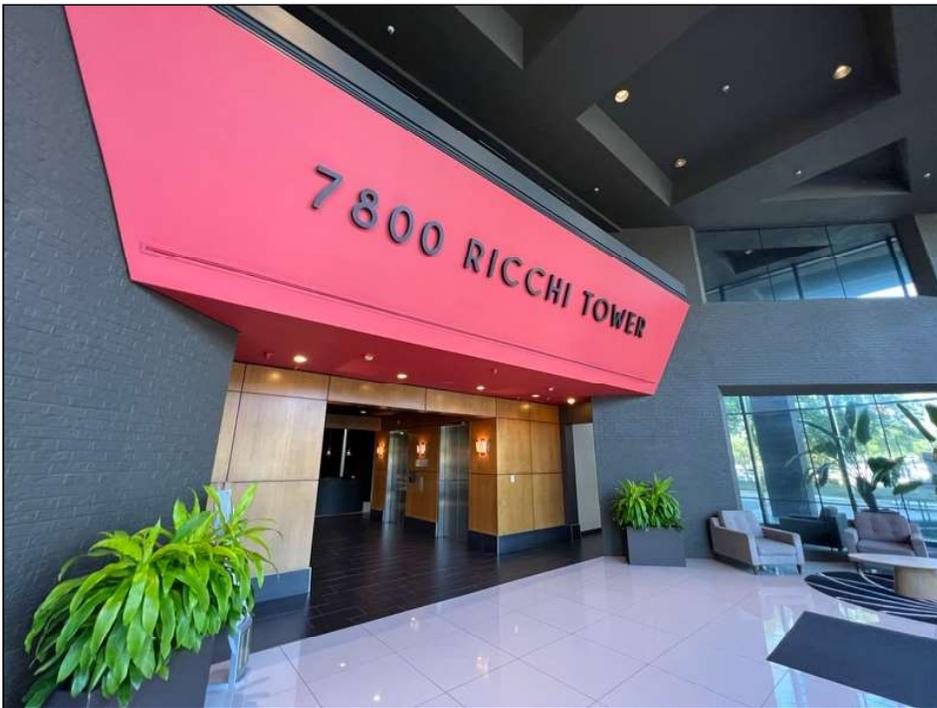
76. Lobby interior finishes

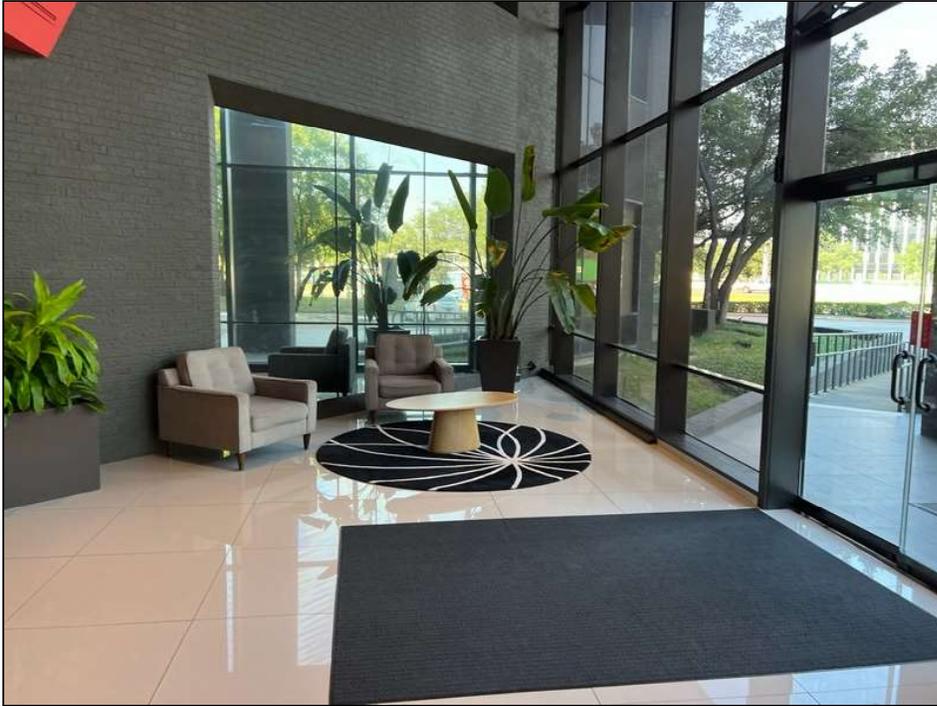
77. Lobby interior finishes

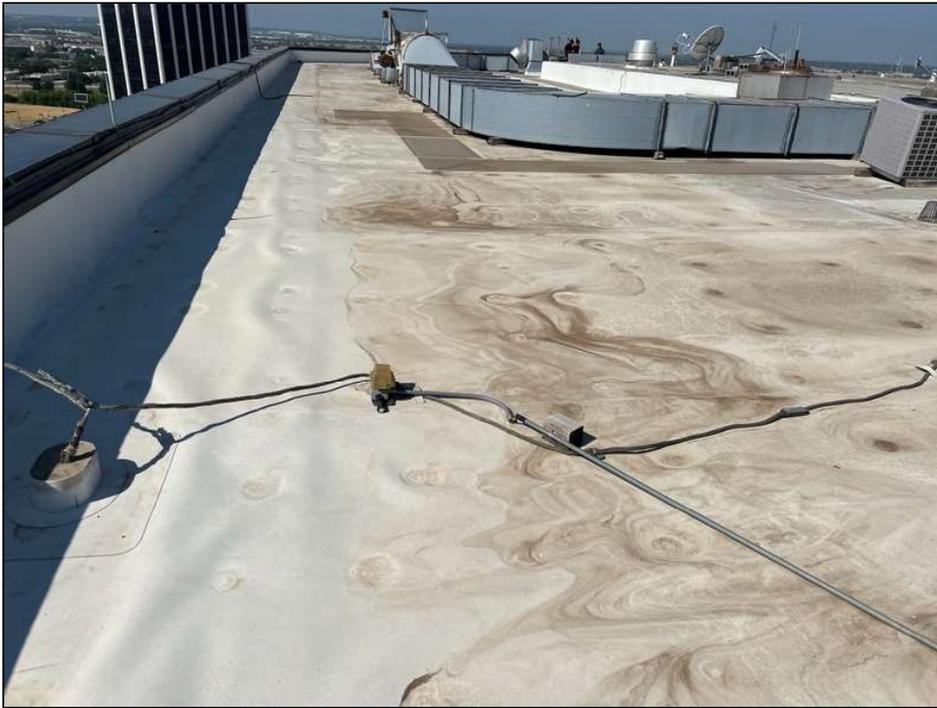
87. Roof tear

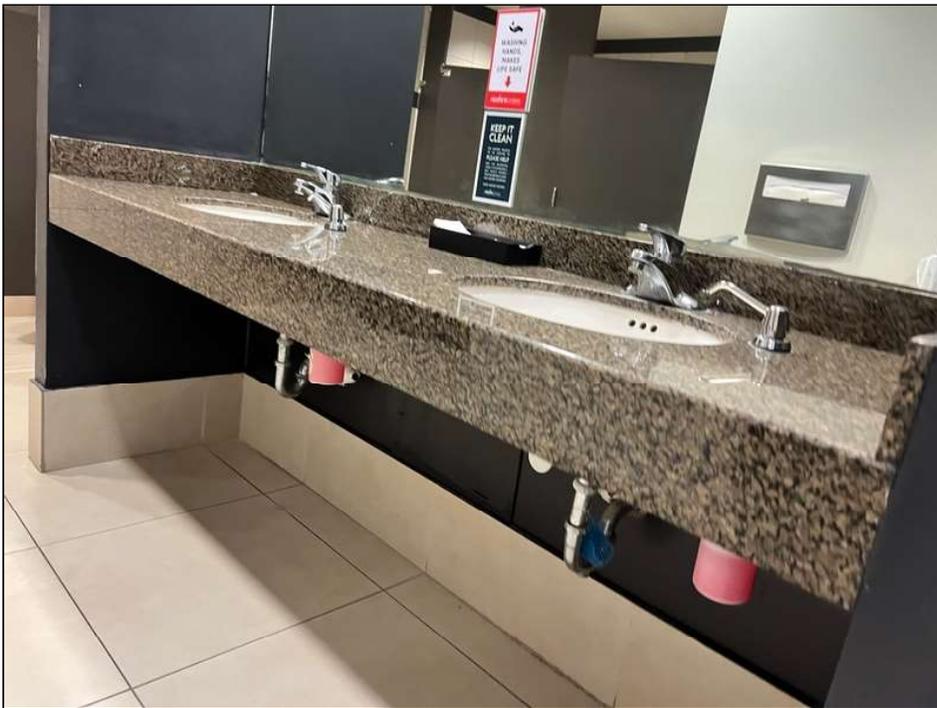
88. Sink pipe protection is needed
